# FE.FG

## SERVICE MANUAL 2008 Model FOREWORD

This Service Manual contains maintenance and repair methods for the Mitsubishi Fuso Truck FE. FG Series. Read this manual carefully as an aid in providing correct, efficient maintenance. Please note that the information and specifications contained within this manual may change without notice. This is due to product modifications and continued vehicle improvements that are made throughout the model years. Should you encounter any discrepancy in the information provided, please do not hesitate to contact your nearest Mitsubishi Fuso Dealer or Mitsubishi Fuso Truck of America, Inc.

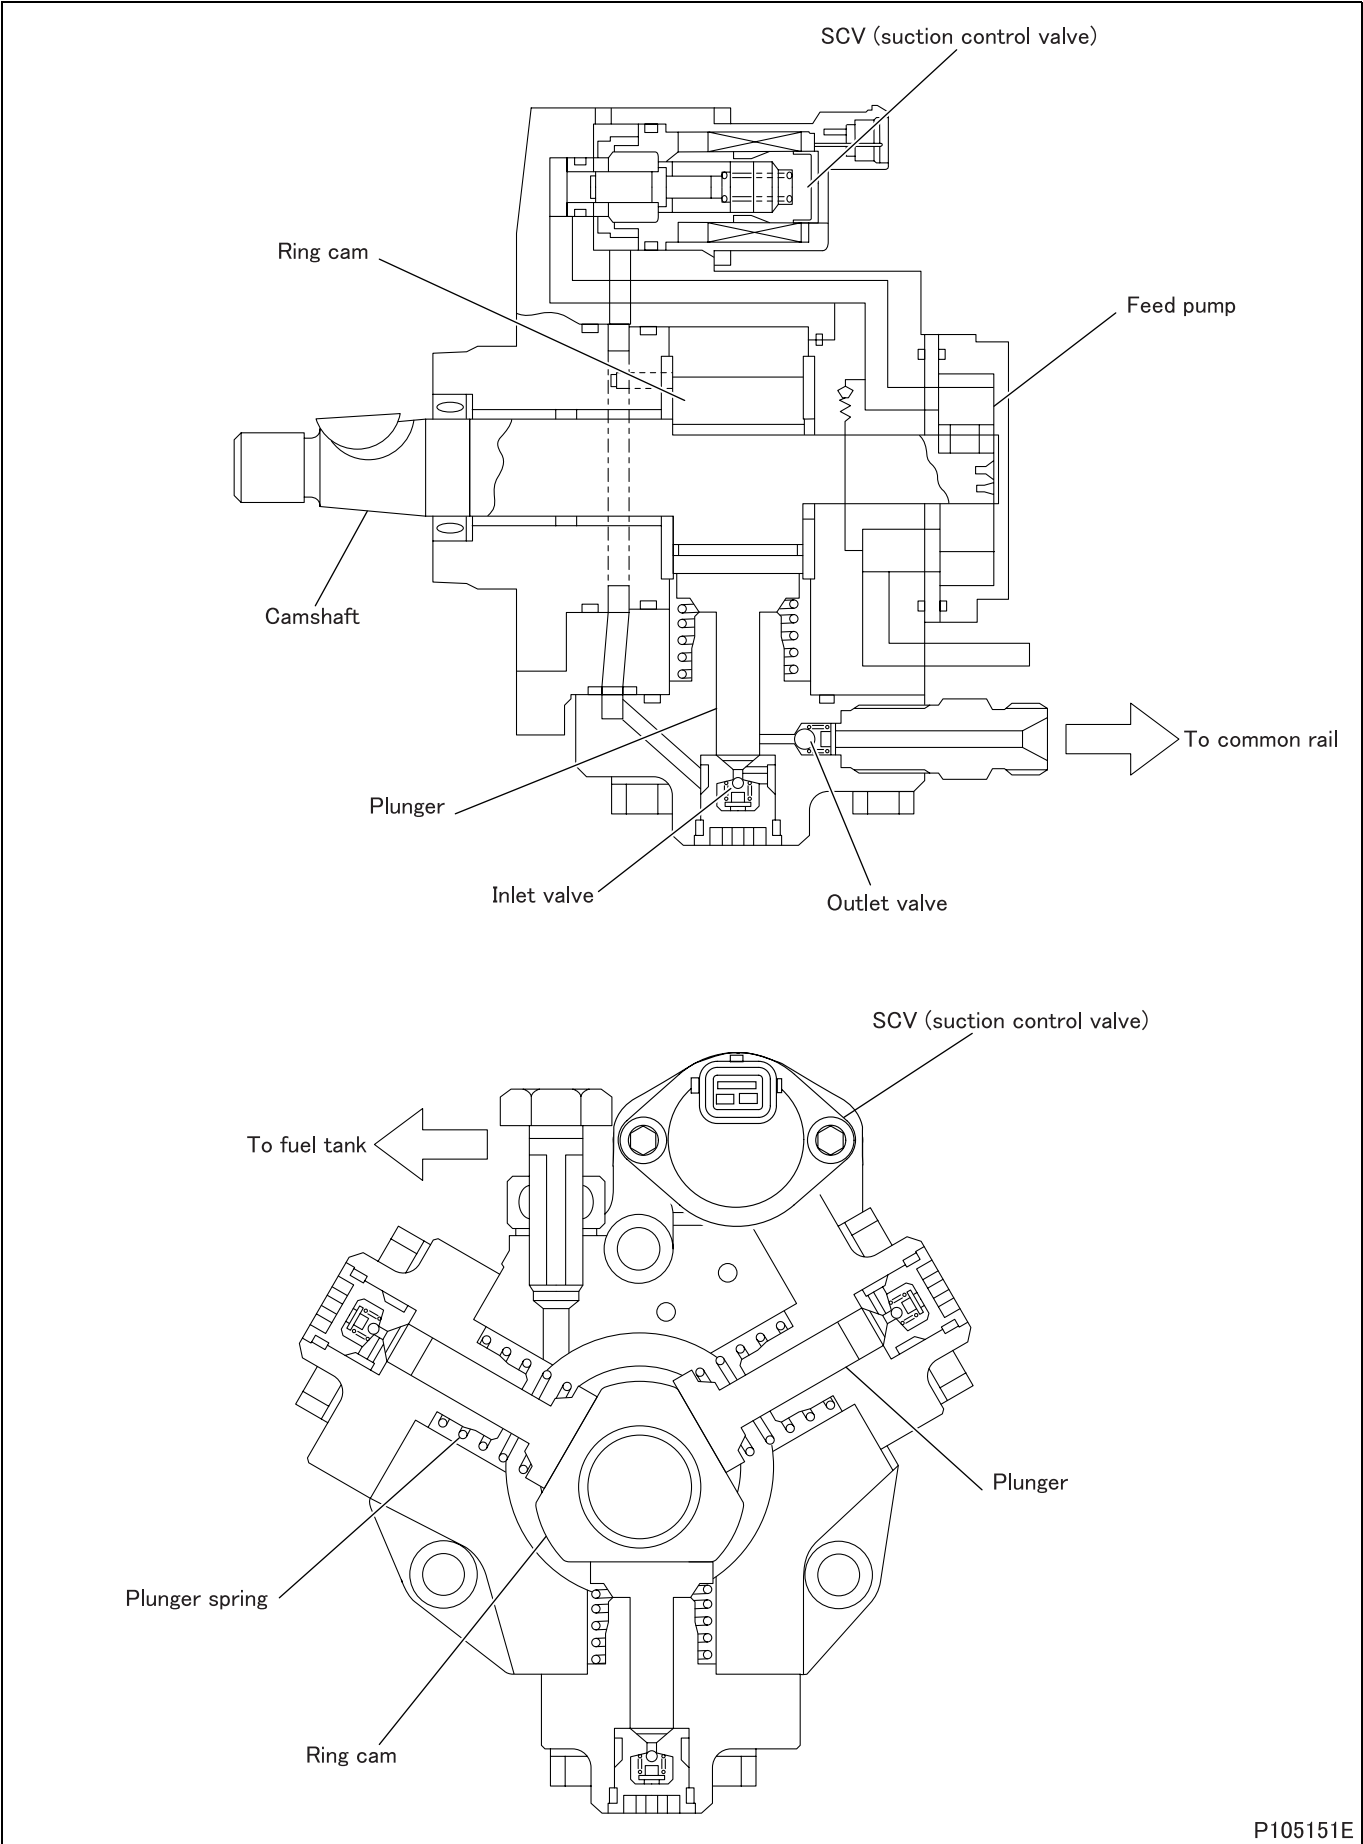
P105151E

## 1.1 Supply pump

- Rotation of the camshaft causes (via the ring cam) up-down movement of the plungers. Fuel in the plunger chambers is thus highly pressurized.

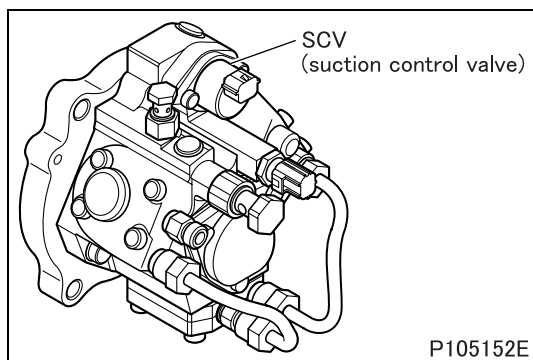
## (1) SCV (suction control valve)

- The SCV (suction control valve) receives fuel from the feed pump and feeds fuel toward the plungers of the supply pump in such a quantity that the fuel pressure corresponds to that required by the engine electronic control unit.
- When the SCV (suction control valve) is not operating, i.e., when current is not flowing, fuel flows at its maximum rate. When current flows, the piston in the common rail pressure solenoid valve is pressed down such that fuel is not fed toward the plungers.

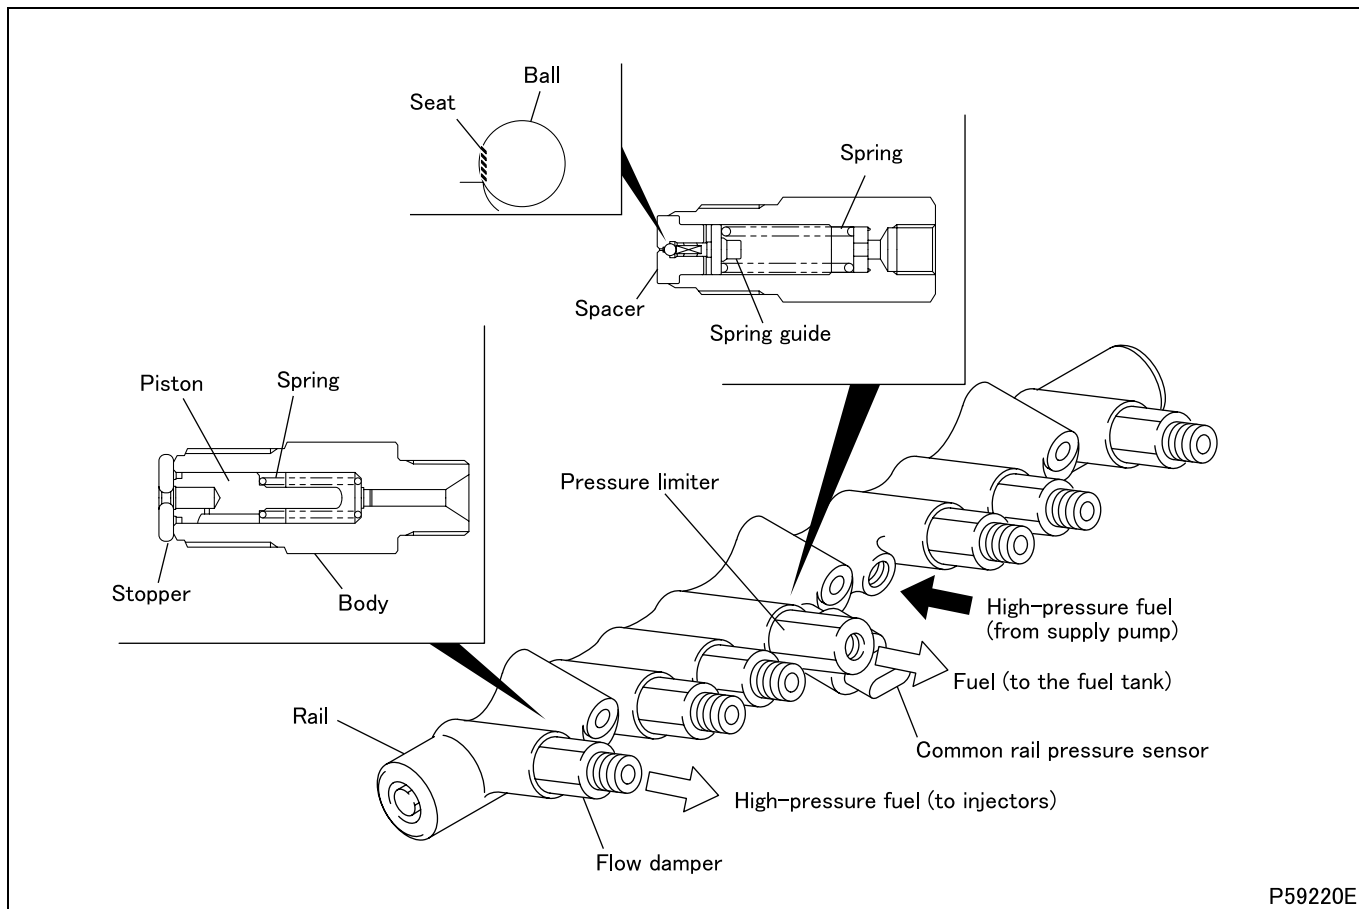
## 1.2 Common rail

- The common rail distributes to the injectors high-pressure fuel that has been fed from the supply pump.
- Each flow damper prevents an abnormal outflow of fuel. It does so by blocking the fuel passage in the event of fuel leakage from the injection pipe or excessive injection of fuel from the injector.
- The common rail pressure sensor is used in feedback control. It senses the fuel pressure inside the common rail and feeds a corresponding signal to the electronic control unit.
- If the fuel pressure in the common rail exceeds a certain, set level, the piston in the pressure limiter pushes and compresses the spring such that fuel is able to escape. The pressure limiting valve thus prevents the fuel pressure from becoming higher than the set pressure.

- If the amount of fuel passing through the flow damper becomes excessively great, the piston presses against the seat, thereby closing the fuel passage and preventing an abnormal outflow of fuel.  
When the piston has pressed against the seat, it does not return to its original position until the engine has been stopped and the pressure in the common rail has come down.

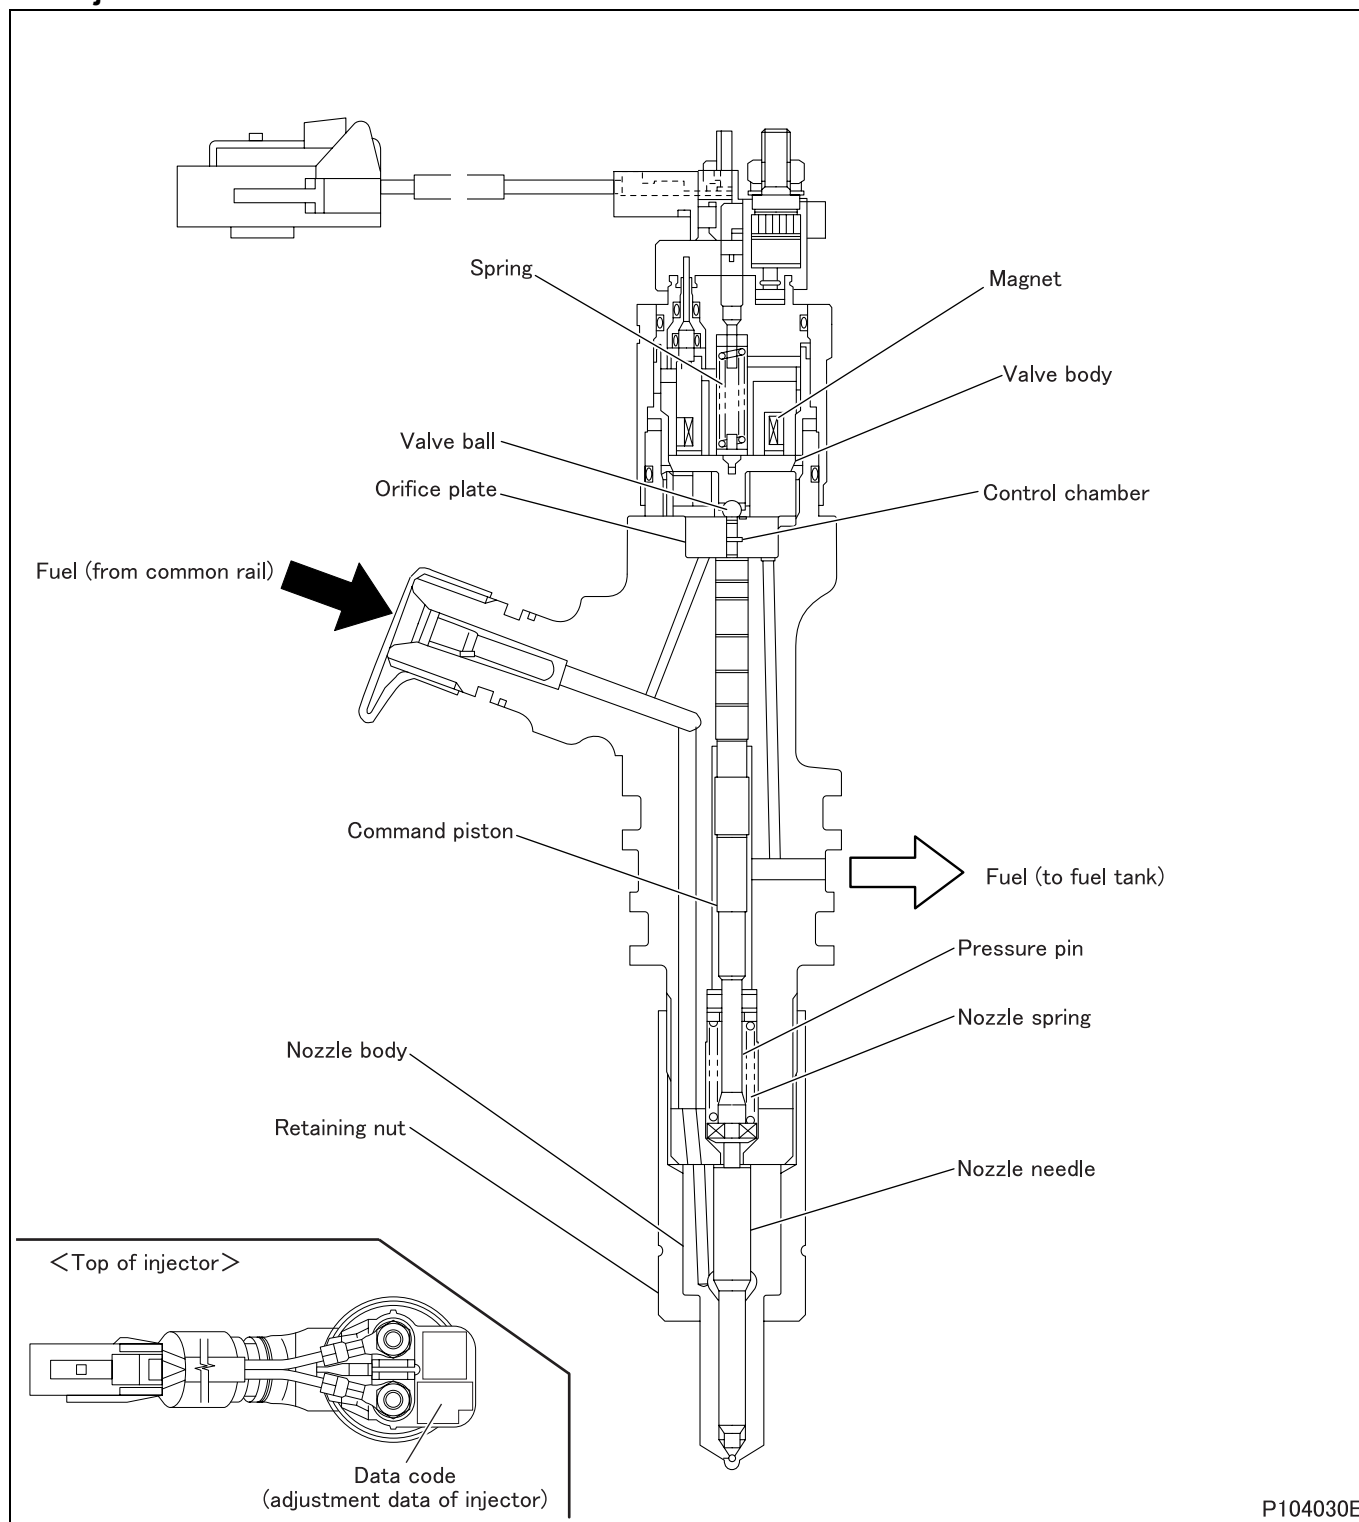
### 1.3 Injector

- In accordance with electrical signals from the engine electronic control unit, each injector supplies high-pressure fuel from the common rail to the relevant combustion chamber of the engine at the optimal timing and in the optimal quantity.

- The injector is divided into the control section and injector section.
- The control section consists of the control chamber, magnet, spring, valve body, valve ball, pressure pin, command piston, and orifice plate. The pressure pin is located between the control section and the injection section.
- The injection section consists of the nozzle body, nozzle needle, nozzle spring, and retaining nut.
- On the top of the injector is marked the data code (adjustment data of injector) for entry of injector correction data into the engine electronic control unit.
- This data code is intended to restrain the fluctuation of injection quantity by each injector with it registered in the engine electronic control unit.

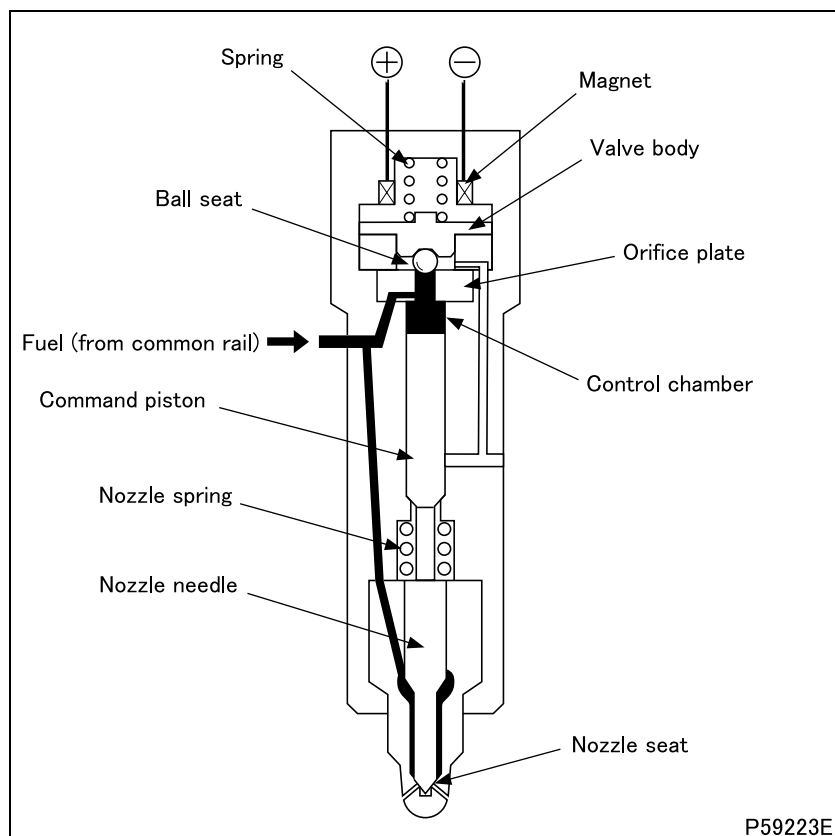
### (1.1) Injection not taking place

- With the magnet not energized, the valve body, is pushed up by the spring in the magnet such that the ball seat is closed.
- The high-pressure fuel acts upon the control chamber via orifice plate. The same pressure acts upon the nozzle needle.
- The fuel pressure acting on the nozzle needle cannot overcome the command piston and nozzle spring, so the nozzle needle stays in its downward-pushed position and injection does not take place.

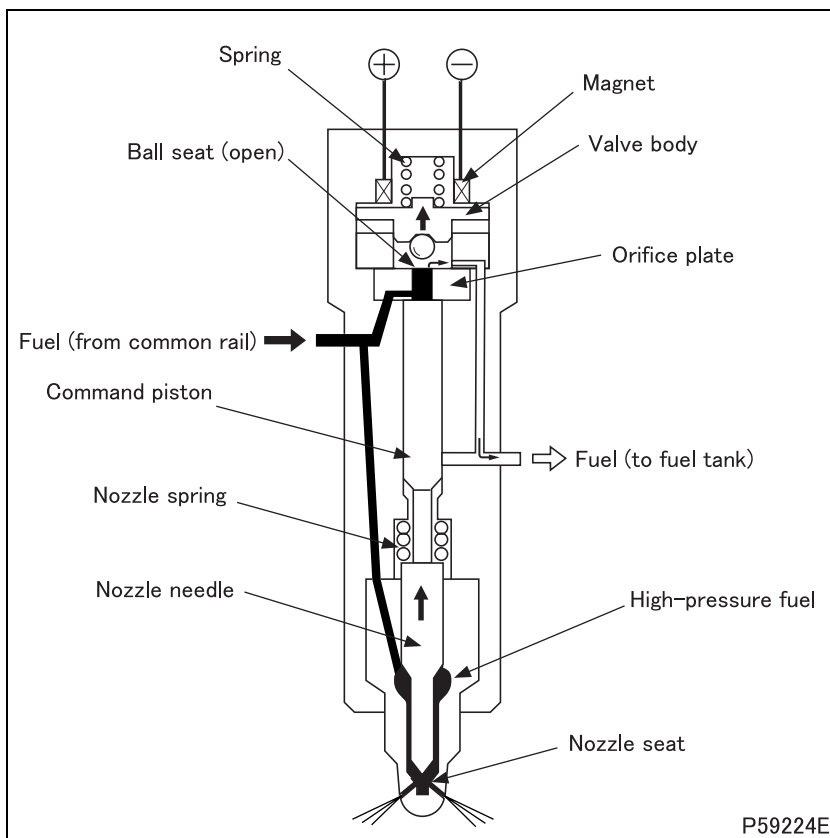
### (1.2) Start of injection

- When the magnet is energized, the resulting electromagnetic force draws the valve body upward, causing the ball seat to open.
- Fuel in the control chamber passes through the ball seat and orifice plate and flows to the fuel tank.
- With the pressure in the control chamber reduced, the fuel acting on the nozzle needle overcomes the command piston and nozzle spring, pushing up the nozzle needle such that injection starts.
- If the magnet remains energized, the injection rate reaches its maximum level.

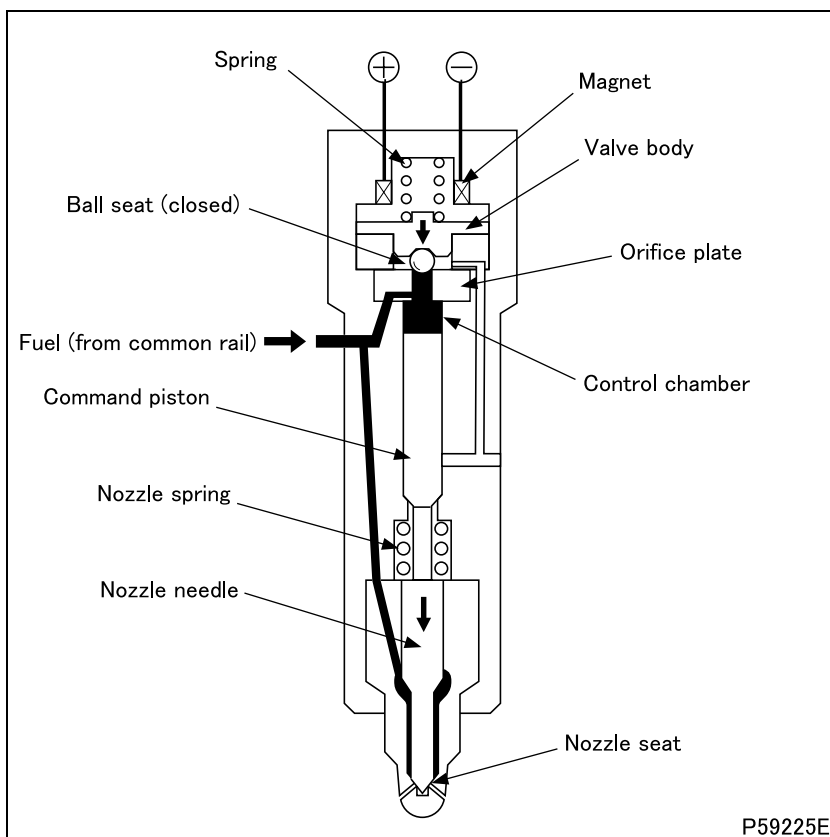
### (1.3) End of injection

- When energization of the magnet is stopped, the valve body is pushed downward by the spring in the magnet such that the ball seat closes. At this time, fuel flows into the control chamber via orifice plate, pushing down the command piston and nozzle needle such that injection finishes.

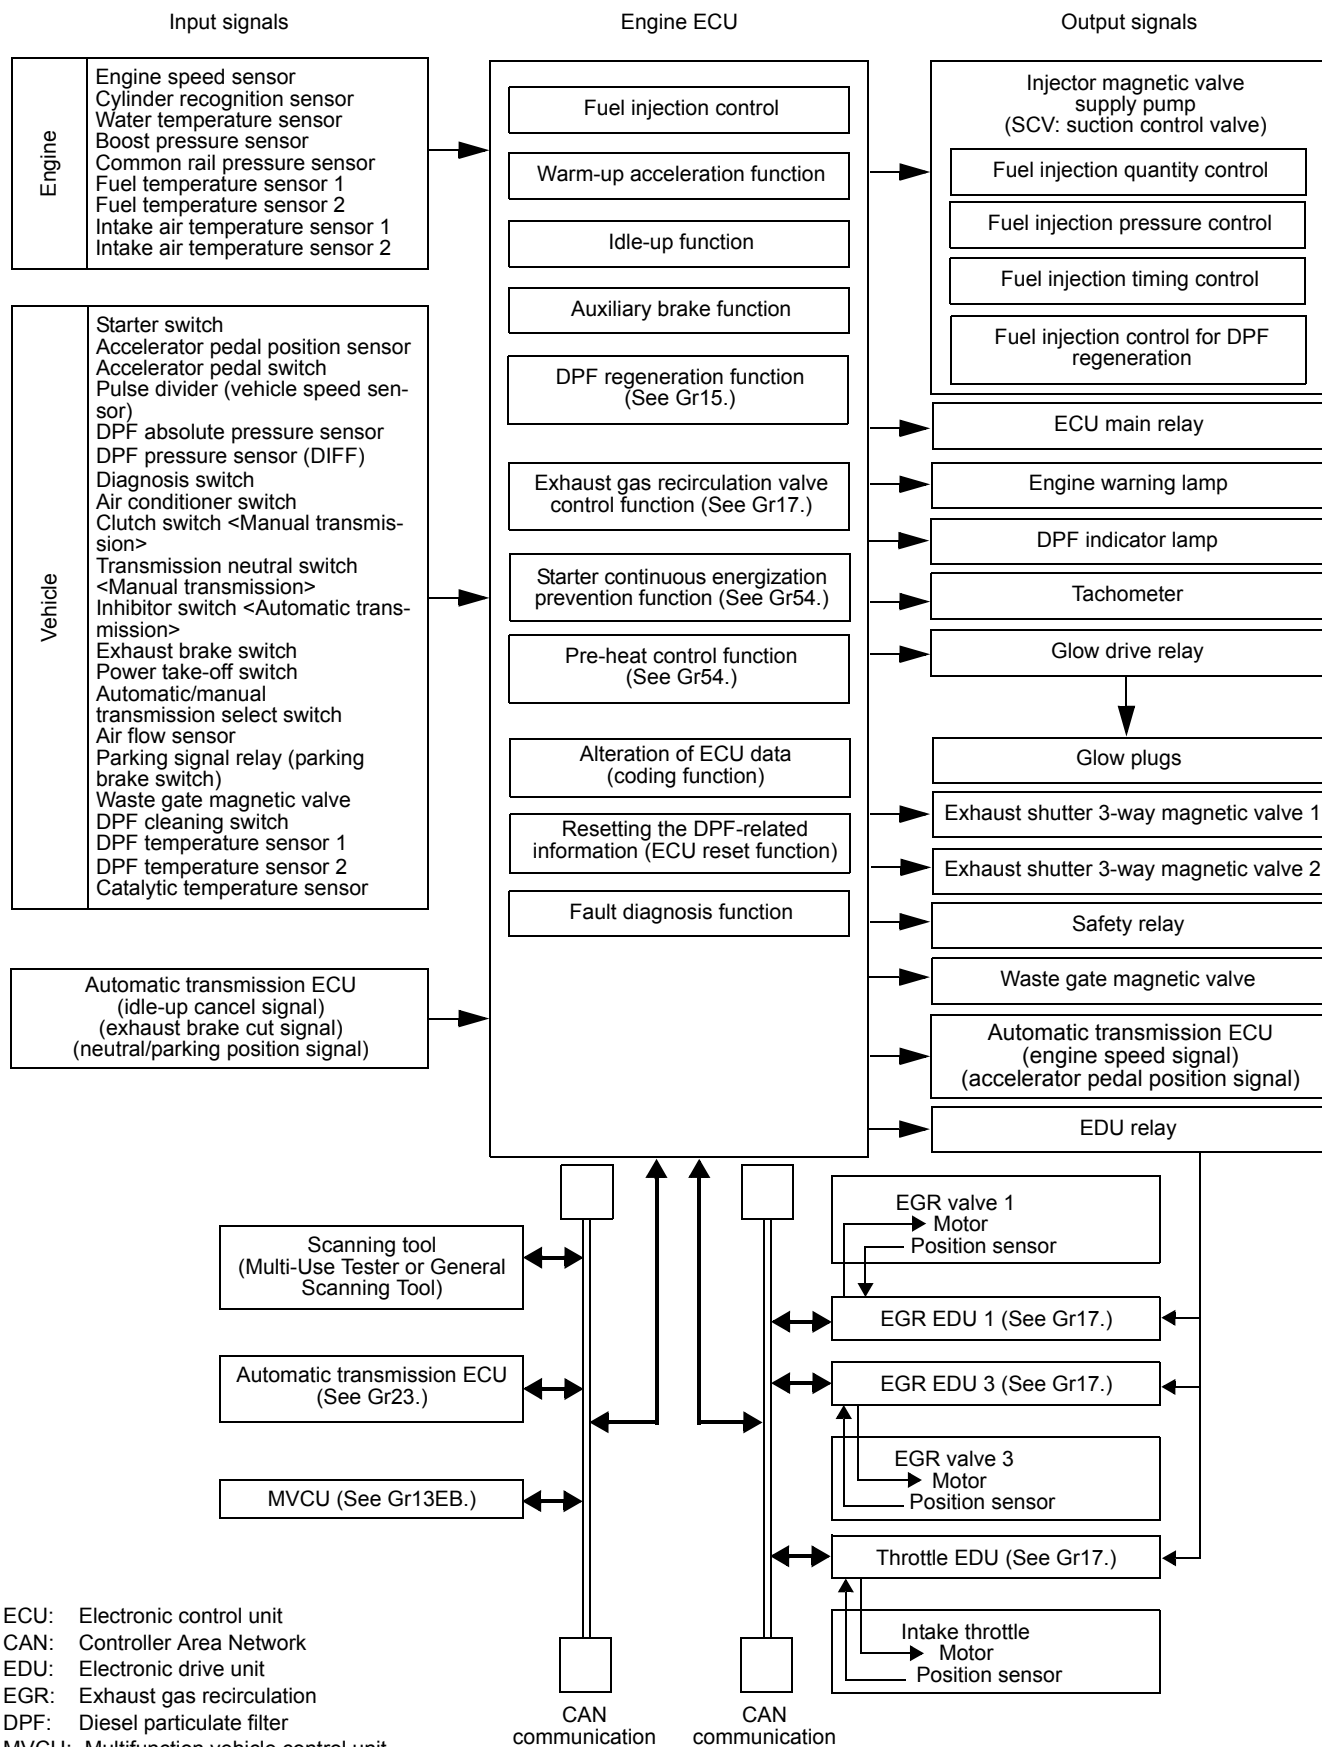
### 2.1 System block diagram

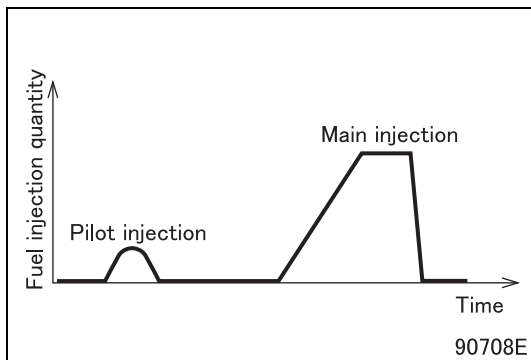
### (1) Pilot injection

- Pilot injection entails the injection of an extremely small amount of fuel ahead of the main injection.
- Pilot injection suppresses heat generation early in the injection cycle and thus suppresses NOx generation and noise at the start of combustion.

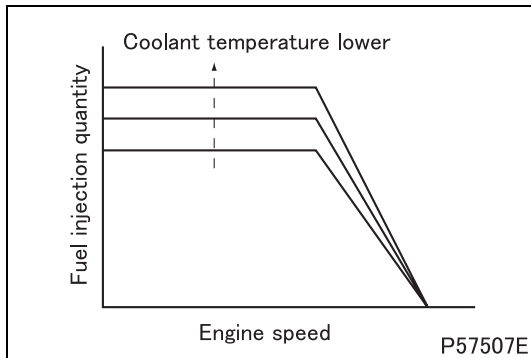
### (1) Fuel injection quantity during engine startup

- During engine startup, the fuel injection quantity is determined in accordance with the engine speed and coolant temperature.

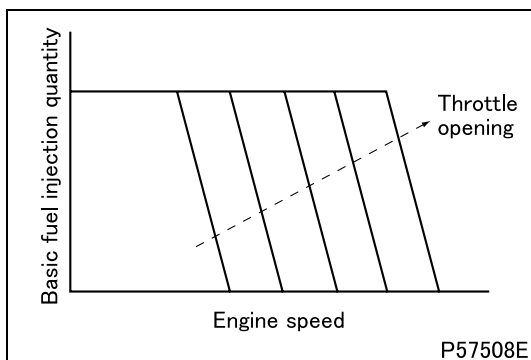
### (2) Basic fuel injection quantity

- The basic fuel injection quantity is determined in accordance with the engine speed and throttle opening.

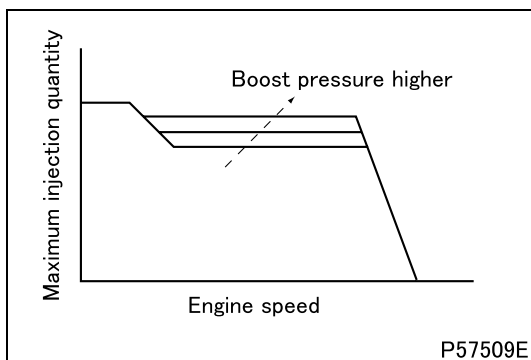
### (3) Maximum injection quantity

- The maximum injection quantity is calculated from the engine speed and boost pressure.

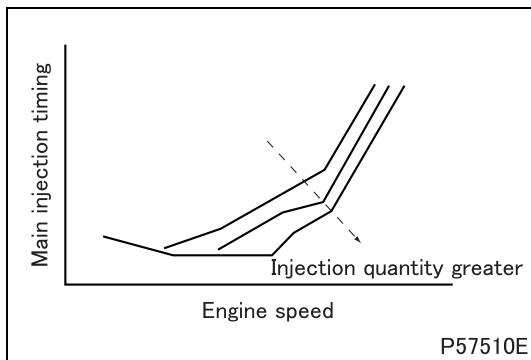
### (1) Main injection timing

- The main injection timing is calculated from the fuel injection quantity and engine speed.

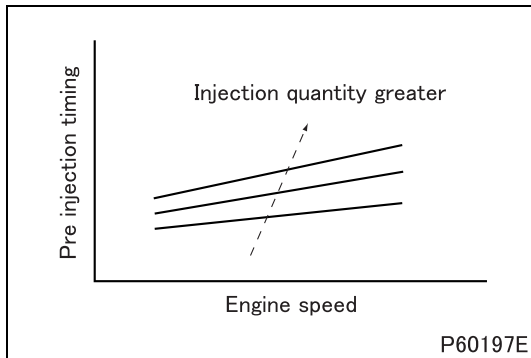
### (2) Pre injection timing

- The pre injection timing is calculated from the fuel injection quantity and engine speed.

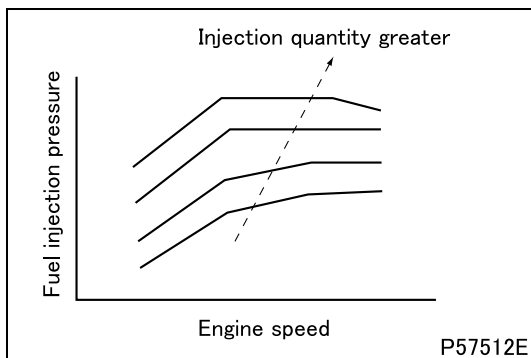
## 2.5 Fuel injection timing control

- The fuel injection pressure is calculated from the fuel injection quantity and engine speed.

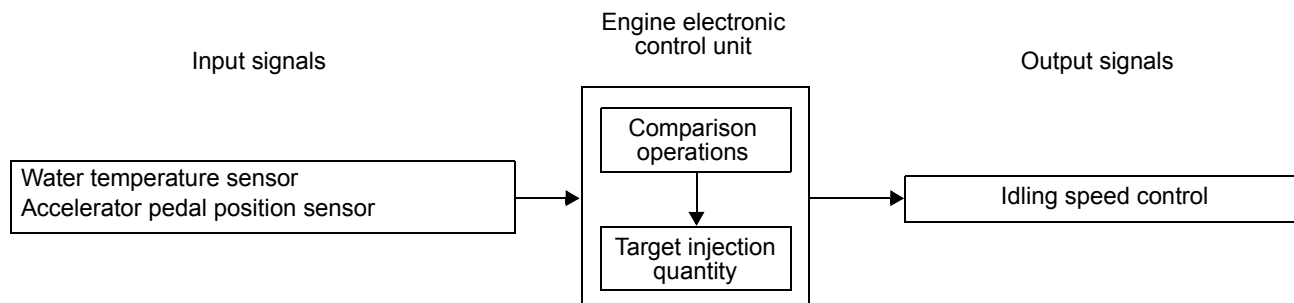
## 2.7 Warm-up acceleration function

- The warm-up acceleration function accelerates engine warm-up by varying the engine's idling speed in accordance with the engine's coolant temperature.

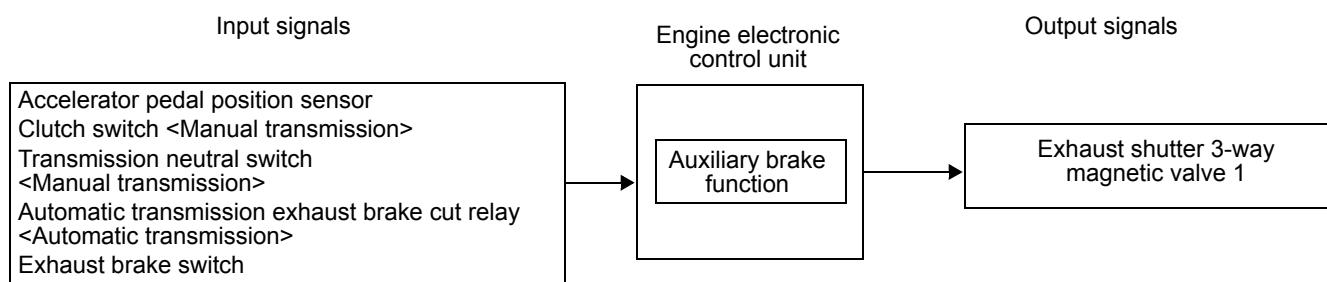
## 2.8 Auxiliary brake function

- The auxiliary brake function activates or deactivates the exhaust shutter 3-way magnetic valve 1 according to the vehicle condition to control the exhaust brake.

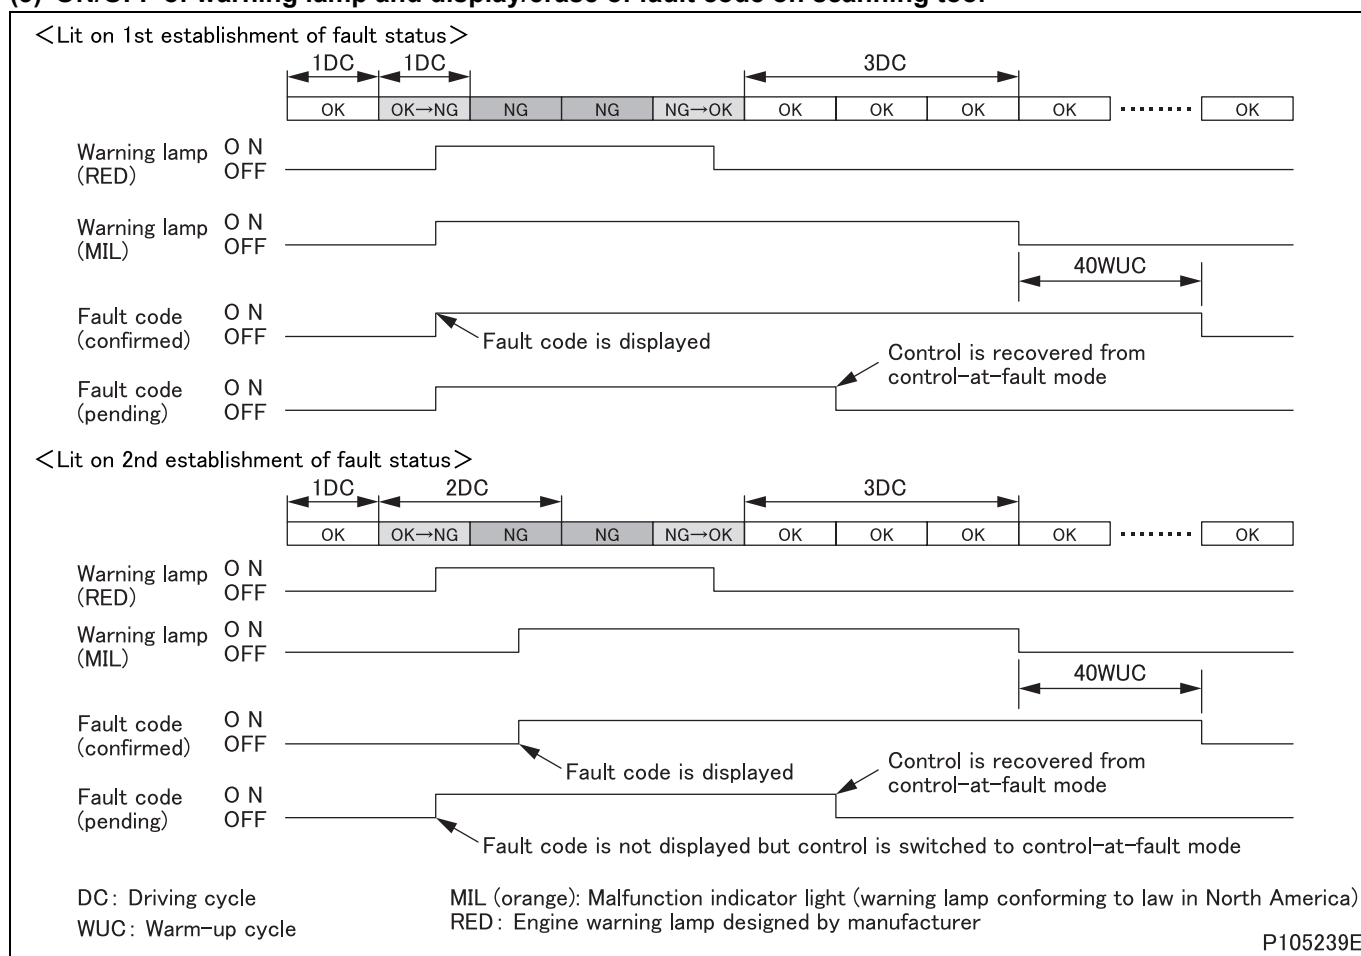
### (3) ON/OFF of warning lamp and display/erase of fault code on scanning tool

- The lighting of warning lamp is effected in two ways depending on fault status as follows.
  - Lit on 1st establishment of fault status (when fault is determined during 1st driving cycle)
  - Lit on 2nd establishment of fault status (when fault is recognized during 1st driving cycle and determined on 2nd driving cycle)
- Warning lamp is extinguished on 4th driving cycle after the electronic control unit is back to normal control mode.
- Fault code on scanning tool is erased in two ways as follows.
  - Erased as desired by means of the scanning tool's (General Scanning Tool or Multi-Use Tester) memory clear function
  - Automatically erased by the electronic control unit on continuation of 40 warm-up cycles in normal condition after warning lamp OFF

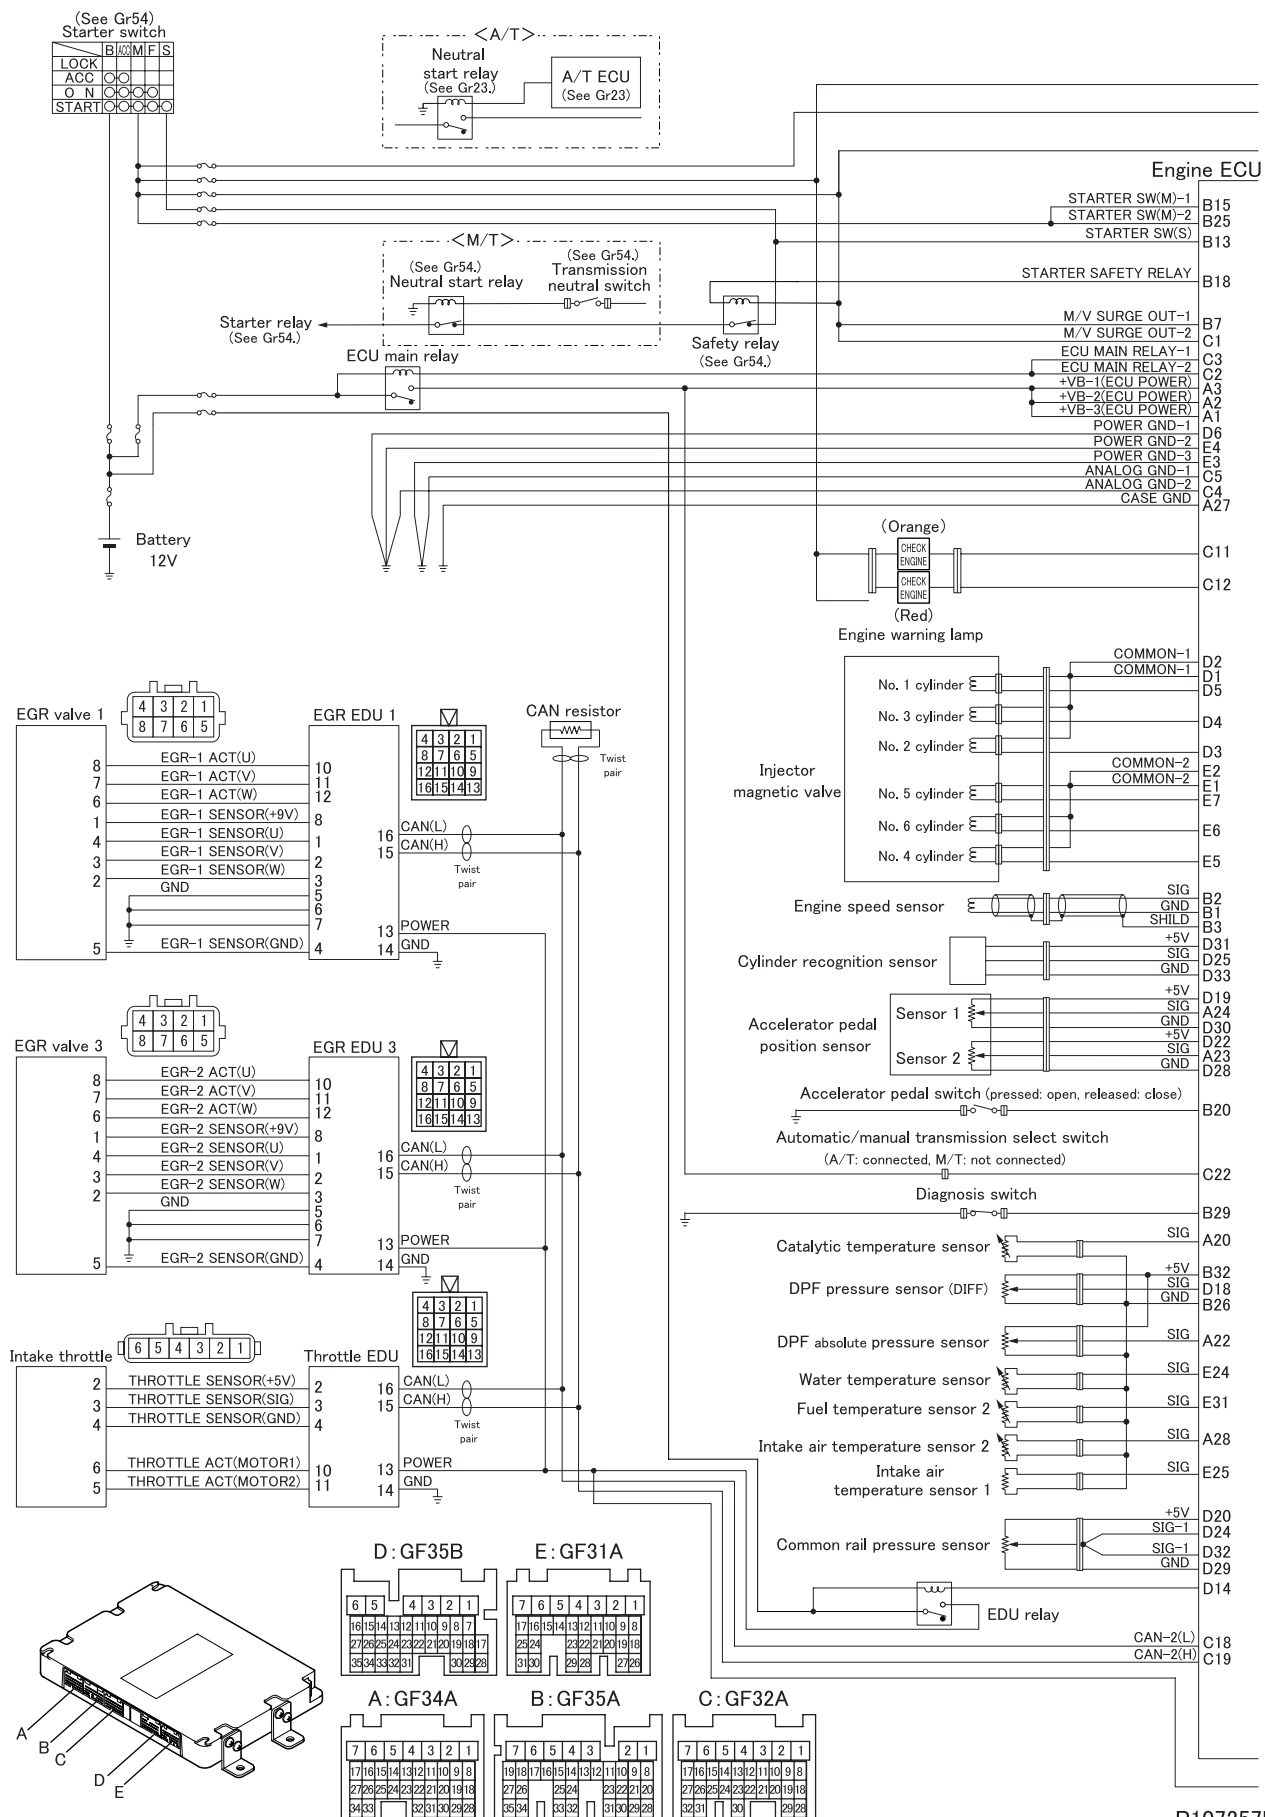
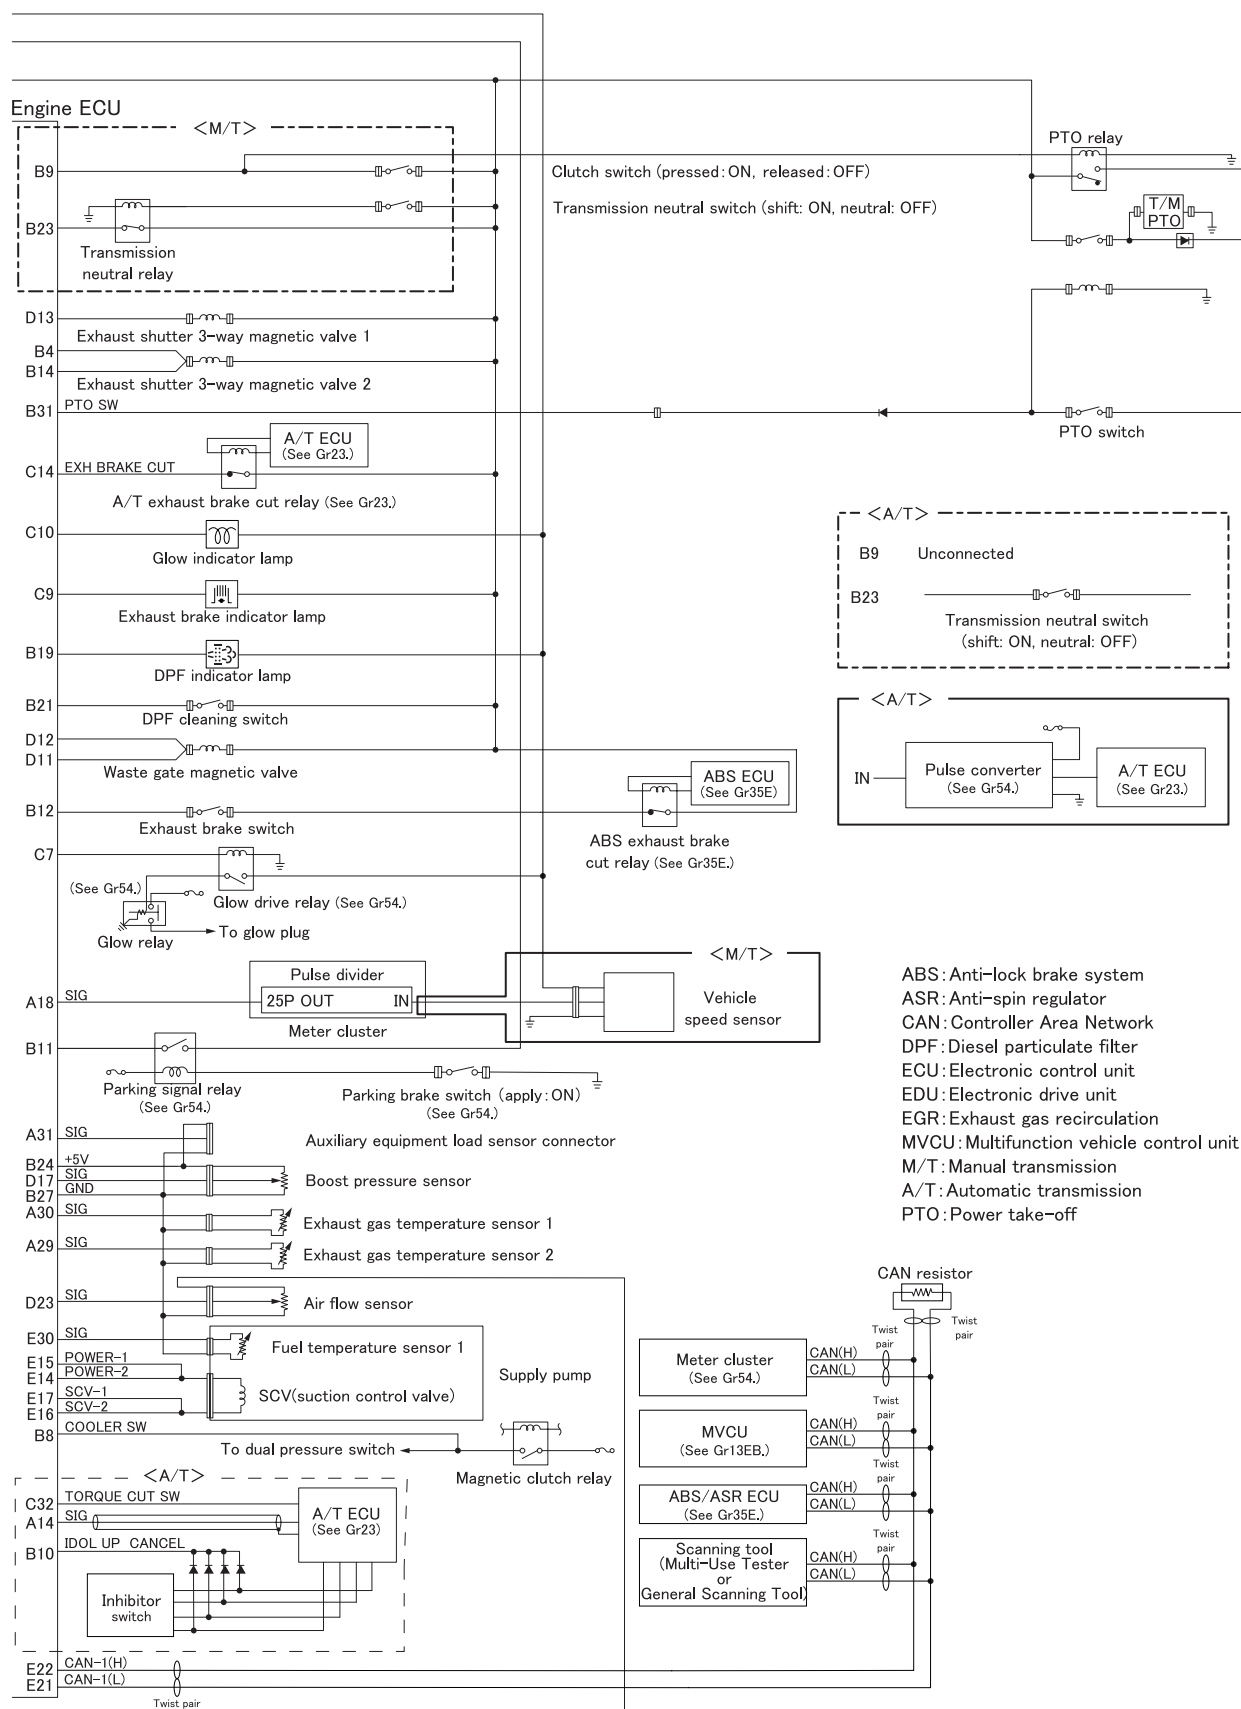
P107257E-1

## 3. Electronic Control Unit Connection Diagram

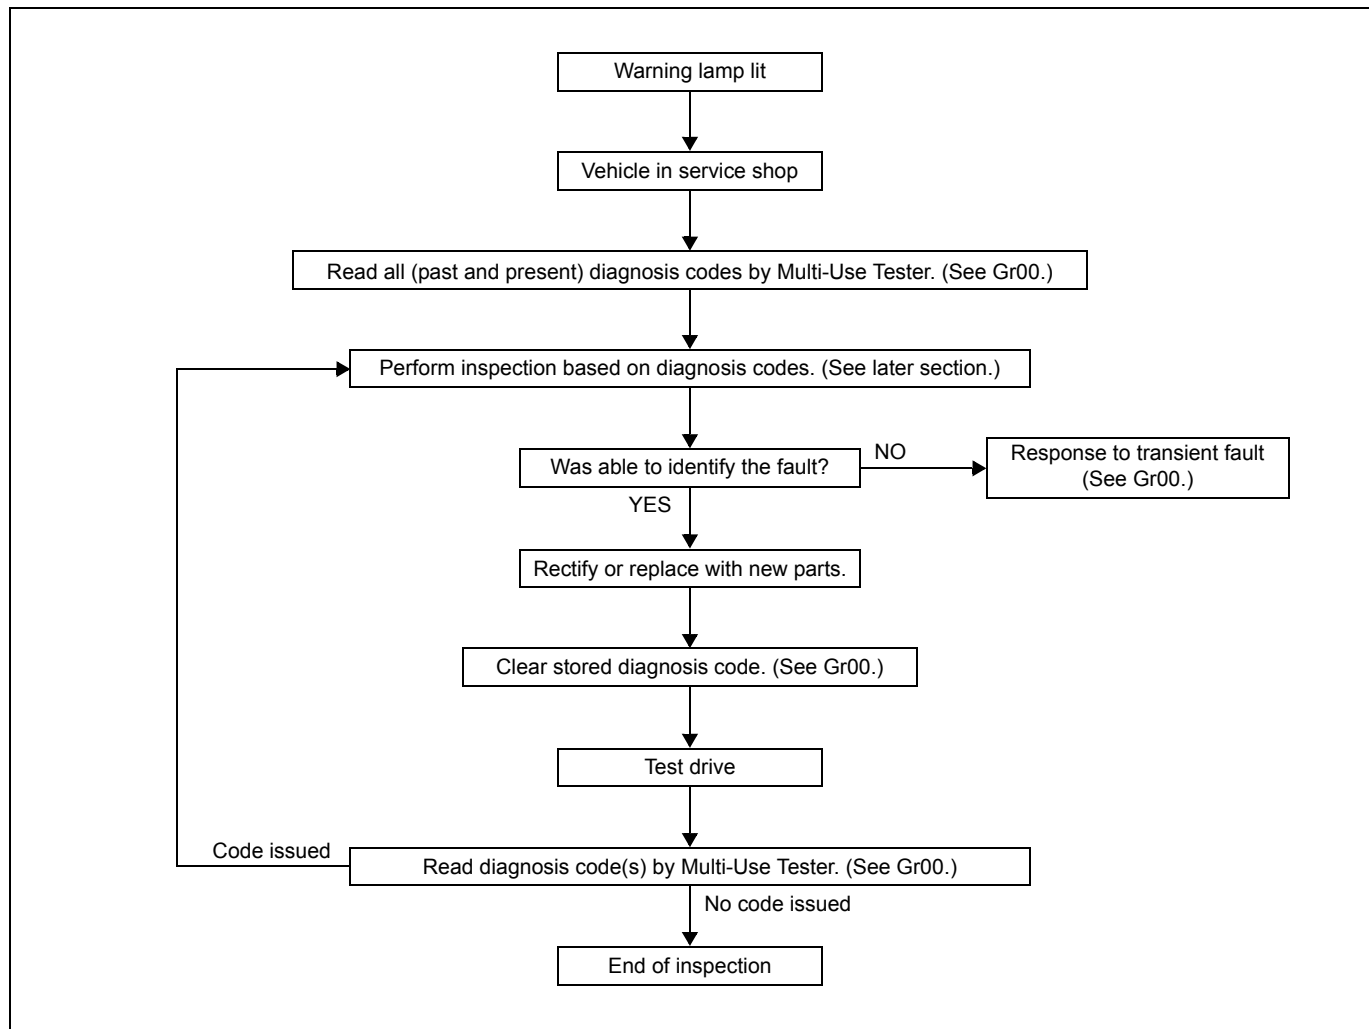
- Perform the inspection in accordance with the following flowchart.

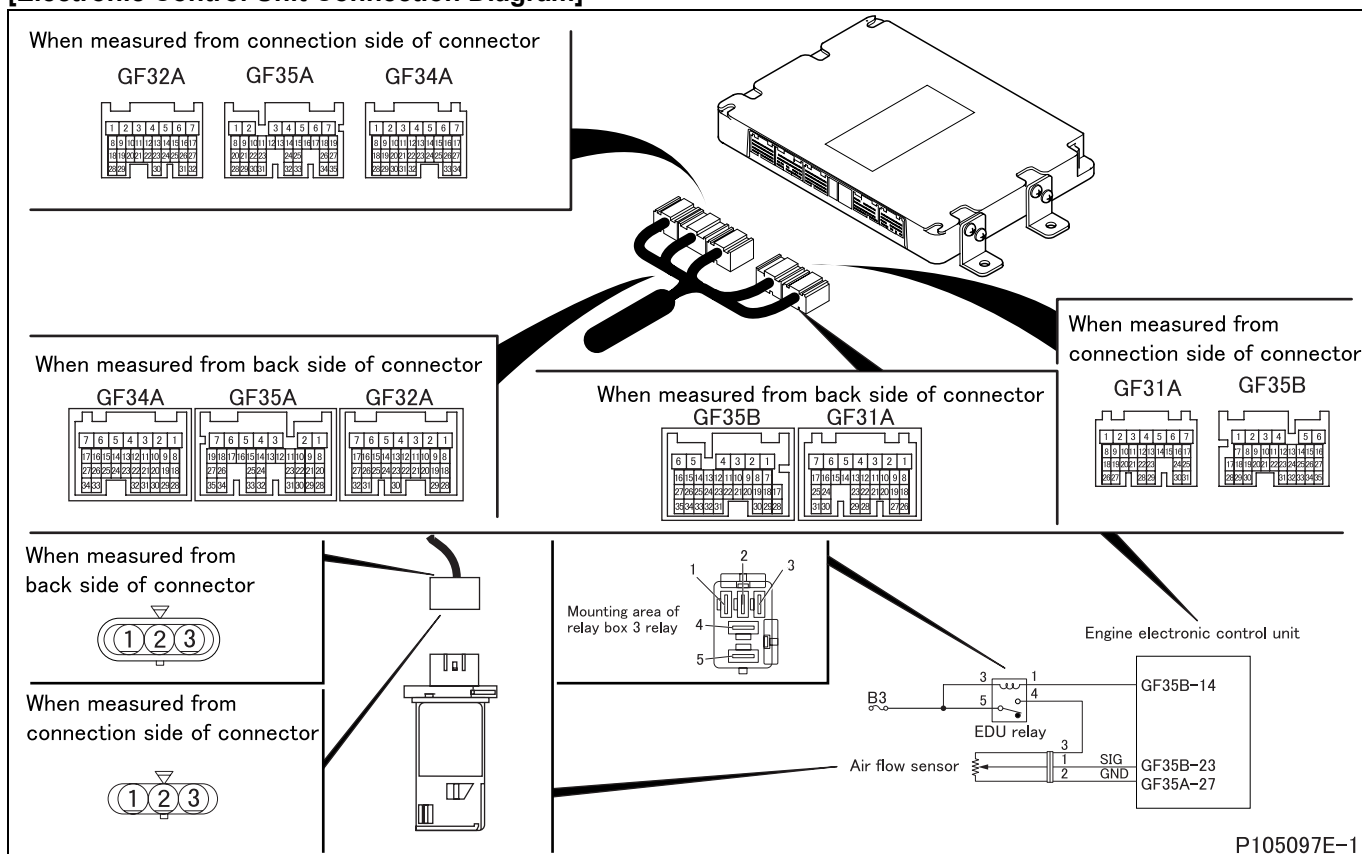
## [Electronic Control Unit Connection Diagram]
