# FE.FG

## SERVICE MANUAL 2008 Model FOREWORD

This Service Manual contains maintenance and repair methods for the Mitsubishi Fuso Truck FE. FG Series. Read this manual carefully as an aid in providing correct, efficient maintenance. Please note that the information and specifications contained within this manual may change without notice. This is due to product modifications and continued vehicle improvements that are made throughout the model years. Should you encounter any discrepancy in the information provided, please do not hesitate to contact your nearest Mitsubishi Fuso Dealer or Mitsubishi Fuso Truck of America, Inc.

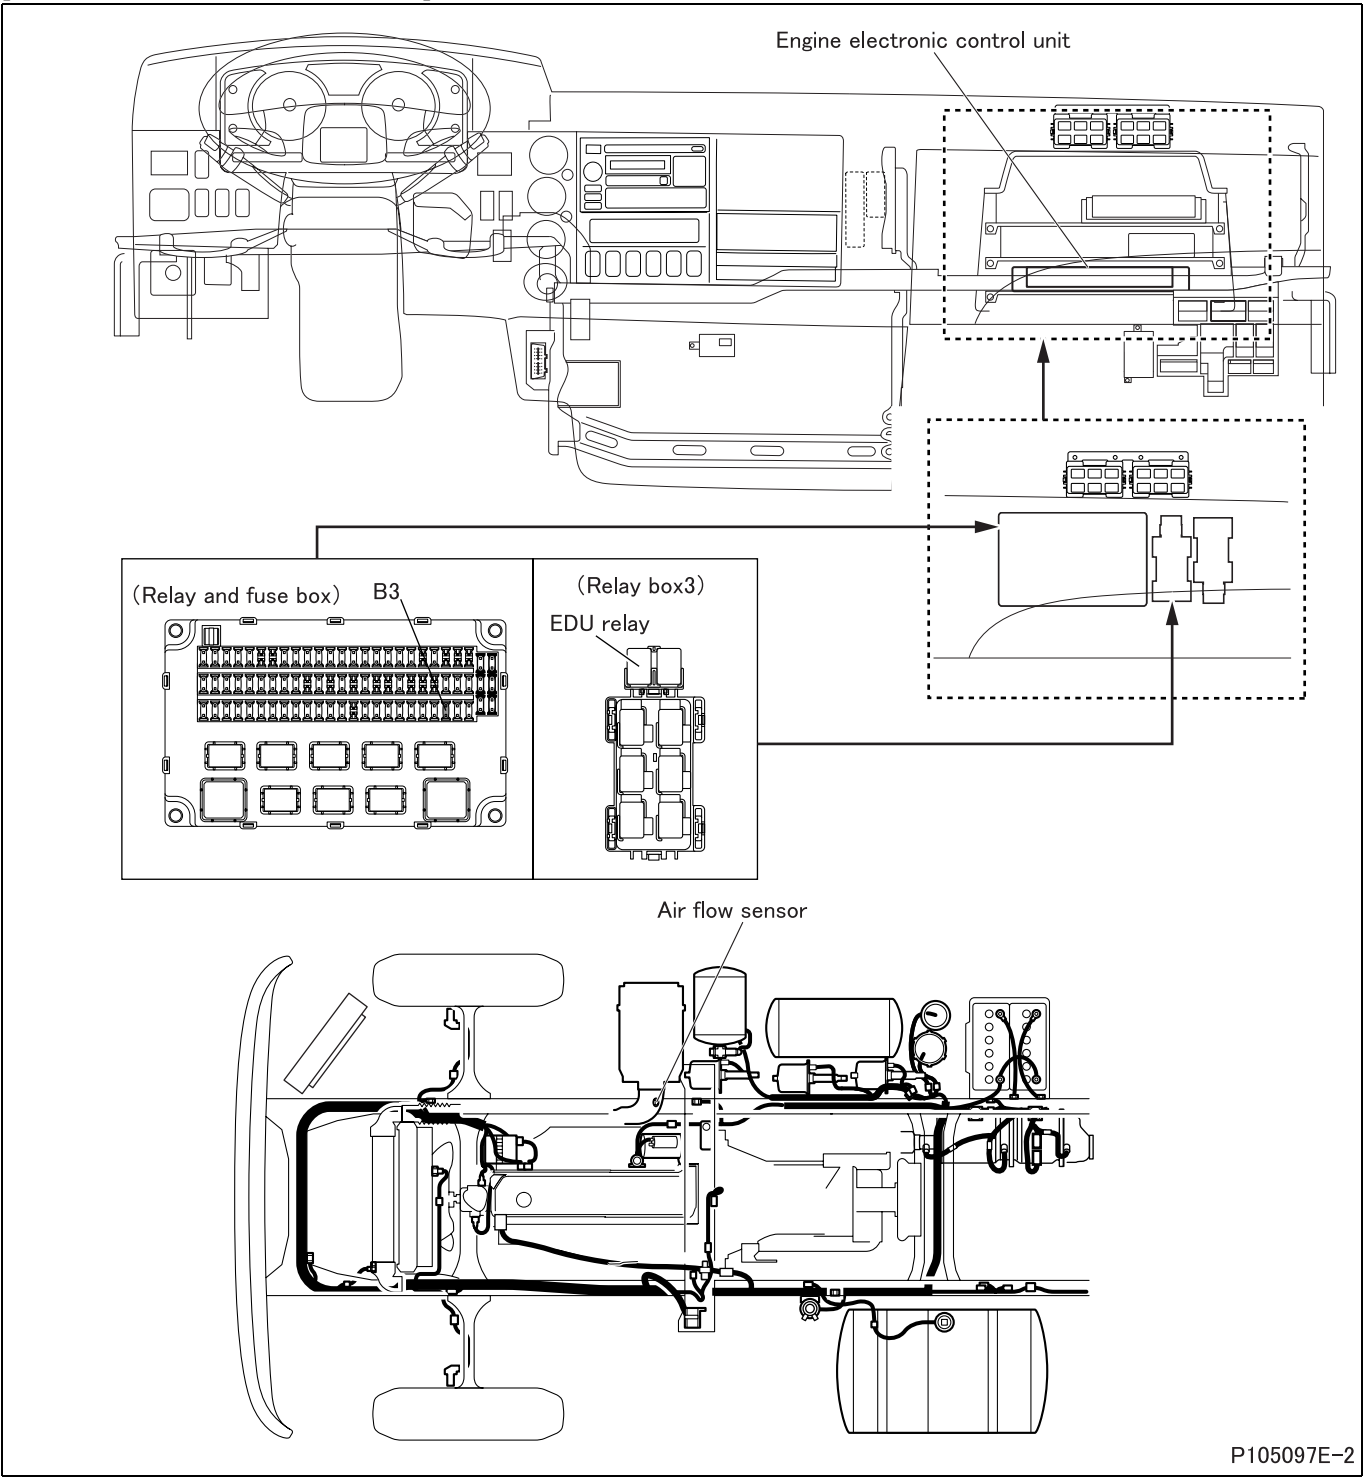
## [Parts Identification and Location]

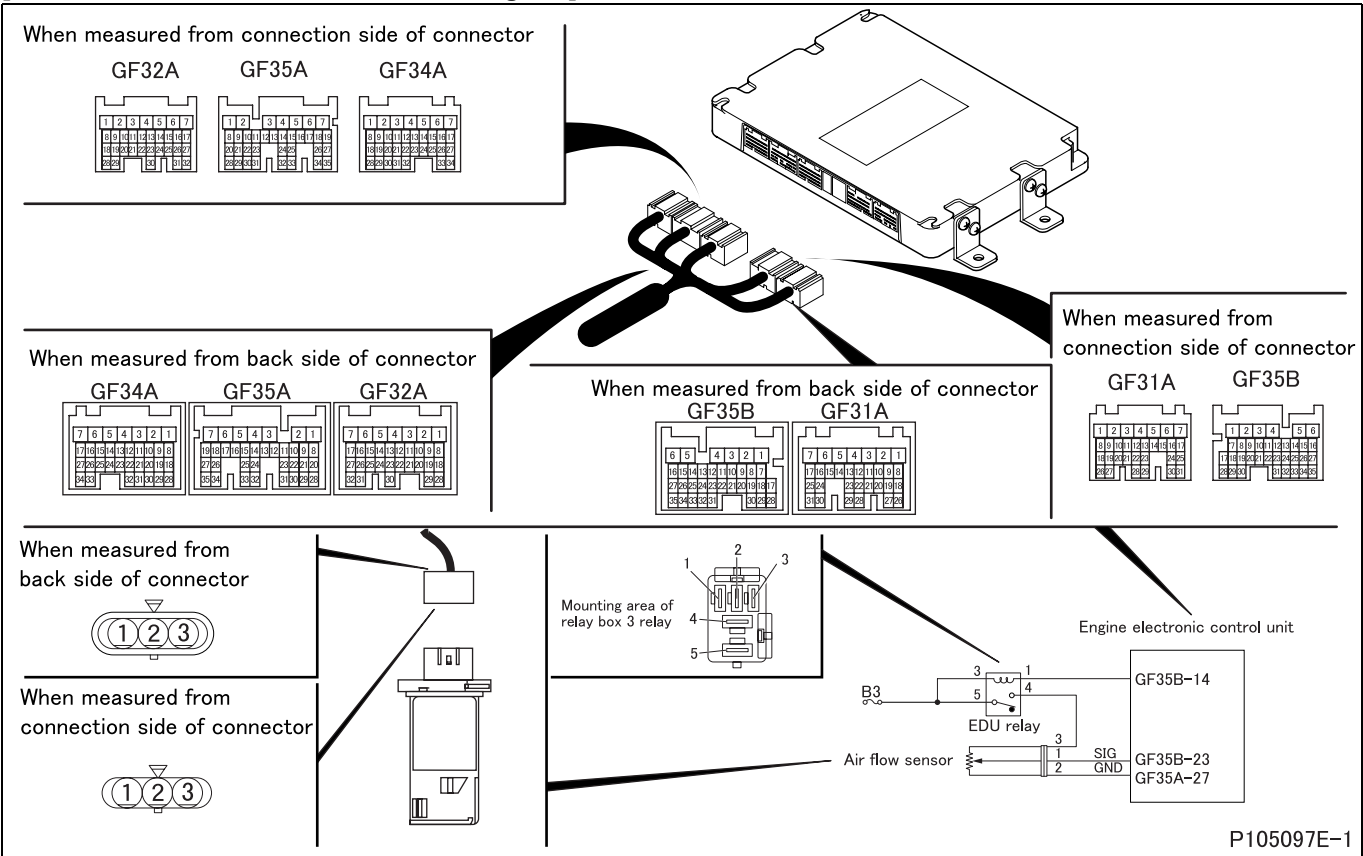
P105097E-1

## [Electronic Control Unit Connection Diagram]

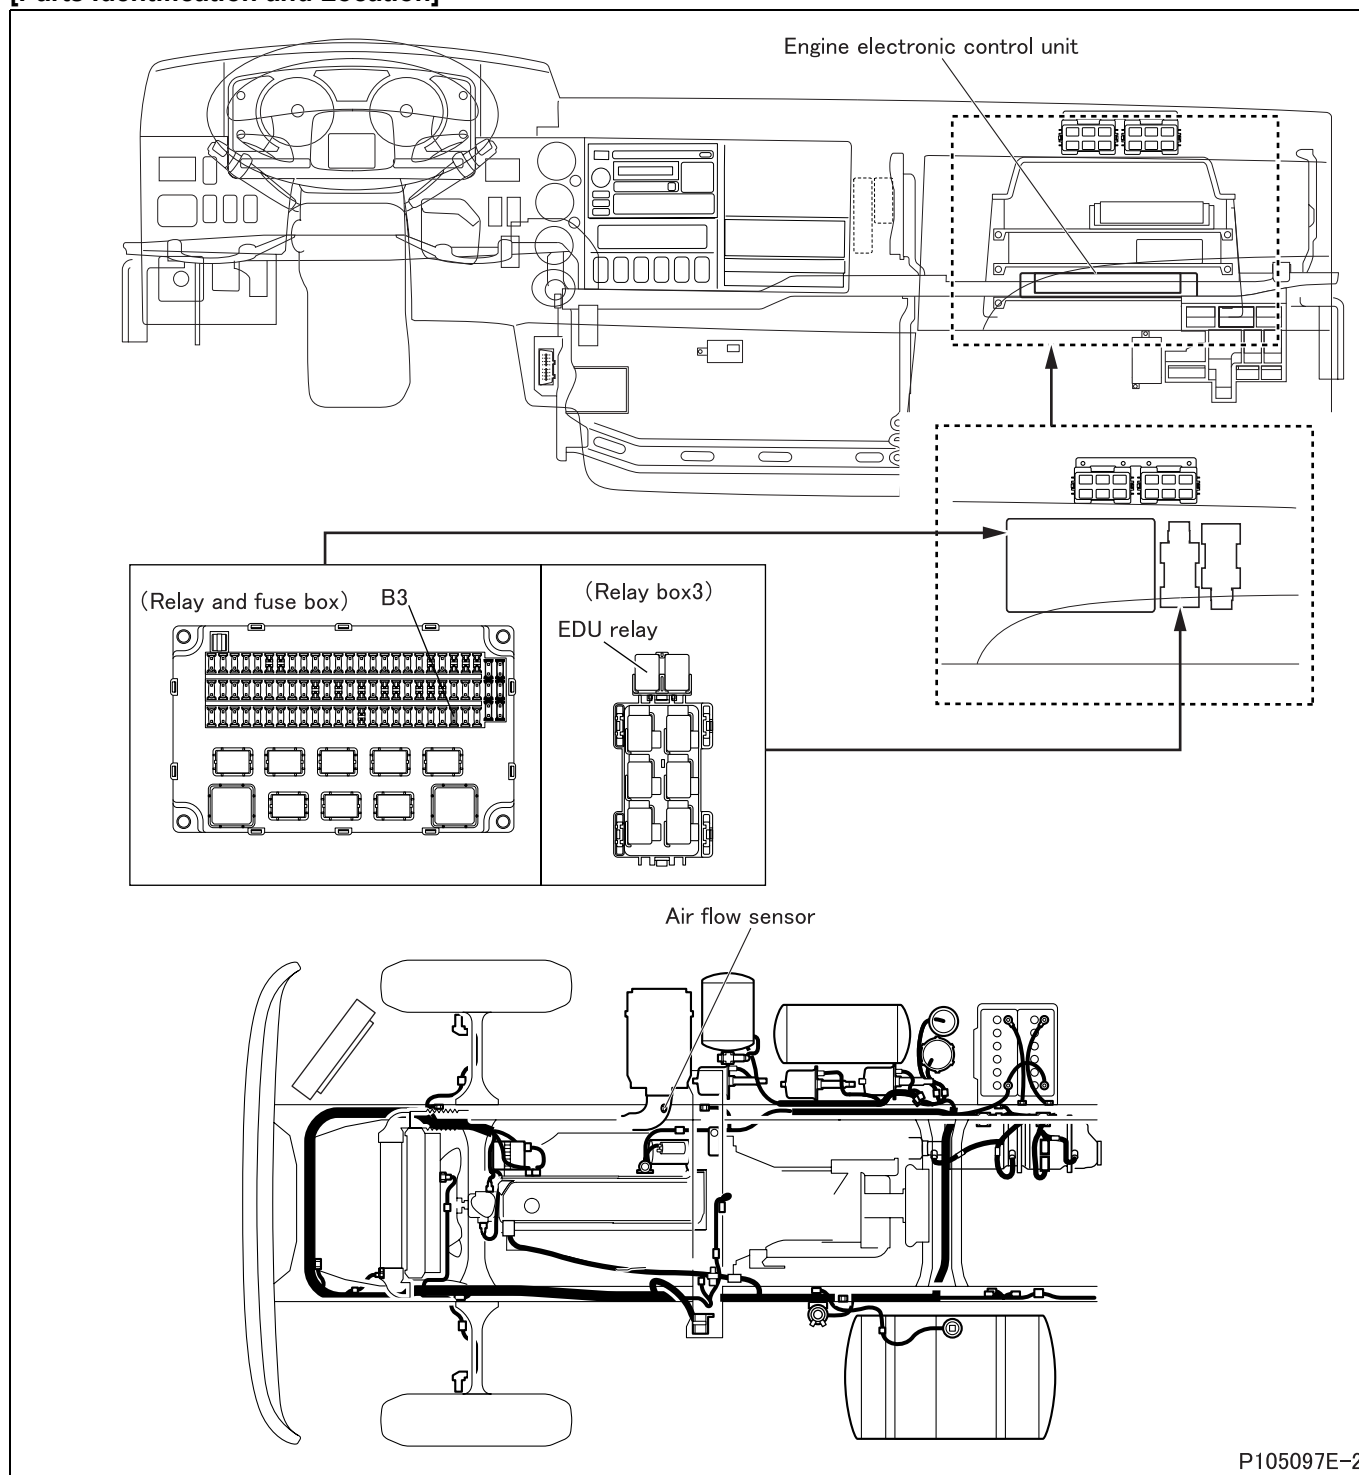
## [Parts Identification and Location]

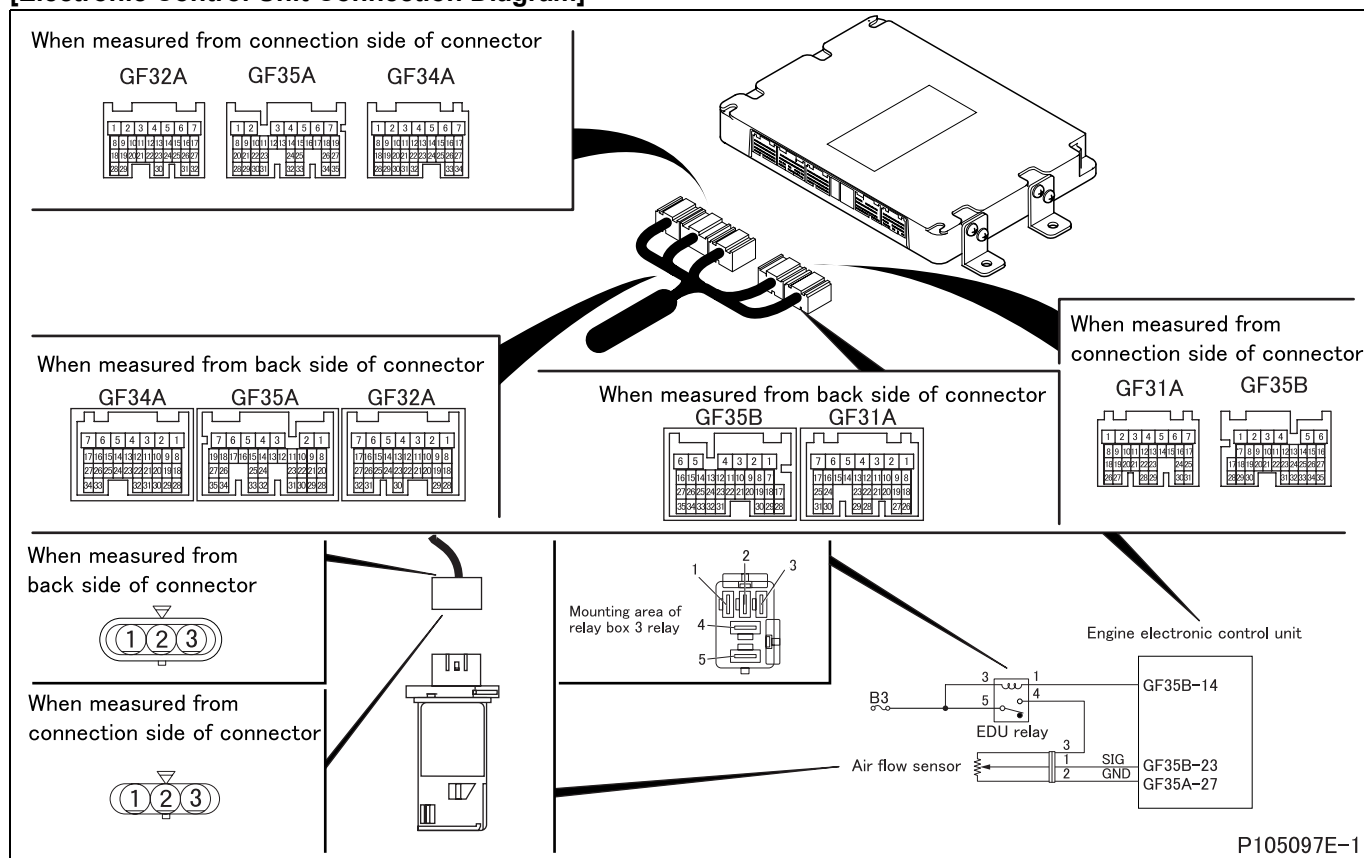
P105097E-1

## [Electronic Control Unit Connection Diagram]

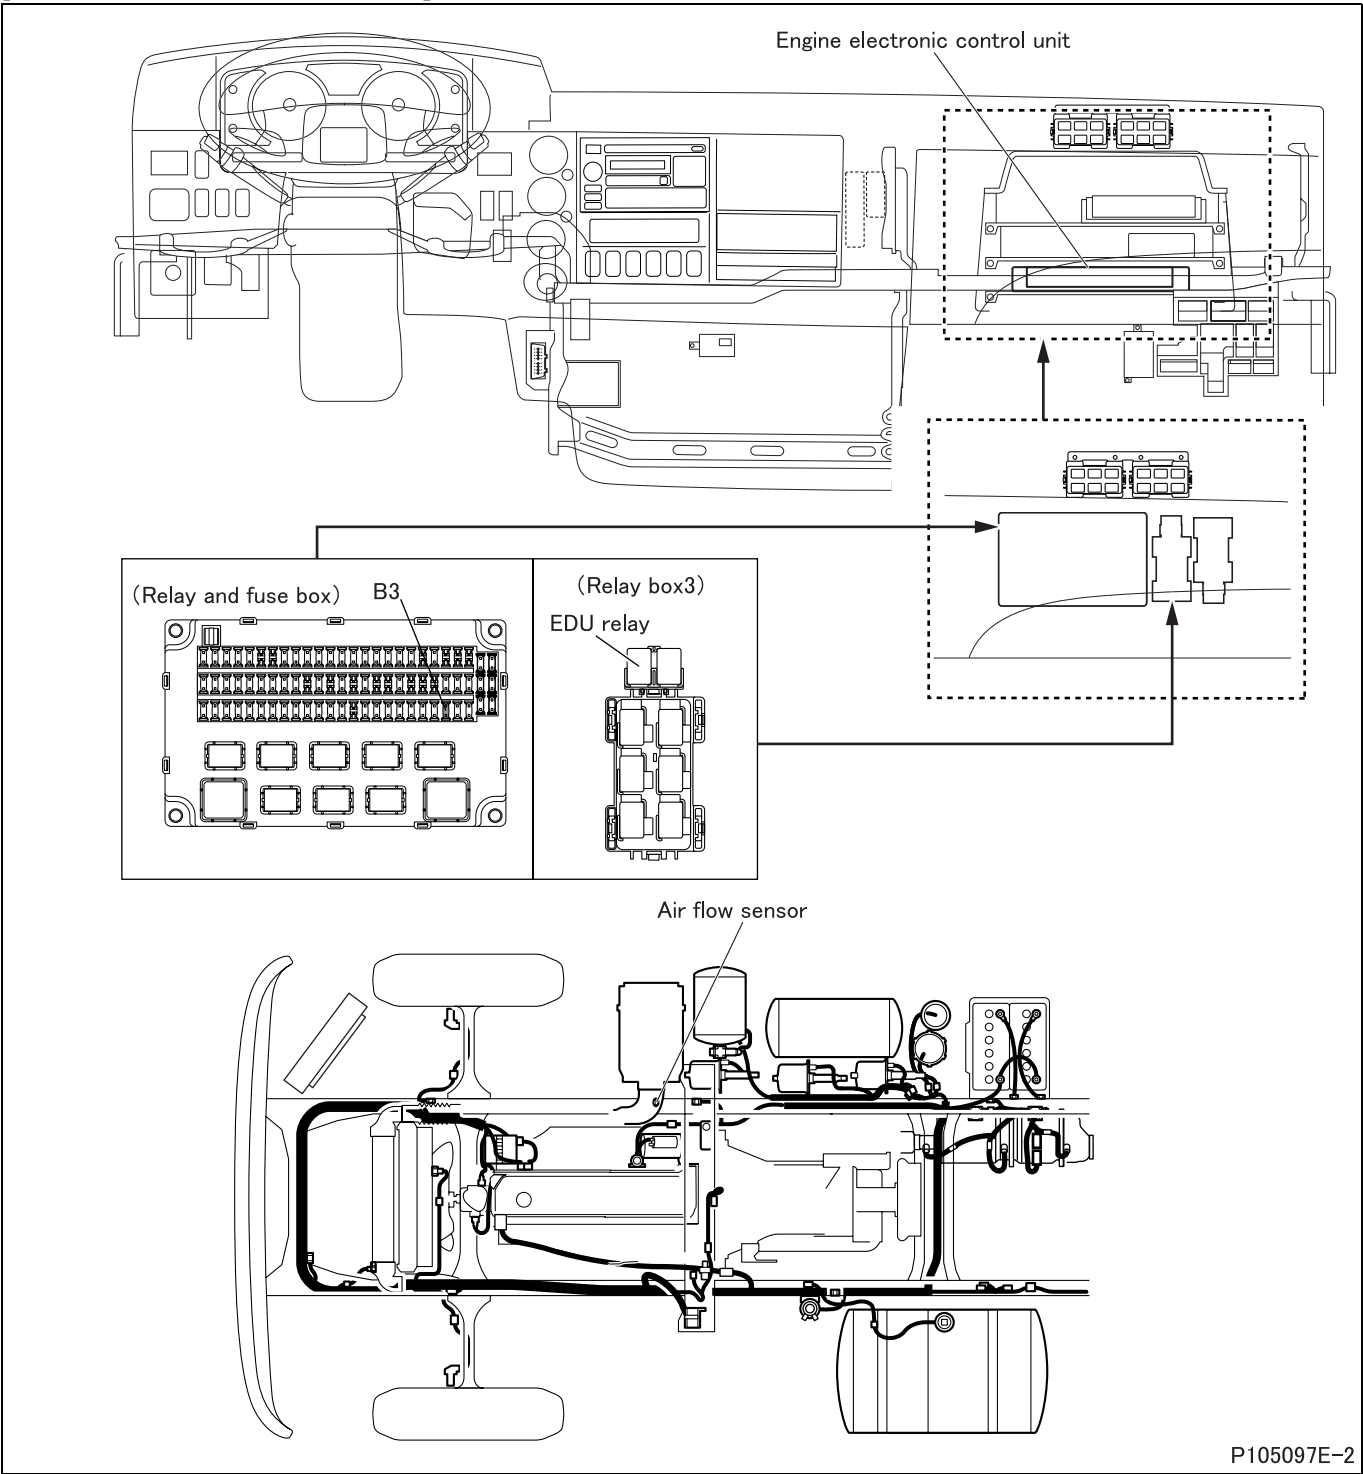
## [Parts Identification and Location]

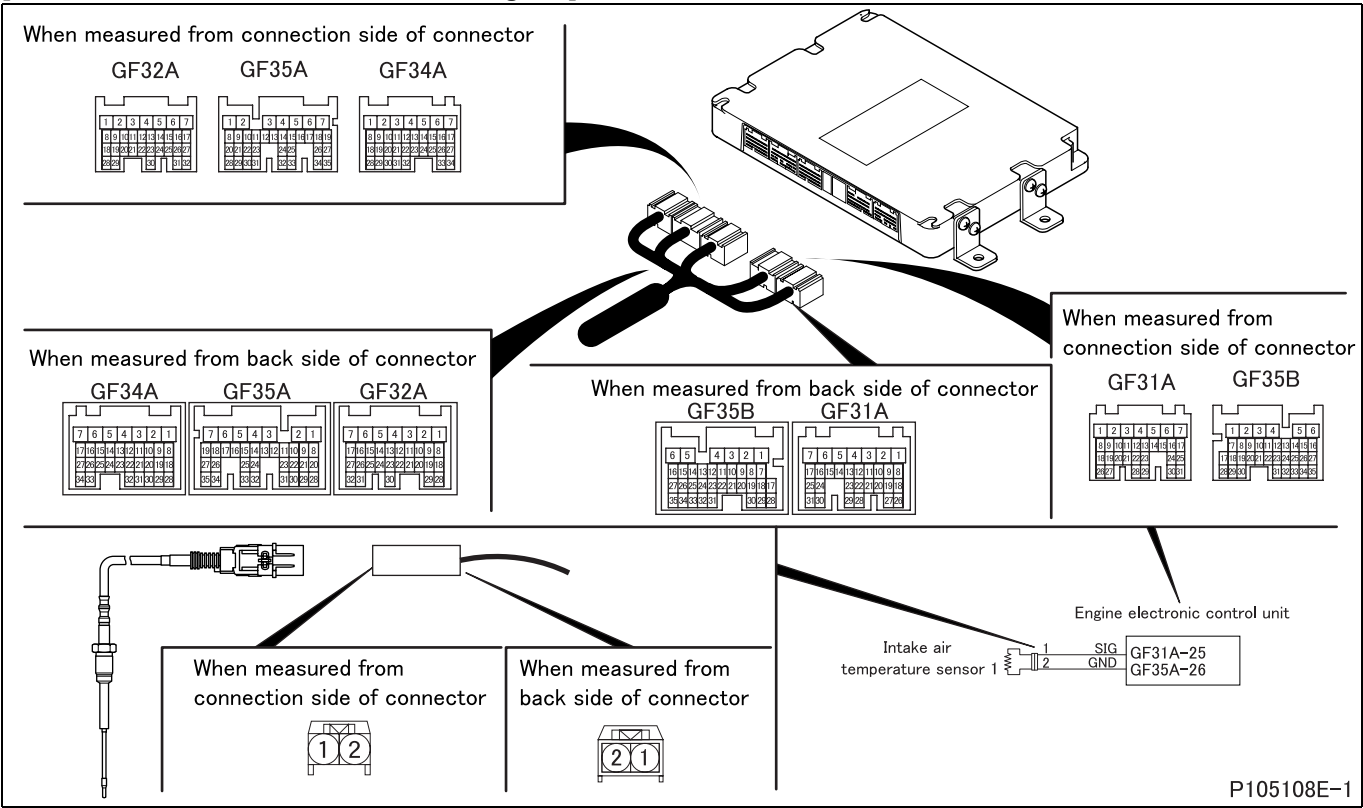
## [Electronic Control Unit Connection Diagram]

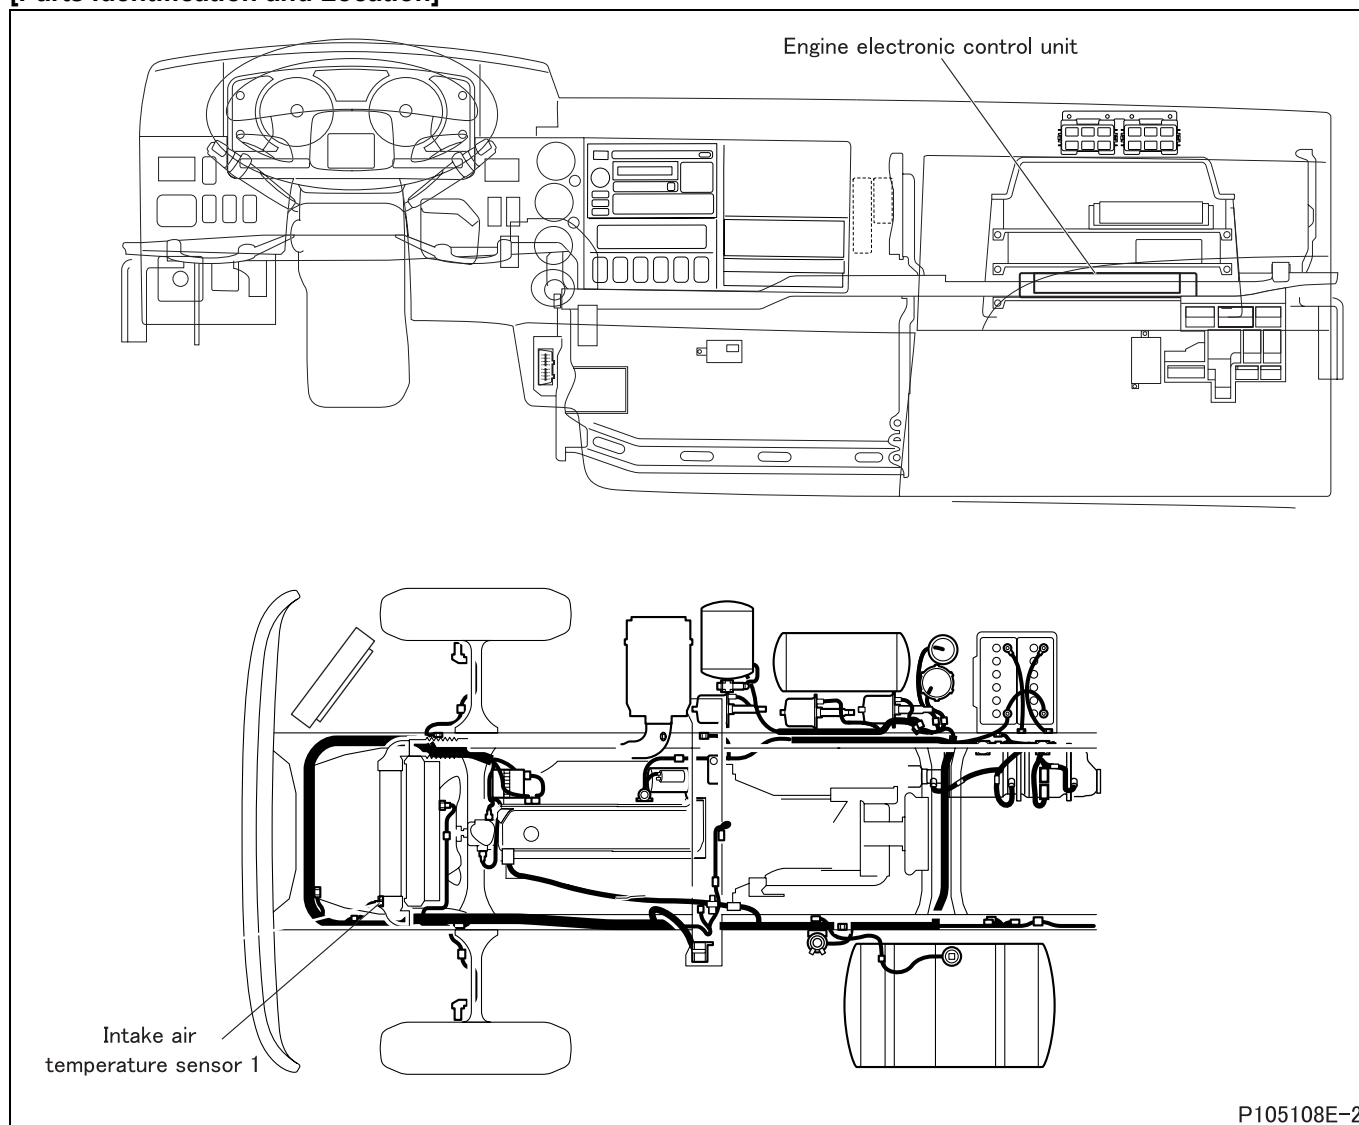
## [Parts Identification and Location]

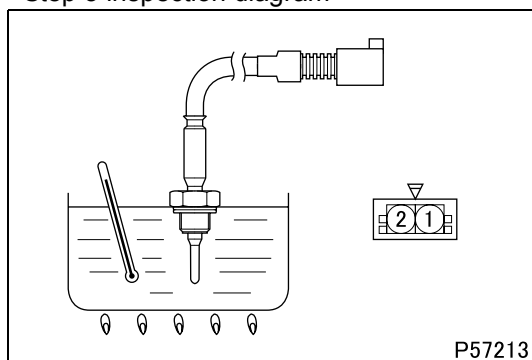
&lt;Step 5 inspection diagram&gt;

| | Inspection condition | | <ul style="list-style-type: none"> <li>• Put intake air temperature sensor 1 in vessel filled with engine oil.</li> <li>• Heat the oil to each of the specified temperatures. Stir the oil well while doing so.</li> </ul> |

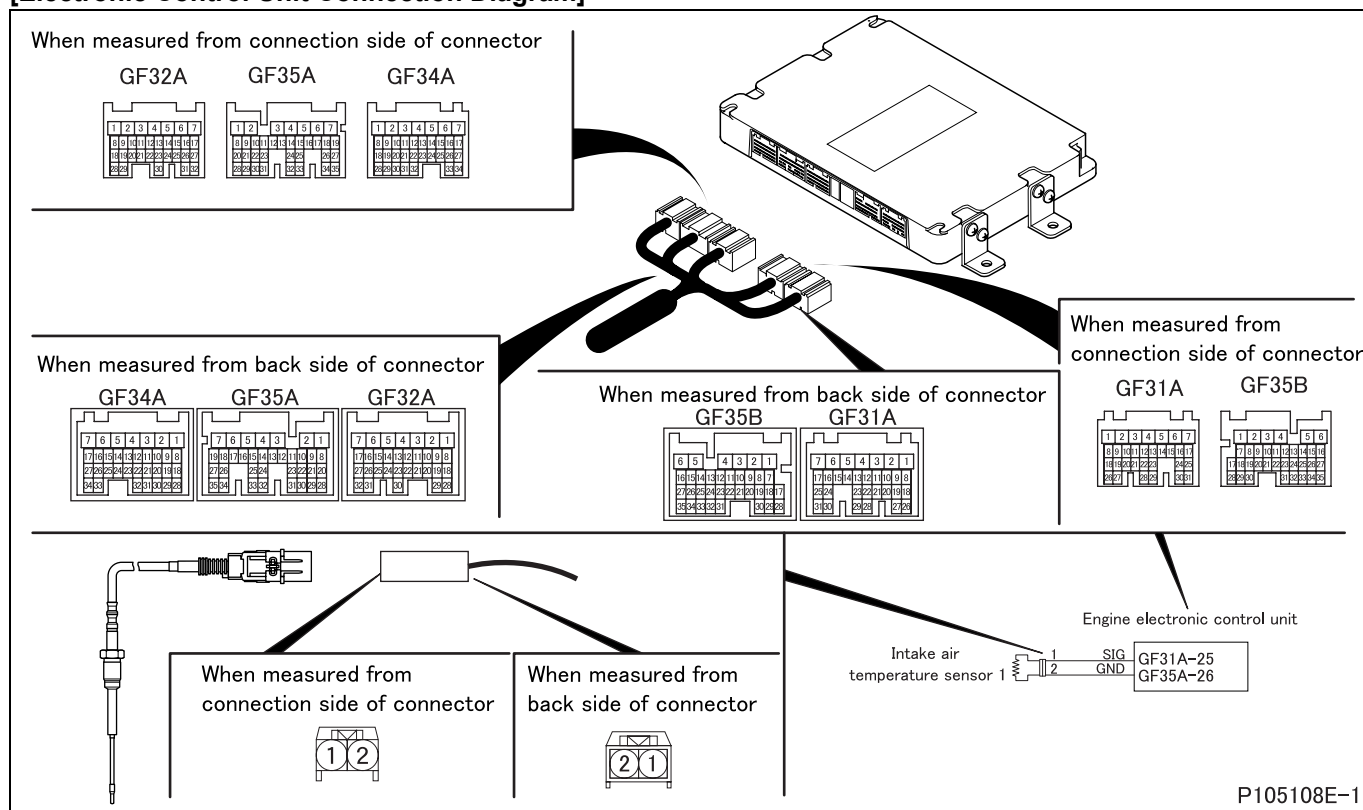
## [Electronic Control Unit Connection Diagram]

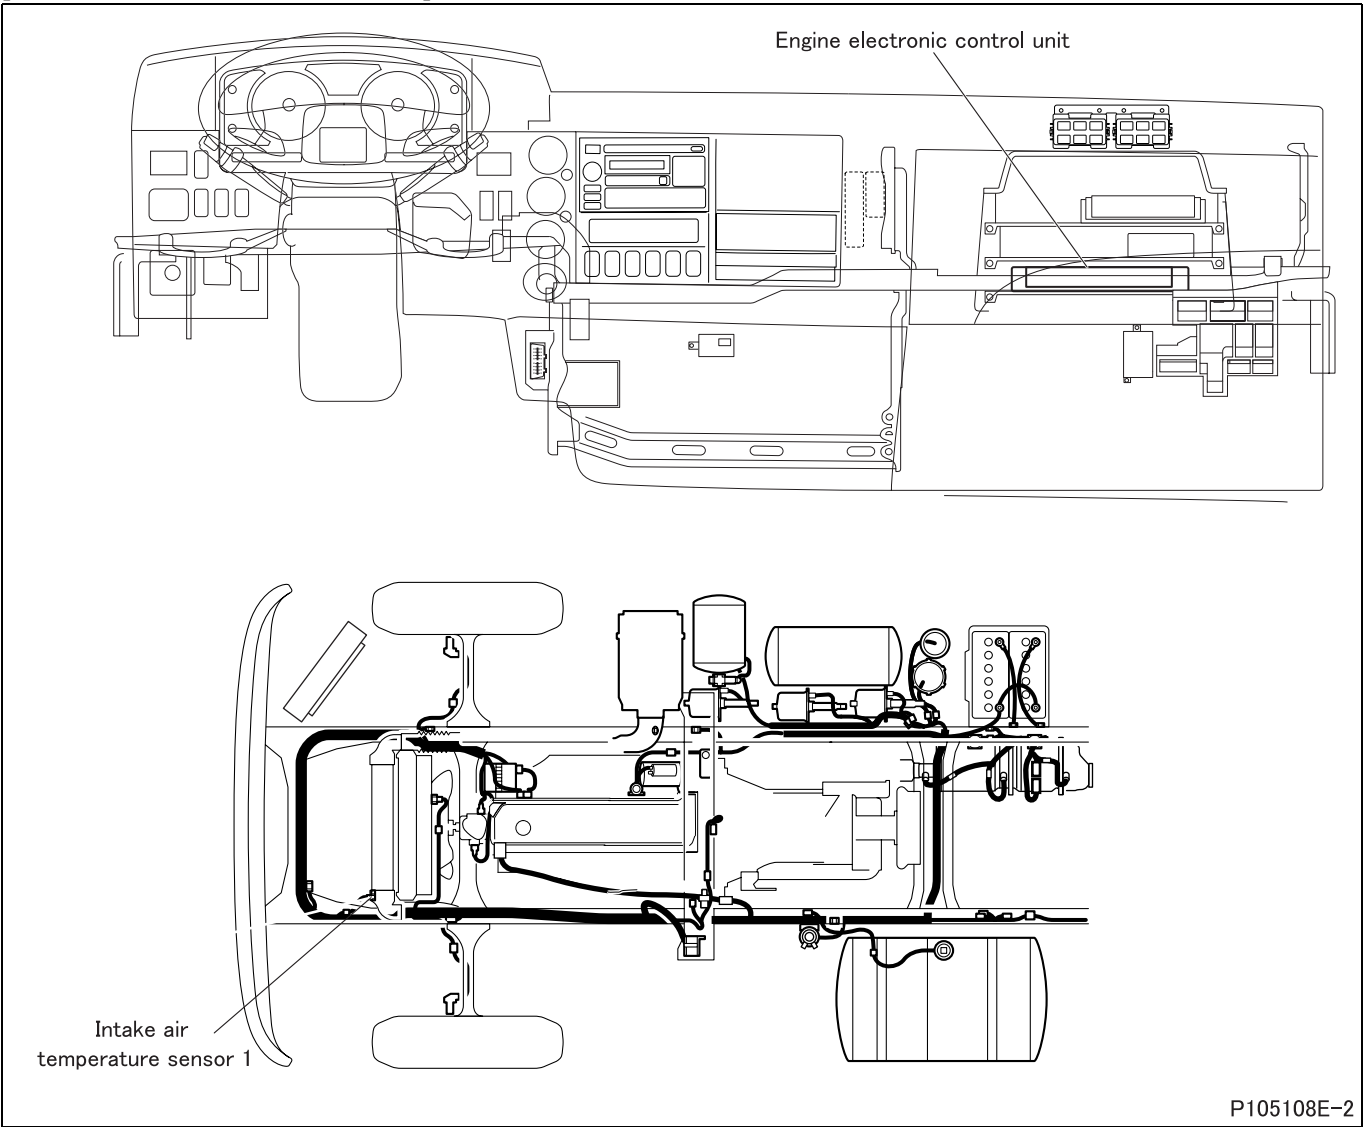
## [Parts Identification and Location]

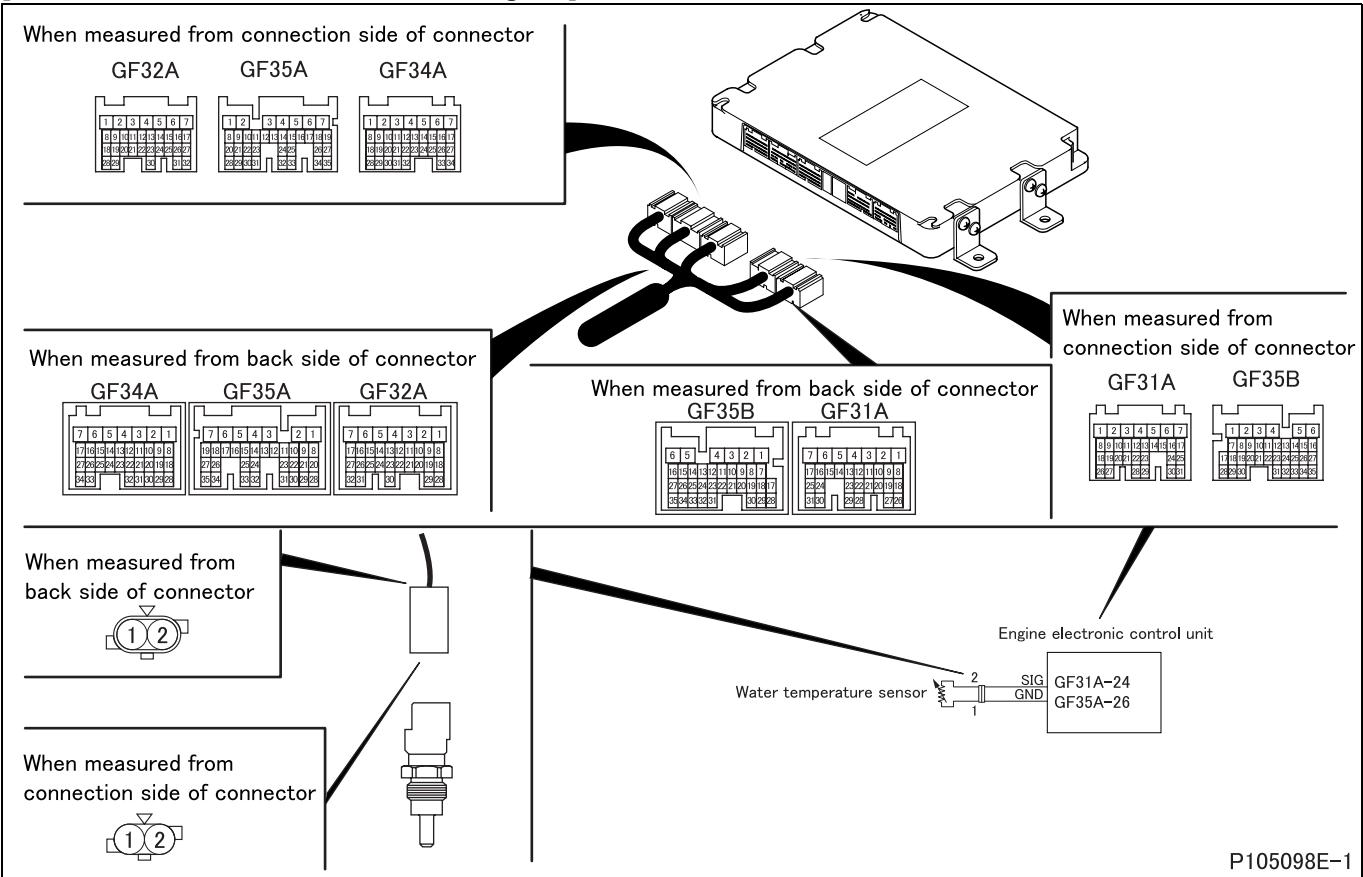
## [Electronic Control Unit Connection Diagram]

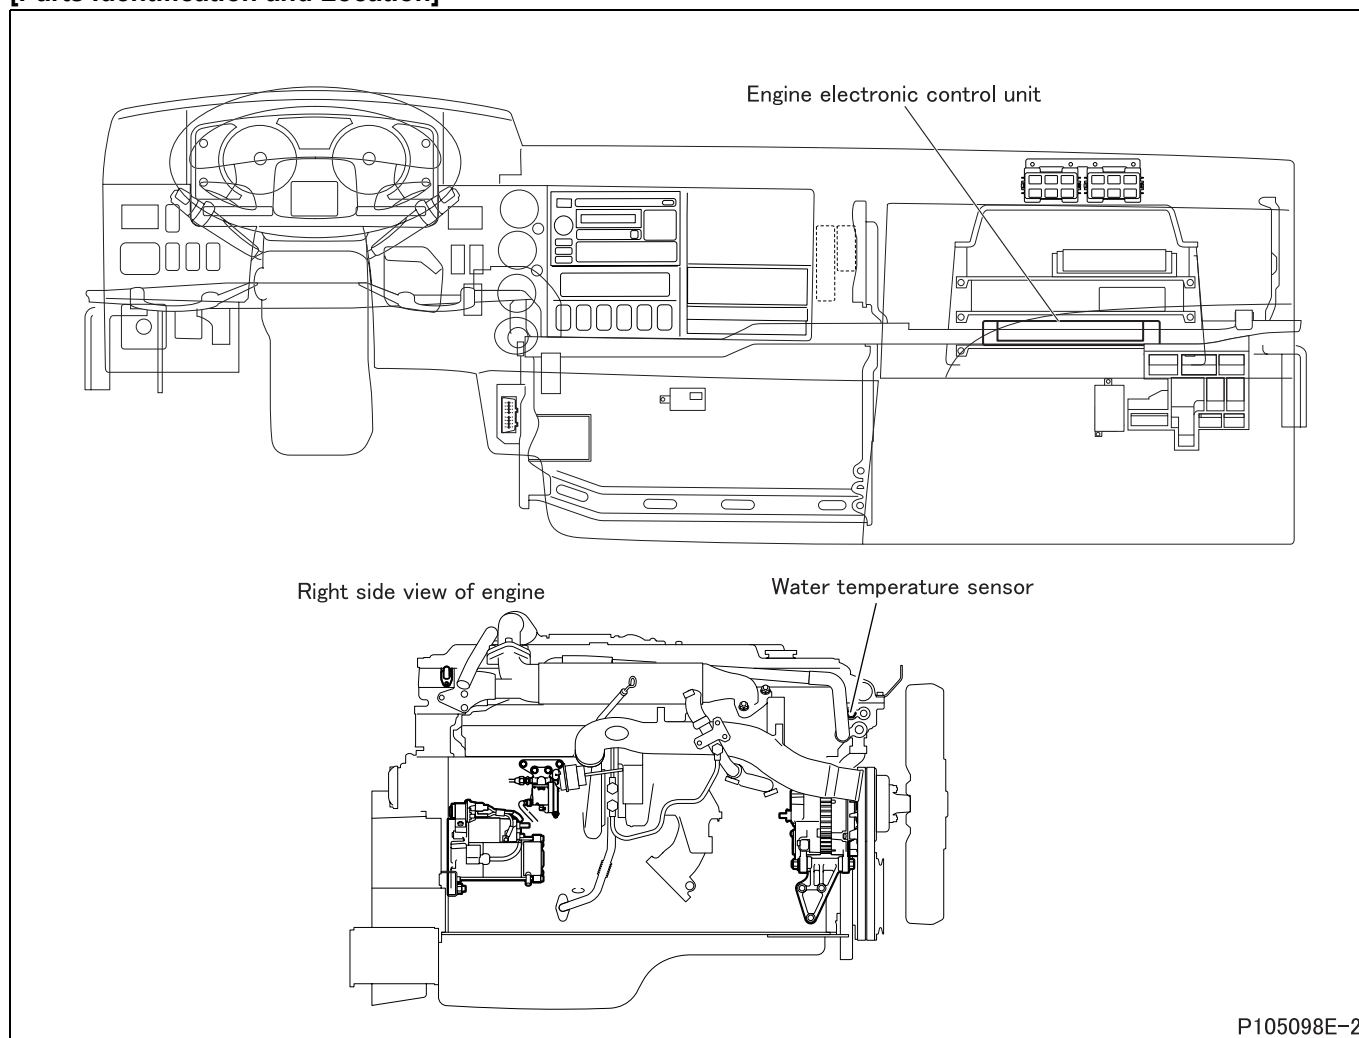
## [Parts Identification and Location]

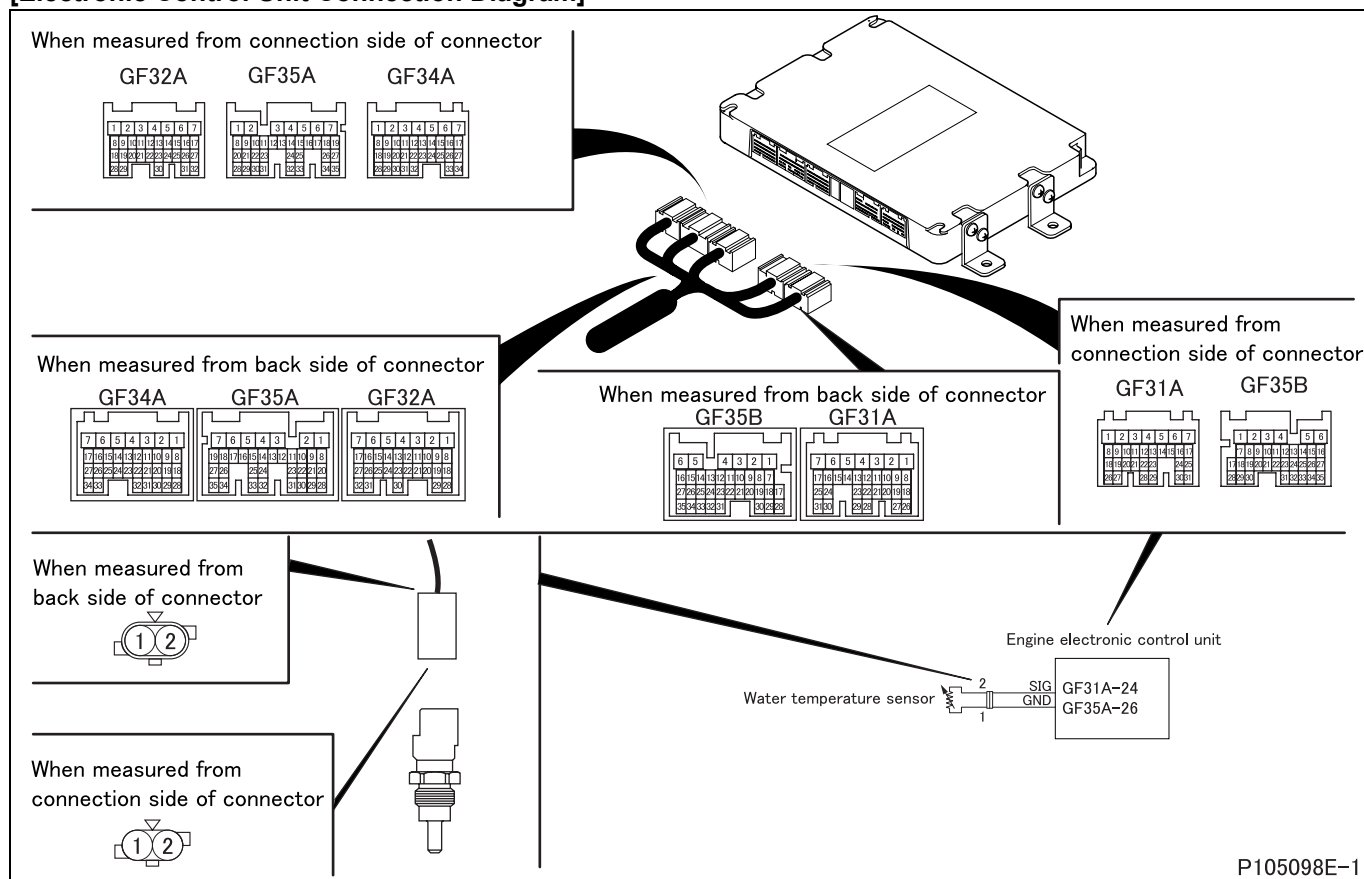
## [Electronic Control Unit Connection Diagram]

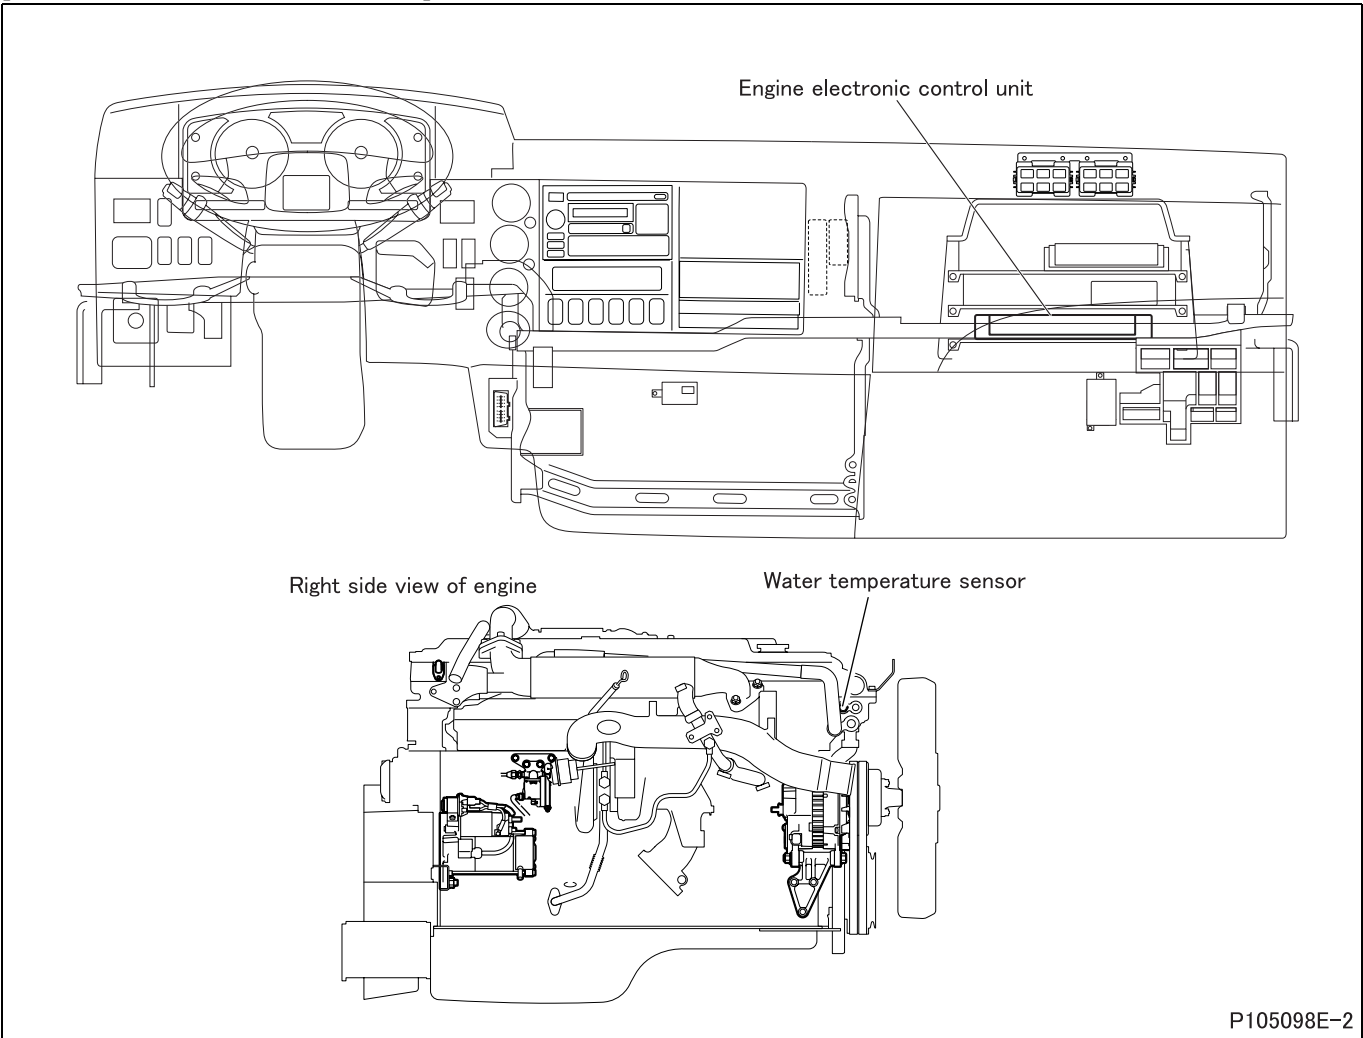
## [Parts Identification and Location]

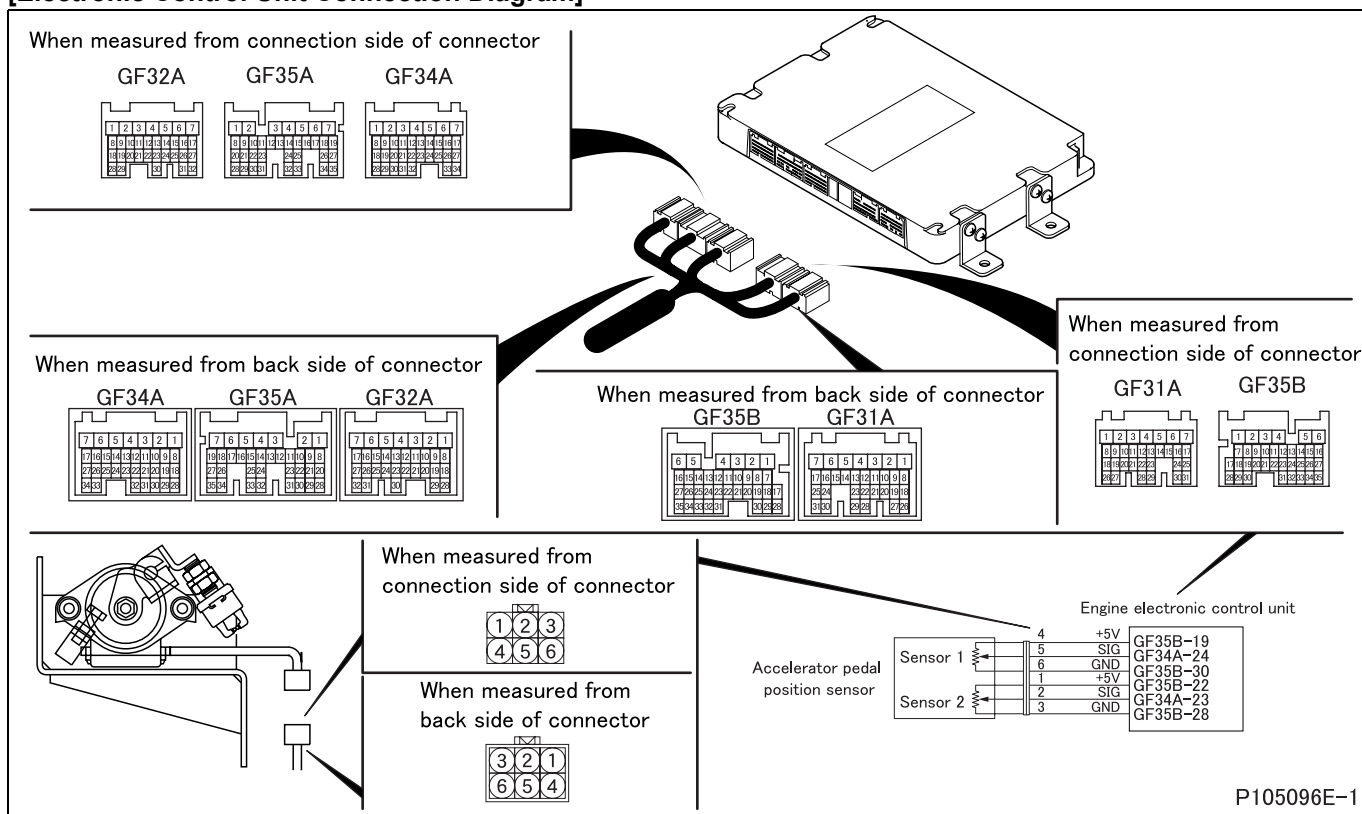
## [Electronic Control Unit Connection Diagram]

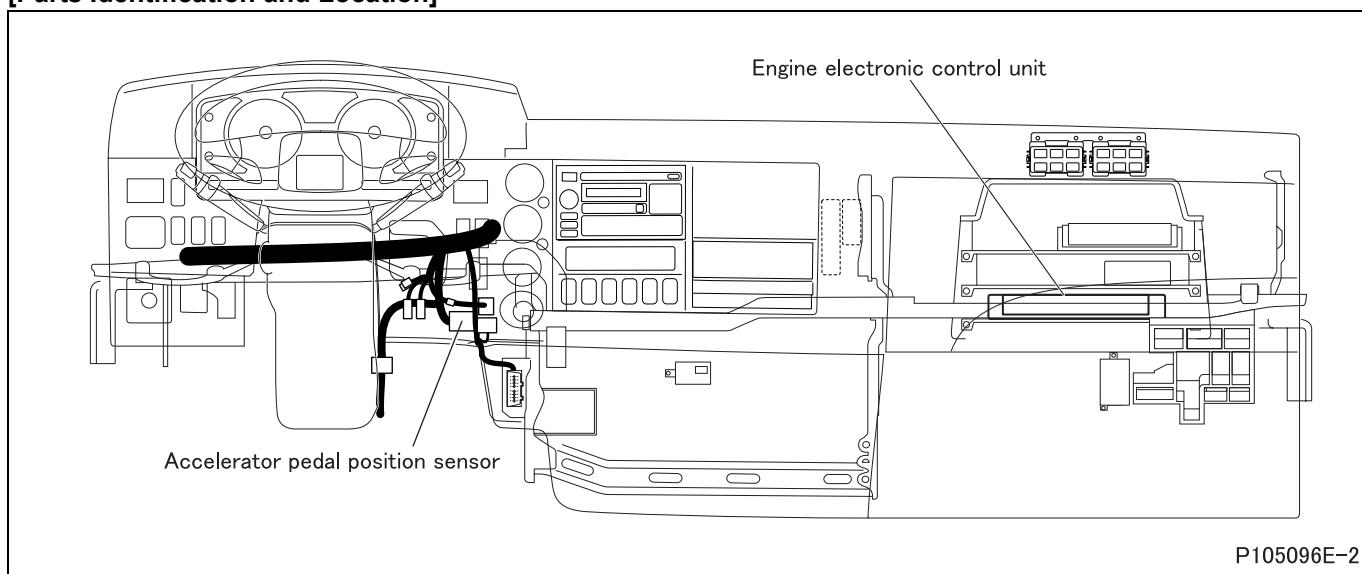
## [Parts Identification and Location]

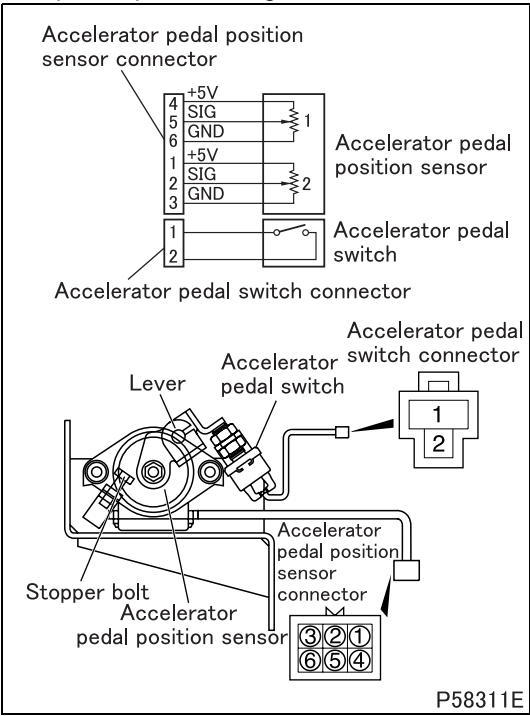
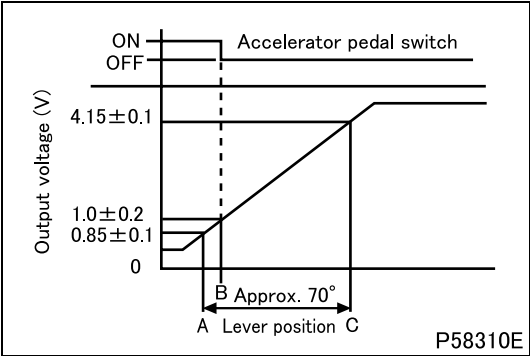
<Step 7 inspection diagram>

| Step 8 | Inspection items | | Inspection by sensor connector |
| | Maintenance item | | Measure value of voltage between connector terminal No. 4 (+) and 6 (-). |

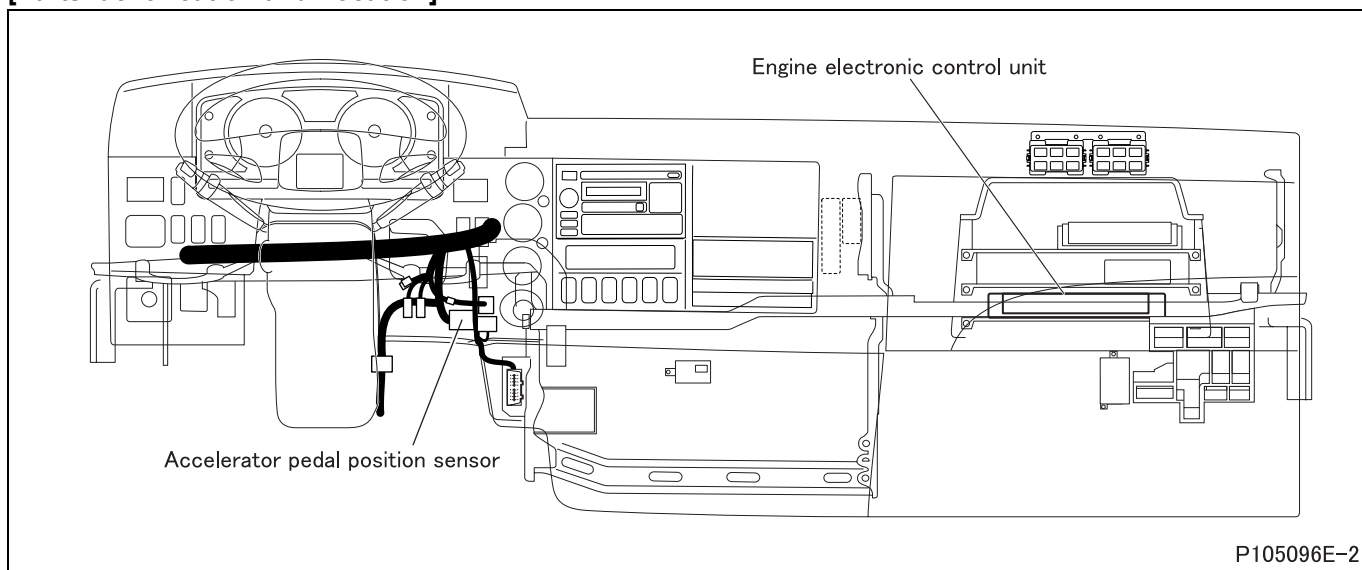
## [Parts Identification and Location]
