# FE.FG

## SERVICE MANUAL 2008 Model FOREWORD

This Service Manual contains maintenance and repair methods for the Mitsubishi Fuso Truck FE. FG Series. Read this manual carefully as an aid in providing correct, efficient maintenance. Please note that the information and specifications contained within this manual may change without notice. This is due to product modifications and continued vehicle improvements that are made throughout the model years. Should you encounter any discrepancy in the information provided, please do not hesitate to contact your nearest Mitsubishi Fuso Dealer or Mitsubishi Fuso Truck of America, Inc.

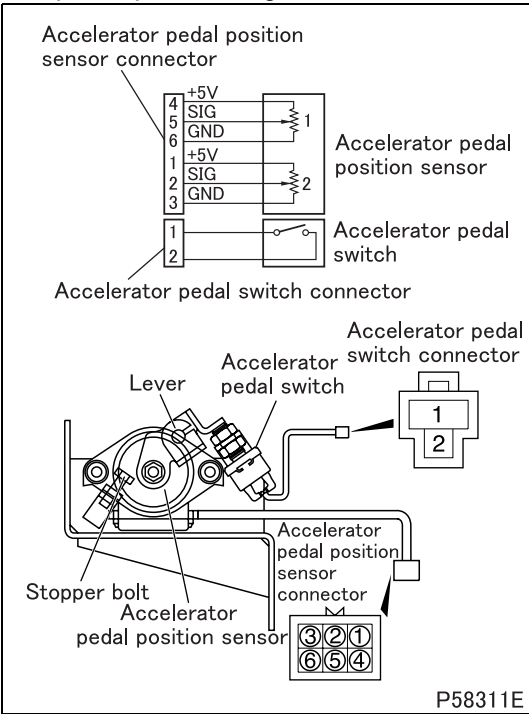
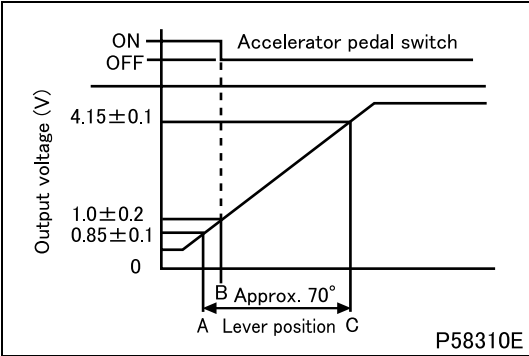
<Step 7 inspection diagram>

| Step 8 | Inspection items | | Inspection by sensor connector |
| | Maintenance item | | Measure value of voltage between connector terminal No. 4 (+) and 6 (-). |

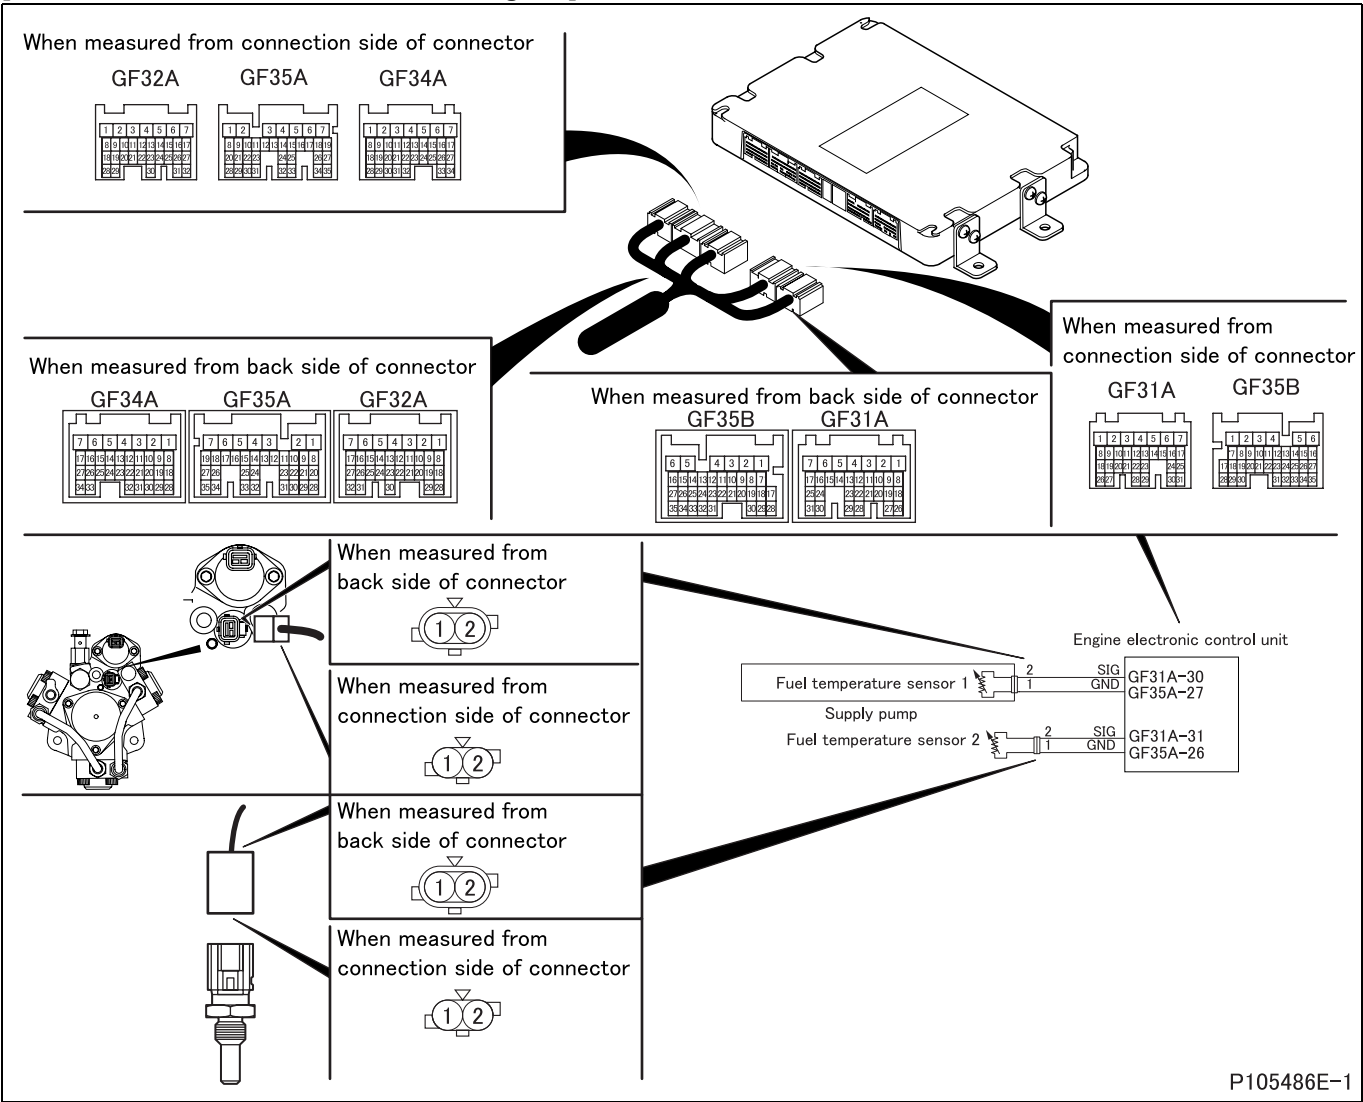
P105486E-1

## [Electronic Control Unit Connection Diagram]

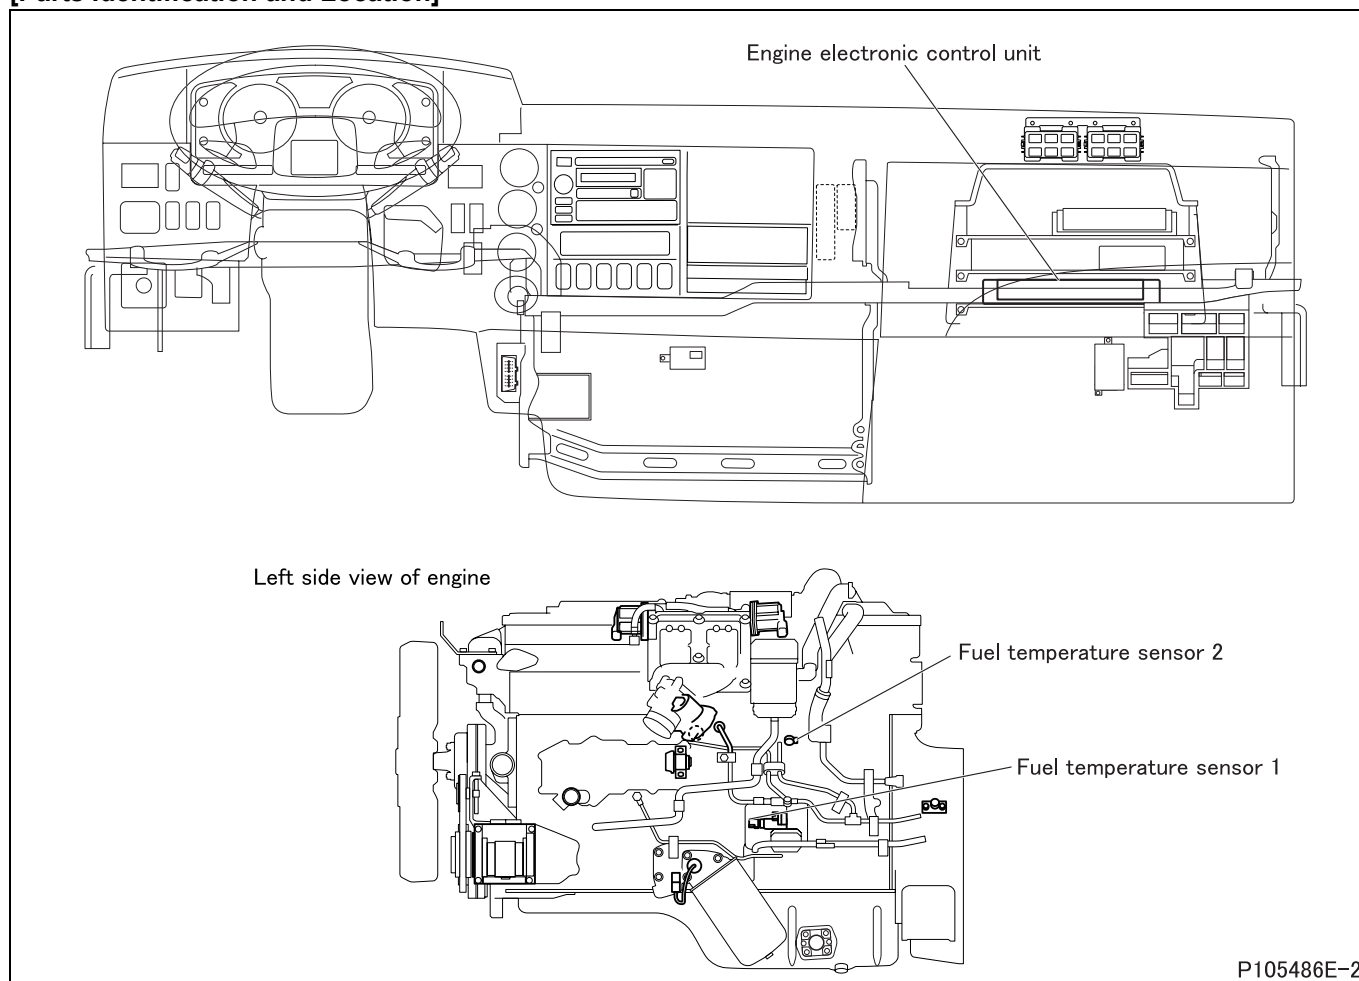
## [Parts Identification and Location]

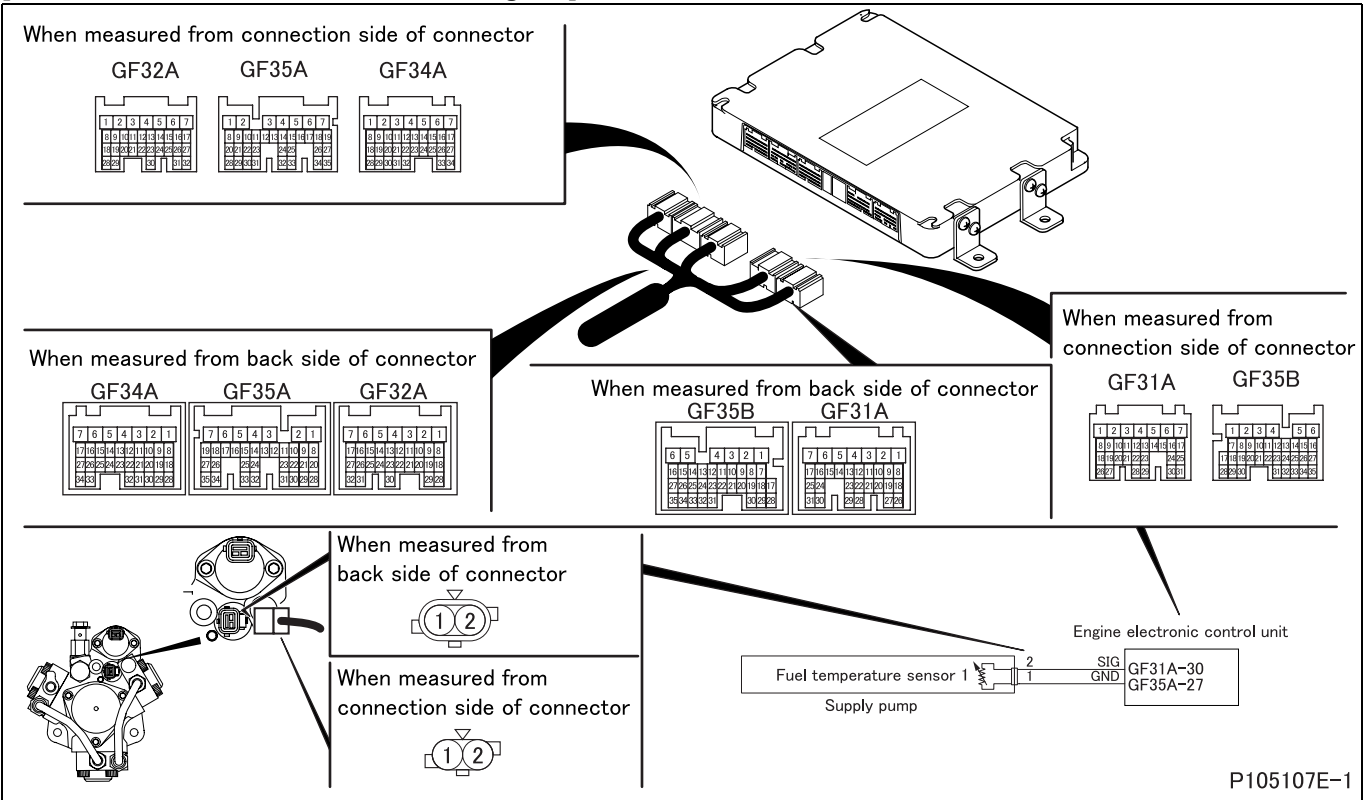
## [Electronic Control Unit Connection Diagram]

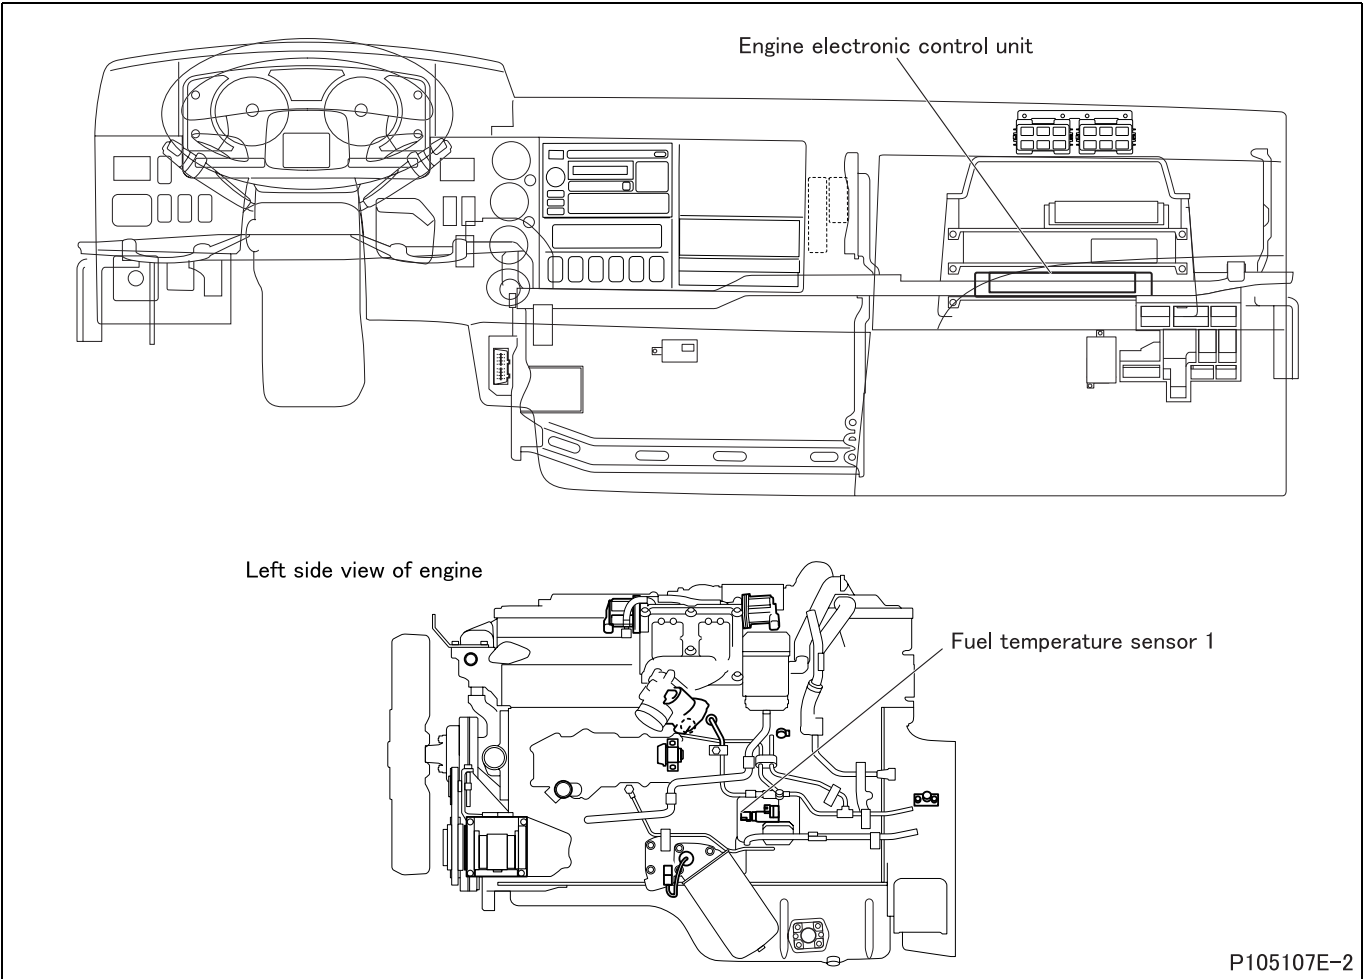
## [Parts Identification and Location]

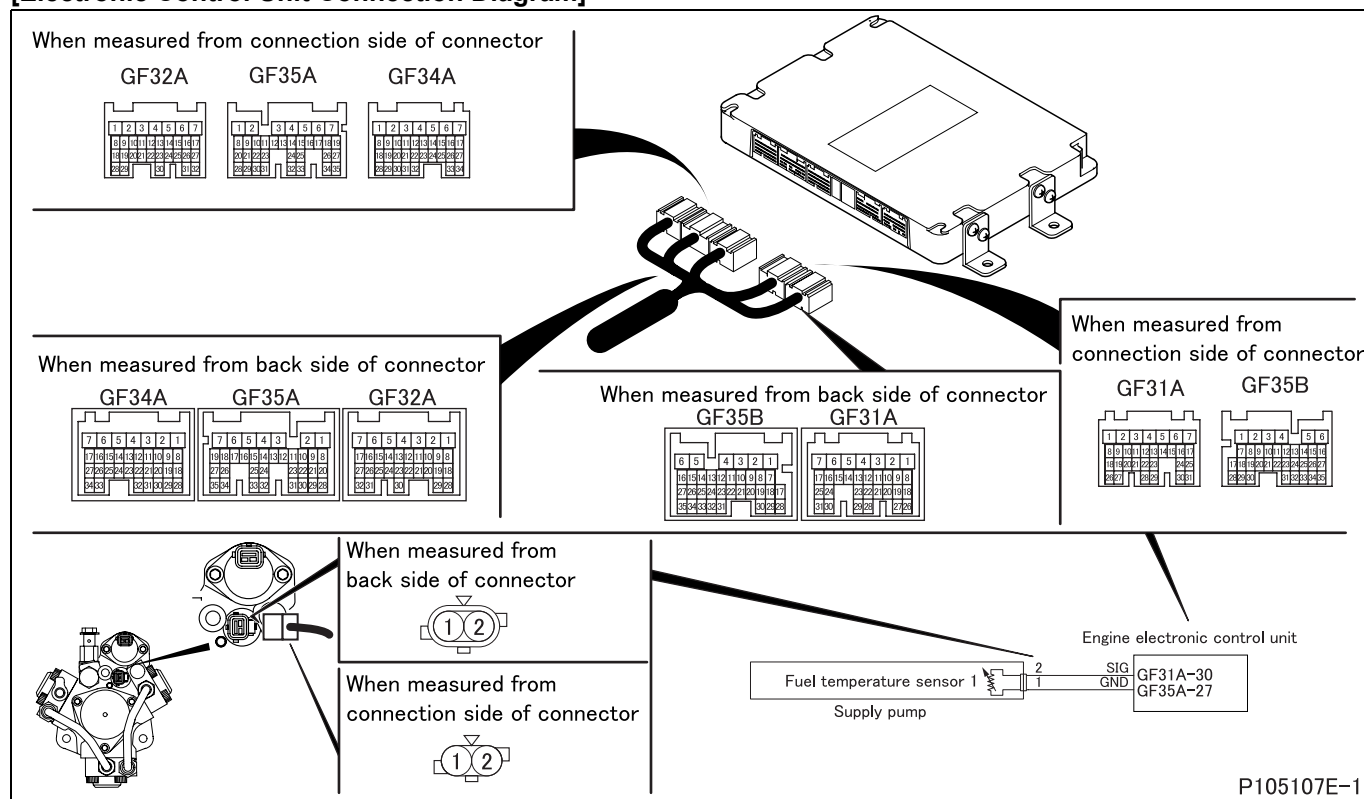
## [Electronic Control Unit Connection Diagram]

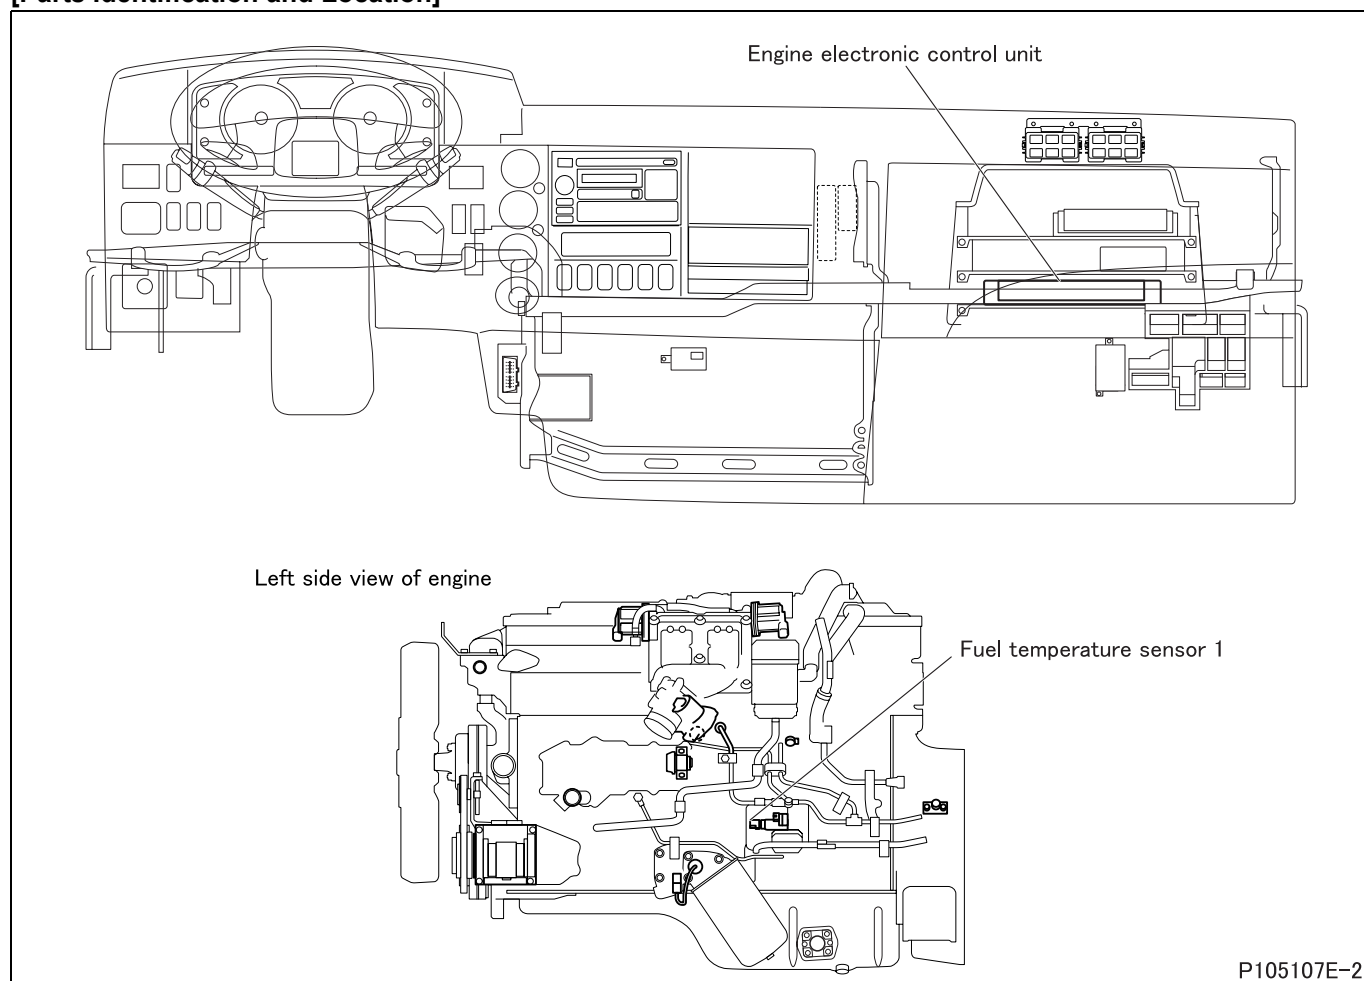
## [Parts Identification and Location]

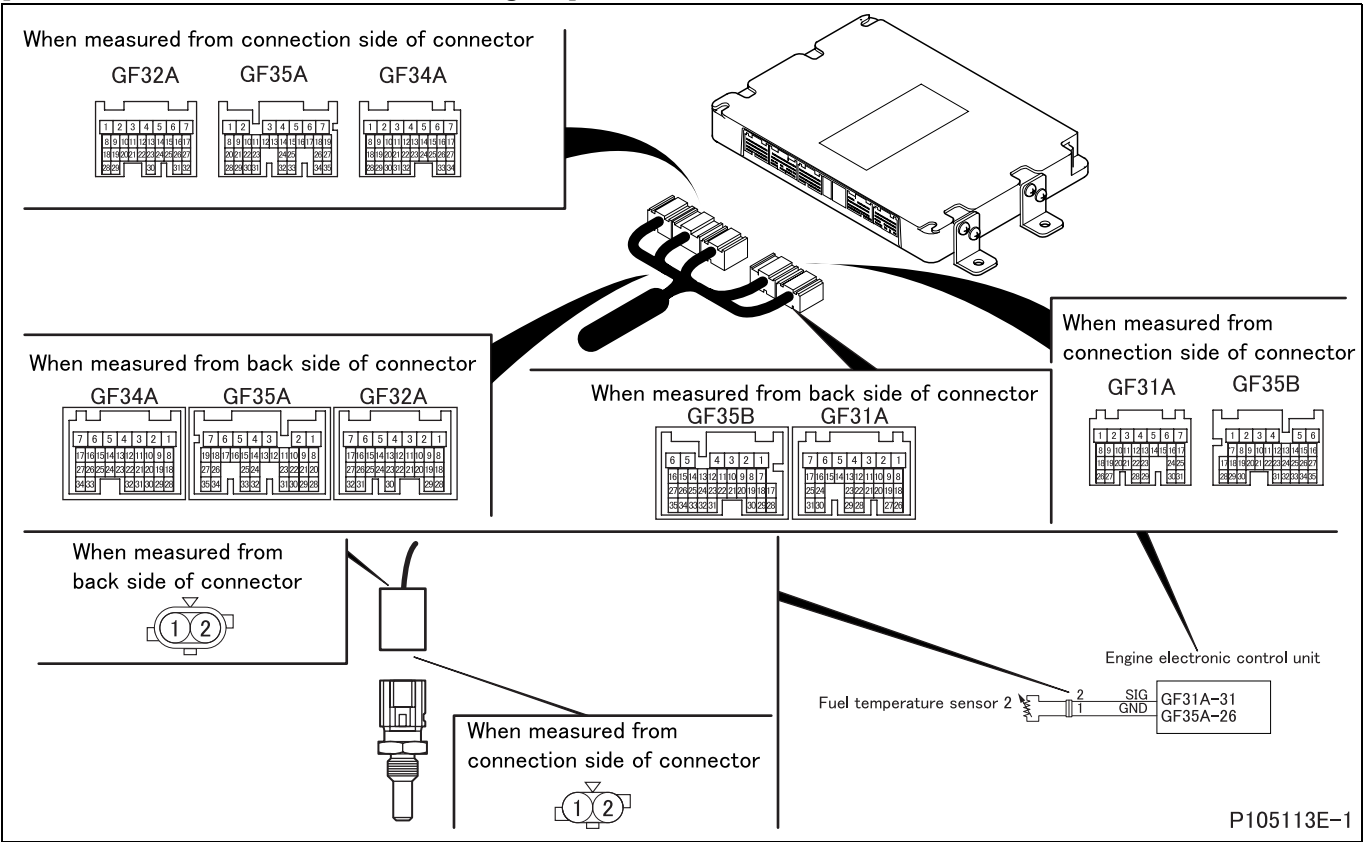
## [Electronic Control Unit Connection Diagram]

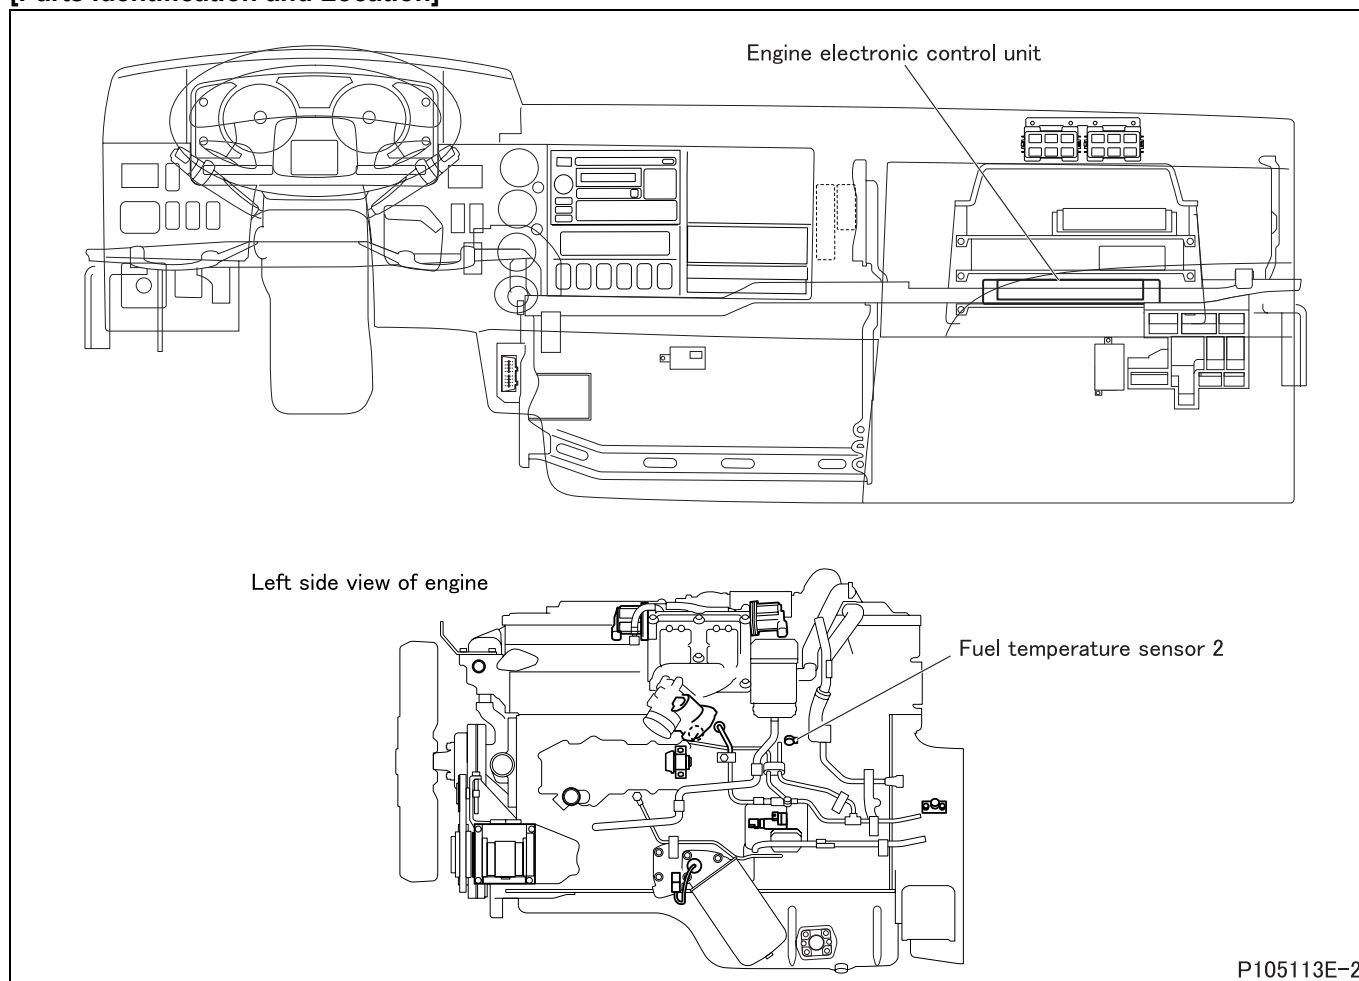
## [Parts Identification and Location]

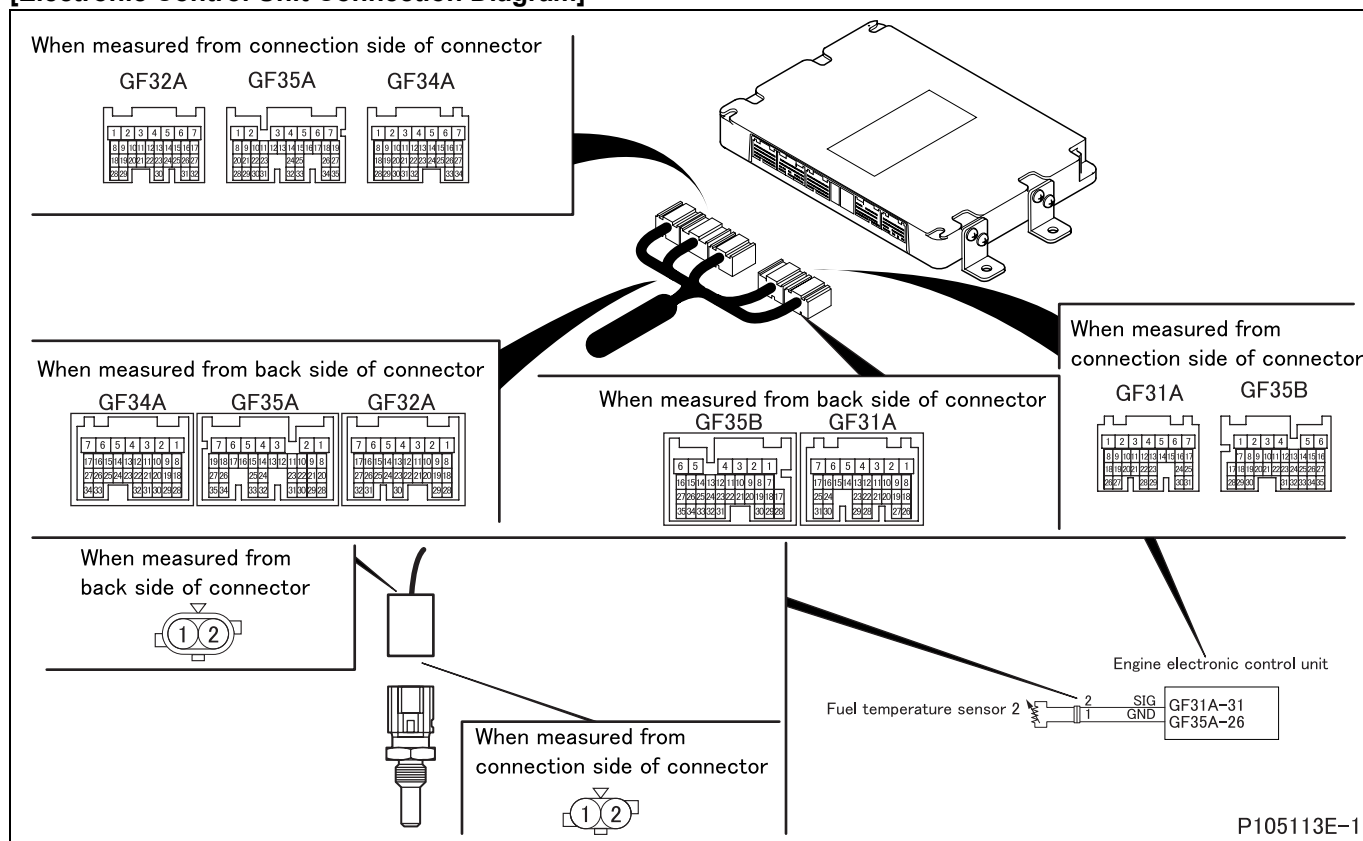
## [Electronic Control Unit Connection Diagram]

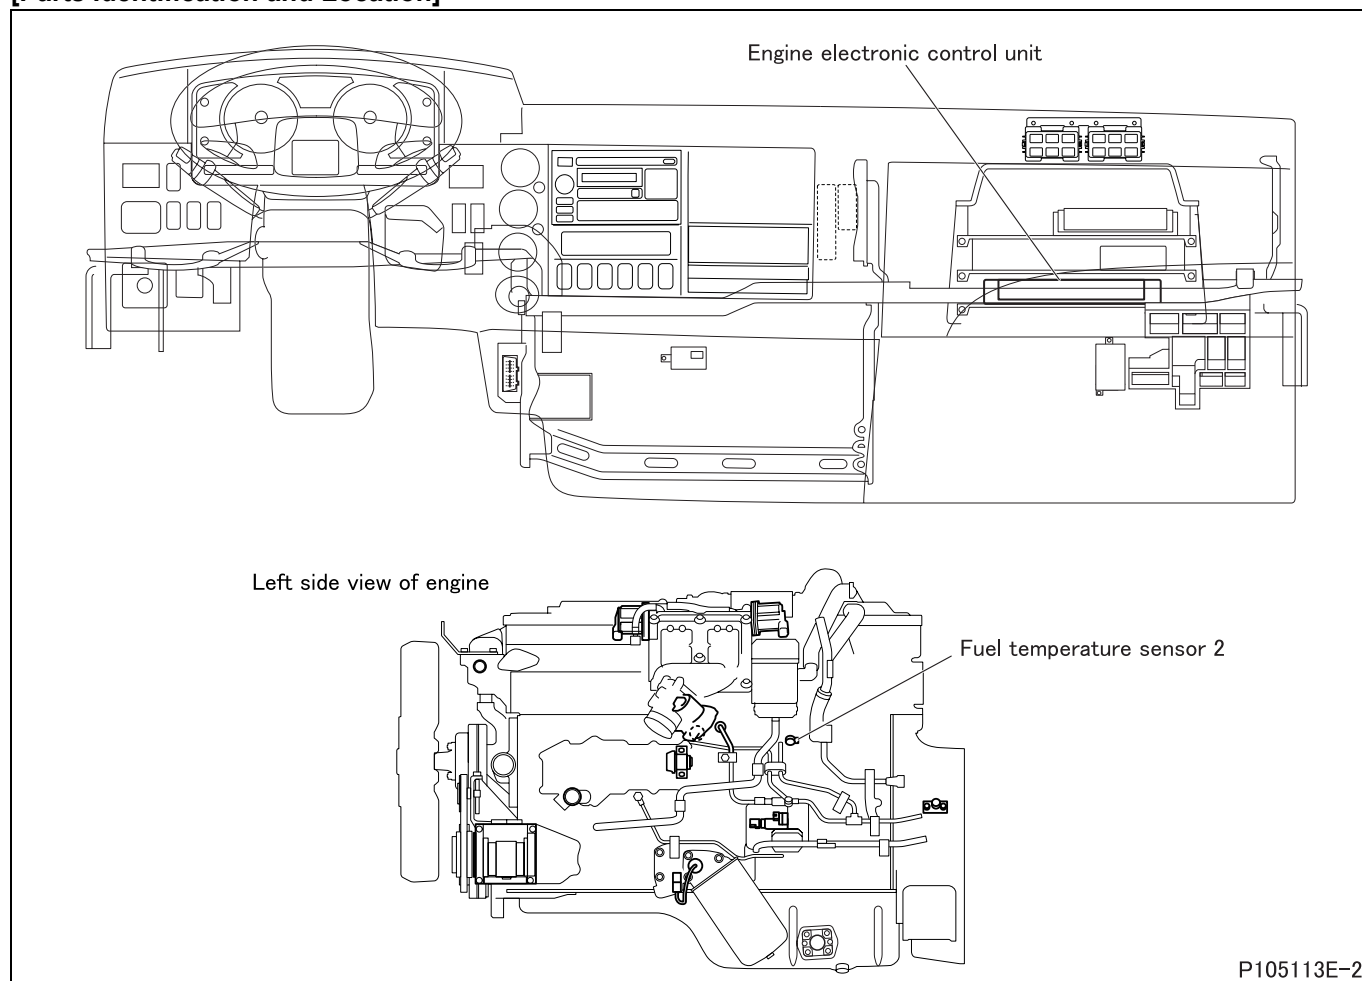
P105113E-2

## [Parts Identification and Location]

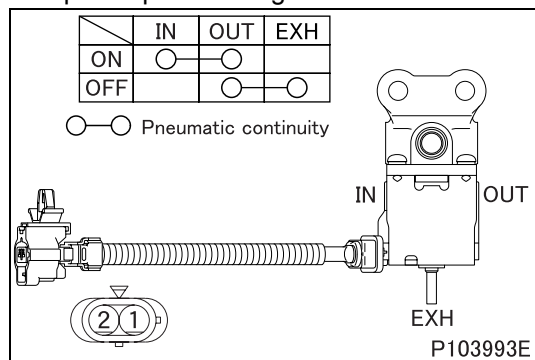
<Step 4 inspection diagram>

| | Inspection condition | | Gradually increase from zero the voltage applied to terminals No. 1 (+) and 2 (–). | |

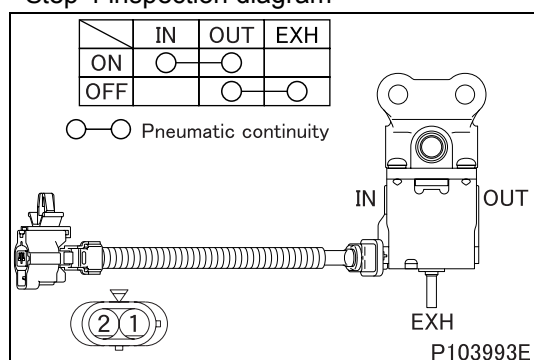
**<Step 4 inspection diagram>**

| | Inspection condition | | Gradually increase from zero the voltage applied to terminals No. 1 (+) and 2 (–). | |

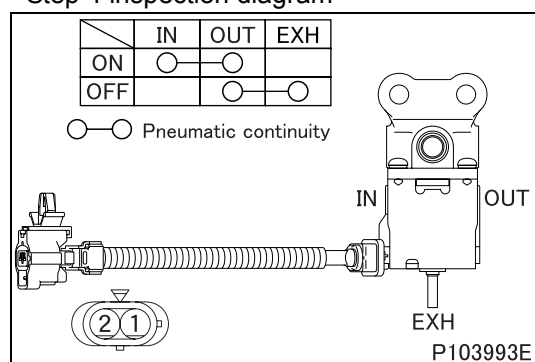
<Step 4 inspection diagram>

| | Inspection condition | | Gradually increase from zero the voltage applied to terminals No. 1 (+) and 2 (–). |

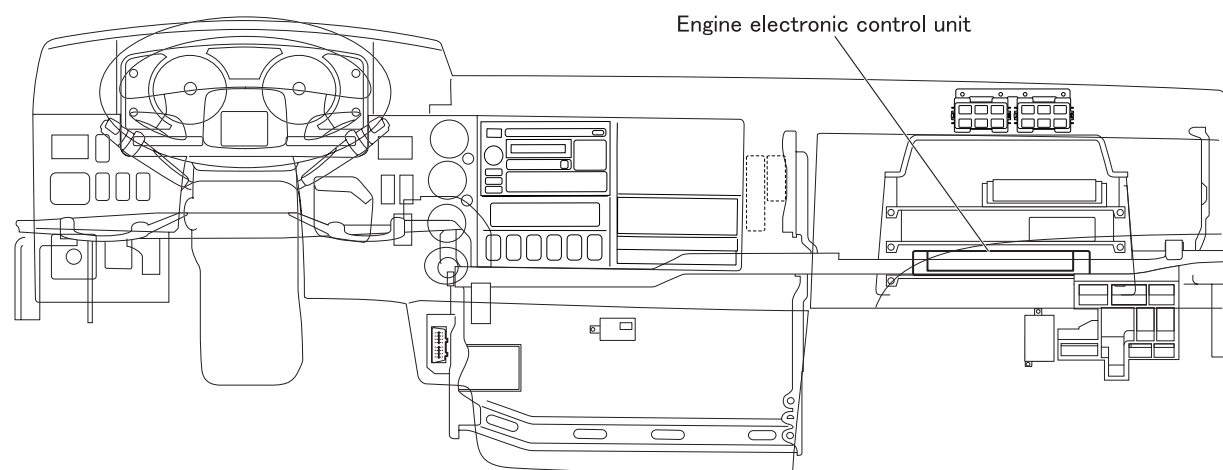
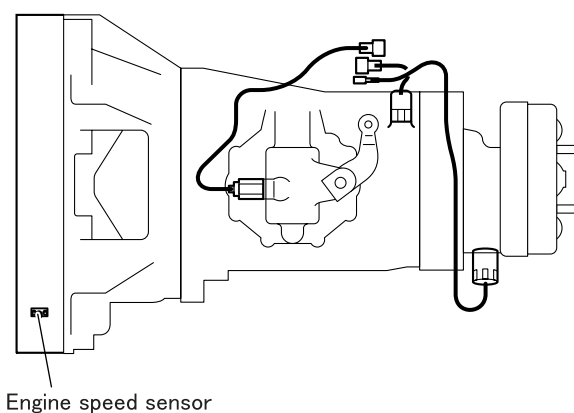
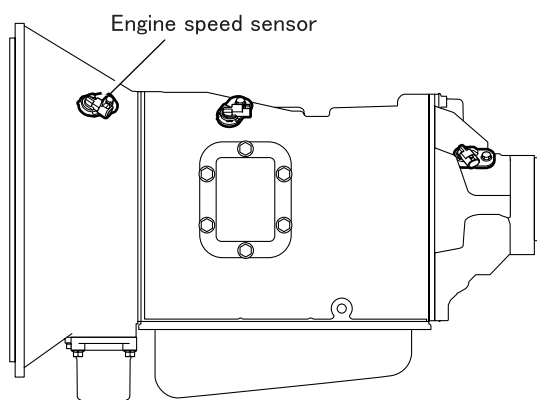
## [Parts Identification and Location]

&lt;Manual transmission&gt;

&lt;Automatic transmission&gt;

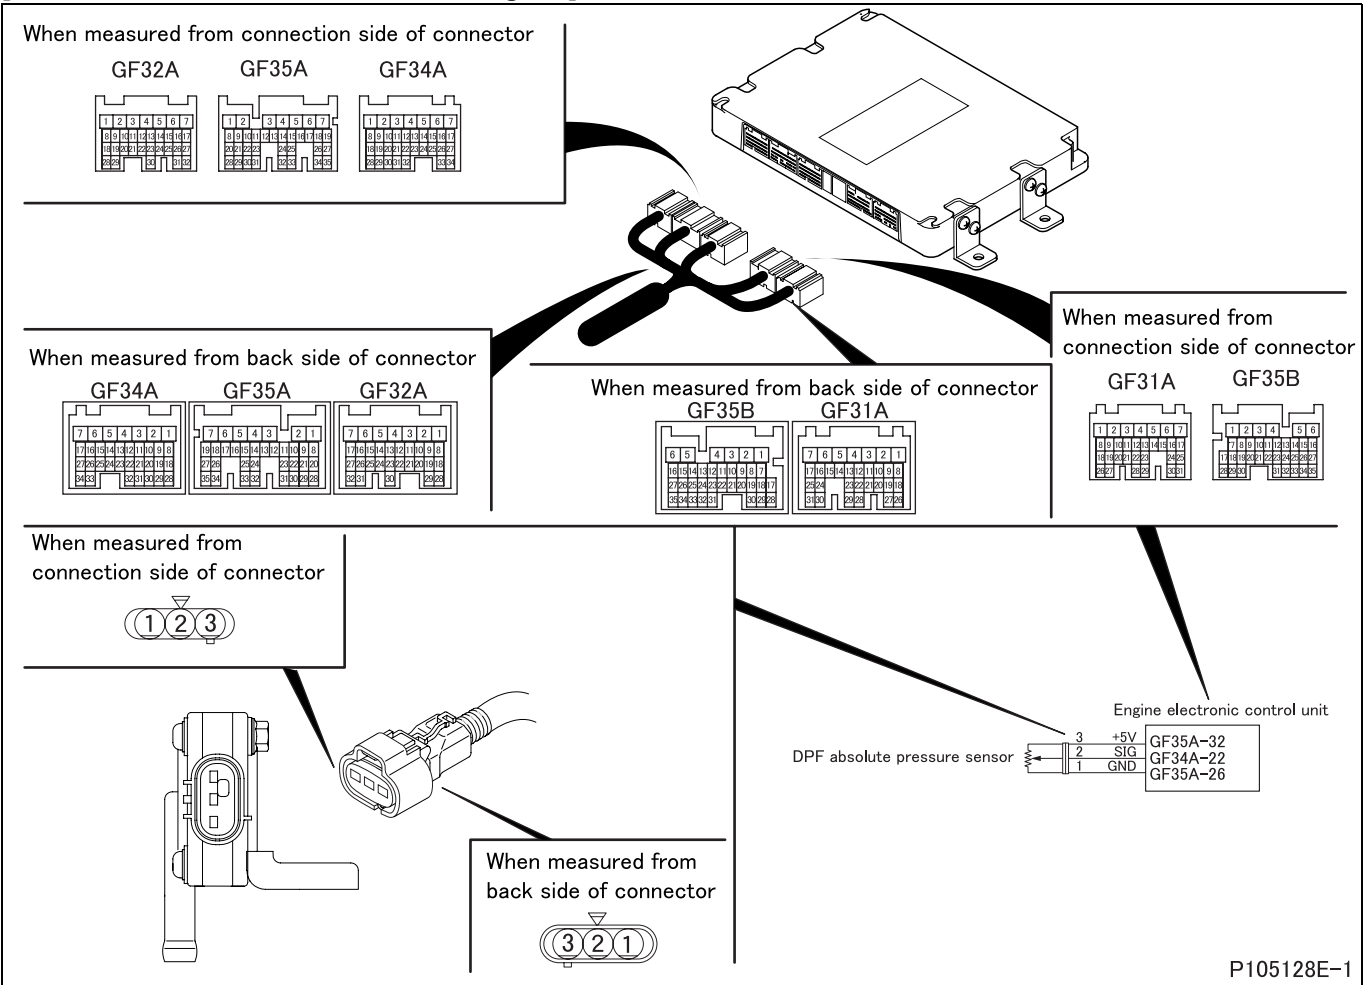
P105128E-1

## [Electronic Control Unit Connection Diagram]

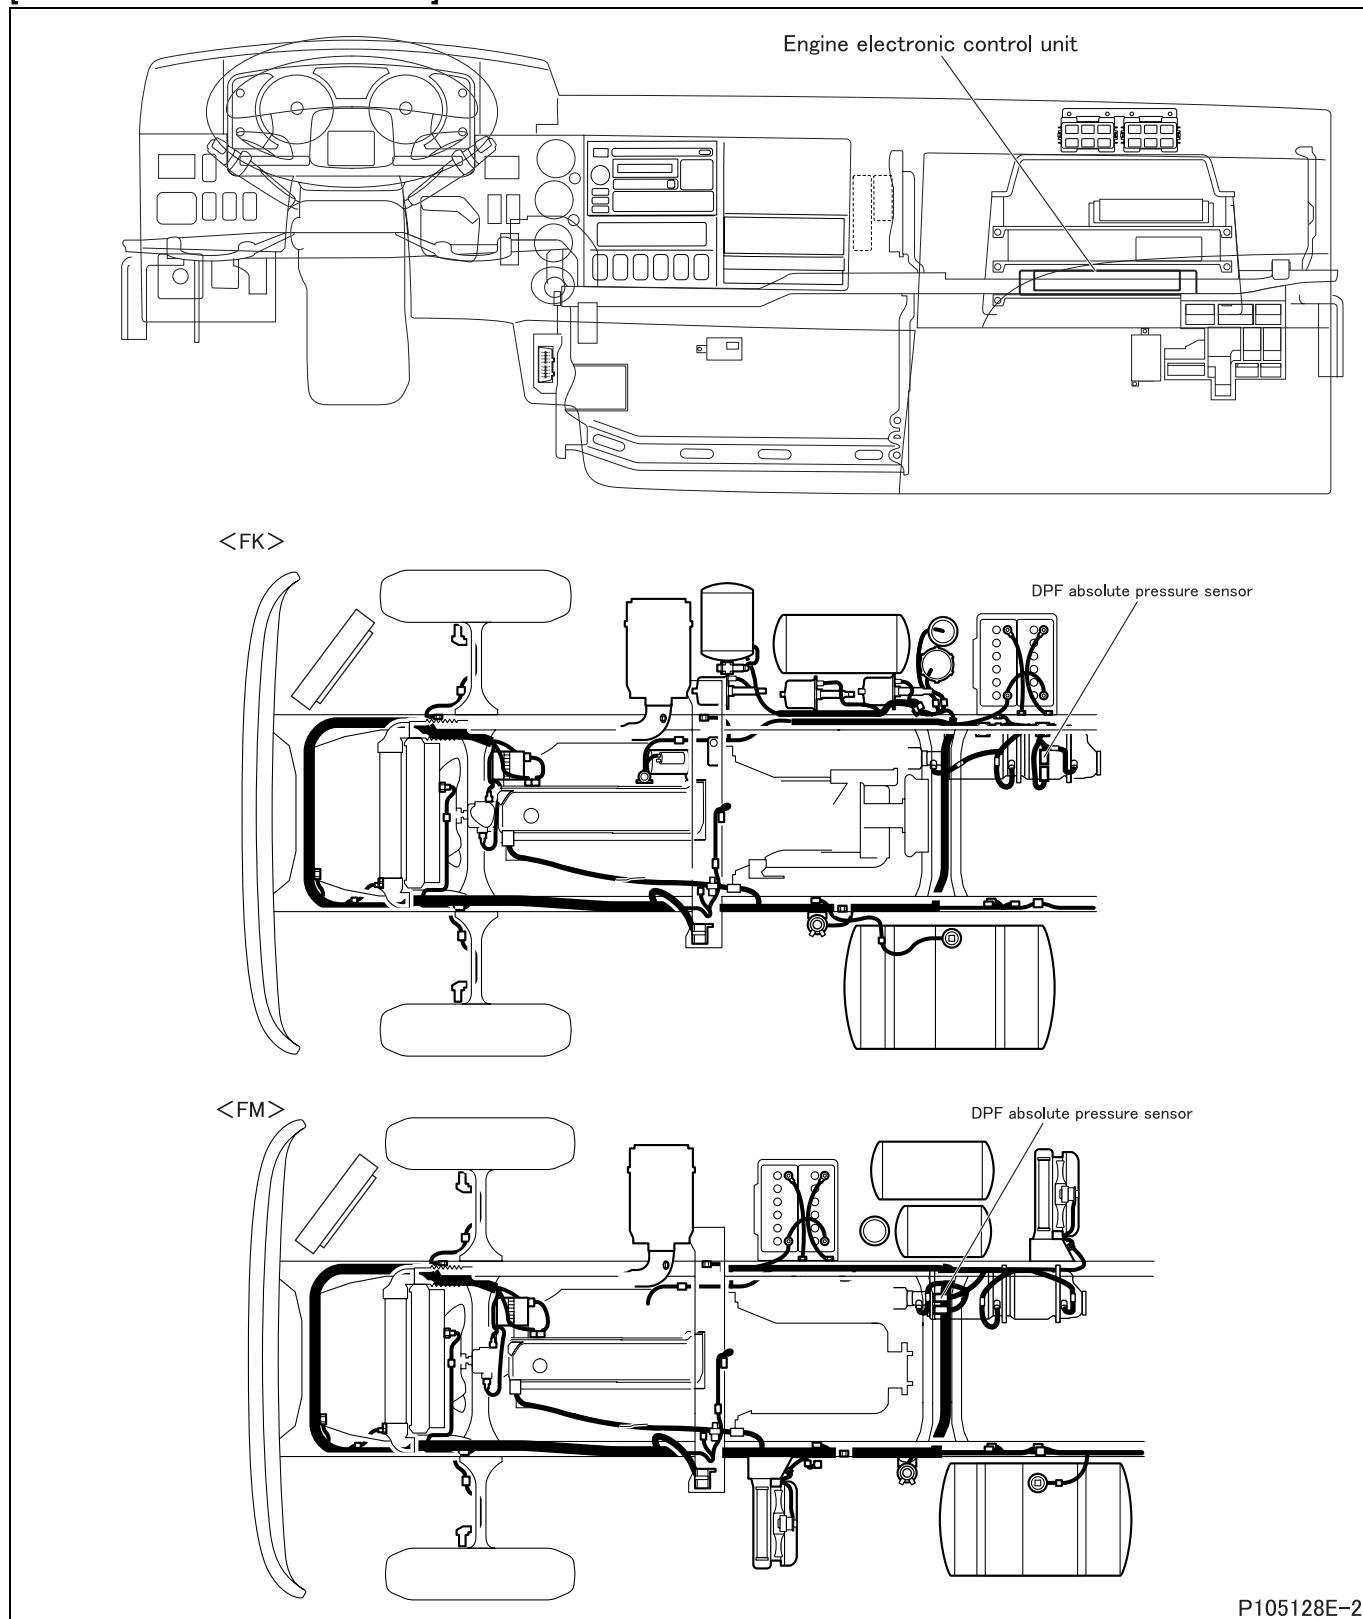
## [Parts Identification and Location]

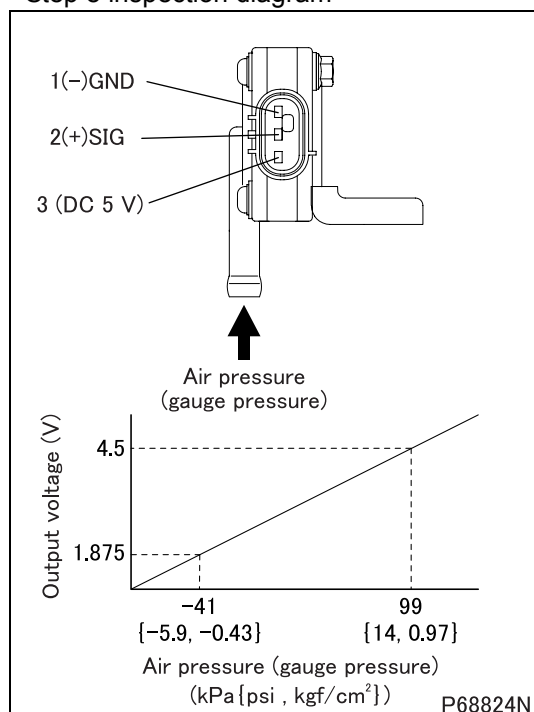
<Step 8 inspection diagram>

| | Inspection condition | | <ul style="list-style-type: none"> <li>Apply voltage DC 5 V across connector terminals No. 3 (+) and 1 (—).</li> <li>Gradually increase applied air pressure.</li> </ul> | |

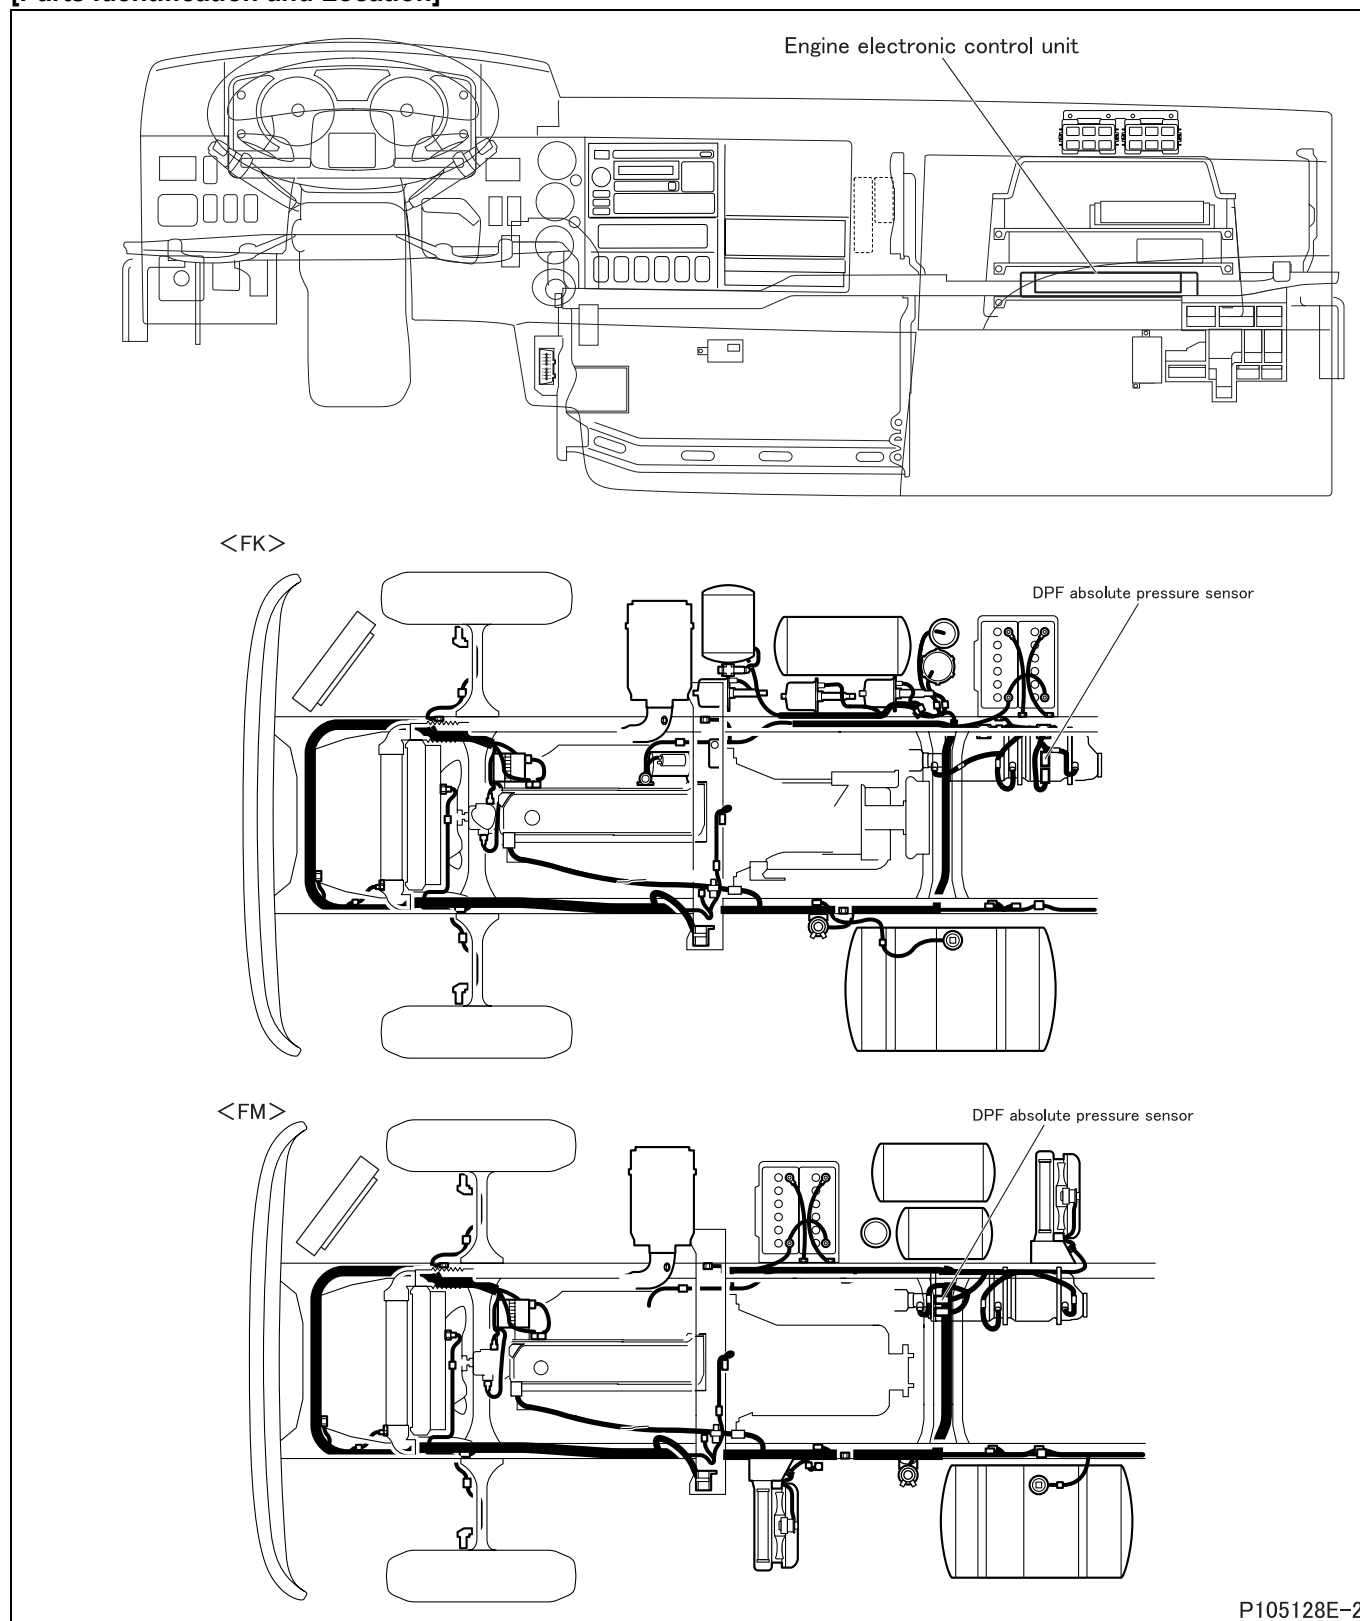
## [Parts Identification and Location]

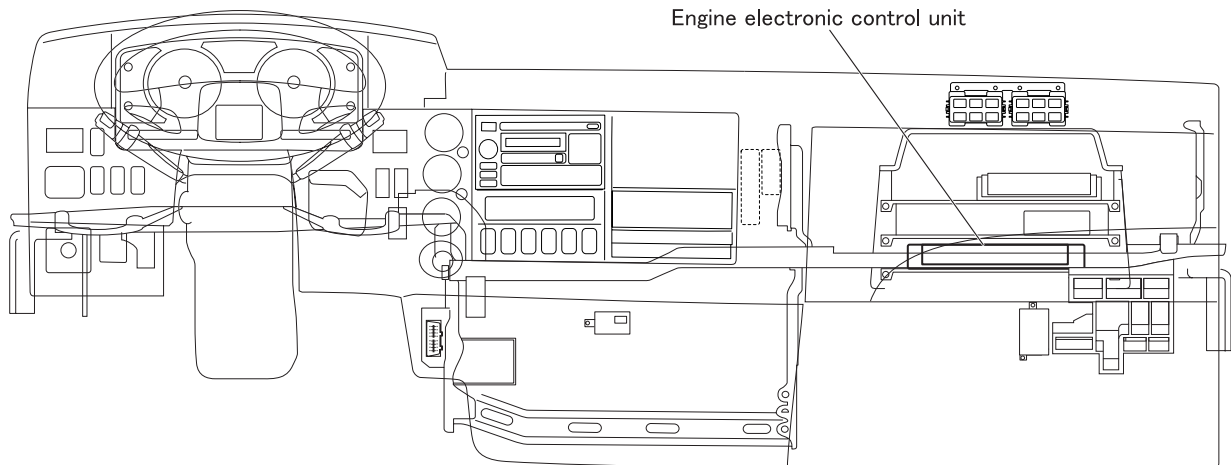
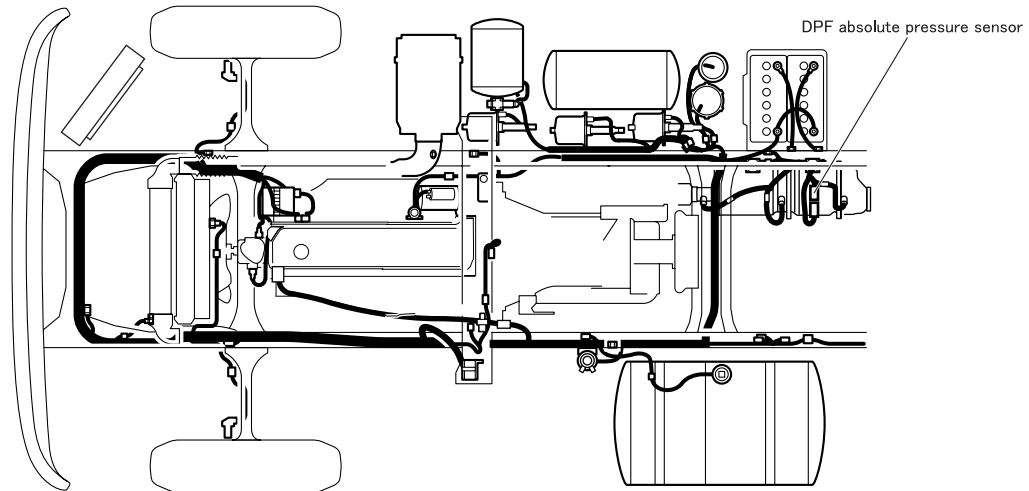
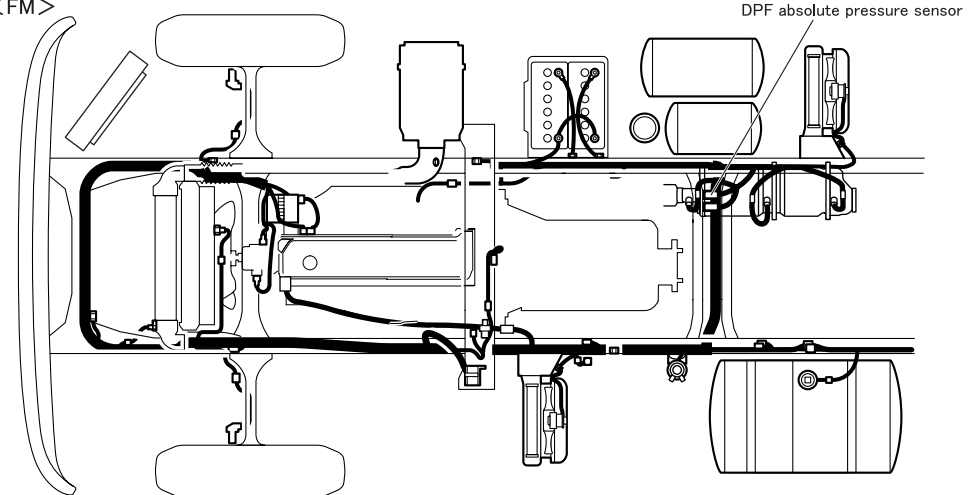
P105128E-2

## [Parts Identification and Location]

&lt;FK&gt;

&lt;FM&gt;
