# FE.FG

## SERVICE MANUAL 2008 Model FOREWORD

This Service Manual contains maintenance and repair methods for the Mitsubishi Fuso Truck FE. FG Series. Read this manual carefully as an aid in providing correct, efficient maintenance. Please note that the information and specifications contained within this manual may change without notice. This is due to product modifications and continued vehicle improvements that are made throughout the model years. Should you encounter any discrepancy in the information provided, please do not hesitate to contact your nearest Mitsubishi Fuso Dealer or Mitsubishi Fuso Truck of America, Inc.

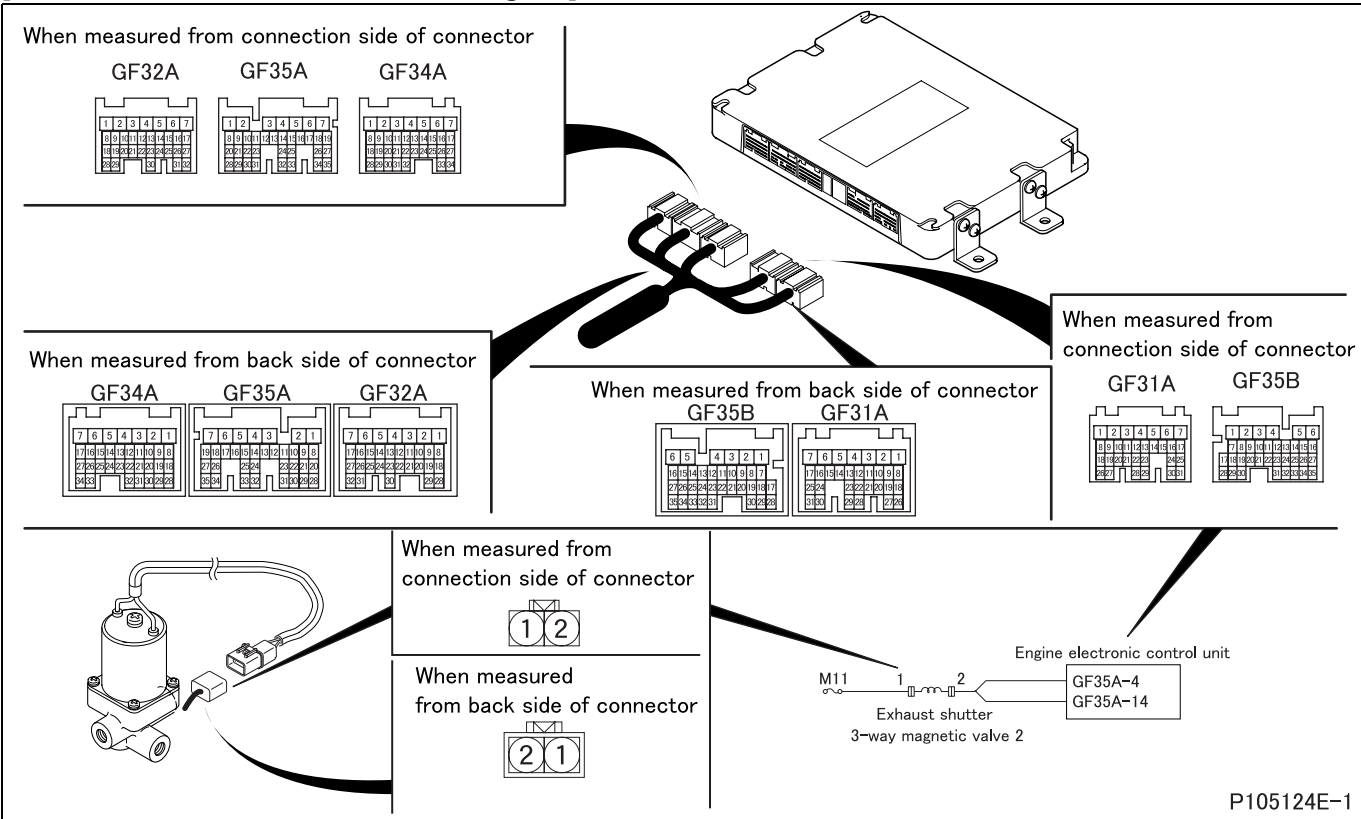
## [Electronic Control Unit Connection Diagram]

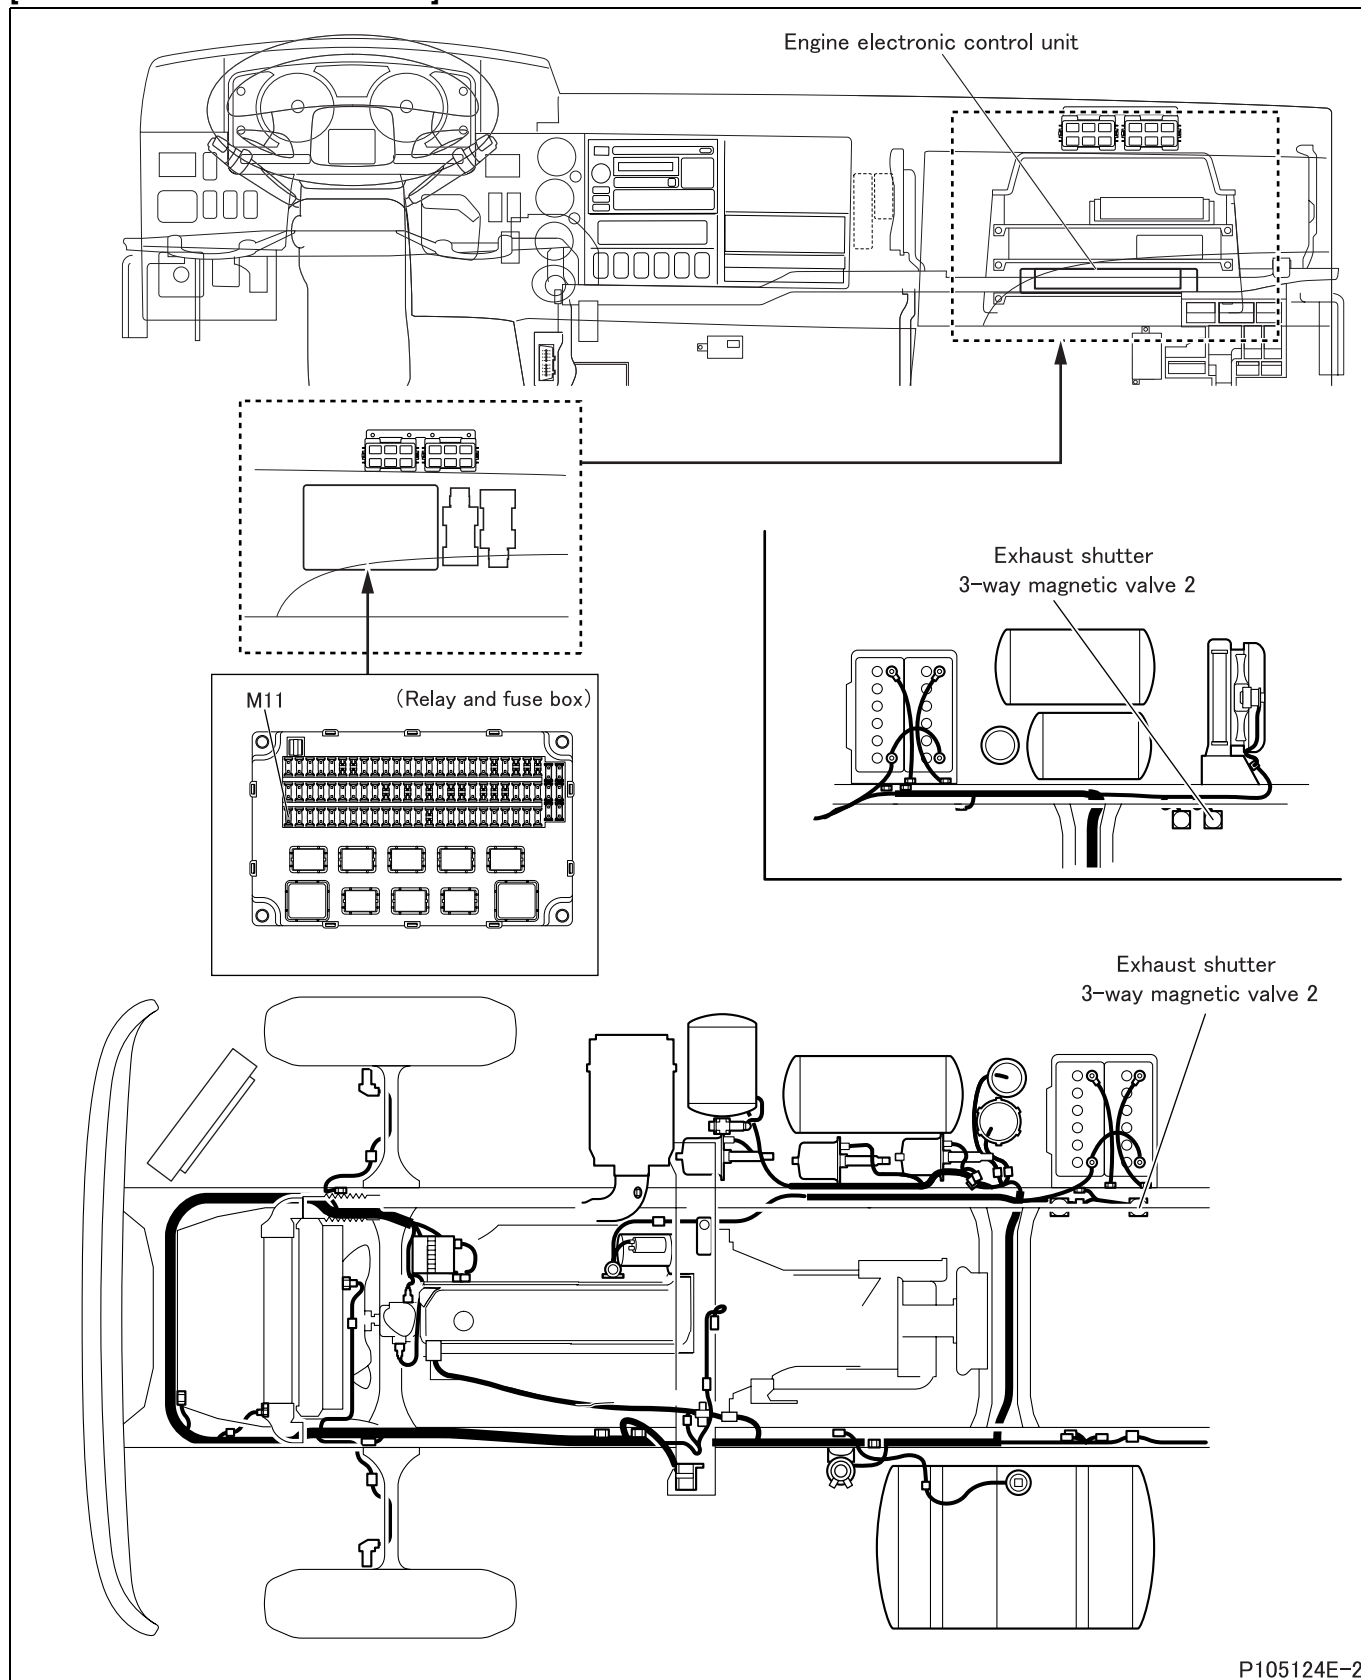
P105124E-2

[Parts Identification and Location]

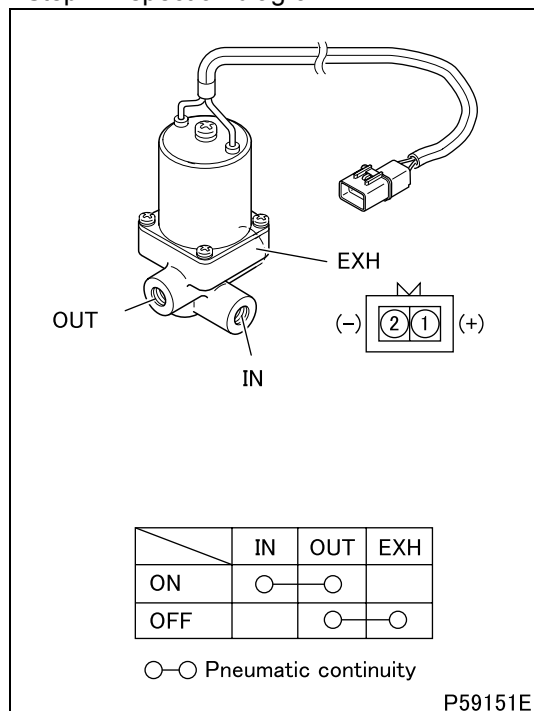
<Step 4 inspection diagram>

| | | NO | Replacement of 3-way magnetic valve | |

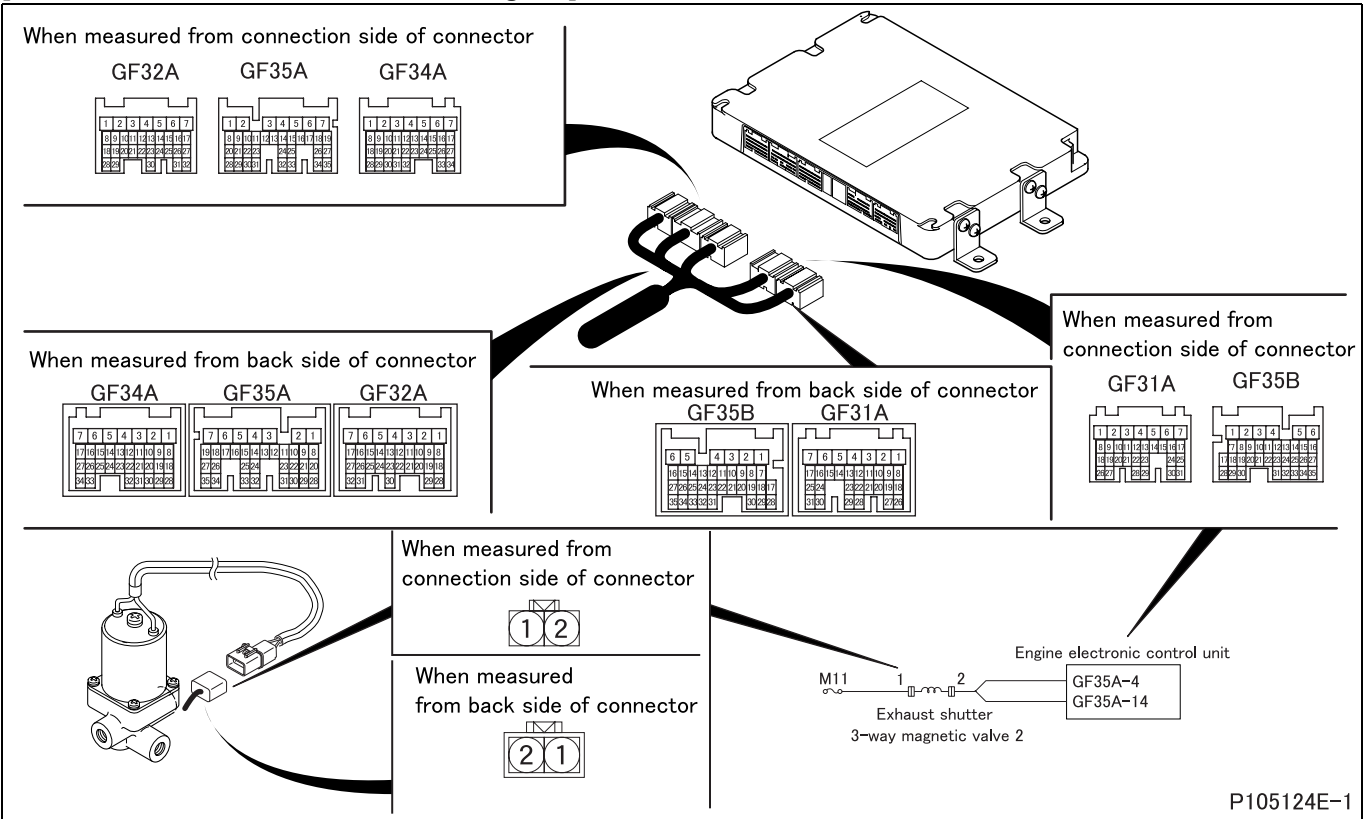
## [Electronic Control Unit Connection Diagram]

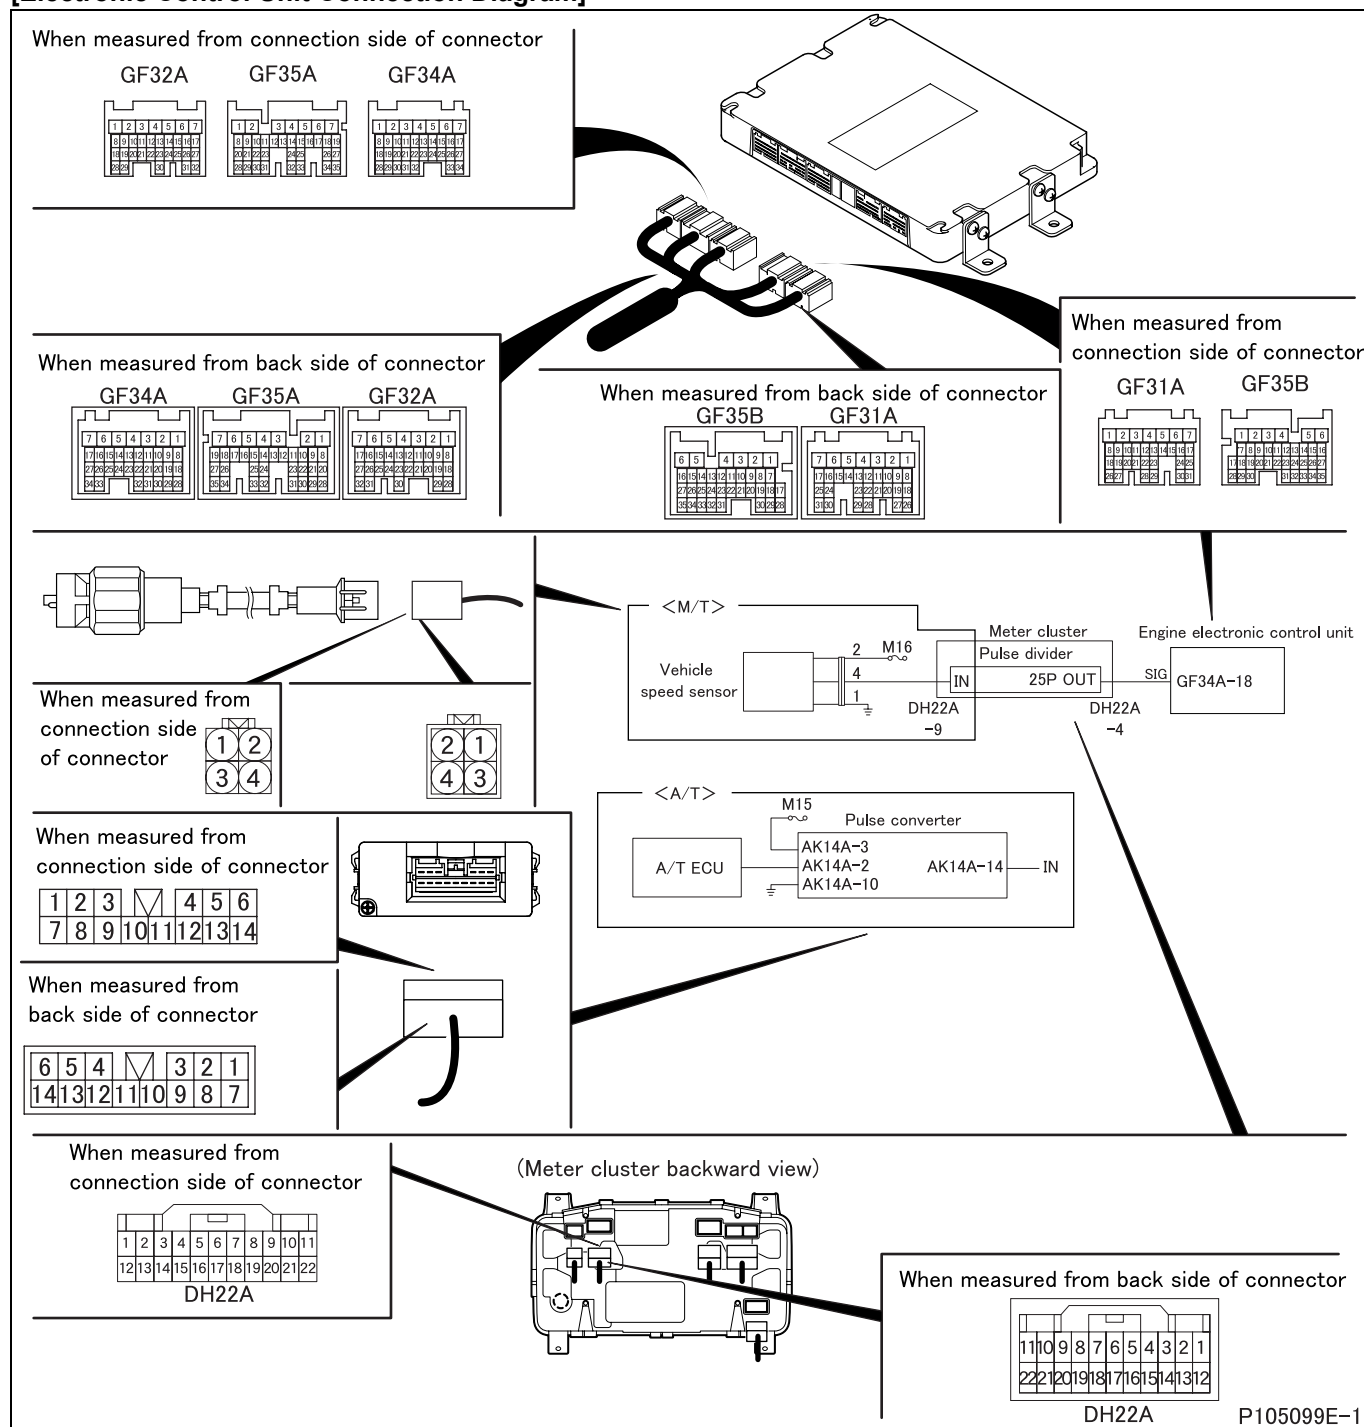
## [Electronic Control Unit Connection Diagram]

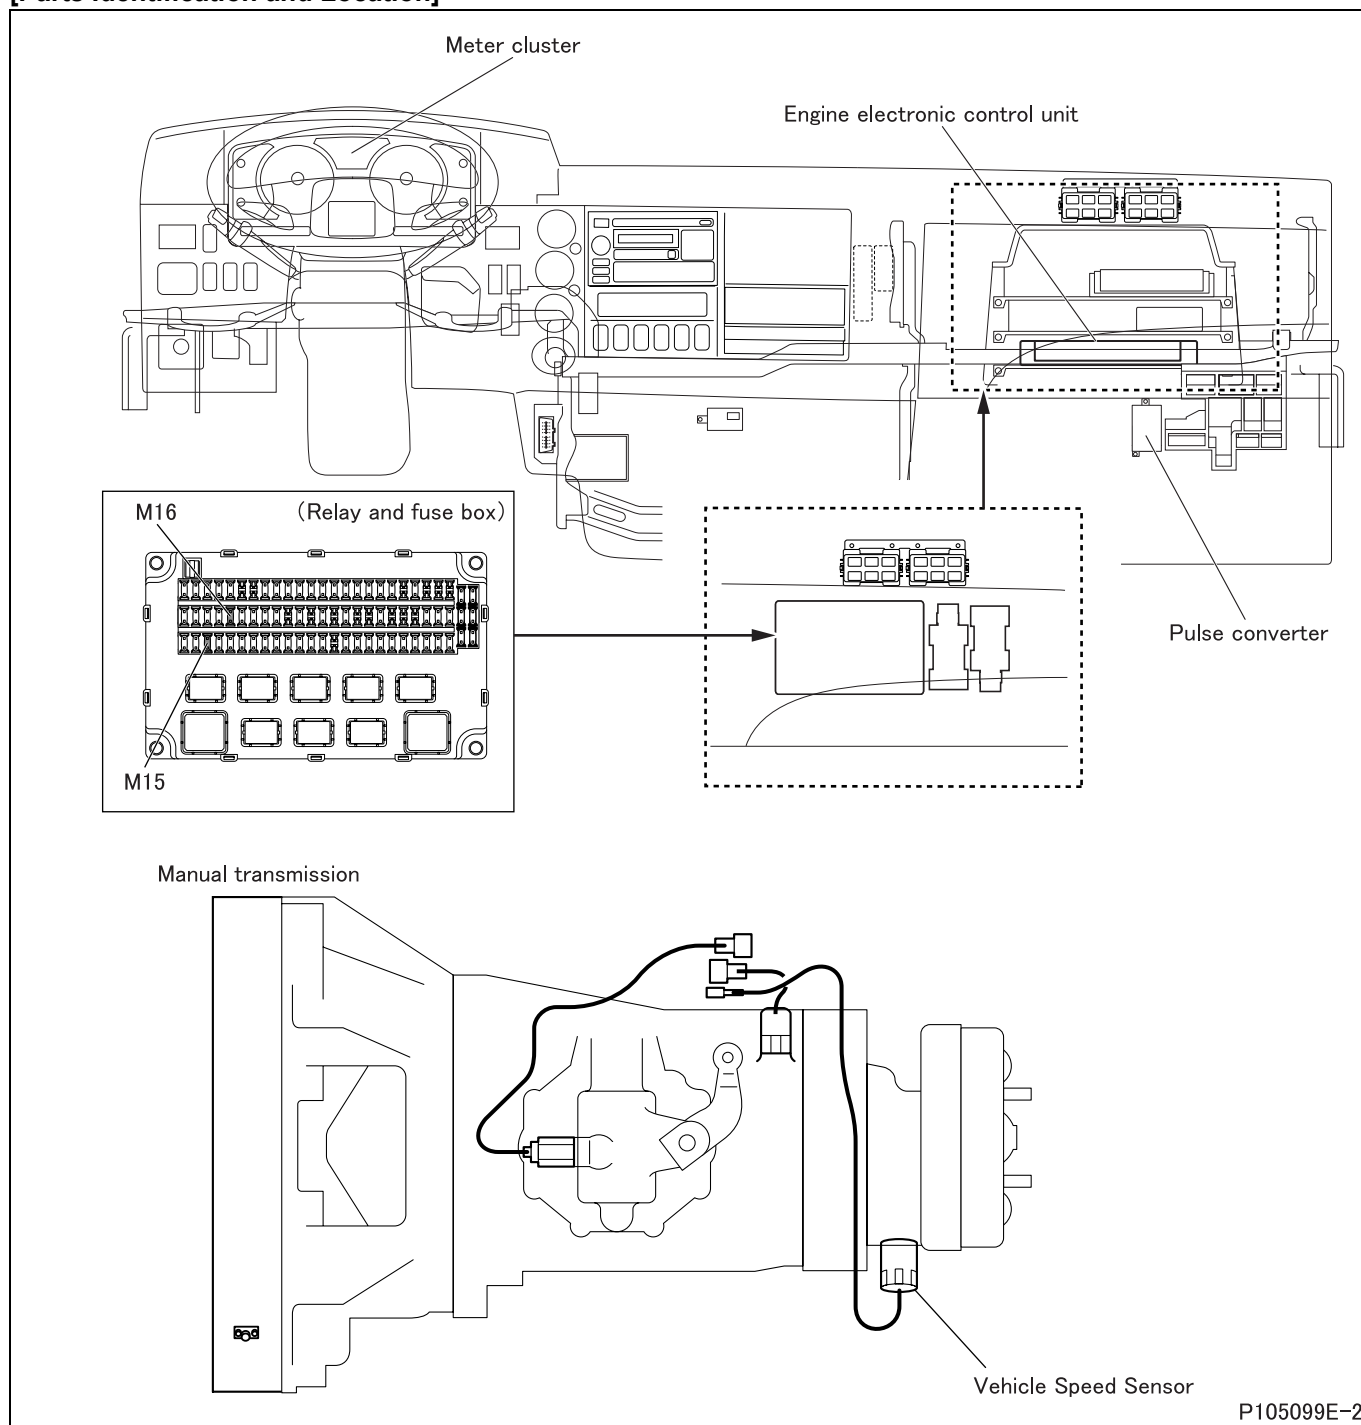
P105099E-2

## [Parts Identification and Location]

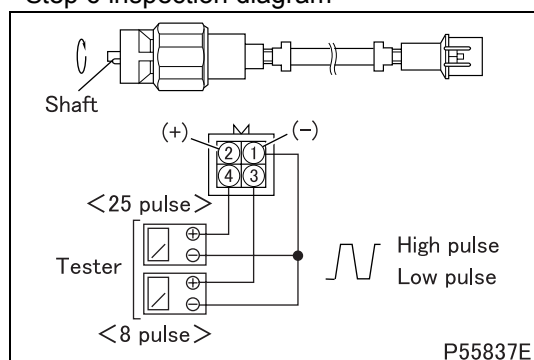
<Step 6 inspection diagram>

| | | NO | Replacement of sensor |

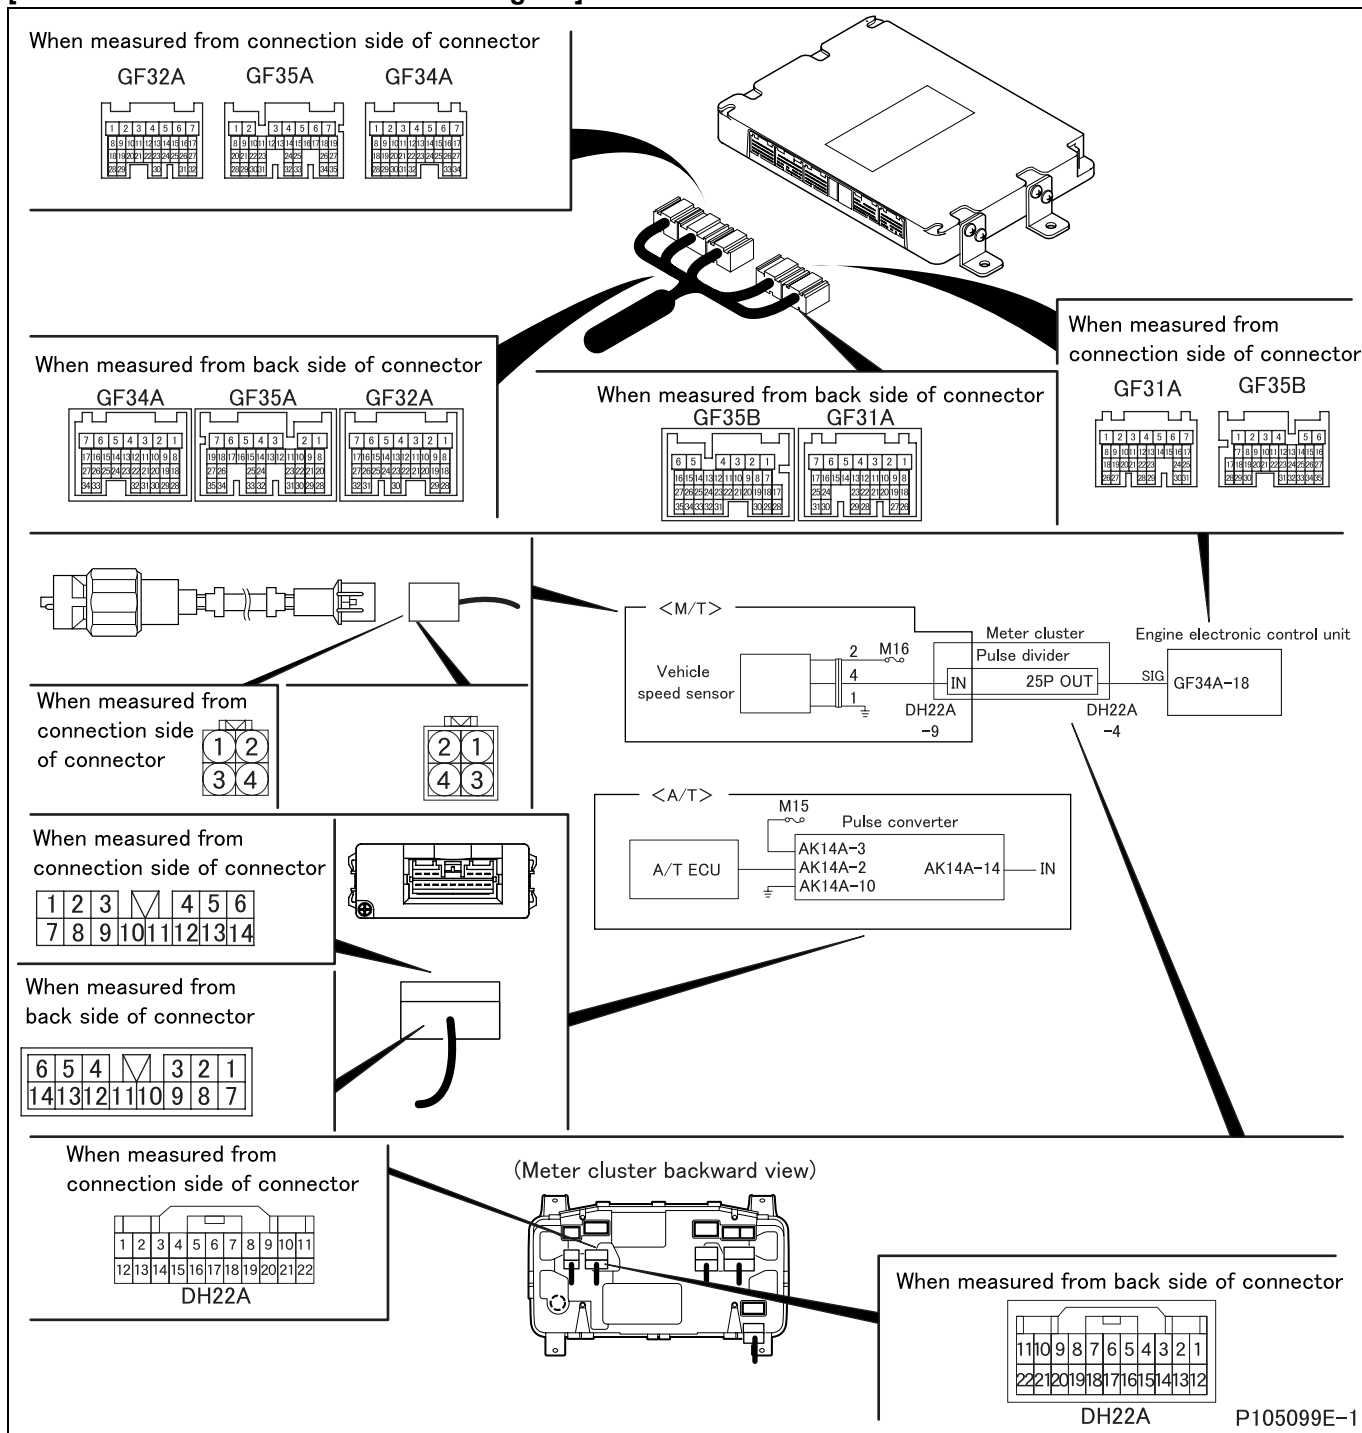
## [Electronic Control Unit Connection Diagram]

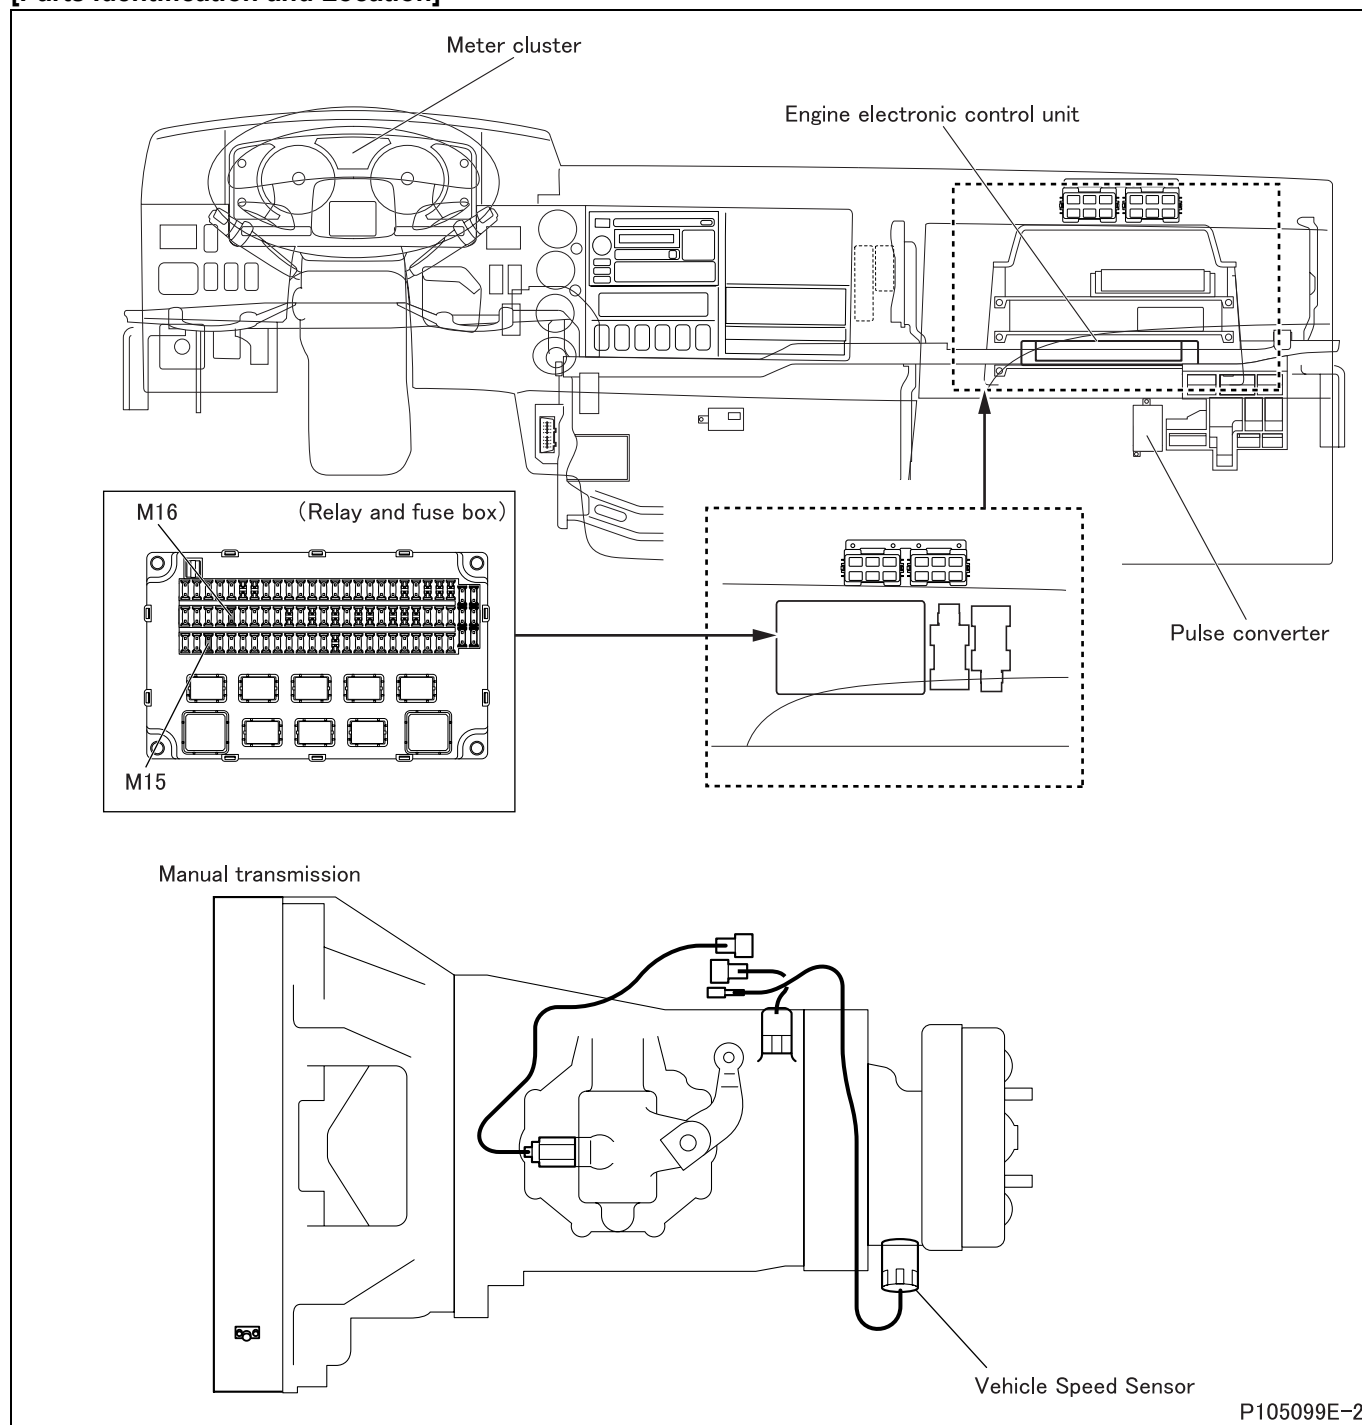
## [Parts Identification and Location]

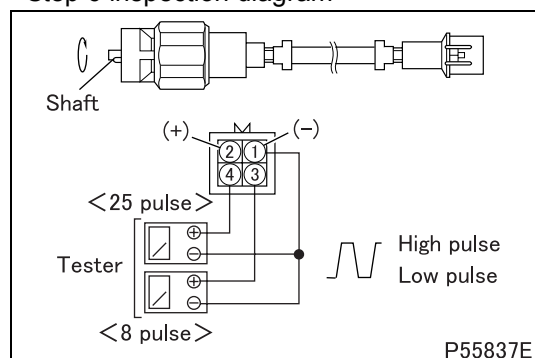
<Step 6 inspection diagram>

| | | NO | Replacement of sensor |

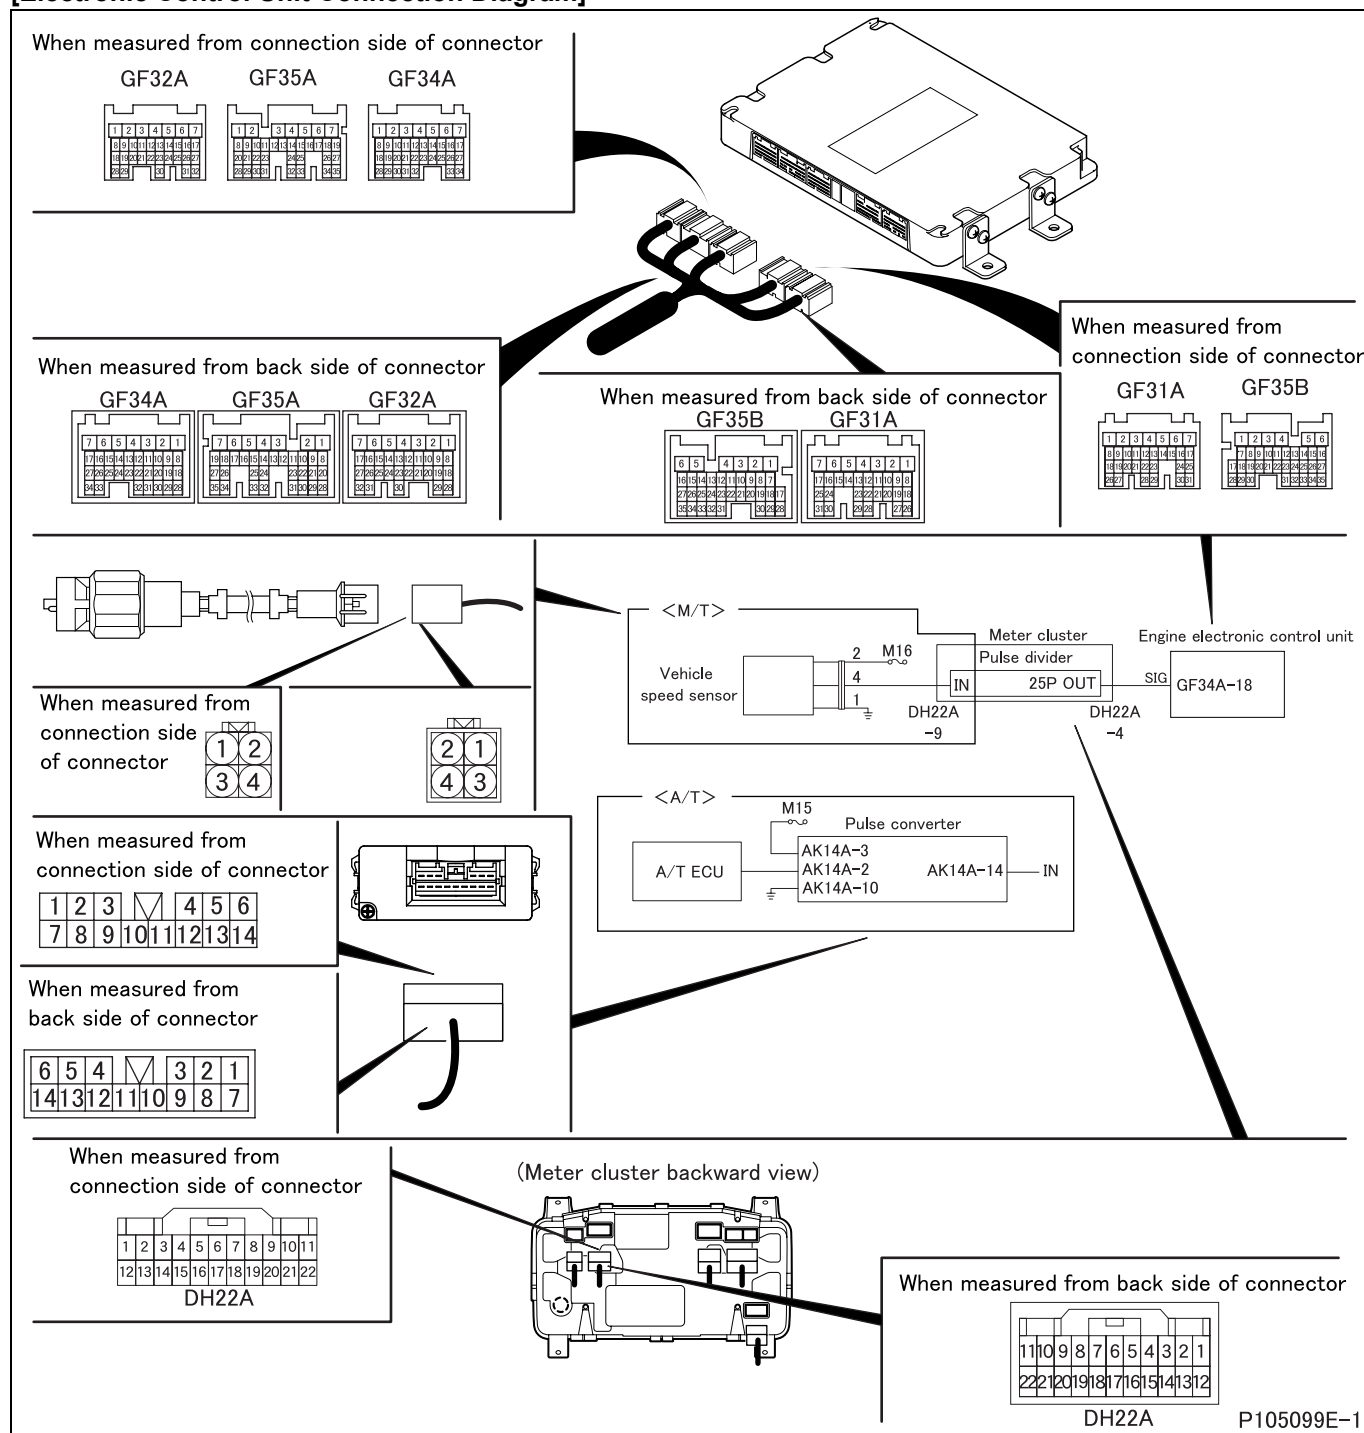
P105099E-1

## [Electronic Control Unit Connection Diagram]

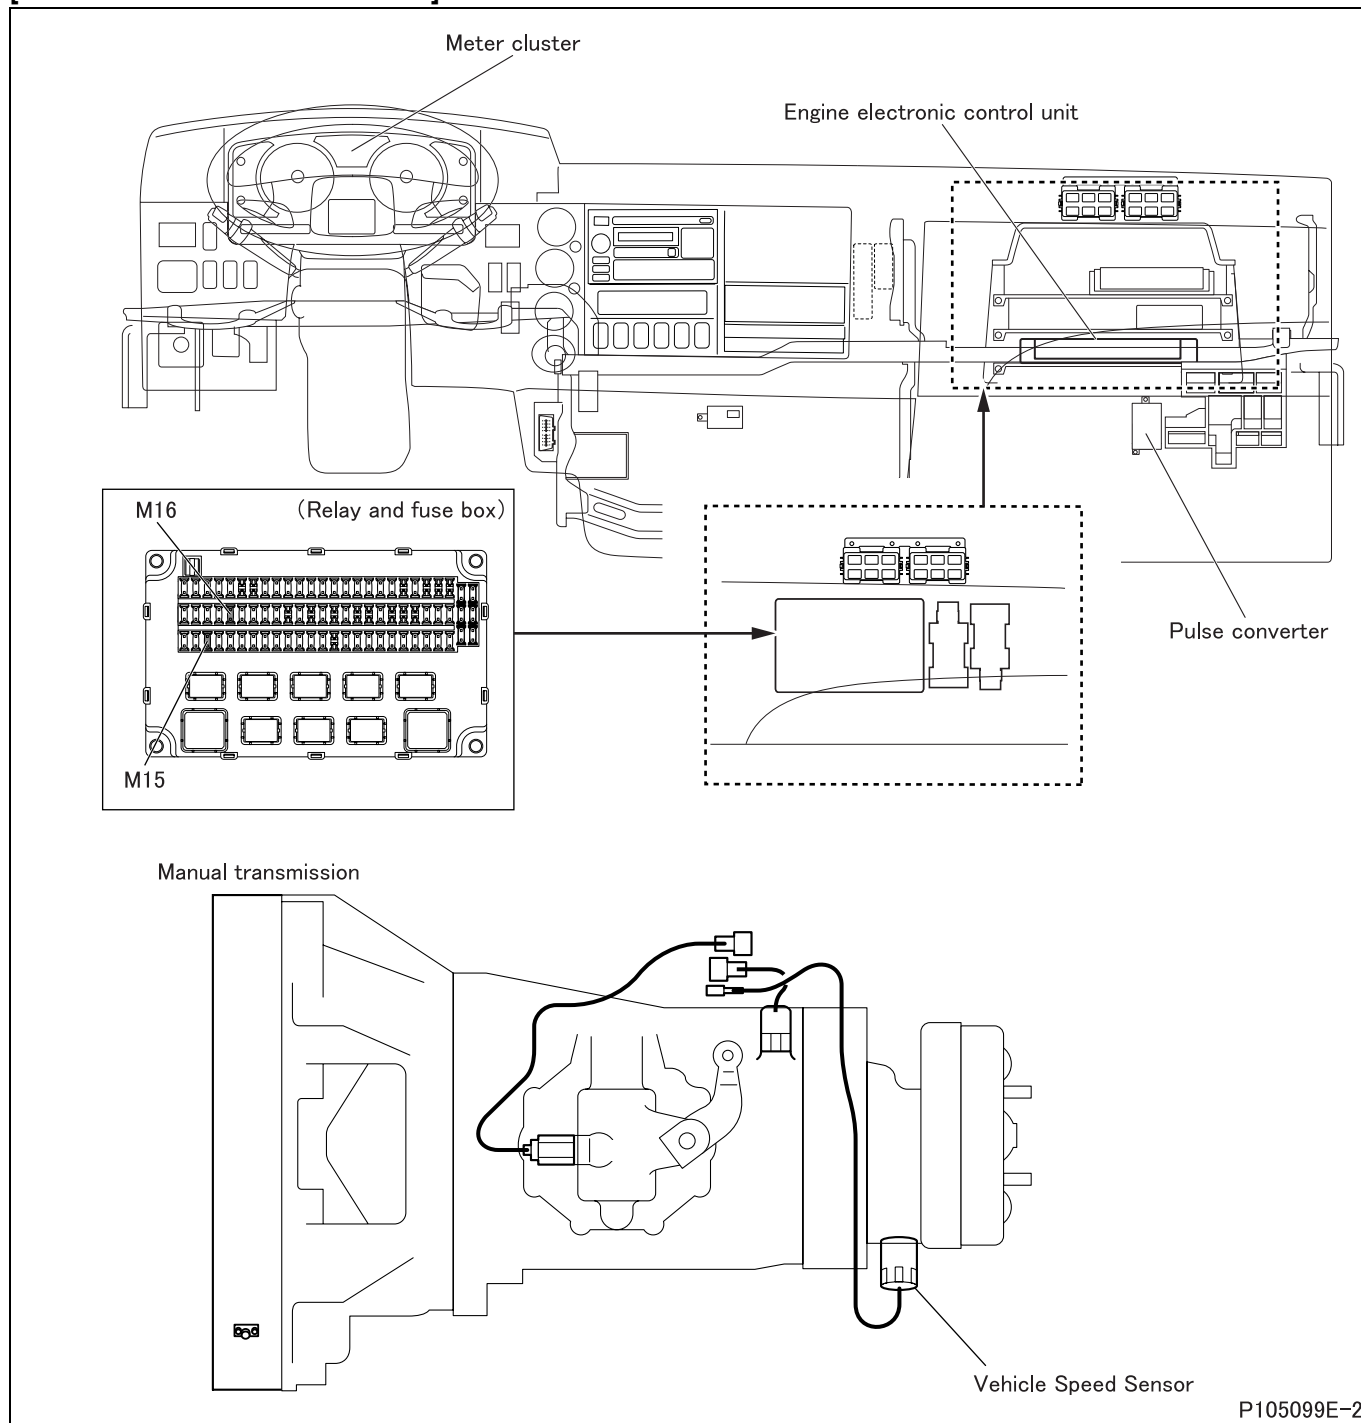
P105099E-2

## [Parts Identification and Location]

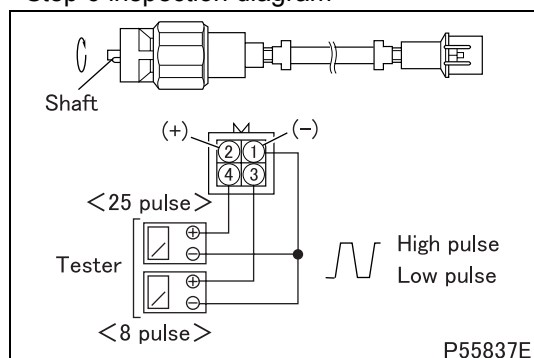
<Step 6 inspection diagram>

| | | NO | Replacement of sensor |

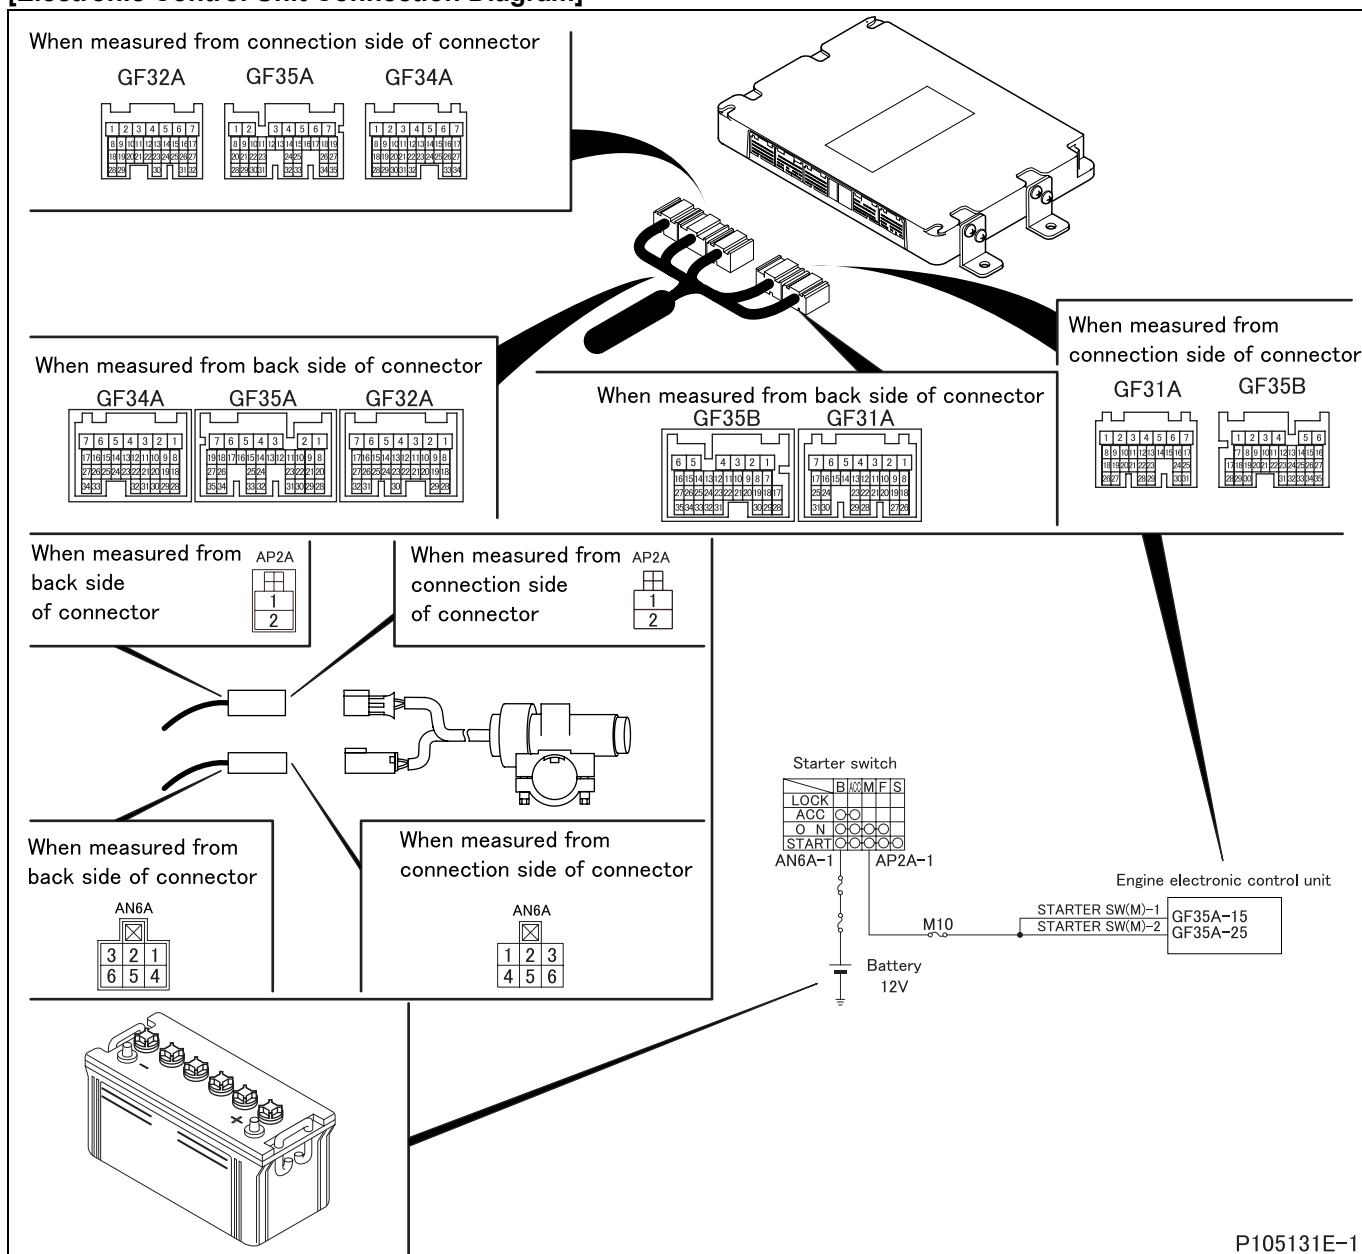
P105131E-1

## [Electronic Control Unit Connection Diagram]

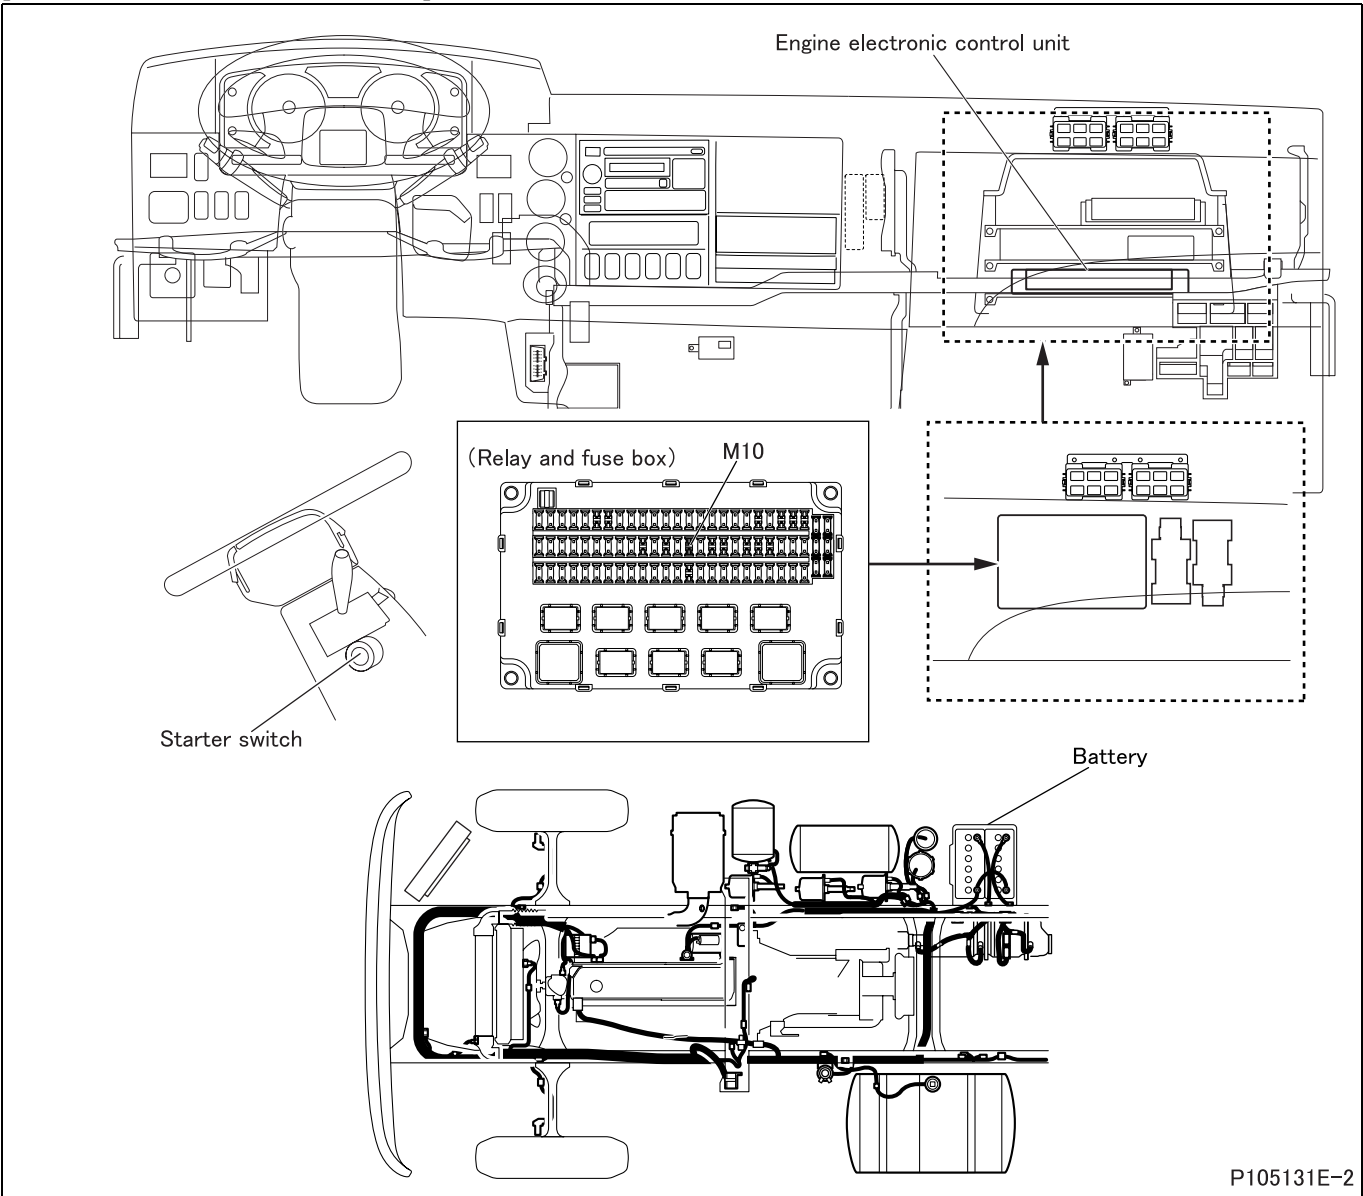
P105131E-2

## [Parts Identification and Location]

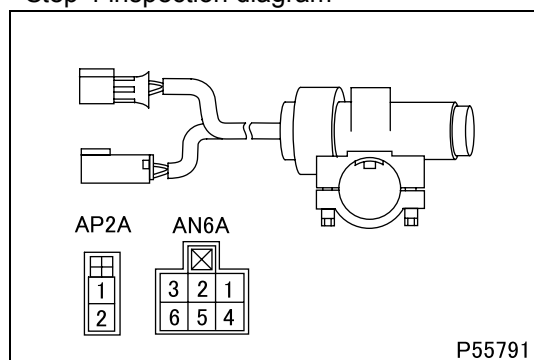
<Step 4 inspection diagram>

| | | NO | Replacement of starter switch | |

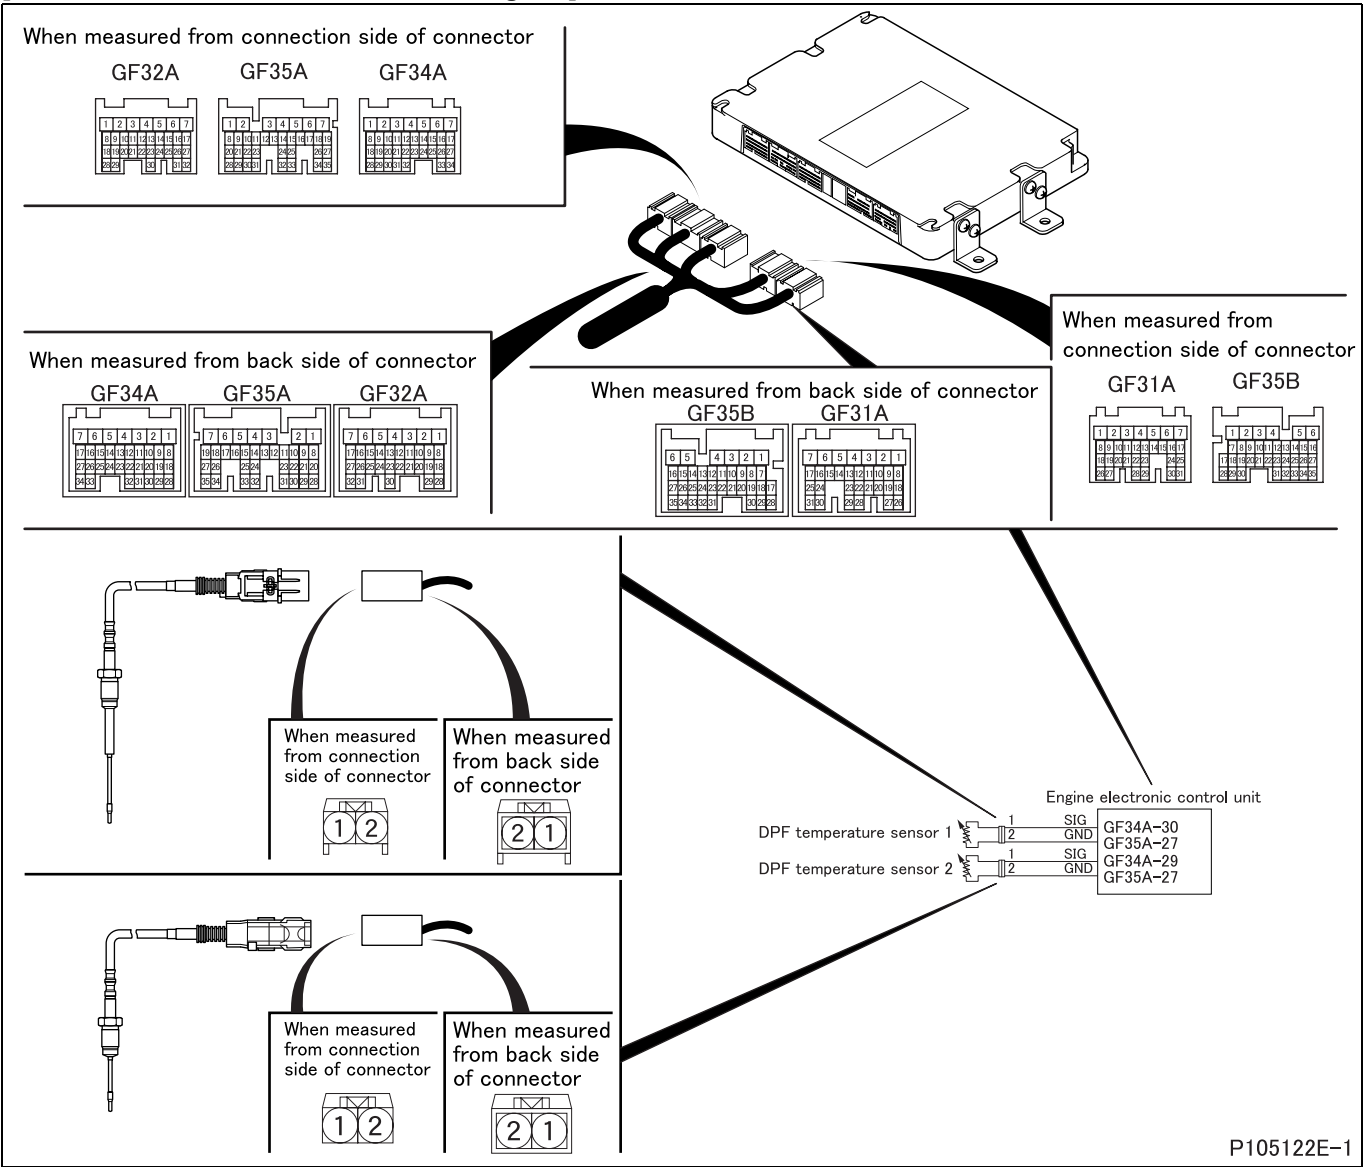
P105122E-1

## [Electronic Control Unit Connection Diagram]
