# FE.FG

## SERVICE MANUAL 2008 Model FOREWORD

This Service Manual contains maintenance and repair methods for the Mitsubishi Fuso Truck FE. FG Series. Read this manual carefully as an aid in providing correct, efficient maintenance. Please note that the information and specifications contained within this manual may change without notice. This is due to product modifications and continued vehicle improvements that are made throughout the model years. Should you encounter any discrepancy in the information provided, please do not hesitate to contact your nearest Mitsubishi Fuso Dealer or Mitsubishi Fuso Truck of America, Inc.

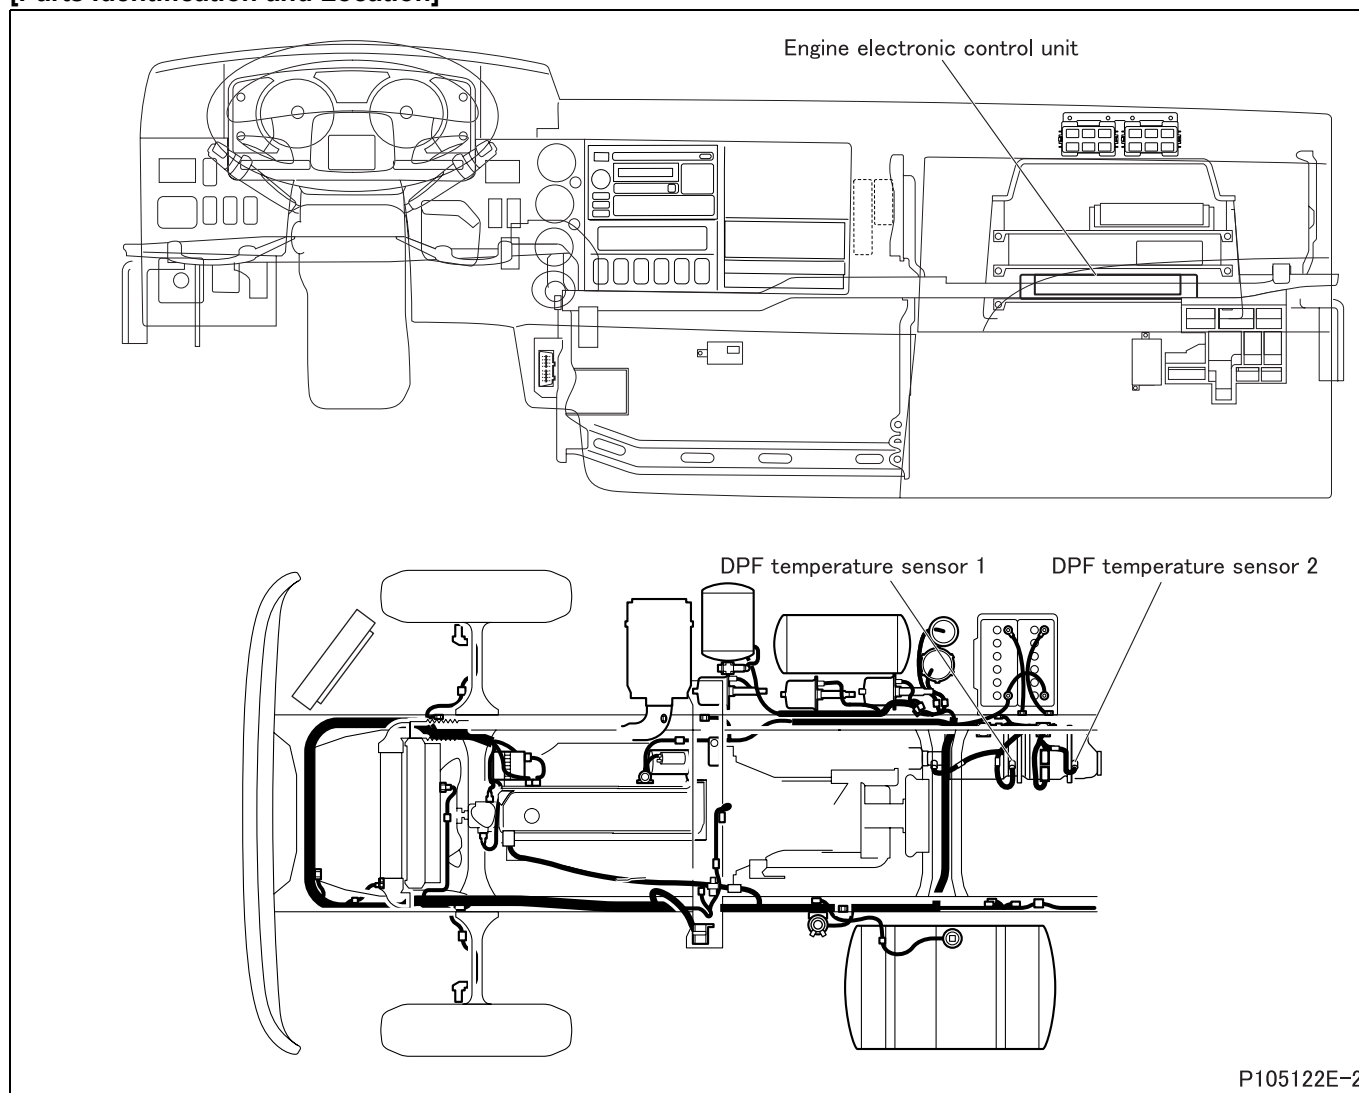
## [Parts Identification and Location]

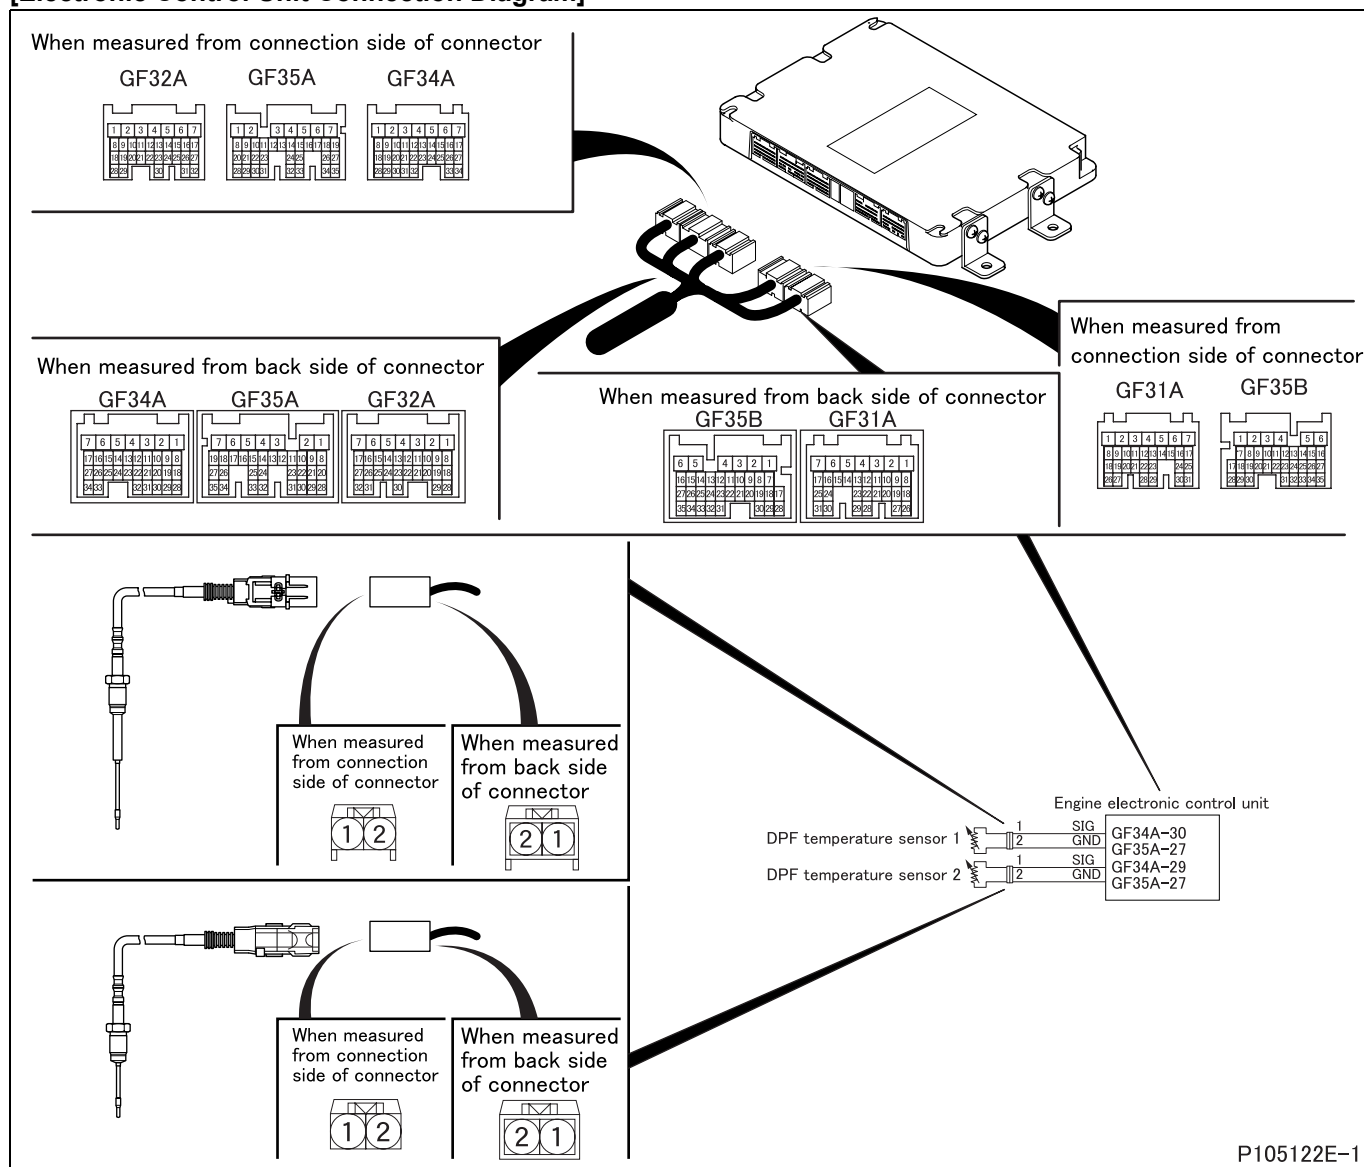
## [Electronic Control Unit Connection Diagram]

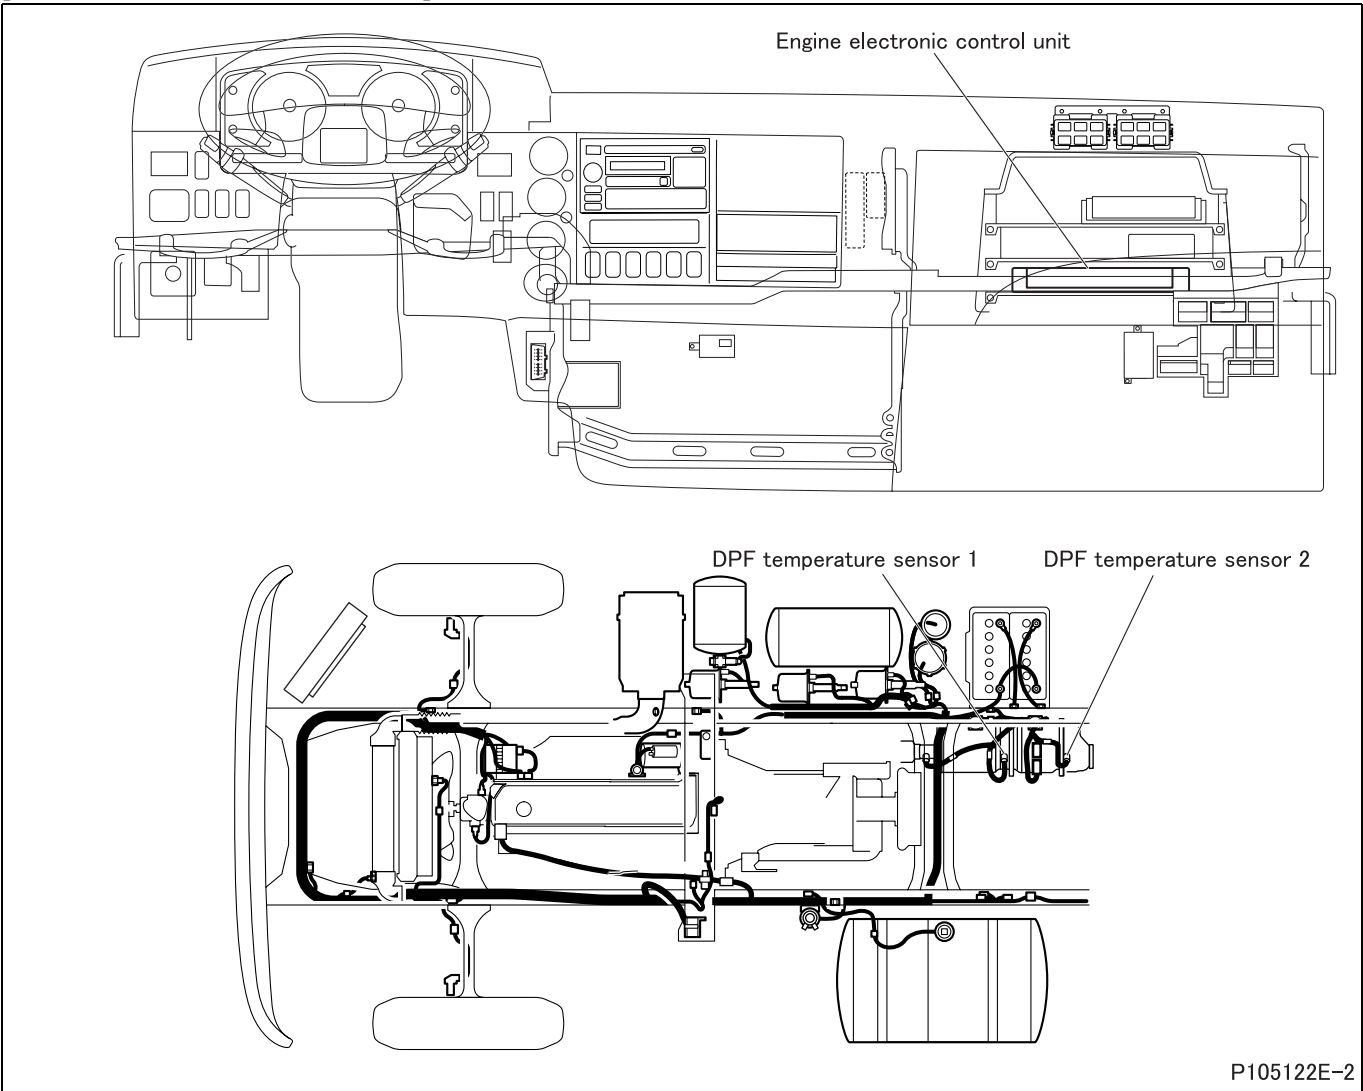
## [Parts Identification and Location]

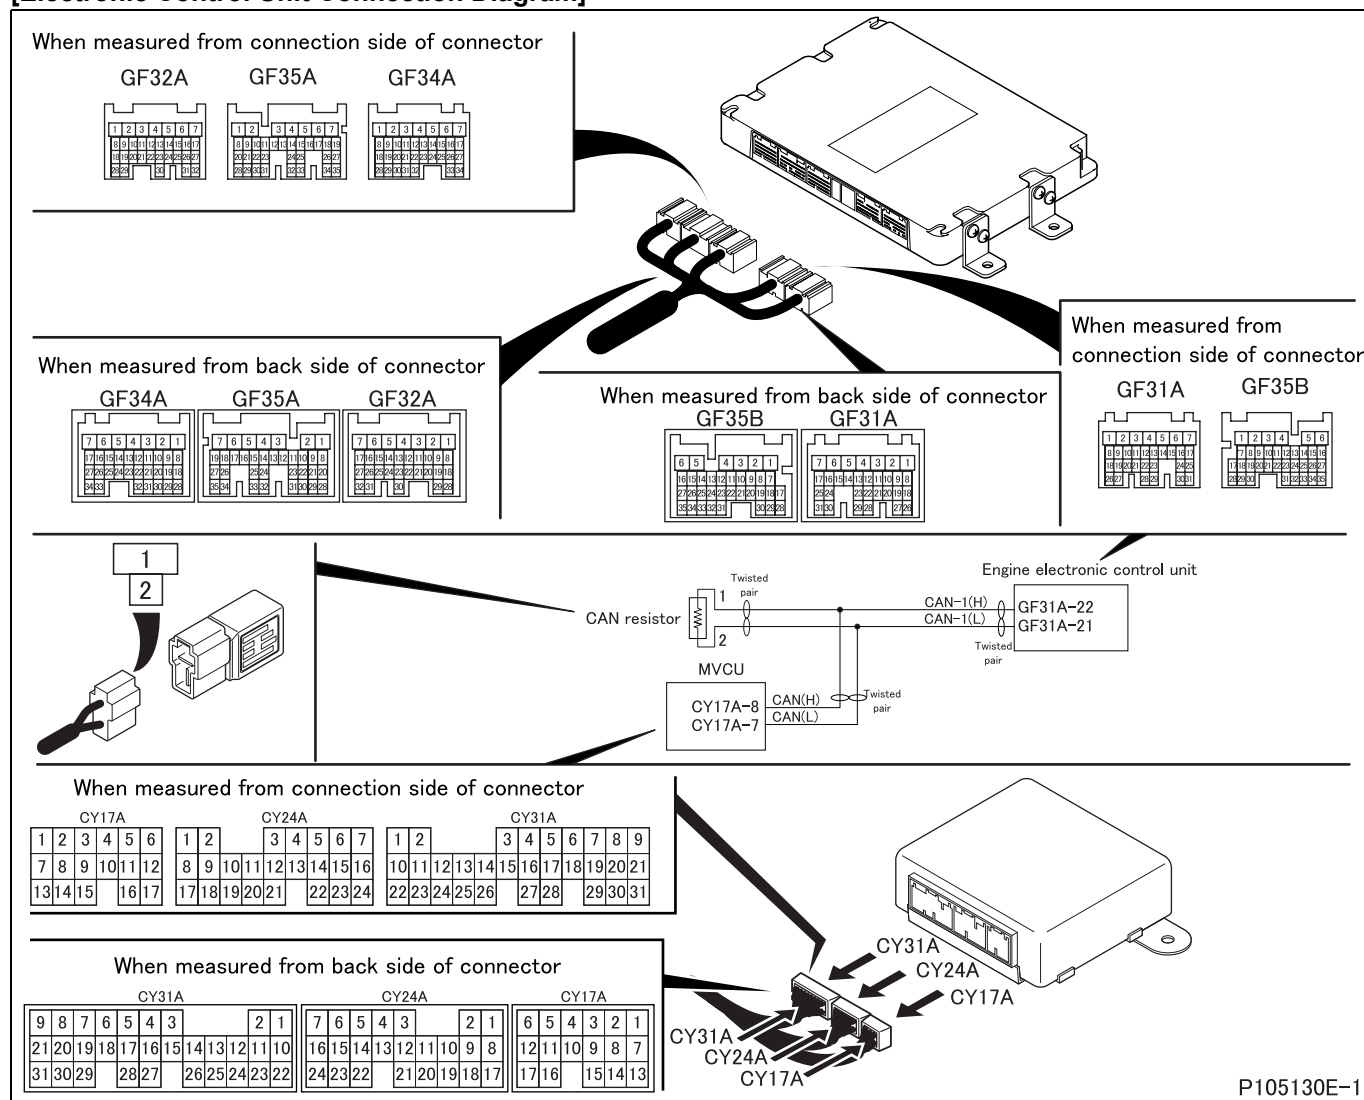
P105130E-1

## [Electronic Control Unit Connection Diagram]

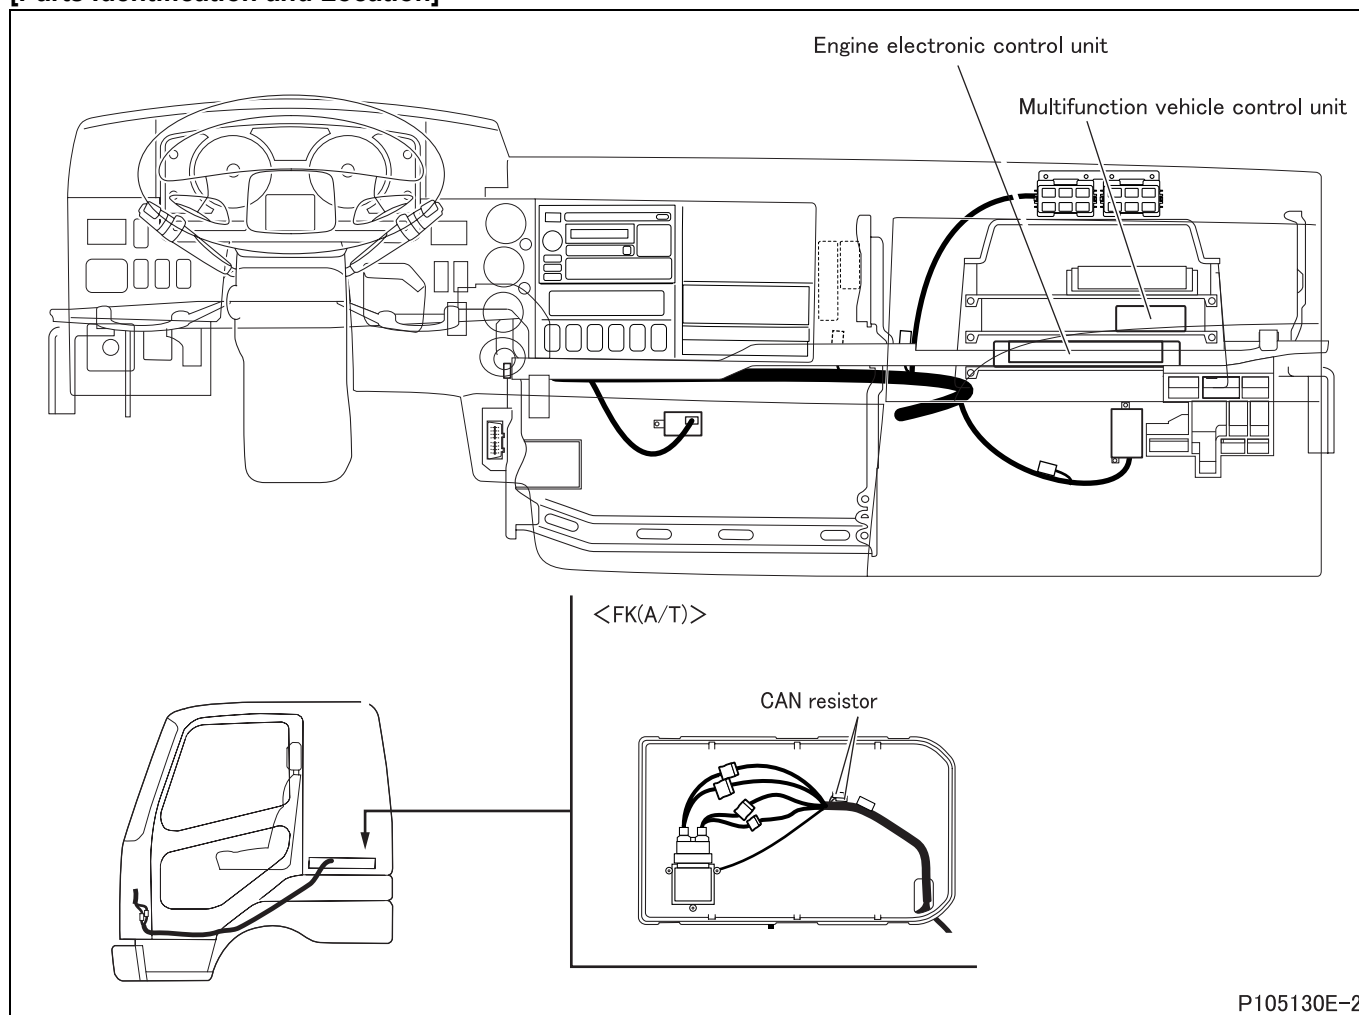
P105130E-2

## [Parts Identification and Location]

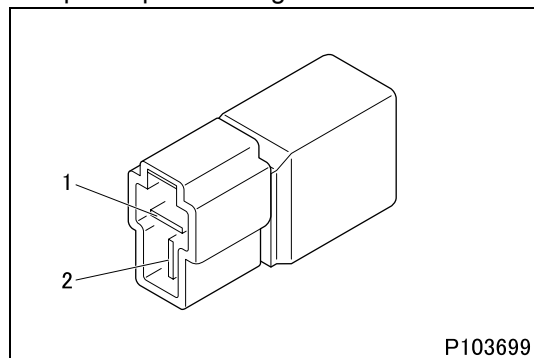
<Step 3 inspection diagram>

| | | NO | Replacement of controller area network resistor |

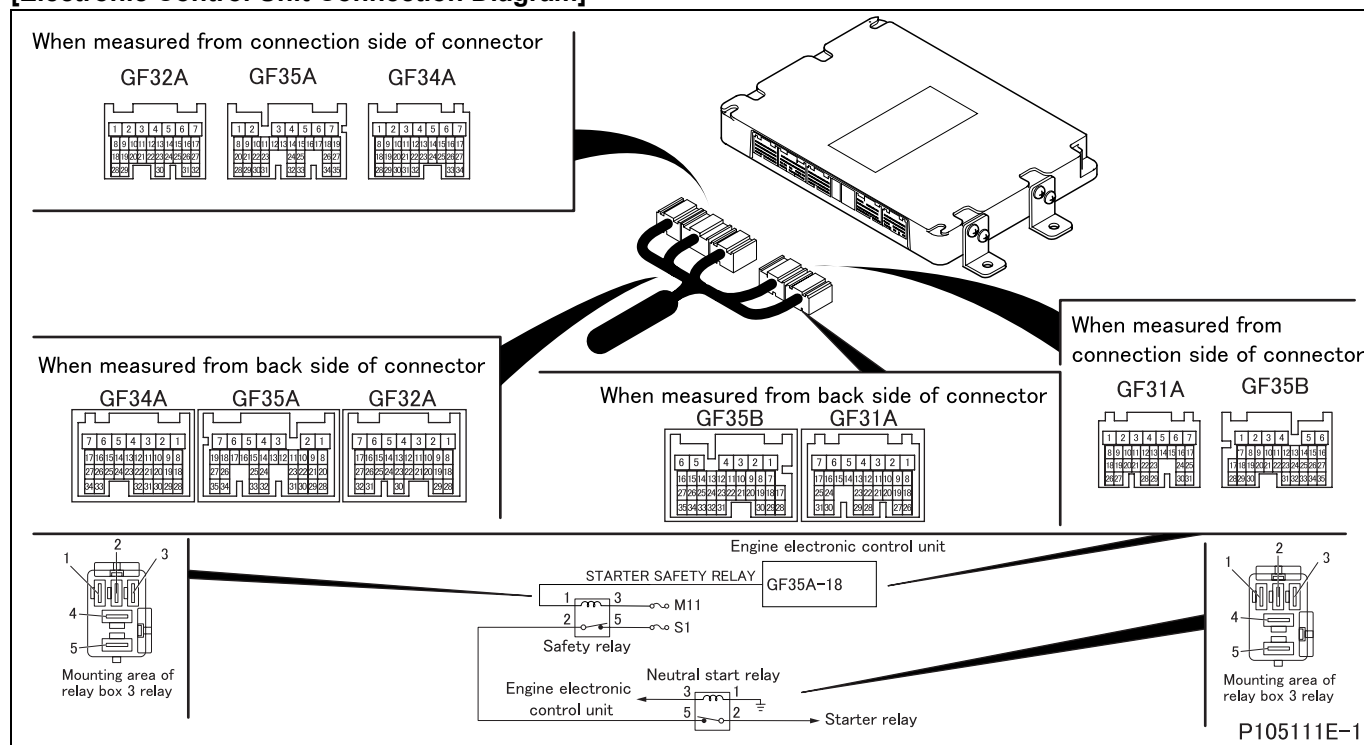
## [Electronic Control Unit Connection Diagram]

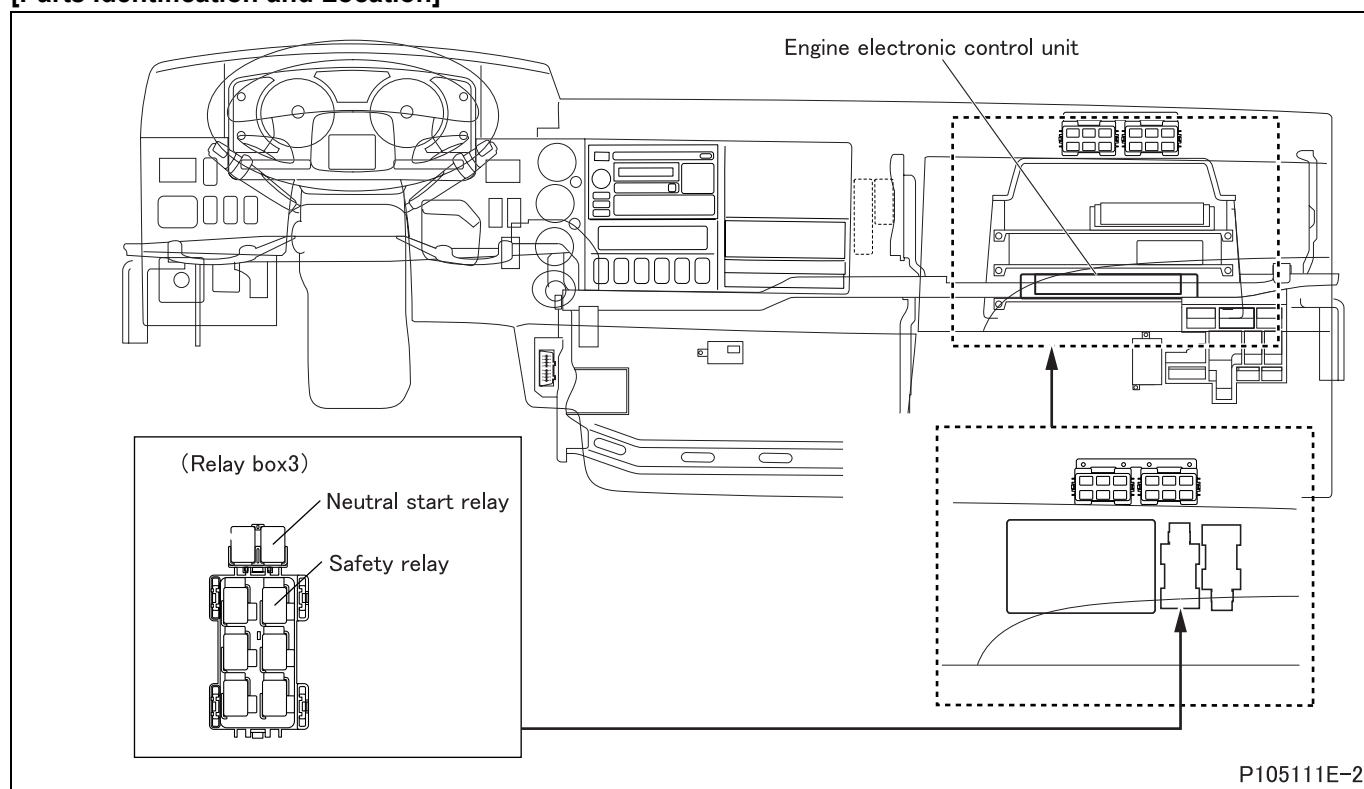
## [Parts Identification and Location]

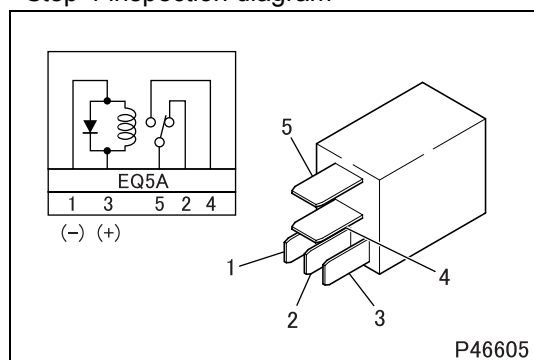
## &lt;Step 4 inspection diagram&gt;

| NO | | Replacement of relay | |

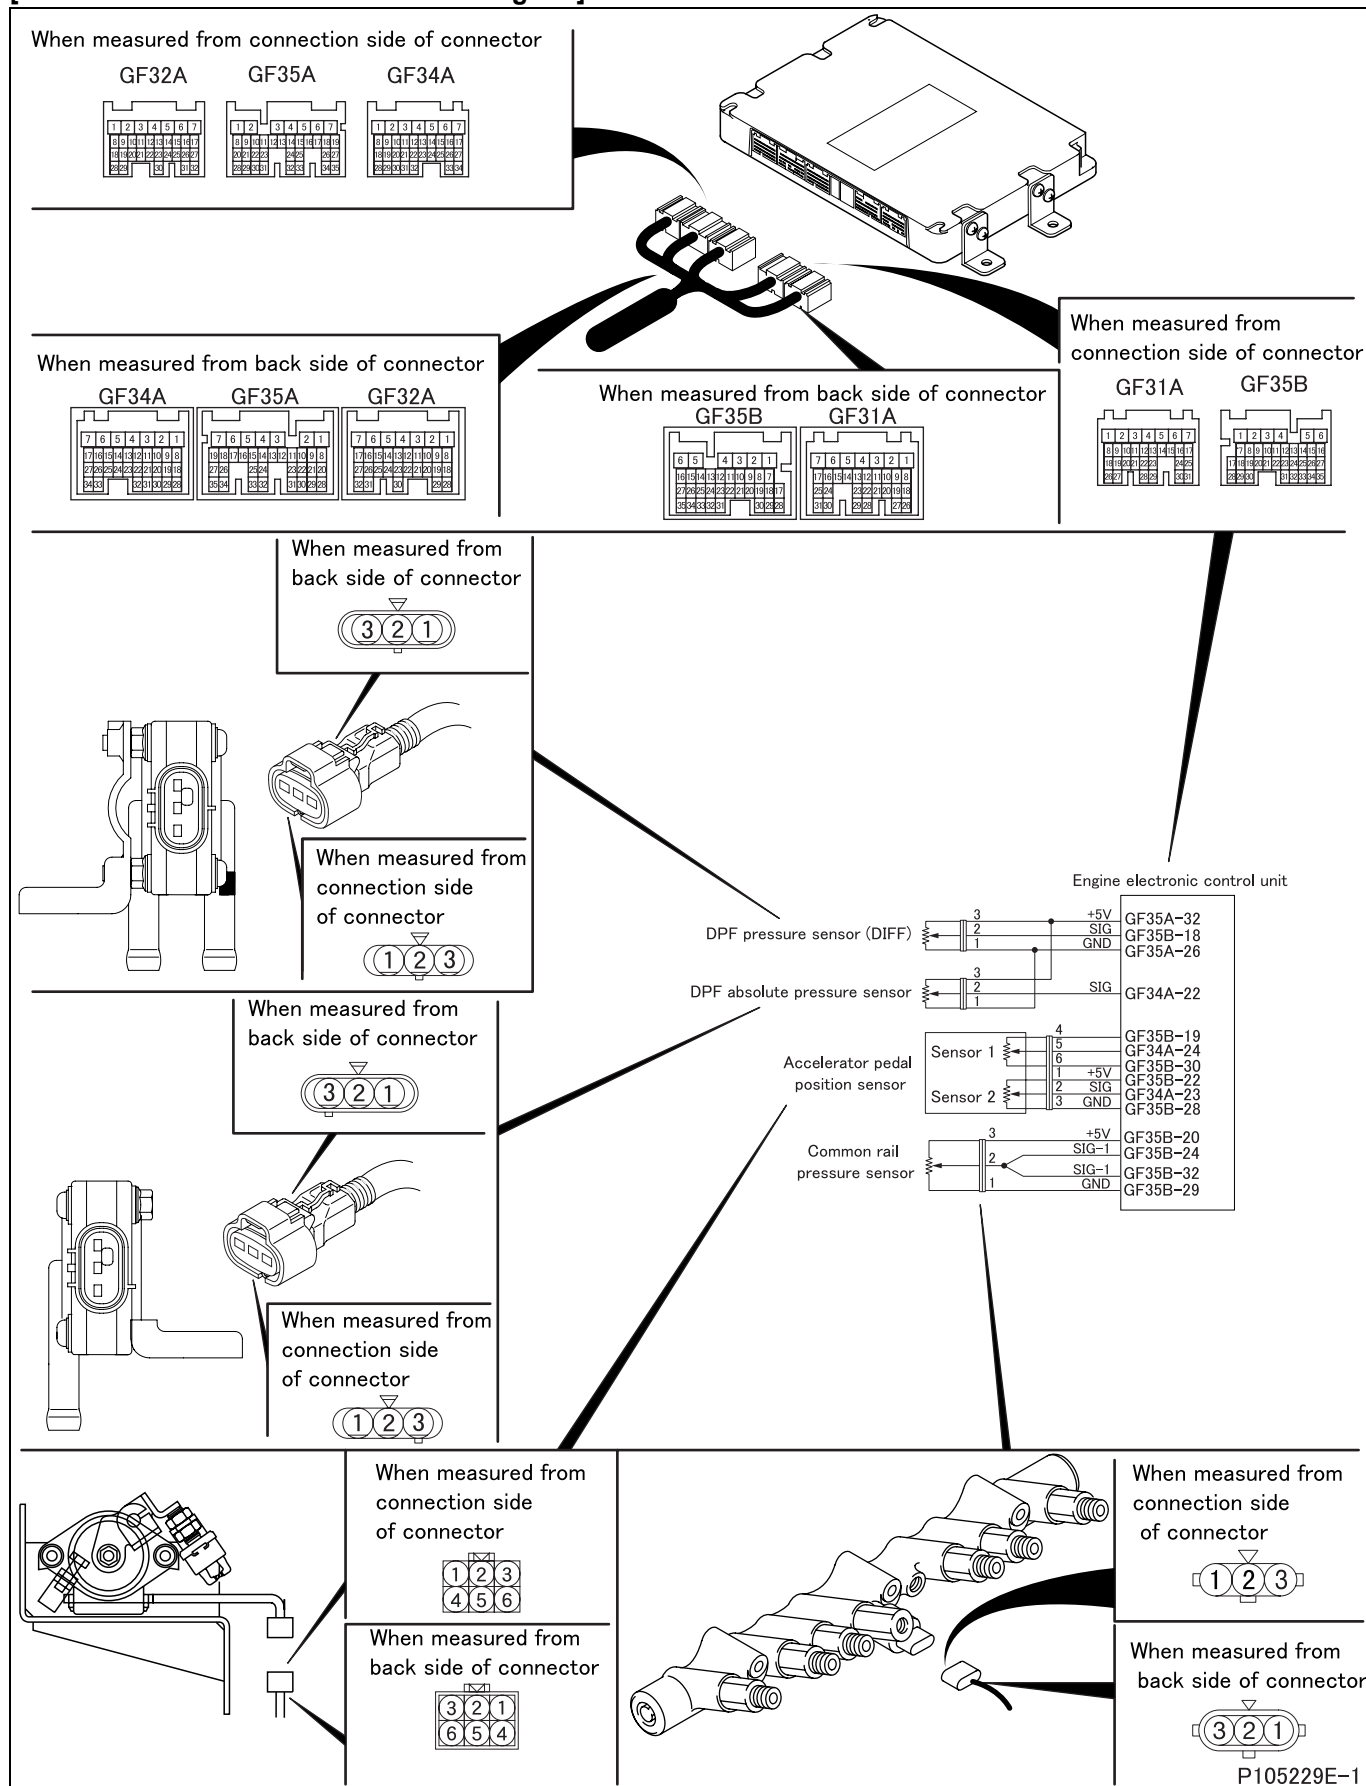
## [Electronic Control Unit Connection Diagram]

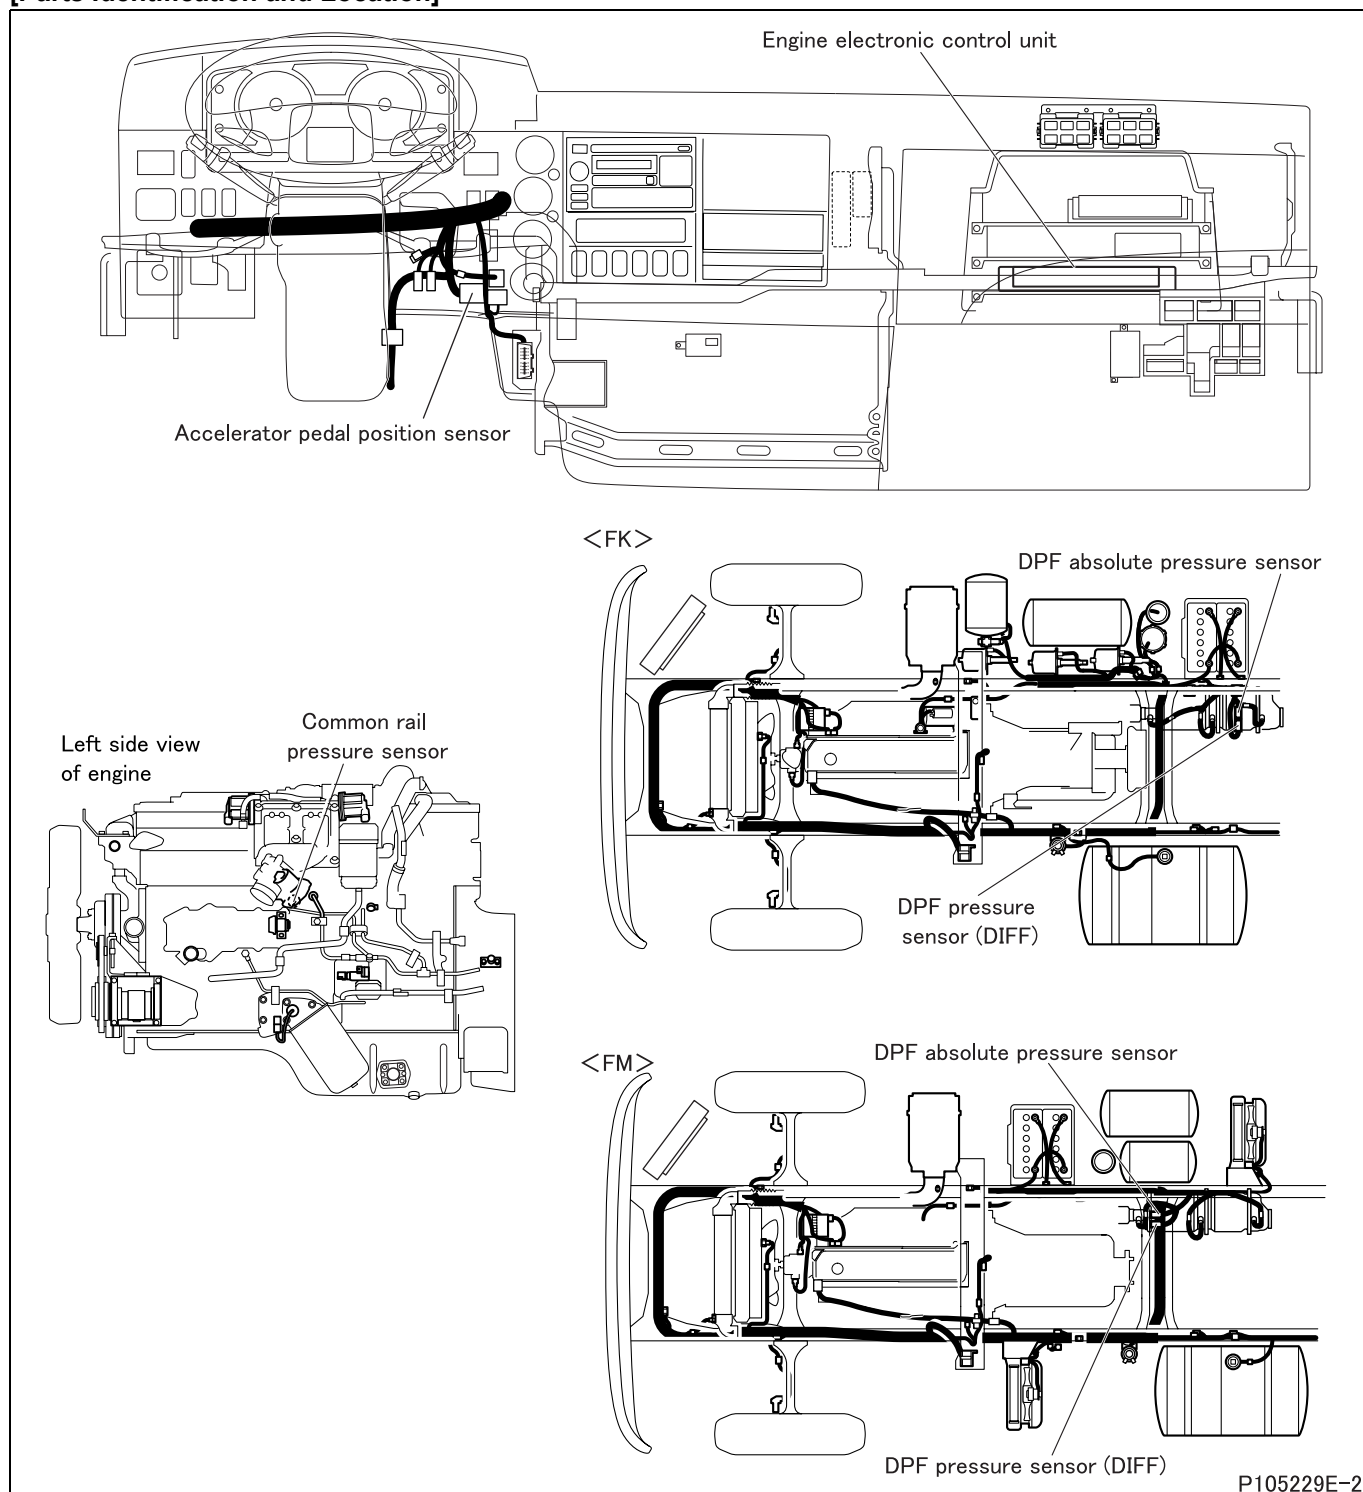
## [Parts Identification and Location]

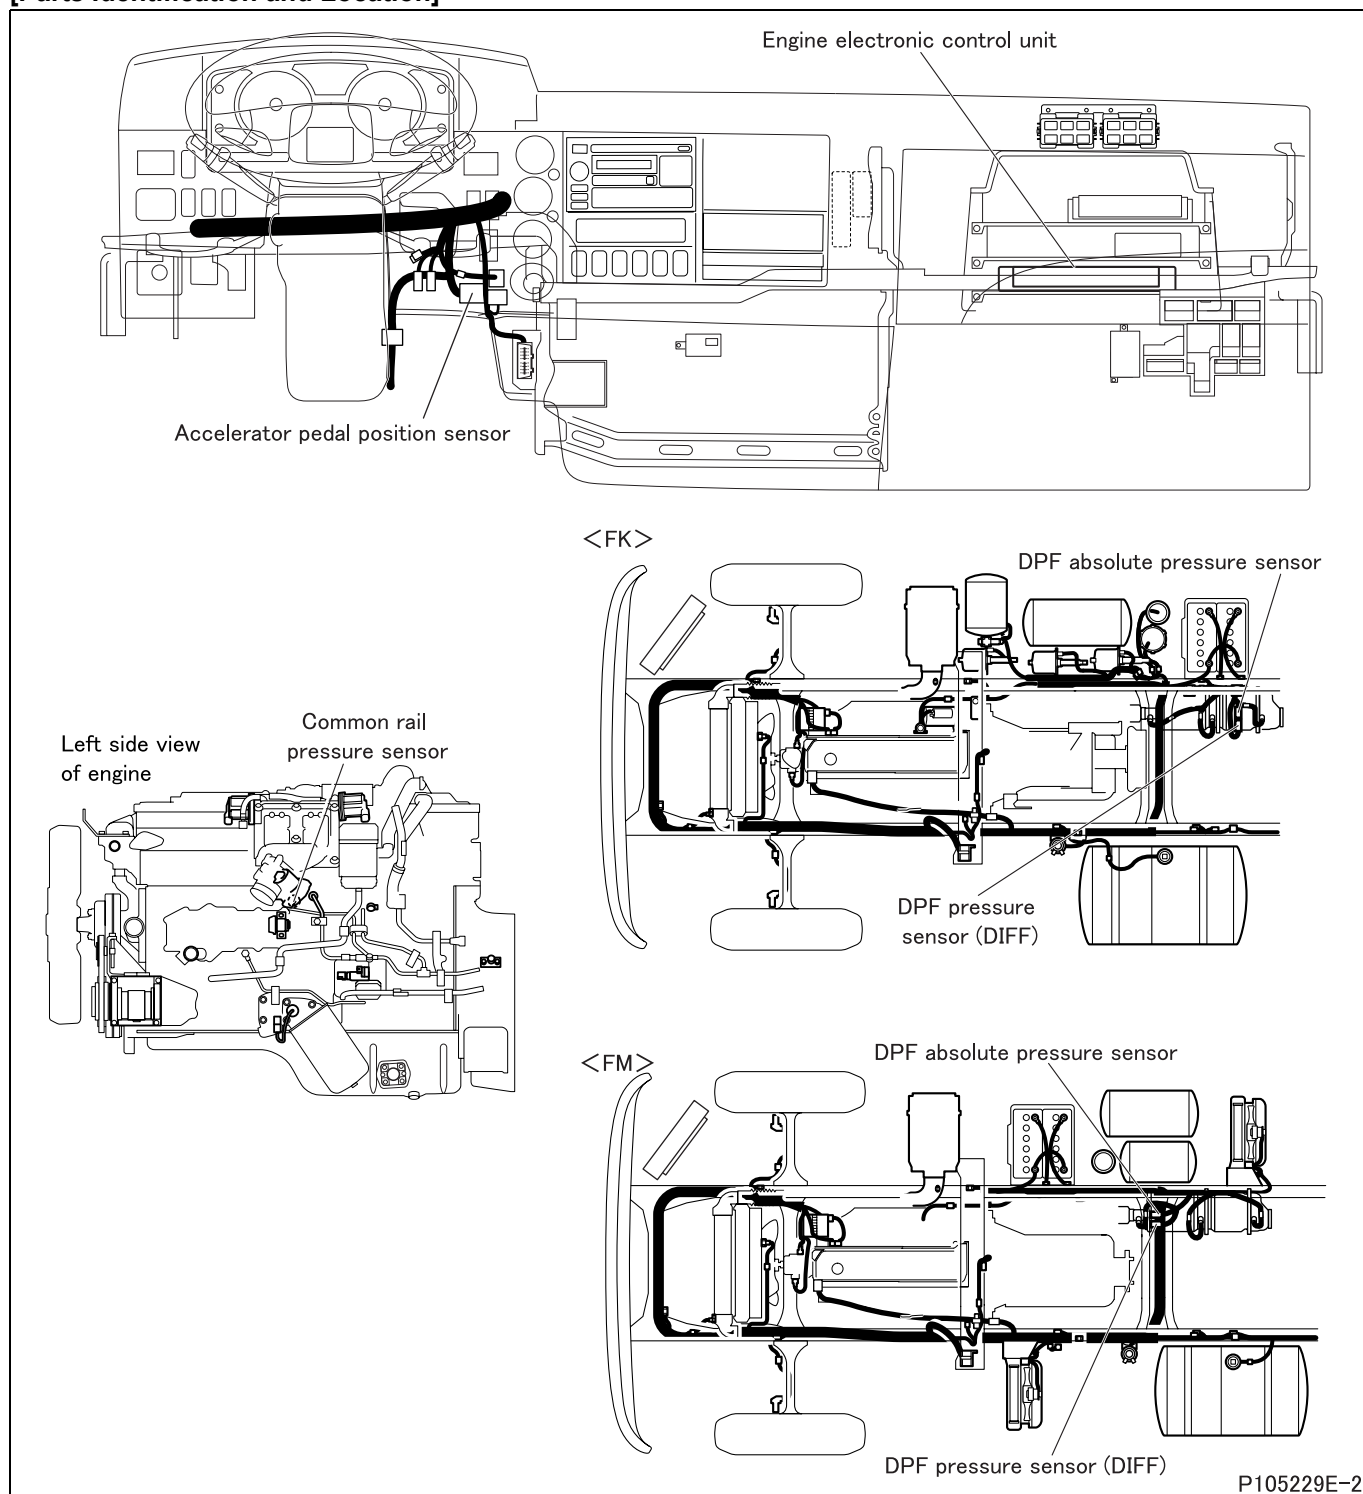
P105229E-2

[Parts Identification and Location]

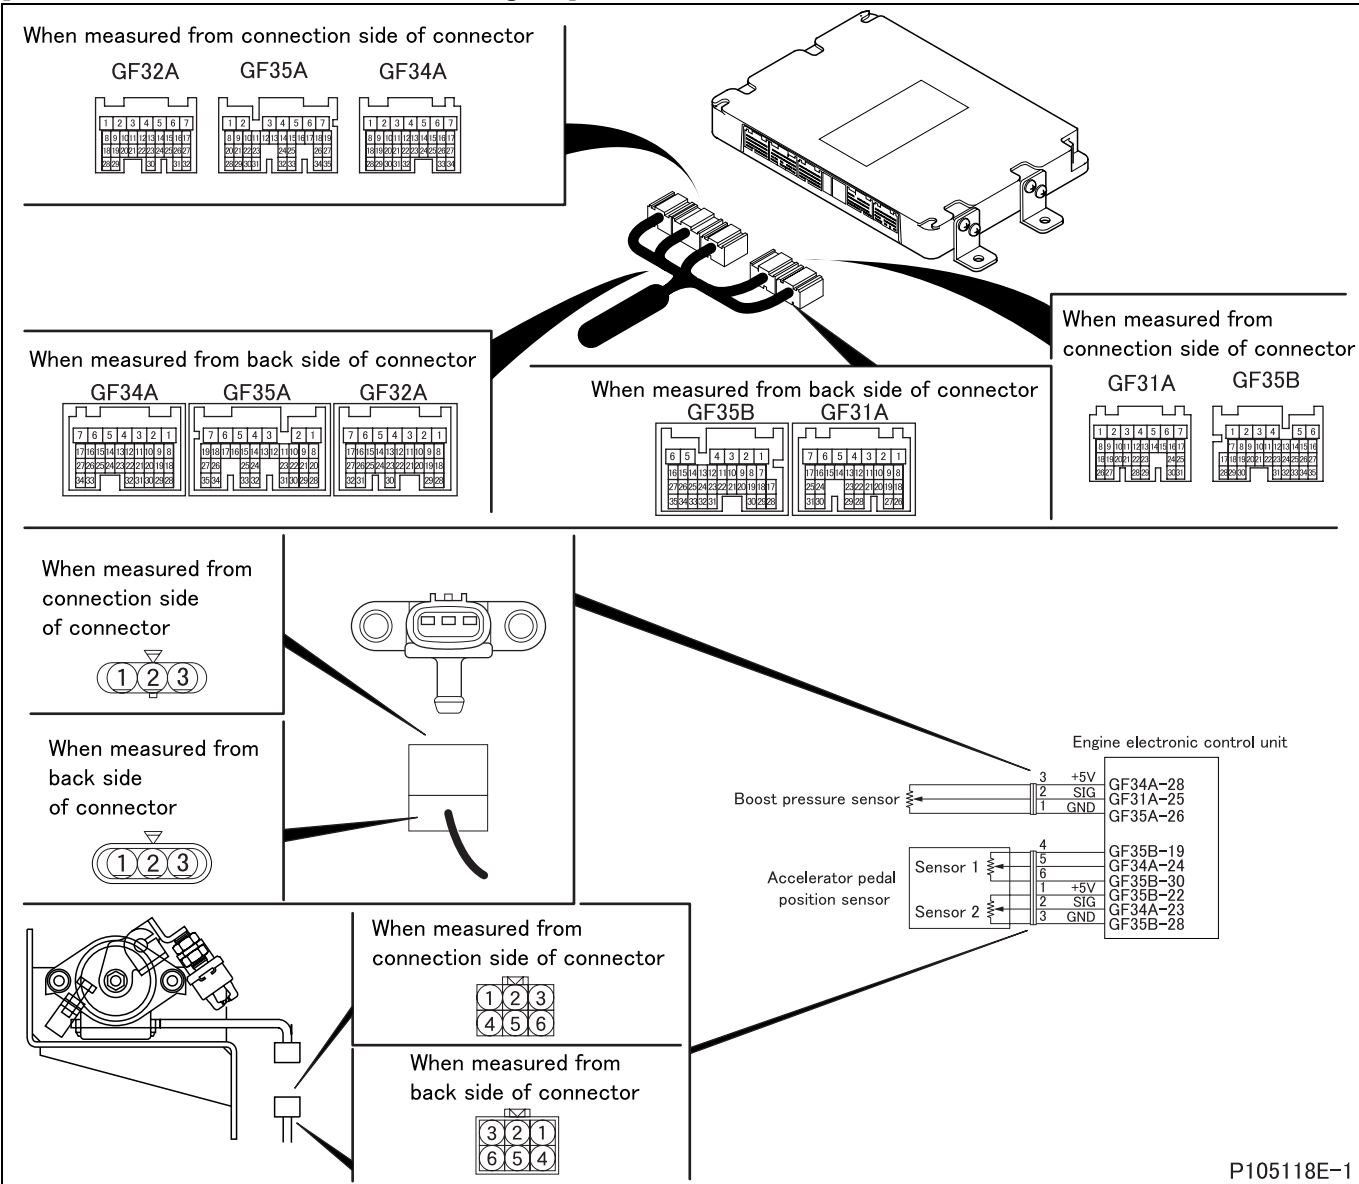
P105118E-1

## [Electronic Control Unit Connection Diagram]

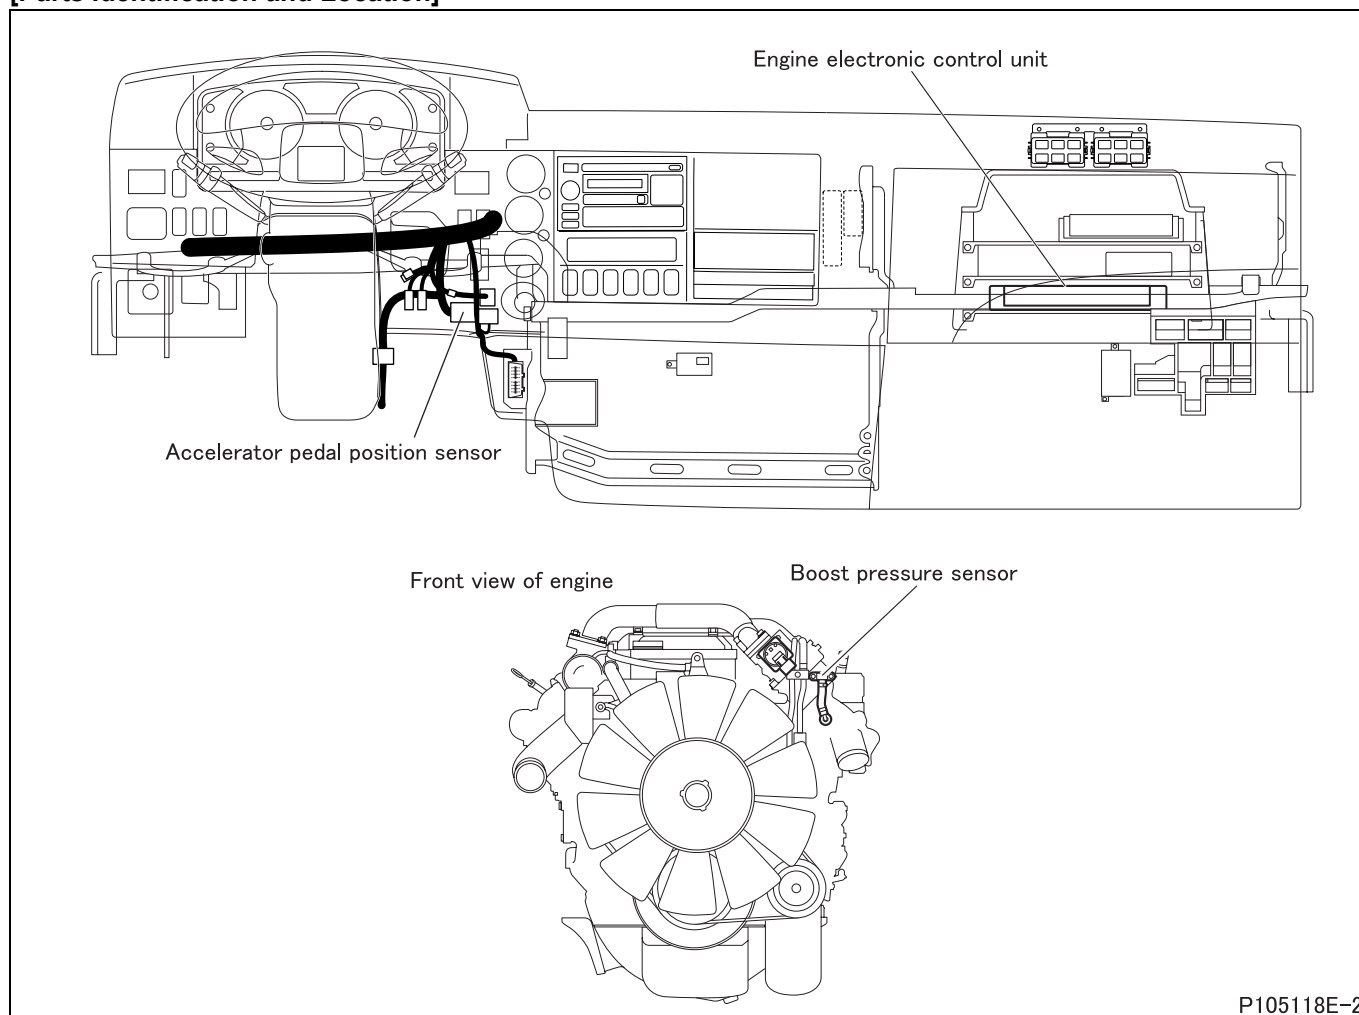
P105118E-2

**[Parts Identification and Location]**

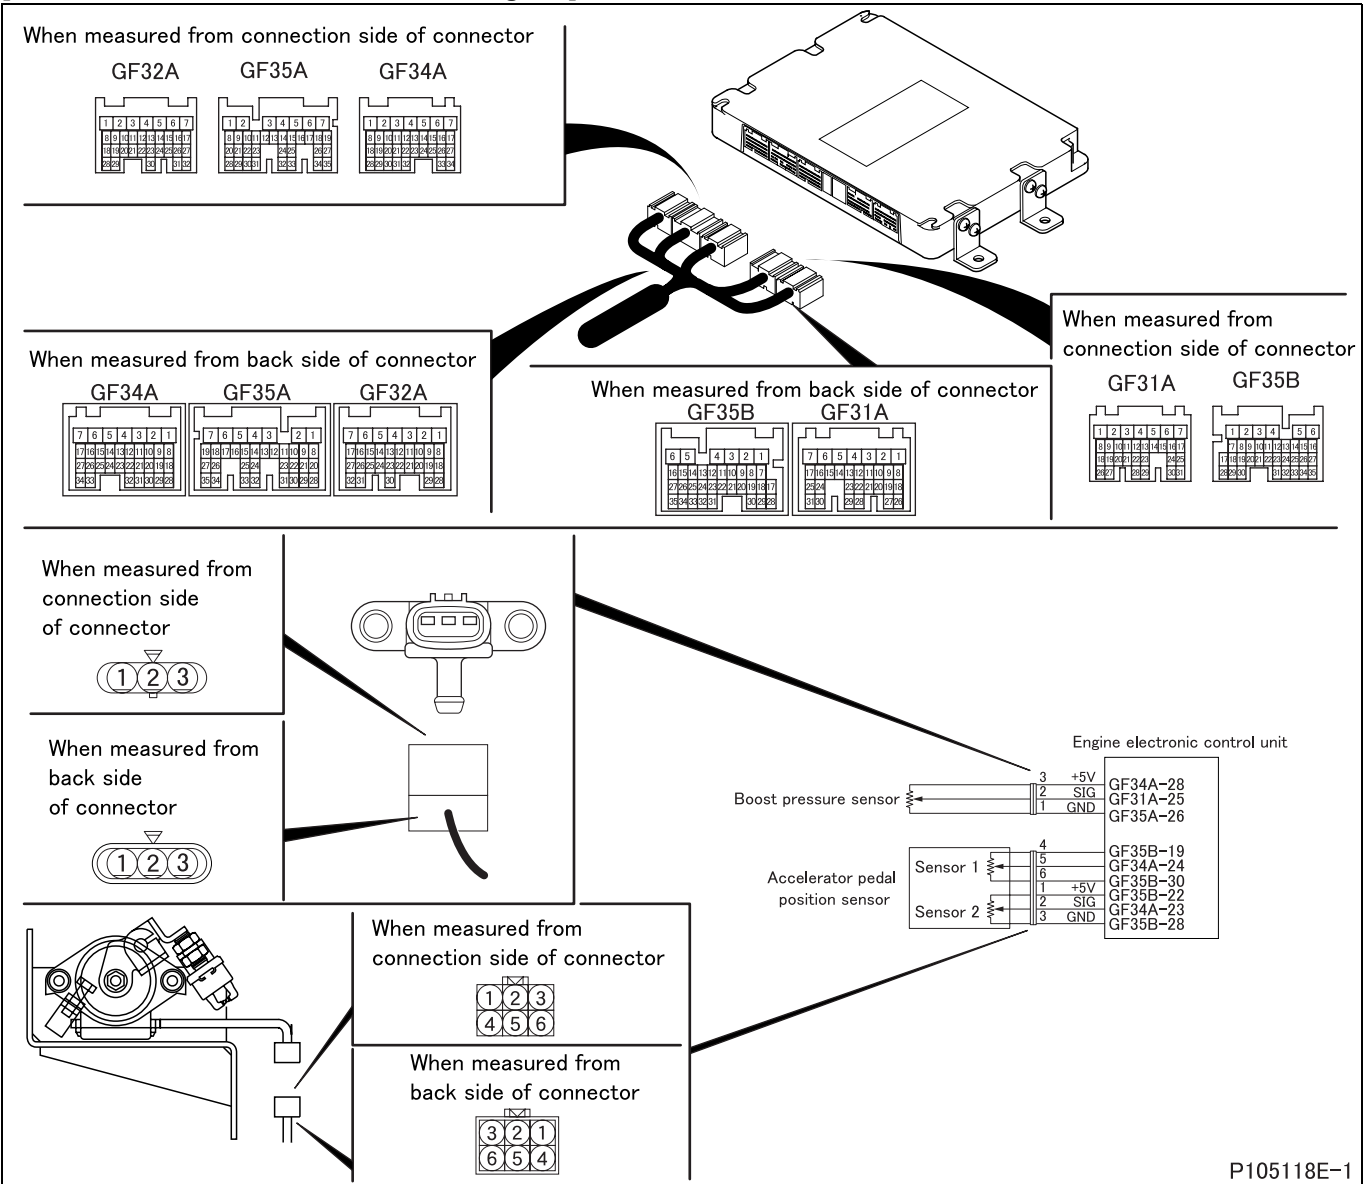
P105118E-1

## [Electronic Control Unit Connection Diagram]

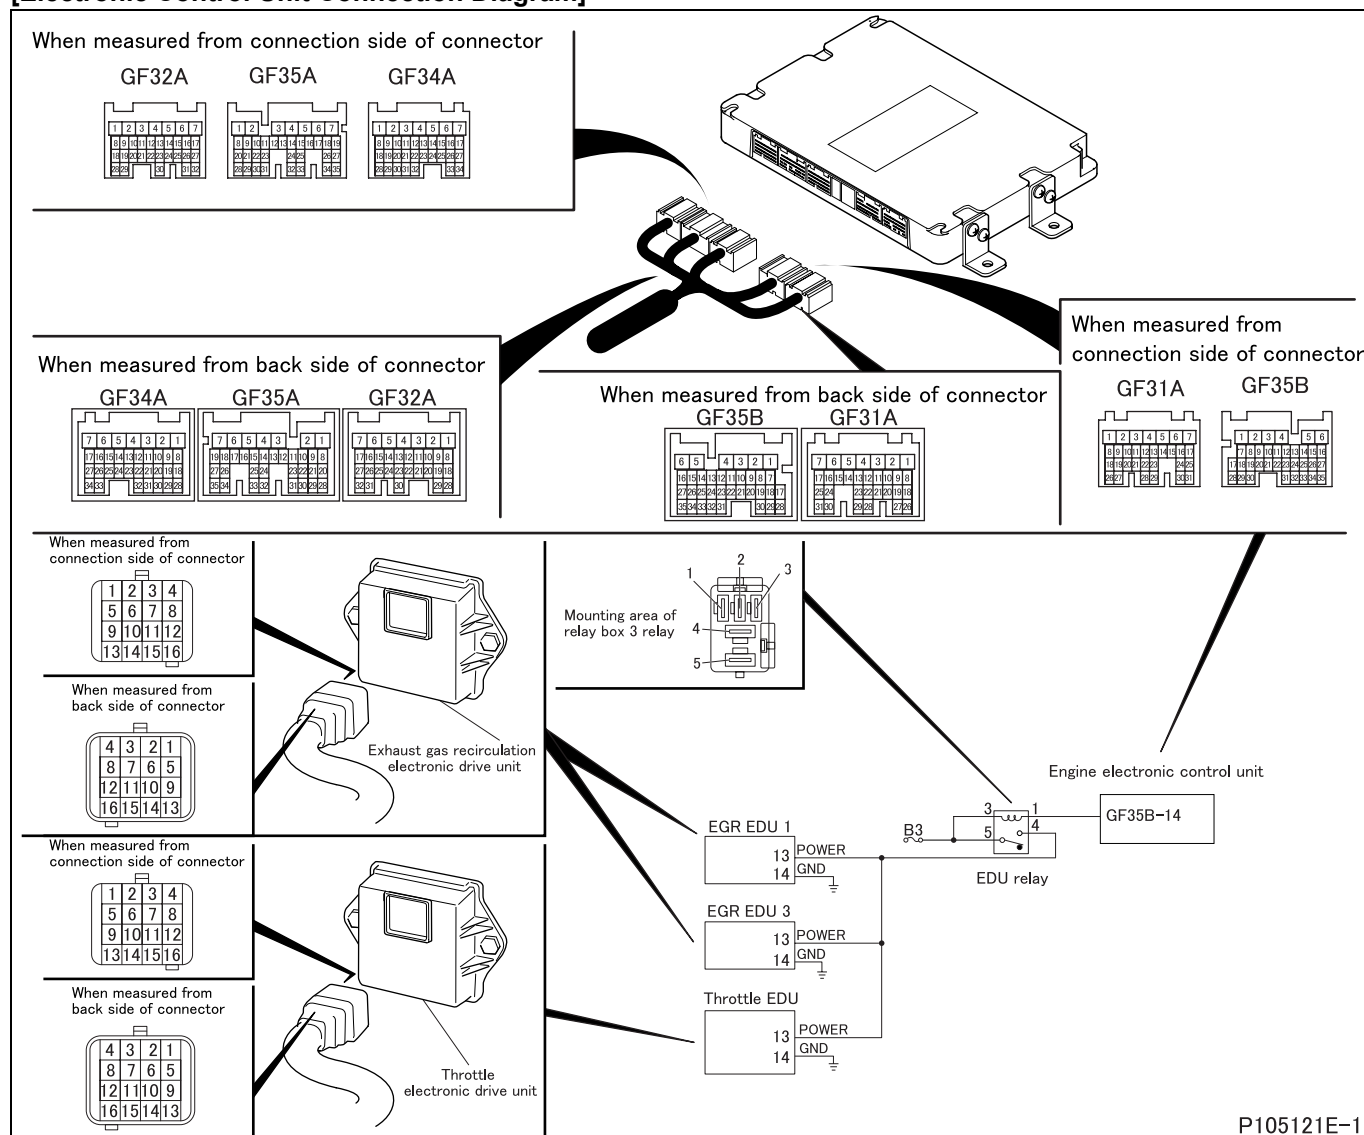
P105121E-1

## [Electronic Control Unit Connection Diagram]

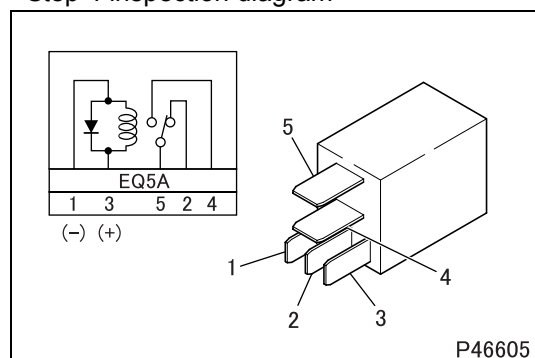
<Step 4 inspection diagram>

| | Inspection condition | | Apply battery voltage across connector terminals No. 3 (+) and 1 (–). |
| NO | | Replacement of relay | |
