# FE.FG

## SERVICE MANUAL 2008 Model FOREWORD

This Service Manual contains maintenance and repair methods for the Mitsubishi Fuso Truck FE. FG Series. Read this manual carefully as an aid in providing correct, efficient maintenance. Please note that the information and specifications contained within this manual may change without notice. This is due to product modifications and continued vehicle improvements that are made throughout the model years. Should you encounter any discrepancy in the information provided, please do not hesitate to contact your nearest Mitsubishi Fuso Dealer or Mitsubishi Fuso Truck of America, Inc.

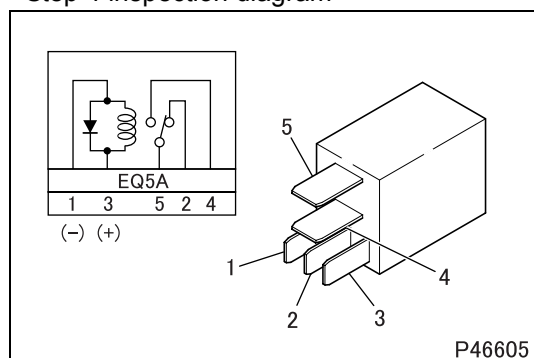
## &lt;Step 4 inspection diagram&gt;

| | Inspection condition | | Apply battery voltage across connector terminals No. 3 (+) and 1 (—). |
| | | NO | Replacement of relay |

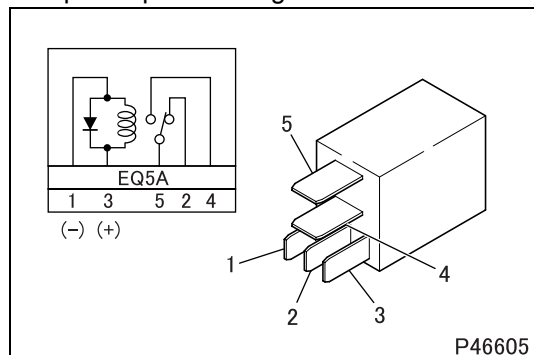
<Step 4 inspection diagram>

| | Inspection condition | | Apply battery voltage across connector terminals No. 3 (+) and 1 (–). |
| | | NO | Replacement of relay |

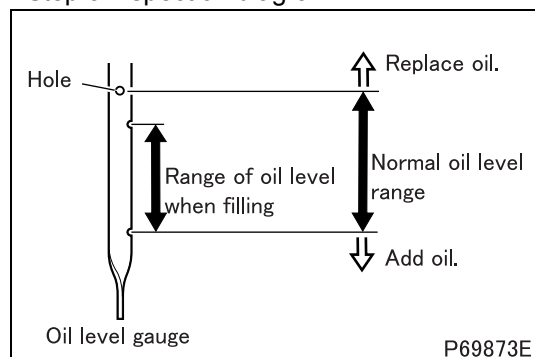
<Step 3 inspection diagram>

| Step 3 | Inspection items | | Inspection of oil level |
| | | NO | After replacement of oil, go to step 4. |

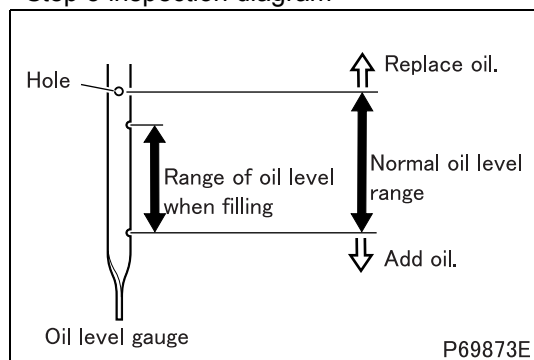
## &lt;Step 3 inspection diagram&gt;

| Step 3 | Inspection items | | Inspection of oil level | |
| | Maintenance item | | Inspection of engine oil level | |
| | | NO | After replacement of oil, go to step 4. | |

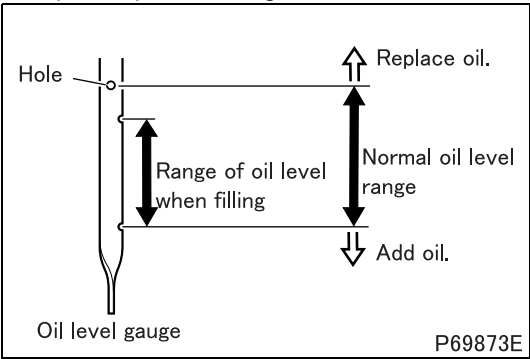
<Step 3 inspection diagram>

| Step 3 | Inspection items | | Inspection of oil level | |
| | Maintenance item | | Inspection of engine oil level | |

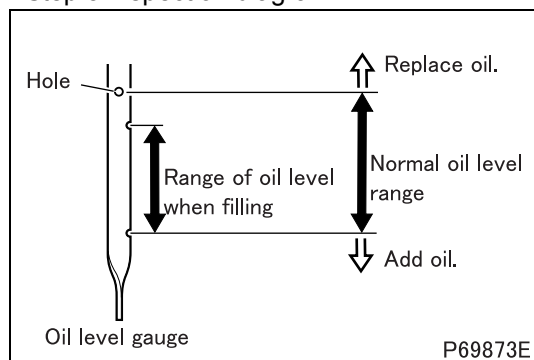
<Step 3 inspection diagram>

| Step 3 | Inspection items | | Inspection of oil level |
| | Maintenance item | | Inspection of engine oil level |
| | Inspection condition | | Engine is stopped. |

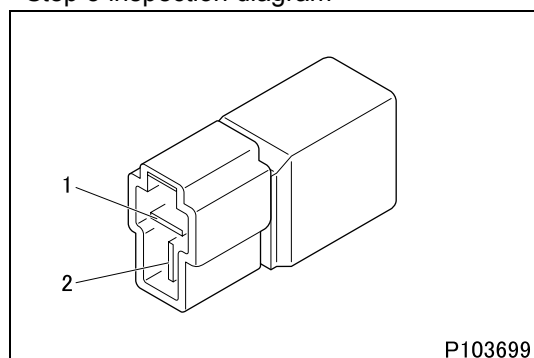
<Step 3 inspection diagram>

| | Inspection condition | | Disconnect connector and measure resistor side. | |

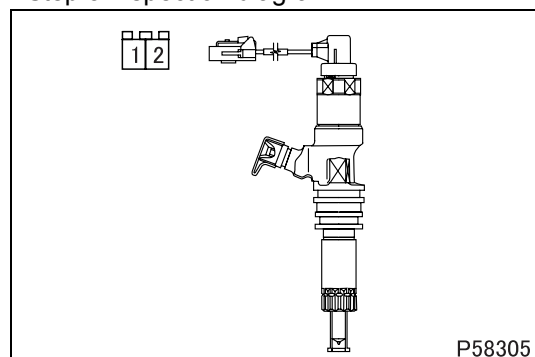
<Step 5 inspection diagram>

| Step 6 | Inspection items | | Inspection of harness between injector magnetic valve and electronic control unit (power supply) |
| | Maintenance item | | Check circuit between following connector terminals. <ul style="list-style-type: none"><li>• Injector magnetic valve (No. 1 cylinder): injector magnetic valve connector terminal No. 2 - electronic control unit connector (GF35B) terminal No. 1 or 2</li><li>• Injector magnetic valve (No. 3 cylinder): injector magnetic valve connector terminal No. 2 - electronic control unit connector (GF35B) terminal No. 1 or 2</li><li>• Injector magnetic valve (No. 5 cylinder): injector magnetic valve connector terminal No. 2 - electronic control unit connector (GF31A) terminal No. 1 or 2.</li></ul> |

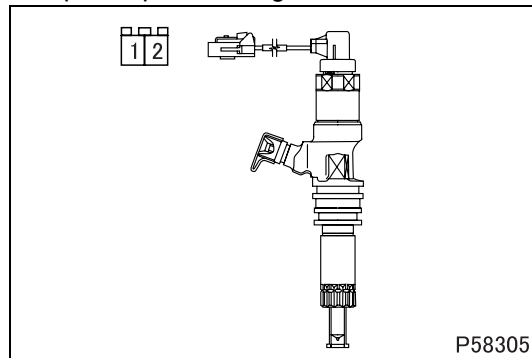
<Step 5 inspection diagram>

| Step 6 | Inspection items | | Inspection of harness between injector magnetic valve and electronic control unit (power supply) |
| | Maintenance item | | Check circuit between following connector terminals. <ul style="list-style-type: none"> <li>• Injector magnetic valve (No. 2 cylinder): injector magnetic valve connector terminal No. 2 - electronic control unit connector (GF35B) terminal No. 1 or 2</li> <li>• Injector magnetic valve (No. 4 cylinder): injector magnetic valve connector terminal No. 2 - electronic control unit connector (GF31A) terminal No. 1 or 2</li> <li>• Injector magnetic valve (No. 6 cylinder): injector magnetic valve connector terminal No. 2 - electronic control unit connector (GF31A) terminal No. 1 or 2.</li> </ul> |

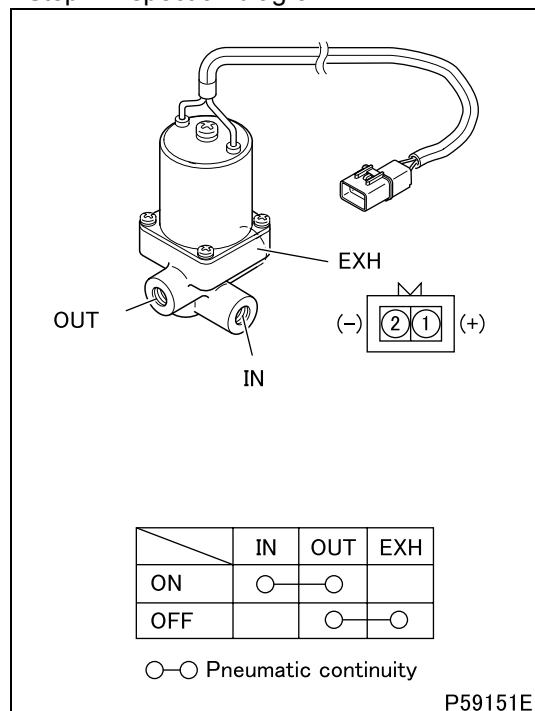
<Step 4 inspection diagram>

| Step 5 | Inspection items | | Inspection of harness between 3-way magnetic valve and electronic control unit (ground) |
| | Maintenance item | | Check circuit between 3-way magnetic valve connector terminal No. 2 and electronic control unit connector (GF35B) terminal No. 13. |

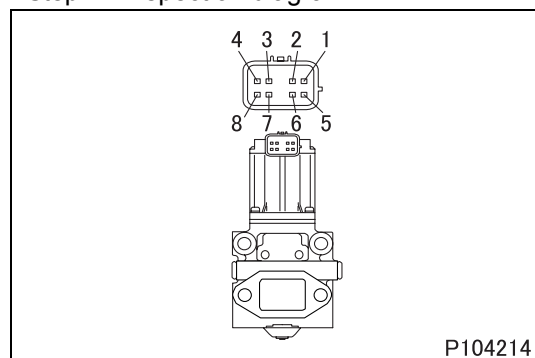
<Step 12 inspection diagram>

| Step 13 | Inspection items | | Inspection of exhaust gas recirculation valve connector (position sensor: power supply) |
| | Maintenance item | | Measure value of voltage between connector terminal No. 1 (+) and 5 (-). |

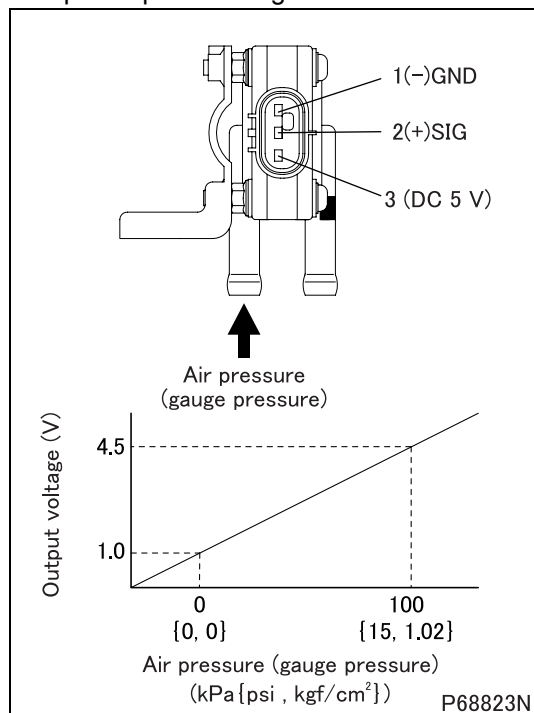
<Step 7 inspection diagram>

| Step 8 | Inspection items | | Inspection of harness between electronic control unit and sensor (power supply) | |
| | Maintenance item | | Measure value of voltage between connector terminal No. 3 (+) and 1 (–). | |

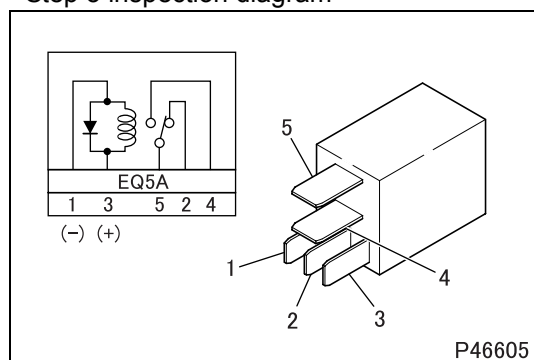
## &lt;Step 3 inspection diagram&gt;

| Step 4 | Inspection items | | Inspection of harness between relay (coil side) and electronic control unit |
| | Maintenance item | | Check circuit between relay connector terminal No. 1 and electronic control unit connector (GF32A) terminal No. 2 or 3. |

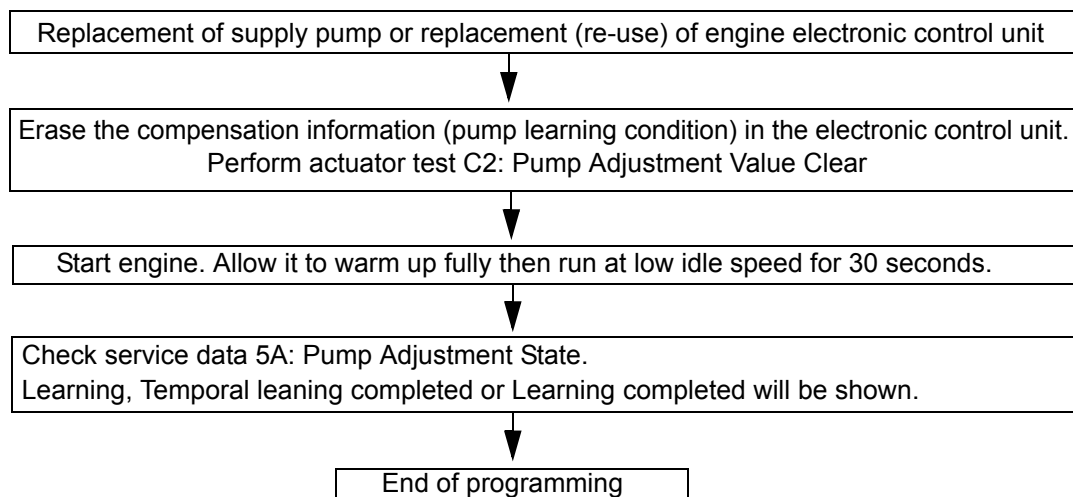
### 7.1 After replacement of supply pump or replacement (re-use) of engine electronic control unit

Also following replacement of the engine electronic control unit with a new one, it is necessary to program in the current supply pump data.

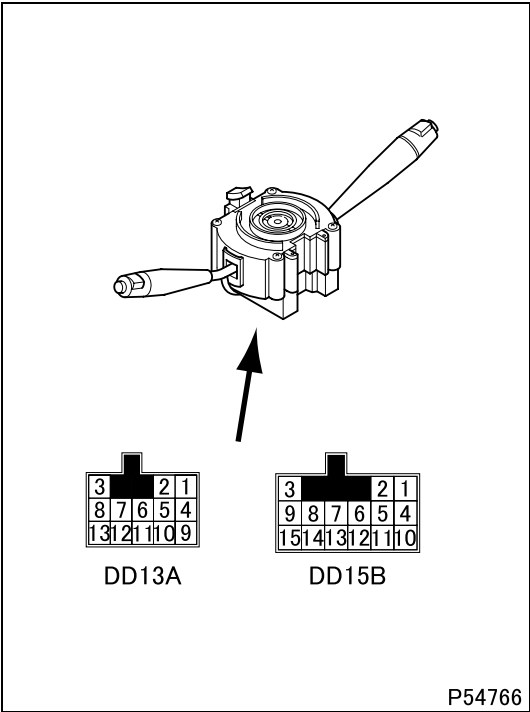
## #001 Inspection of combination switch

DD13A connector connection table

- If there is any abnormality, replace the switch.

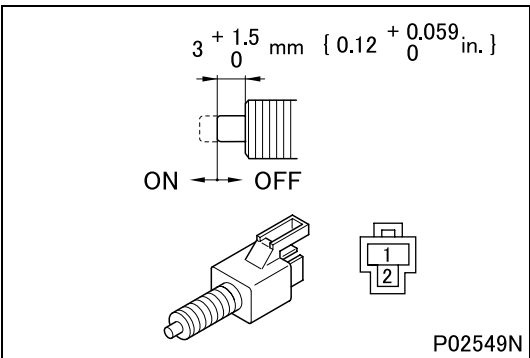
## #031 Inspection of clutch switch

| Switch position | Terminals with continuity |
| ON | 1–2 |

- If there is any abnormality, replace the switch.

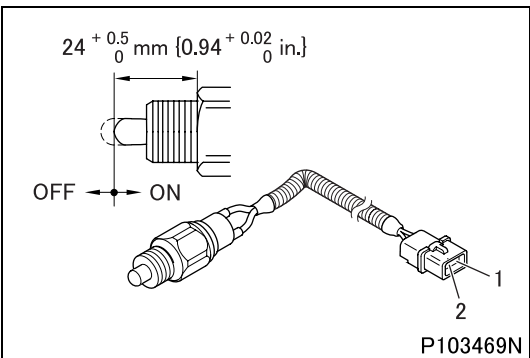
## #056 Inspection of transmission neutral switch

| Switch position | Terminals with continuity |
| ON | 1–2 |

- If there is any abnormality, replace the switch.

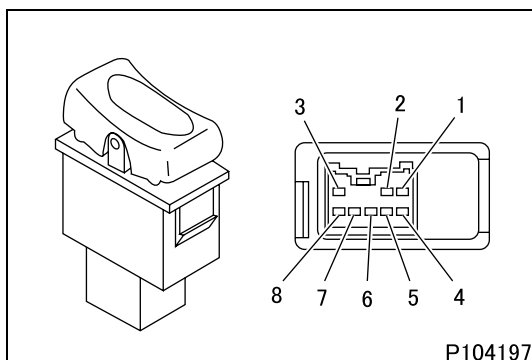
P104197

### #089 Inspection of DPF cleaning switch

| Switch position | Terminals with continuity |
|---|---|
| ON | 7–8 |

- If there is any abnormality, replace the switch.

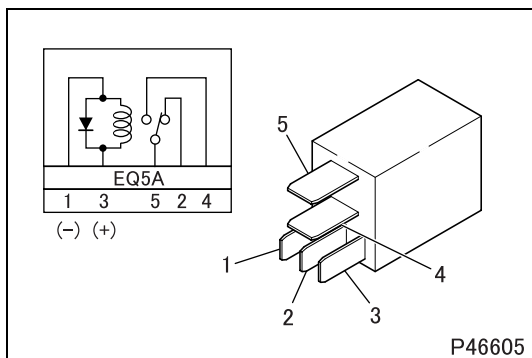
P46605

### #182 Inspection of relay (normally open type with 6 pins)

- Test for continuity and proper operation. If there is any abnormality, replace the relay.

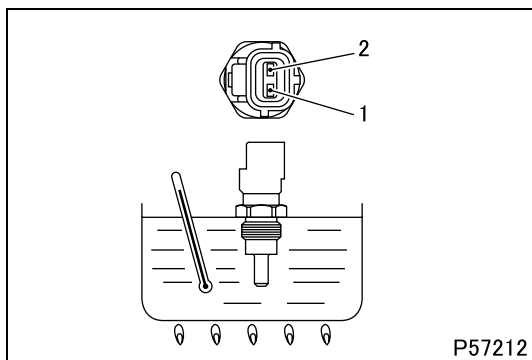
P57212

### #262 Inspection of water temperature sensor

| | 110°C {230°F} | 147.1 ± 2 Ω |

- If either measurement is out of specification, replace the sensor.

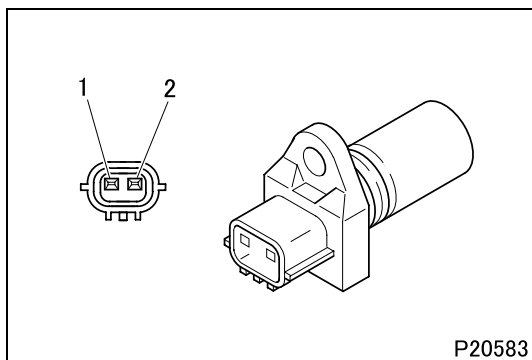
P20583

### #263 Inspection of engine speed sensor

- If the measurement is out of specification, replace the sensor.

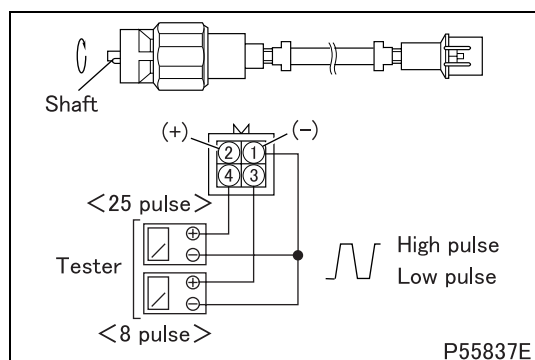
## #265 Inspection of vehicle speed sensor

- With the battery voltage applied to terminals 1 and 2, slowly turn the shaft of the sensor.
- Measure the maximum voltage (high pulse voltage) and minimum voltage (low pulse voltage) occurring at each specified pair of terminals.

| Terminals | Inspection condition | Standard value |
|---|---|---|
| | High pulse voltage | $8 \pm 1$ V |

- If any measurement is out of specification, replace the sensor.

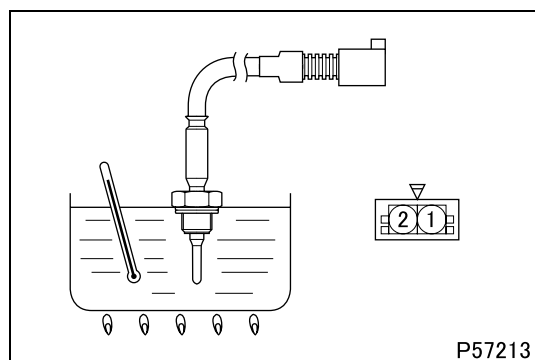
## #305 Inspection of intake air temperature sensor

### <Intake air temperature sensor 1>

| | 150°C {302°F} | $160.4^{+10.3}_{-9.6}$ $\Omega$ |

- If either measurement is out of specification, replace the sensor.

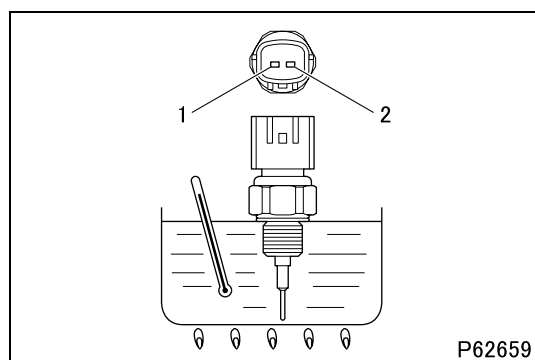
### <Intake air temperature sensor 2>

- The intake air temperature sensor 2 may output false signals if its tip is contaminated. Clean it if necessary. (See Gr15.)
- Place the sensor in a container filled with engine oil.
- Heat the oil to each of the specified temperatures. Stir the oil well while doing so.
- Measure the resistance between terminals 1 and 2.

| | 80°C {176°F} | $6.120^{+1.095}_{-0.907}$ k $\Omega$ |

- If the measurement is out of specification, replace the sensor.

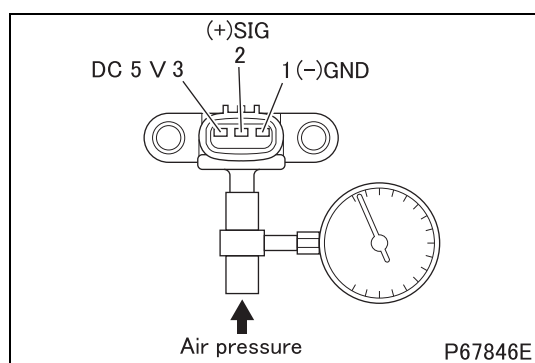
## #318 Inspection of boost pressure sensor

- Apply DC 5 V to terminals 3 and 1.
- Apply air pressure. Gradually increase it and, while doing so, measure the output voltage occurring at terminals 2 and 1 (see the diagram on the left).

- If any measurement is out of specification, replace the sensor.

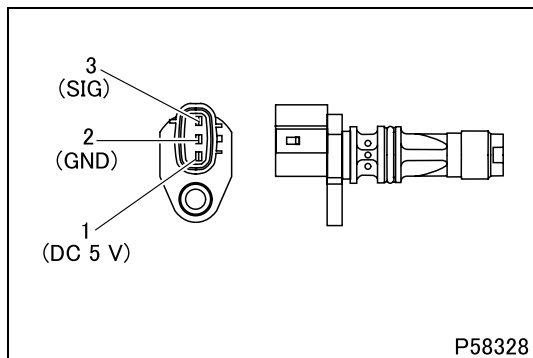
**#320 Inspection of cylinder recognition sensor**

- Measure the resistance between terminals 1 and 2. (The resistance serves as a rough indication only. A pulse output monitor is needed for confirmation of functionality.)

| Standard value | 200 to 1800 $\Omega$ |

- If the measurement is out of specification, replace the sensor.

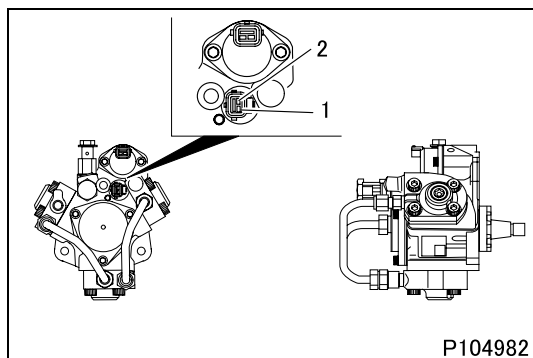
**#323 Inspection of fuel temperature sensor****<Fuel temperature sensor 1>**

- Measure the resistance between terminals 1 and 2.

| | 80°C {176°F} | 0.318 $\pm$ 0.008 k $\Omega$ |

- If any measurement is out of specification, replace the supply pump.

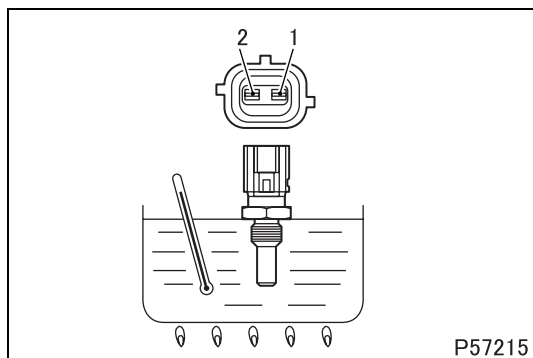
**<Fuel temperature sensor 2>**

- Measure the resistance between terminals 1 and 2.

- If any measurement is out of specification, replace the sensor.

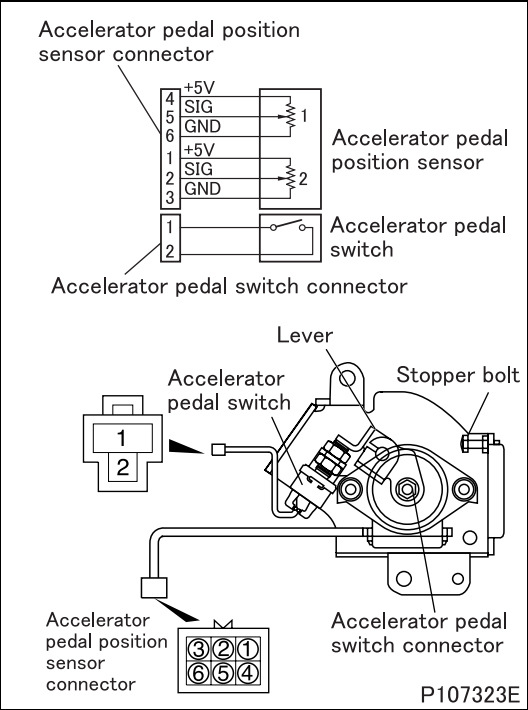
## #324 Inspection of accelerator pedal position sensor

| Standard value | Lever position | Output voltage |
|---|---|---|
| | Full load position C | $4.15 \pm 0.1$ V |

- A: Position in which accelerator pedal switch is fully pushed in by lever
- B: Position at which continuity between terminals 1 and 2 of accelerator pedal switch connector disappears as accelerator pedal is pushed downward
- C: Position in which lever is touching stopper bolt
- If any output voltage is out of specification, make an adjustment.
- If any output voltage is still out of specification when you have made an adjustment, replace the sensor.

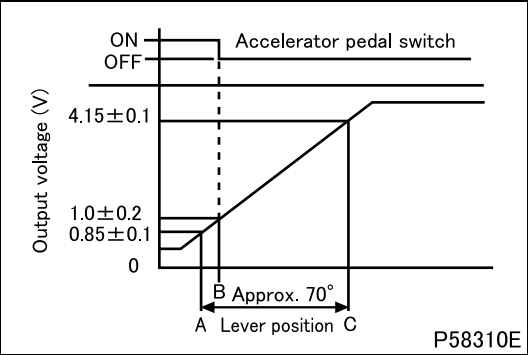
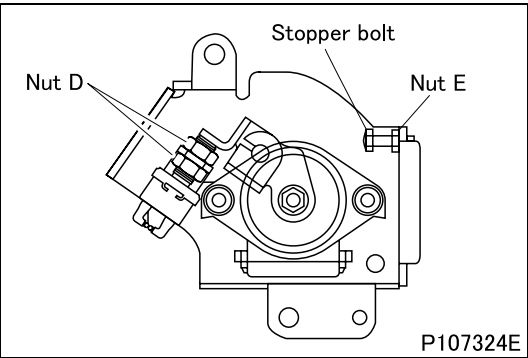
### [Adjustment]

- To adjust the output voltage for the accelerator pedal switch operating position A, use nut D.
- To adjust the output voltage for the full load position C, loosen nut E and make the adjustment using the stopper bolt.
- After making the adjustment, lock the stopper bolt in position with the nut.

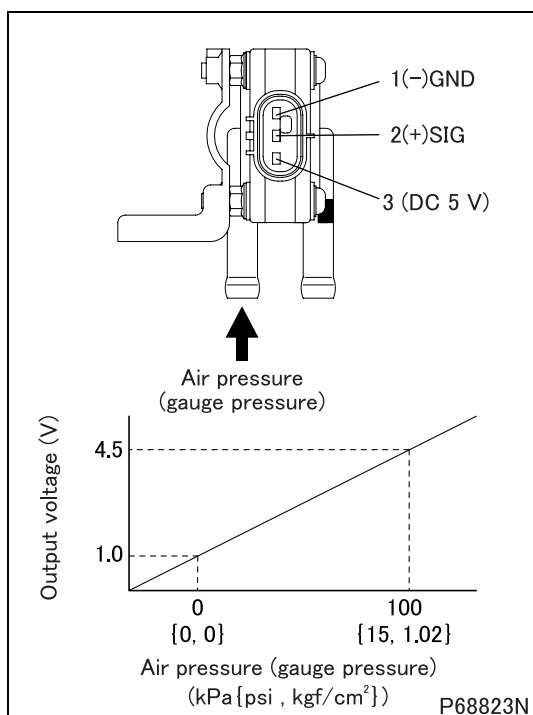
## &lt;DPF absolute pressure sensor&gt;

- Apply DC 5 V to terminals 3 and 1.
- Apply air pressure (gauge pressure) and measure the output voltage occurring at terminals 2 and 1 (left figure).

| | $99 \pm 3.2 \text{ kPa}$ $\{14 \pm 0.5 \text{ psi}, 1.0 \pm 0.03 \text{ kgf/cm}^2\}$ | 4.5 V |

- If the measurement is out of specification, replace the sensor.

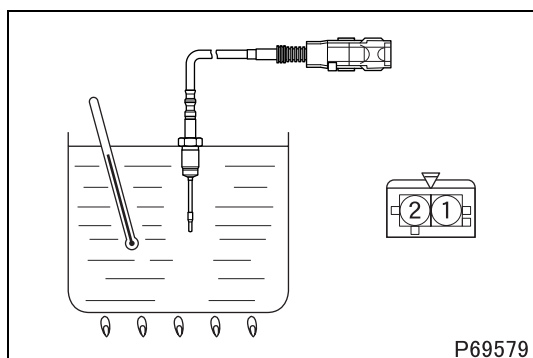
### <DPF temperature sensor 2>

- The DPF temperature sensor 2 may output false signals if its tip is contaminated. Clean it if necessary. (See Gr15.)
- Place the sensor in a container filled with engine oil.
- Heat the oil to each of the specified temperatures. Stir the oil well while doing so.
- Measure the resistance between terminals 1 and 2.

| | 200°C {392°F} | 6.896 $^{+2.064}_{-1.252}$ kΩ |

- If the measurement is out of specification, replace the sensor.

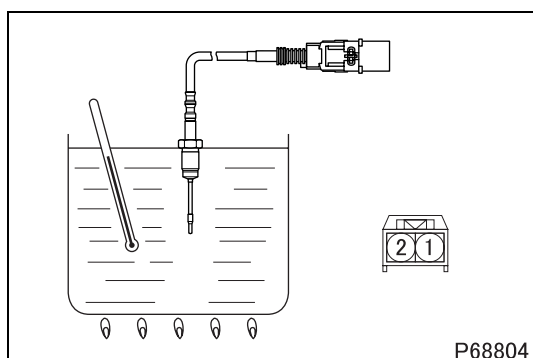
## #338 Inspection of catalytic temperature sensor

- The catalytic temperature sensor may output false signals if its tip is contaminated. Clean it if necessary. (See Gr15.)
- Place the sensor in a container filled with engine oil.
- Heat the oil to each of the specified temperatures. Stir the oil well while doing so.
- Measure the resistance between terminals 1 and 2.

| | 200°C {392°F} | 6.896 $^{+2.064}_{-1.252}$ kΩ |

- If the measurement is out of specification, replace the sensor.

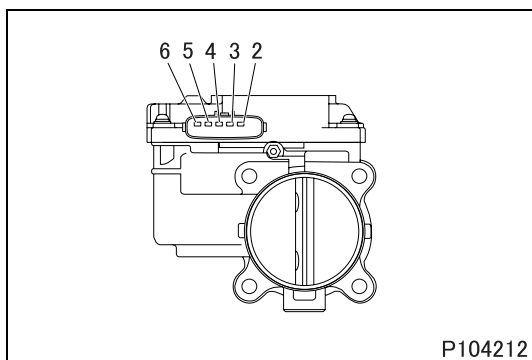
P104212

### #529 Inspection of intake throttle

- Perform the following checks. If there is any abnormality, replace the intake throttle.

#### (2) Position sensor

- The sensor cannot easily be inspected, so you must evaluate it indirectly by inspection of system harnesses and related parts.
- If there is no abnormality in any related part but the system is abnormal, replace the intake throttle.

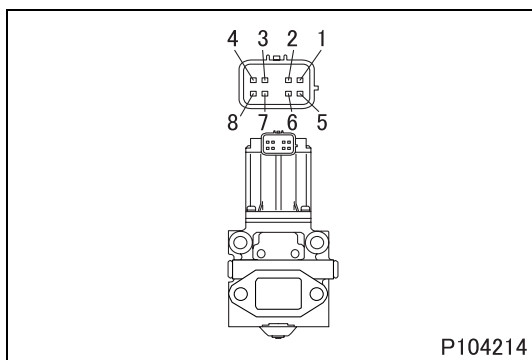
P104214

### #530 Inspection of EGR valve

- Perform the following checks. If there is any abnormality, replace the EGR valve.

#### (2) Position sensor

- The sensor cannot easily be inspected, so you must evaluate it indirectly by inspection of system harnesses and related parts.
- If there is no abnormality in any related part but the system is abnormal, replace the EGR valve.

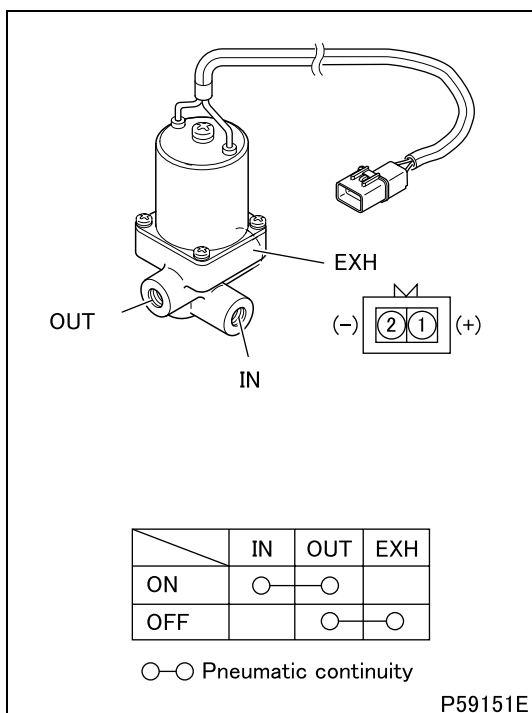
P59151E

### #565 Inspection of 3-way magnetic valve

- Perform the following checks. If there is any abnormality, replace the 3-way magnetic valve.

- Air pressure applied during check: 981 kPa {140 psi, 10 kgf/cm<sup>2</sup>}

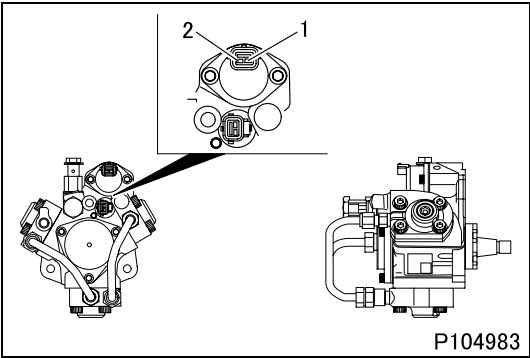
## #574 Inspection of SCV (suction control valve)

- Measure the resistance between terminals 1 and 2.

| Standard value | $2.1 \pm 0.2 \Omega$ |

- If the measurement is out of specification, replace the supply pump.

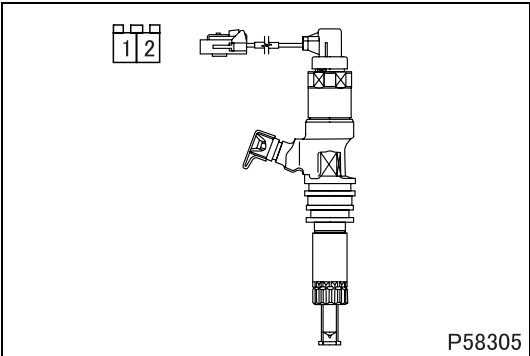
## #582 Inspection of injector

- Measure the resistance between terminals 1 and 2.

| Standard value (at 20°C {68°F}) | $0.45 \pm 0.1 \Omega$ |

- If the measurement is out of specification, replace the injector.

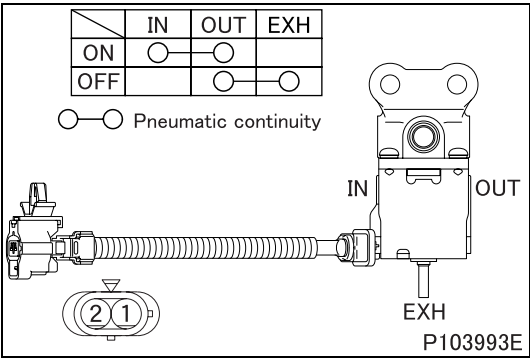
## #601 Inspection of waste gate magnetic valve

- Perform the following checks. If there is any abnormality, replace the waste gate magnetic valve.

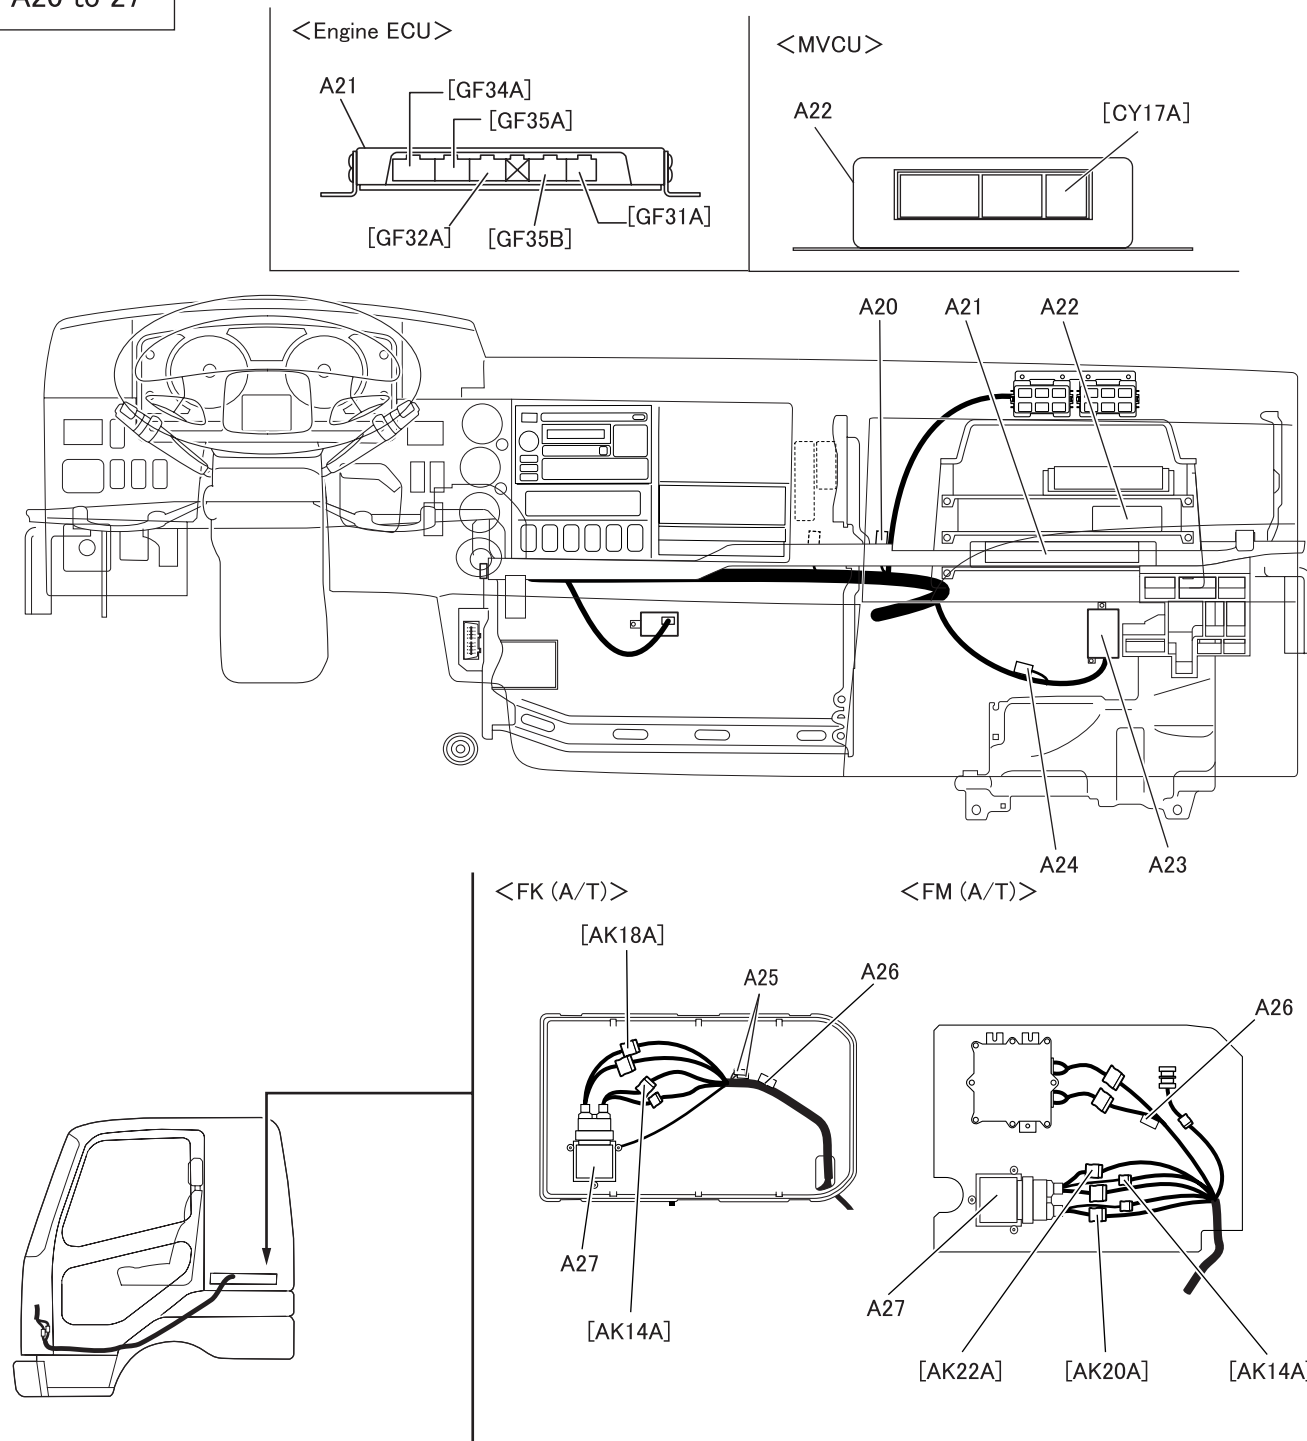
## A20 to 27

- A20 CAN resistor
- A21 Engine ECU
- A22 MVCU
- A23 Pulse converter <A/T>
- A24 Diode unit
- A25 CAN resistor
- A26 Joint connector (J/C-3) <A/T>
- A27 A/T ECU

A/T : Automatic transmission  
 ECU : Electronic control unit  
 MVCU : Multifunction vehicle control unit

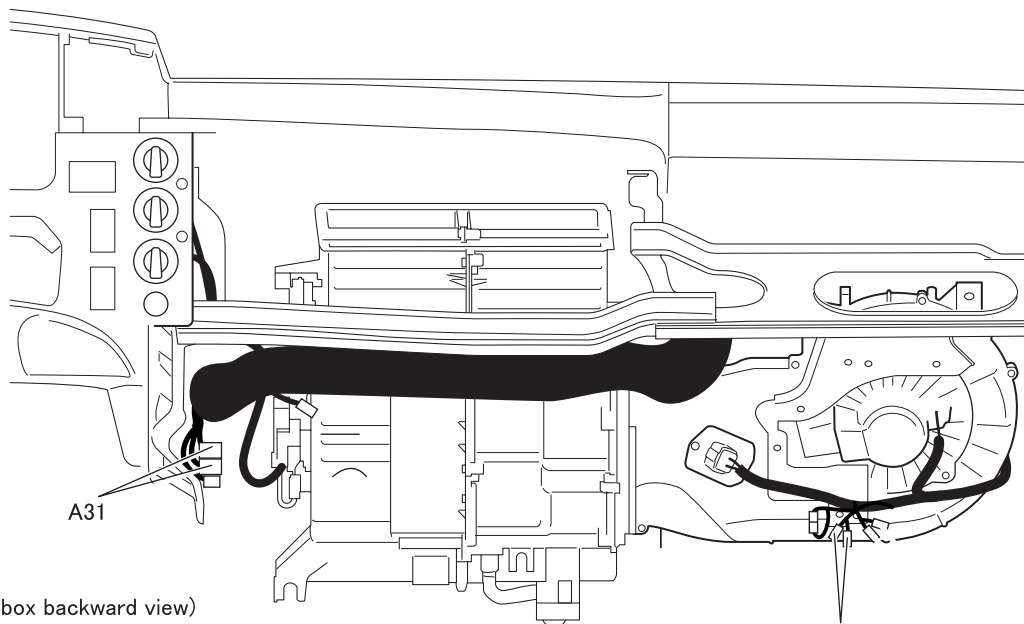
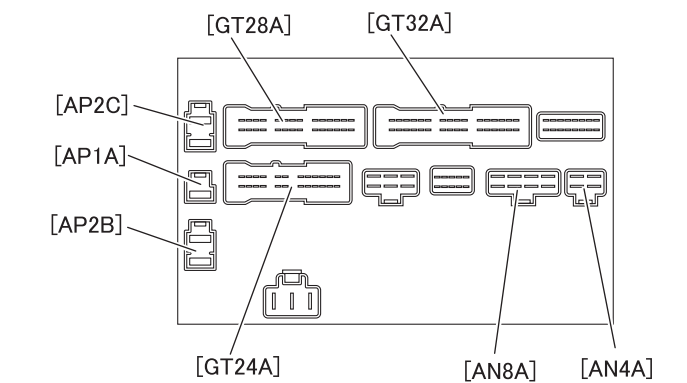
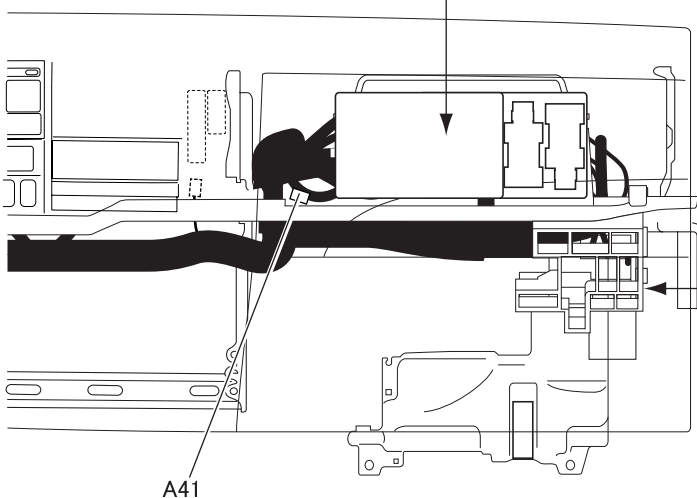
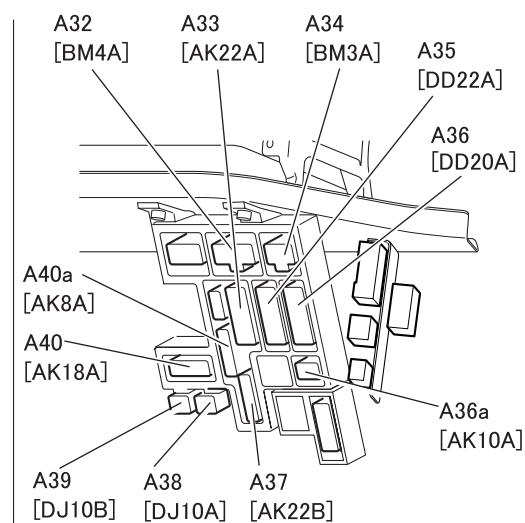
A30 to 41

- A30 Connector (for mixer)
- A31 Connection of cab harness and A/T harness
- A32-36a Connection of cab harness and chassis harness
- A37-40a Connection of cab harness and engine control harness
- A41 Joint connector (J/C-1, 3, 4)

A/T : Automatic transmission

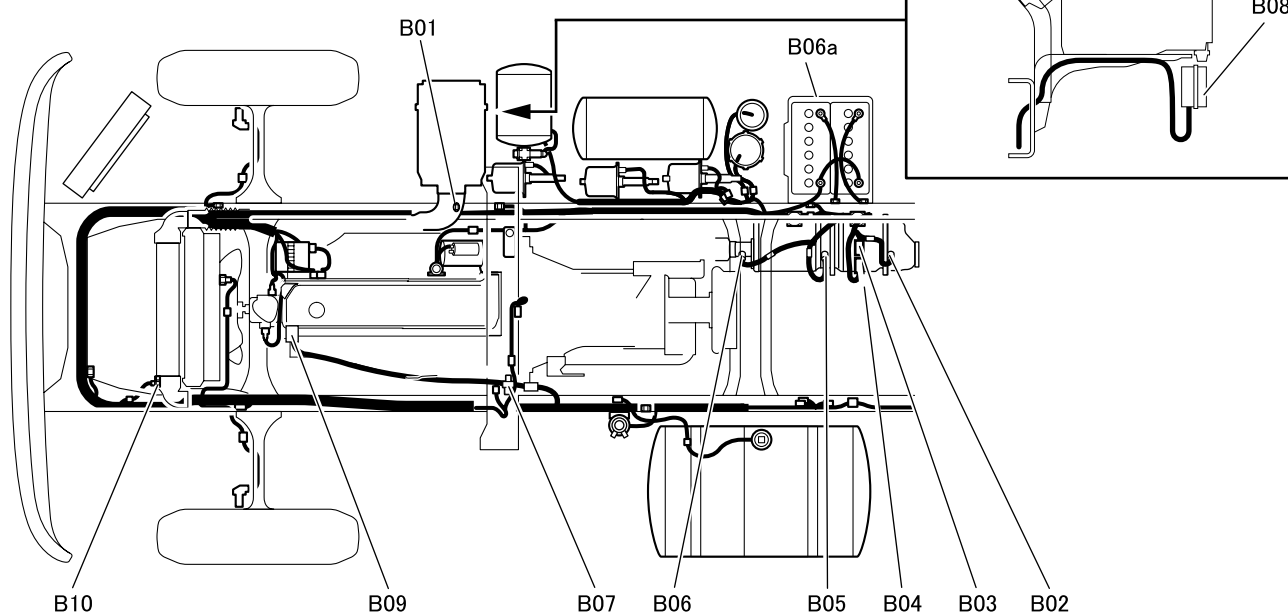
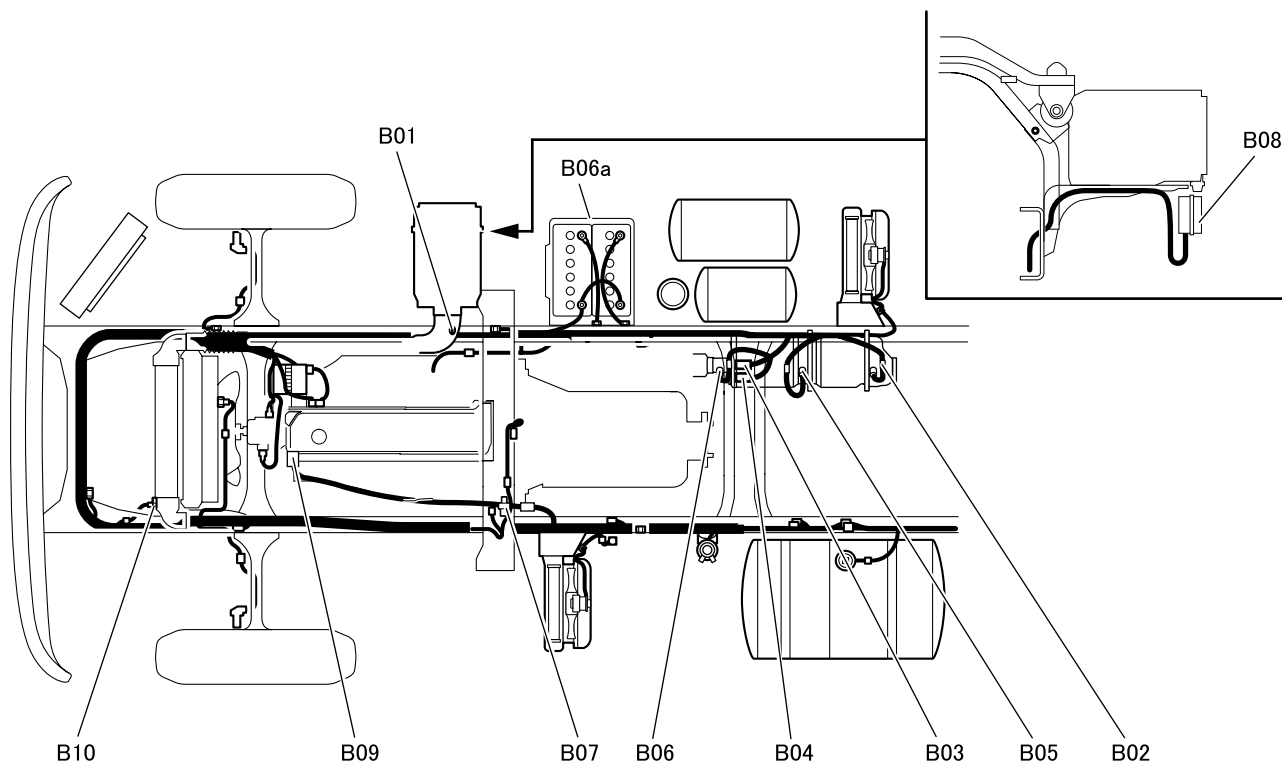
## B01 to 10

| B01 | Air flow sensor | B06 | Catalytic temperature sensor |

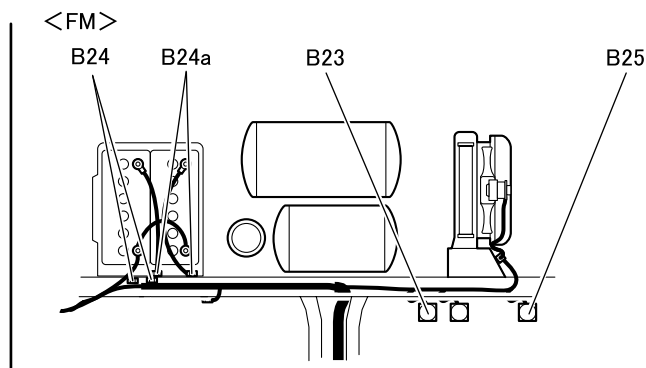
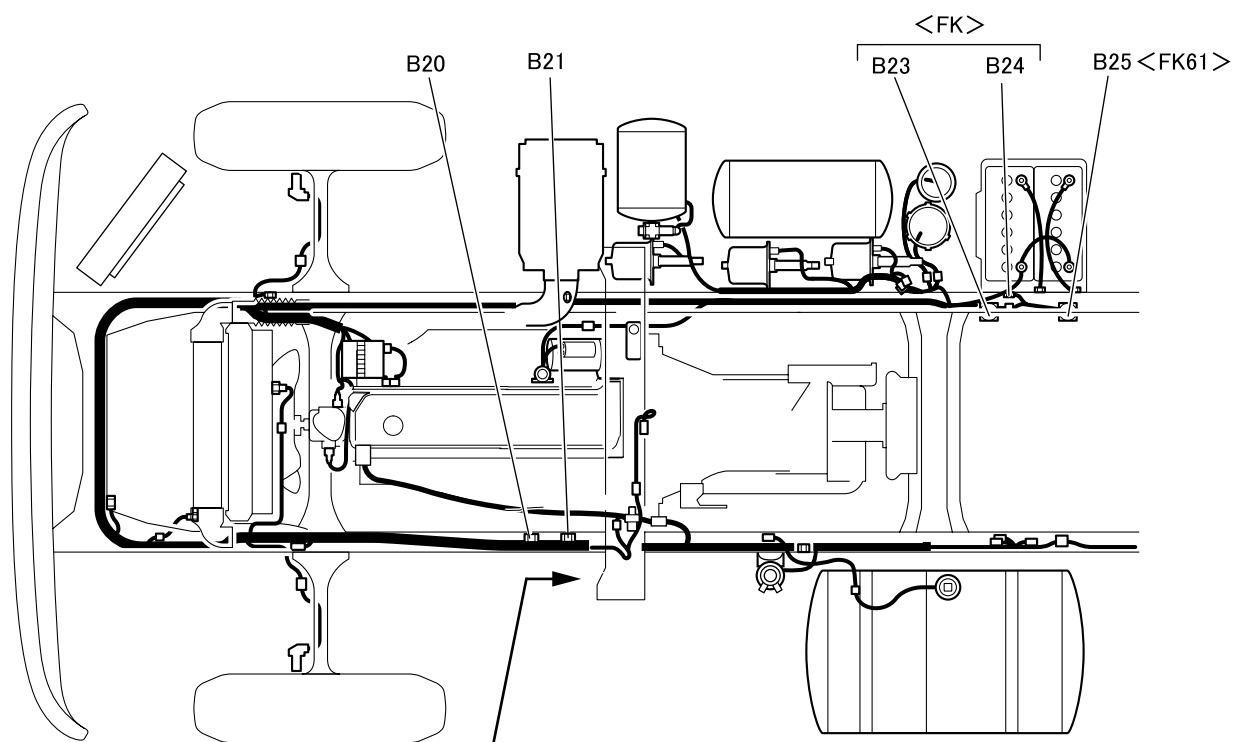
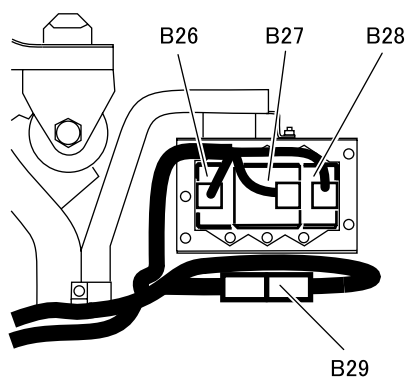
B20 to 29

- B20 Ground
- B21 Ground
- B23 Exhaust shutter 3-way magnetic valve 1
- B24 Ground
- B24a Ground
- B25 Exhaust shutter 3-way magnetic valve 2
- B26 EGR EDU3
- B27 Throttle EDU
- B28 EGR EDU1
- B29 Connection of engine harness and engine control harness

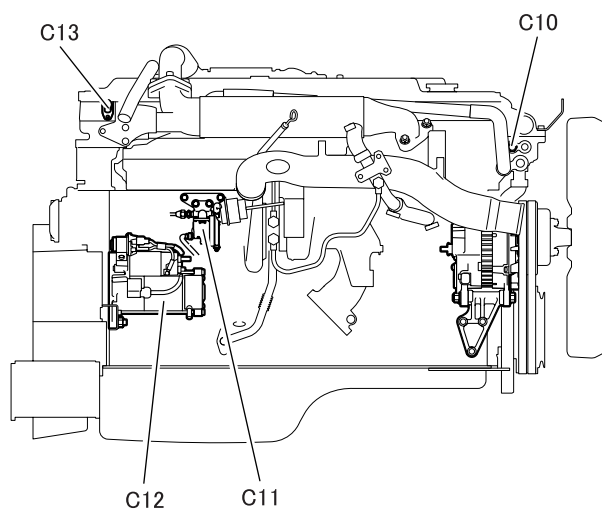
(Right side view)

- C01 Boost pressure sensor
- C02 Injector magnetic valve
- C03 EGR valve 1  
(building into motor, position sensor)
- C03a EGR valve 3  
(building into motor, position sensor)
- C04 Intake air temperature sensor 2
- C05 Common rail pressure sensor
- C06 Throttle actuator  
(building into motor, position sensor)
- C07 Fuel temperature sensor 1
- C08 Fuel temperature sensor 2

- C09 Suction control valve
- C10 Water temperature sensor  
(connects to engine electronic control unit)
- C11 Waste gate magnetic valve
- C12 Starter
- C13 Cylinder recognition sensor

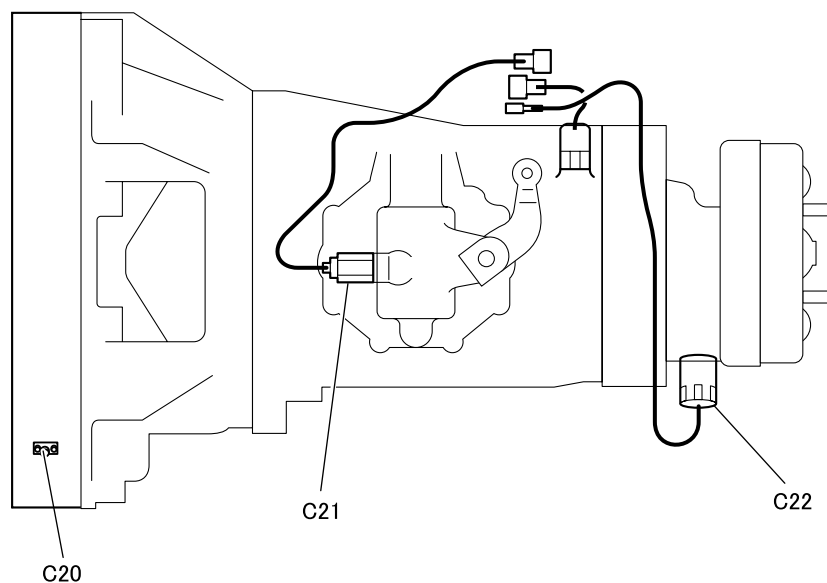
<Manual transmission>

- C20 Engine speed sensor
- C21 Transmission neutral switch
- C22 Vehicle speed sensor

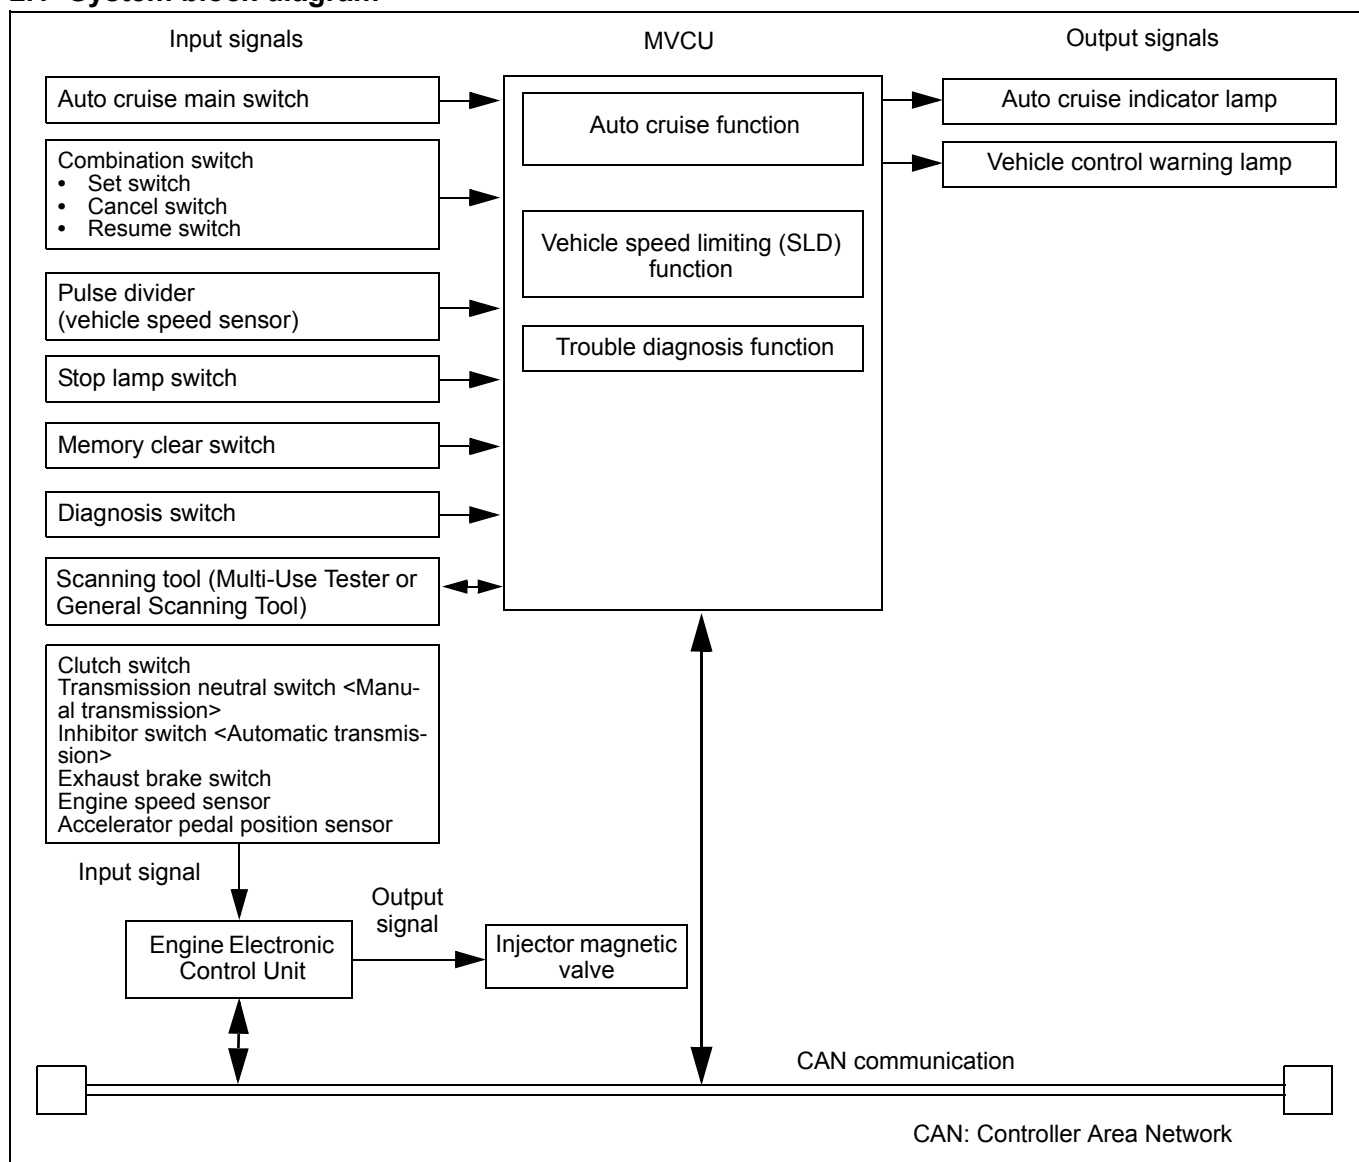
### 2.1 System block diagram

| Part name | Function/operation |
|---|---|
| CAN communication (engine electronic control unit) | MVCU outputs recognized vehicle data on CAN so that engine electronic control unit receives necessary data for control. Engine electronic control unit outputs necessary signals to MVCU for appropriate control of individual systems. |

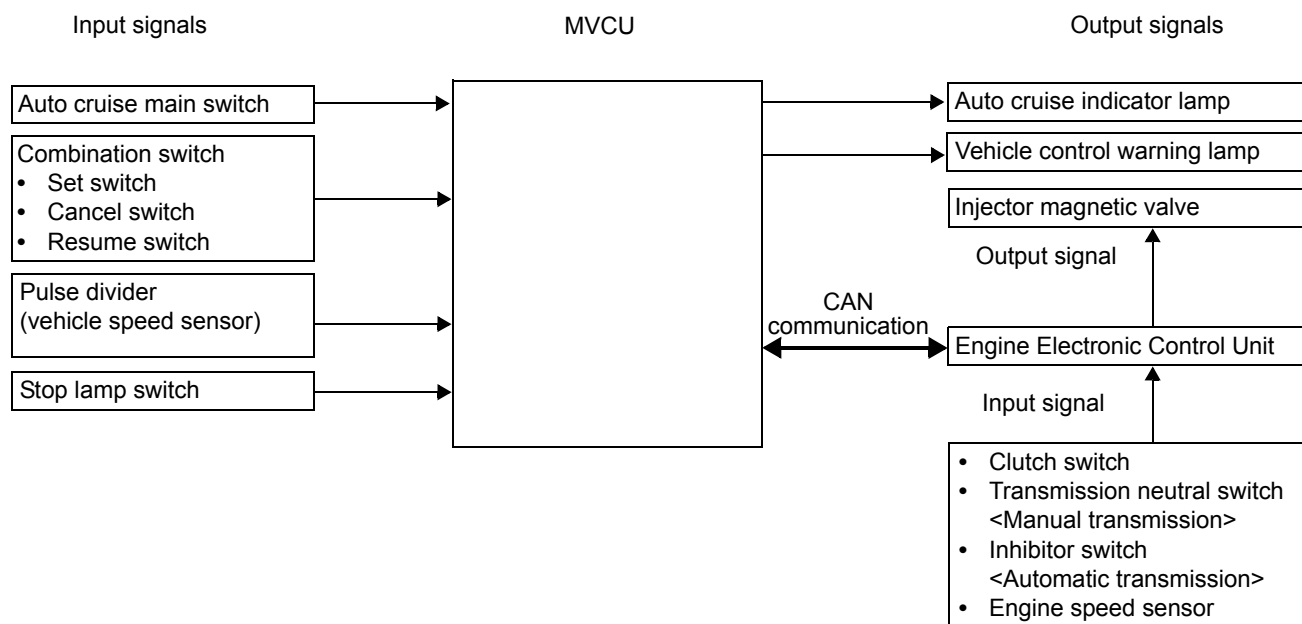
## 2.2 Auto cruise function

- In the auto cruise function, the target vehicle speed is set using the main switch, set switch and resume switch, and the MVCU maintains the set speed by controlling the engine.
