# FE.FG

## SERVICE MANUAL 2008 Model FOREWORD

This Service Manual contains maintenance and repair methods for the Mitsubishi Fuso Truck FE. FG Series. Read this manual carefully as an aid in providing correct, efficient maintenance. Please note that the information and specifications contained within this manual may change without notice. This is due to product modifications and continued vehicle improvements that are made throughout the model years. Should you encounter any discrepancy in the information provided, please do not hesitate to contact your nearest Mitsubishi Fuso Dealer or Mitsubishi Fuso Truck of America, Inc.

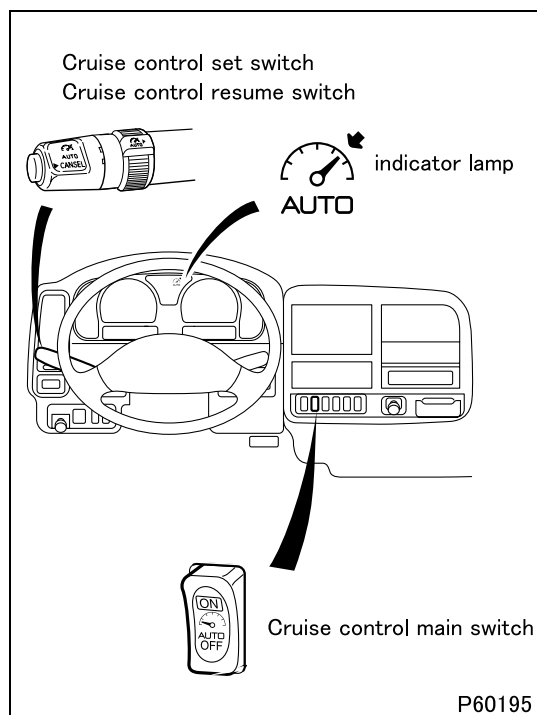
## (1) Setting the auto cruise function

- The operation of the auto cruise function using the set switch and the resume switch as follows:

- To activate the auto cruise function, the following conditions should be met:
  - Shift lever is in 4th or higher gear position.
  - Vehicle speed is increased to approx. 40 km/h {25 MPH} or higher.
  - The auto cruise main switch is in ON position.
  - The clutch and brake pedals are released.

While driving at the set speed, turn set/resume switch to the RESUME position. The vehicle will accelerate. When the desired speed is reached, release the switch; now the new higher speed is set.

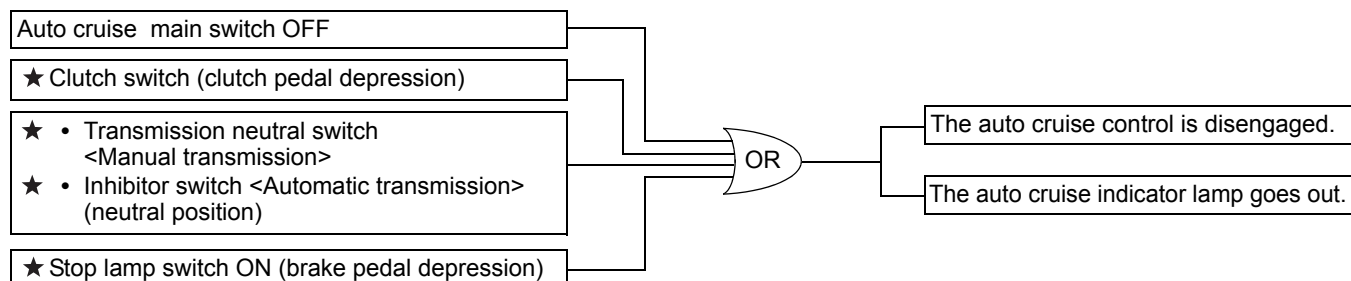
## (2) Disengaging the auto cruise control

The condition marked ★ disengages the auto cruise control temporarily.

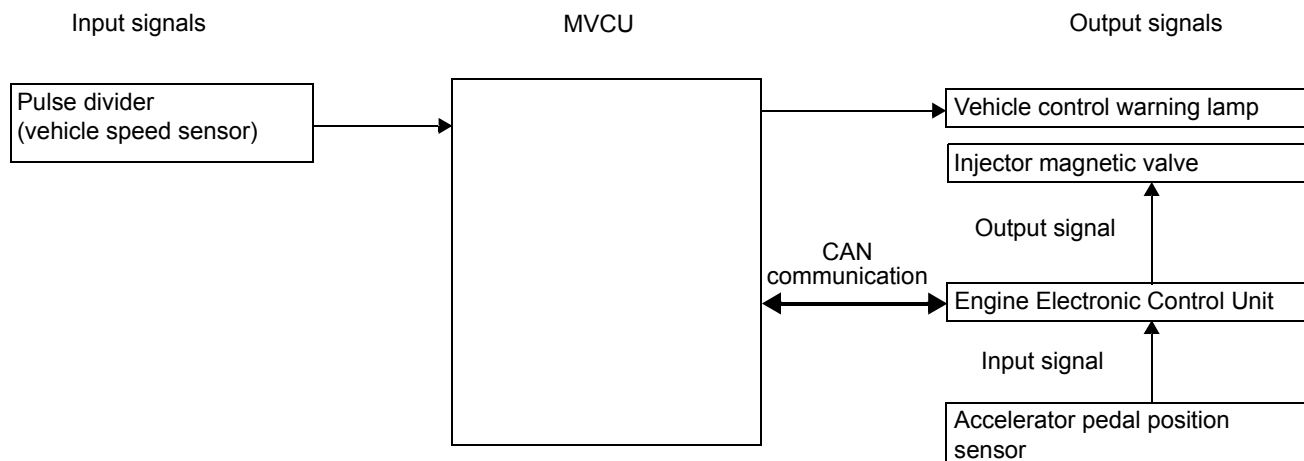
## 2.3 Vehicle speed limiting (SLD) function

- The vehicle speed limiting (SLD) function is designed to send output signals to the engine ECU to restrict the maximum vehicle speed to a preset speed limit regardless of the accelerator pedal operation when the vehicle speed reaches the speed limit on flat or uphill road.

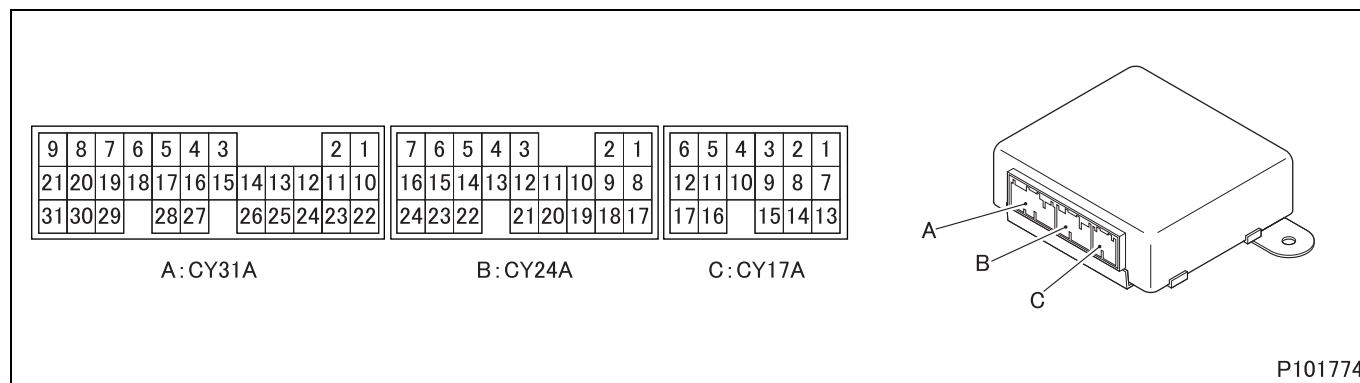
### 7.1 Electronic control unit connector terminal arrangement

The white-on-black numbers (**01**, **02** and so on) correspond to the similarly printed reference numbers in section “3. Inspection Based on Diagnosis Codes”.

| Check item | Check method |
|---|---|
| <b>02</b><br>Stop lamp switch continuity | [Conditions] <ul style="list-style-type: none"> <li>Starter switch in OFF position.</li> <li>Connector disconnected; check at vehicle-side connector</li> </ul> [Criteria] Between terminals: B12 or B13-chassis grounding <ul style="list-style-type: none"> <li>When brake pedal pressed: Continuity established</li> <li>When brake pedal released: No continuity</li> </ul> |

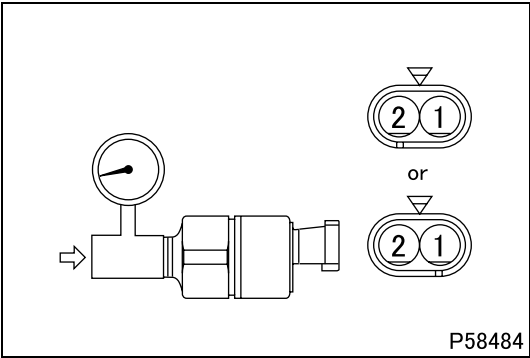
## #042 Stop lamp switch

- Inspect the switch as follows, and replace it if found abnormal.

- Apply air pressure slowly increasing from 0 kPa {0 psi, 0 kgf/cm<sup>2</sup>}.
- Measure air pressure at the point of continuity being established between terminals 1 and 2, to see if it is within the specified limit of standard value.

| Standard value (operating pressure) | 29 ± 9.8 kPa<br>{4.3 ± 1.4 psi, 0.3 ± 0.1 kgf/cm <sup>2</sup> } |

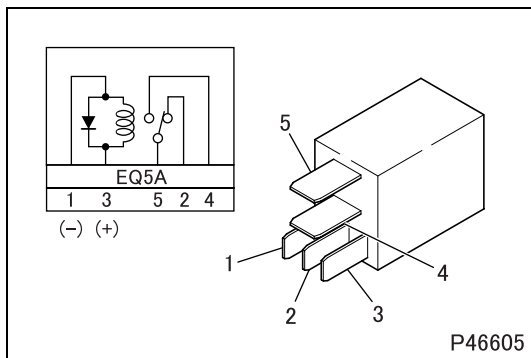
### #201 Relay inspection (normally open 5-pin)

- Check the relay for continuity and function. Replace the relay if found abnormal.

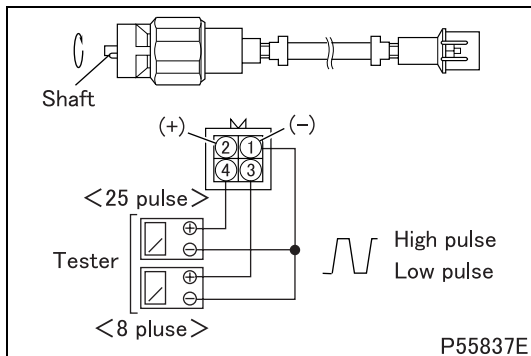
### #265 Vehicle speed sensor inspection

- Slowly rotate the shaft of the vehicle speed sensor with battery voltage applied between terminals 1 and 2 of the sensor.
- Measure maximum value (high pulse voltage) and minimum value (low pulse voltage) of the voltage generated at each terminal.

- If measurements deviate from the specified standard values, replace the sensor.

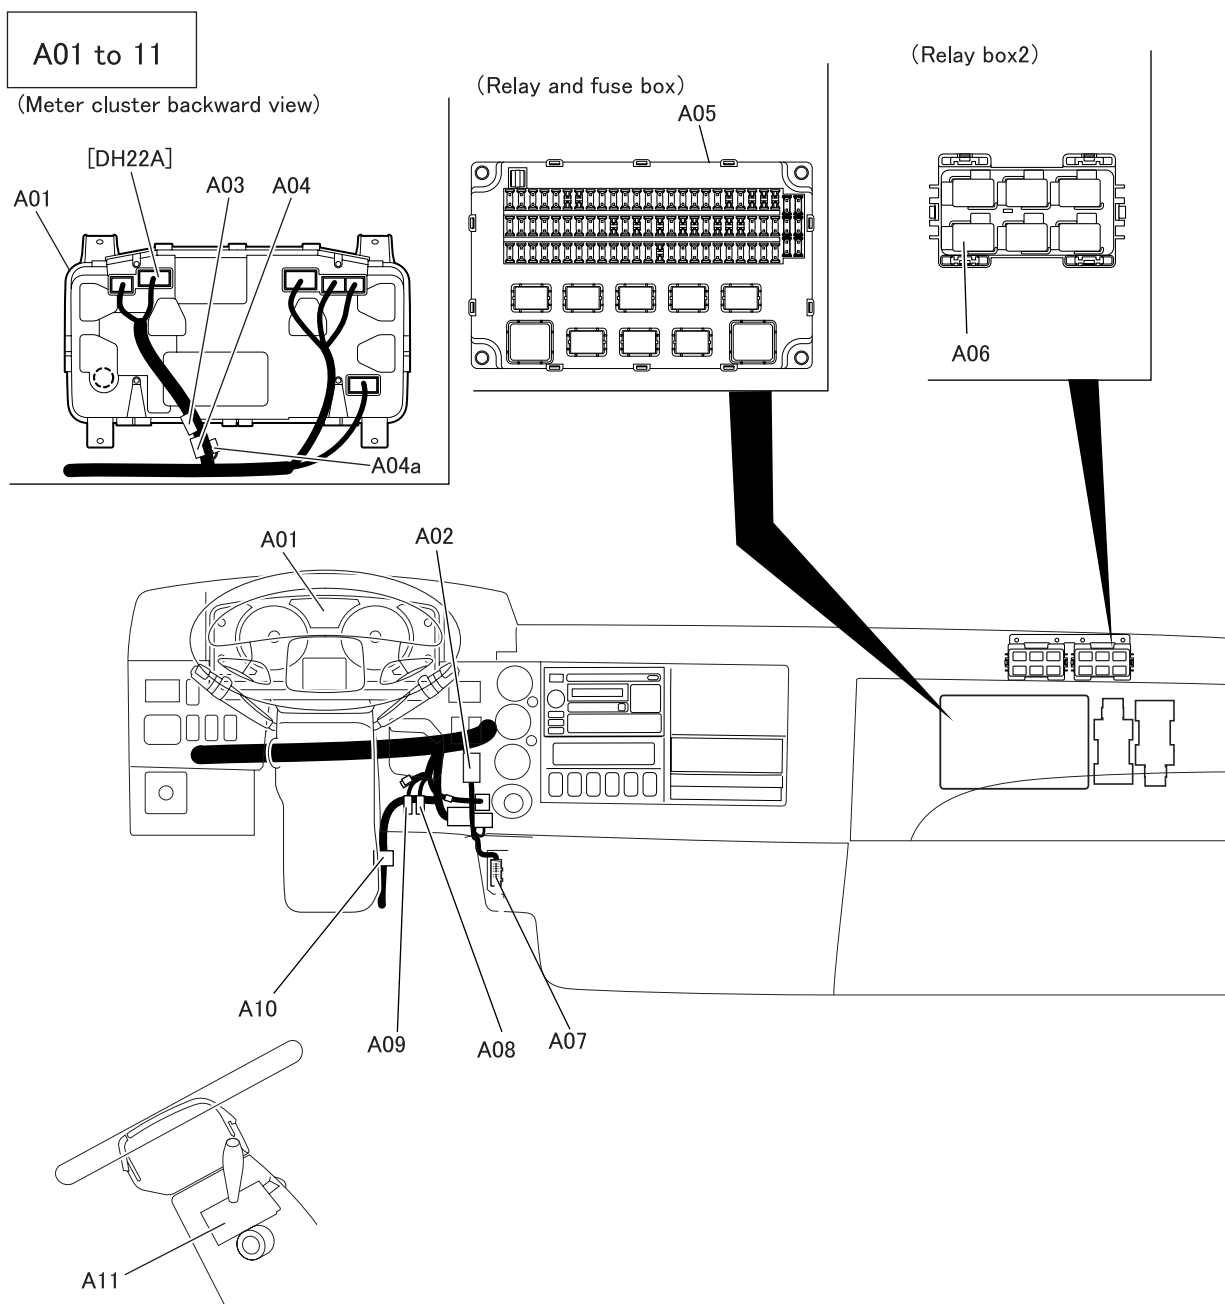
# INSTALLED LOCATIONS OF PARTS

- A01 Meter cluster
- A02 Cruise control main switch
- A03 Joint connector (J/C-2)
- A04 Joint connector (J/C-6)
- A04a CAN resistor
- A05 Relay and fuse box
- A06 Cruise control main relay
- A07 Diagnostic connector
- A08 Diagnosis switch
- A09 Memory clear switch
- A10 Connection of cab harness and headlamp harness
- A11 Combination switch

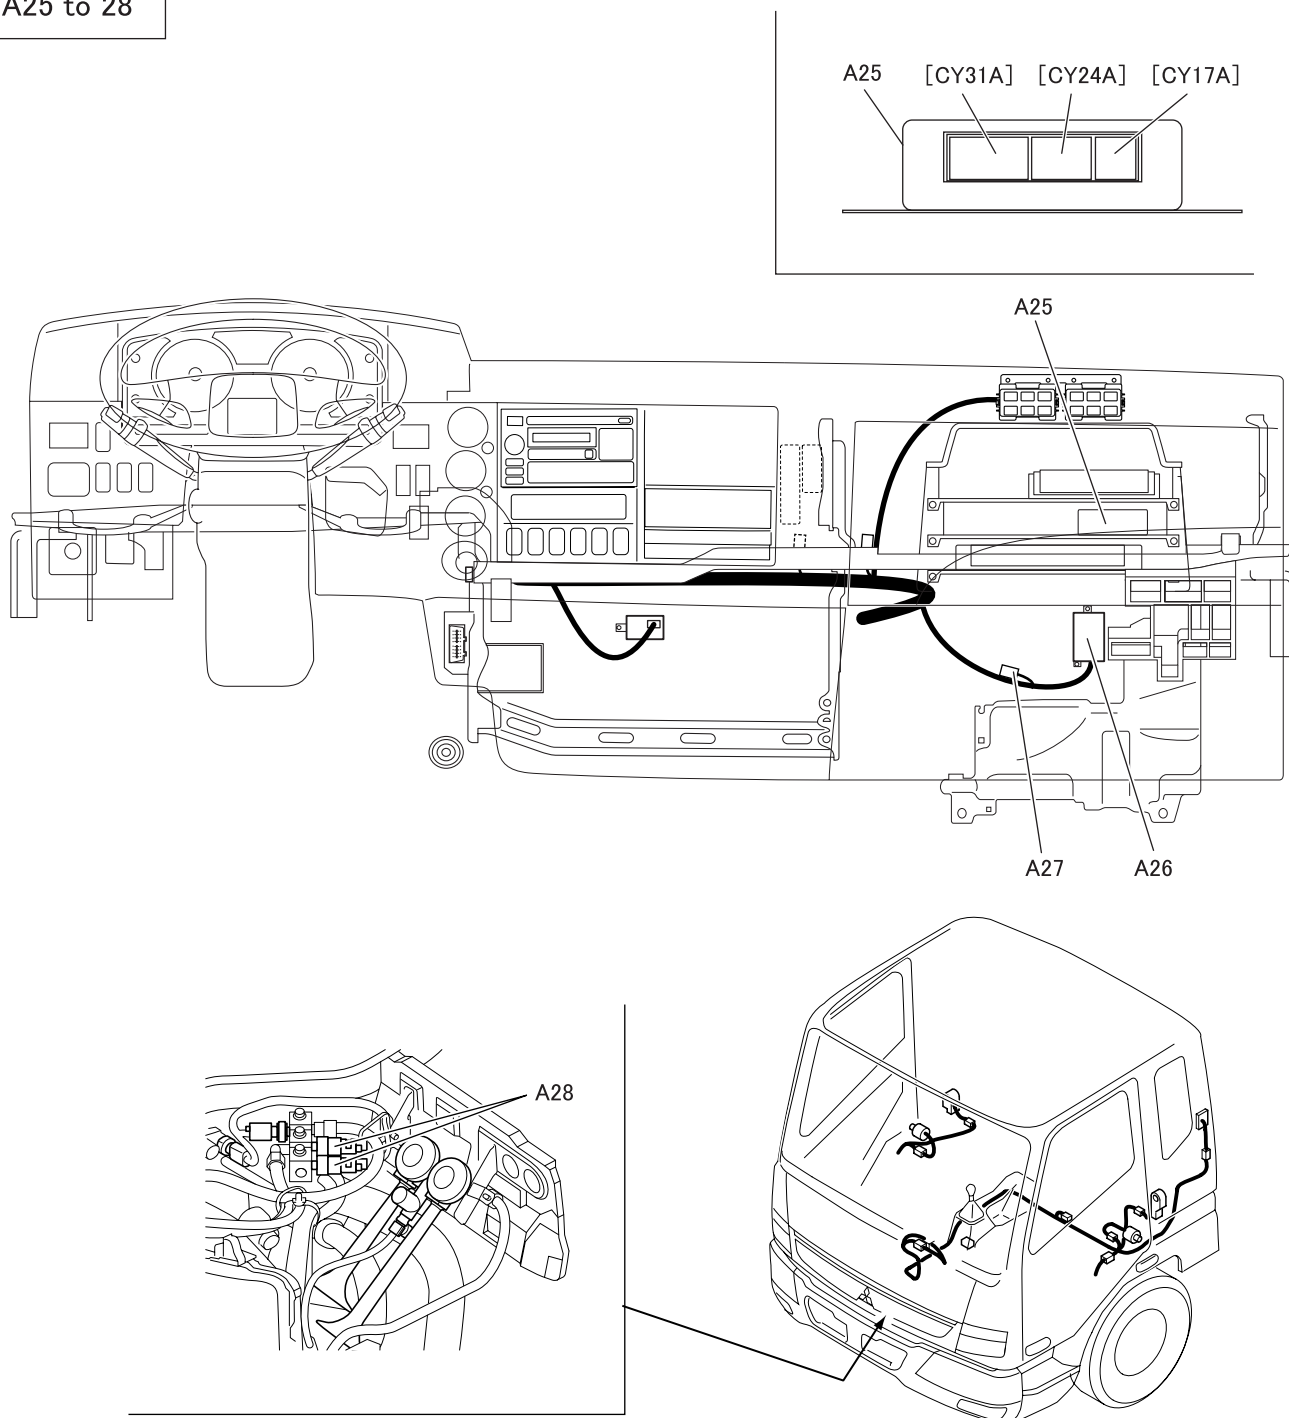
## A25 to 28

- A25 MVCU
- A26 Pulse converter
- A27 Diode unit
- A28 Stop lamp switch

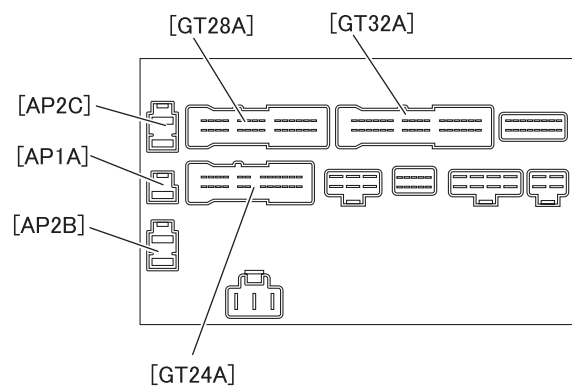
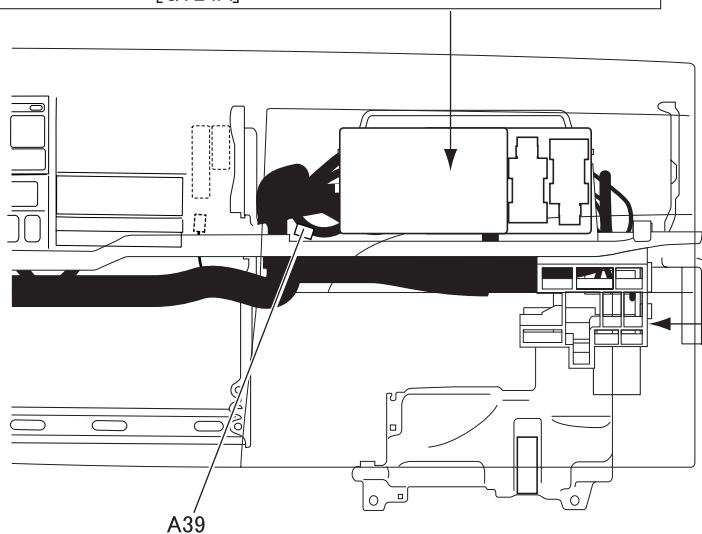
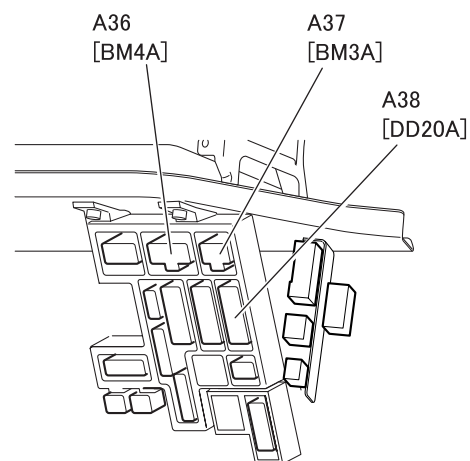
A36 to 39

A36-38 Connection of cab harness and chassis harness  
A39 Joint connector (J/C-1, 4)

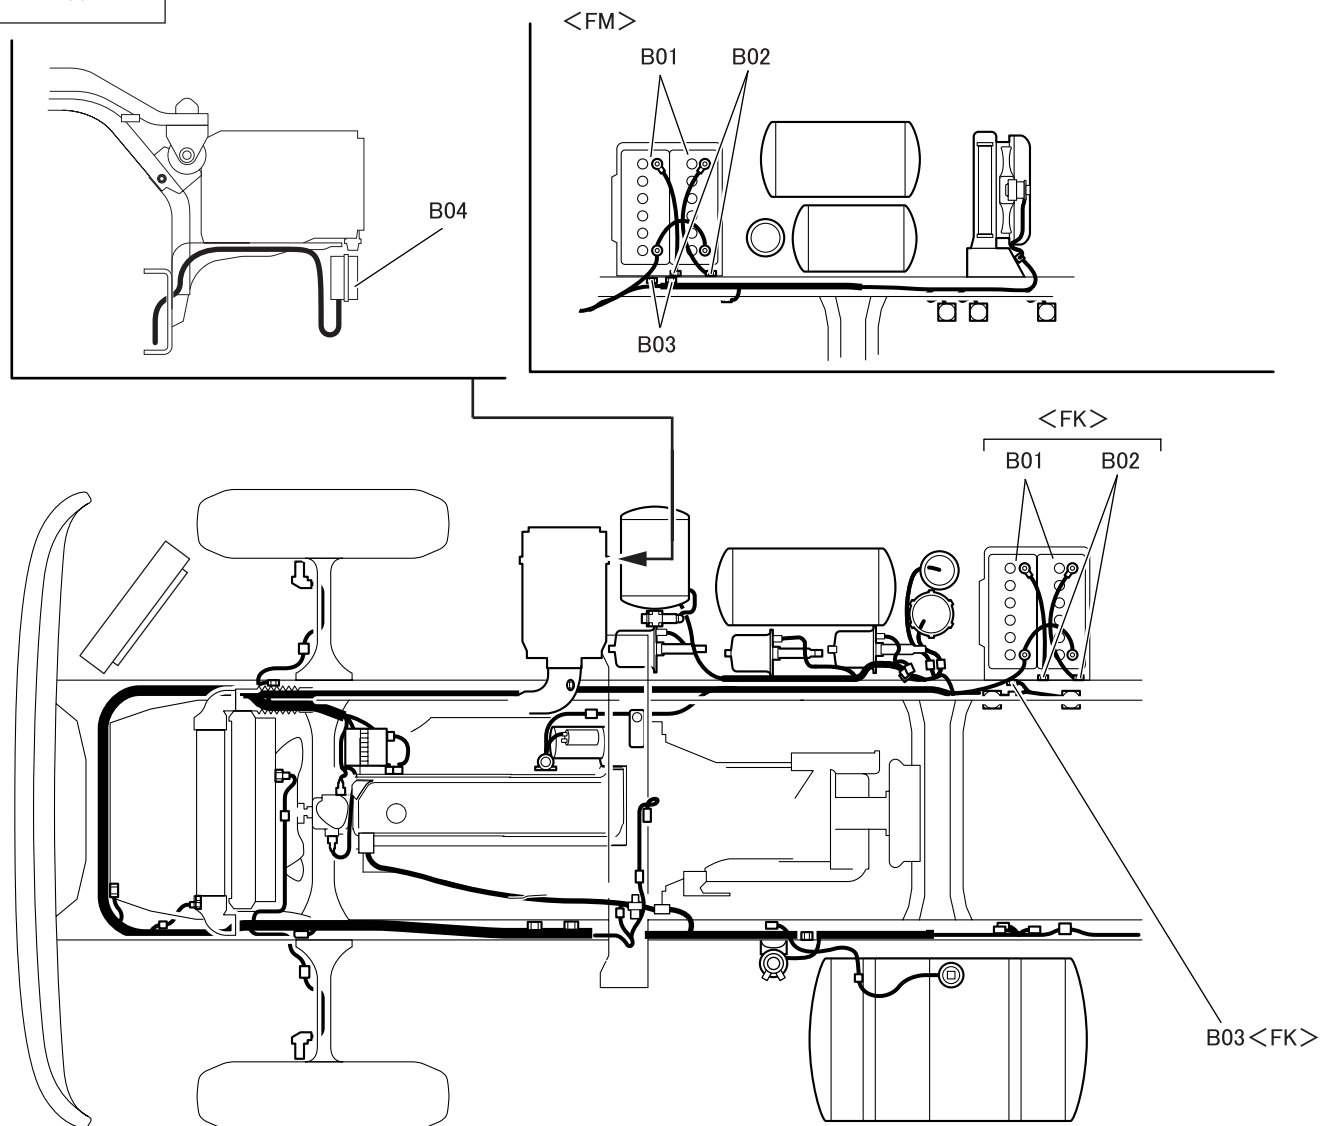
B01 to 04

- B01 Battery  
B02 Ground  
B03 Ground  
B04 High-current fuse box

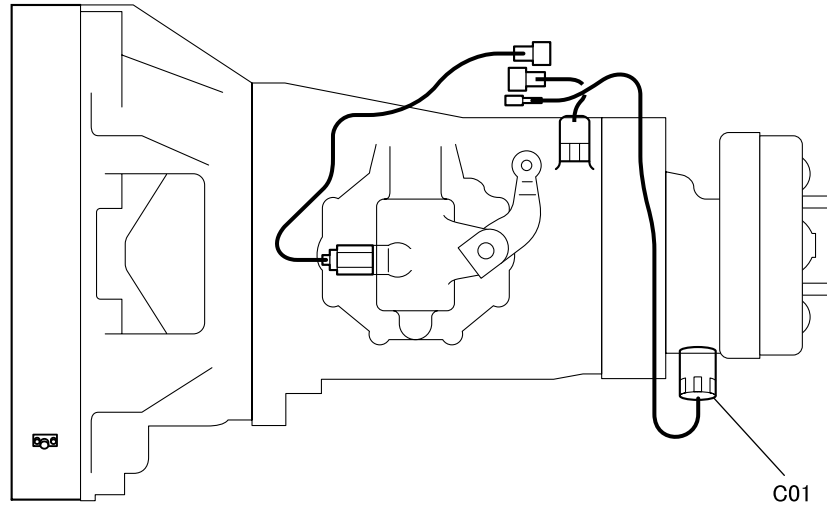
C01 Vehicle speed sensor

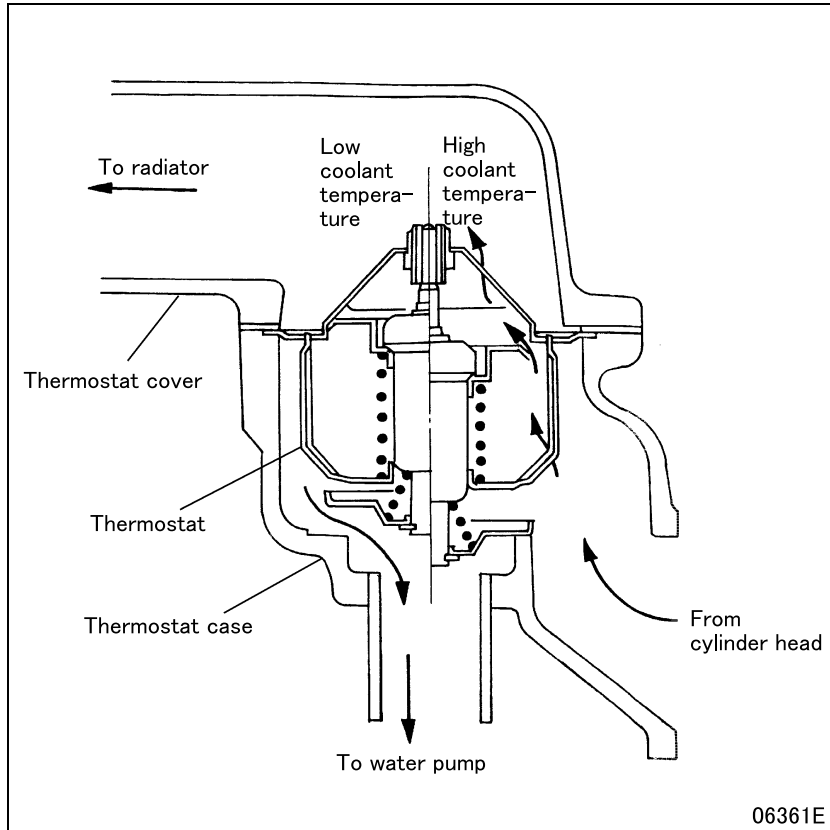
## 2. Thermostat

- The thermostat is a bottom bypass type that uses a wax-filled pellet as its flow-regulating element. When the wax is heated, it melts from solid to liquid, changing its total volume. This allows the valve to open or close in accordance with the coolant temperature, regulating and adjusting the flow of coolant to the radiator and to the water pump (bypassing the radiator).

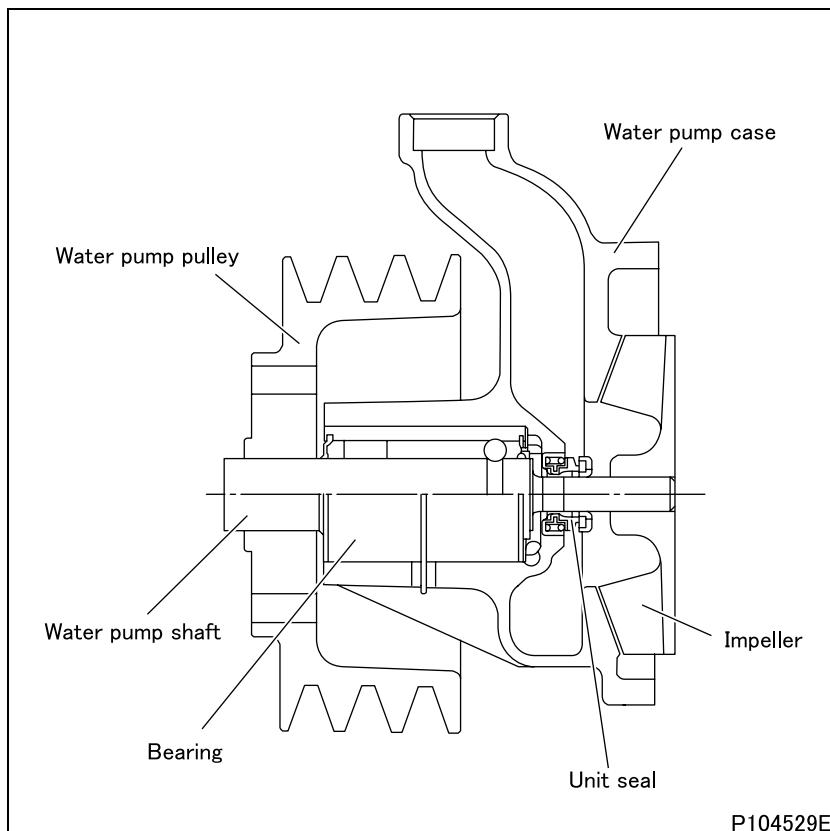
## 3. Water Pump

- The water pump has a drain hole to prevent coolant from entering the unit bearing in case of a defect in the unit seal.

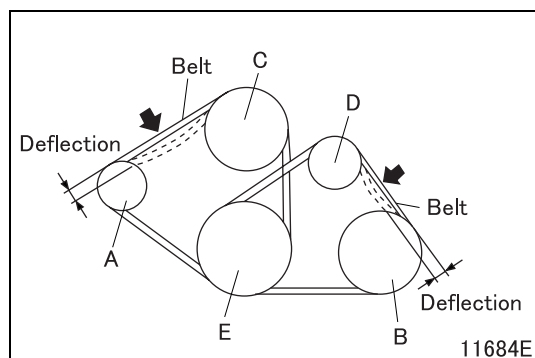
- Press each belt at a central portion between pulleys with a force of approximately 98 N {72 lbs, 10 kgf} as shown in the illustration and measure the amount of deflection of the belt.

- A: Alternator pulley
- B: Air conditioner compressor pulley
- C: Water pump pulley
- D: Tension pulley
- E: Crankshaft pulley

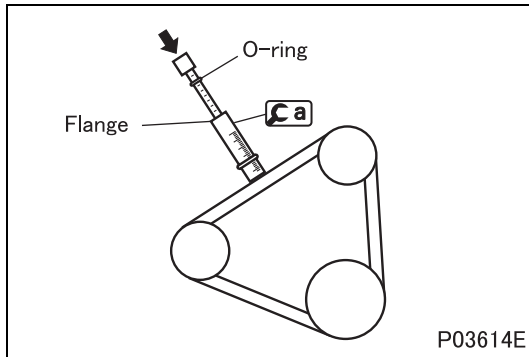
- Place **a** at a central portion between pulleys of the belt and push the handle (indicated by the arrow in the illustration) until the O-ring touches the flange.

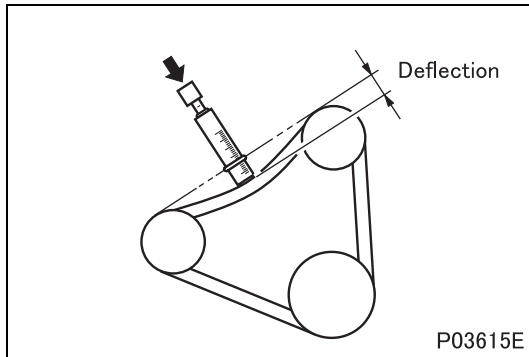
- Measure the amount of deflection of the belt.
- If the measured value deviates from the standard value range, adjust the tension of the belt as follows.

- Loosen the alternator mounting bolts (2 locations) and adjust the tension of the belt by tightening or loosening the adjustment bolt.
- After the adjustment is completed, retighten the mounting bolts firmly.

- Loosen the tension pulley mounting nut and adjust the tension of the belt with the adjusting bolt.
- After adjustment, be sure to tighten the bolt and nut.

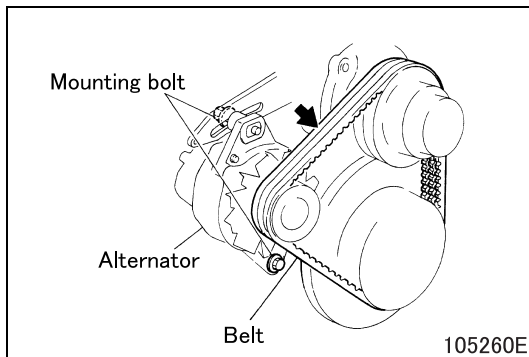
#### [Adjustment]

##### (1) Vehicles with air conditioner

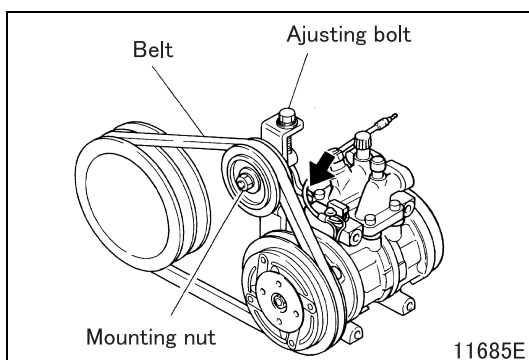
##### (2) Vehicles without air conditioner

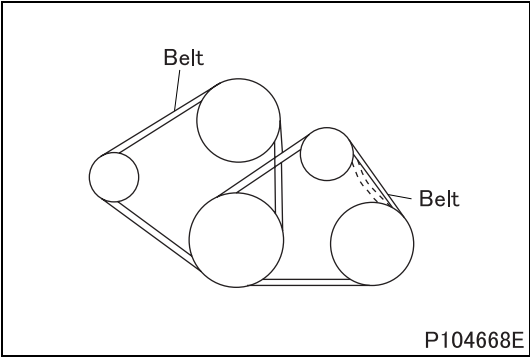
## 2. Inspection of Cracks or Damage of the Belt

- Visually check the belts for possible cracks and damage.
- If any faults are found, replace the belts.

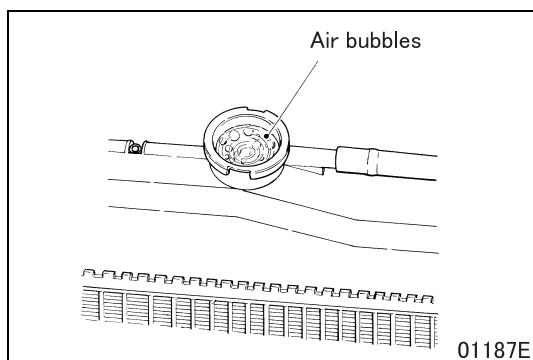
- Run the engine until the coolant temperature rises to approximately 90°C {194°F}.
- If air bubbles appear continuously through the filler port, there is air or exhaust gas penetrating into the cooling system.
- Presence of air in coolant can be an indication of loose cylinder head bolts, loose water pump mounting bolts, loose hose connections, and/or a damaged hose.
- Presence of exhaust gas in coolant can be an indication of a damaged cylinder head gasket and/or cracks in the cylinder head.

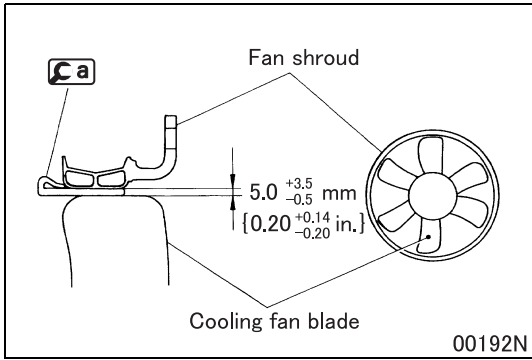
### ■ Installation: Fan shroud

- Using **Ca**, adjust the clearance between the fan shroud and cooling fan blades to the dimension shown in the illustration.

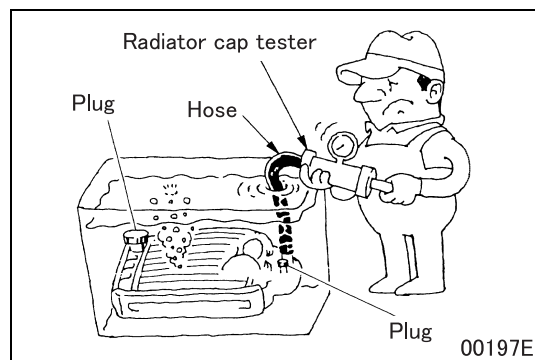
#### ■ Inspection: Air leaking of radiator

- Install hose and radiator cap tester and plug to upper tank.
- Insert plug in lower tank, and immerse the entire body of the radiator in water.
- Apply a specified air pressure using radiator cap tester, and check for any air leakage.
- If any leakage is found, repair or replace radiator.

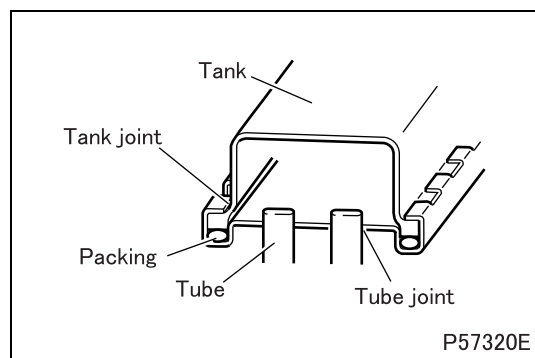
- Replace the following parts according to the leakage location.

| Area of leakage | | Cause |
| Upper tank<br>Lower tank | Tank | Cracked tank |
| | Tank joint | Defective crimping |
| | | Defective packing |
| Tube, tube joint | | Cracked tank |

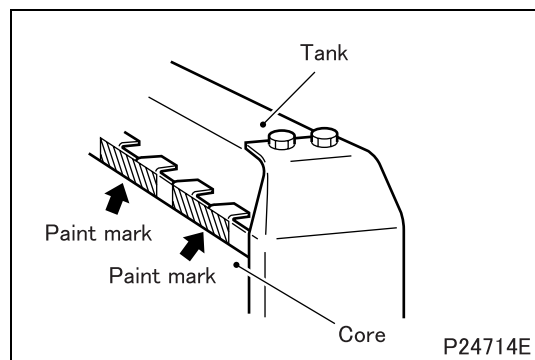
- If there are two paint marks on the joint between the core and upper tank or on the joint between the core and lower tank (which indicates that the tank retaining tabs have been crimped twice before), replace the core with a new part.
- The number of paint marks on the upper tank joint or the lower tank joint corresponds to the number of repairs performed on that joint.

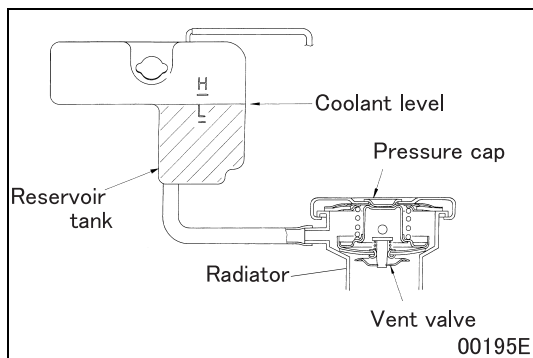
#### (2) Inspection of vent valve

- Note the coolant level in the reservoir tank.
- Start the engine and run it at high speed until the coolant level in the reservoir tank has risen to a certain degree. Stop the engine.
- Allow the system to cool down. When the coolant temperature has dropped to the atmospheric temperature, check if the coolant level in the reservoir tank has subsided to the original level noted earlier.
- If not, the vent valve is deemed faulty. Replace the pressure cap.

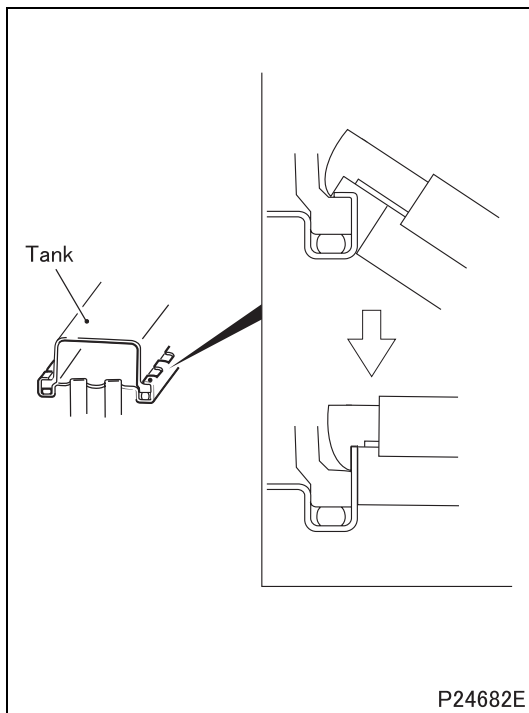
- Use **Ca** to bend open tabs of retain tank in place.
- After tabs are bent open, squeeze the handle of **Ca** to straighten tabs as illustrated.
- After straightening all tabs in the perimeter, hold the pipes connected to the inlet/outlet, and remove tank.

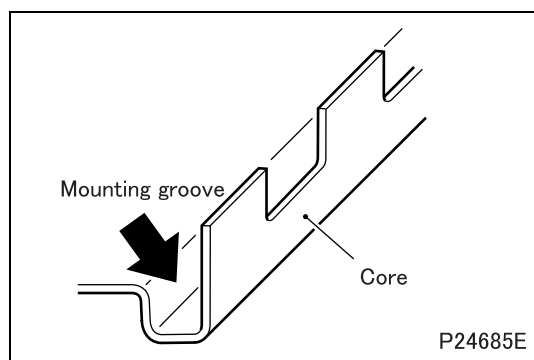
## ■ Inspection: Core groove where tank is to be mounted

- Check the groove on the core where the tank is to be mounted for adhesion of foreign substances or cracks.
- If foreign substances are found, rub the area with #1000 sandpaper or a like gently so as to avoid scratching the surface, or use compressed air to remove them.
- If there are cracks in the groove, repair or replace.

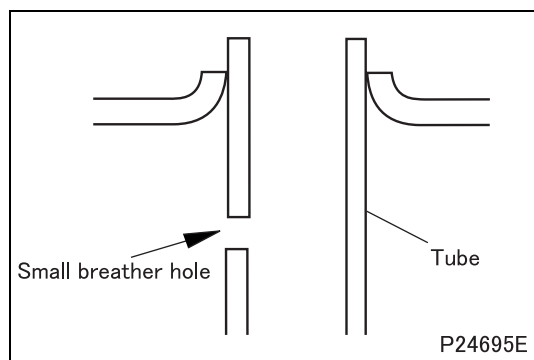
- Using a stainless wire brush, brush both ends A of the leaky tube and the areas B around the tube ends until the base aluminum is exposed.
- Before closing the tube at both ends by welding, drill a small breather hole in the tube.

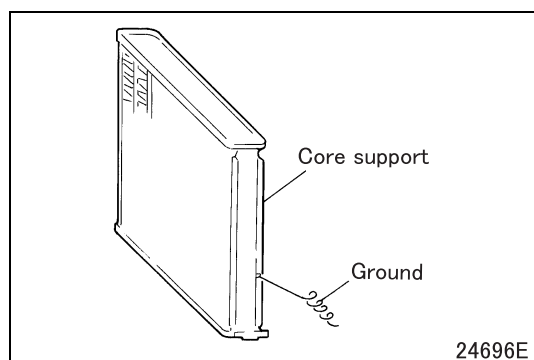
- Ground the core at the support.

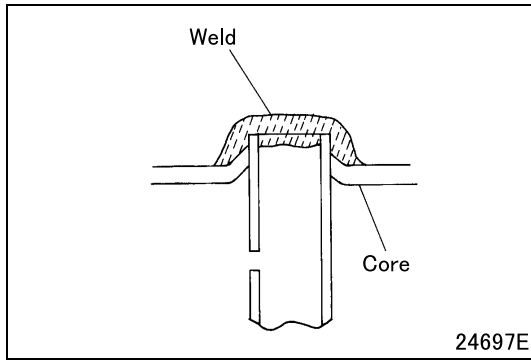
- Close both end of the tube by tungsten inert-gas arc welding (TIG welding).  
Welding conditions
  - Welding rod: A4043 (approx.  $\phi 2$  mm {0.079 in.})
  - Welding current: AC80A
- After welding, check for the following problems. If any of them exist, repair again or replace the core.
  - Undercut
  - Bead crack
  - Base metal crack

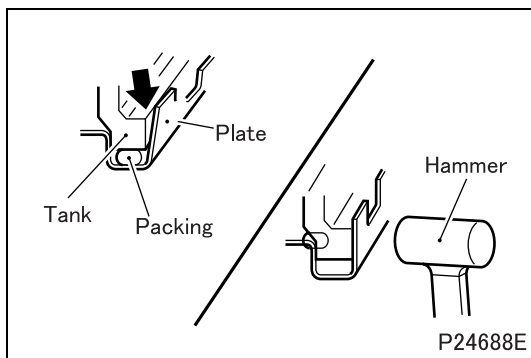
#### ■ Installation: Upper tank, lower tank

- With the tank installed, eliminate any clearance between the tank and core plate by tapping with a rubber (or plastic) hammer.

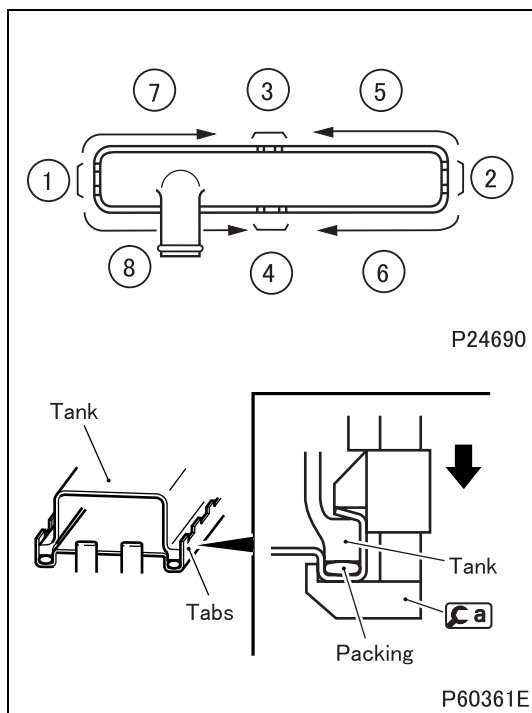
- Following the sequence shown in the diagram, bend tabs for caulking tank.  
1 to 4: Bend two tabs at the center.  
5 to 8: Bend other tabs following the direction of the arrow.

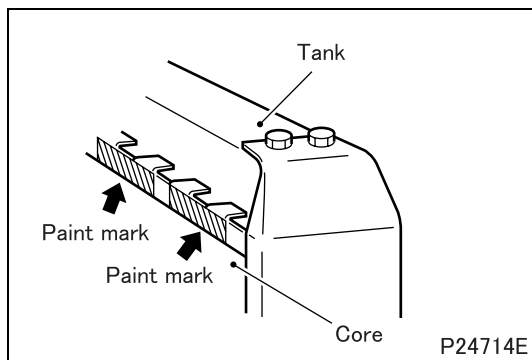
- Paint a mark on the core where it can be easily noticed to indicate that the core has been crimped.

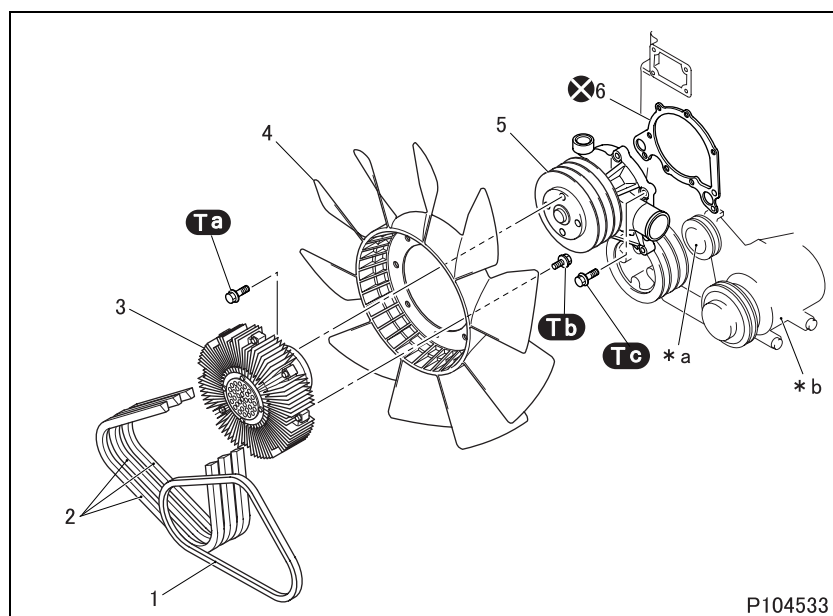
## ● Disassembly sequence

- 1 Belt (for air conditioner)
- 2 Belt (for fan)
- 3 Automatic cooling fan coupling
- 4 Cooling fan
- 5 Water pump
- 6 Water pump gasket

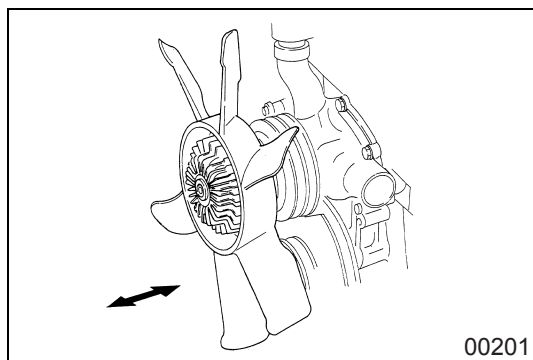
### ■ Inspection: Automatic cooling fan coupling

- Inspect the automatic cooling fan coupling in accordance with the following procedure. If any defect is apparent, replace the unit.
  - Check for leakage of oil from the coupling body.
  - Rotate the automatic cooling fan coupling by hand and check for irregular movement or abnormal noise caused by a defect in the bearing.
  - Check for excessive axial play in the automatic cooling fan coupling when the engine is cool.

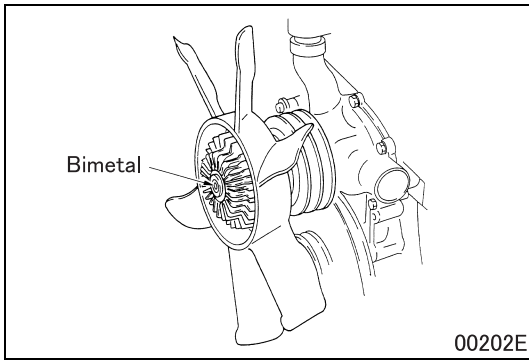
■ **Cleaning: Automatic cooling fan coupling**

- If any foreign particles have adhered to the bimetal, remove them carefully without applying excessive force.

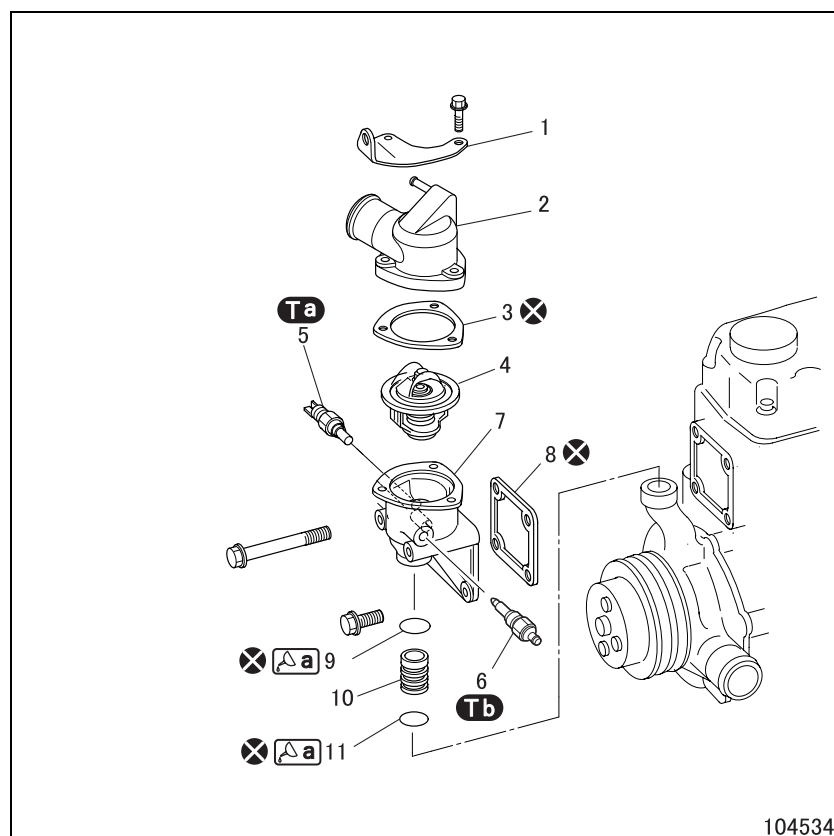
## ● Disassembly sequence

- 1 Fan shroud stay
- 2 Thermostat cover
- 3 Gasket
- 4 Thermostat
- 5 Water temperature sensor
- 6 Overheat alarm switch
- 7 Thermostat case
- 8 Gasket
- 9 O-ring
- 10 Joint
- 11 O-ring

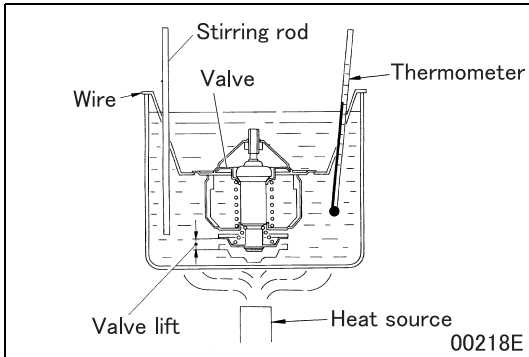
### ■ Inspection: Thermostat

- Stir the water using a stirring rod to maintain an even water temperature in the container, then conduct the tests indicated below.
- If the measured values deviate from the standard value ranges, replace the thermostat.

- Heat the water to a temperature slightly higher than the valve opening temperature. Maintain this temperature for five minutes and measure the valve lift.

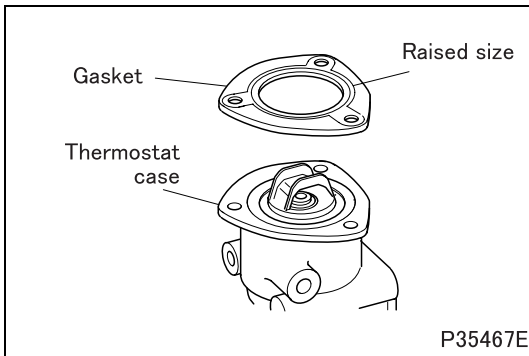
### ■ Installation: Gasket

- Fit the gasket onto the thermostat case in the illustrated direction.

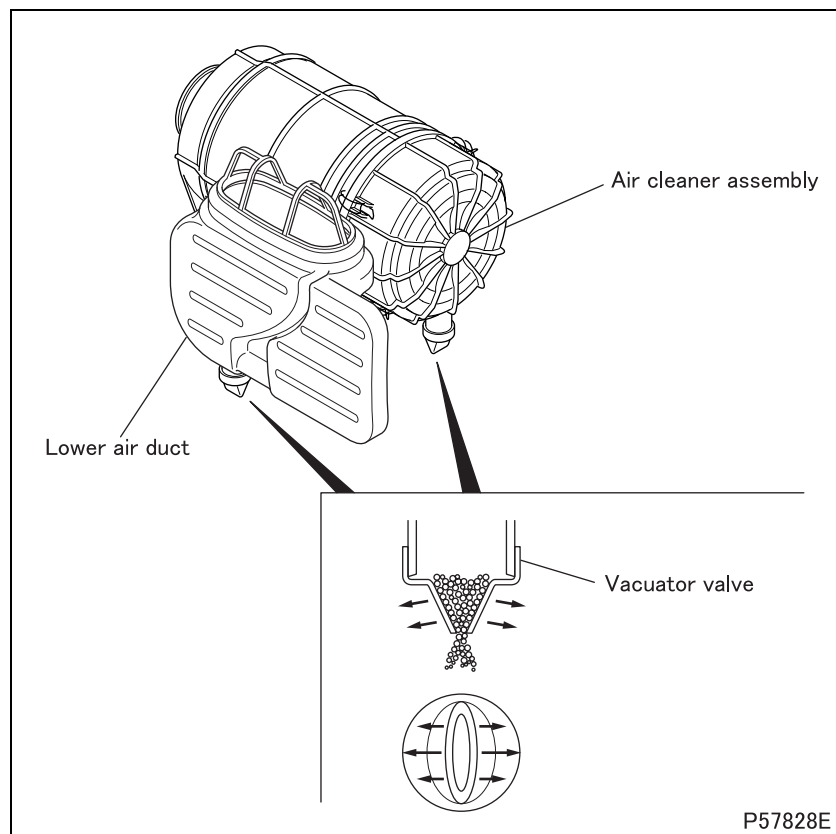
## 1. Air Cleaner

- The air cleaner assembly utilizes single element.
- The lower air duct and air cleaner assembly incorporate a vacuator valve each.
- The vacuator valve automatically works in such a way that when the engine speed drops below a specified level, the valve's rubber boot which is usually subdued by internal vacuum is allowed to spring back and accumulated dust and dirt are discharged as a result.

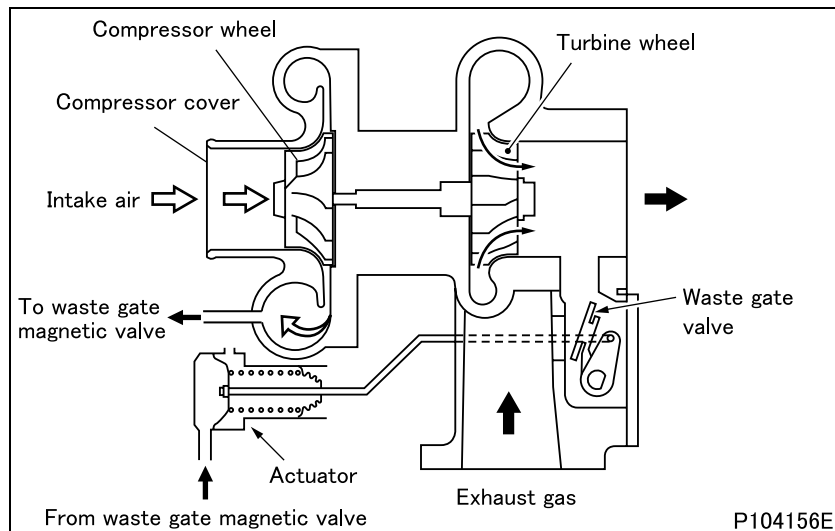
### 2.1 Waste gate mechanism

- The waste gate mechanism, which is operated by an actuator, is designed to let excess exhaust gas bypass the turbocharger, thereby preventing the turbocharger from overrunning and the intake manifold pressure from rising excessively. This ensures that the boost pressure is properly controlled.
- There are two ways of actuator operation of the waste gate mechanism, i.e., a normal control mode in which the waste gate valve is opened by means of pressure in the compressor cover and a diesel particulate filter regeneration control mode in which the waste gate valve is forced to open by air pressure from the air tank in response to a signal from the engine electronic control unit for diesel particulate filter regeneration.

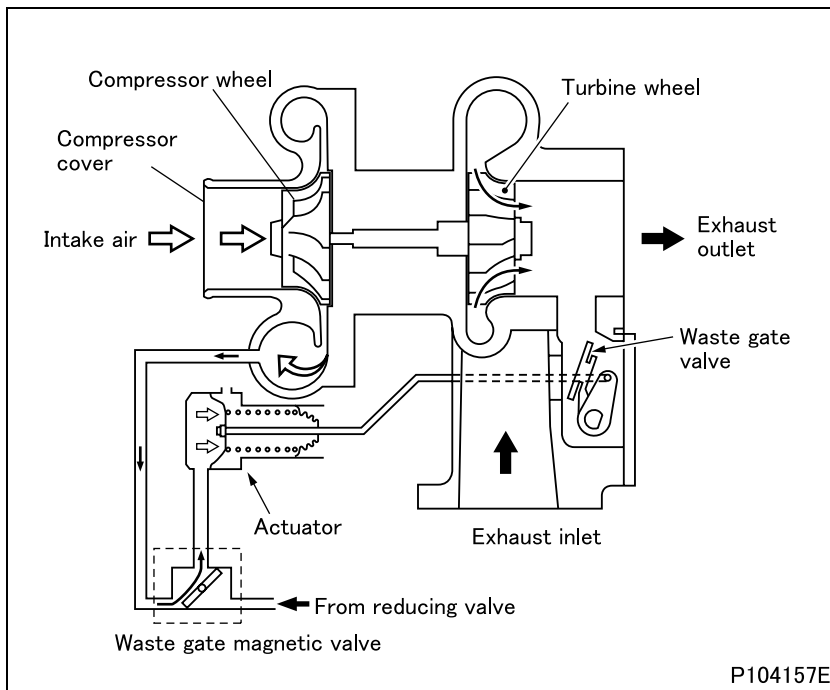
## 2.2 Normal control mode

- Normally, as the waste gate magnetic valve is inactive, air pressure from the compressor wheel acts on the actuator to open the waste gate valve.
- With the opening of the waste gate valve, exhaust gas fed against the turbine wheel is reduced. This decreases the compressor wheel speed and the boost pressure is lowered as a result.

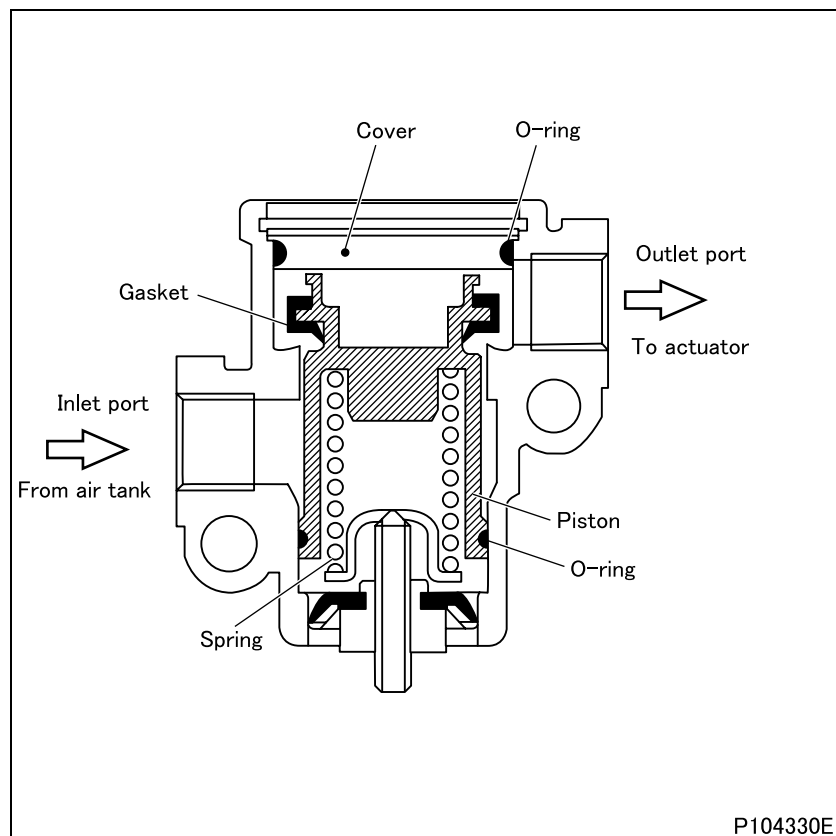
## 3. Reducing Valve

- The reducing valve is designed to reduce air pressure fed from the inlet port to the outlet port to the preset level.
