# FE.FG

## SERVICE MANUAL 2008 Model FOREWORD

This Service Manual contains maintenance and repair methods for the Mitsubishi Fuso Truck FE. FG Series. Read this manual carefully as an aid in providing correct, efficient maintenance. Please note that the information and specifications contained within this manual may change without notice. This is due to product modifications and continued vehicle improvements that are made throughout the model years. Should you encounter any discrepancy in the information provided, please do not hesitate to contact your nearest Mitsubishi Fuso Dealer or Mitsubishi Fuso Truck of America, Inc.

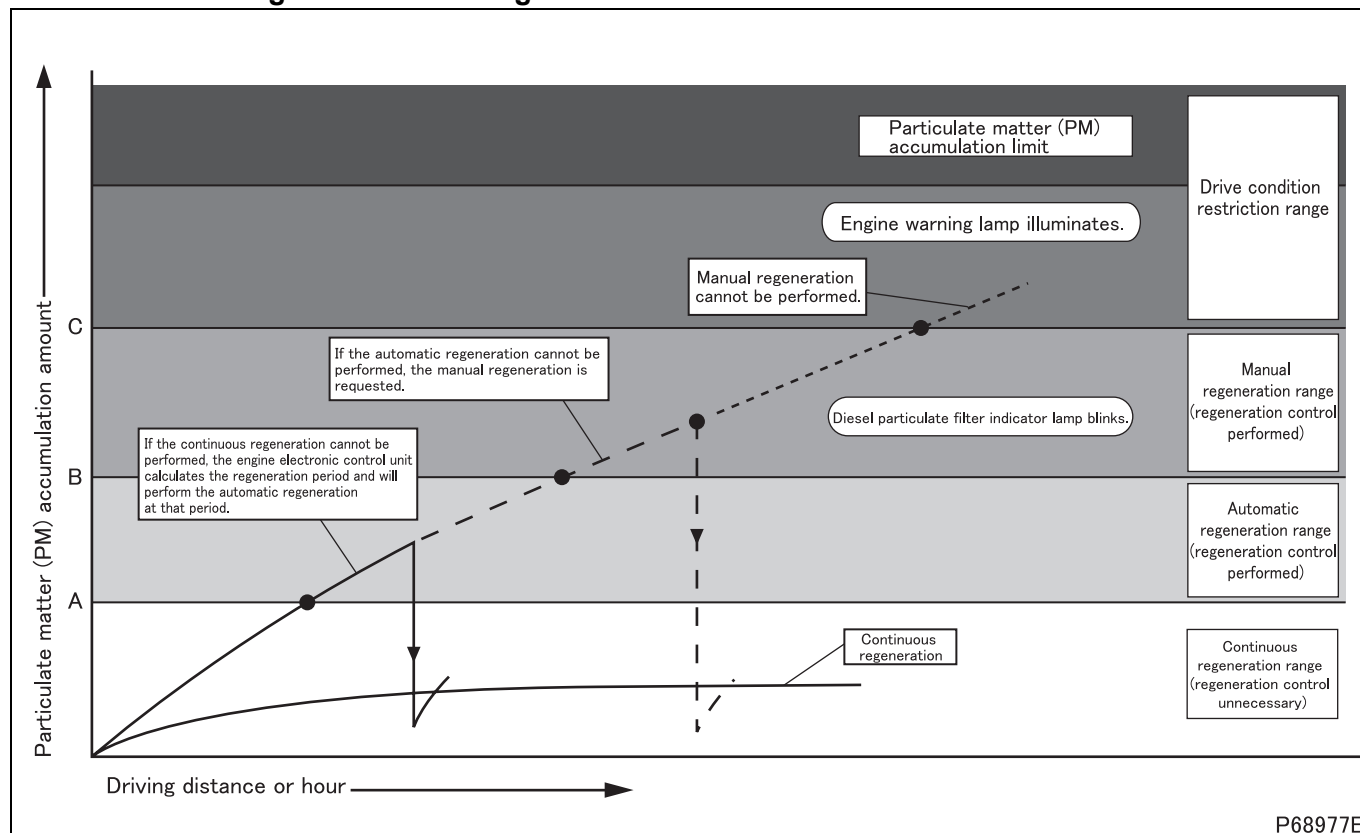
## 4.2 Continuous regeneration and regeneration control

- The above diagram shows the relations between the driving distance or hours and the particulate matter accumulation amount, and the range of each diesel particulate filter regeneration operation.
- The particulate matter accumulation amount increases as the driving distance or hours increase. However, by conducting the regeneration operation that matches the vehicle operating condition and the particulate matter accumulation amount, the particulate matter accumulation amount is reduced to keep the performance of the diesel particulate filter.
- The regeneration is divided into two types - the continuous regeneration utilizing exhaust gas during normal driving operation and the automatic or manual regeneration which uses exhaust gas created by the regeneration control.

- When the particulate matter accumulation level is between A and B on the diagram, the engine electronic control unit decides the regeneration period and the automatic regeneration will be performed at an appropriate period. During regeneration, the unburnt fuel (HC) supplied by the post injection is oxidized by the front oxidation catalyst, and the oxidation heat from that reaction burns the particulate matter accumulated in the ceramic filter.

- When the particulate matter accumulation level is between B and C on the diagram, the engine electronic control unit makes the diesel particulate filter indicator lamp blink. If the diesel particulate filter cleaning switch is turned on by the driver when the following conditions are met, the manual regeneration will take place.

- When the particulate matter accumulation level exceeds C on the diagram, the engine warning lamp illuminates and some restrictions are applied to the driving conditions.

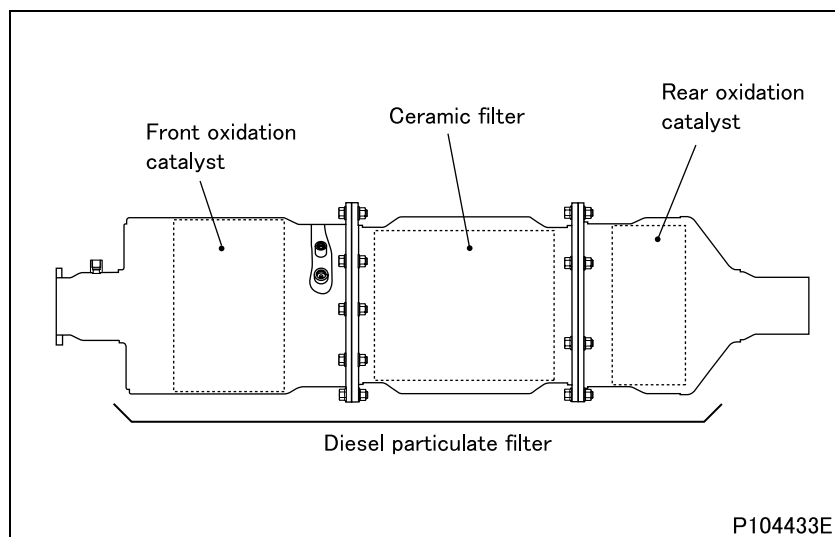
## 4.3 Diesel particulate filter unit

- Diesel particulate filter unit consists of the front oxidation catalyst, ceramic filter and rear oxidation catalyst.

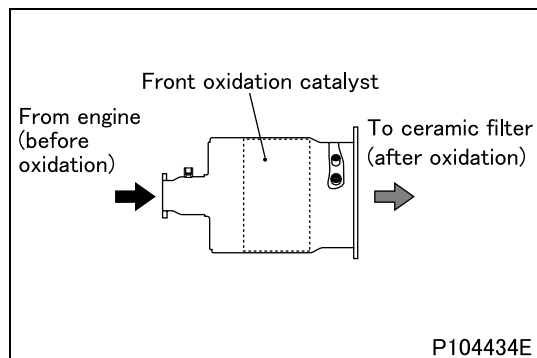
### (1) Front oxidation catalyst

- In normal driving condition, unburnt fuel (HC) and part of the particulate matter in the exhaust gas from the engine is purified by this catalyst.
- During filter regeneration, the unburnt fuel (HC) supplied by the post injection is oxidized by the front oxidation catalyst, and the oxidation heat raises exhaust gas temperature.

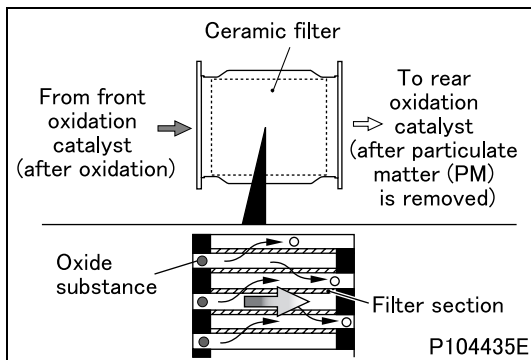
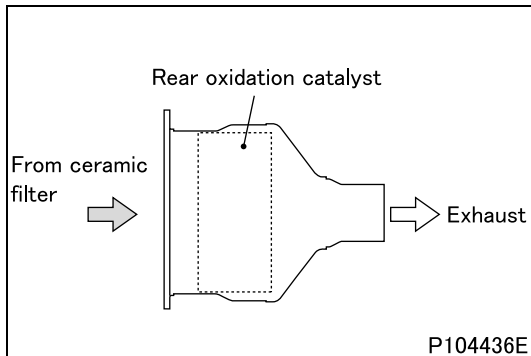
## (2) Ceramic filter

- The ceramic filter is an aggregate of thin tubes, and these tubes are closed at either end alternatively. During normal operation, particulate matter is trapped when the exhaust gas enters a tube and passes through the wall of the tube (filter section) to the adjacent tube.
- During regeneration, the particulate matter accumulated in the filter is cleared by burning at high temperature. This, however, cannot remove the calcium (ash) contained in the engine oil and the ash will accumulate in the filter. The excessively accumulated ash may cause early clogging of the ceramic filter. Therefore, the ceramic filter must be cleaned periodically.

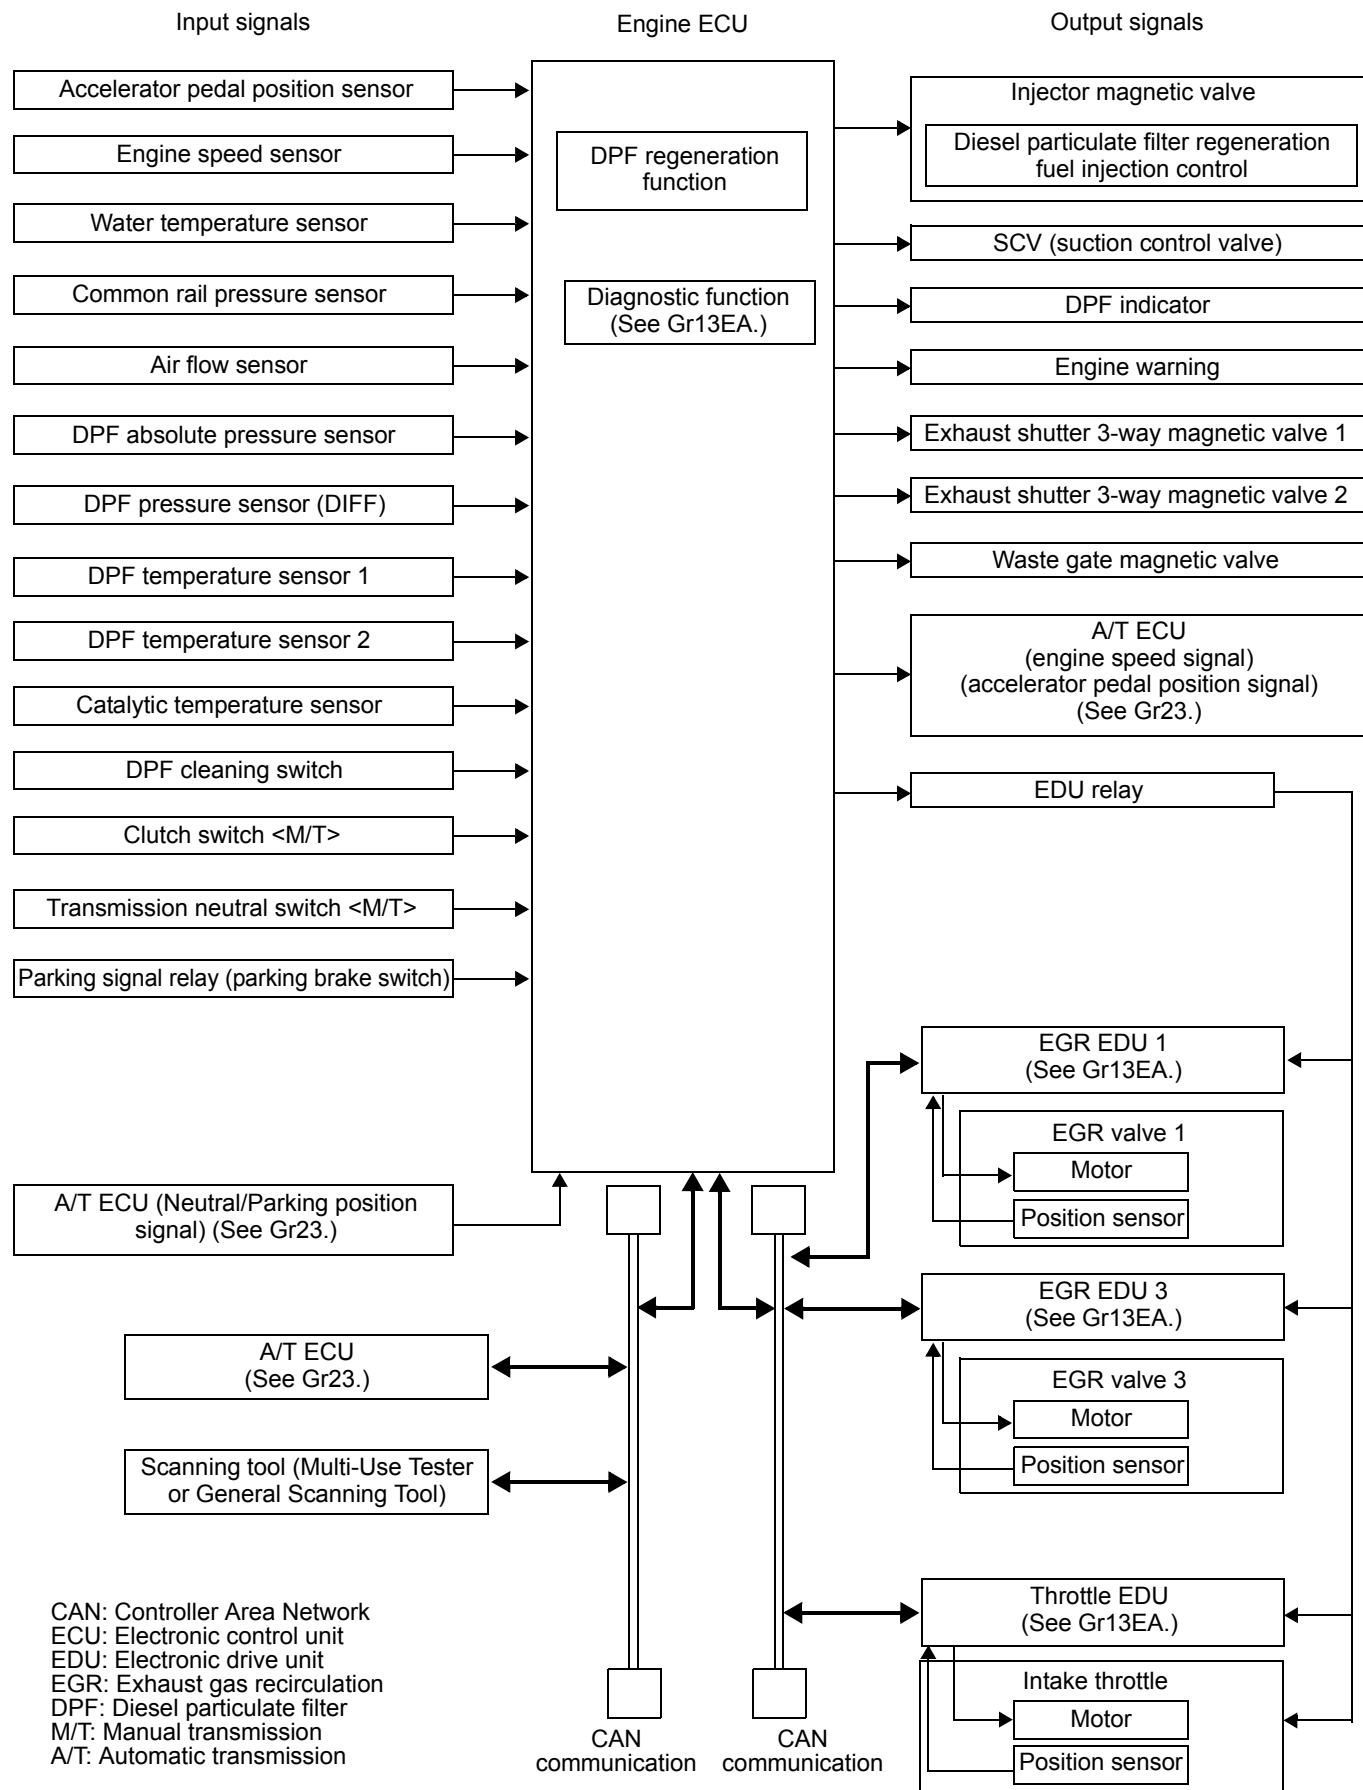
### (1) System block diagram

| Part | Main function/operation |

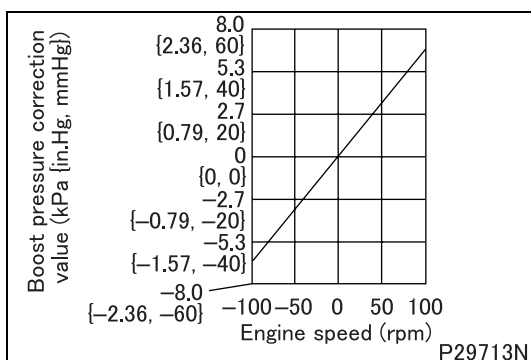
### [Correction for engine speed]

- Subtract the no-load median maximum speed from the engine speed noted during the boost pressure measurement. Using the graph shown on the left, obtain the boost pressure correction value  $P_a$  that corresponds to the difference obtained from the subtraction.
- No-load median maximum speed: 3180 rpm

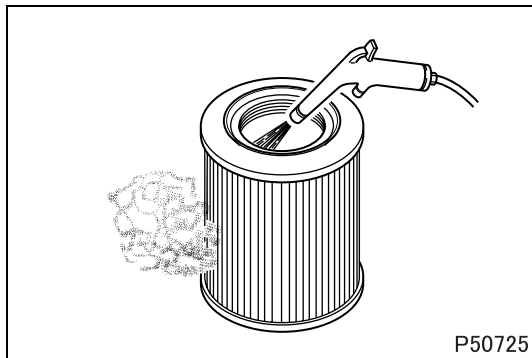
### ■ Cleaning: Filter element

- Blow a jet of compressed air at a pressure not higher than 685 kPa {100 psi, 7 kgf/cm<sup>2</sup>} against the inside surfaces of the element.
- Move the compressed air jet up and down along all pleats of the filter paper element.

- Do not strike the element or hit it against another object to remove dust.
- Do not blow compressed air against outside surfaces of the element.

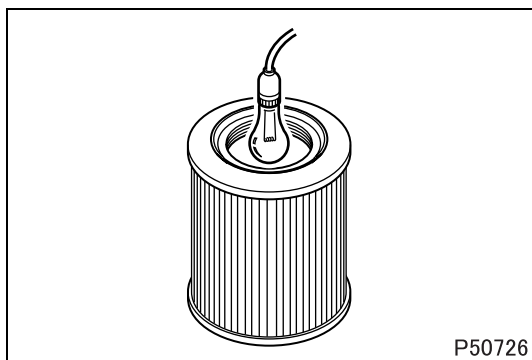
### ■ Inspection: Element

- Shine some electric light inside the element.
- Replace the element if thin spots or broken parts are evident in the filter paper, or if the packing at the top of the element is damaged.

Also replace the element if the dust on the element is damp with oily smoke or soot, regardless of the replacement schedule.

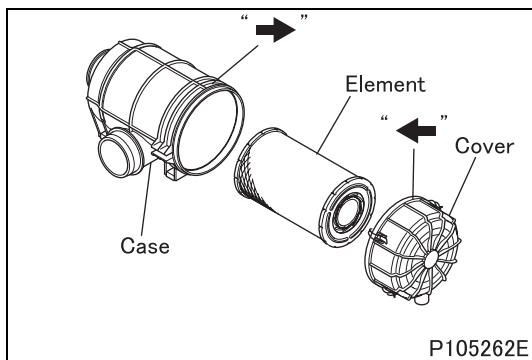
### ■ Installation: Air cleaner cap

➡ : Alignment mark

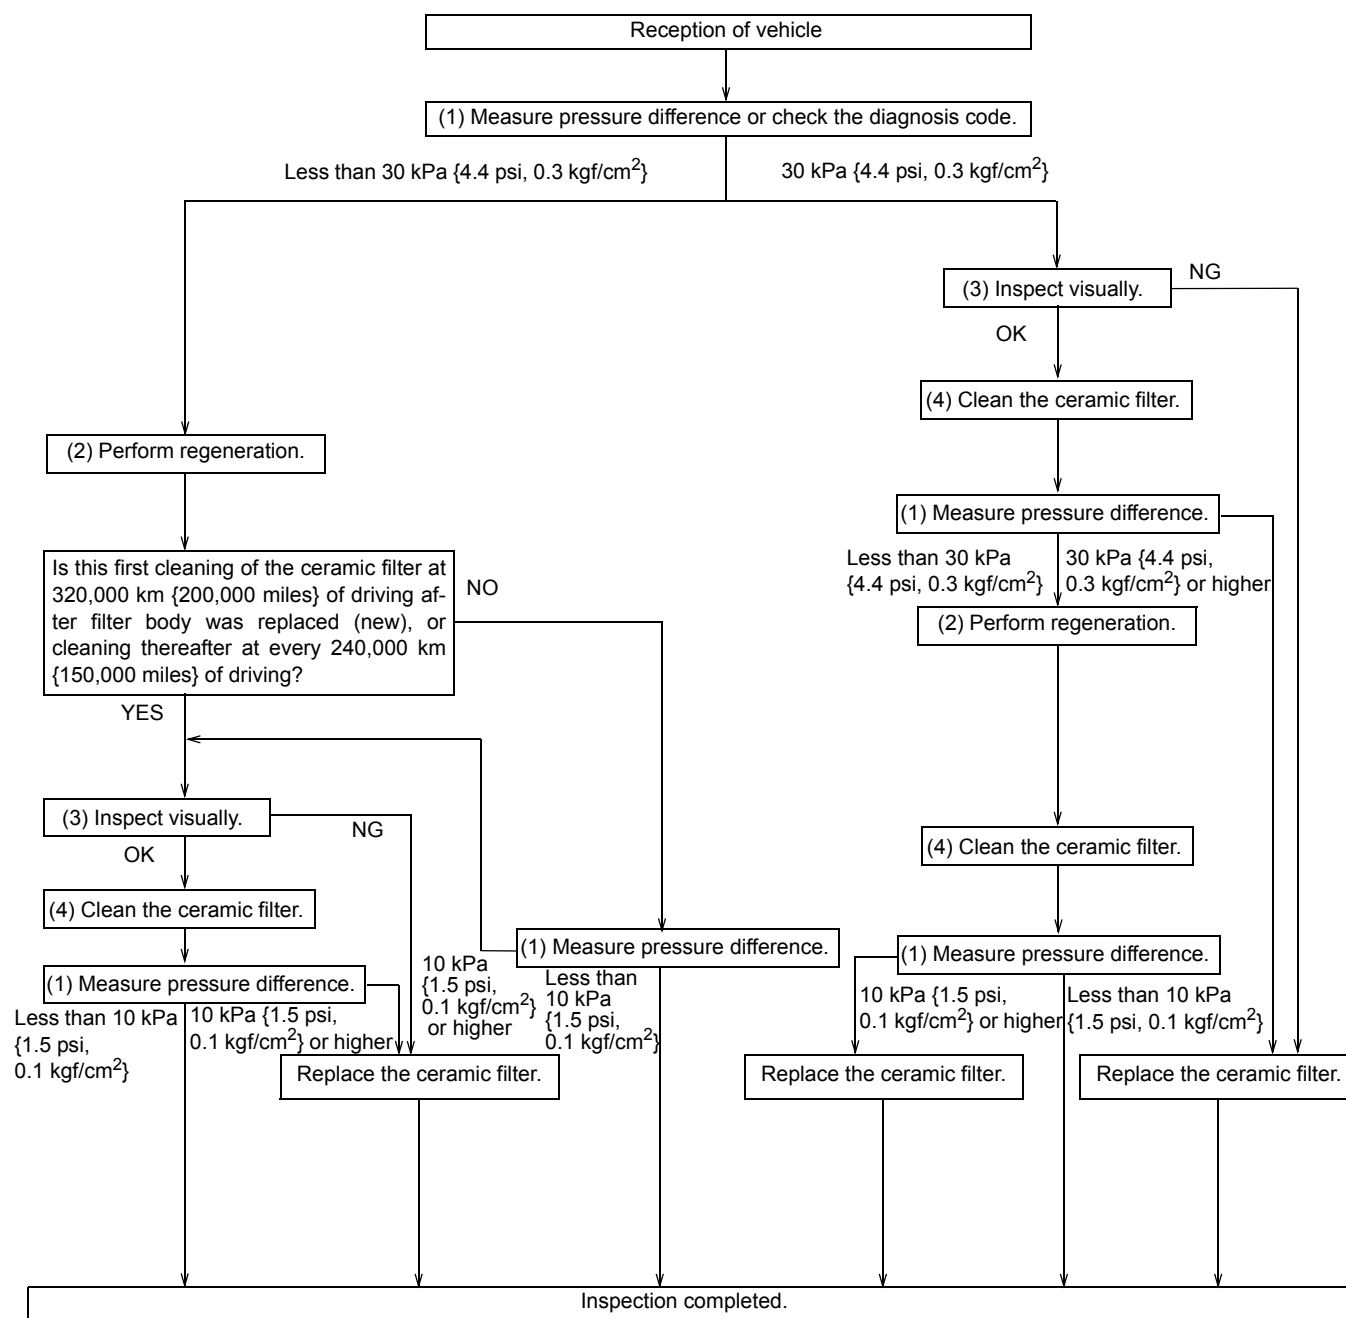
**(1) Measurement of pressure difference**

- Measure the pressure difference with the accelerator pedal fully pressed.
- Measurement can be performed using Multi-Use Tester service data "32: DPF pressure difference".

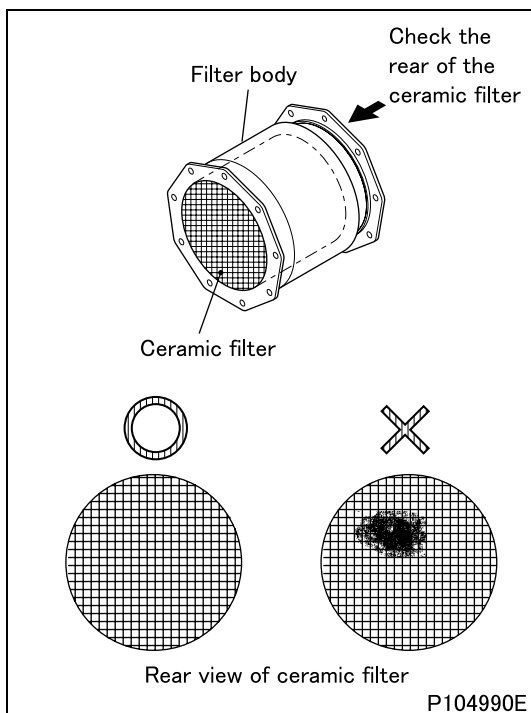
**(3) Visual inspection**

- Disassemble the diesel particulate filter and check the following.
  - Check if a large amount of soot adheres inside the ceramic filter.
  - Damage in the rear of the ceramic filter.
- If a large amount of soot adheres inside the ceramic filter or if a damage is found on the ceramic filter, engine-related fault may be suspected. Replace the diesel particulate filter.

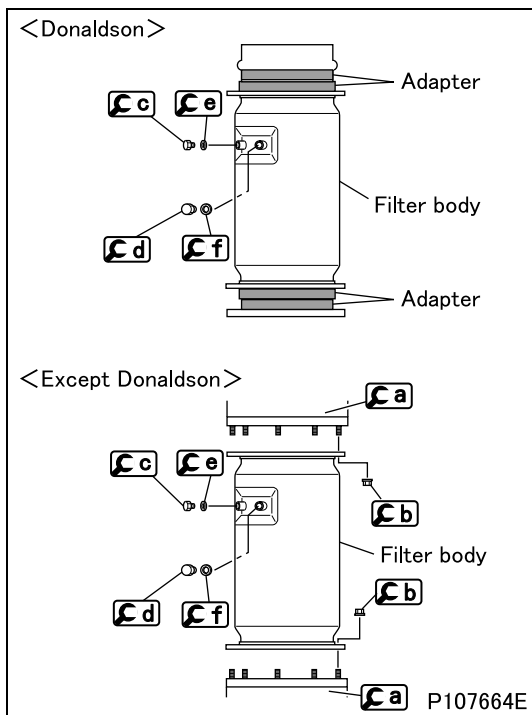
## (4) Cleaning

- Fit the adapter to the filter body. <Donaldson>
- Fit **a** to the filter body with **b** and tighten **b** to the specified torque (43 N·m {32 ft.lbs, 4.4 kgf·m}). <Except Donaldson>
- Fit **c** and **e** to the sensor mounting hole on the filter body and tighten them to the specified torque (30 N·m {22 ft.lbs, 3.1 kgf·m}).
- Fit **d** and **f** to the sensor mounting hole on the filter body and tighten them to the specified torque (40 N·m {30 ft.lbs, 4.1 kgf·m}).

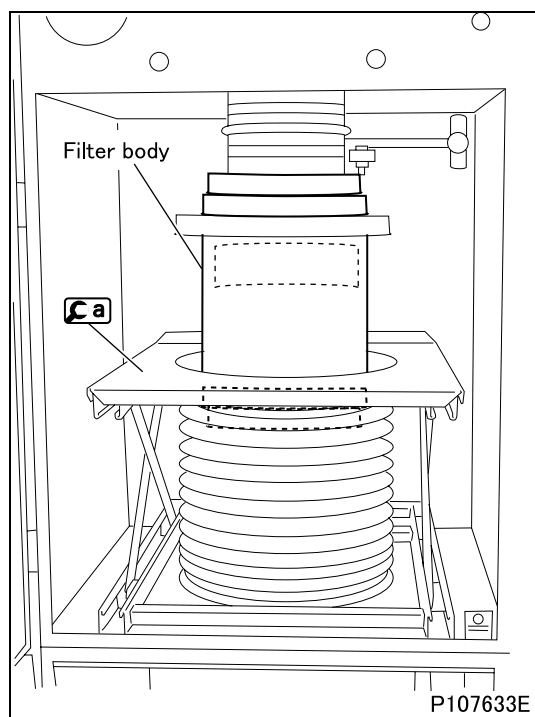
- Set the filter body in **a** with its rear of the filter body side (outlet body installation side) upward.
- Be sure to fit **a** and the filter body with no air leaks between them.
- Set the air pressure. (refer to its instruction manual)
- Set the timer to about 15 minutes (refer to its instruction manual) and perform cleaning.
- For the handling procedure of **a**, refer to its instruction manual.

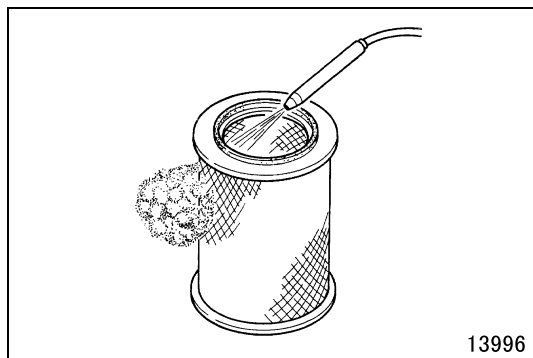
### ■ Cleaning: Element

- Blow a jet of compressed air at a pressure not higher than 685 kPa {100 psi, 7 kgf/cm<sup>2</sup>} against the inside surfaces of the element.
- Move the compressed air jet up and down along all pleats of the filter paper element.

- For element cleaning intervals, see the Maintenance Manual. More frequent cleaning than necessary could damage the element or contaminate the engine inside with dust and foreign matter.
- Do not strike the element or hit it against another object to remove dust.
- Do not blow compressed air against outside surfaces of the element.

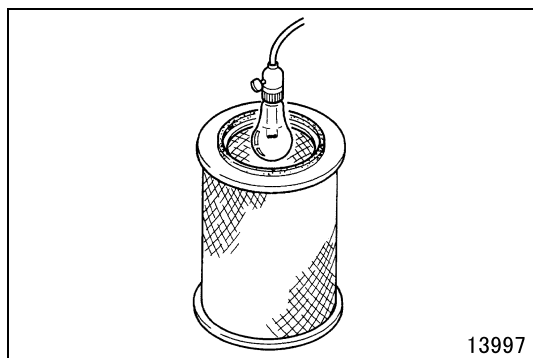
### ■ Inspection: Element

- Shine some electric light inside the element.
  - Replace the element if there are broken or thinned out spots in the filter paper, or if seal is damaged between the element and case contact surface.
- Also, replace the element whenever dust on the element is found damp with lampblack or soot, irrespective of replacement interval.

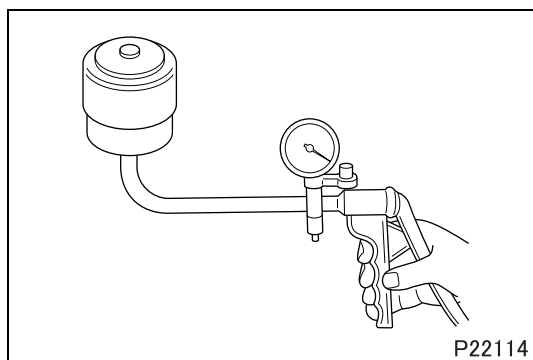
## ■ Inspection: Operation of dust indicator under specified negative pressure

- Apply negative pressure to the dust indicator, and take the reading when the red signal appears in the dust indicator window.
- If the measurement deviates from the standard value, replace the dust indicator.

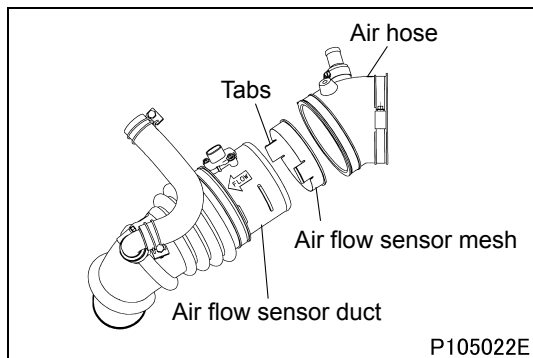
## ■ Installation: Air flow sensor mesh

- Insert tabs of the air flow sensor mesh into the inside slots of the air flow sensor duct.

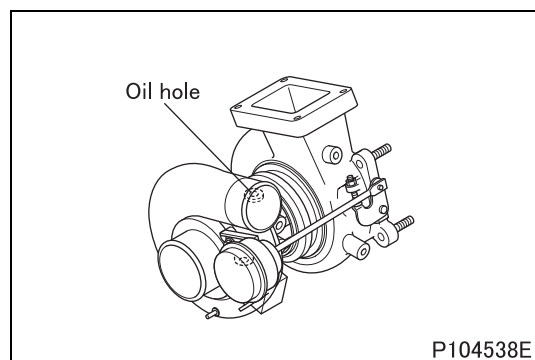
#### ■ Installation: Turbocharger

- Before installing the turbocharger assembly, pour engine oil into the oil hole to ensure smooth operation of the internal parts.

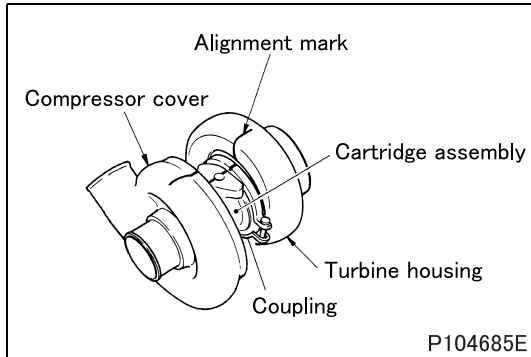
#### ■ Alignment mark

- Put alignment marks on the coupling, turbine housing, compressor cover and cartridge assembly.

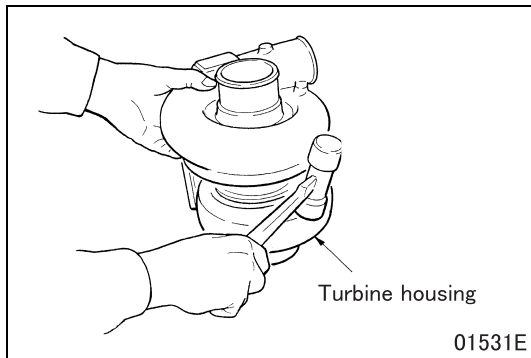
#### ■ Removal: Turbine housing

- Lightly tap around the entire periphery of the turbine housing with a rubber-faced hammer, taking care not to cause damage.
- The blades on the cartridge assembly are easily bent. Make sure that they do not strike the turbine housing.

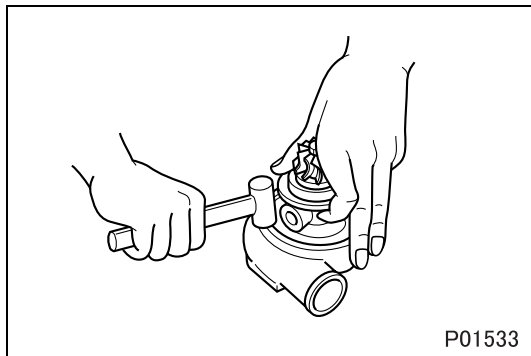
#### ■ Removal: Compressor cover

- Lightly tap around the entire periphery of the compressor cover with a rubber-faced hammer, taking care not to cause damage.
- The blades on the cartridge assembly are easily bent. Make sure that they do not strike the compressor cover.

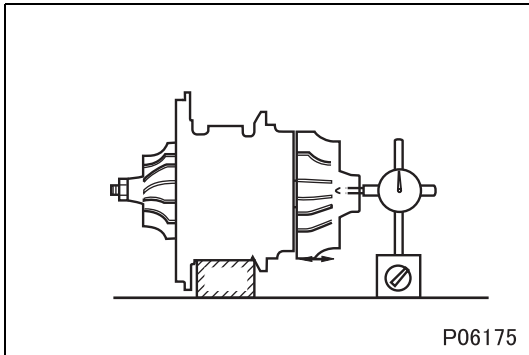
### ■ Inspection: Cartridge assembly

- If the measurement exceeds the specified limit, replace the cartridge assembly.

#### (1) Play in axial direction of shaft

| Location | Maintenance item | | Standard value | Limit | Remedy |
|---|---|---|---|---|---|
| 7 | Cartridge assembly | Play in axial direction of shaft | 0.05 to 0.09<br>{0.0020 to 0.0035} | 0.1<br>{0.0039} | Replace |

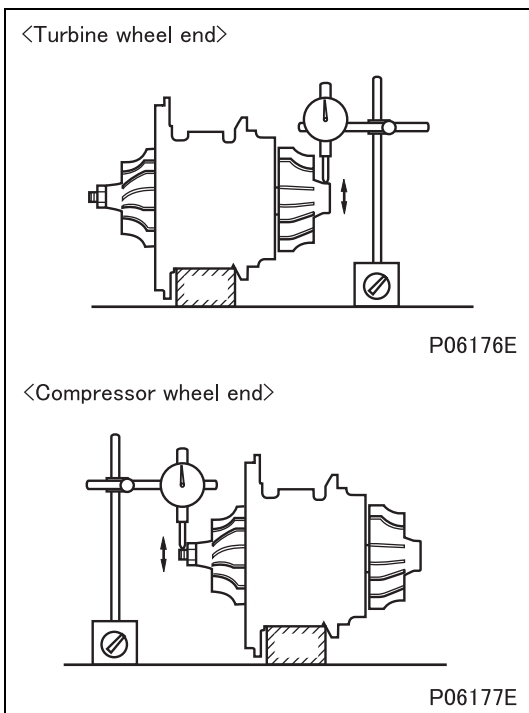
#### (2) Play perpendicular to axis of shaft

| Location | Maintenance item | | Standard value | Limit | Remedy |
|---|---|---|---|---|---|
| | | Play perpendicular to axis of shaft | Turbine wheel end<br>0.40 to 0.53<br>{0.016 to 0.021} | 0.58<br>{0.023} | Replace |
| | | | Compressor wheel end<br>0.55 to 0.66<br>{0.022 to 0.026} | 0.72<br>{0.028} | Replace |

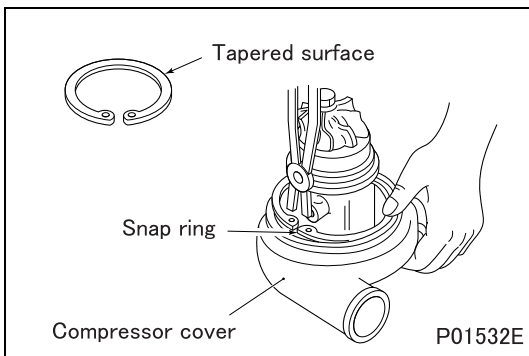
### ■ Installation: Snap ring

- With the tapered surface facing up, install the snap ring into the compressor cover.

- Fit the snap ring into place using hands not to let it spring away.

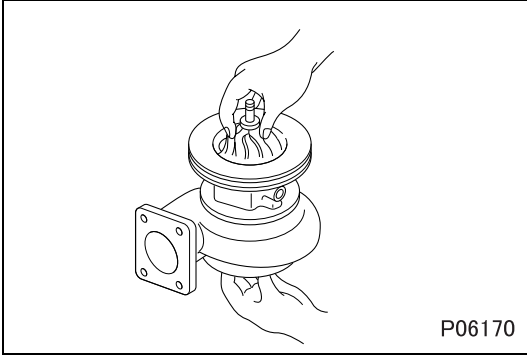
**■ Inspection: Free rotation of cartridge assembly**

- Turn the wheels of the cartridge assembly. They should turn freely without binding.
- If not, disassemble again and correct.

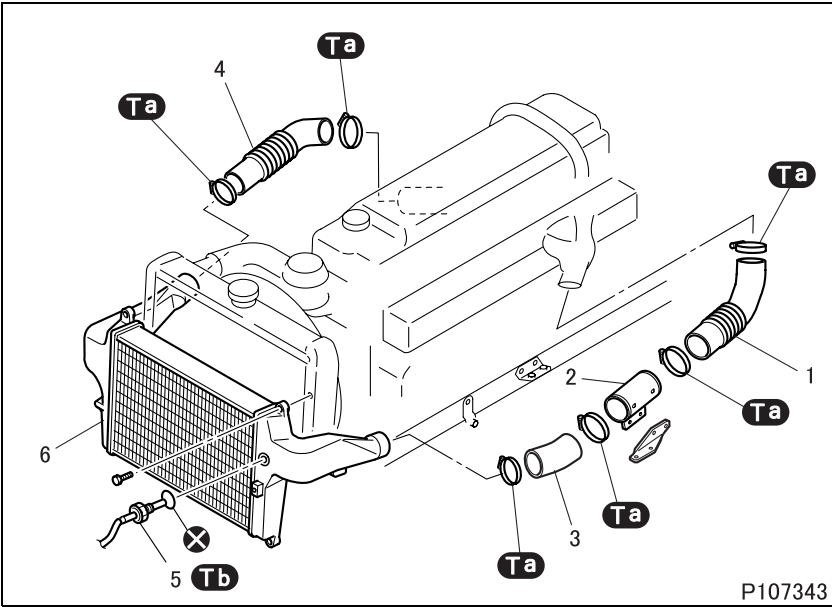
- 1 Air outlet hose
- 2 Air outlet pipe
- 3 Air outlet duct
- 4 Air inlet hose
- 5 Intake air temperature sensor 1
- 6 Intercooler

- When removing the air inlet hose, do not try to pry it off with strong force using a screwdriver or other similar tools. Doing that can damage the fluorolayer on the inner surface of the hose, possibly compromising the oil resistance of the hose.

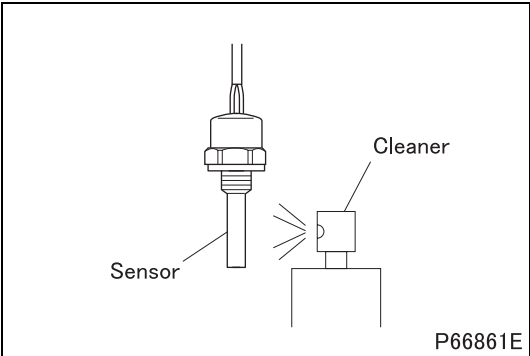
### ■ Inspection: Intake air temperature sensor 1

- Check that the sensor portion is free of soot, oily substance, etc.
- If not, clean the sensor portion as follows.
- Spray a cleaner on the sensor portion from 2 or 3 cm {0.79 to 1.18 in.} away.

- If the sensor portion is fouled excessively, the positive crankcase ventilation (PCV) may be faulty. Inspect the PCV valve and filter to locate the cause and remove it.

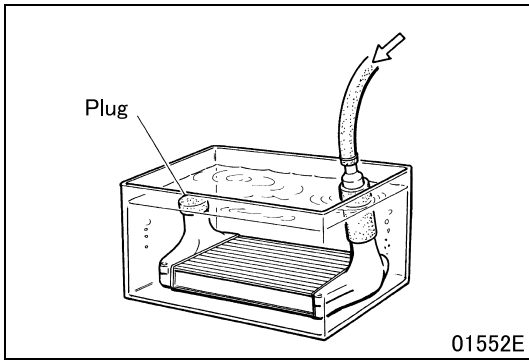
**■ Inspection: Intercooler**

- Plug one of the air ports of the intercooler and immerse it in a tank of water. Apply the specified air pressure to the intercooler through the other air port.
- If leakage is apparent, replace the intercooler.

| Location | Maintenance item | Standard value | Limit | Remedy |
|---|---|---|---|---|
| 6 | Intercooler air leakage<br>(at air pressure of 150 kPa {22 psi, 1.5 kgf/cm <sup>2</sup> }) | 0 cm <sup>3</sup> {0 cu.in.} | – | Replace |

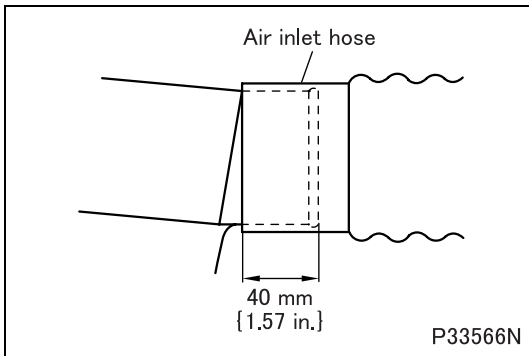
**■ Installation: Air inlet hose**

- Fit each air inlet hose in the direction shown in the illustration.

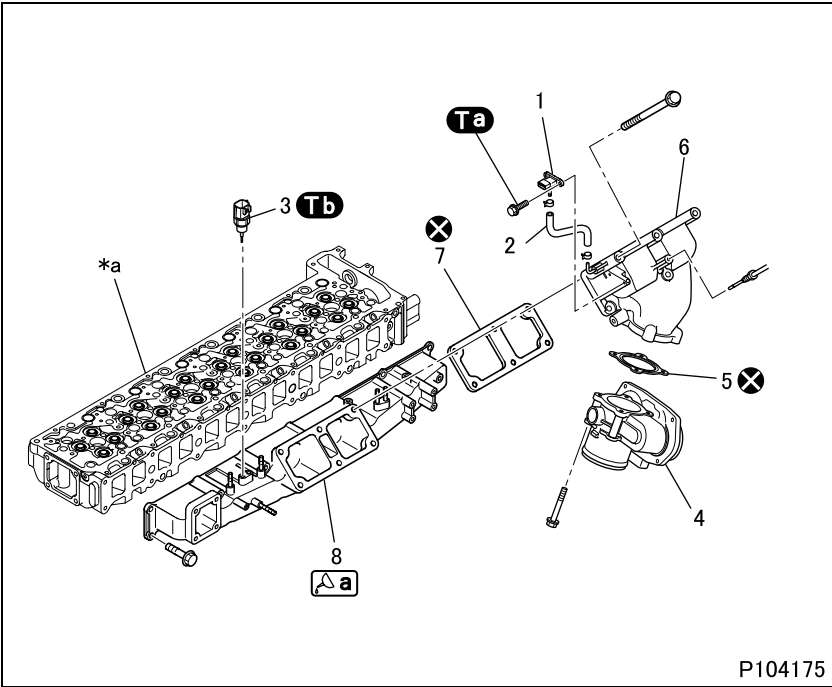
- 1 Boost pressure sensor
- 2 Pressure hose
- 3 Intake air temperature sensor 2
- 4 Intake throttle
- 5 Gasket
- 6 Intake manifold fitting
- 7 Gasket
- 8 Intake manifold

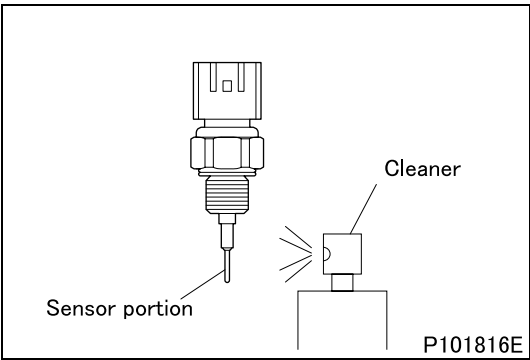
#### ■ Inspection: Intake air temperature sensor 2

- Check that the sensor portion is free of soot, oily substance, etc.
- If not, clean the sensor portion as follows.
- Spray a cleaner on the sensor portion from 2 or 3 cm {0.79 to 1.18 in.} away.  
Recommended cleaners:  
Nonchlorinated solvent
- In 20 to 30 seconds after spraying, wipe the sensor portion clear of the sprayed cleaner using a soft waste cloth the like.

- If the sensor portion is fouled excessively, the positive crankcase ventilation (PCV) may be faulty. Inspect the PCV valve and filter to locate the cause and remove it.

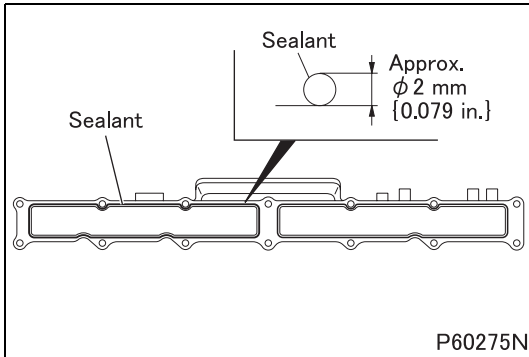
### ■ Installation: Intake manifold

- Clean the sealing surfaces of the intake manifold and cylinder head where they are to be mated with each other.
- Apply an even and continuous bead of sealant onto the intake manifold surface where the cylinder head is to be mounted.
- Install the intake manifold onto the cylinder head within 3 minutes following the application while taking care not to spread the sealant beyond the application area.

- Do not start the engine at least for an hour after the intake manifold has been installed.
- If the intake manifold mounting bolts are subsequently loosened or removed, be sure to apply sealant again upon reassembly.

| Mark | Points of application | Specified lubricant and/or sealant | Quantity |
|---|---|---|---|
| a | Cylinder head mounting surface of intake manifold | ThreeBond 1217H | As required |

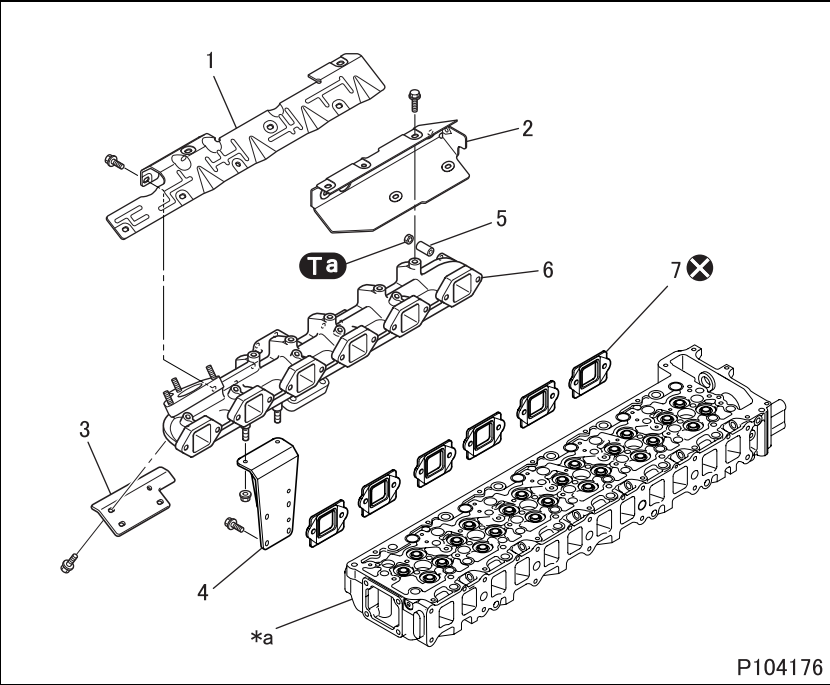
- 1 Exhaust manifold insulator A
- 2 Exhaust manifold insulator B
- 3 Front exhaust manifold insulator
- 4 Exhaust manifold bracket
- 5 Distance piece
- 6 Exhaust manifold
- 7 Gasket

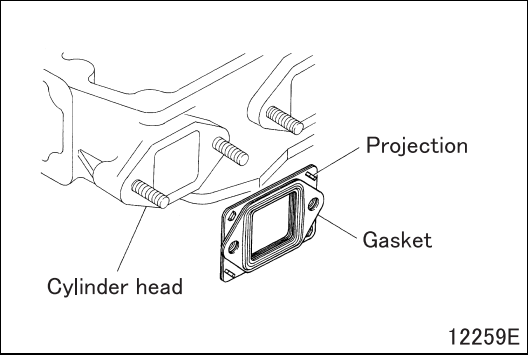
### ■ Installation: Gasket

- Fit the gasket to the cylinder head in the illustrated direction.

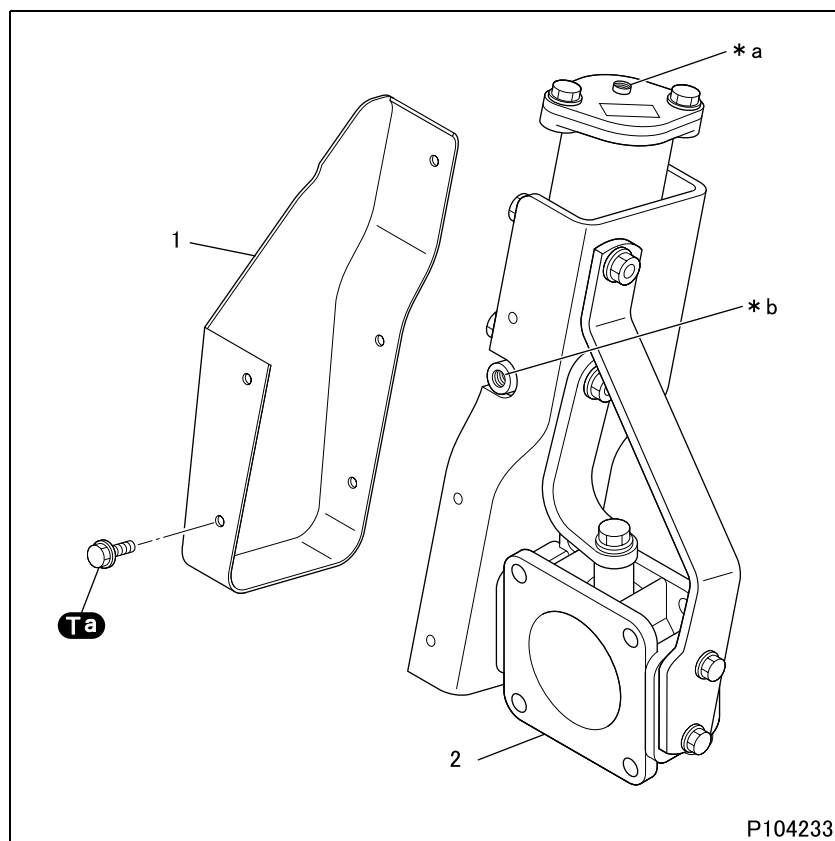
- 1 Cover
- 2 Exhaust shutter

- Exhaust shutter is a disassemblable unit. If there is any abnormality in the control cylinder or elsewhere, replace the exhaust shutter as an assembly.

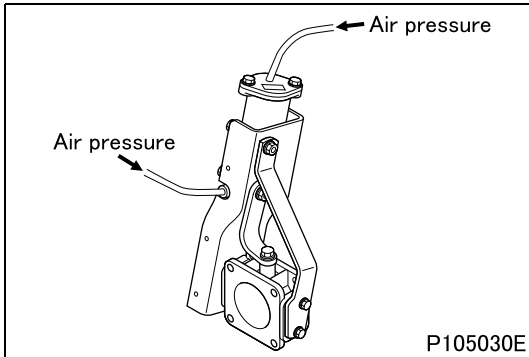
### ■ Inspection: Air leakage from control cylinder

- Introduce the specified air pressure into the control cylinder and check it for air leaks.
- If there is an air leakage, replace the exhaust shutter valve.

| Location | Maintenance item | | Standard value | Limit | Remedy |
|---|---|---|---|---|---|
| 2 | Air leakage from control cylinder<br>(air pressure: $0.64 \pm 0.05$ MPa<br>{ $93 \pm 7.3$ psi, $6.5 \pm 0.5$ kgf/cm <sup>2</sup> }) | | 0 cm <sup>3</sup> {0 cu.in., 0 ml} | — | Replace |

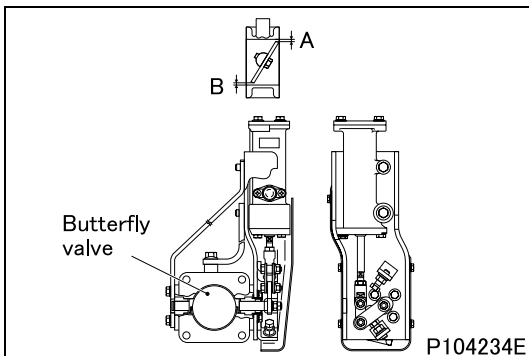
### ■ Inspection: Butterfly valve-to-body minimum clearance

- Apply a specified level of air pressure to the port 1 of the control cylinder. With the butterfly valve fully closed, measure upper clearance A and lower clearance B between the butterfly valve and body.
- If the measurement deviates from the standard value, replace the exhaust shutter valve.

| Location | Maintenance item | | Standard value | Limit | Remedy |
|---|---|---|---|---|---|
| | Butterfly valve-to-body minimum clearance<br>(air pressure: $0.64 \pm 0.05$ MPa<br>{ $93 \pm 7.3$ psi, $6.5 \pm 0.5$ kgf/cm <sup>2</sup> }) | | 0.1 or more<br>{0.0039 or more} | — | Replace |

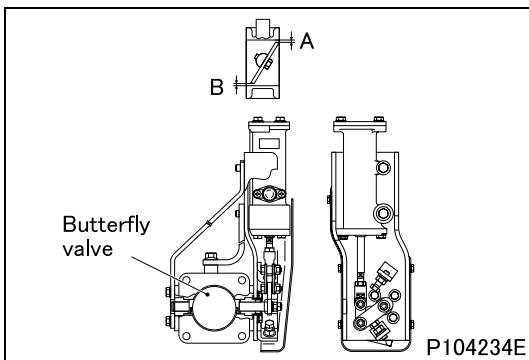
### ■ Inspection: Butterfly valve-to-body clearance (average of upper and lower clearances)

- Perform clearance checks as described below. Replace the exhaust shutter if found defective.

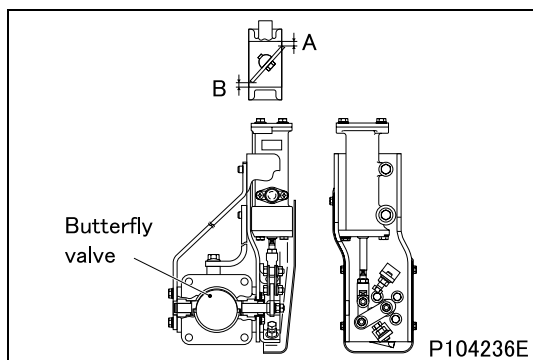
## (3) When butterfly valve is half closed

- Apply a specified level of air pressure to the ports 1 and 2 of the control cylinder. With the butterfly valve half closed, measure upper clearance A and lower clearance B between the butterfly valve and body. Average the measured values to obtain the butterfly valve-to-body clearance for service.

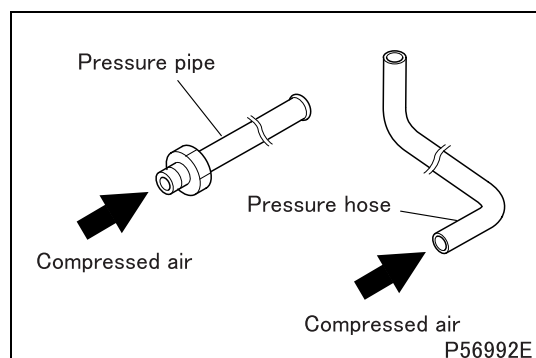
#### ■ Inspection: Pressure pipe and hose

- Check the pressure pipe and hose for clogging by blowing compressed air into the pipe and hose.

- Inspection must be performed on an individual pressure pipe or hose.
- If compressed air is blown into the pressure pipe or hose with diesel particulate filter pressure sensor still installed, the sensor may become damaged.

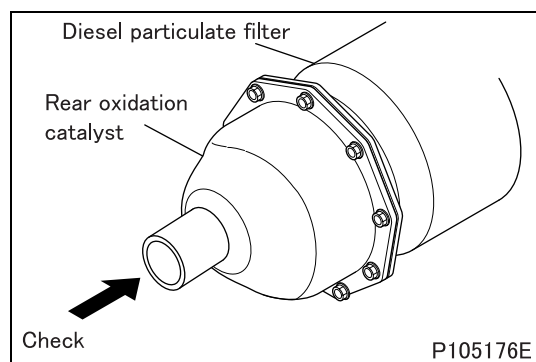
#### ■ Inspection: Diesel particulate filter

- Check the inside of the rear oxidation catalyst and the diesel particulate filter for adhesion of soot.
- If a large amount of soot is adhered, replace the ceramic filter as it may be damaged.

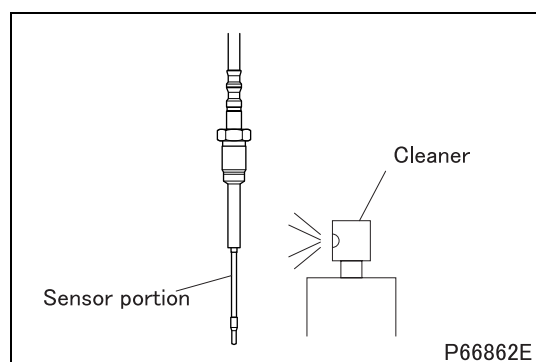
#### ■ Inspection: Temperature sensor

- Check that the sensor portion is free of soot, oily substance, etc.
- If not, clean the sensor portion as follows.
- Spray a cleaner on the sensor portion from 2 or 3 cm {0.79 or 1.18 in.} away.  
Recommended cleaners:  
Nonchlorinated solvent
- In 20 to 30 seconds after spraying, wipe the sensor portion clear of the sprayed cleaner using a soft waste cloth the like.

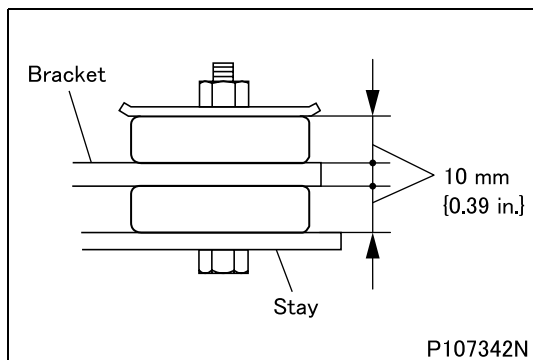
### ■ Installation: Cushion rubber (tail pipe)

- Compress the cushion rubber until the dimensions shown in the illustration are achieved.

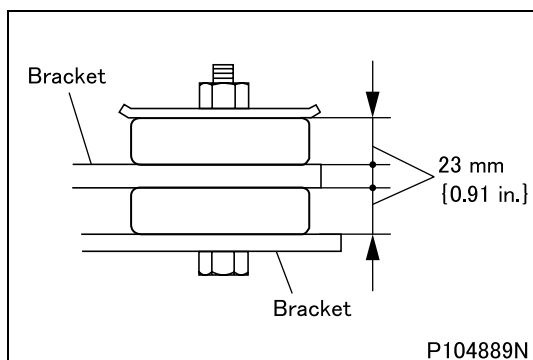
### ■ Installation: Cushion rubber (diesel particulate filter)

- Compress the cushion rubber until the dimensions shown in the illustration are achieved.

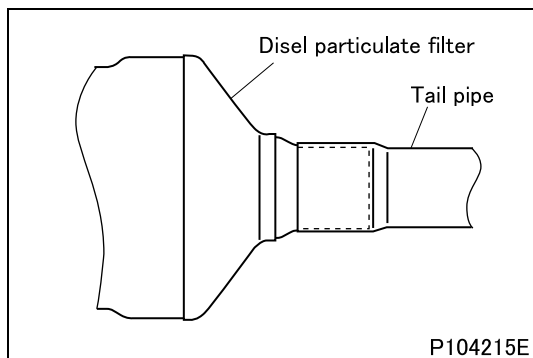
### ■ Installation: Tail pipe

- Insert the tail pipe onto the diesel particulate filter until the larger diameter portion of the pipe contacts the pipe at the rear of the filter.

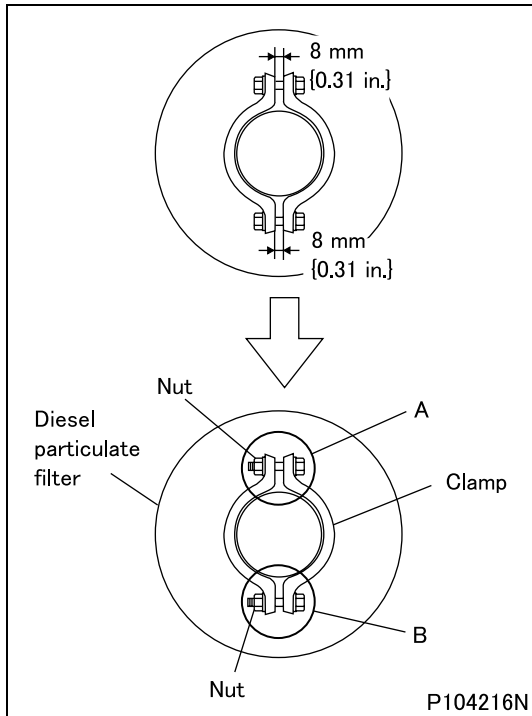
#### ■ Installation: Clamp

- Install the clamp and temporarily tighten nuts until the dimensions shown in the illustration are achieved.
- After the tightening, retighten the nut in the section A to the specified torque.  
Then, tighten the nut in the section B to the specified torque.

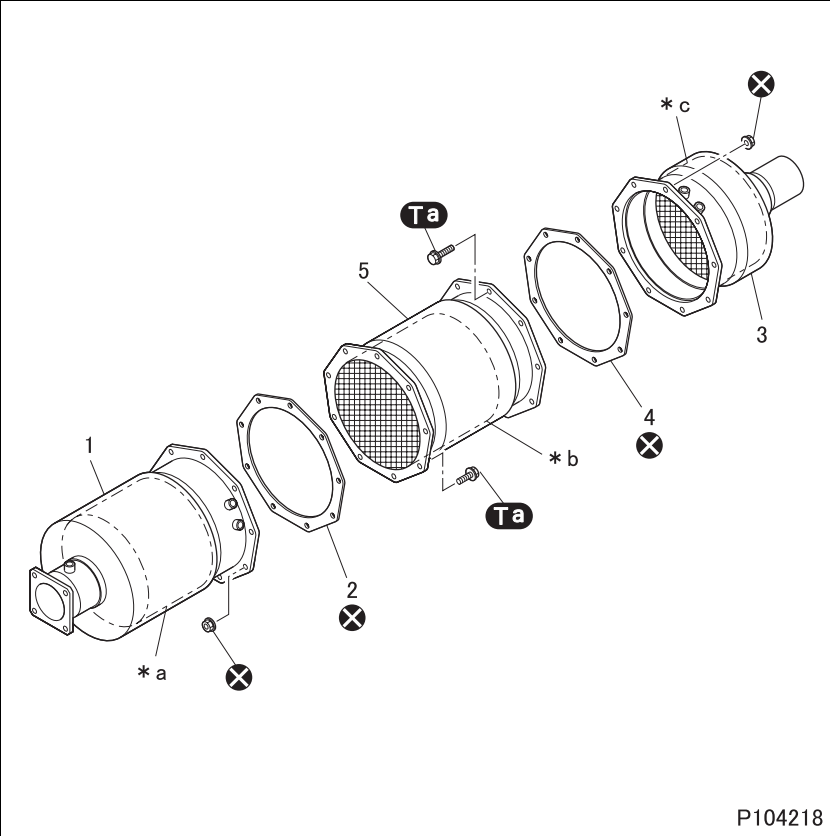
- 1 Inlet body
- 2 Gasket
- 3 Outlet body
- 4 Gasket
- 5 Filter body

- Visually inspect the front oxidation catalyst in the inlet body.
- If there is abnormality such as broken part, replace the inlet body as a unit.

- Visually inspect the rear oxidation catalyst in the outlet body.
- If there is abnormality such as broken part, replace the outlet body as a unit.

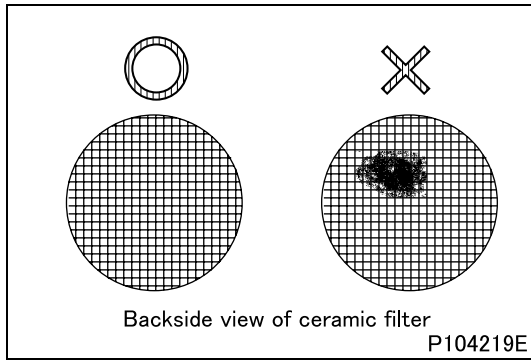
**■ Inspection: Filter body**

- Check the ceramic filter for damage while looking into the rear side of the filter body.
- If there is any abnormality, replace the whole filter body.
- If there is not any abnormality such as broken part but the ceramic filter is so dirty that it should be cleaned, clean it. (See “ON-VEHICLE INSPECTION AND ADJUSTMENT”.)
