# FE.FG

## SERVICE MANUAL 2008 Model FOREWORD

This Service Manual contains maintenance and repair methods for the Mitsubishi Fuso Truck FE. FG Series. Read this manual carefully as an aid in providing correct, efficient maintenance. Please note that the information and specifications contained within this manual may change without notice. This is due to product modifications and continued vehicle improvements that are made throughout the model years. Should you encounter any discrepancy in the information provided, please do not hesitate to contact your nearest Mitsubishi Fuso Dealer or Mitsubishi Fuso Truck of America, Inc.

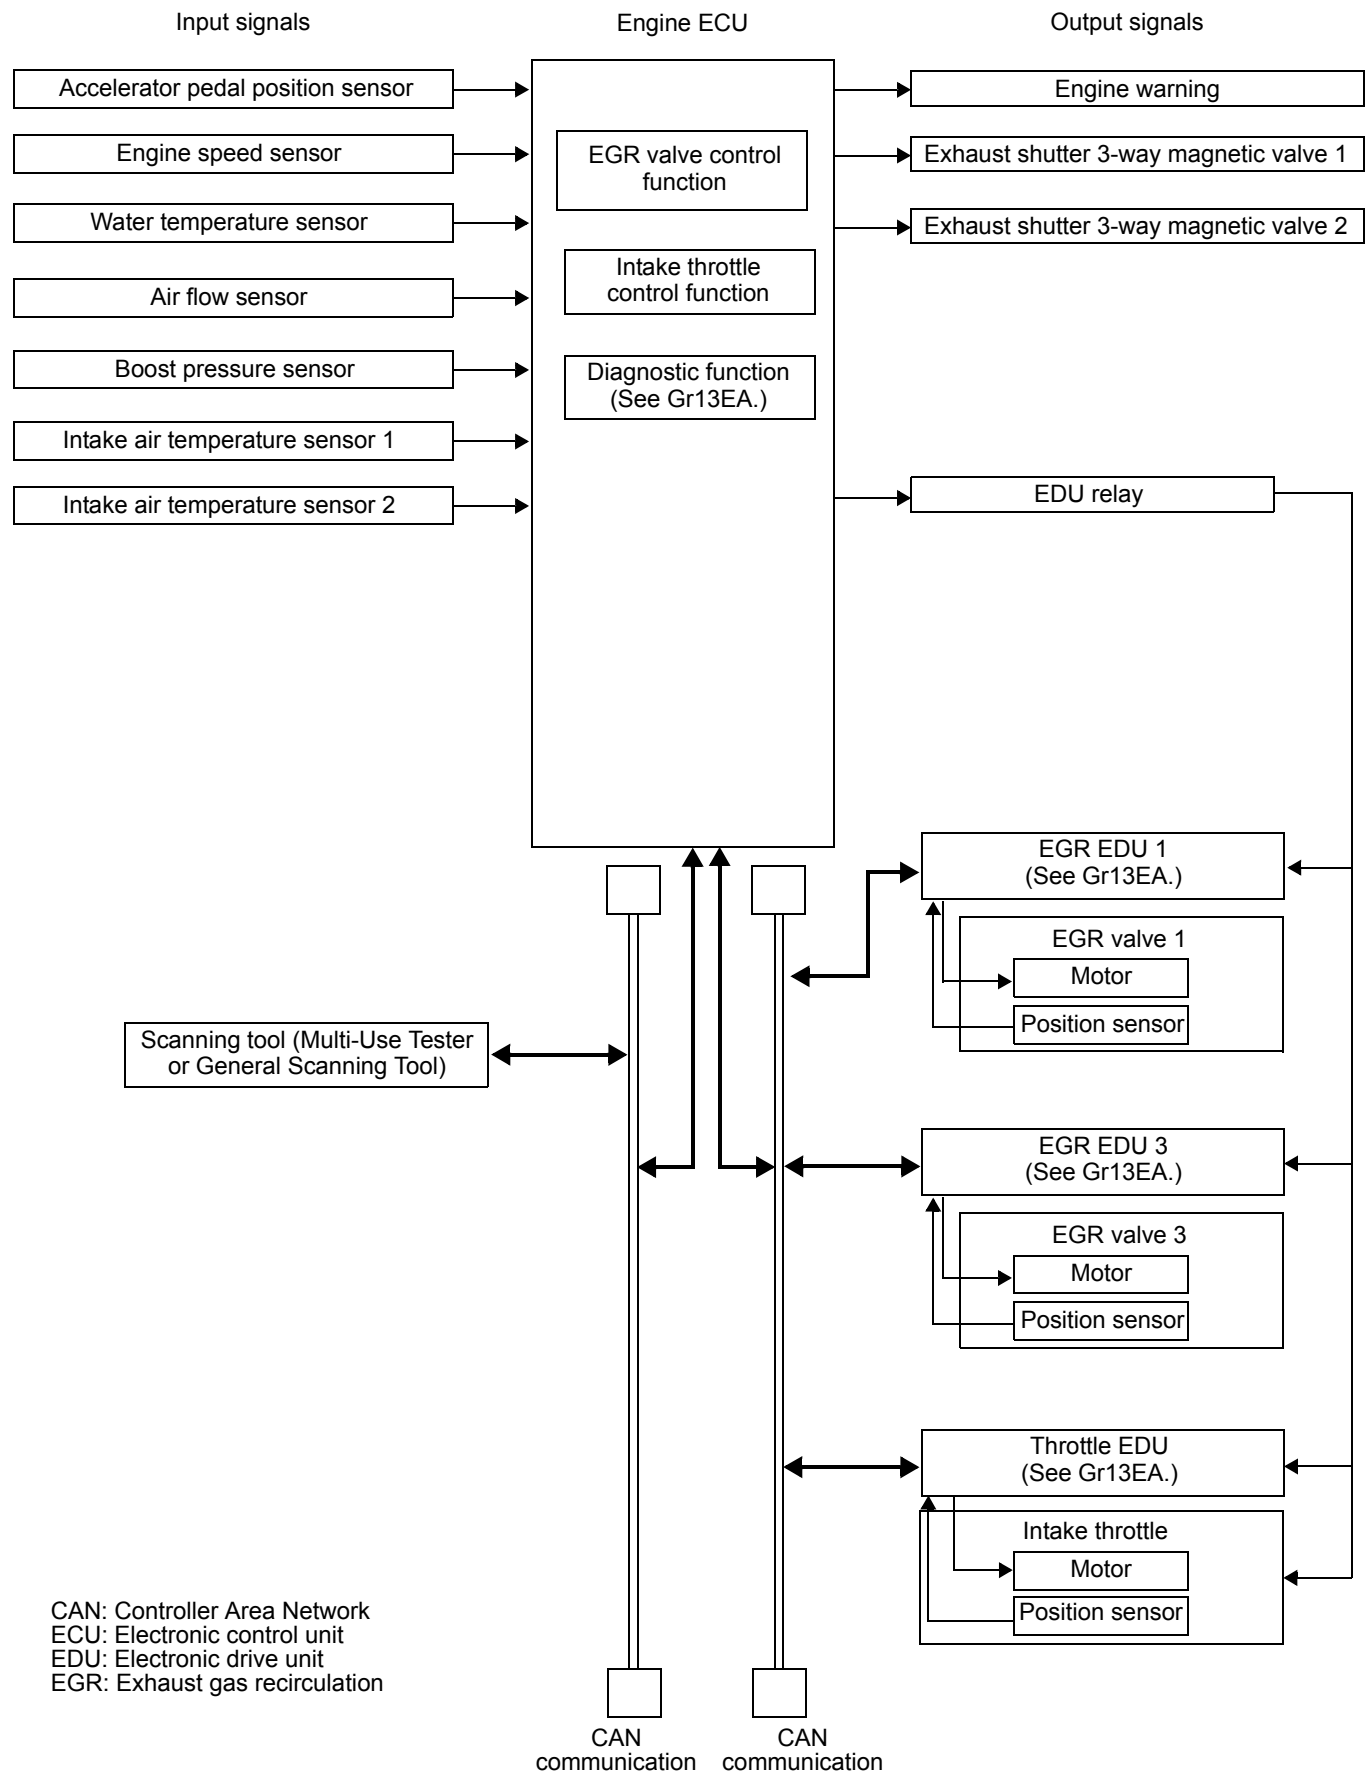
### (1) System block diagram

- In the exhaust gas recirculation system, the engine electronic control unit controls the exhaust gas recirculation magnetic valve in accordance with information from sensors on various aspects of the engine (engine speed, coolant temperature, throttle opening, etc.).
- Exhaust gas recirculation involves the introduction of inert gases in the post-combustion exhaust emissions into the intake manifold. By reducing the combustion temperature, it reduces the amount of nitrogen oxides (NOx), which are harmful, in the exhaust emissions. Further, an exhaust gas recirculation cooler cools the recirculated exhaust emissions, thereby reducing the peak combustion temperature.

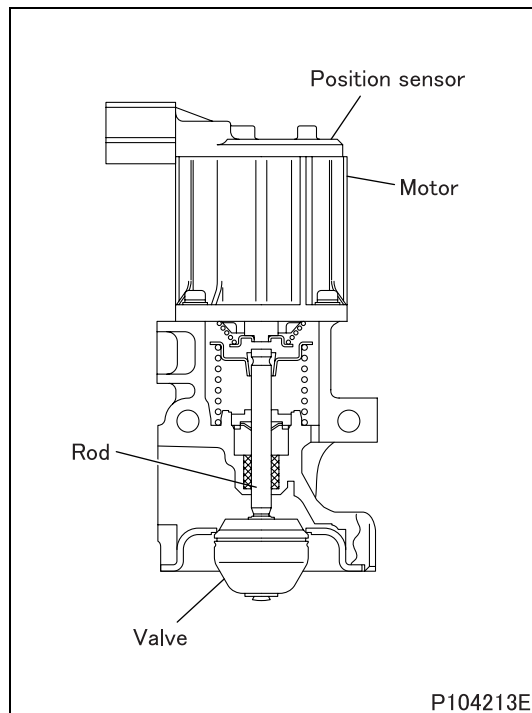
### (2.1) Exhaust gas recirculation valve

- A motor in the exhaust gas recirculation valve is driven by control signals from the exhaust gas recirculation electronic drive unit. Via a rod, the motor's operation opens and closes the valve.

- In accordance with data from sensors, the engine electronic control unit determines the exhaust gas recirculation valve opening that suits the operating condition and sends a control signal (this indicates the target exhaust gas recirculation valve opening) to the exhaust gas recirculation electronic drive unit.  
When necessary to prevent black smoke emissions and engine speed instability (for example, when the engine is heavily loaded, when the engine is lightly loaded, and when the exhaust brake is operating), the engine electronic control unit stops exhaust gas recirculation valve control.

- The exhaust gas recirculation electronic drive unit activates the exhaust gas recirculation valve motor. At the same time, it monitors the extent of valve lift using a position sensor and sends this information (this indicates the actual exhaust gas recirculation valve opening) to the engine electronic control unit.  
This operation makes it possible for the target exhaust gas recirculation valve opening indicated by the engine electronic control unit to be precisely maintained.

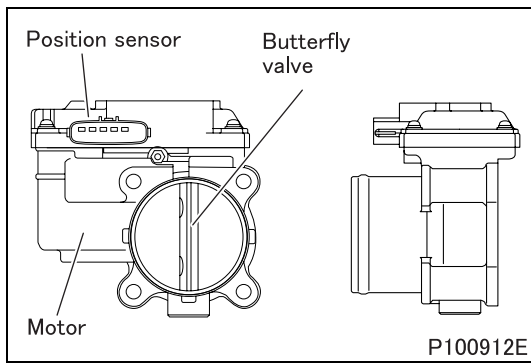
### (3.1) Intake throttle

- In accordance with signals from the throttle electronic drive unit, the motor opens and closes the butterfly valve, thereby adjusting the intake air amount such that the effectiveness of exhaust gas recirculation is maximized.

- When the engine electronic control unit determines from sensor data on the engine speed and engine loading that the vacuum pressure in the intake manifold is low, it increases the amount of exhaust emissions introduced into the intake manifold by determining an appropriate butterfly valve opening and by sending corresponding control signals (these indicate the target throttle opening) to the throttle electronic drive unit.
- The throttle electronic drive unit activates the valve motor. At the same time, it monitors the valve opening using a position sensor and sends this information (this indicates the actual throttle opening) to the engine electronic control unit.  
This operation makes it possible for the target throttle opening indicated by the engine electronic control unit to be precisely maintained.

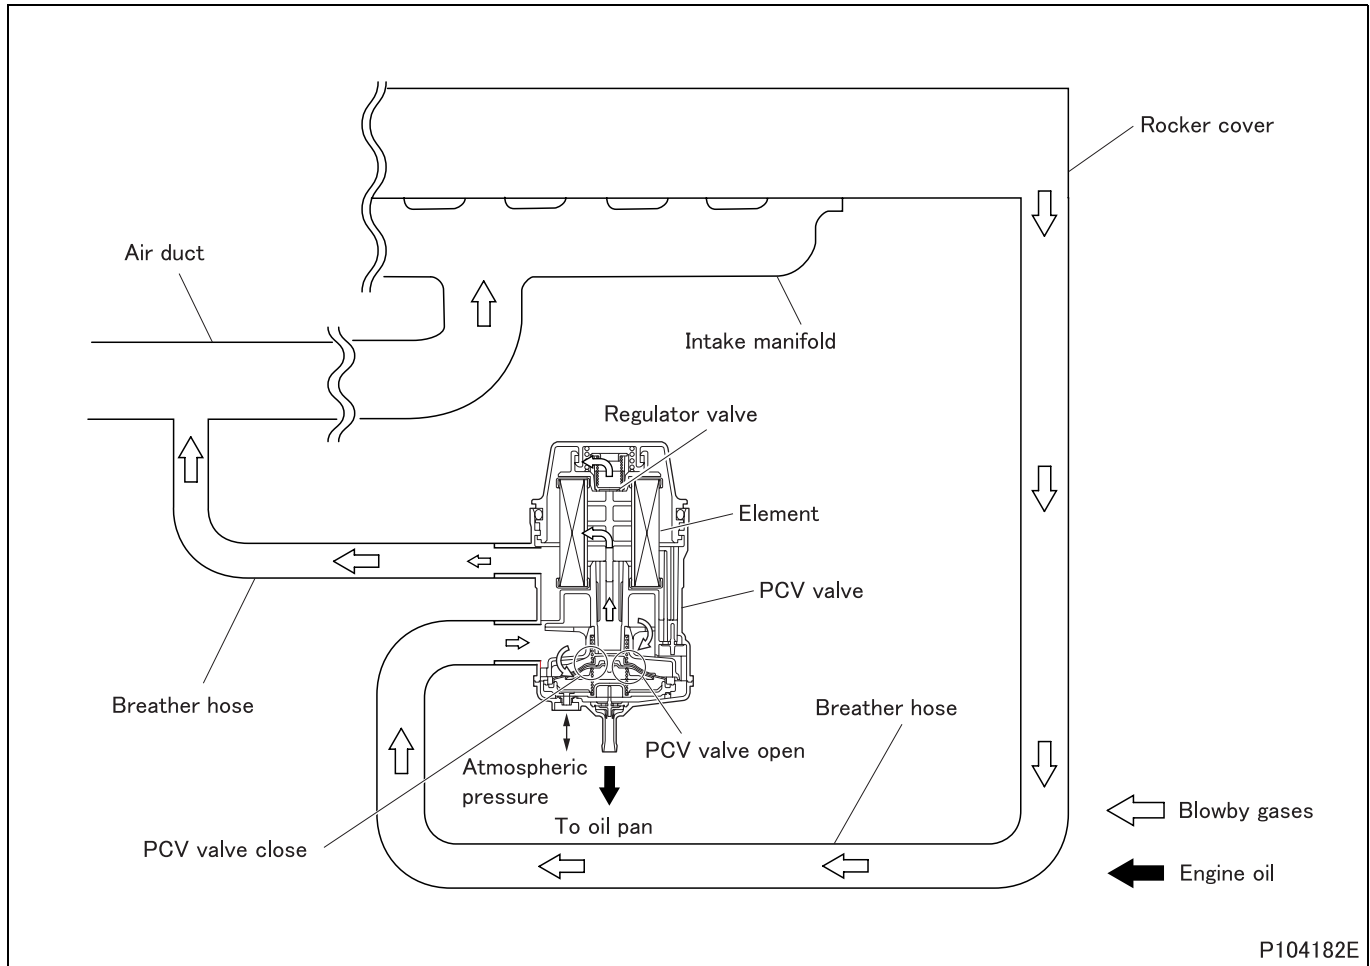
PCV: Positive Crankcase Ventilation

- The blowby gas return system returns blowby gases to an air duct to prevent them from being released to the outside air.
- The PCV valve keeps constant the pressure inside the crankcase.
- The oil in the blowby gas is separated by the wire mesh and the element in the PCV valve and is returned to the oil pan.
- When the element is clogged, the regulator valve opens and the blowby gas is returned to the breather hose.

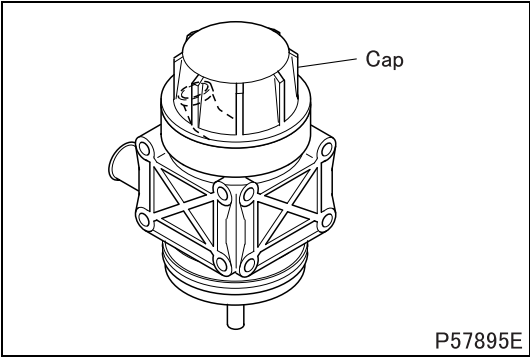
### [Removal]

- Loosen the cap by hand.

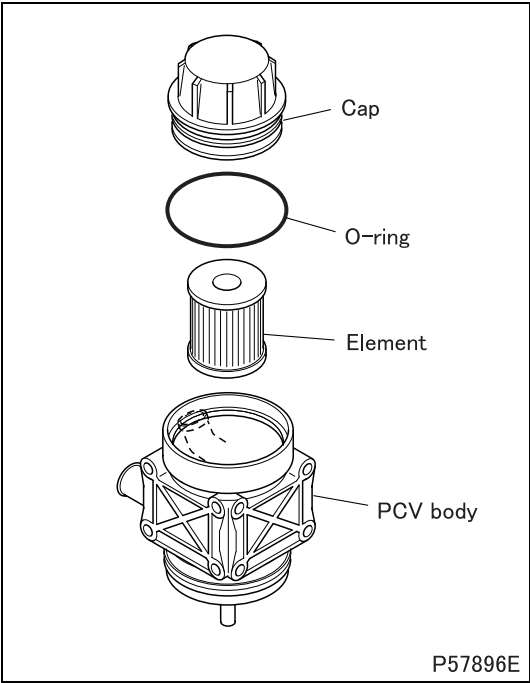
### [Installation]

- Clean the thread on the cap.
- Lightly smear the O-ring with engine oil and fit it on the cap.
- Securely tighten the cap until it stops slightly above the PCV body.

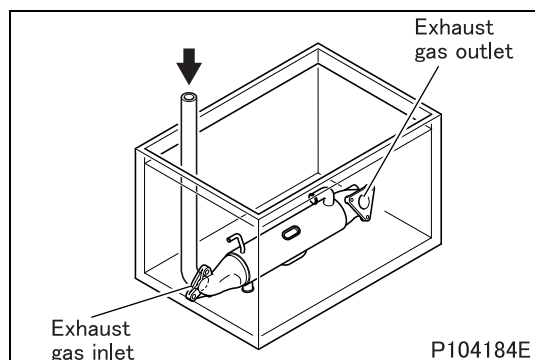
### ■ Inspection: Exhaust gas recirculation cooler

- Perform the following inspection. If any abnormality is found, replace the exhaust gas recirculation cooler.

#### (1) Exhaust gas passage side

- Fit a cover over the exhaust gas outlet of the exhaust gas recirculation cooler, and connect a hose to the exhaust gas inlet. Then, submerge the exhaust gas recirculation cooler in a container of water. Make sure the coolant passage is full of water.
- Apply specified air pressure through the hose. Check that air does not leak from any part of the exhaust gas recirculation cooler.

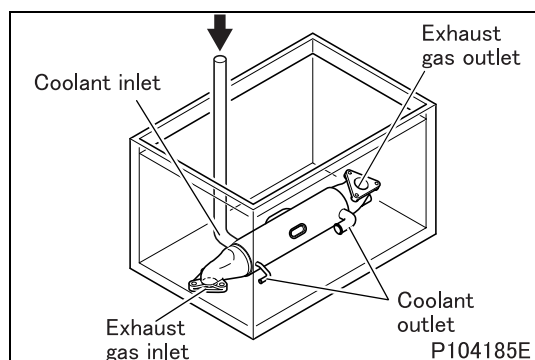
#### (2) Coolant passage side

- Fit covers over the exhaust gas recirculation cooler's exhaust gas inlet, exhaust gas outlet, and coolant outlet, and connect a hose to the coolant inlet. Then, submerge the exhaust gas recirculation cooler in a container of water.
- Apply air pressure of 300 kPa {44 psi, 3 kgf/cm<sup>2</sup>} through the hose. Check that air does not leak from any part of the exhaust gas recirculation cooler.

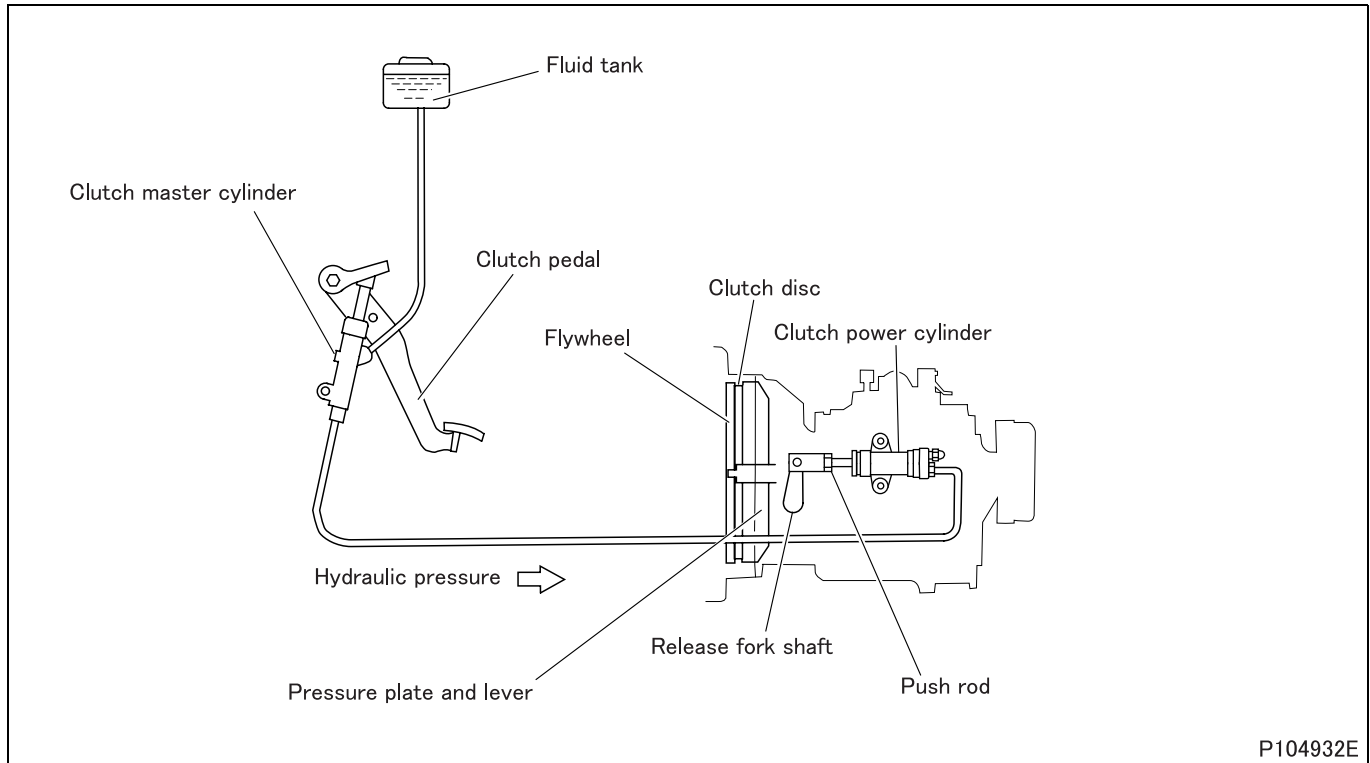
## 1. Clutch Control

- Hydraulic pressure is used to control the clutch operation.
- When the clutch pedal is pressed, a force is applied to the clutch master cylinder, pushing the push rod in the clutch master cylinder. As a result, hydraulic pressure is generated, activating the clutch power cylinder or the clutch booster and disengaging the clutch.

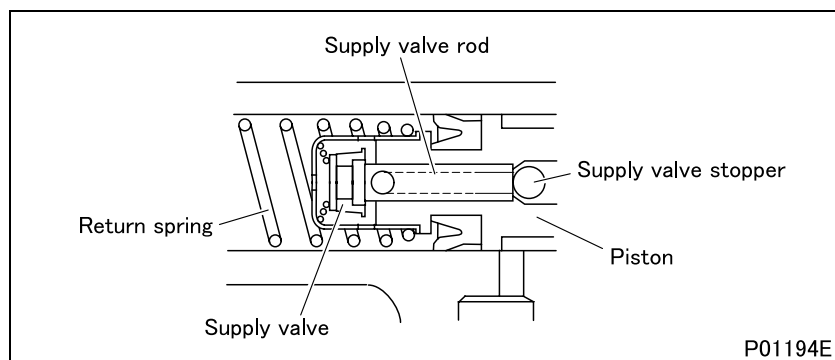
### 2.1 Before clutch pedal is pressed

- Because the piston is pushed against the push rod by the return spring, the supply valve rod contacts the supply valve stopper, leaving the supply valve open.
- As a result, the fluid passage on the fluid tank side is connected to the fluid passage on the clutch side.

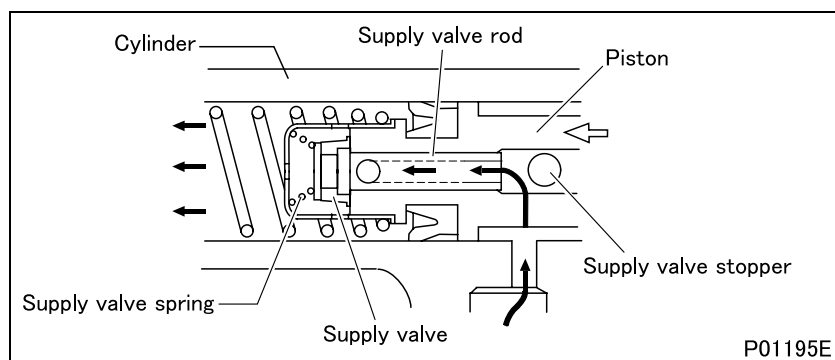
### 2.2 When clutch pedal is pressed

- When the push rod pushes the piston, the supply valve rod leaves the supply valve stopper, and at the same time, the spring force of the supply valve spring closes the supply valve.
- When the piston is further pushed, the hydraulic pressure is generated in the cylinder, which activates the clutch booster or clutch power cylinder.
- As a result, the fluid is supplied by the movement amount of the piston.

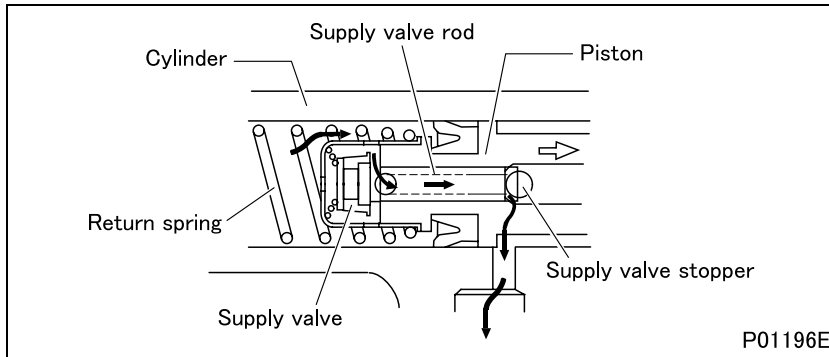
### 2.3 When clutch pedal is released

- When the piston is pushed back by the hydraulic pressure in the cylinder and the return spring, the supply valve rod contacts the stopper, opening the supply valve.
- As a result, the fluid on the clutch side returns to the fluid tank, and hydraulic pressure is lost.

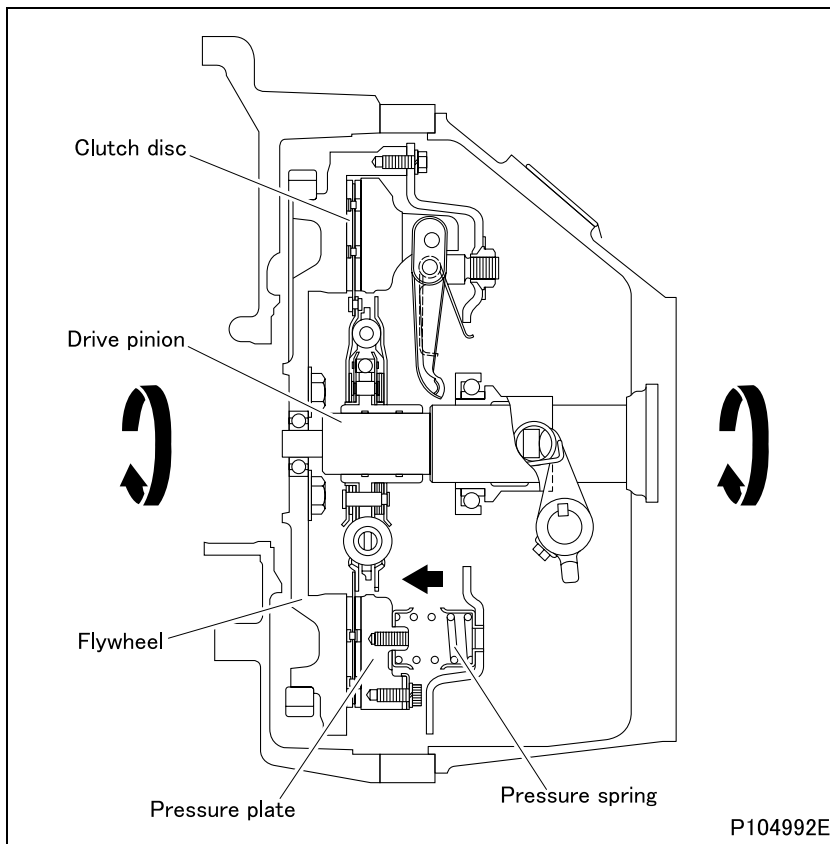
### 3.1 When clutch pedal is released

- The force of the pressure spring acts on the pressure plate, which in turn keeps the clutch disc pressed against the flywheel.
- Pressed against the flywheel, the clutch disc rotates together with the flywheel and transmits the engine power to the transmission drive pinion.

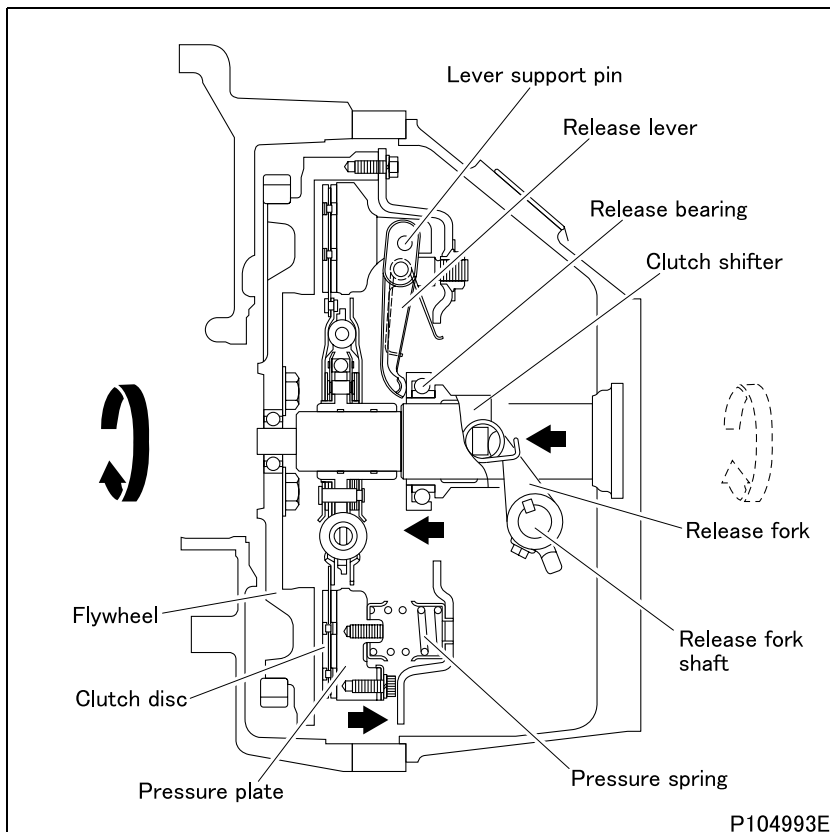
### 3.2 When clutch pedal is pressed

- The hydraulic pressure from the clutch master cylinder activates the clutch booster or clutch power cylinder. As a result, the release fork shaft activates the release fork, pushing out the clutch shifter as well as the release bearing, which then pushes the release lever.
- The release lever compresses the pressure spring with the lever support pin as the fulcrum and pull back the pressure plate coupled to the clutch cover. As a result, clearance is created between the clutch disc and flywheel, and the engine power is not transmitted to the transmission.

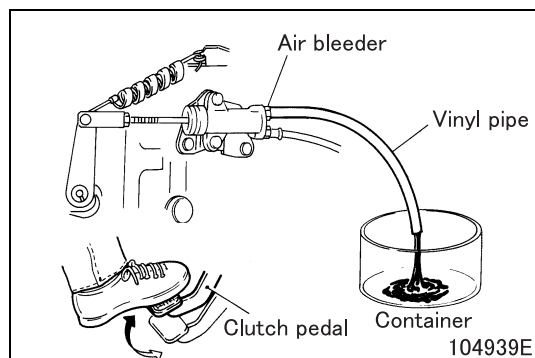
#### 1.1 Work before replacement

- Install one end of a vinyl pipe onto the air bleeder of the clutch booster or clutch power cylinder. Place the loose end into a container.

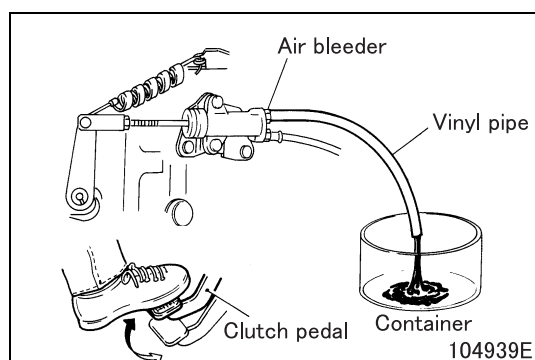
### 2.1 Work before air bleeding

- Install one end of a vinyl pipe onto the air bleeder in the clutch booster or clutch power cylinder. Place the loose end into a container as in the replacement procedure.

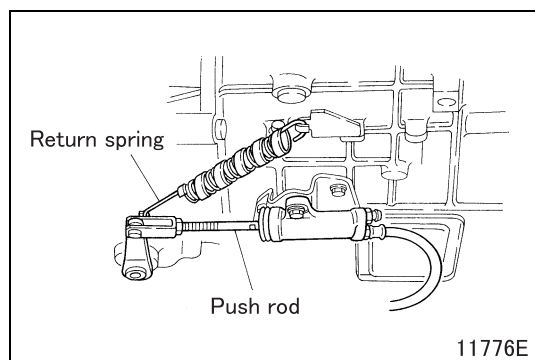
### 3.1 Clutch power cylinder push rod travel

- Perform this work after completing clutch pedal adjustment and air bleeding work.

#### [Adjustment]

- Loosen the nut and extend the push rod by turning head of the rod until the rod no longer moves.
- Return the hexagonal nut portion of the rod to the following value from this condition, and tighten the nut.  
Return amount: 3 turns
- If the rod does not return to the above value, the clutch disc has worn beyond the service limit. Replace the clutch disc.
- After adjustment, install the return spring.

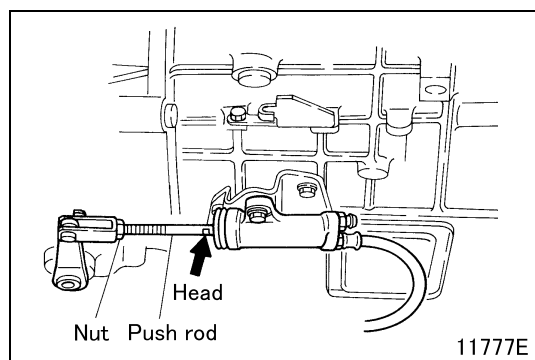
### 3.2 Clutch pedal play

#### [Inspection]

- Push the clutch pedal by hand and measure the movement amount (movement amount of push rod of clutch master cylinder and movement amount of push rod of clutch power cylinder) until resistance is felt.
- If the measured value deviates from the standard value, readjust clutch pedal play or replace clutch faulty parts.

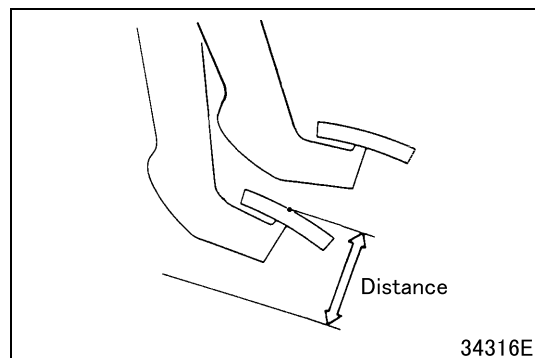
- Perform inspection at the position where the clutch is engaged in the following procedure.
- Apply the parking brake and run the engine at idle.
- Depressing the clutch pedal, shift the gear shift lever to the forward highest gear position.
- Gradually release the clutch pedal, and measure the clearance between the pedal and floor just before the clutch is engaged.

- If the measured value is less than the standard value, repeat the adjustment of the play of clutch pedal or replace faulty parts.

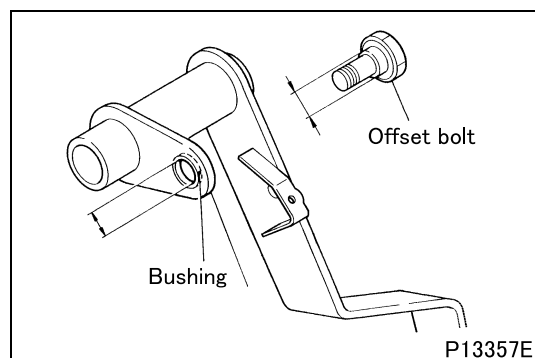
#### ■ Inspection: Clearance between offset bolt and bushing

- If the measured value does not conform to the standard value, replace the bushing.

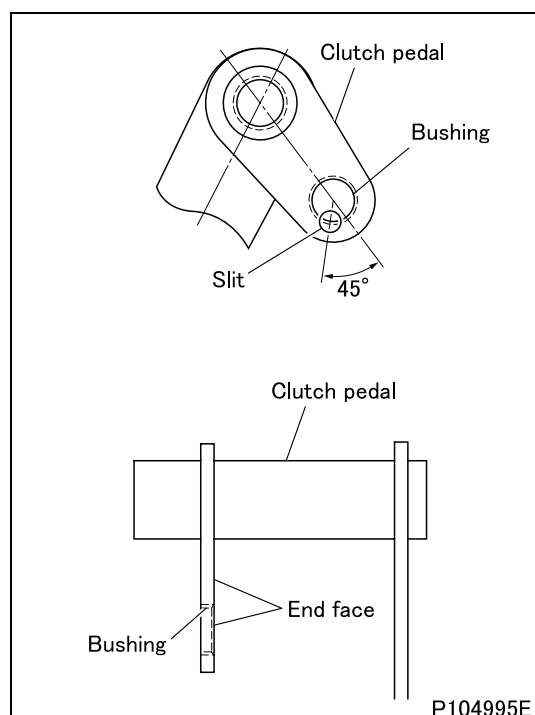
#### Removal and installation of bushing

- Adjust the slit of the bushing within the range of the angle shown in the illustration and press the bushing into the end face of the clutch pedal.

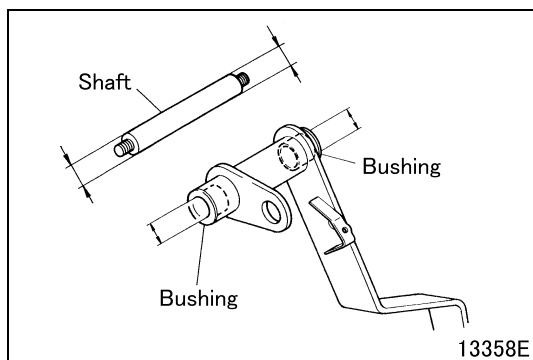
## ■ Inspection: Clearance between bushing and pedal shaft

- If the measured value does not conform to the standard value, replace the bushing.

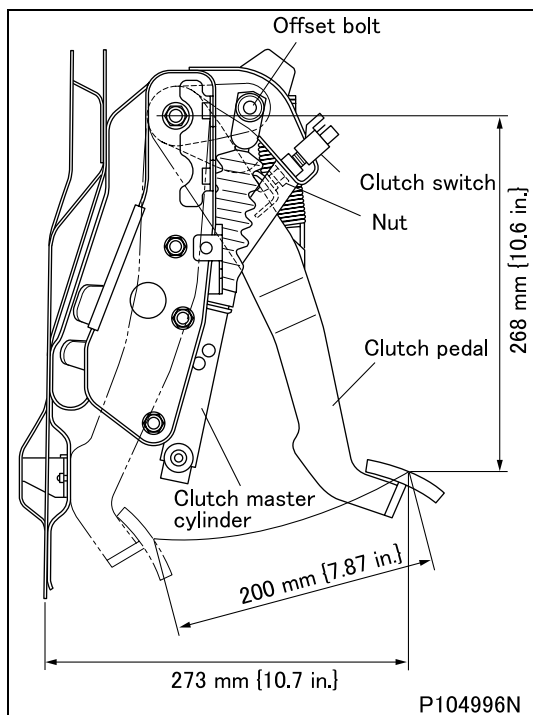
## ■ Adjustment: Clutch pedal

- Loosen the offset bolt.
- Rotate the clutch switch such that the distances indicated in the drawing are achieved on the clutch pedal. Tighten the nut fixing the clutch switch.

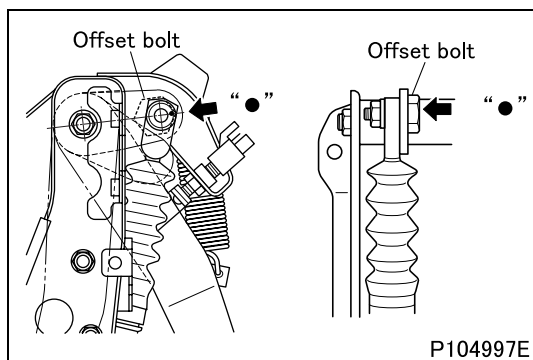
- Prior to the previous steps, temporarily tighten offset bolt such that “•” mark on the bolt is located as illustrated.

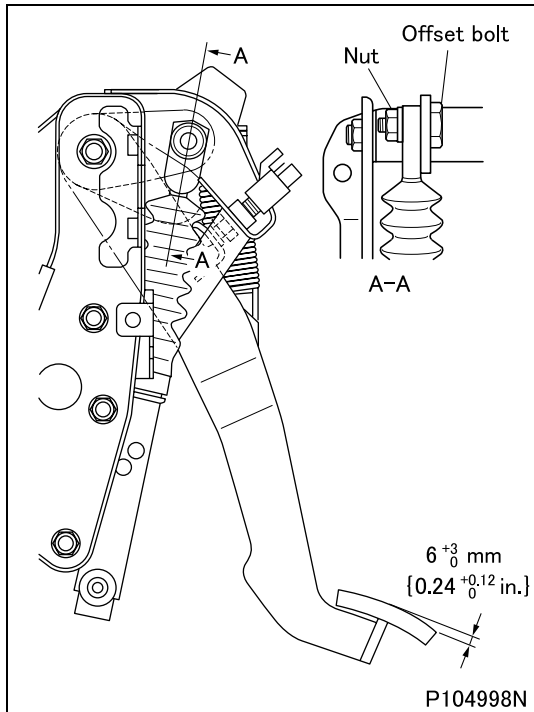
- Now, rotate the offset bolt such that the clutch pedal has the play indicated in the drawing at its end. Tighten the nut.

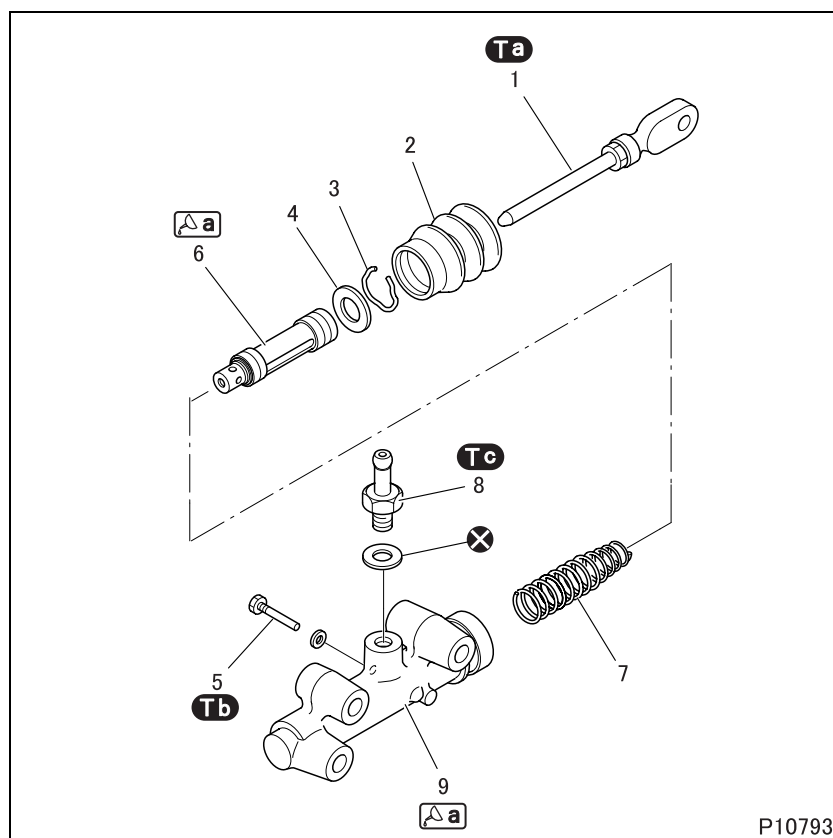
## ● Disassembly sequence

- 1 Push rod
- 2 Boot
- 3 Piston stop ring
- 4 Piston stop plate
- 5 Supply valve stopper
- 6 Piston
- 7 Return spring
- 8 Nipple
- 9 Cylinder

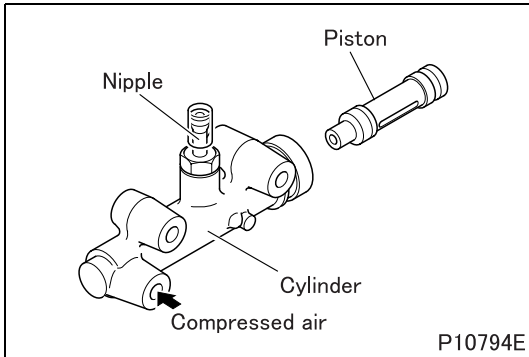
### ■ Removal: Piston

- Close the opening of the nipple on the cylinder. Wrap the cylinder body with a shop towel or equivalent around the opening to catch the piston.
- Feed compressed air gradually starting from 0 kPa {0 psi, 0 kgf/cm<sup>2</sup>} to remove the piston.

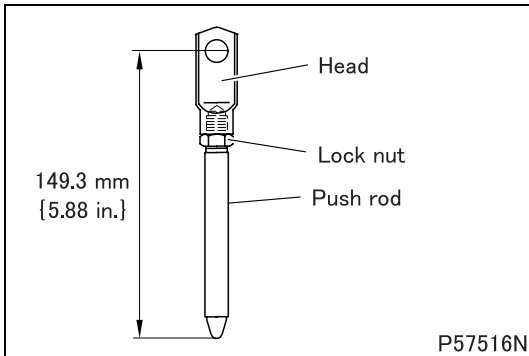
### ■ Adjustment: Push rod length

- If the illustrated dimension does not conform to the standard value, loosen the lock nut of the push rod and turn the head to adjust.
- After adjustment, tighten the lock nut.

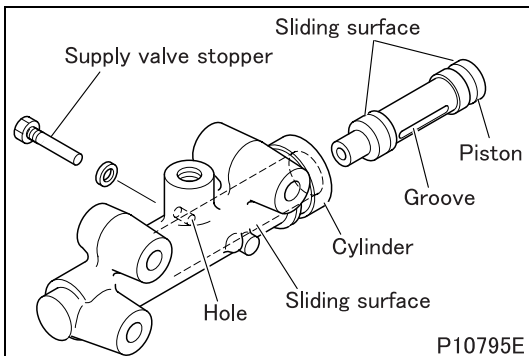
### ■ installation: Piston

- Apply grease to sliding surfaces of the piston and cylinder.
- Align the piston groove with the cylinder hole, and use the supply valve stopper as a detent.

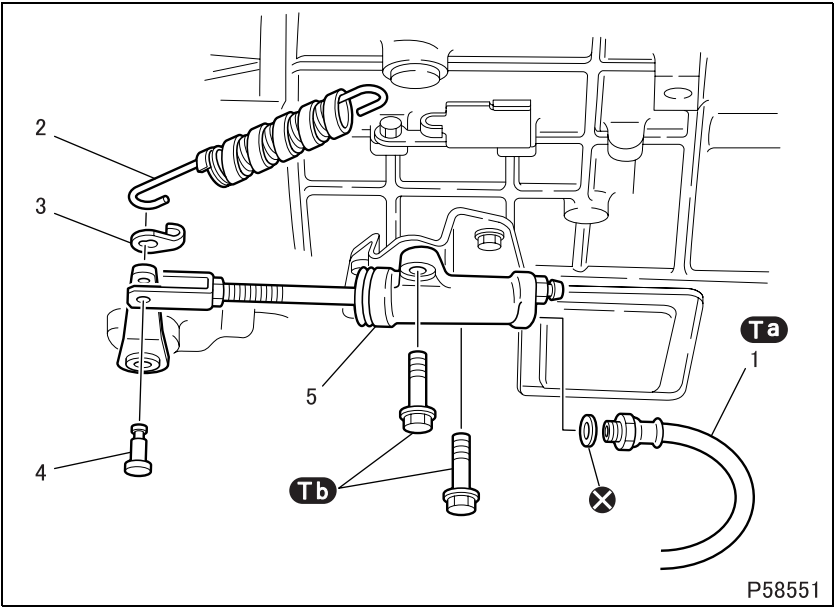
● Removal sequence

- 1 Fluid hose
- 2 Return spring
- 3 Return spring claw
- 4 Clevis pin
- 5 Clutch power cylinder  
(See later section.)

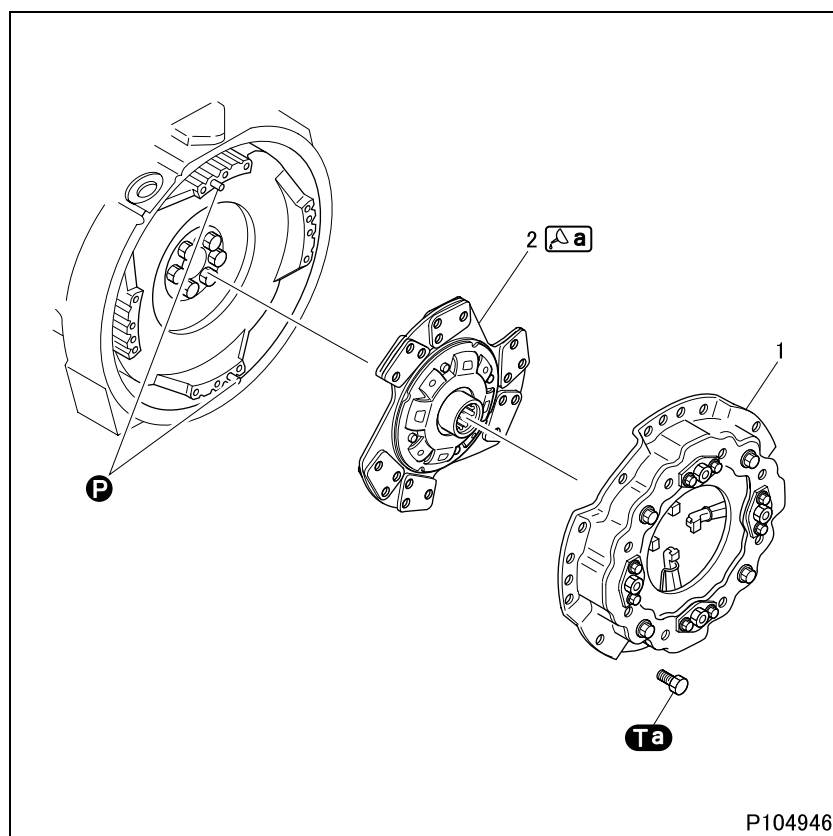
## ● Removal sequence

- 1 Pressure plate and lever assembly (See later section.)
- 2 Clutch disc

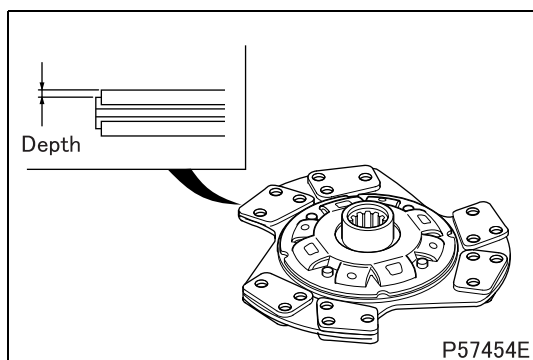
### ■ Inspection: Clutch disc

#### (1) Depth from facing surface to rivet <Woven> or cup <Ceramic metal>

- If the measured value is equal to or less than the limit, replace the clutch disc.

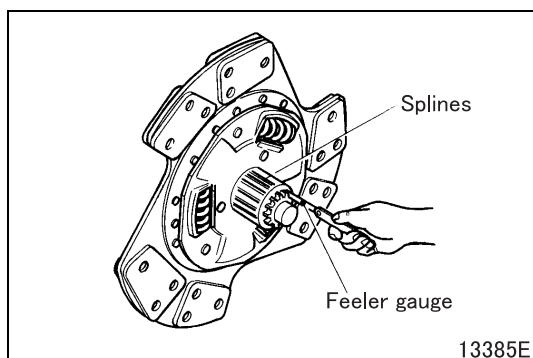
#### (2) Play in revolving direction in splines

- Reshape a feeler gauge such that it can be inserted into the drive pinion splines. Then, using the gauge, measure the splines for play in revolving direction.
- If the measured value is equal to or exceeds the limit, replace the clutch disc.

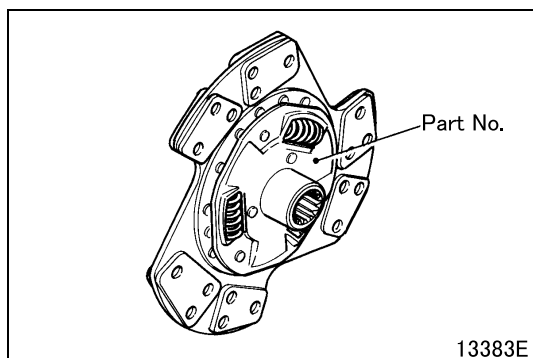
### ■ Installation: Clutch disc

- Install the clutch disc so that its Part No. can be seen.

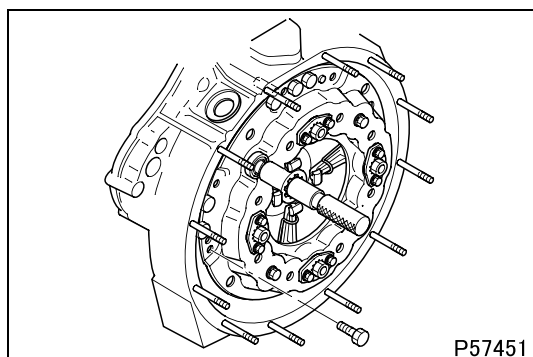
### ■ Installation: Pressure plate and lever assembly

- Install the pressure plate and lever assembly by following the removal procedure in reverse.  
(See “■ Removal: Pressure plate and lever assembly”.)
- Tighten the bolts diagonally and gradually to the specified torque.

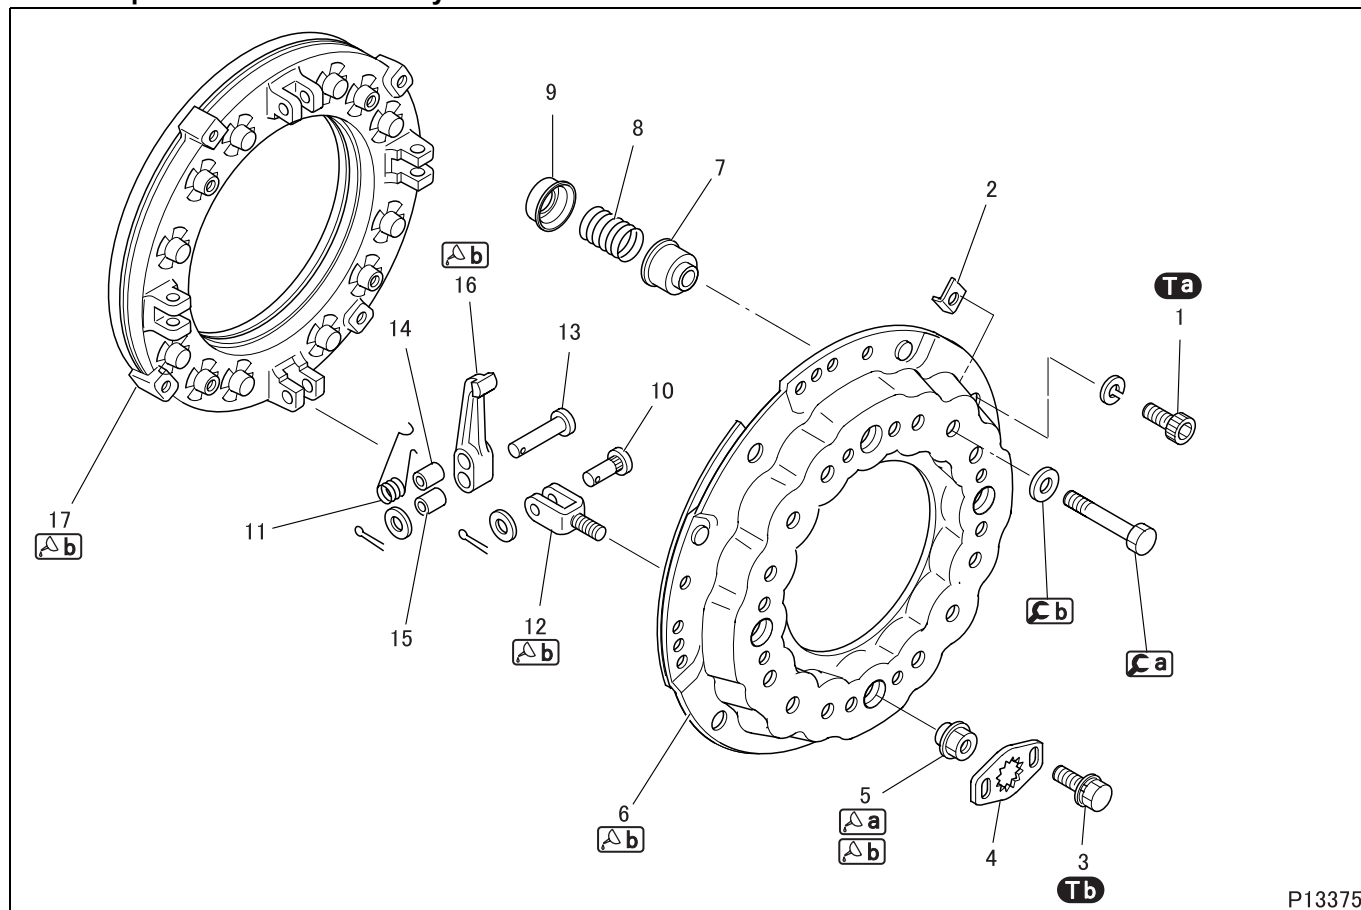
P13375

## Pressure plate and lever assembly

| Location | Maintenance item | | Standard value | Limit | Remedy |
|---|---|---|---|---|---|
| 1, 6 | Clearance between strap bolt and strap plate of clutch cover | | 0 to 0.16<br>{0 to 0.0063} | 0.3<br>{0.012} | Replace |
| 8 | Pressure spring | Installed load<br>(installed length 56.05 {2.21}) | 1081 N<br>{240 lbs, 110.2 kgf} | 919 N<br>{205 lbs,<br>93.7 kgf} | Replace |
| 10, 14 | Clearance between lever support pin and bushing | | 0.017 to 0.126<br>{0.00067 to 0.0050} | 0.4 {0.016} | Replace |
| 13, 15 | Clearance between release lever pin and bushing | | 0.016 to 0.118<br>{0.00063 to 0.0046} | 0.4 {0.016} | Replace |
| 17 | Pressure plate | Thickness | 30.8 ± 0.1<br>{1.21 ± 0.0039} | 28 {1.10} | Replace |
| | | Flatness | 0 to 0.05 {0 to 0.0020} | 0.2 {0.0079} | Correct or<br>replace |
| | | Inside diameter of fitting hole<br>of strap bolt | 10.2 to 10.25<br>{0.402 to 0.404} | 10.5<br>{0.41} | Replace |

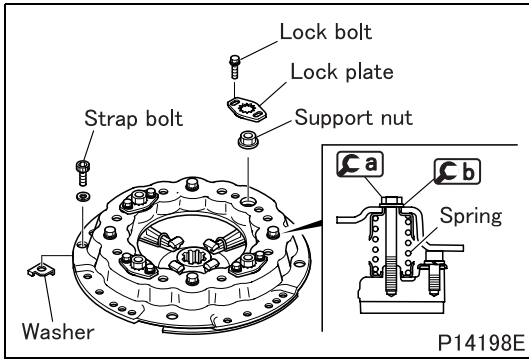
### ■ Removal: Clutch cover

- Secure with **Ca** and **Cb** at 4 locations and remove the strap bolt, washer, lock bolt, lock plate and support nut while pushing and compressing the pressure spring.

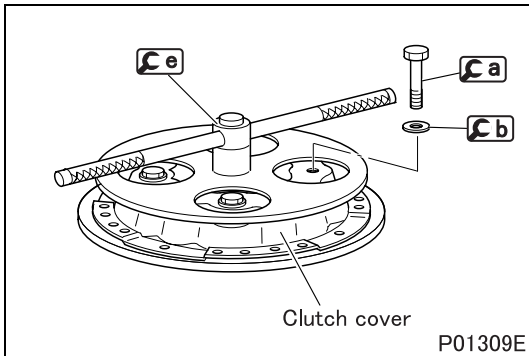
- Remove **Ca** and **Cb** (4 locations) using **Ce** with the pressure spring pushed and compressed.
- Gradually loosen **Ce** and remove the clutch cover after the pressure spring becomes ineffective.

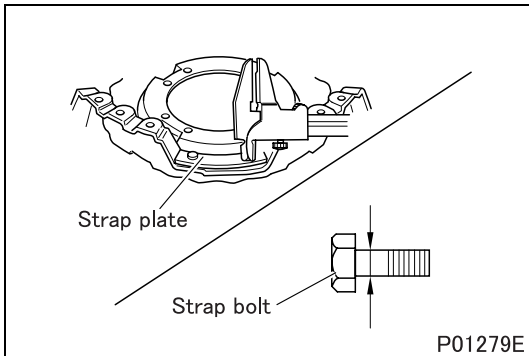
### ■ Inspection: Clearance between strap bolt and strap plate of clutch cover

- If the measured value exceeds the specified limit, replace faulty parts.

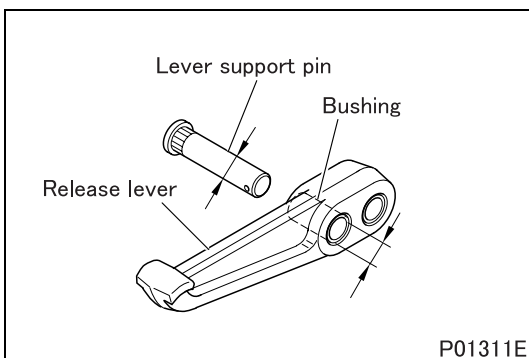
### ■ Inspection: Clearance between lever support pin and bushing

- If the measured value exceeds the specified limit, replace the bushing.

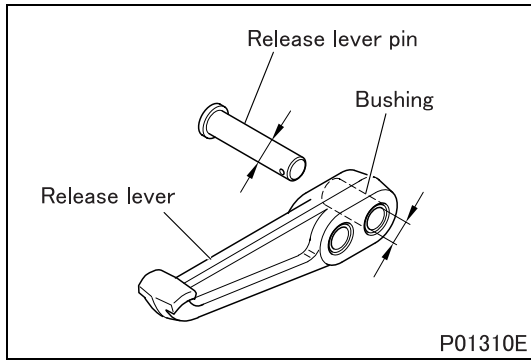
## ■ Inspection: Clearance between release lever pin and bushing

- If the measured value exceeds the specified limit, replace the bushing.

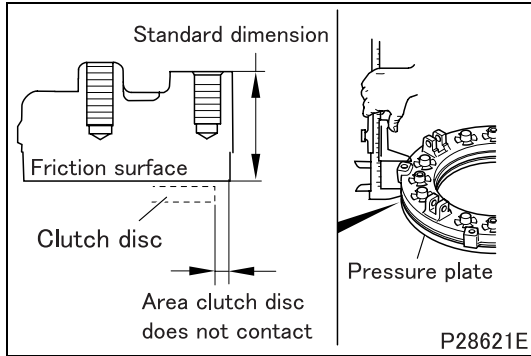
## ■ Inspection: Pressure plate

### (1) Thickness

- Measure the thickness of the pressure plate at the friction surface in the following procedure. If the measured value exceeds the specified limit, replace the pressure plate.
- Measure the standard dimension (area the clutch disc does not contact).

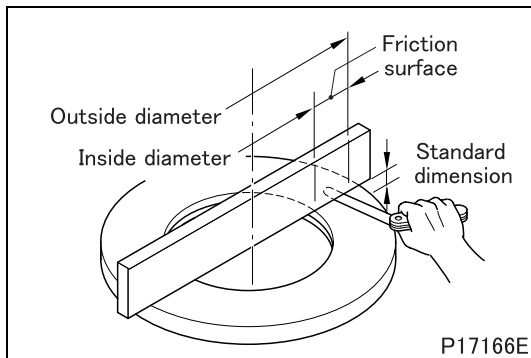
- Measure the clearance between the friction surface (within the illustrated range) and the standard dimension, and deduct this value from the standard dimension. This value is the thickness of the pressure plate.

| Outside diameter | 370 mm {14.6 in.} |
| Inside diameter | 240 mm {9.45 in.} |

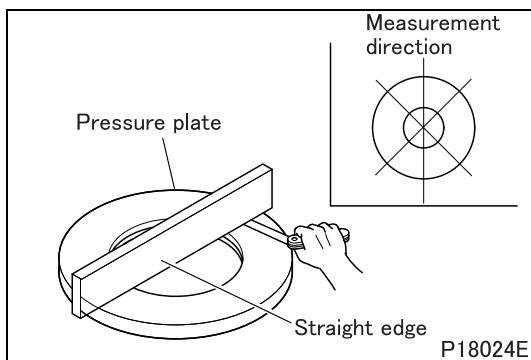
### (2) Flatness

- Measure the clearance between the pressure plate and straight edge. (Consider the pressure plate as a plane.)
- If the measured value exceeds the specified limit, correct or replace the pressure plate.

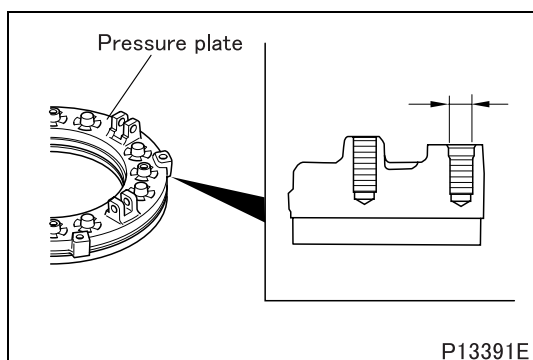
### (3) Inside diameter of strap bolt fitting hole

- If the measured value exceeds the specified limit, replace the pressure plate.

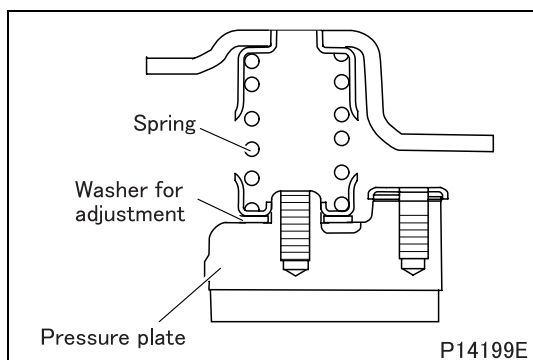
### ■ Installation: Pressure spring

- If the pressure plate is corrected by grinding, assemble between the pressure plate and pressure spring a washer for adjustment equivalent to the correction amount by grinding.

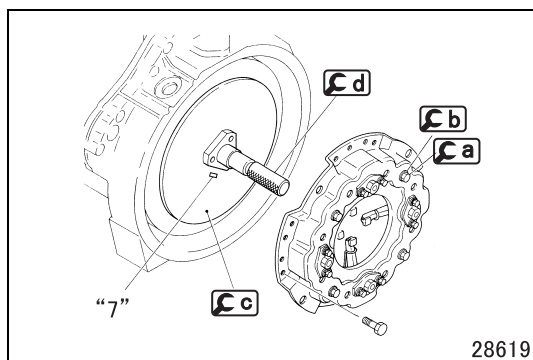
### ■ Inspection: Height of release lever

- After installing the pressure plate and lever, be sure to remove **a** and **b** (4 locations) to perform inspection and adjustment.

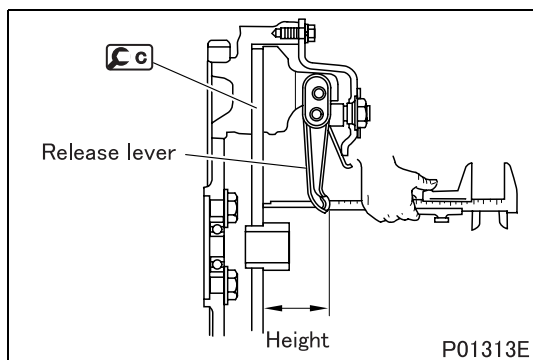
- Measure the height from **c** to the top surface of each release lever (4 locations).
- If the measured value deviates from the standard value, make adjustment in the following procedure. Even if the measured value is within the standard value, make adjustment when the mutual difference between each measured value is 0.5 mm or more.

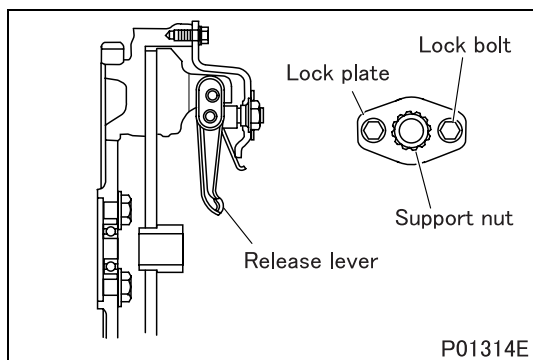
## [Adjustment]

- Remove the lock bolt and lock plate, and turn the support nut to adjust the release lever.
- After adjustment, install the lock plate, and secure the support nut. Then, check the height of the release lever.
