# FE.FG

## SERVICE MANUAL 2008 Model FOREWORD

This Service Manual contains maintenance and repair methods for the Mitsubishi Fuso Truck FE. FG Series. Read this manual carefully as an aid in providing correct, efficient maintenance. Please note that the information and specifications contained within this manual may change without notice. This is due to product modifications and continued vehicle improvements that are made throughout the model years. Should you encounter any discrepancy in the information provided, please do not hesitate to contact your nearest Mitsubishi Fuso Dealer or Mitsubishi Fuso Truck of America, Inc.

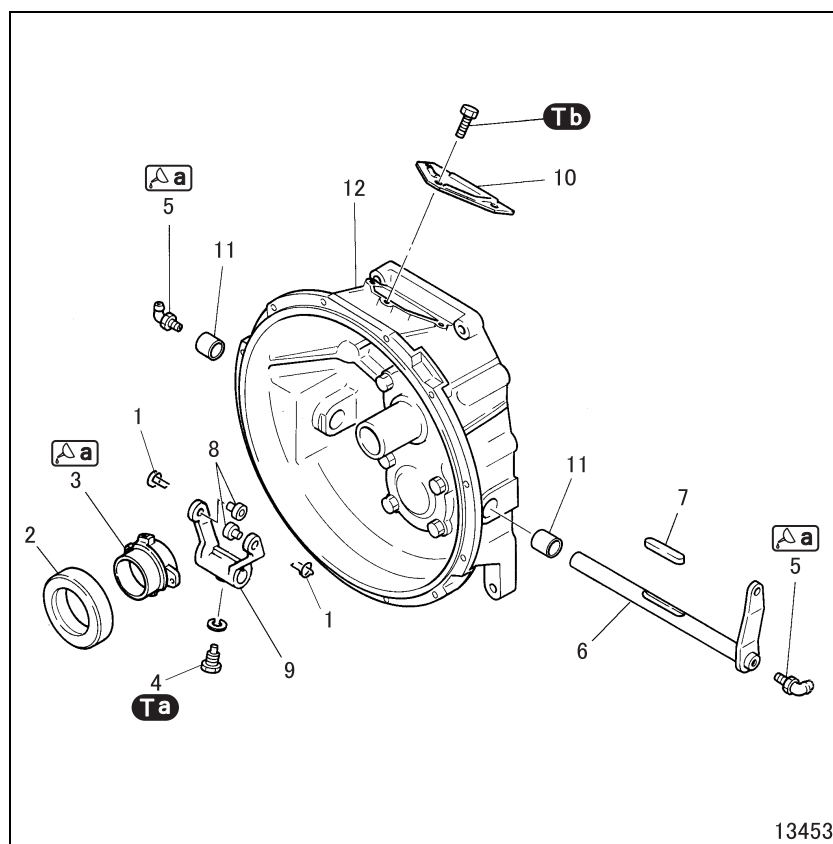
## ● Disassembly sequence

- 1 Return spring
- 2 Release bearing
- 3 Clutch shifter
- 4 Set screw
- 5 Grease nipple
- 6 Release fork shaft
- 7 Key
- 8 Cam follower
- 9 Release fork
- 10 Clutch housing cover
- 11 Needle roller bearing
- 12 Clutch housing

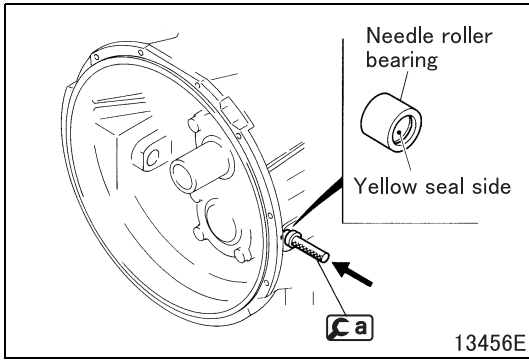
### ■ Installation: Needle roller bearing

- Install the needle roller bearing with the yellow seal side facing outward.

- To prevent damage, do not strike the needle roller bearing directly with a hammer when installing it.

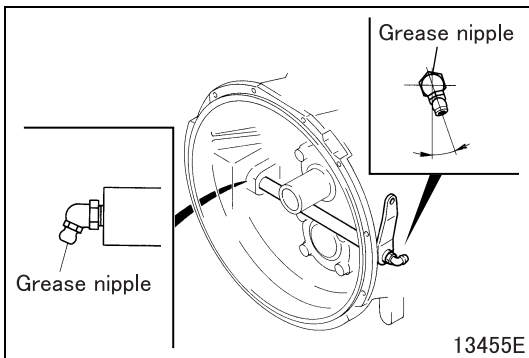
### ■ Installation: Grease nipple and connector

- Install the grease nipple and connector on the clutch housing in the illustrated direction.

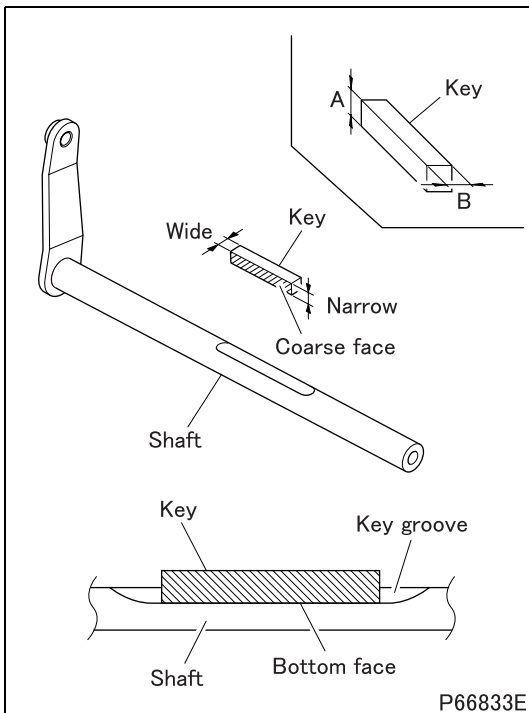
### ■ Installation: Key

- Install the key such that the faces with coarse finish face the front and rear of the vehicle.
- If it is difficult to identify the coarse faces, measure the illustrated dimensions A and B. Then, install the key such that the faces with greater (wide) dimensions face up and down.

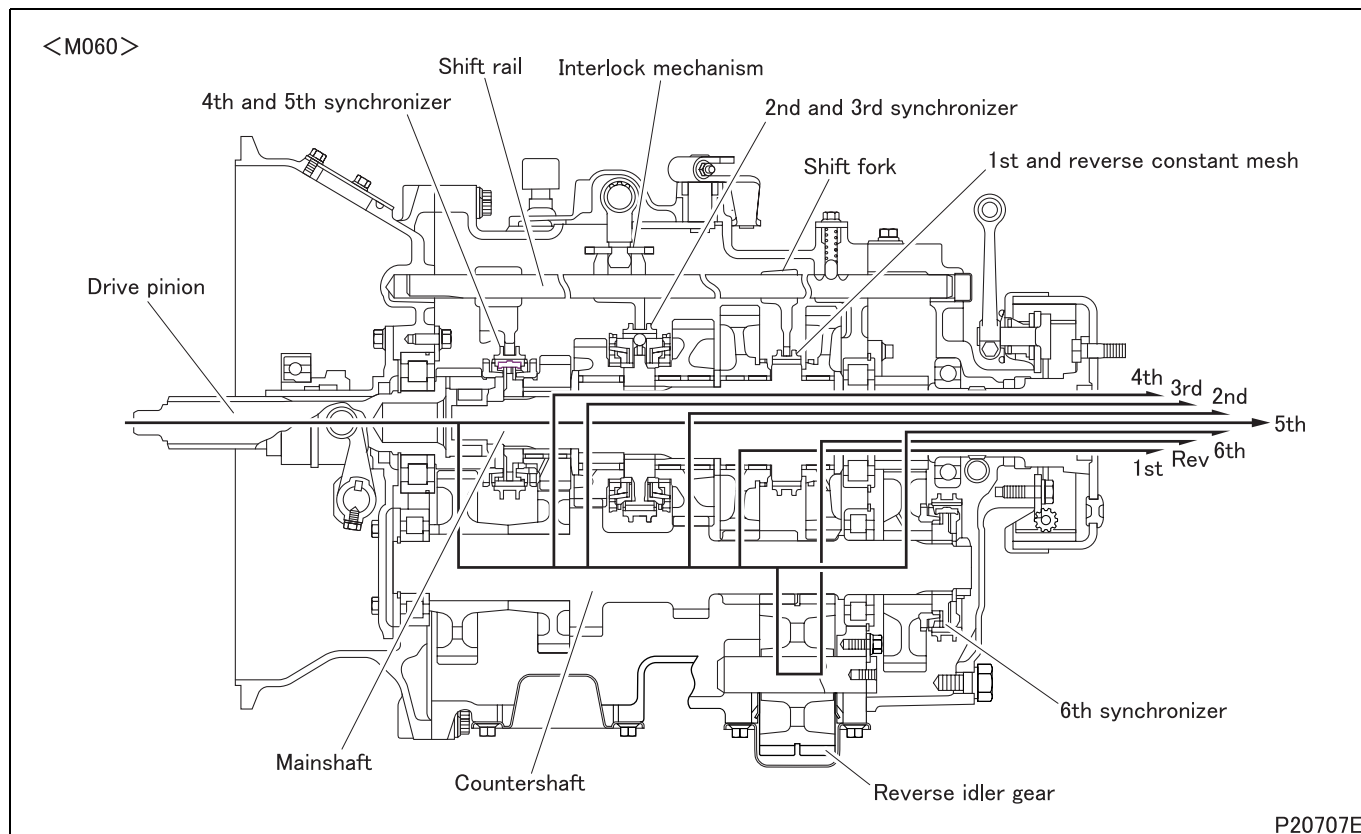
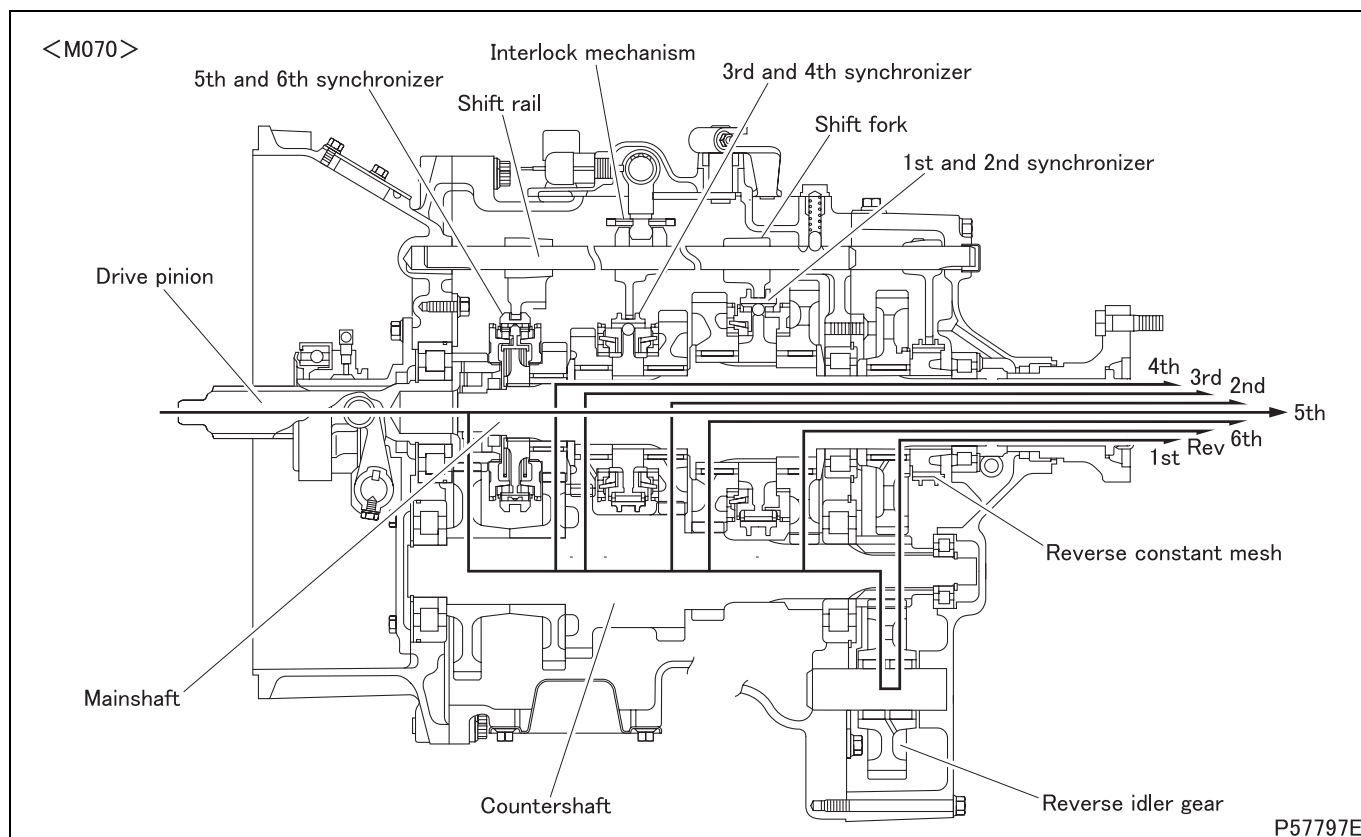
## 1. Transmission

- The transmission uses an interlock mechanism to avoid double engagement.

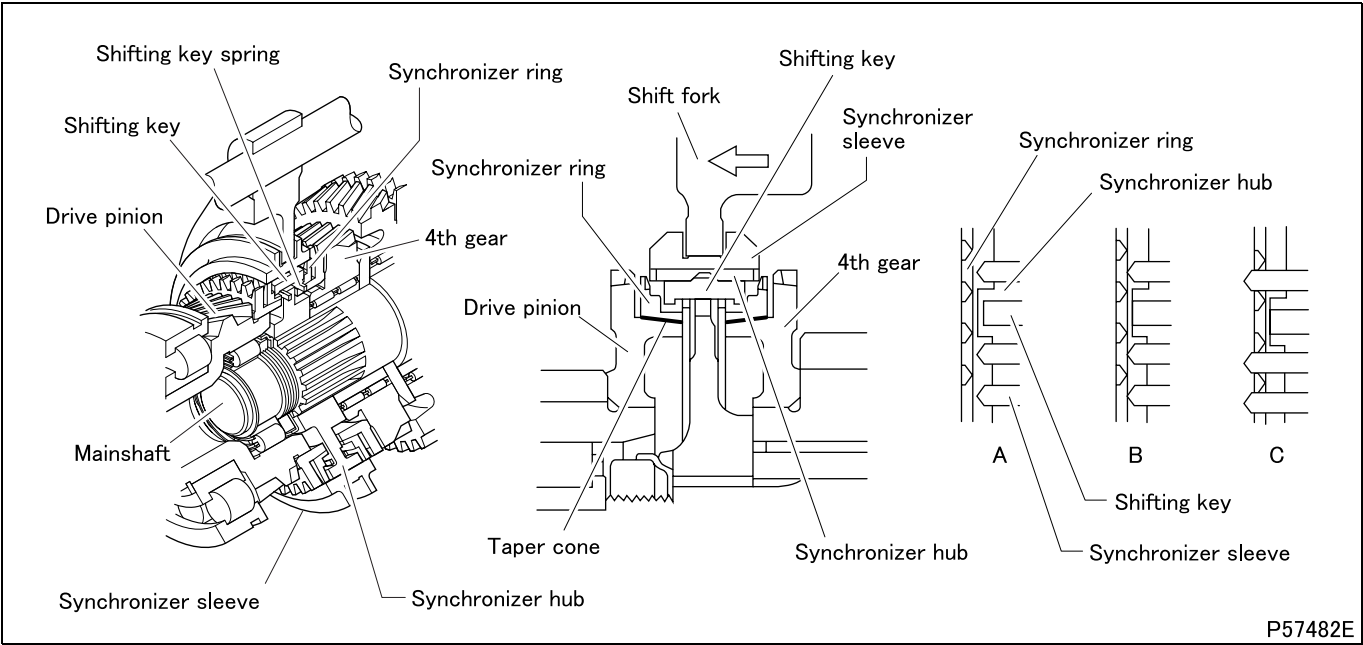
### 2.1 Single cone type <M060>

The following descriptions are for 5th (drive pinion) side of 4th and 5th synchronizer.

- The inside of the synchronizer hub engages the spline of the mainshaft and rotates with it. The outside of the synchronizer hub has a spline that engages the synchronizer sleeve and three keyways.

- Shifting keys are inserted into these keyways. When the gear shift is in neutral, the protrusions of the shifting key engages grooves in the synchronizer sleeve and are pressed against the inside of the synchronizer sleeve by shifting keys springs.

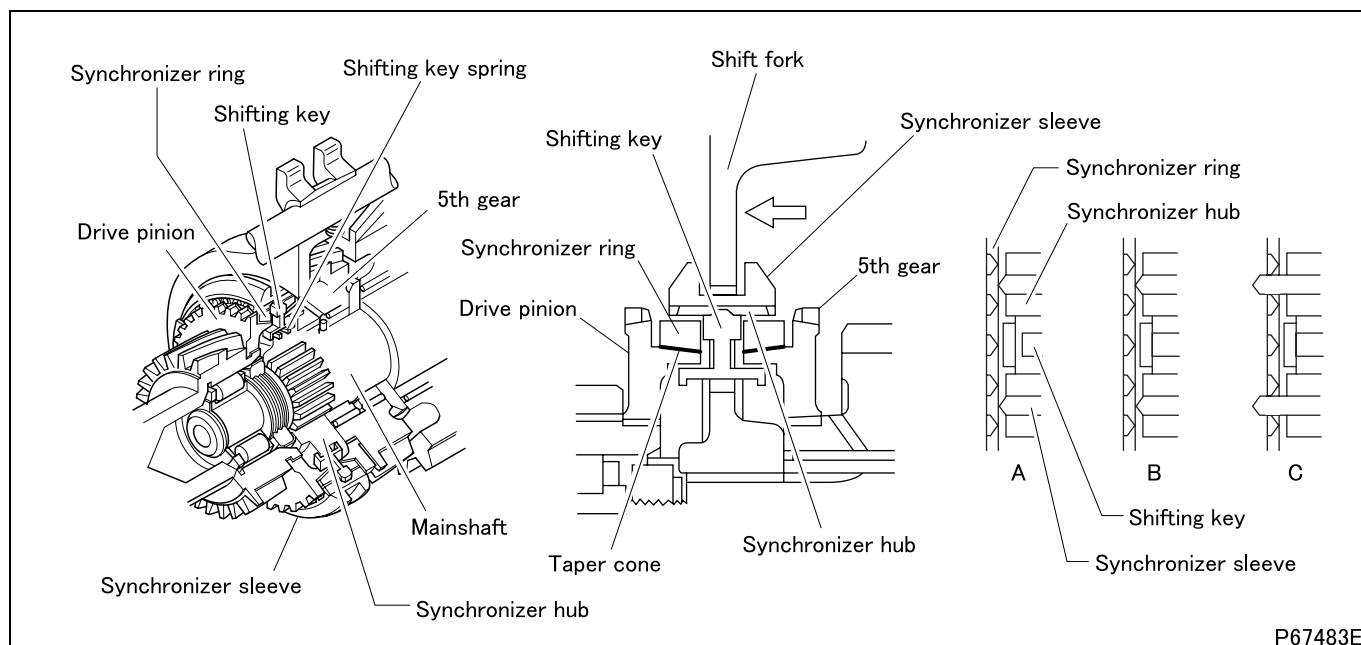
P67483E

## 2.2 Single cone type <M070>

The following descriptions are for 6th (drive pinion) side of 5th and 6th synchronizer.

- The inside of the synchronizer hub engages the spline of the mainshaft and rotates with it. The outside of the synchronizer hub has a spline that engages the synchronizer sleeve and three keyways.

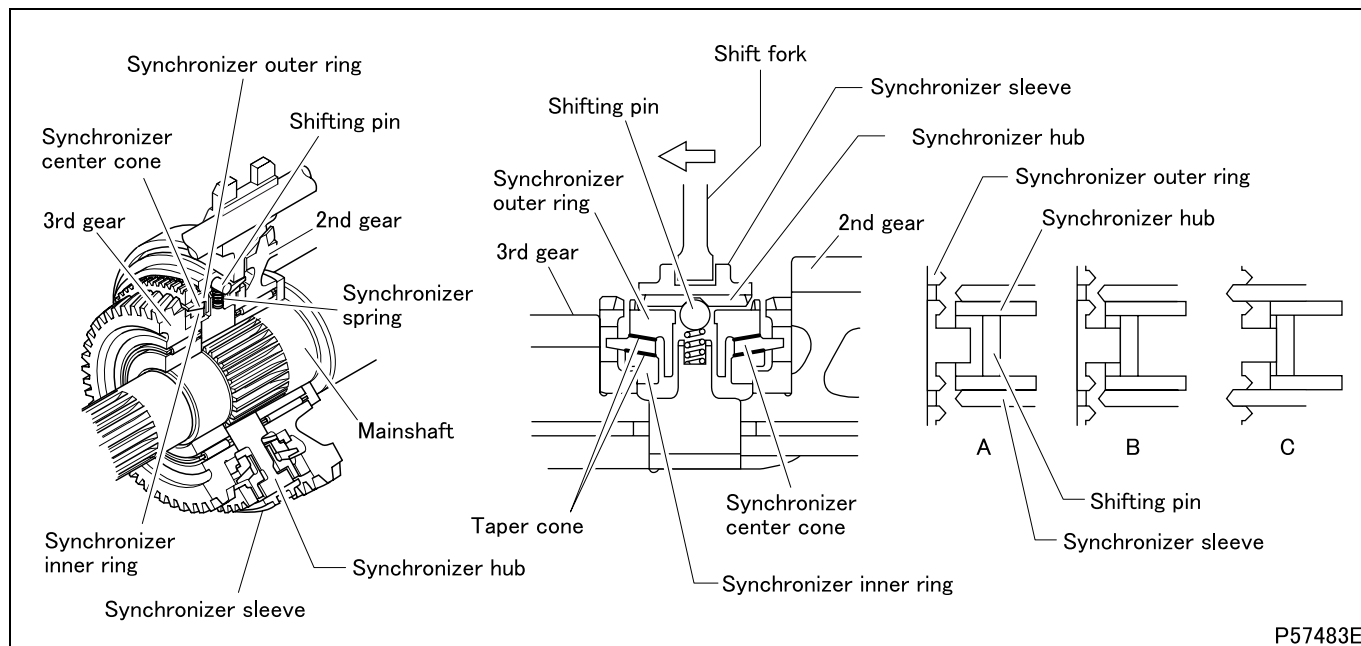
P57483E

## 2.3 Double cone type

The following descriptions are for 3rd side of 2nd and 3rd synchronizer <M060>.

- The synchromesh structure and operation are basically the same as for the single cone type. The synchronizer ring is divided into three parts (synchronizer inner ring, synchronizer center cone and synchronizer outer ring) and the center cone (both the inside and outside surfaces are tapered) is sandwiched between the taper cones of the outer ring and inner ring to shorten the time required for synchronization with cone clutches at two locations.

- The taper cones of synchronizer rings, which act as cone clutches, generate friction torque and perform synchronous operation.
- The rotation speed of the synchronizer hub becomes gradually closer to that of the gear of the 3rd gear due to the synchronous operation, and eventually they rotate at the same speed. This allows the synchronizer sleeve to move smoothly to engage the synchronizer hub and gear, completing the shift change (Figure C).

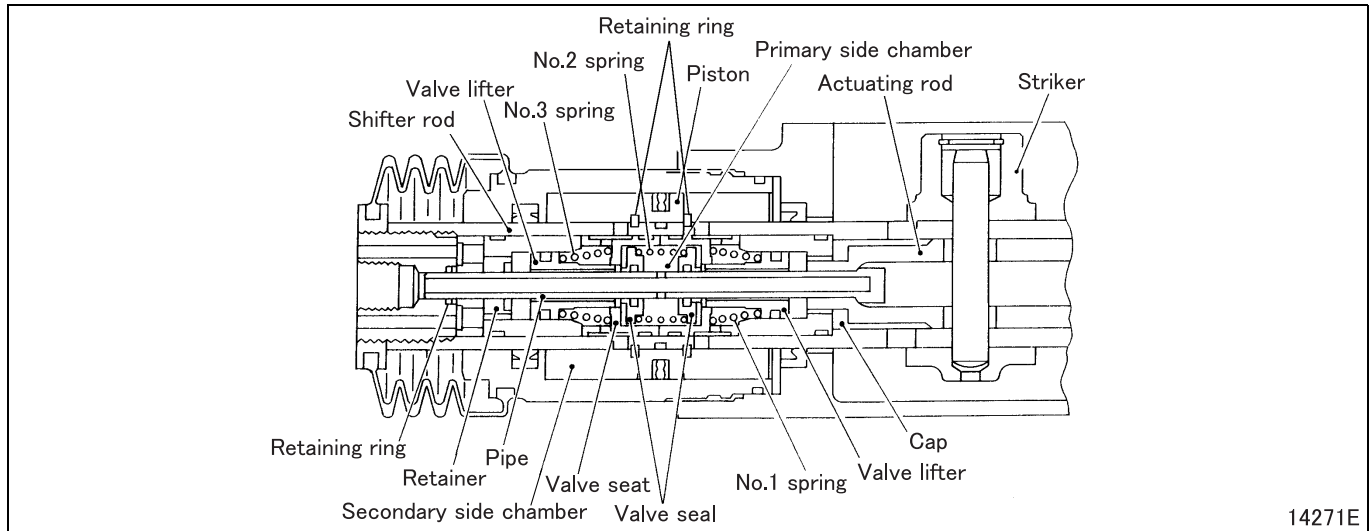
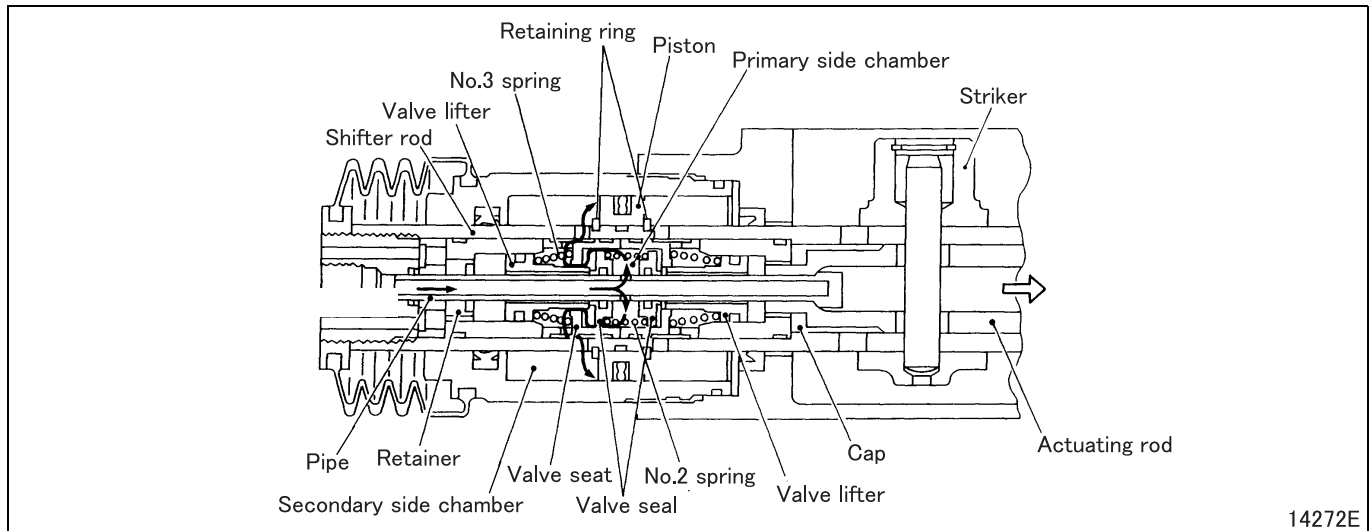
### 3. Power Shift

#### 3.1 When activated

- When actuating rod is moved in the direction of the arrow as illustrated, shifter rod and the actuating rod move relative to this movement. Valve lifter presses No.3 spring against valve seal to overcome the combined repercussive forces of the compressed air acting on the valve seal and No.2 spring. The valve seal separates from valve seat, and the compressed air supplied to primary side chamber is let into secondary side chamber via the opening between the valve seat and the valve seal. The compressed air flows into the cylinder through the hole and groove of the valve seal and the vent hole of shifter rod to put pressure on piston, generating output.

- The output given to piston is transmitted to shifter rod via retaining ring to assist striker which is fixed on the shifter rod. This operates the shift fork on the transmission side, shifting the gears. Thus, gear shifting is completed.

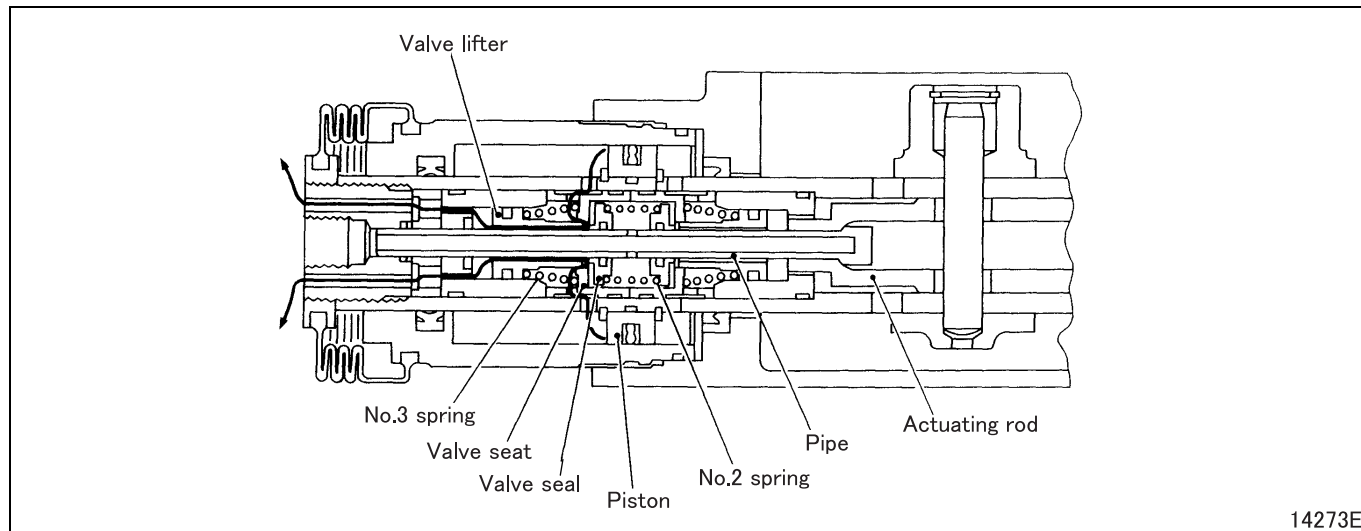
## 3.2 When releasing

- When gear shifting is completed and the input is released, actuating rod is returned to the valve center position (the condition before operation) by the combined repercussive forces of the compressed air of valve lifter, the steel ball, and valve springs. As the valve lifter returns, valve seal seats against valve seat, cutting off the flow of compressed air from primary side chamber to secondary side chamber. As the input rod returns, clearance is generated between the valve lifter and the valve seal.
- The compressed air in the cylinder of secondary side chamber is discharged into the atmosphere through the clearance between valve lifter and pipe. This eliminates the pressure difference between the chambers on both sides of piston, so output is lost.

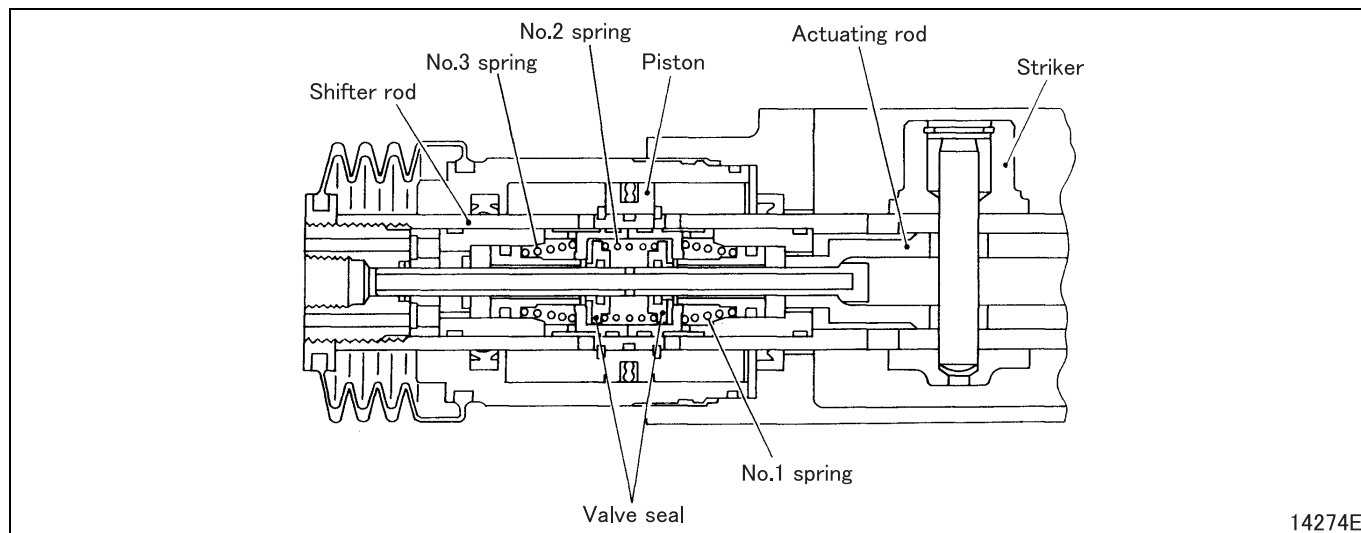
## 3.3 When not operating (non-boosting)

- To operate the power shift, that is, to open the valve and let the compressed air into the output chamber, actuating rod on the input side and shifter rod on the output side must generate relative disengagement.
- When the operating force is transmitted from the gear shift lever to actuating rod, and the resistance on the transmission side is less than the combined repercussive forces working on the relative disengagement of the input side and output side (repercussive forces of No.1 to 3 springs; pressure on valve seal; and sliding resistance on various parts), the mechanism, from the actuating rod to striker, is integrated and does not generate relative disengagement. Therefore, the valve does not open, and without boosting operation, piston moves in the cylinder to shift gears.

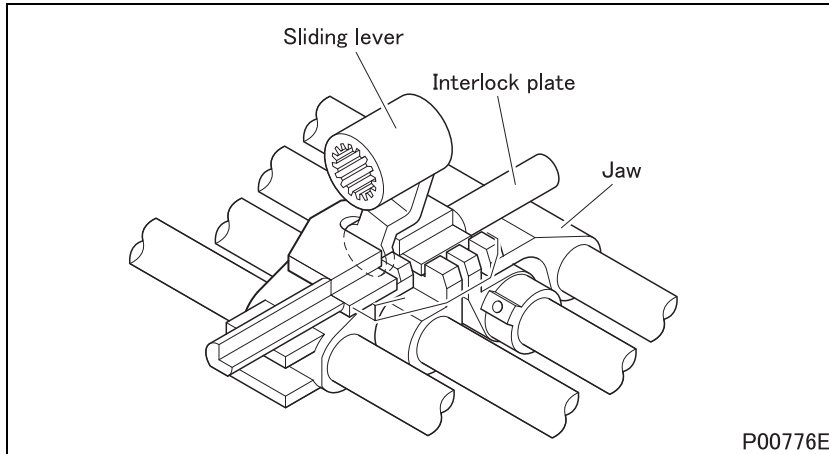
#### 4. Interlock Mechanism

- The interlock mechanism is a mechanism to prevent double engagement of gears.
- The rail beneath the interlock plate locks jaws except jaws shifted by gear shift sliding lever, preventing double engagement of gears.

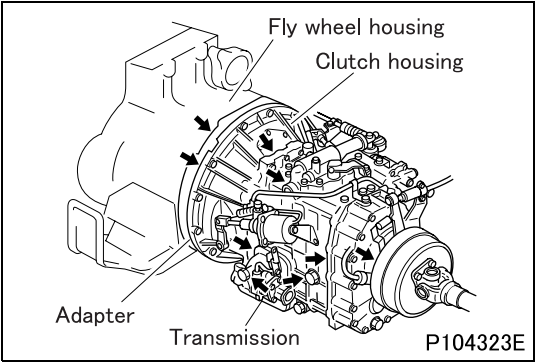
### 1.1 Inspection of oil leakage at each part of transmission body

- Check the oil leakage at each part of transmission body in visual.

If the oil leakage is found, replace the defective part.

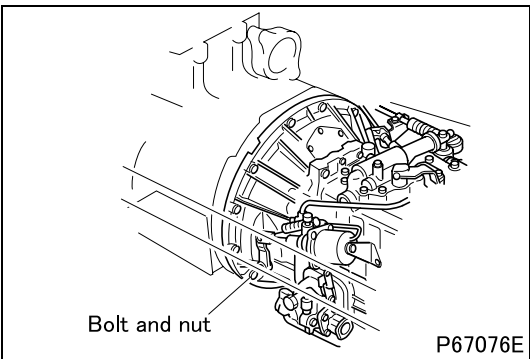
- Check the transmission mounting bolts and nuts for looseness.
- Retighten any loose bolt or nut to the specified torque.

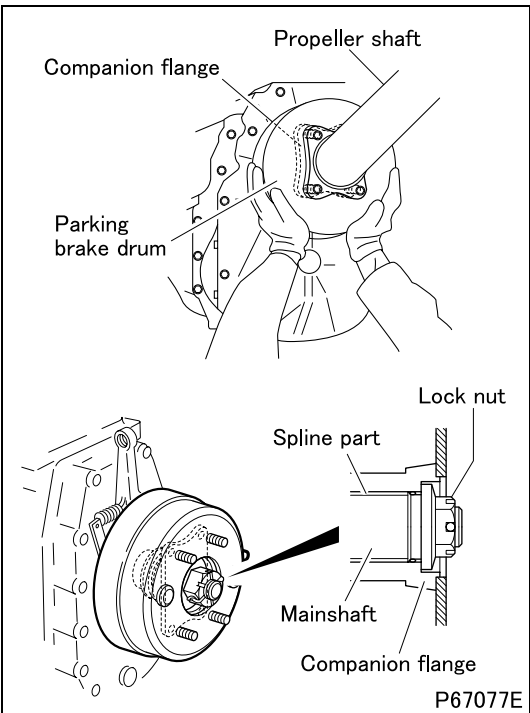
## 3. Inspection of Play and Looseness in Companion Flange

- Check the propeller shaft mounting bolts for looseness. (See Gr25.)
- Move the parking brake drum or companion flange in axial and vertical directions to check for excessive play between the companion flange and mainshaft.
- If excessive play is detected, remove the propeller shaft, then check the lock nut for looseness and the splines on companion flange and mainshaft for abnormalities. If any part is found defective, replace the part. (See the “EXTENSION HOUSING” section.)

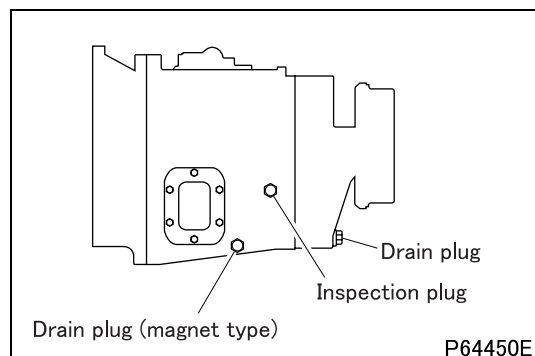
### [Inspection]

- When draining transmission oil, check for oil quality, metal chips and metal powder.
- The following conditions are indicative of internal troubles; hence overhaul is required.
  - Viscosity is too high
  - A foreign odor
  - Too many metal particles

- Remove the drain plug to drain transmission oil. Drainage can be made quickly with the inspection plug removed.
- After draining transmission oil, apply sealant to the drain plug and tighten it to the specified torque. Magnet type drain plugs should be cleaned before installation.
- Fill transmission oil of the specified quantity from the inspection plug hole.
- After filling, check that oil is filled up to the neck of the inspection plug hole. If oil is not sufficient, replenish it.
- After completing work, apply sealant to the inspection plug and tighten it to the specified torque.

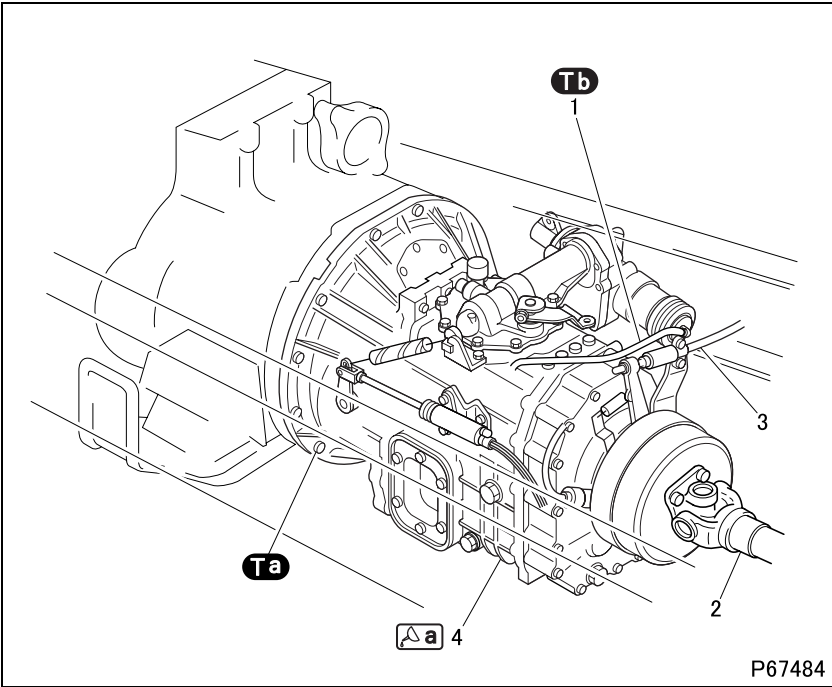
## ● Disassembly sequence

- 1 Air tube
- 2 Propeller shaft (See Gr25.)
- 3 Parking brake cable <M060> (See Gr36A.)
- 4 Transmission

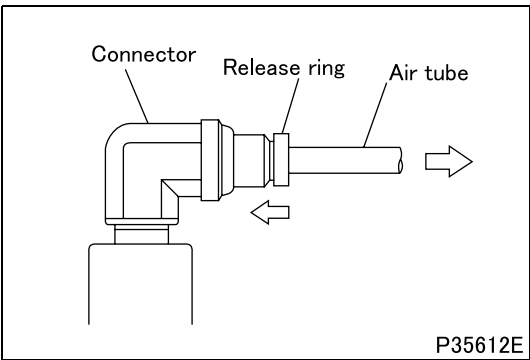
### ■ Removal: Air tubes <M060>

- Pressing the release ring on the tip of the snap-on hose connector against the connector, pull off the air tube.

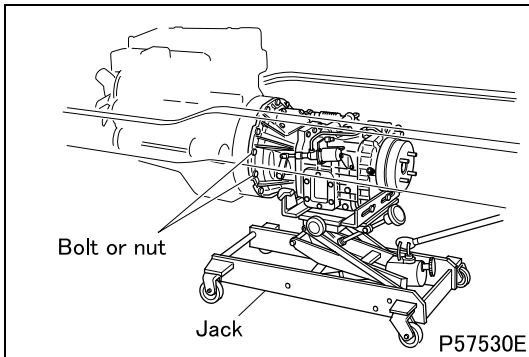
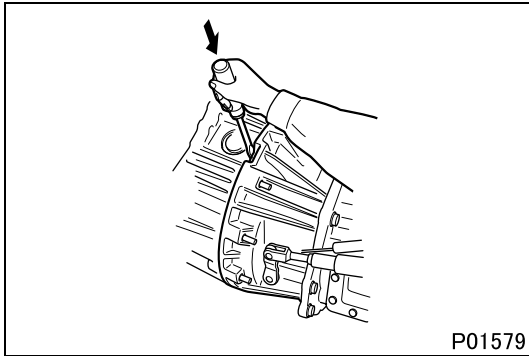
### ■ Removal: Transmission

- Support the transmission on a transmission jack and remove transmission mounting bolts or nuts.

- If the transmission is shaken strongly, there is a risk of damage to the spline that couples the drive pinion with the clutch.

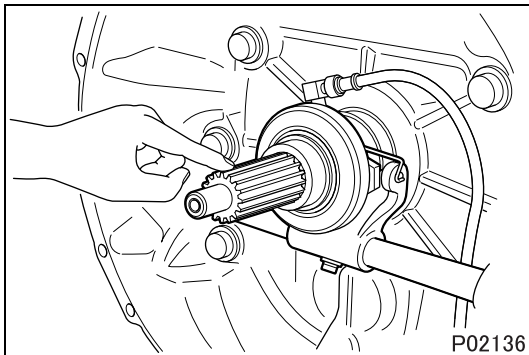
### ■ Installation: Transmission

- Check the spline of the drive pinion for rust.
- If rust is found, remove it using a wire brush.
- Rub grease evenly onto the clutch disc sliding surface of the drive pinion using your hand.

- Make sure that you apply only the necessary amount of grease because too much grease can drip and cause clutch slip.

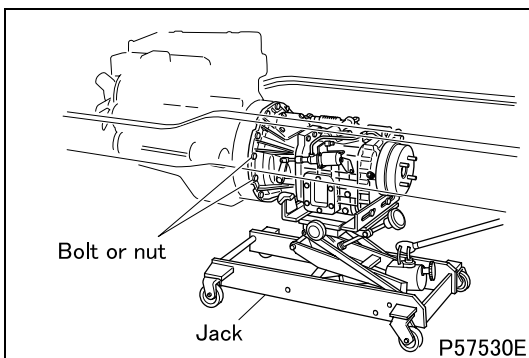
- While supporting the transmission on a transmission jack, insert the drive pinion end into pilot bearing of the flywheel. In so doing, take care of the spline of drive pinion.
- Tighten transmission mounting bolts or nuts to the specified torque.

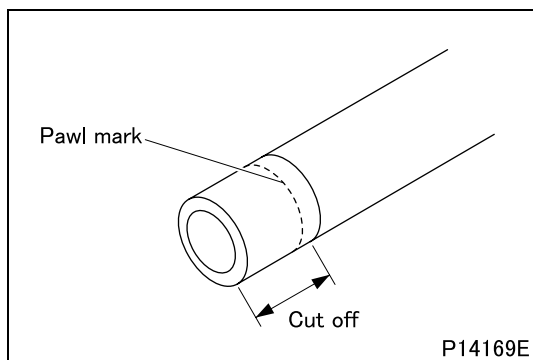
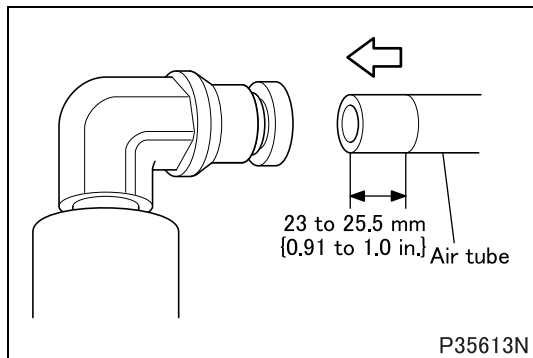
## ■ Installation: Air tubes <M060>

- When the air tube is disconnected from the snap-on tube connector, a “pawl mark” made by the connector is left on the peripheral surface of the tube end. When the disconnected tube is reused, to avoid possible harm of this mark, cut off the tube end portion at the mark. At the same time, check that the portion of the tube that will go into the connector is free of foreign matter (residual tape, etc.) and any damage on the surface. Cut off damaged portion from the tube.
- Thoroughly remove dirt and grease, if any, from inside the snap-on connector.
- Fit the air tube firmly into the snap-on connector.
- The insertion depth of the air tube into the connector is as shown. If the tube is not inserted to this depth, its connection is incomplete.

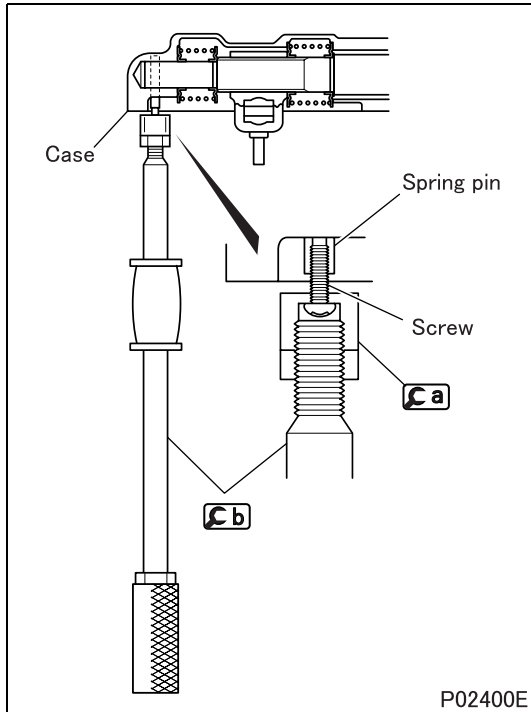
### ■ Removal: Spring pin

- Tap the spring pin using an M4 tap.
- Insert **C a** with an M4 screw of appropriate length into the spring pin, and remove the spring pin using **C b**.

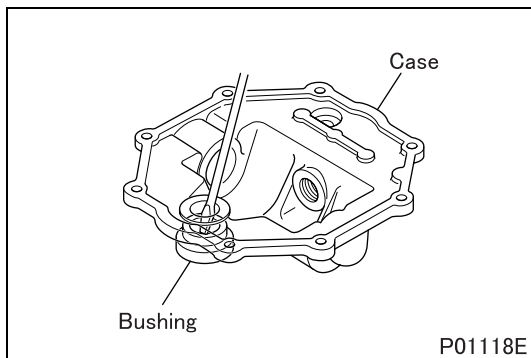
### ■ Removal: Bushing

- Remove the bushing with a screwdriver while taking care not to damage the gear select lever case.

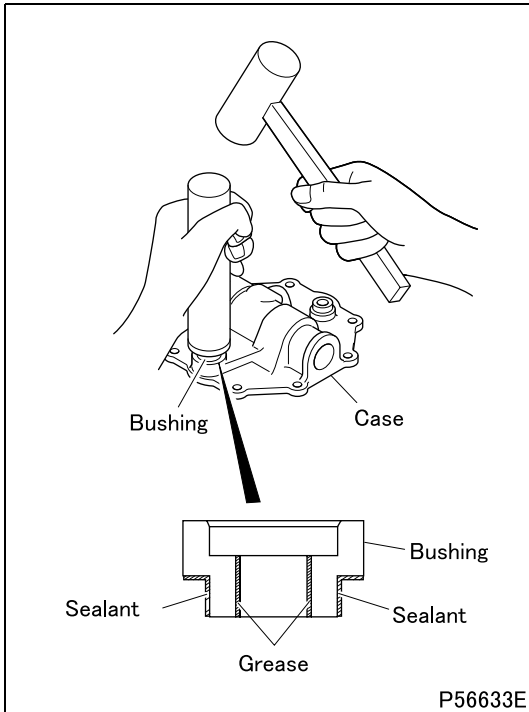
### ■ Installation: Bushing

- Clean the bushing and bushing mounting surface of the select lever case.
- Apply grease to the inner surface of the bushing and sealant to its outer surface.

- Do not allow sealant to adhere to the inner surface of the bushing as it may cause malfunction of the gear select lever.

- Mount the bushing by evenly tapping it using a round bar of outer diameter of approximately 40 mm {1.57 in.}.

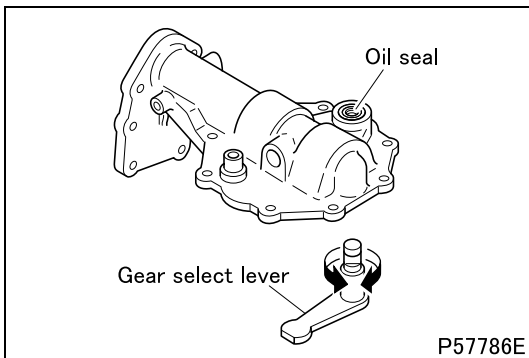
### ■ Installation: Gear select lever

- Install the gear select lever while turning so that the oil seal is not damaged in the lip.

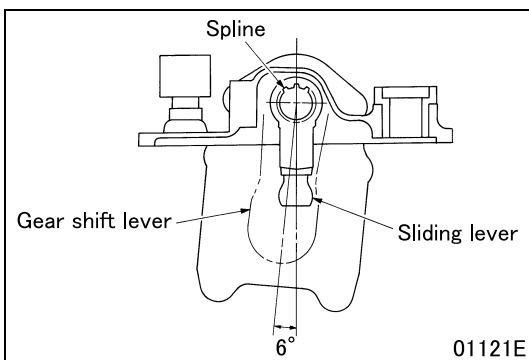
### ■ Installation: Gear shift lever

- Install the gear shift lever aligning with the spline so that it is placed at the illustrated angle to the gear shift sliding lever.

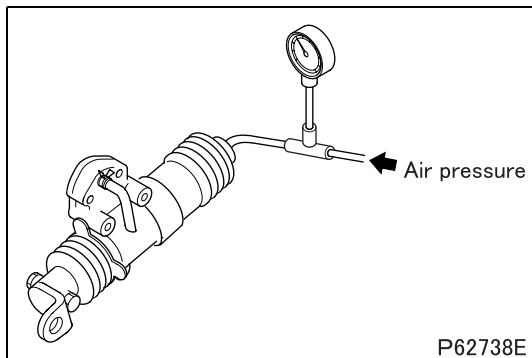
### ■ Inspection: Power shift

#### (1) Inspection of air tightness

- Apply the specified pressure from the connector, and check air tightness when the power shift is not operating (valve in neutral position) and when it is operating (in both directions of pushing and pulling the valve).
- If the measured value exceeds the limit, replace defective parts.

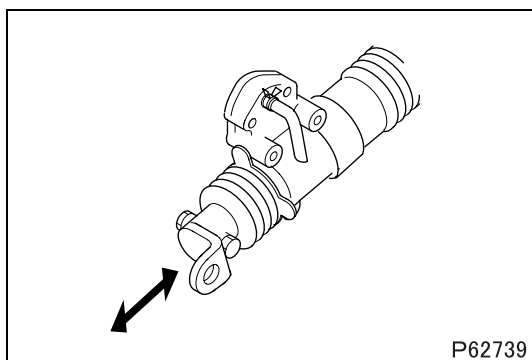
#### (2) Sliding resistance in shifting direction

- Measure sliding resistance in the shifting direction of the shift cable connecting hole position. Perform shifting for conditioning four or five times before measurement.
- If the measurement exceeds the specified standard value, apply grease on all sliding surfaces.
- After applying grease, measure again; if the measurement deviates from the standard value, replace the defective part(s).

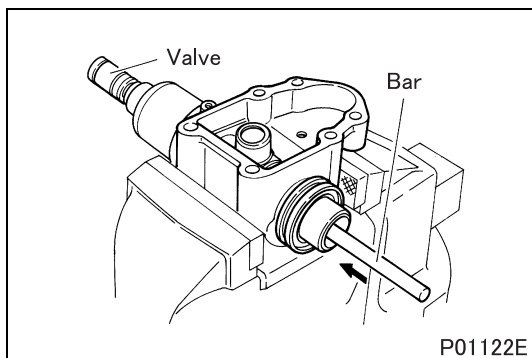
### ■ Removal: Valve

- Gently drive valve out from the shifter rod from the lever side using bar.

- Do not drive valve too hard or you will damage the valve parts.

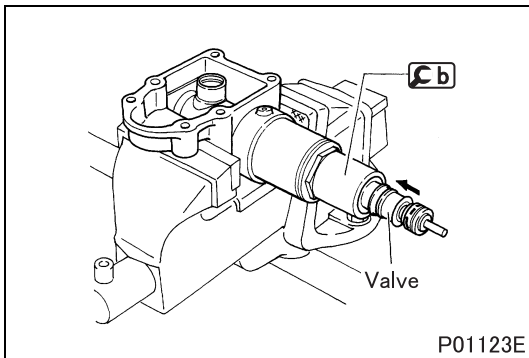
### ■ Installation: Cylinder

- Install the cylinder by following the removal sequence in reverse. (See “■ Removal: Cylinder”.)

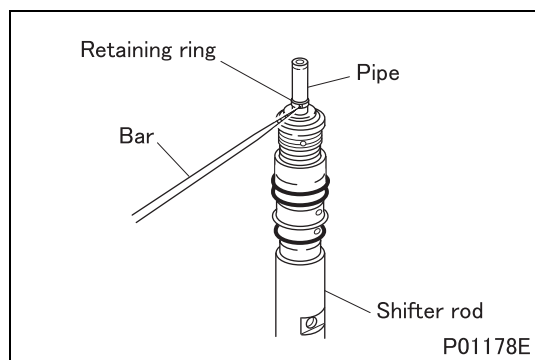
**■ Removal: Retaining ring**

- Secure the rod in a vice with caution.
- Remove the retaining ring from the pipe using something like needle.

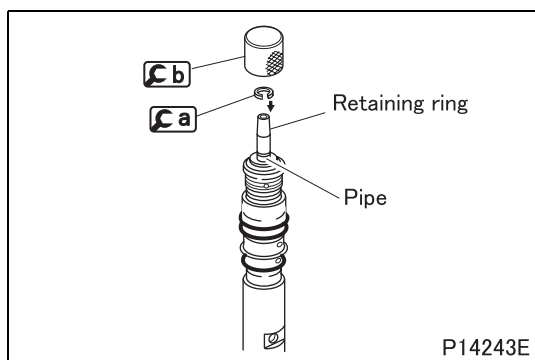
### ■ Installation: Retaining ring

- Attach **C a** to the pipe tip, push the retaining ring in a straight line using **C b**, and secure it in the pipe groove.
- If the ring jams up during installation, reinstall it.

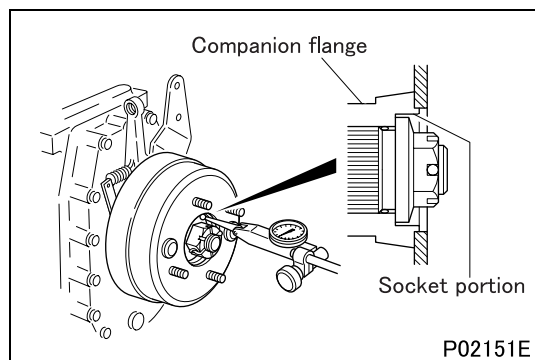
### ■ Inspection: Runout at socket portion of companion flange

- If the measured value exceeds the limit, replace the companion flange.

| Location | Maintenance item | Standard value | Limit | Remedy |
|---|---|---|---|---|
| 6 | Runout at socket portion of companion flange | 0 to 0.15 {0 to 0.0059} | 0.15<br>{0.0059} | Replace |

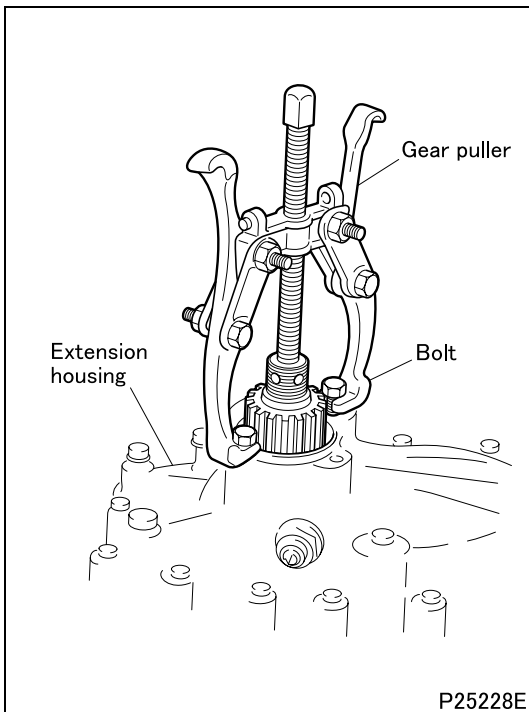
### ■ Removal: Extension housing

- Remove the extension housing using support plate and shoe mounting bolts or bolts (M060: M10 × 1.5 mm, M070: M12 × 1.75 mm) and a commercially available gear puller.

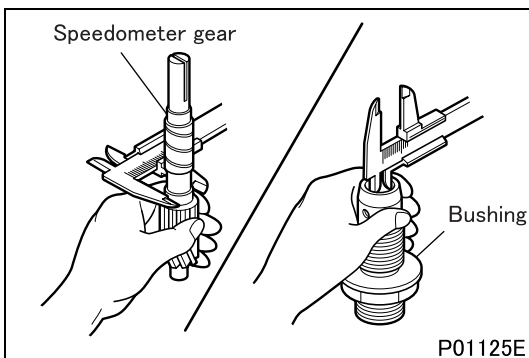
### ■ Inspection: Clearance between speedometer gear bushing and speedometer gear

- If the clearance is higher than the limit, replace the faulty parts.

| Location | Maintenance item | Standard value | Limit | Remedy |
|---|---|---|---|---|
| 11, 12 | Clearance between speedometer gear bushing and speedometer gear | 0.02 to 0.07<br>{0.00079 to 0.0028} | 0.15<br>{0.0059} | Replace |

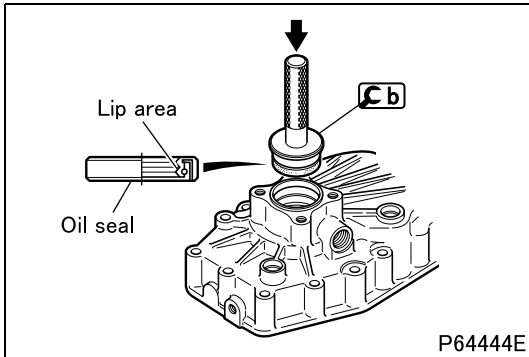
### ■ Installation: Oil seal

- Apply grease to the lip area of the oil seal.
- Install the oil seal into the extension housing in the direction as illustrated.

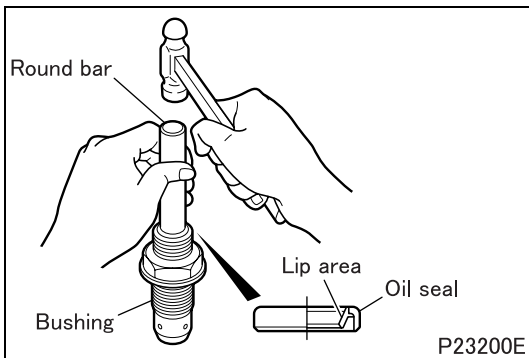
### ■ Installation: Oil seal

- Apply grease to the lip area of the oil seal.
- Install the oil seal evenly in the illustrated direction using a round bar with an outer diameter of approx. 15 mm {0.59 in.}.

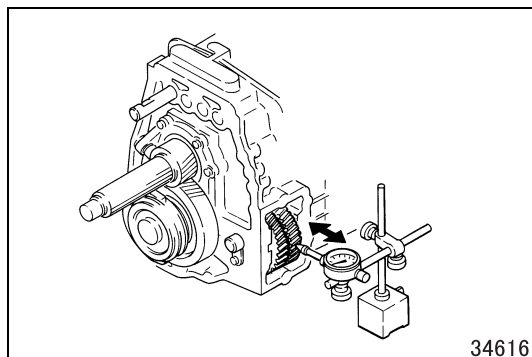
#### ■ Inspection: Reverse idler gear

- After removing the reverse idler gear cover, carry out the following inspection.
- If the measured value exceeds the limit, replace defective parts.

##### (1) Play in diameter direction

| Location | Maintenance item | Standard value | Limit | Remedy |
|---|---|---|---|---|
| - | Play of reverse idler gear in diameter direction | 0.05 to 0.07<br>{0.0020 to 0.0028} | 0.12<br>{0.0047} | Replace |

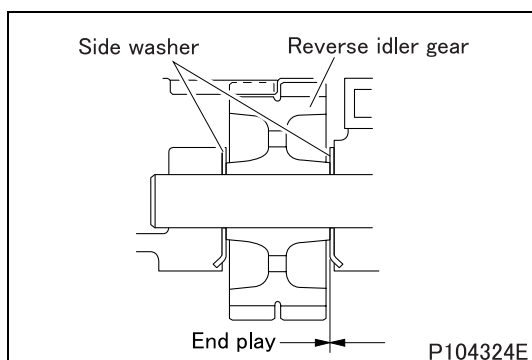
##### (2) End play

- Measure the end play using feeler gauge.

| Location | Maintenance item | Standard value | Limit | Remedy |
|---|---|---|---|---|
| | End play of reverse idler gear | 0.2 to 0.9<br>{0.0079 to 0.035} | 1.2<br>{0.047} | Replace |

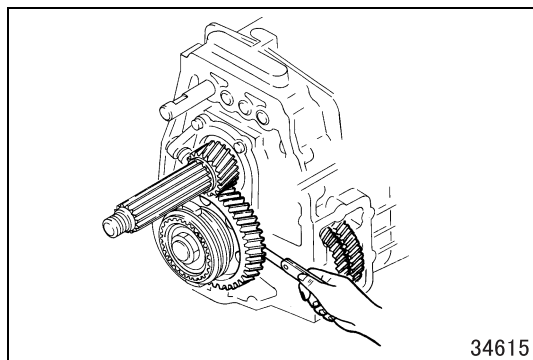
#### ■ Inspection: End play of countershaft 6th gear

- Measure the end play using feeler gauge.
- If the measurement exceeds the limit, replace defective parts.

| Location | Maintenance item | Standard value | Limit | Remedy |
|---|---|---|---|---|
| - | End play of countershaft 6th gear | 0.25 to 0.40<br>{0.0098 to 0.016} | 0.5<br>{0.020} | Replace |

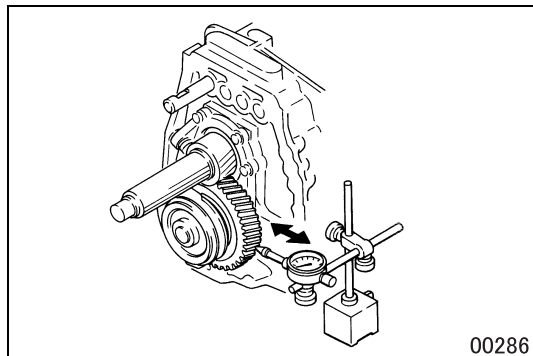
#### ■ Inspection: Play of countershaft 6th gear in the diameter direction

- If the measurement exceeds the limit, replace defective parts.

| Location | Maintenance item | Standard value | Limit | Remedy |
|---|---|---|---|---|
| | Play of countershaft 6th gear in the diameter direction | 0.105 to 0.150<br>{0.0041 to 0.0059} | 0.3<br>{0.012} | Replace |

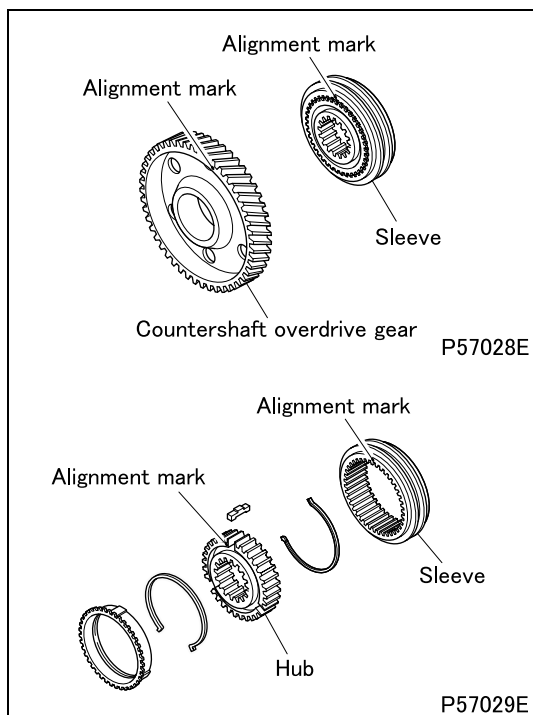
### ■ Alignment mark: Synchronizer sleeve, synchronizer hub and countershaft 6th gear

- Put an alignment mark on each one location of the synchronizer sleeve and countershaft 6th gear before disassembly.
- Put an alignment mark on the synchronizer hub in alignment with the alignment mark on the synchronizer sleeve before disassembly.

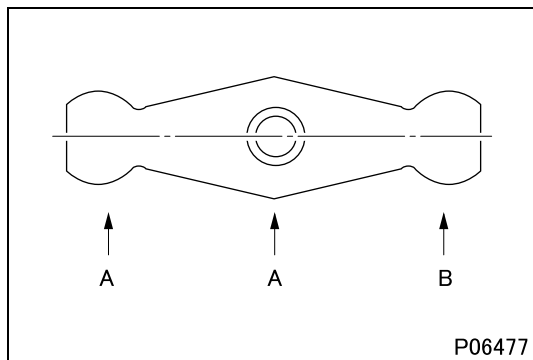
### ■ Inspection: Bend of 6th gear shift lever

- Measure bend B on the basis of illustrated A-A.
- If the measurement exceeds the limit, replace the 6th gear shift lever.

| Location | Maintenance item | Standard value | Limit | Remedy |
|---|---|---|---|---|
| 2 | Bend of 6th gear shift lever | 0 to 0.05 {0 to 0.0020} | 0.1 {0.0039} | Replace |

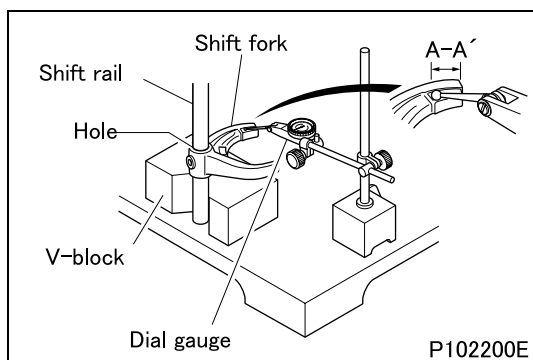
### ■ Inspection: Tilt of 6th gear shift fork tip

- Measure the tilt (difference between A and A') of claw A-A' against the 6th gear shift rail hole of 6th gear shift fork with pressing the rail to V-block and standing it vertically.
- If the measurement exceeds the limit, replace the 6th gear shift fork.

| Location | Maintenance item | Standard value | Limit | Remedy |
|---|---|---|---|---|
| 4 | Tilt of 6th gear shift fork claw | 0 to 0.1 {0 to 0.0039} | 0.2 {0.0079} | Replace |

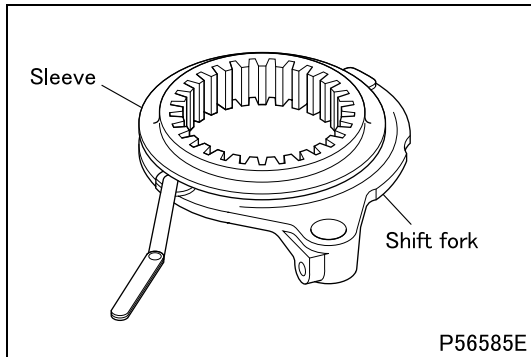
■ **Inspection: Clearance between 6th gear shift fork and synchronizer sleeve**

- If the measurement exceeds the limit, replace defective shift parts.

| Location | Maintenance item | Standard value | Limit | Remedy |
|---|---|---|---|---|
| 4, 11 | Clearance between 6th gear shift fork and synchronizer sleeve | 0.3 to 0.5<br>{0.012 to 0.020} | 1.0<br>{0.039} | Replace |

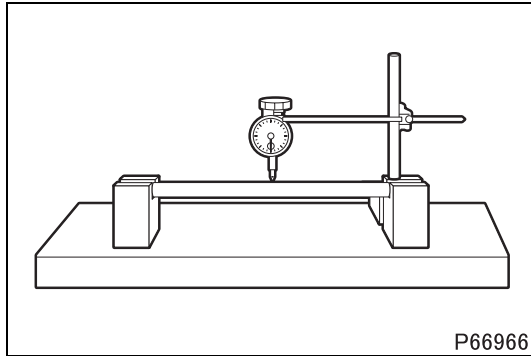
■ **Inspection: Bend of 6th gear shift rail**

- Measure the extent of bending at the middle of the 6th gear shift rail.
- While rotating the 6th gear shift rail by one revolution, read how much the dial gauge needle will move. A half of the reading observed represents the bend, if any, of the shaft.
- If measurement exceeds the limit, replace the 6th gear shift rail.

| Location | Maintenance item | Standard value | Limit | Remedy |
|---|---|---|---|---|
| 5 | Bend of 6th gear shift rail | 0 to 0.02 {0 to 0.00079} | 0.04<br>{0.0016} | Replace |
