# FE.FG

## SERVICE MANUAL 2008 Model FOREWORD

This Service Manual contains maintenance and repair methods for the Mitsubishi Fuso Truck FE. FG Series. Read this manual carefully as an aid in providing correct, efficient maintenance. Please note that the information and specifications contained within this manual may change without notice. This is due to product modifications and continued vehicle improvements that are made throughout the model years. Should you encounter any discrepancy in the information provided, please do not hesitate to contact your nearest Mitsubishi Fuso Dealer or Mitsubishi Fuso Truck of America, Inc.

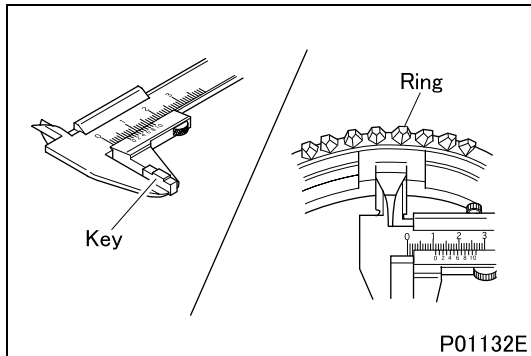
■ **Inspection: Clearance between synchronizer ring keyway and shifting key**

- If the measurement exceeds the limit, replace defective parts.

| Location | Maintenance item | Standard value | Limit | Remedy |
|---|---|---|---|---|
| 10, 13 | Clearance between synchronizer ring keyway and shifting key | 4.75 to 4.95<br>{0.187 to 0.195} | 5.8 {0.228} | Replace |

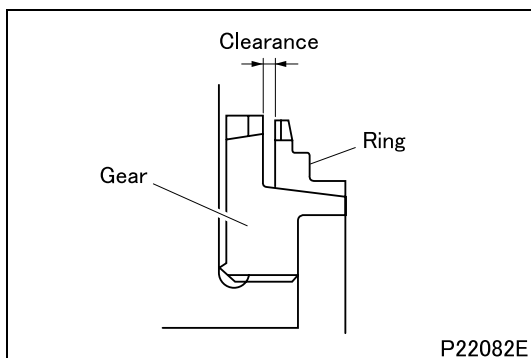
■ **Inspection: Clearance between synchronizer ring and countershaft 6th gear**

- When measuring this value, evenly press the synchronizer ring to the gear side and measure all around the circumference.
- If the measurement is less than the limit, replace both ring and gear.

| Location | Maintenance item | Standard value | Limit | Remedy |
|---|---|---|---|---|
| 10, 15 | Clearance between synchronizer ring and countershaft 6th gear | 1.45 to 1.85<br>{0.057 to 0.073} | 0.2<br>{0.0079} | Replace |

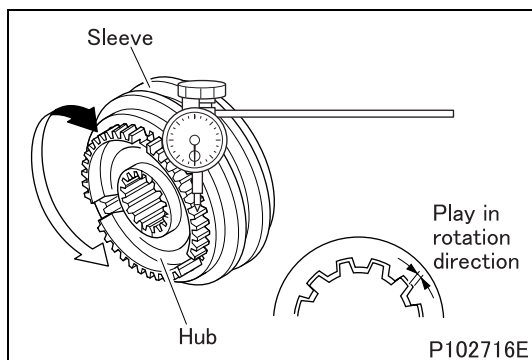
### ■ Inspection: Play of synchronizer sleeve and synchronizer hub in rotation direction

- Hold the synchronizer sleeve and measure the play with rotating the synchronizer hub.
- If the measurement exceeds the limit, replace defective parts.

| Location | Maintenance item | Standard value | Limit | Remedy |
|---|---|---|---|---|
| 11, 14 | Play in the rotation direction of synchronizer sleeve and synchronizer hub | 0.052 to 0.148<br>{0.0020 to 0.0058} | 0.3<br>{0.012} | Replace |

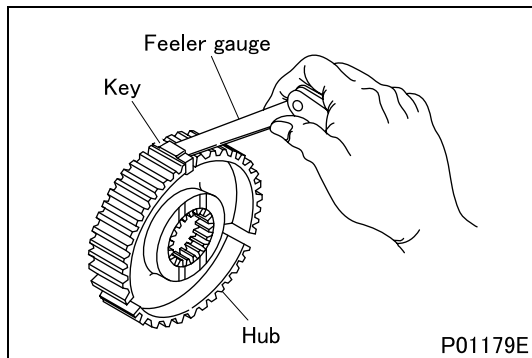
### ■ Inspection: Clearance between shifting key and synchronizer hub keyway

- If the measurement exceeds the limit, replace defective parts.

| Location | Maintenance item | Standard value | Limit | Remedy |
|---|---|---|---|---|
| 13, 14 | Clearance between shifting key and synchronizer hub keyway | 0.05 to 0.20<br>{0.0020 to 0.0079} | 0.5<br>{0.020} | Replace |

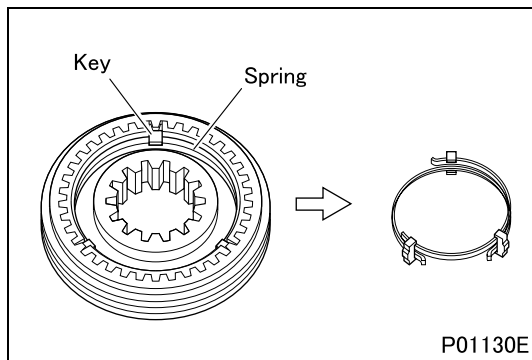
### ■ Installation: Shifting key spring

- After inserting the shifting key into the synchronizer hub groove, install the shifting key spring so that its opening is not located at the shifting key position.
- Install so that openings of the two shifting key springs are not located at the same position.

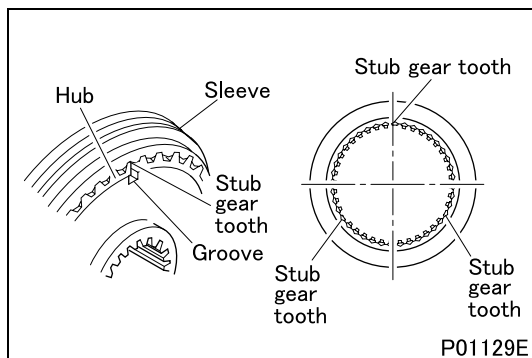
### ■ Installation: Synchronizer sleeve and synchronizer hub

- When replacing the synchronizer sleeve or synchronizer hub with a new one, align the plunger grooves (three locations) of the synchronizer hub with stub gear teeth (three locations) of the synchronizer sleeve to install.

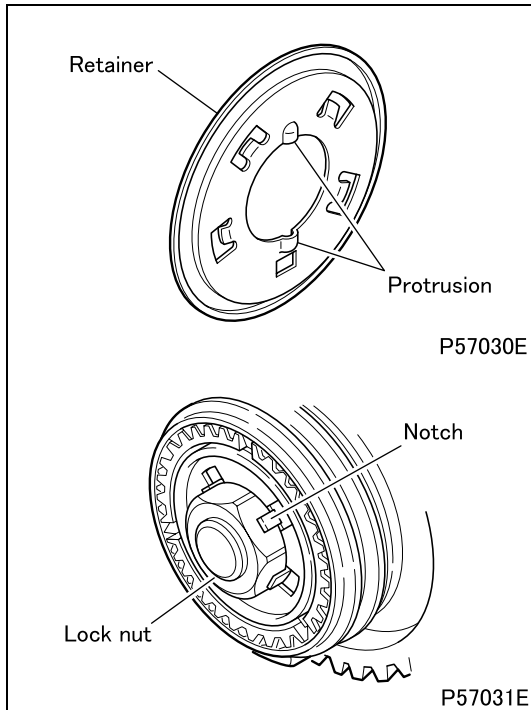
#### ■ Installation: Shifting key retainer

- Fit the protrusions (two locations of the shifting key retainer into the grooves of the synchronizer hub to install.
- After tightening with the lock nut, bend four notches of the shifting key retainer toward the lock nut side.

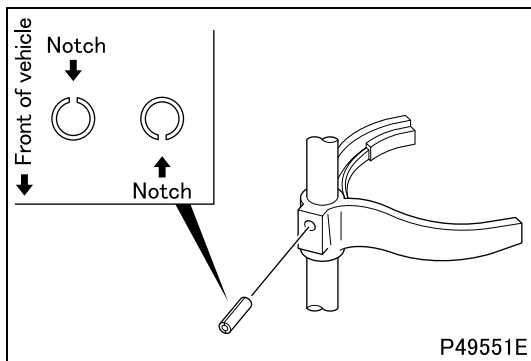
#### ■ Installation: Spring pin

- Install the spring pin in the illustrated direction (with the notch of the spring pin facing the front or rear of the vehicle). Install so that the spring pin protrudes from the reverse gear shift fork by 0 to 0.5 mm {0 to 0.020 in.}.

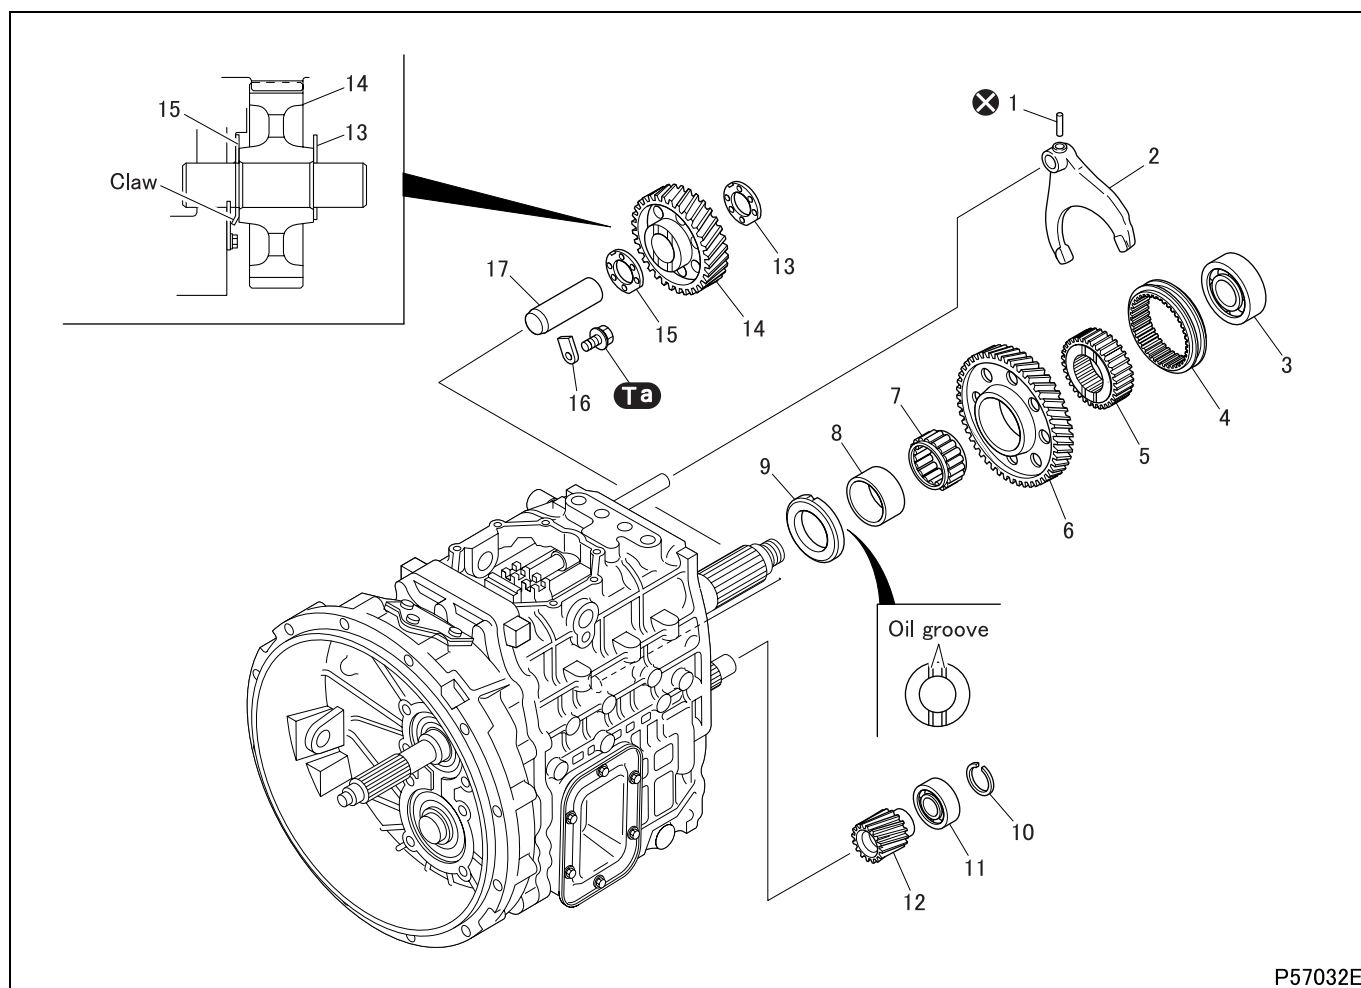
## ● Disassembly sequence

- 1 Spring pin
- 2 Reverse gear shift fork
- 3 Mainshaft rear rear bearing
- 4 Synchronizer sleeve
- 5 Reverse hub
- 6 Mainshaft reverse gear
- 7 Needle bearing
- 8 Mainshaft reverse gear bearing sleeve
- 9 Thrust washer
- 10 Snap ring

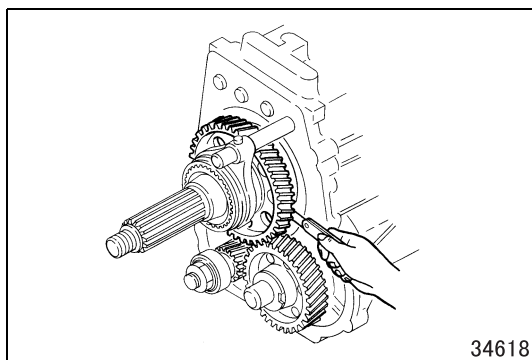
### ■ Inspection: End play of mainshaft reverse gear

- Measure the end play using feeler gauge.
- If the measurement exceeds the limit, replace defective parts.

| Location | Maintenance item | Standard value | Limit | Remedy |
|---|---|---|---|---|
| - | End play of mainshaft reverse gear | 0.20 to 0.40<br>{0.0079 to 0.016} | 0.5 {0.020} | Replace |

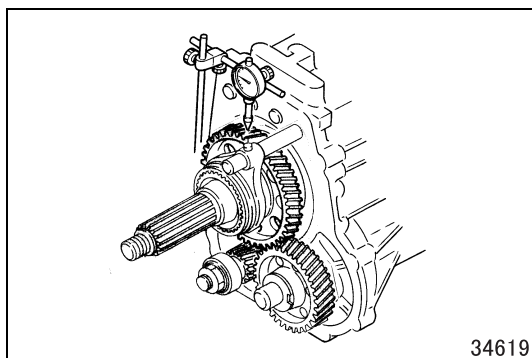
### ■ Inspection: Play of mainshaft reverse gear in the diameter direction

- If the measured value exceeds the limit, replace defective parts.

| Location | Maintenance item | Standard value | Limit | Remedy |
|---|---|---|---|---|
| | Play in the diameter direction of mainshaft reverse gear | 0.06 to 0.10<br>{0.0024 to 0.0039} | 0.10<br>{0.0039} | Replace |

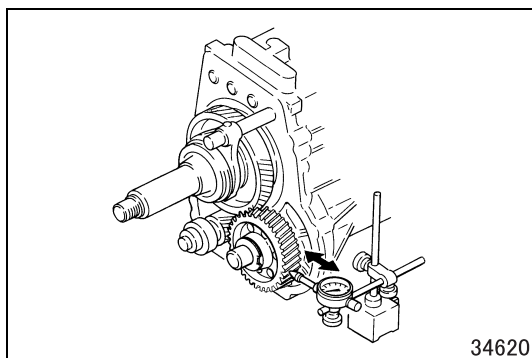
### ■ Inspection: Play of reverse idler gear in the diameter direction

- If the measured value exceeds the limit, replace defective parts.

| Location | Maintenance item | Standard value | Limit | Remedy |
|---|---|---|---|---|
| | Play in the diameter direction after assembly of reverse idler gear | 0.05 to 0.07<br>{0.0020 to 0.0028} | 0.15<br>{0.0059} | Replace |

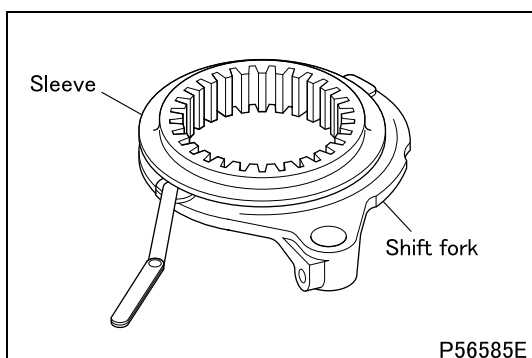
### ■ Inspection: Tilt of claws of reverse gear shift fork

- For the inspection of reverse gear shift fork, see the "Transmission body (SHIFT RAILS AND SHIFT FORKS <M070>)".

### ■ Inspection: Clearance between reverse gear shift fork and synchronizer sleeve

- If the measurement exceeds the limit, replace defective parts.

| Location | Maintenance item | Standard value | Limit | Remedy |
|---|---|---|---|---|
| 2, 4 | Clearance between reverse gear shift fork and synchronizer sleeve | 0.3 to 0.5<br>{0.012 to 0.020} | 1.0<br>{0.039} | Replace |

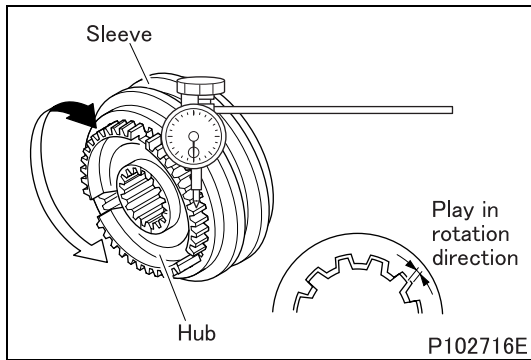
■ **Inspection: Play of synchronizer sleeve and synchronizer hub in rotation direction**

- Hold the synchronizer sleeve and measure the play with rotating the synchronizer hub.
- If the measurement exceeds the limit, replace defective parts.

| Location | Maintenance item | Standard value | Limit | Remedy |
|---|---|---|---|---|
| 4, 5 | Play in the rotation direction of synchronizer sleeve and reverse hub | 0.052 to 0.148<br>{0.0020 to 0.0058} | 0.3<br>{0.012} | Replace |

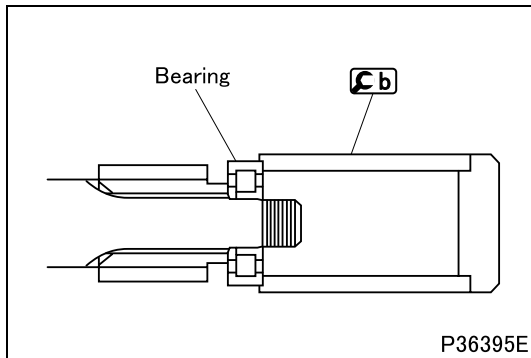
■ **Installation: Countershaft rear bearing**

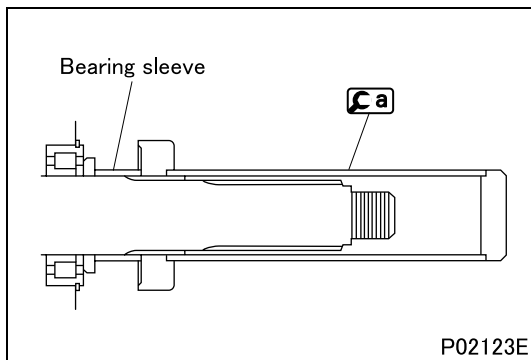
■ **Installation: Mainshaft and reverse gear bearing sleeve**

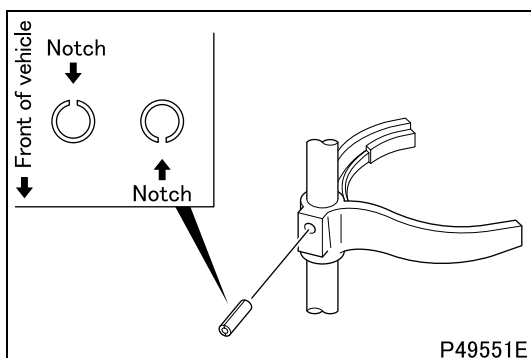
■ **Installation: Spring pin**

- Install the spring pin in the illustrated direction (with the notch of the spring pin facing the front or rear of the vehicle). Install so that the spring pin protrudes from the reverse gear shift fork by 0 to 0.5 mm. {0 to 0.020 in.}

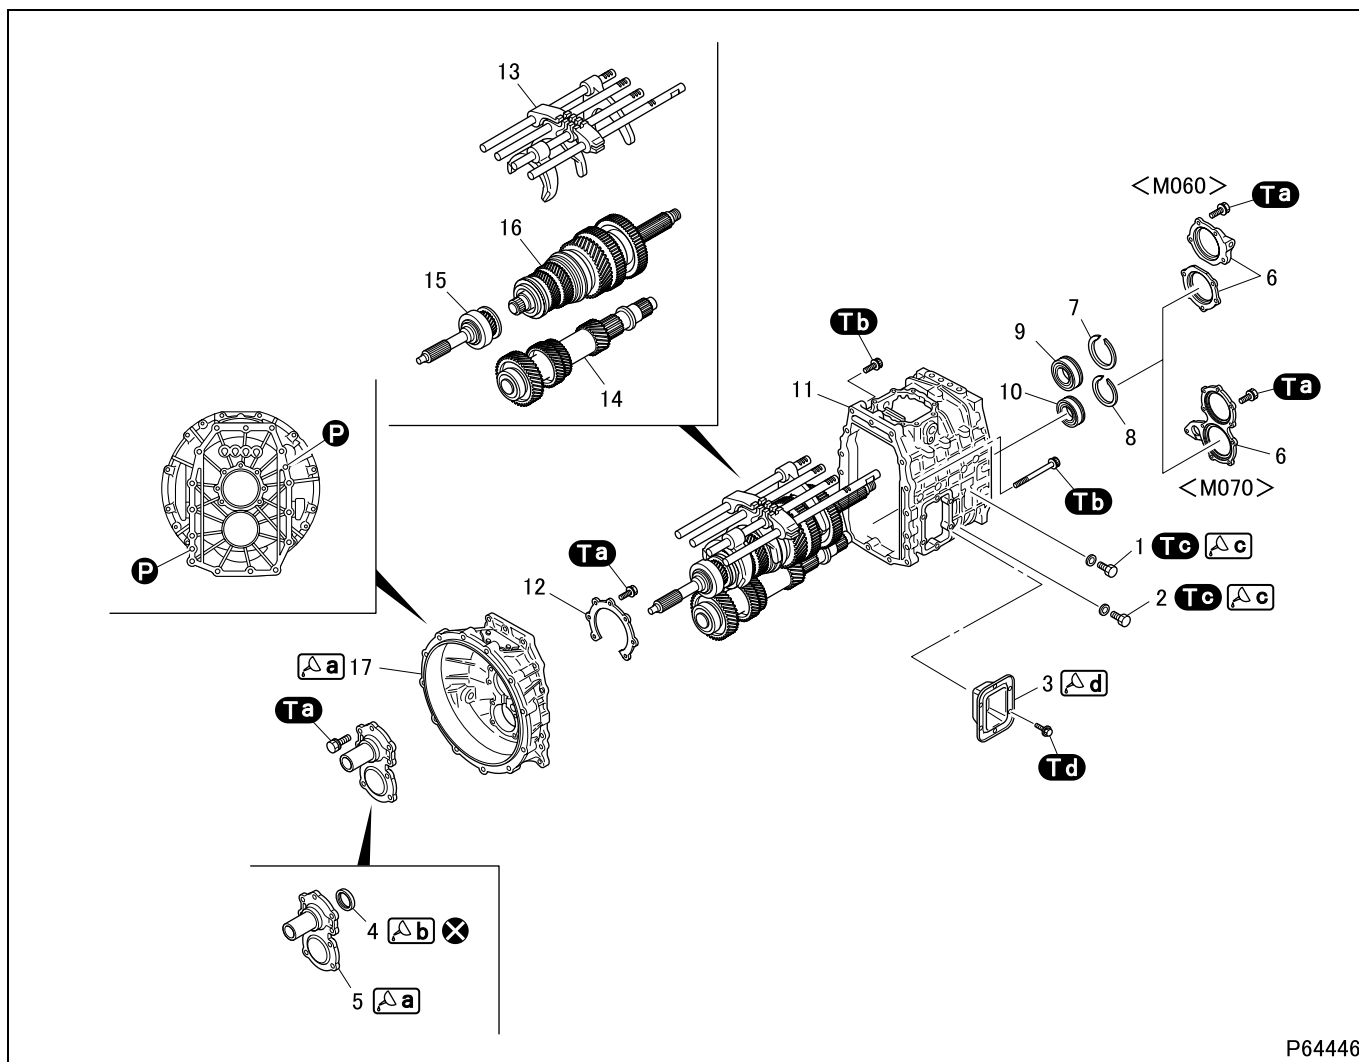
P64446

## ● Disassembly sequence

- After removing the front bearing retainer, perform work with the transmission laid vertically on its clutch housing side. Apply a batten to the clutch housing to prevent damage to the drive pinion.
- If the countershaft, drive pinion and mainshaft assembly is not to be disassembled, only the shift rail and shift fork can be removed with the assembly still fitted in the clutch housing.

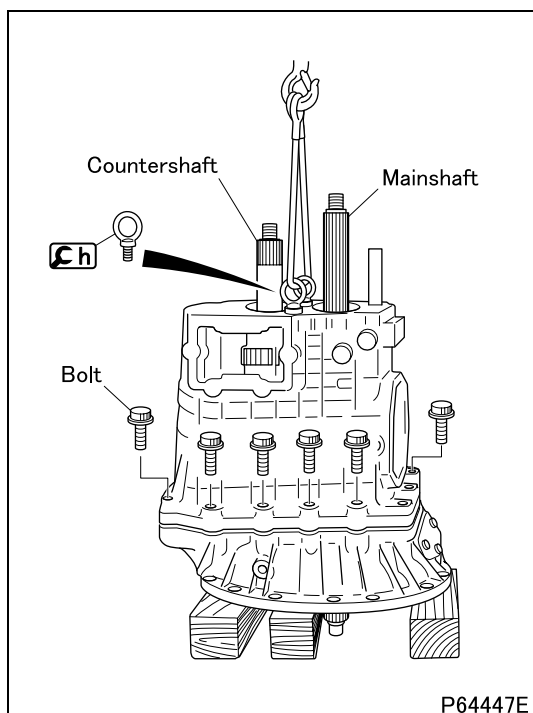
### ■ Removal: Transmission case

- There are two methods of removing the transmission case, using a crane and using a gear puller.

#### (1) Method of using a crane

- Attach **01h** to the transmission case and prepare for hoisting it with a crane.
- After removing bolts, hoist the transmission case with a crane and keep hitting the rear ends of the countershaft and mainshaft, and clutch housing. Use a plastic hammer to remove the transmission case.

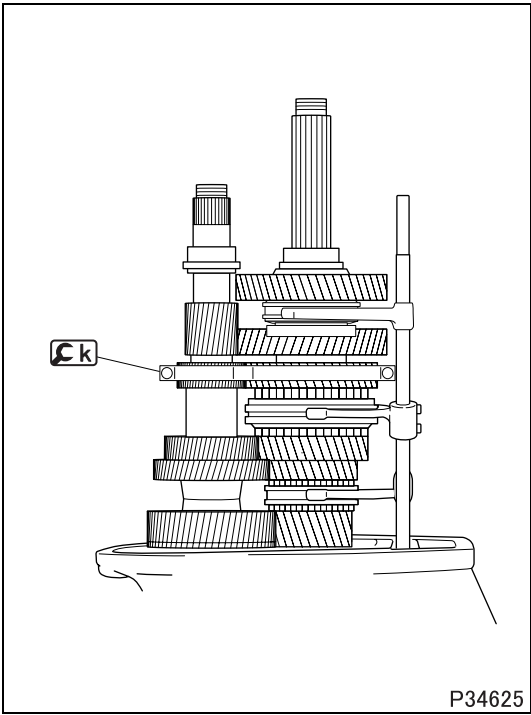
■ Removal: Shift rail and shift fork, countershaft, drive pinion and mainshaft

- After removing the transmission case, secure the countershaft and the 2nd or 3rd gear area of the countershaft and mainshaft with

for safety. Be sure to tighten the steel lifting band enough to prevent it from coming undone, but not excessively.

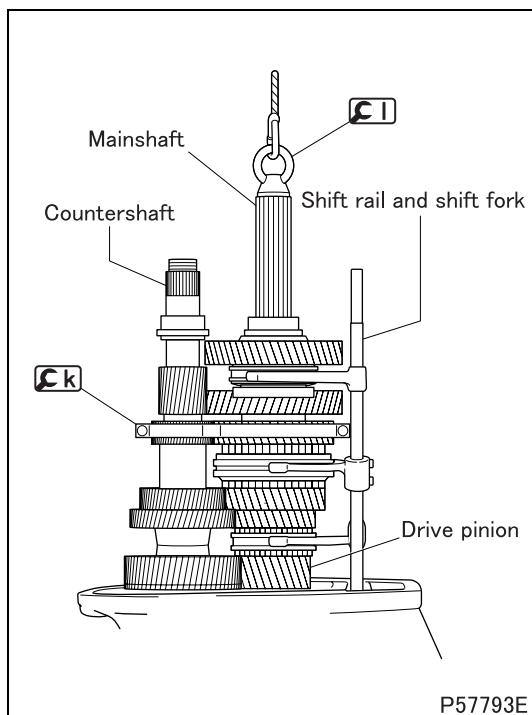
- Leave the countershaft and mainshaft secured with (Ck).
- Install (C1) on the mainshaft and make preparations for lifting it up with a crane.
- Secure the shift rail and shift fork with a rubber band to prevent it from coming undone from the mainshaft.
- Apply a batten to the clutch housing or intermediate plate, and while keeping hitting it, hoist the transmission body. Use a plastic hammer to remove the shift rail and shift fork, countershaft, drive pinion and mainshaft.

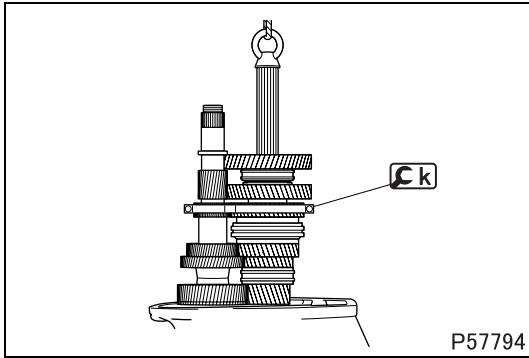
- Fix the 2nd gears or 3rd gears of the countershaft and mainshaft using **(Ck)** to ensure safety. Tighten steel lifting band adequately enough to prevent it from coming undone, but not excessively.
- Install the shift rail and shift fork on the mainshaft.

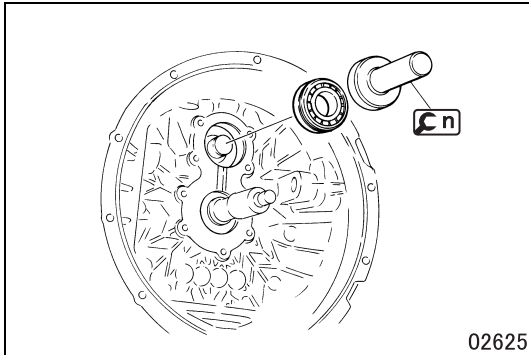
- After installation of the transmission case, place it so that the countershaft faces upward, and install the countershaft front bearing on the clutch housing or intermediate plate using **(Cn)**.

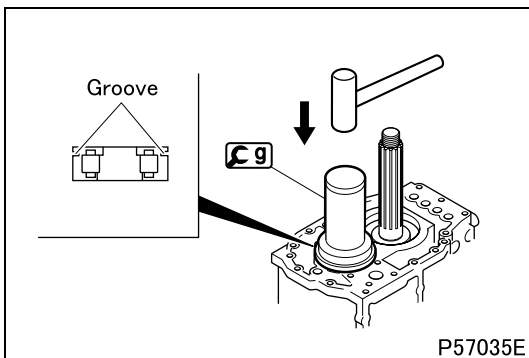
### ■ Installation: Mainshaft rear bearing

- Install the mainshaft rear bearing on the transmission case in the illustrated direction.

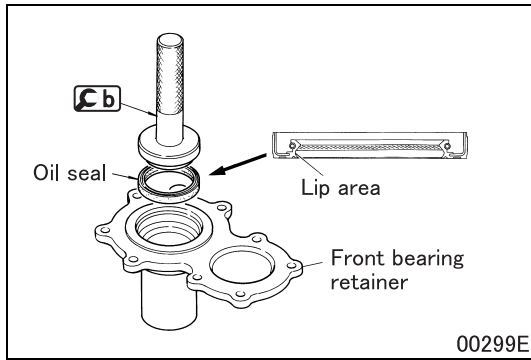
**■ Installation: Oil seal**

- Apply grease to the lip area of the oil seal and install it on the front bearing retainer in the illustrated direction.

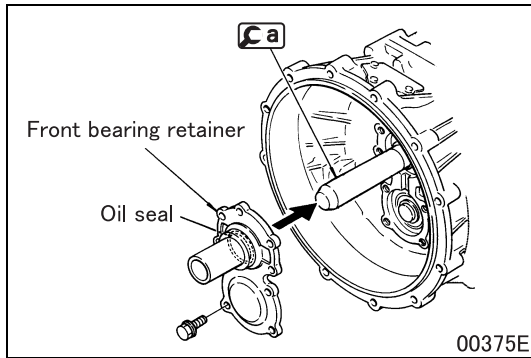
**■ Installation: Front bearing retainer**

- Install **ca** on the drive pinion to protect the oil seal.
- Apply sealant to the clutch housing mounting surface of the front bearing retainer to install.

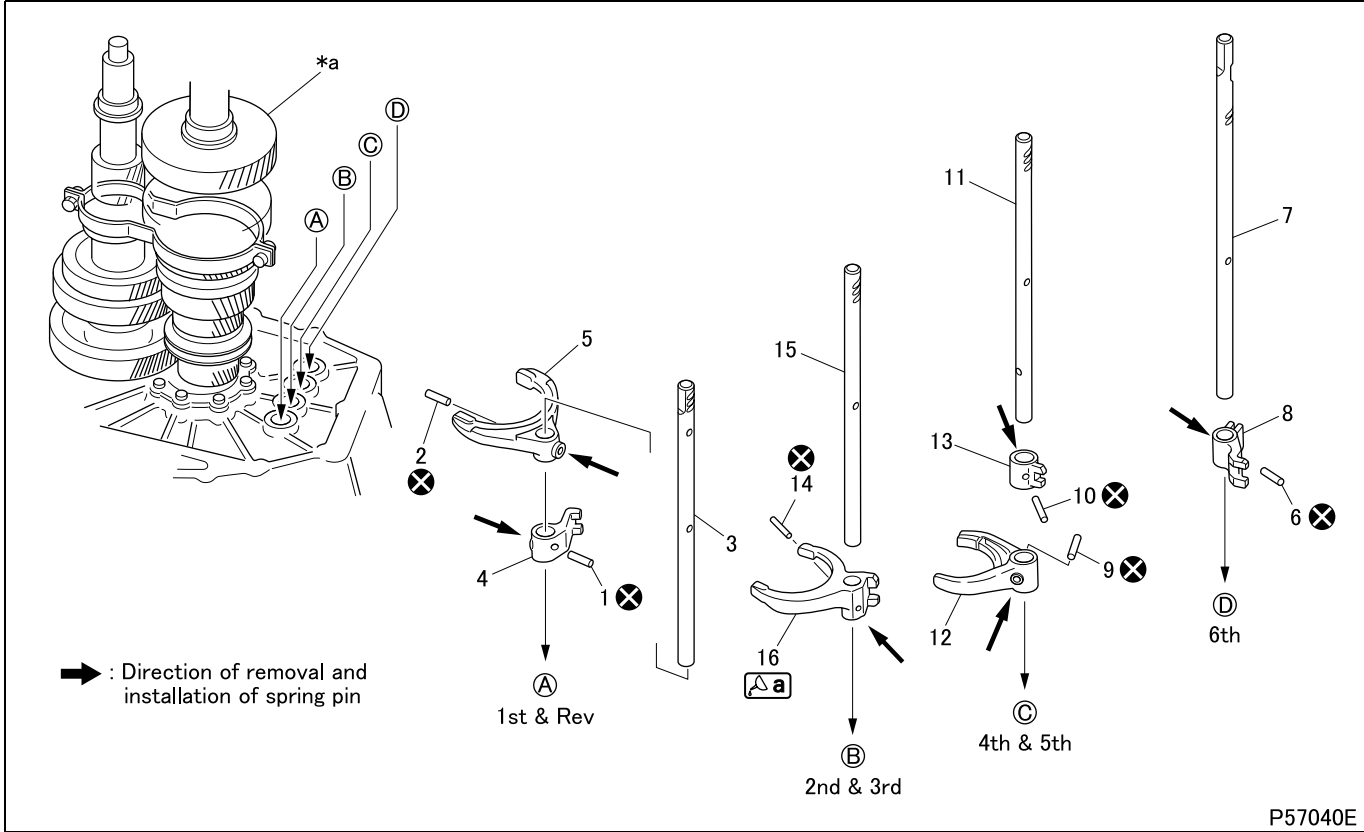
## Shift rail and shift fork <M060>

## ● Disassembly sequence

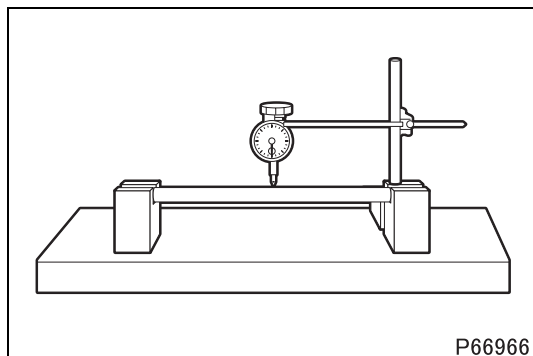
#### ■ Inspection: Bend of shift rail

- Measure the extent of bending at the middle of each of gear shift rail.
- While rotating the gear shift rail by one revolution, read how much the dial gauge needle will move. A half of the reading observed represents the bend, if any, of the shaft.
- If measurement exceeds the limit, replace the gear shift rail.

| Location | Maintenance item | Standard value | Limit | Remedy |
|---|---|---|---|---|
| <b>3, 11, 15</b> | Bend of gear shift rail | 0 to 0.04 {0 to 0.0015} | 0.08<br>{0.0031} | Replace |

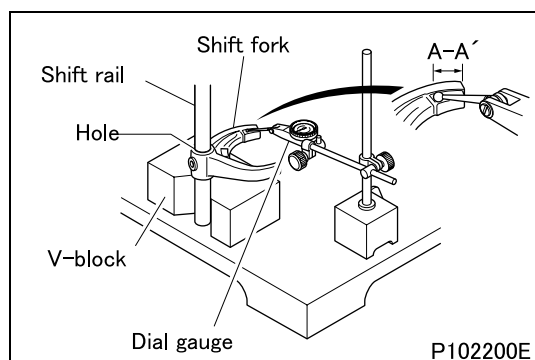
#### ■ Inspection: Tilt of gear shift fork claws

- Measure the tilt (difference between A and A') of claw A-A' against the gear shift rail hole of gear shift forks with pressing the rail to V-block and standing it vertically.
- If the measurement exceeds the limit, replace the gear shift forks.

| Location | Maintenance item | Standard value | Limit | Remedy |
|---|---|---|---|---|
| <b>5, 12, 16</b> | Tilt of gear shift fork claw | 0 to 0.1 {0 to 0.0039} | 0.2 {0.0079} | Replace |

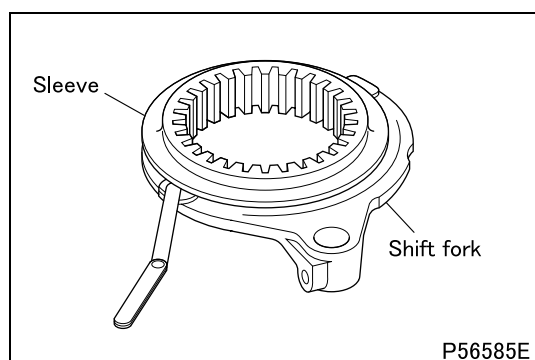
#### ■ Inspection: Clearance between gear shift fork and synchronizer sleeve of mainshaft

- If the measurement exceeds the limit, replace defective parts.

| Location | Maintenance item | Standard value | Limit | Remedy |
|---|---|---|---|---|
| <b>5, *a</b> | Clearance between 1st and reverse gear shift fork and mainshaft synchronizer sleeve | 0.3 to 0.5<br>{0.012 to 0.020} | 1.0 {0.039} | Replace |

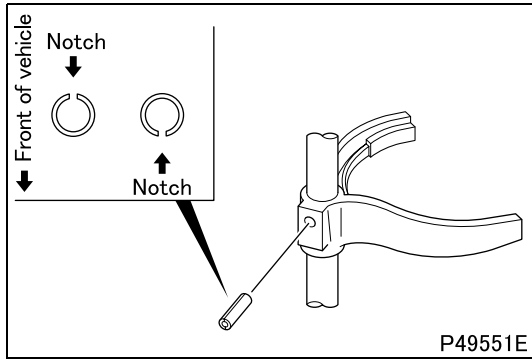
### ■ Installation: Spring pin

- Install the spring pin in the illustrated direction (the spring pin notch to be positioned forward or rearward of the vehicle). When installing the spring pin, leave 0 to 0.5 mm {0 to 0.020 in.} outside from each gear shift rail or each gear shift rail jaw.

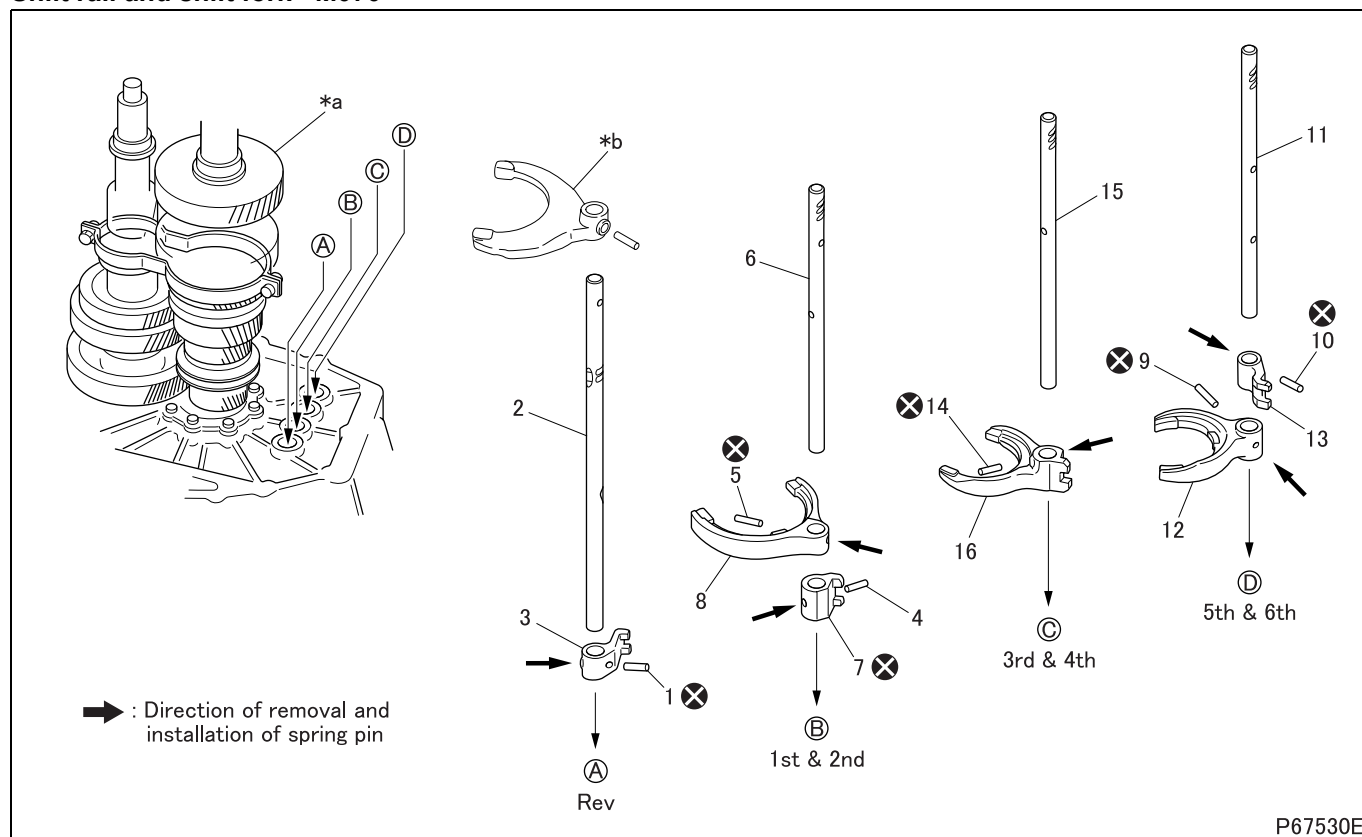
## Shift rail and shift fork <M070>

### ● Disassembly sequence

- 1 Spring pin
- 2 Reverse gear shift rail
- 3 Reverse gear shift rail jaw
- 4 Spring pin
- 5 Spring pin
- 6 1st and 2nd gear shift rail jaw
- 7 1st and 2nd gear shift rail
- 8 1st and 2nd gear shift fork

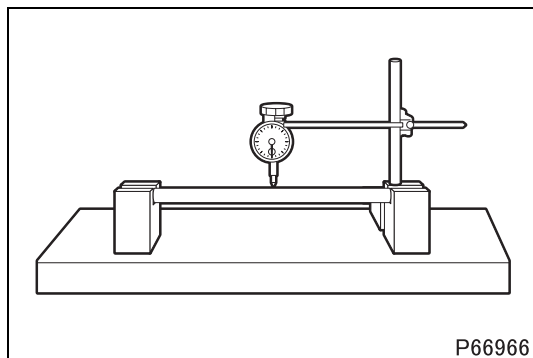
#### ■ Inspection: Bend of shift rail

- Measure the extent of bending at the middle of each of gear shift rail.
- While rotating the gear shift rail by one revolution, read how much the dial gauge needle will move. A half of the reading observed represents the bend, if any, of the shaft.
- If measurement exceeds the limit, replace the gear shift rail.

| Location | Maintenance item | | Standard value | Limit | Remedy |
|---|---|---|---|---|---|
| 2, 7,<br>11, 15 | Bend of gear shift rail | Reverse gear shift rail | 0 to 0.05 {0 to 0.0020} | 0.09<br>{0.0035} | Replace |
| | | Except reverse gear shift rail | 0 to 0.04 {0 to 0.0016} | 0.07<br>{0.0028} | Replace |

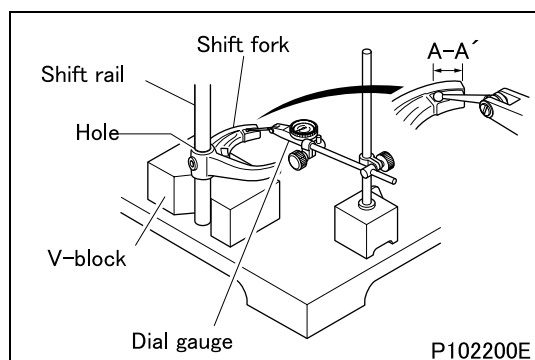
#### ■ Inspection: Tilt of gear shift fork claws

- Measure the tilt (difference between A and A') of claw A-A' against the gear shift rail hole of gear shift forks with pressing the rail to V-block and standing it vertically.
- If the measurement exceeds the limit, replace the gear shift forks.

| Location | Maintenance item | | Standard value | Limit | Remedy |
|---|---|---|---|---|---|
| 8, 12,<br>16, *b | Tilt of gear shift fork claw | | 0 to 0.1 {0 to 0.0039} | 0.2<br>{0.0079} | Replace |

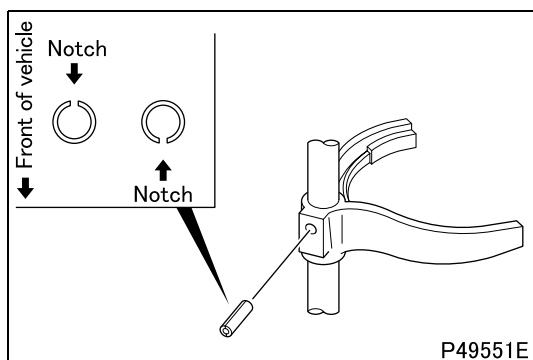
### ■ Installation: Spring pin

- Install the spring pin in the illustrated direction (the spring pin notch to be positioned forward or rearward of the vehicle). When installing the spring pin, leave 0 to 0.5 mm {0 to 0.02 in.} outside from each gear shift rail or each gear shift rail jaw.

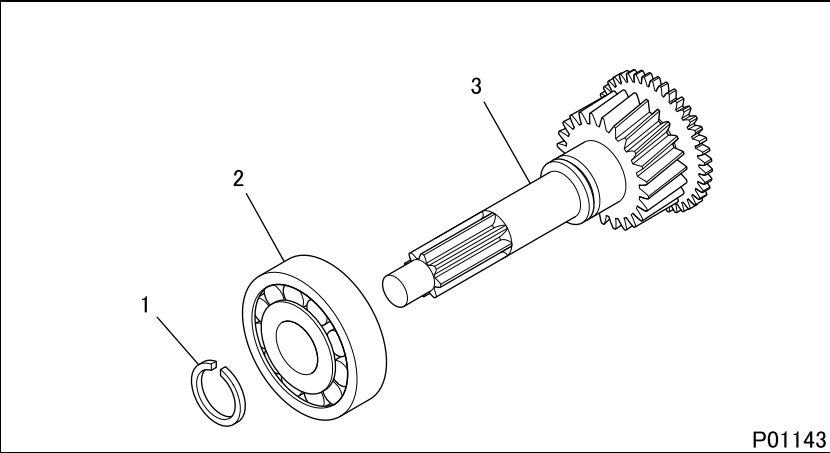
● Disassembly sequence

- 1 Snap ring
- 2 Drive pinion bearing
- 3 Drive pinion

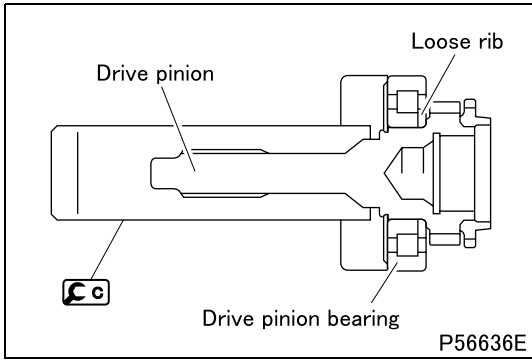
**■ Installation: Drive pinion bearing**

- Install the drive pinion bearing, facing the loose rib in the illustrated direction.

- Be careful not to install the drive pinion bearing in the wrong direction. Otherwise, the bearing cannot be removed because the inner shaft of the bearing remains in the drive pinion during removal.

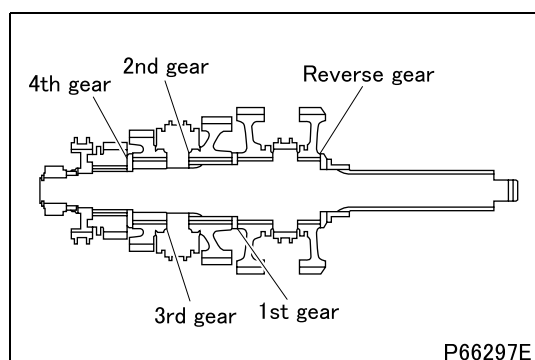
### ■ Inspection: End play of each gear

- Measure the end play using feeler gauge.
- If the measurement exceeds the limit, replace defective parts.

| Location | Maintenance item | | Standard value | Limit | Remedy |
|---|---|---|---|---|---|
| - | End play | 1st gear | 0.15 to 0.35<br>{0.0059 to 0.014} | 0.5 {0.020} | Replace |

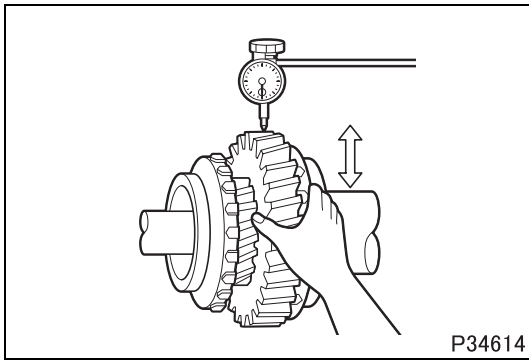
#### ■ Inspection: Play of gears in diameter direction

- If the measurement exceeds the limit, replace defective parts.

| Location | Maintenance item | | Standard value | Limit | Remedy |
|---|---|---|---|---|---|
| - | Play in the diameter direction | 1st gear | 0.05 to 0.08<br>{0.0020 to 0.0031} | 0.12<br>{0.0047} | Replace |

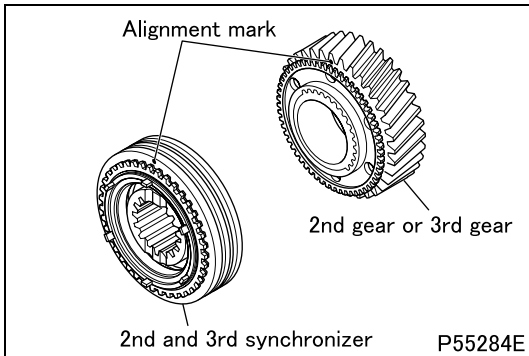
#### ■ Alignment marks: 2nd gear, 2nd and 3rd synchronizer and 3rd gear

- Put alignment marks on the 2nd gear, synchronizer sleeve of the 2nd and 3rd synchronizer and 3rd gear, each at one location before disassembly.

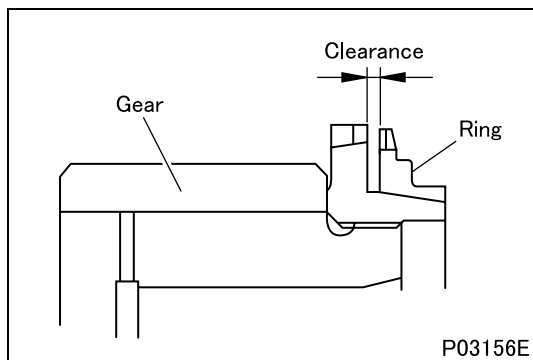
## ■ Inspection: Clearance between synchronizer ring of 4th and 5th synchronizer and 4th gear or drive pinion

- Conduct a measurement on the entire circumference while pressing each synchronizer ring against gears evenly.
- If the measurement is less than the limit, replace both ring and gear.

| Location | Maintenance item | | Standard value | Limit | Remedy |
|---|---|---|---|---|---|
| - | Clearance between gear and synchronizer ring | 4th gear synchronizer | 1.48 to 1.77<br>{0.058 to 0.070} | 0.2<br>{0.0079} | Replace |

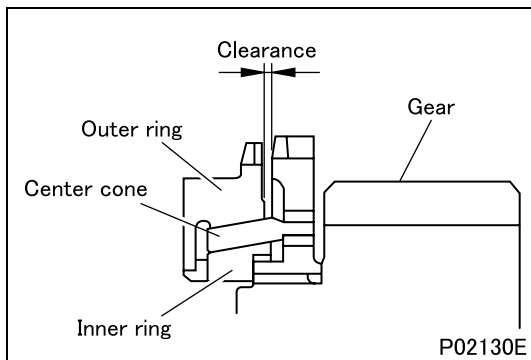
■ **Inspection: Clearance between synchronizer outer ring of 2nd and 3rd synchronizer and 2nd gear or 3rd gear**

- When measuring the clearance, press each ring and the center cone evenly against the gear and measure all around the circumference.
- If the measurement is less than the limit, replace both ring and gear.

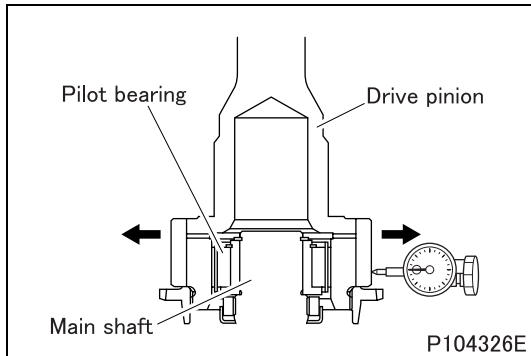
■ **Inspection: Play of pilot bearing in diameter direction**

- Carry out the measurement with installing the drive pinion, pilot bearing and main shaft and holding the main shaft as illustrated.
- Measure the play with moving the gear of drive pinion in diameter direction.
- If the measurement exceeds the limit, replace the pilot bearing.

| Location | Maintenance item | | Standard value | Limit | Remedy |
|---|---|---|---|---|---|
| 7 | Play in the diameter direction pilot bearing | | - | 0.12<br>{0.0047} | Replace |

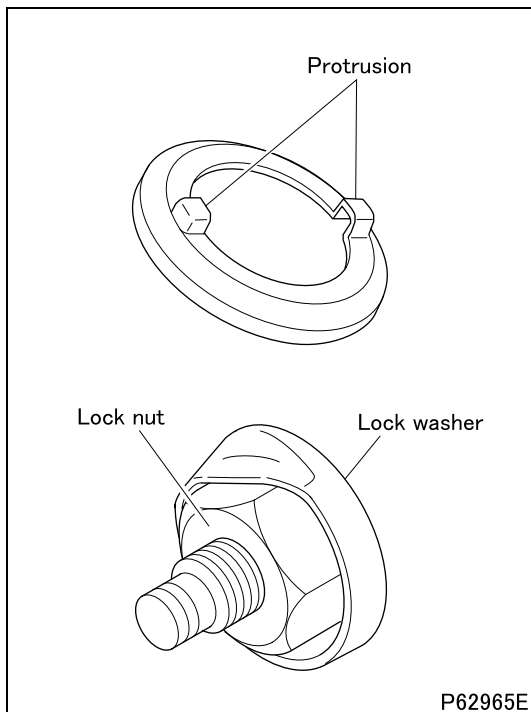
■ **Installation: Lock washer**

- Install so that protrusions of the lock washer fit into the grooves of the synchronizer hub of the 4th and 5th synchronizer.
- After tightening the lock nut to the specified torque, secure it by bending the lock washer.

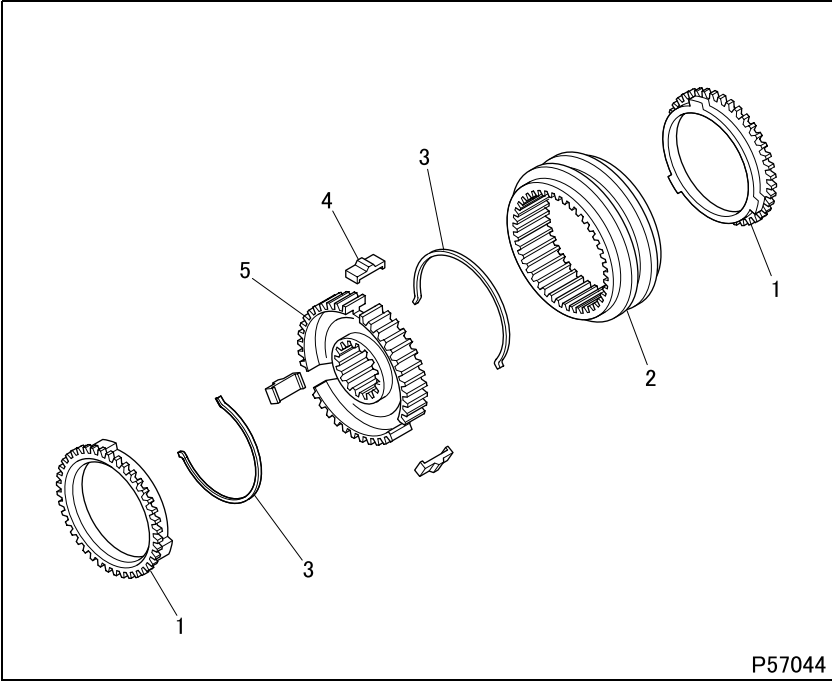
### ● Disassembly sequence

- 1 Synchronizer ring
- 2 Synchronizer sleeve
- 3 Shifting key spring
- 4 Shifting key
- 5 Synchronizer hub

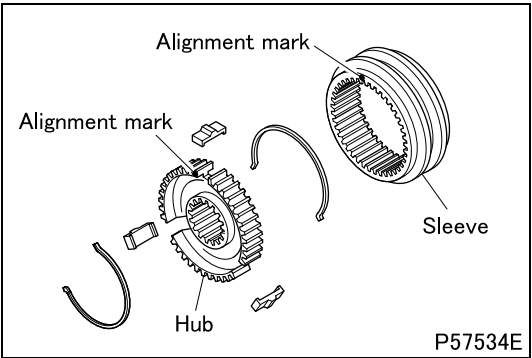
### ■ Alignment marks: Synchronizer sleeve and synchronizer hub

- Put alignment marks on the synchronizer sleeve and synchronizer hub, each at one location before disassembly.

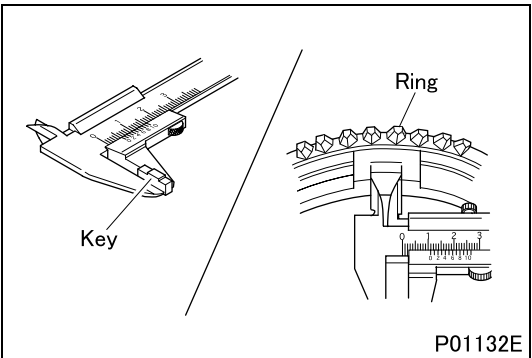
### ■ Inspection: Clearance between synchronizer ring keyway and shifting key

- If measurement exceeds the limit, replace defective parts.

| Location | Maintenance item | Standard value | Limit | Remedy |
|---|---|---|---|---|
| 1, 4 | Clearance between synchronizer ring keyway and shifting key | 4.75 to 4.95<br>{0.187 to 0.195} | 5.8<br>{0.23} | Replace |

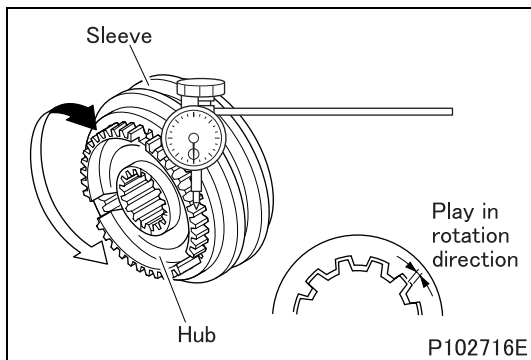
■ **Inspection: Play of synchronizer sleeve and synchronizer hub in rotation direction**

- Hold the synchronizer sleeve and measure the play with rotating the synchronizer hub.
- If the measurement exceeds the limit, replace defective parts.

| Location | Maintenance item | Standard value | Limit | Remedy |
|---|---|---|---|---|
| 2, 5 | Play in the rotation direction of synchronizer sleeve and synchronizer hub | 0.052 to 0.148<br>{0.0020 to 0.0058} | 0.3<br>{0.012} | Replace |

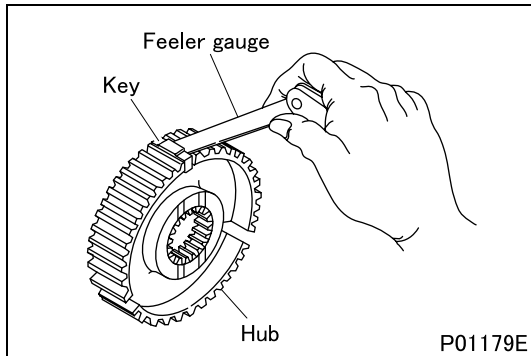
■ **Inspection: Clearance between shifting key and synchronizer hub keyway**

- If measurement exceeds the limit, replace defective parts.

| Location | Maintenance item | Standard value | Limit | Remedy |
|---|---|---|---|---|
| 4, 5 | Clearance between shifting key and synchronizer hub keyway | 0.05 to 0.20<br>{0.0020 to 0.0079} | 0.5<br>{0.020} | Replace |

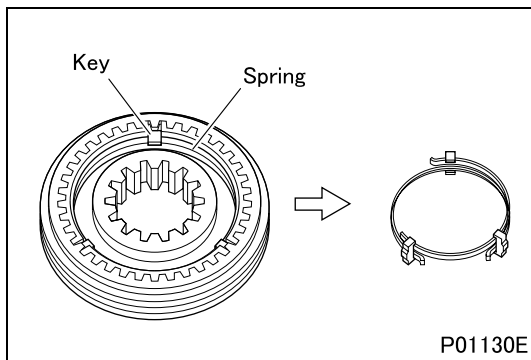
■ **Installation: Shifting key spring**

- After inserting the shifting key into the synchronizer hub groove, install the shifting key spring so that its opening is not located at the shifting key position.
- Install so that openings of the two shifting key springs are not located at the same position.

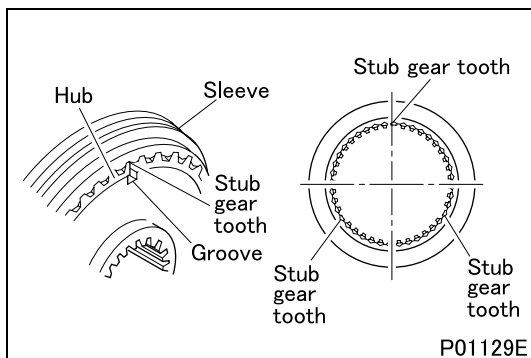
■ **Installation: Synchronizer sleeve and synchronizer hub**

- When replacing the synchronizer sleeve or synchronizer hub with a new one, align the plunger grooves (three locations) of the synchronizer hub with stub gear teeth (three locations) of the synchronizer sleeve to install.

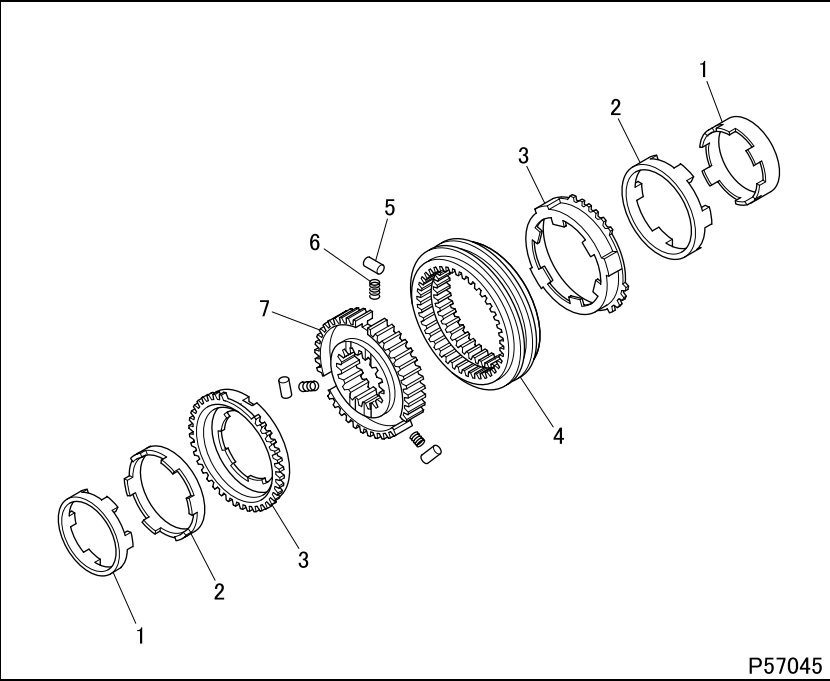
### Disassembly sequence

- 1 Synchronizer inner ring
- 2 Synchronizer center cone
- 3 Synchronizer outer ring
- 4 Synchronizer sleeve
- 5 Shifting pin
- 6 Synchronizer spring
- 7 Synchronizer hub

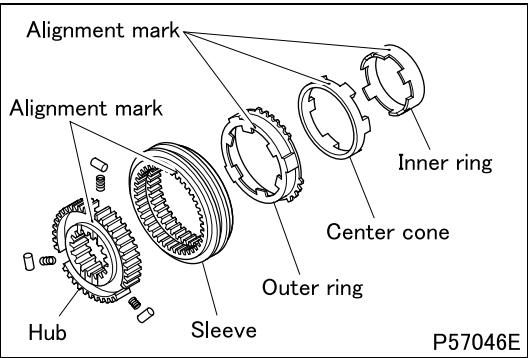
### Alignment marks: Synchronizer inner ring, center cone, outer ring and hub

- Put alignment marks on the synchronizer inner ring, center cone, outer ring and hub, each at one location, aligning with the alignment mark put on the synchronizer sleeve before disassembly.

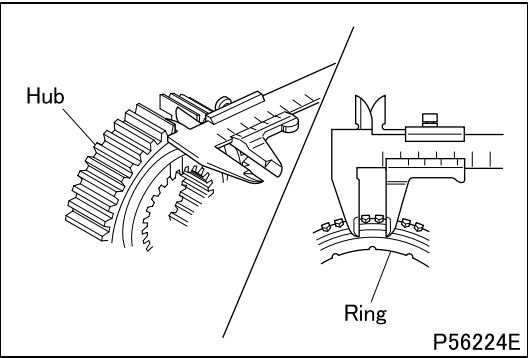
### Inspection: Clearance between synchronizer outer ring protrusion and synchronizer hub groove

- If the measurement exceeds the limit, replace defective parts.

| Location | Maintenance item | Standard value | Limit | Remedy |
|---|---|---|---|---|
| 3, 7 | Clearance between protrusions of synchronizer outer ring and synchronizer hub groove | 4.8 to 5.4<br>{0.19 to 0.21} | 6.5<br>{0.26} | Replace |

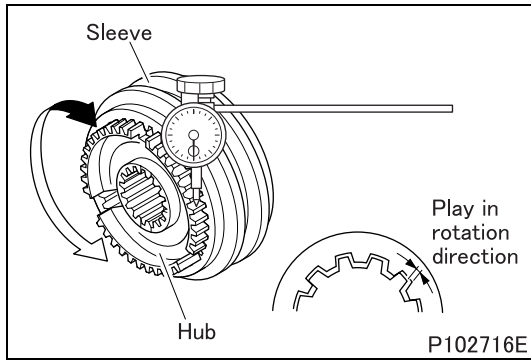
■ **Inspection: Play of synchronizer sleeve and synchronizer hub in rotation direction**

- Hold the synchronizer sleeve and measure the play with rotating the synchronizer hub.
- If the measurement exceeds the limit, replace defective parts.

| Location | Maintenance item | Standard value | Limit | Remedy |
|---|---|---|---|---|
| 4, 7 | Play in the rotation direction of synchronizer sleeve and synchronizer hub | 0.052 to 0.148<br>{0.0020 to 0.0058} | 0.3<br>{0.012} | Replace |

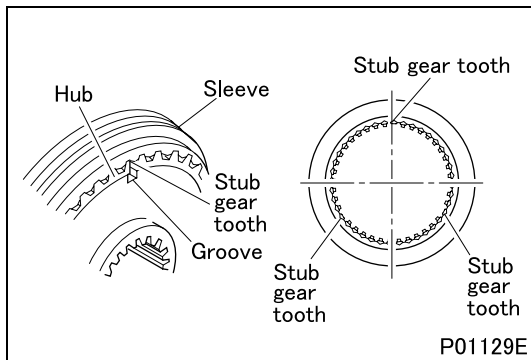
■ **Installation: Synchronizer sleeve and synchronizer hub**

- When replacing the synchronizer sleeve or synchronizer hub with a new one, align the plunger grooves (three locations) of the synchronizer hub with stub gear teeth (three locations) of the synchronizer sleeve to install.

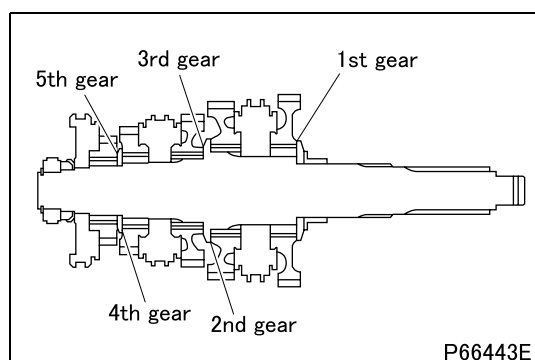
### ■ Inspection: End play of each gear

- Measure the end play using feeler gauge.
- If the measurement exceeds the limit, replace defective parts.

| Location | Maintenance item | | Standard value | Limit | Remedy |
|---|---|---|---|---|---|
| – | End play | 1st gear | 0.35 to 0.55<br>{0.014 to 0.022} | 0.75<br>{0.030} | Replace |

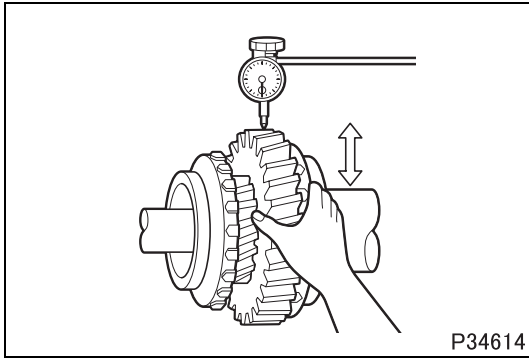
■ **Inspection: Play of gears in diameter direction**

- If the measurement exceeds the limit, replace defective parts.

| Location | Maintenance item | | Standard value | Limit | Remedy |
|---|---|---|---|---|---|
| – | Play in the diameter direction | 1st gear | 0.05 to 0.09<br>{0.0020 to 0.0035} | 0.10<br>{0.0039} | Replace |
