# FE.FG

## SERVICE MANUAL 2008 Model FOREWORD

This Service Manual contains maintenance and repair methods for the Mitsubishi Fuso Truck FE. FG Series. Read this manual carefully as an aid in providing correct, efficient maintenance. Please note that the information and specifications contained within this manual may change without notice. This is due to product modifications and continued vehicle improvements that are made throughout the model years. Should you encounter any discrepancy in the information provided, please do not hesitate to contact your nearest Mitsubishi Fuso Dealer or Mitsubishi Fuso Truck of America, Inc.

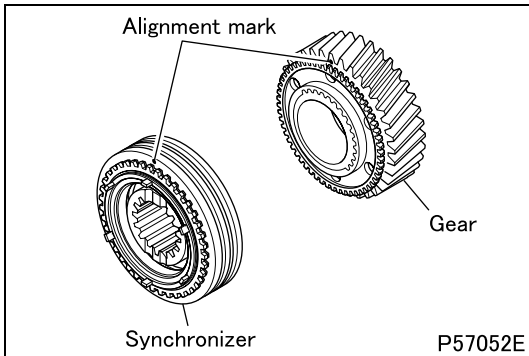
■ **Alignment marks: 2nd gear, 2nd synchronizer, 3rd gear, and 3rd and 4th synchronizer and 4th gear**

- Put alignment marks on each gear and each synchronizer sleeve of the synchronizer, each at one location before disassembly.

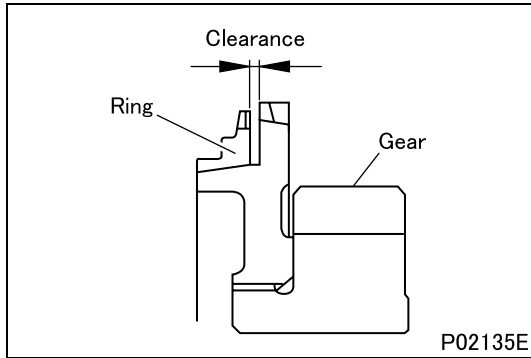
### ■ Inspection: Clearance between synchronizer ring of 5th and 6th synchronizer and 5th gear or drive pinion

- When measuring the clearance, press each ring evenly against the gear and measure all around the circumference.
- If the measurement is less than the limit, replace the ring together with gear or drive pinion.

| Location | Maintenance item | | Standard value | Limit | Remedy |
|---|---|---|---|---|---|
| – | Clearance between gear and synchronizer ring | 2nd gear and 2nd synchronizer | 1.21 to 1.79<br>{0.0048 to 0.0070} | 0.2<br>{0.0079} | Replace |

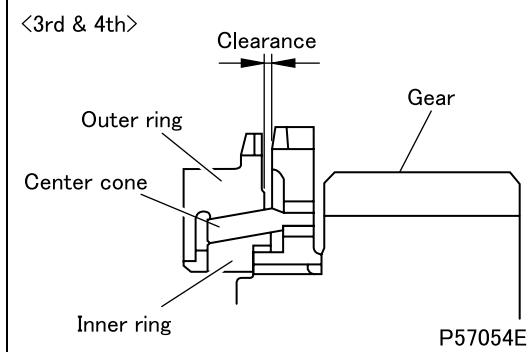
### ■ Inspection: Clearance between each gear and synchronizer outer ring of each synchronizer

- When measuring the clearance, press each synchronizer ring and center cone evenly against the gear and measure all around the circumference.
- If the measurement is less than the limit, replace both ring and gear.

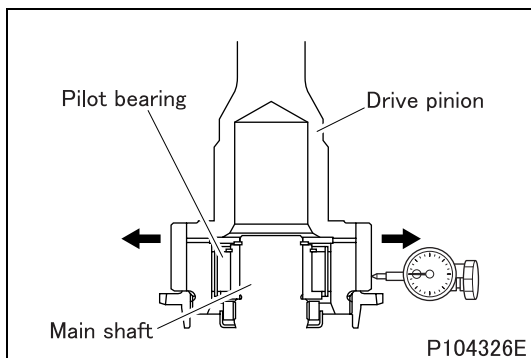
### ■ Inspection: Play of pilot bearing in diameter direction

- Carry out the measurement with installing the drive pinion, pilot bearing and main shaft and holding the main shaft as illustrated.
- Measure the play with moving the gear of drive pinion in diameter direction.
- If the measurement exceeds the limit, replace the pilot bearing.

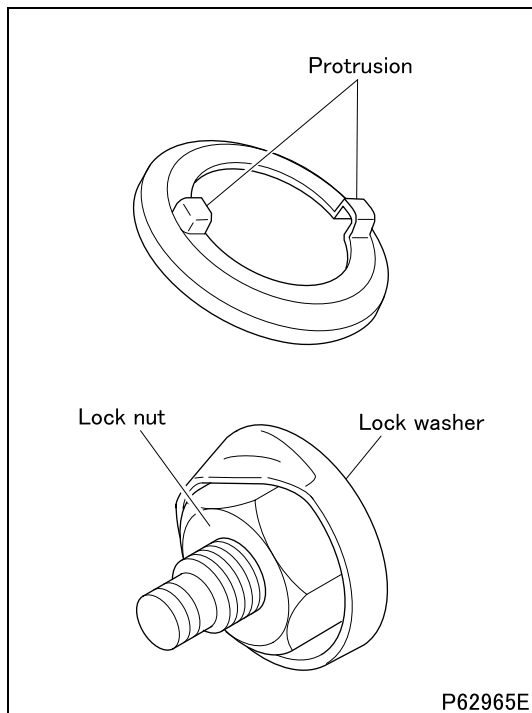
### ■ Installation: Lock washer

- Install so that protrusions of the lock washer fit into the grooves of the synchronizer hub of the 5th and 6th synchronizer.
- After tightening the lock nut to the specified torque, secure it by bending the lock washer.

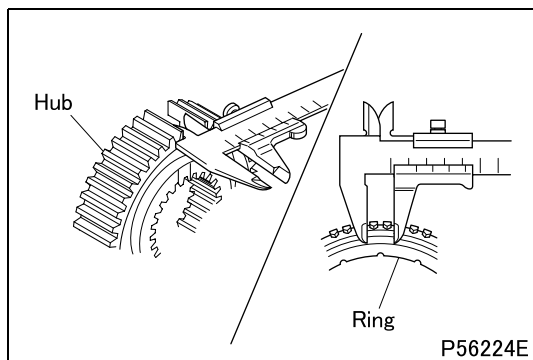
### ■ Inspection: Clearance between synchronizer outer ring protrusion and synchronizer hub groove

- If measurement exceeds the limit, replace defective parts.

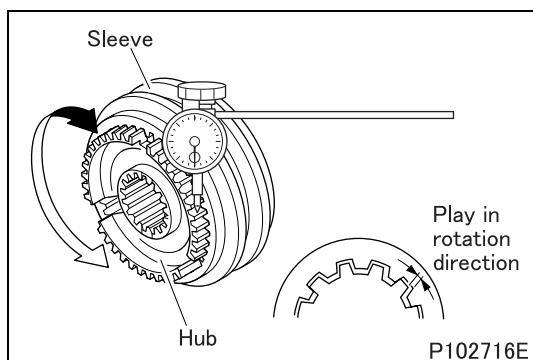
### ■ Inspection: Play of synchronizer sleeve and synchronizer hub in rotation direction

- Hold the synchronizer sleeve and measure the play with rotating the synchronizer hub.
- If the measurement exceeds the limit, replace defective parts.

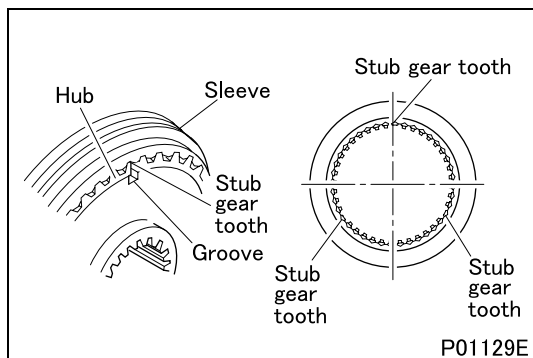
### ■ Installation: Synchronizer sleeve and synchronizer hub

- When replacing the synchronizer sleeve or synchronizer hub with a new one, align the plunger grooves (three locations) of the synchronizer hub with stub gear teeth (three locations) of the synchronizer sleeve to install.

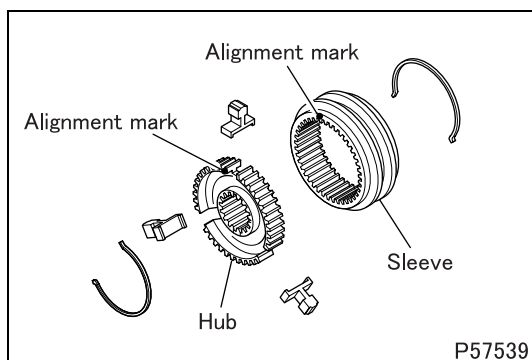
P57539

## ■ Alignment marks: Synchronizer sleeve and synchronizer hub

- Put alignment marks on the synchronizer sleeve and synchronizer hub, each at one location before disassembly.

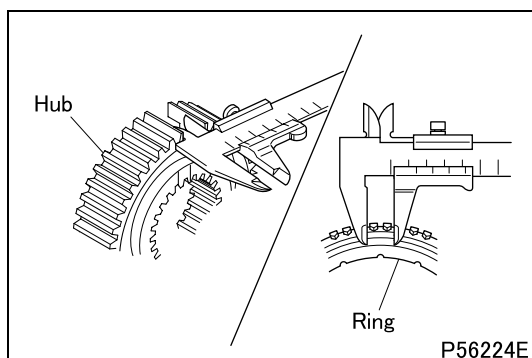
P56224E

## ■ Inspection: Clearance between synchronizer ring protrusion and synchronizer hub groove

- If measurement exceeds the limit, replace defective parts.

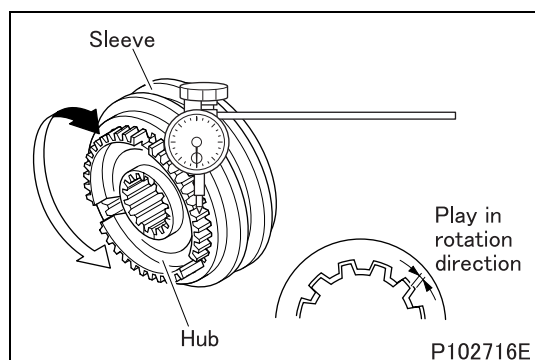
## ■ Inspection: Play of synchronizer sleeve and synchronizer hub in rotation direction

- Hold the synchronizer sleeve and measure the play with rotating the synchronizer hub.
- If the measurement exceeds the limit, replace defective parts.

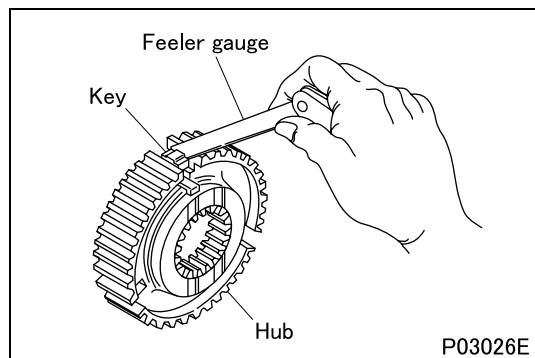
## ■ Inspection: Clearance between shifting key and synchronizer hub keyway

- If measurement exceeds the limit, replace defective parts.

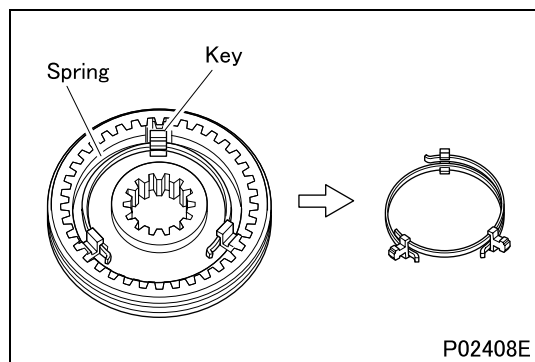
## ■ Installation: Shifting key spring

- After inserting the shifting key into the synchronizer hub groove, install the shifting key spring so that its opening is not located at the shifting key position.
- Install so that openings of the two shifting key springs are not located at the same position.

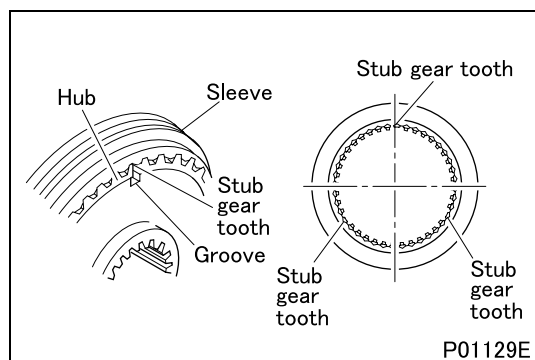
## ■ Installation: Synchronizer sleeve and synchronizer hub

- When replacing the synchronizer sleeve or synchronizer hub with a new one, align the plunger grooves (three locations) of the synchronizer hub with stub gear teeth (three locations) of the synchronizer sleeve to install.

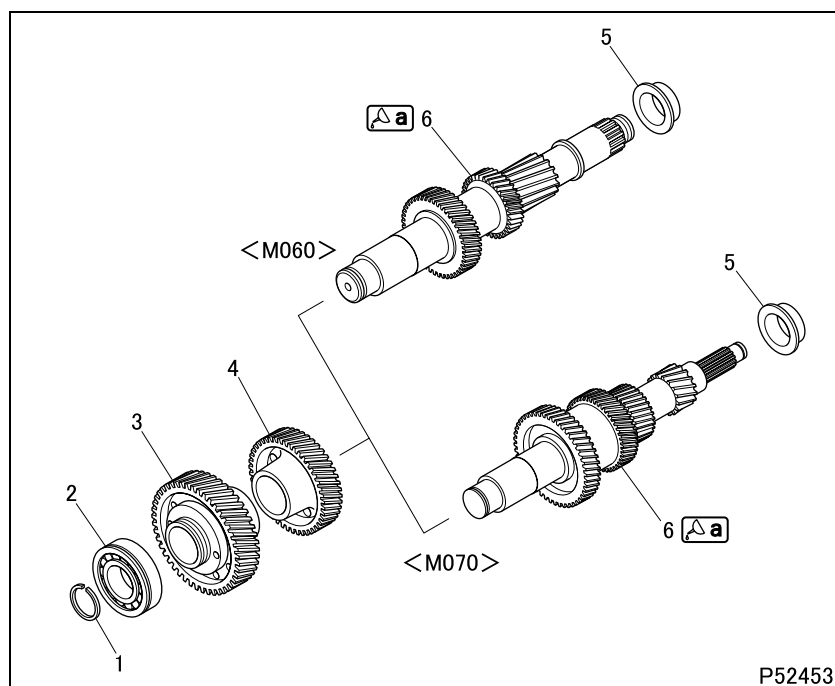
## ● Disassembly sequence

- 1 Snap ring
- 2 Countershaft front bearing
- 3 Countershaft constant mesh gear
- 4 Countershaft 4th gear <M060>  
Countershaft 5th gear <M070>
- 5 Countershaft rear bearing inner race
- 6 Countershaft

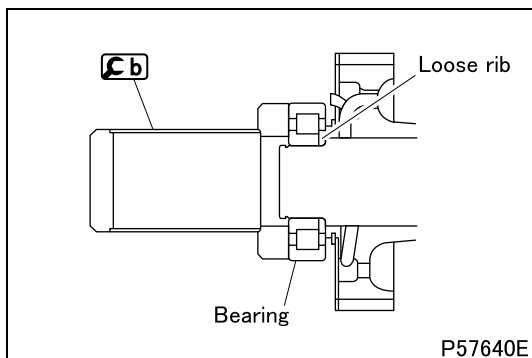
### ■ Installation: Countershaft front bearing

- Install the countershaft front bearing, facing the loose rib in the illustrated direction.

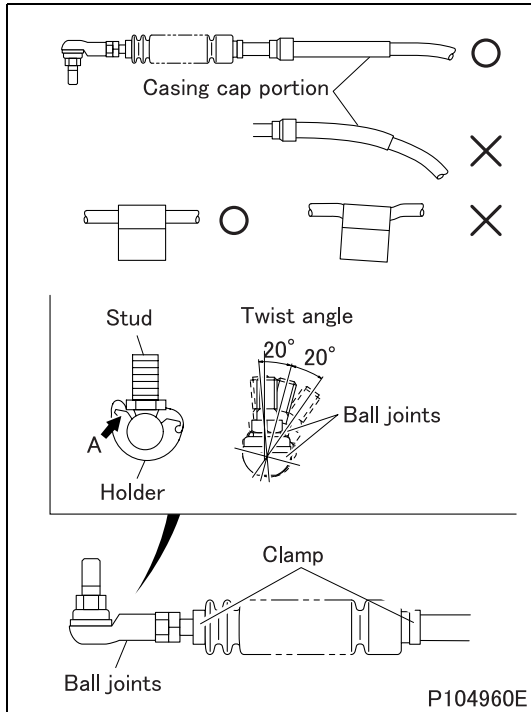
### ■ Installation: Shift cable and select cable

- Install the casing cap portion as a straight line.
- The radius of the cable bend shall be 200 mm {7.87 in.} or more.
- Make sure that there is no obstruction in movement of the cable.
- Install the clamps at right angles to the cable.
- Do not twist clamps at either ends of the boot.
- Check for the identification mark on the shift cable.
- The twist angle of ball joints at both ends of the cables shall be 20 degrees or less.
- Make sure that the ball joints face the correct direction. Installing them in the wrong direction can remarkably reduce durability of the cables.

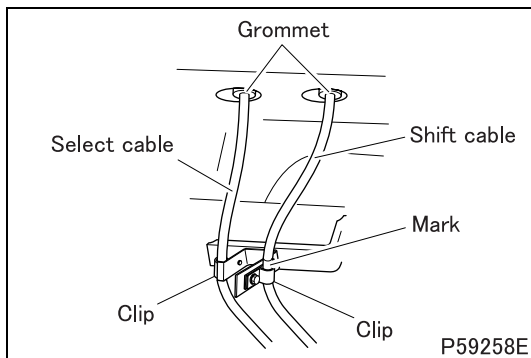
- Insert the shift cable and select cable into the interior from under the cab floor.
- Clamp the shift cable at the marking area.

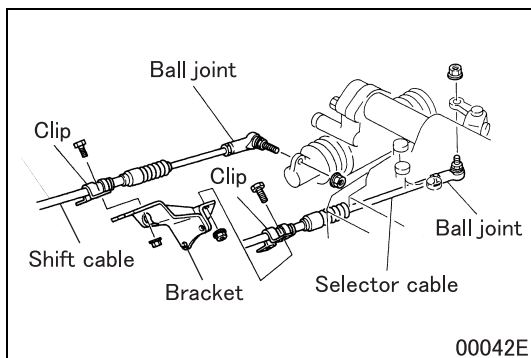
- Install the cable clip to the bracket temporarily and connect the ball joint to the shift lever or select lever.
- Arrange the cable so that it not twisted, then tighten the clip permanently.

- Make sure that the ball joint face the correct direction.

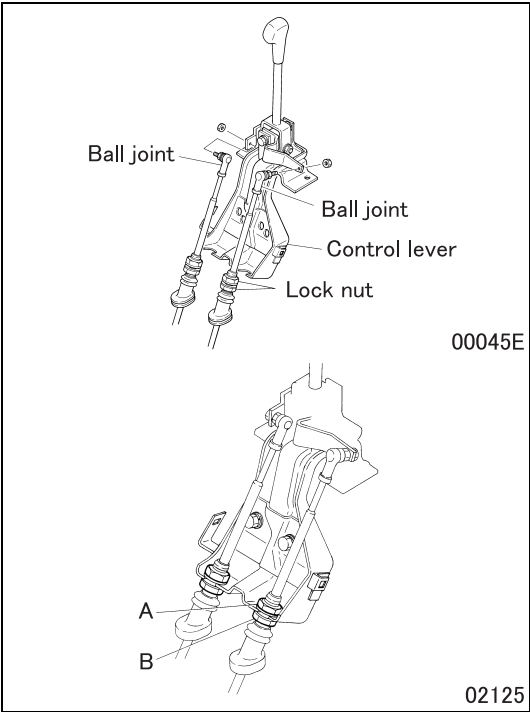
- Tilt the cab down.
- Install the control lever.
- Install the cable on the control lever temporarily and connect the ball joint to the shift lever and select lever. Arrange the cable so that it is not twisted, then tighten lock nuts permanently.

- **When installing the lock nut, tighten lower nut B. Do not move upper nut A.**

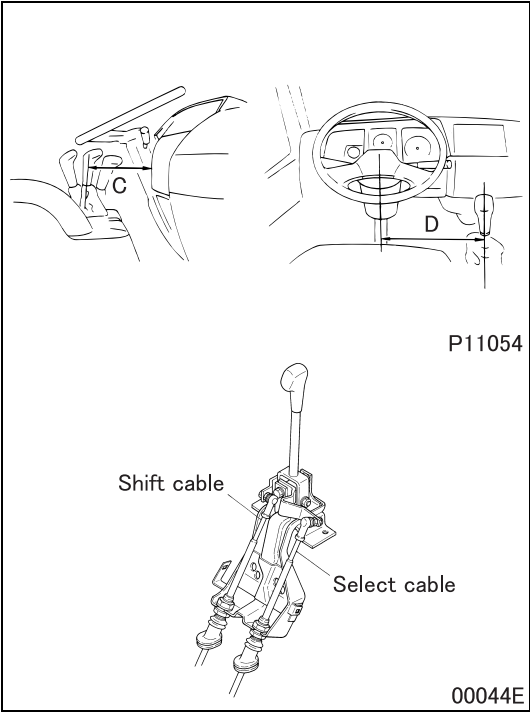
- If the gear shift lever leans to the front or rear, or to the left or right, excessively, adjust the length of the cable and the position of the gear shift lever.

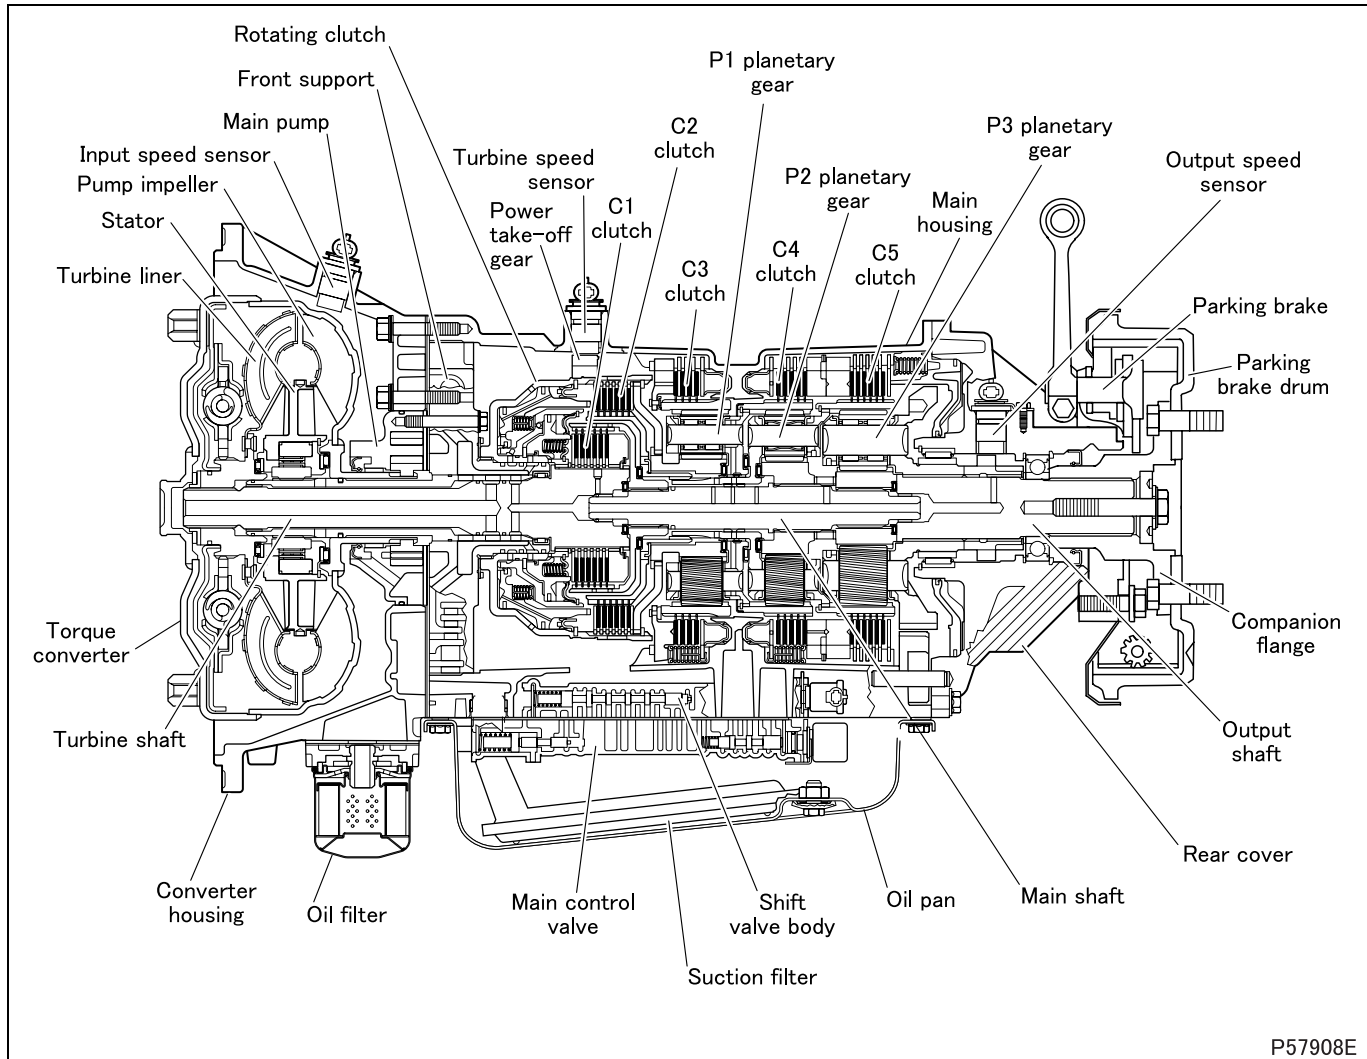
## 1.1 Automatic transmission

- This automatic transmission is a combination of a torque converter with lock-up mechanism and full automatic 5-speed gear system.

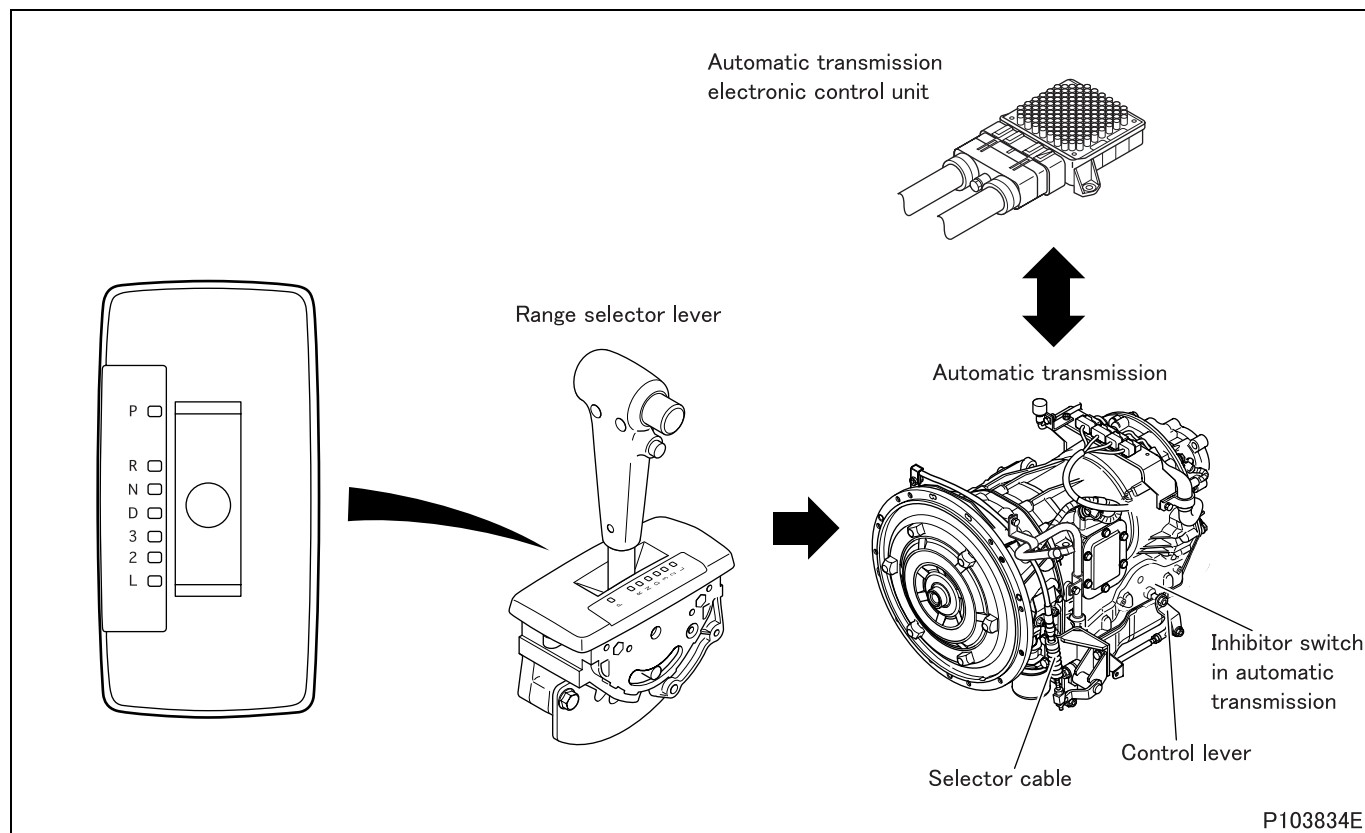
## 1.2 Automatic transmission control

- When the range selector lever is operated to a desired range position, the control lever is rotated via the selector cable and the selected range is detected by the inhibitor switch.
- The detected range is transmitted to the automatic transmission electronic control unit, which in turn sends a corresponding speed change command to the automatic transmission.

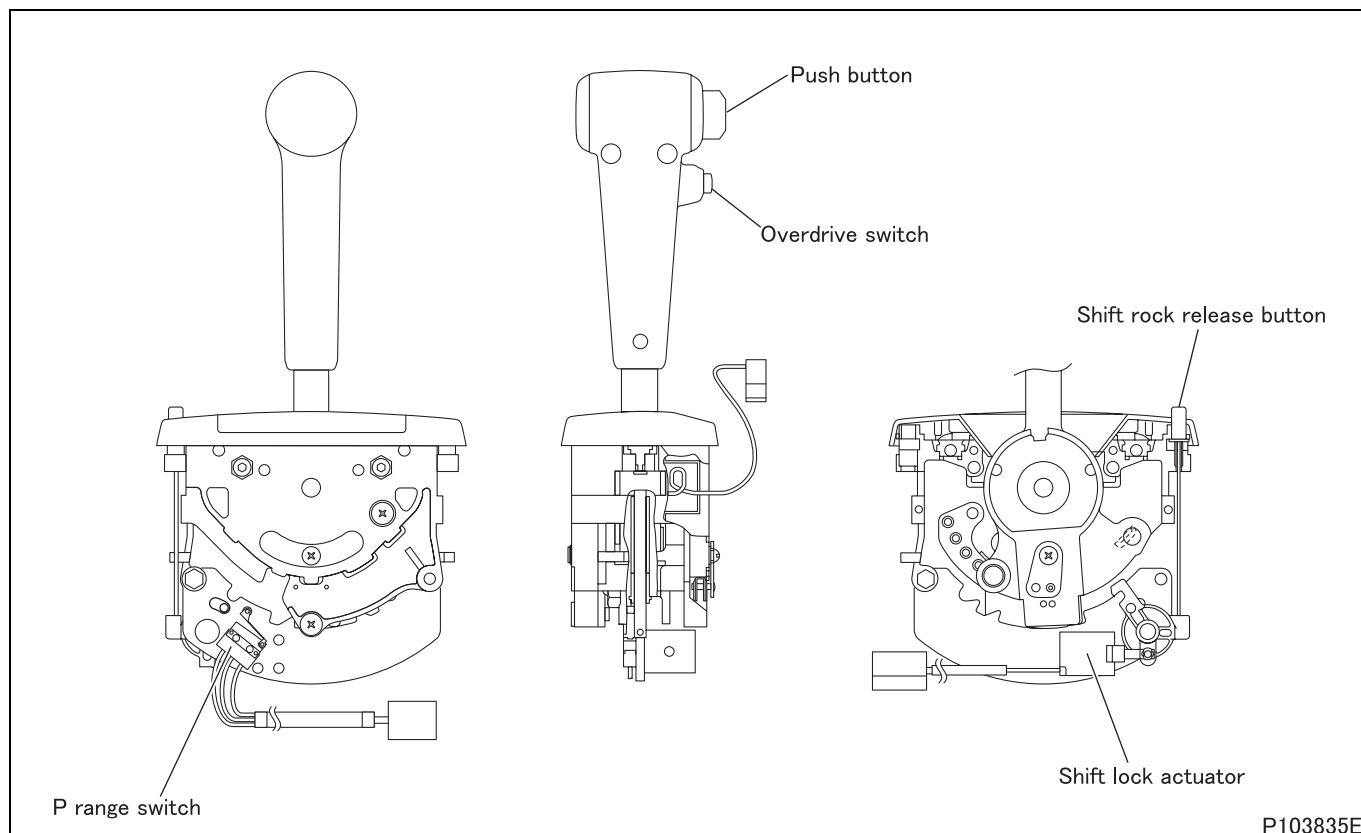
### 1.3 Range selector lever

- The P range switch detects whether the range selector lever is in P range to control the key interlock function.
- The shift lock actuator is used to control the P shift lock function.
- The shift lock release button releases the P shift lock function mechanically without using the shift lock actuator. This button is used when the P shift lock function is faulty.

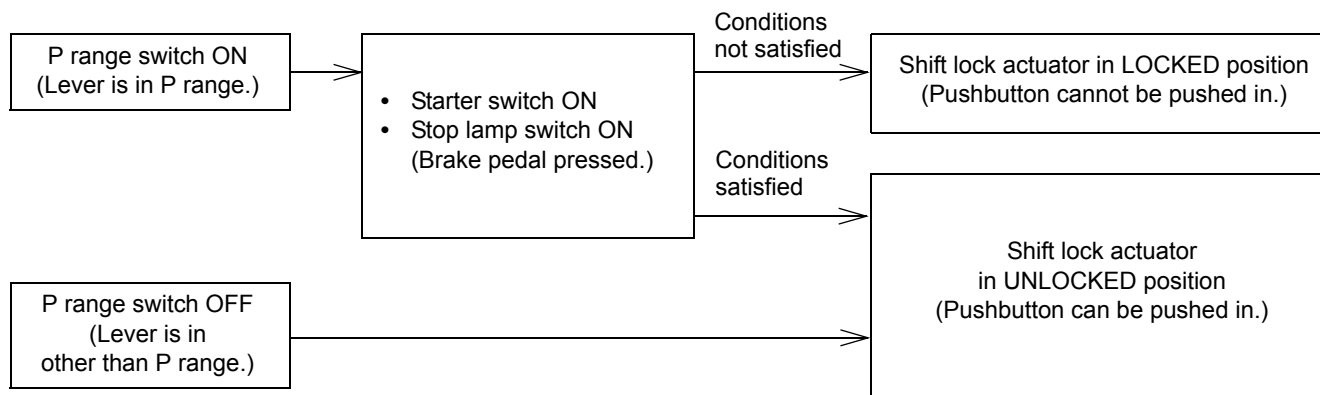
## (2) P shift lock function

- When shifting gear from P range, if the operation condition of the shift lock actuator is not satisfied, the pushbutton on the range selector lever cannot be pushed in (the gearshift cannot be performed).

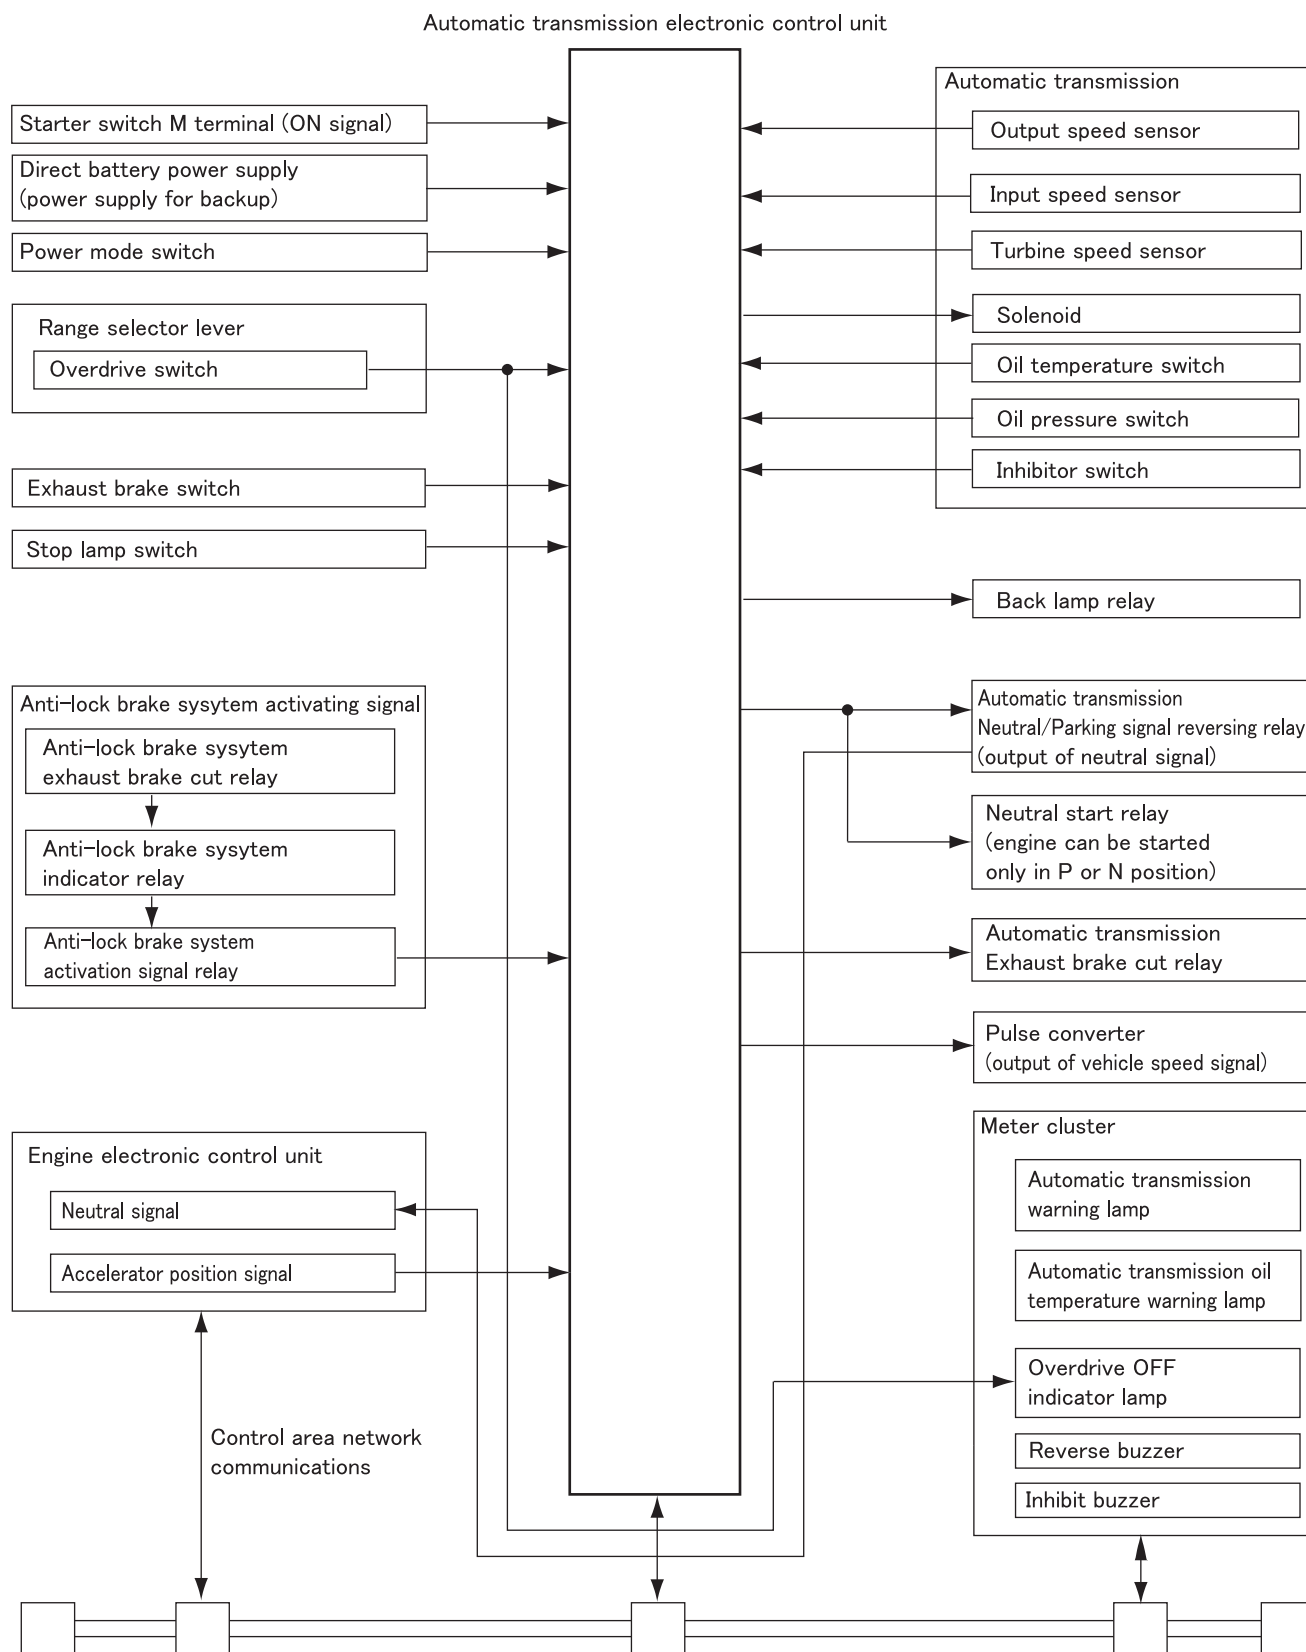
P104669E

### 2.1 System block diagram

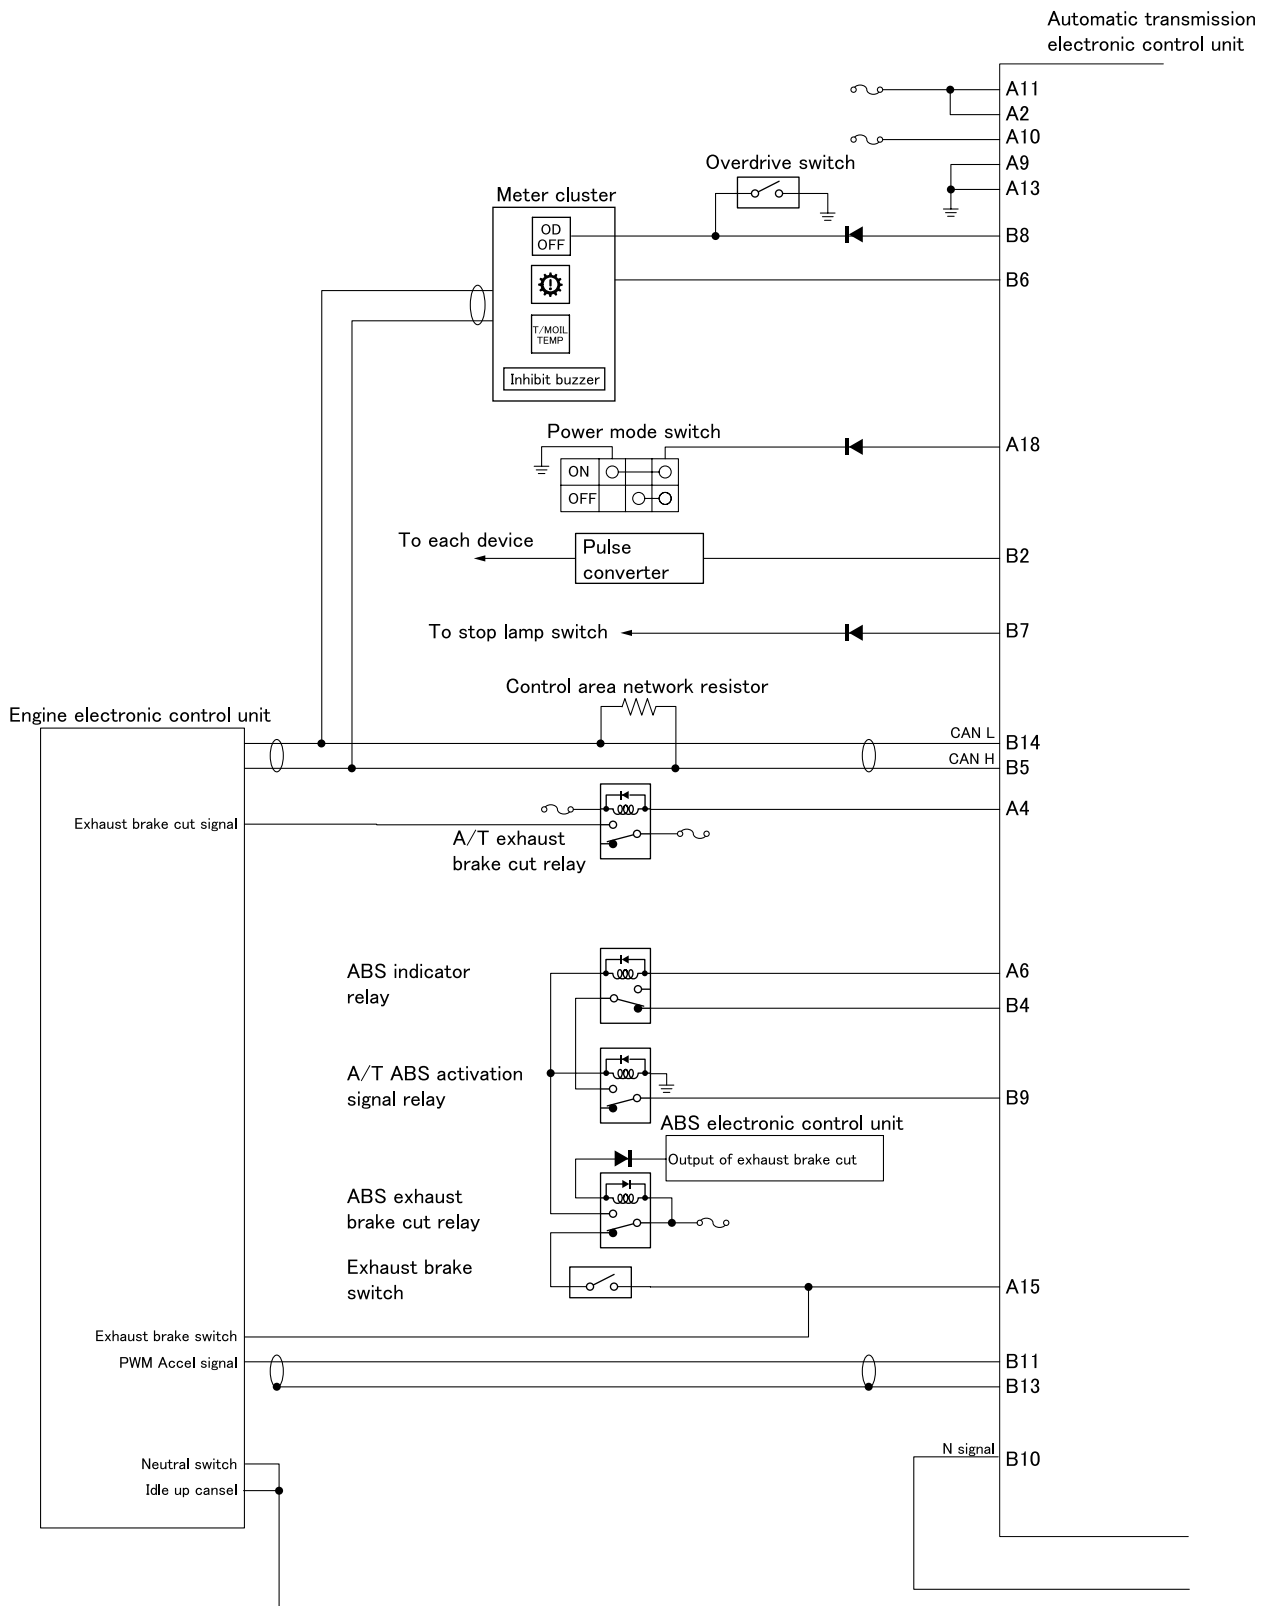
## 3. Electronic Control Unit Connection Diagram

ABS : Anti-lock brake system  
A/T : Automatic transmission

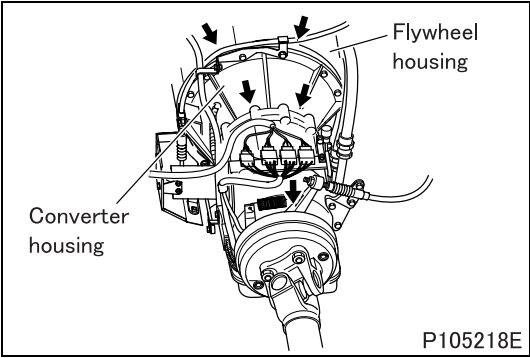
### 1.1 Inspection of oil leakage at each part of transmission body

- Check the oil leakage at each part of automatic transmission body in visual.  
If the oil leakage is found, replace the defective part.

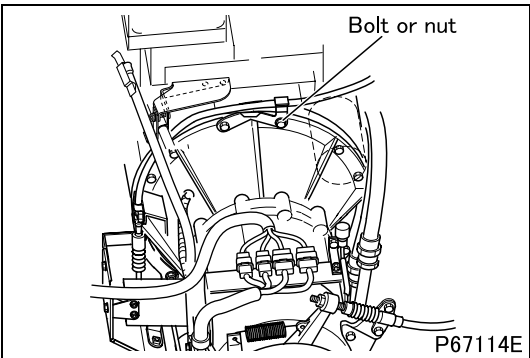
- Check the automatic transmission mounting bolts or nuts for looseness.
- Retighten any loose bolt or nut to the specified torque.

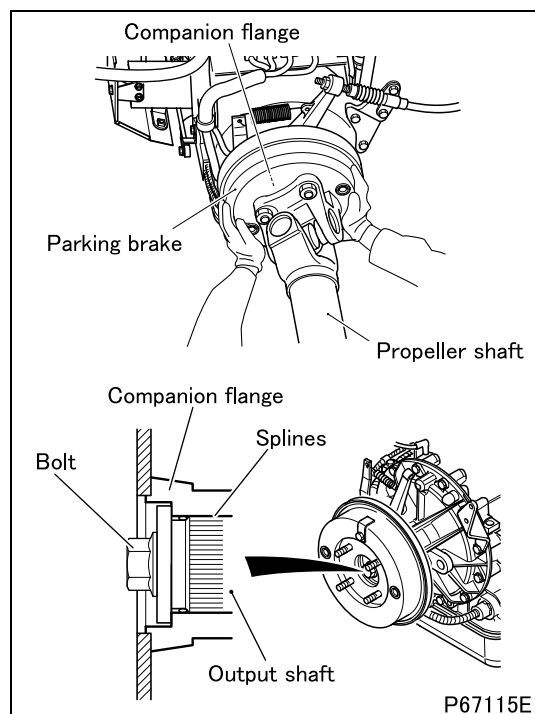
- Move the companion flange and parking brake <FK61> in axial and vertical directions to check for excessive play between the companion flange and output shaft.
- If excessive play is detected, remove the propeller shaft, then check the bolt for looseness and the splines on companion flange and output shaft for abnormalities.
- If any bolt is loose, tighten it to the specified torque.
- If the companion flange is found defective, replace the part. (See “parking brake”.)
- If the companion flange is not found defective, the output shaft may be defective, contact the Allison Service Station for repair.

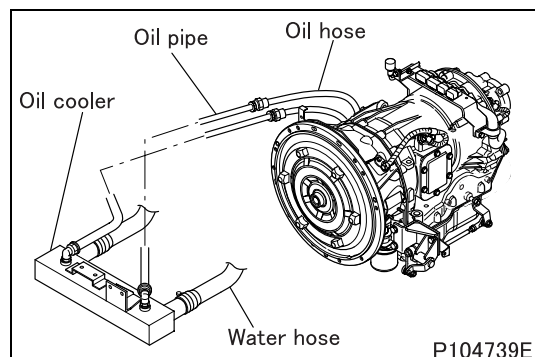
- Check the automatic transmission cooling system for fluid leak and damage. If any abnormality is found, replace the faulty part.

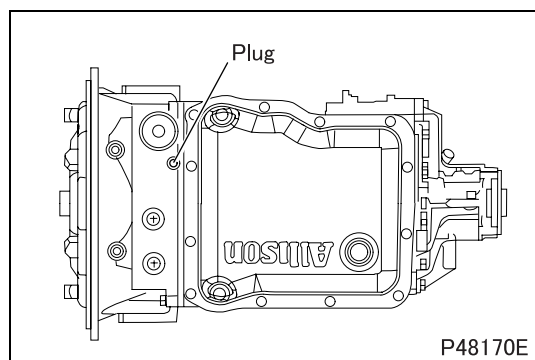
- Remove main oil pressure plug (7/16 UNF-2A) on the lower part of the transmission case, and install the pressure gauge.
- Be sure to prevent foreign particles from entering the pressure detecting port.
- Conduct a sufficient warm-up operation, and raise oil temperature to 60 to 80°C {140 to 176°F} (for reference: run the vehicle for 20 to 30 minutes).
- Lift up the vehicle so that the rear wheels can rotate.
- Measure the oil pressure in each range when the engine runs at 600 rpm and 2100 rpm, and make sure whether the result is within the standard value.
- When having finished the measurement, remove foreign particles in the pressure detection port before installing the plug, then tighten plug to the specified torque.

- The main oil pressure is low in all ranges.
  - Too low automatic transmission fluid level
  - Clogged filter element
  - Clogged suction filter
  - Faulty control valve (leaking or sticking inside)
  - Worn or damaged oil pump
- If the automatic transmission proper is found defective, contact the Allison Service Station for repair.

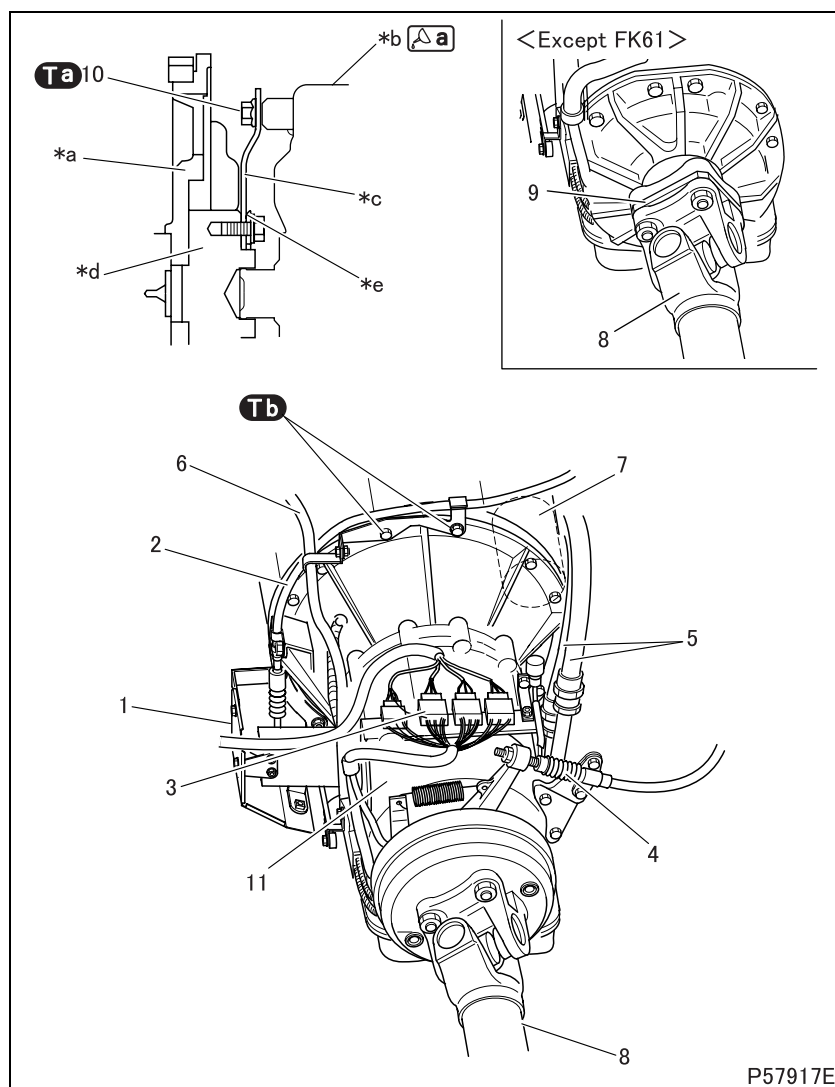
# REMOVAL AND INSTALLATION OF AUTOMATIC TRANSMISSION

- 1 Control cover
- 2 Selector cable (See AUTOMATIC TRANSMISSION CONTROL.)
- 3 Harness connector
- 4 Parking brake cable
- 5 Oil hose (See OIL COOLER.)
- 6 Level gauge
- 7 Starter (See Gr54.)
- 8 Propeller shaft (See Gr25.)
- 9 Spacer <Except FK61>
- 10 Flex bolt
- 11 Automatic transmission

- \*a:** Flywheel  
**\*b:** Torque converter  
**\*c:** Flex plate  
**\*d:** Flywheel adapter  
**\*e:** Wear plate

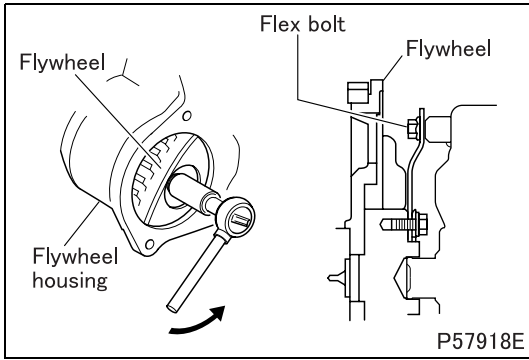
### ■ Removal: Automatic transmission

- Place the automatic transmission in N range.
- Turn flywheel to remove flex bolts in succession.

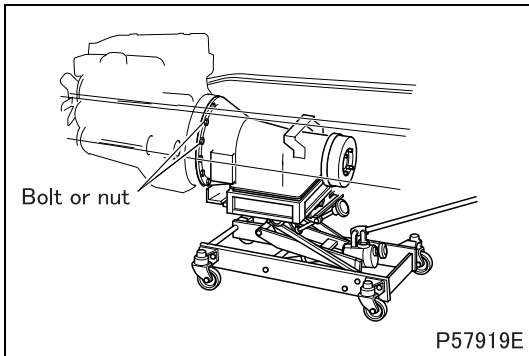
- Pinch the oil pan of automatic transmission with blocks of wood, and support it with jack to remove automatic transmission mounting bolt or nut.
- Remove automatic transmission by pulling it out backward.

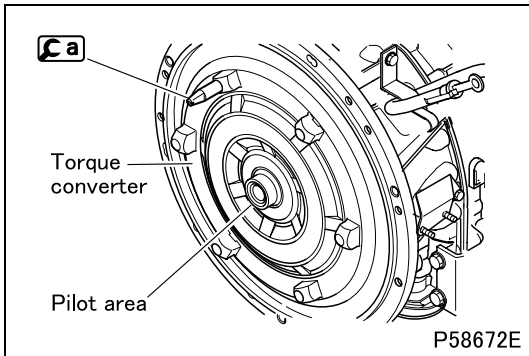
### ■ Installation: Automatic transmission

- Apply grease to pilot area of torque converter.
- Install **Ca** at least one location in the tapped hole on the periphery of torque converter.

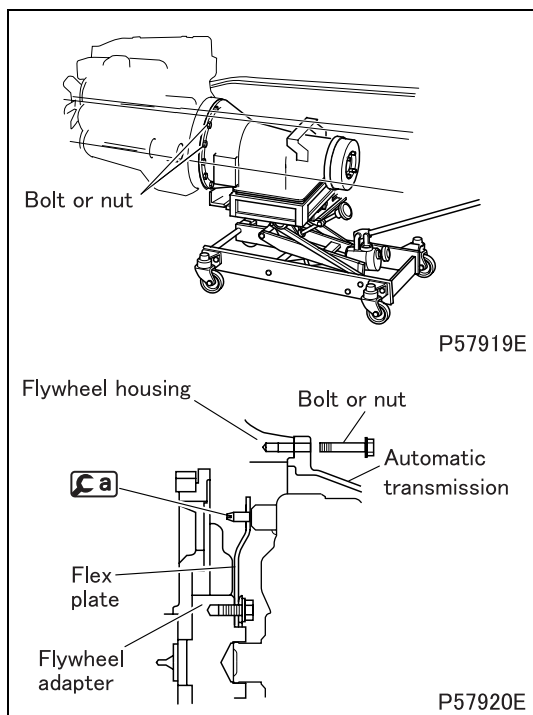
- Install automatic transmission on flywheel housing so that **Ca** aligns with the hole in the flex plate installed on the flywheel.
- Tighten automatic transmission mounting bolt or nut to the specified torque.

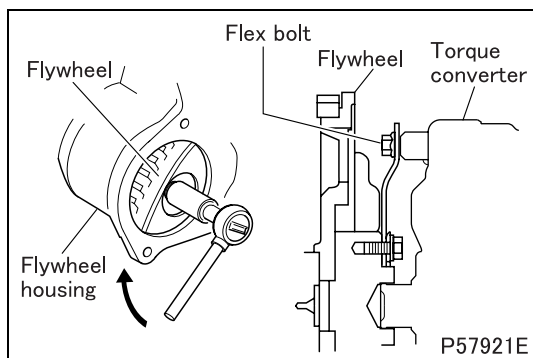
- Turn flywheel, and temporarily tighten flex bolts in succession from the starter window (six locations).
- Where **Ca** is installed, remove **Ca** to install flex bolts.
- Finally, fully tighten flex bolts to the specified torque.

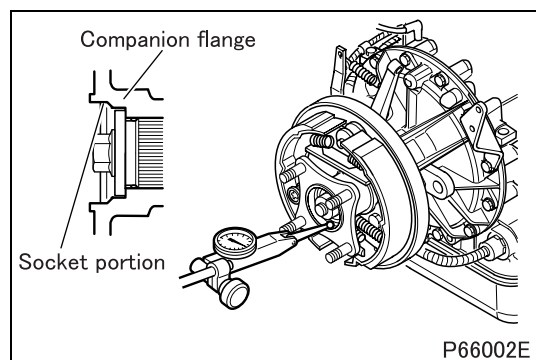
**■ Inspection: Runout of socket portion of companion flange**

- Replace the companion flange if the measured value is higher than the limit.

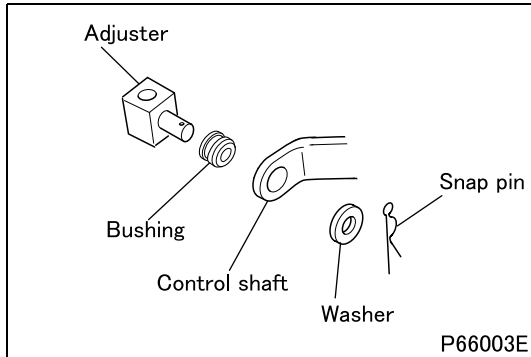
### ■ Installation: Adjuster

- Fit the adjuster to the control shaft and prevent it from coming off with the snap pin. Then, check that the adjuster smoothly rotates in the control shaft.
- If the adjuster does not turn smoothly, replace it together with the washer, snap pin and control shaft. Replace the bushing as well if it is worn out or damaged.

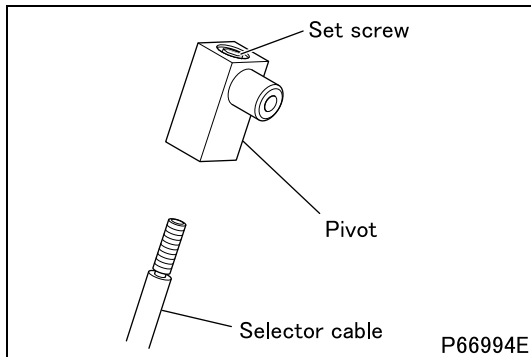
### ■ Installation: Pivot

- Install the pivot onto the threaded end of the selector cable. Using the setscrew on top of it, position the pivot to face in necessary direction.

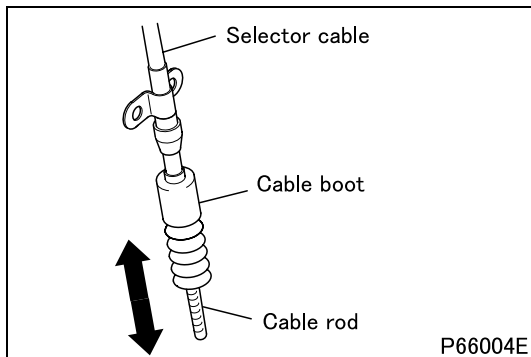
### ■ Installation: Selector cable

- Connect the selector cable to the interior range selector lever. Then, give strokes to the selector lever and if it does not move smoothly, replace the selector cable.
- Replace the selector cable if the cable boot or cable rod is damaged.

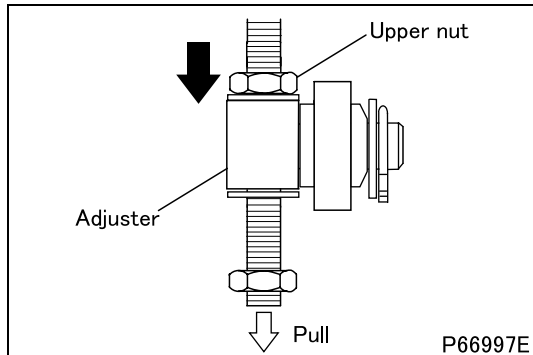
- Pull down the wire end with a force of 10 to 20 N {7.4 ft.lbs (1 to 2 kgf)}.
- Tighten the upper nut by hand until it contacts the adjuster with the load applied.

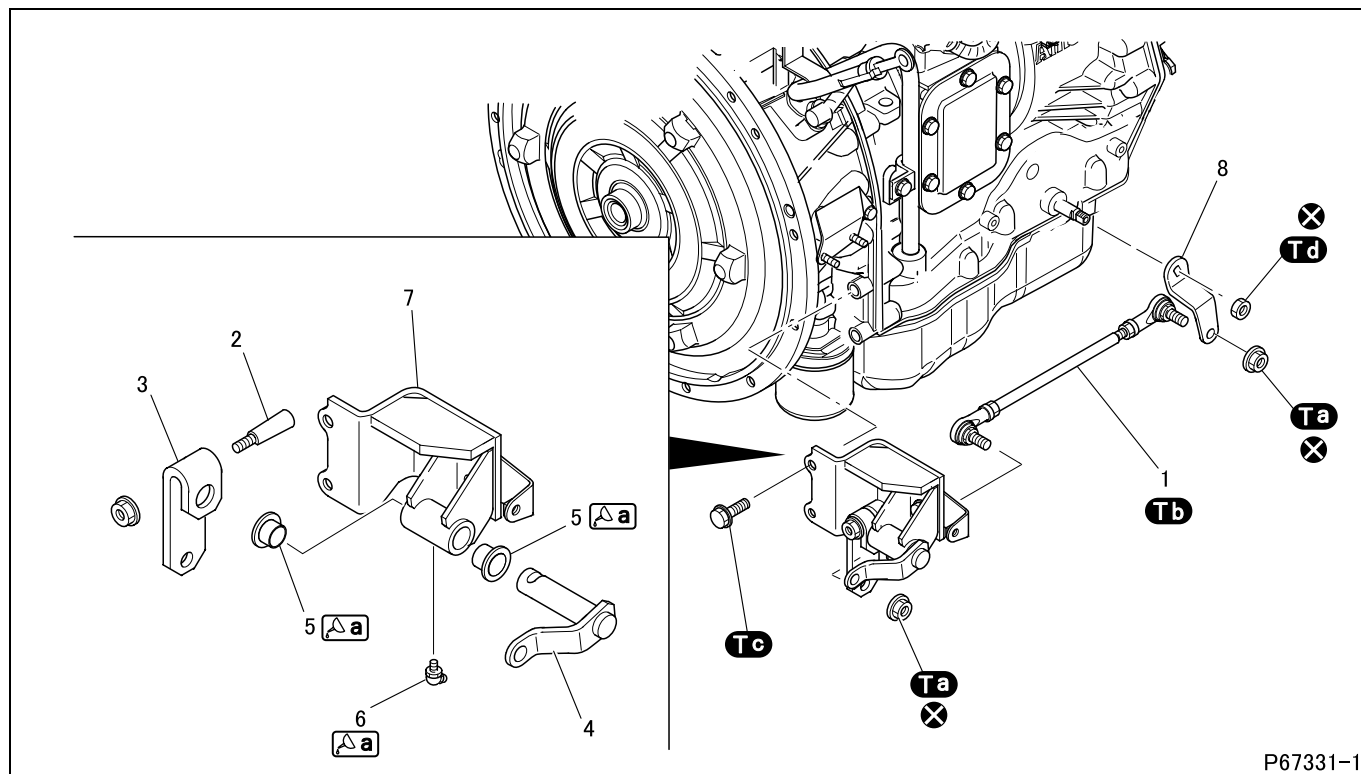
### Control Lever

- 1** Shift rod  
**2** Lock pin  
**3** Select lever  
**4** Control shaft  
**5** Bushing  
**6** Grease nipple  
**7** Control bracket  
**8** Control lever  
 ⊗: Non-reusable part

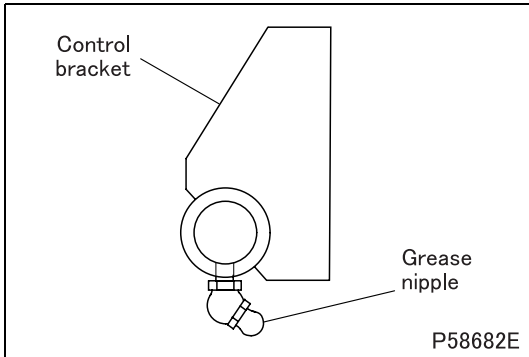
**■ Installation: Grease nipple**

- Screw in grease nipple 2 to 4 mm {0.079 to 0.16 in.} (approx. 3 to 5 turns) to install it to the control bracket in the direction shown in the drawing.

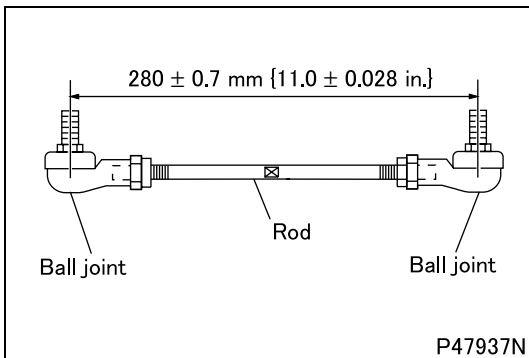
**■ Installation: Shift rod**

- Turn rod to adjust length of shift rod.
- Adjustment should be performed evenly on both the right and left ball joints.

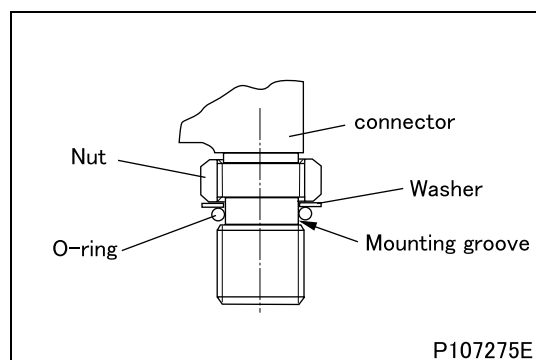
### ■ Installation: Connector

- Tighten the nut of the connector by hand until it touches the connector and install the O-ring securely in the mounting groove.
- Tighten the connector by hand until the washer touches the automatic transmission or oil cooler and then loosen it to the connection angle to the oil pipe.
- While keeping the connector in this position, tighten the nut to the automatic transmission or oil cooler side to the specified torque.
