# FE.FG

## SERVICE MANUAL 2008 Model FOREWORD

This Service Manual contains maintenance and repair methods for the Mitsubishi Fuso Truck FE. FG Series. Read this manual carefully as an aid in providing correct, efficient maintenance. Please note that the information and specifications contained within this manual may change without notice. This is due to product modifications and continued vehicle improvements that are made throughout the model years. Should you encounter any discrepancy in the information provided, please do not hesitate to contact your nearest Mitsubishi Fuso Dealer or Mitsubishi Fuso Truck of America, Inc.

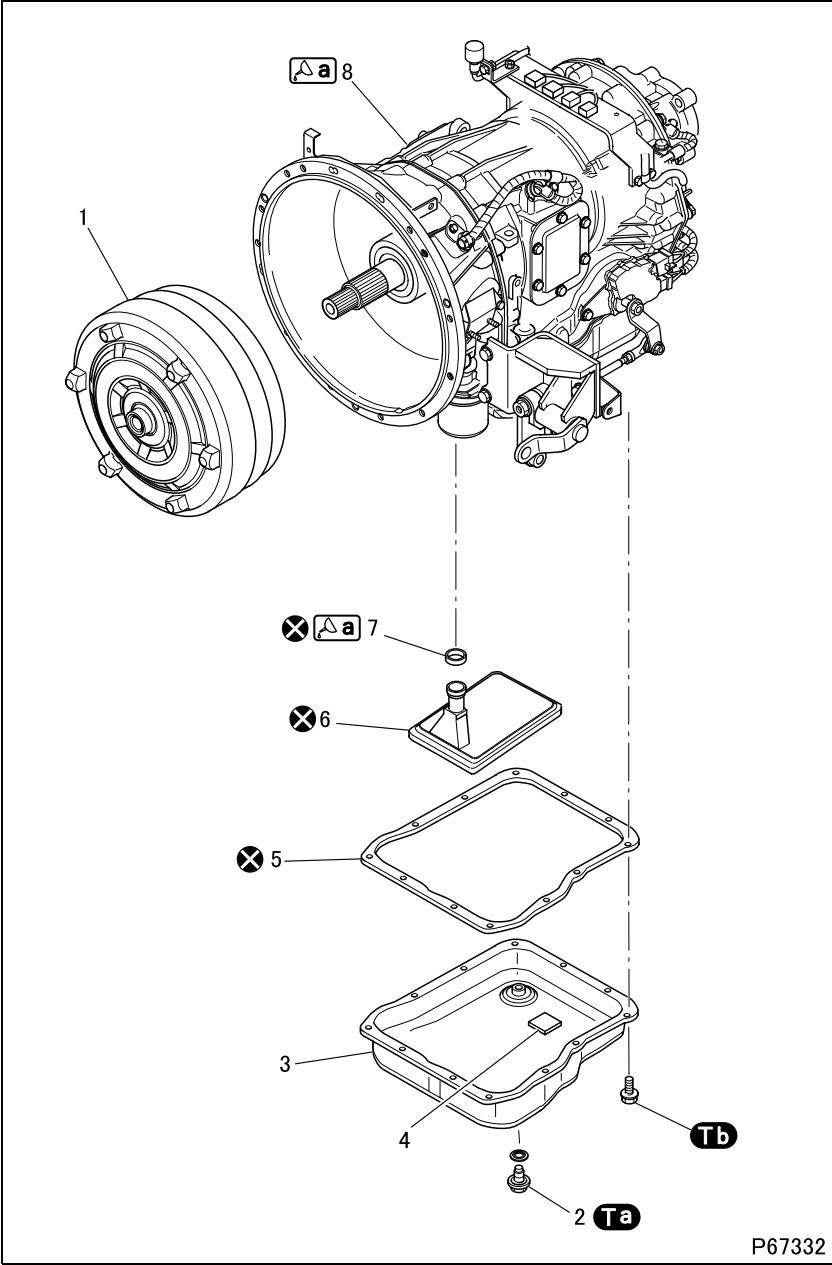
- 1 Torque converter
- 2 Drain plug
- 3 Oil pan
- 4 Magnet
- 5 Gasket
- 6 Suction filter
- 7 Seal ring
- 8 Automatic transmission

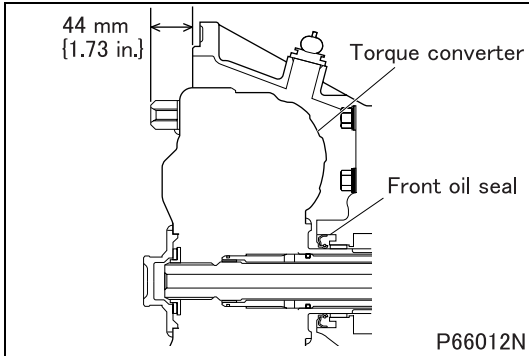
### ■ Installation: Torque converter

- Apply automatic transmission fluid to the front oil seal and install the torque converter.

- When inserting the torque converter, do not damage the front oil seal.
- Measure the depth of the torque converter from its surface to the mounting surface of the case to make sure that the torque converter is installed into position.

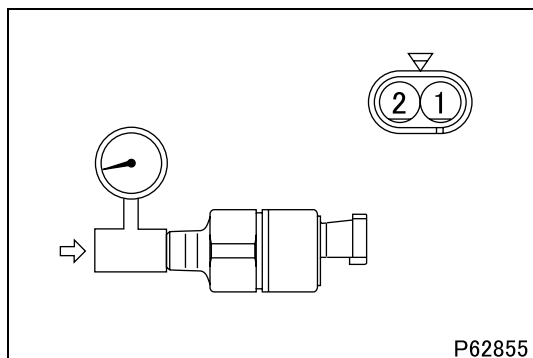
## #042 Inspection of stop lamp switch

- Apply air pressure to the switch gradually from 0 kPa {0 psi, 0 kgf/cm<sup>2</sup>}.
- Measure the air pressure when continuity is established across terminals 1 and 2, and make sure that the air pressure is within the standard value.

| Standard value (operating pressure) | 29 ± 9.8 kPa {4.2 ± 1.4 psi, 0.3 ± 0.1 kgf/cm <sup>2</sup> } |

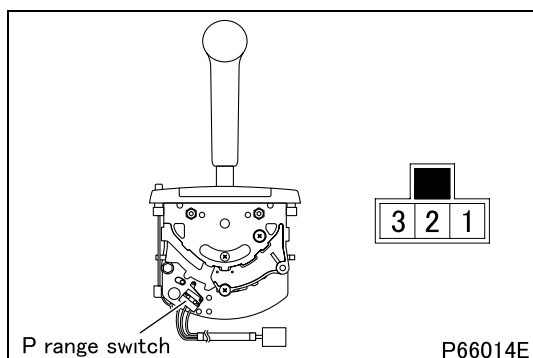
| Item | | Specifications | |
|---|---|---|---|
| | 3rd | 2.415 | 3.064 |

| Switch position | Terminals with continuity |
| Except P range position | 2 – 3 |

- If any abnormality is found, replace the range selector lever.

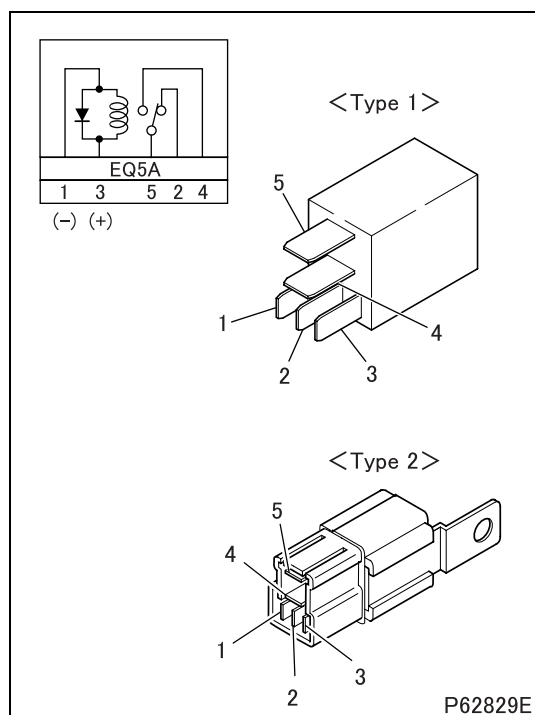
### #201 Inspection of relay (normally open type, 5-pin)

- Perform a continuity check and an operation check. If there is any abnormality, replace the relay.

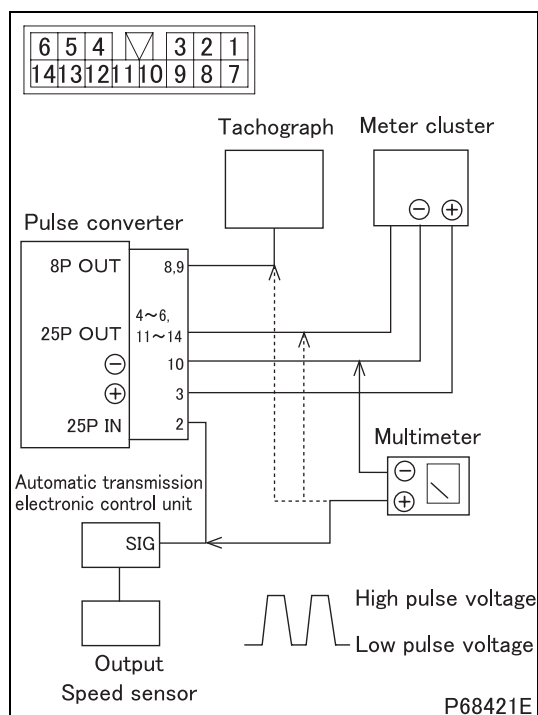
### #352 Inspection of pulse converter

- Check the pulse converter with the automatic transmission electronic control unit installed in the vehicle.
- With the starter switch in the ON position, slowly turn the wheels by means of a chassis dynamo or any other appropriate means.
- Measure the maximum voltage (high pulse voltage) and minimum voltage (low pulse voltage) values of the voltage between each of input and output terminals and terminal 10 of the pulse converter.

- If measurement meets the standard value, signals from the automatic transmission electronic control unit should be normal. Accordingly, replace the pulse converter.
- If measurement deviates from the standard value, check the automatic transmission.

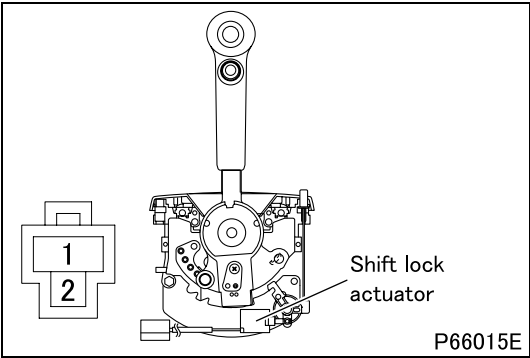
## #535 Inspection of shift lock actuator

- This inspection should be performed after the P range switch inspection.
- Shift the range selector lever in P range.
- Check that the pushbutton cannot be pressed (the lever cannot be shifted from P range to other ranges).
- Starting from 0 V, gradually apply direct current voltage between the terminals 1 and 2.
- Measure the voltage when it becomes possible to press in the pushbutton and shift from P range to other ranges.

- If any abnormality is found, replace the range selector lever.

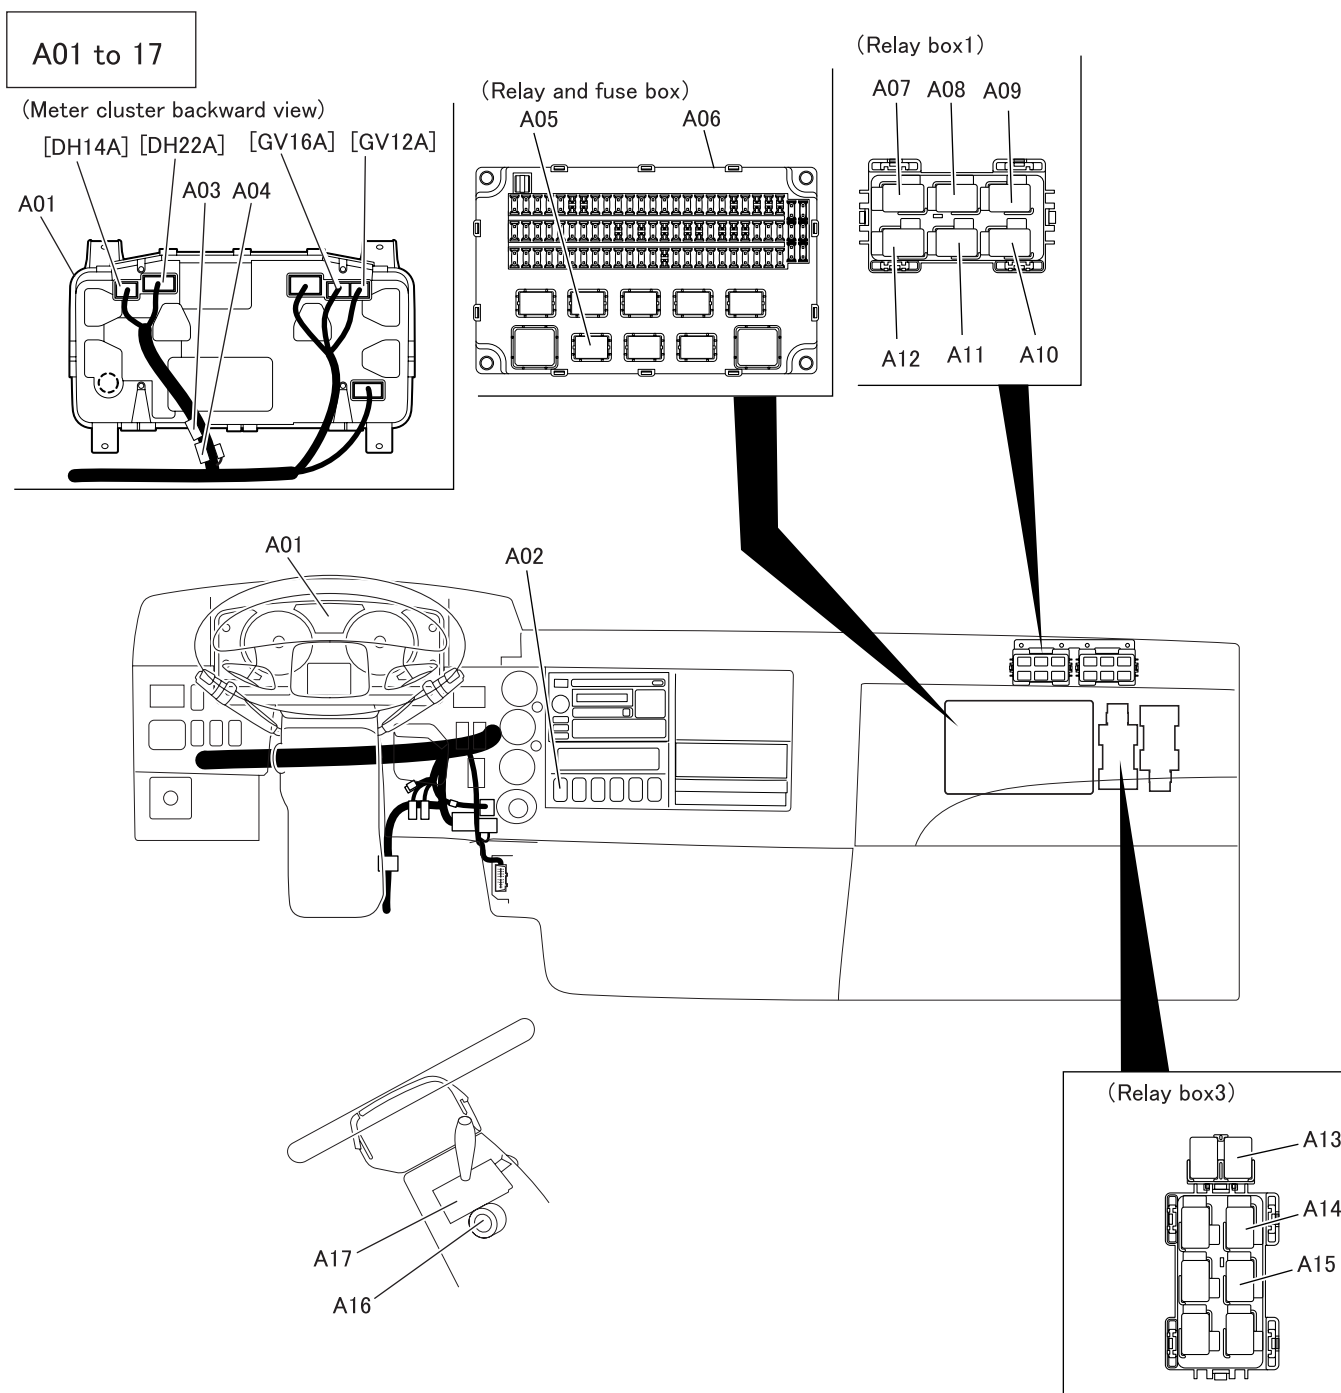
- A01 Meter cluster
- A02 Power mode switch
- A03 Joint connector (J/C-2)
- A04 Joint connector (J/C-6)
- A05 Stop lamp relay
- A06 Relay and fuse box
- A07 P shift lock relay
- A08 A/T N/P signal reversing relay
- A09 A/T exhaust brake cut relay

- A10 ABS indicator relay
- A11 A/T ABS activation signal relay
- A12 A/T back lamp relay
- A13 Neutral start relay
- A14 Safety relay
- A15 ABS exhaust brake cut relay
- A16 Starter switch
- A17 Combination switch

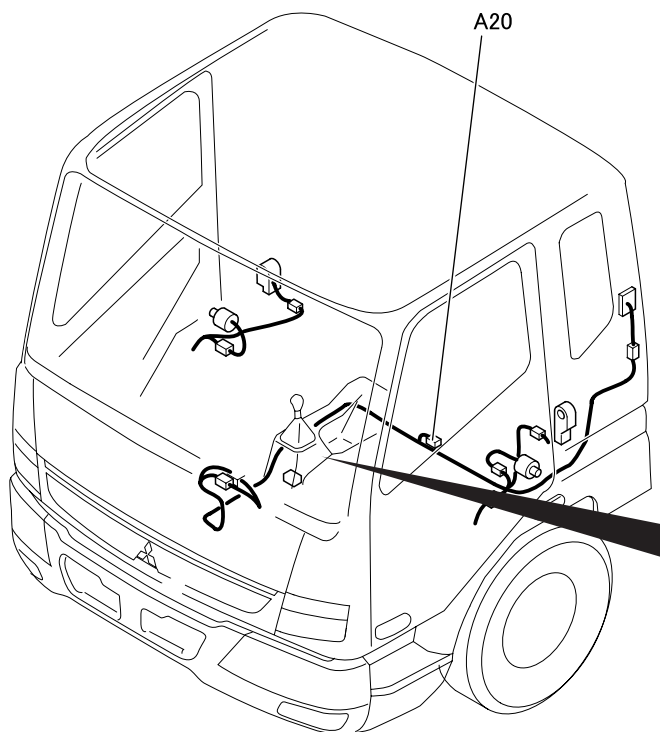
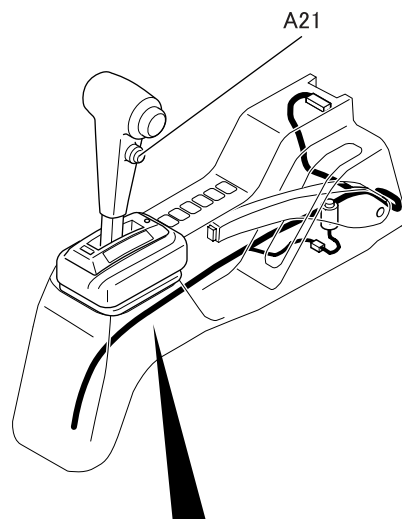
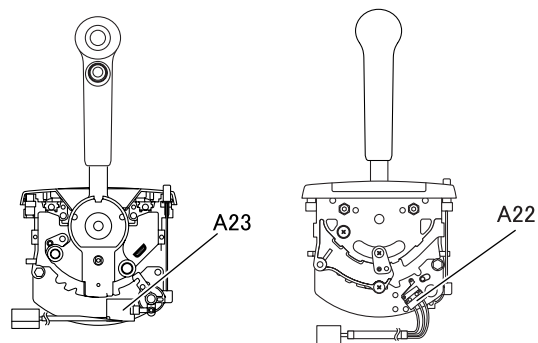
## A20 to 23

- A20 Diode unit
- A21 Over drive switch
- A22 P range switch
- A23 Shift lock actuator

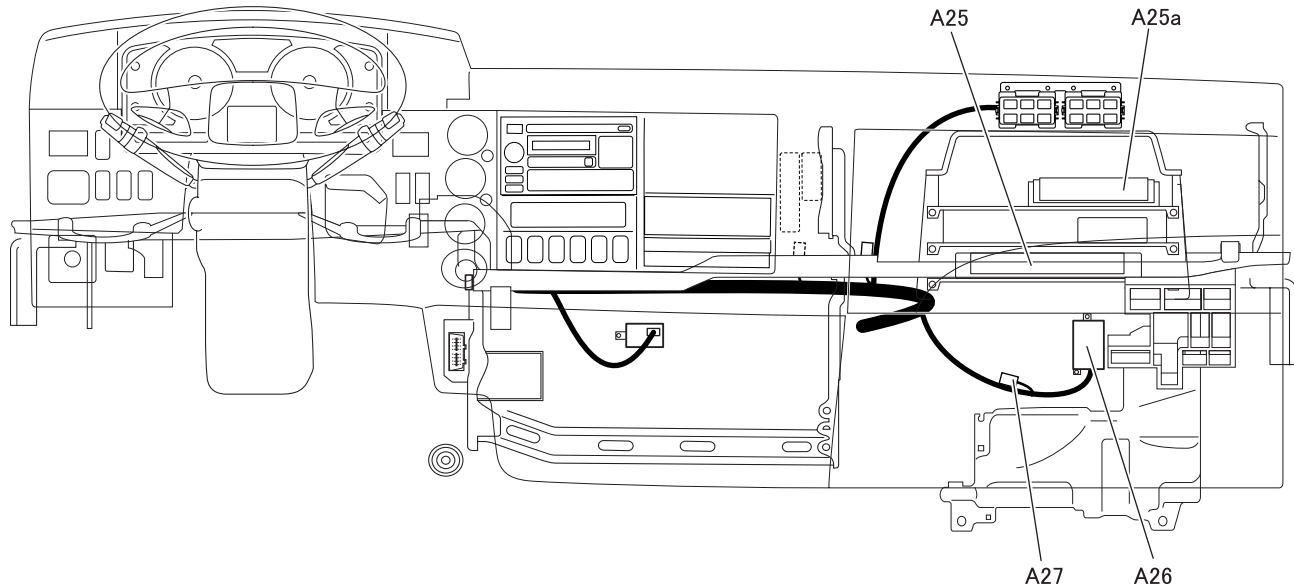
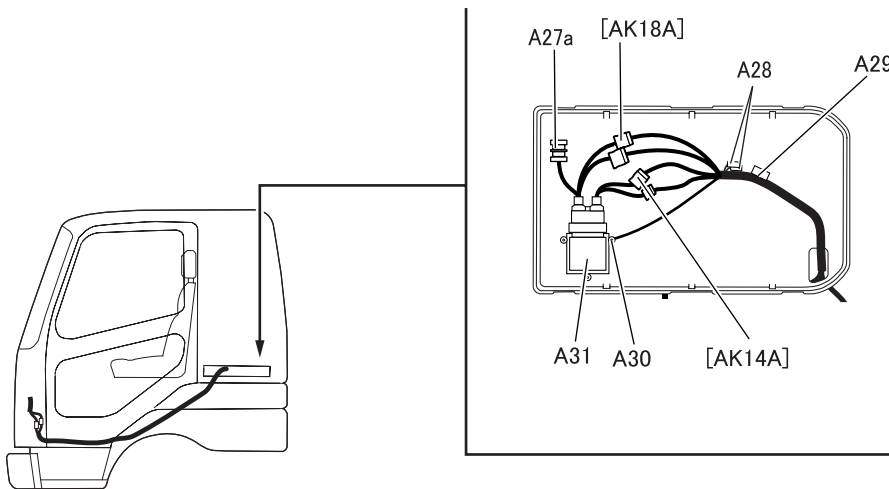
A25 to 31

- A25 Engine ECU
- A25a ABS ECU
- A26 Pulse converter
- A27 Diode unit
- A27a Diagnostic connector  
(For allison exclusive diagnosis tool)
- A28 CAN resistor  
Diode unit
- A29 Joint connector (J/C)
- A30 Ground
- A31 A/T ECU

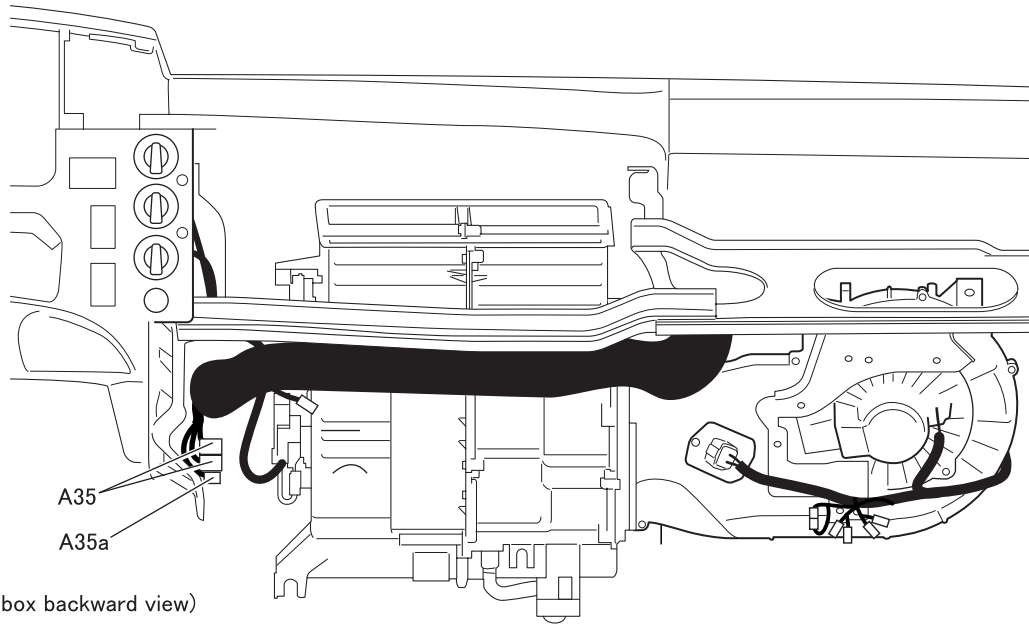
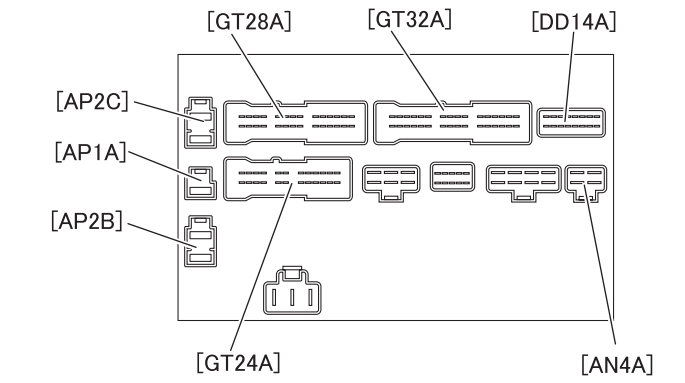
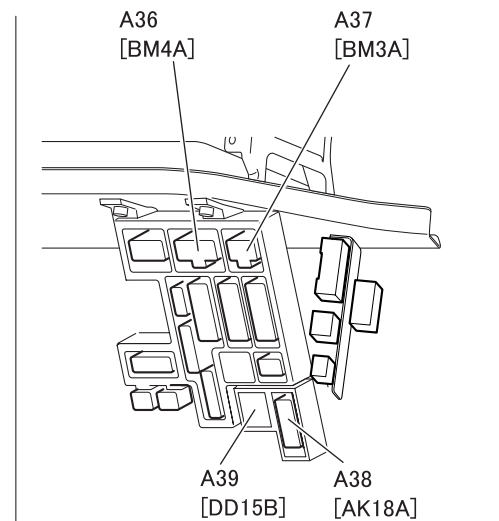
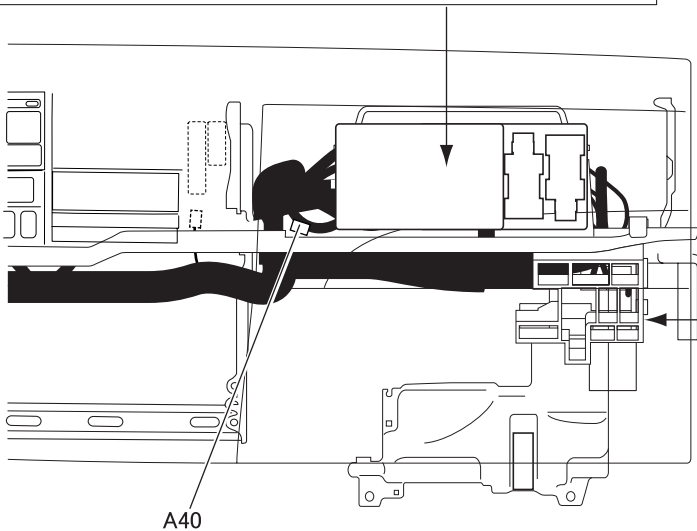
## A35 to 40

(Relay and fuse box backward view)

- A35 Connection of cab harness and A/T harness
- A35a Connection of cab harness and center floor harness
- A36-37 Connection of cab harness and chassis harness
- A38-39 Connection of A/T harness and chassis harness
- A40 Joint connector (J/C-1, 3, 4)

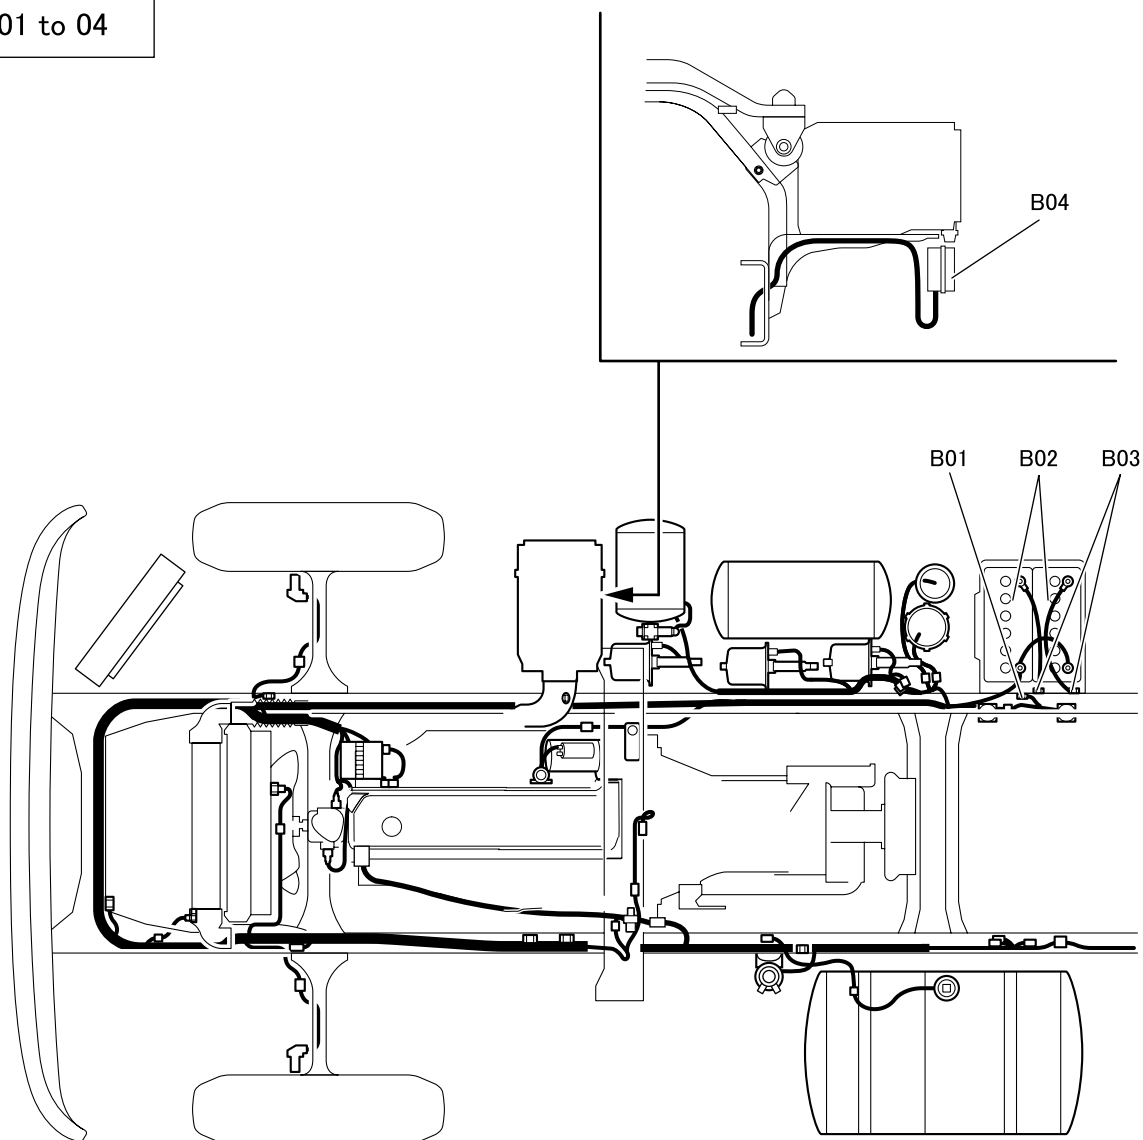
B01 to 04

- B01 Ground
- B02 Battery
- B03 Ground
- B04 High-current fuse box

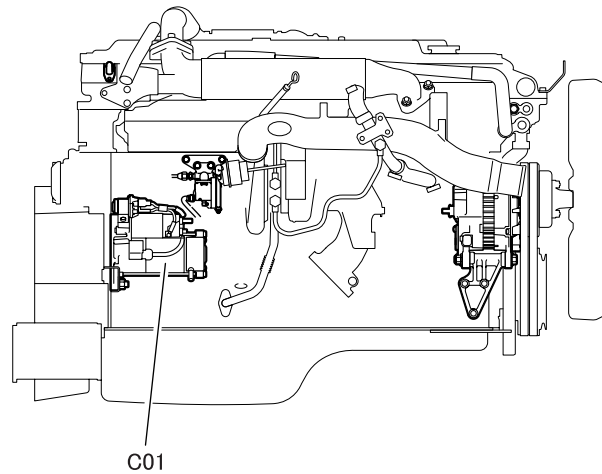
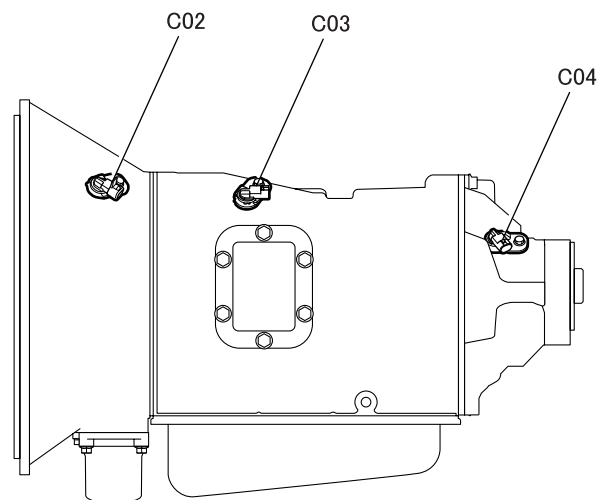
C01 to 04

- C01 Starter
- C02 Input speed sensor
- C03 Turbine speed sensor
- C04 Output speed sensor

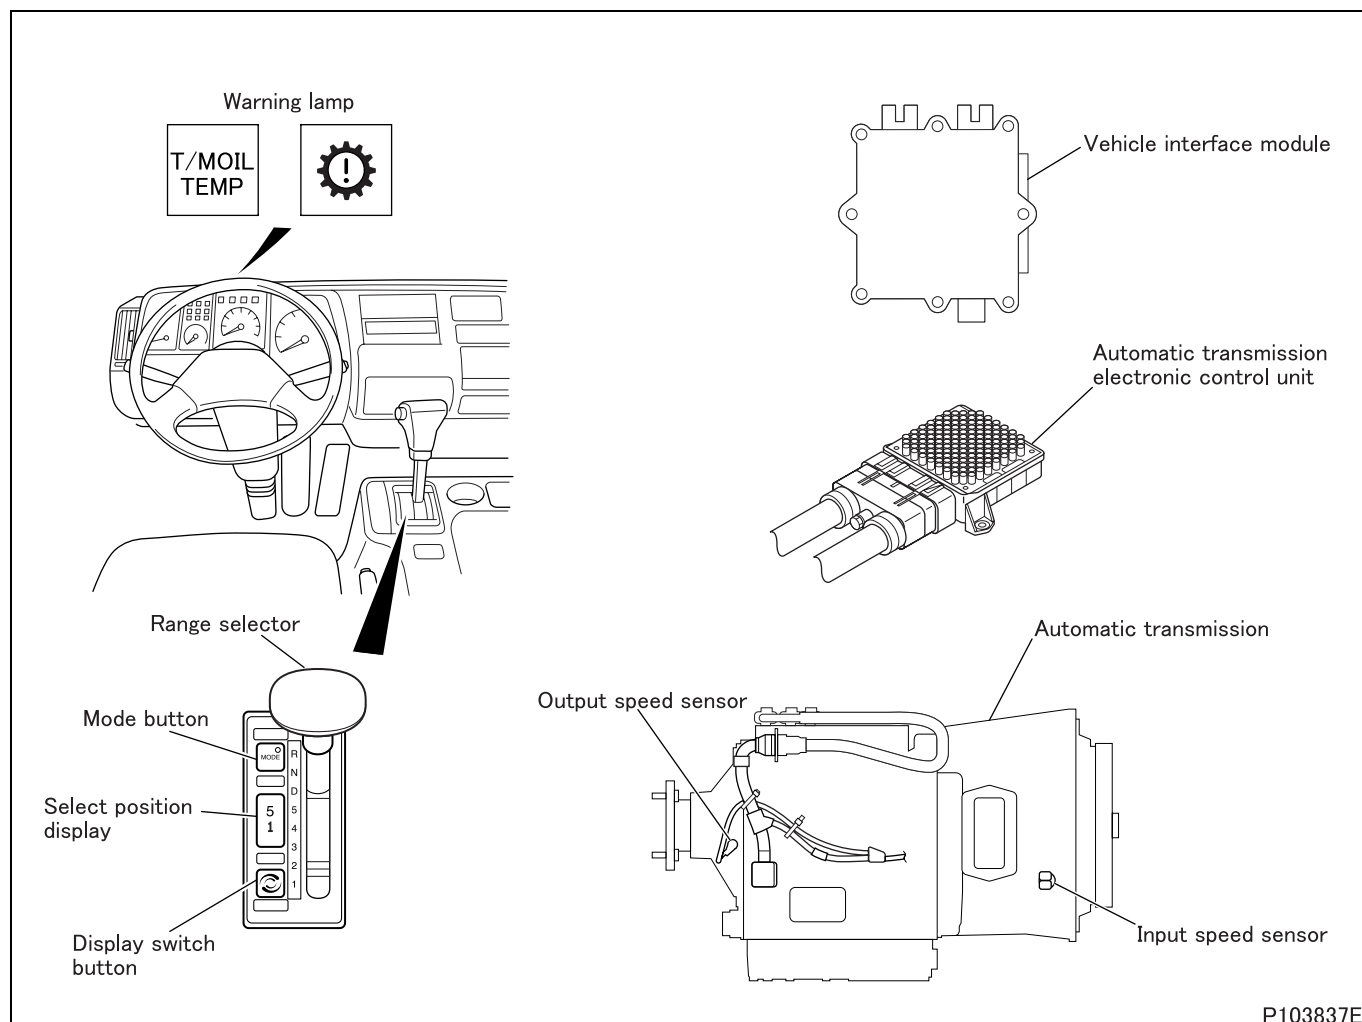
## 2. Automatic Transmission Control System

- Electronic control (ATEC: Allison Transmission Electronic Control) system is composed of vehicle interface module, automatic transmission electronic control unit, range selector, throttle position sensor, electronic hydraulic valve body, and harnesses connecting these units.
- The automatic transmission electronic control unit receives electric signals, which are sent by each sensor and shift selector, processes them, transmits the signals to an appropriate solenoid, and thereby controls the transmission.

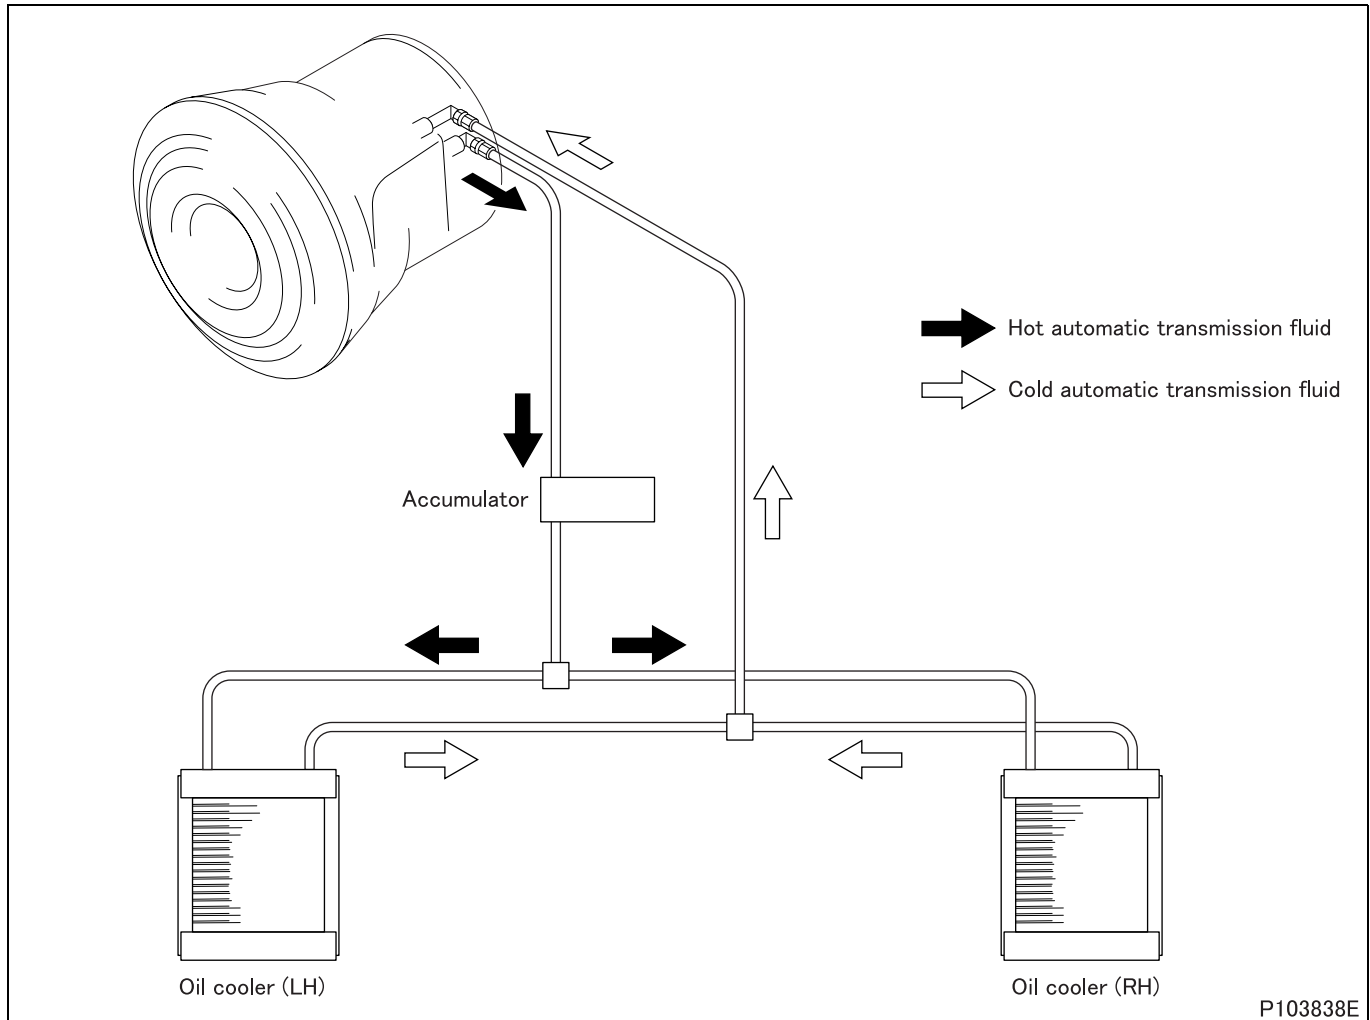
## 3. Oil Cooler System

- As the automatic transmission operates, the automatic transmission fluid becomes high temperature. Then the high temperature fluid is cooled down by two oil coolers and returned to recirculate in the automatic transmission again.
- The automatic transmission fluid also becomes high pressure due to the operation of the automatic transmission. To regulate the fluid pressure to keep the oil line from overloading, an accumulator is provided.

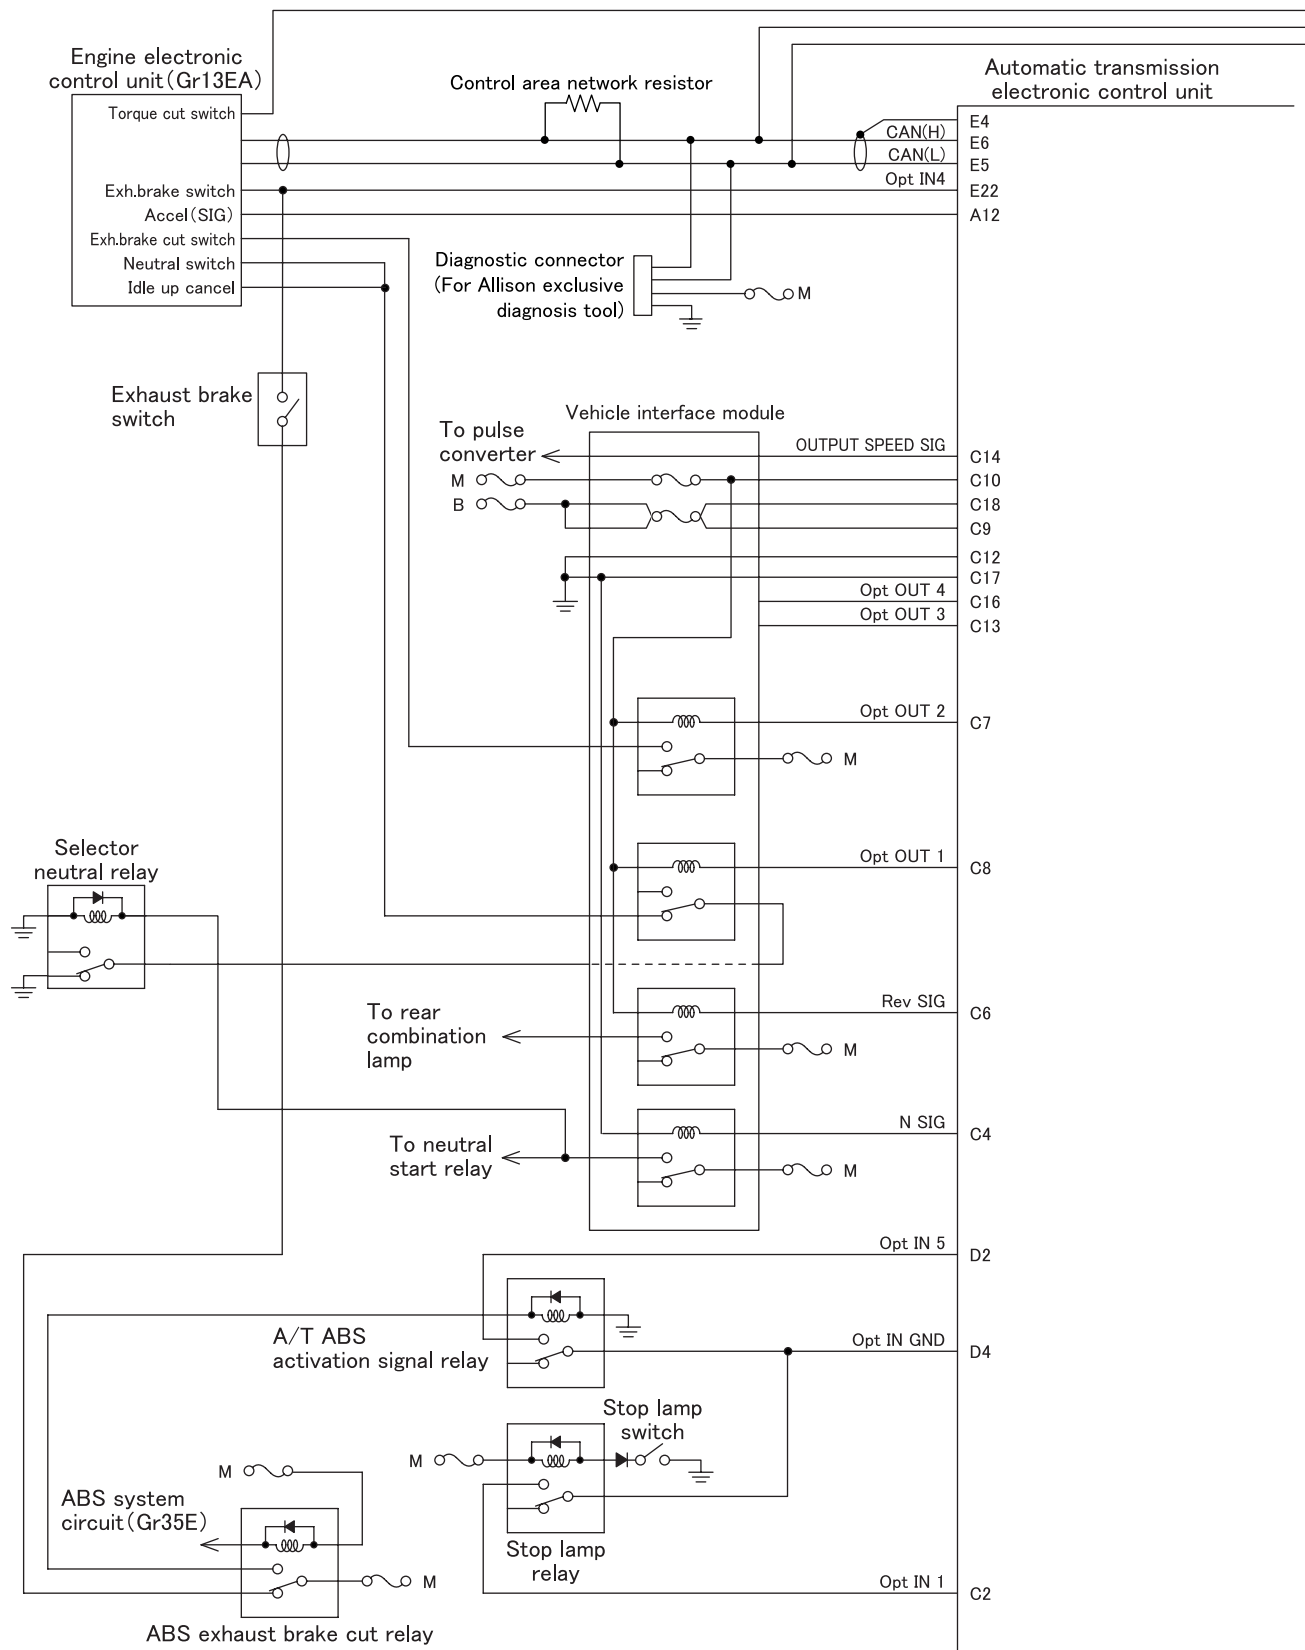
## 4. Electronic Control Unit Connection Diagram

B: Direct battery power supply  
M: Starter switch M terminal power supply  
ABS: Anti-lock brake system  
A/T: Automatic transmission

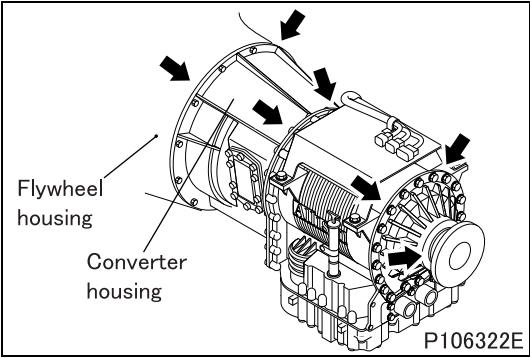
## 1. Inspection of Automatic Transmission Oil Leakage

- Check the oil leakage at each part of automatic transmission body in visual.  
If the oil leakage is found, replace the defective part.

- Check there is not oil stain on flywheel housing and automatic transmission mounting part caused by oil leakage from engine.
- If there is the oil stain, remove the automatic transmission and clean the mounting surface of converter housing and flywheel housing using brake cleaner etc. after repairing oil leakage part. Because the oil stain may loosen the automatic transmission mounting bolts. (See “REMOVAL AND INSTALLATION OF AUTOMATIC TRANSMISSION”.)

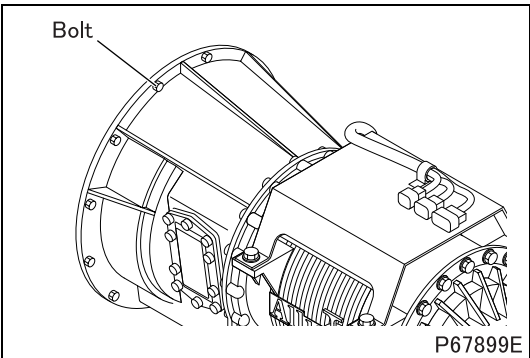
## 2. Check for Looseness in Automatic Transmission Mounting Bolts

| Mark | Parts to be tightened | Tightening torque | Remarks |
|---|---|---|---|
| — | Bolt (automatic transmission mounting) | 40.2 {30, 4.1} | — |

- Check the automatic transmission mounting bolts for looseness.
- Retighten any loose bolt to the specified torque.

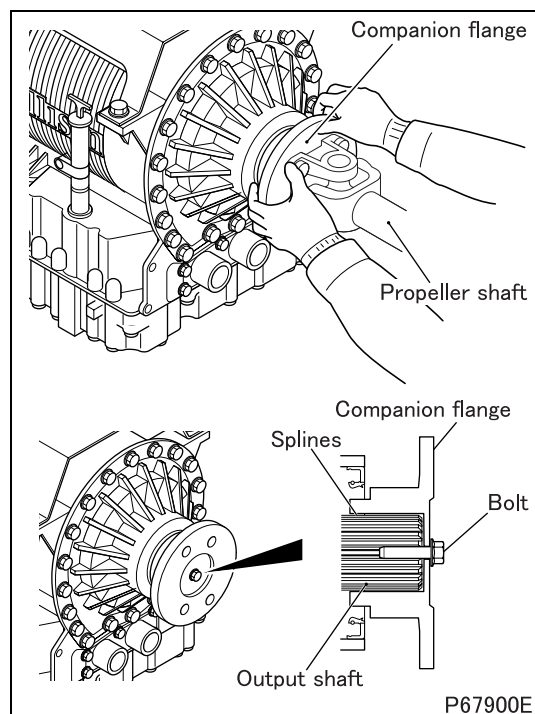
### 3. Inspection of Play and Looseness in Companion Flange

| Mark | Parts to be tightened | Tightening torque | Remarks |
|---|---|---|---|
| – | Bolt (companion flange mounting) | 70 to 80 {52 to 59, 7.1 to 8.2} | – |

- Move the companion flange in axial and vertical directions to check for excessive play between the companion flange and output shaft.
- If excessive play is detected, remove the propeller shaft, then check the bolt for looseness and the splines on companion flange and output shaft for abnormalities.
- If any bolt is loose, tighten it to the specified torque.
- If the companion flange is found defective, replace the part.
- If the companion flange is not found defective, the output shaft may be defective, contact the Allison Service Station for repair.

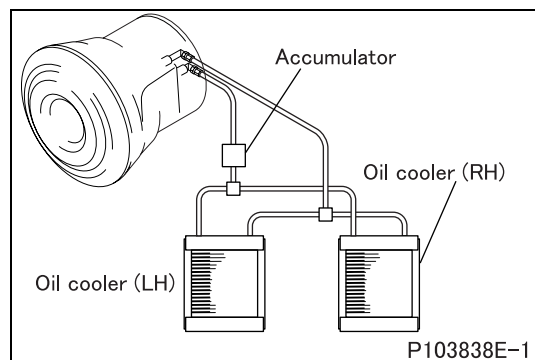
### 4. Inspection of Automatic Transmission Cooling System

- Check the automatic transmission cooling system for fluid leak and damage. If any abnormality is found, replace the faulty part.

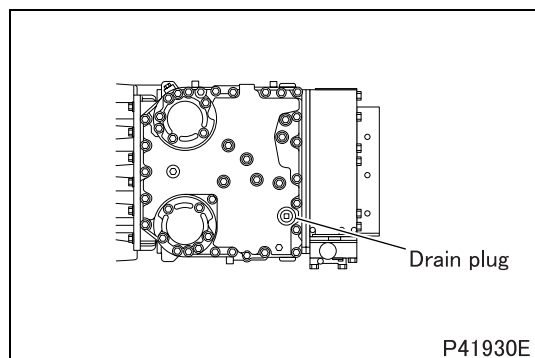
#### 6.1 Discharge

| Mark | Parts to be tightened | Tightening torque | Remarks |
|---|---|---|---|
| – | Drain plug | 25 to 32 {18 to 24, 2.6 to 3.3} | – |

- Put the automatic transmission fluid receptacle under the transmission oil pan; then remove drain plug behind the oil pan to discharge automatic transmission fluid.

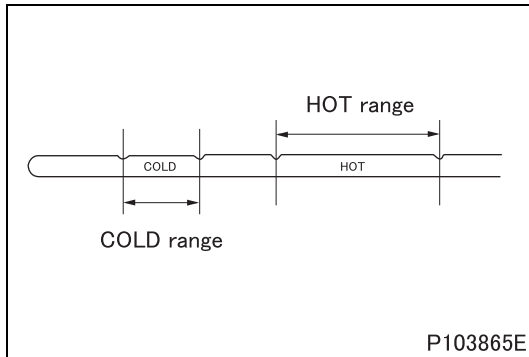
- Replenish automatic transmission fluid until it reaches the low position of the specified range of level gauge. Then, check the level of automatic transmission fluid. The level of automatic transmission fluid must be within the specified range of the level gauge.

“COLD” range: When temperature is low; 15 to 50°C {59 to 122°F}

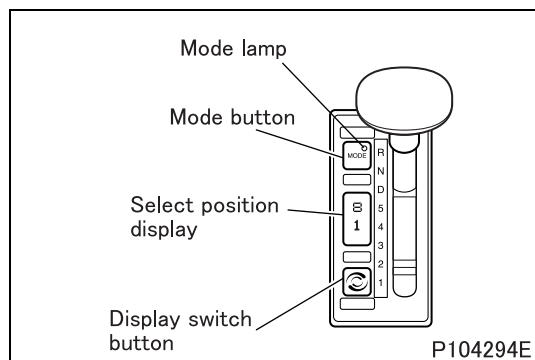
## 7. Level Check of Automatic Transmission Fluid

- This automatic transmission can check automatic transmission fluid level by operating the range selector.

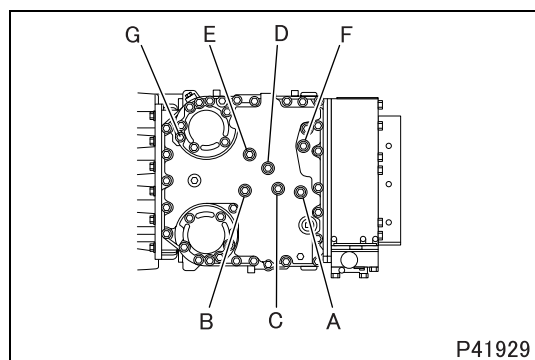
- Decide the pressure item to check according to the content of troubles, and measure the line pressure based on the following procedure.
- Remove the plug from the pressure detecting port of the gear-box casing, and install the pressure gauge.

- A: Main oil pressure
- B: C1 clutch oil pressure
- C: C2 clutch oil pressure
- D: C3 clutch oil pressure
- E: C4 clutch oil pressure
- F: C5 clutch oil pressure
- G: Lock-up oil pressure

- Conduct a sufficient warm-up operation, and raise oil temperature to 60 to 80°C {140 to 176°F}.
- Remove the propeller shaft to simulate the running condition.
- Measure the main oil pressure, clutch oil pressures and lock-up clutch pressure at idling condition and simulated running condition. Make sure the following conditions are satisfied.
  - Measured main oil pressure and lock-up clutch oil pressure are within the standard value.
  - The difference between the measured clutch oil pressure and the main oil pressure is 75 kPa {11 psi, 0.8 kgf/cm<sup>2</sup>} or lower and also satisfies the standard value.
- After measurement, remove dust and dirt around the pressure detecting ports and tighten the plugs to the specified torque.

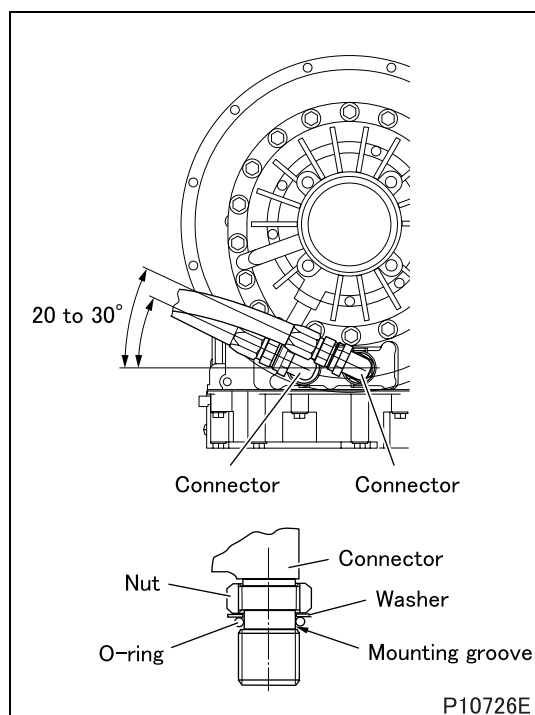
#### ■ Installation: Connector

- Tighten the nut of the connector by hand until it touches the connector and install the O-ring securely in the mounting groove.
- Tighten the connector by hand until the washer touches the automatic transmission and then loosen it to the angle shown in the illustration.
- While keeping the connector in this position, tighten the nut to the automatic transmission side.

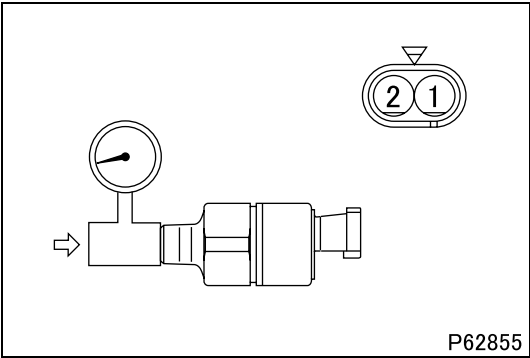
## #042 Inspection of stop lamp switch

- Apply air pressure to the switch gradually from 0 kPa {0 psi, 0 kgf/cm<sup>2</sup>}.
- Measure the air pressure when continuity is established across terminals 1 and 2, and make sure that the air pressure is within the standard value.

| Standard value<br>(operating pressure) | $29 \pm 9.8$ kPa { $4.2 \pm 1.4$ psi, $0.3 \pm 0.1$ kgf/cm <sup>2</sup> } |

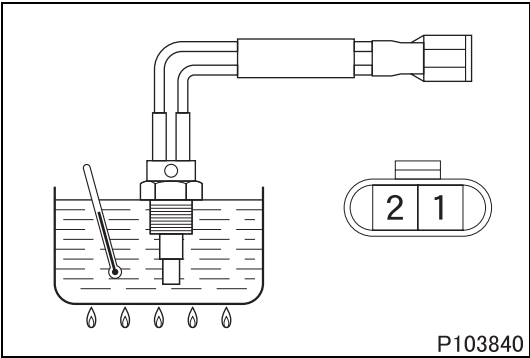
## #153 Inspection of automatic transmission fluid temperature switch

- Place the switch in a container.
- Raise the oil temperature to the specified values and stir the oil.
- Measure the operating temperature between terminals 1 and 2 respectively.

- If the measured value deviates from the standard value, replace the switch.

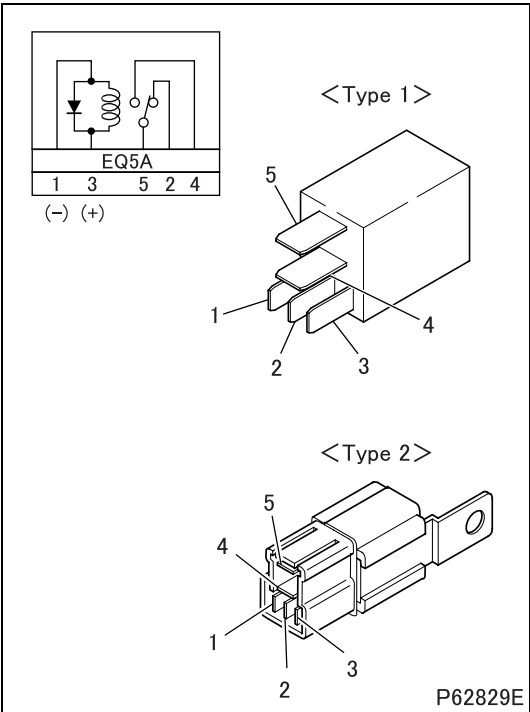
## #201 Inspection of relay (normally open, 5-pin type)

- Perform a continuity check and an operation check. If there is any abnormality, replace the relay.

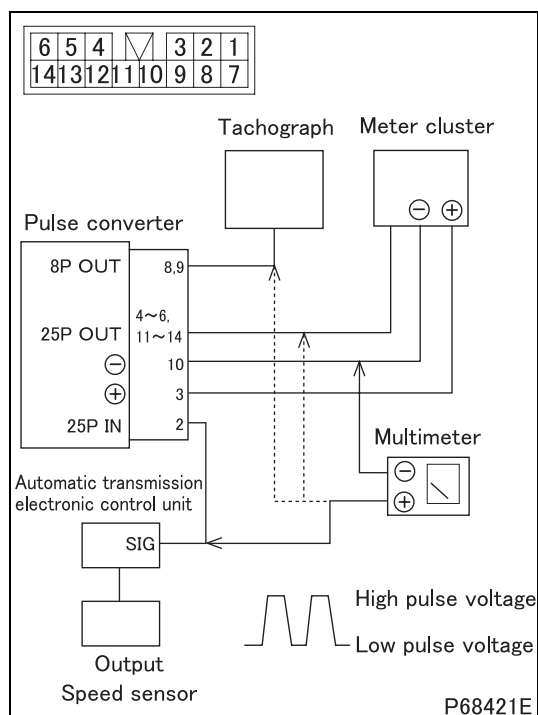
### #352 Inspection of pulse converter

- Check the pulse converter with the automatic transmission electronic control unit installed in the vehicle.
- With the starter switch in the ON position, slowly turn the wheels by means of a chassis dynamo or any other appropriate means.
- Measure the maximum voltage (high pulse voltage) and minimum voltage (low pulse voltage) values of the voltage between each of input and output terminals and terminal 10 of the pulse converter.

- If measurement meets the standard value, signals from the automatic transmission electronic control unit should be normal. Accordingly, replace the pulse converter.
- If measurement deviates from the standard value, check the automatic transmission.

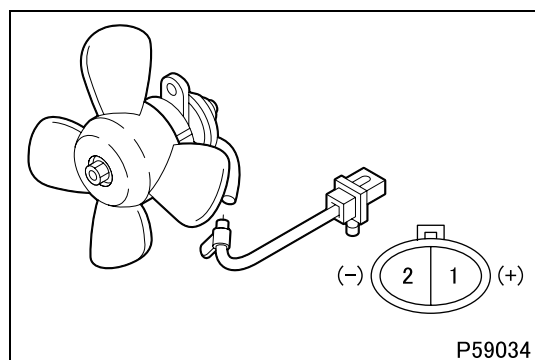
### #489 Inspection of motor

- Check that the motor runs when the battery voltage is applied to terminals 1 and 2.
- If there is any abnormality, replace the motor.
