# FE.FG

## SERVICE MANUAL 2008 Model FOREWORD

This Service Manual contains maintenance and repair methods for the Mitsubishi Fuso Truck FE. FG Series. Read this manual carefully as an aid in providing correct, efficient maintenance. Please note that the information and specifications contained within this manual may change without notice. This is due to product modifications and continued vehicle improvements that are made throughout the model years. Should you encounter any discrepancy in the information provided, please do not hesitate to contact your nearest Mitsubishi Fuso Dealer or Mitsubishi Fuso Truck of America, Inc.

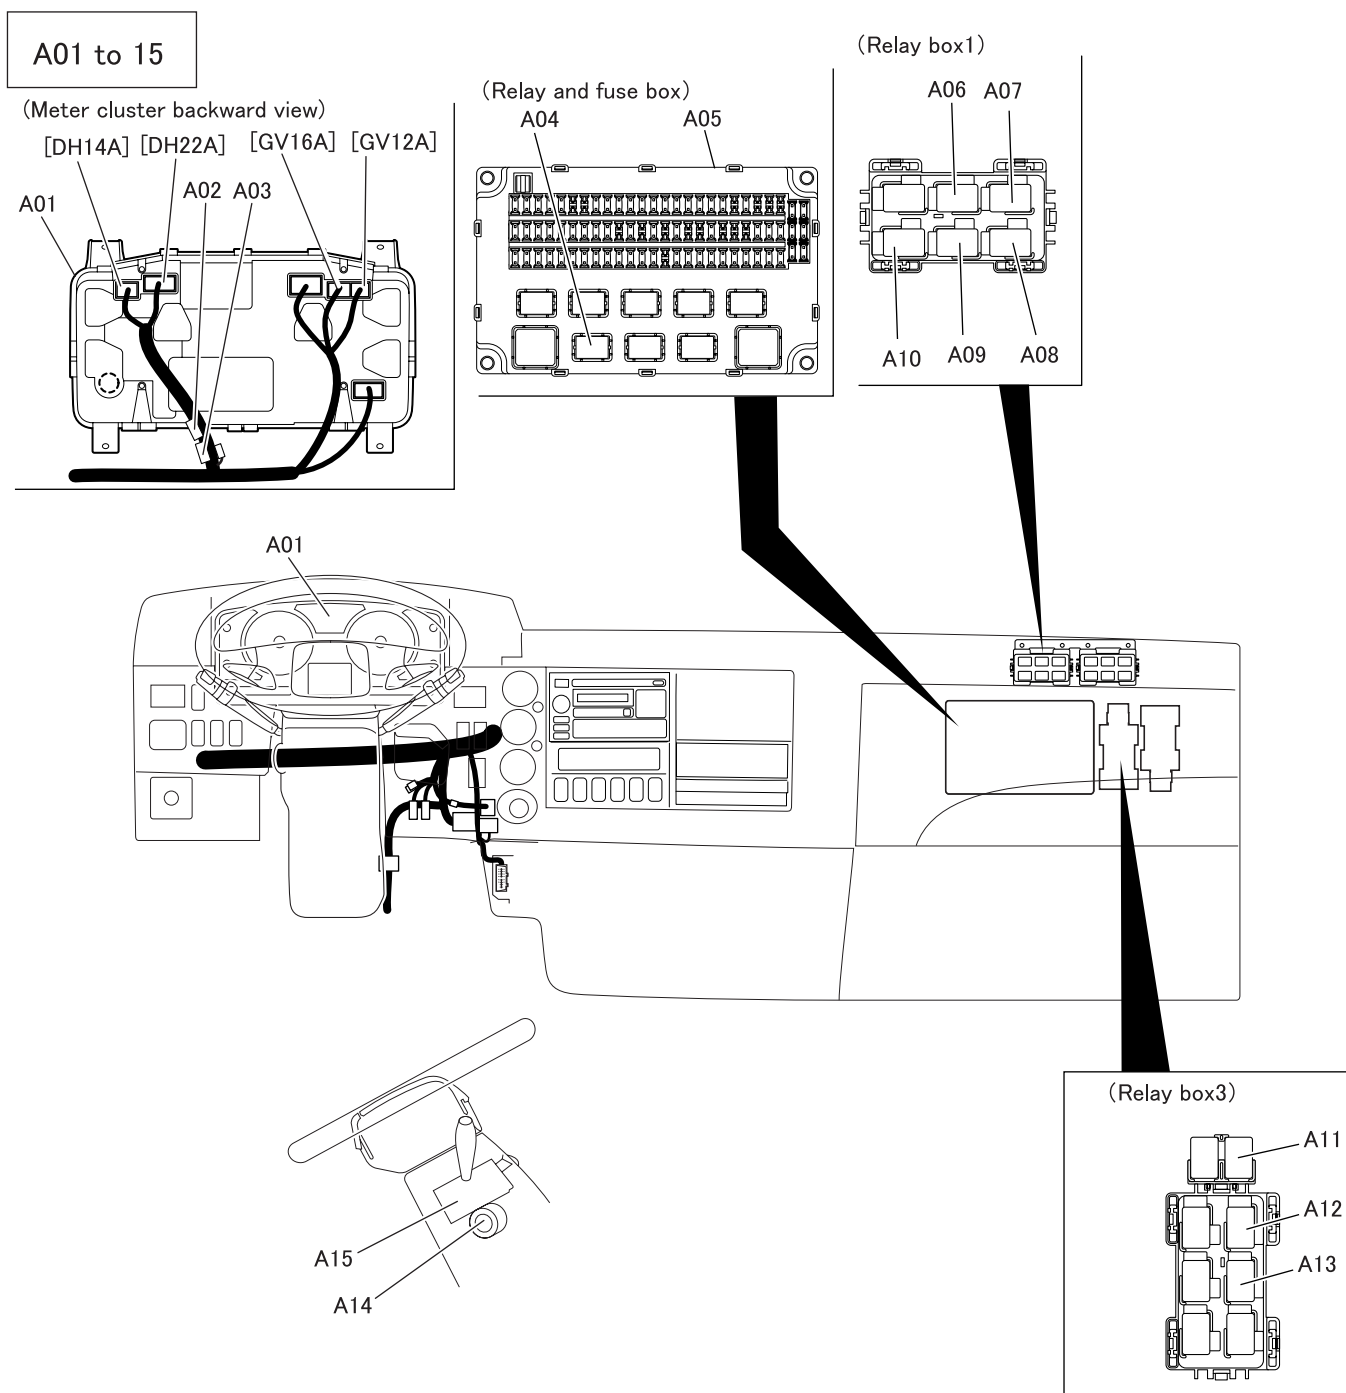
# INSTALLED LOCATIONS OF PARTS

A01 Meter cluster  
A02 Joint connector (J/C-2)  
A03 Joint connector (J/C-6)  
A04 Stop lamp relay  
A05 Relay and fuse box  
A06 Fan motor relay-1  
A07 Fan motor relay-2  
A08 Selector neutral relay

A09 A/T ABS activation signal relay  
A10 A/T stop lamp relay  
A11 Neutral start relay  
A12 Safety relay  
A13 ABS exhaust brake cut relay  
A14 Starter switch  
A15 Combination switch

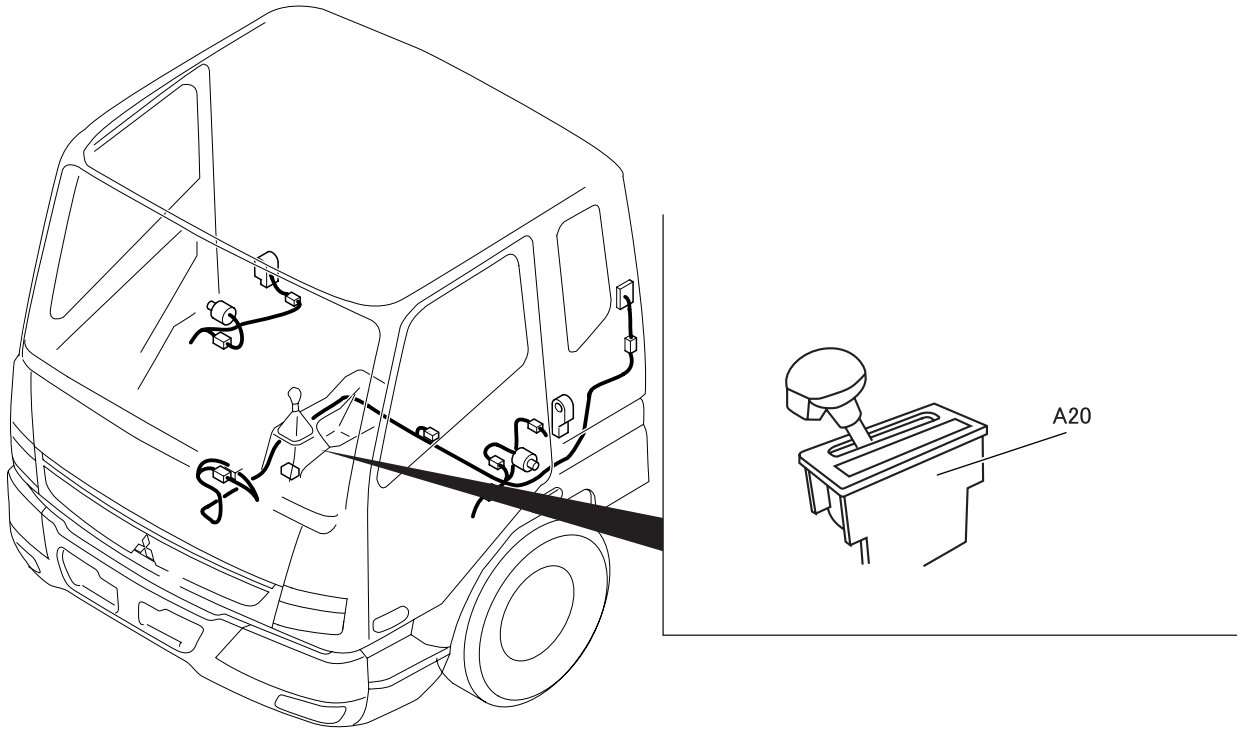
A20 Range selector

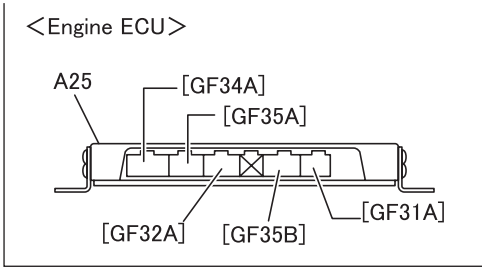
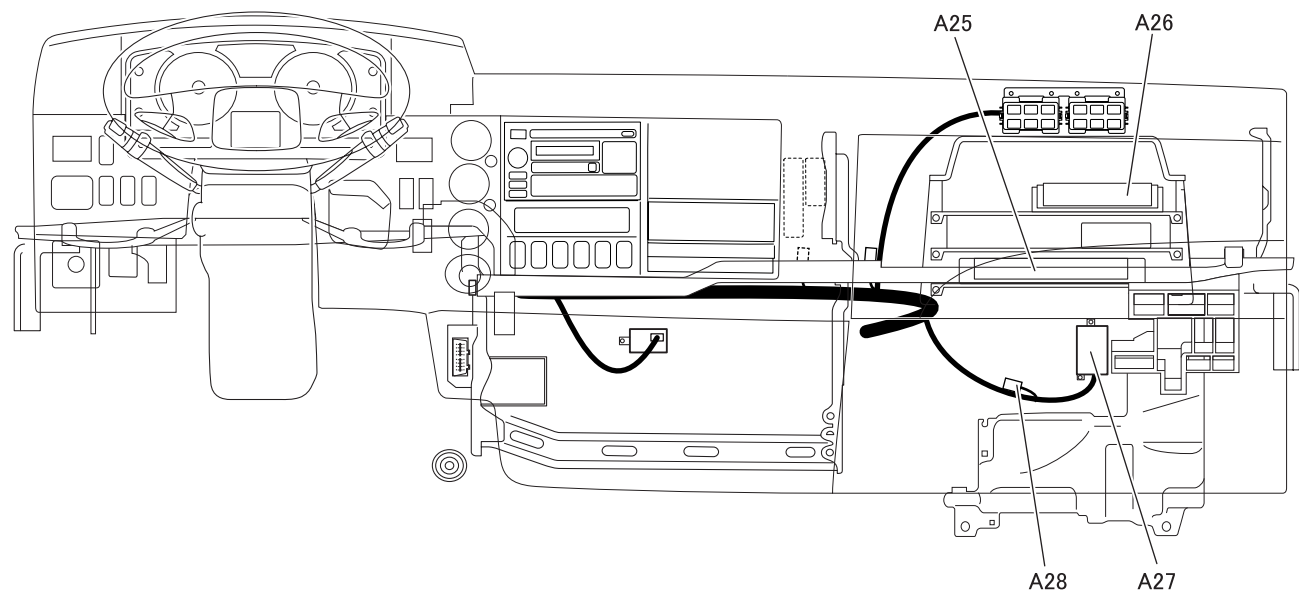
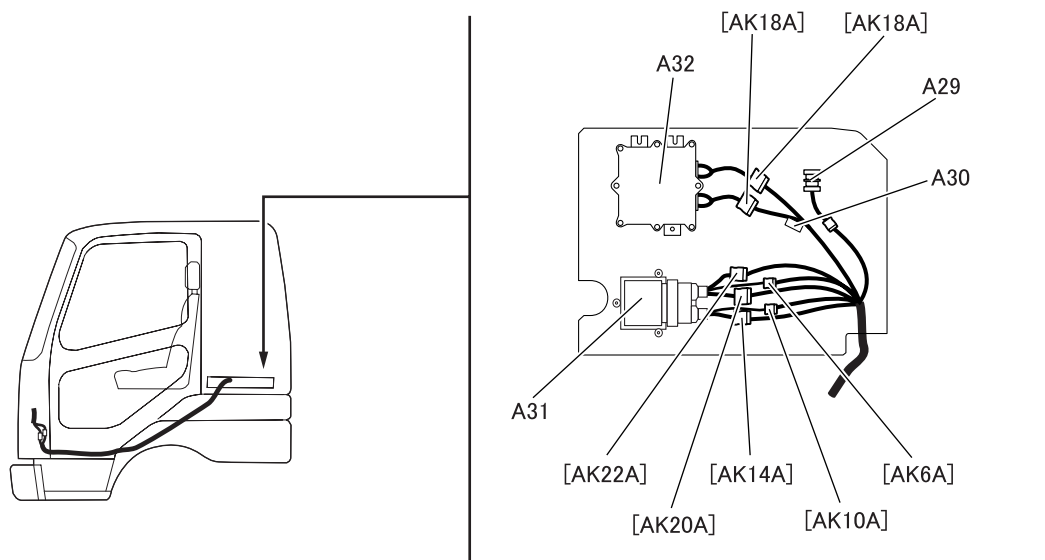
A25 to 32

- A25 Engine ECU
- A26 ABS ECU
- A27 Pulse converter
- A28 Diode unit
- A29 Diagnostic connector  
(for allison exclusive diagnosis tool)
- A30 Joint connector (J/C-3)
- A31 A/T ECU
- A32 Vehicle interface module

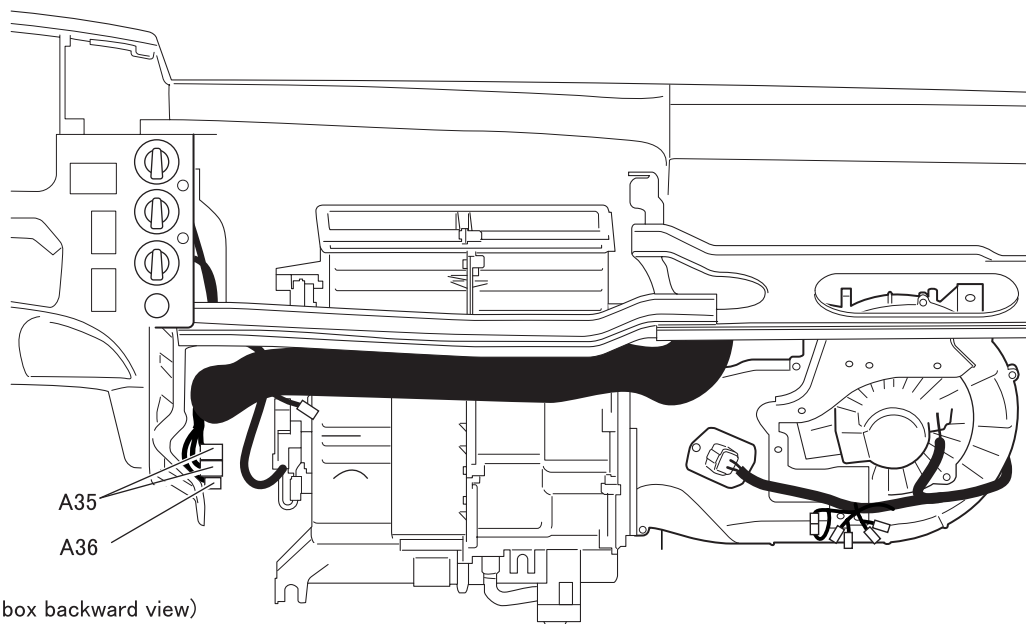
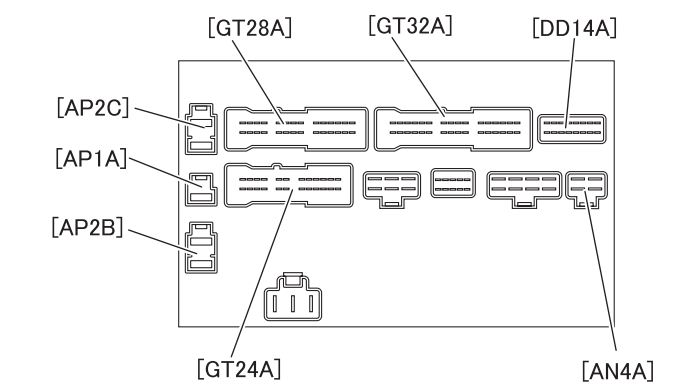
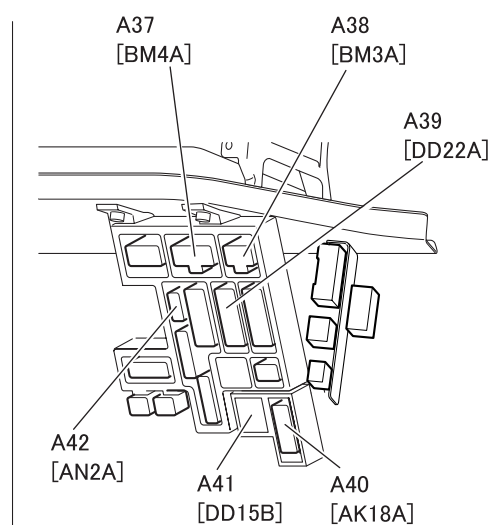
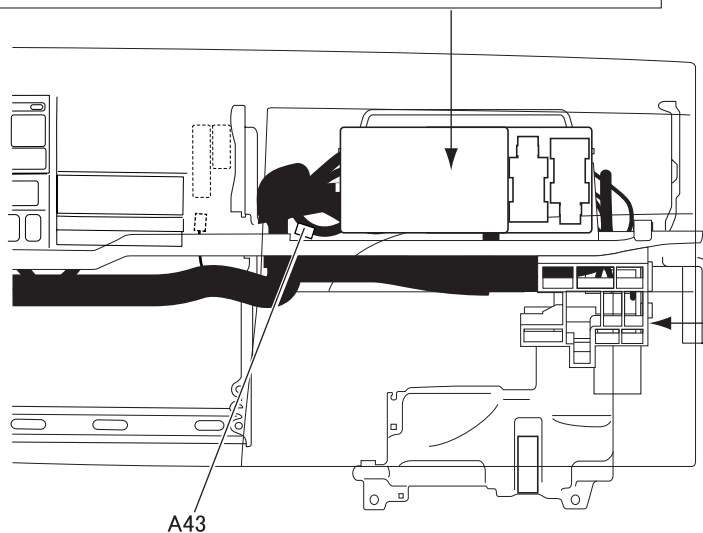
## A35 to 43

(Relay and fuse box backward view)

- A35 Connection of cab harness and A/T harness
- A36 Connection of cab harness and center floor harness
- A37-39 Connection of cab harness and chassis harness
- A40-41 Connection of A/T harness and chassis harness
- A42 Connection of cab harness and chassis harness
- A43 Joint connector (J/C-1, 3, 4)

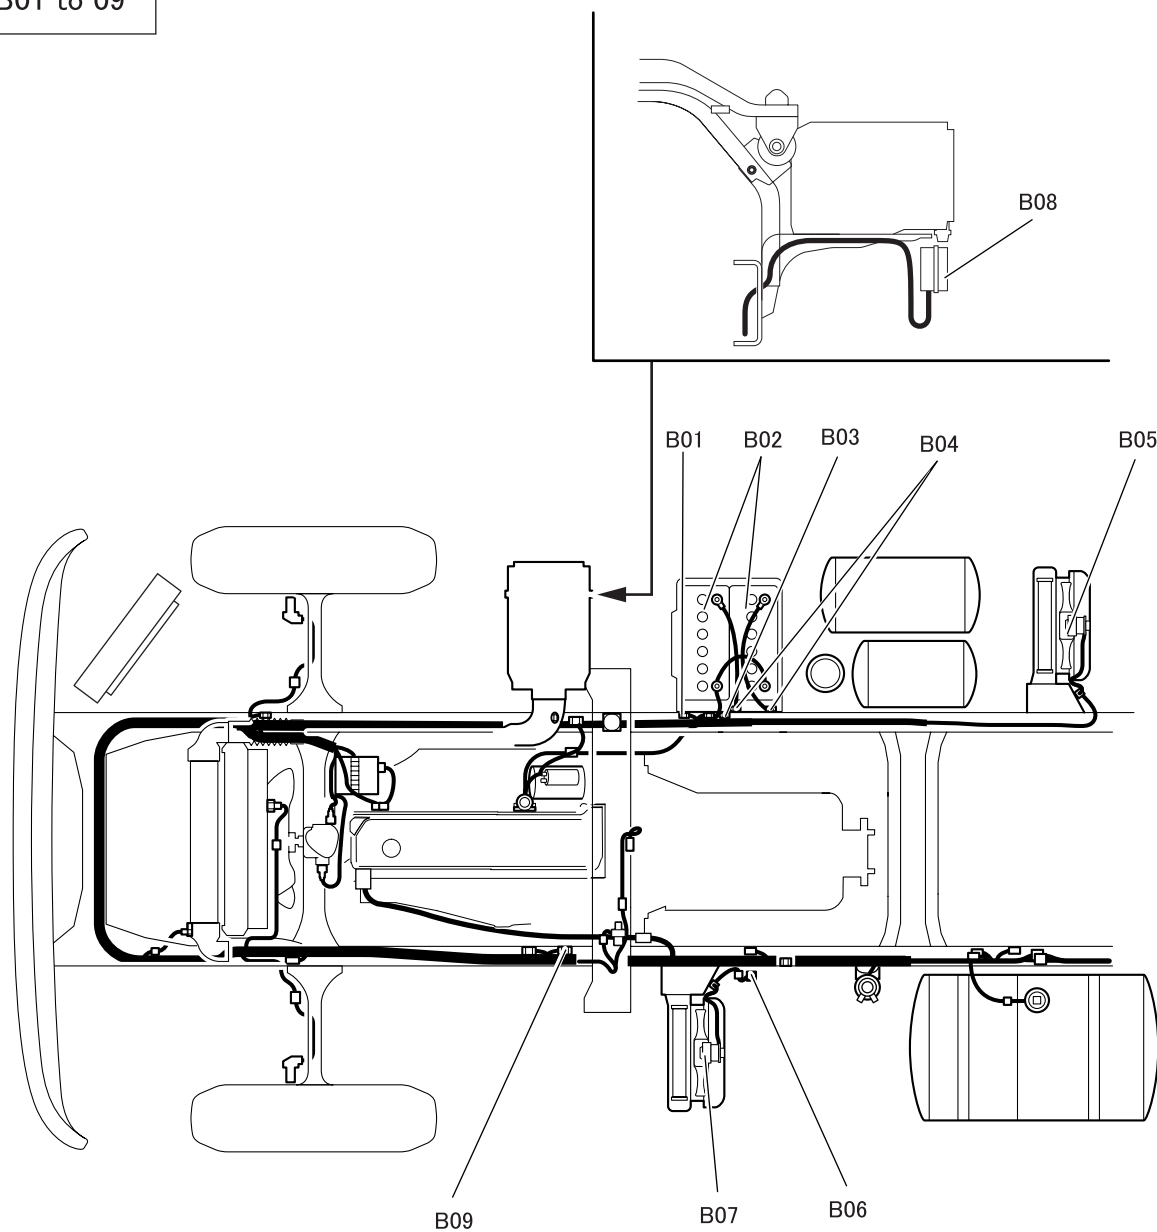
B01 to 09

- B01 Ground
- B02 Battery
- B03 Ground
- B04 Ground
- B05 Motor2
- B06 A/T fluid temperature switch
- B07 Motor1
- B08 High-current fuse box
- B09 Ground

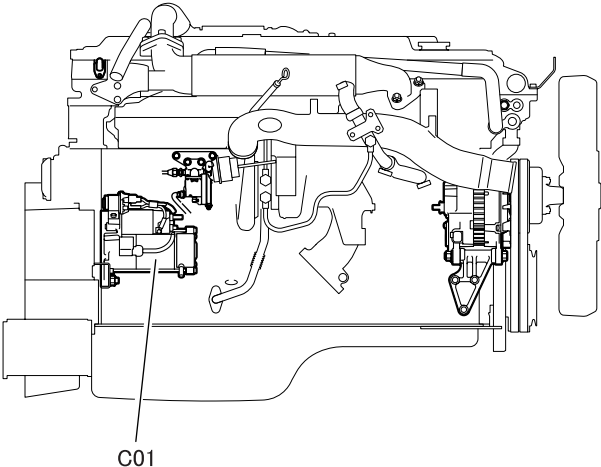
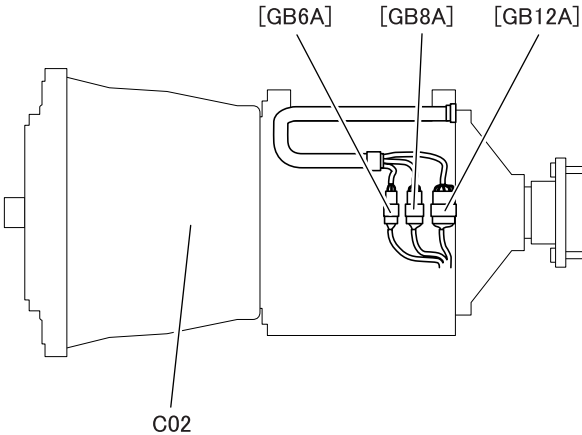
C01 to 02

- C01 Starter
- C02 Automatic transmission

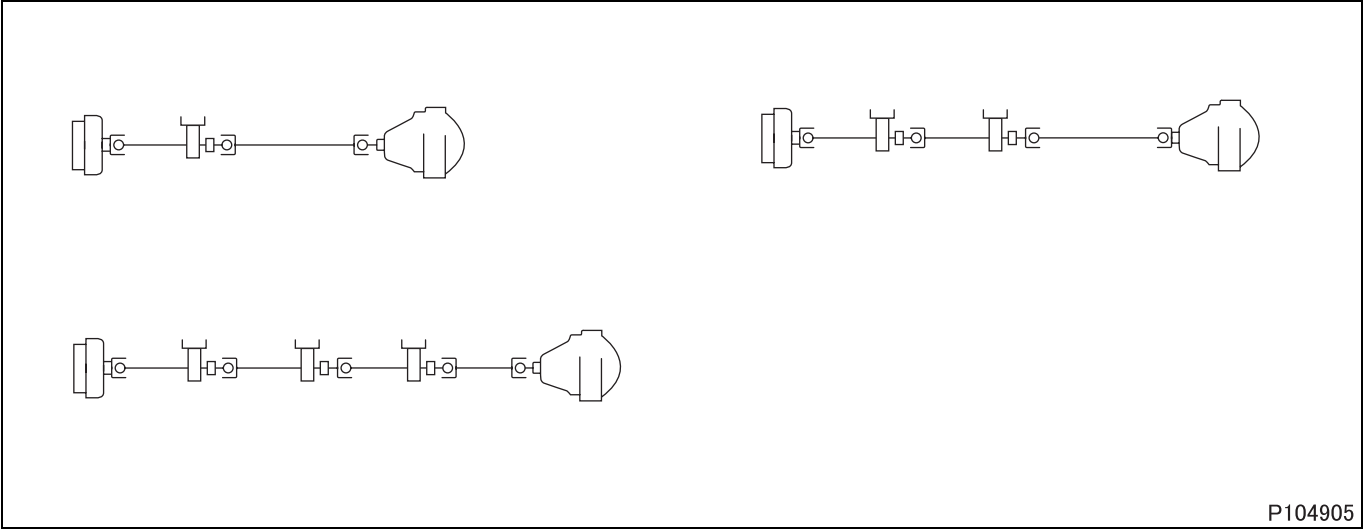
### 1. Configuration of Propeller Shaft Connection

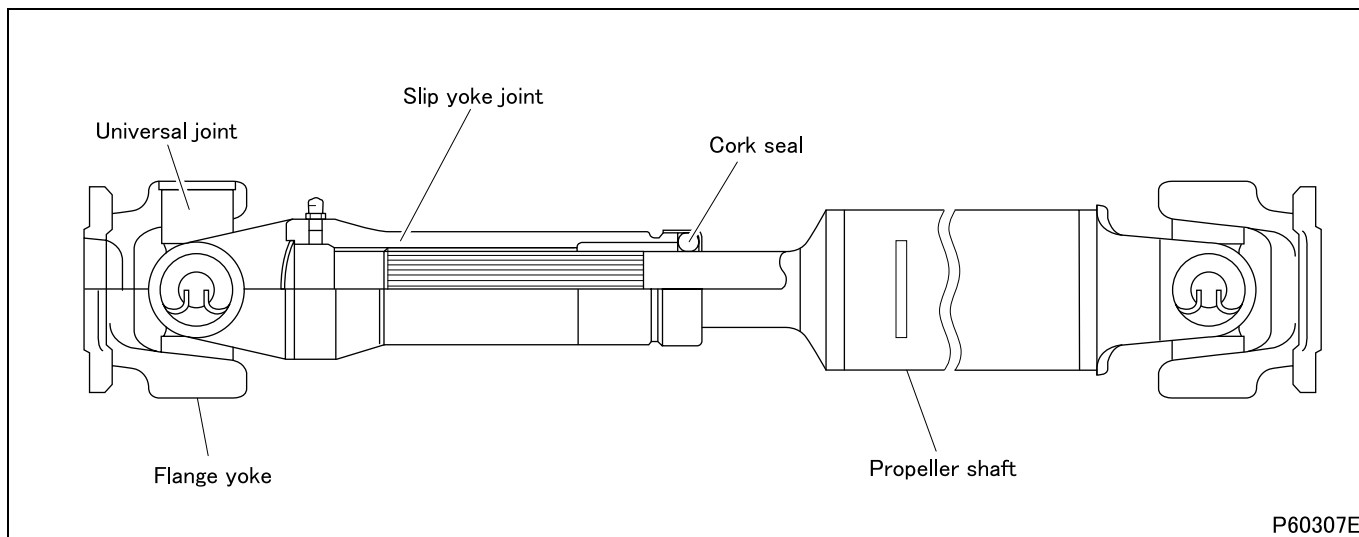
## 2. Propeller Shaft <Without Center Bearing>

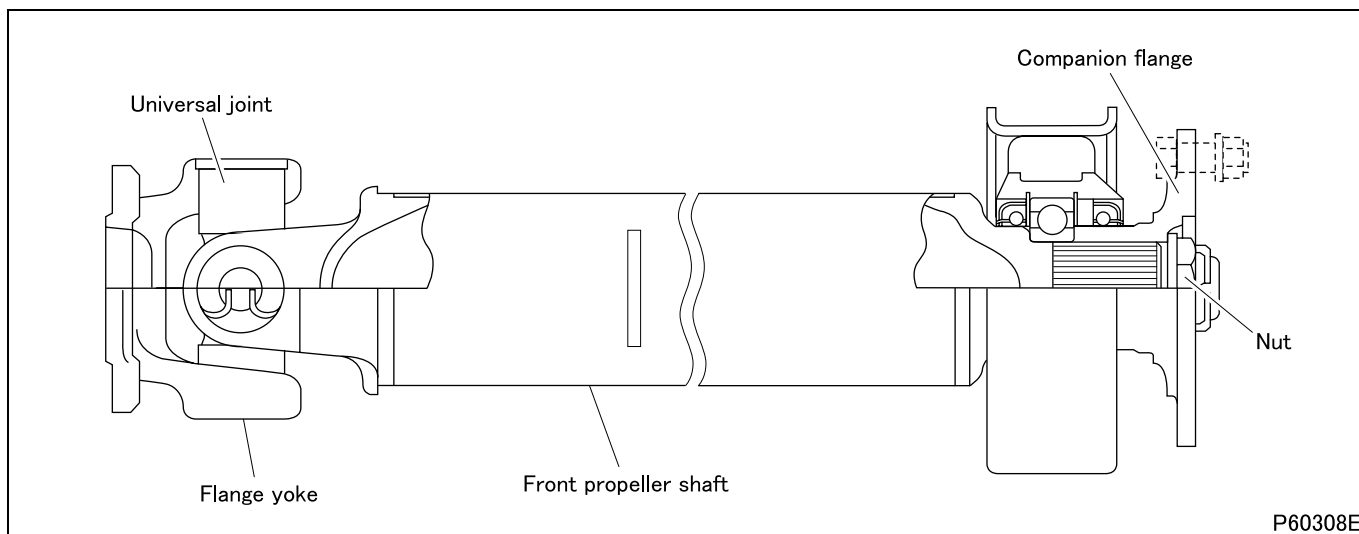
## 3. Propeller Shaft <With Center Bearing>

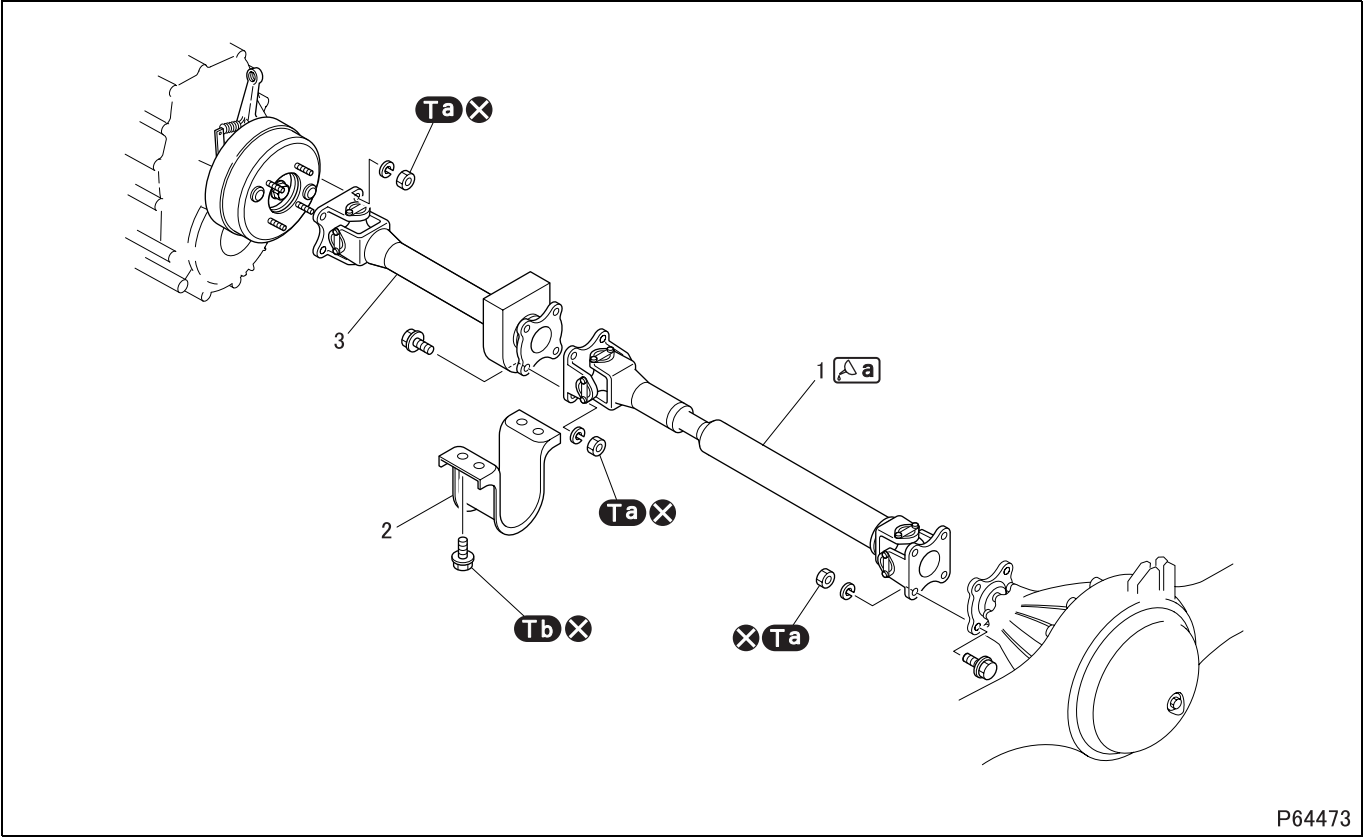
• Shown above is a tandem propeller shaft. The same service procedure applies to other propeller shafts.

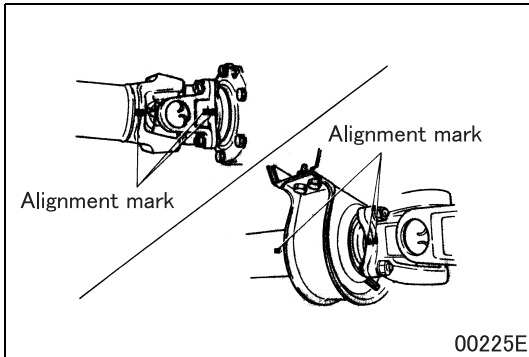
**■ Alignment mark: Propeller shaft**

- Be sure to make alignment marks before removal.

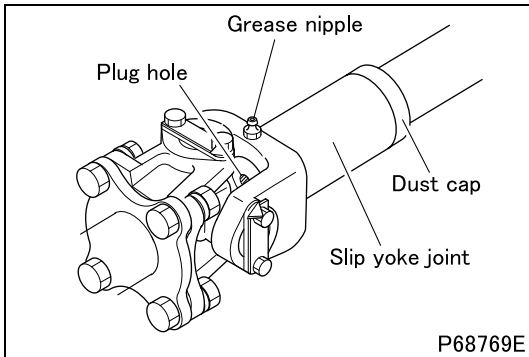
**■ Lubrication: Propeller shaft <Without center bearing>**

- Fill grease through the grease nipple, with the plug hole in the slip yoke joint stopped, until supplied grease overflows from the dust cap side.

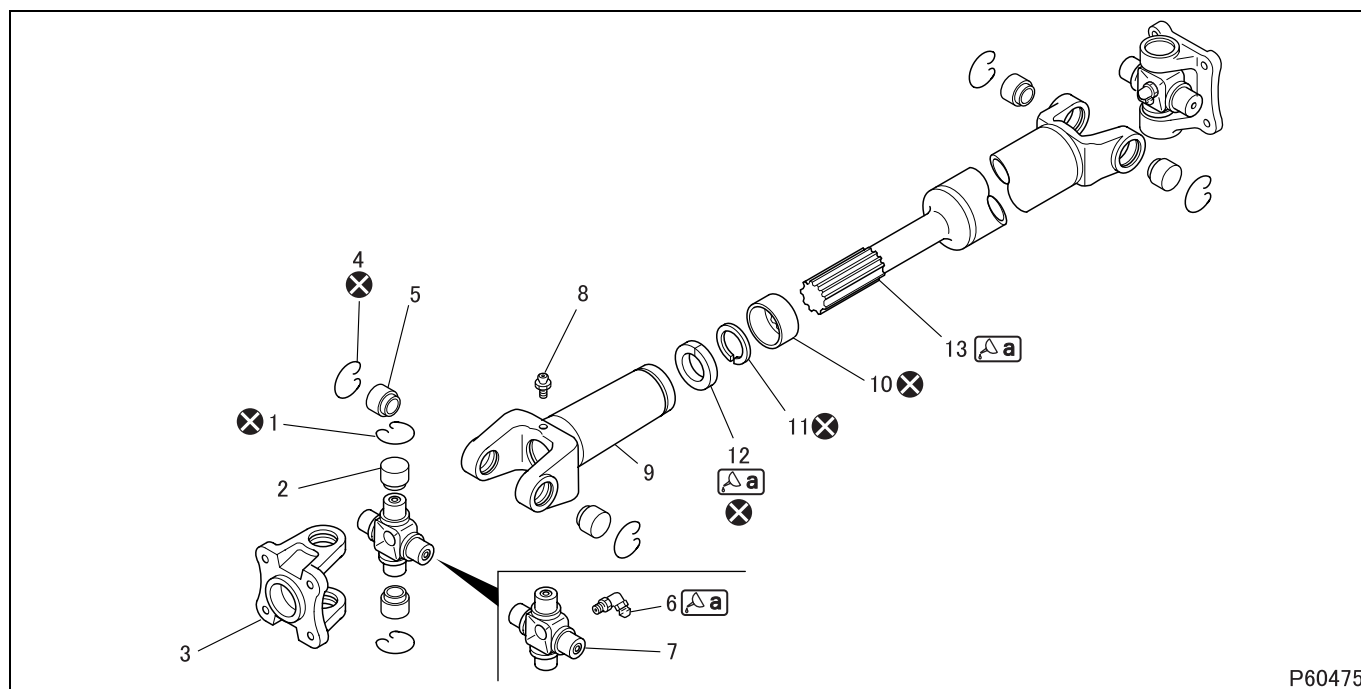
- Balance piece installing position (at flange yoke, slip yoke joint or propeller shaft) depends on the unbalance of the propeller shaft. This illustration is an example.

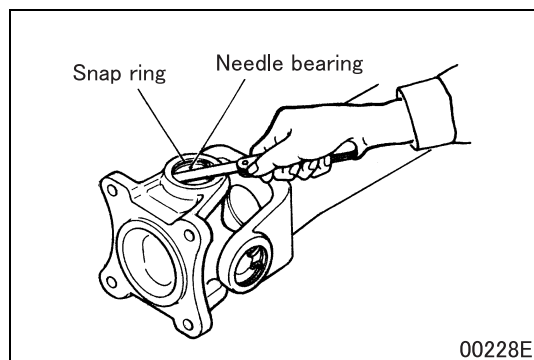
### ■ Inspection: Axial clearance of spider

- Press strongly down the needle bearing, and measure clearance between the snap ring and needle bearing.
- If the measurement exceeds the standard value, change snap ring thickness for adjustment.

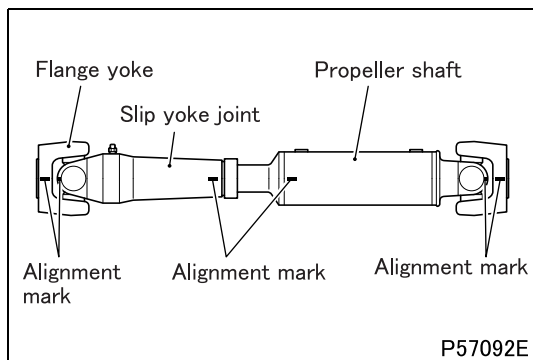
## ■ Alignment mark: Propeller shaft

- To prevent assembly of wrong parts, make alignment marks on flange yoke, slip yoke joint and propeller shaft.

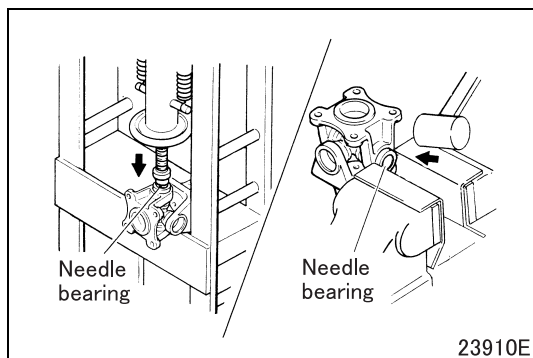
## ■ Removal: Needle bearing

- Make alignment marks on the needle bearing and spider.
- Force out the needle bearing halfway from the yoke using a press, then remove it with a vise.

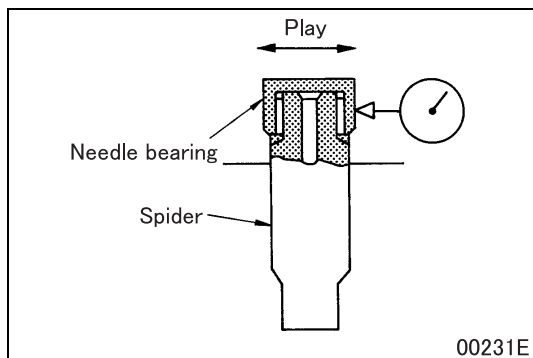
## ■ Inspection: Clearance between needle bearing and spider

- If the measurement exceeds the limit, replace with the universal joint spider kit.

| Location | Maintenance item | Standard value | Limit | Remedy |
|---|---|---|---|---|
| 2, 5, 7 | Clearance between needle bearing and spider | 0.02 to 0.07<br>{0.00079 to 0.0028} | 0.2<br>{0.00079} | Replace |

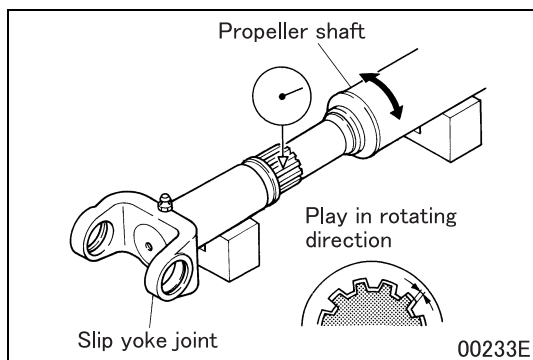
#### ■ Inspection: Play in rotation direction between slip yoke joint and propeller shaft spline

- If the measurement exceeds the limit, replace the slip yoke joint and propeller shaft in a set.

| Location | Maintenance item | Standard value | Limit | Remedy |
|---|---|---|---|---|
| 9, 13 | Play in rotation direction between slip yoke joint and<br>propeller shaft spline | 0.07 to 0.18<br>{0.0028 to 0.0071} | 0.3 {0.012} | Replace |

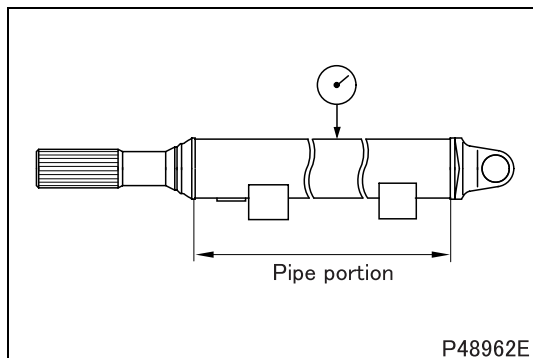
#### ■ Inspection: Bend of propeller shaft

- Before measuring the bend of pipe, remove paint from the propeller shaft where the dial gauge is set and the pipe is supported with V blocks using a paint remover.
- Measure bend of propeller shaft at the center of its pipe portion.
- To measure the bend of propeller shaft, turn it fully once and read the dial gauge indicator. The bend is one half of the indicated value.
- If the measurement deviates from the standard value, correct the bend with a press or replace the propeller shaft.

- Remove paint taking care not to damage the pipe portion of the shaft.
- Check the propeller shaft for cracks in the welded area after correcting the bend using a press. If a crack is caused, replace the propeller shaft instead of correcting it by welding.

| Location | Maintenance item | Standard value | Limit | Remedy |
|---|---|---|---|---|
| 13 | Bend of propeller shaft | 0 to 0.6 {0 to 0.024} | – | Correct or<br>replace |

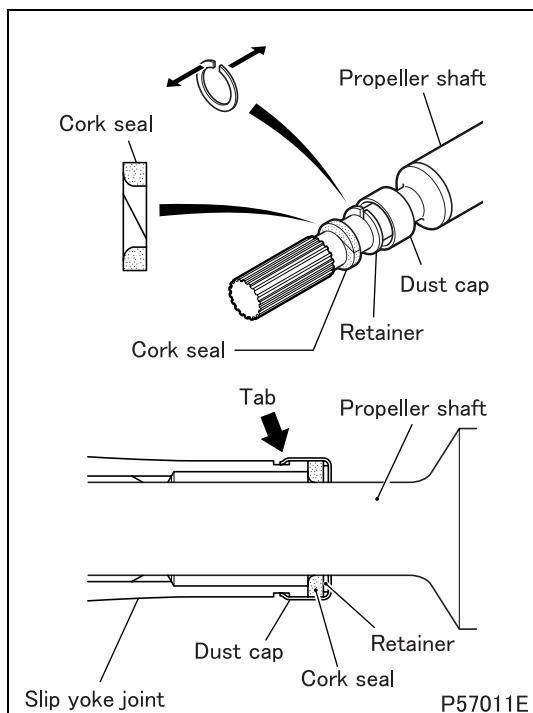
#### ■ Installation: Dust cap, retainer and cork seal

- After inserting the dust cap into the propeller shaft, carefully open the retainer right and left, assemble it to the propeller shaft and return it to the original condition.
- Apply grease to the inside circumference of the cork seal and assemble it to the propeller shaft, facing it in the illustrated direction in the same method as the retainer.
- Apply sufficient grease to the splined portion of the propeller shaft, then fit the propeller shaft into the slip yoke joint.
- Press the dust cap against the slip yoke joint in such a way that the cork seal is compressed, and crimp its tabs to engage with the recesses in the slip yoke joint.

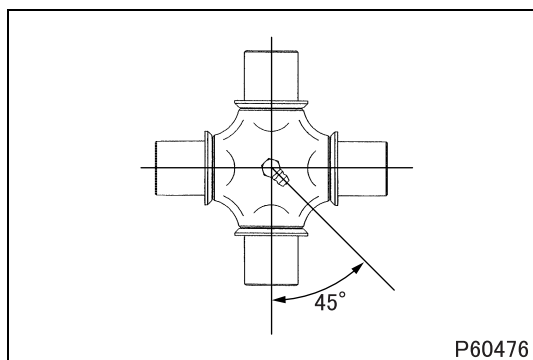
## ■ Installation: Spider

- Fit grease nipple to the spider facing it in the illustrated direction.

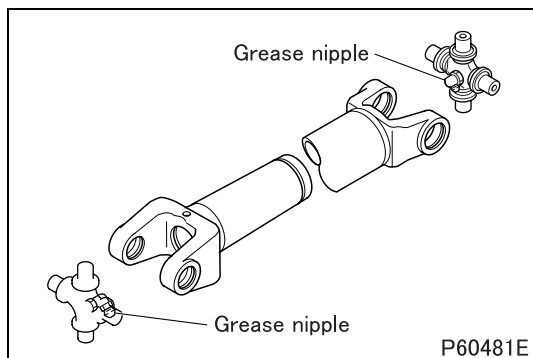
- Install spiders on both ends of the propeller shaft so that their respective grease nipple faces in the same direction.

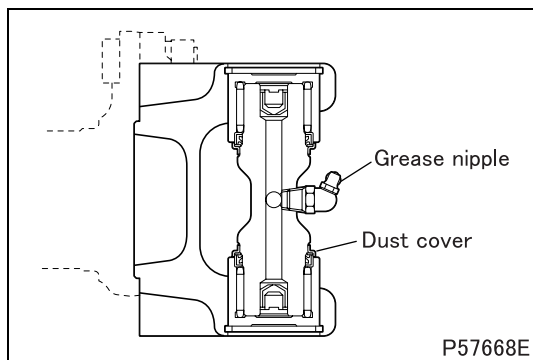
## ■ Lubrication: Grease nipple

- Fill grease through the grease nipple until supplied grease overflows from four dust covers of the spider.
- If grease does not overflow from all of the four dust covers or rust, water and dirt come out with grease, replace the spider with the spider kit.

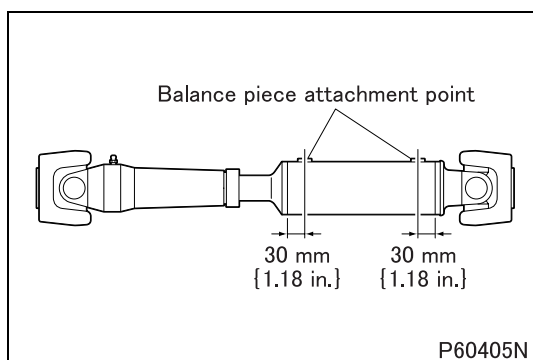
## ■ Inspection: Permissible unbalance amount of propeller shaft

- Attach appropriate balance pieces and lock plate to the illustrated points so that the unbalance amount comes within the standard value.
- Maximum balance piece allowance for one point is 120 g {4.23 oz}.
- Use a combination that keeps the number of balance pieces to a minimum.

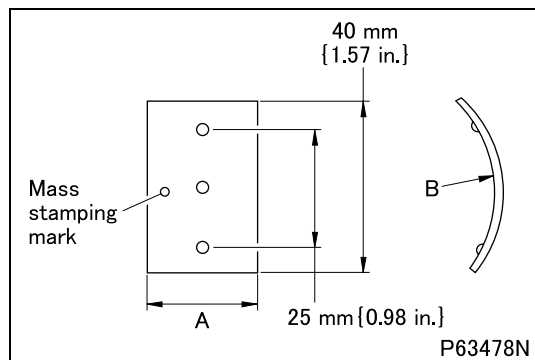
**Types of balance pieces**

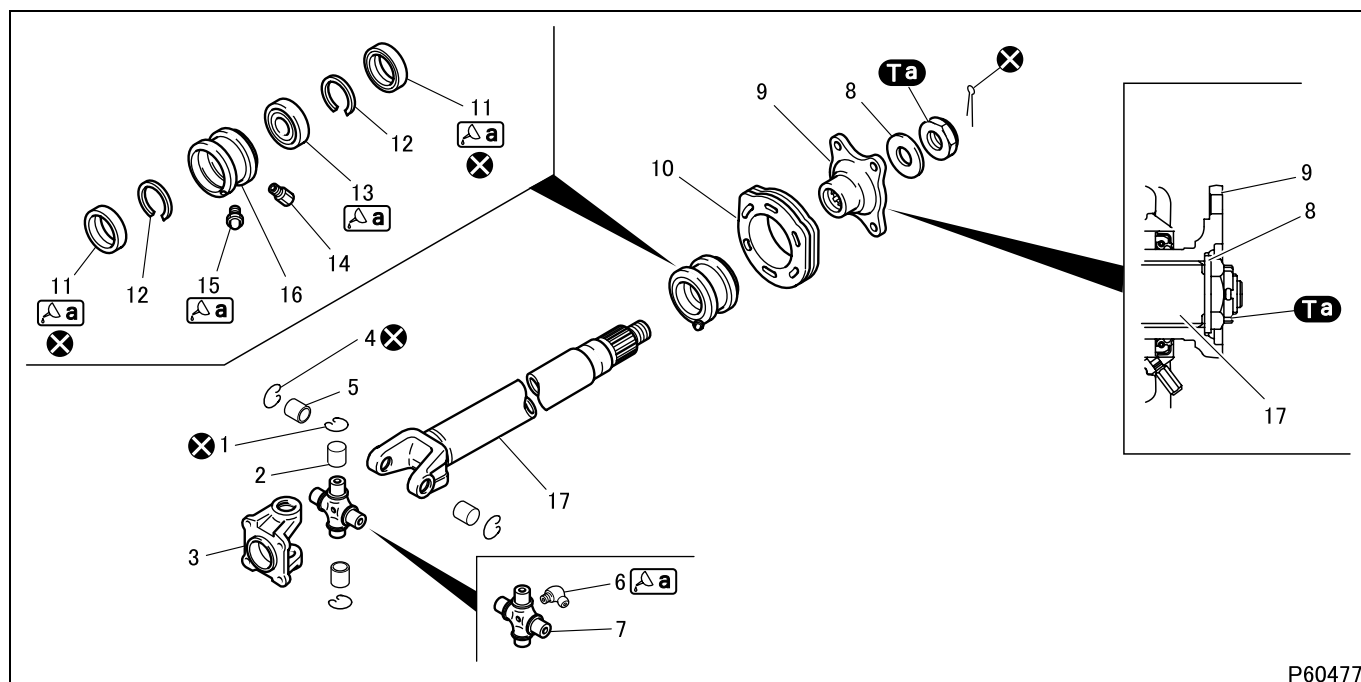
P60477

# PROPELLER SHAFT <P8>

<With center bearing>

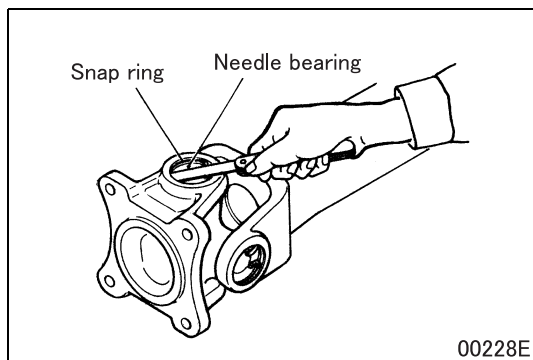
### ■ Inspection: Axial clearance of spider

- Press strongly down the needle bearing, and measure clearance between the snap ring and needle bearing.
- If the measurement exceeds the standard value, change snap ring thickness for adjustment.

- Use snap rings for both ends with the same thickness as much as possible to ensure rotation balance.

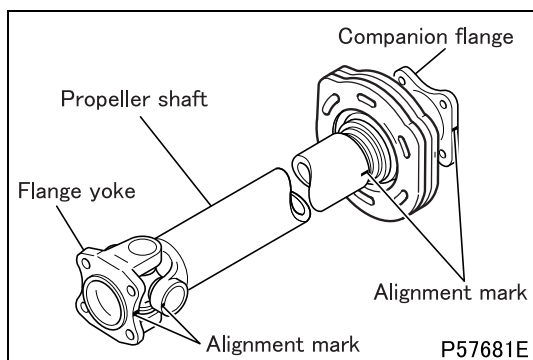
### ■ Alignment mark: Propeller shaft

- To prevent assembly of wrong parts, make alignment marks on flange yoke, companion flange and propeller shaft.

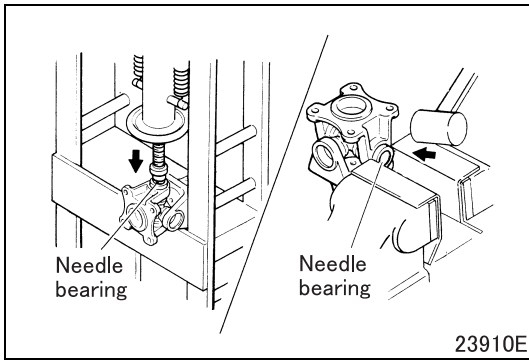
#### ■ Removal: Needle bearing

- Make alignment marks on the needle bearing and spider.
- Force out the needle bearing halfway from the yoke using a press, then remove it with a vise.

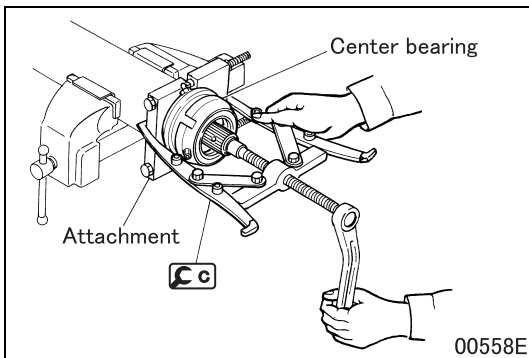
#### ■ Removal: Center bearing

- Using **Cc**, remove the center bearing with the aid of the attachment.

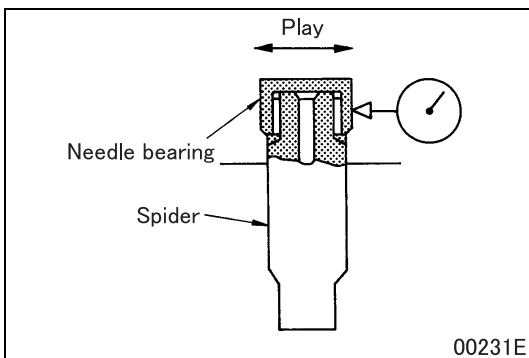
#### ■ Inspection: Clearance between needle bearing and spider

- If the measurement is higher than the limit, replace with the universal joint spider kit.

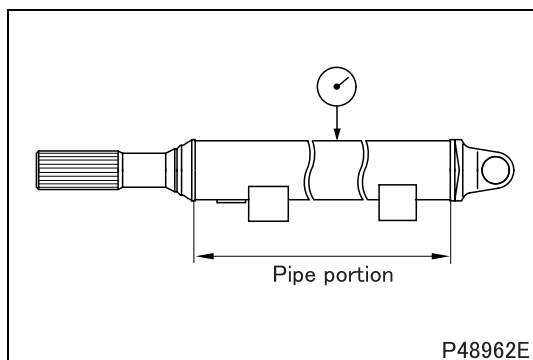
## ■ Inspection: Bend of propeller shaft

- Before measuring the bend of pipe, remove paint from the propeller shaft where the dial gauge is set and the pipe is supported with V blocks using a paint remover.
- Measure bend of propeller shaft at the center of its pipe portion.
- To measure the bend of propeller shaft, turn it fully once and read the dial gauge indicator. The bend is one half of the indicated value.
- If the measurement deviates from the standard value, correct the bend with a press or replace the propeller shaft.

- Remove paint using care not to damage the pipe portion of the shaft.
- Check the propeller shaft for cracks in the welded area after correcting the bend using a press. If a crack is caused, replace the propeller shaft instead of correcting it by welding.

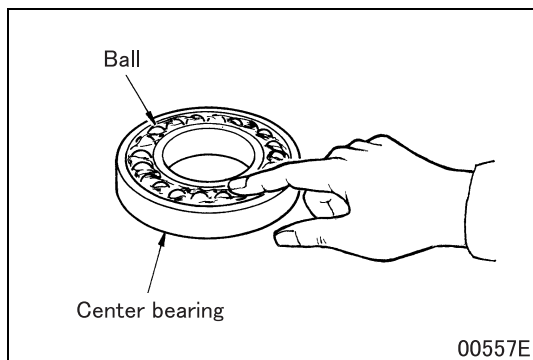
## ■ Installation: Center bearing

- Fill space between balls of the center bearing with grease.

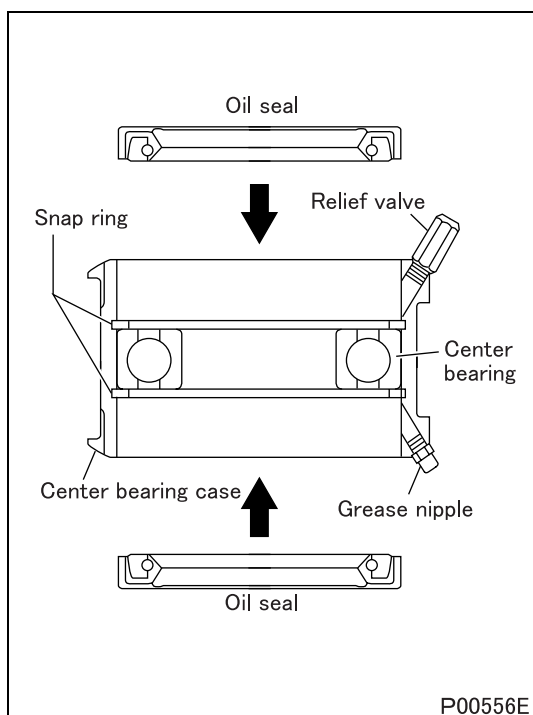
## ■ Installation: Oil seal

- Apply grease to the oil seal lip.
- Install the oil seal in the illustrated direction, aligning it with the end face of the center bearing case.

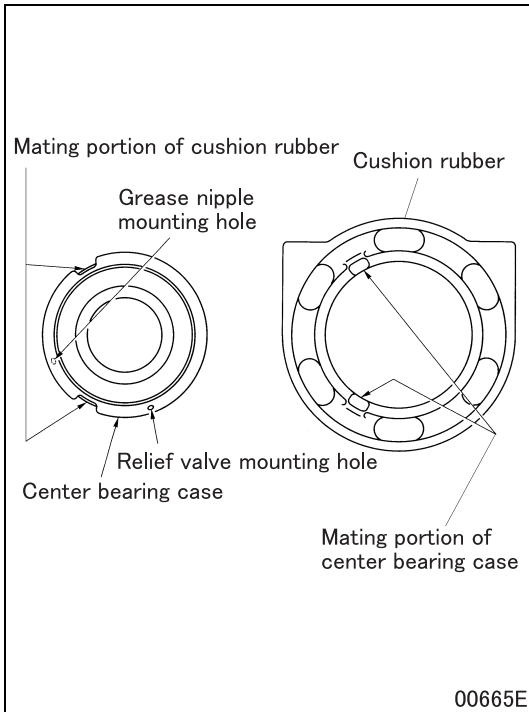
#### ■ Installation: Cushion rubber

- Fit the illustrated portion of the cushion rubber in the illustrated portion of the center bearing case by aligning them. If it is difficult to fit it in, apply soapy water for smooth fitting.

- Grease deteriorates cushion rubber. Be sure to use soapy water.**
- Assemble the cushion rubber so that grease nipple mounting holes face downward.

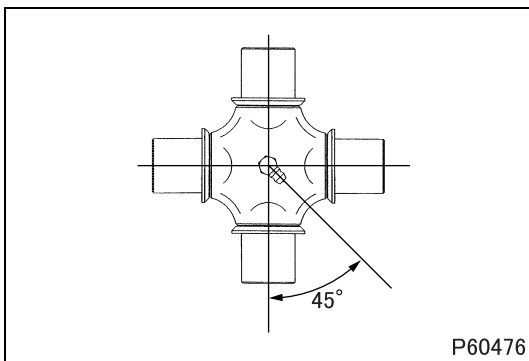
#### ■ Installation: Grease nipple

- Fit grease nipple to the spider facing it in the illustrated direction.

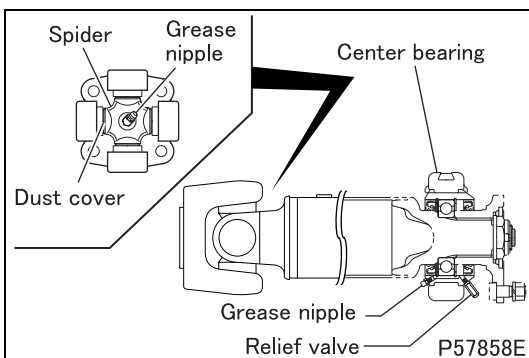
#### ■ Lubrication: Grease nipple

- Fill grease through the grease nipple until supplied grease overflows from four dust covers of the spider.
- If grease does not overflow from all of the four dust covers or rust, water and dirt come out with grease, replace the spider with the spider kit.
- Fill grease through the grease nipple until supplied grease overflows from the relief valve of the center bearing.

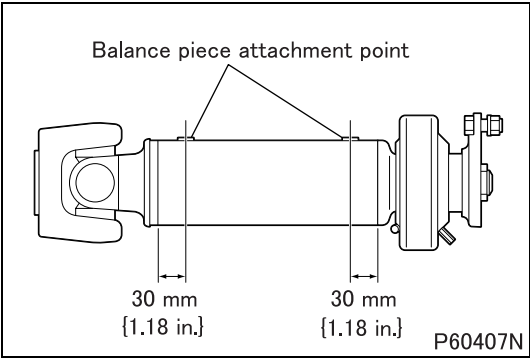
## ■ Inspection: Permissible unbalance amount of propeller shaft

- Attach appropriate balance pieces and lock plate to the illustrated points so that the unbalance amount comes within the standard value.
- Maximum balance piece allowance for one point is 120 g {4.23 oz}.
- Use a combination that keeps the number of balance pieces to a minimum.

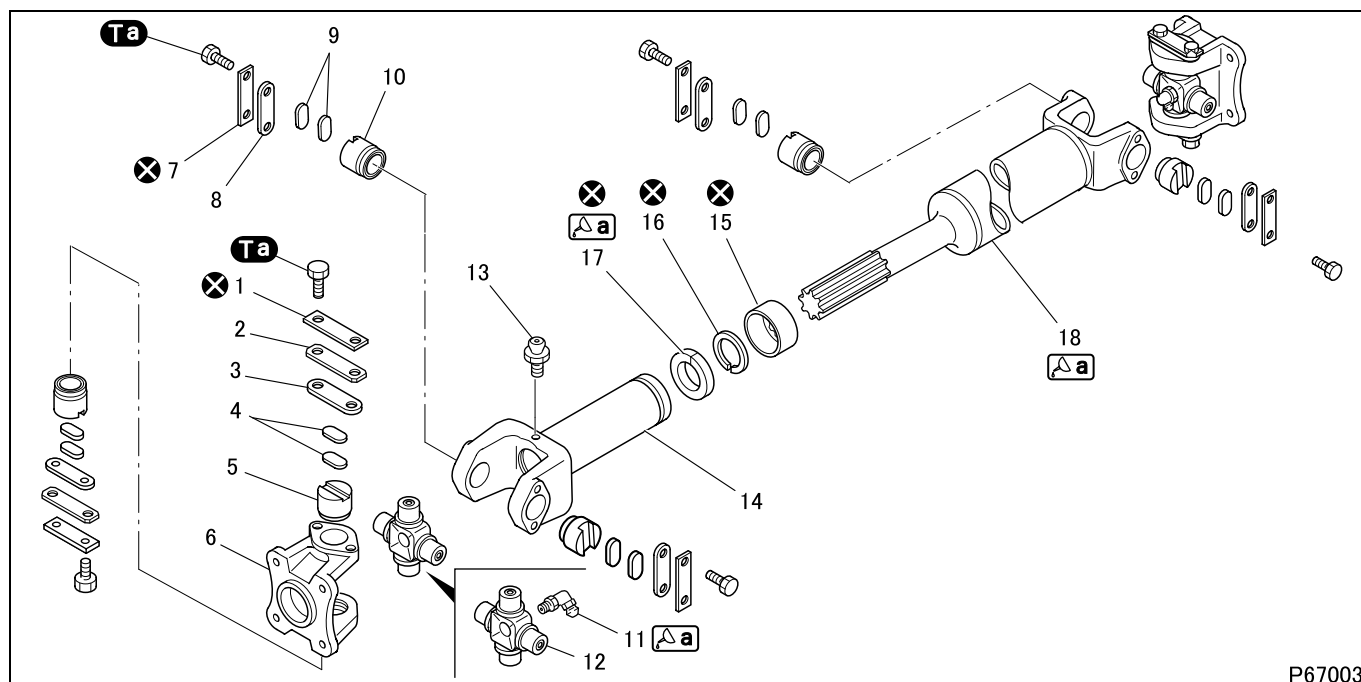
P67003

# PROPELLER SHAFT <P10>

<Without center bearing>

- Balance piece installing position (at flange yoke, slip yoke joint or propeller shaft) depends on the unbalance of the propeller shaft. This illustration is an example.

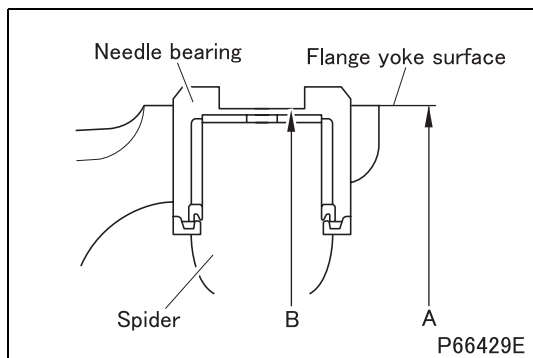
### ■ Inspection: Axial clearance of spider

- Measure the clearance of needle bearing (shim adjusting allowance=  $A - B$ ).
- If the measurement exceeds the standard value, adjust the clearance by changing thickness of the shim.  
Types of shim: 0.1 mm {0.0039 in.}, 0.2 mm {0.0079 in.}

- **Never allow the shim to protrude from the flange yoke surface.**
- **Use shims for both ends with the same thickness as much as possible to ensure rotation balance.**

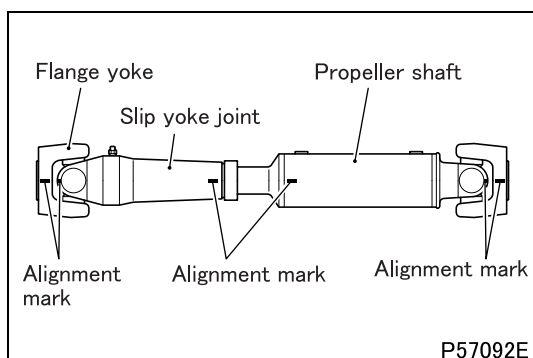
### ■ Alignment mark: Propeller shaft

- To prevent assembly of wrong parts, make alignment marks on flange yoke, slip yoke joint and propeller shaft.

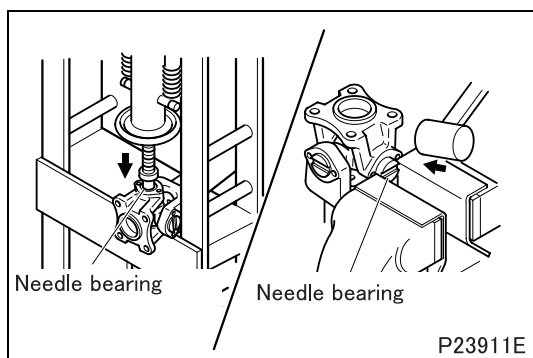
### ■ Removal: Needle bearing

- Make alignment marks on the needle bearing and spider.
- Force out the needle bearing halfway from the yoke using a press, then remove it with a vise.
