# FE.FG

## SERVICE MANUAL 2008 Model FOREWORD

This Service Manual contains maintenance and repair methods for the Mitsubishi Fuso Truck FE. FG Series. Read this manual carefully as an aid in providing correct, efficient maintenance. Please note that the information and specifications contained within this manual may change without notice. This is due to product modifications and continued vehicle improvements that are made throughout the model years. Should you encounter any discrepancy in the information provided, please do not hesitate to contact your nearest Mitsubishi Fuso Dealer or Mitsubishi Fuso Truck of America, Inc.

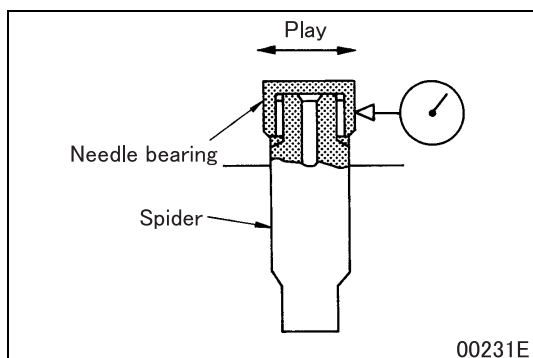
### ■ Inspection: Clearance between needle bearing and spider

- If the measurement exceeds the limit, replace with the universal joint spider kit.

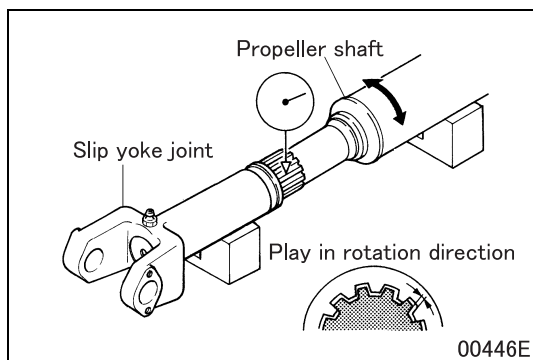
#### ■ Inspection: Play between slip yoke joint and propeller shaft spline

- If the measurement exceeds the limit, replace the slip yoke joint and propeller shaft in a set.

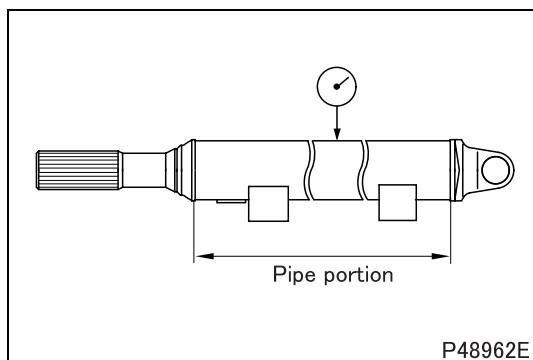
#### ■ Inspection: Bend of propeller shaft

- Before measuring the bend of pipe, remove paint from the propeller shaft where the dial gauge is set and the pipe is supported with V blocks using a paint remover.
- Measure bend of propeller shaft at the center of its pipe portion.
- To measure the bend of propeller shaft, turn it fully once and read the dial gauge indicator. The bend is one half of the indicated value.
- If the measurement deviates from the standard value, correct the bend with a press or replace the propeller shaft.

- Remove paint using care not to damage the pipe portion of the shaft.
- Check the propeller shaft for cracks in the welded area after correcting the bend using a press. If a crack is caused, replace the propeller shaft instead of correcting it by welding.

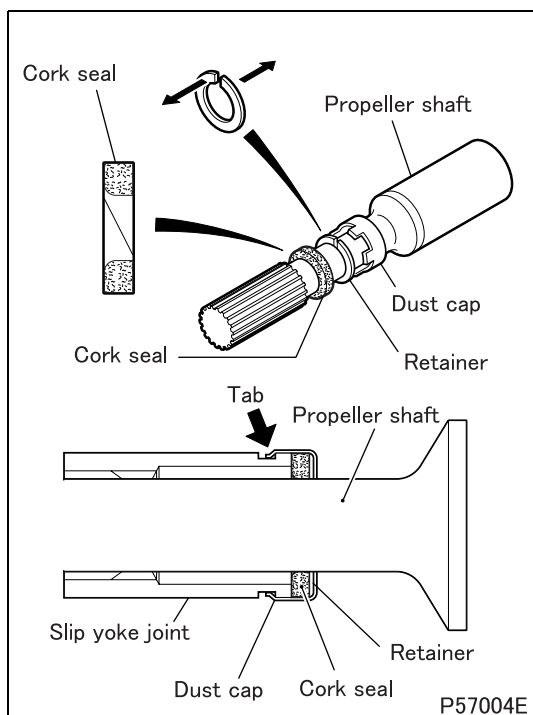
#### ■ Installation: Dust cap, retainer and cork seal

- After inserting the dust cap into the propeller shaft, carefully open the retainer right and left, assemble it to the propeller shaft and return it to the original condition.
- Apply grease to the inside circumference of the cork seal and assemble it to the propeller shaft, facing it in the illustrated direction in the same method as the retainer.
- Apply sufficient grease to the splined portion of the propeller shaft, then fit the propeller shaft into the slip yoke joint.
- Press the dust cap against the slip yoke joint in such a way that the cork seal is compressed, and crimp its tabs to engage with the recesses in the slip yoke joint.

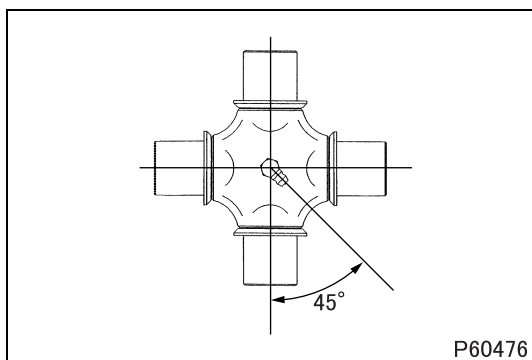
## ■ Installation: Spider

- Fit grease nipple to the spider facing it in the illustrated direction.

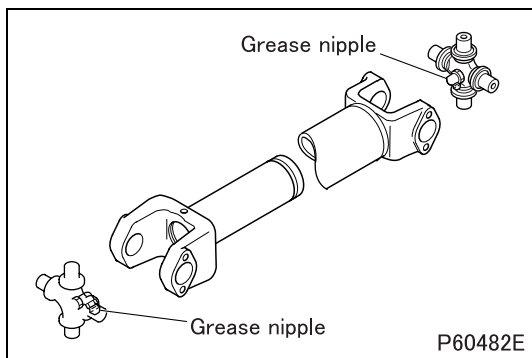
- Install spiders on both ends of the propeller shaft so that their respective grease nipple faces in the same direction.

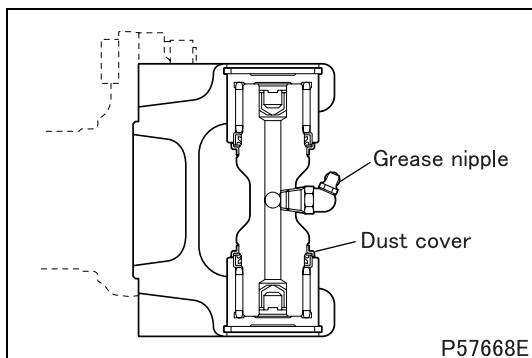
## ■ Lubrication: Grease nipple

- Fill grease through the grease nipple until supplied grease overflows from four dust covers of the spider.
- If grease does not overflow from all of the four dust covers or rust, water and dirt come out with grease, replace the spider with the spider kit.

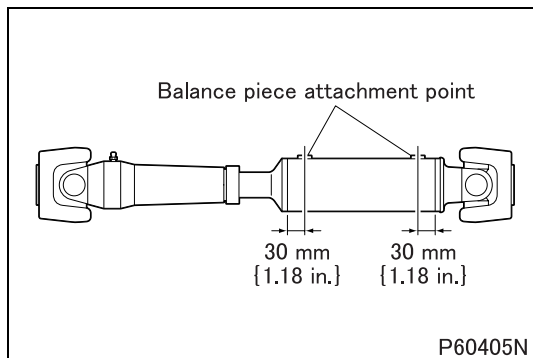
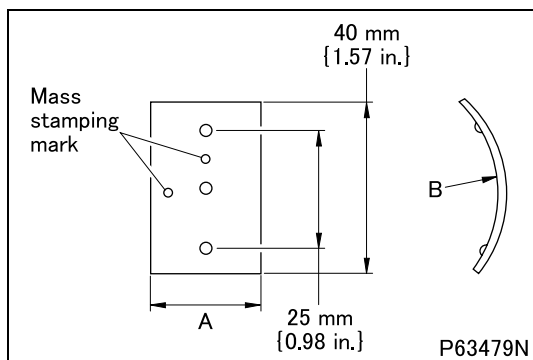
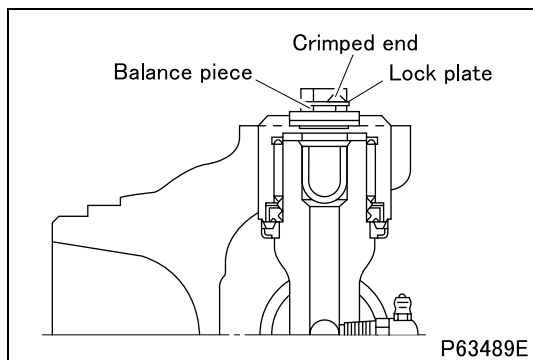
### (1) Polar coordinate method

- Attach appropriate balance pieces to the illustrated points so that the unbalance amount comes within the standard value.
- Maximum balance piece allowance for one point is 120 g {4.23 oz}.
- Use a combination that keeps the number of balance pieces to a minimum.

- The 90° component of force method is preferable for balancing the propeller shaft if the amount of imbalance is large because it requires less balance pieces.

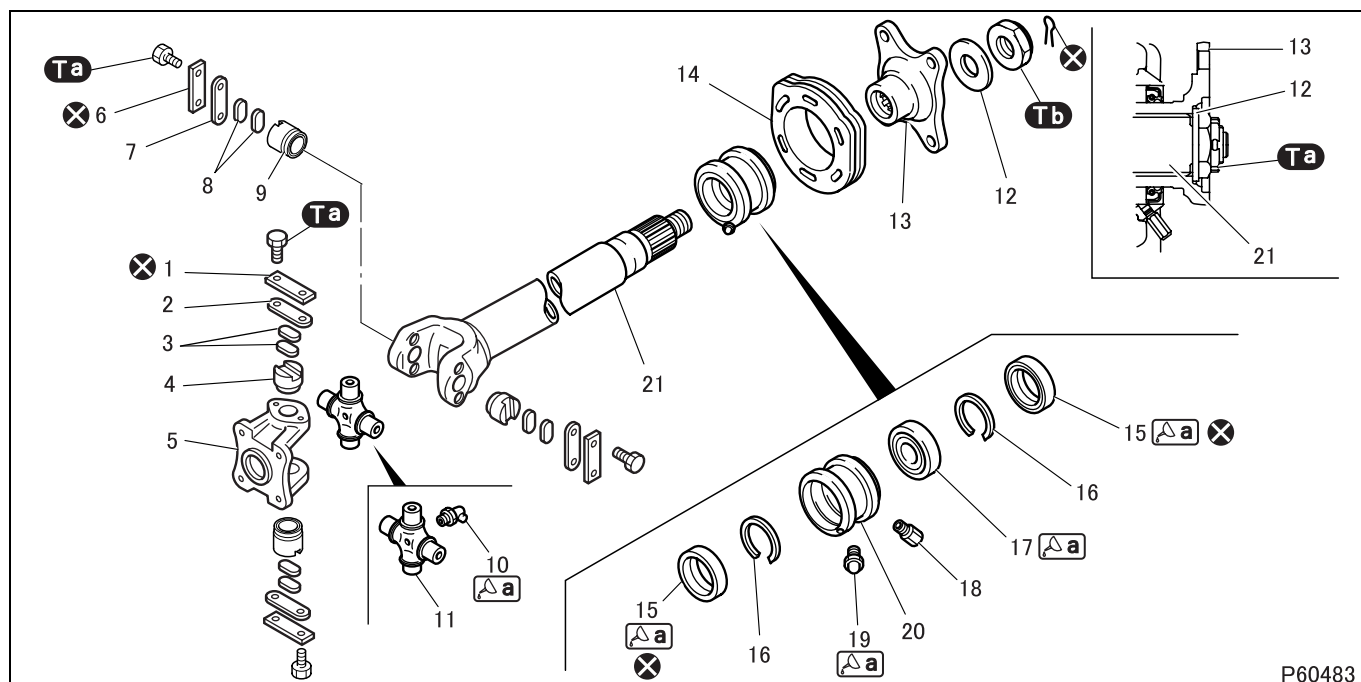
<With center bearing>

- Balance piece installing position (at flange yoke or propeller shaft) depends on the unbalance of the propeller shaft. This illustration is an example.

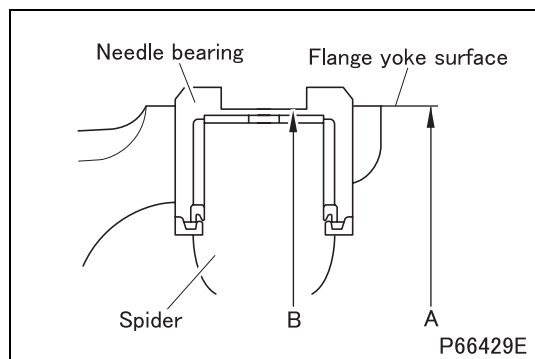
#### ■ Inspection: Axial clearance of spider

- Measure the clearance of needle bearing (shim adjusting allowance =  $A - B$ ).
- If the measurement exceeds the standard value, adjust the clearance by changing thickness of the shim.  
Types of shim: 0.1 mm {0.0039 in.}, 0.2 mm {0.0079 in.}

- **Never allow the shim to protrude from the flange yoke surface.**
- **Use shims for both ends with the same thickness as much as possible to ensure rotation balance.**

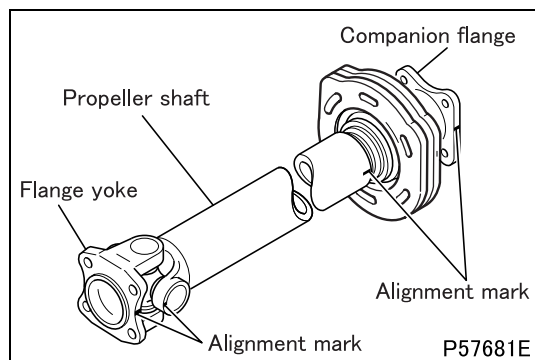
#### ■ Alignment mark: Propeller shaft

- To prevent assembly of wrong parts, make alignment marks on flange yoke, companion flange and propeller shaft.

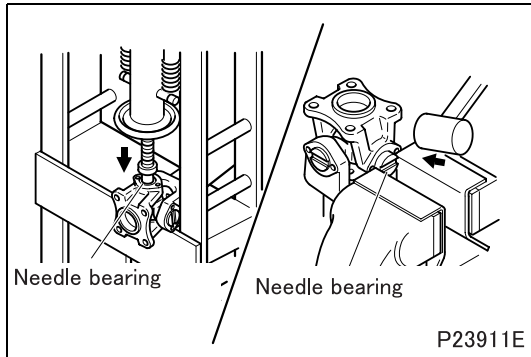
### ■ Removal: Needle bearing

- Make alignment marks on the needle bearing and spider.
- Force out the needle bearing halfway from the yoke using a press, then remove it with a vise.

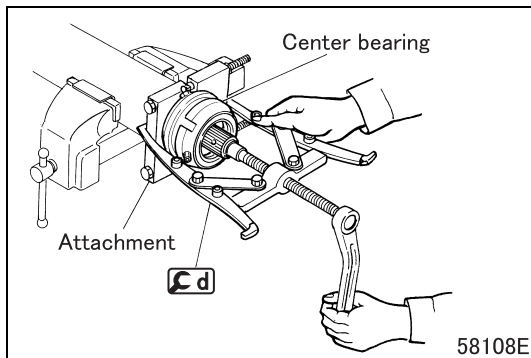
### ■ Removal: Center bearing

- Using

, remove the center bearing with the aid of the attachment.

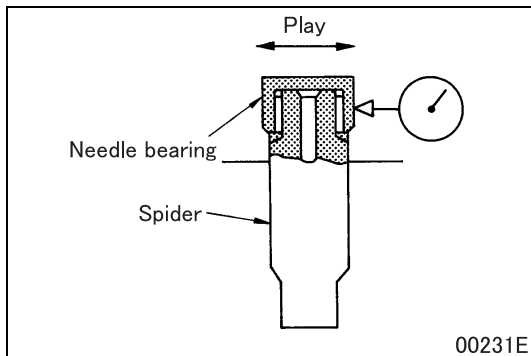
### ■ Inspection: Clearance between needle bearing and spider

- If the measurement is higher than the limit, replace with the universal joint spider kit.

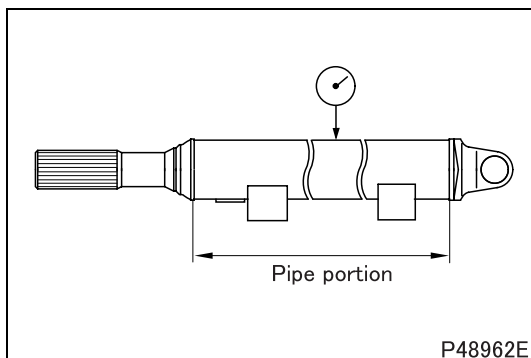
### ■ Inspection: Bend of propeller shaft

- Before measuring the bend of pipe, remove paint from the propeller shaft where the dial gauge is set and the pipe is supported with V blocks using a paint remover.
- Measure bend of propeller shaft at the center of its pipe portion.
- To measure the bend of propeller shaft, turn it fully once and read the dial gauge indicator. The bend is one half of the indicated value.
- If the measurement deviates from the standard value, correct the bend with a press or replace the propeller shaft.

- Remove paint using care not to damage the pipe portion of the shaft.
- Check the propeller shaft for cracks in the welded area after correcting the bend using a press. If a crack is caused, replace the propeller shaft instead of correcting it by welding.

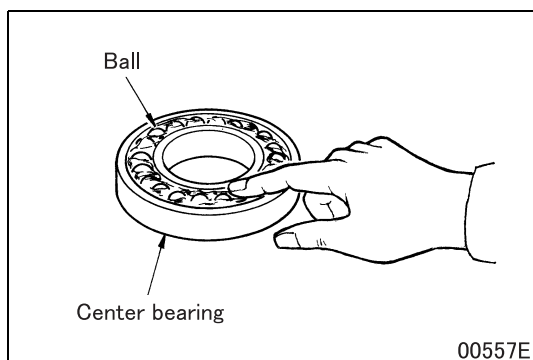
### ■ Installation: Center bearing

- Fill space between balls of the center bearing with grease.

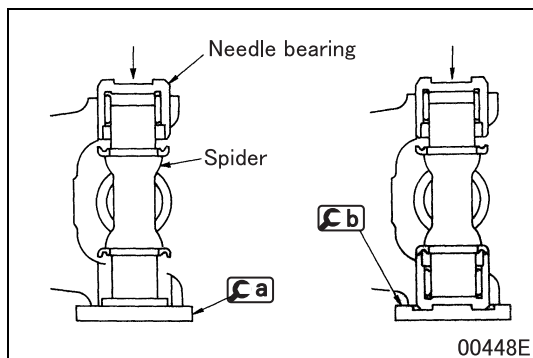
## ■ Installation: Grease nipple

- Fit grease nipple to the spider facing it in the illustrated direction.

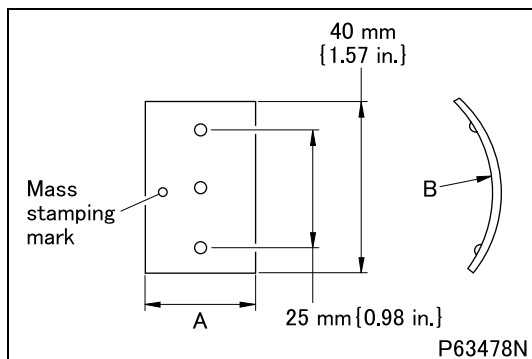
### (1) Polar coordinate method

- Attach appropriate balance pieces and lock plate to the illustrated points so that the unbalance amount comes within the standard value.
- Maximum balance piece allowance for one point is 120 g {4.23 oz}.
- Use a combination that keeps the number of balance pieces to a minimum.

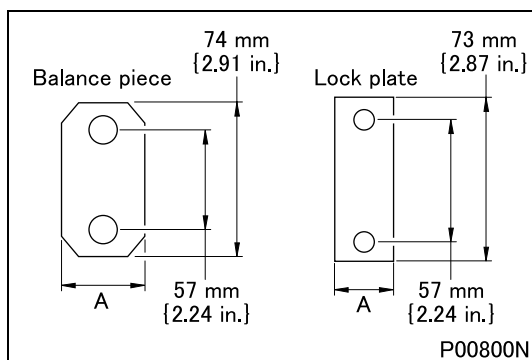
### (2) 90° component of force method

- Attach appropriate balance pieces and lock plate to the illustrated points so that the unbalance amount comes within the standard value.
- Maximum balance piece allowance for one point is 120 g {4.23 oz}.
- Use a combination that keeps the number of balance pieces to a minimum.

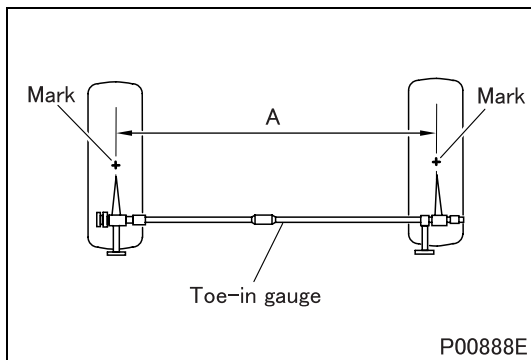
### 1.1 Inspection and adjustment of toe-in

- Direct the front wheels exactly to forward running position.
- Put a mark on both the right and left tires at the height of the front wheel axis in the center of the tire width.

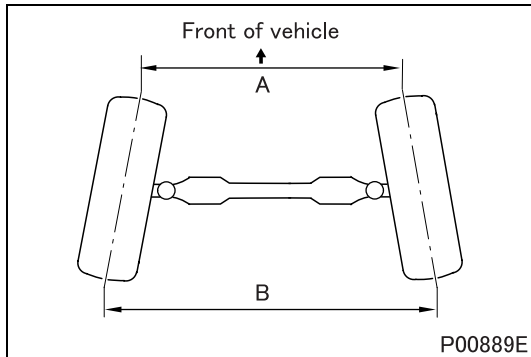
- Align the two points of the toe-in gauge with respective marks and measure distance A between the marks.

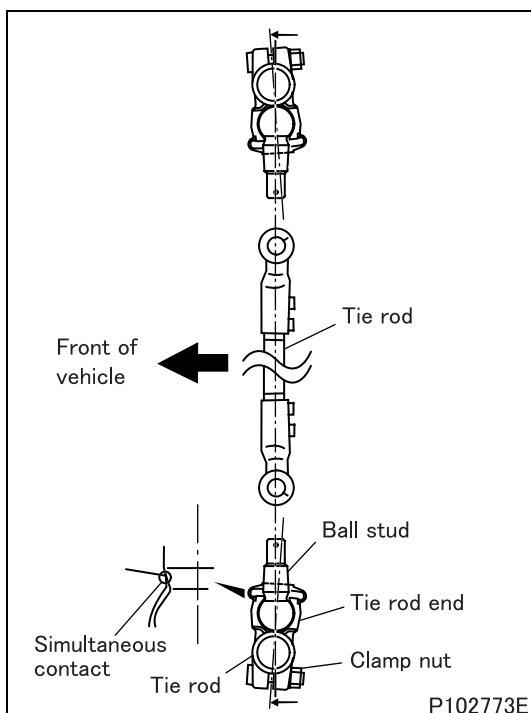
- ★ Loosen the right and left nuts of tie rod.
- Turn the tie rod with a pipe wrench to adjust the toe-in.  
C: When adjusting to the toe-out direction  
D: When adjusting to the toe-in direction
- After adjustment, apply grease to the nut and tighten it to the specified torque.

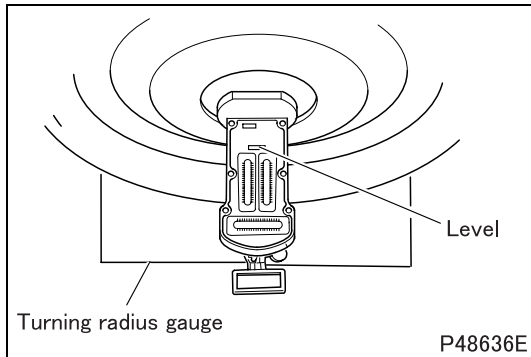
- Keep the turning radius gauge locked.
- Jack up the vehicle and set the right and left front wheels so that respective ground contact area centers of the two wheels and turn table centers may meet.

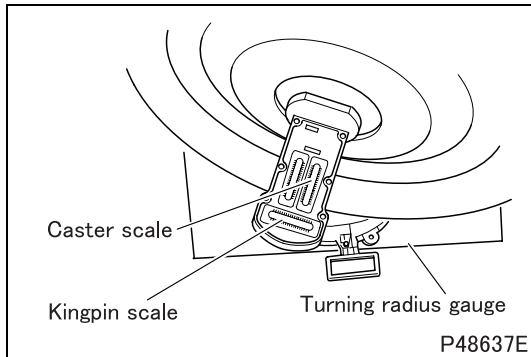
- Unfasten locking of the turning radius gauge, and set the scale to 0 degrees.
- As with the camber measurement in Section 1.2, attach the camber/caster/kingpin gauge and set the level so that the bubble remains in the middle.

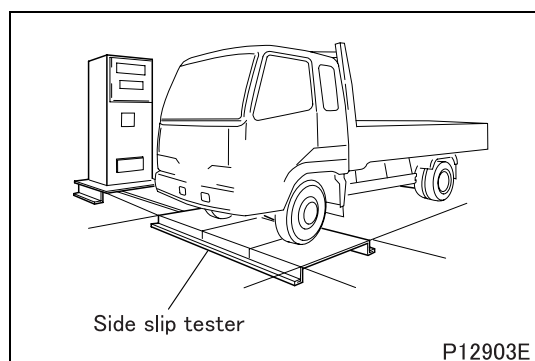
- Set the front wheels exactly to forward running position.
- Move the vehicle forward past the side slip tester as slowly as possible to inspect side slip.

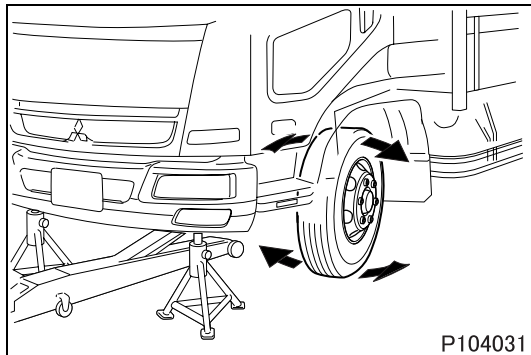
## 5. Inspection of Wheel Bearing for Play

- Jack up the vehicle.
- Try to move the top and bottom of the front tire by hands in the illustrated directions to inspect the wheel bearing for play.
- If play is found with the feel of hands, repeat the inspection procedure while having the brake pedal pressed by another personnel. When the play is removed by operating the brake pedal, the symptom indicates that there is play in the wheel bearing, not in the suspension or other related parts. Then inspect the turning torque of the wheel bearing and adjust it as required. (See WHEEL HUB AND BRAKE DRUM or WHEEL HUB AND ROTOR.)
- If the turning torque of the wheel bearing cannot be adjusted correctly or the play still remains after the adjustment, replace the wheel bearing with a new one. (See WHEEL HUB AND BRAKE DRUM or WHEEL HUB AND ROTOR.)

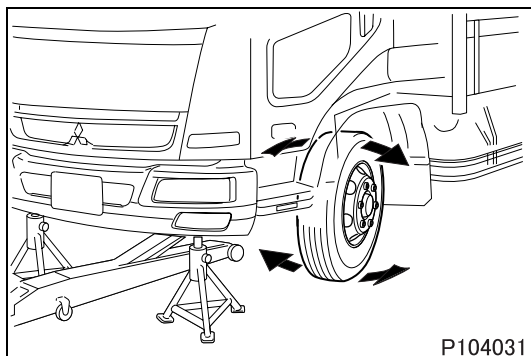
## 6. Inspection of Knuckle Joint for Play

- Jack up the vehicle.
- Try to move the top and bottom of the front tire by hands in the illustrated directions to inspect the knuckle joint for play.
- If play is found with the feel of hands, repeat the inspection procedure while having the brake pedal pressed by another personnel. If there is any play, it may be caused by the play in the knuckle joint. Check each part and replace a defective part. (See KNUCKLE AND KING PIN, FRONT AXLE.)

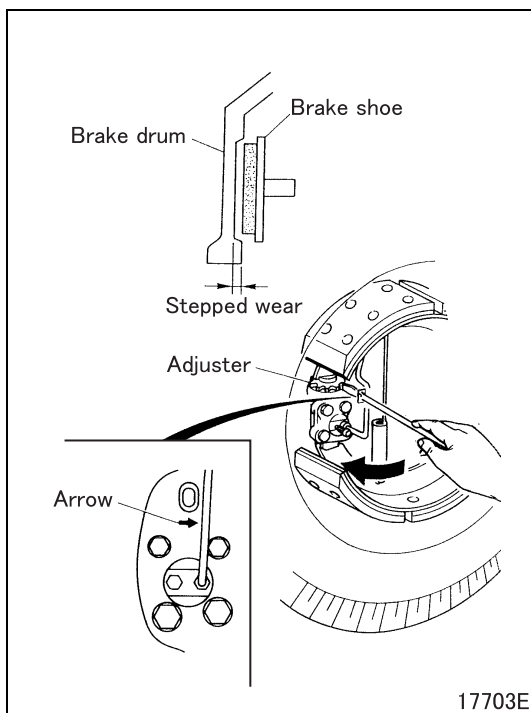
- If the brake drum has stepped wear and the wear prevents the wheel hub and brake drum from being removed, the removal can still be effected by taking the following procedure. After the removal, correct or replace the brake drum.

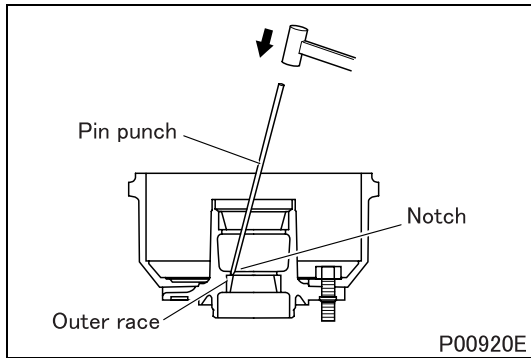
- Drive out the inner bearing outer race by tapping evenly at two notches in the wheel hub.

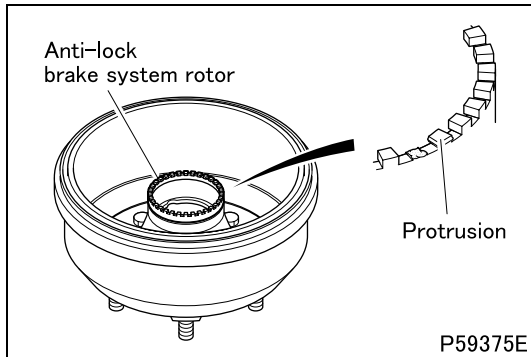
### ■ Inspection: Anti-lock brake system rotor

- Check the protrusions of the anti-lock brake system rotor for chipping and flattening.
- If any abnormality is found, replace the anti-lock brake system rotor.

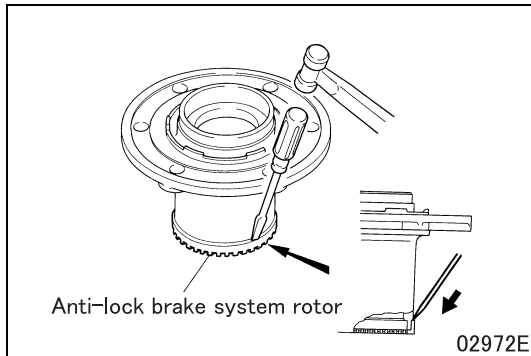
### Replacement of anti-lock brake system rotor

- Be careful not to damage the wheel hub.

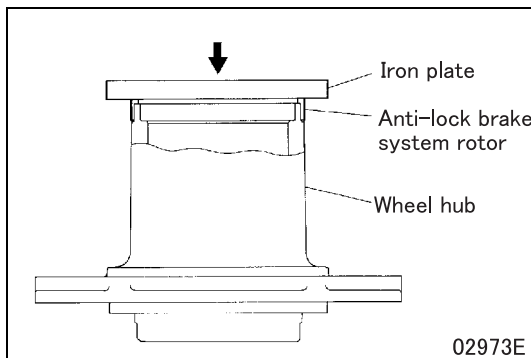
#### [Installation]

- Warm the anti-lock brake system rotor to approximately 150°C {302°F}, press it evenly using an iron plate, and press it into the wheel hub so that there is no clearance between the wheel hub and the anti-lock brake system rotor.

- When pressing, do not make dents in the rotor.

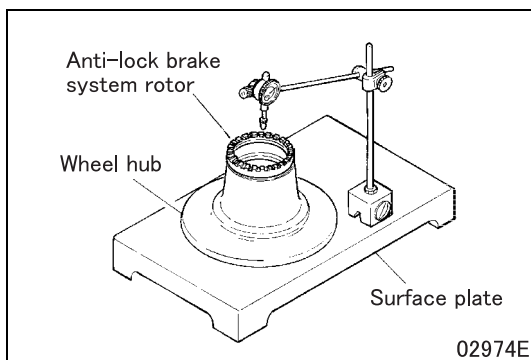
#### [Inspection]

- If runout is out of the standard value, reassemble.
- If runout is out of the standard value after reassembly, replace the defective part(s).

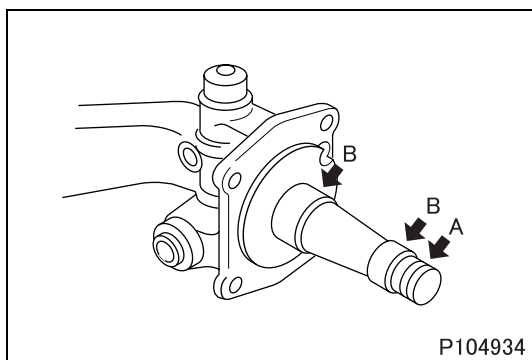
## ■ Inspection: Knuckle

- If the lock nut tightening threads (A) are damaged, repair the damage using a die to ensure accurate adjustment of starting torque.
- Replace the knuckle if it apparently has stepped, tapered, uneven or other abnormal wear or damage in the outer bearing fitting surface (B).

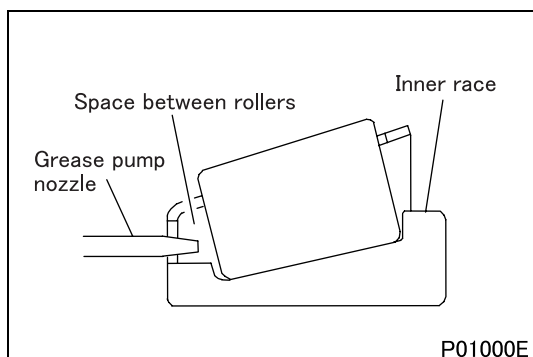
## ■ Installation: Packing of grease in inner bearing inner race

- Insert the grease pump nozzle into the space between rollers of the outer and inner bearing inner race to pack grease sufficiently.

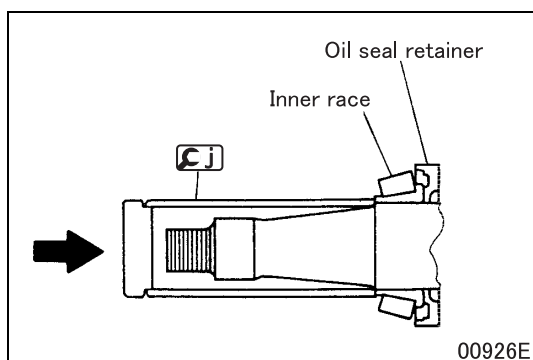
## ■ Installation: Inner bearing inner race, oil seal retainer

press-fit oil seal retainer and inner bearing inner race simultaneously.

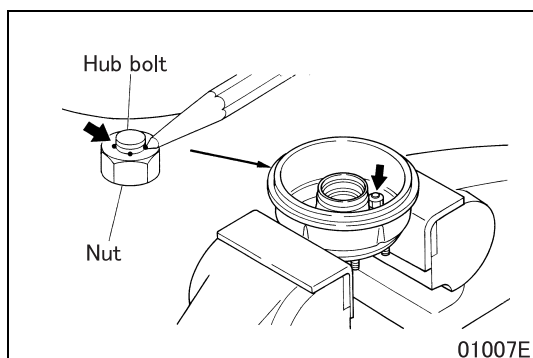
## ■ Installation: Hub bolts

- As for hub bolt, tighten nut at specified torque, and caulk at 4 positions for prevention of loosening.

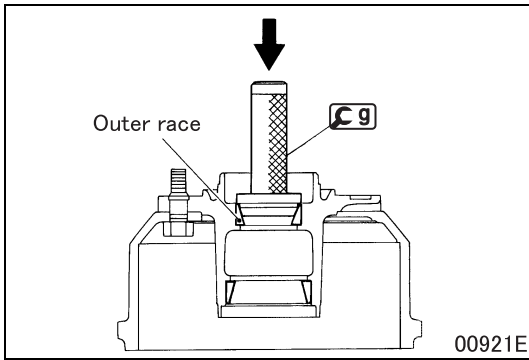
#### ■ Installation: Outer bearing outer race

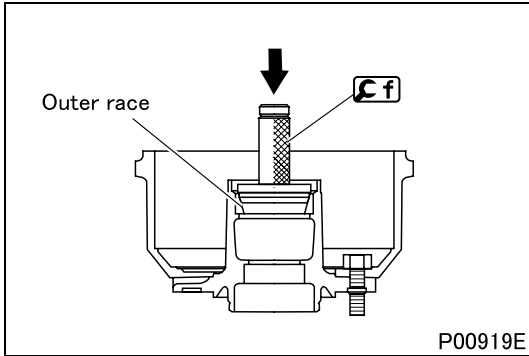
#### ■ Installation: Inner bearing outer race

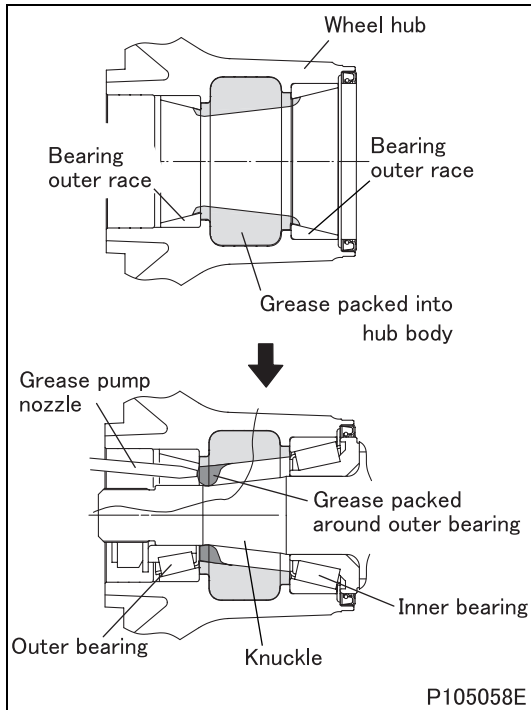
## <Manner 1>

- Pack grease in the wheel hub body so much that grease covers the outer and inner bearing outer races to ensure that grease will reach the outer and inner bearings as shown in the drawing.
- After installing the wheel hub in the knuckle, insert a grease pump nozzle into the wheel hub and add grease to around the outer bearing before installing the outer bearing inner race.

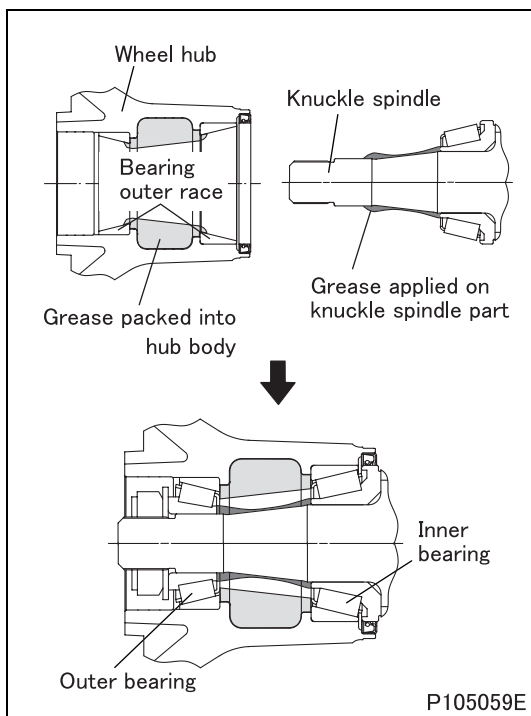
## <Manner 2>

- Pack grease in the wheel hub body so much that grease covers the outer and inner bearing outer races to ensure that grease will reach the outer and inner bearings as shown in the drawing.
- Before installing the wheel hub in the knuckle, apply grease to the knuckle spindle.

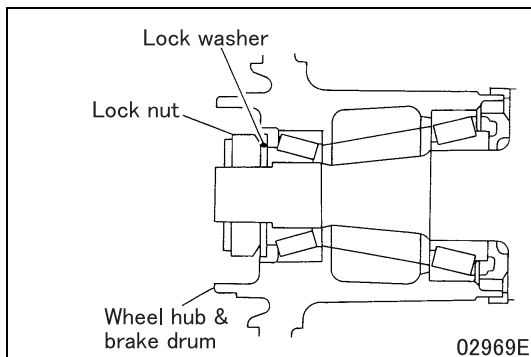
## ■ Adjustment: Starting torque of wheel hub bearing

- Unless this adjustment procedure is performed, seizure of the wheel hub bearing can be caused.

- Do not tighten the lock nut without turning the wheel hub and brake drum, or tighten it to the specified torque within three turns. Failure to observe the above will make the installed condition of the inner bearing faulty, causing poor rotation and seizure.**

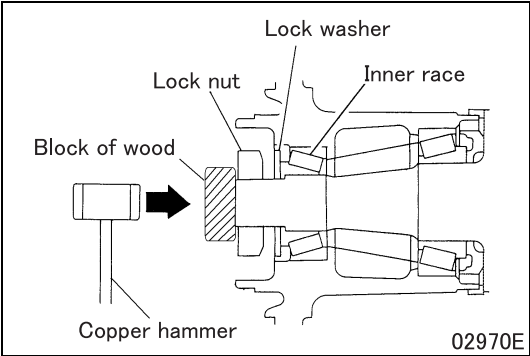
- Perform the following work to pull the outer bearing inner race toward the lock nut side.
- Loosen the lock nut to create clearance between the outer bearing inner race and lock nut.
- Apply a block of wood to the end face of the axle housing, and tap it two or three times while turning the wheel hub and brake drum.

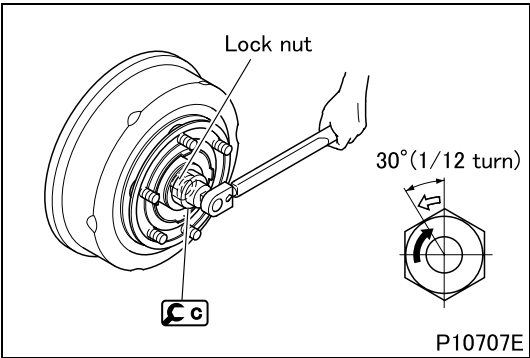
- ★ Tighten lock nut at specified torque, and after it, return to the loosening direction as shown by the amount of 30 degrees (1/12 turn).

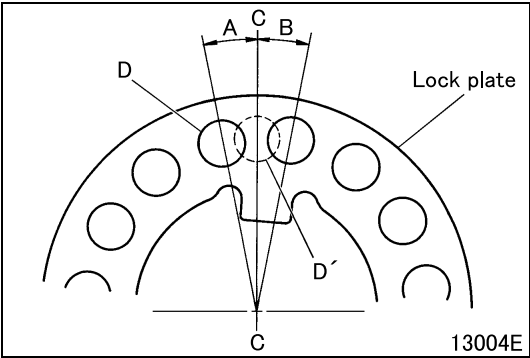
- Fit the lock plate into place and check to ensure that all of the mounting holes in the lock nut and the lock plate are in alignment, and tighten the mounting bolts.
- If the mounting holes of the lock nut and the lock plate are out of alignment, align them by the procedures shown in the following table.

| Lock nut hole position | How to align lock plate hole |
| Range A | Loosen lock nut and align holes. |
| Range B | Turn over lock plate, loosen lock nut and align holes. |
| On line C–C | Turn over lock plate and align holes.<br>(Hole position changes from D' to D.) |

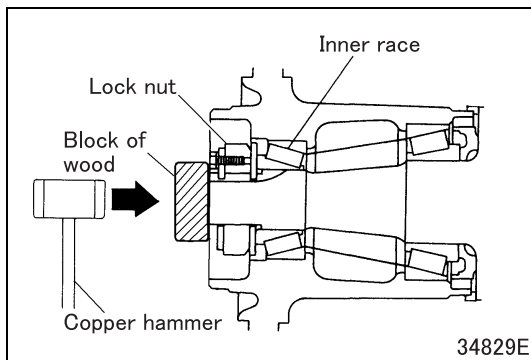
- Perform the following work to pull the outer bearing inner race toward the lock nut side again.
- Apply a block of wood to the end face of the axle housing, and tap it two or three times while turning the wheel hub and brake drum.
- Make sure that there is no looseness in the axial direction.
- Perform a measurement again after adjustment. If the measured value is out of the standard value, repeat the work from the item marked with ★, since adjustment of the lock nut may be insufficient.
- If the result is found to be abnormal, replace the outer and inner bearings.

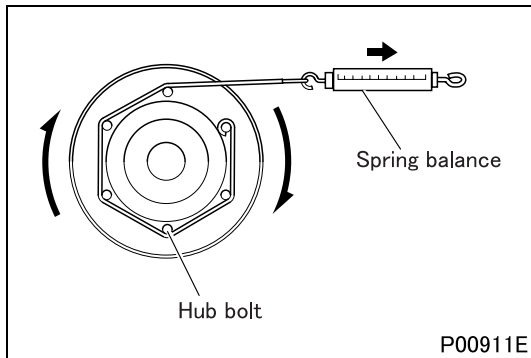
## [Inspection]

- After assembly of the lock nut, fasten a spring balance to hub bolt and measure tangential force.
- If the tangential force meets the specified value, the starting torque will become the standard value.
- If the measurement deviates from the specified value, repeat the work from the item marked with ★, since adjustment of the lock nut may be insufficient.
- If the result is found to be abnormal, replace outer and inner bearings.

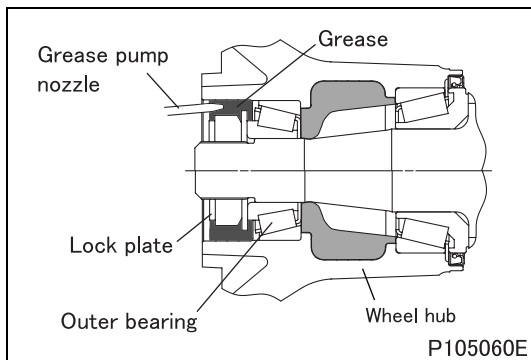
## ■ Installation: Packing of grease in outside of wheel hub

- Unless this packing procedure is performed, seizure of the wheel hub bearing can be caused.
- For a grease amount, pack the specified amount using a measuring cup.

- Do not pile grease in the wheel hub cap. Otherwise, grease does not reach the outer bearing, causing poor lubrication of the bearing.

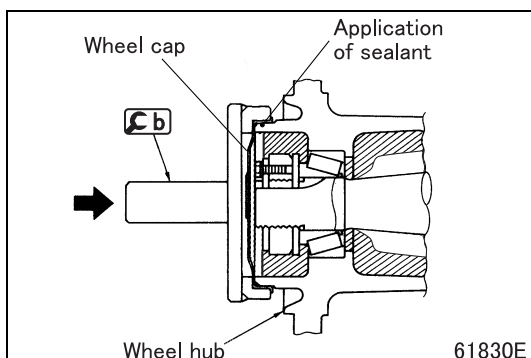
## ■ Installation: Wheel hub cap

- Apply sealant to the wheel hub cap fitting surface with the wheel hub, and press the wheel hub cap in the wheel hub using

- Adhesion of grease to the fitting surface with the wheel hub causes water entry and grease leakage.
- If the wheel hub cap is tapped with a hammer for installation, the fitting surface is deformed, impairing waterproof effect.

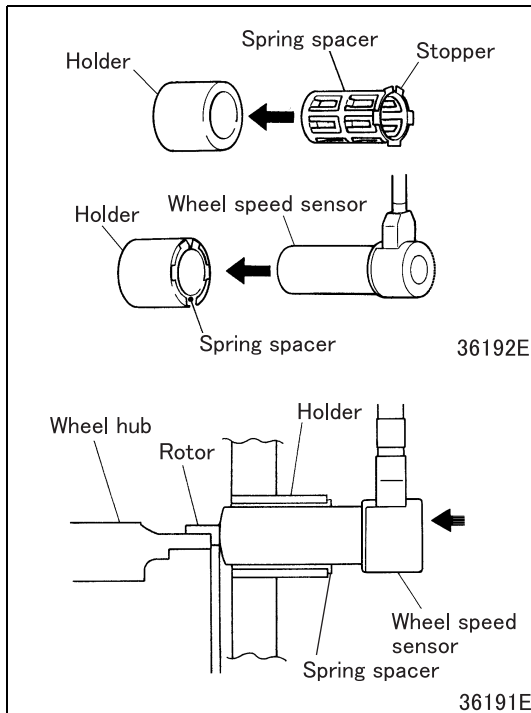
### ■ Installation: Wheel speed sensor and spring spacer

- Insert the spring spacer into the holder of the knuckle and press it in until its stoppers knock against the holder.
- Insert the wheel speed sensor and press it in until it knocks against the rotor with tactile feel.
- Slowly turn the wheel hub and brake drum two or three times (2 seconds per turn) to make sure that they turn smoothly.

- **When installing the wheel speed sensor, never apply excessive force to the sensor, such as hitting with a hammer, prying with a screwdriver or pulling the harness, since these actions can result in the breaking of wire.**

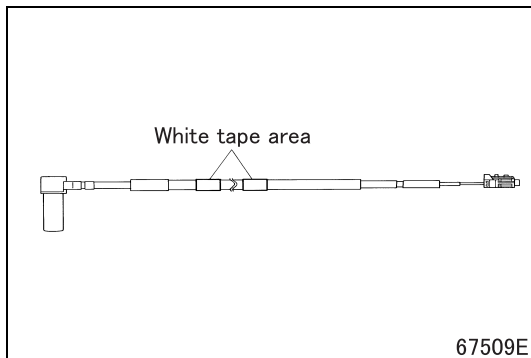
### ■ Installation: Harness of wheel speed sensor

- Be sure to secure clip positions of the wheel speed sensor harness at the white tape area to avoid interference with other parts, twist and slack.

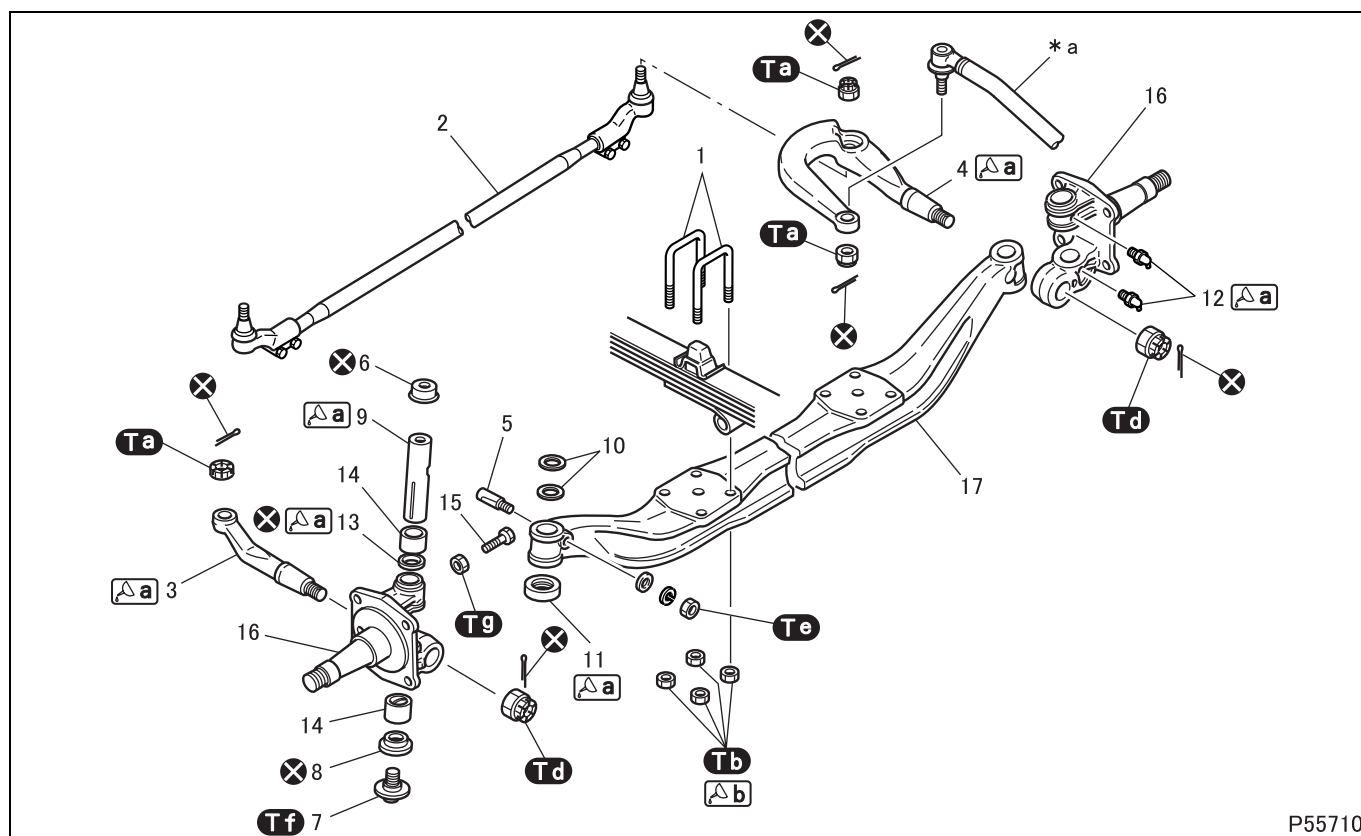
P55710

## ● Disassembly sequence

| Location | Maintenance item | | Standard value | Limit | Remedy |
|---|---|---|---|---|---|
| <b>9</b> | Outer diameter of kingpin | | 34.985 to 34.998<br>{1.377 to 1.378} | 34.9<br>{1.374} | Replace |
| <b>9, 14</b> | Clearance between kingpin and bushing | | 0.02 to 0.06<br>{0.00079 to 0.0024} | 0.15<br>{0.0059} | Replace |
| <b>9, 17</b> | Clearance between kingpin and axle | | 0.002 to 0.04<br>{0.00008 to 0.0157} | 0.1<br>{0.0039} | Replace |
| <b>14</b> | Inner diameter of bushing (after having been pressed into knuckle) | | 35.018 to 35.045<br>{1.378 to 1.379} | – | Replace |
| <b>17</b> | Front axle | Horizontal bend | 2.5 {0.098} or less | 7 {0.28} | Replace |

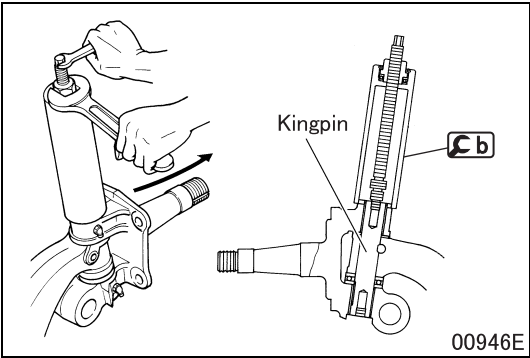
### ■ Removal: Kingpin

into the kingpin threads to remove the kingpin.

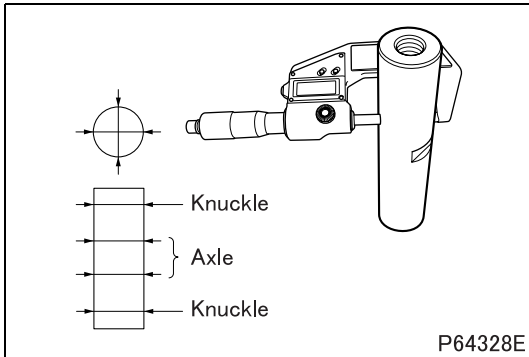
### ■ Inspection: Outer diameter of kingpin

- Take measurement at a total four levels on the kingpin: two levels for the axle fitting portion and one level each for the upper and lower knuckle fitting portions.
- If the measured value is under the limit, replace the kingpin with a new one.

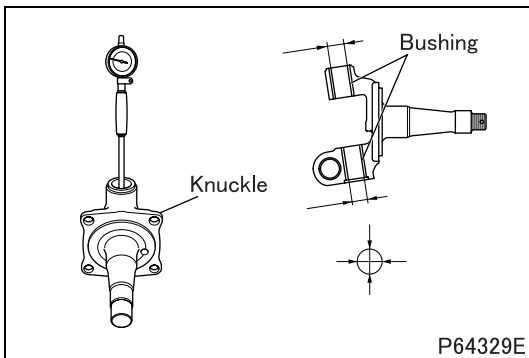
### ■ Inspection: Clearance between kingpin and bushing

- Measure the inner diameter of the upper and lower bushings using a cylinder gauge and calculate the clearance deducting the outer diameter of the kingpin from the inner diameter of the bushing.  
If the clearance exceeds the limit, replace the bushings with new ones.

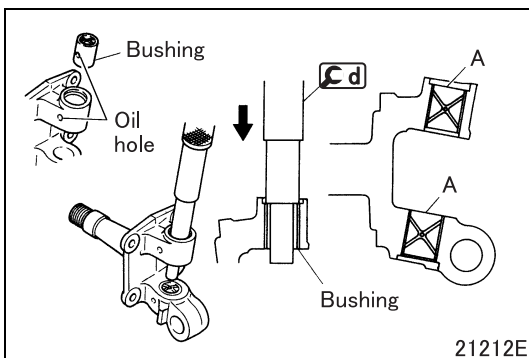
#### [Installation]

- Install bushing in with oil hole aligned to oil hole of knuckle, until end surface A becomes flush with knuckle end surface.

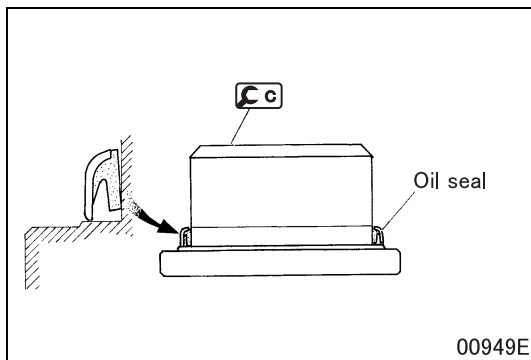
- Apply grease to lip area of oil seal, and set oil seal on **Cc**.

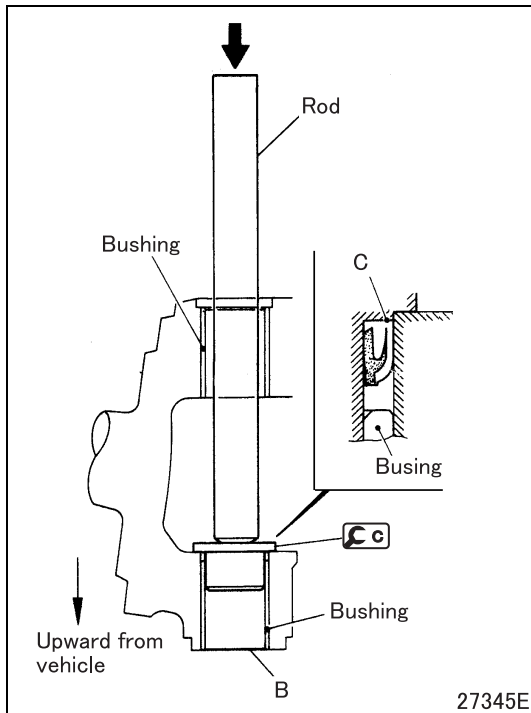
- Next, install **Cc** on the knuckle in the illustrated direction.
- Insert rod into kingpin hole, and attach it to **Cc**.
- Hit the head using a hammer until **Cc** comes to rest at knuckle.
- Make sure that end of bushing at B is flush with knuckle surface.
- End surface of oil seal at C shall not be protruding from knuckle.

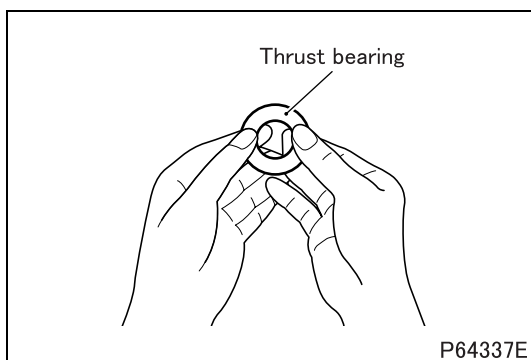
## ■ Inspection: Thrust bearing

- Inspect the aspect and smooth turning of the thrust bearing. If any crack, damage, or un-smooth turning is found, replace the thrust bearing with a new one.

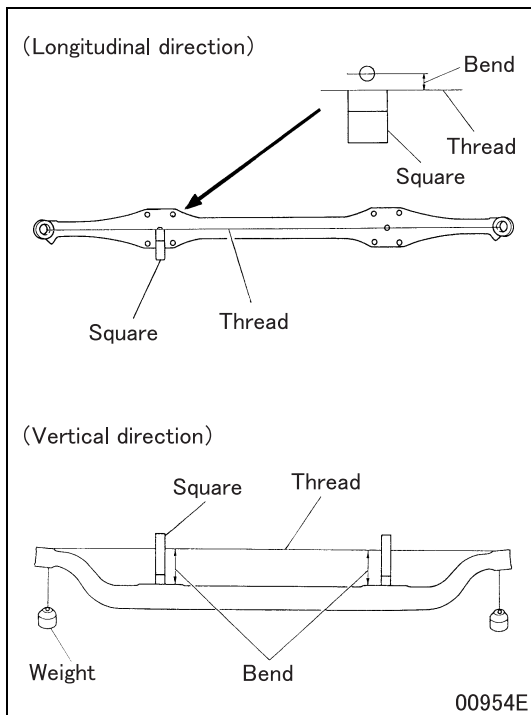
## ■ Inspection: Front axle

### (1) Bend of front axle in the longitudinal direction and vertical direction

- Put a piece of thread through kingpin holes of the front axle and hang weights at both ends.
- Use a square to find bend to each of longitudinal and vertical directions.
- If the measured value exceeds the limit, replace the front axle.

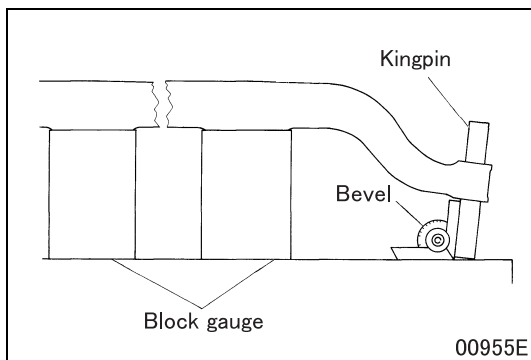
### (2) Kingpin inclination angle

- Set the kingpin on the front axle as illustrated to measure the angle.
- If the measured value deviates from the standard value, replace the front axle.

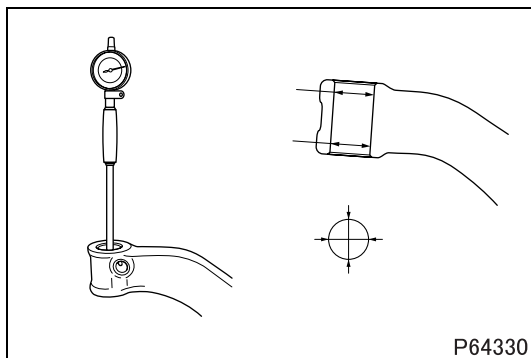
### (3) Clearance between kingpin and front axle

- Measure the inner diameter of the axle's hole where the kingpin is inserted using a cylinder gauge and calculate the clearance deducting the outer diameter of the kingpin from the inner diameter.

If the clearance exceeds the limit, replace the axle or the kingpin with a new one.

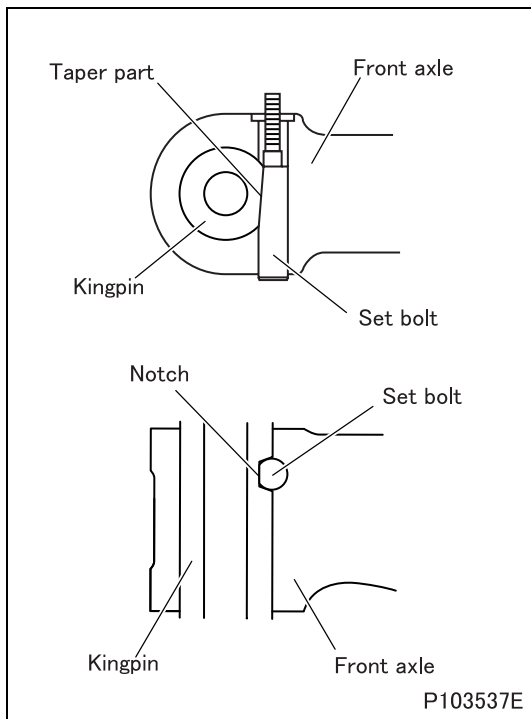
#### ■ Installation: Set bolt

- Install the set bolt so that the taper part of the set bolt is aligned with the notch of the kingpin.

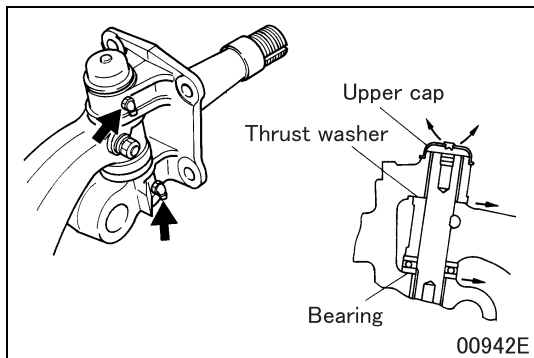
#### ■ Greasing: Grease nipple

- Supply grease through the grease nipple of the knuckle.
- Supply grease until it overflows from the dust plug of the upper cap, thrust washer and press portion of the bearing.

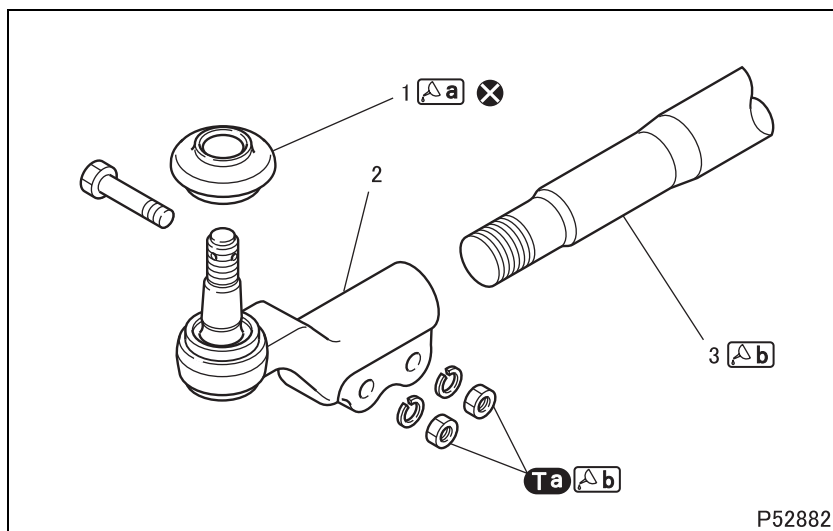
## ● Disassembly sequence

- 1 Dust cover
- 2 Tie rod end
- 3 Tie rod

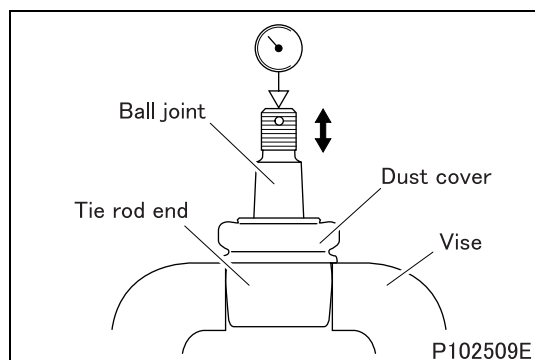
## ■ Inspection: Tie rod end

## (1) Play

- The position of the ball joint with applying no load is adjusted to standard position.
- Measure each play of the ball joint with applying the specified push and pull load from the standard position.
- Total each play and if the total deviates from standard value, replace the tie rod end.

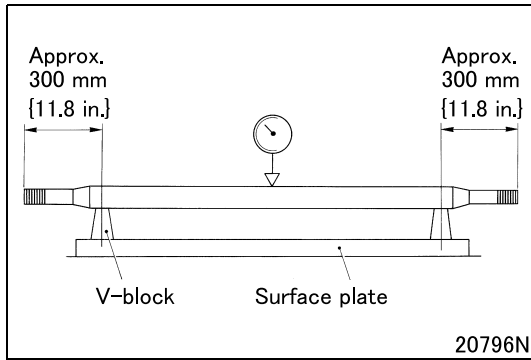
## ■ Inspection: Bend of tie rod

- Measure the bend of the tie rod at its center.

- **Give the tie rod one complete turn and read the dial gauge at this time. The bend is one half of the reading.**
- If the measured value exceeds the limit, correct or replace the tie rod.

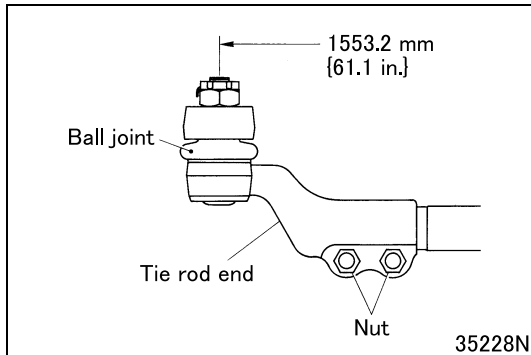
## ■ Installation: Tie rod end

- Install the tie rod end on the tie rod so that the distance between centers of the ball joint of tie rod ends is to the illustrated dimension, and tighten nuts to the specified torque.

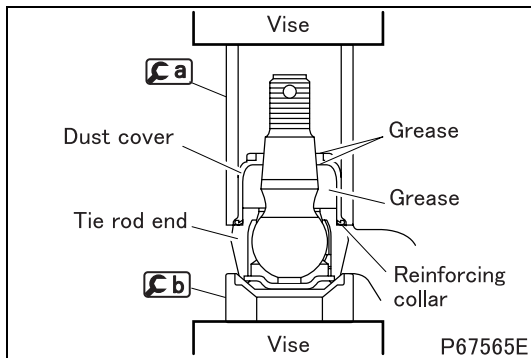
## ■ Installation: Dust cover

- Seal grease in the inside of the dust cover and apply grease to the lip area. Cover the dust cover and tie rod end with **(a)** and **(b)** as illustrated, and press them using a vise so that the reinforcing collar is brought into intimate contact with the tie rod end.
