# FE.FG

## SERVICE MANUAL 2008 Model FOREWORD

This Service Manual contains maintenance and repair methods for the Mitsubishi Fuso Truck FE. FG Series. Read this manual carefully as an aid in providing correct, efficient maintenance. Please note that the information and specifications contained within this manual may change without notice. This is due to product modifications and continued vehicle improvements that are made throughout the model years. Should you encounter any discrepancy in the information provided, please do not hesitate to contact your nearest Mitsubishi Fuso Dealer or Mitsubishi Fuso Truck of America, Inc.

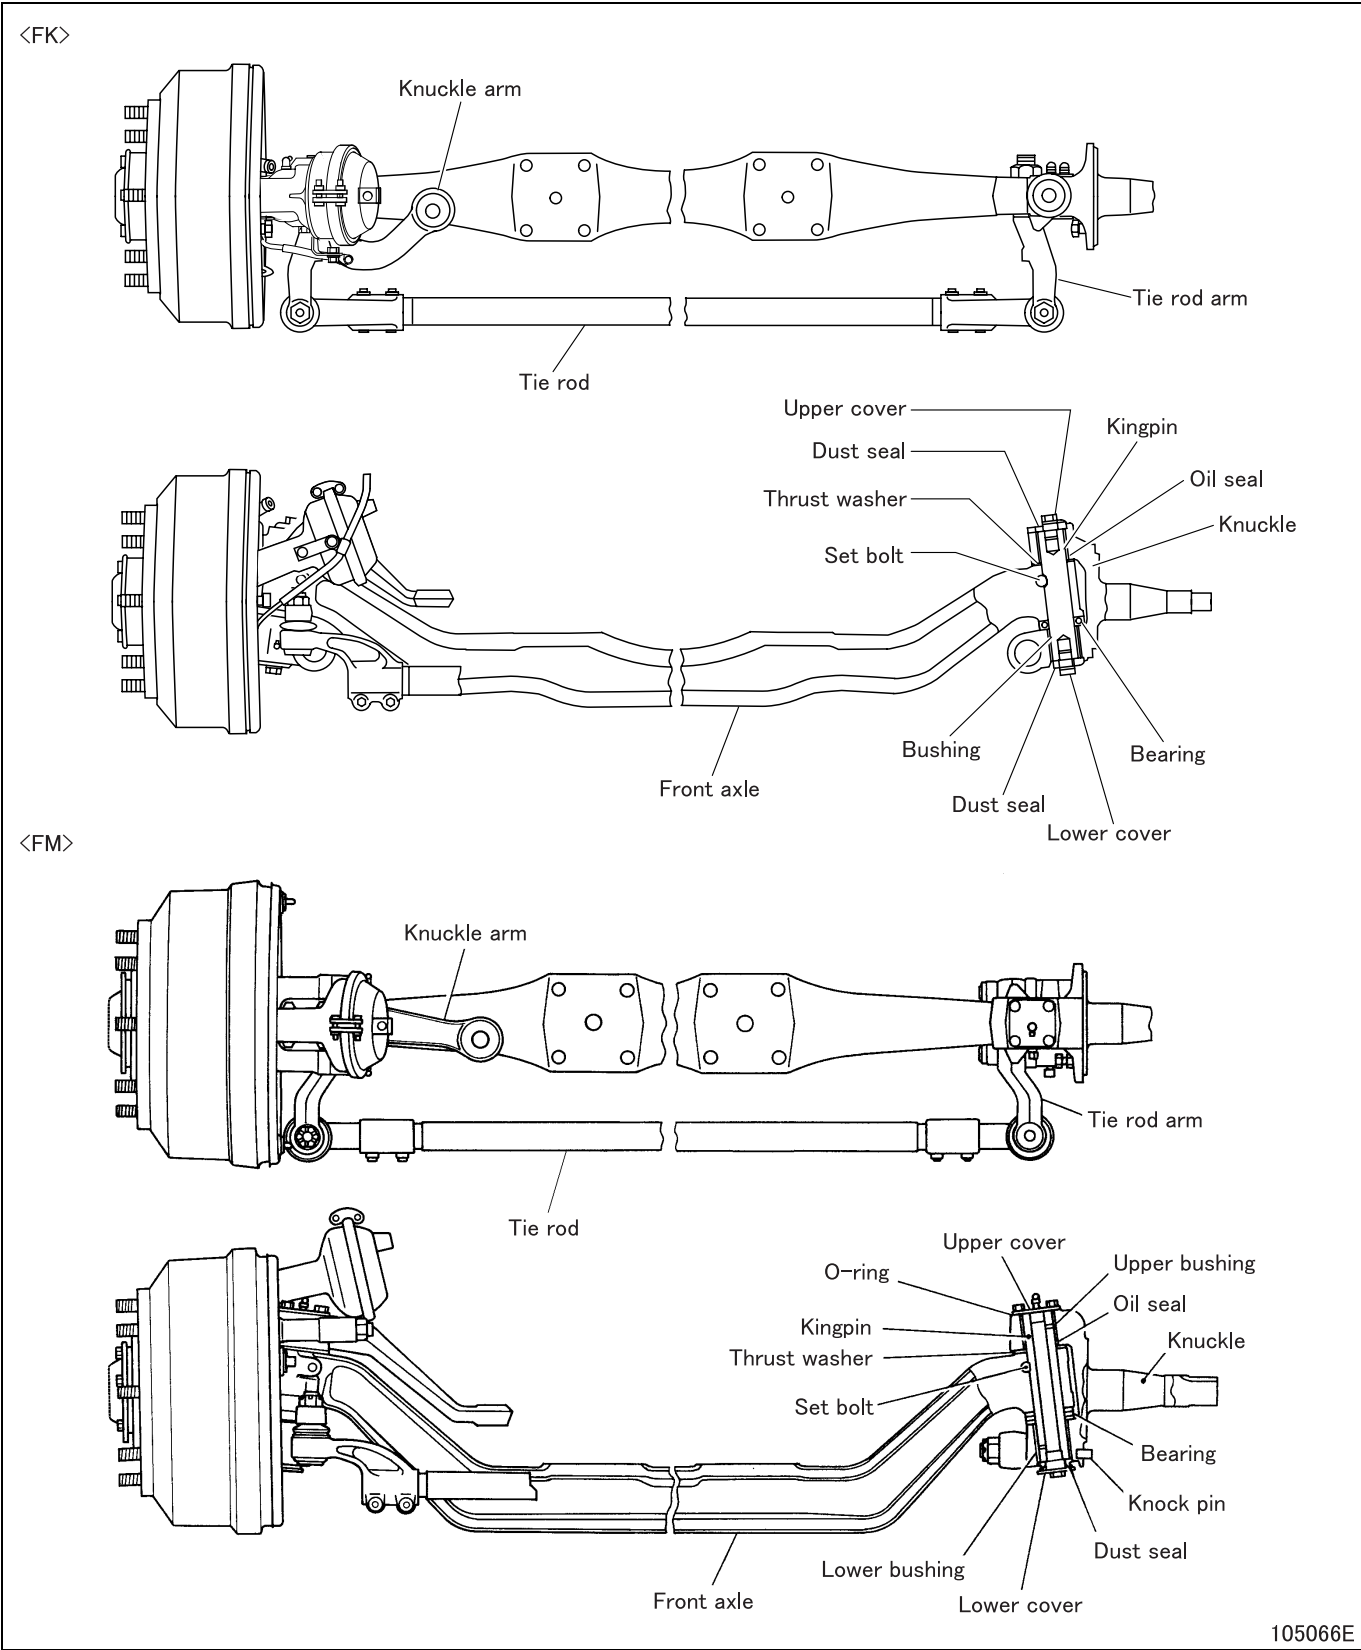
## 2. Front Axle, Knuckle and Kingpin

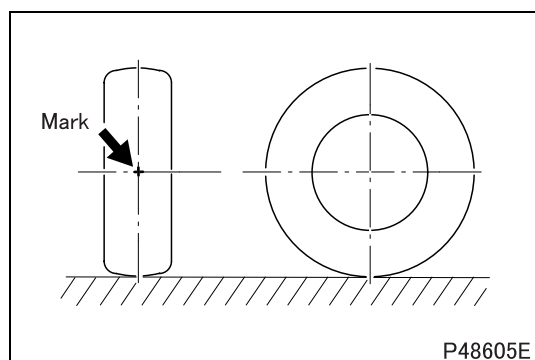
#### 1.1 Inspection and adjustment of toe-in

- Direct the front wheels exactly to forward running position.
- Put a mark on both the right and left tires at the height of the front wheel axis in the center of the tire width.

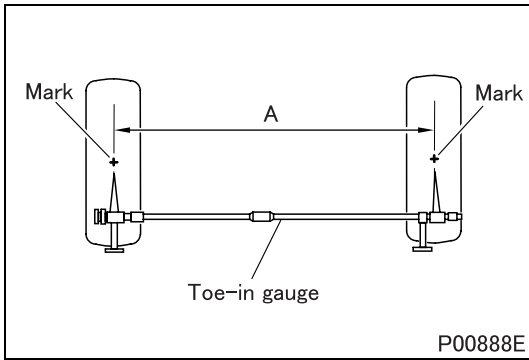
- Align the two points of the toe-in gauge with respective marks and measure distance A between the marks.

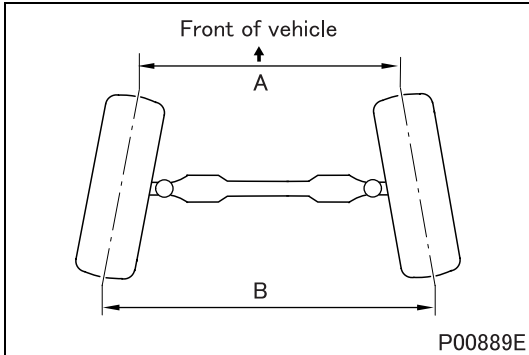
- Push the vehicle to roll the tires 180 degrees.
- Measure distance B between the marks that have moved to the rear of the vehicle.
- If toe-in (difference between A and B) deviates from the standard value, adjust.

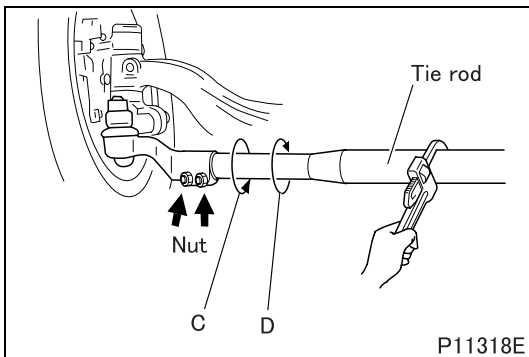
#### [Adjustment]

- ★ Loosen the right and left nuts of tie rod.
- Turn the tie rod with a pipe wrench to adjust the toe-in.  
C: When adjusting to the toe-out direction  
D: When adjusting to the toe-in direction
- After adjustment, tighten the nut to the specified torque.

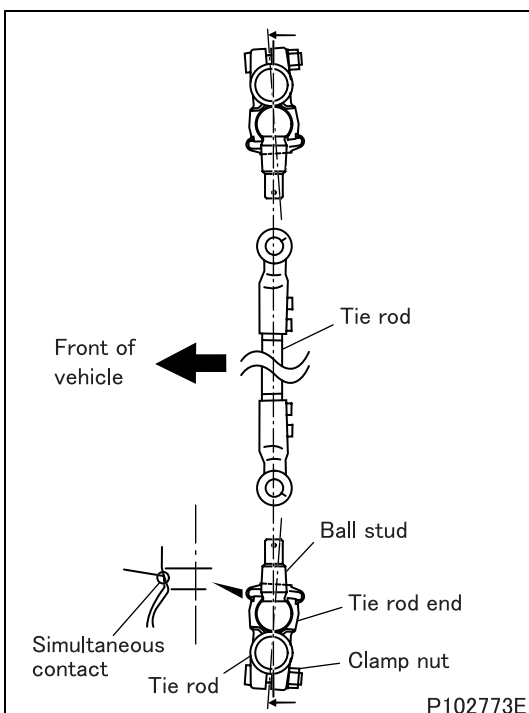
- Hold down the tie rod toward the front or rear of the vehicle with the front wheels directed to forward running position so that the right and left tie rod ends are in contact with the ball studs at the same time.
- In this state adjust the toe-in and tighten the clamp nut to secure the tie rod end.

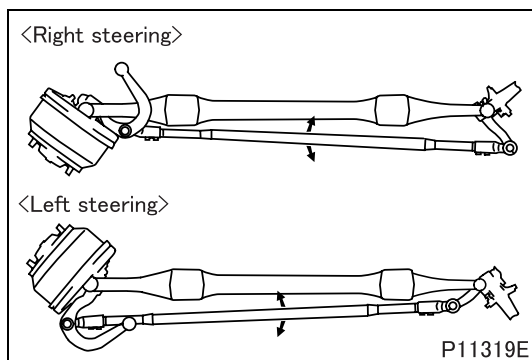
- After adjustment, turn the steering wheel to the extreme left (the state in which the knuckle stopper bolt is contacted), and move the tie rod in the longitudinal direction of the vehicle by hand to make sure that the tie rod moves.  
Do the same for right steering.  
(If the tie rod swings, the tie rod ends should be in contact with the ball studs at the same time.)

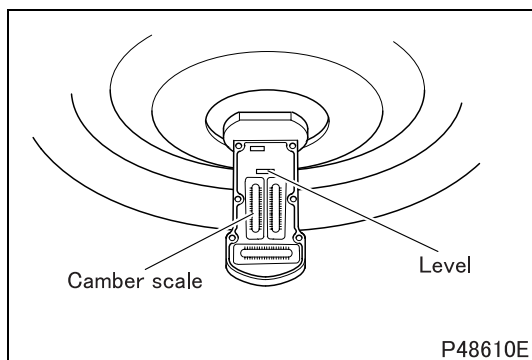
## 1.2 Inspection of camber

- Direct the front wheels exactly to forward running position.
- Remove the wheel hub cap.
- Wipe off grease from the knuckle end, and bring the camber/caster/kingpin gauge into intimate contact with the front wheel hub.
- Place the level so that the bubble remains in the middle, and read center of bubbles on camber scale in this state to find the camber. Do the same for the right and left front tires.
- If the measured value deviates from the standard value, abnormalities such as wear of kingpin and bushing, loose hub bearing, and bend of knuckle and front axle are suspected. Inspect each part and replace defective parts.

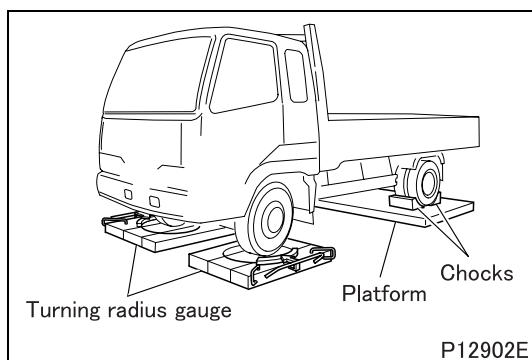
## 1.3 Inspection of caster and kingpin inclination angle

- Prepare a platform with the same height as the turning radius gauge and place it under the rear wheels so that the vehicle may be placed level.
- Apply chocks to the rear wheels.

- Keep the turning radius gauge locked.
- Jack up the vehicle and set the right and left front wheels so that respective ground contact area centers of the two wheels and turn table centers may meet.

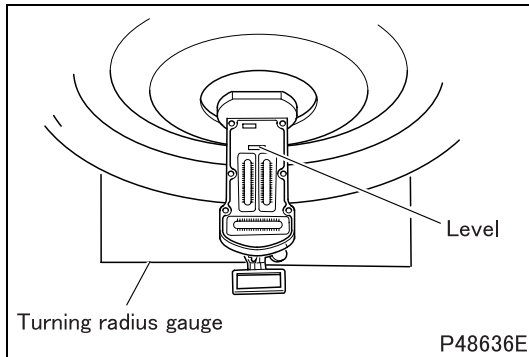
- Unfasten locking of the turning radius gauge, and set the scale to 0 degrees.
- As with the camber measurement in Section 1.2, attach the camber/caster/kingpin gauge and set the level so that the bubble remains in the middle.

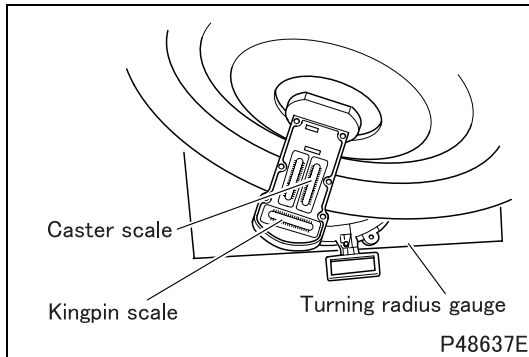
- Apply brake pedal, and with brake applied to the front wheels, turn steering wheel slowly from the point of 0 degrees on the turning radius gauge until the direction is changed by 20 degrees to the right side in the case of the right front wheel and to 20 degrees to the case of the left front wheel.

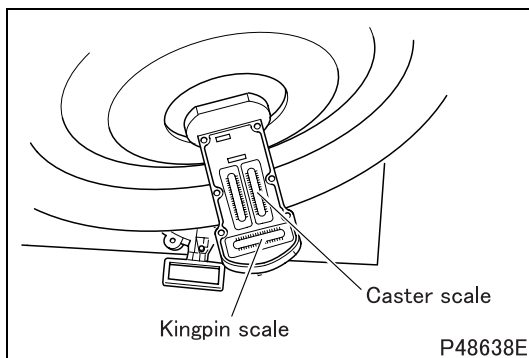
- Reverse this position, turn the steering wheel slowly until the direction of the front wheels changes by 20 degrees in the opposite direction.
- Read the center of the bubbles at this position of the caster scale and kingpin scale to find caster and kingpin inclination angles.
- If the measured value deviates from the standard value, abnormalities such as wear of kingpin and bushing, loose hub bearing, and bend of knuckle and front axle are suspected. Inspect each part and replace defective parts.

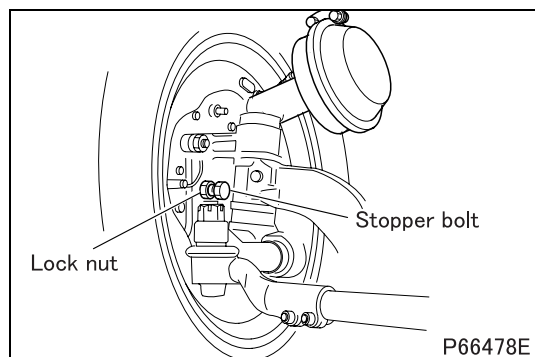
- Set the turning radius gauge and a platform on the vehicle in the same manner as in the case of the caster and kingpin inclination angle measurement performed in Section 1.3.
- Turn the steering wheel right or left completely from the position where the turning radius gauge is set to 0 degrees, and read the scale of the turning radius gauge to measure the steering angle.
- If the measured value deviates from the standard value, adjust with the knuckle stopper bolt and tighten the lock nut to the specified torque.

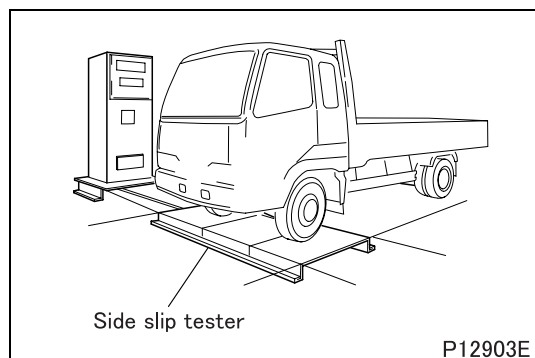
- Set the front wheels exactly to forward running position.
- Move the vehicle forward past the side slip tester as slowly as possible to inspect side slip.

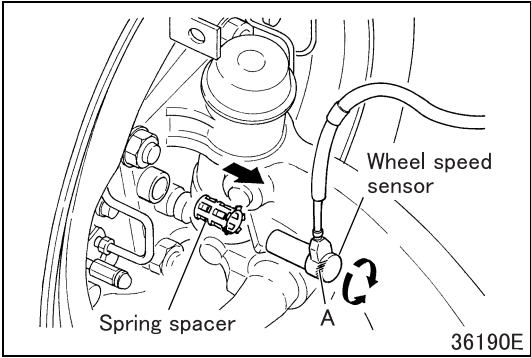
### ■ Removal: Wheel speed sensor and spring spacer

- Pinch diagonally shaded area A of the wheel speed sensor with pliers and remove it while turning it a little.

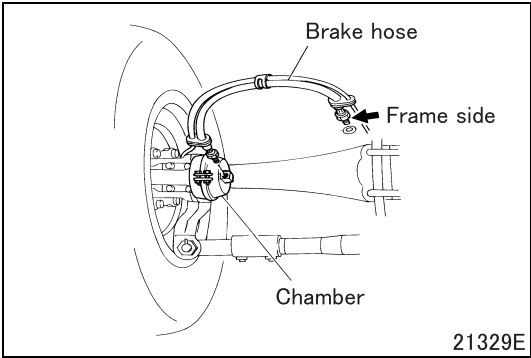
### ■ Removal: Brake hose

- When removing the brake hose, remove it from the frame side first, and then from the brake chamber side.

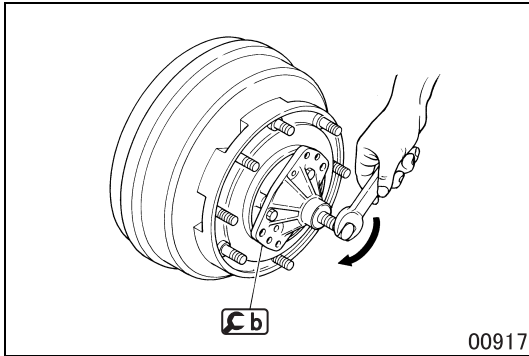
### ■ Removal: Wheel hub and brake drum

- If the brake drum has stepped wear and the wear prevents the wheel hub and brake drum from being removed, the removal can still be effected by taking the following procedure. After the removal, correct or replace the brake drum.

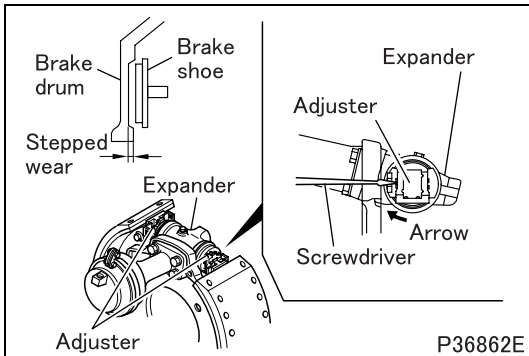
- Remove the dust cover.
- Turn the adjusting screw of the expander in the direction of the arrow, and widen clearance between the brake drum and brake shoe to remove.

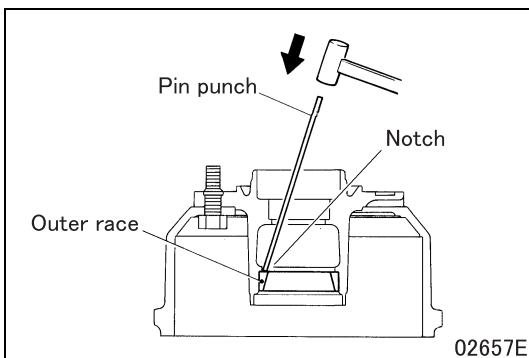
### ■ Removal: Inner bearing outer race

- Drive out the inner bearing outer race by tapping evenly at two notches in the wheel hub.

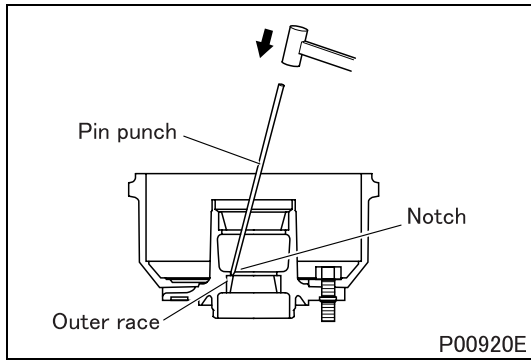
## ■ Removal: Outer bearing outer race

- Drive out the outer bearing outer race by tapping evenly at two notches in the wheel hub.

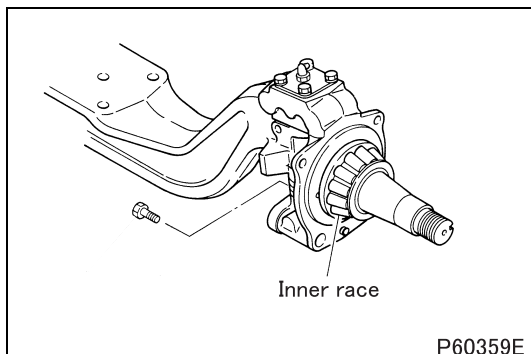
## ■ Removal: Inner bearing inner race <FM>

- Insert two bolts (M14 × 1.5 mm) into the knuckle stopper bolt or screw plug mounting hole of the knuckle evenly to push out the inner bearing inner race.

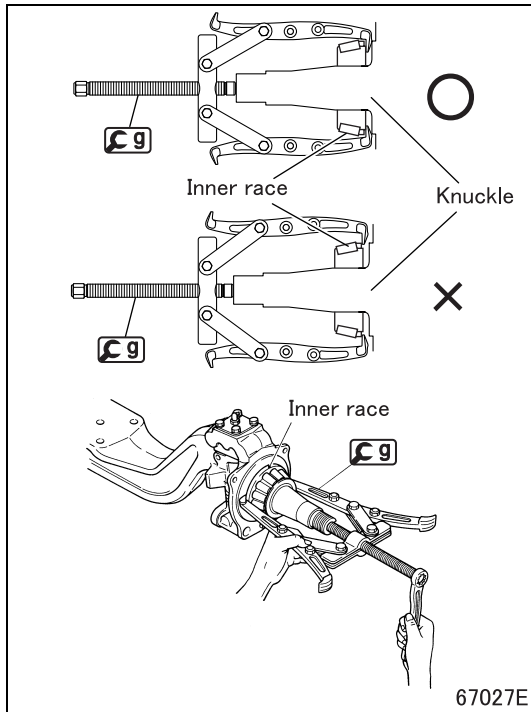
- Hook the claw of **C9** to the clearance between the knuckle and inner bearing race to remove.

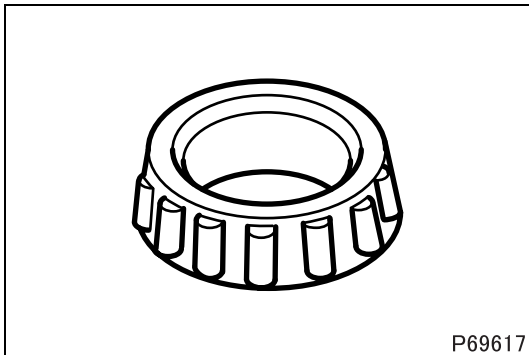
#### ■ Inspection: Outer bearing inner race

- Inspect the outer bearing inner race after cleaning the bearing to remove grease completely.
- If any damage, wear, or poor rotating condition is evident in the inner race, replace it with a new one.
- The inner race and the outer race should be replaced as a set.

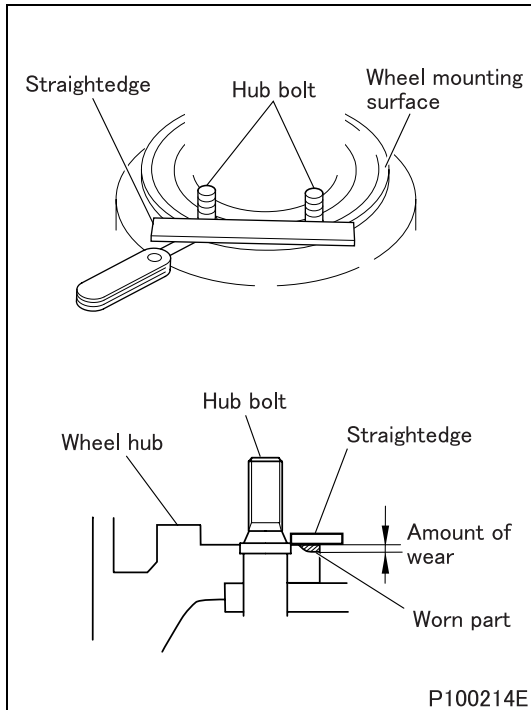
## ■ Inspection: Wheel hub

- Check the disc wheel mounting surface of the wheel hub by watching and touching. If there is damage or crack on it, replace the wheel hub.
- Make sure that there is not rust, dust, paint or foreign body on the disc wheel mounting surface of the wheel hub to prevent the wheel nut to loosen.
- If any abnormality is found, remove it with sandpaper.

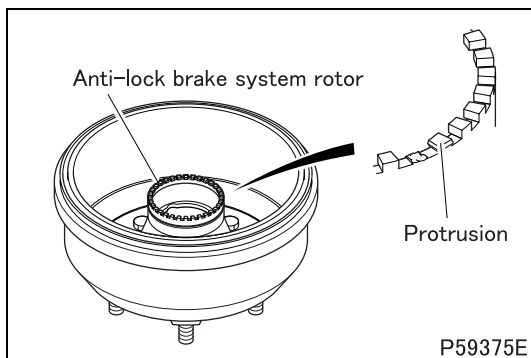
## ■ Inspection: Anti-lock brake system rotor

- Check the protrusions of the anti-lock brake system rotor for chipping and flattening.
- If any abnormality is found, replace the anti-lock brake system rotor.

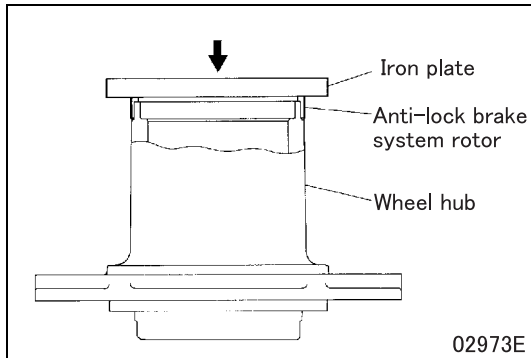
#### [Installation]

- Warm the anti-lock brake system rotor to approximately 150°C {302°F}, press it evenly using an iron plate, and press it into the wheel hub so that there is no clearance between the wheel hub and the anti-lock brake system rotor.

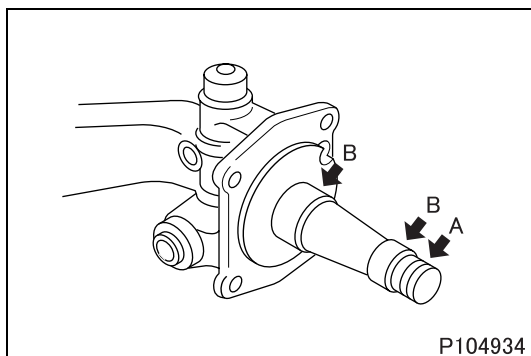
### ■ Inspection: Knuckle

- If the lock nut tightening threads (A) are damaged, repair the damage using a die to ensure accurate adjustment of starting torque.
- Replace the knuckle if it apparently has stepped, tapered, uneven or other abnormal wear or damage in the outer bearing fitting surface (B).

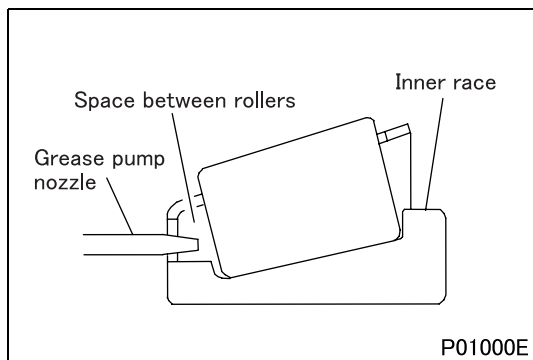
### ■ Installation: Packing of grease in inner bearing inner race

- Insert the grease pump nozzle into the space between rollers of the outer and inner bearing inner race to pack grease sufficiently.

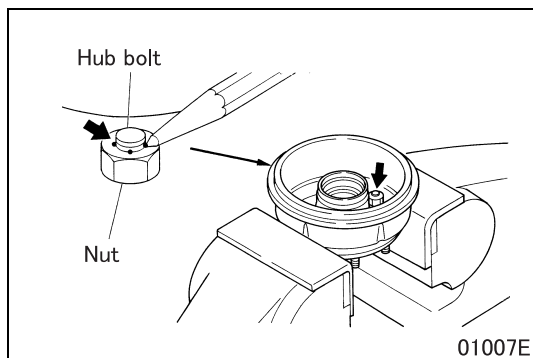
### ■ Installation: Hub bolts

- As for hub bolt, tighten nut at specified torque, and caulk at 4 positions for prevention of loosening.

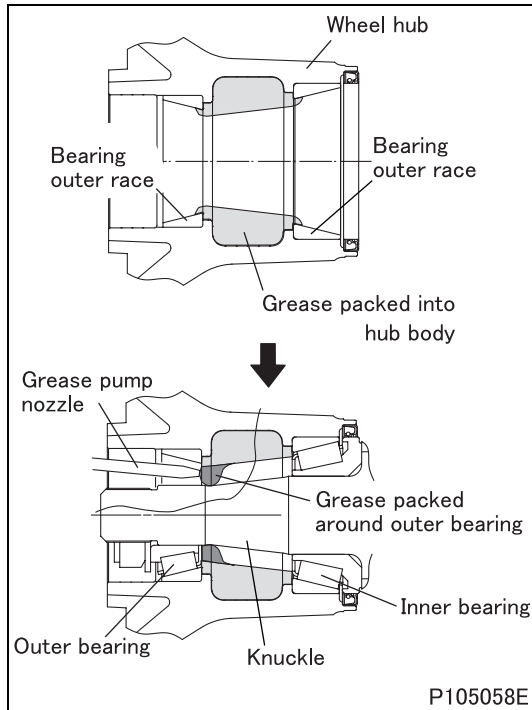
#### <Manner 1>

- Pack grease in the wheel hub body so much that grease covers the outer and inner bearing outer races to ensure that grease will reach the outer and inner bearings as shown in the drawing.
- After installing the wheel hub in the knuckle, insert a grease pump nozzle into the wheel hub and add grease to around the outer bearing before installing the outer bearing inner race.

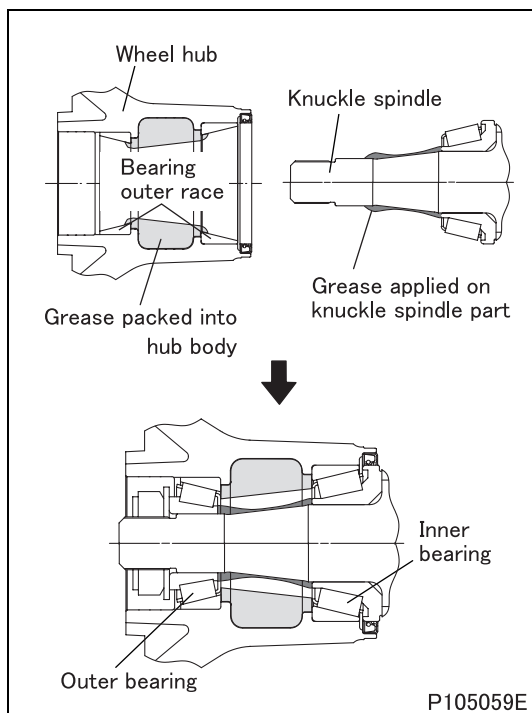
#### <Manner 2>

- Pack grease in the wheel hub body so much that grease covers the outer and inner bearing outer races to ensure that grease will reach the outer and inner bearings as shown in the drawing.
- Before installing the wheel hub in the knuckle, apply grease to the knuckle spindle.

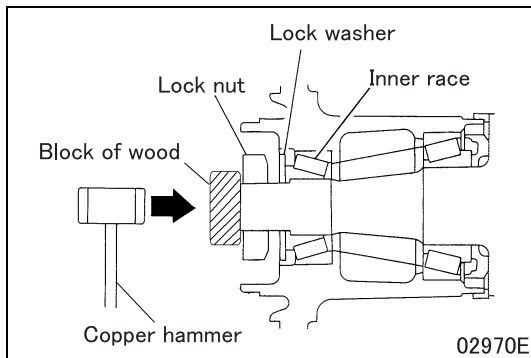
- Perform the following work to pull the outer bearing inner race toward the lock nut side.
- Loosen the lock nut to create clearance between the outer bearing inner race and lock nut.
- Apply a block of wood to the end face of the axle housing, and tap it two or three times while turning the wheel hub and brake drum.

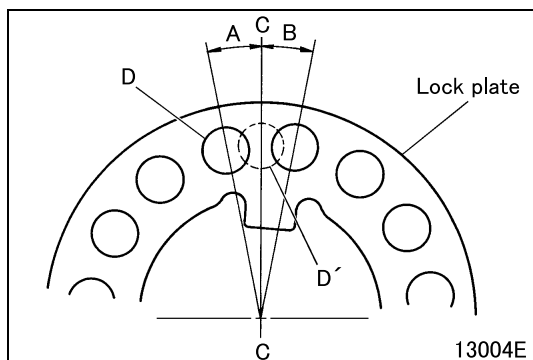
- Fit lock plate into place check to ensure that all of the mounting holes in lock nut and the lock plate are in alignment, and tighten mounting bolts.
- If the mounting holes of lock nut and lock plate are out of alignment, align them by the procedures shown in the following table.

| Lock nut hole position | How to align lock plate hole |
| Range A | Loosen lock nut and align holes. |
| Range B | Turn over lock plate, loosen lock nut and align holes. |
| On line C-C | Turn over lock plate and align holes.<br>(Hole position changes from D' to D.) |

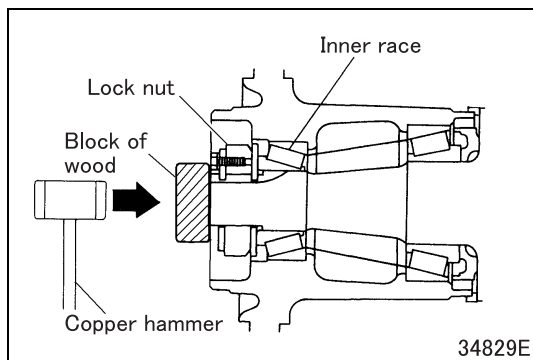
- Perform the following work to pull the outer bearing inner race toward the lock nut side again.
- Apply a block of wood to the end face of the axle housing, and tap it two or three times while turning the wheel hub and brake drum.
- Make sure that there is no looseness in the axial direction.
- Perform a measurement again after adjustment. If the measured value is out of the standard value, repeat the work from the item marked with ★, since adjustment of the lock nut may be insufficient.
- If the result is found to be abnormal, replace the outer and inner bearings.

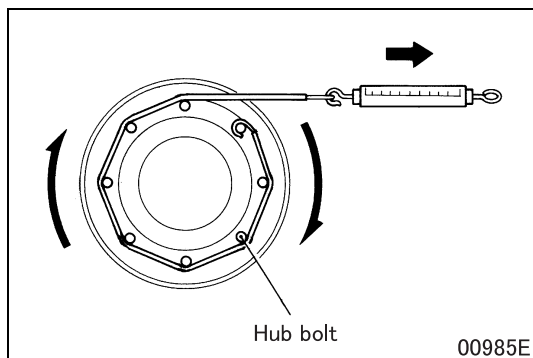
## [Inspection]

- After assembly of the lock nut, fasten a spring balance to hub bolt and measure tangential force.
- If the tangential force meets the specified value, starting torque will become the standard value.
- If the measurement deviates from the specified value, repeat the work from the item marked with ★, since adjustment of the lock nut may be insufficient.
- If the result is found to be abnormal, replace outer and inner bearings.

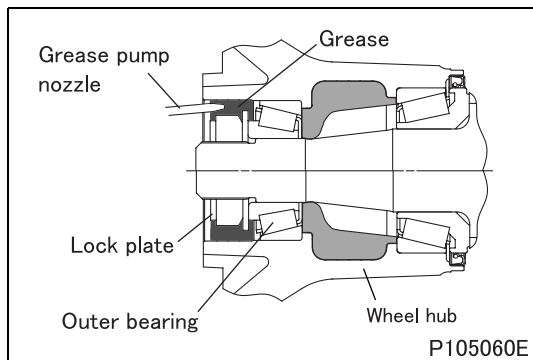
- Pack grease up to the lock plate using a grease pump nozzle so that a wall is formed outside the outer bearing as shown in the illustration.

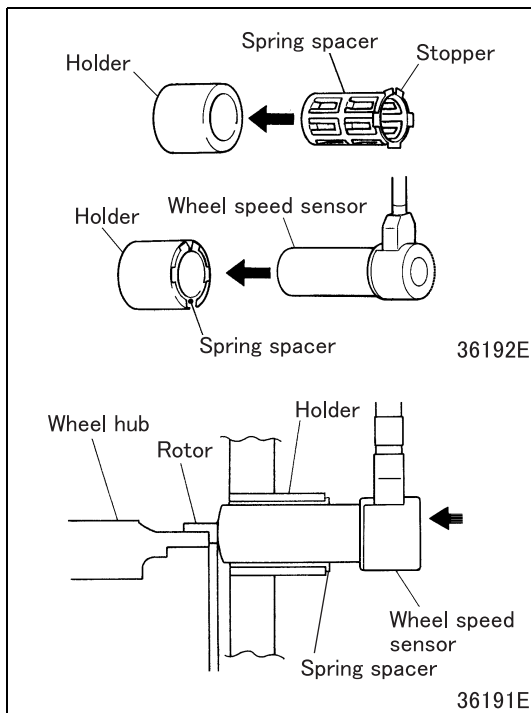
#### ■ Installation: Wheel speed sensor and spring spacer

- Insert the spring spacer into the holder of the knuckle and press it in until its stoppers knock against the holder.
- Insert the wheel speed sensor and press it in until it knocks against the rotor with tactile feel.
- Slowly turn the wheel hub and brake drum two or three times (2 seconds per turn) to make sure that they turn smoothly.

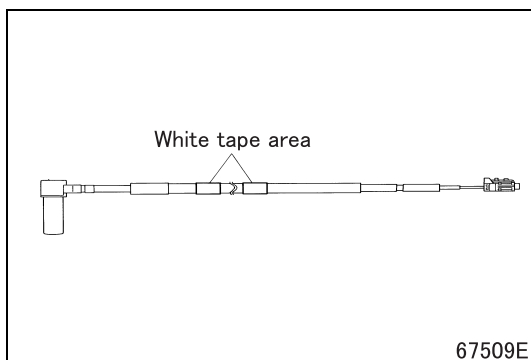
#### ■ Installation: Harness of wheel speed sensor

- Be sure to secure clip positions of the wheel speed sensor harness at the white tape area to avoid interference with other parts, twist and slack.

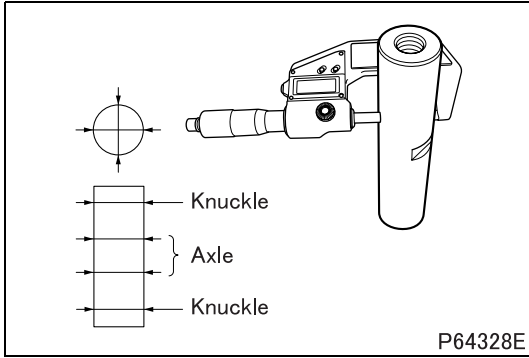
### ■ Inspection: Outer diameter of kingpin

- Take measurement at a total four levels on the kingpin: two levels for the axle fitting portion and one level each for the upper and lower knuckle fitting portions.
- If the measured value is under the limit, replace the kingpin with a new one.

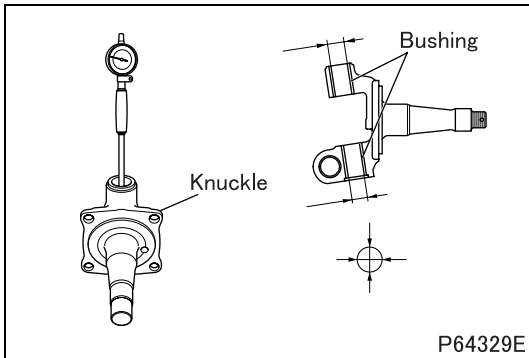
### ■ Inspection: Clearance between kingpin and bushing

- Measure the inner diameter of the upper and lower bushings using a cylinder gauge and calculate the clearance deducting the outer diameter of the kingpin from the inner diameter of the bushing.  
If the clearance exceeds the limit, replace the bushings with new ones.

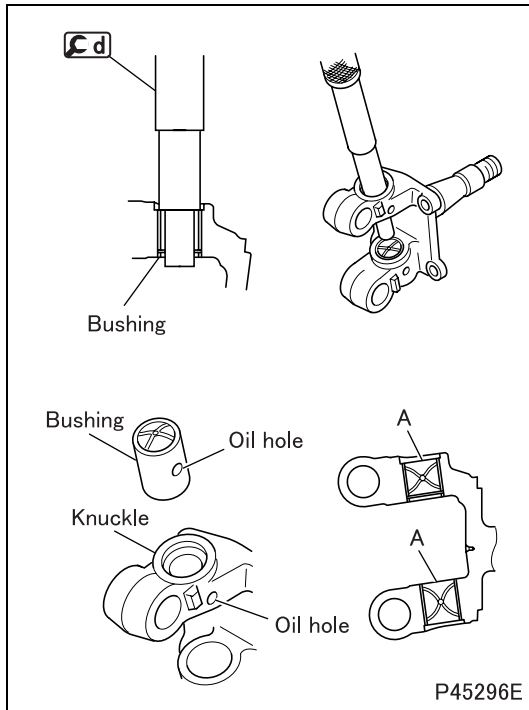
- Install bushing in with oil hole aligned to oil hole of knuckle, until end surface A becomes flush with knuckle end surface.

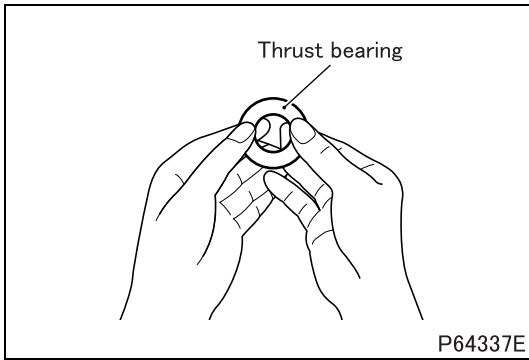
### ■ Inspection: Thrust bearing

- Inspect the aspect and smooth turning of the thrust bearing. If any crack, damage, or un-smooth turning is found, replace the thrust bearing with a new one.

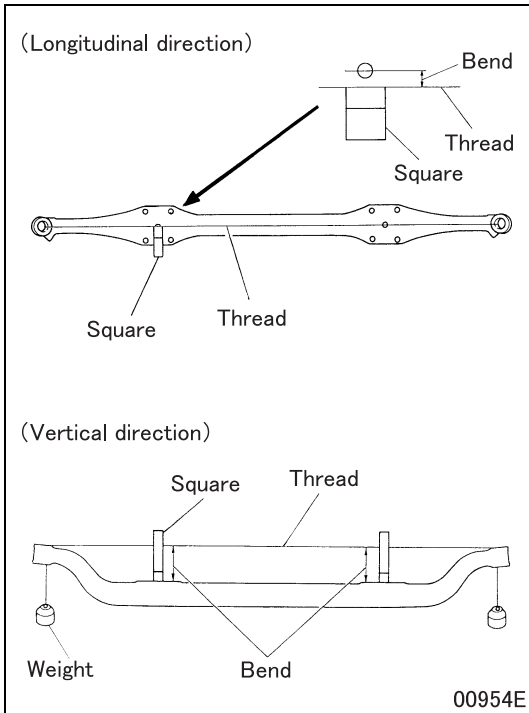
### ■ Inspection: Front axle

#### (1) Bend of front axle in the longitudinal direction and vertical direction

- Put a piece of thread through kingpin holes of the front axle and hang weights at both ends.
- Use a square to find bend to each of longitudinal and vertical directions.
- If the measured value exceeds the limit, replace the front axle.

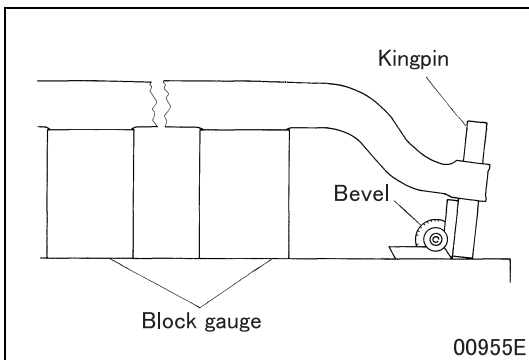
#### (2) Kingpin inclination angle

- Set the kingpin on the front axle as illustrated to measure the angle.
- If the measured value deviates from the standard value, replace the front axle.

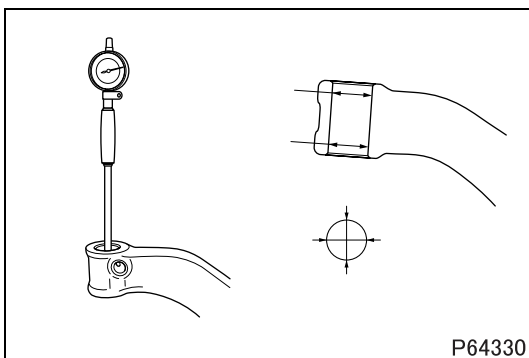
#### (3) Clearance between kingpin and front axle

- Measure the inner diameter of the axle's hole where the kingpin is inserted using a cylinder gauge and calculate the clearance deducting the outer diameter of the kingpin from the inner diameter.

If the clearance exceeds the limit, replace the axle or the kingpin with a new one.

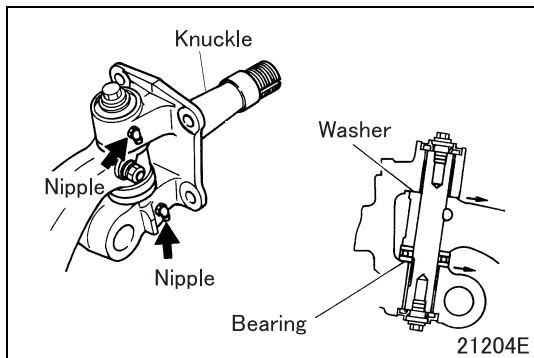
#### ■ Greasing: Grease nipple

- Supply grease through the grease nipple of the knuckle.
- Supply grease until it overflows from the thrust washer and press portion of the bearing.

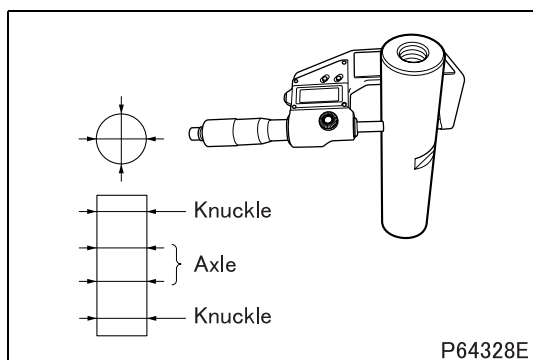
| Step 6 | Inspection items | | Inspection of sensor connector | |

### ■ Inspection: Outer diameter of kingpin

- Take measurement at a total four levels on the kingpin: two levels for the axle fitting portion and one level each for the upper and lower knuckle fitting portions.
- If the measured value is under the limit, replace the kingpin with a new one.

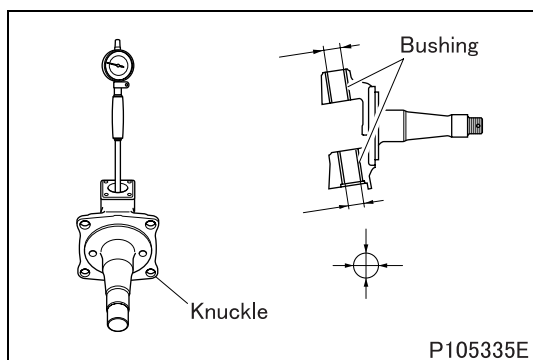
### ■ Inspection: Clearance between kingpin and bushing

- Measure the inner diameter of the upper and lower bushings using a cylinder gauge and calculate the clearance deducting the outer diameter of the kingpin from the inner diameter of the bushing.  
If the clearance exceeds the limit, replace the bushings with new ones.

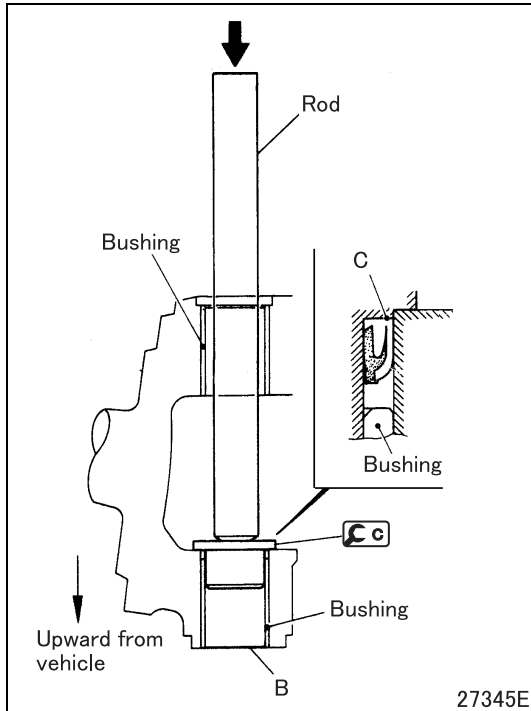
- Next, install **Cc** on the knuckle in the illustrated direction.
- Insert rod into kingpin hole, and attach it to **Cc**.
- Hit the head using a hammer until **Cc** comes to rest at knuckle.
- Make sure that end of bushing at B is flush with knuckle surface.
- End surface of oil seal at C shall not be protruding from knuckle.

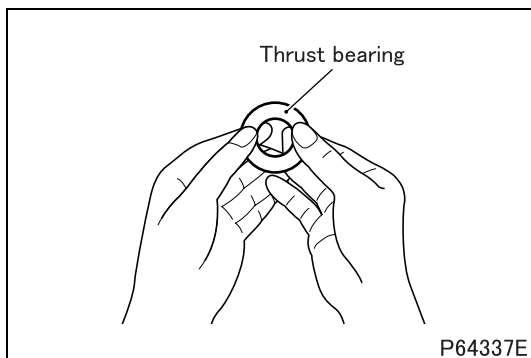
## ■ Inspection: Thrust bearing

- Inspect the aspect and smooth turning of the thrust bearing. If any crack, damage, or un-smooth turning is found, replace the thrust bearing with a new one.

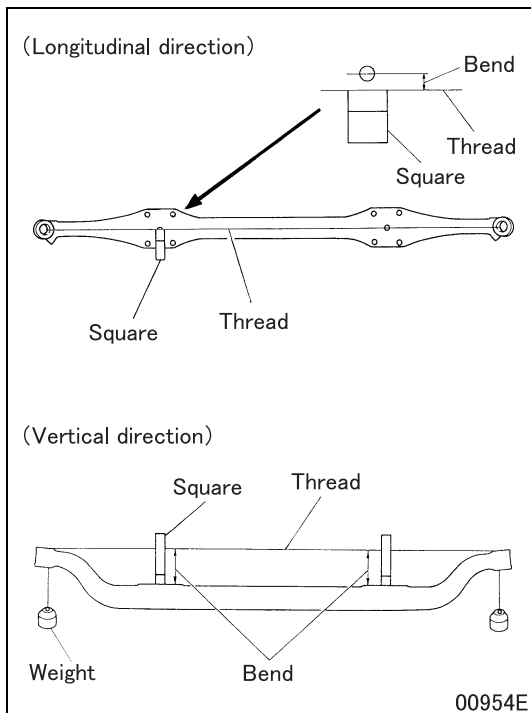
## ■ Inspection: Front axle

### (1) Bend of front axle in the longitudinal direction and vertical direction

- Put a piece of thread through kingpin holes of the front axle and hang weights at both ends.
- Use a square to find bend to each of longitudinal and vertical directions.
- If the measured value exceeds the limit, replace the front axle.

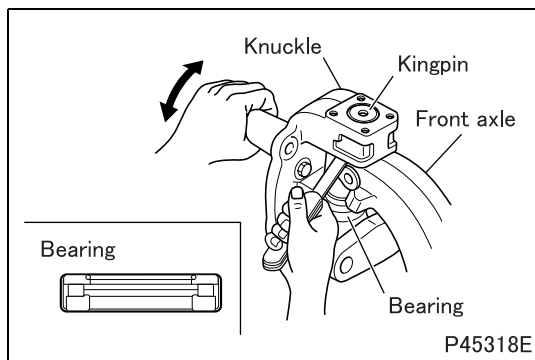
### ■ Inspection: Thrust washer, bearing, knuckle and front axle

- Provisionally assemble kingpin and bearing, move 2 or 3 times knuckle to have them fit.
- Measure clearance between front axle upper surface and knuckle downside.
- Adjust if the measured value exceeds the limit.

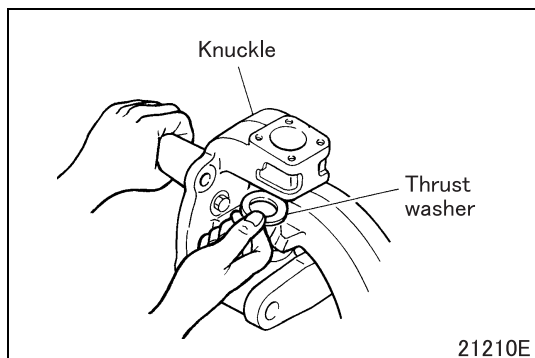
#### [Adjustment]

- Kinds of adjusting thrust washers  
2.9 to 3.6 mm {0.114 to 0.142 in.} (8 kinds with every 0.1 mm {0.0039 in.} difference)
- Select a thrust washer so as to make clearance as small as possible.
- After assembly, make sure that the knuckle moves smoothly.

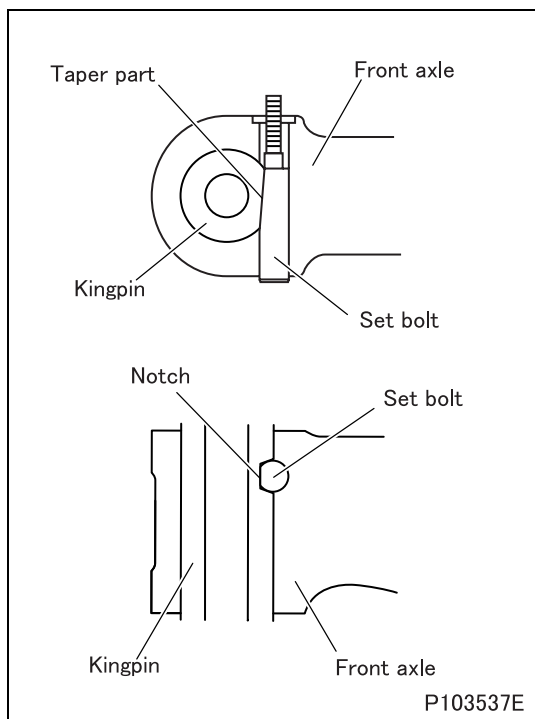
### ■ Installation: Set bolt

- Install the set bolt so that the taper part of the set bolt is aligned with the notch of the kingpin.

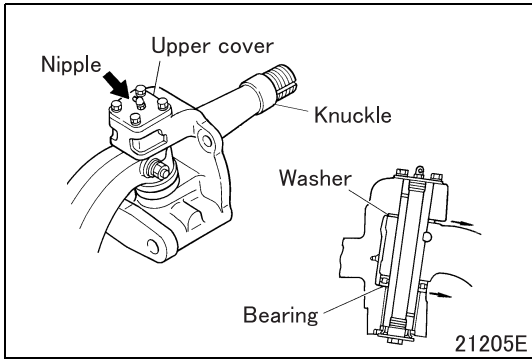
**■ Greasing: Grease nipple**

- Supply grease through the grease nipple of the upper cover.
- Supply grease until it overflows from the thrust washer and press portion of the bearing.

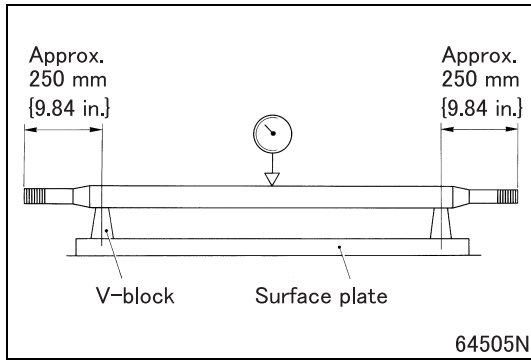
## ■ Inspection: Bend of tie rod

- Measure the bend of the tie rod at its center.

- **Give the tie rod one complete turn and read the dial gauge at this time. The bend is one half of the reading.**
- If the measured value exceeds the limit, correct or replace the tie rod.

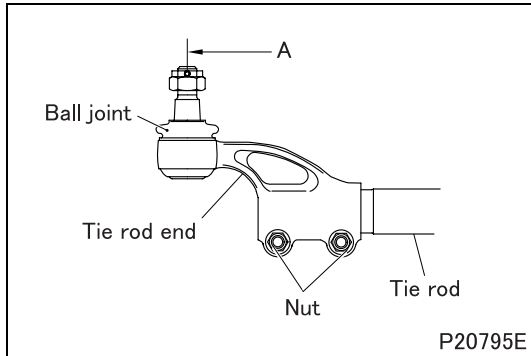
## ■ Installation: Tie rod end

- Install the tie rod end on the tie rod so that the distance between centers of the ball joints of tie rod ends is to the illustrated dimension A, and tighten nuts to the specified torque.

A: 1678 mm {66.1 in.} <FK>  
1672 mm {65.8 in.} <FM>

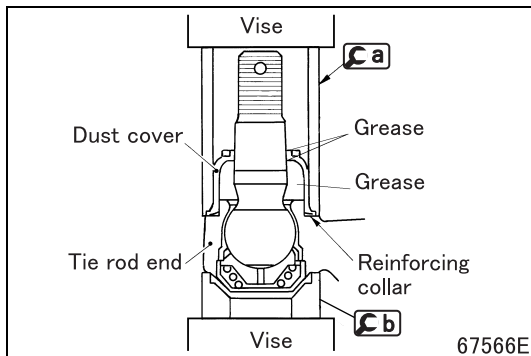
## ■ Installation: Dust cover

- Seal grease in the inside of the dust cover and apply grease to the lip area. Cover the dust cover and tie rod end with **(C a)** and **(C b)** as illustrated, and press them using a vise so that the reinforcing collar is brought into intimate contact with the tie rod end.

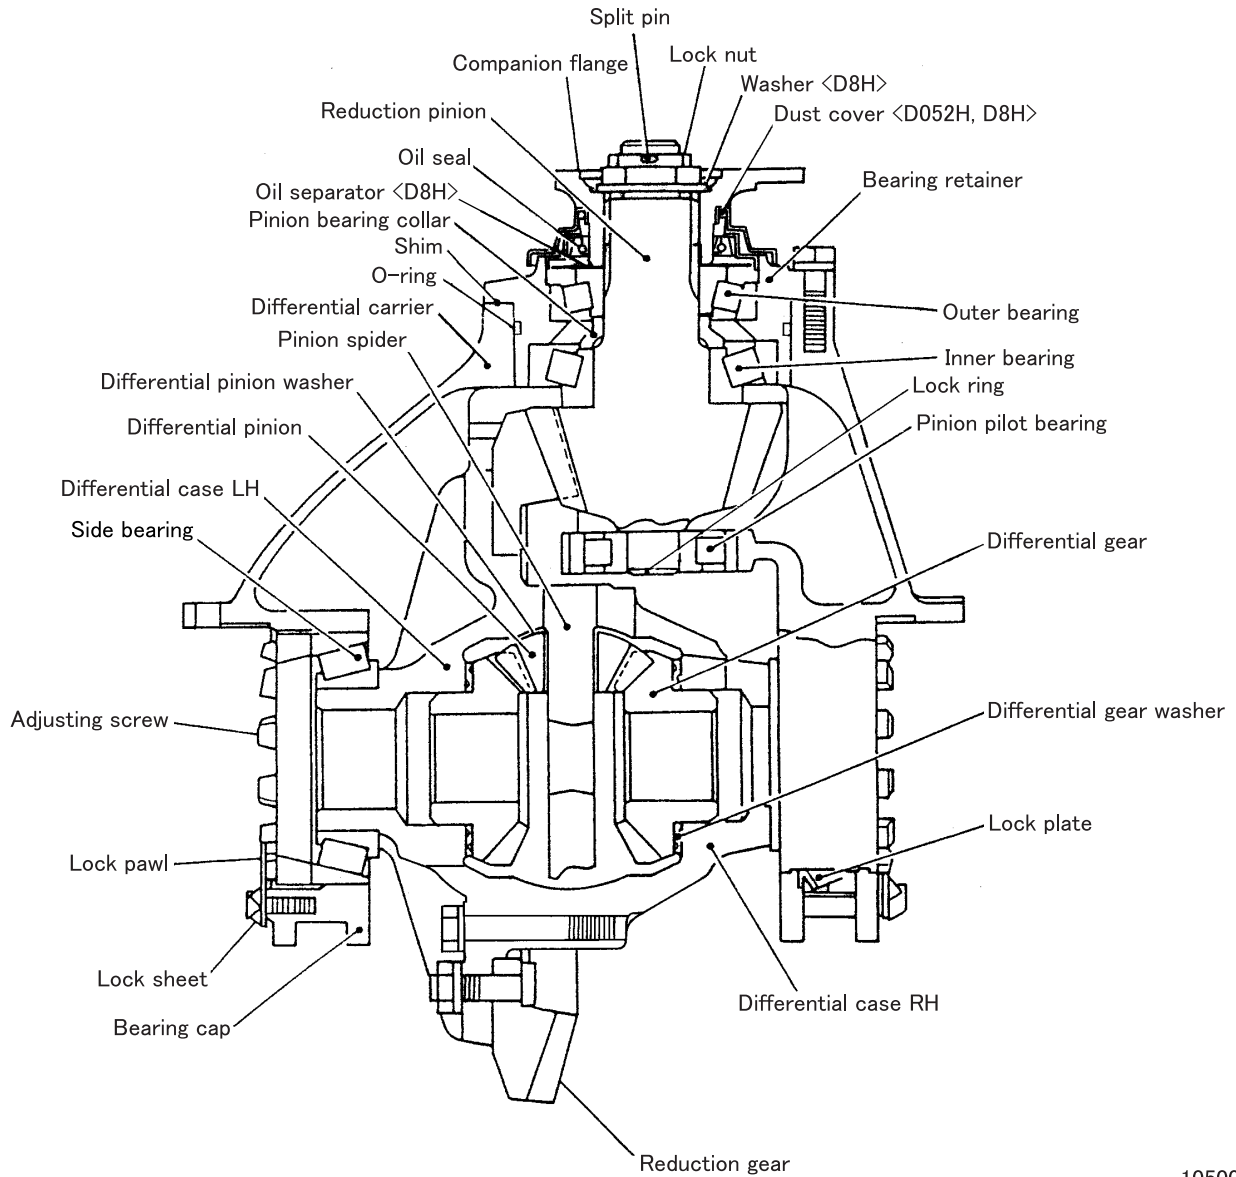
105002E

## 2. Reduction and Differential

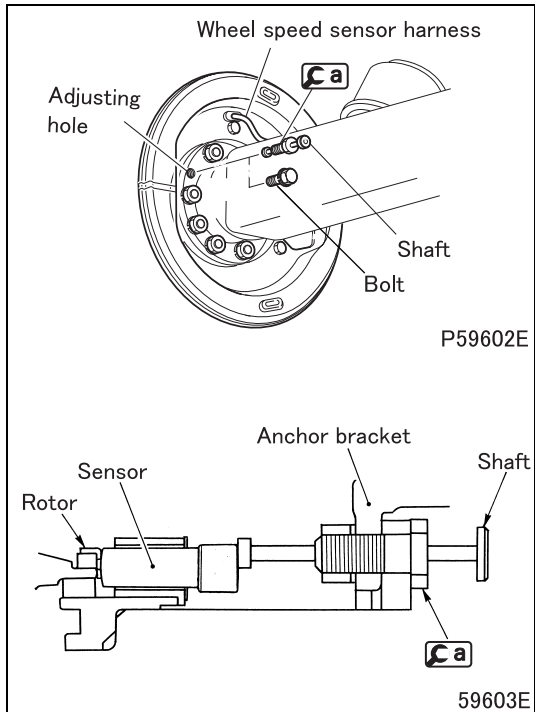
**<FM>**

- Remove the bolt on the back of the anchor bracket.
- Install **Ca** in the adjusting hole.
- Push the shaft of **Ca** until the sensor comes into contact with the rotor.
- After adjustment, tighten the bolt to the specified torque.

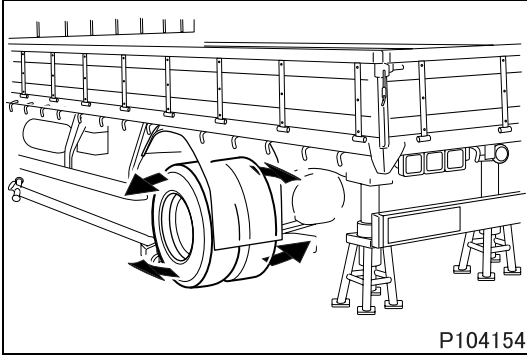
### 3. Inspection of Wheel Bearing for Play

- Jack up the vehicle.
- Try to move the top and bottom of the rear tire by hands in the illustrated directions to inspect the wheel bearing for play.
- If play is found with the feel of hands, repeat the inspection procedure while having the brake pedal pressed by another personnel. When the play is removed by operating the brake pedal, the symptom indicates that there is play in the wheel bearing, not in the suspension or other related parts. Then inspect the turning torque of the wheel bearing and adjust it as required. (See WHEEL HUB AND BRAKE DRUM.)
- If the turning torque of the wheel bearing cannot be adjusted correctly or the play still remains after the adjustment, replace the wheel bearing with a new one. (See WHEEL HUB AND BRAKE DRUM.)

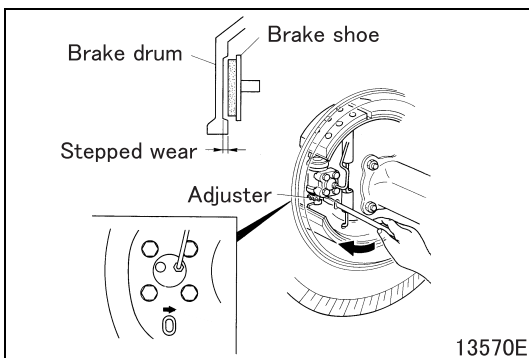
### <FK61>

- Turn the adjuster from the adjusting hole in the opposite direction to the arrow on the backing plate to increase the clearance between the brake drum and the brake shoe. Then, remove the wheel hub and brake drum.
