# FE.FG

## SERVICE MANUAL 2008 Model FOREWORD

This Service Manual contains maintenance and repair methods for the Mitsubishi Fuso Truck FE. FG Series. Read this manual carefully as an aid in providing correct, efficient maintenance. Please note that the information and specifications contained within this manual may change without notice. This is due to product modifications and continued vehicle improvements that are made throughout the model years. Should you encounter any discrepancy in the information provided, please do not hesitate to contact your nearest Mitsubishi Fuso Dealer or Mitsubishi Fuso Truck of America, Inc.

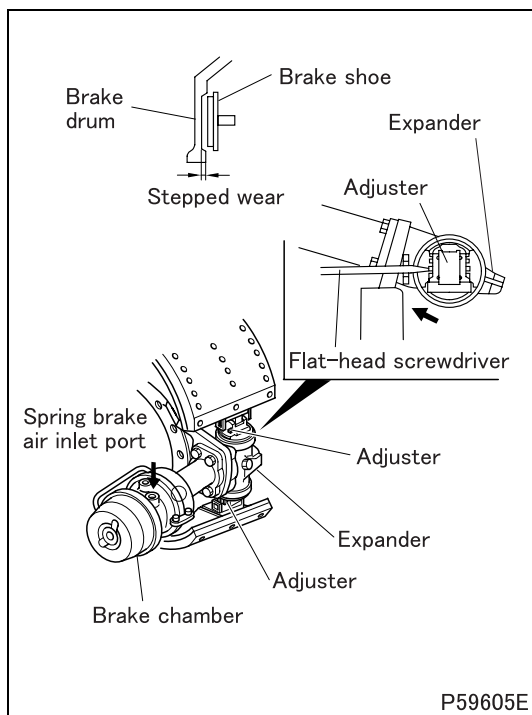
## <FK62, FK65, FM>

- Remove the dust cover behind the anchor bracket.
- Release the spring brake. (See Gr35B.)
- Turn the adjuster on the expander in the direction of the arrow to increase the clearance between the brake drum and shoe. Then, remove the wheel hub and brake drum.
- Install the dust cover behind the anchor bracket.

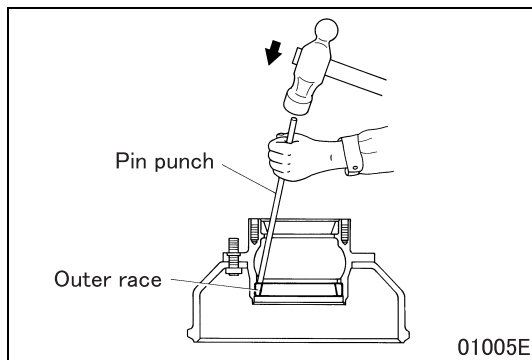
## ■ Removal: Inner bearing outer race

- Drive out the inner bearing outer race by tapping evenly at four notches in the wheel hub.

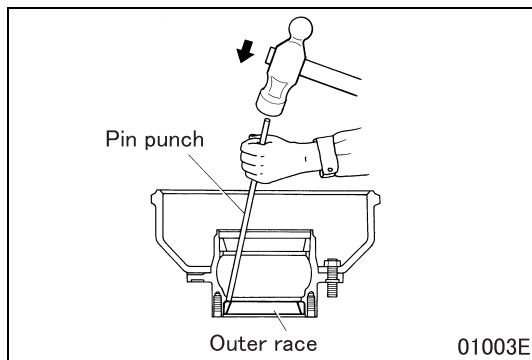
## ■ Removal: Outer bearing outer race

- Drive out the outer bearing outer race by tapping it evenly at four notches in the wheel hub.

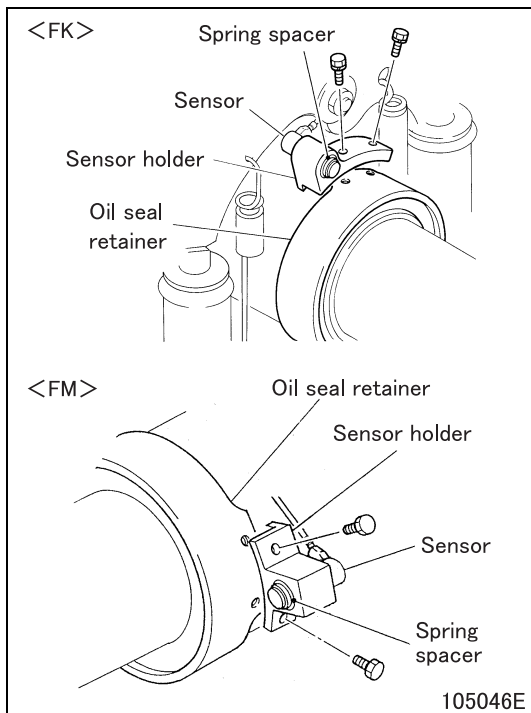
### ■ Removal: Sensor holder, wheel speed sensor and spring spacer

- Remove the wheel speed sensor complete with the sensor holder and spring spacer from the oil seal retainer.

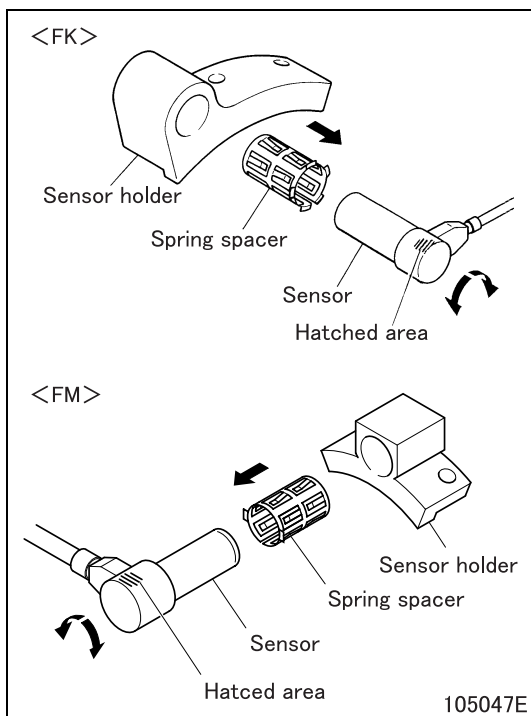
- Pinch hatched area of the wheel speed sensor with pliers and remove it while turning it a little.
- If the wheel speed sensor can be removed easily, replace the spring spacer.

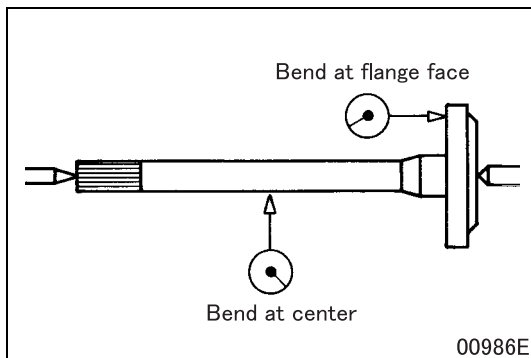
## ■ Inspection: Axle shaft

- Perform the following inspection. If the measurement exceeds the limit, replace the axle shaft.

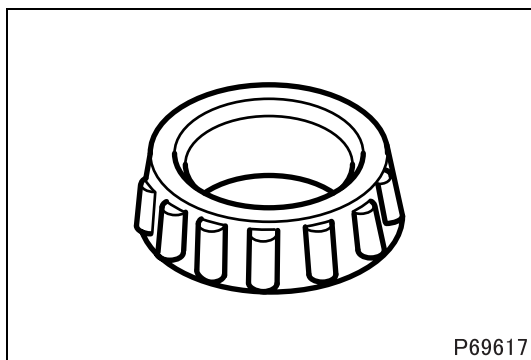
## ■ Inspection: Outer bearing inner race

- Inspect the outer bearing inner race after cleaning the bearing to remove grease completely.
- If any damage, wear, or poor rotating condition is evident in the inner race, replace it with a new one.
- The inner race and the outer race should be replaced as a set.

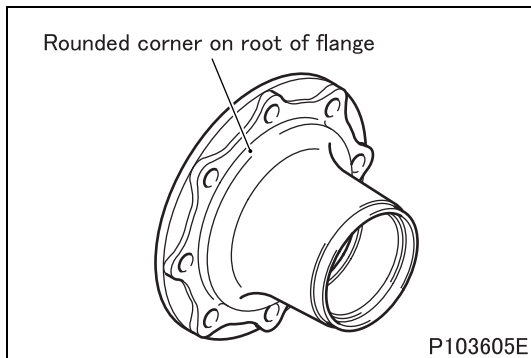
- Using feeler gauges to measure the amount of wear at the outer periphery of the wheel hub.  
Measure the amount of wear in the area of every hub bolt.
- If the amount of wear at any point exceeds the following standard value, inspect the crack check of wheel hub.  
Wear standard value: 0.8 mm {0.031 in.}

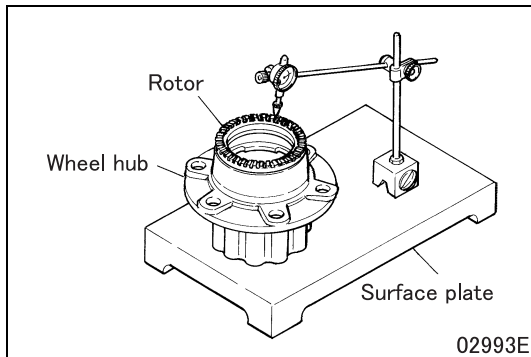
- Warm the anti-lock brake system rotor to approximately 150°C {302°F}, press it evenly using an iron plate, and press it into the wheel hub so that there is no clearance between the wheel hub and the anti-lock brake system rotor.

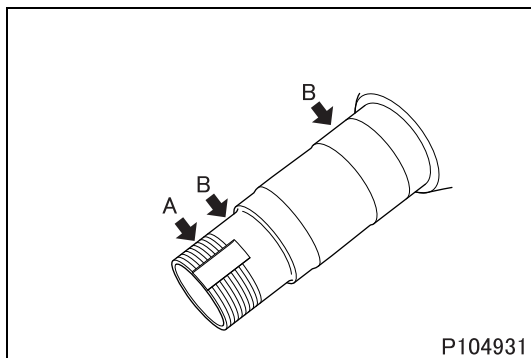
- If the lock nut tightening threads (A) are damaged, repair the damage using a dice to ensure accurate adjustment of starting torque.
- Replace the axle housing if it apparently has stepped, tapered, uneven or other abnormal wear or damage in the outer bearing fitting surface (B).

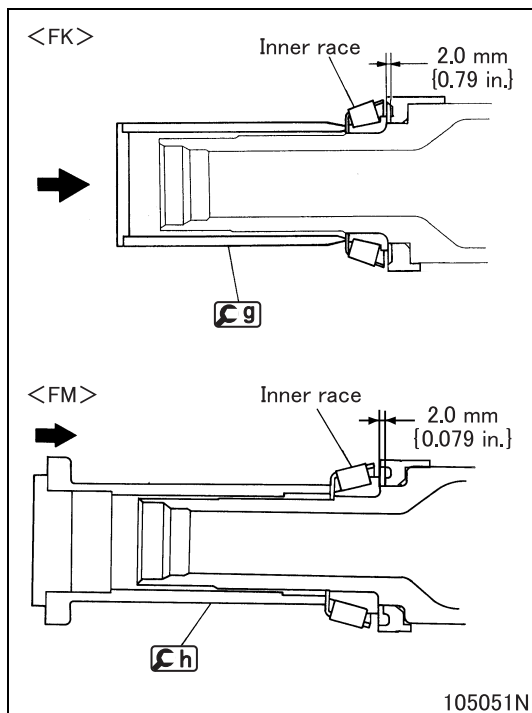
- Insert the grease pump nozzle into the space between rollers of the inner bearing inner race to pack grease sufficiently.

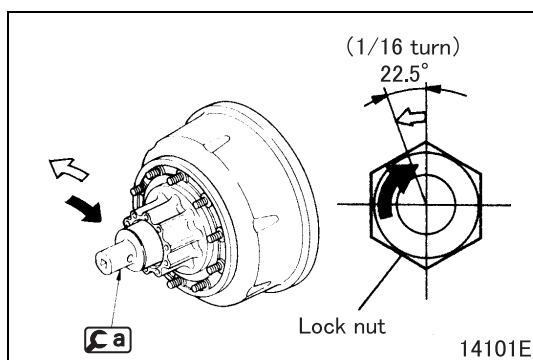
- Perform the following work to pull the outer bearing inner race toward the lock nut side.
- While rotating the wheel hub and brake drum, tap the end of the axle tube a couple of times.

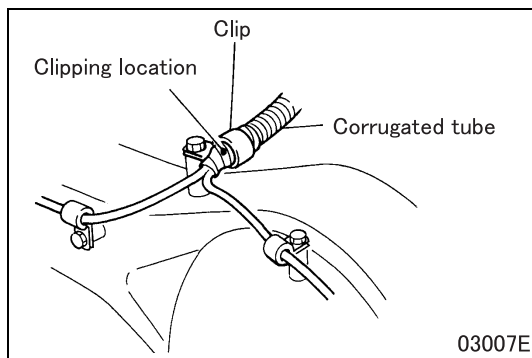
- Bundle the harnesses of the left- and right-hand wheel speed sensors into a corrugated tube.
- Arrange the corrugated tube such that the white-tape portions of the tube are aligned with the clips on the housing. With the tube correctly arranged, face the slit of the corrugated tube down, and wrap both ends of the tube with black tape (designed for harness bundling) in a half lap pattern.
- Additionally wrap the tube with tape at three locations in the tube intermediate section.

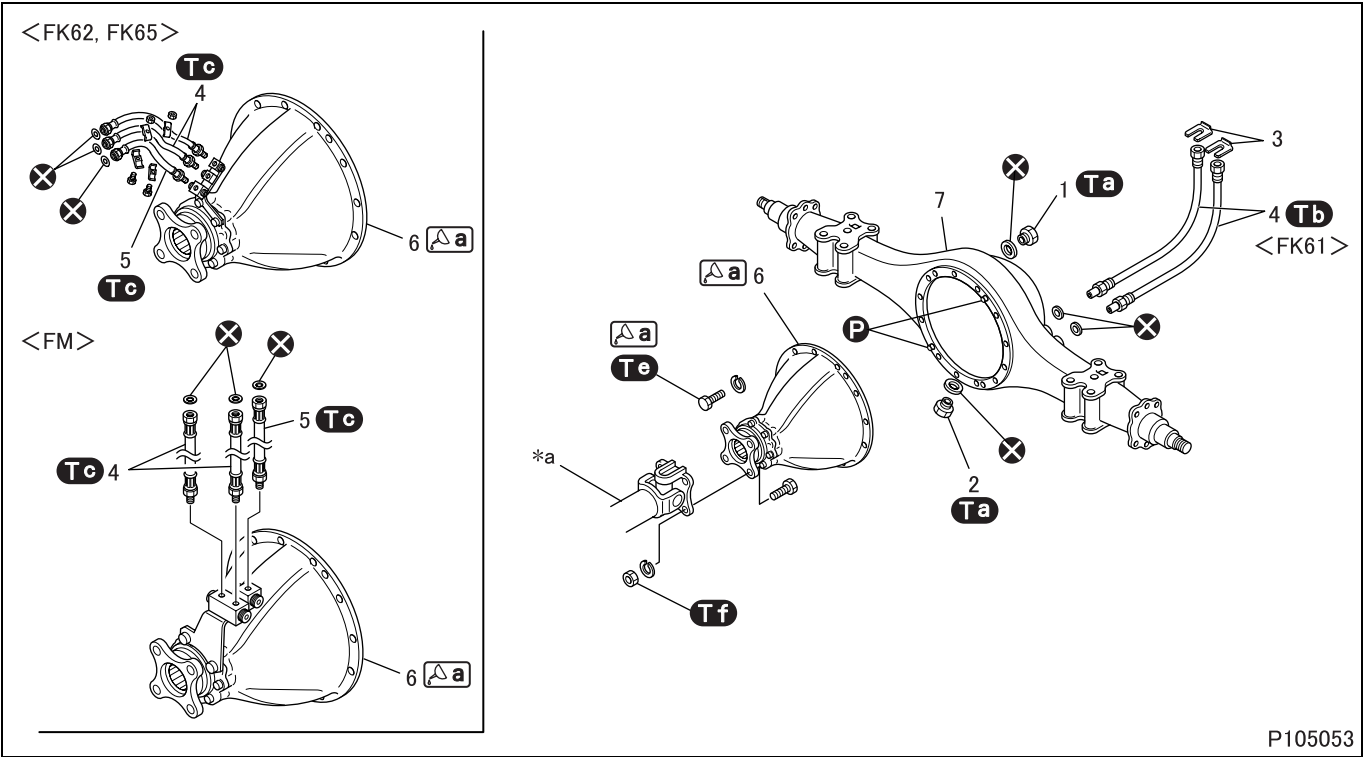
- 1 Inspection plug
- 2 Drain plug
- 3 Clip <FK61>
- 4 Brake hose
- 5 Spring brake hose <FK62, FK65, FM>
- 6 Reduction and differential (See later section.)

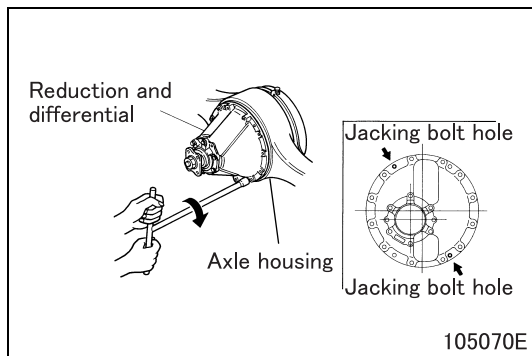
- Make two jacking bolts (M12 × 1.25 mm) available.
- Install and tighten the bolts evenly into the jacking holes in the reduction and differential.
- Jack away and remove the reduction and differential from the axle housing.

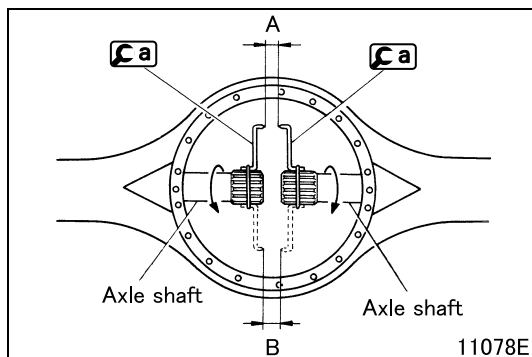
- Install axle shaft in axle housing.
- Install **Ca** on axle shaft.
- Measure clearance A.
- Turn axle shaft 180°.
- Measure clearance B.
- The difference between A and B is the amount of bend of axle housing.
- If the measurement exceeds the limit, replace the axle housing.

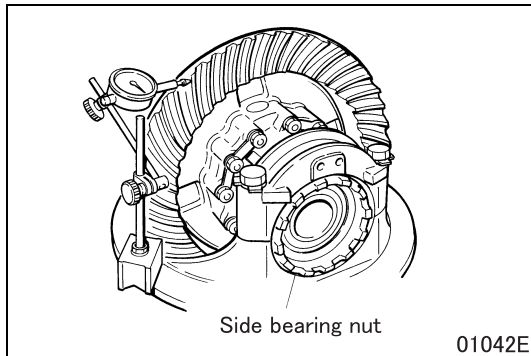
- If backlash is found faulty, the amount of tightening of the side bearing nut is probably inappropriate.

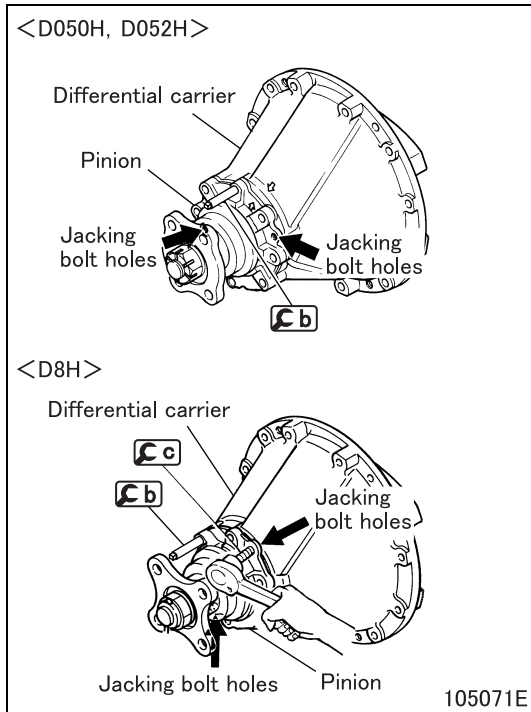
## ■ Removal: Pinion

- Make two jacking bolts (M12 × 1.25 mm) available. <D050H>
- Install two pieces of **C b** diagonally.
- Make two jacking bolts (M14 × 1.5 mm) available or **C c**. <D8H>
- Install and tighten the bolts or **C c** evenly into the jacking holes in the pinion.
- Jack away and remove the pinion from the differential carrier.

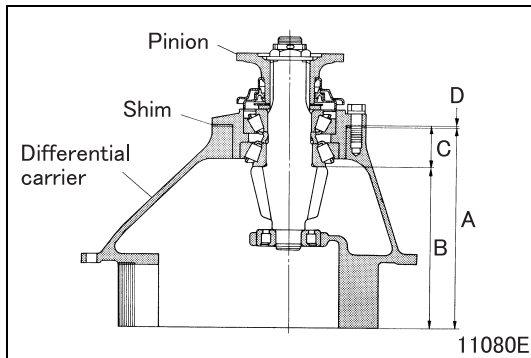
## ■ Adjustment: Pinion

- Perform the following steps to adjust A, B and C within the specified dimensions.
- Calculate shim thickness D by using the following formula based on the machining error data stamped on pinion and differential carrier.
- Formula:

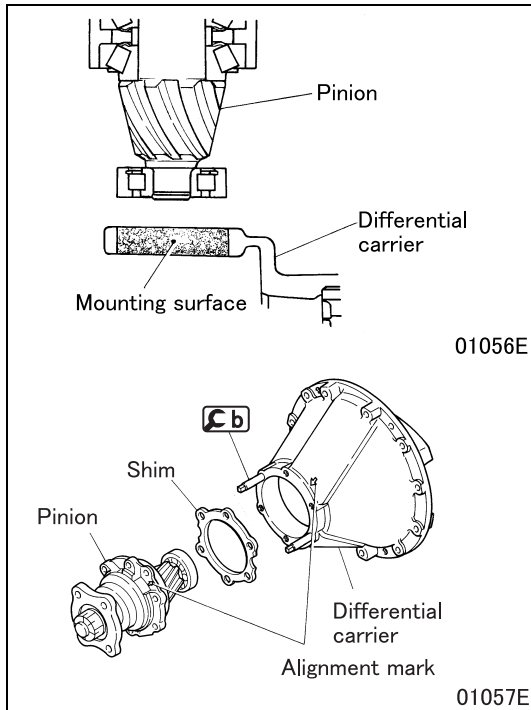
#### ■ Installation: Pinion

- Apply sealant to the pilot bearing mounting surface of the differential carrier.
- Apply gear oil to the fitting area of the pinion and differential carrier.
- Aligning the embossed alignment mark on the bearing retainer of the pinion assembly with that on the differential carrier, mount the pinion assembly.

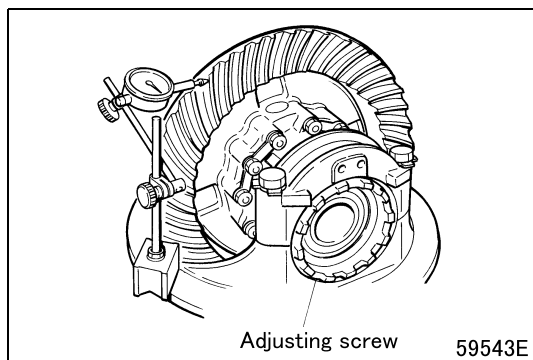
### ■ Adjustment: Backlash between reduction gear and reduction pinion

- Adjust by means of the right- and left-hand adjusting screws, taking care not to change the starting torque.

- When one side bearing nut is loosened, be sure to tighten the other one by the same amount to prevent the side bearing starting torque from changing.

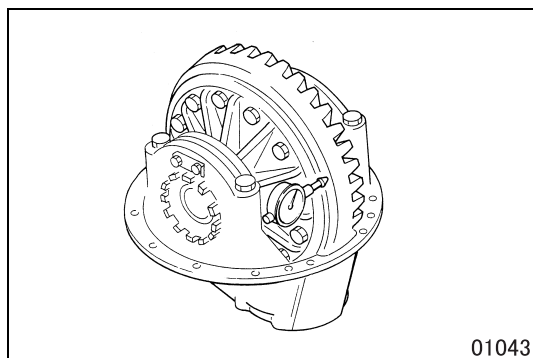
### ■ Inspection: Wobble at back face of reduction gear

- Measure at R145 mm {5.71 in.} <D050H, D052H> or R185 mm {7.28 in.} <D8H> from the center of the reduction gear.

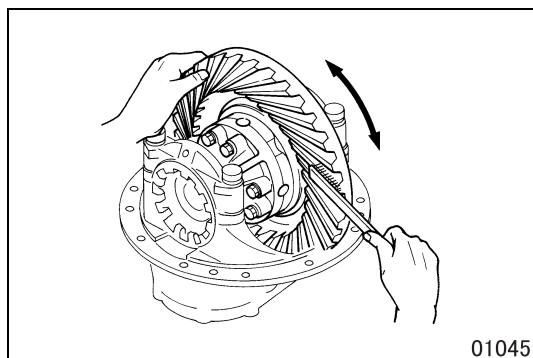
### ■ Inspection: Tooth contact of reduction gear

- Apply red lead to three to four teeth at three equally spaced points of the reduction gear.
- Turn the reduction gear several times to check for tooth contact.
- Adjust tooth contact if it is remarkably offset.

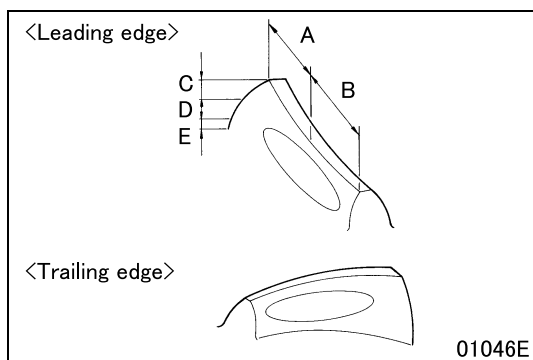
### ● Correct tooth contact at no load

#### <Reduction gear>

- A: Heel
- B: Toe
- C: Face
- D: Flank
- E: Clearance

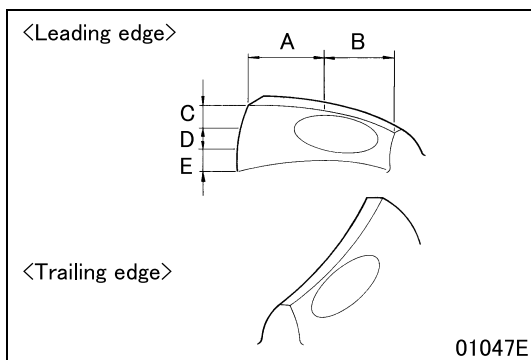
#### <Reduction pinion>

- A: Heel
- B: Toe
- C: Face
- D: Flank
- E: Clearance

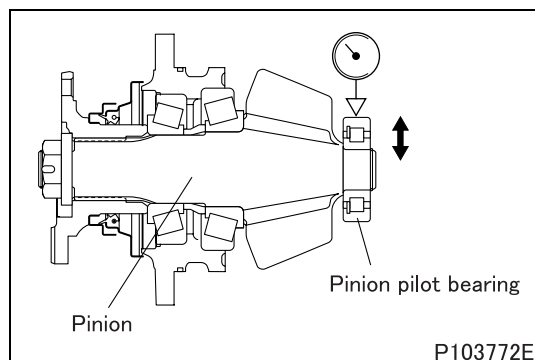
### ■ Inspection: Play in radial direction of pinion bearing

- Hold the pinion and measure the play with moving the pinion pilot bearing in radial direction.
- If the measured value exceeds the limit, replace the pinion pilot bearing.

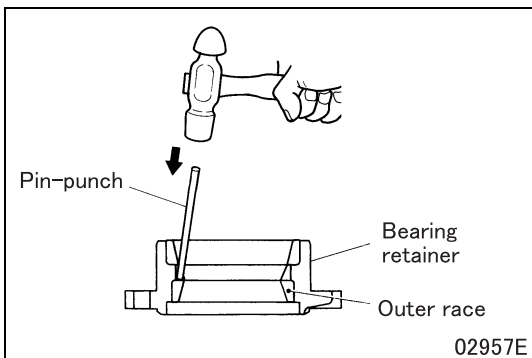
### ■ Removal: Outer bearing outer race

- Drive out the outer bearing outer race by tapping evenly at two notches in bearing retainer.

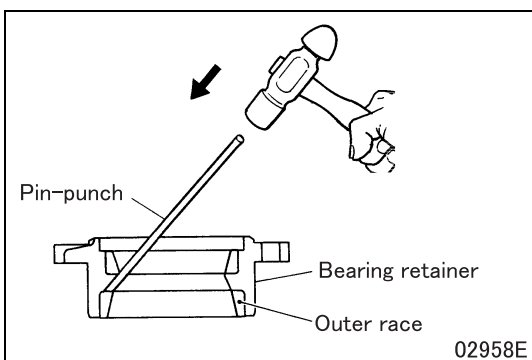
### ■ Removal: Inner bearing outer race

- Drive out the inner bearing outer race by tapping evenly at two notches in bearing retainer.

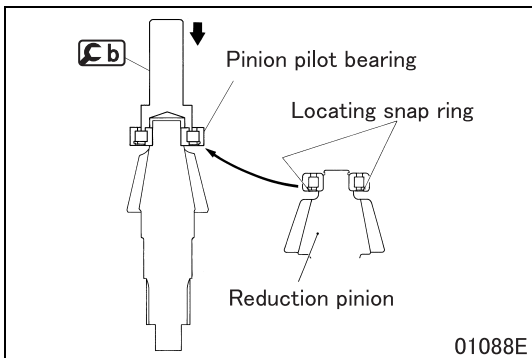
### ■ Installation: Pinion pilot bearing

- Install the pinion pilot bearing in the illustrated direction.
- After installing it, fit the lock ring.

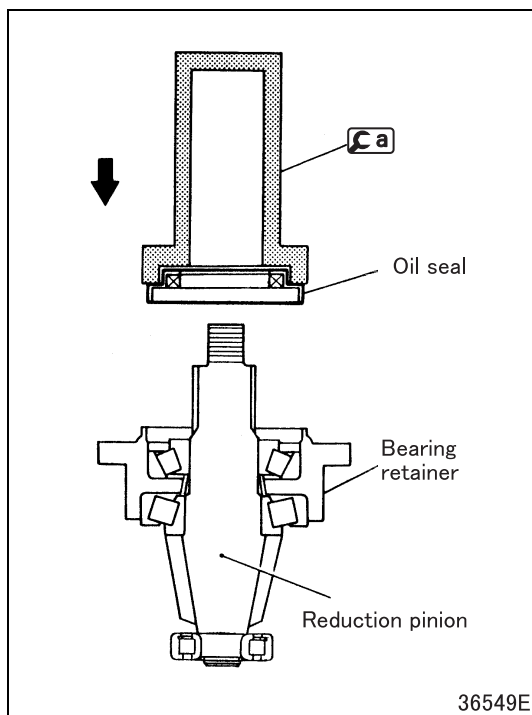
## ■ Installation: Oil seal

- Apply grease to the lip area of the oil seal and install it on the bearing retainer in the illustrated direction.

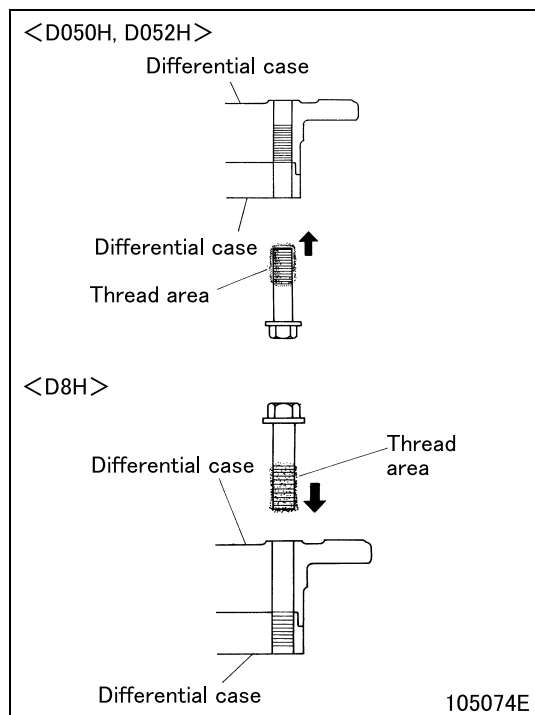
#### ■ Installation: Differential cases

- Apply rust preventive over the entire bolt surface. After applying it, blow off the excess rust preventive on the bolt using compressed air.
- Apply thread lock cement to the bolt threads.
- Tighten the bolt to the specified torque.

- The bolts must be coated with rust preventive before they are tightened to the specified torque.
- Do not drive the vehicle for at least an hour after the bolts have been tightened to let the thread lock cement harden.
- Do not drive the vehicle at full torque for at least four hours after the bolts have been tightened to let the thread lock cement harden.

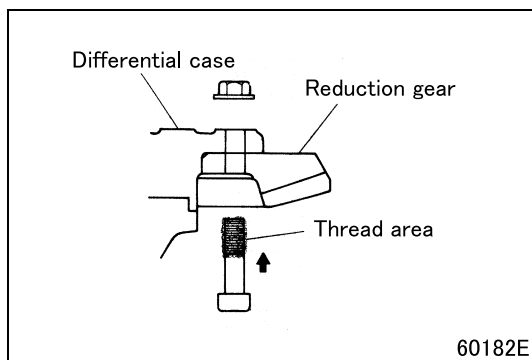
## ■ Installation: Differential case and reduction gear

- Apply rust preventive over the entire bolt surface. After applying it, blow off the excess rust preventive on the bolt using compressed air.
- Apply thread lock cement to the bolt threads.
- Tighten the bolt to the specified torque.

- The bolts must be coated with rust preventive before the nuts are tightened to the specified torque.
- Do not drive the vehicle for at least an hour after the bolts have been tightened to let the thread lock cement harden.
- Do not drive the vehicle at full torque for at least four hours after the bolts have been tightened to let the thread lock cement harden.

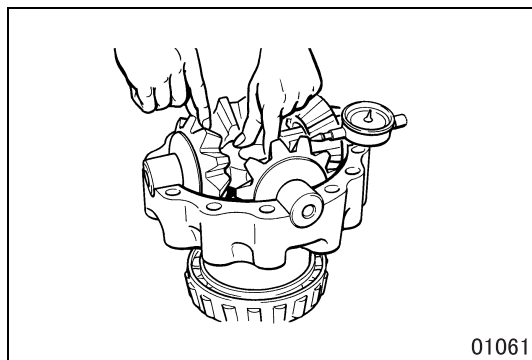
## ■ Adjustment: Backlash between differential gear and differential pinion

- If the measurement is equal to or exceeds the limit, replace the differential gear washers.

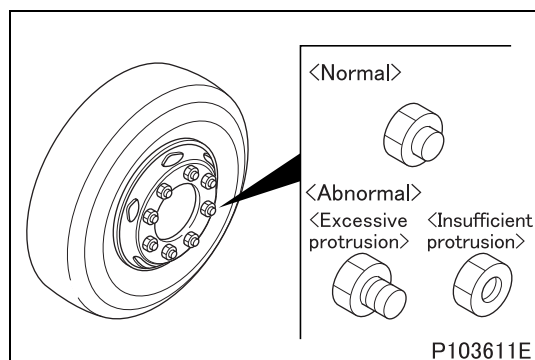
### 1.1 Visual inspection

- Check the end of each hub bolt for proper length of protrusion from the wheel nut. Excessive length of protrusion can lead to an elongated hub bolt and insufficient length can lead to a broken bolt. If any abnormality is found, replace all of the wheel nuts and hub bolts on the wheel. (See WHEEL AND TIRE, Gr26 and 27.)
- If there is any rust seepage from the wheel nuts, hub bolts, or disc wheel, check them for crack or other damage which may cause the rust. (See WHEEL AND TIRE.)

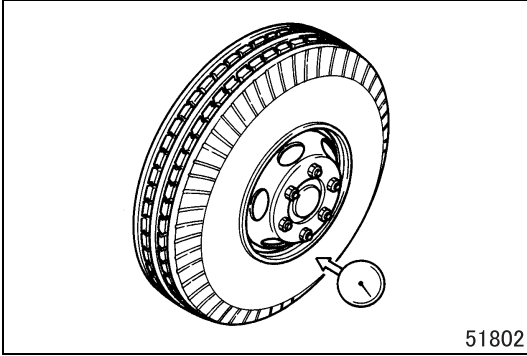
### ■ Inspection: Tire lateral runout

- Measure the disc wheel for lateral runout.
- If the disc wheel's maximum runout is located near the mark on the wheel, install the tire such that the mark on the tire is 180° away from the mark on the disc wheel.
- Measure the tire again for lateral runout.
- If the measured value still does not conform to the standard value, replace the tire.

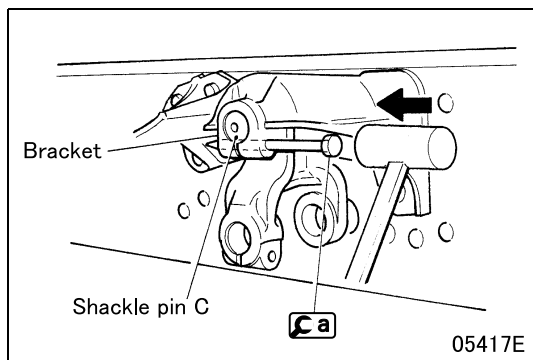
### ■ Installation: Shackle pin C

- Align the bolt hole of the rear spring rear bracket with the bolt groove of the shackle pin C using **Ca**.

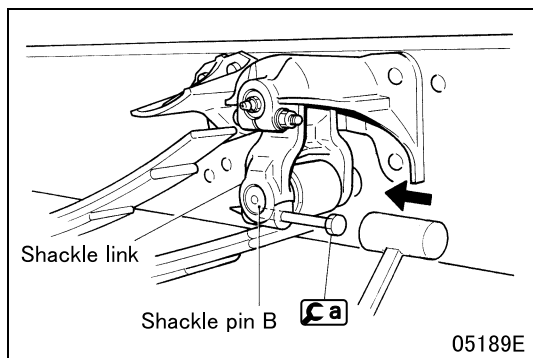
### ■ Installation: Shackle pin B

- Align the bolt hole of the shackle link with the bolt groove of the shackle pin B using **Ca**.

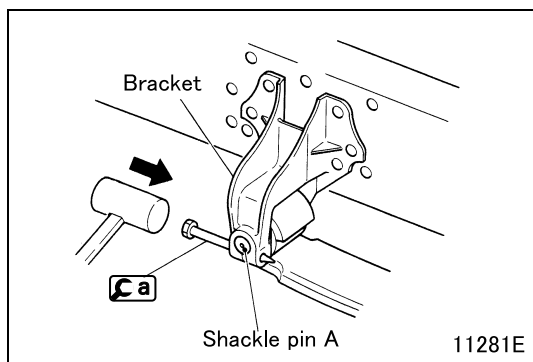
### ■ Installation: Shackle pin A

- Align the bolt hole of the rear spring front bracket with the bolt groove of the shackle pin A using **Ca**.

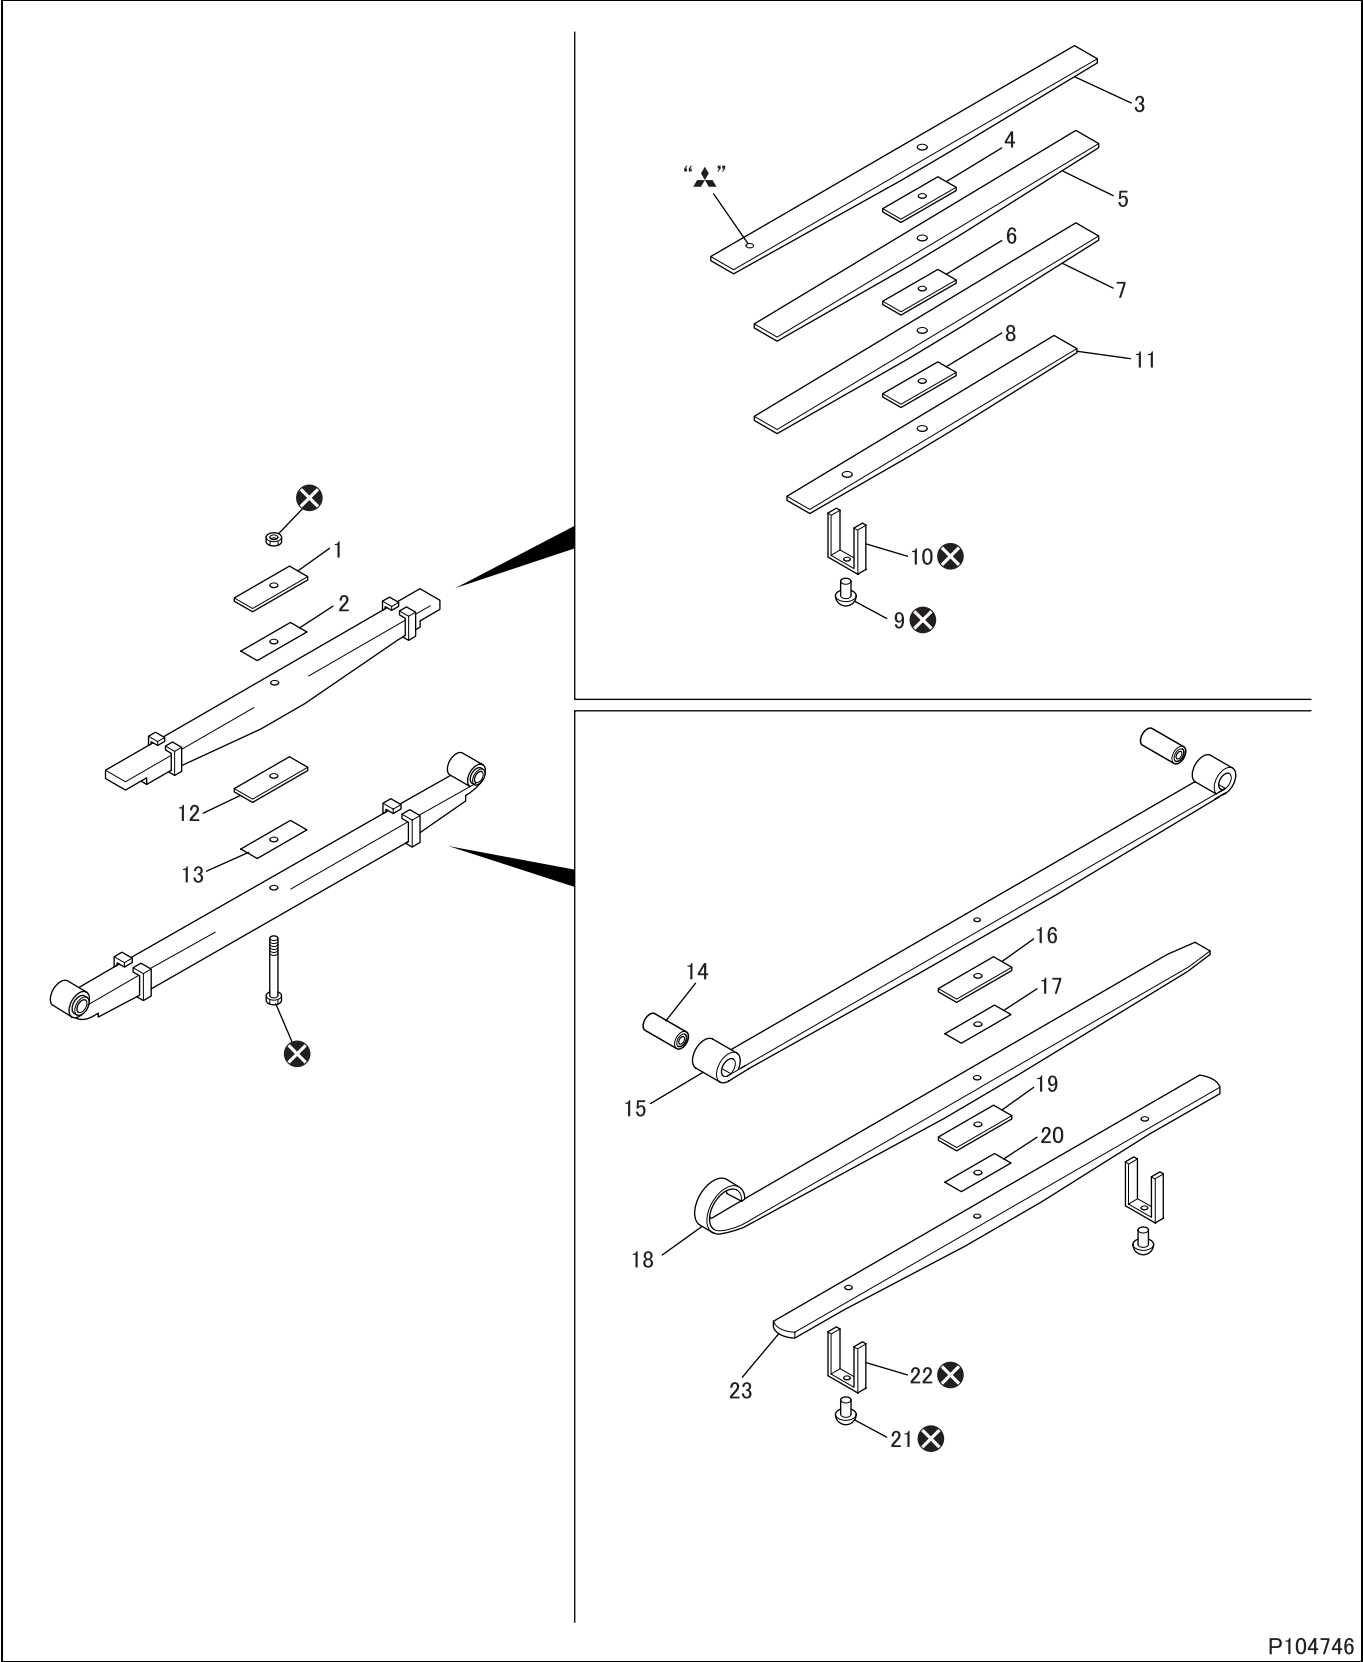
P104746

- Leaf spring assemblies vary slightly in number of spring leaves and other components depending on vehicle models. This section describes a typical one of these leaf spring assembly variations.

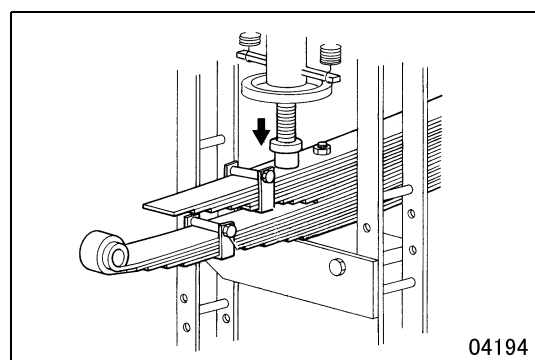
### ■ Compression: Leaf spring

- Compress the leaf springs using a press for subsequent operations.
- For a leaf spring using bending type clips, unbend the clip ends using a chisel or a similar tool.

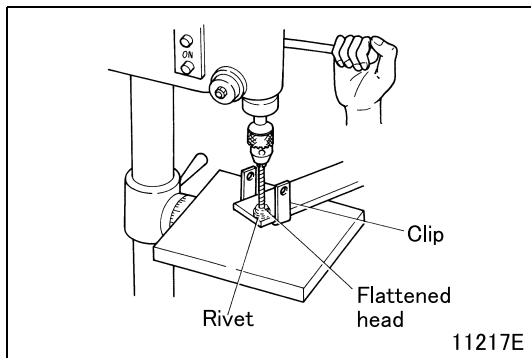
### ■ Removal: Clip

- Using a drill press, break the flattened head of the rivet and remove the clip from the leaf spring.

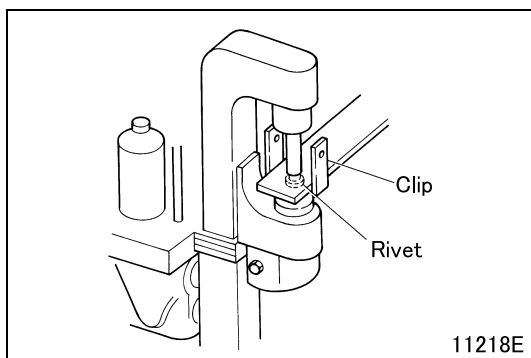
### ■ Installation: Clip

- Using a riveting machine, rivet a clip onto the leaf spring.

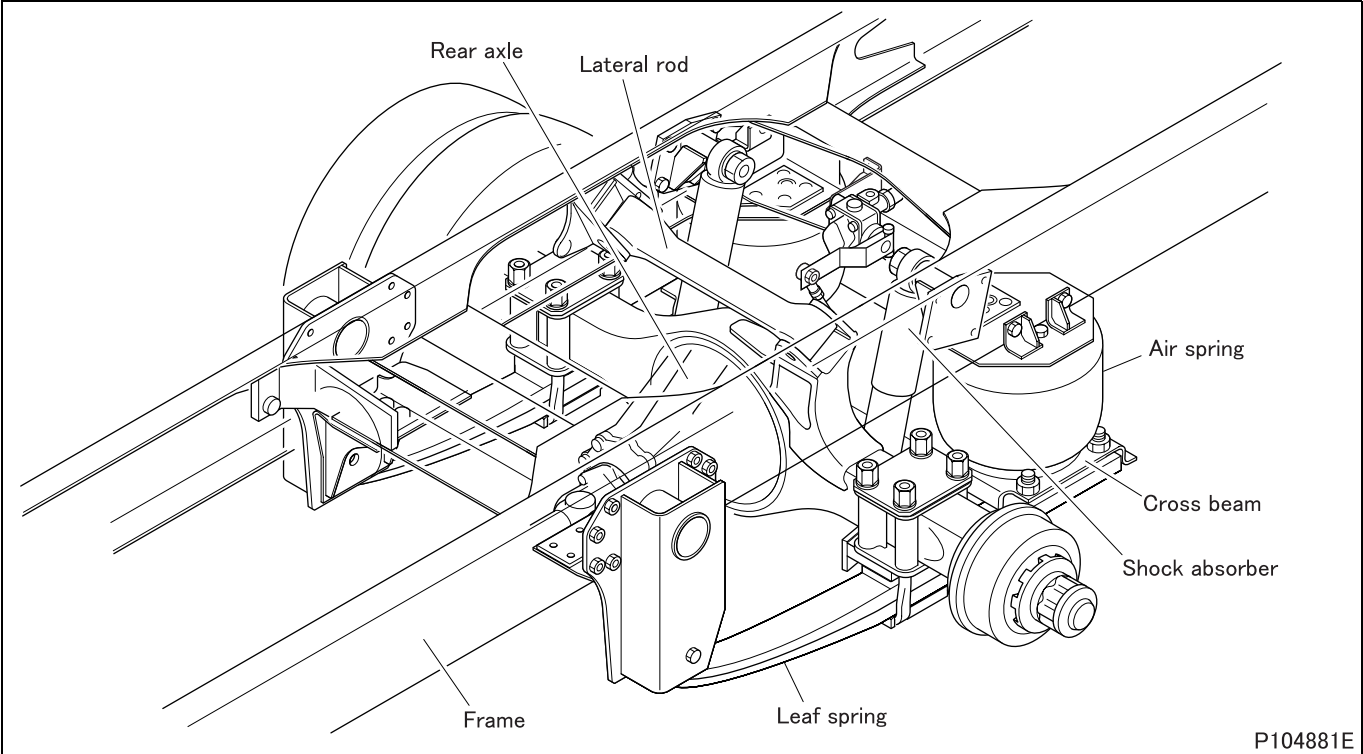
P104881E

- Air spring, leaf spring, cross beam, and shock absorber are installed between frame and rear axle to support the vehicle body mass and absorb the vibration and shock from the road surface to prevent them from being directly transmitted to the vehicle body, thus protecting the vehicle body, occupants, and cargos. This construction also restricts irregular vibration of the wheels to ensure driving stability. The air spring is characterized by softer spring. Therefore, lateral rod is installed to reduce rolling which is larger in a softer suspension.
- Leveling valve is fitted on the rear axle housing. The leveling valve senses the increase and decrease of loads and controls the internal pressure of the air spring depending upon the load.

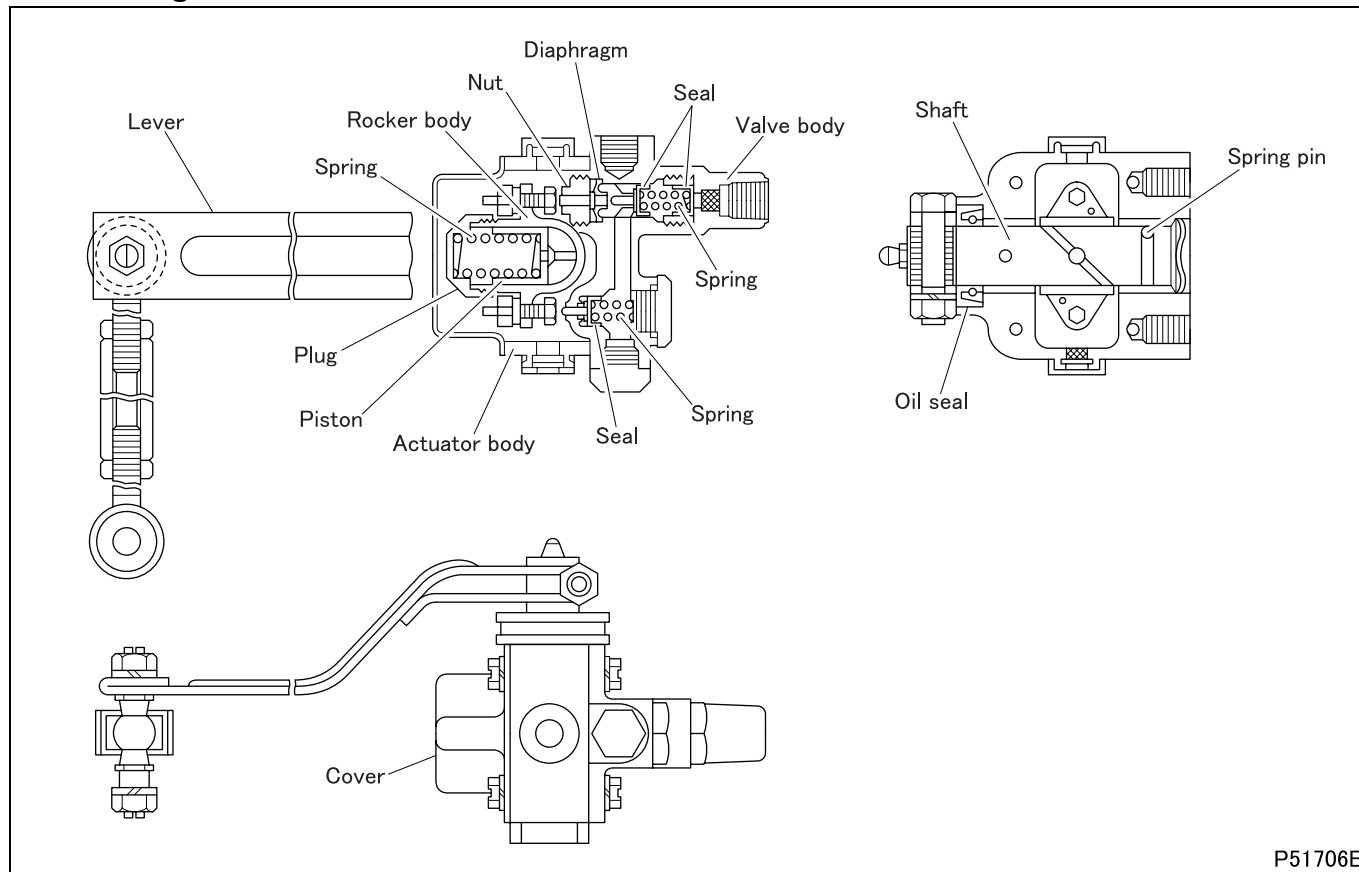
P51706E

- The leveling valve is a control device which supplies or discharges compressed air to or from the air spring according to loads. The leveling valve body is mounted on the frame.

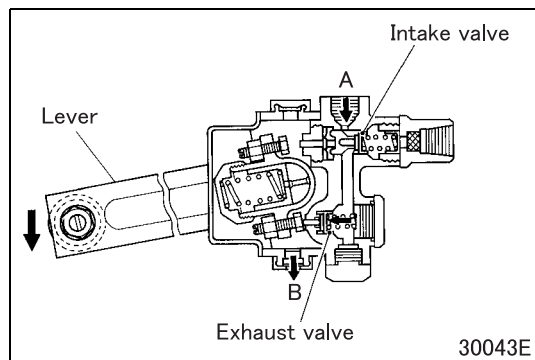
### 3.1 When load decreased

- The lever of the leveling valve is lowered below the neutral position. When the lever moves down beyond the dead zone, exhaust valve is opened. Since intake valve remains closed, therefore, the air from discharge port A flows through the opened exhaust valve and is discharged into the atmosphere from exhaust port B.

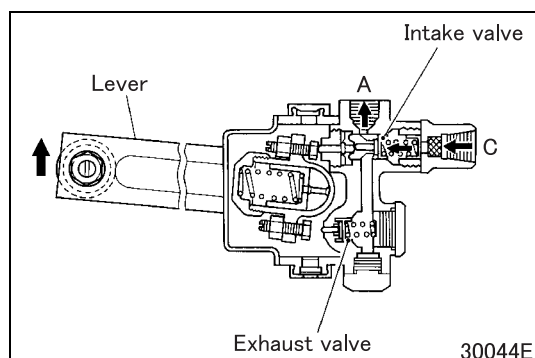
### 3.2 When load increased

- The lever of the leveling valve is raised above the neutral position. When the lever moves up beyond the dead zone, intake valve is opened. Since exhaust valve remains closed, therefore, the air flows from supply port C to discharge port A.

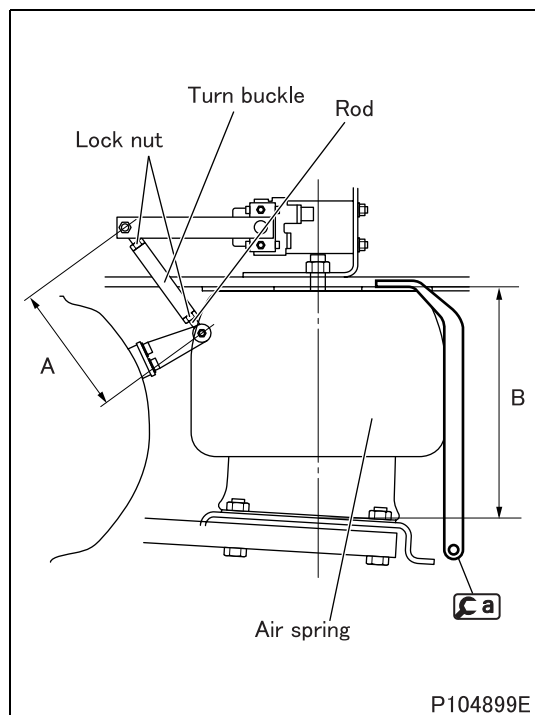
- Adjust air spring with no occupant in the vehicle.

- Set air pressure in the air tank to the specified value.
- To prevent dead zone (play) of levelling valve from affecting adjustment, loosen lock nut of rod first, then turn turn buckle to shorten rod length A (distance between centers of eye sections at rod end). Then gradually extend the distance.
- Measure height of air spring using standard scale. When height B is the following value, tighten lock nut of rod.  
B: 329 mm {13.0 in.}

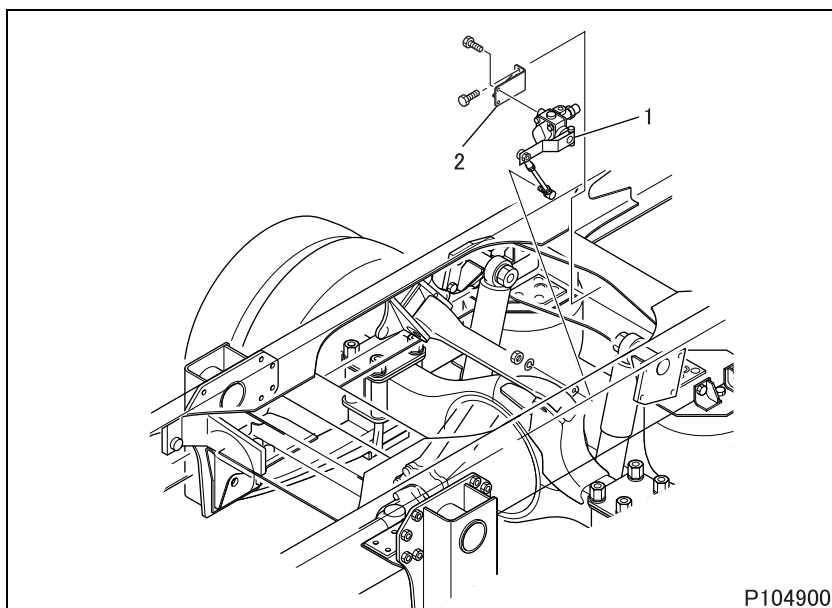
## ● Removal sequence

- 1 Leveling valve (See later section.)
- 2 Bracket

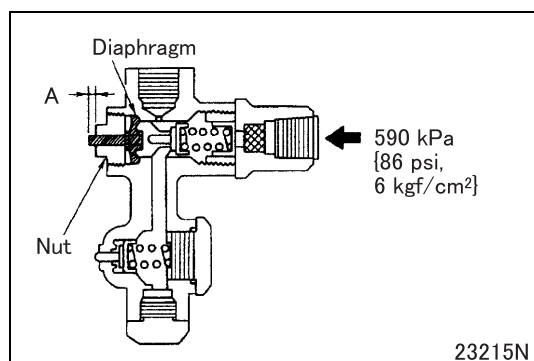
### ■ Installation: Diaphragm

- Install diaphragm nut such that the projection length A of diaphragm (stem) meets the standard value when the specified air pressure of 590 kPa {86 psi, 6 kgf/cm<sup>2</sup>} is applied to the inlet side.

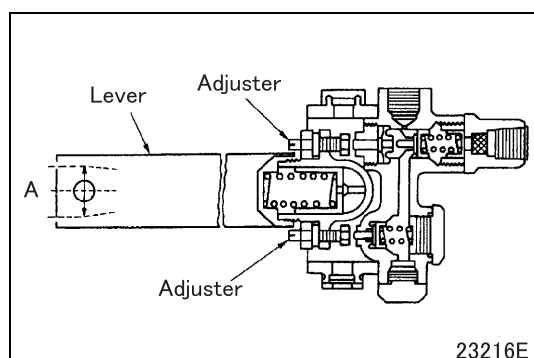
### ■ Adjustment: Dead zone at the lever end

- Adjust dead zone A (lever end hole moving range where no air flow in nor out the valve) for the standard value, using adjuster.

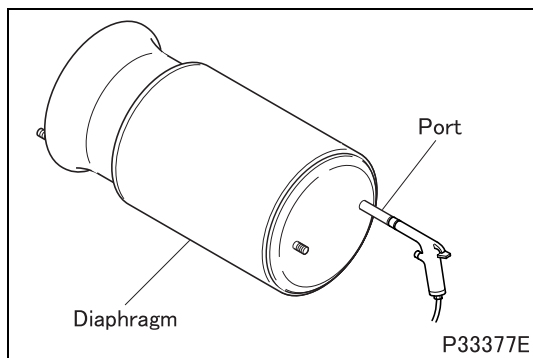
### ■ Removal: Diaphragm

- Inject air from the inlet port to expand the diaphragm.
- While keeping this condition, remove the diaphragm which is caught between piston and bump stopper.

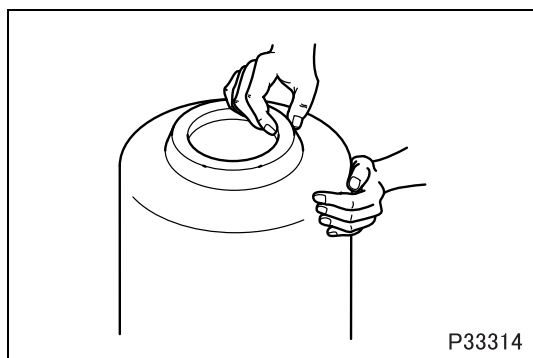
### ■ Installation: Diaphragm

- Before installing, apply tire cream to the diaphragm-to-bump stopper joint.

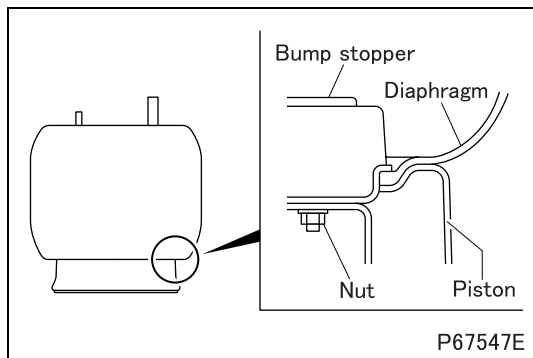
- Pull together bump stopper and diaphragm making sure they are in close contact, then install piston and secure it with nut.

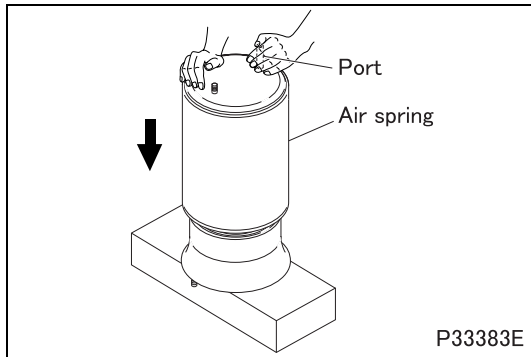
## ■ Installation: Air spring

- Holding the air spring body erect, apply your hand over the port.
- While blocking the port to prevent the diaphragm from being damaged, press the air spring with air shut in.
- Gradually release air from the port to contract the diaphragm to a height at which the air spring will be installed to the vehicle.

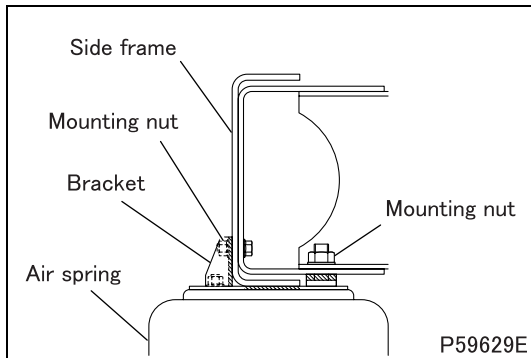
## ■ Installation: Air spring bracket

- Tighten the mounting nut to the specified torque while attaching the air spring bracket closely to the side frame mounting surface (diagonally shaded area) as shown in the drawing.

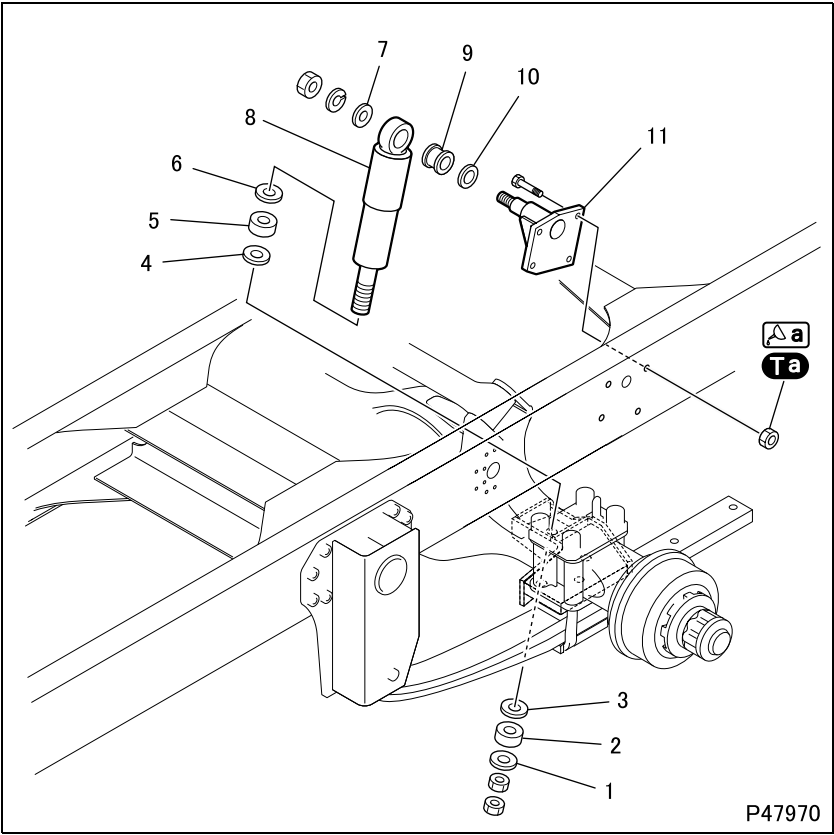
## ● Removal sequence

- 1 Washer A
- 2 Rubber bushing
- 3 Centering washer
- 4 Centering washer
- 5 Rubber bushing
- 6 Washer C
- 7 Washer B
- 8 Shock absorber
- 9 Rubber bushing
- 10 Washer B
- 11 Shock absorber upper bracket

- Before removing the shock absorber, be sure to remove the nut that holds cross beam and air spring to prevent the air spring from being damaged.

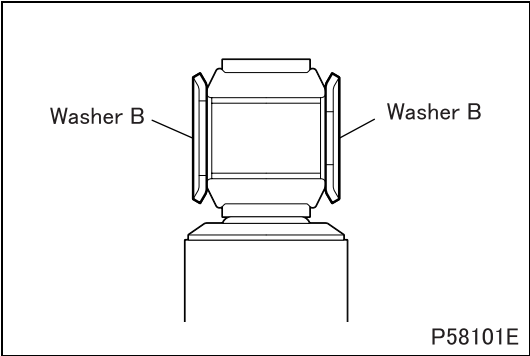
### ■ Installation: Washer B

- Install the washer B in the illustrated direction.

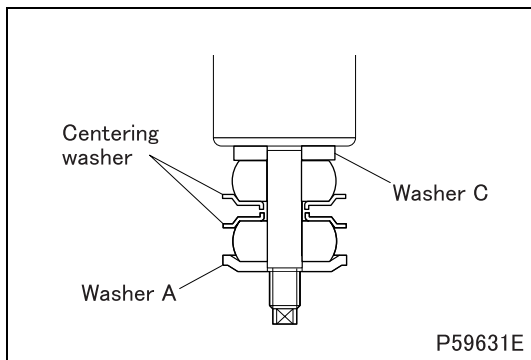
■ **Installation: Washer A and centering washer**

- Install the washer A and centering washer in the illustrated direction.

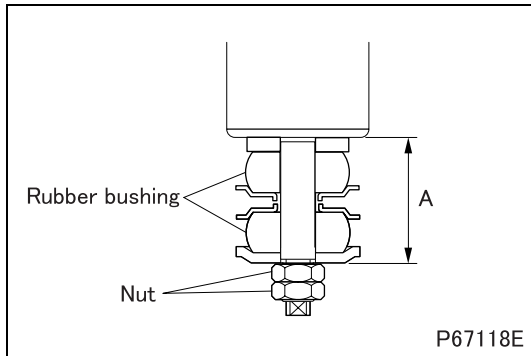
■ **Installation: Rubber bushing**

- Tighten the nut for the dimension A as indicated below.  
A: 68 mm {2.68 in.}

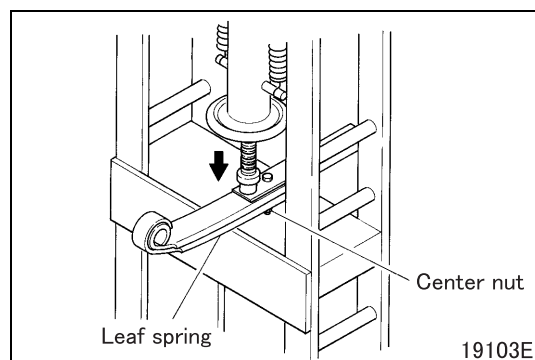
#### ■ Compression: Leaf spring

- Using a press, compress the leaf spring as illuminated for subsequent operations.
