# FE.FG

## SERVICE MANUAL 2008 Model FOREWORD

This Service Manual contains maintenance and repair methods for the Mitsubishi Fuso Truck FE. FG Series. Read this manual carefully as an aid in providing correct, efficient maintenance. Please note that the information and specifications contained within this manual may change without notice. This is due to product modifications and continued vehicle improvements that are made throughout the model years. Should you encounter any discrepancy in the information provided, please do not hesitate to contact your nearest Mitsubishi Fuso Dealer or Mitsubishi Fuso Truck of America, Inc.

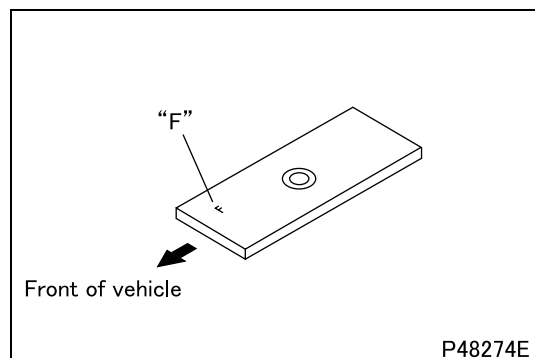
#### ■ Installation: Caster shim

- Install the caster shim so that the mark "F" on the shim turns to the front of vehicle.

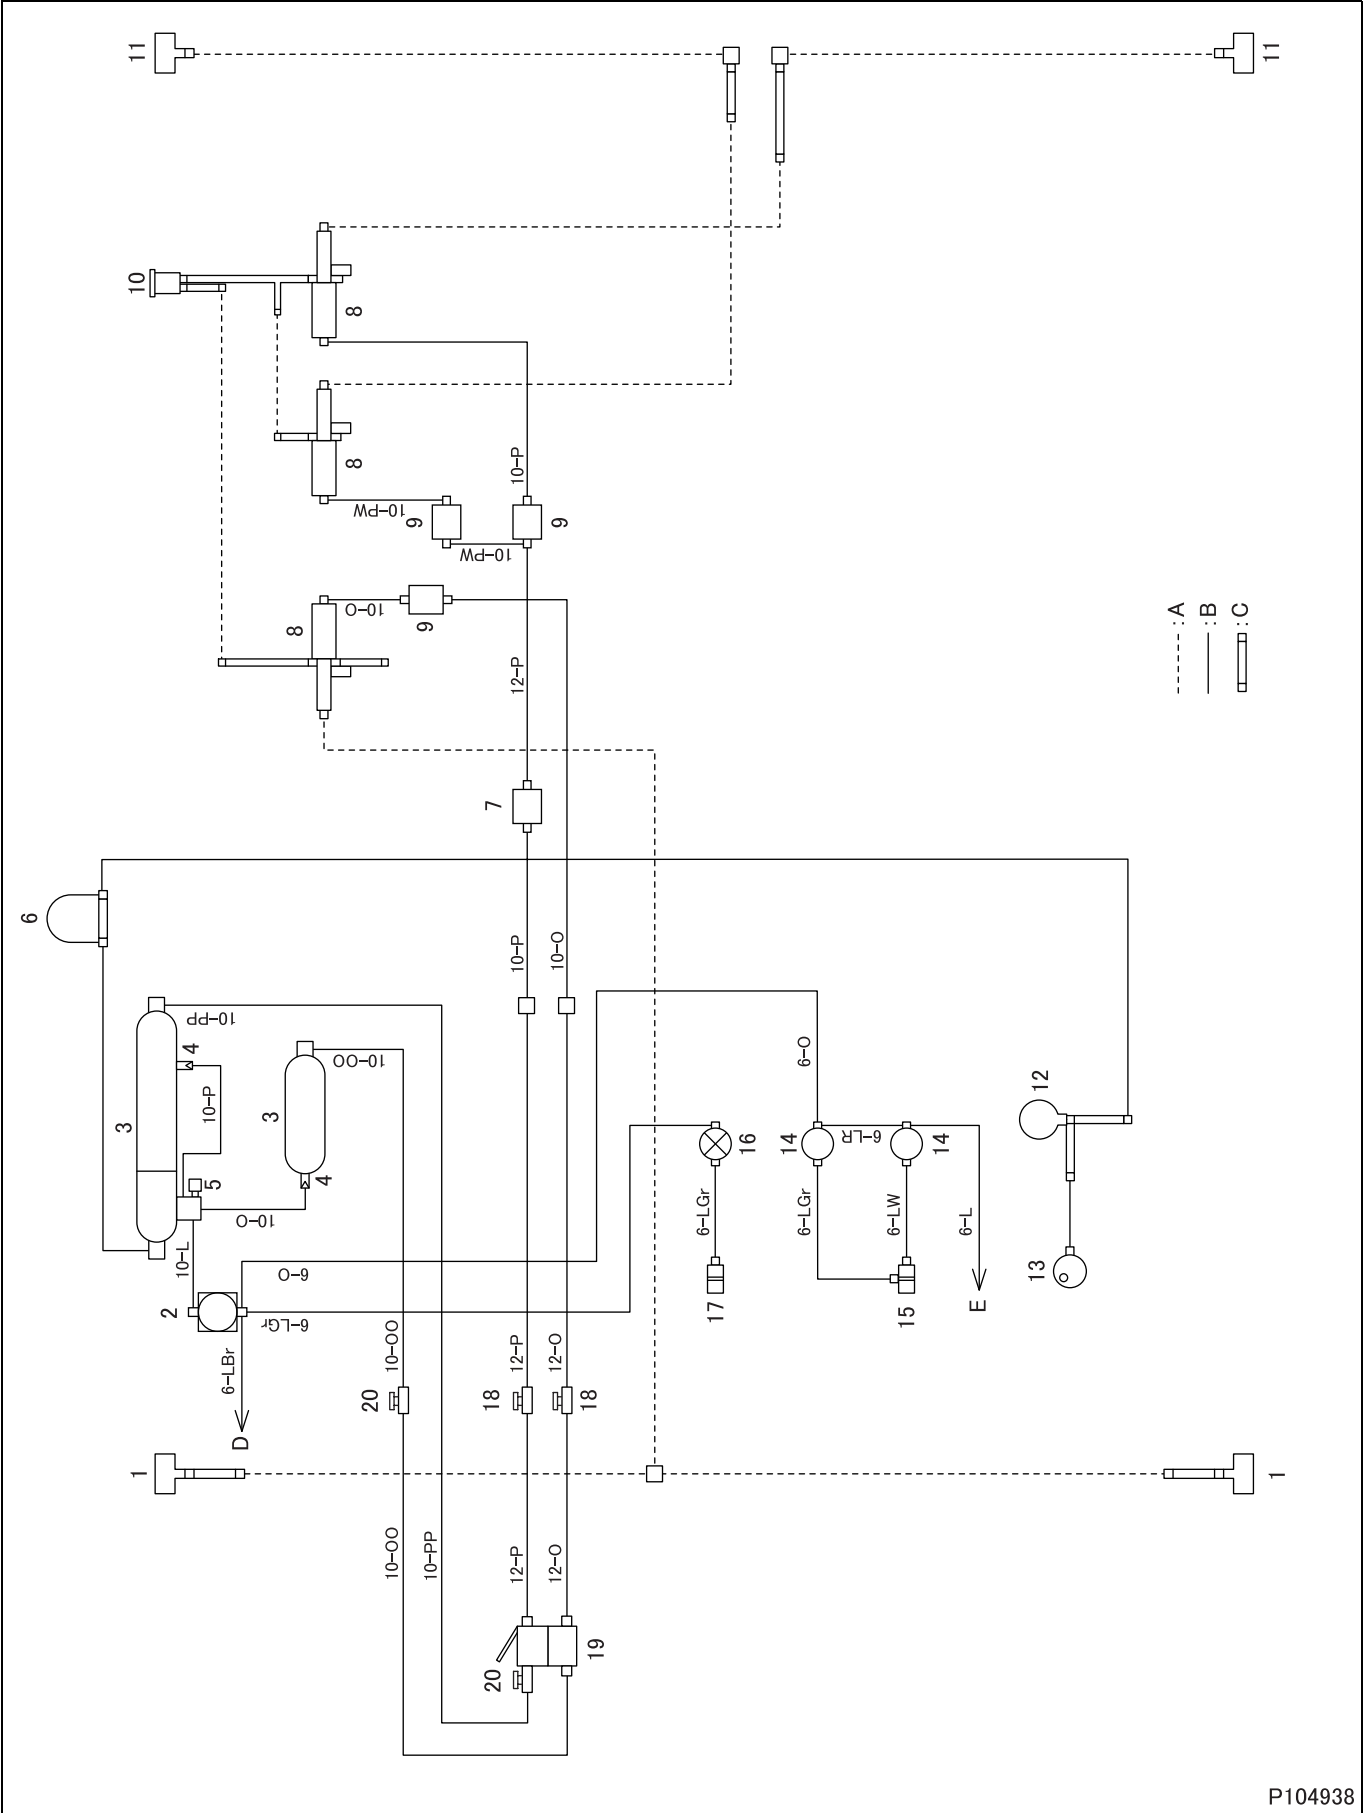
## 1. Brake System

| 1 Front wheel cylinder | 11 Rear wheel cylinder | A : Fluid line |
| 2 Supply valve | 12 Air compressor | B : Air line |

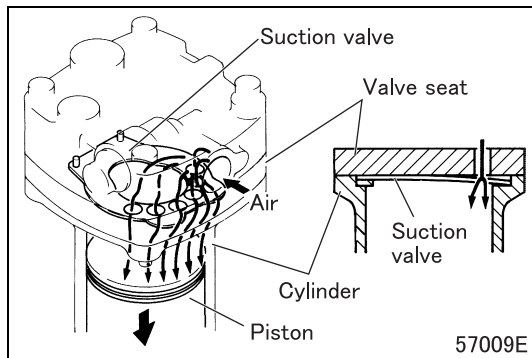
### 2.1 During suction

- When the piston goes down during the suction stroke cycle, the vacuum causes the suction valve to open, allowing air to be drawn into the cylinder.

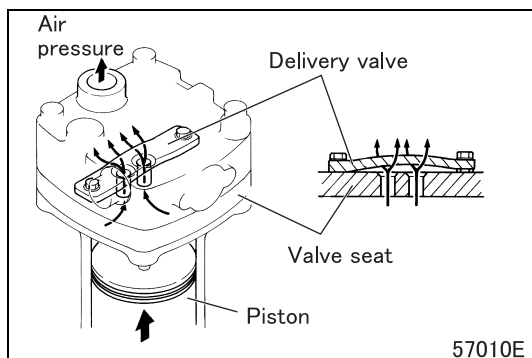
### 2.2 During compression and delivery

- When the piston goes up during the compression and delivery stroke cycle, the suction valve is closed by air pressure.
- Air pressure compressed by the piston forces open the delivery valve and makes its way to the air dryer and air tank.

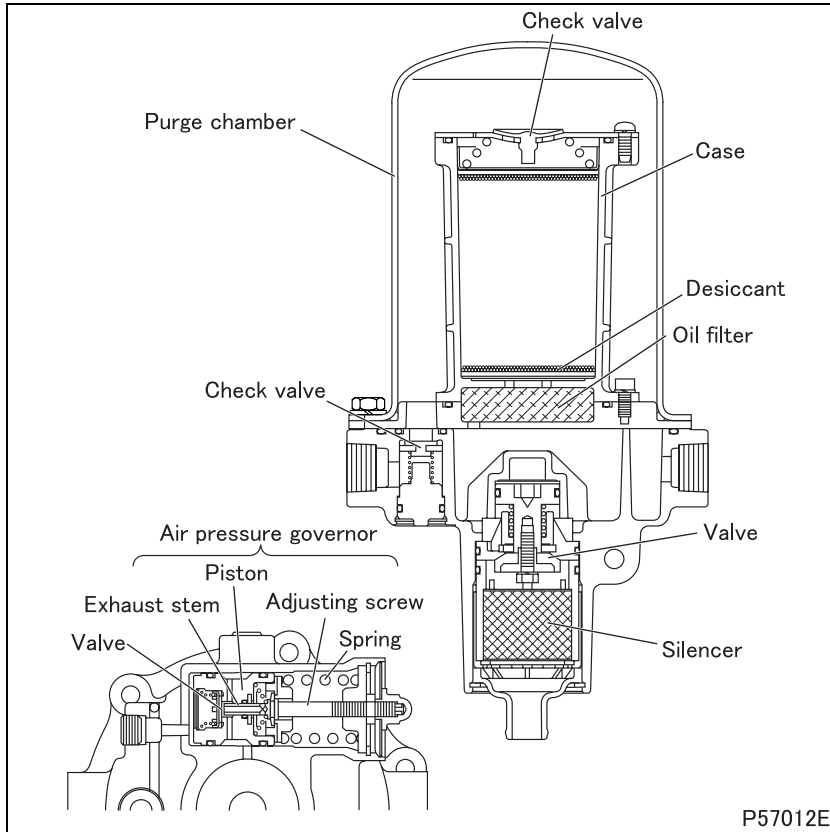
- The air dryer protects brake components by removing moisture and oil from air that has been compressed by the air compressor.
- The air dryer incorporates an air pressure governor, which keeps the pressure in the air tank constant by releasing air compressed by the air compressor to the atmosphere when the pressure in the air tank makes such operation necessary.

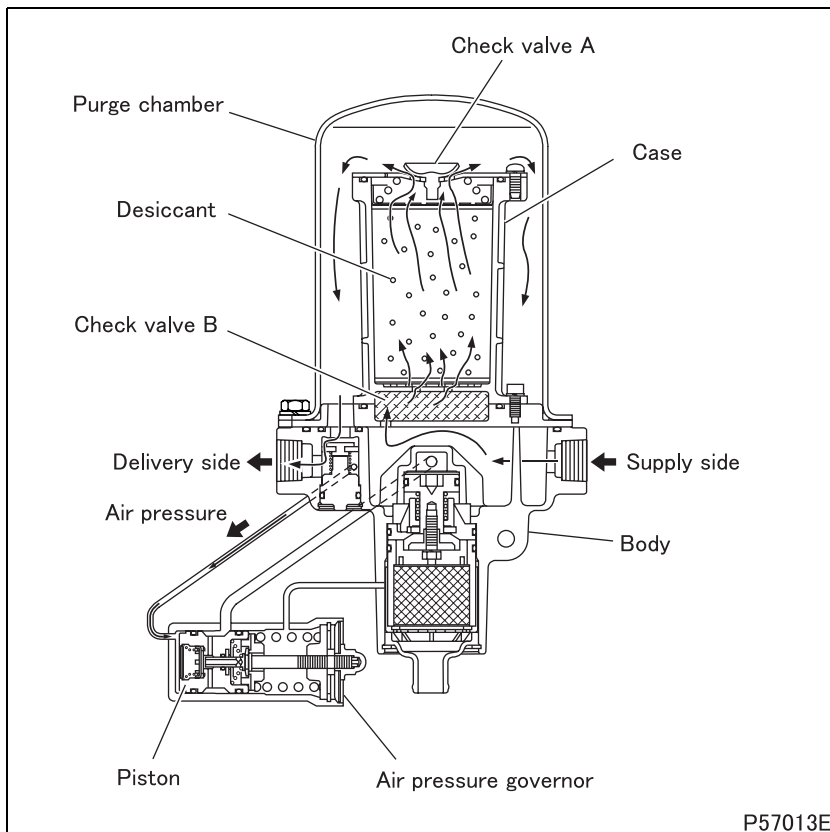
#### 3.1 Drying action

- While the air tank is being charged, air from the air compressor enters the air dryer's supply side. Moisture and oil are separated from the air inside the body and collect in the bottom. The air then passes through the oil filter, which removes smaller oil droplets and particles of dust. The air then flows into the case, where the desiccant removes any remaining moisture.
- As the air flows upward in the case, it makes contact with increasingly dry desiccant and thus contains less and less moisture. When the air reaches the top of the case, it is dry. It flows through the check valve A, purge chamber, and check valve B, and it is then supplied from the delivery side to the air tank. Air pressure also acts upon the piston in the air pressure governor.

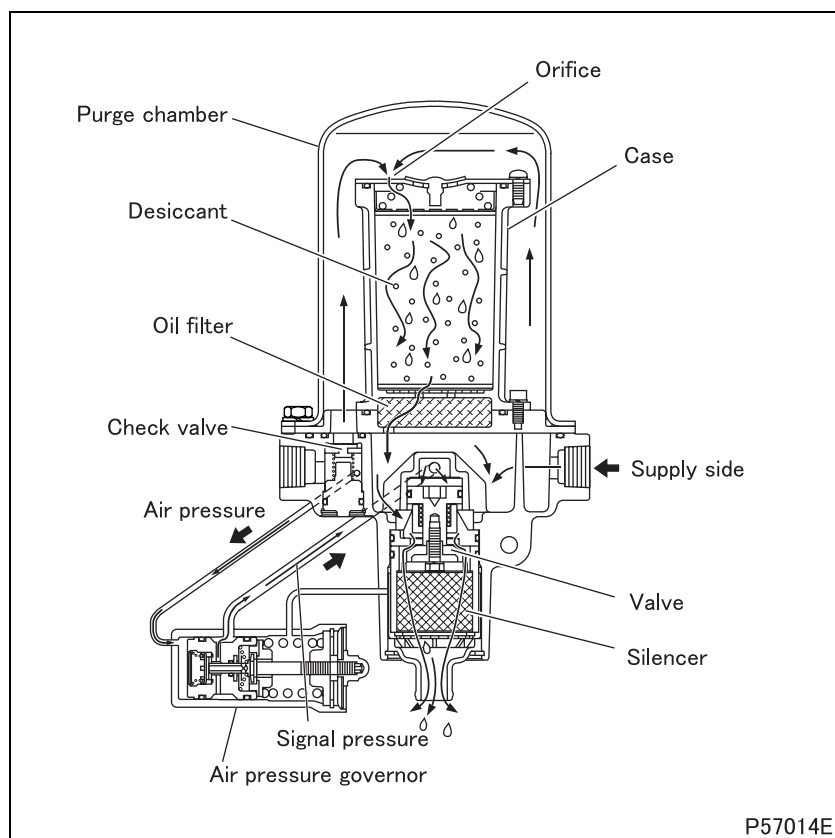
## 3.2 Regeneration of desiccant

- When the air pressure in the air tank reaches the upper threshold level, signal pressure from the air pressure governor causes the valve in the air dryer's control port to open. As a result, the pressure in the case cleans the oil filter and pushes the water and oil out into the atmosphere.

- Following the rapid drop in pressure, dry air in the purge chamber flows through the orifice, expands, and becomes super-dry. As this super-dry air flows backward through the case, it carries moisture from the desiccant out into the atmosphere, thereby completing the desiccant's regeneration.

- During the regeneration process, the check valve is closed. Thus, the signal pressure from the air pressure governor continues to act upon the control port and the valve remains open. Air from the air compressor thus flows through the valve, through the silencer, and out into the atmosphere.

- The regeneration process continues until air consumption causes the pressure in the air tank to decrease to the governor lower threshold level.

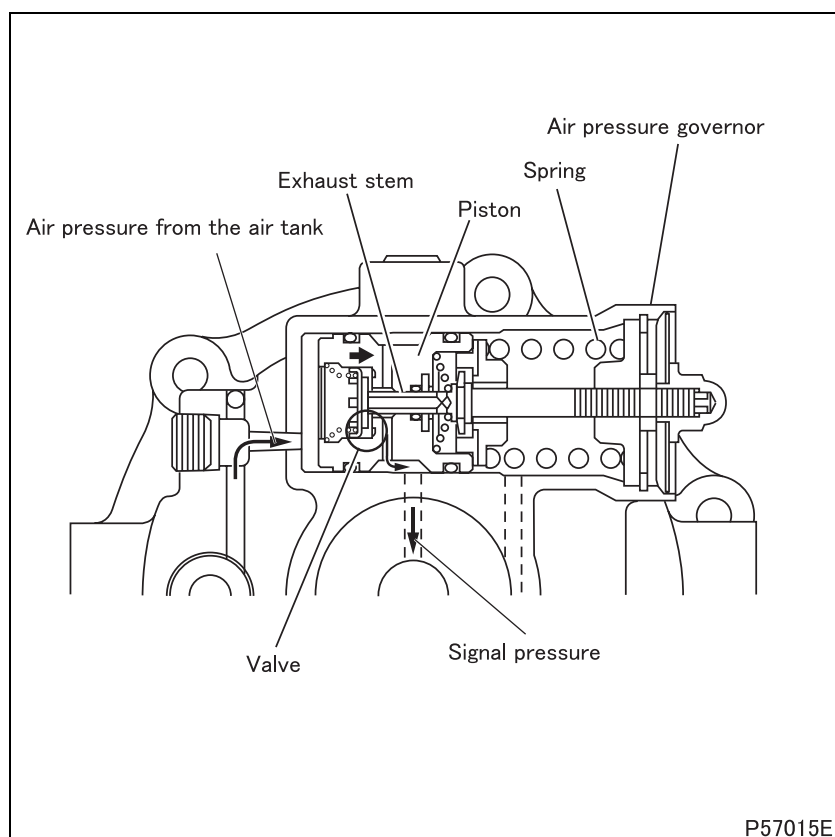
## 3.3 Operation when tank pressure reaches upper threshold level

- Air pressure from the air tank continuously acts upon the piston.
- When the tank pressure increases to such a level that it overcomes the spring, it pushes the piston upward such that the valve closes.
- When the tank pressure increases further and exceeds the upper threshold level, the piston is pushed upward further such that the exhaust stem opens the inlet valve. Air pressure from the air tank thus flows out of the air pressure governor as signal pressure, causing the valve to open. Regeneration of the air dryer's desiccant thus begins.

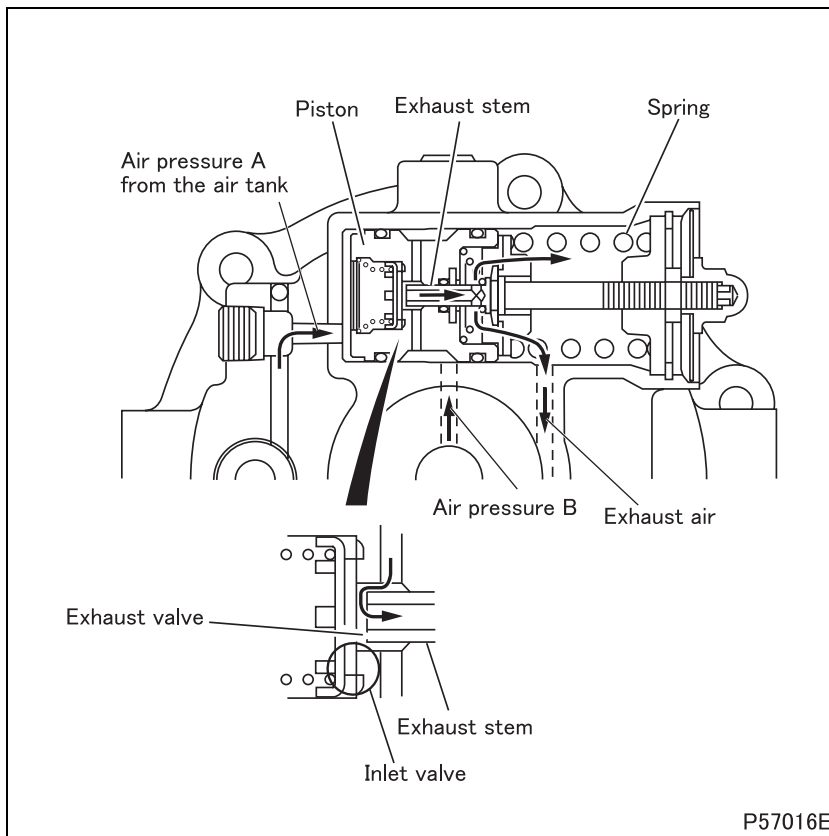
### 3.4 Operation when tank pressure reaches lower threshold level

- When the air pressure A from the air tank drops below the lower threshold level, the piston is pushed downward by the spring such that the inlet valve closes and the exhaust valve opens. As a result, air pressure flows through the exhaust stem and escapes to the atmosphere.

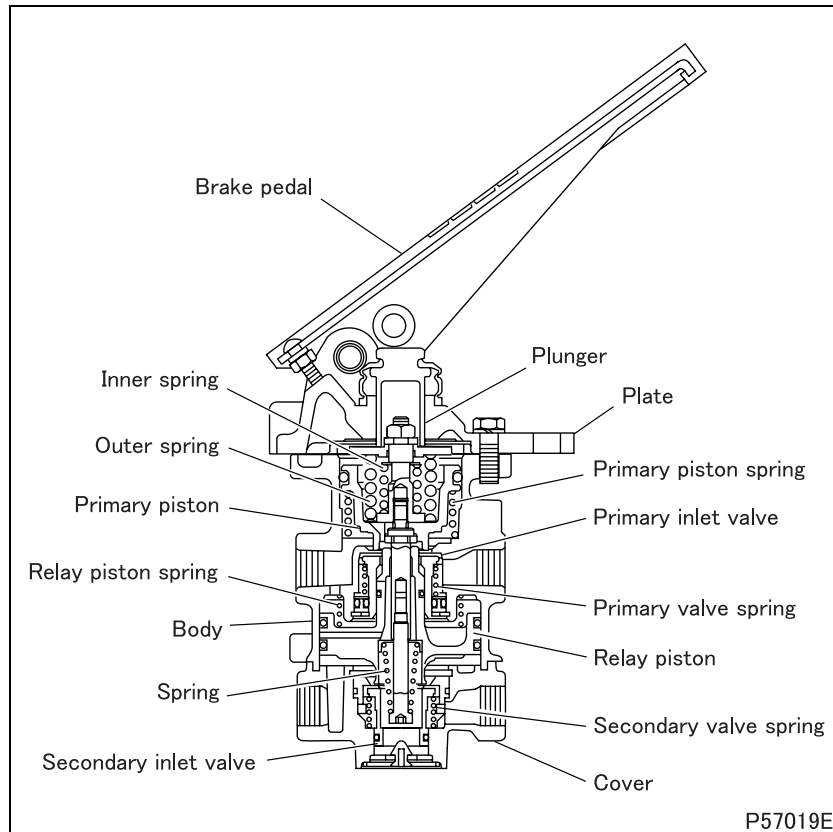
- The dual brake valve controls the braking force of the vehicle by feeding pressurized air to the brake booster in accordance with the brake pedal depression angle of brake pedal.

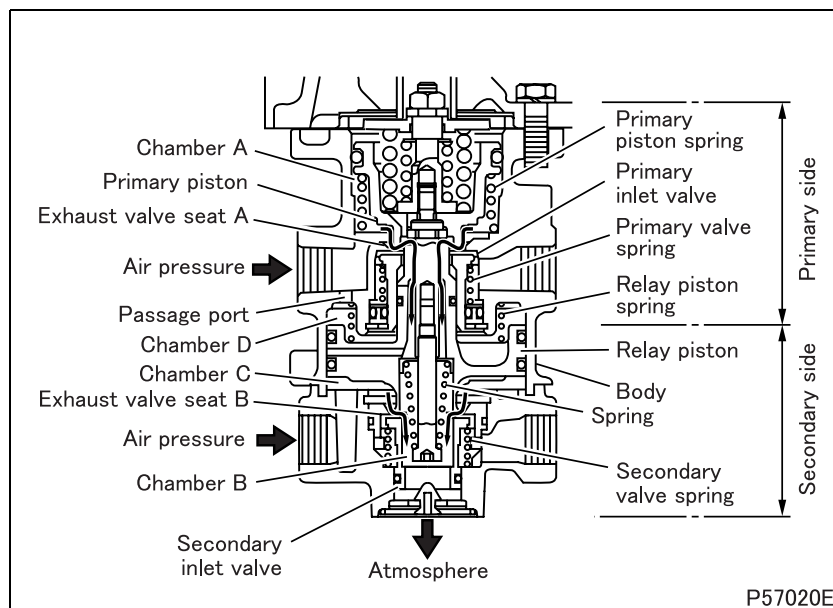
#### (1) When brake not operating

- The percussive forces of primary valve springs, secondary valve spring seat primary inlet valve at primary side, and inlet valve at secondary side, on their respective seats. This shuts off air from the air tank to maintain airtightness.
  - The percussive force of primary piston spring raises primary piston to its upper position. Exhaust valve seat A opens and chamber A is open to atmosphere via chamber B.
  - Since the percussive force of spring is stronger than the percussive force of relay piston spring, relay piston is raised to its upper position and exhaust valve seat B is opened. This opens chamber C to atmosphere via chamber B.
- Chamber A at the primary side and chamber D at the upper part of relay piston at the secondary side are connected via passage port of body.

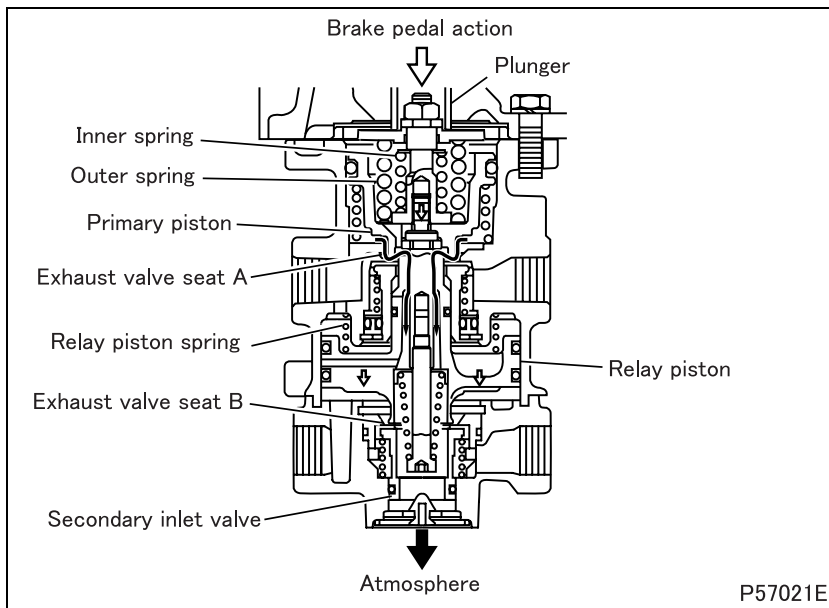
**(2) When pressing brake pedal (before braking pressure is generated)**

- Pressing the brake pedal (illustrated as pedal action), forces down primary piston via plunger.
- Forcing down primary piston changes the balance between the repercussive forces of inner spring and outer spring, and the repercussive force of relay piston spring, forcing down relay piston. This seats the relay piston on secondary inlet valve and closes exhaust valve seat B.
- This closes the secondary side exhaust passage; however, primary side exhaust valve seat A remains open. No braking pressure is generated at either primary or secondary sides.

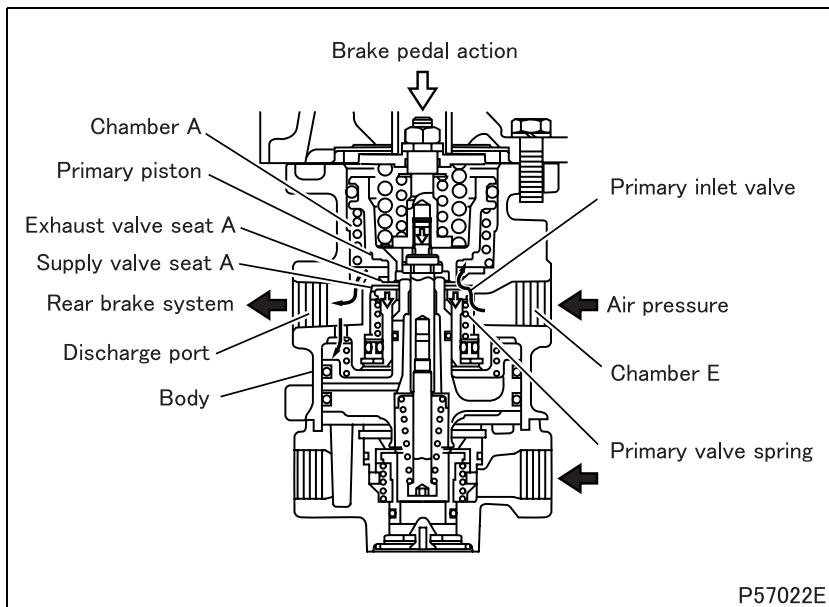
**(3.1) Primary side**

- As the brake pedal is pressed further (illustrated as brake pedal action), primary piston is forced down until it is seated on primary inlet valve, closing exhaust valve seat A.
- Primary inlet valve is forced down, compressing primary valve spring, and supply valve seat A of body separates from the primary inlet valve. The air in chamber E flows into chamber A and is fed to rear brake system via discharge port as braking pressure.

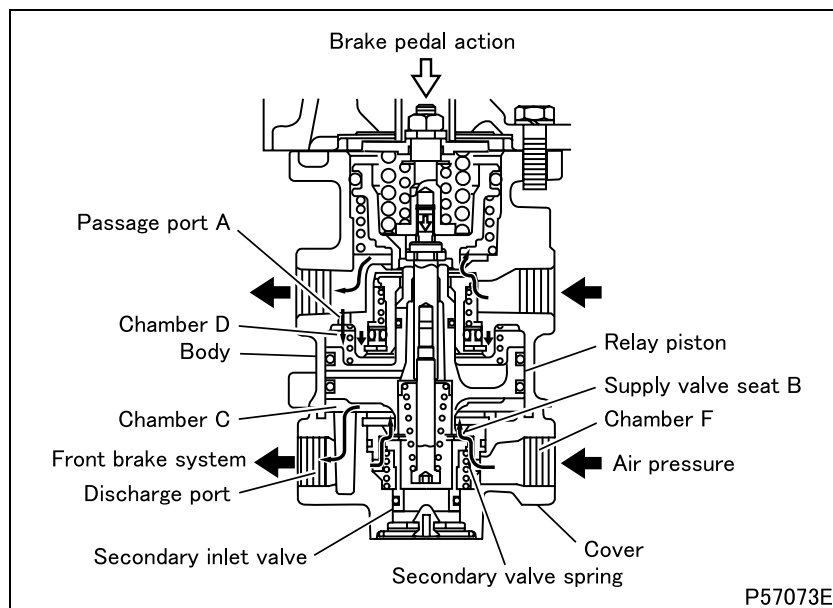
## (3.2) Secondary side

- The air at the primary side flows into chamber D via passage port of body.
- The air fed into chamber D acts on the upper part of relay piston to force down the relay piston and compress secondary valve spring, forcing down secondary inlet valve.
- This separates supply valve seat B and secondary inlet valve of cover.
- The air in supply port chamber F flows into chamber C and is fed to front brake system via discharge port as braking pressure.

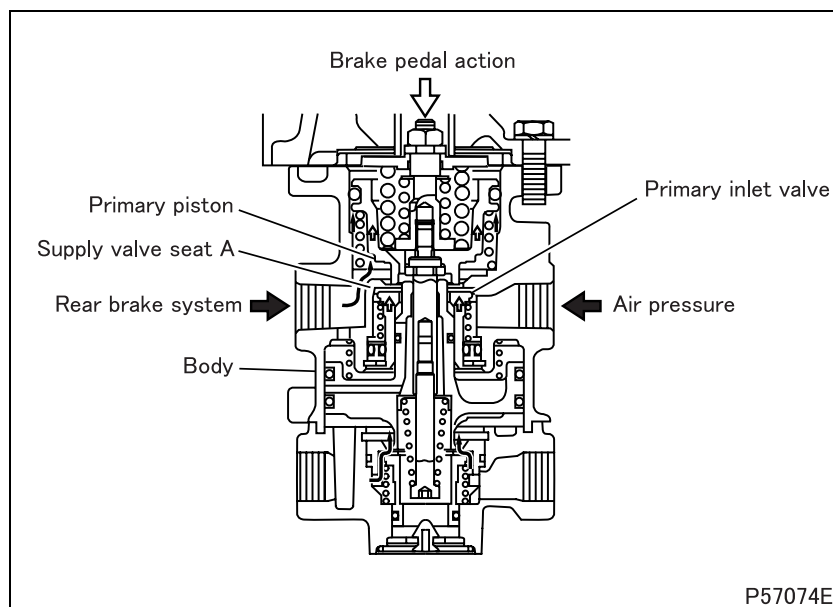
## (4) Stabilization of braking pressure

- When the brake pedal remains pressed at the specified depression angle, the braking air pressure stabilizes at the pressure corresponding to the brake pedal depression angle.

### (4.1) Primary side

- The braking air pressure fed under the bottom of primary piston raises the primary piston and primary inlet valve together in tandem.
- Primary inlet valve makes contact with supply valve seat A of body, then the supply of air from the air tank ceases and the increases in the braking air pressure stops. This stabilizes braking pressure for the rear brake system.

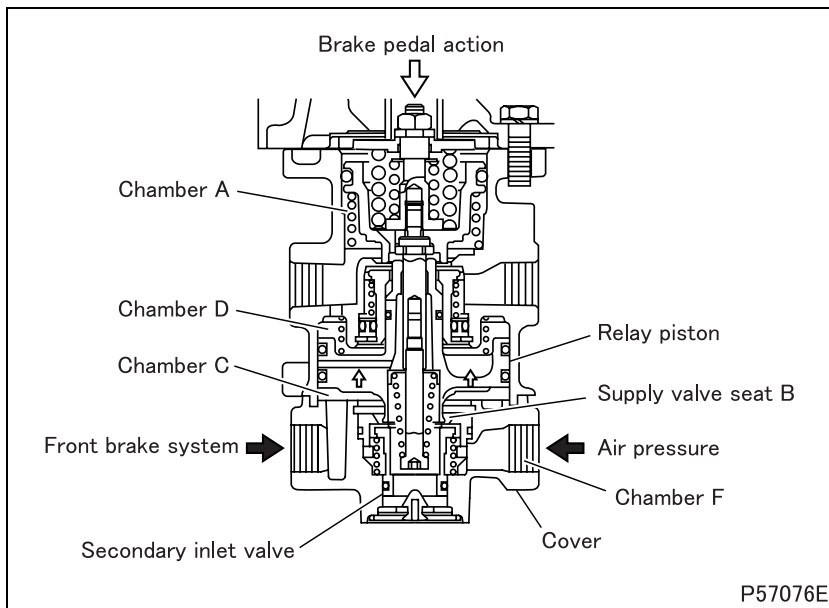
#### (4.2) Secondary side

- As the braking pressure (pressure in chamber C) for the front brake system balances the pressures in chambers A and D, the force raising relay piston disappears, and the relay piston rises in tandem with secondary inlet valve.
- Secondary inlet valve makes contact with supply valve seat B of cover, then the supply of air from supply port chamber F to chamber C ceases. This stabilizes brake pressure for the front system.

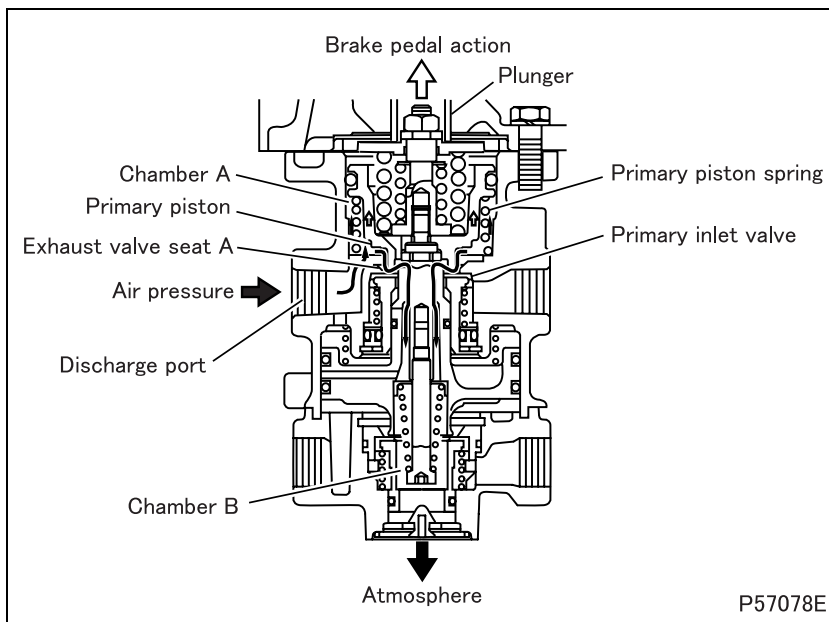
#### (5) Release of brake pressure

##### (5.1) Primary side

When the brake pedal is released (illustrated as brake pedal action), primary piston spring and air pressure at discharge port (pressure in chamber A) raise plunger and primary piston. Then, exhaust valve seat A at the lower end of the primary piston separates from primary inlet valve. The air pressure of the rear brake system flows through chamber A to be discharged from exhaust passage chamber B into atmosphere.

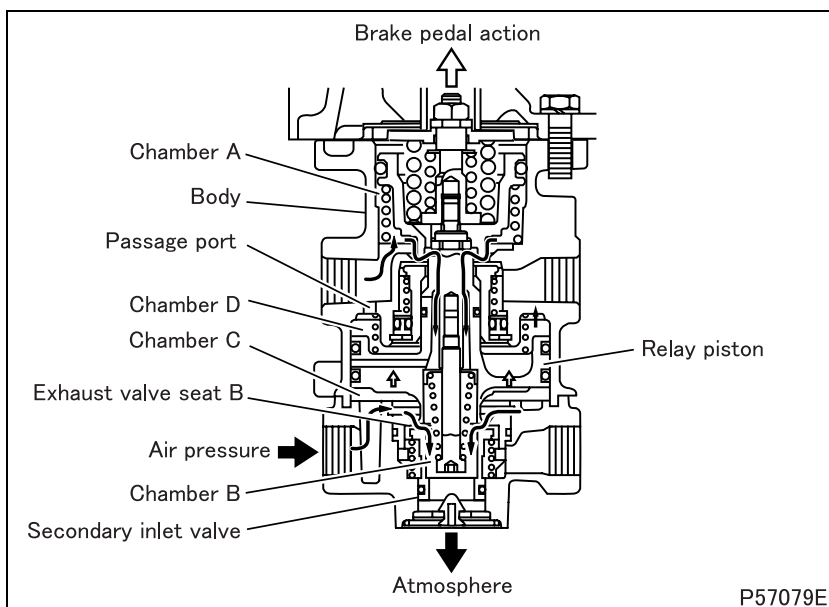
##### (5.2) Secondary side

- As the air pressure in the rear brake system drops, the air pressure in chamber D is discharged via passage port of body, and chambers A and B into atmosphere.
- This changes the air pressure balance between chambers D and C. The air pressure in chamber C raises relay piston, and exhaust valve seat B at the lower end of the relay piston separates from secondary inlet valve. Air pressure in the front brake system is discharged from exhaust passage chamber B into atmosphere.

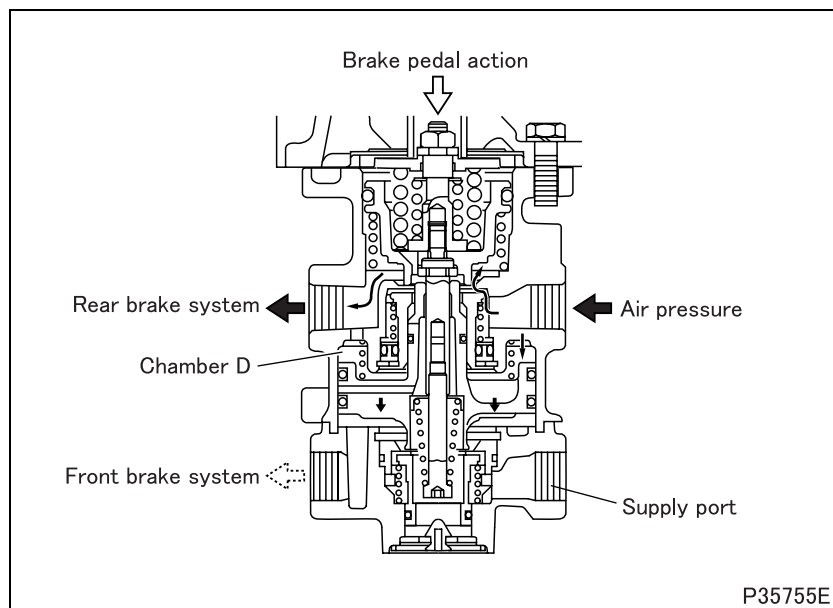
### (6.1) Operation when the air pipe of the front brake system fails

- The primary side operates the same as normal, generating braking pressure in rear brake system.
- At the secondary side, even if the primary side generates air pressure in chamber D, braking pressure is not generated in front brake system, since no air pressure is generated in supply port.

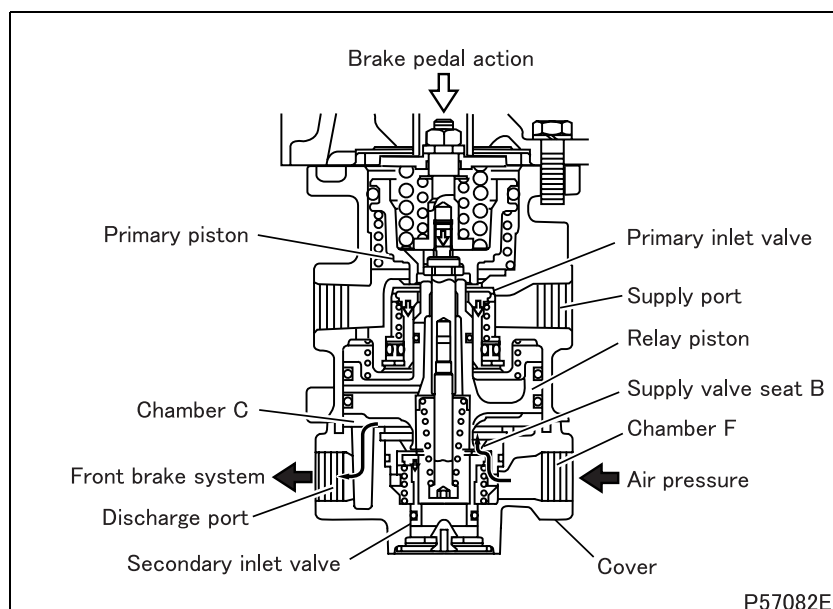
### (6.2) Operation when the air pipe of the rear brake system fails

- In the rear brake system, air pressure is not generated up to supply port. Therefore, even if the brake pedal is pressed (causing primary piston to force down primary inlet valve), braking pressure is not generated.
- If the brake pedal is pressed further (illustrated as brake pedal action), primary piston makes contact with relay piston and they force down secondary inlet valve.
- This action separates supply valve seat B of cover from secondary inlet valve. The air pressure flows into chamber C from chamber F and is fed to front brake system via discharge port as braking pressure.

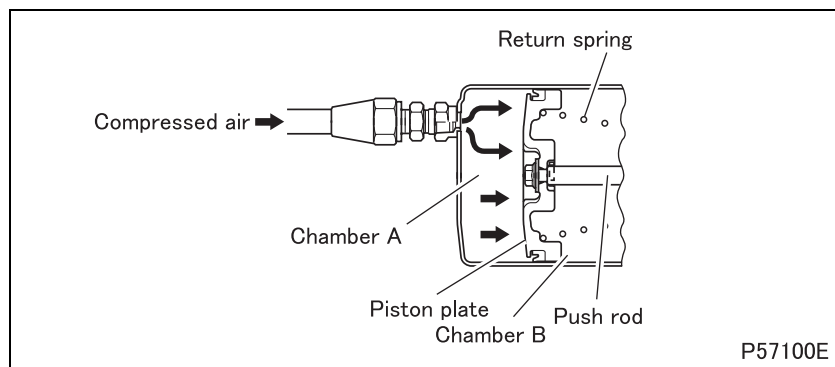
### 5.1 Power cylinder area

- Operation of the dual brake valve feeds compressed air into chamber A, activating the piston plate. As chamber B is opened to the atmosphere, a pressure difference between chambers A and B is generated. When this force becomes greater than the spring force of the return spring, the piston plate moves to the right.
- The piston plate is fitted with the push rod that transmits the force of the compressed air received at the piston plate to hydraulic piston area.

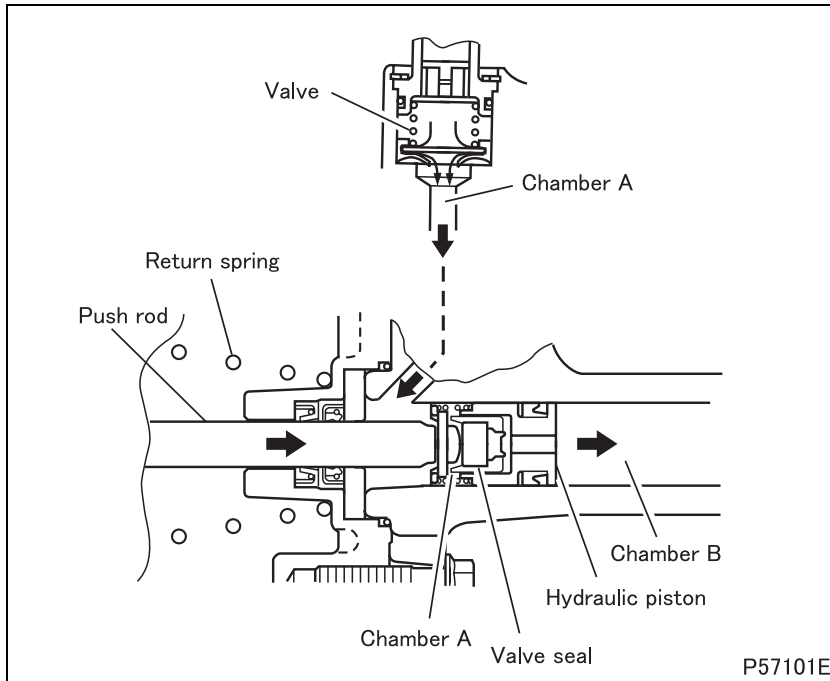
### (1) When functioning

- The movement of the piston plate compresses the return spring, which moves the push rod, then the hydraulic piston to the right.
- The valve seal seats on the hydraulic piston, closing the passage between the chamber A on the fluid tank side and the chamber B on the wheel cylinder side. As the hydraulic piston moves to the right, the brake fluid in the chamber B is pressurized, and power is transmitted to the wheel cylinder.
- As the hydraulic piston moves to the right, the chamber A expands in volume and the pressure in the chamber drops. This causes the valve to open, and brake fluid is now drawn from the fluid tank.

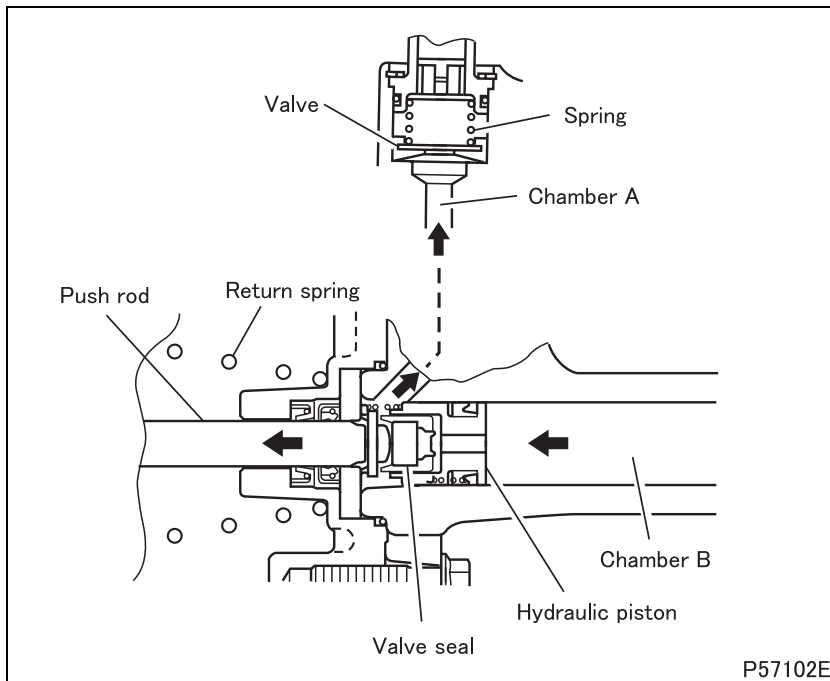
### (2) When released

- Releasing the brake pedal frees the compressed air at the rear side of the piston plate into the atmosphere. The hydraulic piston is returned to its original position by the spring force of the return spring of the push rod and the brake fluid pressure of chamber B, then the valve seal hits the push rod, connecting chamber B and chamber A.
- The brake fluid flows back through the chamber A to the valve, where it compresses the spring and flows around the periphery of the valve and back to the fluid tank.
- The valve is held into position when equilibrium is reached between the brake fluid pressure and the force of the spring.

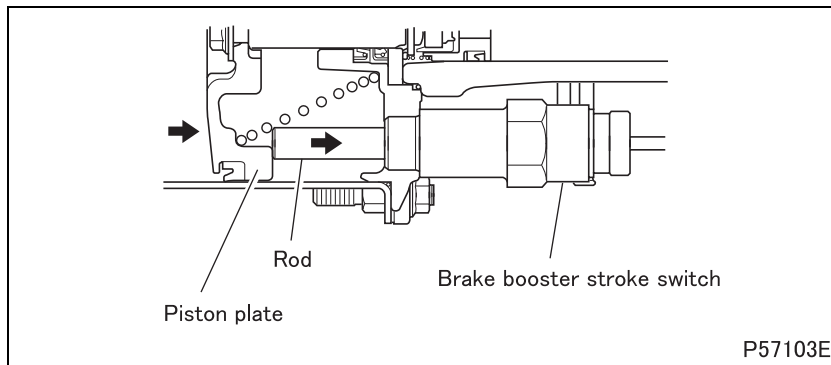
## 5.3 Brake booster stroke switch area

- When the brake lining is excessively worn, or the brake fluid leaks due to fractured brake piping, etc., the stroke of the piston plate grows excessive. As a result, the piston plate hits the rod and pushes it to the right.
- This moves the brake booster stroke switch to the ON position. The warning lamp on the meter cluster illuminates to alert the driver.

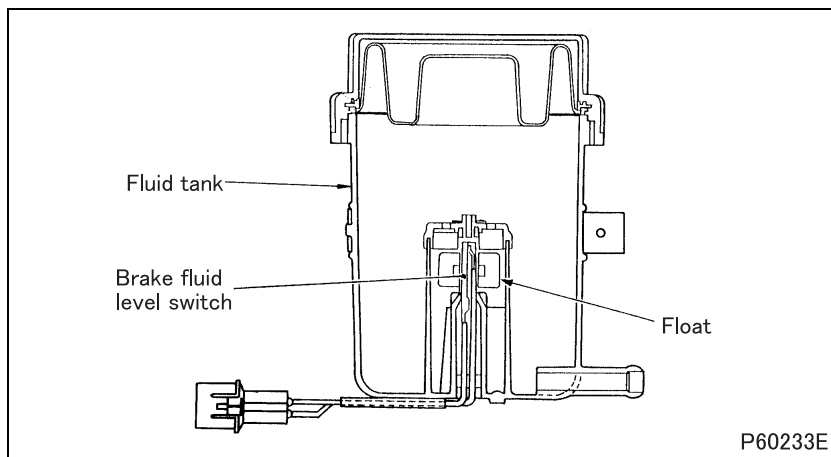
- The fluid tank is equipped with a brake fluid level switch which is designed to sense the brake fluid level in the tank. If the brake fluid level drops below a certain level, the float moves accordingly to actuate the brake fluid level switch. This causes the warning lamp on the meter cluster to turn on, alerting the driver.

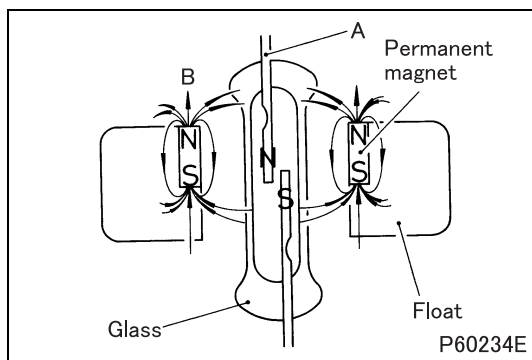
- When the brake fluid level in the fluid tank drops so much as to bring the float to or below the L level, many magnetic lines of flux B pass through the contact (ferromagnetic body A). As a result, the ends of the contacts turn into north and south poles. This causes the contacts to pull each other and attach together against their own force of spring, thereby forming an electric circuit.

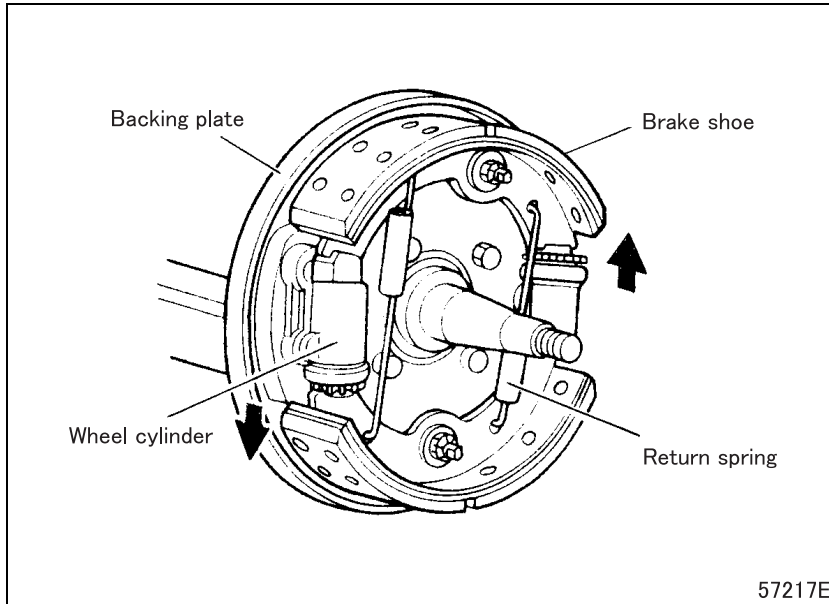
- The front drum brake is of a 2-leading type.
- Single-acting wheel cylinders activate brake shoes, both as a leading shoe, in forward-travel braking. By self-boosting effect, the 2-leading shoe brake generates a great stopping power.

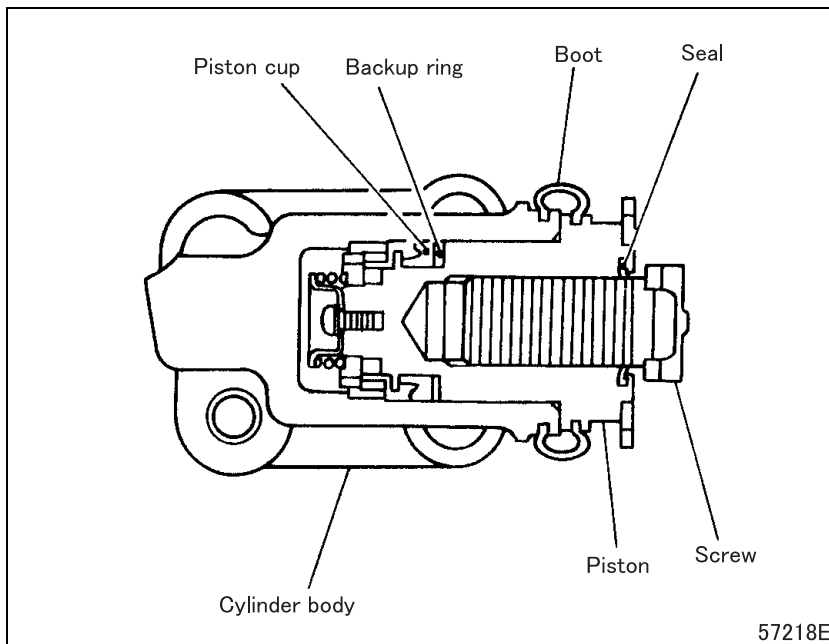
### 7.1 Wheel cylinder

- The wheel cylinder is equipped with an automatic adjuster mechanism to compensate for lining wear and maintain the correct clearance between the lining and the drum. The adjustment is made each time braking is performed.

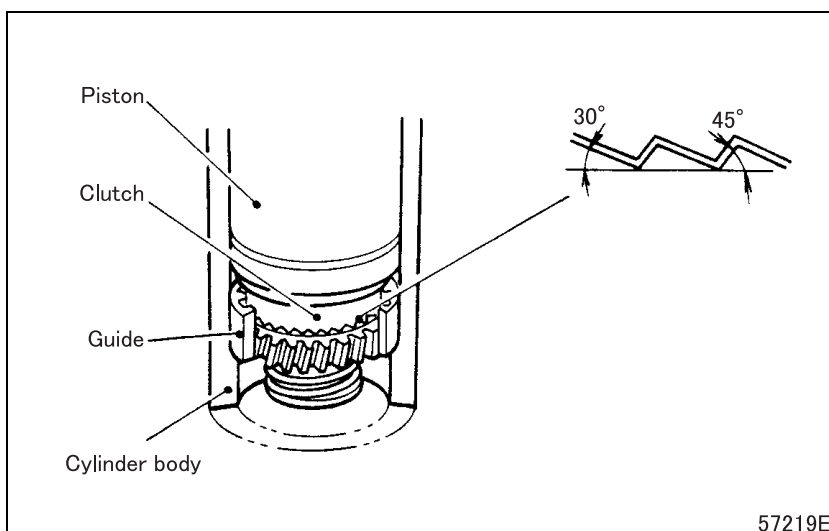
#### (1) Automatic adjuster mechanism

30°: The teeth can easily slide over the others as the piston is pushed out forward.

45°: As the piston rotates back, the teeth are positively held in mesh.

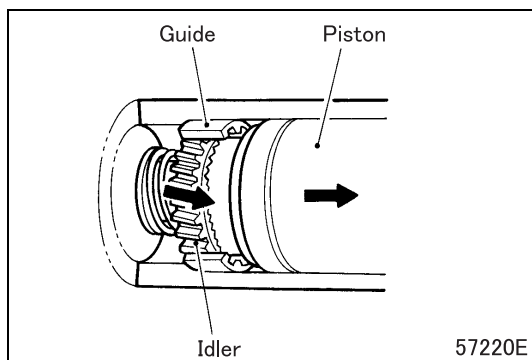
## (1.1) When brake is being applied

- As brake fluid pressure is applied to the wheel cylinder, the piston is pushed out.
- As the piston is pushed out, the idler of the piston, which is in mesh with the internal helical gear of the guide on the cylinder body, rotates as it moves with the piston.

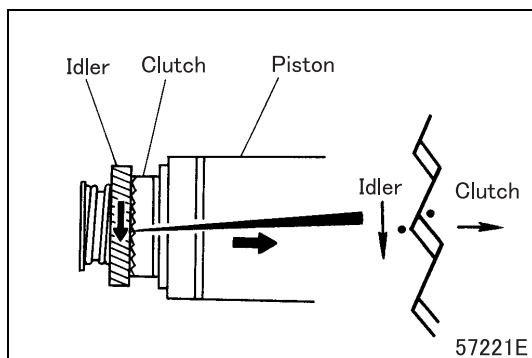
- As the idler rotates, the mesh between the idler and clutch comes loose.

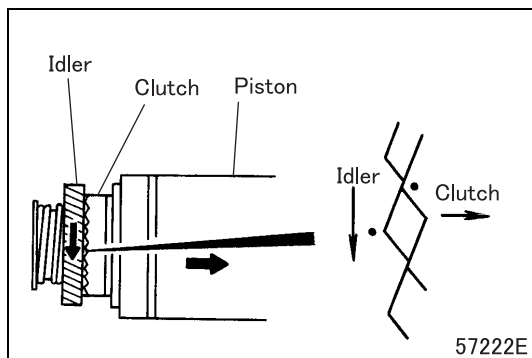
### ● When the brake shoe clearance is to specification

- The idler rotates in proportion to how far the piston travels. When the brake shoe clearance is to specification, the rotation of the idler is not enough to cause its teeth to slide over the teeth of the clutch.

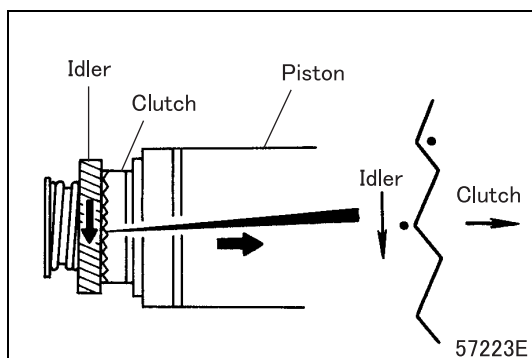
### ● When the brake shoe clearance is excessive

- When the brake shoe clearance is excessive, the rotation of the idler is sufficient to cause its teeth to go over the teeth of the clutch by one tooth before meshing with them again.

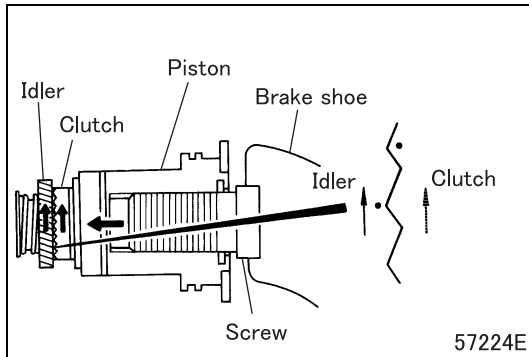
### (1.3) When brake is being released

- As the brake fluid pressure drops and the piston is pulled in, the idler rotates back along the guide on the cylinder body.
- When the brake shoe clearance is to specification, the original mesh of the clutch has been maintained. With this, the piston is pulled in to the original position without turning.
- When the brake shoe clearance is excessive, the mesh between the idler and clutch has changed by one tooth. As a result, the piston rotates by the amount corresponding to one tooth as it is pulled in.

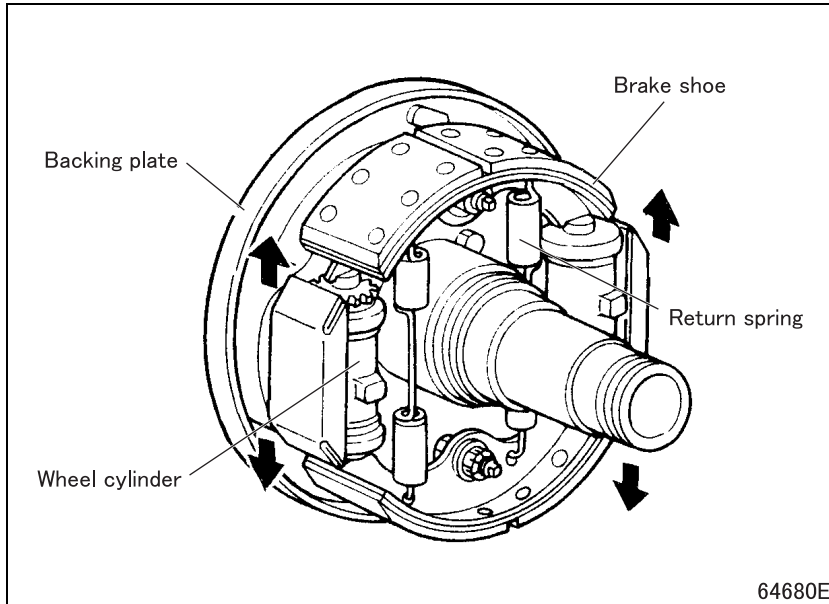
- The rear drum brake is of a dual 2-leading type.
- Double-acting wheel cylinders activate brake shoes, both as a leading shoe, in forward- and rearward-travel braking. By self-boosting effect, the dual 2-leading shoe brake generates a great stopping power.

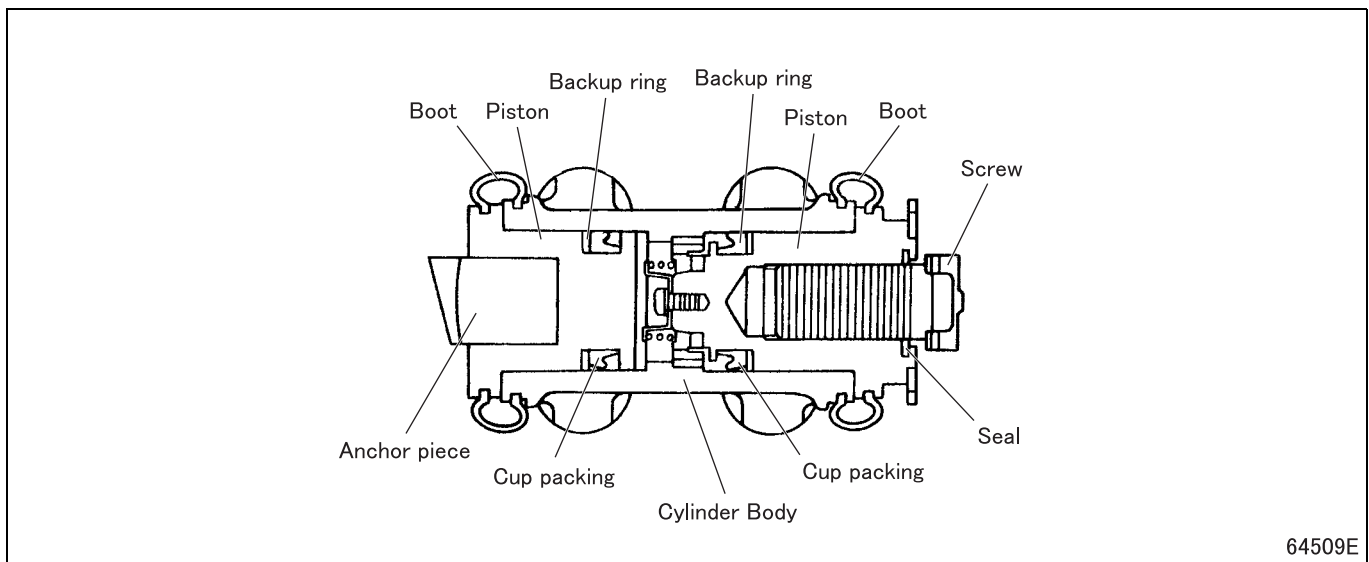
- The wheel cylinder is equipped with an automatic adjuster mechanism to compensate for lining wear and maintain the correct clearance between the lining and the drum. The adjustment is made each time braking is performed.
- The automatic adjuster mechanism operates on the same principles as those for the front drum brake.
