# FE.FG

## SERVICE MANUAL 2008 Model FOREWORD

This Service Manual contains maintenance and repair methods for the Mitsubishi Fuso Truck FE. FG Series. Read this manual carefully as an aid in providing correct, efficient maintenance. Please note that the information and specifications contained within this manual may change without notice. This is due to product modifications and continued vehicle improvements that are made throughout the model years. Should you encounter any discrepancy in the information provided, please do not hesitate to contact your nearest Mitsubishi Fuso Dealer or Mitsubishi Fuso Truck of America, Inc.

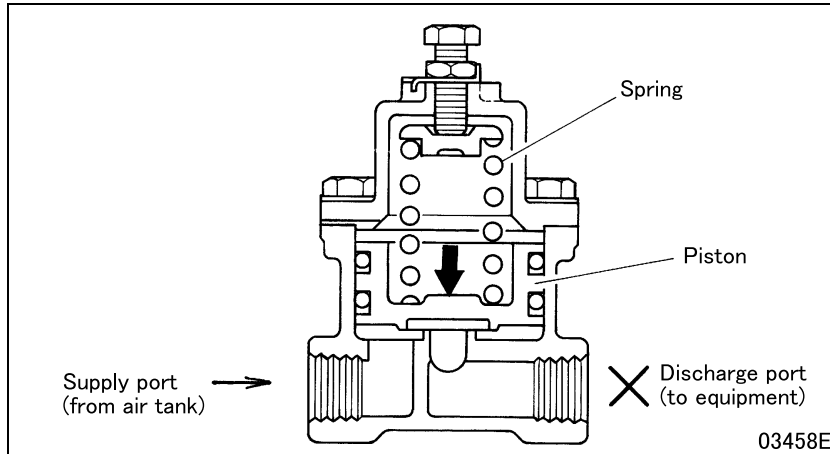
- Should air leak from any air system, the supply valve cuts off air supply to maintain braking air.
- The supply valve operates in such a way that when air pressure in any air system of equipment is lowered below the threshold level, the spring pushes down the piston to shut off the leaking air passage.

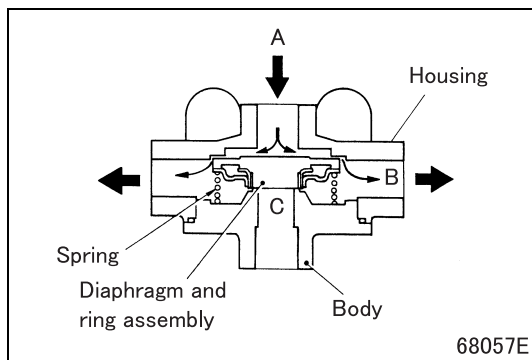
- Air pressure A from the supply port pushes down diaphragm and ring assembly tightly up against body, thus shutting down chamber B from chamber C. It further presses down spring, causing the diaphragm and ring assembly to leave housing, which allows air pressure A to flow into chamber B.

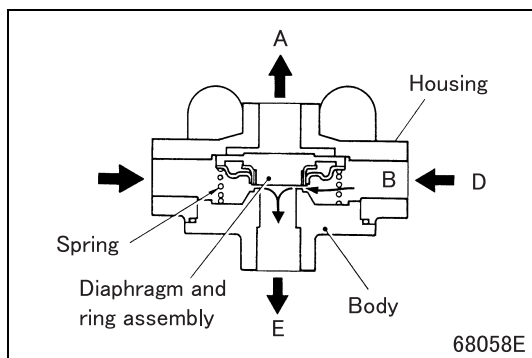
- Air pressure A is released from the supply port and the tension of spring causes diaphragm and ring assembly to leave body. At the same time, air pressure D from the brake chamber is discharged into the atmosphere through exhaust port E.

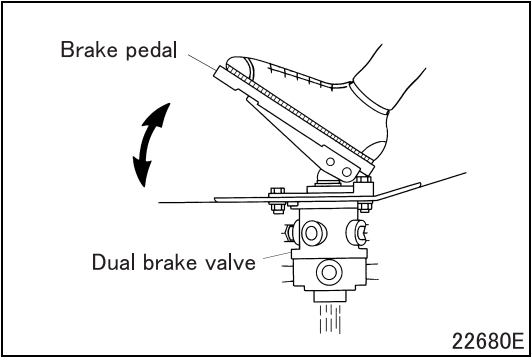
- When the brake pedal is pressed and released, exhaust noise should be heard from the dual brake valve. Check if the pedal fully returns to its original position without hitching.

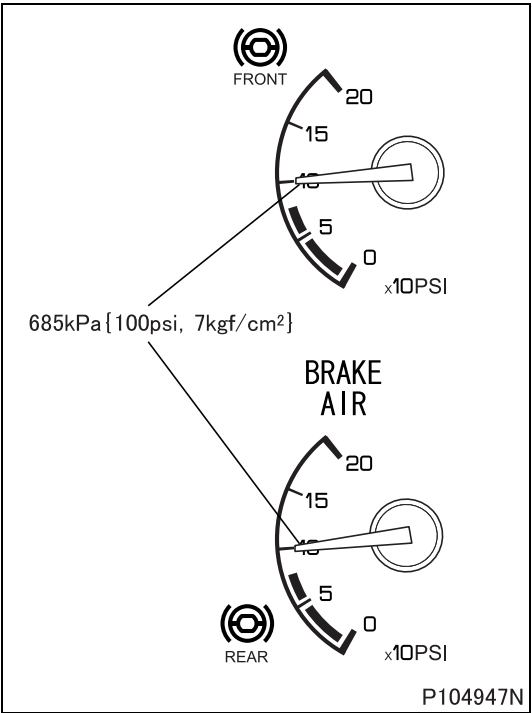
- Fully discharge compressed air by opening the drain cock on the air tank.
- With the engine started and set at idle, measure the time it takes for the air pressure indicated on the gauge to rise from 0 kPa {0 psi, 0 kgf/cm<sup>2</sup>} to 685 kPa {100 psi, 7 kgf/cm<sup>2</sup>}. The time taken depends on the vehicle model.

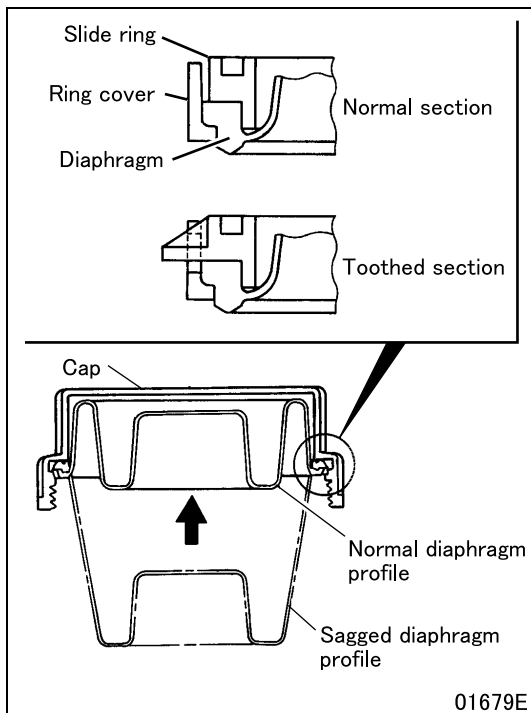
- If the diaphragm is not in the normal profile after the brake fluid is replenished, press it into the normal profile before installing the cap.

If the brake fluid leaks through the cap, check if the diaphragm has been installed as shown in the illustration.

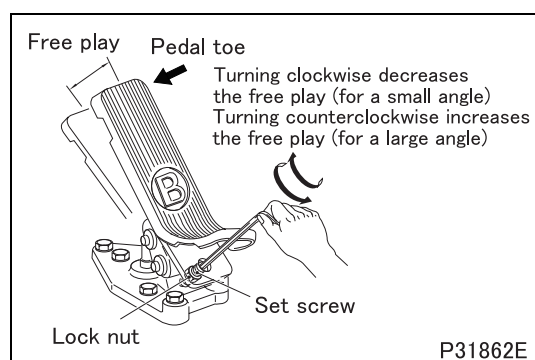
- Measure the free play of the brake pedal by pressing the pedal tip by hand.
- If the measurement deviates from the standard values, make an adjustment.

- Loosen the lock nut and adjust the free play by turning the set screw.
- After adjustment, tighten the lock nut to the specified torque.

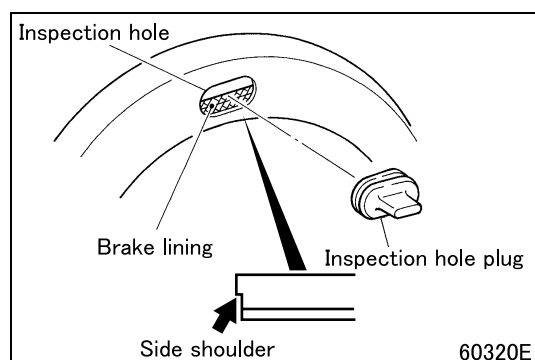
- Remove the inspection hole plug from the inspection hole in the backing plate. Through the inspection hole, measure the thickness of the brake lining.
- If any lining is worn down to the step on the side face, replace all linings on that axle.
- After the inspection, be sure to install the plug onto the inspection hole.

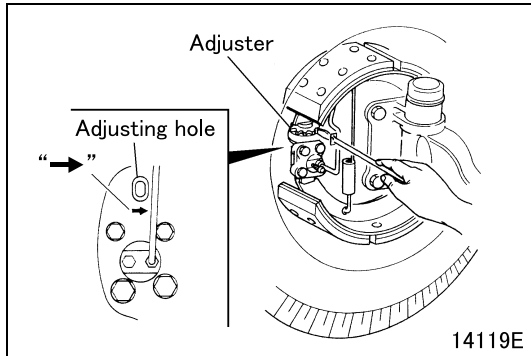
- Jack up front wheel, and make sure that hub bearings are not loose. If loose, adjust the hub bearings. (See Gr26A.)
- Insert the screwdriver into the adjusting hole, turn the tire by hand, and turn the adjuster of front wheel to the direction as shown by arrow on the backing plate so that wheel will turn with slight friction.
- Step on brake pedal a few times, and make sure that tire turns by hand with slight friction. If wheel turns lightly, do over the above-mentioned procedure.

- Return the adjuster 8 or 9 notches opposite to the direction of arrow.
- Turn tire by hand and make sure that there is no friction. If there is friction, do over the above-mentioned procedure.

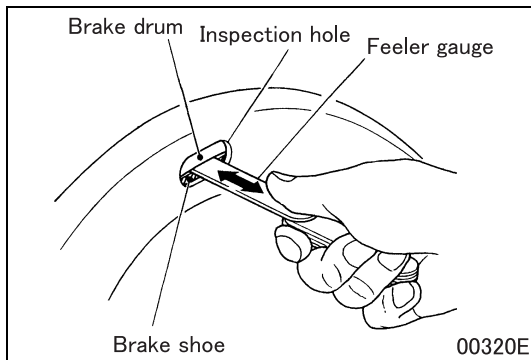
- Insert a 0.2 mm {0.0079 in.} feeler gauge through the inspection hole between the brake drum and lining, and make sure that you can slide the gauge to and fro with slight resistance.

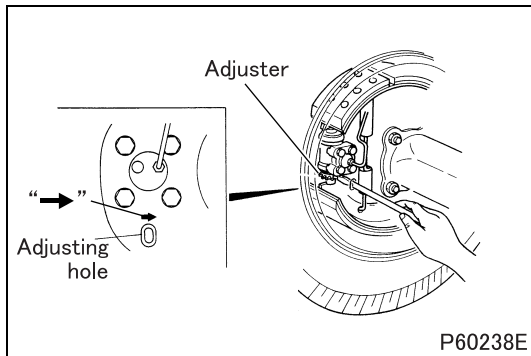
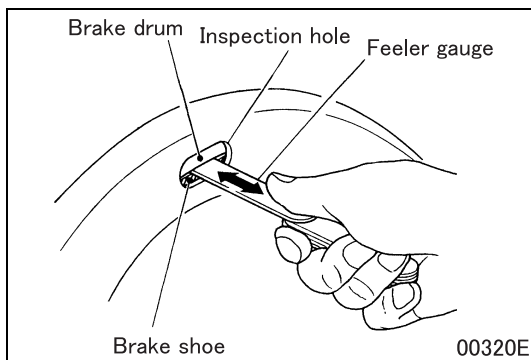
- Jack up front wheel, and make sure that hub bearings are not loose. If loose, adjust the hub bearings. (See Gr27.)
- Insert the screwdriver into the adjusting hole, turn the tire by hand, and turn the adjuster of front wheel to the direction as shown by arrow on the backing plate so that wheel will turn with slight friction.
- Step on brake pedal a few times, and make sure that tire turns by hand with slight friction.  
If wheel turns lightly, do over the above-mentioned procedure.
- Return the adjuster 8 or 9 notches opposite to the direction of arrow.
- Turn tire by hand and make sure that there is no friction. If there is friction, do over the above-mentioned procedure.
- Insert a 0.2 mm {0.0079 in.} feeler gauge through the inspection hole between the brake drum and lining, and make sure that you can slide the gauge to and fro with slight resistance.

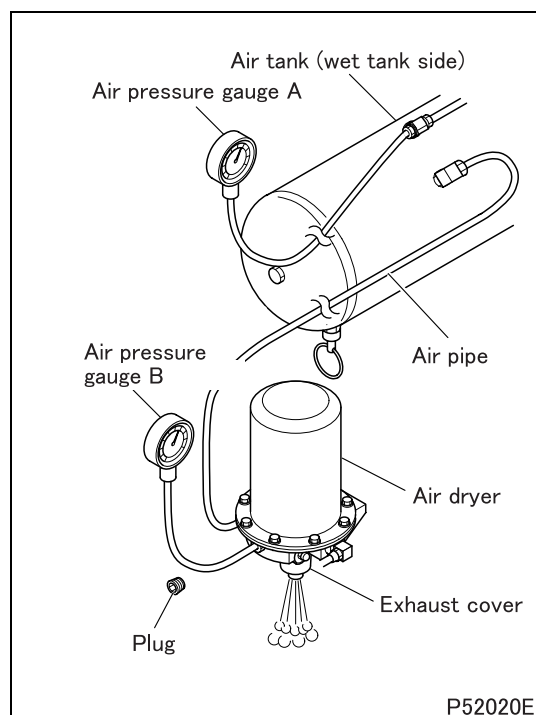
- Install the air pressure gauge A between the air dryer and air tank (wet tank side).
- Remove the plug from the air dryer at the location shown in the drawing. Connect air pressure gauge B at that point.

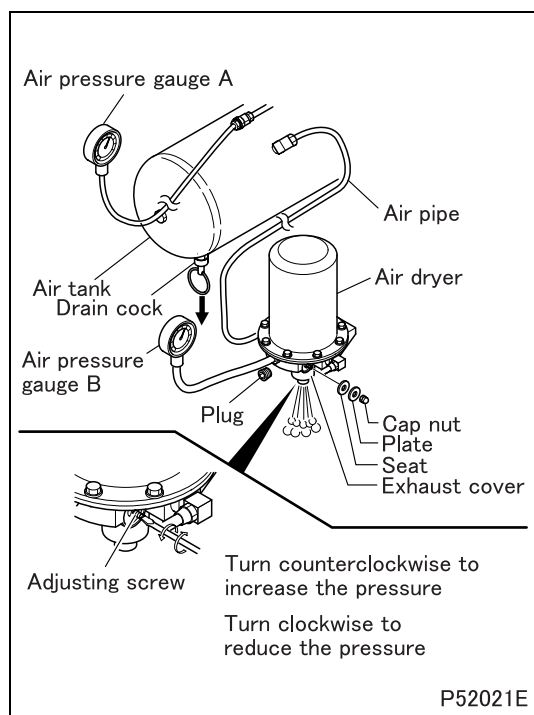
- Remove the cap nut, plate, and seat.
- Start the engine and gradually increase the air pressure in the air tank.
- Turn the adjusting screw until the pressure indicated by air pressure gauge A when air is expelled from the exhaust cover is the standard value (the upper threshold pressure).

- With the upper threshold pressure indicated, air from the air compressor is expelled from the exhaust cover continuously. With the equipment in this condition, open the drain cock to gradually reduce the air pressure. When air stops being expelled from the exhaust cover, check whether the pressure indicated by air pressure gauge B is the standard value (the lower threshold pressure). If the indicated pressure deviates from the standard value, replace relevant parts of the air compressor governor as an assembly.

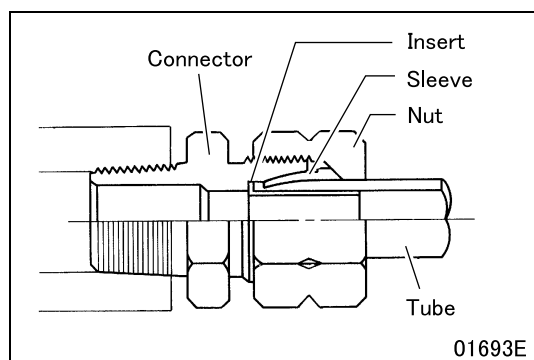
- The nylon tube (hereafter referred as “tube”), on which an insert has been installed, is retained in the connector by tightening the nut onto the connector, which causes the sleeve to bite into the tube and thereby air tightness is achieved. Therefore, once the nut is tightened, the tube, insert and sleeve are all deformed and cannot be reused. (See later section.)
- For information on removal and installation of the tube, see the procedure. (See later section.)

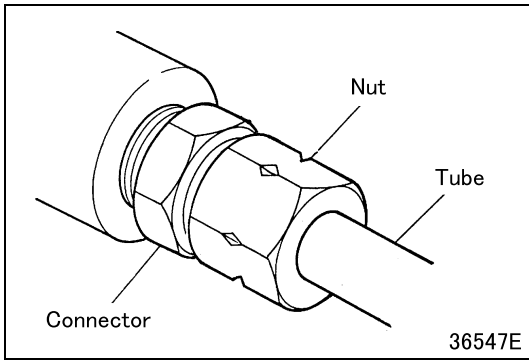
- Completely release air pressure from the tube.
- Before removing the tube from the connector, clean the periphery of the connector, nut and tube. A connector which is contaminated inside must not be reused.

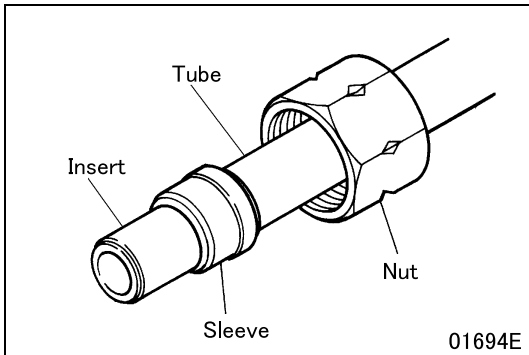
- Ensure that the insert, sleeve, nut and tube are arranged as shown in the illustration.

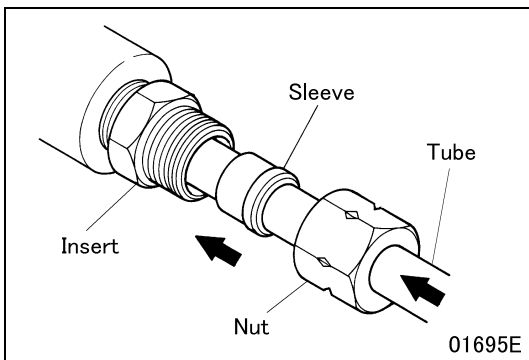
- Insert the tube into the connector until it reaches the end of the connector. Press the sleeve into the connector and temporarily tighten the nut by hand.
- Tighten the nut to the specified torque. Then, pull the tube to ensure that it will not come off and there is no air leakage.

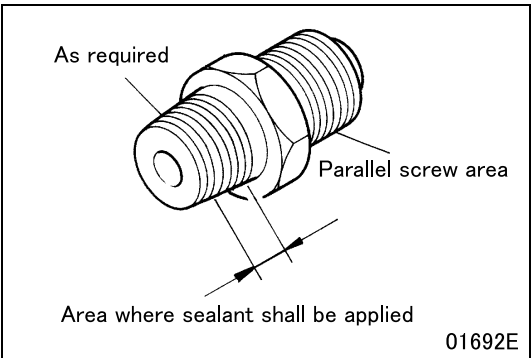
- When installing once removed connector of air system for brakes, remove remainder of sealant, oil, and water sufficiently.
- Apply sealant to threads leaving 1 or 2 threads on top blank.

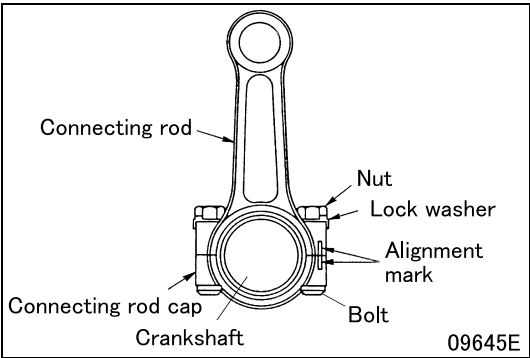
#### ■ Installation: Connecting rod cap and connecting rod

- Assemble the connecting rod and cap while noting their alignment marks.
- Install bolts in such a way that the notches in the bolt heads are directed toward the inside of the connecting rod cap.
- After assembly, bend the lock washers.

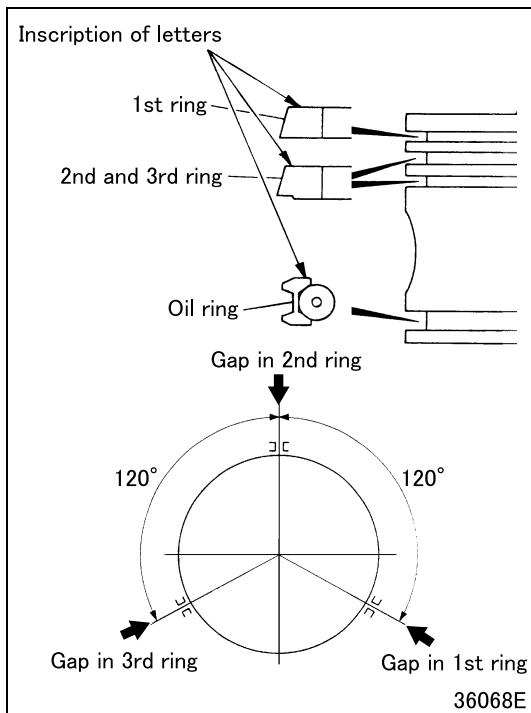
#### ■ Installation: Compression rings

- Install the compression rings, ensuring that their end gaps are located as shown in the illustration.
- Install the compression rings by following the removal sequence in reverse.

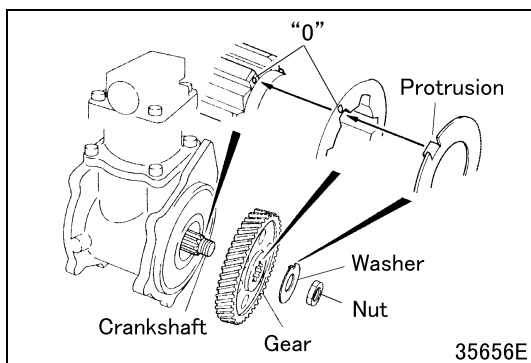
#### ■ Installation: Lock washer, compressor gear

- Install the compressor gear onto the crankshaft, ensuring that “O” mark on the compressor gear is aligned with “O” mark on the crankshaft.
- Insert the protrusion of the lock washer such that the “O” mark on the compressor gear remains exposed.
- Tighten the nut to the specified torque. Bend one part at the bottom of the lock washer toward the nut to prevent the nut from loosening.

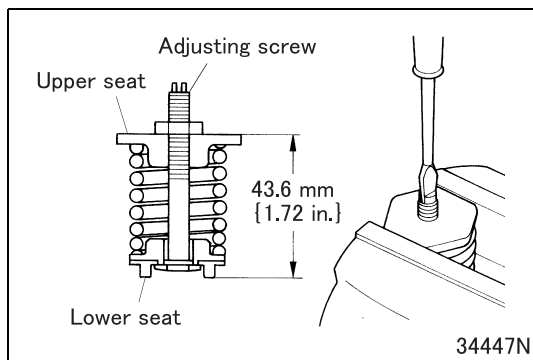
### ■ Adjustment: Adjusting screw

- Turn the adjusting screw to achieve the indicated dimension from the top of the upper spring seat to the bottom of the lower spring seat. Doing so will facilitate the threshold pressure adjustment to the specified value.

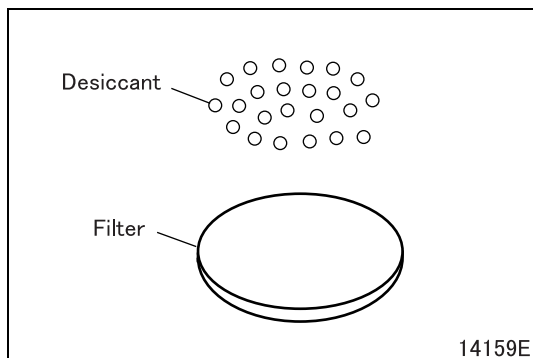
### ■ Installation: Filters, desiccant, and filter plate

- Install the filters with their soft layers facing the desiccant.

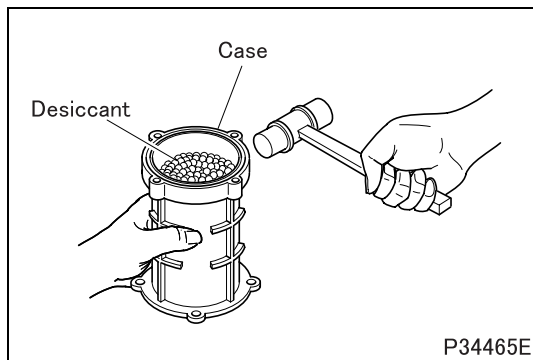
- Place the desiccant in the case, then settle the desiccant by tapping gently and evenly around the case with a plastic hammer.

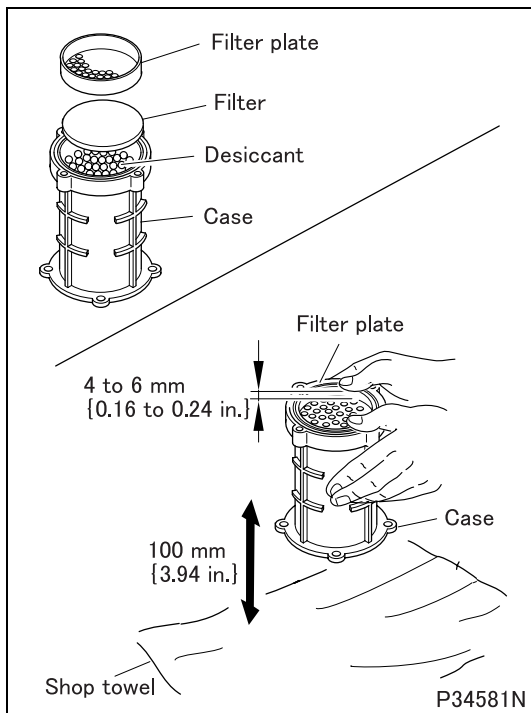
- Place the soft layer side of the filter on the desiccant, and place the filter plate on the case, then tap the desiccant down.

- Unless the tapping procedure is performed, particles of desiccant may escape and create blockages in brake lines, thus preventing normal brake operation.

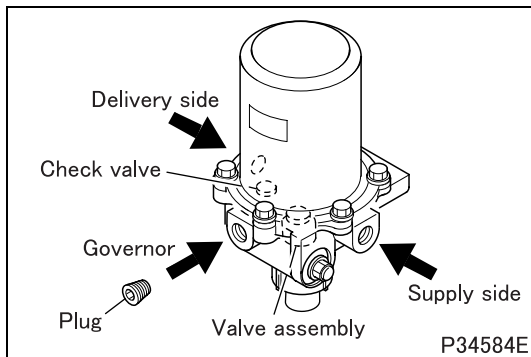
#### ■ Inspection: Air leakage

- Completely plug the delivery side of the air dryer, then apply air pressure of 49 kPa {7.1 psi, 0.5 kgf/cm<sup>2</sup>} or 780 kPa {115 psi, 8 kgf/cm<sup>2</sup>} to the supply side and check that no air leaks from any joint.  
Leakage from the valve assembly must not exceed 20 cm<sup>3</sup> {1.22 cu.in.} per minute.
- Increase the pressure applied to the supply side to 932 kPa {135 psi, 9.5 kgf/cm<sup>2</sup>} to cause purging (regeneration). Check that no air leaks from the check valve and from the air pressure governor (with the plug removed).

- If there is air leakage from the air pressure governor or the check valves, charging (pressure filling) and purging (regeneration) will be performed continuously.

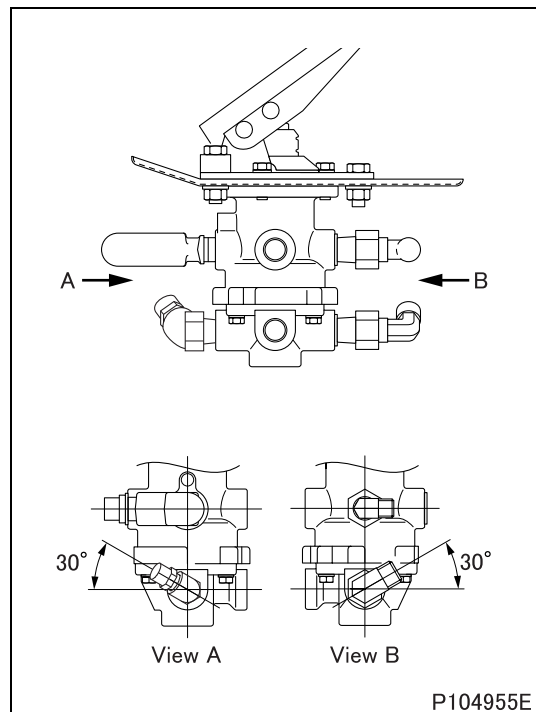
**■ Installation: Connector**

- After tightening each connector to a torque just beyond the lower limit of the specified torque, adjust its direction by turning it within one turn. The installed angles of the connectors must be as shown in the illustration.

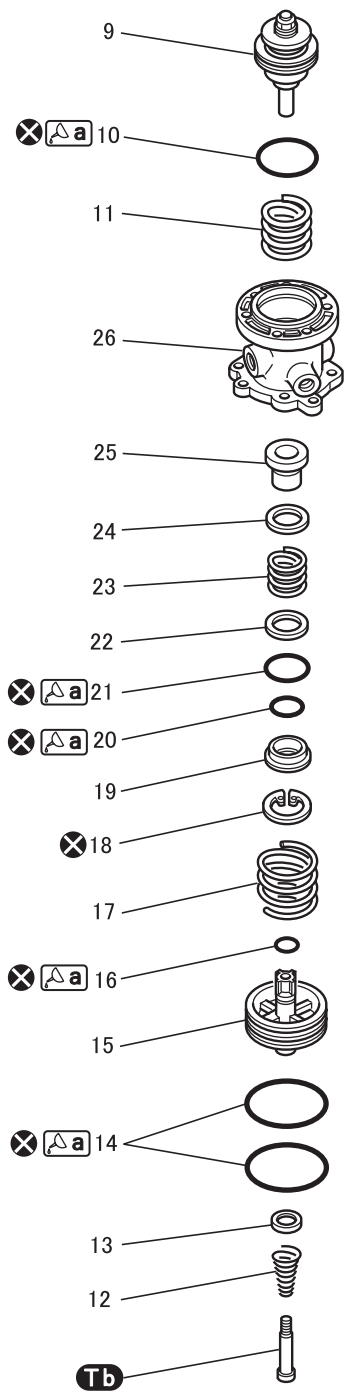
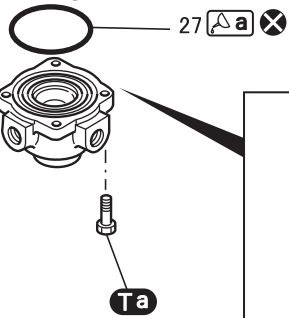
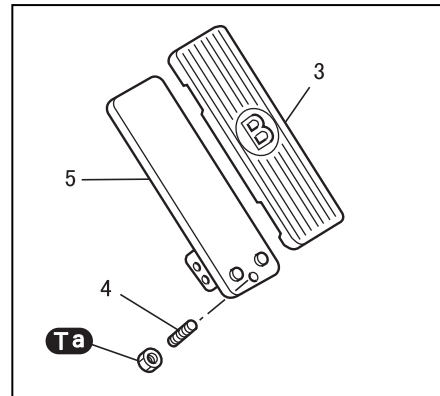
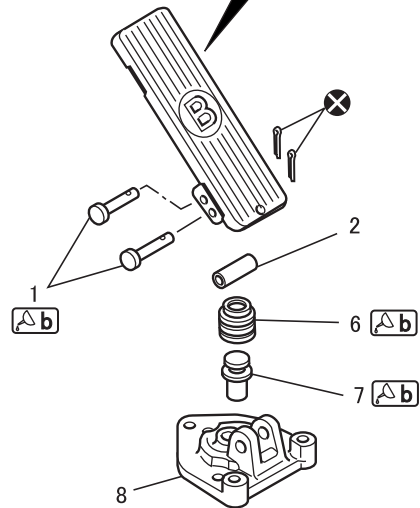
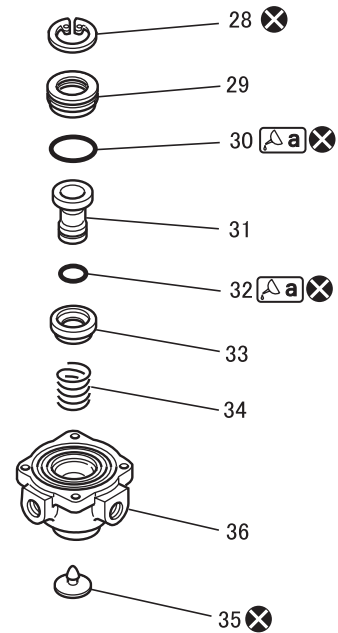
## DUAL BRAKE VALVE

## ● Disassembly sequence

| 1 Straight pin | 14 O-ring | 27 O-ring |

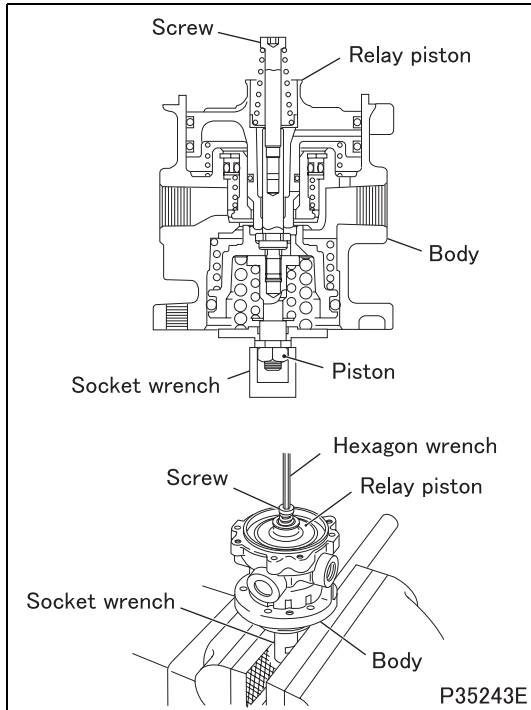
### ■ Removal: Relay piston

- Hold a socket wrench (10 mm {0.39 in.} between the flats) on vise.
- Insert the head of self-locking bolt into socket wrench to tighten body.

- You must be careful when you loosen screw, because the spring in body can forcibly eject relay piston. To avoid this hazard, press down on the relay piston with your hand when you carry out the above work.

- Using a hexagon wrench, slowly loosen the screw and remove the relay piston.  
Hexagon wrench: HEX4

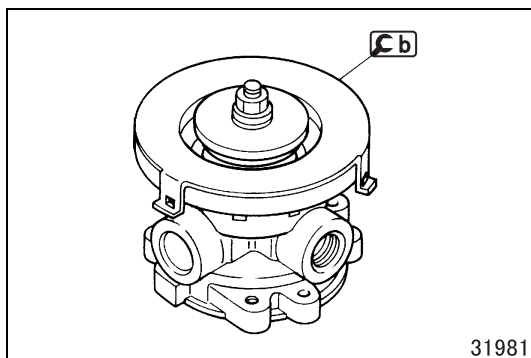
### ■ Installation: Piston

- Install **b** to prevent the piston from jumping out.
- After installing the body and cover, remove **b**.

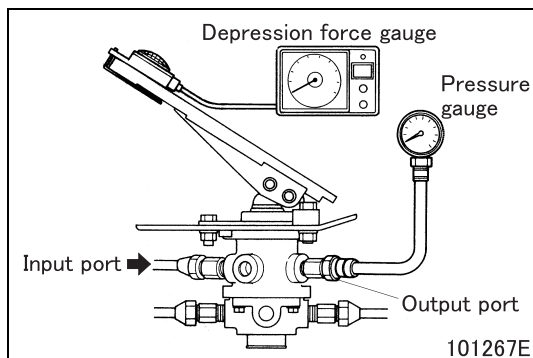
## ■ Inspection: Dual brake valve

- When performing the functional check, check if primary output pressure and pedal depression force relative to the specified pedal depression angles conform to the corresponding standard values.

- While applying an air pressure of 0.7 MPa {100 psi, 7 kgf/cm<sup>2</sup>} to the primary input port, check for air leakage.
- If air leakage is found, proceed as follows.

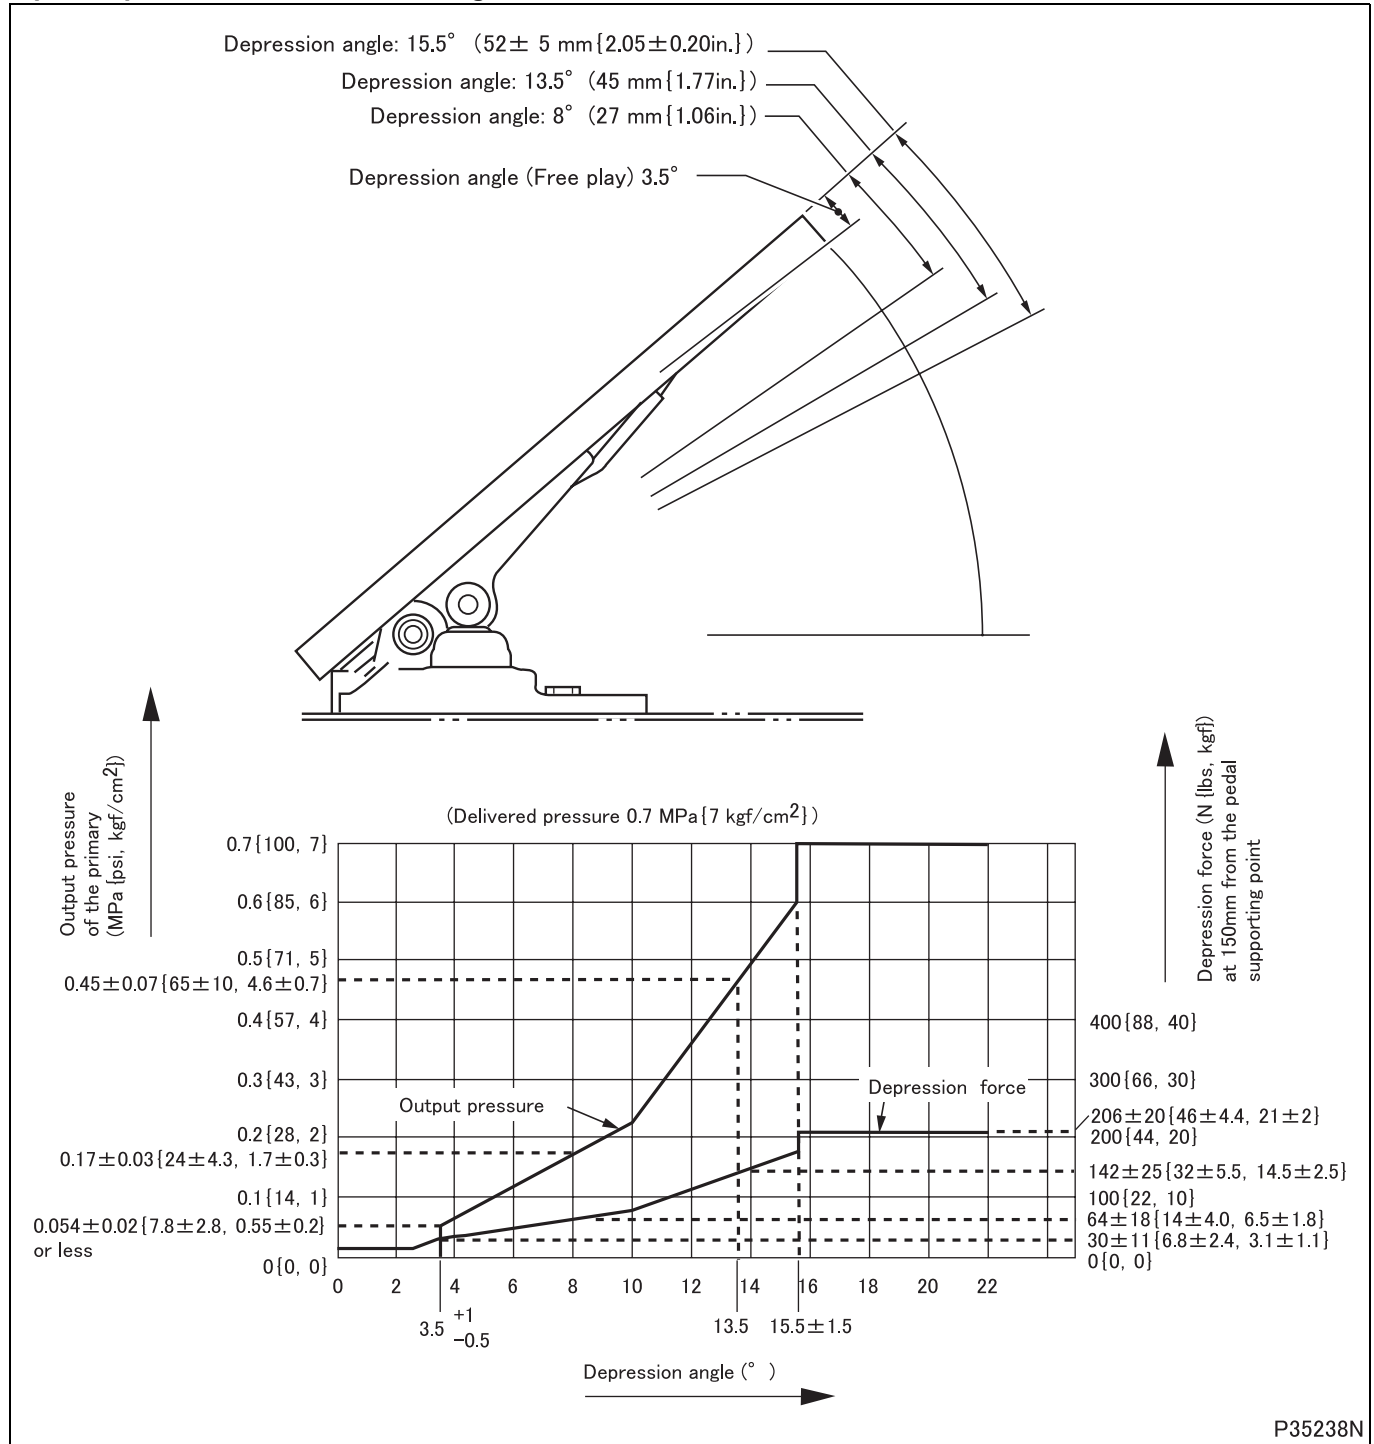
# Input/output characteristic curve diagram

- Secure the set screw in the correct position by tightening the lock nut to the specified torque.
- Now, while observing the pressure gauges, check if primary output pressure and pedal depression force relative to the specified pedal depression angles conform to the corresponding standard values shown in the input/output characteristic curve diagram.

- If the output pressure is lower than the standard values, replace the piston.

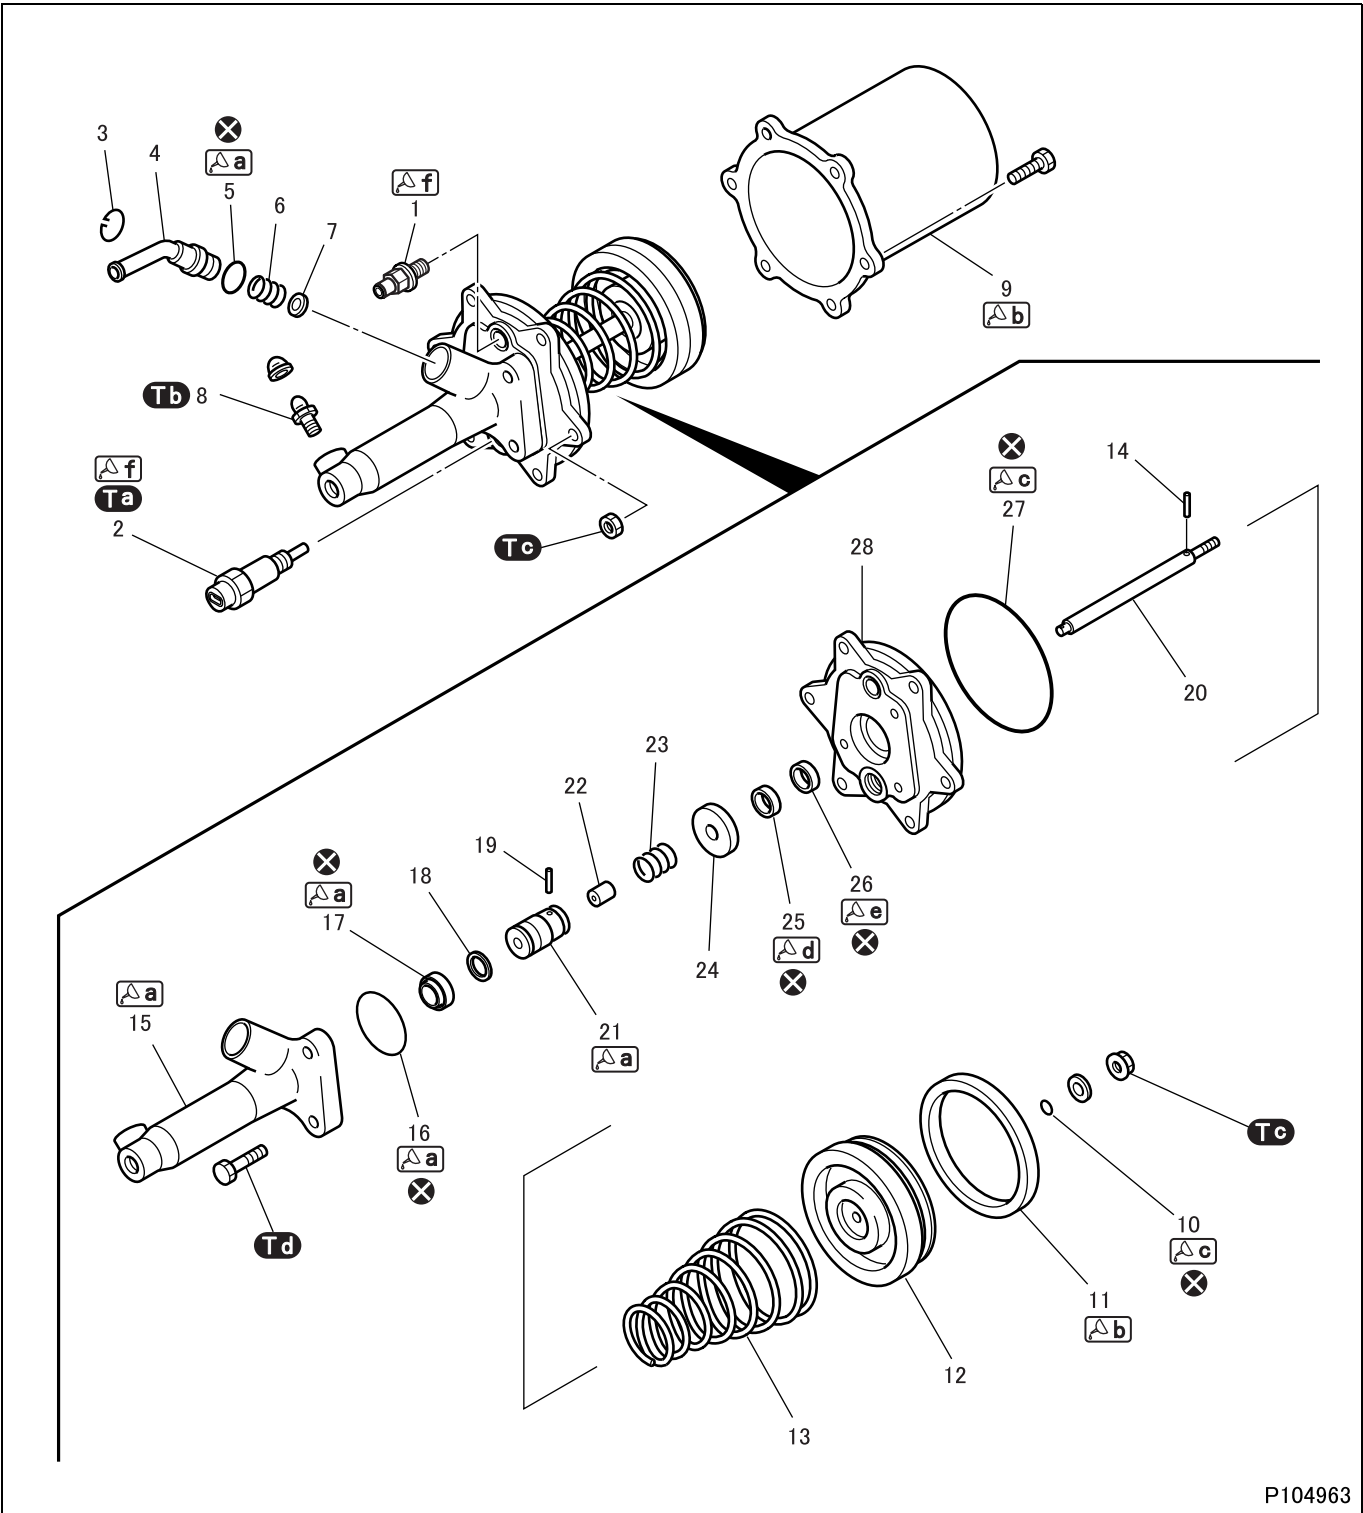
P104963

# BRAKE BOOSTER

### ● Disassembly sequence

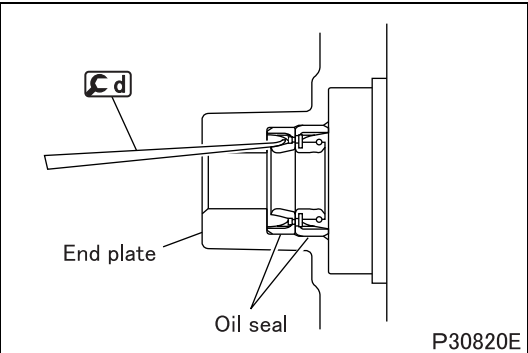
### ■ Removal: Oil seal

- Remove the oil seals by tapping them evenly while taking care not to damage the inner surface of the end plate.

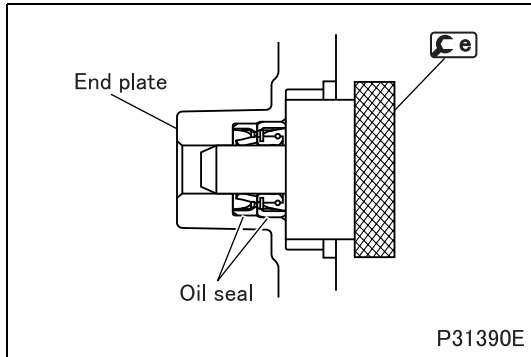
### ■ Installation: Oil seal

- Install each oil seal on the end plate in the illustrated direction.

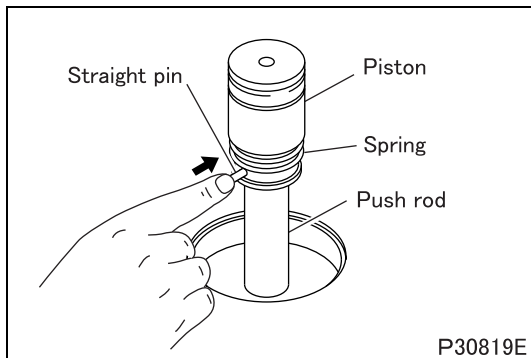
### ■ Installation: Hydraulic piston

- Align the holes of the hydraulic piston, valve seal and push rod before inserting the straight pin.
- After inserting the straight pin, make sure that the hydraulic piston spring is hanging over the straight pin and working as a stopper.

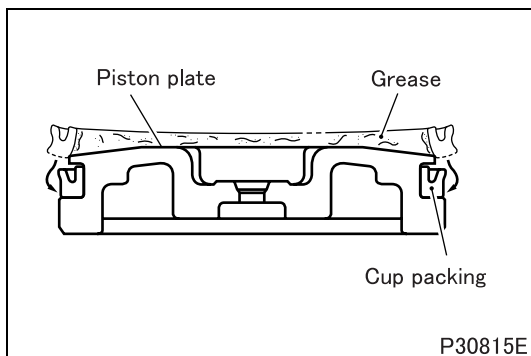
### ■ Installation: Cup packing

- Apply grease to the entire surface of the cup packing before installing it as shown in the illustration.

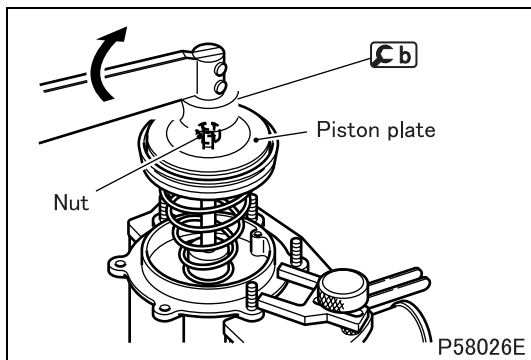
## ■ Installation: Piston plate

- Tighten the nut to the specified torque while pressing the piston plate fully towards the end plate.

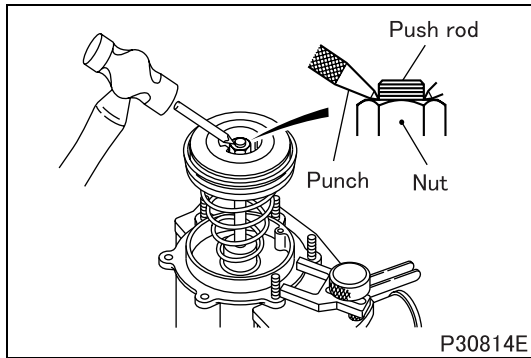
- After tightening the nut at specified torque, caulk the nut and push rod thread area.

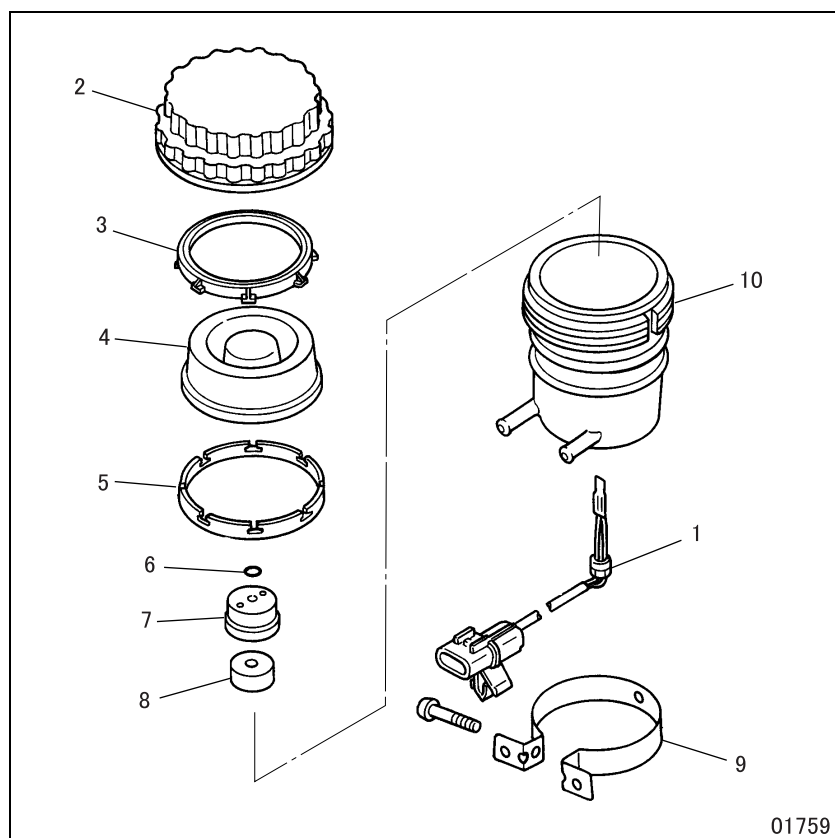
# FLUID TANK

## ● Disassembly sequence

- 1 Fluid level switch
- 2 Cap
- 3 Slide ring
- 4 Diaphragm
- 5 Ring cover
- 6 Stopper ring
- 7 Float stopper
- 8 Float
- 9 Fluid tank bracket
- 10 Tank

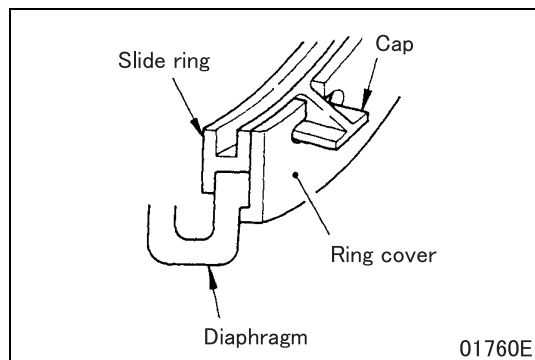
## ■ Installation: Slide ring, diaphragm

- Engage the slide ring hook firmly onto the ring cover. Ensure that the diaphragm is installed correctly, as shown in the illustration.

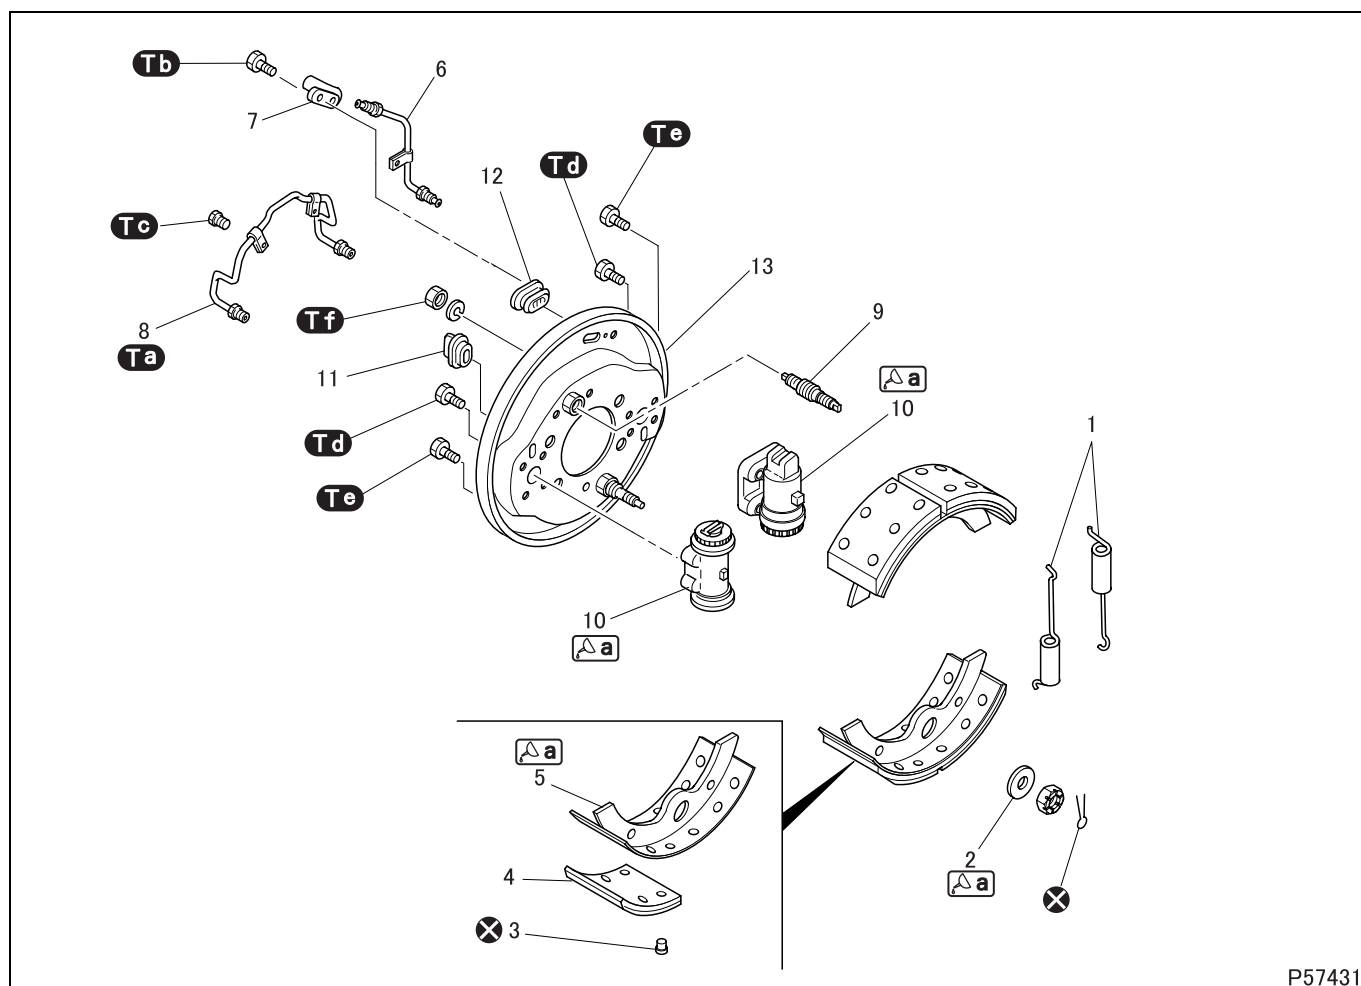
# FRONT WHEEL BRAKE

## ● Disassembly sequence

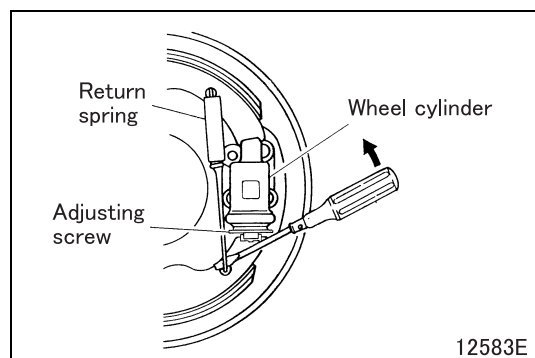
### ■ Removal: Return spring

- Using a flat-head screwdriver, remove the return spring. To do this, rest the screwdriver on the wheel cylinder adjusting screw. Then, with the adjusting screw as a fulcrum, engage the screwdriver with the spring hook and pry away the spring.

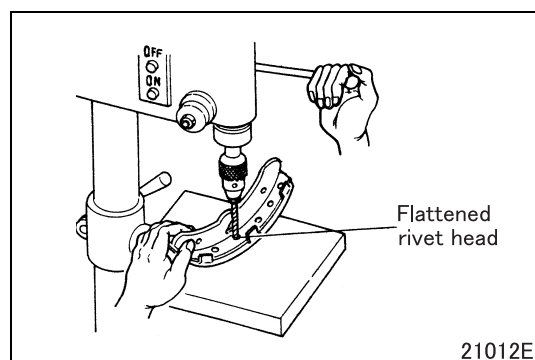
### ■ Removal: Brake lining

- Using a drilling machine, break the flattened rivet heads on the brake shoe side to release the brake lining.

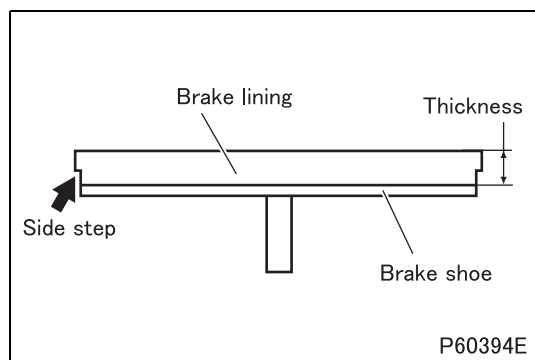
### ■ Inspection: Brake lining thickness

- If the brake lining is worn down to the side step, replace all brake linings on that axle.

| Location | Maintenance item | Standard value | Limit | Remedy |
|---|---|---|---|---|
| 4 | Brake lining thickness | 12 {0.47} | 5 {0.20}<br>(side step shows wear limit) | Replace |

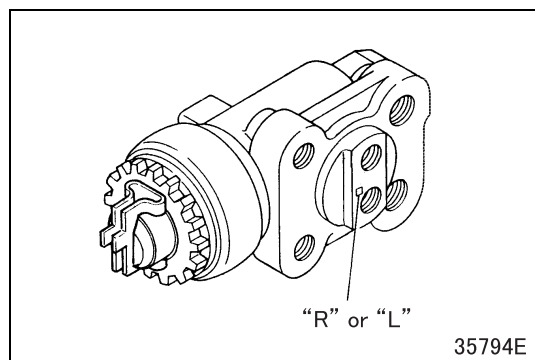
### ■ Installation: Wheel cylinder

"R": Right-hand side wheel

"L": Left-hand side wheel

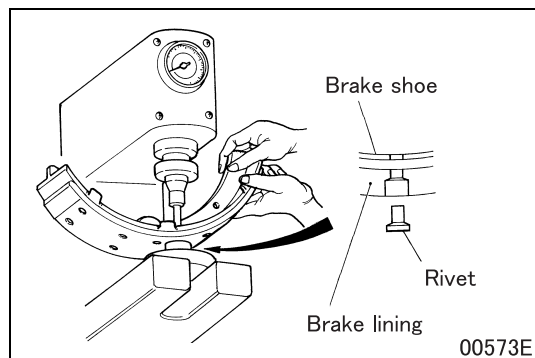
### ■ Installation: Brake lining

- Using cleaning fluid, clean the brake shoe surface to which the brake lining is to be mounted. Then, dry the shoe surface.
- Insert rivets from the brake lining to the shoe. Stake them, starting from the center of the shoe towards the ends. Ensure that the shoe-to-lining clearance conforms to the following values.
  - Around the rivets (within  $\phi 20$  mm {0.79 in.}): 0.05 mm {0.0020 in.} or less
  - Except around the rivets: 0.2 mm {0.0079 in.} or less
  - The staking load for the rivets should be  $22 \pm 0.98$  kN {4950  $\pm$  220 lbs, 2200  $\pm$  100 kgf}.

- New replacement brake linings that are to be installed on the same axle should all be in the same size and have the same identification mark. Otherwise, braking performance can be different from left to right.

- After assembly, check the brake drum-to-lining clearance. Correct as required.

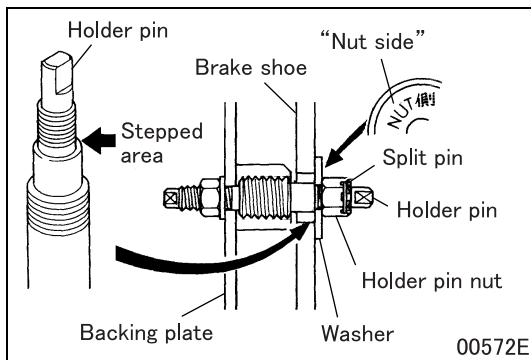
#### ■ Installation: Brake shoe

- Install the brake shoe.
- Insert the washer with the stamped word "NUT side" facing away from the brake shoe. Tighten the holder pin nut until the washer is slightly against the stepped area on the holder pin. Back off the holder pin nut between 0 to 60° until the first split pin holes in the nut and holder pin align with each other.
- Insert the split pin through the hole and bend it over.

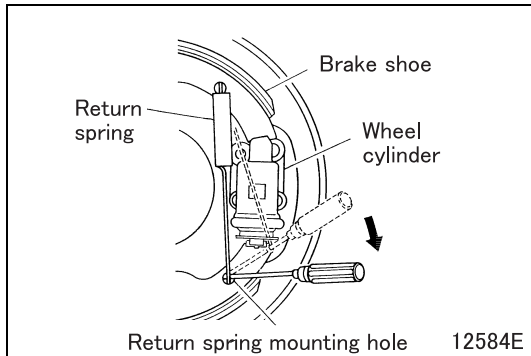
#### ■ Installation: Return spring

- Install the shorter hook of the return spring onto the brake shoe which is on the opposite side from the wheel cylinder adjuster.
- Hook up a small Phillips screwdriver tip to the longer hook of the return spring of the brake shoe assembly and install the return spring using the screwdriver like a prying lever.

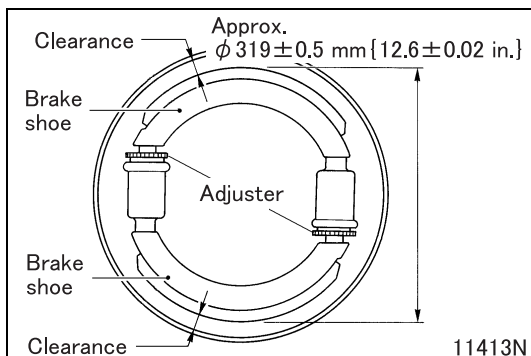
- Turn the adjuster until the distance between the brake shoes, indicated in the illustration, is obtained.
- Adjust the brake shoe-to-drum clearance evenly across by moving the brake shoe.

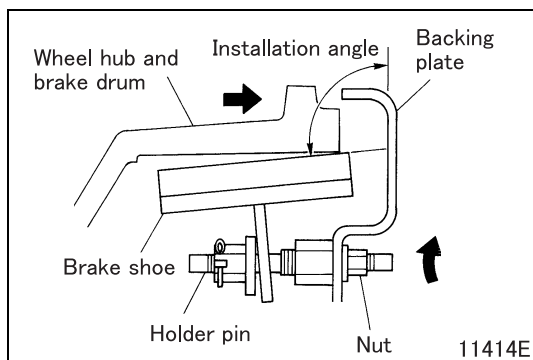
- Secure the wheel hub and brake drum onto the front wheel brake. (See Gr26A.)  
If the installation angle exceeds 90°, the wheel hub and brake drum cannot be installed correctly. If this is the case, loosen the nut while turning the holder pin in order to bring the installation angle as much close to 90° as possible.

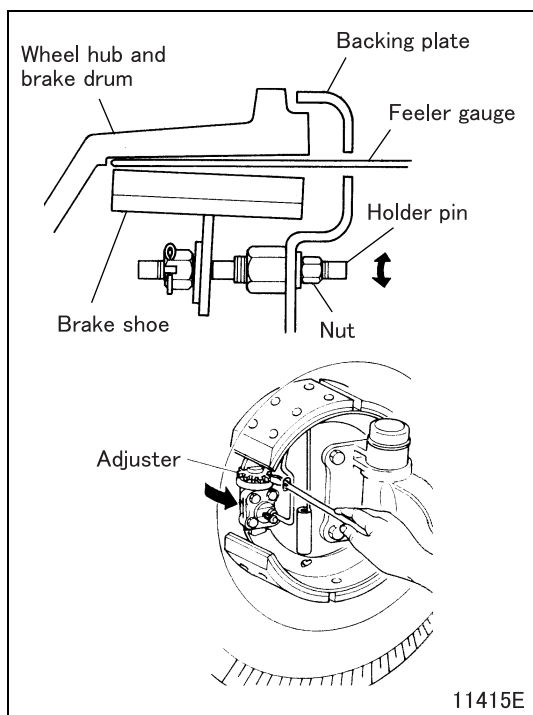
- ★ Expand the brake shoe towards the brake drum by turning the adjuster until it takes a reasonable force to insert a 0.2 mm feeler gauge between the brake drum and lining and out.
- ★ Loosen the nut and turn the holder pin clockwise or counter-clockwise until the feeler gauge can be inserted and out with a slight resistance.
- Repeat the above steps, shown with ★, until it takes a reasonable force to insert the feeler gauge between the brake drum and lining and out.
- Lightly press the brake pedal a couple of times to regain the even drum-to-lining clearance obtained earlier.
- Repeat the above steps, shown with ★, until it takes a reasonable force to insert the feeler gauge between the brake drum and lining and out.
