# FE.FG

## SERVICE MANUAL 2008 Model FOREWORD

This Service Manual contains maintenance and repair methods for the Mitsubishi Fuso Truck FE. FG Series. Read this manual carefully as an aid in providing correct, efficient maintenance. Please note that the information and specifications contained within this manual may change without notice. This is due to product modifications and continued vehicle improvements that are made throughout the model years. Should you encounter any discrepancy in the information provided, please do not hesitate to contact your nearest Mitsubishi Fuso Dealer or Mitsubishi Fuso Truck of America, Inc.

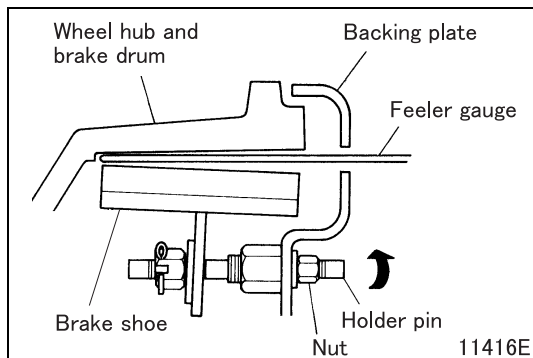
- When it takes a reasonable force to insert the feeler gauge between the brake drum and lining and out, this is because the feeler gauge is in contact with the entire width of the brake shoe.
- Now, pull out the feeler gauge. Then, with the feeler gauge inserted again, turn the holder pin until it takes a substantial force to remove and insert the feeler gauge across the entire width of the brake shoe.
- Tighten the nut to the specified torque.

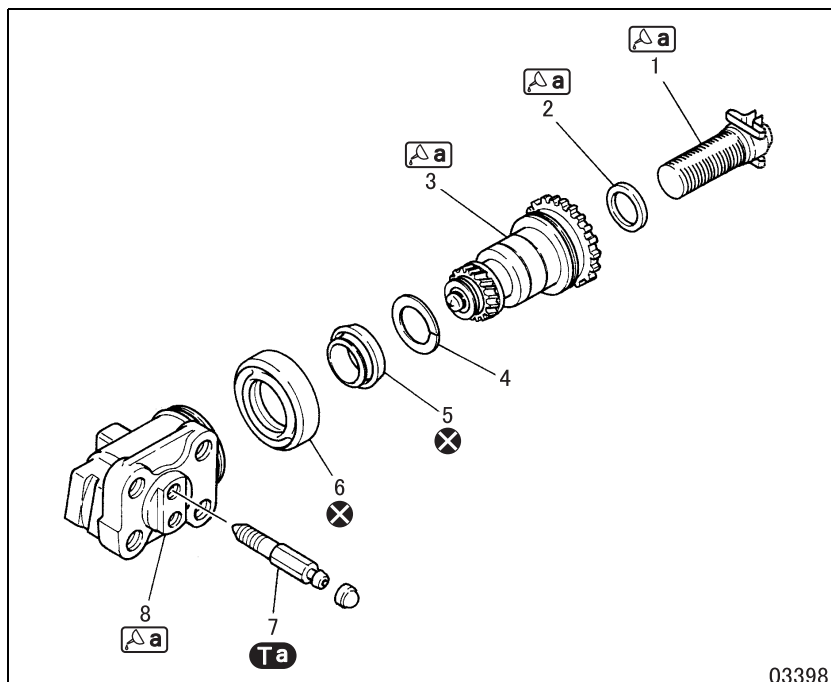
- 1 Screw
- 2 Seal
- 3 Piston
- 4 Backup ring
- 5 Piston cup
- 6 Boot
- 7 Air bleeder (only for the rear side)
- 8 Body

| Location | Maintenance item | Standard value | Limit | Remedy |
|---|---|---|---|---|
| 3, 8 | Clearance between piston and body | 0.03 to 0.09<br>{0.0012 to 0.0035} | 0.2<br>{0.0079} | Replace |

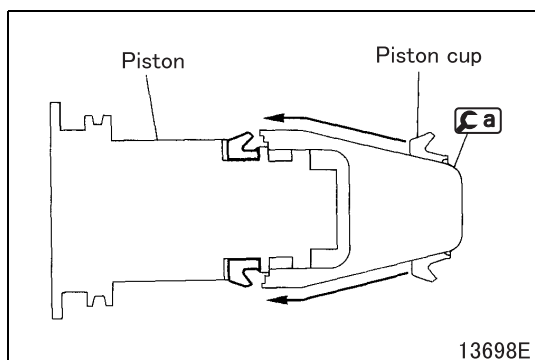
### ■ Installation: Piston cup

- Using **Ca**, install the piston cup as shown in the illustration.

- Install the piston cup correctly, facing it as shown in the illustration, in order to prevent poor braking performance and brake fluid leakage.
-

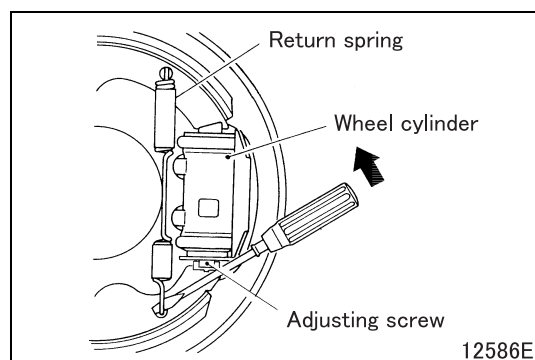
### ■ Removal: Return spring

- Using a flat-head screwdriver, remove the return spring. To do this, rest the screwdriver on the wheel cylinder adjusting screw. Then, with the adjusting screw as a fulcrum, engage the screwdriver with the spring hook and pry away the spring.

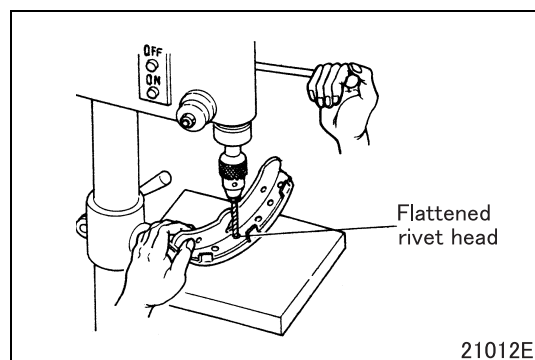
### ■ Removal: Brake lining

- Using a drilling machine, break the flattened rivet heads on the brake shoe side to release the brake lining.

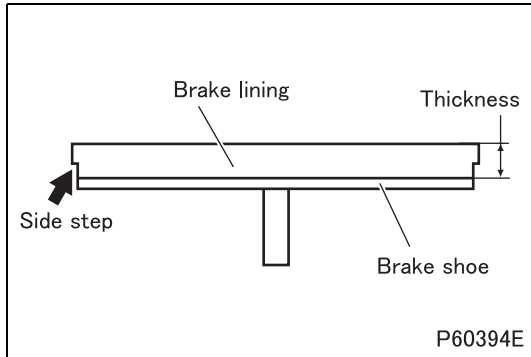
### ■ Inspection: Brake lining thickness

- If the brake lining is worn down to the side step, replace all brake linings on that axle.

| Location | Maintenance item | Standard value | Limit | Remedy |
|---|---|---|---|---|
| 4 | Brake lining thickness | 12.9 {0.51} | 5 {0.20}<br>(side shoulder means wear limit) | Replace |

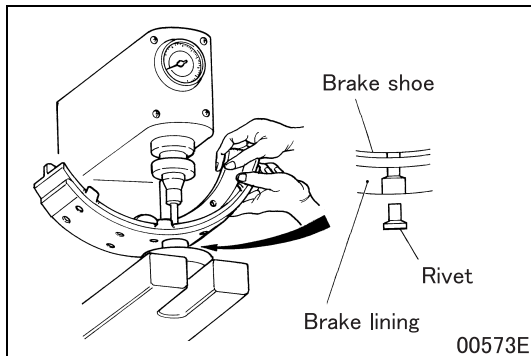
### ■ Installation: Brake lining

- Using cleaning fluid, clean the brake shoe surface to which the brake lining is to be mounted. Then, dry the shoe surface.
- Insert rivets from the brake lining to the shoe. Stake them, starting from the center of the shoe towards the ends. Ensure that the shoe-to-lining clearance conforms to the following values.
  - Around the rivets (within  $\phi 20$  mm {0.0079 in.}): 0.05 mm {0.0020 in.} or less
  - Except around the rivets: 0.2 mm {0.0079 in.} or less
  - The staking load for the rivets should be  $22 \pm 0.98$  kN {4950  $\pm$  220 lbs, 2200  $\pm$  100 kgf}.

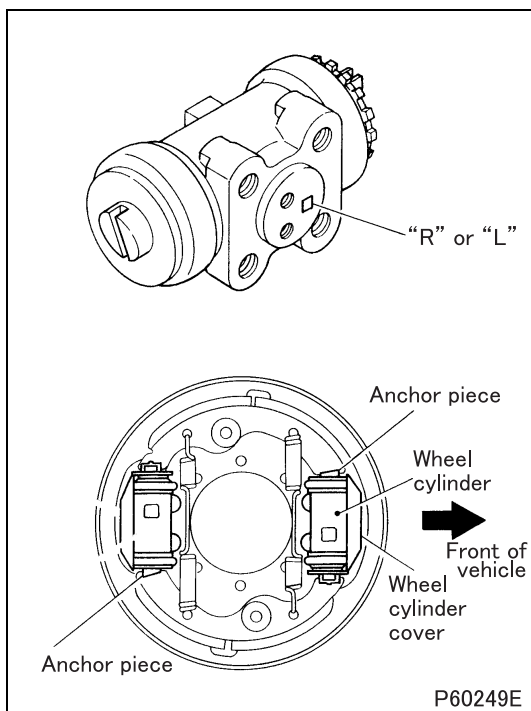
### ■ Installation: Wheel cylinder

- The illustration shows a right-hand wheel. Left-hand wheels are symmetrically arranged relative to the illustration.
- Install the anchor pieces in the direction shown.

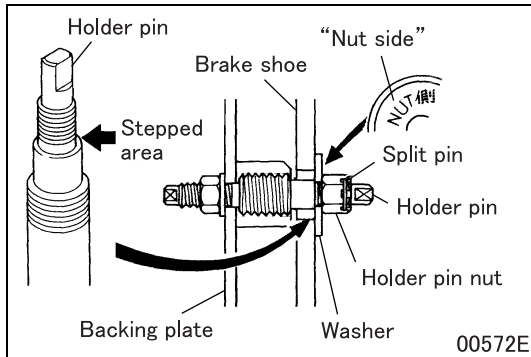
#### ■ Installation: Brake shoe

- Install the brake shoe.
- Insert the washer with the stamped word "NUT side" facing away from the brake shoe. Tighten the holder pin nut until the washer is slightly against the stepped area on the holder pin. Back off the holder pin nut between 0 to 60° until the first split pin holes in the nut and holder pin align with each other.
- Insert the split pin through the hole and bend it securely.

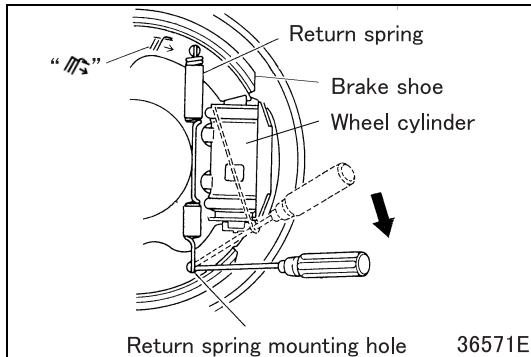
#### ■ Installation: Return spring

- Install the shorter hook of the return spring onto the brake shoe which is on the opposite side from the wheel cylinder adjuster.
- Hook up a small Phillips screwdriver tip to the longer hook of the return spring of the brake shoe assembly and install the return spring using the screwdriver like a prying lever.

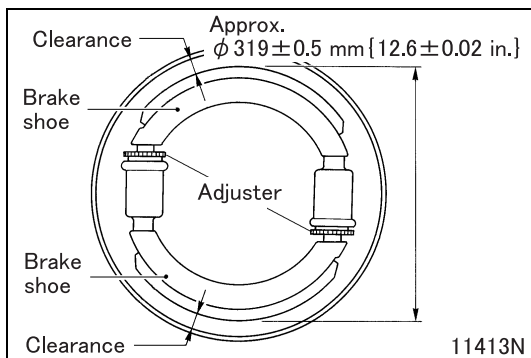
- Turn the adjuster until the distance between the brake shoes, indicated in the illustration, is obtained.
- Adjust the brake shoe-to-drum clearance evenly across by moving the brake shoe.

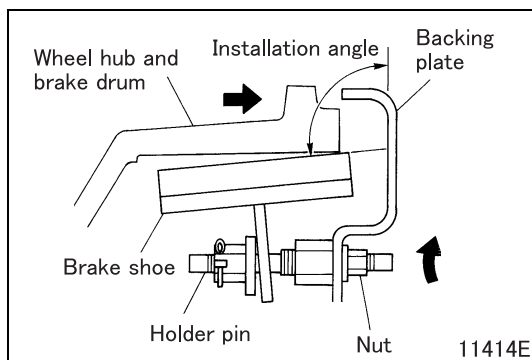
- Secure the wheel hub and brake drum onto the rear wheel brake. (See Gr27.)  
If the installation angle exceeds 90°, the wheel hub and brake cannot be installed correctly. If this is the case, loosen the nut while turning the holder pin in order to bring the installation angle as much close to 90° as possible.

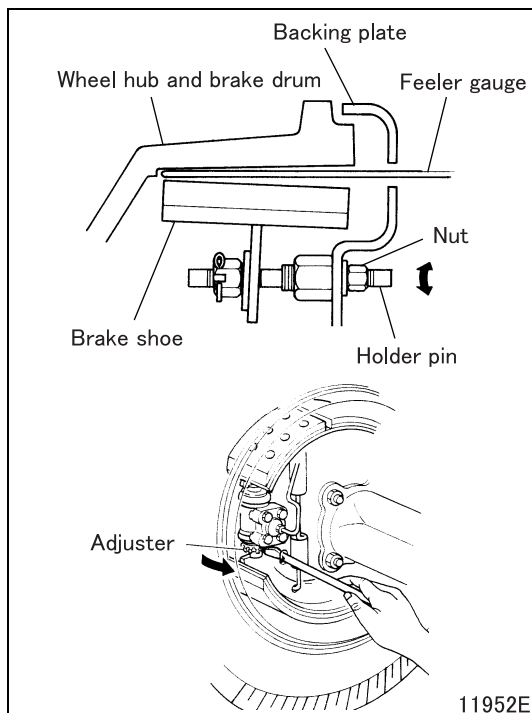
- ★ Expand the brake shoe towards the brake drum by turning the adjuster until it takes a reasonable force to insert a 0.2 mm {0.0079 in.} feeler gauge between the brake drum and lining and out.
- ★ Loosen the nut and turn the holder pin clockwise or counter-clockwise until the feeler gauge can be inserted and out with a slight resistance.
- Repeat the above steps, shown with ★, until it takes a reasonable force to insert the feeler gauge between the brake drum and lining and out.
- Lightly press the brake pedal a couple of times to regain the even drum-to-lining clearance obtained earlier.
- Repeat the above steps, shown with ★, until it takes a reasonable force to insert the feeler gauge between the brake drum and lining and out.

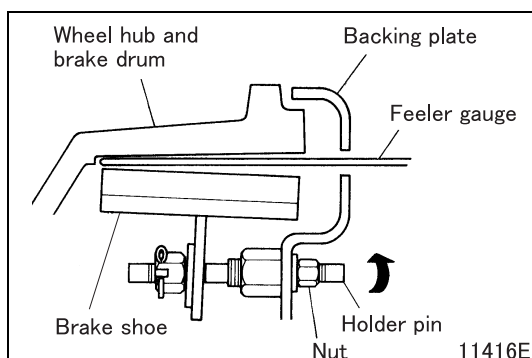
- When it takes a reasonable force to insert the feeler gauge between the brake drum and lining and out, this is because the feeler gauge is in contact with the entire width of the brake shoe.
- Now, pull out the feeler gauge. Then, with the feeler gauge inserted again, turn the holder pin until it takes a substantial force to remove and insert the feeler gauge across the entire width of the brake shoe.
- Tighten the nut to the specified torque.

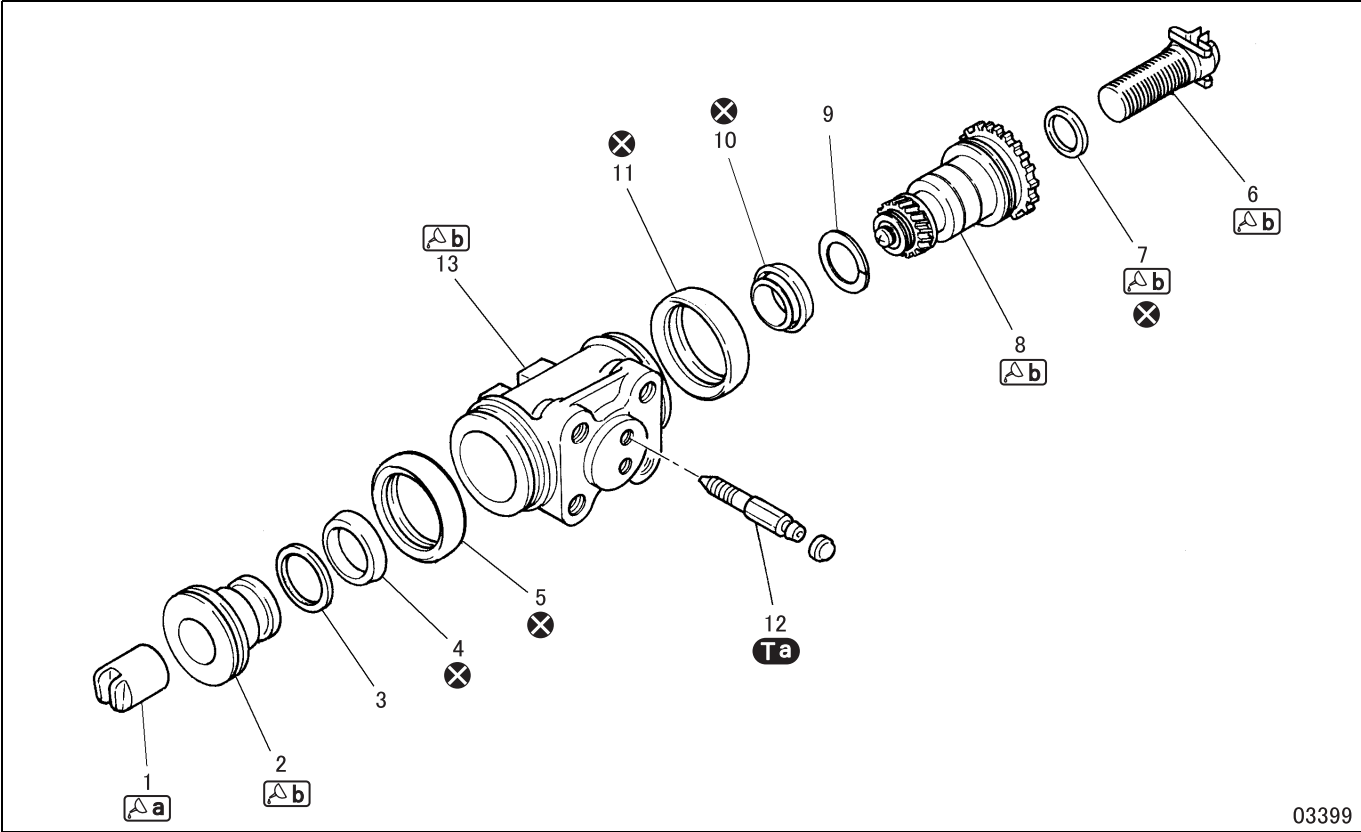
### ● Disassembly sequence

| Location | Maintenance item | Standard value | Limit | Remedy |
|---|---|---|---|---|
| 2, 8, 13 | Clearance between piston and body | 0.03 to 0.09<br>{0.0012 to 0.0035} | 0.2 {0.0079} | Replace |

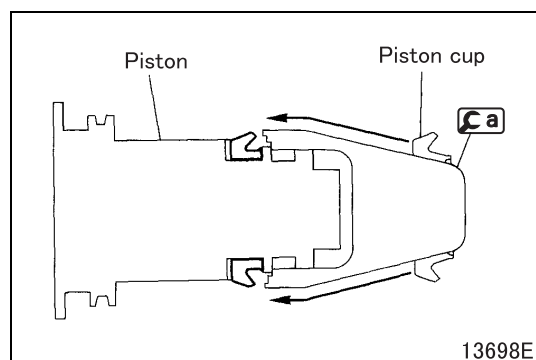
### ■ Installation: Piston cup

- Install the piston cup correctly, facing it as shown in the illustration, in order to prevent poor braking performance and brake fluid leakage.

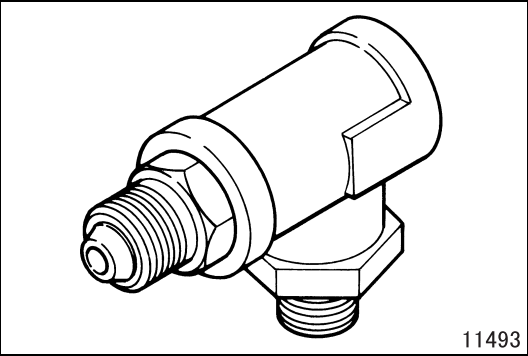
- Do not disassemble this check valve because it is a unit construction.

| Location | Maintenance item | Standard value | Limit | Remedy |
|---|---|---|---|---|
| - | Pressure difference between inlet and outlet | 29 kPa<br>{4.3 psi, 0.3 kgf/cm <sup>2</sup> }<br>or less | - | Replace |

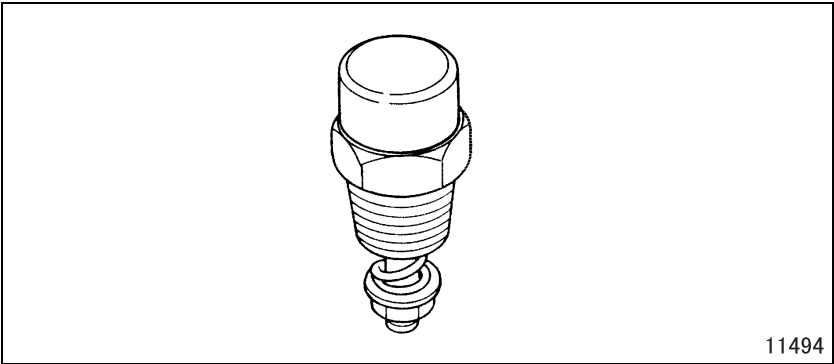
| Location | Maintenance item | Standard value | Limit | Remedy |
|---|---|---|---|---|
| - | Release pressure | 950 ± 20 kPa<br>{135 ± 2.8 psi,<br>9.7 ± 0.2 kgf/cm <sup>2</sup> } | - | Replace |

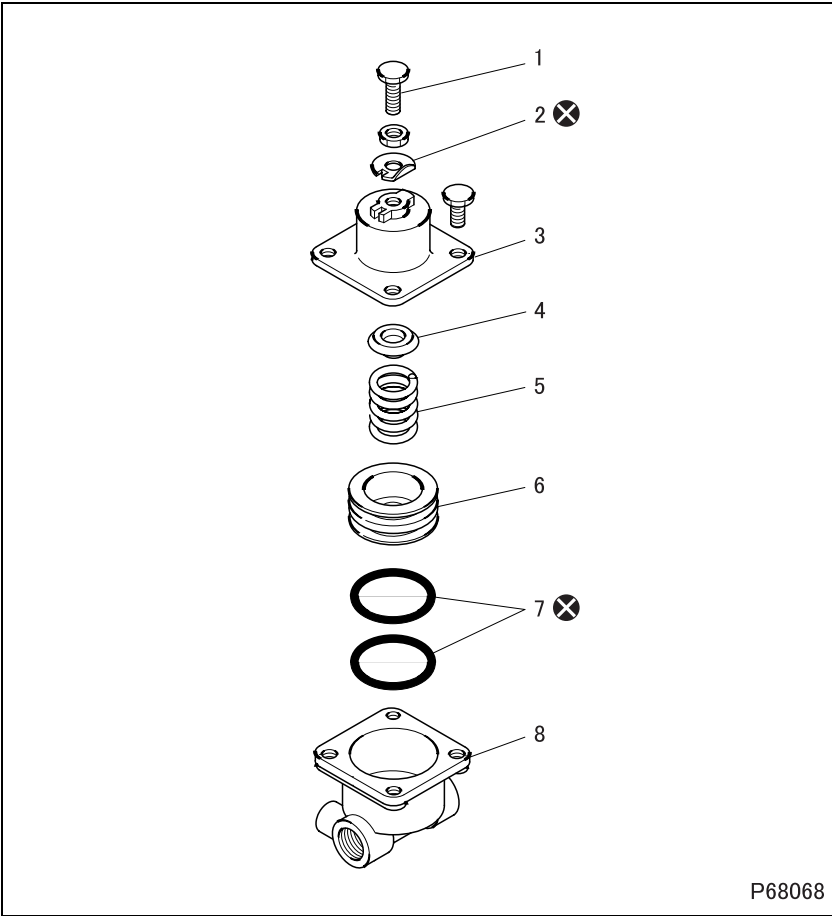
P68068

### ● Disassembly sequence

- Do not move the lock nut or adjusting bolt unless required for replacement or adjustment.

| Location | Maintenance item | | Standard value | Limit | Remedy |
|---|---|---|---|---|---|
| - | FK61, FM61, FM65 | Specified pressure | Valve opening pressure | 345 ± 29 kPa<br>{50 ± 4.3 psi,<br>3.5 ± 0.3 kgf/cm <sup>2</sup> } | Adjust or replace |
| - | FM64 | Specified pressure | Valve opening pressure | 471 ± 29 kPa<br>{68 ± 4.3 psi,<br>4.8 ± 0.3 kgf/cm <sup>2</sup> } | Adjust or replace |
| | | | Valve closing pressure | 441 ± 20 kPa<br>{64 ± 2.8 psi,<br>4.5 ± 0.2 kgf/cm <sup>2</sup> } | |

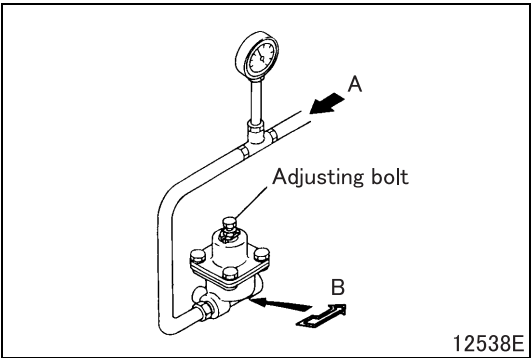
### ■ Adjustment: Supply valve

- Adjust by turning adjusting bolt after loosening lock nut. After adjusting, tighten the lock nut without turning the adjusting bolt, and bend claw washer to secure the lock nut.
  - Adjust adjusting bolt so that air is discharged from the outlet port (arrow mark B in the illustration), when valve opening pressure is applied to the inlet port (arrow mark A in the illustration).
  - After adjusting valve opening pressure, adjust adjusting bolt so that air is not discharged from the outlet port (arrow mark B in the illustration) when valve closing pressure is applied to the inlet port (arrow mark A in the illustration).
- B : Arrow showing the air flow direction

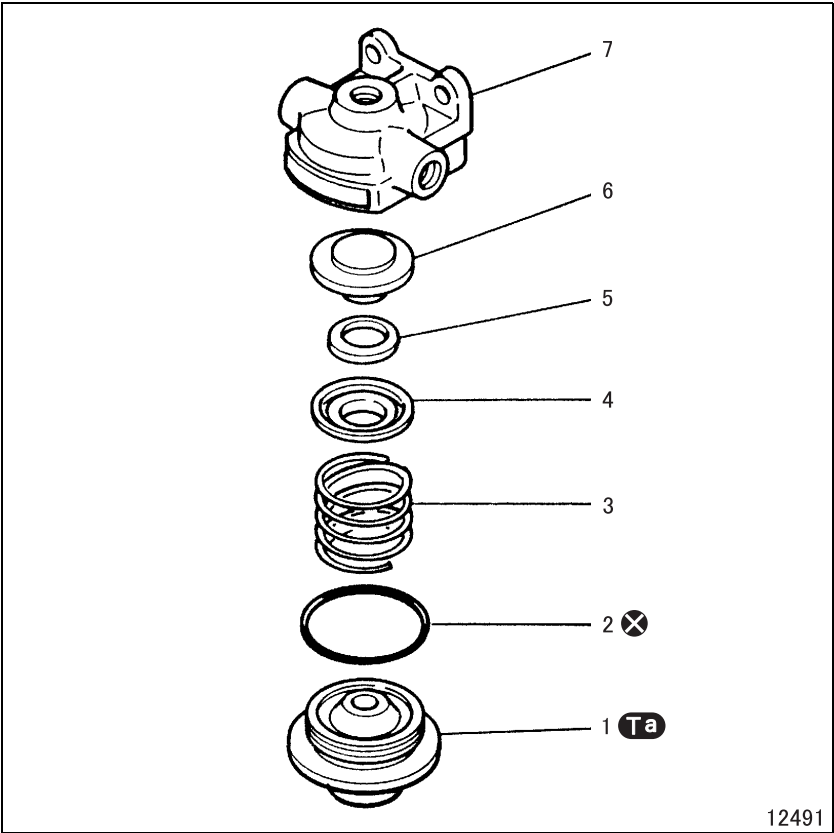
- 1 Body
- 2 O-ring
- 3 Spring
- 4 Retainer
- 5 Ring
- 6 Diaphragm & ring
- 7 Housing

| Mark | Parts to be tightened | Tightening torque | Remarks |
|---|---|---|---|
| Ta | Body | 17 to 23 {12 to 17, 1.7 to 2.3} | – |

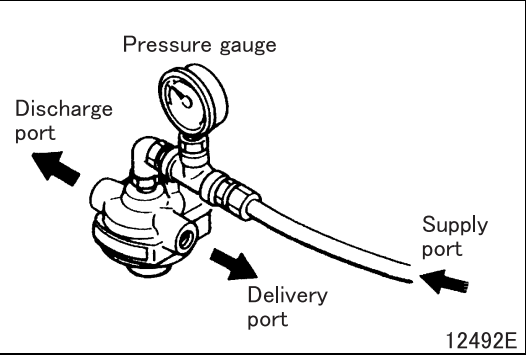
■ Adjustment: Quick release valve

- Connect pipe to the valve with a pressure gauge installed as shown and apply air pressure increasingly to the air supply port. Air should flow out from the discharge ports when the pressure gauge reads  $9.8 \pm 4.9$  kPa { $1.4 \pm 0.7$  psi,  $0.1 \pm 0.05$  kgf/cm<sup>2</sup>} (activating pressure).

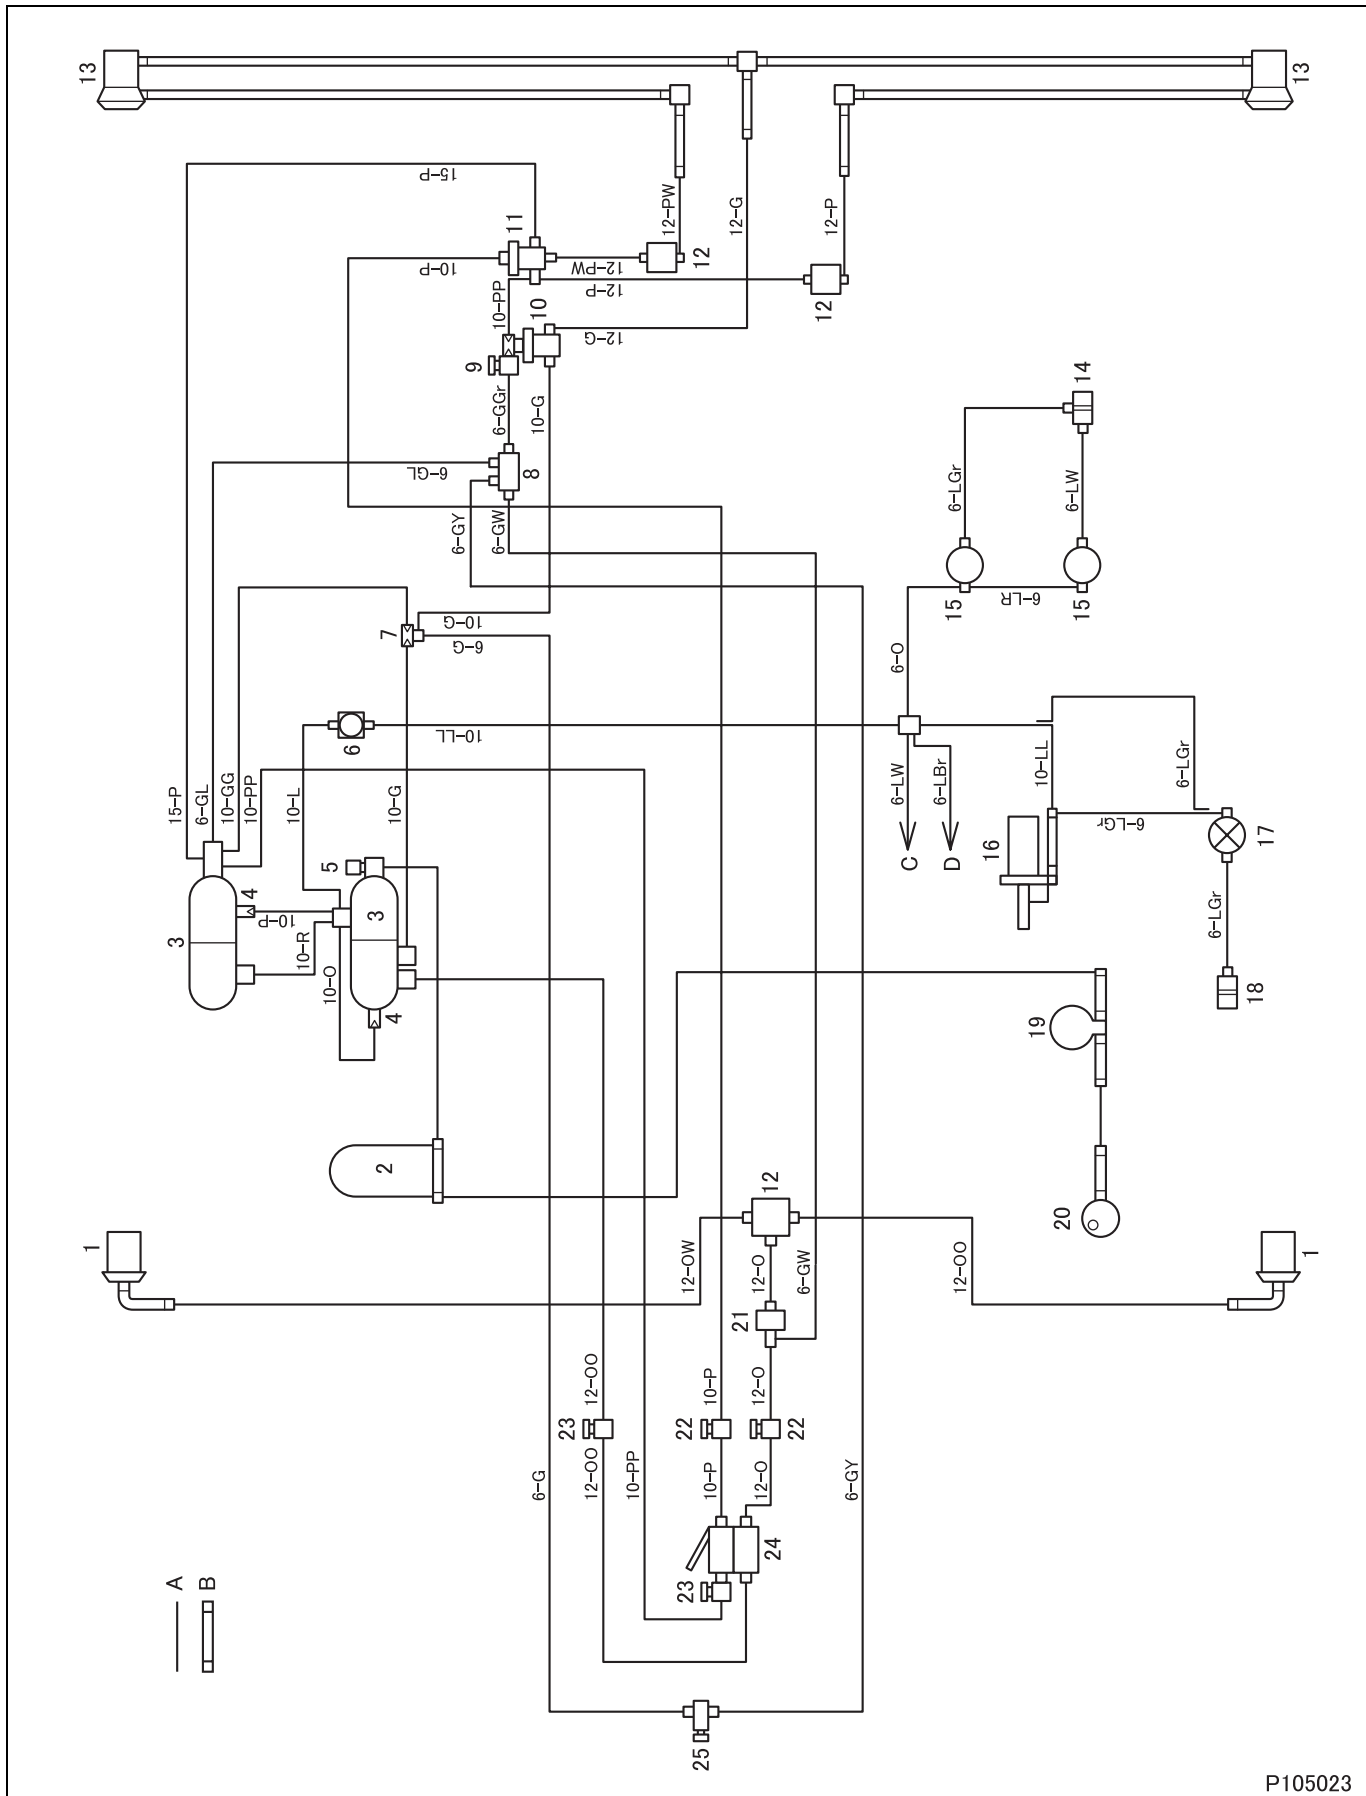
P105023

| <b>1</b> Front brake chamber | <b>11</b> Relay valve | <b>22</b> Stop lamp switch |

- The brake system is a full-air, all wheel brake type consisting of separate front and rear systems.
- Parking brake control valve is fitted as a safety mechanism. It provides normal braking action on the spring brake of rear brake chamber even if the rear brake system air line fails.
- An exhaust brake system, of the exhaust pipe opening and closing valve type, is fitted as a sub-brake system.

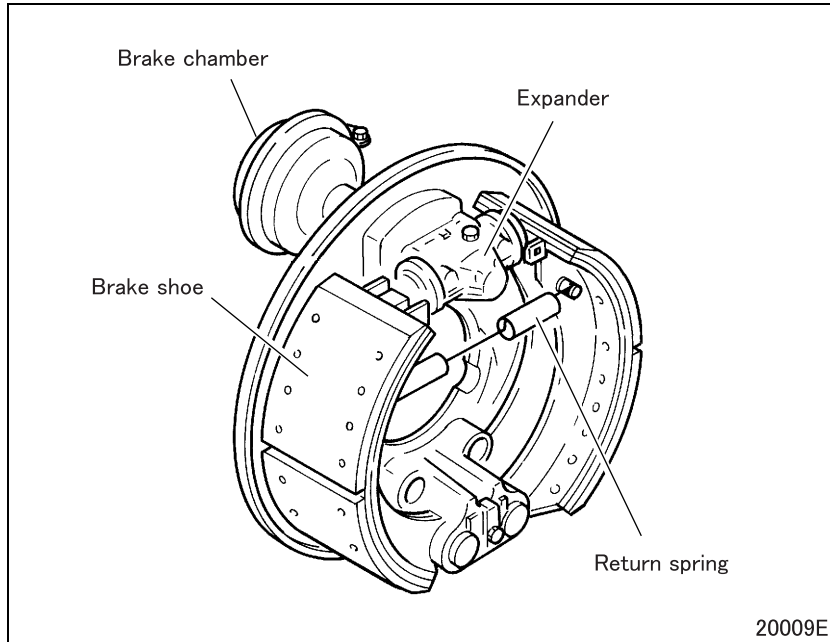
## 5. Front Drum Brake

- The front drum brake is a leading-trailing shoe type brake.
- The double-acting expander ensures that, in both the forward- and rearward-travel braking, one of the brake shoes operates as a leading shoe which, through self-boosting effect, generates a great stopping power.

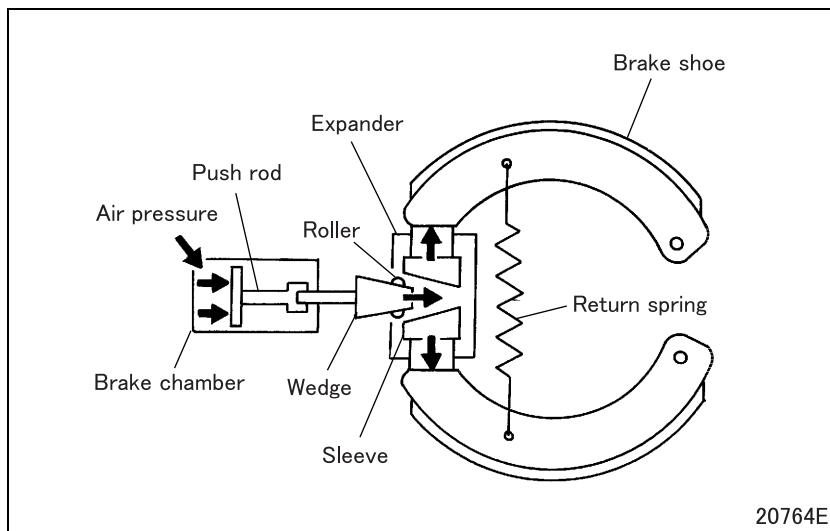
### 5.1 Wedge mechanism

- When air pressure is applied to the brake chamber, the push rod is pushed into the wedge.
- This causes the wedge to push open the sleeves of the expander through rollers, expanding the brake shoes.

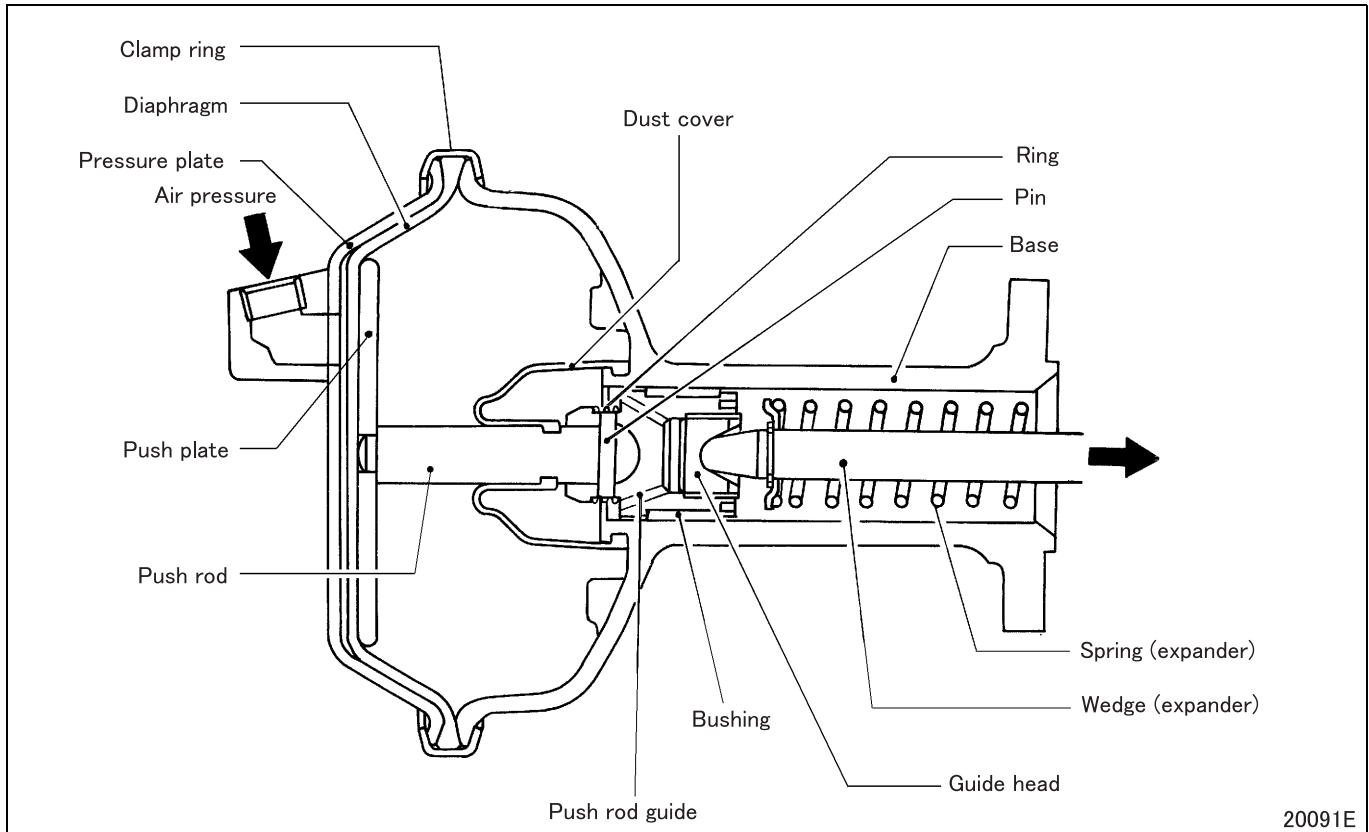
## 5.2 Brake chamber

- When air pressure is applied to the brake chamber, the diaphragm moves to push the push rod which in turn pushes the wedge.
- When air pressure is released, the wedge and push rod are pushed back by the spring.

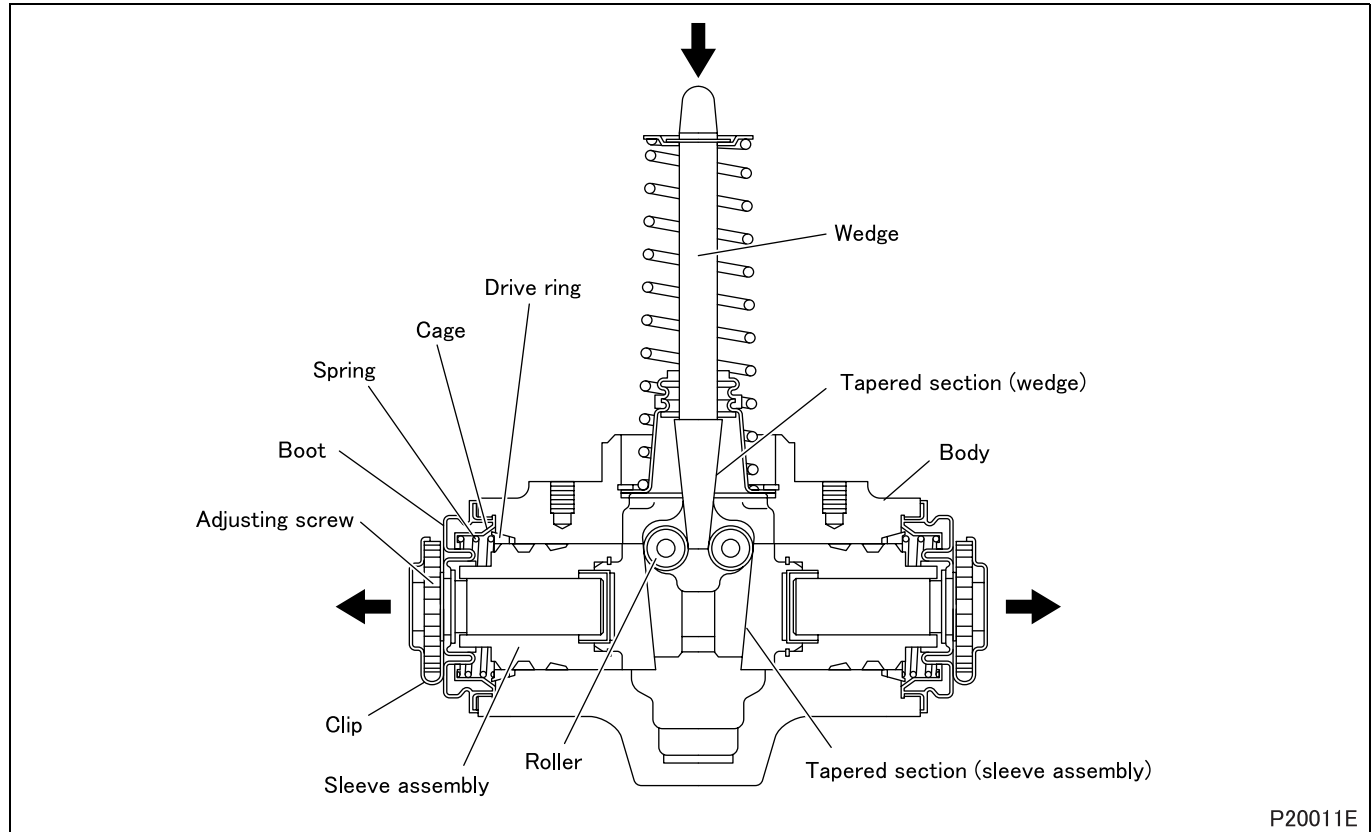
## 5.3 Expander

- When the wedge is pushed, its tapered section slides in between the rollers, pushing them open.
- The rollers roll along tapered section of the sleeve assemblies to push the sleeve assemblies and adjusting screws outward.
- The expander body incorporates an automatic adjuster mechanism which automatically adjusts the brake shoe-to-drum clearance.

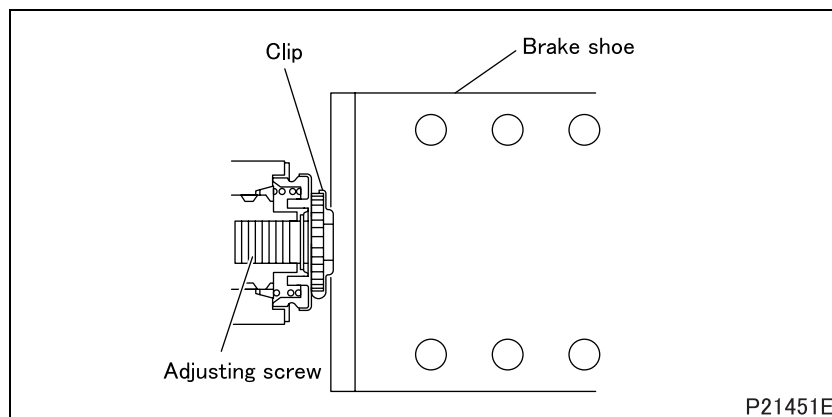
### (1) Automatic adjusting mechanism

- The adjusting screw has its turning blocked by the clip.
- The clip has its turning blocked by the brake shoe.

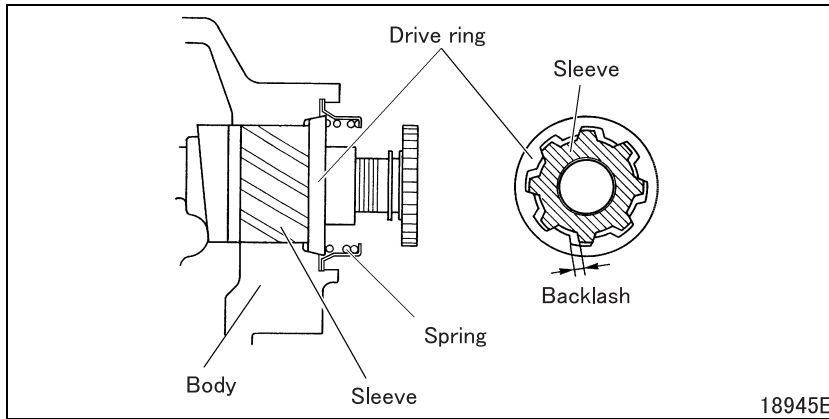
**(1.1) In case that brake shoe clearance is specified value**

- Before the brake is operated, the bottom of the sleeve assembly is in contact with the body.
- The drive ring is pushed against the body by the spring, being fixed in position.

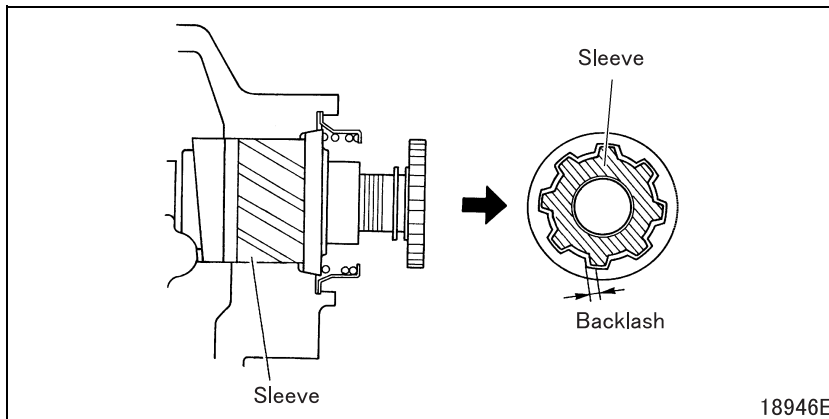
- When the brake is operated, the sleeve assembly moves within the range of backlash.

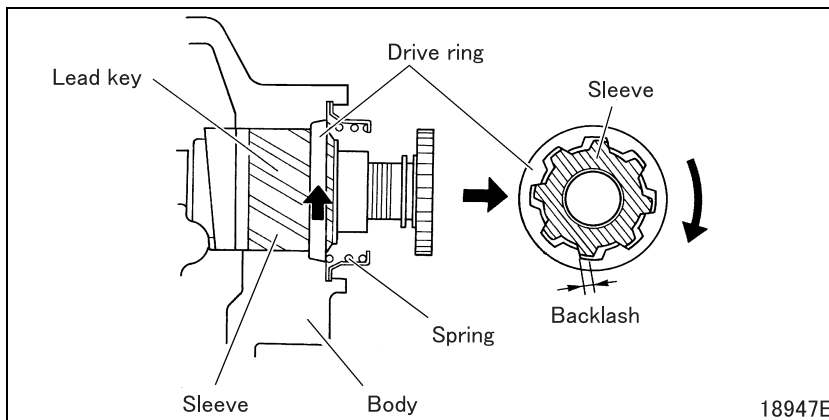
**(1.2) In case that brake shoe clearance exceeds specified value**

- When the brake is operated, the sleeve assembly moves beyond the range of backlash. Therefore, the drive ring is turned by the lead keys of the sleeve assembly since it is pushed by the spring.
- The drive ring is kept pressed against the body by the spring.

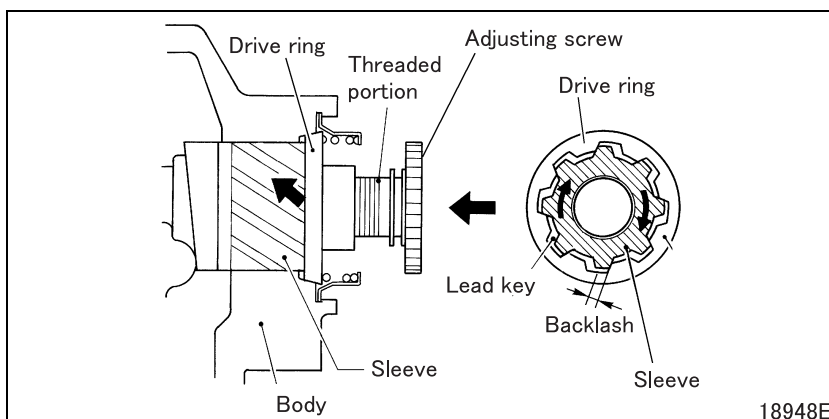
- When the brake is released, the sleeve assembly moves back until its bottom comes into contact with the body. At this time, the sleeve assembly moves without turning by the amount of backlash. After that point, the sleeve assembly is turned by the lead keys of drive ring. This causes adjusting screw to move out along threads, adjusting the brake shoe clearance to the specified value.

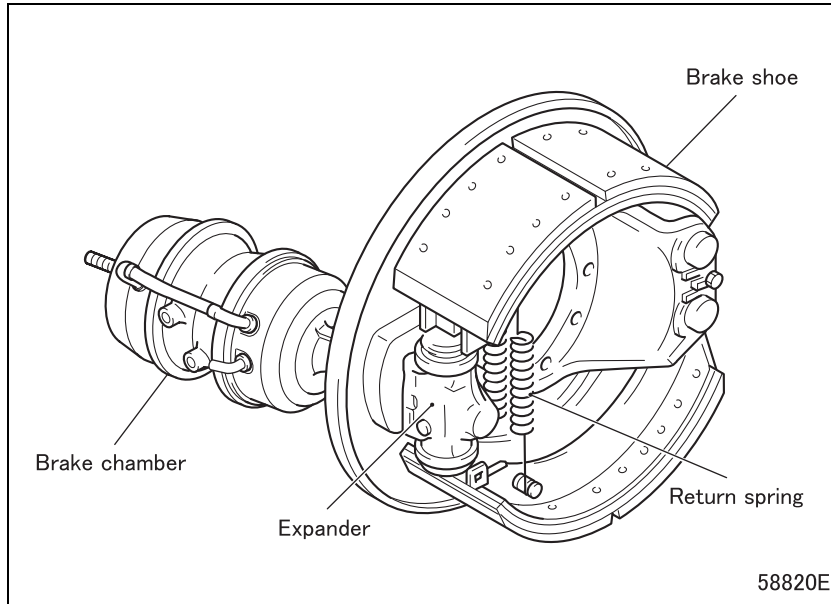
## 6. Rear Drum Brake

- The rear drum brake is a leading-trailing shoe type brake.
- The double-acting expander ensures that, in both the forward- and rearward-travel braking, one of the brake shoes operates as a leading shoe which, through self-boosting effect, generates a great stopping power.

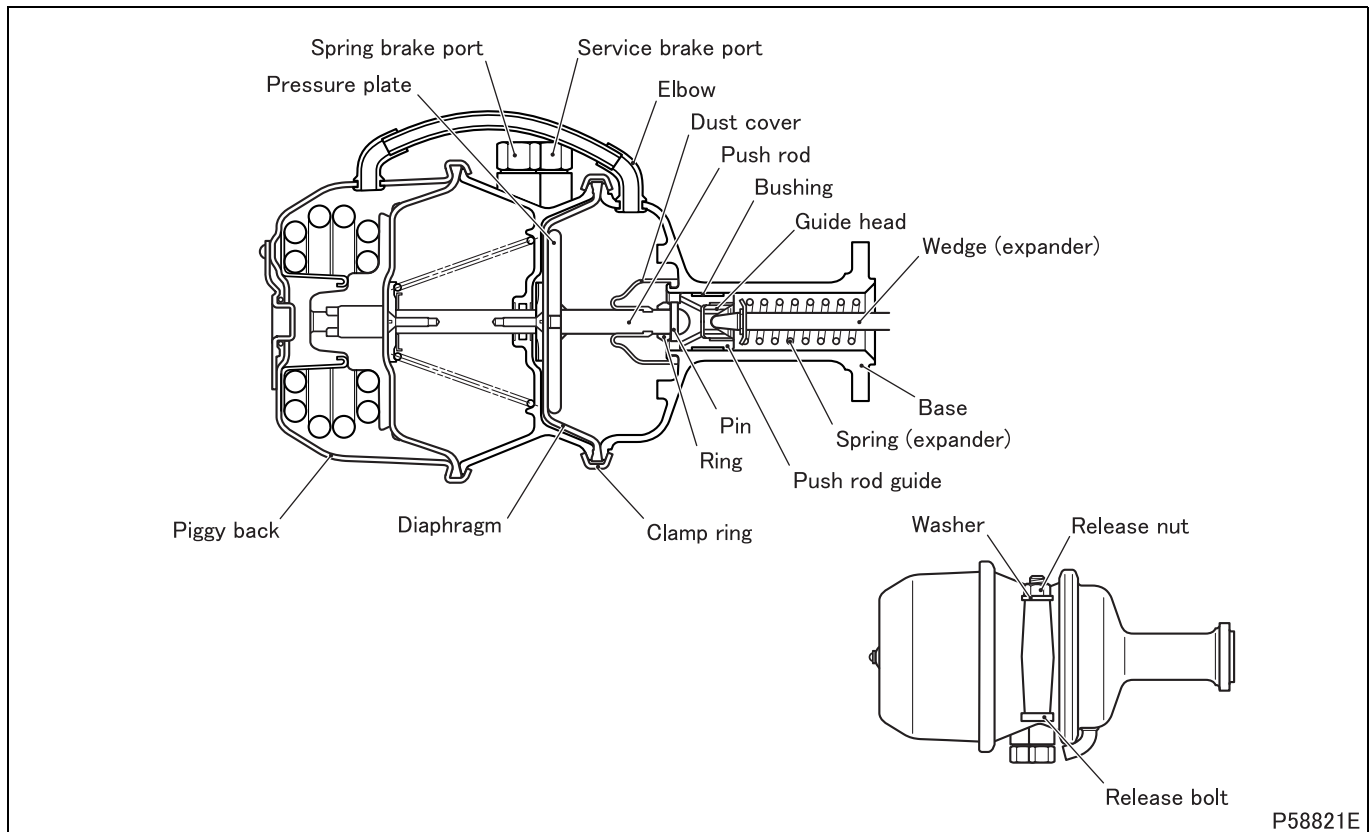
### 6.2 Brake chamber

- The brake chamber offers a spring brake (wheel parking brake) function as well as service brake function.
- Washer, release nut and release bolt are used when releasing the spring brake mechanically.

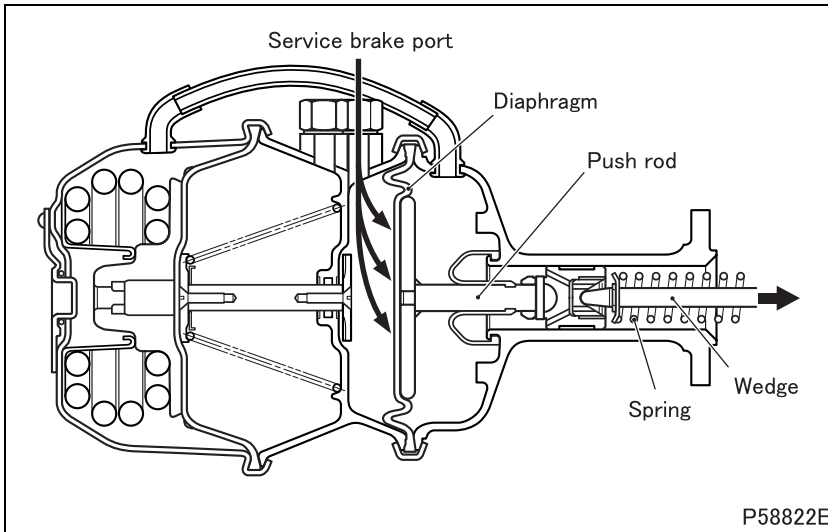
### (1.1) When applied

- Air pressure introduced through the service brake port pushes the diaphragm which in turn pushes the push rod and wedge.

- Air pressure is discharged from the service brake port, which causes the wedge and push rod to be returned by the spring.

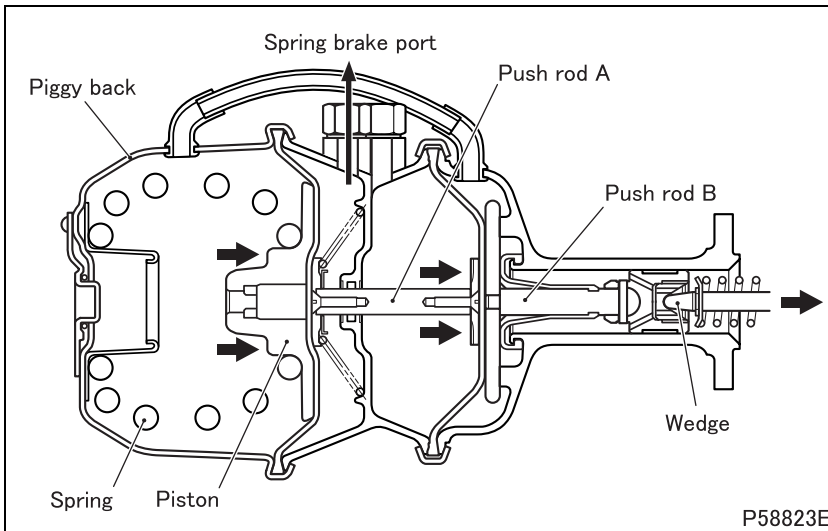
### (2.1) When applied

- Air pressure is discharged from the spring brake port, which causes the piston, push rods A, B and wedge to be pushed by the spring of piggy back.

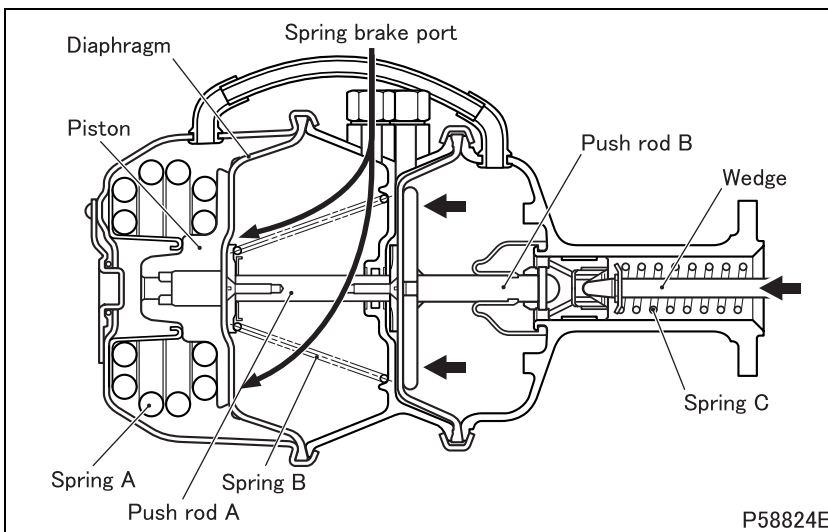
### (2.2) When released

- Air pressure introduced through the spring brake port pushes back the piston through the diaphragm, compressing the spring.
- This causes push rod A to be pushed back by spring B.
- Wedge and push rod B are returned by spring C.

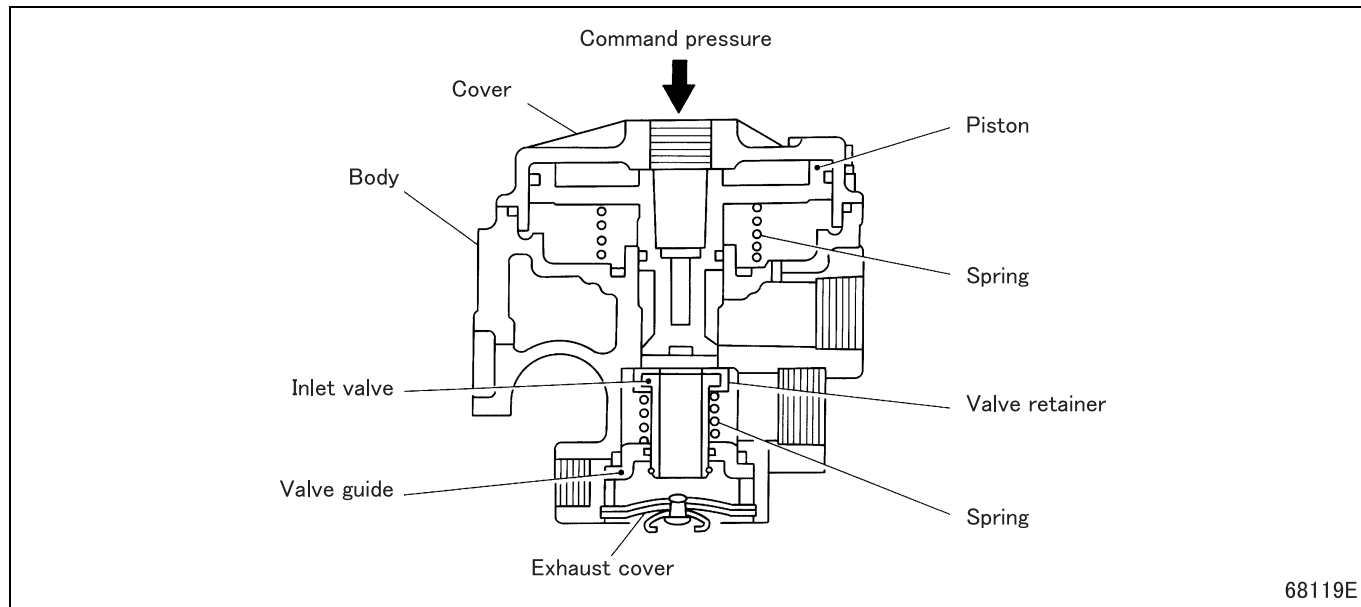
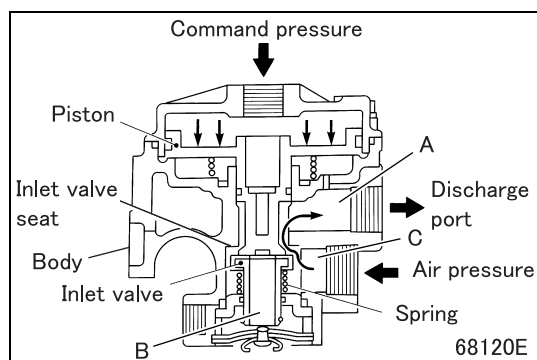
## 7. Relay Valve

### 7.1 When brake pedal is depressed

- When command pressure comes in, piston moves downward to seat on inlet valve, closing exhaust passage chamber B. The inlet valve is then pushed down against spring, opening the gap between inlet valve seat of body and inlet valve. As a result, air pressure from the air tank flows from chamber C to chamber A, supplied to discharge port.

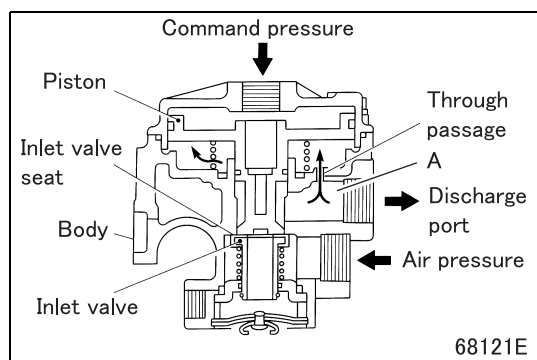
### 7.2 Stabilization of brake pressure

- When command pressure is maintained at a given level, the air pressure from discharge port is also stabilized. The air pressure in chamber A passes through passage to act on the bottom surface of piston, which pushes up the piston and inlet valve, each being held tightly up against each other. When the inlet valve touches inlet valve seat of body, it stops the supply of the air pressure from the air tank, stabilizing the brake air pressure at a given level.

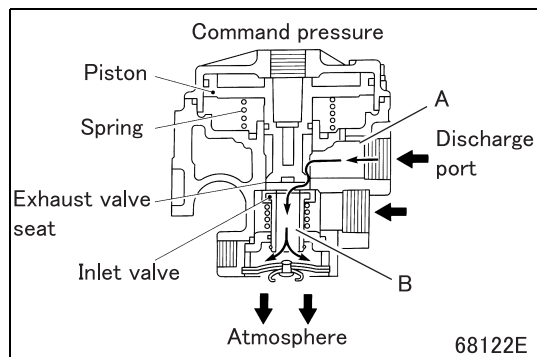
### 7.3 Release of brake pressure

- When there is no command pressure, piston is pushed up by spring and the air pressure (pressure in chamber A) on the side of discharge port. This results in exhaust valve seat on the lower end of the piston leaving inlet valve. Air pressure on the discharge side is therefore discharged into atmosphere through exhaust passage chamber B.
