# FE.FG

## SERVICE MANUAL 2008 Model FOREWORD

This Service Manual contains maintenance and repair methods for the Mitsubishi Fuso Truck FE. FG Series. Read this manual carefully as an aid in providing correct, efficient maintenance. Please note that the information and specifications contained within this manual may change without notice. This is due to product modifications and continued vehicle improvements that are made throughout the model years. Should you encounter any discrepancy in the information provided, please do not hesitate to contact your nearest Mitsubishi Fuso Dealer or Mitsubishi Fuso Truck of America, Inc.

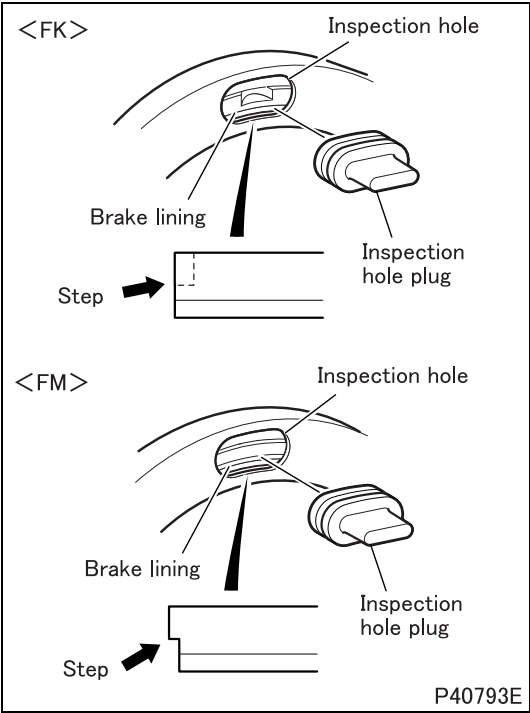
- Remove the inspection hole plug from the inspection hole in the dust cover. Through the inspection hole, measure the thickness of the brake lining.
- If any lining is worn down to the step on the side face, replace all linings on that axle.
- After the inspection, be sure to install the plug onto the inspection hole.

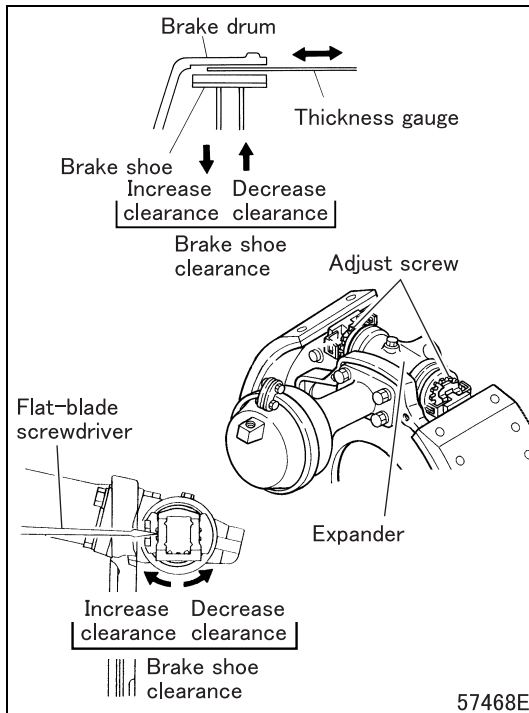
## 5. Initial Adjustment of Clearance between Brake Drum and Shoe

- Jack up front wheel, and make sure that hub bearings are not loose. If loose, adjust the hub bearings. (See Gr26B.)
- Remove the inspection hole plug from the dust cover.
- Through one of the inspection holes, insert a 0.3 to 0.5 mm {0.012 to 0.020 in.} thickness gauge between the brake lining and drum. Adjust the adjusting screw on the expander such that the gauge can be inserted and out with slight resistance. Repeat this through the other inspection hole.
- After adjustment, be sure to install the inspection hole plug.

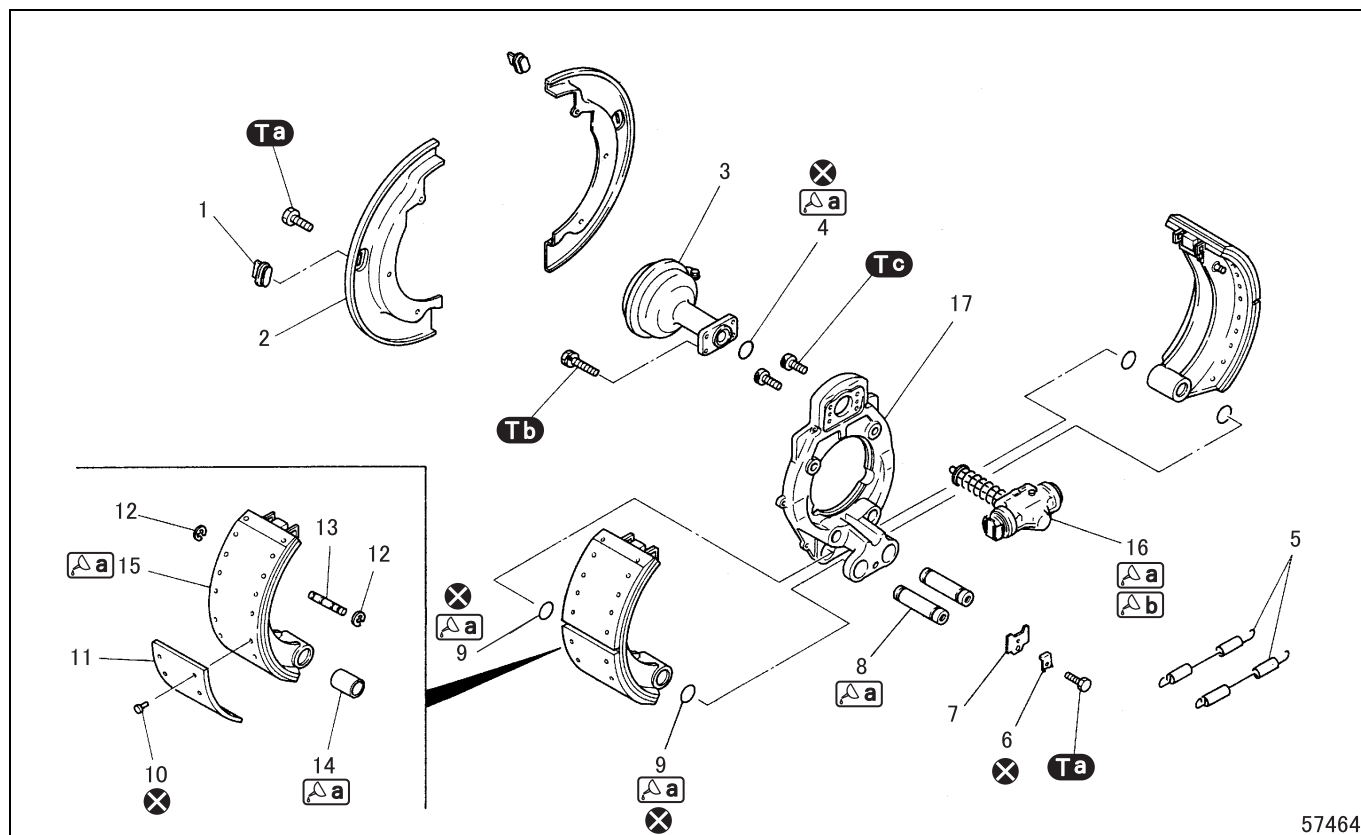
# FRONT WHEEL BRAKE

- For information on removal and installation of front drum brake, refer to Gr26B.

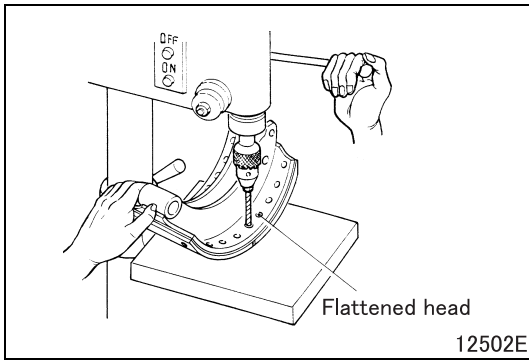
#### ■ Removal: Brake lining

- Using a drilling machine, break the flattened rivet heads on the brake shoe side to release the brake lining.

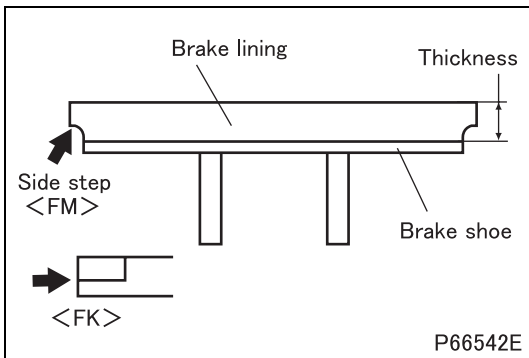
#### ■ Inspection: Brake lining thickness

- If the brake lining is worn down to the side step, replace all brake linings on that axle.

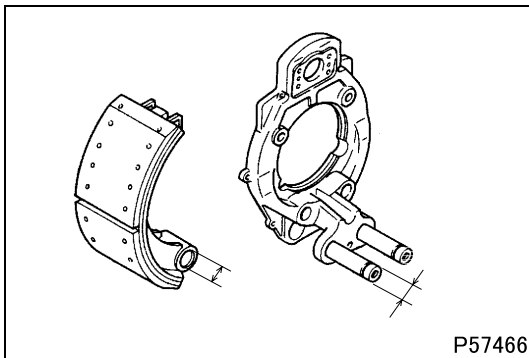
#### ■ Inspection: Clearance between anchor pin and bushing

- If the measurement exceeds the limit, replace the bushing.

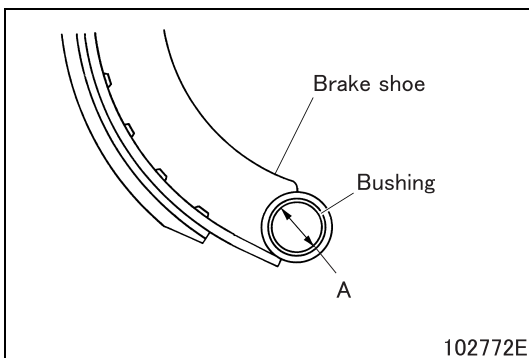
- With the bushing installed in the brake shoe, measure the inner diameter of the bushing.
- If the measured value is out of the dimension A shown below, ream the bushing.

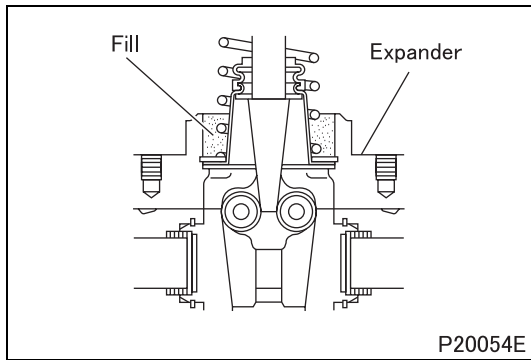
### ■ Installation: Expander

- Fill the expander with the specified quantity of grease as shown in the illustration.

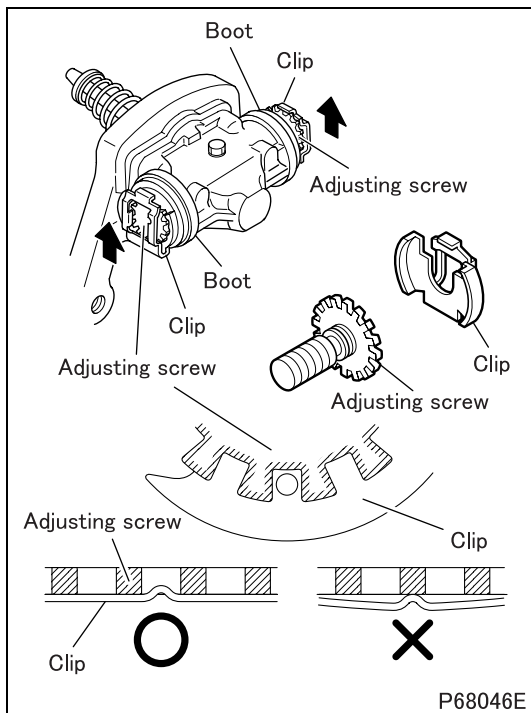
### ■ Installation: Brake shoe

- Turn adjusting screw of expander assembly fully clockwise by hand.  
(Return of a screwing portion of adjusting screw)
- Confirm whether the open part of clip is in the drum side; if it is not in the drum side, turn adjusting screw further clockwise to match the position. (This rotation is due to the rotation sleeve assembly)

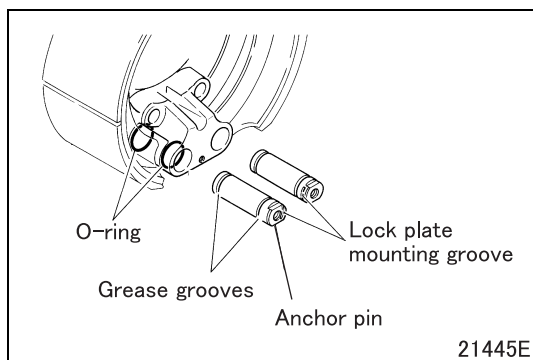
- Apply grease in grease grooves of the anchor pins.
- Install anchor pins in the illustrated direction.

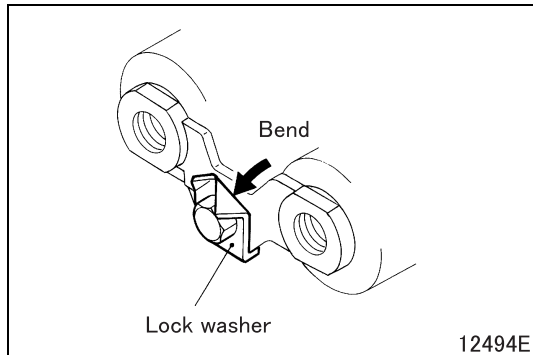
## ■ Installation: Lock washer

- After tightening the lock plate bolt to the specified torque, stake the lock washer at one location.

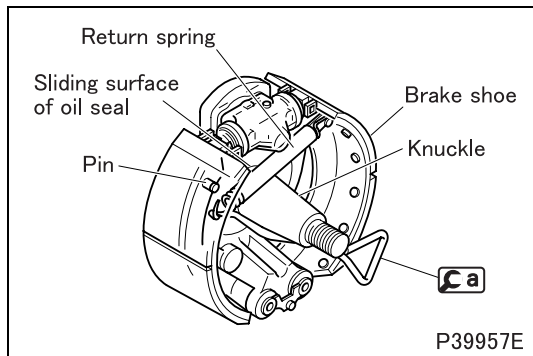
## ■ Installation: Return spring

- Fit the hooked part at one end of the return spring onto the pin in one of the brake shoe.
- Fit the hooked part at the other end of the return spring onto

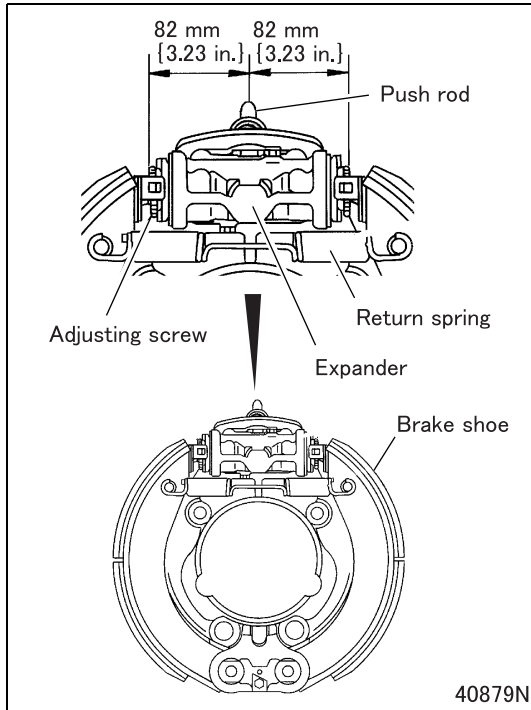
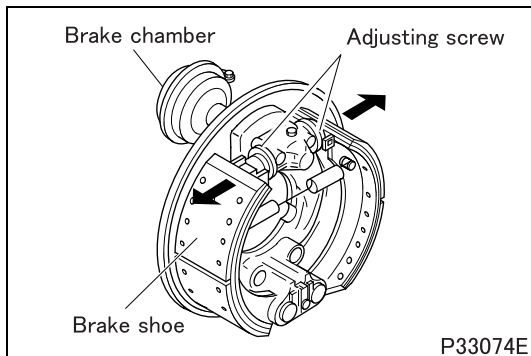
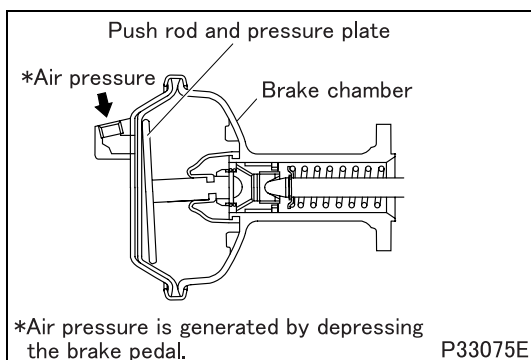
## ■ Inspection: Check of operation

- Ensure that the installed dimension of 82 mm {3.23 in.} is satisfied on the expander. If not, disassemble the expander and reinstall the adjusting screw(s). (See later section.)
- Reinstall the expander and brake shoes.
- Expand the brake shoes by pushing the push rod over its full stroke.
- Return the push rod to its original position and check whether the expander returns to the required dimension of 82 mm {3.23 in.}.
- If the results are unsatisfactory, check the force of the brake springs and the degree of stiffness in the brake shoes. Also inspect the expander again.

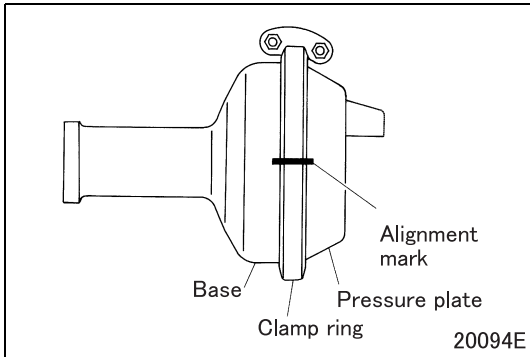
**■ Alignment mark: Brake chamber**

- Disassemble clamp ring, pressure plate and base, ensuring that alignment marks are properly aligned.

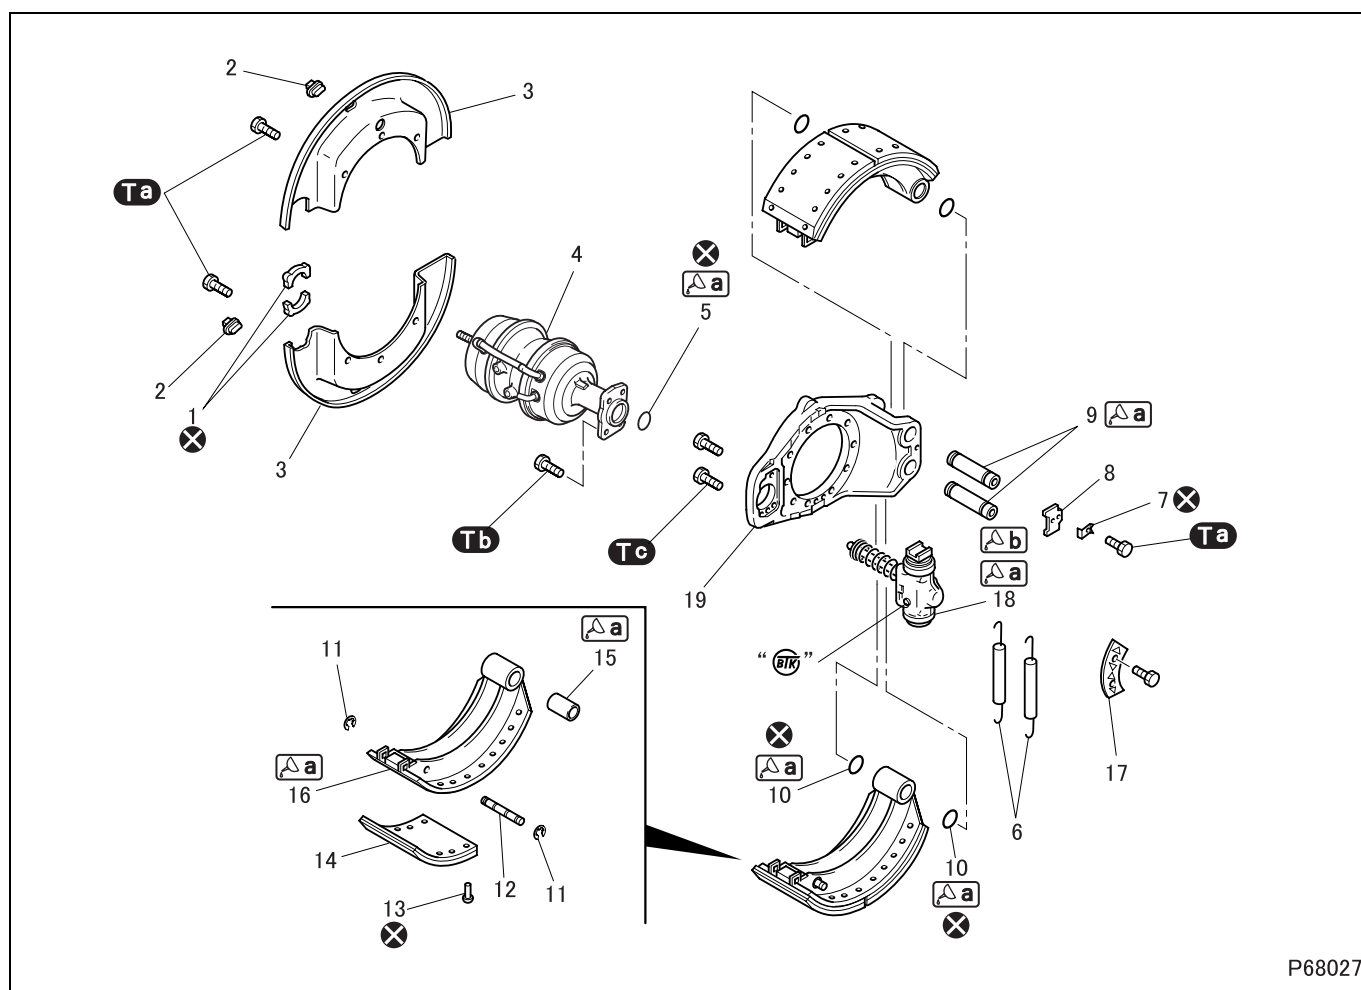
# REAR WHEEL BRAKE

- For information on removal and installation of rear drum brake, see Gr27.

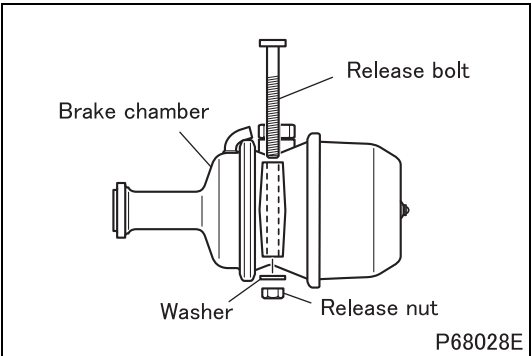
#### ■ Mechanical release of parking brake

- Release spring brake mechanically.
- Remove the release bolt, washer and release nut from the brake chamber.

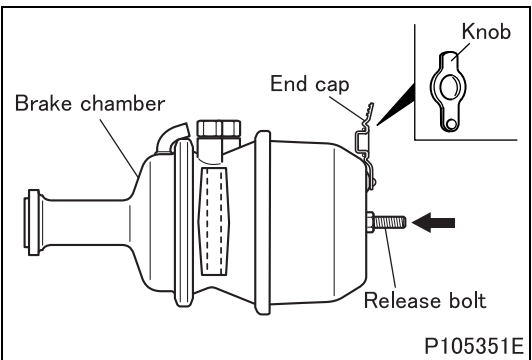
- Remove the end cap without failing to pull up its knob by hand or using a plier or other tools.

- Insert the release bolt deep into the chamber and turn it a quarter turn.
- Pull the release bolt to check that it does not come off the chamber.
- If the release bolt is pulled off, repeat the above procedure; insert the bolt deep into the chamber and turn it a quarter turn again.

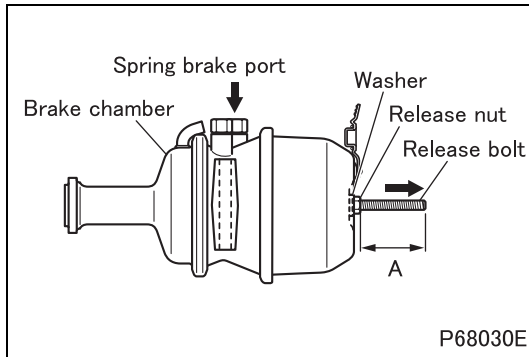
- Attach the washer and the release nut.
- While applying an air pressure of 640 kPa {92 psi, 6.5 kgf/cm<sup>2</sup>} into the spring brake port (by setting the hand control valve to the released position), turn the release nut until the threaded portion of the release bolt extends by the dimension A shown below.

A: 82 mm {3.23 in.} <FK>

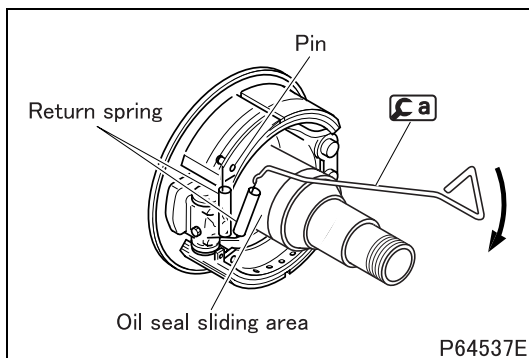
#### ■ Removal: Return spring

- Fit into the hooked part at one end of the return spring and use it to pry the return spring free.

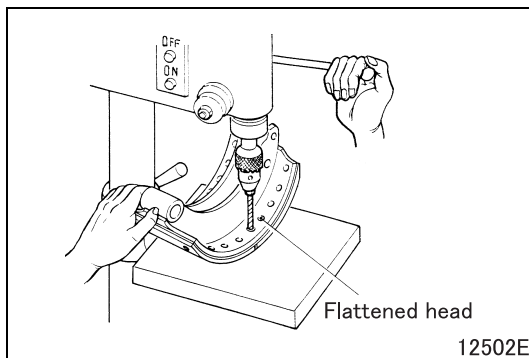
#### ■ Removal: Brake lining

- Using a drilling machine, break the flattened rivet heads on the brake shoe side to release the brake lining.

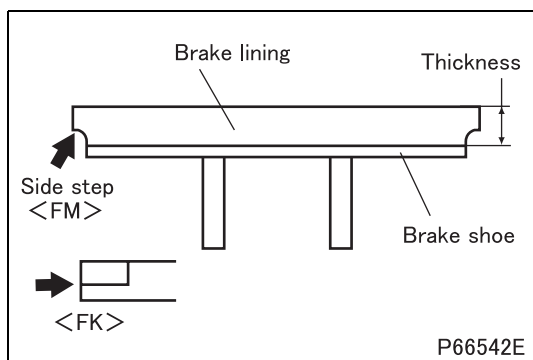
### ■ Inspection: Brake lining thickness

- If the brake lining is worn down to the side step, replace all brake linings on that axle.

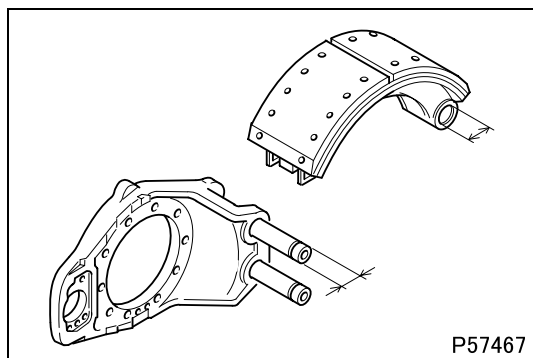
### ■ Inspection: Clearance between anchor pin and bushing

- If the measurement exceeds the limit, replace the bushing.

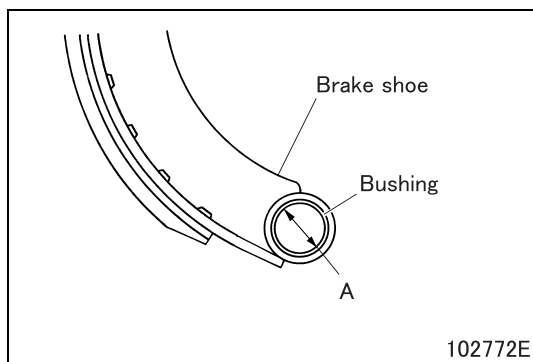
- With the bushing installed in the brake shoe, measure the inner diameter of the bushing.
- If the measured value is out of the dimension A shown below, ream the bushing.

$$35^{+0.05}_0 \text{ mm } \{1.38^{+0.002}_0 \text{ in.}\} <FM>$$

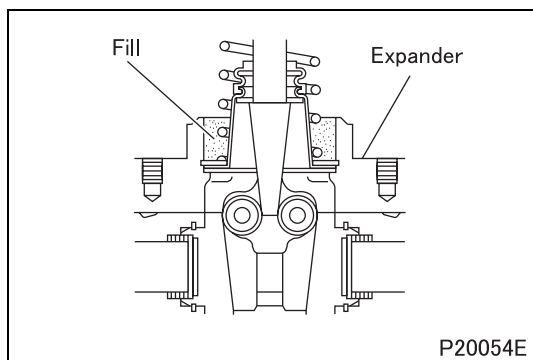
### ■ Installation: Expander

- Fill the expander with the specified quantity of grease as shown in the illustration.

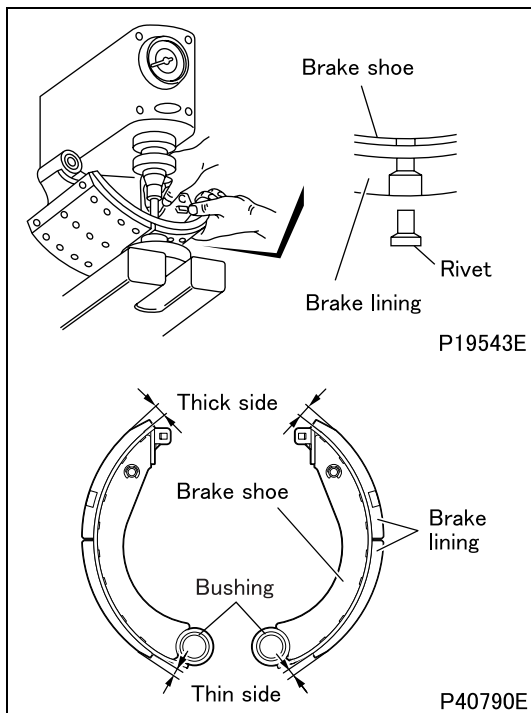
### ■ Installation: Brake lining

- Using cleaning fluid, clean the brake shoe surface to which the brake lining is to be mounted. Then, dry the shoe surface.
- Mount the brake lining on the brake shoe with the thin side of the brake lining pointing the bushing for the brake shoe.
- Insert rivets from the brake lining to the shoe. Stake them, starting from the center of the shoe towards the ends.
- The staking load for the rivets should be  $19.6 \pm 0.98 \text{ kN}$   $\{4410 \pm 220 \text{ lbs}, 2000 \pm 100 \text{ kgf}\}$ .

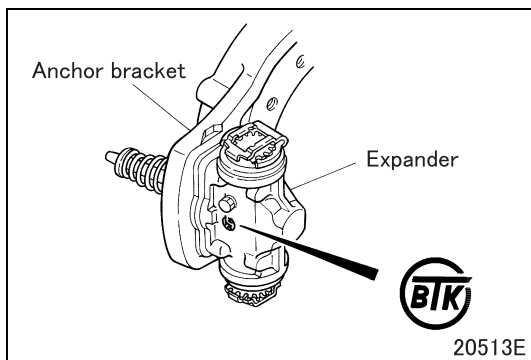
### ■ Installation: Brake shoe

- Turn adjusting screw of expander assembly fully clockwise by hand.
- Install clip with the open side facing the drum. Turn adjusting screw further clockwise to match the position if alignment is incorrect.

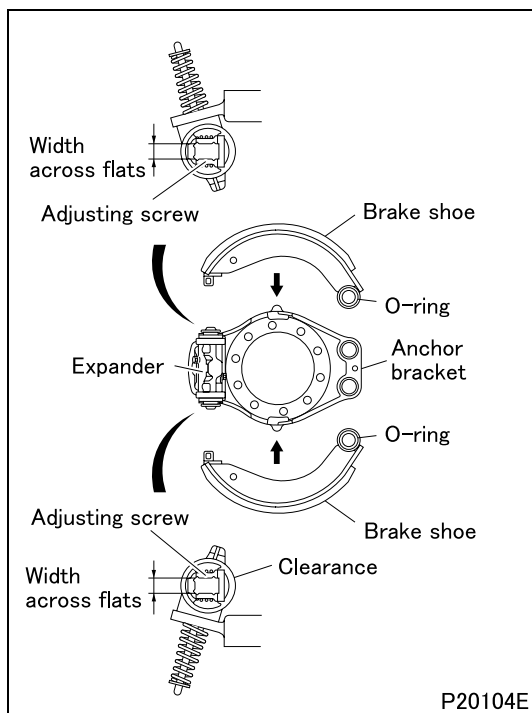
- Install brake shoes such that their end may accurately fall within the width across flats of clip.

- When installing brake shoes, be careful not to damage clips and O-rings.

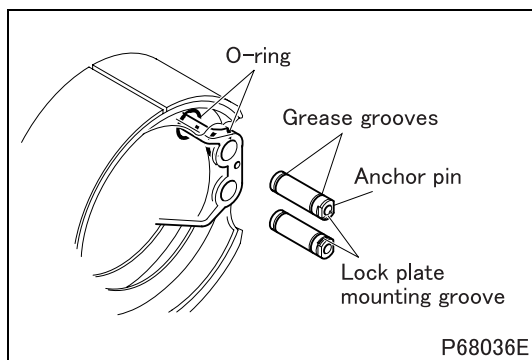
- Apply grease in grease grooves of the anchor pins.
- Install anchor pins in the illustrated direction.

- Take care not to install anchor pins in the wrong direction. Otherwise, damaged O-rings will result.

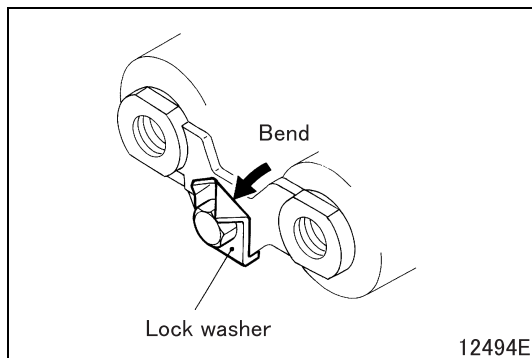
## ■ Installation: Lock washer

- After tightening the lock plate bolt to the specified torque, stake the lock washer at one location.

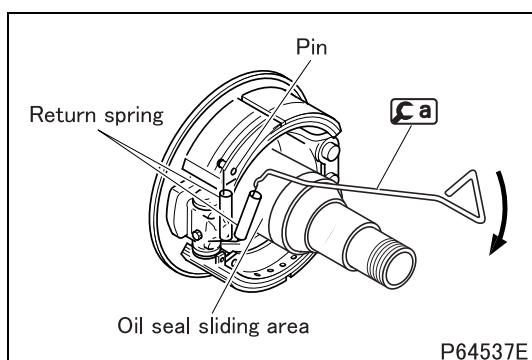
## ■ Installation: Return spring

- Fit the hooked part at one end of the return spring onto the pin in one of the brake shoe.
- Fit the hooked part at the other end of the return spring onto

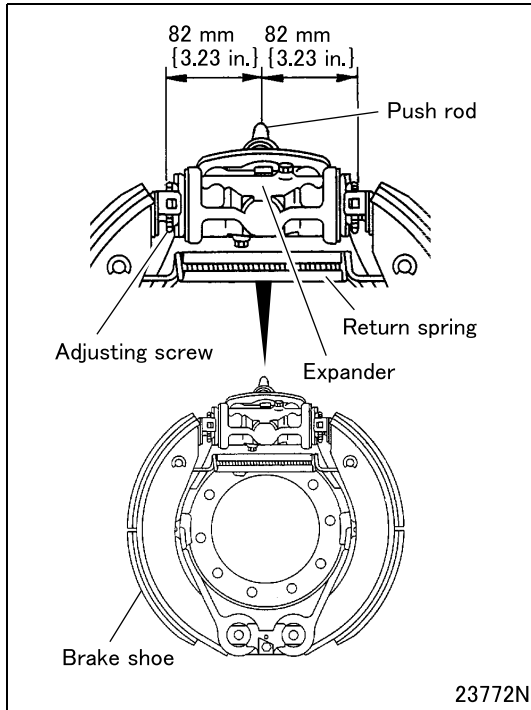
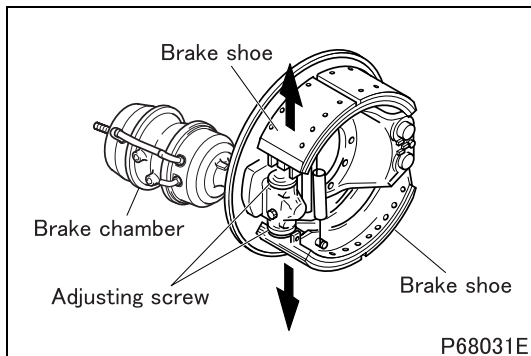
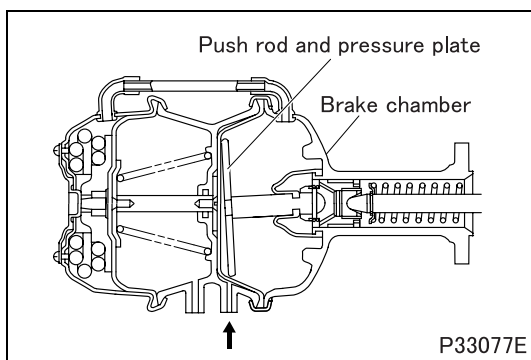
### ■ Inspection: Check of operation

- Ensure that the installed dimension of 82 mm {3.23 in.} is satisfied on the expander. If not, disassemble the expander and reinstall the adjusting screw(s). (See later section.)
- Reinstall the expander and brake shoes.
- Expand the brake shoes by pushing the push rod over its full stroke.
- Return the push rod to its original position and check whether the expander returns to the required dimension of 82 mm {3.23 in.}.
- If the results are unsatisfactory, check the force of the brake springs and the degree of stiffness in the brake shoes. Also inspect the expander again.

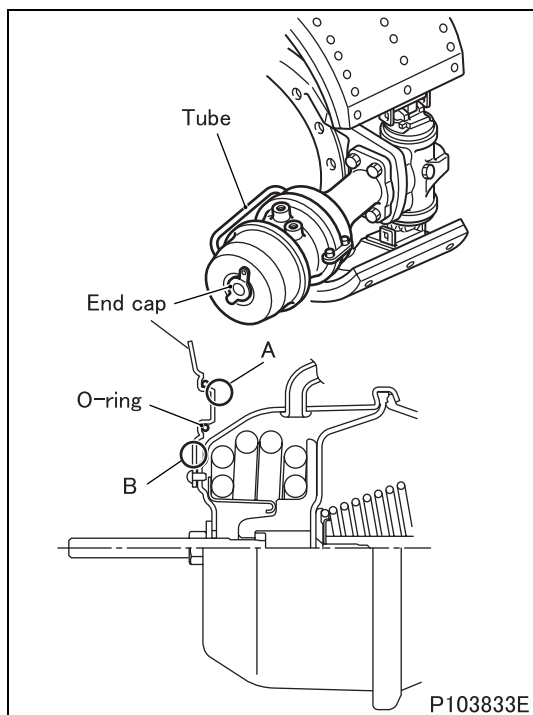
## ■ Cancellation of mechanical release of parking brake

- To cancel the mechanical release of parking brake, perform the mechanical release procedure in reverse while confirming the following items.  
(See “■ Mechanical release of parking brake”.)
- Clean the end cap mounting position and confirm that there is no water or dust in that position.
- Confirm that an O-ring is attached to the end cap.
- Using a  $\phi 15$  mm or thinner rod with a dull end such as a release bolt, push in the concave section at the center of the end cap squarely into the piggy back. A click is heard when the section A is securely seated into the piggy back.
- When seating the end cap, be careful not to bend or twist the section B.
- Confirm that there is no damage on the tube and the tube is installed securely.

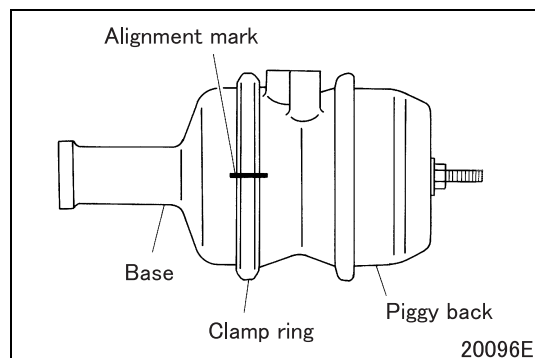
#### ■ Alignment mark: Brake chamber

- Put an alignment mark and then disassemble the clamp ring, pressure plate and base.

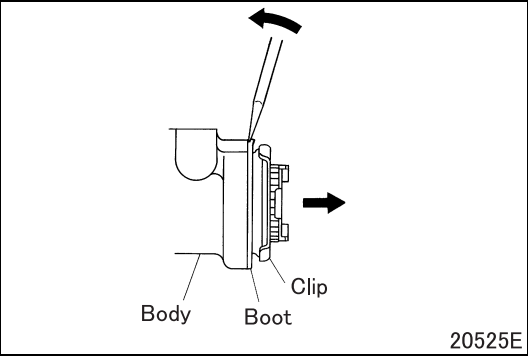
#### ■ Removal: Adjusting screw and boot

- Using a flat-blade screwdriver, break the connection between boot and body.
- Turn adjusting screw assembly counterclockwise to remove the adjusting screw assembly together with boot.

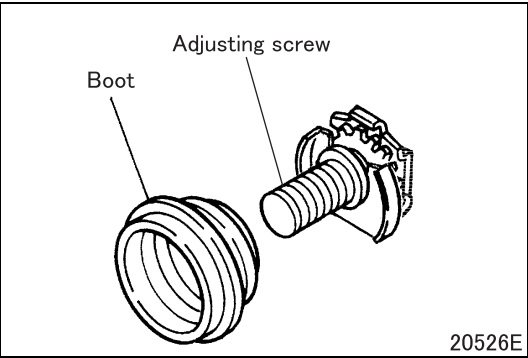
- Remove boot from adjusting screw assembly.

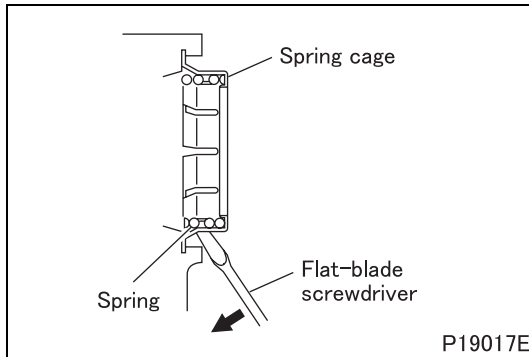
#### ■ Removal: Spring cage

- Remove spring cage while holding it with fingers so as to prevent spring from springing out.

- Be careful of spring springing out.

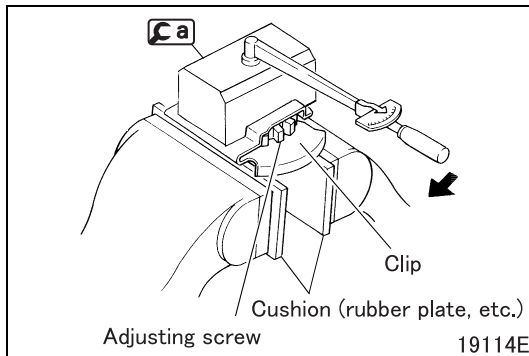
#### ■ Inspection: Clip

- Clamp adjusting screw in a vise.

- Use cushions such as rubber plates between jaws to prevent damage to adjusting screw. Damaged threads of the adjusting screw can cause the automatic adjusting mechanism to fail to operate properly.

to the clip.
- The reading when clip starts to turn shows the holding torque.
- If the measured value deviates from the standard value, replace the clip.

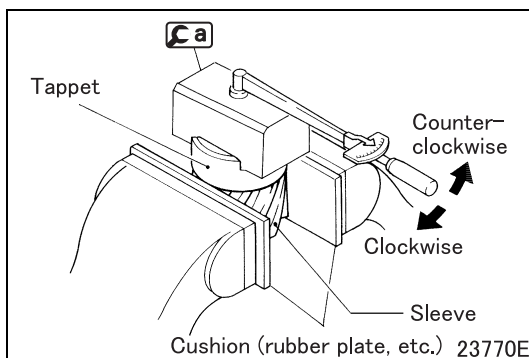
#### ■ Inspection: Rotating torque of sleeve <FK>

- Clamp sleeve assembly in a vise.
- Install

.
- Read the torque when tappet starts to turn.
- If the measured value deviates from the standard value, replace the sleeve.

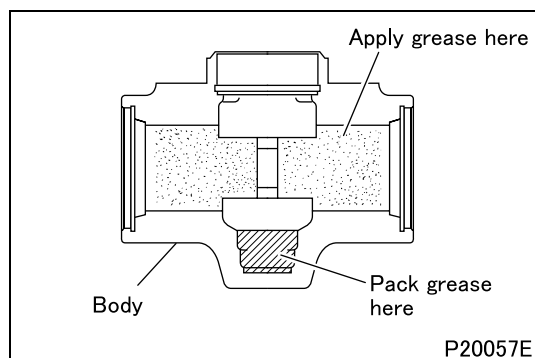
## ■ Installation: Body

- Coat inner surface of the body with grease.
- Fill the portion shown in the illustration with grease.

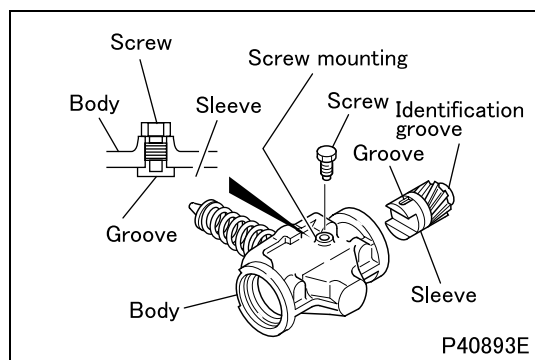
- If screw is not inserted up to the position shown, the screw is possibly not in slot in sleeve.
- Check that sleeve does not fall off.

- The sleeve to be used differs from each other depending on the type of brake. Select a proper sleeve for the brake by checking the identification grooves provided in the tip of the sleeve.  
2 identification grooves <FK>  
No identification groove <FM>
- Apply grease to the outer periphery, threaded area and roller contacting surface of sleeve.
- Align slot in sleeve with screw fitting hole in body to fit the sleeve.
- Apply sealant to the threads of screw and tighten the screw to the specified torque.

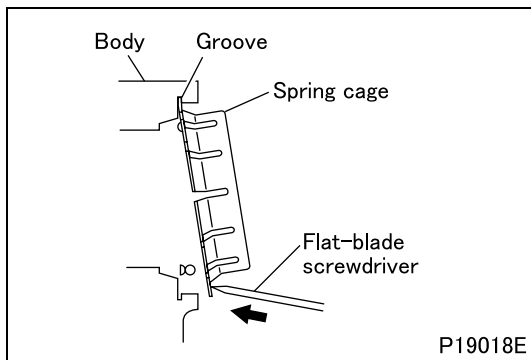
#### ■ Installation: Spring cage

- Fit one side of the spring cage into the groove of the body.
- Using a flat-blade screwdriver, push the other side of spring cage in position.

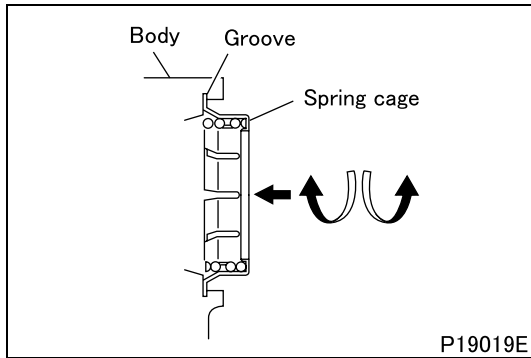
- To check that the spring cage is securely fitted in the groove of the body, turn the spring cage while pushing it. If it turns smoothly, it shows proper fit.

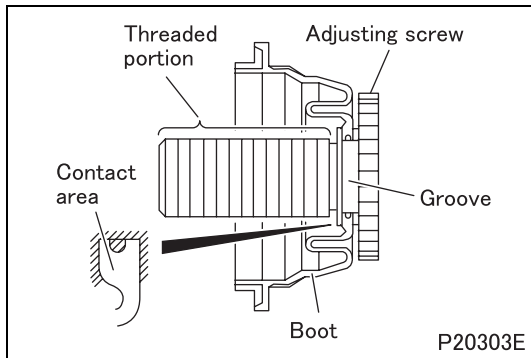
#### ■ Installation: Adjusting screw and boot

- Apply grease to the boot at the contacting area with the adjusting screw and to the thread area of the adjusting screw.
- Fit the boot into the groove of adjusting screw.

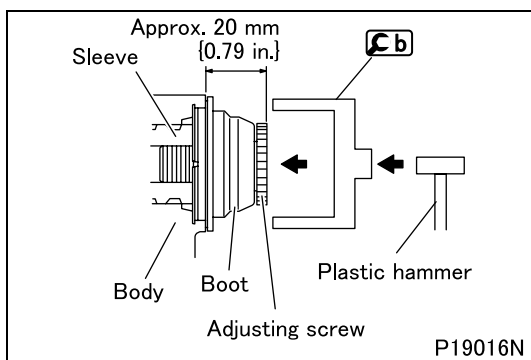
- Screw the adjusting screw in the sleeve until the end face to end face distance between the adjusting screw and the body is approx. 20 mm {0.79 in.}.
- Lightly pull at the adjusting screw to make sure that the sleeve slides.
- Press-fit the boot with **Cb**.

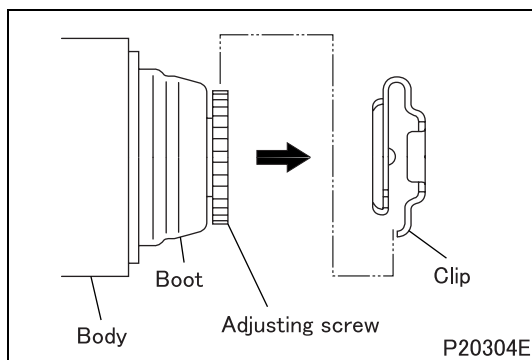
## ■ Installation: Clip

- To facilitate fitting the clip to the adjusting screw, turn the adjusting screw until it comes off the boot.
- Fit the clip.

- Use care not to damage boot when fitting the clip.

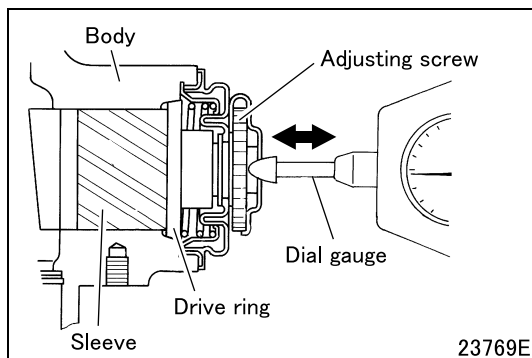
## ■ Inspection: Backlash between drive ring and sleeve

- Apply the probe of the dial gauge to the adjusting screw and move the assembly in the arrow direction to measure the backlash between the drive ring and the sleeve.
- If the measured value deviates from the standard value, replace the drive ring and sleeve.

- When measuring the backlash, be careful so that the drive ring, pushed by the sleeve, does not move off from the body.

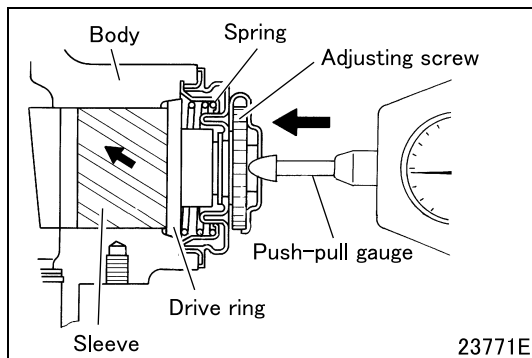
## ■ Inspection: Automatic adjuster mechanism actuating force

- Pull the adjust screw (as much as it cannot be pulled any further). This makes the sleeve to push the drive ring against the force of the spring and the drive ring comes apart from the body.
- Back off the adjust screw (as much as possible with light force) in the direction of the arrow until the backlash between the drive ring and sleeve is eliminated.
- Using a push-pull gauge, push the adjust screw in the direction of the arrow. While doing this, note the maximum reading on the gauge.
- If the measurement deviates from the standard value, replace the sleeve.

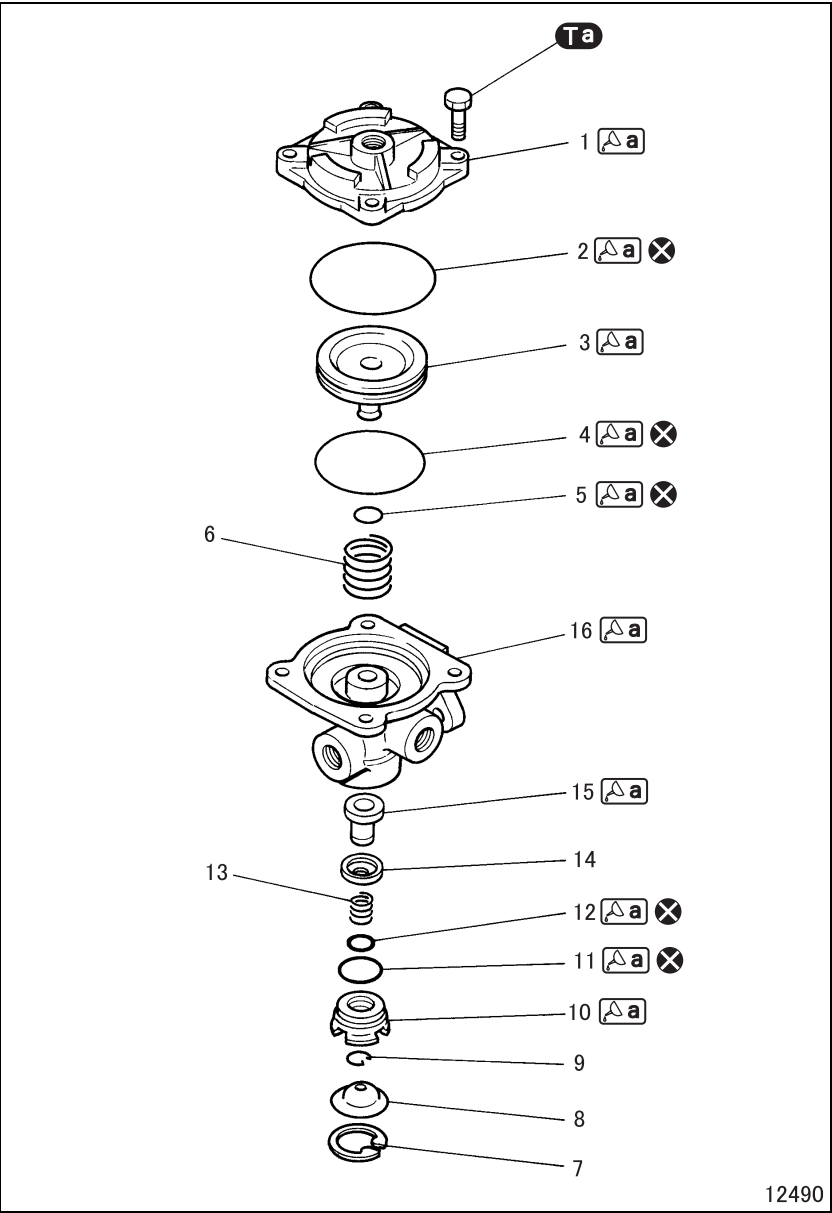
● Disassembly sequence

- 1 Cover
- 2 O-ring
- 3 Relay piston
- 4 O-ring
- 5 O-ring
- 6 Spring
- 7 Retaining ring
- 8 Exhaust cover
- 9 Retaining ring
- 10 Valve guide
- 11 O-ring
- 12 O-ring
- 13 Spring
- 14 Valve retainer
- 15 Inlet valve
- 16 Body

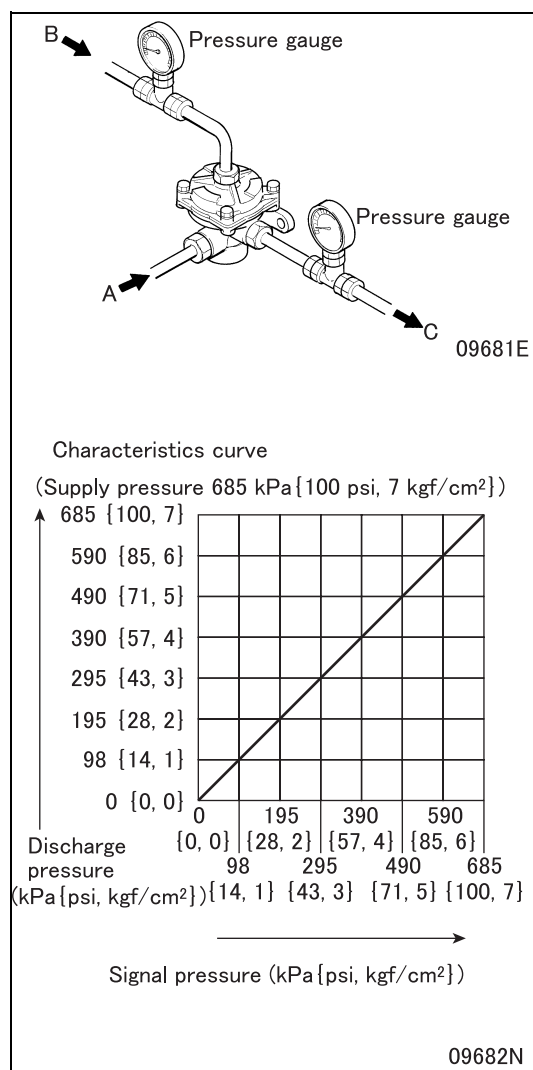
#### ■ Adjustment: Relay value

- Mount the gauges on the pipes as illustrated. Apply pressurized air to air supply port A and indicated pressure port B, and measure the difference in operating pressure between the indicated pressure and the discharge pressure.

If any fault is found, replace springs.

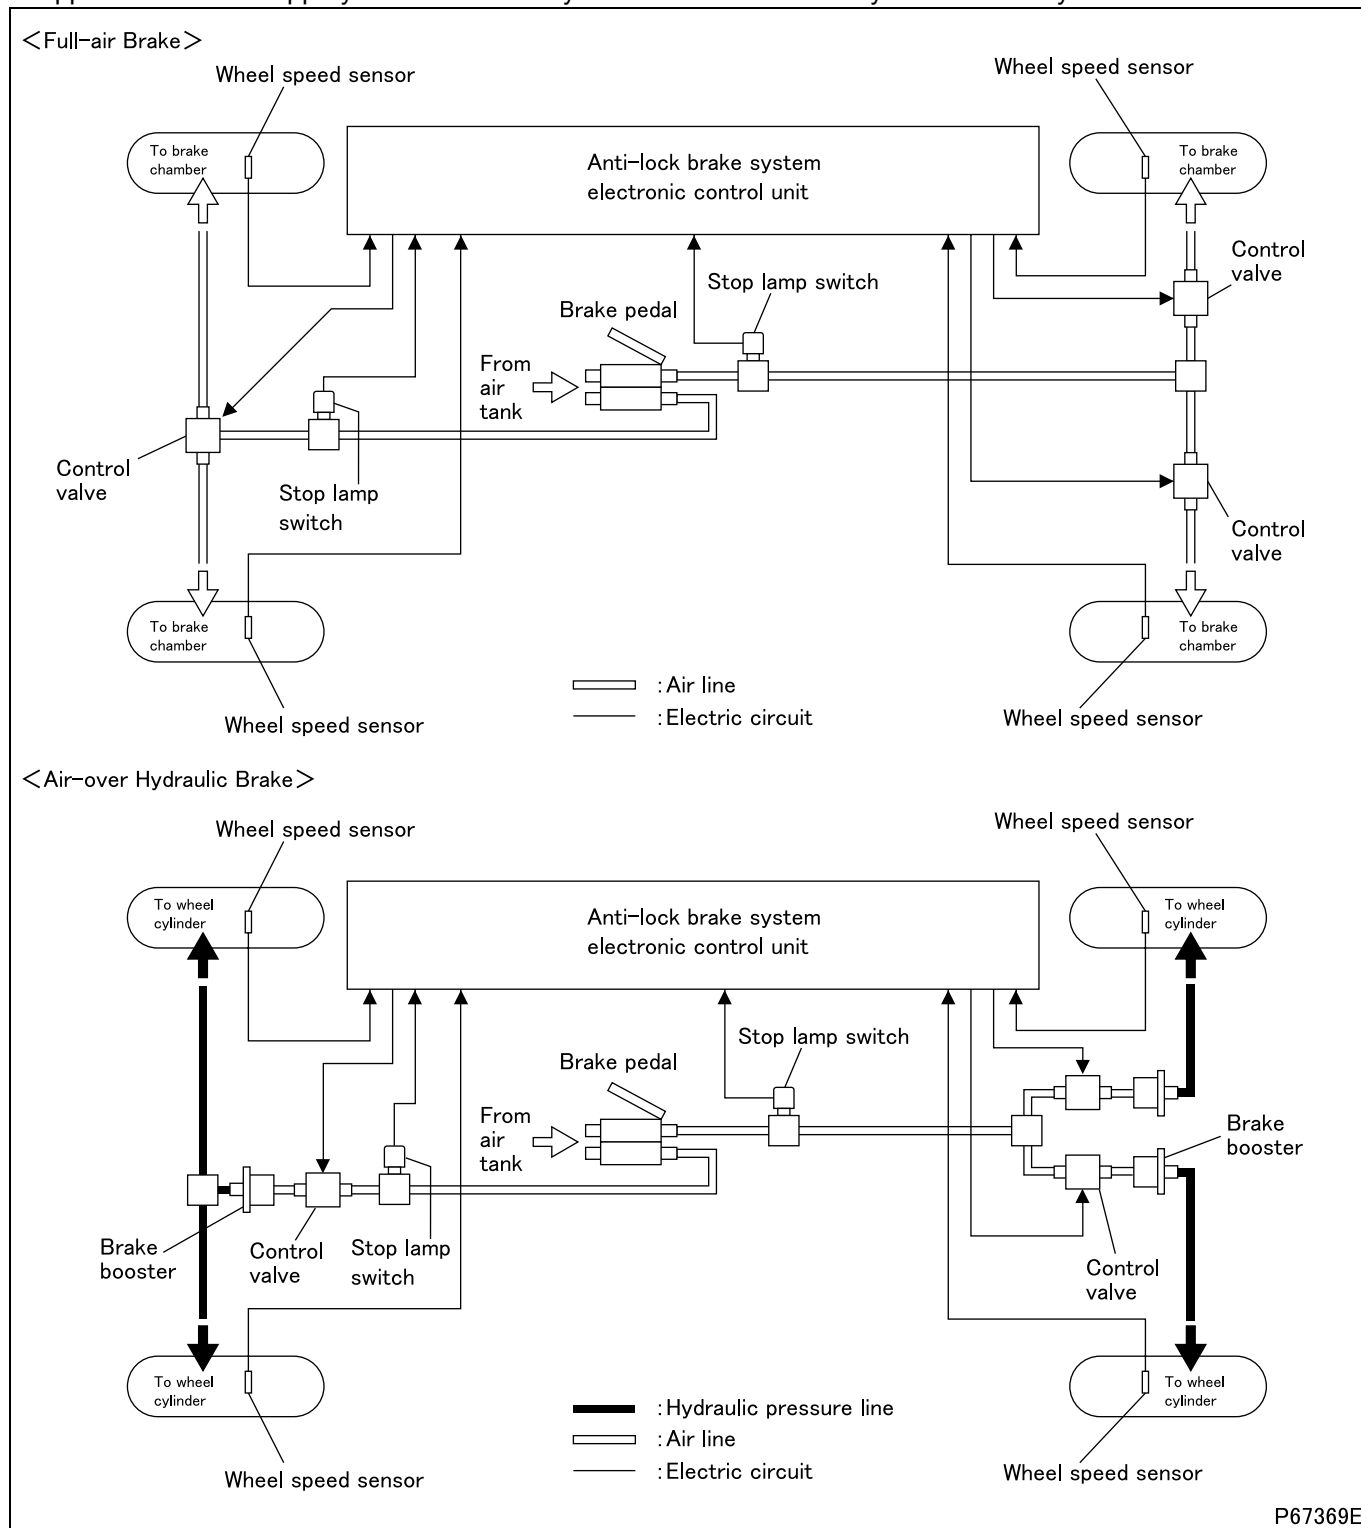
- The anti-lock brake system (ABS) prevents wheel lock-up and resultant skid that can occur when the brakes are applied hard or on slippery roads and thereby maintains vehicle stability and steerability.

- Shown above is not a piping diagram but an illustration for explaining about the structure and operation of the anti-lock brake system. For details of the system piping diagram, see Gr35.

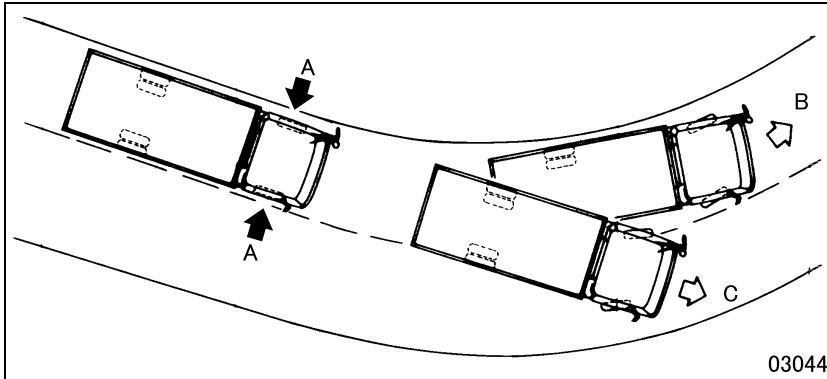
### (1) Wheel lock-up on slippery curve

- If a wheel lock-up occurs during braking on a slippery curve, the vehicle will lose steerability and may skid out of the intended course no matter how the driver manipulates the steering wheel.
- A: Brakes application point (wheel lock-up)  
B: Intended course  
C: Skidding out of course

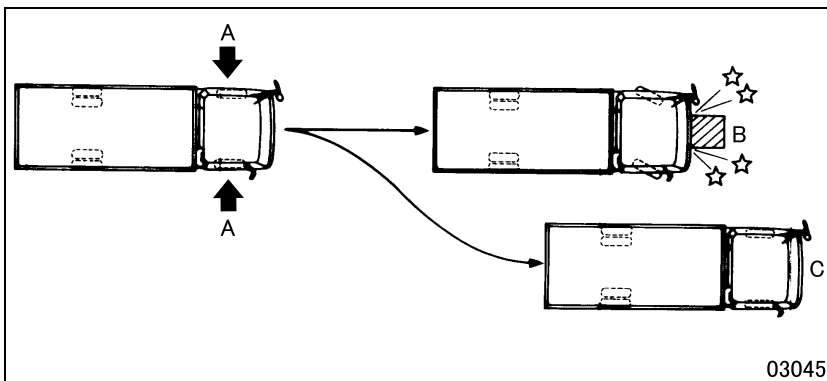
### (2) Wheel lock-up on slippery straight road

- If a wheel lock-up occurs on a slippery straight road during hard braking in an attempt to avoid an obstacle ahead, the vehicle will lose steerability and will not be able to avoid the obstacle no matter how the driver maneuvers the steering wheel.
- A: Brakes application point (wheel lock-up)  
B: Obstacle  
C: Course to avoid obstacle

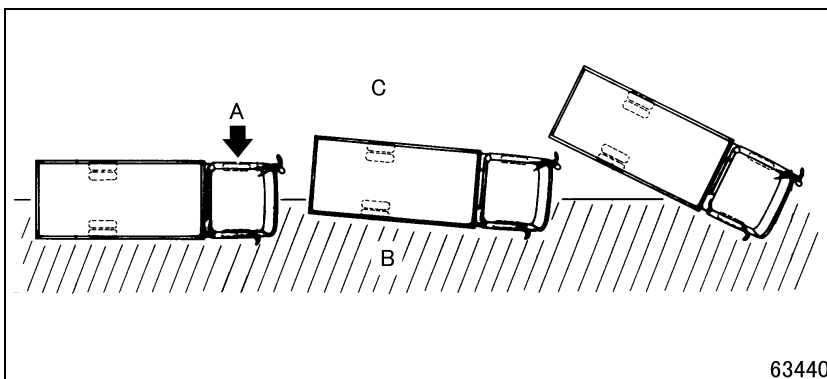
### (3) Split $\mu$ (wheel lock-up on road surface different in coefficient of friction between left and right sides)

- Tires in contact with one side of the road that has a smaller coefficient of friction tend to slip more easily than those on the other side and lock up first. In this state, braking efficiency is out of balance between the wheels and the vehicle can lose stability and go out of steering control. Braking hard under such conditions can cause the vehicle to spin.
- A: Brakes application point (wheel lock-up)  
B: Less slippery road surface  
C: More slippery road surface
