# FE.FG

## SERVICE MANUAL 2008 Model FOREWORD

This Service Manual contains maintenance and repair methods for the Mitsubishi Fuso Truck FE. FG Series. Read this manual carefully as an aid in providing correct, efficient maintenance. Please note that the information and specifications contained within this manual may change without notice. This is due to product modifications and continued vehicle improvements that are made throughout the model years. Should you encounter any discrepancy in the information provided, please do not hesitate to contact your nearest Mitsubishi Fuso Dealer or Mitsubishi Fuso Truck of America, Inc.

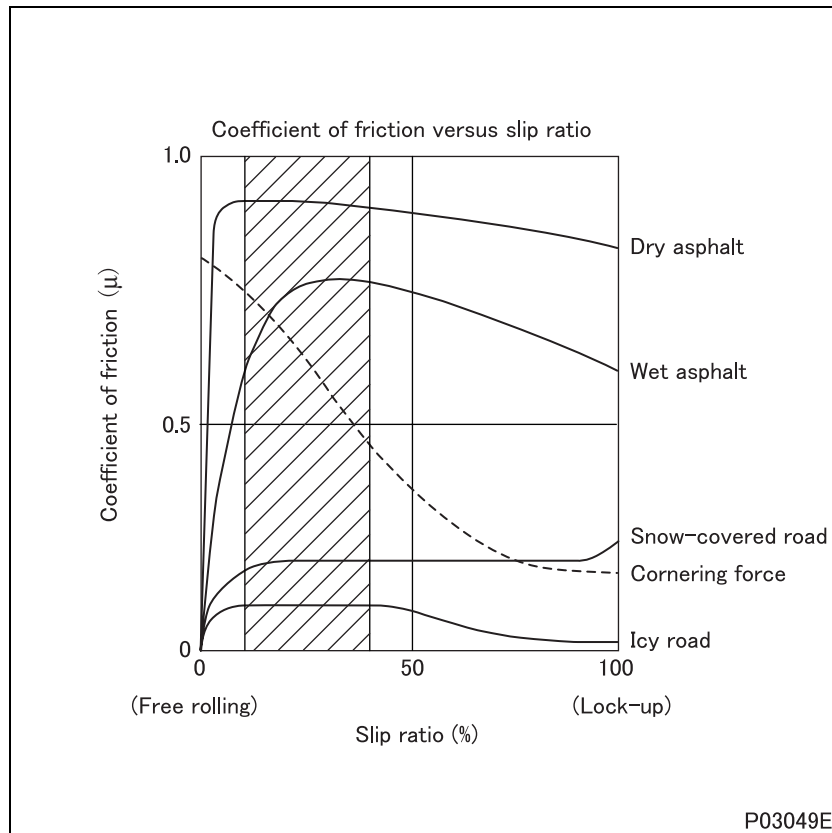
- A slip ratio of 0% means that there is no slip between the wheel and road surface. A slip ratio of 100% represents a wheel lock-up.

- The graph shows the change in the tire's coefficient of friction during the process of free rolling to lock-up; as the brake pedal is gradually pressed, the tires begin to slip while rolling along on the road surface.
- Pressing the brake pedal further causes the tires to stop rolling and only slip. This is a wheel lock-up.
- As the graph shows, the coefficient of friction peaks when the slip ratio comes within the hatched range.
- In other words, the maximum coefficient of friction of the tires can be obtained if the slip ratio is brought within the hatched range by applying the brakes, not hard but moderately.
- On vehicles equipped with anti-lock brake system, the electronic control unit controls the braking force to be within the hatched range so that the tires are not locked but have a maximum coefficient of friction, thereby ensuring stable braking performance.

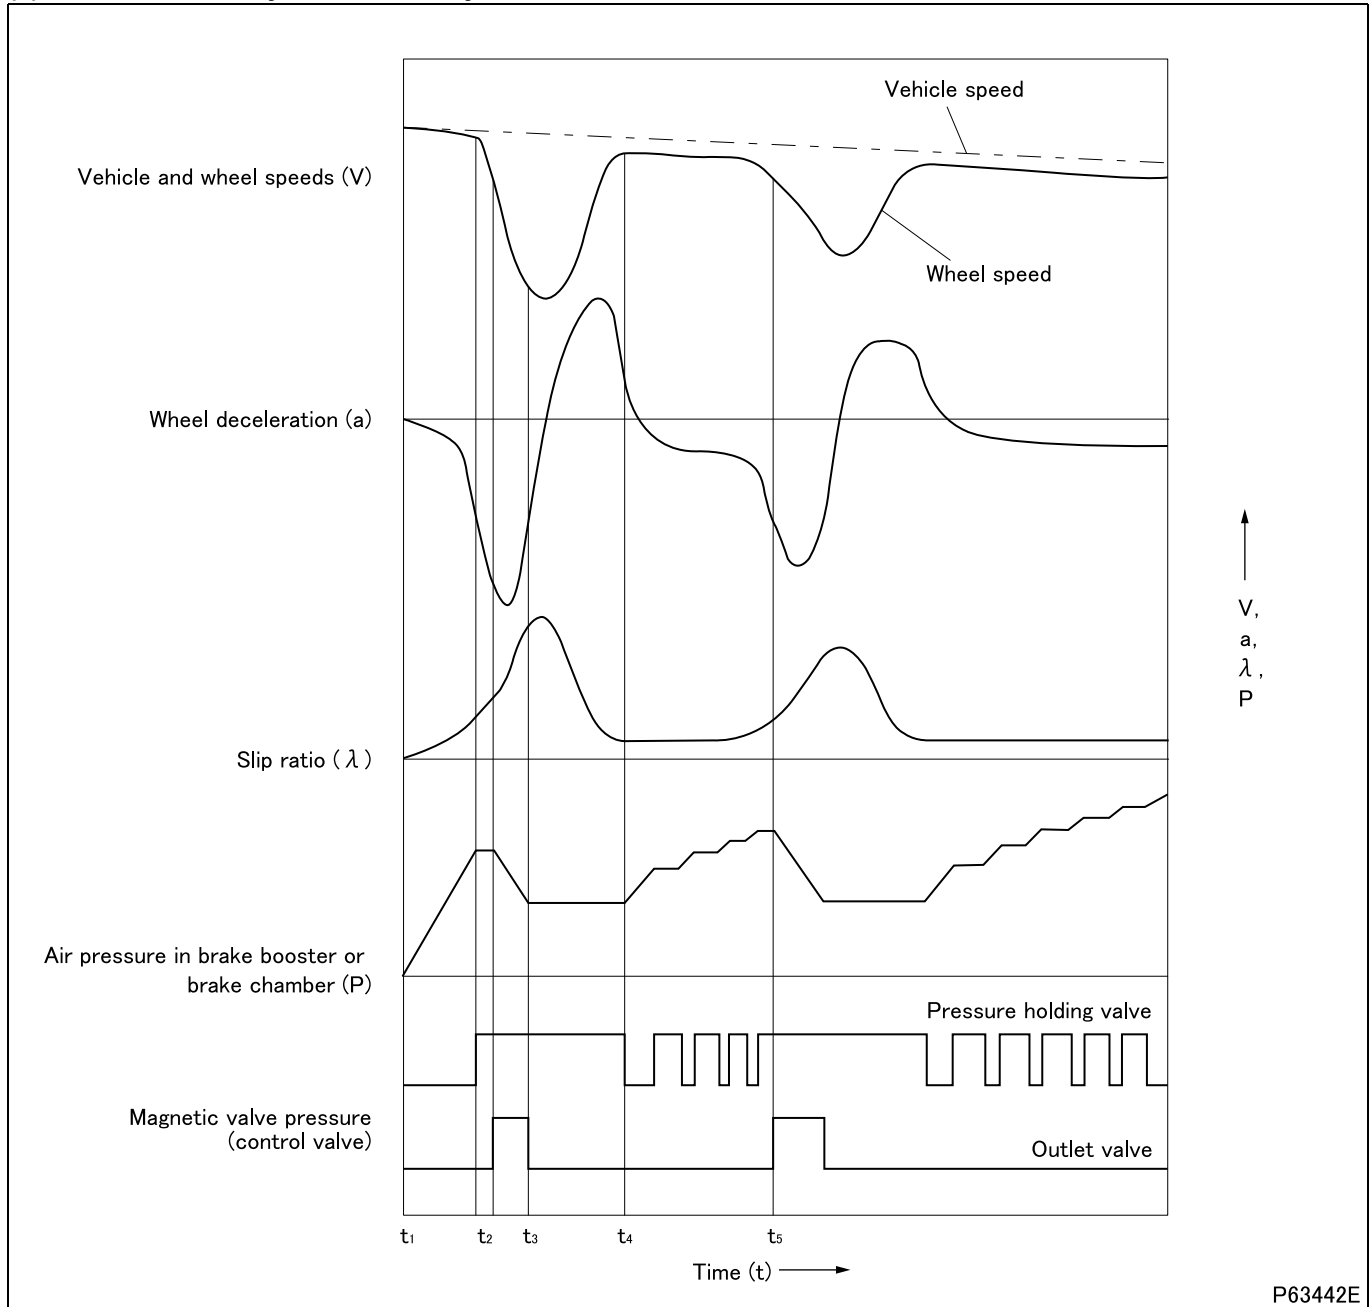
## (1) Anti-lock brake system control cycle

- The above chart depicts the control characteristics of the anti-lock brake system, indicating changes in vehicle speed, wheel speeds and brake booster or brake chamber air pressures with the lapse of time (t) after the application of brakes.
- The electronic control unit computes the wheel speeds while estimating the vehicle speed according to wheel speed sensor output signals received and thus constantly monitors wheel slip ratio and wheel deceleration.
- When the electronic control unit detects a wheel lock-up being imminent, it sends control signals to the appropriate magnetic valves in the control valves. Required anti-lock control is thus effected as shown in the above chart.

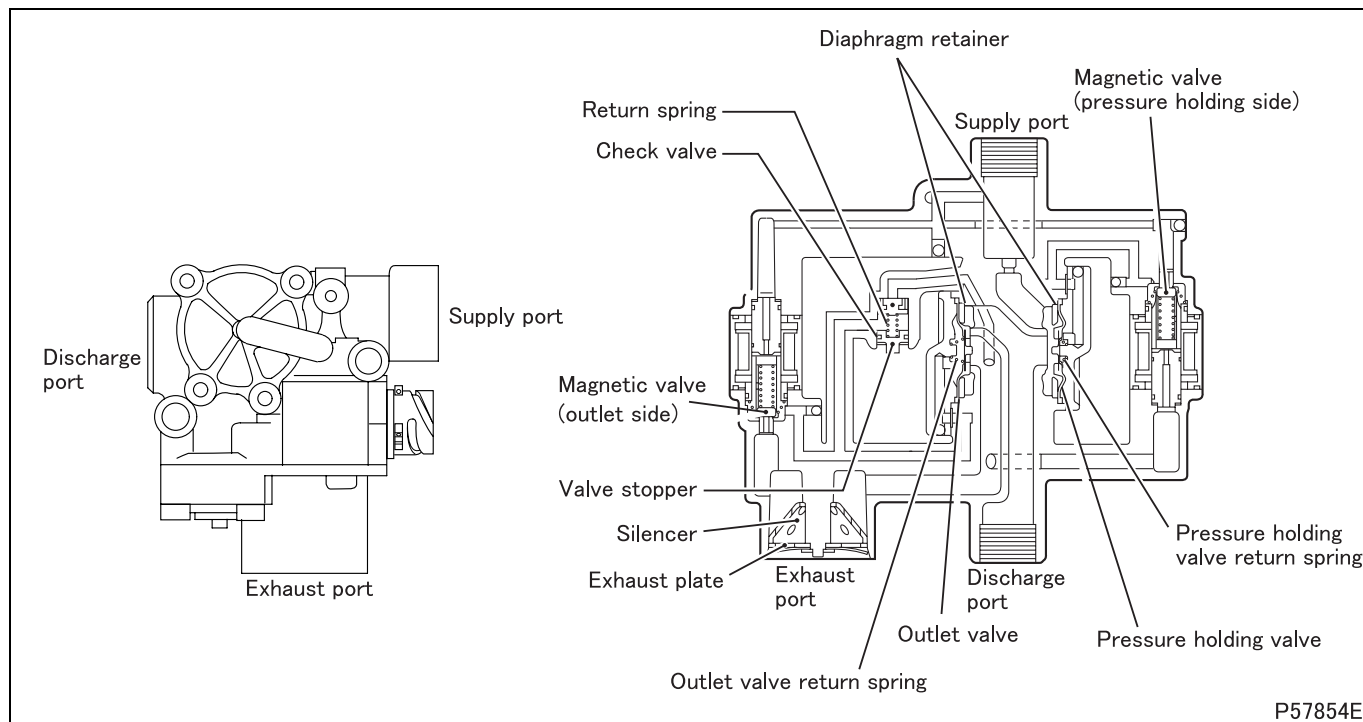
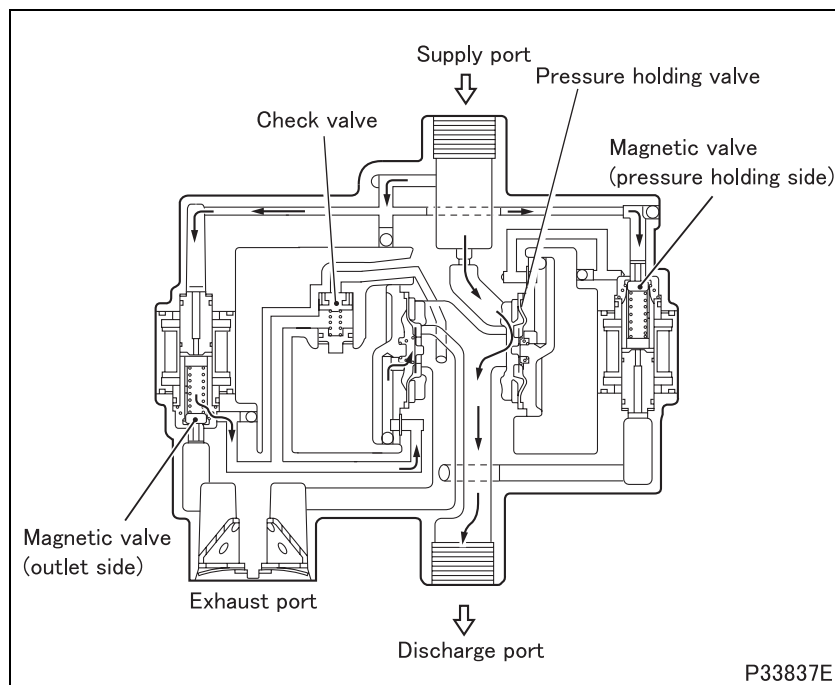
### (1) Normal braking

- At normal braking, if there is no wheel lock-up tendency, the magnetic valve does not actuate. Air pressure that is the same as that from the dual brake valve is pressure-fed to the brake booster or brake chamber.
- Normally, the air pressure from the air discharge port is released from the exhaust port when the brake pedal is disengaged, but if the exhaust port is blocked by freezing, etc., the air pressure at the discharge port acts upon the pressure holding valve causing drag of the brakes.

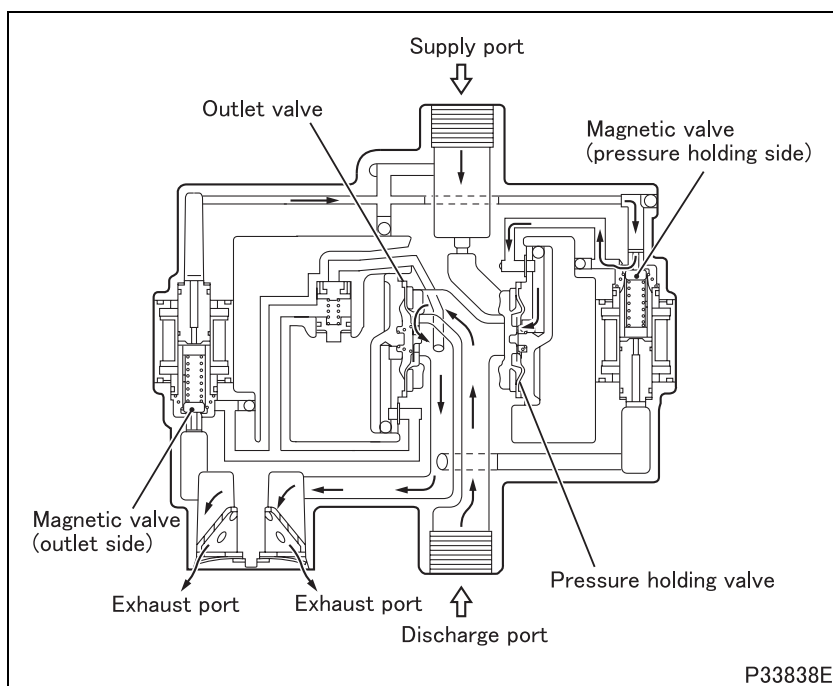
## (2) When pressure decreased

- When braking is applied at  $t_1$  in the anti-lock brake control cycle above, the air pressure in the brake booster or brake chamber rises, the vehicle speed and wheel speed both begin to drop, and when the wheel show the lock-up tendency at  $t_2$ , the control signal is sent from the electronic control unit to turn on the magnetic valve (holding valve) and magnetic valve (outlet valve).
- The pressure holding valve closes and the outlet valve opens. This discharges and decreases the air pressure in the brake chamber, and eases the lock-up tendency of the wheel. ( $t_2$  to  $t_3$ )

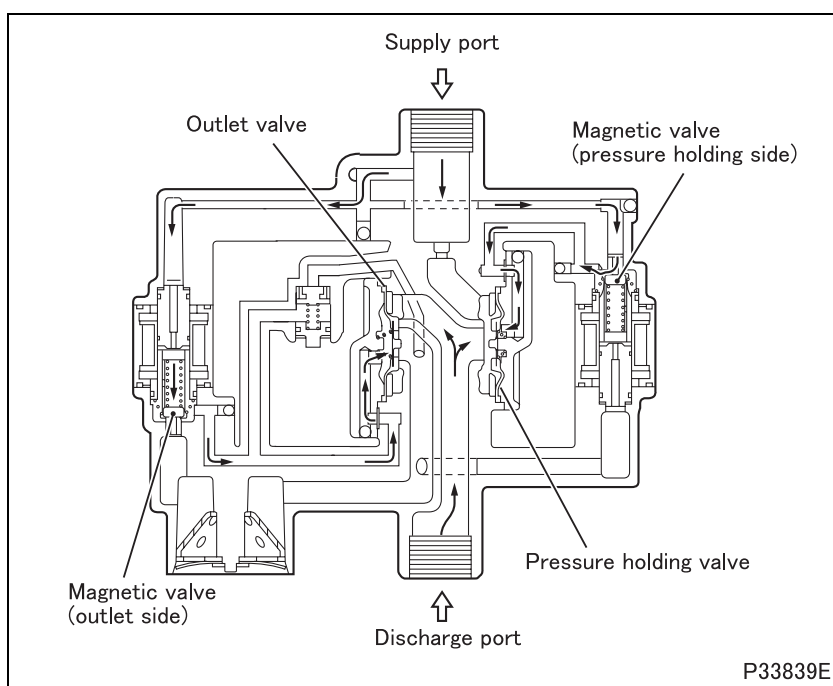
## (3) When pressure held

- The magnetic valve (outlet valve) at  $t_3$  in the anti-lock brake system control cycle above turns off, the outlet valve closes, the air pressure in the brake booster or brake chamber is held, the slip ratio approaches  $\lambda=0$ , and the wheel speed accelerates.
- At  $t_4$ , the magnetic valve (holding) repeats turning on and off until it reaches  $t_5$  and momentarily releases the pressure holding valve which causes the pressure to rise gradually. Then the wheel speed decelerates. This control cycle (from  $t_2$  to  $t_5$ ) repeats until the vehicle stops.

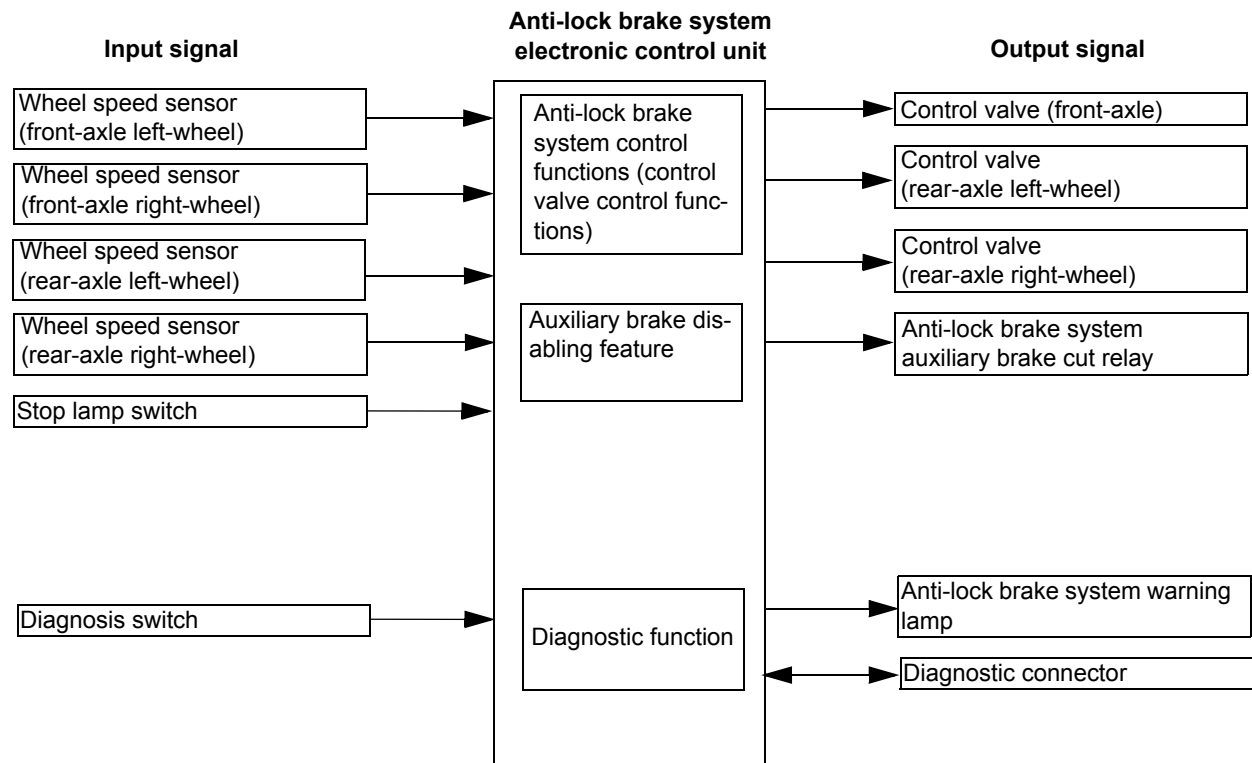
### 2.1 System block diagram

| Part name | Primary function or operation |
| Wheel speed sensor | Detection of wheel speed |

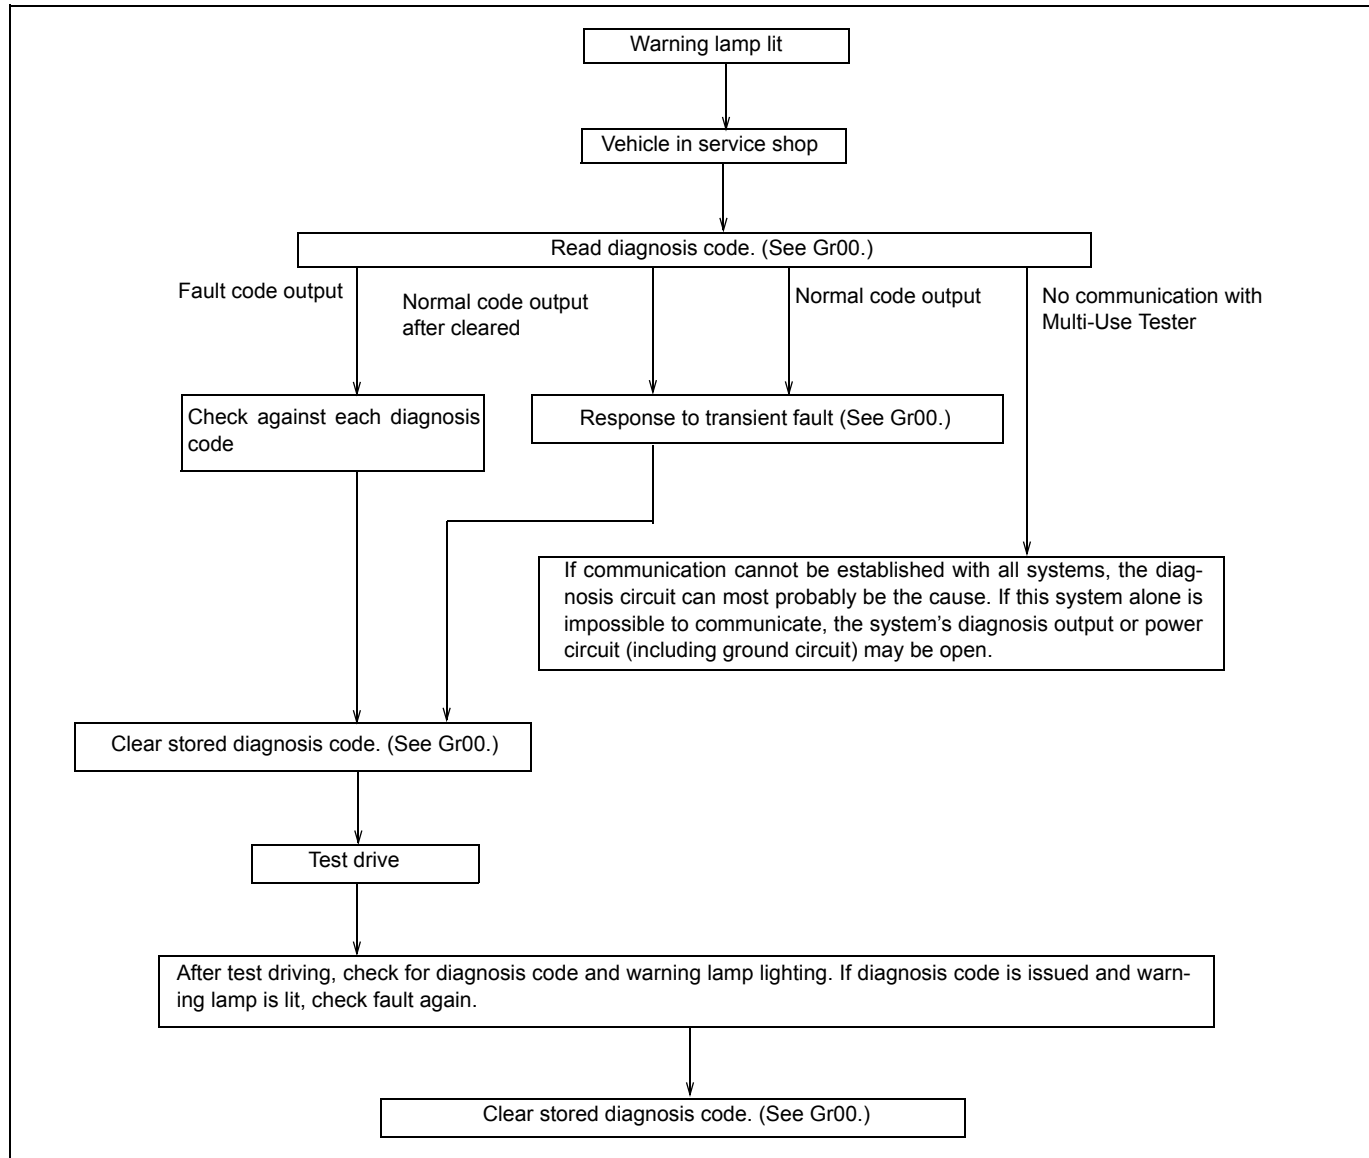
## 1. Diagnosis Procedure

- The system should be inspected in accordance with the following flowchart.  
System inspection can be accomplished basically in two ways according to trouble symptom and diagnosis code as shown below.
- Check against each diagnosis code stored in memory by the electronic control unit
- Response to transient fault

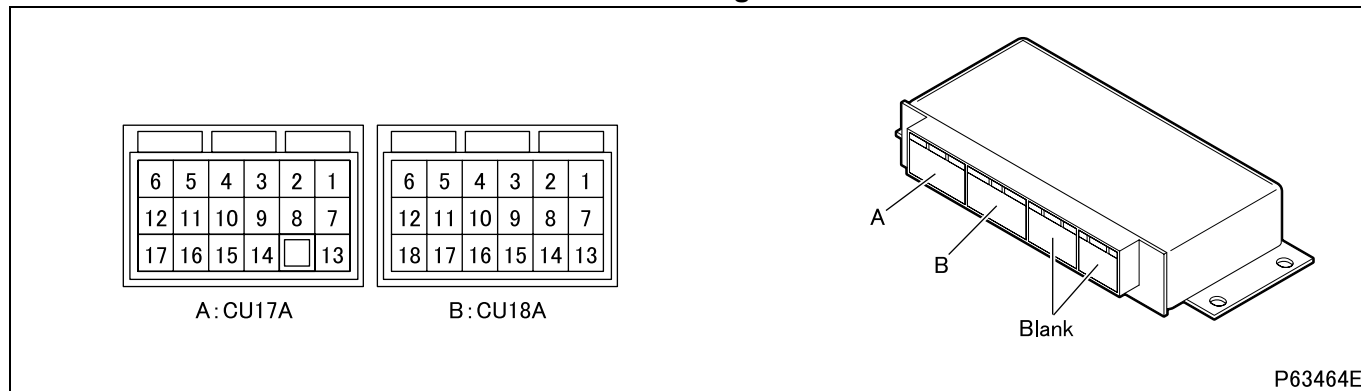
### 7.1 Electronic control unit connector terminal arrangement

- As essential part of troubleshooting, this inspection is performed to ensure that various signals from the electronic control unit are duly transmitted via vehicle harnesses and connectors. Note that **01**, **02**... shown in the table are also found in “3. Inspection Based on Diagnosis Code” of this manual.

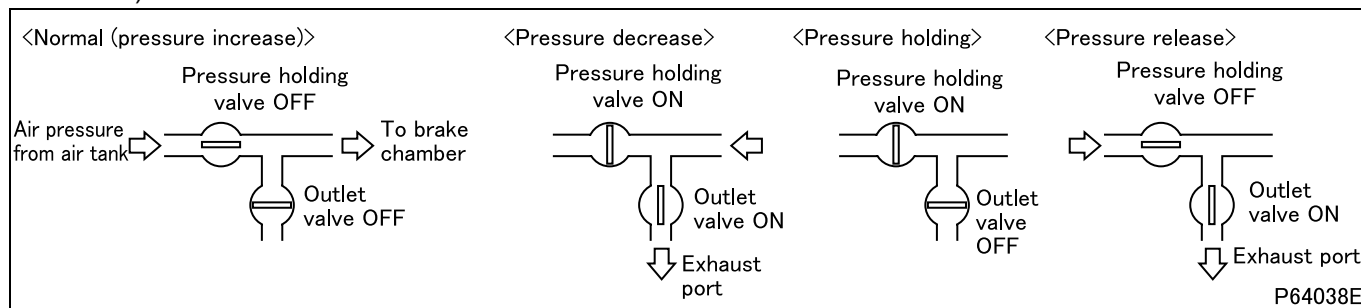
### 1.3 Operational inspection of control valve

- The operational inspection of the control valve for each wheel is performed by effecting a train of relative workings of its outlet and pressure holding valves (to increase, decrease, hold and release pressure).
- The operation of the control valve is as depicted below. (For details, see "STRUCTURE AND OPERATION" in this manual.)

- For the inspection, use Multi-Use Tester actuator test procedures.
  - Actuator test No. 21 to 24 (anti-lock brake system valve test 1): Inspect the control valve by effecting false activation of the electronic control unit with pressure decreased, pressure held and pressure slowly increased (repetition of pressure increase and holding).
  - Actuator test No. 25 to 28 (anti-lock brake system valve test 2): Check for air exhaust noise and braking power by making the control valve operate (to release, increase, decrease and hold pressure).

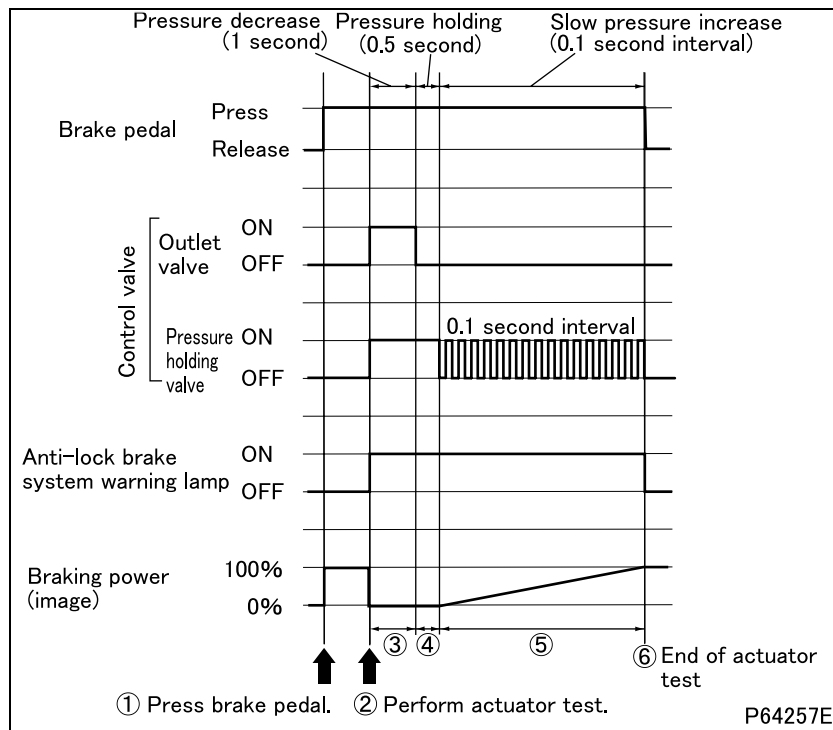
## (3) Inspection with false activation of anti-lock brake system

- Hold the brake pedal down throughout the actuator test. (1)
- Perform Multi-Use Tester actuator test [anti-lock brake system valve test 1] on the wheel under inspection. (2)
- Both the outlet and pressure holding valves are activated (ON). Air pressure in the brake chamber is decreased (for 1 second). Verify by the brake tester that the pressure decrease results in a drop in braking power. (3)
- Air pressure in the brake chamber is held for 0.5 second with the outlet valve deactivated (OFF) and the outlet valve activated (ON). Braking power remains down. (4)
- The pressure holding valve minutely repeats a cycle of ON (pressure holding) and OFF (pressure increase). Braking power should gradually increase back to 100%. (5)
- The actuator test ends. Release the brake pedal. (6)
- If any abnormality is observed, inspect outlet and pressure holding valve workings of the control valve.

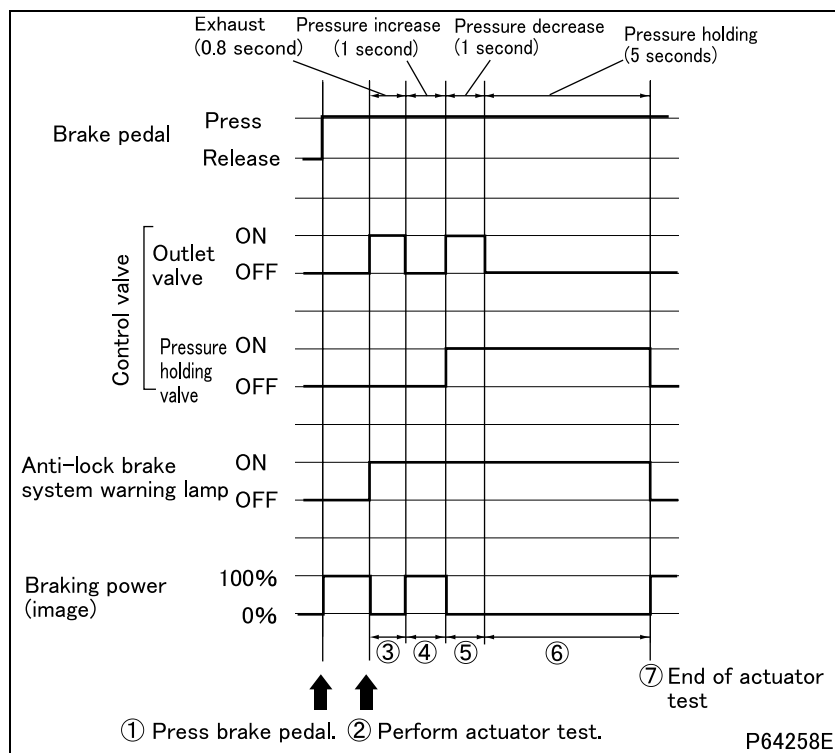
#### (4) Inspection of outlet and pressure holding valve workings of control valve

- Hold down the brake pedal throughout the test. (1)
- Perform Multi-Use Tester actuator test [anti-lock system valve test 2] on the wheel under inspection. (2)

- The outlet valve is activated (ON) and the pressure holding valve is deactivated (OFF). Air pressure from the brake chamber and air tank is let out (for 0.8 second). Braking power should drop with an air exhaust noise heard from the control valve. (3)

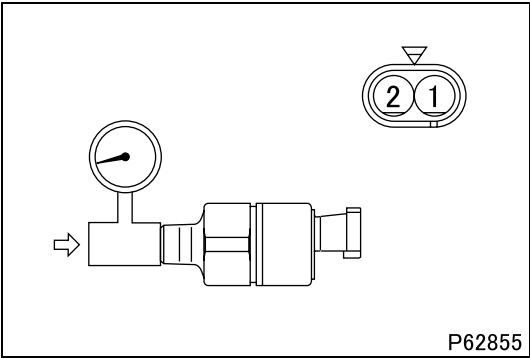
## #042 Inspection of stop lamp switch

- Perform the following checks. Replace the switch if faulty.
- (1) Check without air pressure applied**
  - Check that there is no continuity between the terminals 1 and 2.
- (2) Check with air pressure applied**
  - Apply air pressure slowly, starting with 0 kPa {0 psi, 0 kgf/cm<sup>2</sup>}.
  - Check that air pressure is at the standard value when continuity is established between the terminals 1 and 2.

| Standard value (working pressure) | $29 \pm 9.8 \text{ kPa}$<br>{ $4.2 \pm 1.4 \text{ psi}$ , $0.3 \pm 0.1 \text{ kgf/cm}^2$ } |

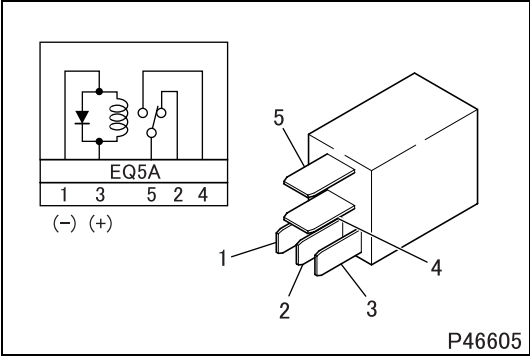
## #180 Inspection of relay (normally open 5-pin relay)

- Check the relay for continuity and function. If faulty, replace the relay.

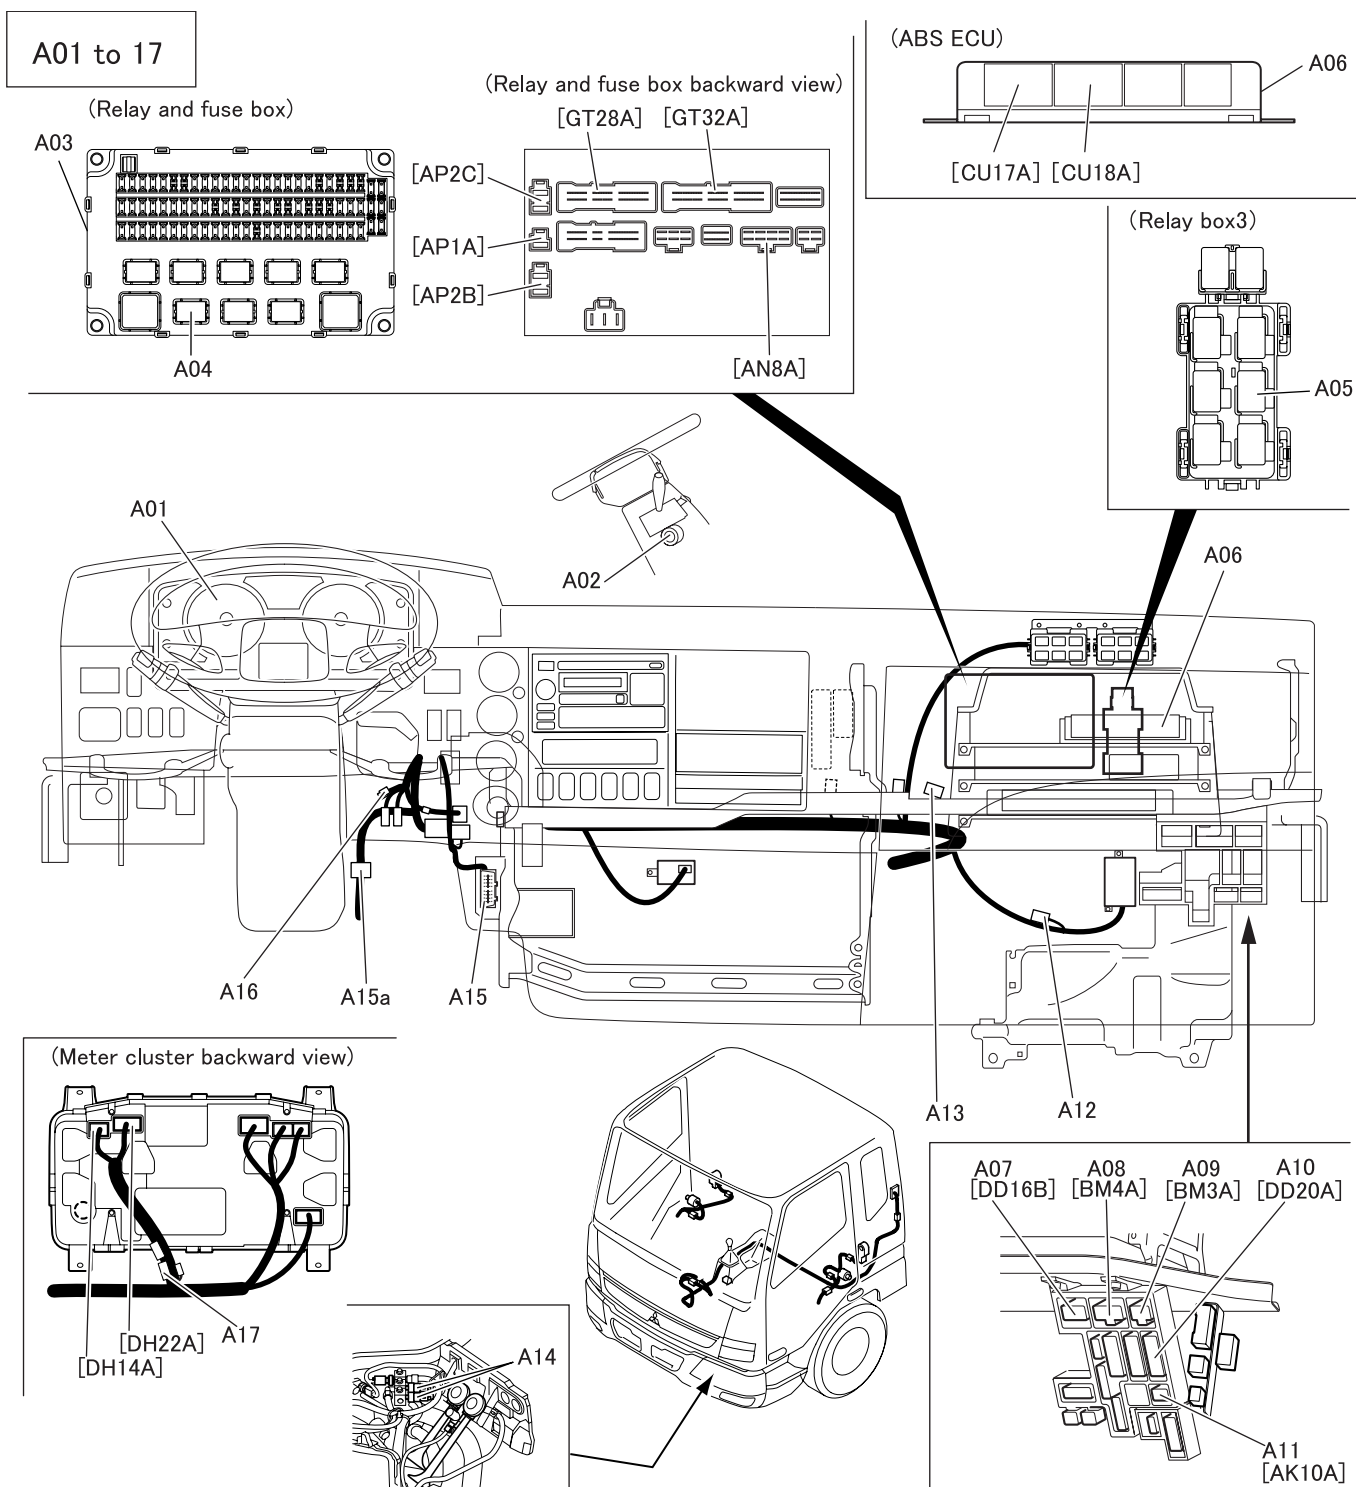
- A01 Meter cluster
- A02 Starter switch
- A03 Relay and fuse box
- A04 Stop lamp relay
- A05 ABS exhaust brake cut relay
- A06 ABS ECU
- A07-11 Connection of cab harness and chassis harness
- A12 Diode unit
- A13 Joint connector (J/C-1)
- A14 Stop lamp switch

- A15 Diagnostic connector
- A15a Connection of cab harness and headlamp harness
- A16 Diagnosis switch
- A17 Joint connector (J/C-6)

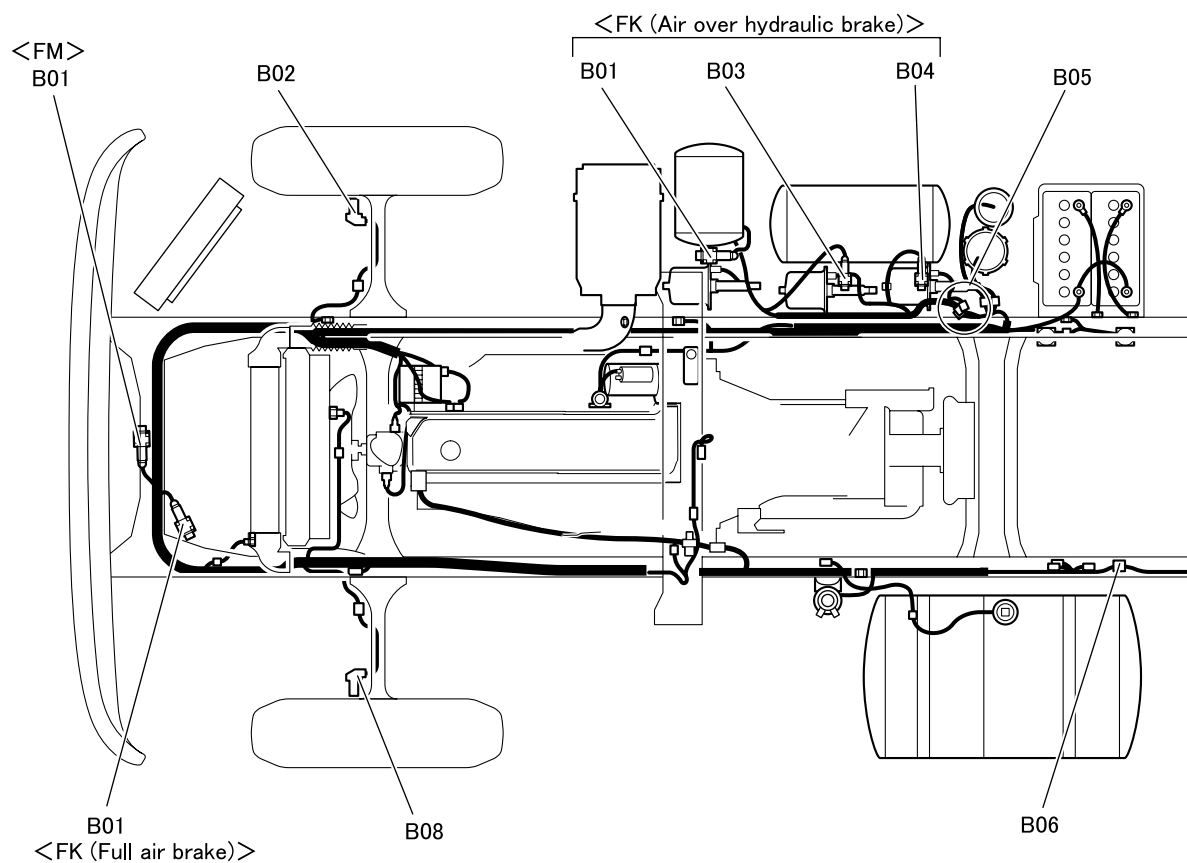
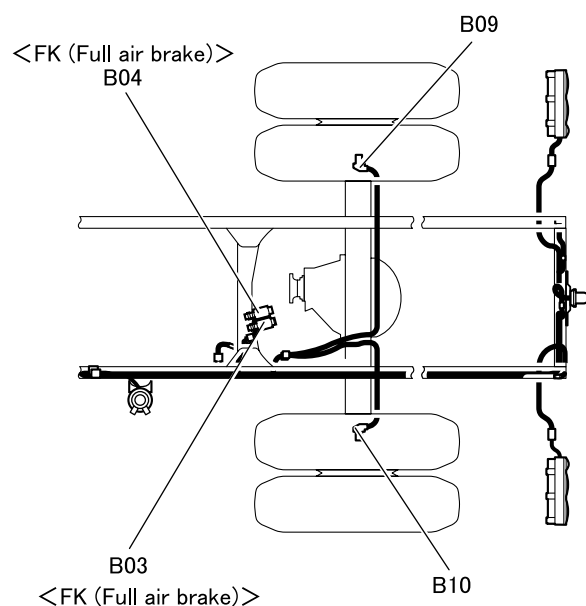
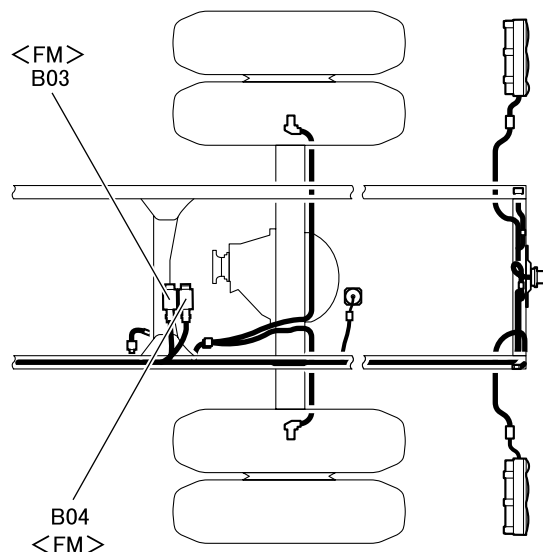
## B01 to 10

- B01 Control valve (Front)
- B02 Front wheel speed sensor, RH
- B03 Control valve, LH (Rear)
- B04 Control valve, RH (Rear)
- B05 Connection of chassis harness and ABS harness

- B06 Connection of chassis harness and rear chassis harness
- B08 Front wheel speed sensor, LH
- B09 Rear wheel speed sensor, RH
- B10 Rear wheel speed sensor, LH

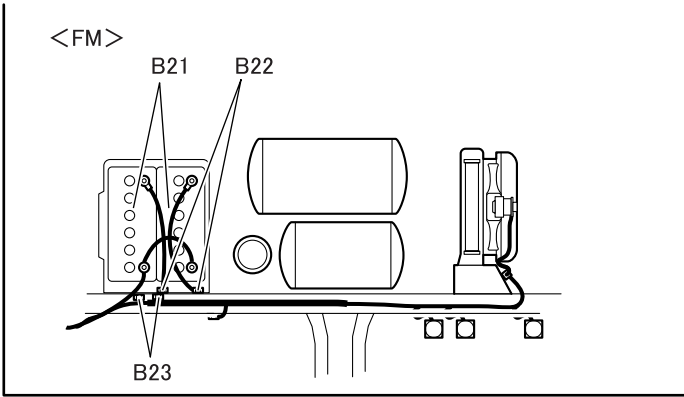
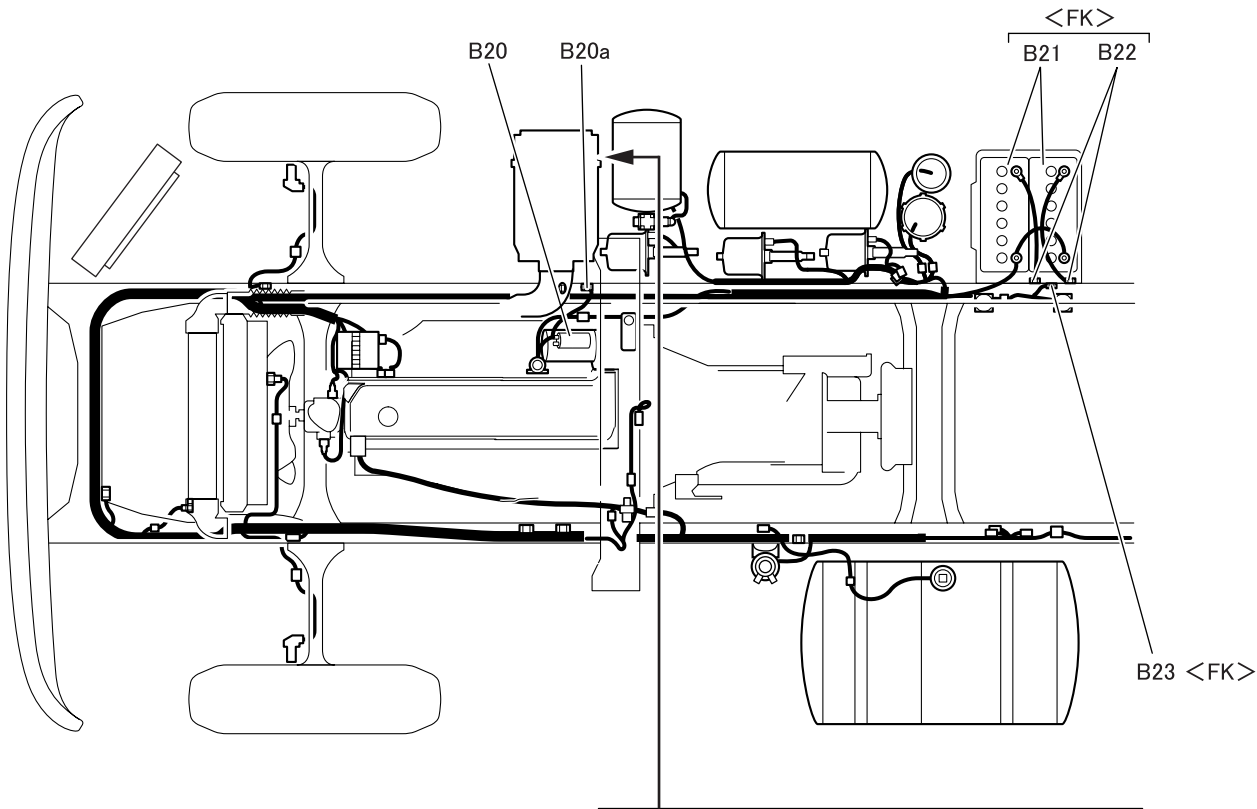
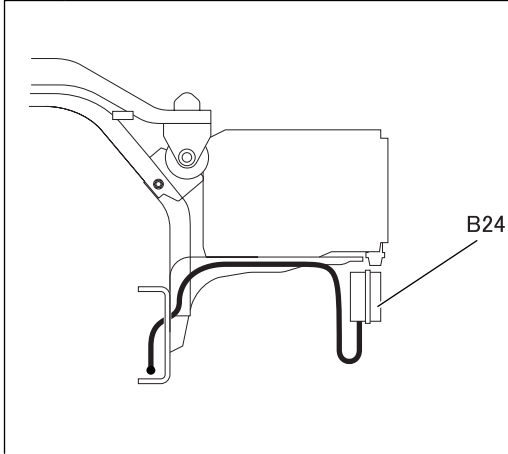
B20 to 24

- B20 Starter
- B20a Ground
- B21 Battery
- B22 Ground
- B23 Ground
- B24 High-current fuse box

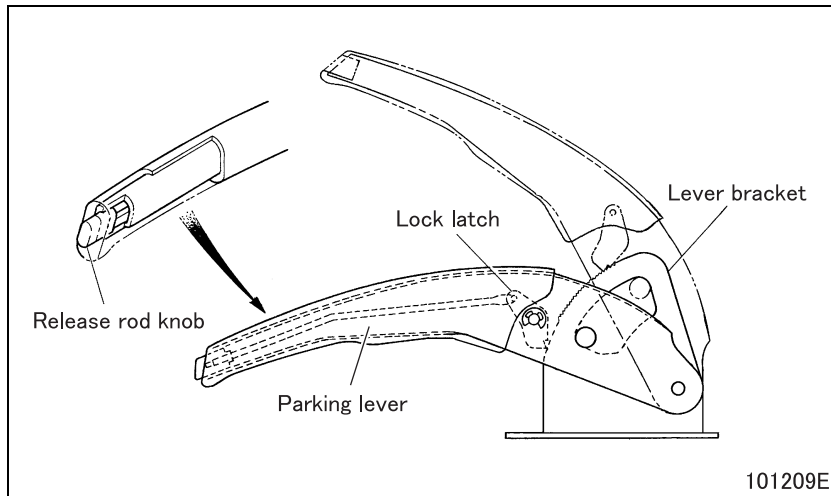
## 2. Parking Brake Lever

- Pulling the parking brake lever makes the parking brake work, at which point the lock latch engages with the lever bracket and the lever is locked.
- To release the parking brake lever, slightly pull it up while pushing the release rod knob. This disengages the lock latch from the lever bracket, allowing the parking brake lever to return to the released position.

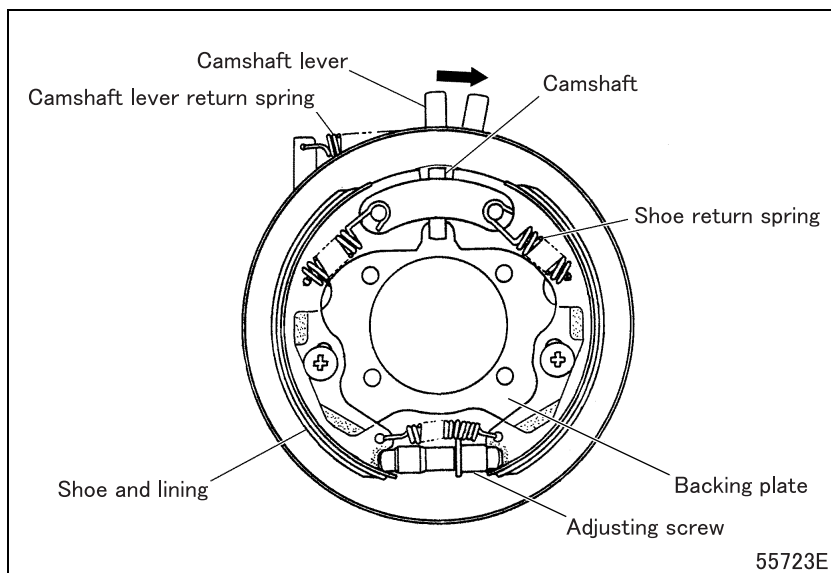
## 3. Parking Brake

- The camshaft lever that actuates the shoe and lining is a built-in component of the parking brake.
- Pulling the parking brake lever pulls the parking brake cable, which in turn pull the camshaft lever.
- When the camshaft lever is pulled, it rotates the camshaft to expand the shoe and linings. At the same time the adjusting screw moves and both shoe and linings work as a leading shoe.
- When the parking brake lever (parking lever) is returned to the released position, the repercussive force of the shoe return spring releases the brake.

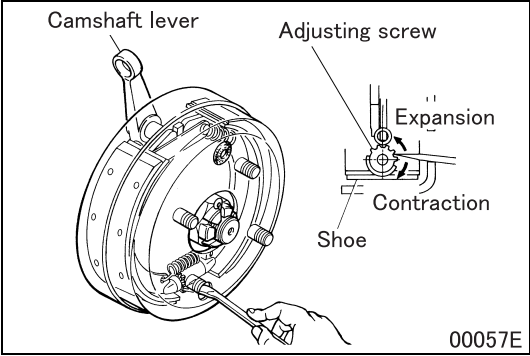
- Chock the front wheels and raise the rear wheels with a jack.
- Operate the parking brake lever to release the parking brake. (The parking lever is released from locking.)
- Using a standard screwdriver inserted through the shoe adjusting hole in the parking brake drum, turn the adjusting screw in the expansion direction shown to bring the shoe into close contact with the brake drum.
- Turn the adjusting screw 8 notches in the contraction direction shown from the position where the shoe is in close contact with the drum. The shoe clearance should be adjusted to the standard value.

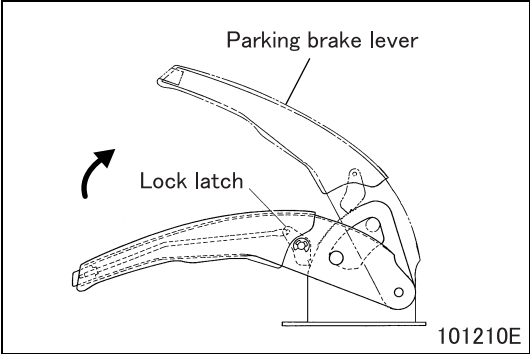
- Pull the parking brake lever from the released position with the specified operating physical force and count the number of cleared notches.
- If the count of notches deviates from the specified range of standard values, adjust the length of the parking brake cable.
- If the count of notches (pulling stroke) is still out of the specified range after cable length adjustment, check the parking brake shoe clearance.

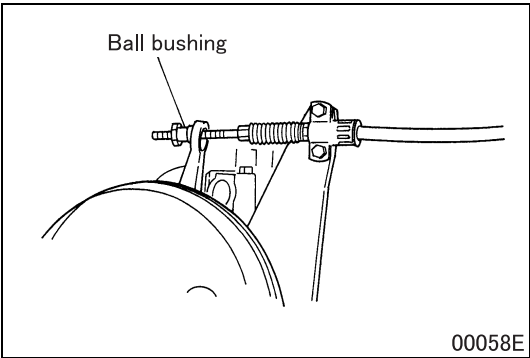
- Turn the ball bushing to adjust the length of the parking brake cable.

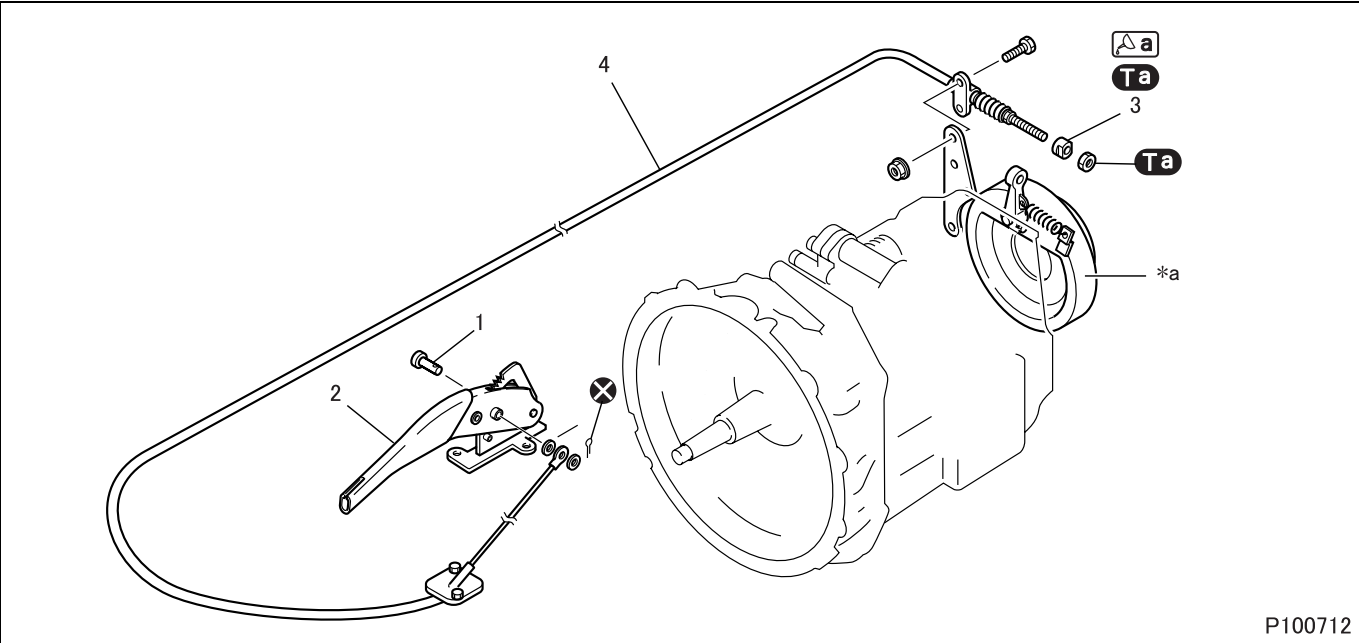
- 1 Clevis pin
- 2 Parking brake lever (See later section.)
- 3 Ball bushing

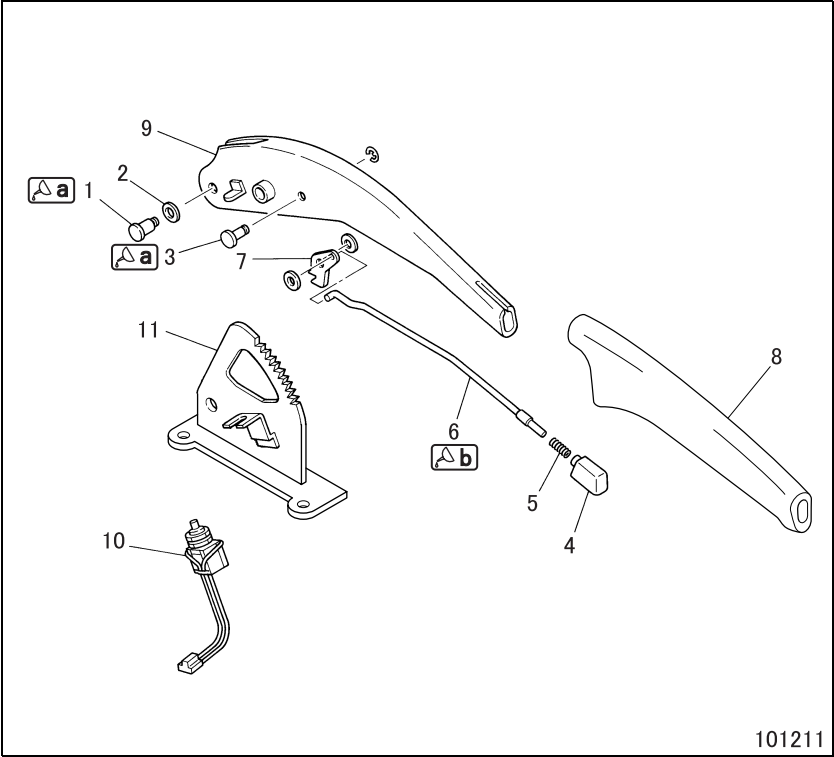
## Parking Brake Lever

- 1 Pin
- 2 Spacer
- 3 Pin
- 4 Release rod knob
- 5 Return spring
- 6 Release rod
- 7 Lock latch
- 8 Grip
- 9 Parking brake lever
- 10 Parking brake switch
- 11 Lever bracket

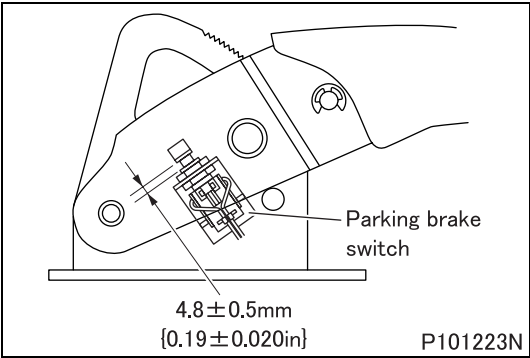
### ■ Installation: Parking brake switch

- Install the parking brake switch to the illustrated dimension.

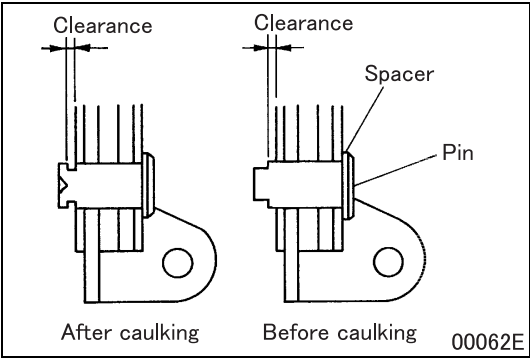
■ Installation: Pin

- Do not use a spacer if clearance before caulking is less than 0.6 mm {0.024 in.}. If the clearance is between 0.6 mm and 0.96 mm {0.024 and 0.038 in.}, adjust it with a spacer.
- Make sure that the clearance after caulking is as shown in the table below. Reassemble if the clearance is out of the dimensions shown in the table below.

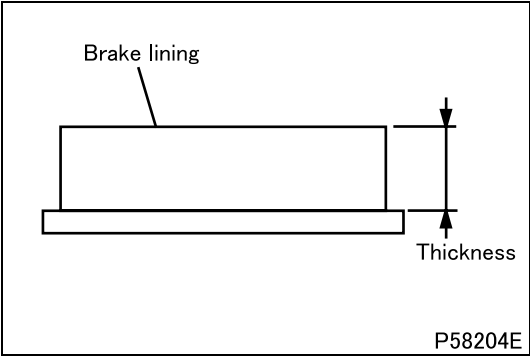
■ Inspection: Brake lining thickness of shoe and lining

- If the measured value is lower than the limit, replace the shoe and lining.

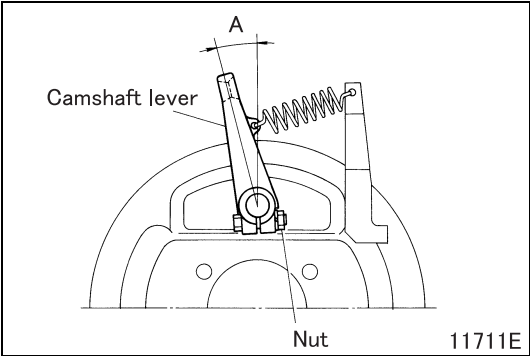
■ Installation: Camshaft lever

- Align the camshaft lever with illustrated angle A and tighten the nut to the specified torque.
