# FE.FG

## SERVICE MANUAL 2008 Model FOREWORD

This Service Manual contains maintenance and repair methods for the Mitsubishi Fuso Truck FE. FG Series. Read this manual carefully as an aid in providing correct, efficient maintenance. Please note that the information and specifications contained within this manual may change without notice. This is due to product modifications and continued vehicle improvements that are made throughout the model years. Should you encounter any discrepancy in the information provided, please do not hesitate to contact your nearest Mitsubishi Fuso Dealer or Mitsubishi Fuso Truck of America, Inc.

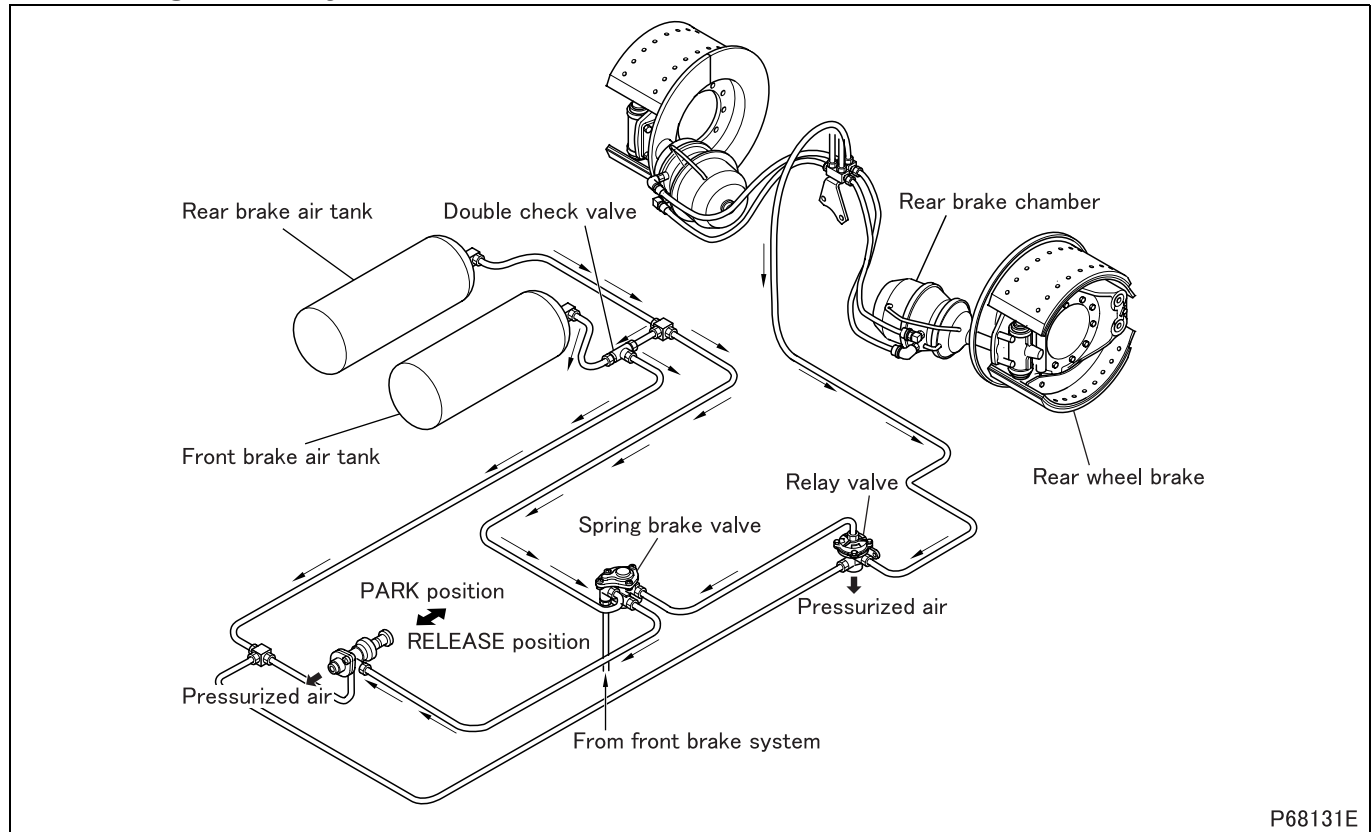
## 1. Parking Brake System

- In the wheel parking brake system, operating parking brake control valve causes rear brake chamber, which contains a spring brake, to apply rear wheel brake, generating braking force.
- Pulling out the knob of parking brake control valve to the PARK position, feeds pressurized air from the parking brake control valve and spring brake valve to relay valve. This exhausts pressurized air in the spring brake in rear brake chamber through the exhaust port of the relay valve, causing the spring brake to generate braking force.
- Pushing in the knob of parking brake control valve to the RELEASE position, feeds pressurized air from rear brake air tank to relay valve via the parking brake control valve. Consequently in the separate air system, pressurized air from the rear brake air tank is fed to the spring brake of rear brake chamber via the relay valve, releasing the wheel parking brake.

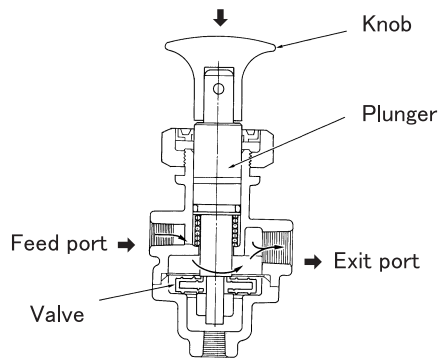
68109E

- When the air pressure at feed port reaches 420 kPa {61 psi, 4.3 kgf/cm<sup>2</sup>} or higher, pushing in knob causes valve at the top of plunger to close the exhaust port, feeding pressurized air to exit port.

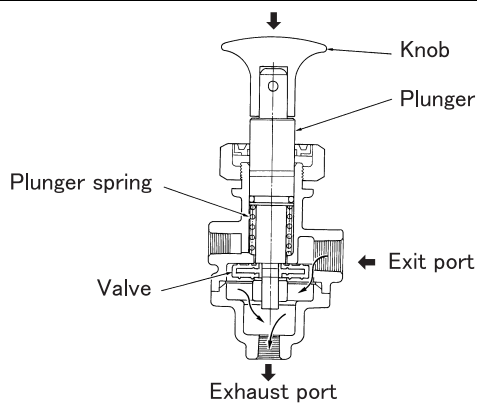
68110E

- Pulling out knob causes valve at the top of plunger to open exhaust port, and remains in that position, closing the feed port. This exhausts the air returned from exit port through the air exhaust port.
- When the air pressure at the supply port drops to 275 kPa {40 psi, 2.8 kgf/cm<sup>2</sup>} or lower, the repulsive force of plunger spring overcomes the air pressure acting on valve pushing out knob automatically. This exhausts the air through exit port.

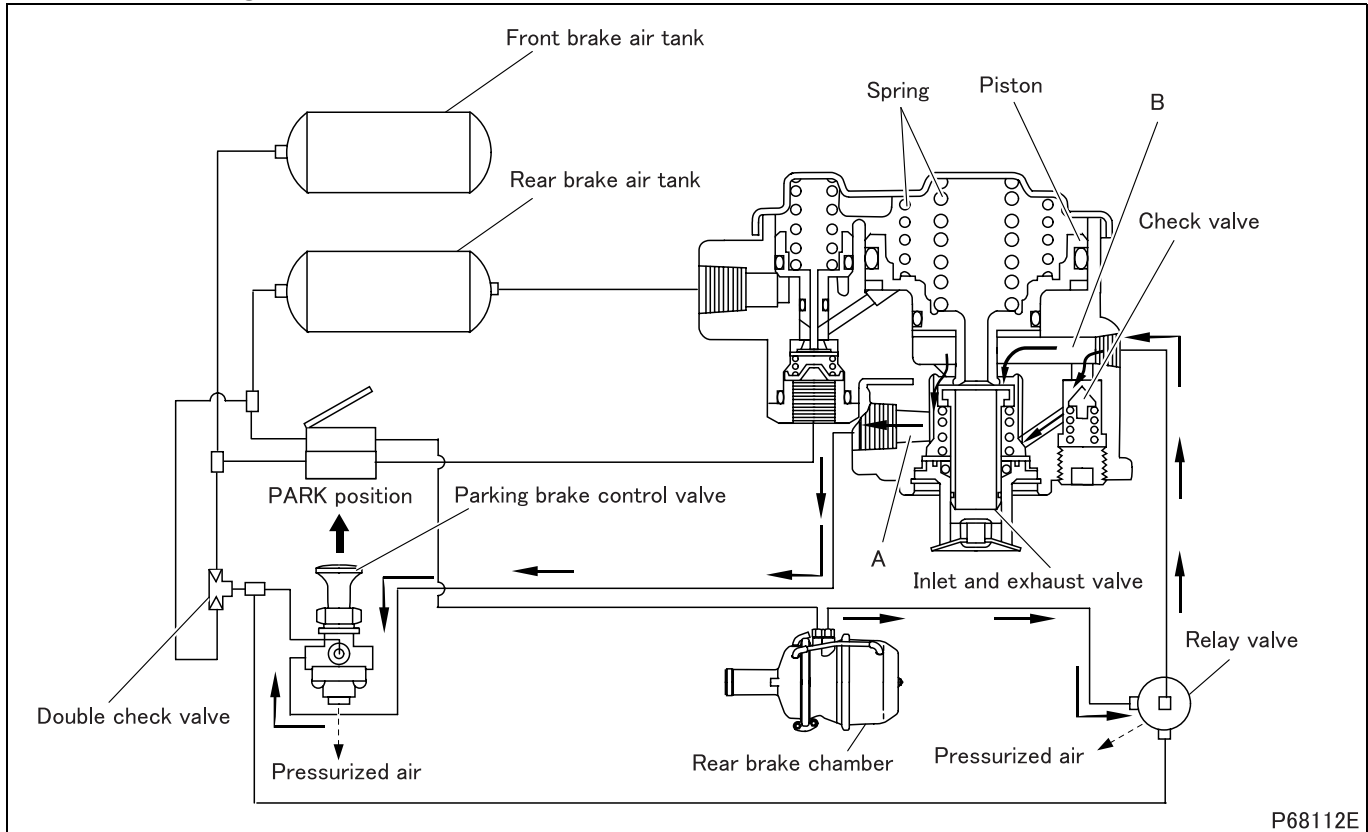
### 3.1 When parking brake is operated

- Pulling out the knob of parking brake control valve to PARK position, exhausts the pressurized air in chamber A of the spring brake valve through the parking brake control valve. Then, the pressurized air in chamber B of the spring brake valve forces down check valve, passes through chamber A, and is exhausted through the parking brake control valve.
- When the air pressure in chamber B of the spring brake valve drops sufficiently, springs at the top of piston force the piston down, opening inlet and exhaust valve. This exhausts the pressurized air, which is fed to relay valve, from the spring brake valve.
- Relay valve exhausts the pressurized air from the spring brake in rear brake chamber through the exhaust port.
- The spring brake of rear brake chamber operates to generate braking force.

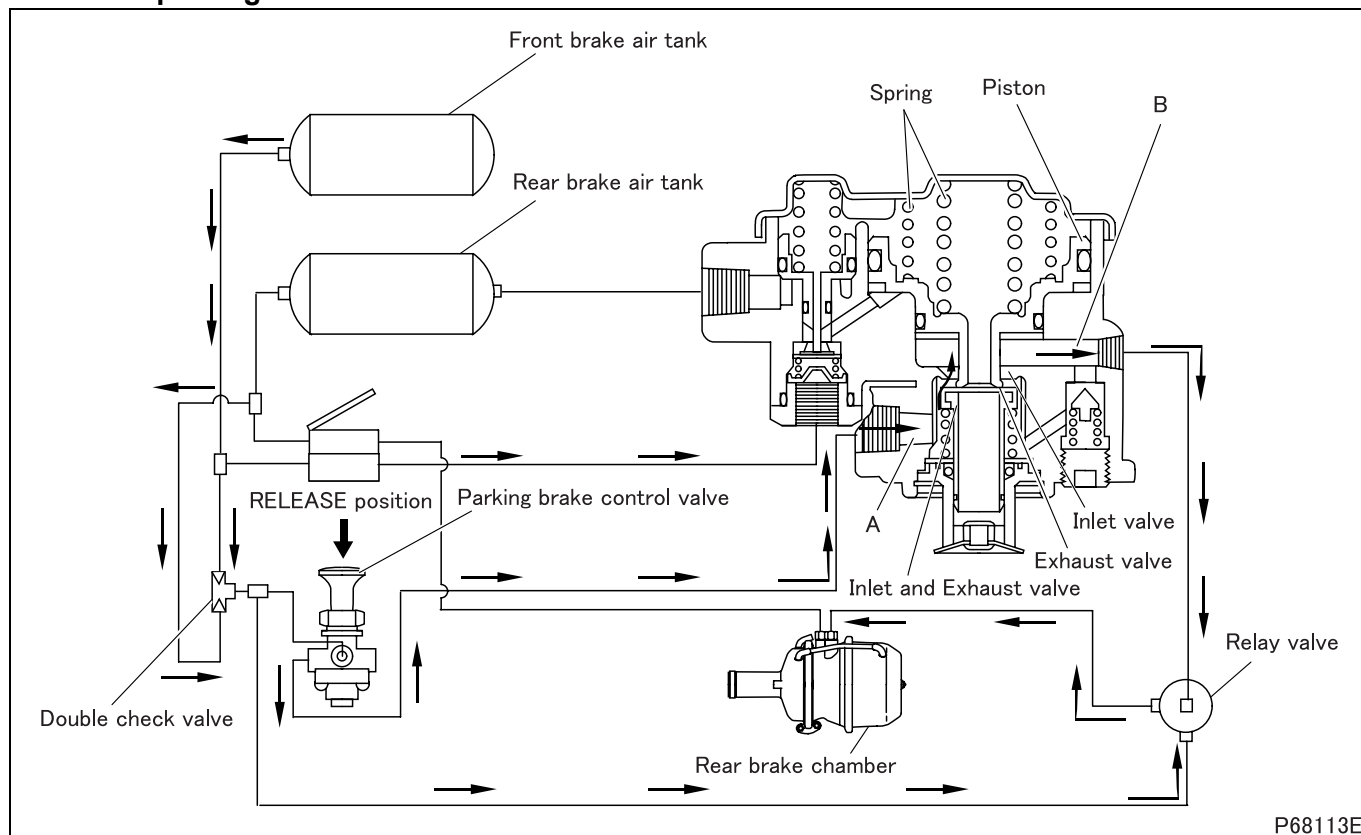
## 3.2 When parking brake is released

- Pushing in the knob of parking brake control valve to RELEASE position, causes the pressurized air to flow through chamber A of the spring brake valve to chamber B, then the pressurized air is fed to relay valve as air pressure.
- As the air pressure in chamber B rises further, the rising force of piston overcomes the repercussive force of springs. This closes exhaust valve of inlet and exhaust valve, and at the same time lifts the piston and the inlet and exhaust valve together.
- As piston and inlet and exhaust valve rise further, the inlet and exhaust valve closes inlet valve, isolating chambers A and B from each other, stopping the air flow between them.
- When it receives pressurized air, relay valve feeds pressurized air in the separate air system to the spring brake, releasing the wheel parking brake.

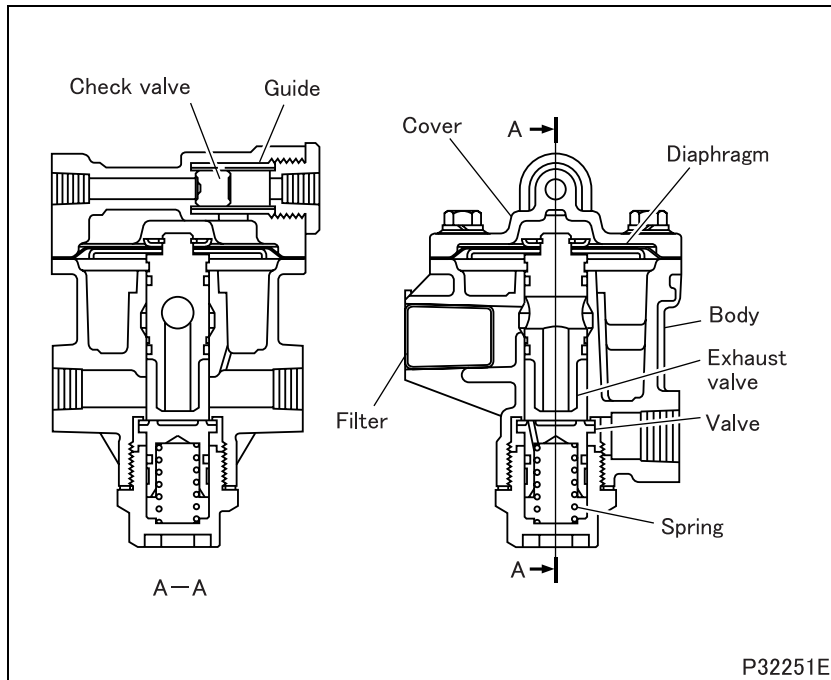
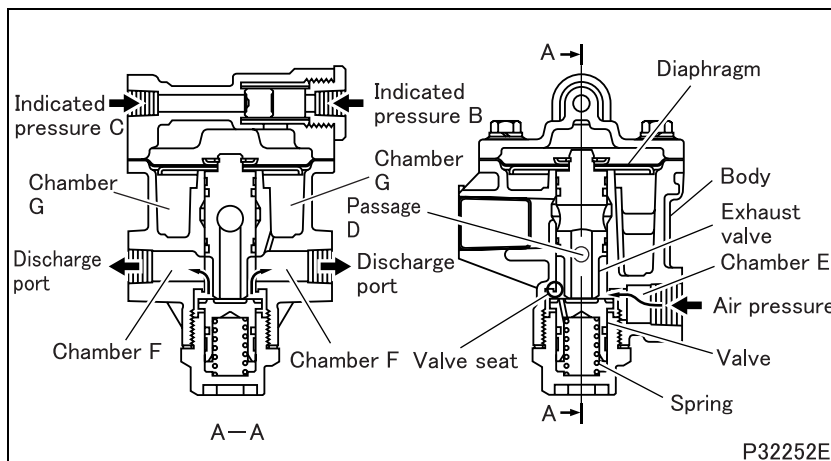
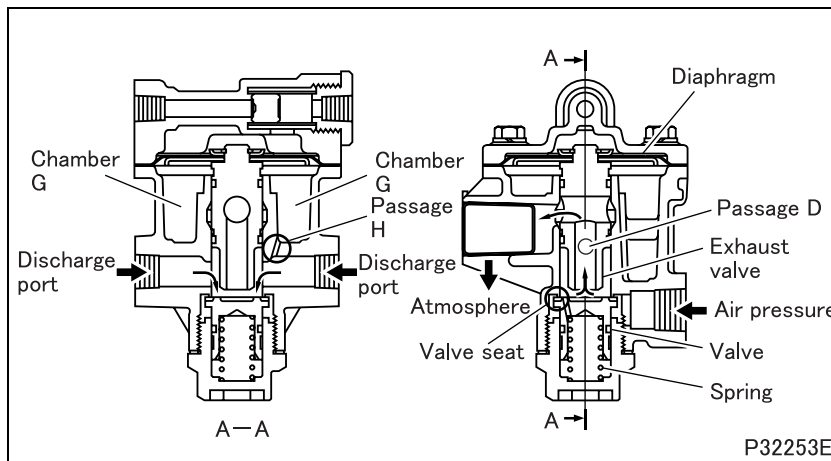
## 4. Relay Valve (With Double Check Valve)

- The relay valve supplies air from the air tank to the brake system under indicated pressure.
- A check valve is incorporated in the cover for double check valve operation.

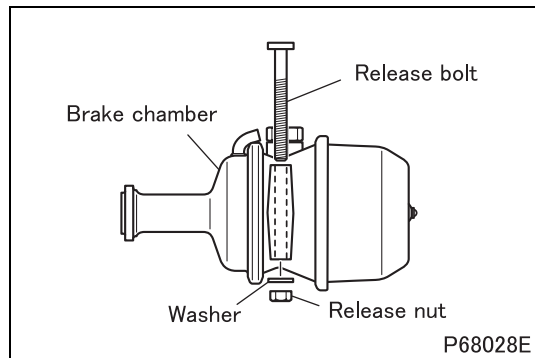
- Release spring brake mechanically.
- Remove the release bolt, washer and release nut from the brake chamber.

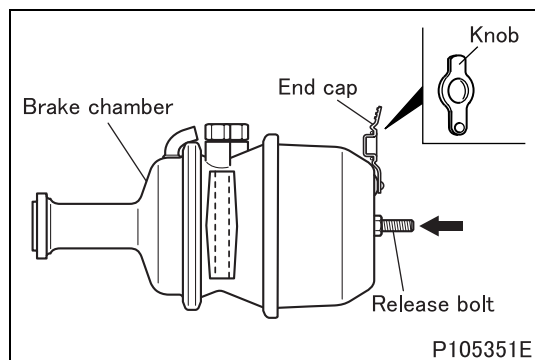
- Remove the end cap without failing to pull up its knob by hand or using a plier or other tools.

- Never remove the end cap by inserting a screwdriver or other tools into the brake chamber and prying it to open the chamber. Failure to observe the above can cause the brake chamber to be damaged, allowing water to intrude into the brake chamber. The water can cause rust on spring, leading to breakage in the spring.**

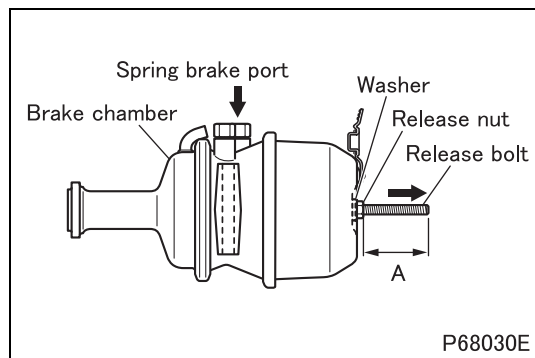
- Insert the release bolt deep into the chamber and turn it a quarter turn.
- Pull the release bolt to check that it does not come off the chamber.
- If the release bolt is pulled off, repeat the above procedure; insert the bolt deep into the chamber and turn it a quarter turn again.

- Attach the washer and the release nut.
- While applying an air pressure of 640 kPa {92 psi, 6.5 kgf/cm<sup>2</sup>} into the spring brake port (by setting the hand control valve to the released position), turn the release nut until the threaded portion of the release bolt extends by the dimension A shown below.

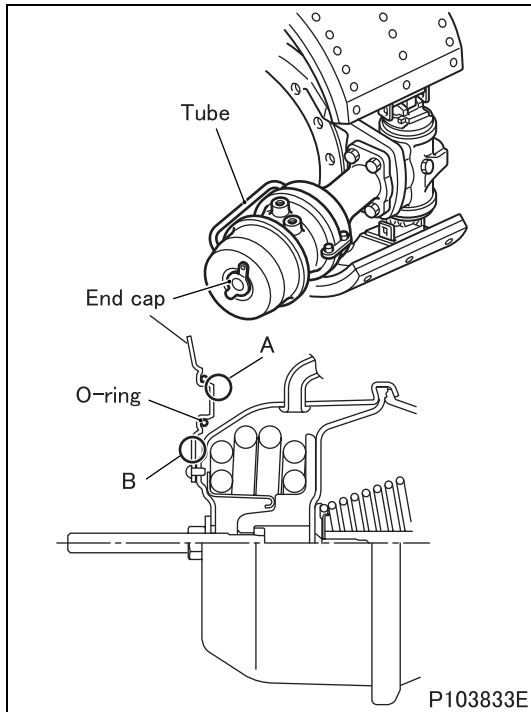
### Cancellation of mechanical release of parking brake

- To cancel the mechanical release of parking brake, perform the mechanical release procedure in reverse while confirming the following items.
- Clean the end cap mounting position and confirm that there is no water or dust in that position.
- Confirm that an O-ring is attached to the end cap.
- Using a  $\phi 15$  mm or thinner rod with a dull end such as a release bolt, push in the concave section at the center of the end cap squarely into the piggy back. A click is heard when the section A is securely seated into the piggy back.
- When seating the end cap, be careful not to bend or twist the section B.
- Confirm that there is no damage on the tube and the tube is installed securely.

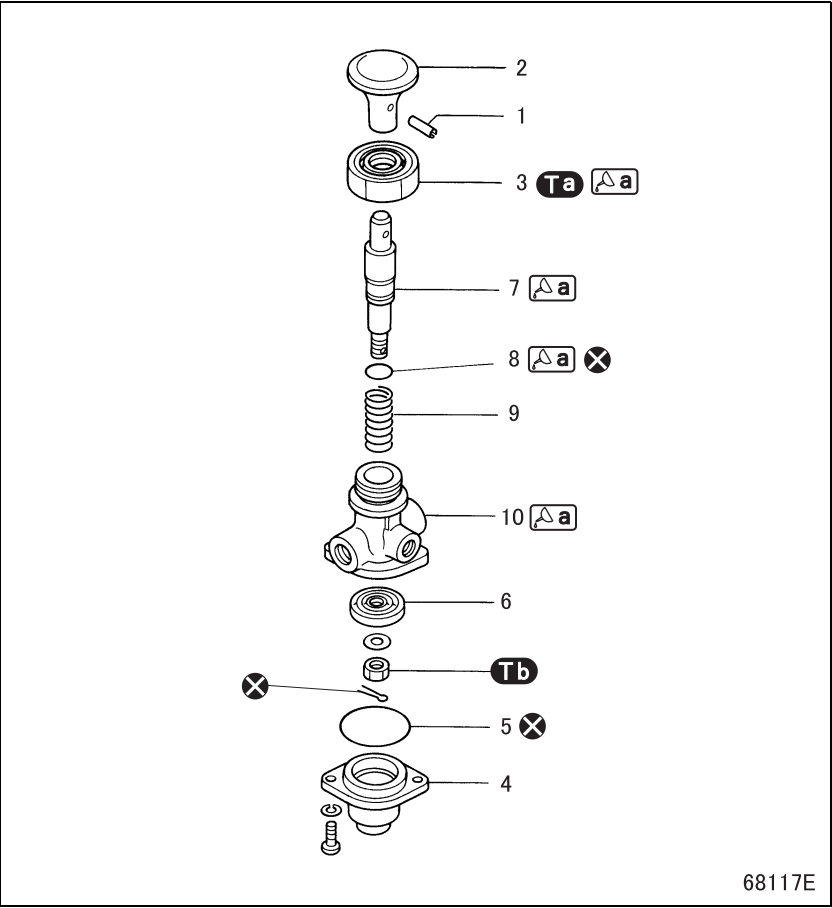
# PARKING BRAKE CONTROL VALVE

- 1 Spring pin
- 2 Knob
- 3 Seal nut
- 4 Cover
- 5 Seal ring
- 6 Valve
- 7 Plunger
- 8 O-ring
- 9 Plunger spring
- 10 Body

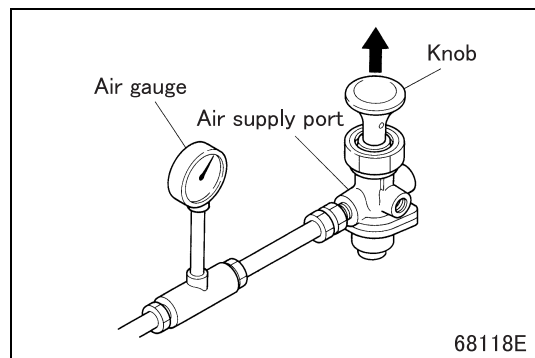
### ■ Inspection: Parking brake control valve

- While pushing in knob, feed air pressure of 685 kPa {100 psi, 7 kgf/cm<sup>2</sup>} via air supply port.
- Gradually decrease the air pressure and confirm that the air pressure required to push out the knob from its pushed-in position is the standard value.

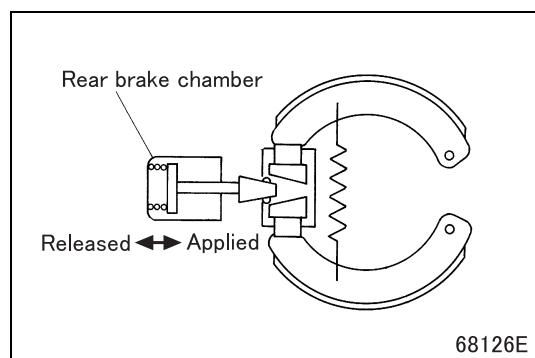
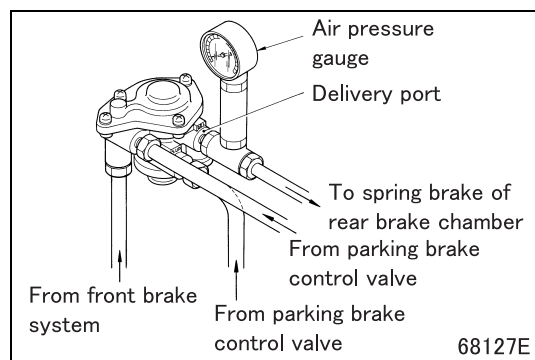
### ■ Inspection: Spring brake valve

- Place wheel chocks at the rear wheels to prevent the vehicle from moving.
- Start the engine to raise the air pressure until the air pressure gauge reads  $805^{+29}_{-20}$  kPa { $115^{+4.3}_{-2.8}$  psi,  $8.2^{+0.3}_{-0.2}$  kgf/cm<sup>2</sup>}.
- Confirm that when the knob of the parking brake control valve is pulled out to the PARK position, rear brake chamber operates immediately, applying the wheel parking brake.
- Confirm that when the knob of the parking brake control valve is pushed in to the RELEASE position, rear brake chamber operates, releasing the wheel parking brake.
- Mount air pressure gauge on delivery port of the spring brake valve.
- Read air pressure gauge when the knob of the parking brake control valve is pushed to the RELEASE position.  
Specified value: 655 kPa {951 psi, 6.67 kgf/cm<sup>2</sup>}

- Confirm that when the knob of the parking brake control valve is pulled out to the PARK position, the reading of air pressure gauge drops immediately to 0 kPa {0 psi, 0 kgf/cm<sup>2</sup>}. If the air pressure gauge indicator needle drops slowly, replace check valve, since it is probably faulty.

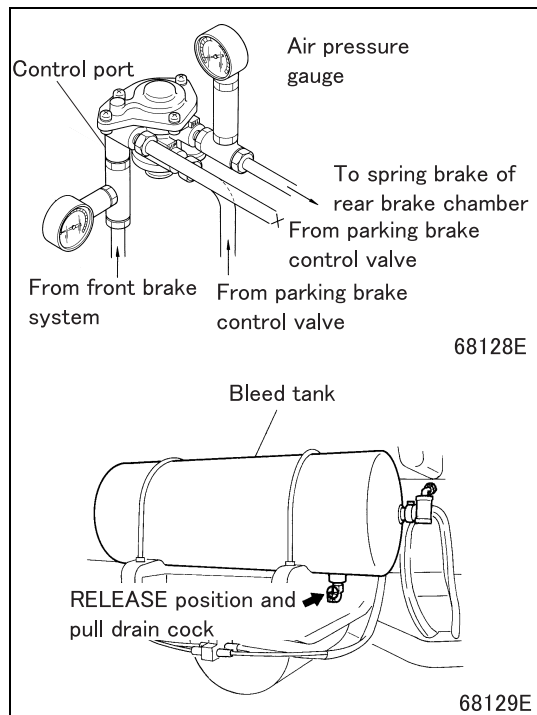
- Mount air pressure gauge on control port.
- Push in the knob of the parking brake control valve to the RELEASE position and pull drain cock to completely bleed tank of the rear brake system.

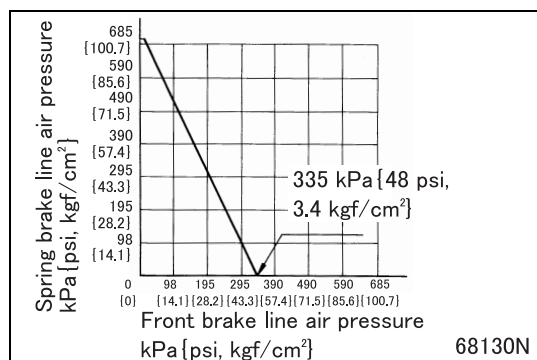
- Have the brake pedal depressed several times and read the drop in the air pressure on both air pressure gauges every time the brake is pressed to confirm that each value conforms to the specified value indicated on the performance curve diagram.
- Press the brake pedal several times to compress the air until rear brake chamber operates on the wheel parking brake locking the rear wheels completely.

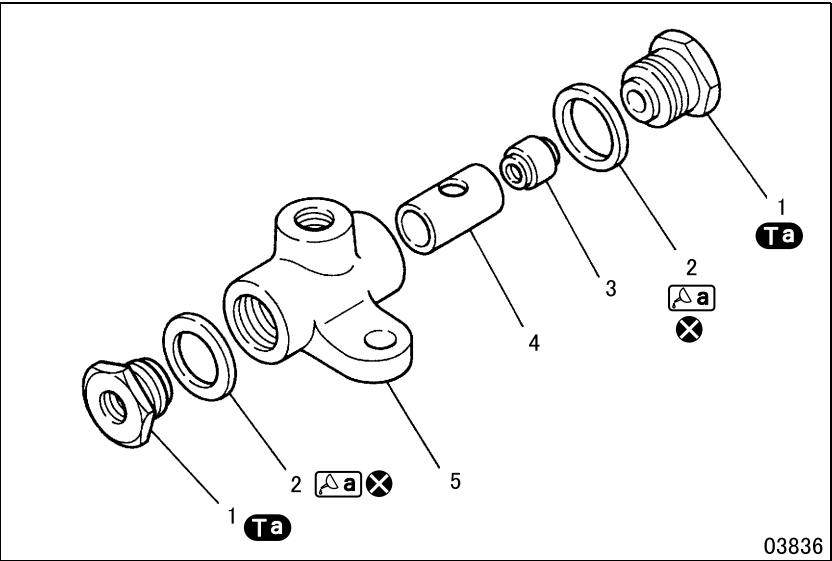
- 1 Joint
- 2 Packing
- 3 Check valve
- 4 Sleeve
- 5 Body

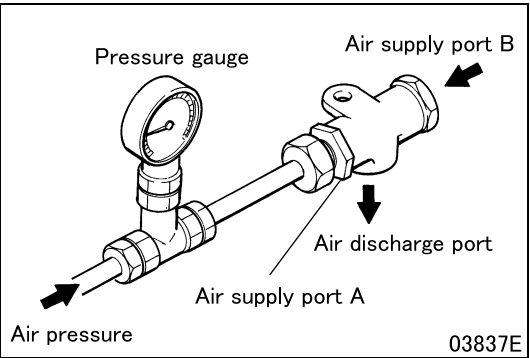
### Inspection: Double check valve

- Apply the specified air pressure into the air supply port A. Air should come out the air discharge port and no air should come out from the air supply port B.
- Repeat this by applying air pressure into the air supply port B.

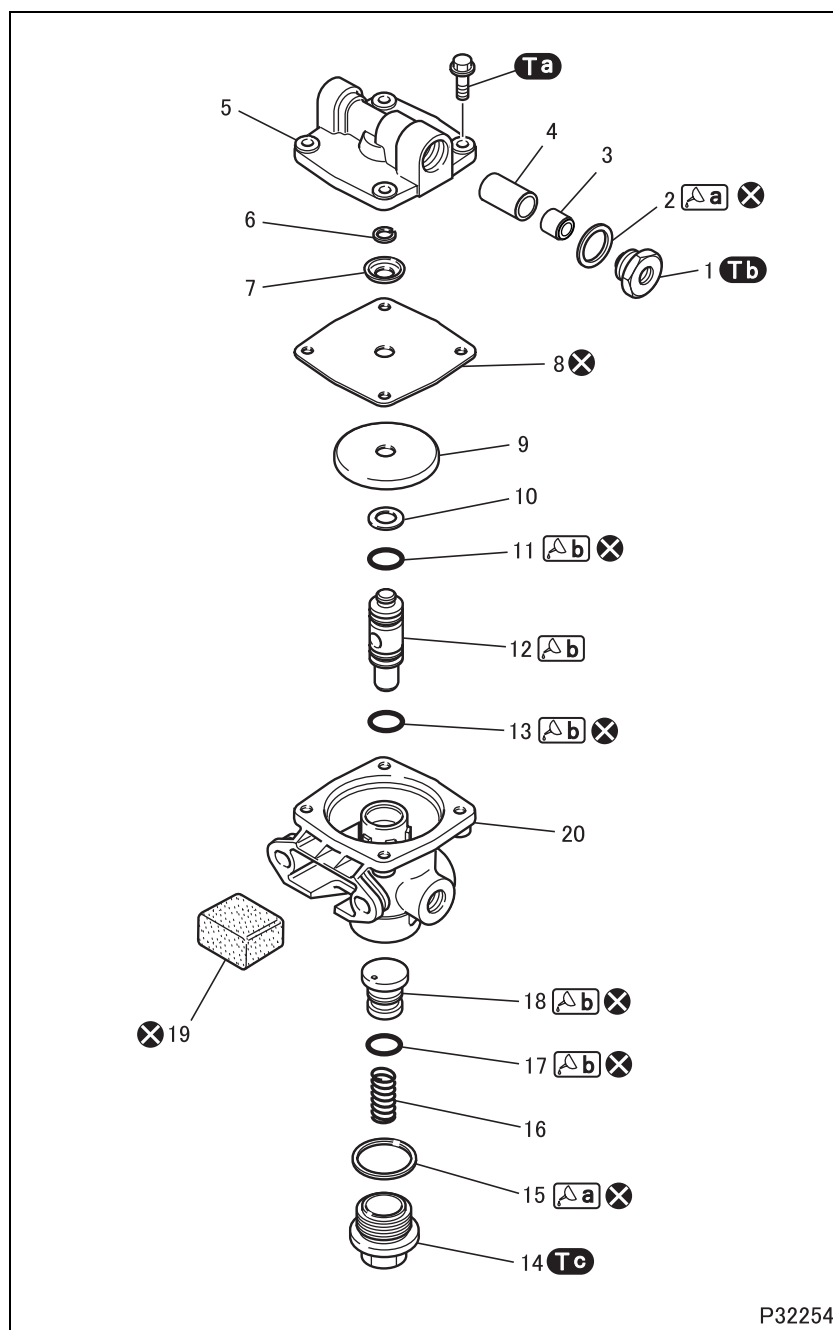
# RELAY VALVE (WITH DOUBLE CHECK VALVE)

- 1 Connector
- 2 Packing
- 3 Check valve
- 4 Guide
- 5 Cover
- 6 C-clip
- 7 Diaphragm washer
- 8 Diaphragm
- 9 Diaphragm washer
- 10 Shim
- 11 O-ring
- 12 Exhaust valve
- 13 O-ring
- 14 Cap
- 15 Packing
- 16 Valve spring
- 17 O-ring
- 18 Valve
- 19 Filter
- 20 Body

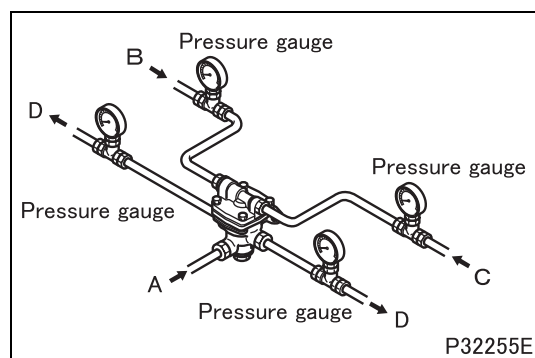
### ■ Inspection: Relay valve

- With air pressure of 685 kPa {7 kgf/cm<sup>2</sup>} applied to the air supply port A, apply air pressure to the signal port B or C and check whether the discharge pressure from the discharge port D complies with the characteristic curve.
- If there is any abnormality, replace the piston spring and intake valve spring.

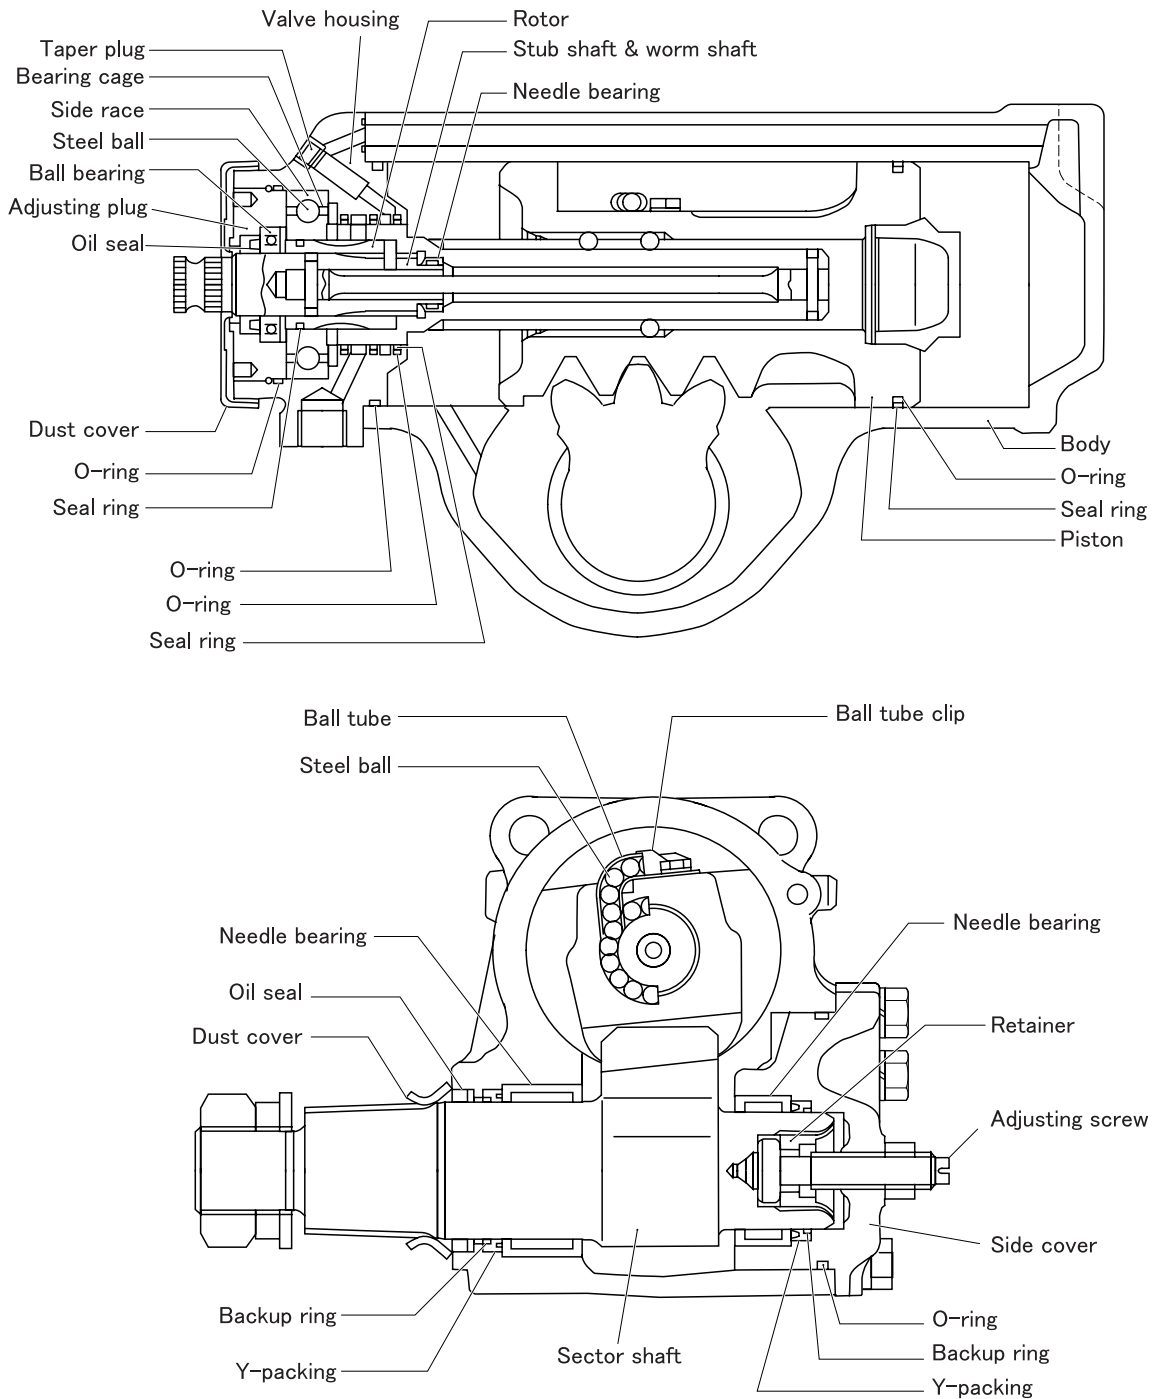
P105075E

- A rotary valve is adopted for the valve, the center of the power steering. For steering reaction force and return of the valve, the valve operates lightly and smoothly at low speed by means of the torsion bar, and provides stable steering feel up to high speed.

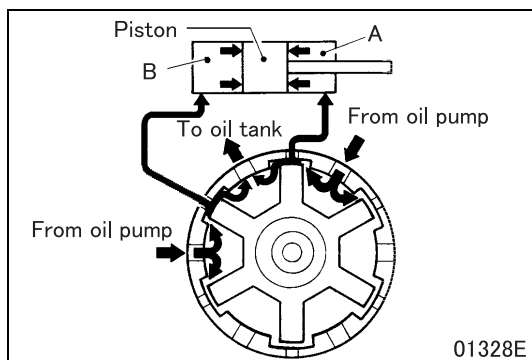
## 3.1 When moving straight forward

- As equal pressure is applied to cylinder chambers A and B on both sides of the piston, the piston is placed in neutral position.

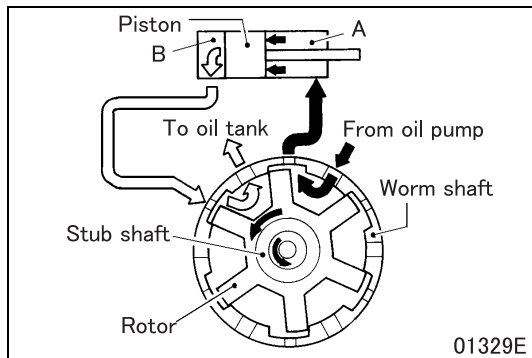
## 3.2 When turning the steering wheel

- When the steering wheel is turned, the stub shaft is twisted, which causes the rotor to shut off oil supply passages to cylinder chamber B. As a result, pressure difference is caused between cylinder chamber A and cylinder chamber B, and the piston moves, facilitating rotation of the worm shaft.

The illustration shows a condition when the steering wheel is turned to the left.

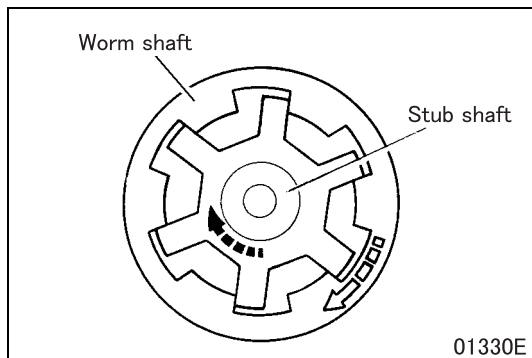
## 3.3 When hydraulic circuit fails

- The turning force of the stub shaft alone turns the worm shaft.

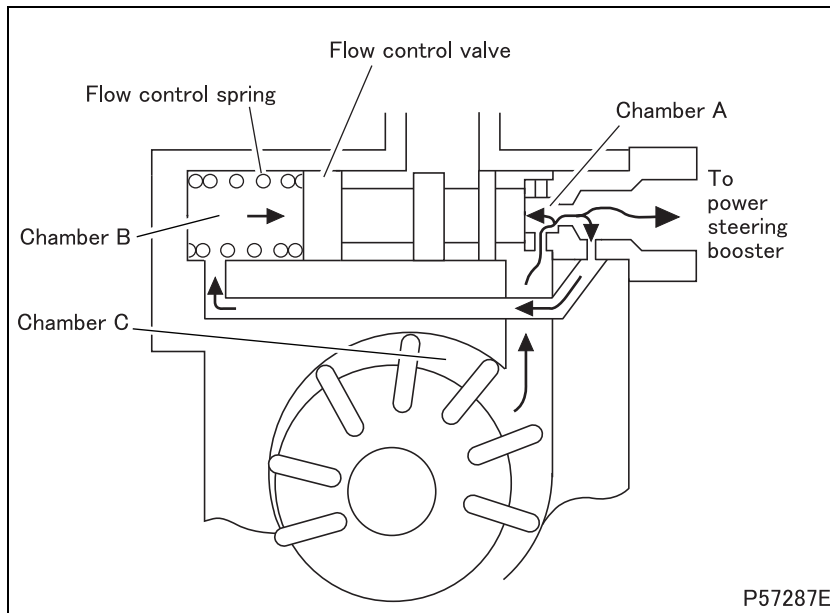
#### (1.1) When not functioning (oil pump in operation at low speed)

- Oil pressure in the chamber A is weaker than the combined force of oil pressure in the chamber B and tension of the flow control spring, and the flow control valve remains stationary.

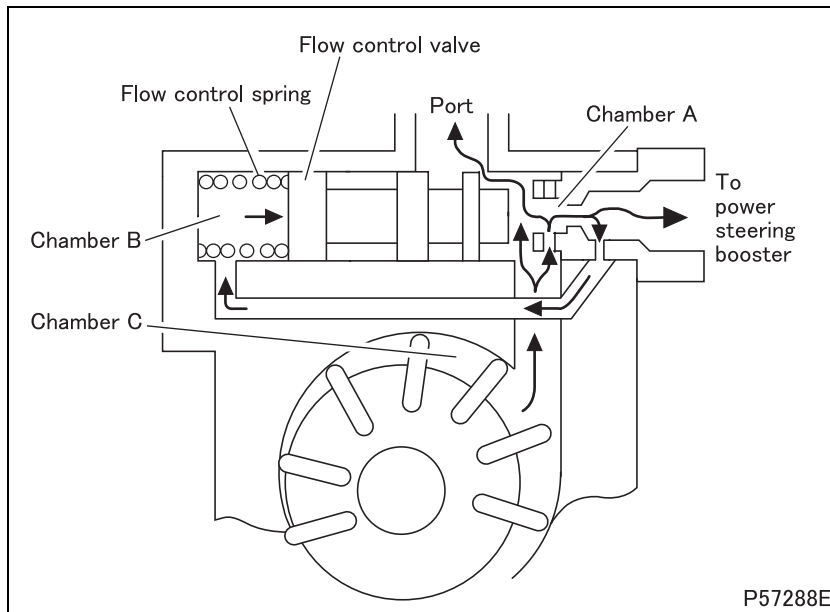
#### (1.2) When functioning (oil pump in operation at middle to high speeds)

- Oil pressure in the chamber A overcomes the combined force of oil pressure in the chamber B and tension of the flow control spring, and the flow control valve is shifted.
- Port is made open to release oil pressure, and the flow rate from the chamber A is maintained constant.

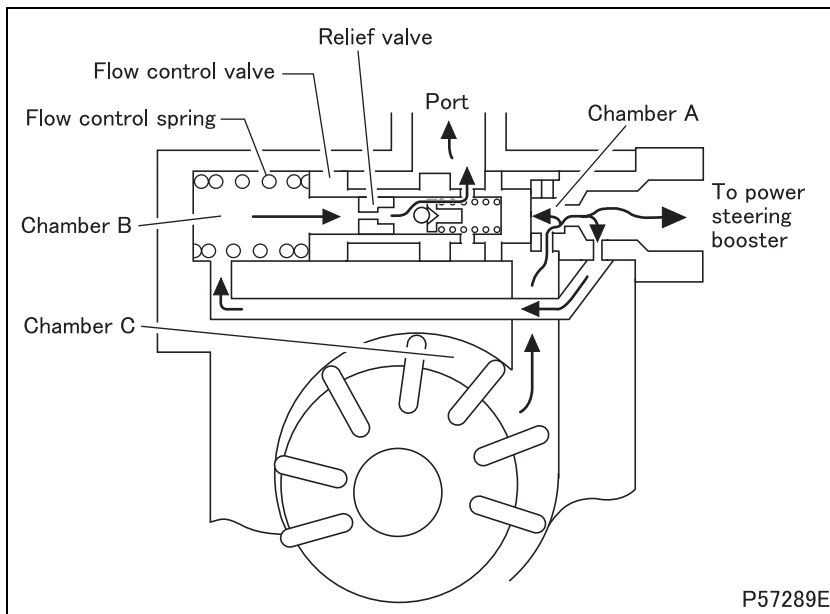
## (2) Operation of relief valve

- When the combined force of oil pressure in the chamber B and tension of the flow control spring overcomes oil pressure in the chamber A, the flow control valve is shifted. Further increased oil pressure in the chamber B pushes the relief valve to open port, thus preventing excessive oil pressure from going to the chamber C.

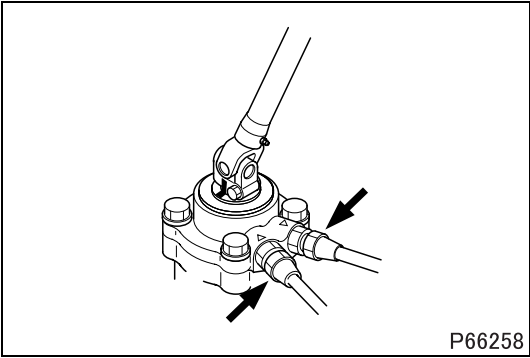
### 1.1 Draining

- Jack up the front wheels.
- Loosen feed and return pipes connected to the power steering booster.

- Repeatedly turn the steering wheel fully left and right to drain the hydraulic fluid from the power steering booster, and then tighten the feed pipe and return pipe.

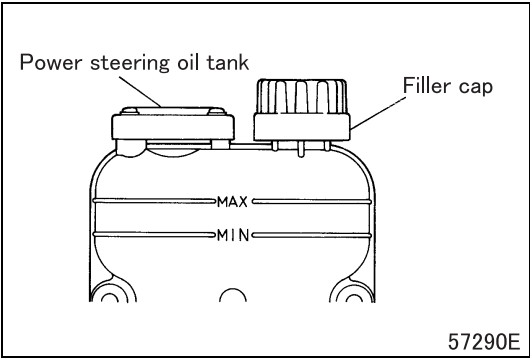
### 1.2 Filling

- Pour fluid into the power steering oil tank up to the bottom of the filler cap.
- Bleed the power steering system of air.

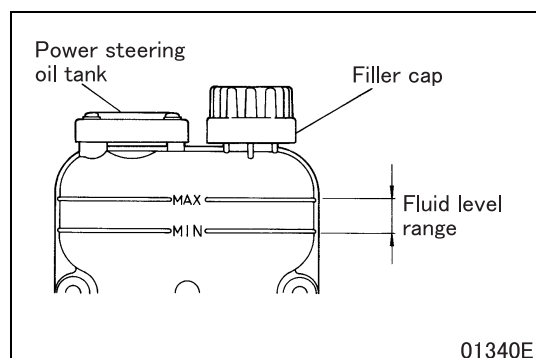
- Pour fluid to the power steering oil tank up to the bottom of the filler cap.
- With the engine stopped, jack up the front wheels.
- Repeatedly turn the steering wheel fully left and right. When the fluid level has dropped, add fluid enough to maintain the fluid level within the specified range.
- Start the engine to idle.
- When the fluid level has dropped, stop the engine and add fluid.
- Restart the engine. While checking for a drop in the fluid level, repeatedly replenish the hydraulic fluid until the fluid level is stabilized.

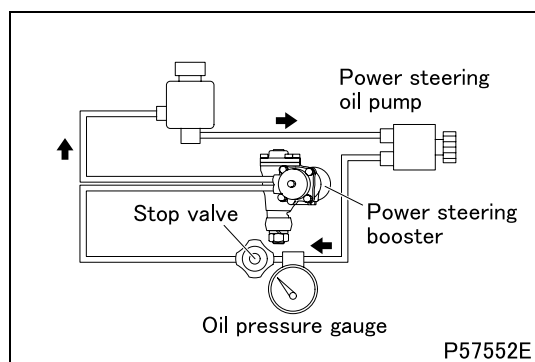
- Perform the tests with the following measuring conditions to verify normal operation of the power steering booster and power steering oil pump.
- Install oil pressure gauge capable of measuring upward of 14.7 MPa {2130 psi, 150 kgf/cm<sup>2</sup>} and stop valve between power steering oil pump and power steering booster, then bleed air.
- Start engine to idle.
- Turn steering wheel left and right several times to raise fluid temperature up to 50 to 60°C {122 to 140°F}.
- With the engine idling, fully open stop valve.

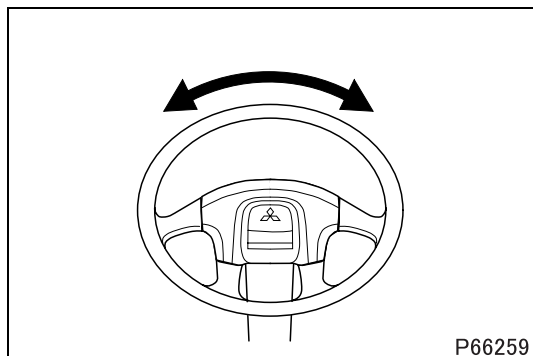
- With the vehicle placed straight forward, start the engine and gently turn the steering wheel right and left to measure its peripheral play.
- If the play deviates from the standard value, check tightening points and backlash of the power steering booster.

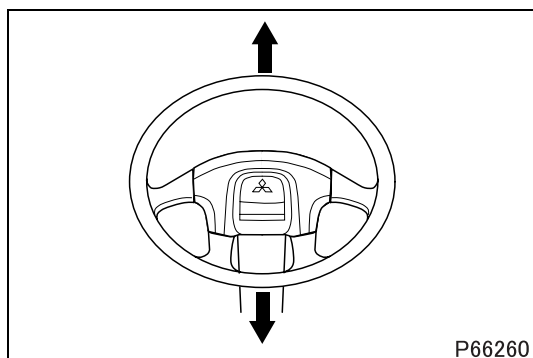
## 5. Steering Column Looseness

- Push and pull the steering wheel by hand to check the steering column for looseness.
- With the steering column tilted all the way forward, pull the steering wheel backward and check the steering column for looseness.
- If the steering column is loose, adjust the tilting and telescoping lever.

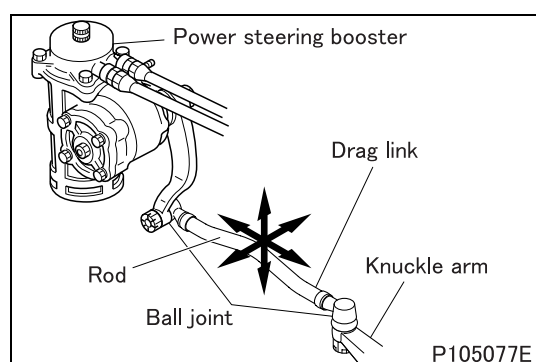
## 6. Inspection of Drag Link Ball Joint

### (1) Backlash

- With the vehicle in the stationary state, hold the rod of the drag link and move it in the forward, backward, vertical and lateral directions of the vehicle and check for play at the ball joints. Be sure to check the power steering booster and ball joints on both sides of the knuckle arm.
- If play is excessive, replace the drag link.

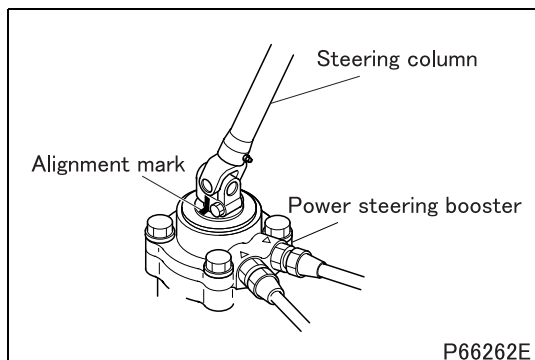
### ■ Alignment mark: Steering column and power steering booster

- Provide alignment marks on the steering column and power steering booster.

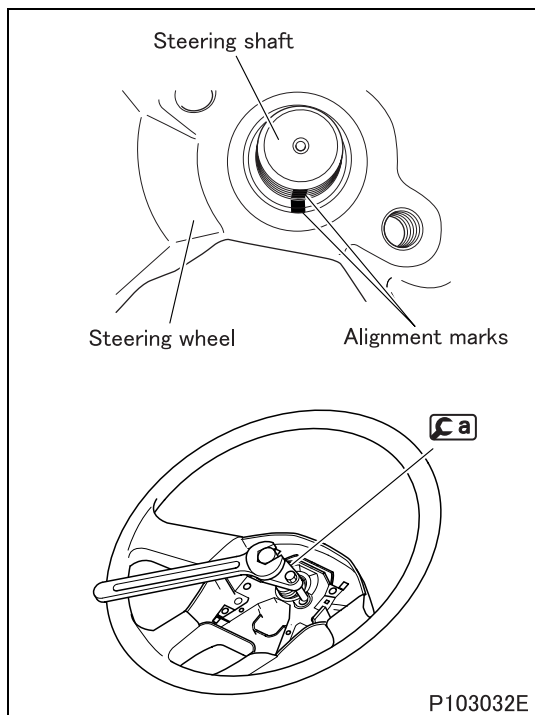
### ■ Removal: Steering wheel

- After removing the steering wheel mounting nut, be sure to put alignment marks on the steering wheel and steering shaft.

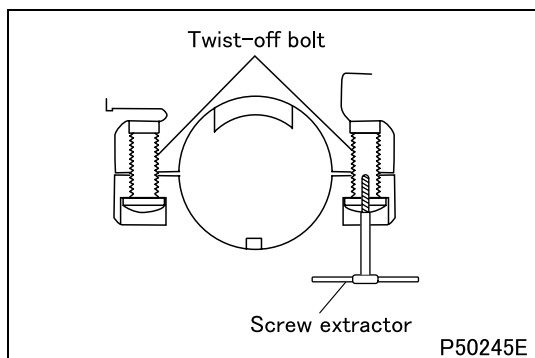
### ■ Removal: Starter switch

- Drill a hole of 5.5 to 6 mm {0.22 to 0.24 in.} in diameter to a depth of 10 to 15 mm {0.39 to 0.59 in.} in the twist-off bolt.
- Using the drilled hole, screw the screw extractor counterclockwise into the twist-off bolt and remove it.

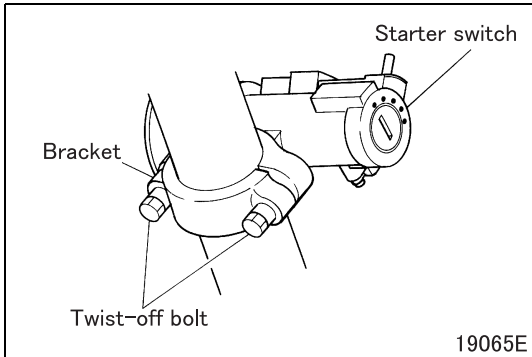
### ■ Installation: Starter switch

- Install the starter switch using new twist-off bolts.
- Twist off the bolt head of the twist-off bolt.
- Check for operation of the steering lock function of the starter switch.

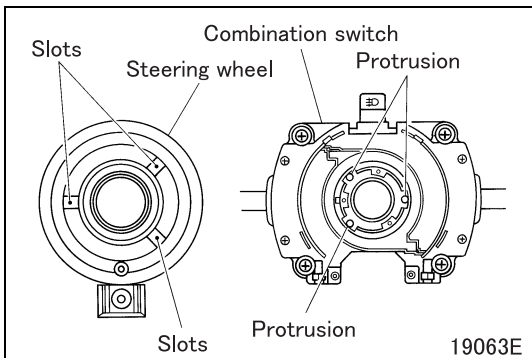
### ■ Installation: Steering wheel

- Align slots in steering wheel with cancel cam protrusions of combination switch.

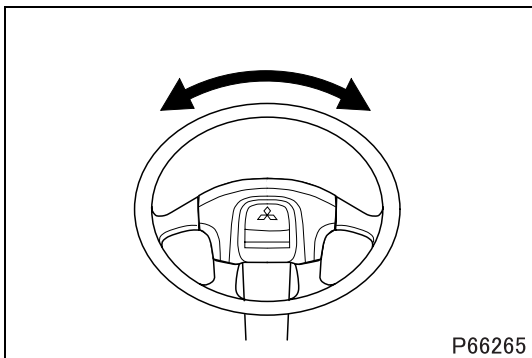
### ■ Inspection: Noise from steering wheel

- Lightly turn the steering wheel left and right and check for noise and other abnormalities.
- If any abnormality is found, disassemble the steering wheel, remove the cause and reinstall.

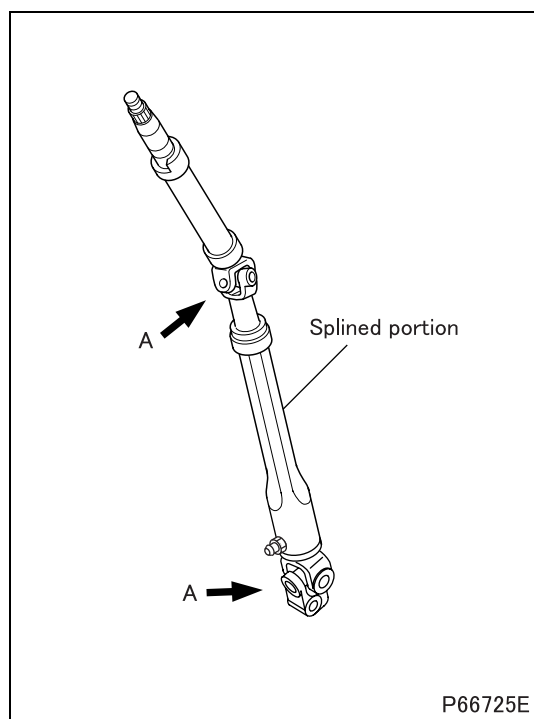
#### ■ Installation: Steering joint

- When the steering joint has been separated at the splined portion, reconnect it so that the yokes of the upper and lower joints will face in the same direction (arrows A).

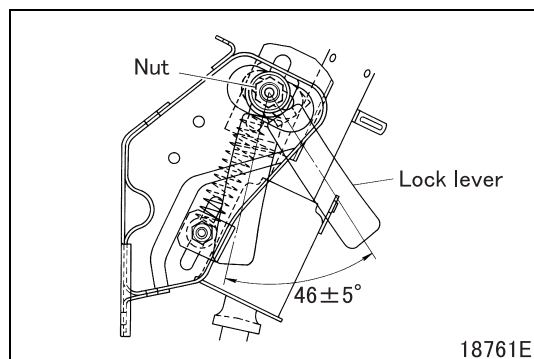
#### ■ Installation: Lock lever

- Install the lock lever so that its operating range conforms to the angle indicated in the illustration.

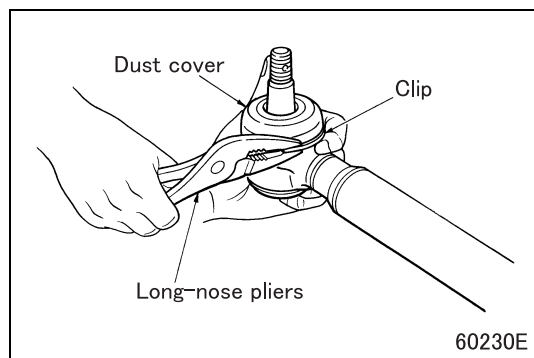
**■ Removal: Clip**
**CAUTION** ⚠

- When removing the clip, take care not to deform or damage the clip and dust cover.
- Do not reuse the removed clip if it is deformed.

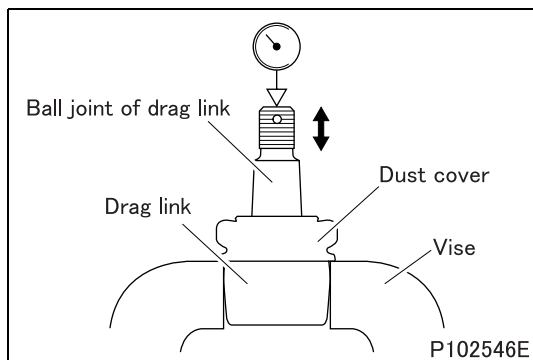
### ■ Inspection: Drag link

#### (1) Play

- The position of the ball joint with applying no load is adjusted to standard position.
- Measure each play of the ball joint with applying the specified push and pull load from the standard position.
- Total each play and if the total deviates from standard value, replace the tie rod end.

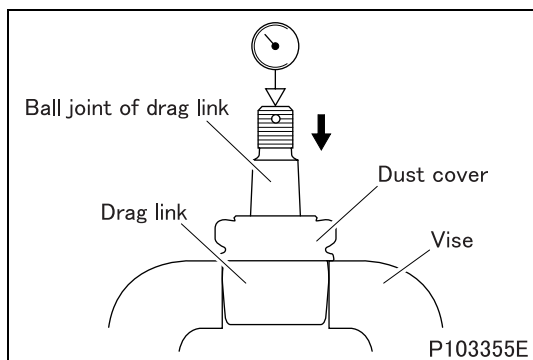
##### <Except FK61>

- Fix the drag link with a vise.

- If measured value deviates from the standard value with applying the specified load (push) to the ball joint, replace the drag link.

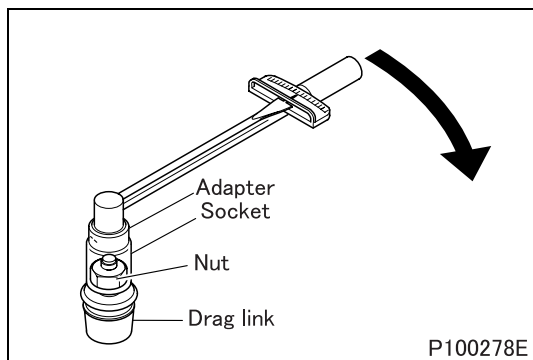
#### (2) Rotation torque

- Install the drag link mounting nut on the drag link.
- Install the socket, adapter and torque wrench to measure the rotation torque.
- If the measured value deviates from the standard value, replace the drag link.

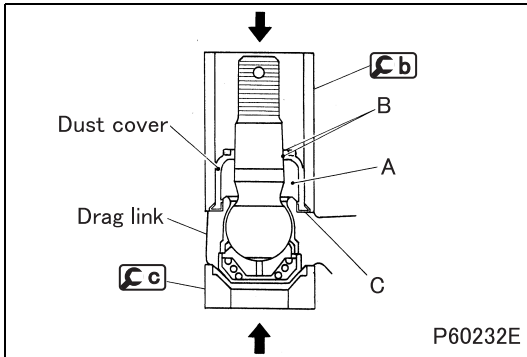
### ■ Installation: Dust cover <Except FK61>

- Fill inside A with grease and apply grease to lip B of the dust cover.
- Pinch the dust cover with **C b** and **C c** and install reinforced collar C using a vise so that it is in close contact with the drag link.

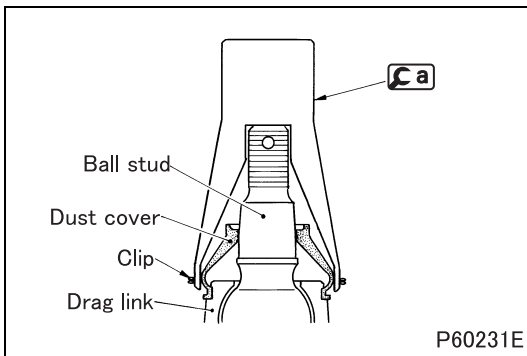
### ■ Installation: Clip

- Set the ball stud so that it is vertical.
- Put **C a** on the drag link.
- Install the clip in the dust cover groove.

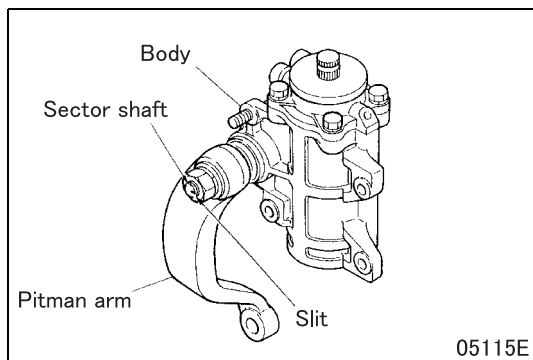
### ■ Preparatory work: Setting of pitman arm at neutral position

- Move the pitman arm and set the V-groove slit of the sector shaft at the center of the body to place gear engagement in neutral position.
