# FE.FG

## SERVICE MANUAL 2008 Model FOREWORD

This Service Manual contains maintenance and repair methods for the Mitsubishi Fuso Truck FE. FG Series. Read this manual carefully as an aid in providing correct, efficient maintenance. Please note that the information and specifications contained within this manual may change without notice. This is due to product modifications and continued vehicle improvements that are made throughout the model years. Should you encounter any discrepancy in the information provided, please do not hesitate to contact your nearest Mitsubishi Fuso Dealer or Mitsubishi Fuso Truck of America, Inc.

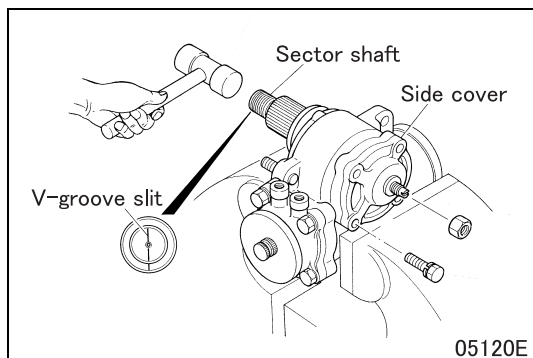
### ■ Removal: Sector shaft and side cover

- Make sure that the piston is at the neutral position (the V-groove slit of the end face of the sector shaft is in the center of the body).
- Tap the end face of the sector shaft to remove the sector shaft and side cover.

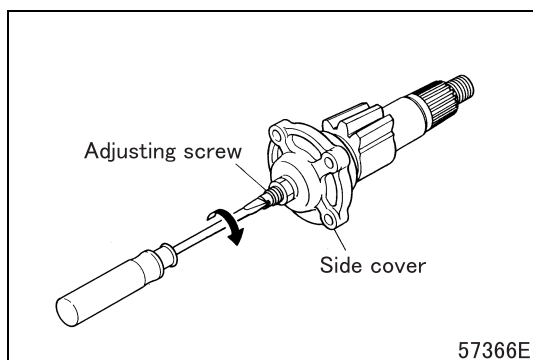
### ■ Removal: Side cover

- Remove the side cover by tightening the adjusting screw.

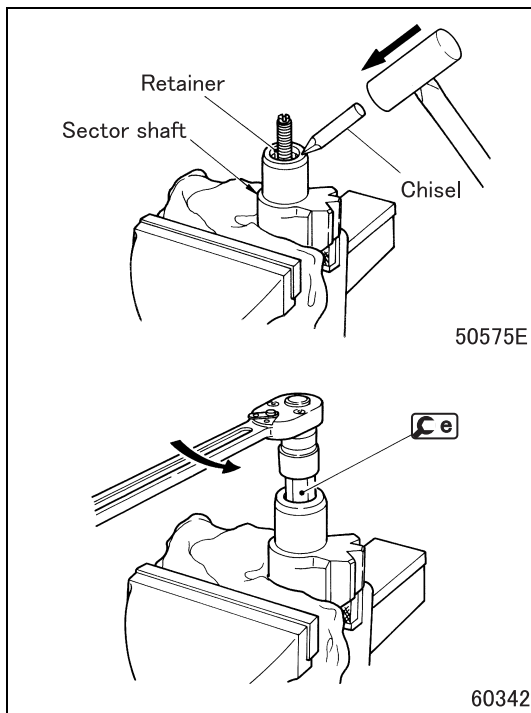
#### ■ Removal: Retainer

- Raise the caulked areas (two locations) of the retainer with a chisel.

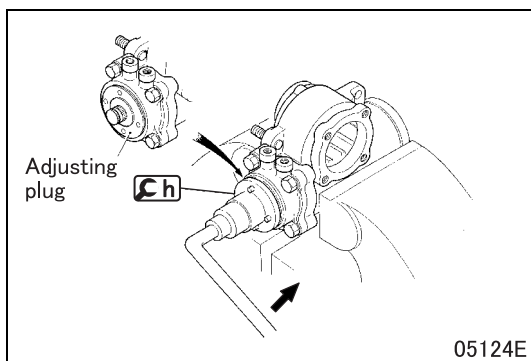
#### ■ Removal: Piston screw and valve housing

- Before removing the piston and valve housing, return the adjusting valve by approximately 180° using

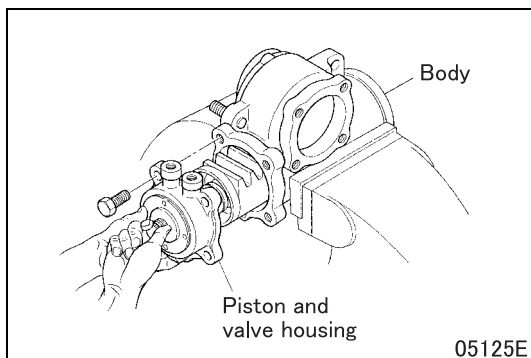
- Remove the piston and valve housing from the body.

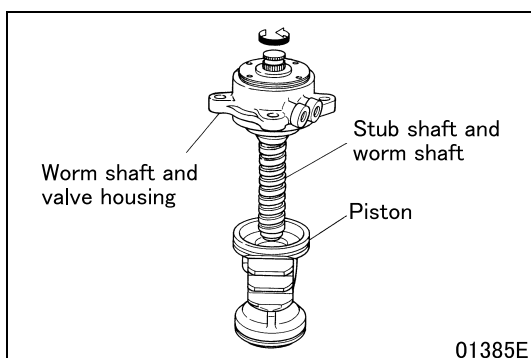
#### ■ Removal: Piston

- Hold the worm shaft and valve housing with the piston facing downward, and turn the stub shaft and worm shaft to remove the piston.

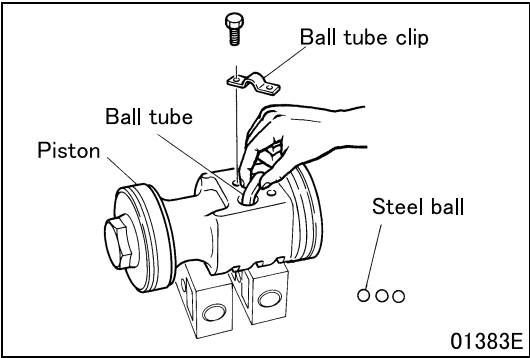
## ■ Removal: Ball tube and steel ball

- After removing the steel balls from the piston, remove the ball tube clip and pinch the ball tube with fingers and lightly move it to remove from the piston.

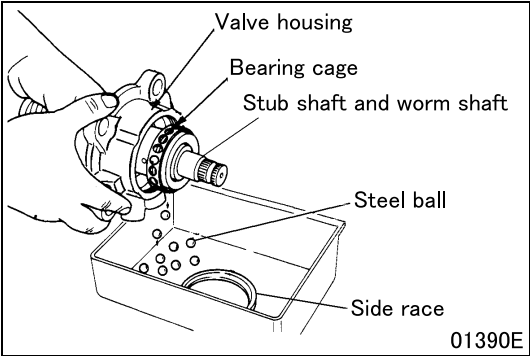
## ■ Removal: Stub shaft and worm shaft

- Press out the piston assembled side of the stub shaft and worm shaft to remove from the valve housing.

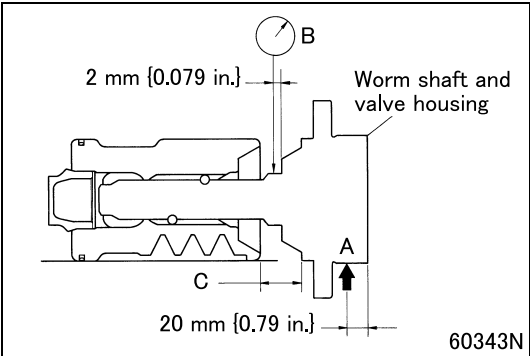
## ■ Inspection: Looseness in piston and stub shaft and worm shaft

- Pull the worm shaft and valve housing to the dimension C as illustrated.
- Measure looseness B of the worm shaft and valve housing in the radial direction when a force of 49 N {11 lbs, 5 kgf} is applied to illustrated area A.
- If the measured value exceeds the limit, replace the defective part(s).

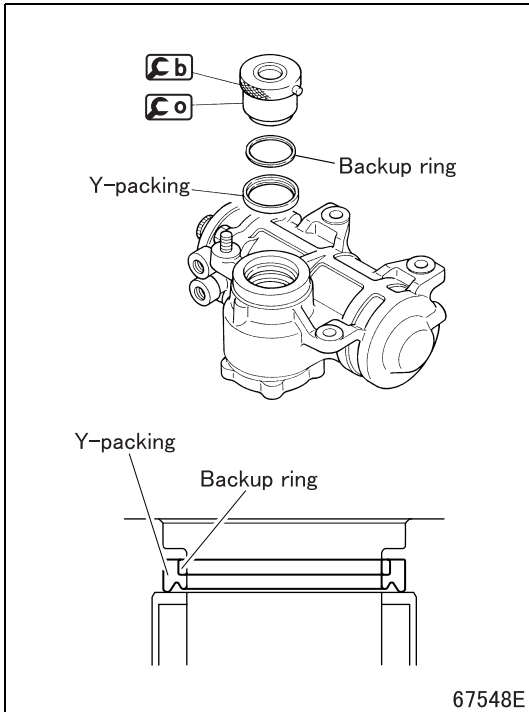
### ■ Installation: Backup ring and Y-packing

- Fill the Y-packing groove with grease and install it in the illustrated direction.
- The backup ring can be easily installed in the illustrated shape. After installation, form it with ㇿb and ㇿo.

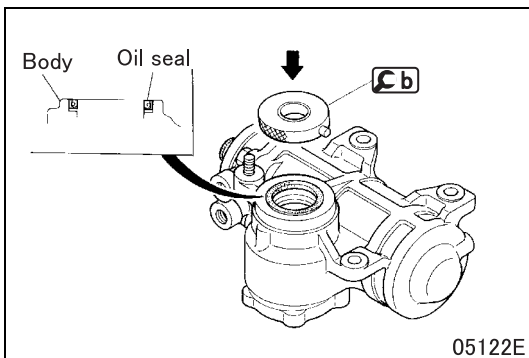
### ■ Installation: Oil seal

- Install the oil seal on the body in the illustrated direction.

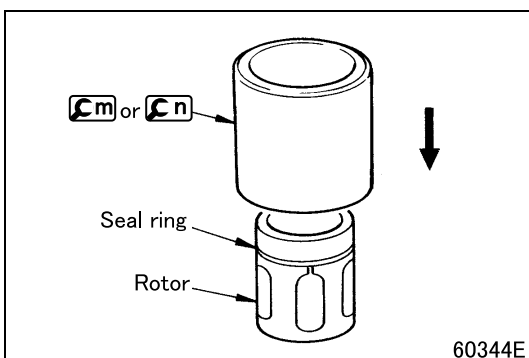
### ■ Installation: Seal ring

- Install the seal ring on the rotor.
- Form the seal ring with ㇿm or ㇿn.

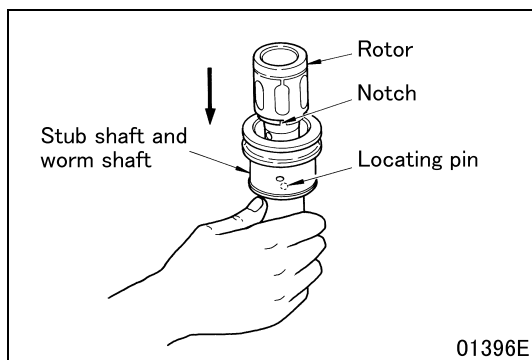
## ■ Installation: Rotor

- Install the notch of the rotor so that it is in alignment with the locating pin of the stub shaft and worm shaft.

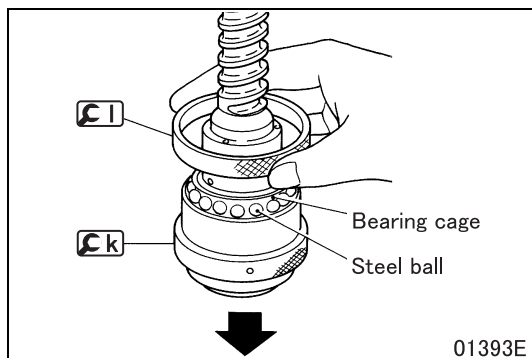
## ■ Installation: Side race, steel ball and bearing cage

- Assemble 1 onto k and install the stub shaft and worm shaft in the illustrated direction.
- Install the bearing cage and steel balls onto the stub shaft and worm shaft.

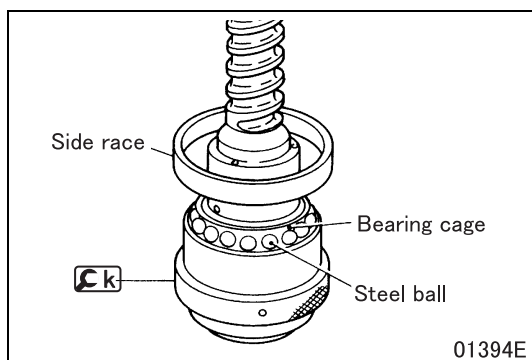
- Hold 1 by hand and slide k downward to set the steel balls in place.

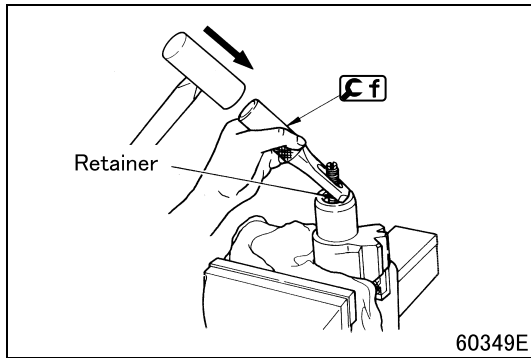
#### ■ Installation: Retainer

- Fill the adjusting screw mounting hole of the sector shaft with grease.
- Install the adjusting screw on the sector shaft.
- Install the retainer on the sector shaft using **C e**.
- After tightening, return the retainer by 180° once. Then, retighten it to the torque of 39 N·m {29 ft.lbs, 4 kgf·m} and return it by 20°.
- Make sure that the adjusting screw turns smoothly.

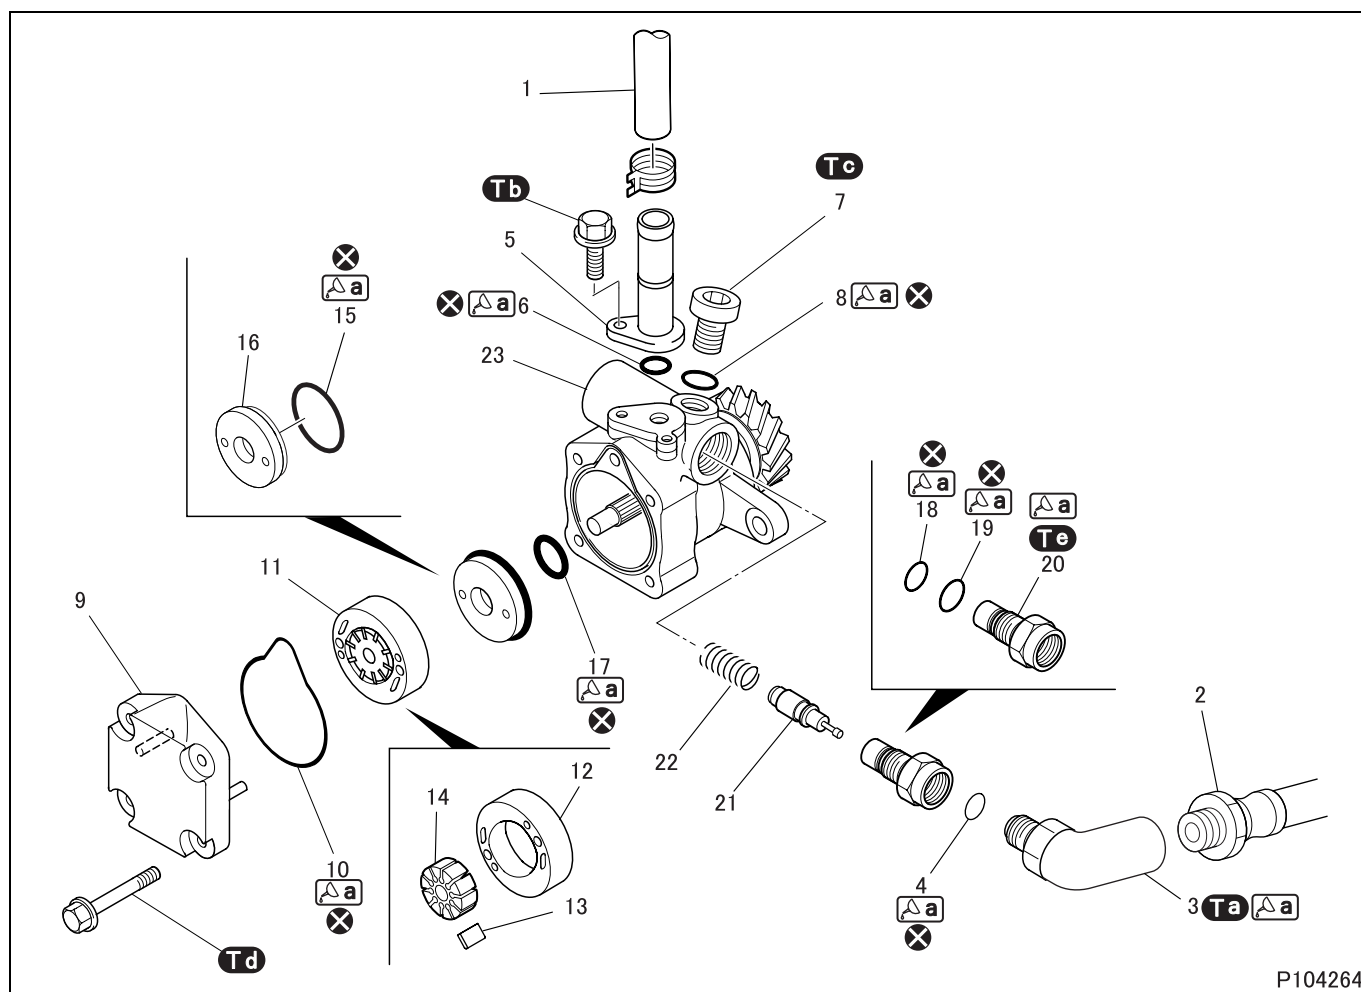
P104264

# POWER STEERING OIL PUMP <FK>

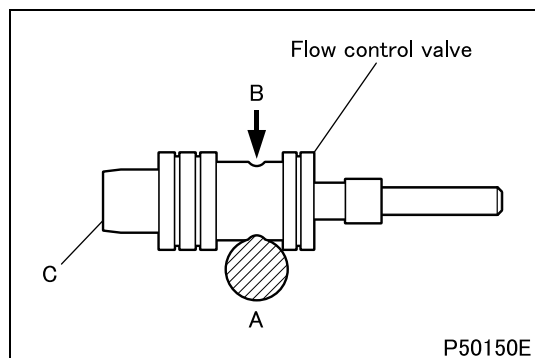
#### ■ Inspection: Flow control valve

- Plug port A of the flow control valve by a finger.
- Apply air pressure (390 to 490 kPa {57 to 71 psi, 4 to 5 kgf/cm<sup>2</sup>}) to port B.
- Check for any air leakage from port C.
- If there is any abnormality, replace the power steering oil pump.

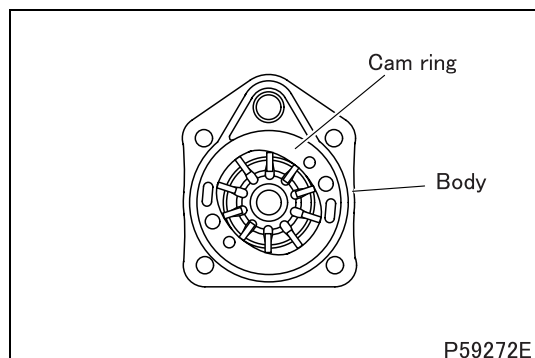
#### ■ Installation: Cam ring

- Install the cam ring on the body in the illustrated direction.

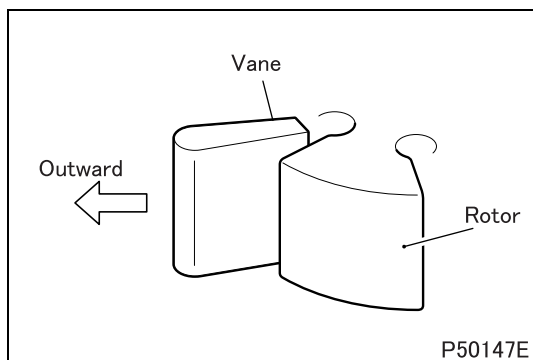
## ■ Installation: Vane

- Install the vane on the rotor with its rounded area facing outward.

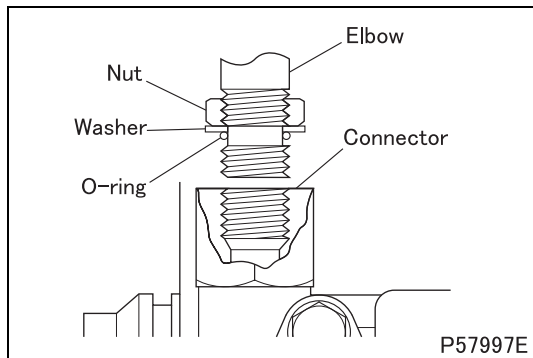
## ■ Installation: Elbow

- Make sure that the nut and washer of the elbow and O-ring are correctly positioned.
- Clean the O-ring mount completely and apply power steering oil to it. When assembling the O-ring, apply automatic transmission fluid to it to prevent damage.

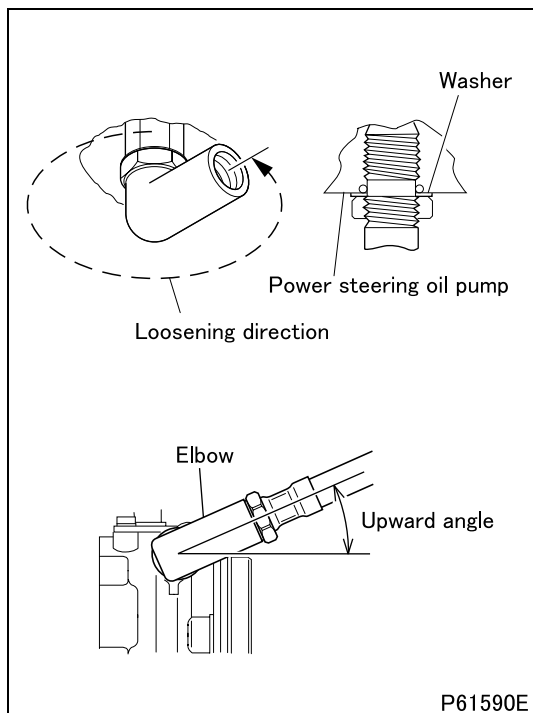
- Screw in the power steering oil pump by hand until the washer contacts the connector mounting surface. From that position, align the power steering oil pump with the upward angle of 20° from the horizontal direction of the body of the power steering oil pump in the loosening direction.

- When returning the power steering oil pump to the specified position, do not turn it by more than 270°.

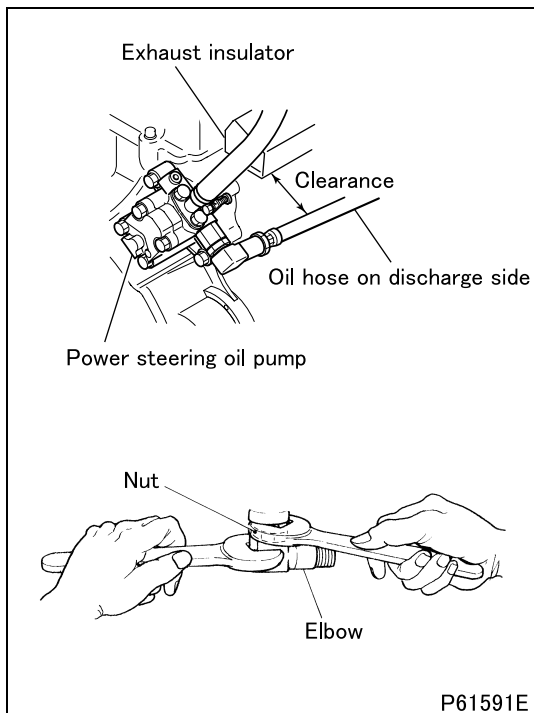
#### ■ Installation: Oil hose (discharge side)

- When installing the oil hose on the discharge side, provide sufficient clearance (approximately 50 mm {2.0 in.} or more) to the exhaust insulator.
- Hold down the elbow with a spanner to prevent displacement of the elbow position and tighten the nut to the specified torque.

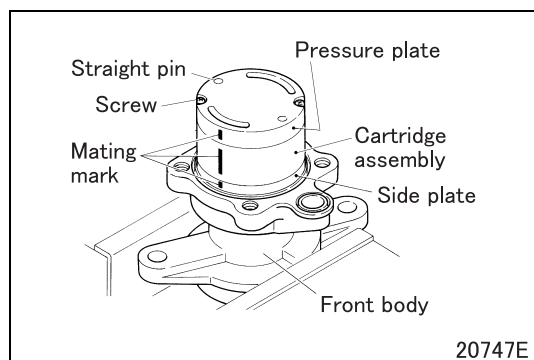
#### ■ Removal: Cartridge assembly

- Put mating marks on the outer surfaces of the pressure plate, cartridge assembly and side plate.
- Remove the screw, and then, remove the pressure plate, cartridge assembly, side plate and straight pin as a set from the front body.

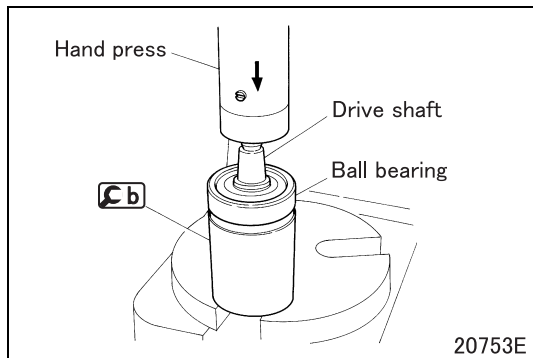
## ■ Removal: Ball bearing

- Remove the ball bearing toward the drive side (gear side) of the drive shaft.

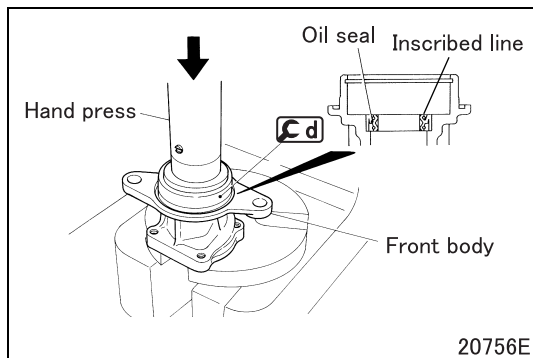
## ■ Installation: Oil seal

- Install the oil seal on the front body in the illustrated direction.

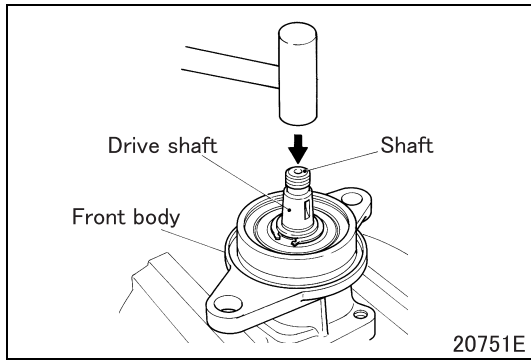
#### ■ Installation: Drive shaft

- When installing the drive shaft into the front body, if it is not inserted into the normal position by hand, lightly tap the shaft with a plastic hammer to install.

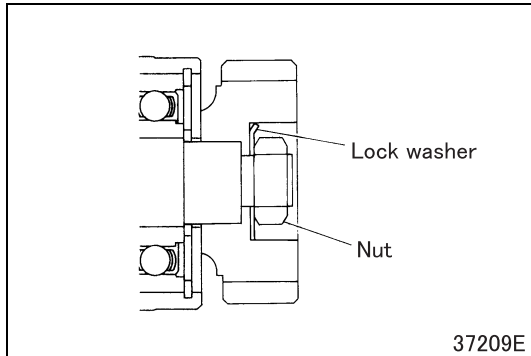
#### ■ Installation: Lock washer

- After tightening the nut, bend one location on the circumference of the lock washer.

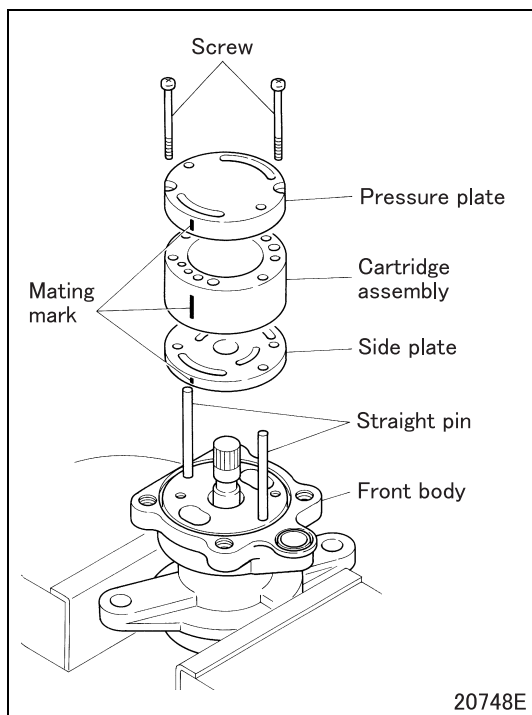
## ■ Installation: Cartridge assembly

- Install the straight pin on the front body.
- Install the side plate, cartridge assembly and pressure plate in alignment with mating marks put at the time of disassembly, and tighten screws to the specified torque.

- Do not mistake pin holes of each part when installing.

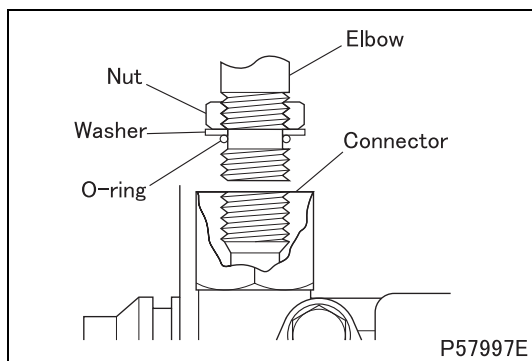
## ■ Installation: Elbow

- Make sure that the nut and washer of the elbow and O-ring are correctly positioned.
- Clean the O-ring mount completely and apply power steering oil to it. When assembling the O-ring, apply automatic transmission fluid to it to prevent damage.

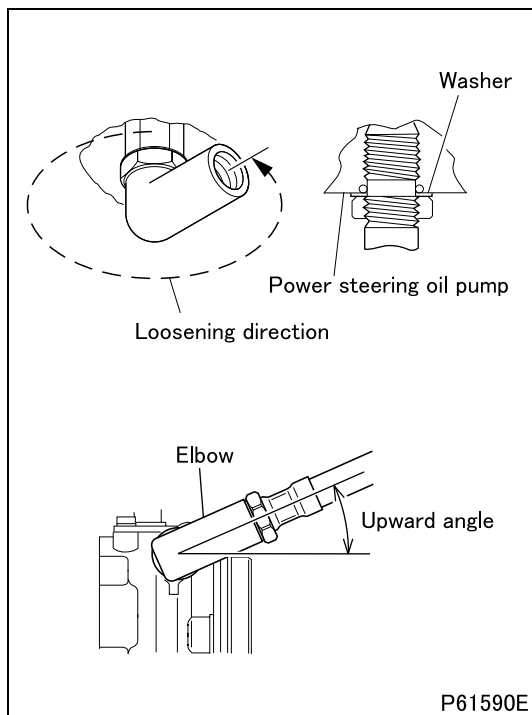
- Screw the elbow in the power steering oil pump by hand until the washer contacts the connector mounting surface. From that position, align the elbow with the upward angle of 20° from the horizontal direction of the body of the power steering oil pump in the loosening direction.

- When returning the elbow to the specified position, do not turn it by more than 270°.

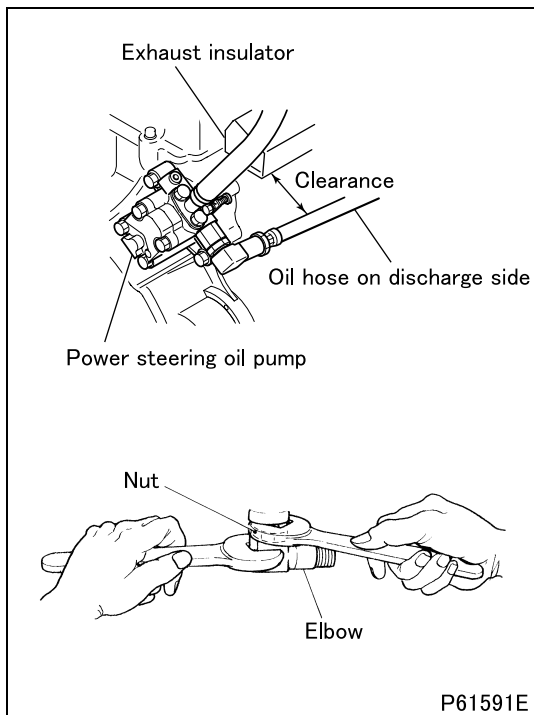
#### ■ Installation: Oil hose (discharge side)

- When installing the oil hose on the discharge side, provide sufficient clearance (approximately 50 mm {2.0 in.} or more) to the exhaust insulator.
- Hold down the elbow with a spanner to prevent displacement of the elbow position and tighten the nut to the specified torque.

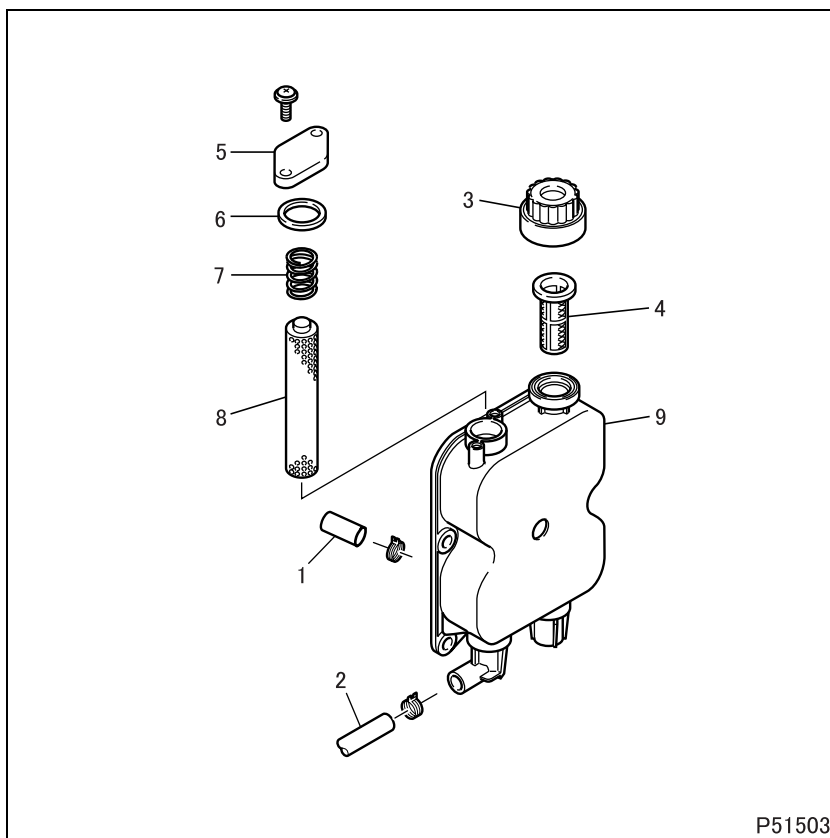
# POWER STEERING OIL TANK

- 1 Hose
- 2 Hose
- 3 Cap
- 4 Strainer
- 5 Filter cap
- 6 Packing
- 7 Spring
- 8 Filter
- 9 Tank body

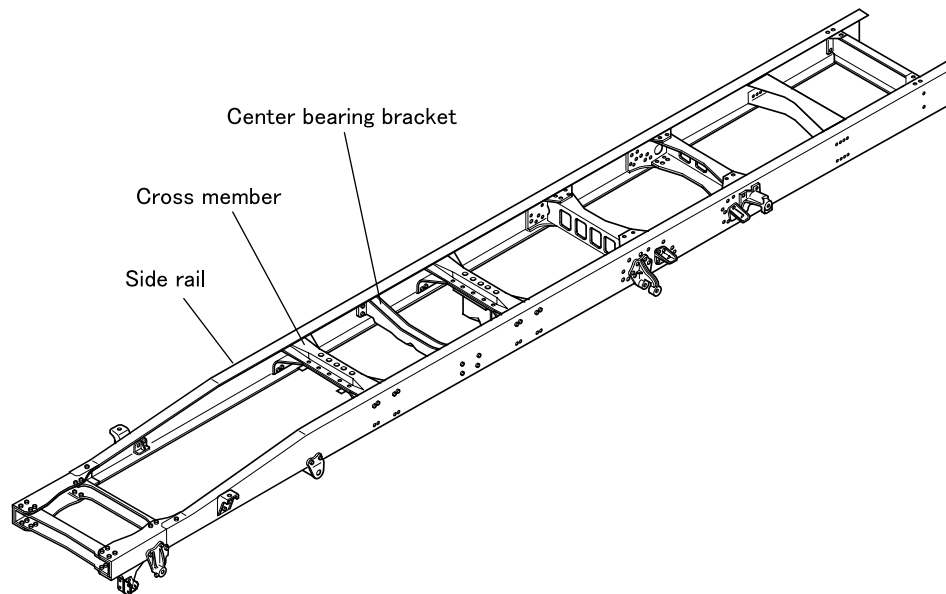
P104844E

## 1. Frame

- The frame has cross members fastened to the web of the side rails (lateral linkage) so that stress on the joints is minimal. This allows joint rivets to maintain tightness and ensures long-lasting high torsional rigidity.
- Unlike vertical linkage where cross members are fastened to the flange of side rails, no rivets appear on top of the frame, greatly facilitating body mounting.

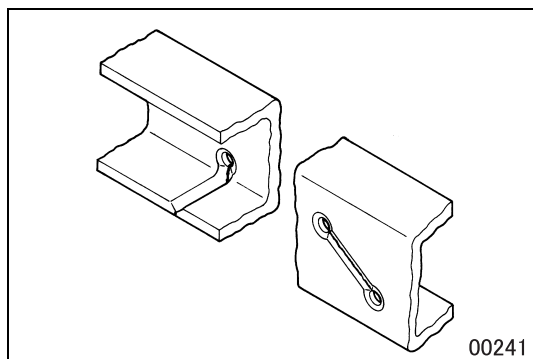
- Using a grinder, cut a 90° V-channel at the crack to a depth of approximately 2/3 of the frame plate thickness, then fill the channel with filler metal by welding.

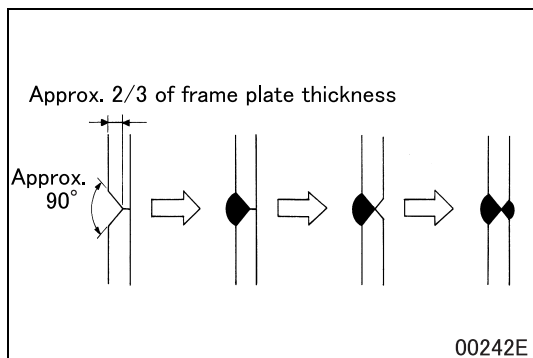
- Next, make a similar V-channel on the opposite side of the weld. At the same time, deposit metal to cover up the hole or holes at both ends of the crack by welding.

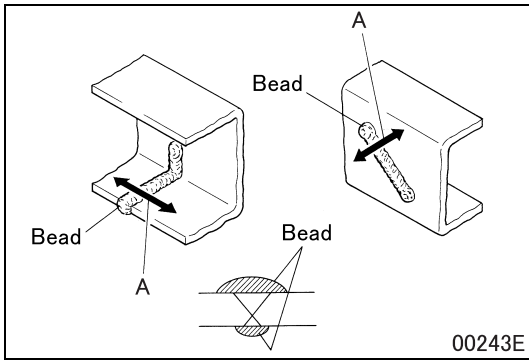
- After welding, run a grinder over the bead at right angles A.
- Remove the notched portion from the weld and finish the ground surfaces flat to a thickness equal to the original plate thickness.

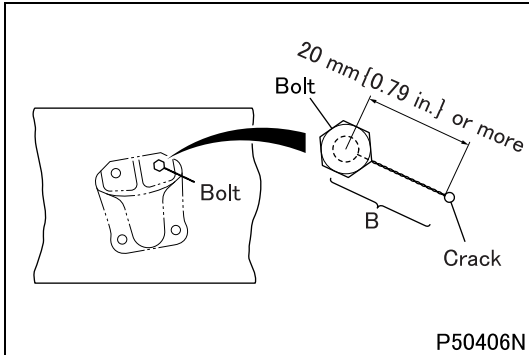
- To make the edges of the cracked hole even, temporarily tighten the bolt in the hole.
- First, weld to close the crack at a point at least 20 mm {0.79 in.} apart from the center of the bolt.  
For this welding, refer to the aforementioned welding procedures for crack repair.
- Remove the temporary bolt. After making hole edges even, weld to close the rest of the crack B. Simultaneously fill the hole with weld metal.
- Drill a hole at the location of original hole, and install a rivet or bolt in it.

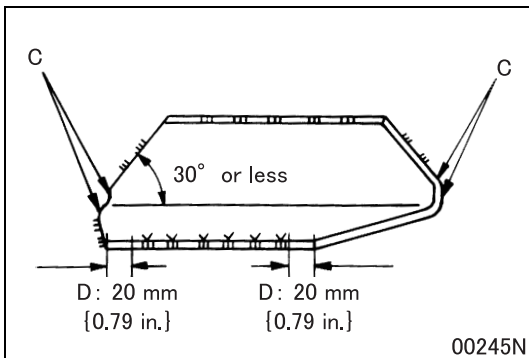
- To prevent the concentration of welding stress at both ends C of the reinforcement plate, cut the ends at a bevel of 30° or less for welding. Do not weld at points D.
- The reinforcement plate must have enough to cover the cracked area.

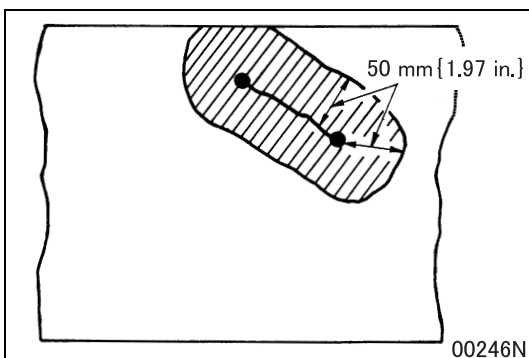
- After welding, heat the hatched area to 600 to 700°C {1110 to 1290°F}.

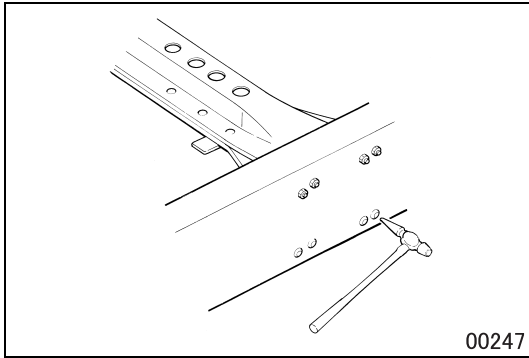
- Lightly tap the head of each rivet using an inspection hammer and feel or listen for the echo to determine if the rivet is loose.
- Rusting between rivet and frame plate is an indication of loosened rivet.

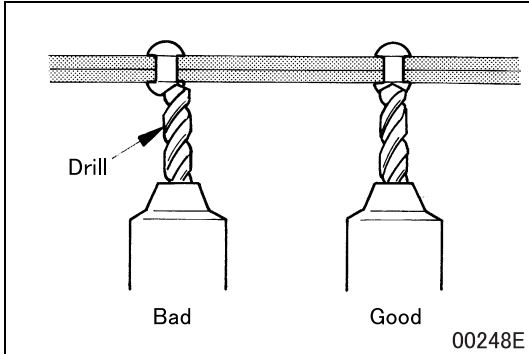
- To remove a rivet, make a dent in the middle of the loosened rivet's head with a punch, and then, eliminate its head using a drill or grinder.

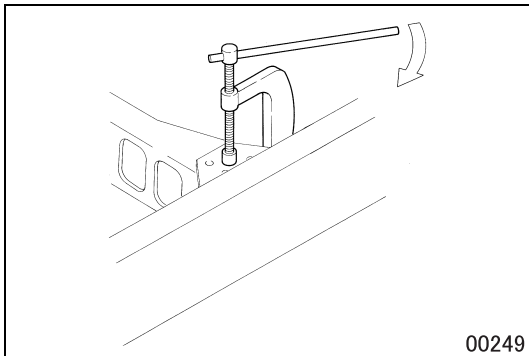
- Before riveting, clamp the two plates closely together near the rivet hole using a C vice.
- Using a riveting machine, drive the rivet (cold rivet) into the rivet hole.
- If riveting is unfeasible, ream the rivet hole, drive a reamer bolt into the hole, fully tighten the nut, then weld it in place. For the reamer bolt and nut to be used, use a flange bolt and a flange nut.

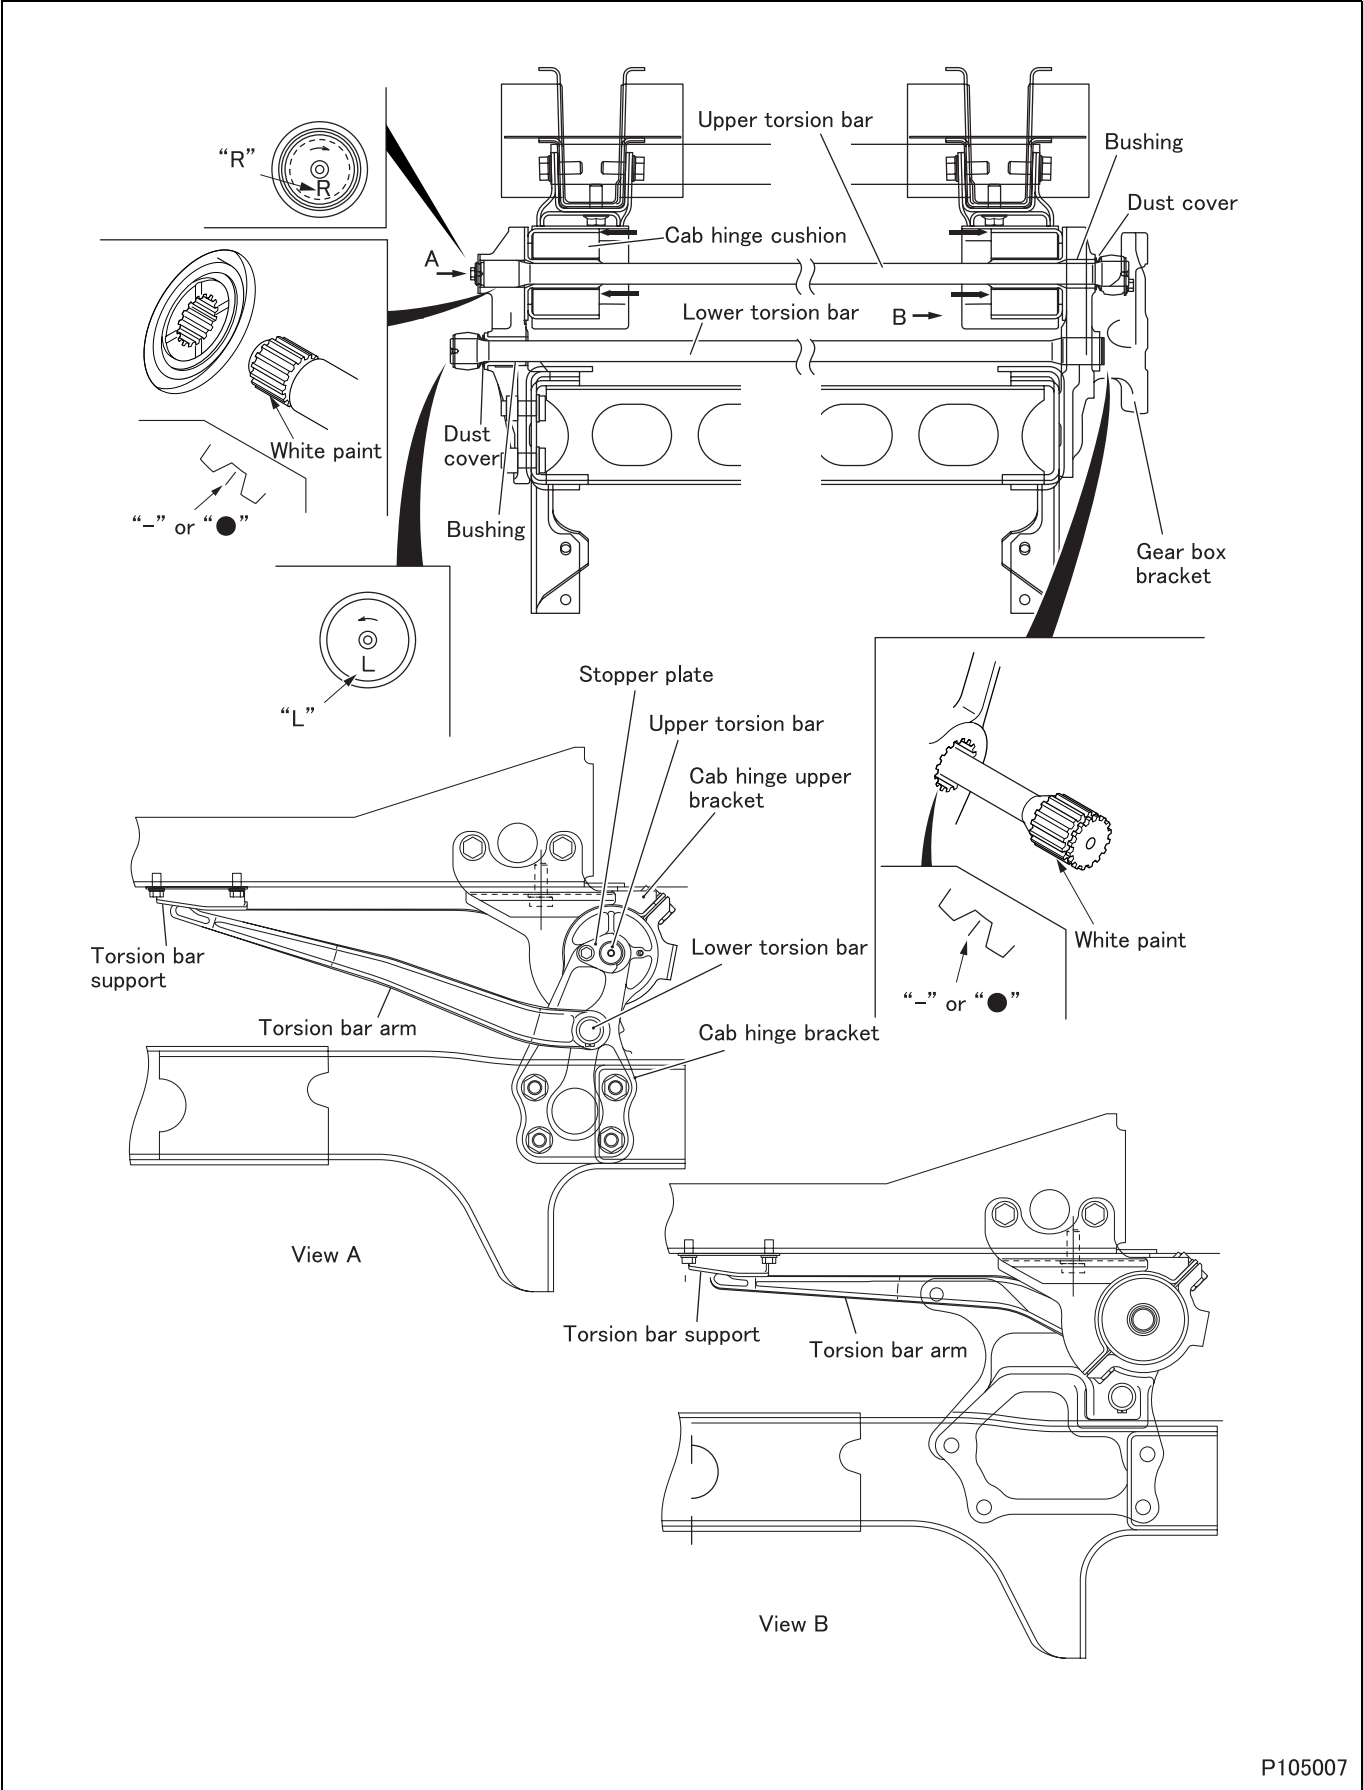
P105007

- Upper torsion bar and lower torsion bar have their particular torsional directions. To ensure that they are installed correctly, the upper and lower torsion bars have “L” or “R” indicating the direction of torsion stamped at the RH end faces.
- Upper torsion bar has alignment mark (white paint) which should be aligned with alignment mark “—” or “●” on cab hinge bracket.
- Lower torsion bar has alignment mark (white paint) which should be aligned with alignment mark “—” or “●” on gearbox bracket.

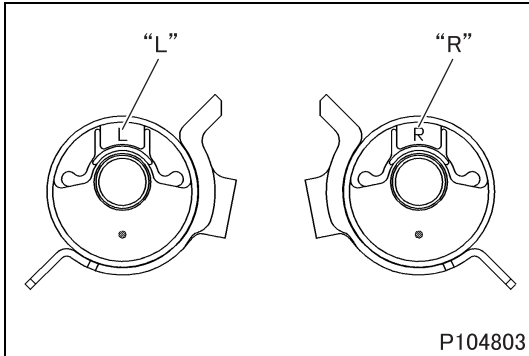
- Cab hinge cushion uses a liquid-filled rubber element.
- Cab hinge cushion has the identification mark “L” or “R”.

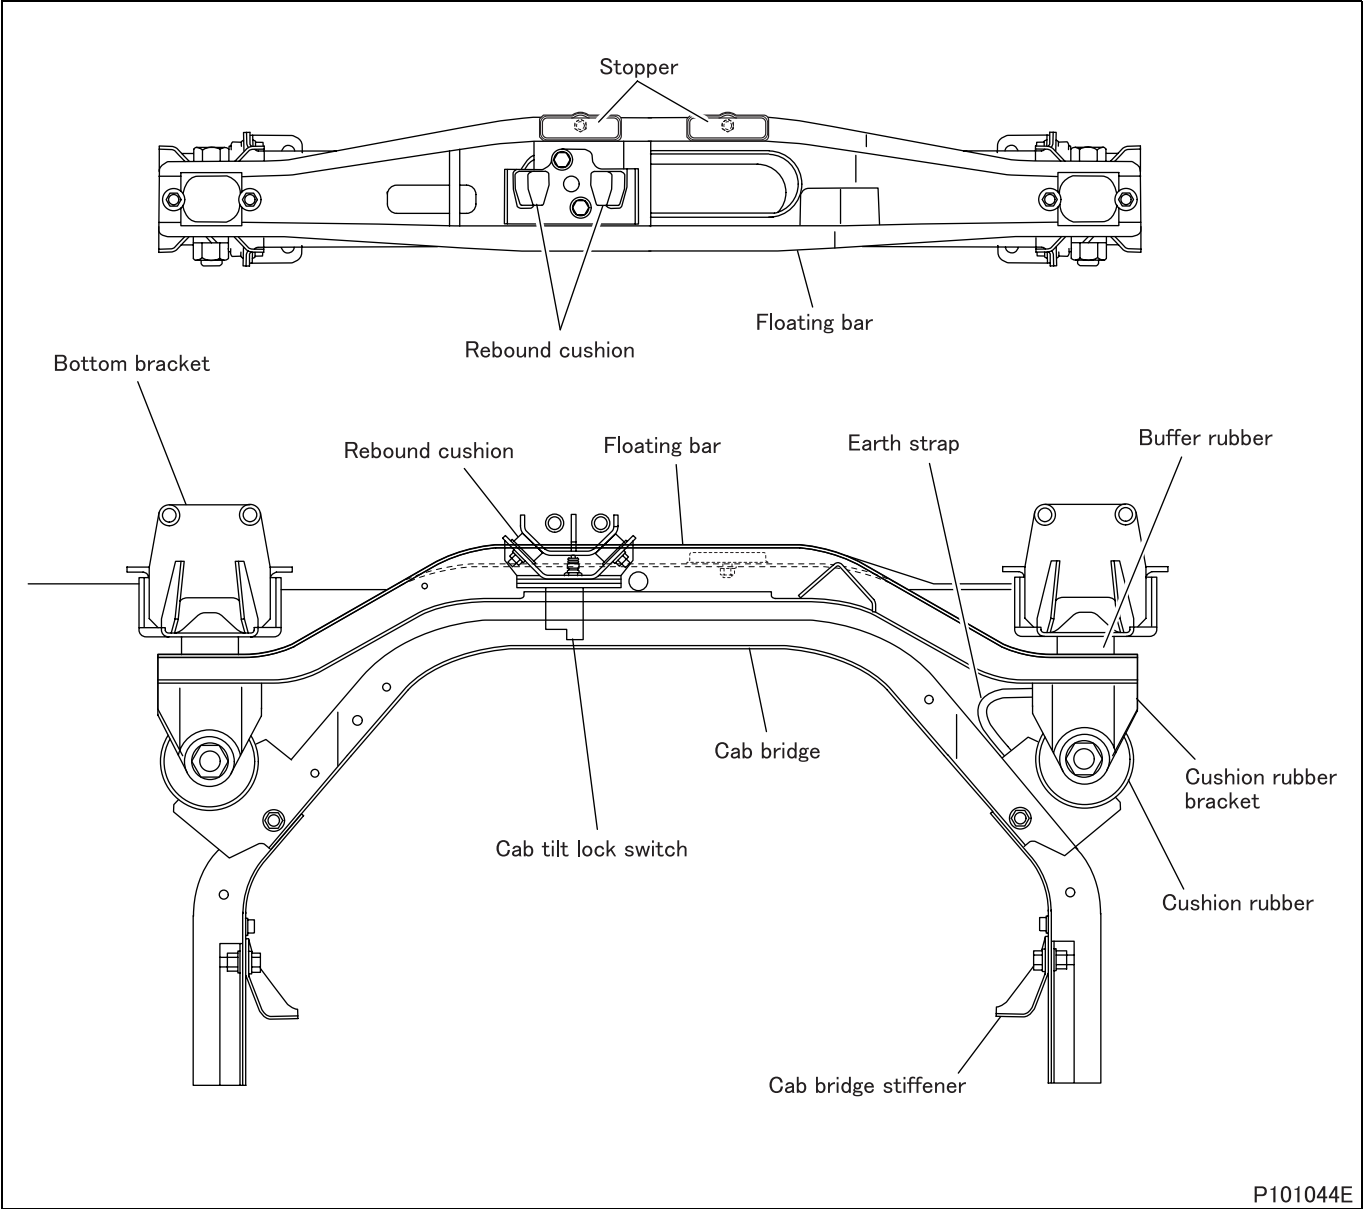
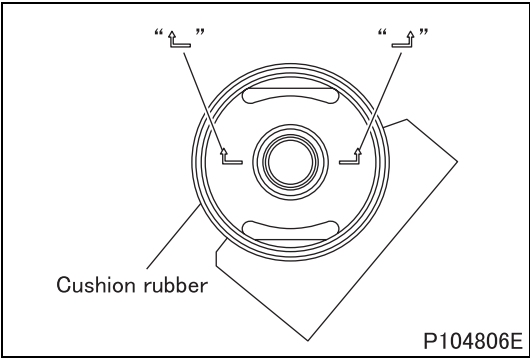
- Cushion rubbers have the identification mark showing the installing direction.

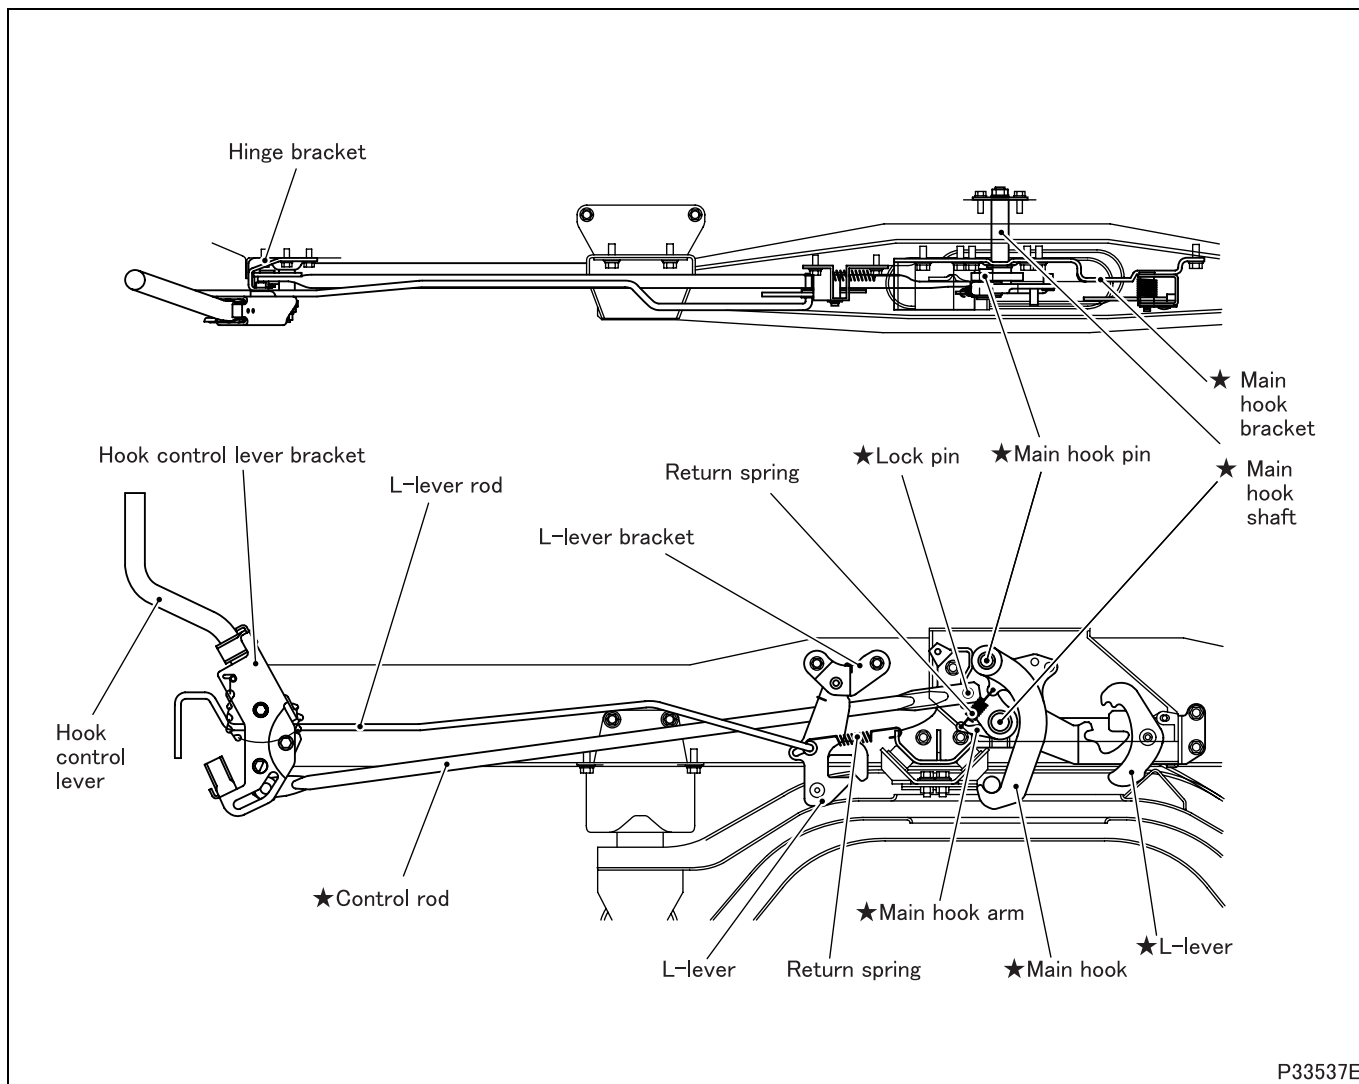
- Lock pin, main hook pin and main hook shaft all have their heads caulked after installation. Therefore, the parts marked with “★” which form a main hook assembly cannot be disassembled.

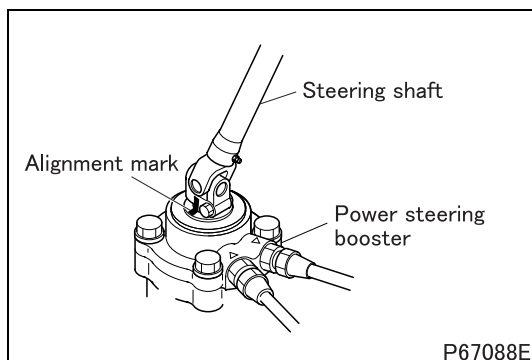
- With the cab tilted up in the normal tilting state, provide alignment marks on the steering shaft and power steering booster.
- Remove the steering shaft and bind it to the cab with a string or the like.

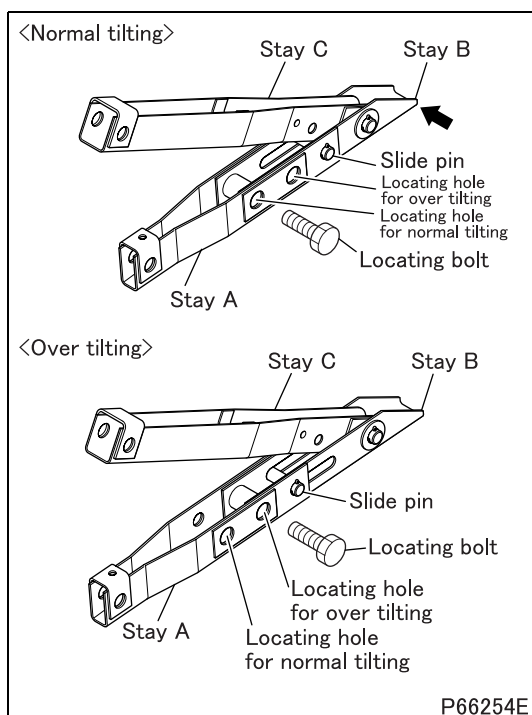
- Without the cab tilted up, change the state of the cab stays from normal tilting to over tilting by the following procedure.
  - Remove the locating bolt.
  - Slide the stay B by force in the illustrated direction.
  - Install the locating bolt in the locating hole for over tilting.

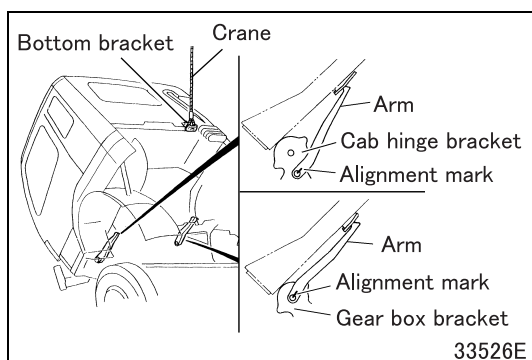
- With the cab tilted up, attach the wire rope to bottom bracket securely to enable the cab to be tilted down while being supported by crane.
- Make alignment marks on torsion bar arms, gear box bracket and cab hinge bracket, then remove the torsion bar arms.

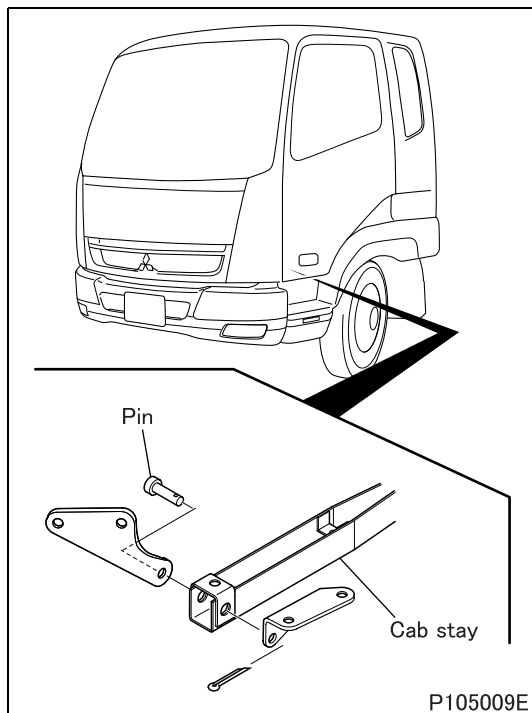
- Tilt down cab slowly while supporting it by the crane.
- Remove clevis pin to separate cab stay and cab.

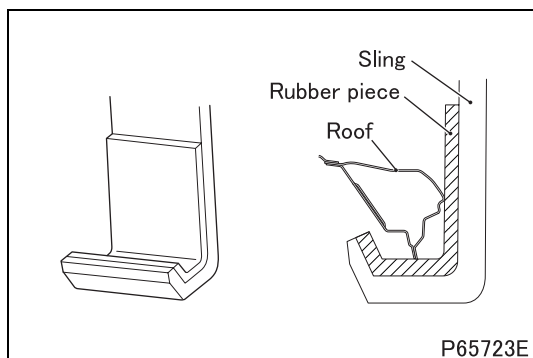
- Have ready cab sling like a one shown in the drawing.

- Get ready a sling rigid enough to support the mass.
- Sling must be lined with rubber piece to prevent deformation of roof of the cab when the cab is lifted.

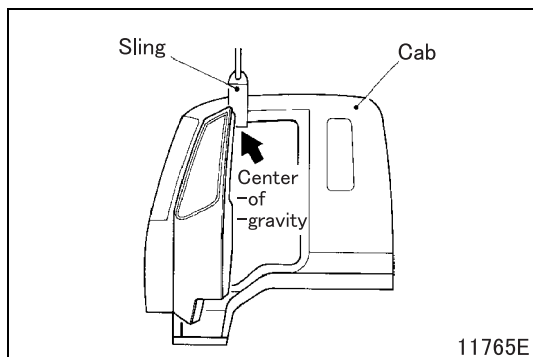
- Install sling at center-of-gravity of cab. To check the sling position, slightly lift the cab and see whether the cab remains horizontal. If necessary, adjust the sling position.

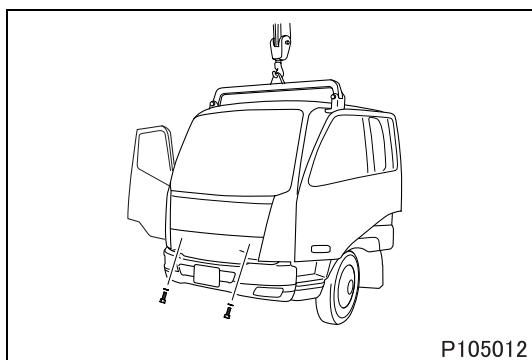
- Slowly lower cab further down until it is seated on the cab hinges. At this point, check for lateral alignment of the cab at the right and left cab hinges. If necessary, make adjustments for proper seating of the cab.
- Hold the cab hinge cushions with the bolts then remove the sling.
