# FE.FG

## SERVICE MANUAL 2008 Model FOREWORD

This Service Manual contains maintenance and repair methods for the Mitsubishi Fuso Truck FE. FG Series. Read this manual carefully as an aid in providing correct, efficient maintenance. Please note that the information and specifications contained within this manual may change without notice. This is due to product modifications and continued vehicle improvements that are made throughout the model years. Should you encounter any discrepancy in the information provided, please do not hesitate to contact your nearest Mitsubishi Fuso Dealer or Mitsubishi Fuso Truck of America, Inc.

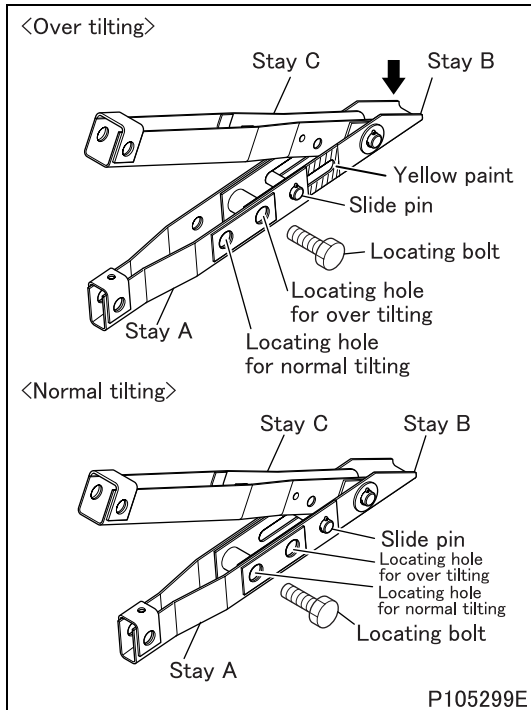
- With the cab tilted down, change the state of the cab stays from over tilting to normal tilting by the following procedure.
  - Remove the locating bolt.
  - Slide the stay B by force in the illustrated direction.
  - Install the locating bolt in the locating hole for normal tilting.
- Tilt up the cab in the normal tilting state. With their alignment marks in line, install the steering shaft to the power steering booster.

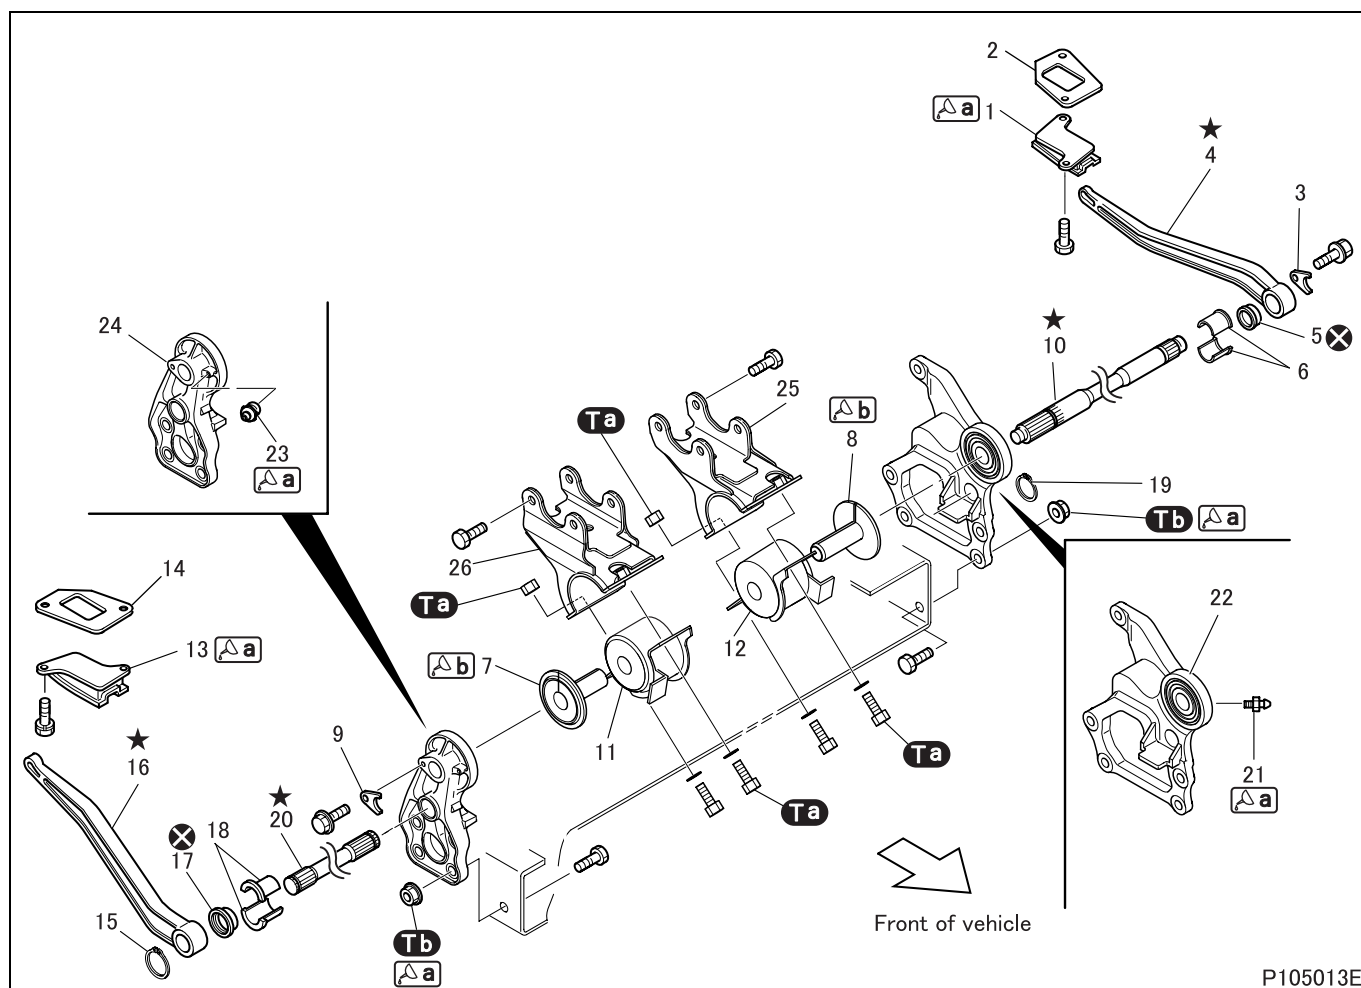
- Parts marked with “★” should be mounted when installing the cab. For assembly, see removal and installation of cab.

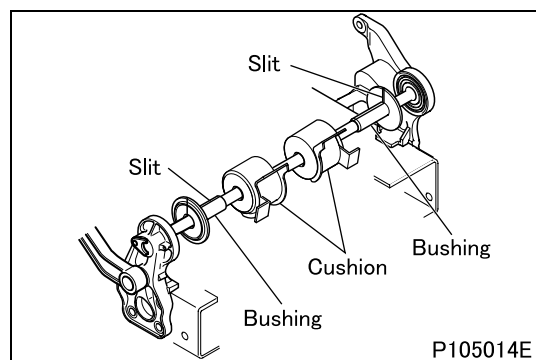
- Slide the cab hinge bushings to the center of the vehicle. Open the slits and remove the cab hinge bushings.

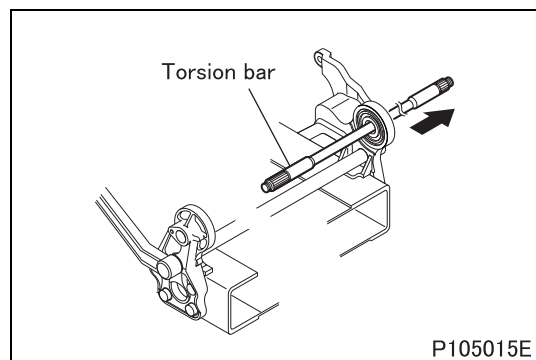
- Remove upper torsion bar in the direction shown.

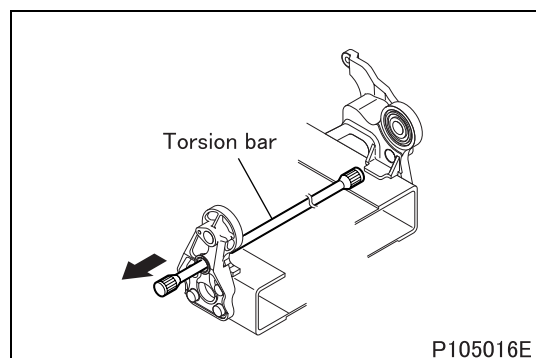
- Remove lower torsion bar in the direction shown.

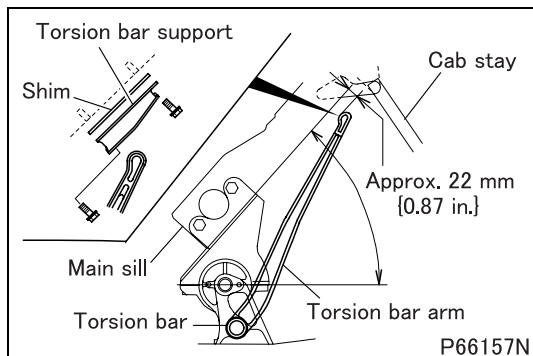
### ■ Installation: Torsion bar arm, right-hand

- Tilt the cab and support it with cab stay.
- Install torsion bar arm onto lower torsion bar such that clearance between the arm and cab main sill is as specified in the illustration.
- If the specified clearance cannot be obtained, adjust it using shim. Insert the shim between the cab main sill and torsion bar support when installing the support onto the sill.

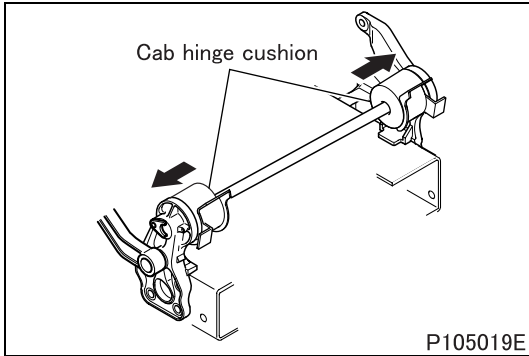
#### ■ Installation: Cab hinge cushion

- Install the cab hinge cushions with pressing them against the outside of the vehicle.

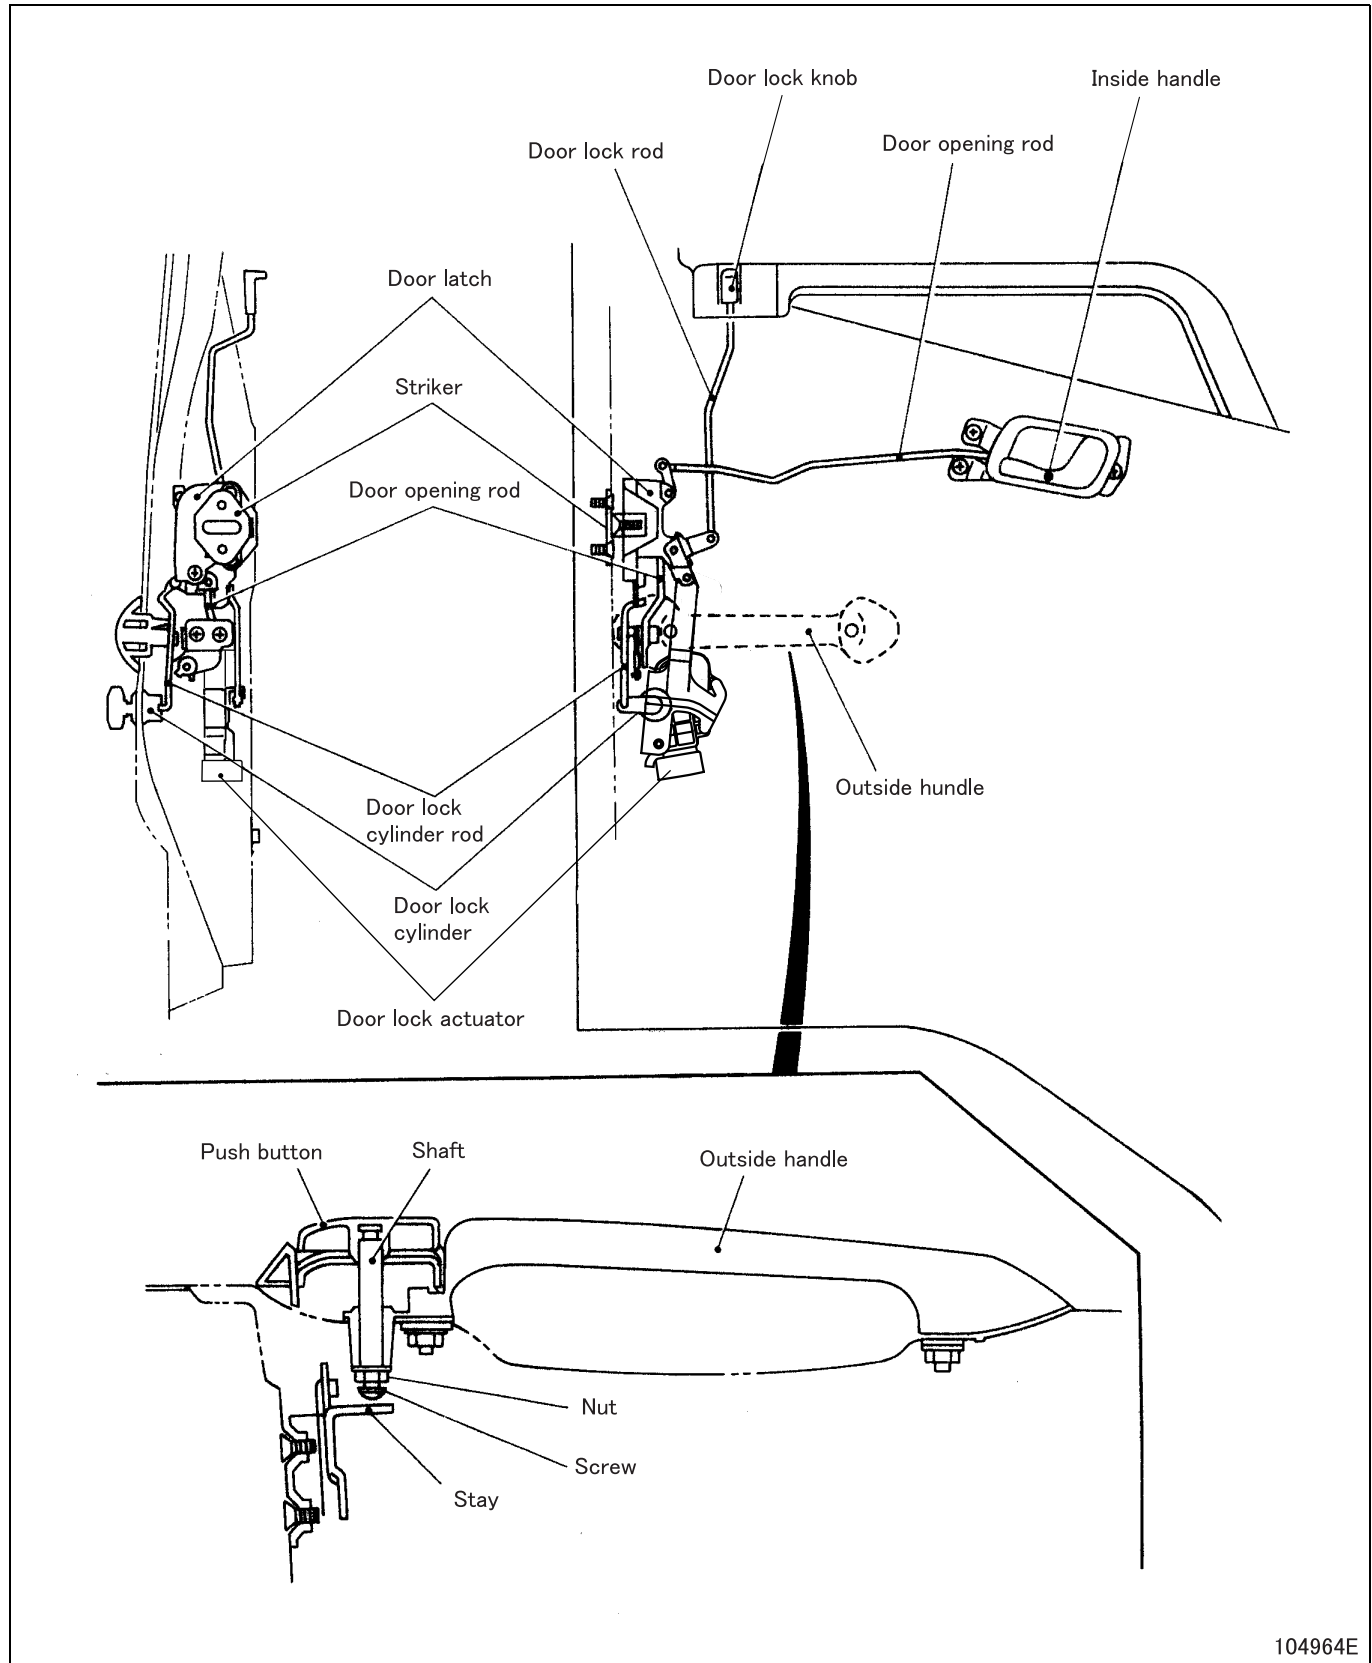
- Push button stroke of outside handle can be adjusted to optimize opening and closing of the door.
- To adjust the stroke, turn screw on shaft.
- The head of screw pushes stay, and this moves door opening rod, releasing door latch.

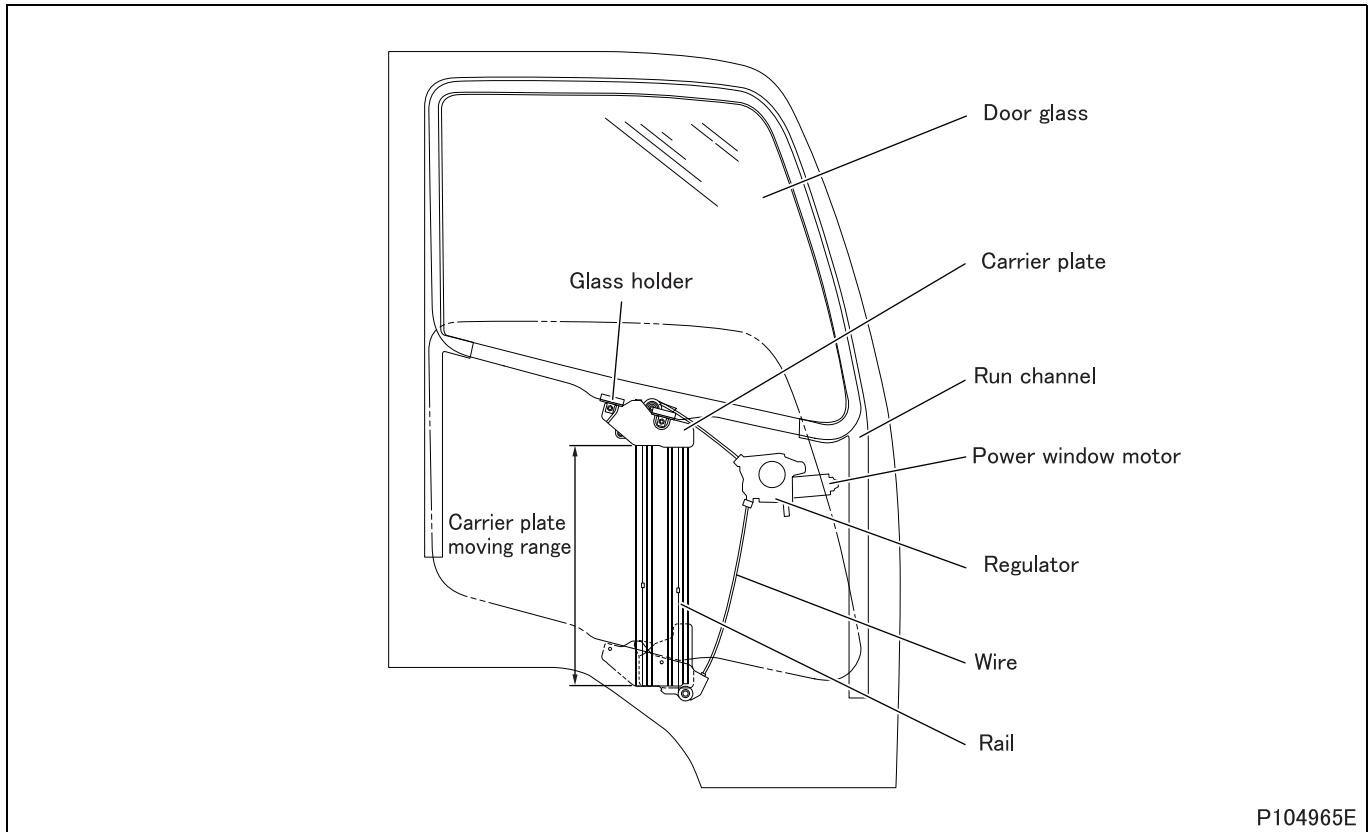
- Regulator is so constructed that it is interlocked with power window motor and carrier plate through wire.
- When power window motor is rotated, carrier plate is wound up or down by wire to raise or lower door glass.

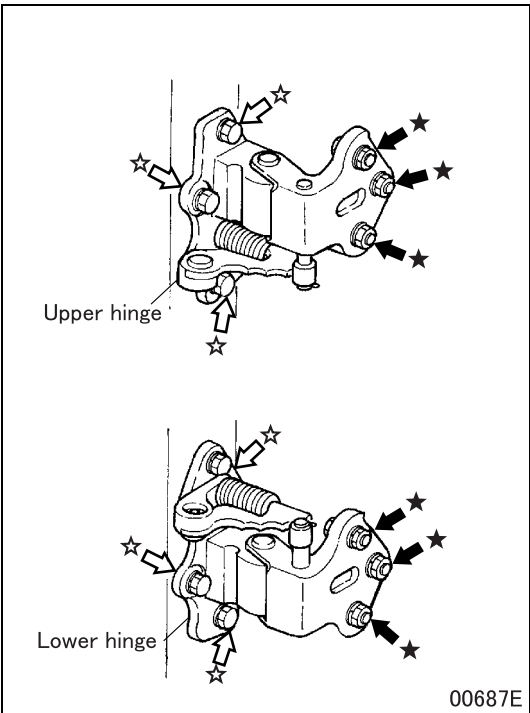
### 1.1 Adjustment of hinge positions

- Use ★ marked bolts to adjust gap.
- Use ★ marked bolts to adjust flushness.

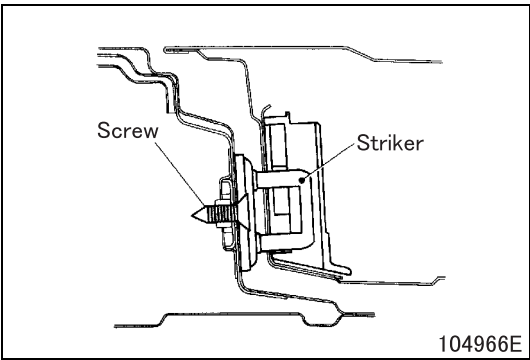
### 1.2 Adjustment of striker position

- Use mounting screw to make the adjustment.

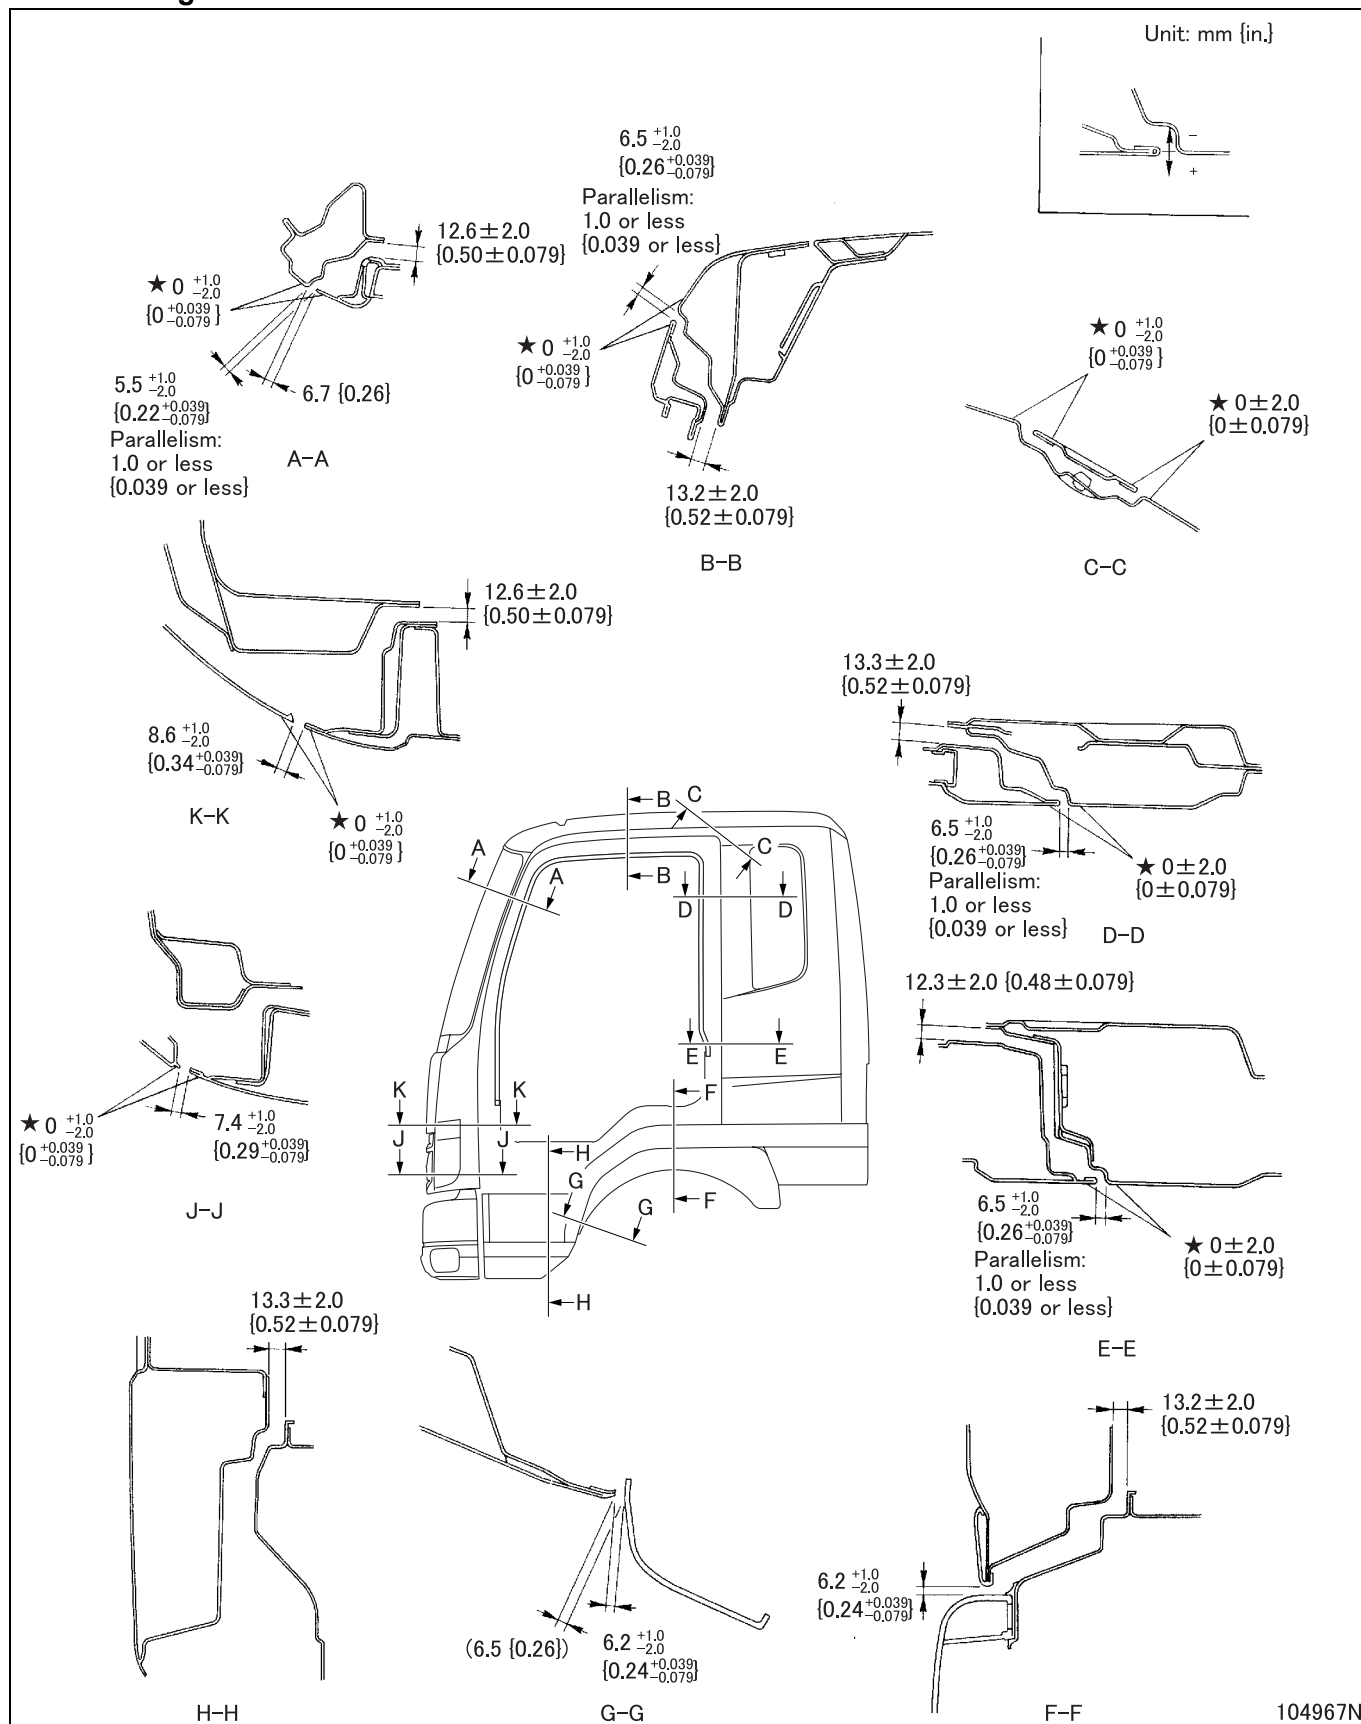
## 1.3 Door alignment dimensions

“★” shows step dimensions (shows a tolerance direction of step dimensions, + indicating the outside dimension and - indicating the inside dimension).

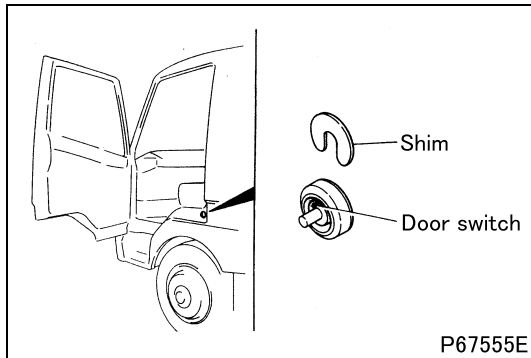
#### ■ Adjustment: Door switch

- If the door ajar warning lamp does not illuminate with the door opened ajar, reduce the number of shims to make the adjustment.
- If the door ajar warning lamp illuminates with the door fully closed, increase the number of shims to make the adjustment.  
Thickness of shim: 0.6 mm {0.024 in.}/piece

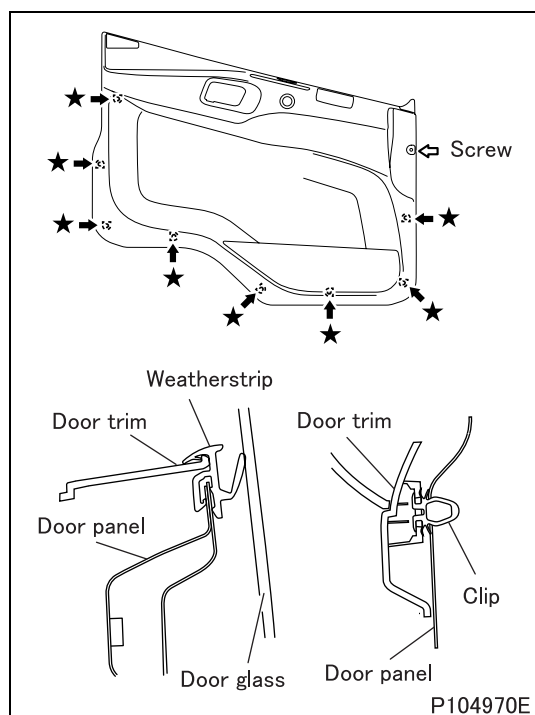
## ■ Removal: Door trim

- Remove the screw (1 place).
- The door trim, which has clips on the back, is secured to the door panel in the illustrated position (8 places). Pull the area near these clips toward you by hand to remove the door trim from the door panel.

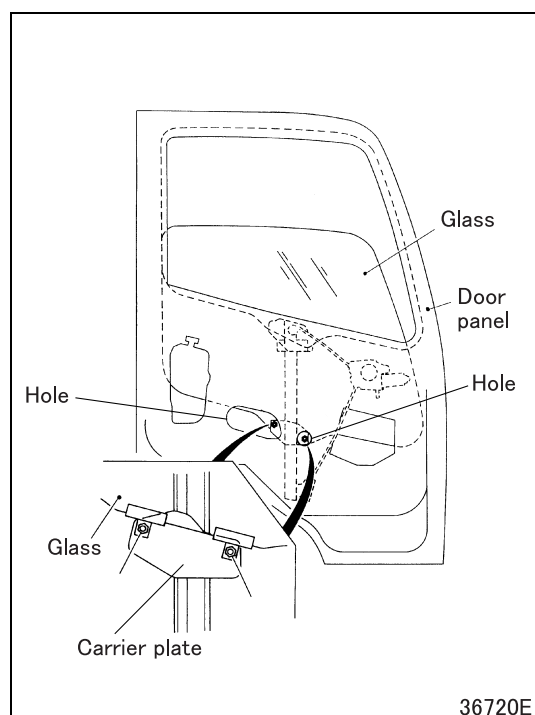
#### ■ Removal: Door glass

- Move door glass until bolts of the door glass become visible through holes in the door panel.
- While supporting door glass by hand, remove bolts of carrier plate.
- Remove door glass through the open space in the door.

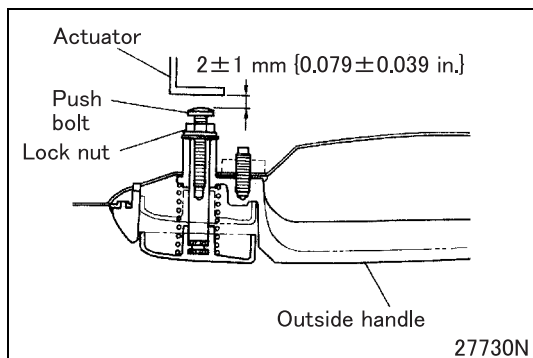
### ■ Installation: Outside handle

- Turn push bolt of outside handle to adjust the gap between the push bolt and door actuator as indicated in the illustration.

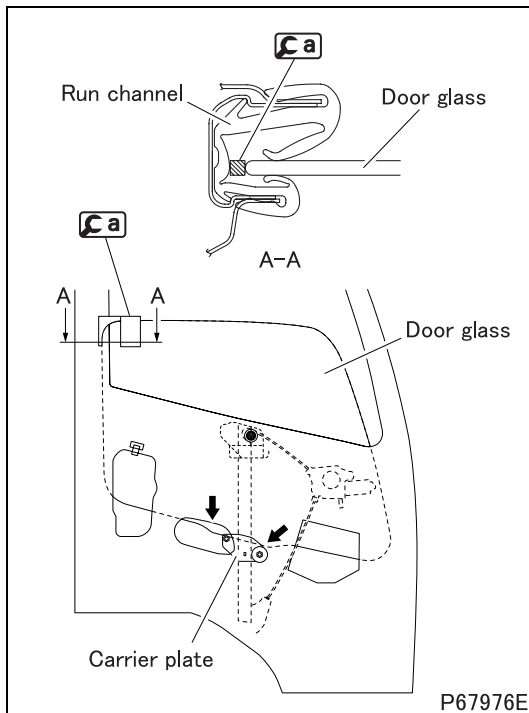
#### ■ Installation: Door glass

- Move the carrier plate to the position where the door glass mount can be seen from the door panel holes (2 places indicated by arrow).
- Temporarily fasten the door glass to the carrier plate with bolts.
- Install **Ca** in the illustrated position of the door glass.
- Lightly push the door glass toward the rear of the vehicle and tighten the bolts to the specified torque while keeping door glass, **Ca** and run channel in close contact.

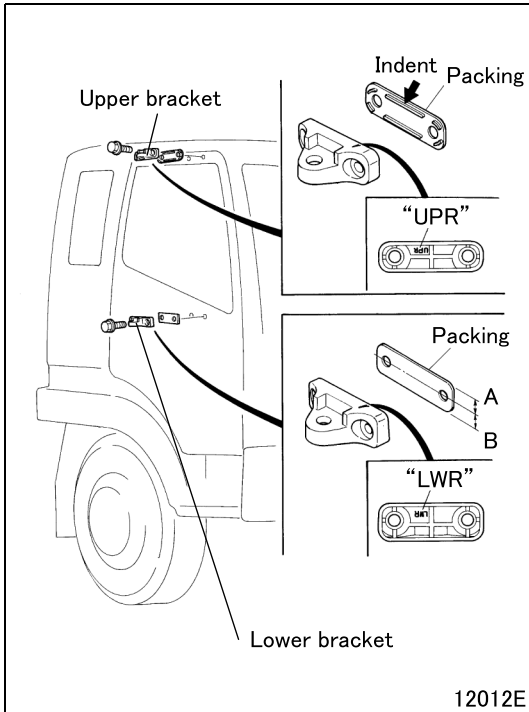
### ■ Installation: Mirror stay bracket and packing

- "UPR" and "LWR" identification marks are marked on mirror stay upper bracket and mirror stay lower bracket respectively.
- Install indent on packing, facing mirror stay upper bracket.
- Installation hole is offset on packing.  
A: 13.8 mm {0.54 in.}  
B: 17.2 mm {0.68 in.}

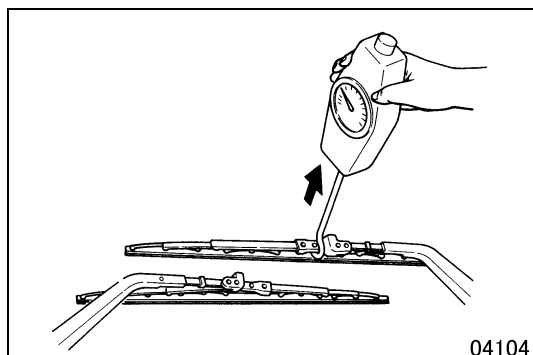
#### ■ Inspection: Wiper arm pressing force

- If the measured value is out of the standard, replace the wiper arm.

| Location | Maintenance item | Standard value | Limit | Remedy |
|---|---|---|---|---|
| 7 | Wiping force of wiper arm | 7.65 ± 0.49 N<br>{1.72 ± 0.11 lbs,<br>0.78 ± 0.05 kgf} | — | Replace |

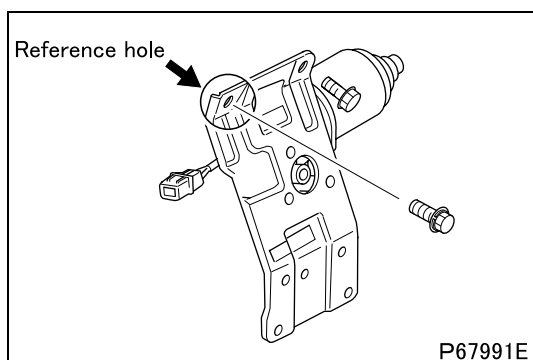
#### ■ Installation: Wiper motor and bracket

- Wiper motor and bracket has a reference hole for installation.
- Tighten bolt starting with the location identified by the reference hole.

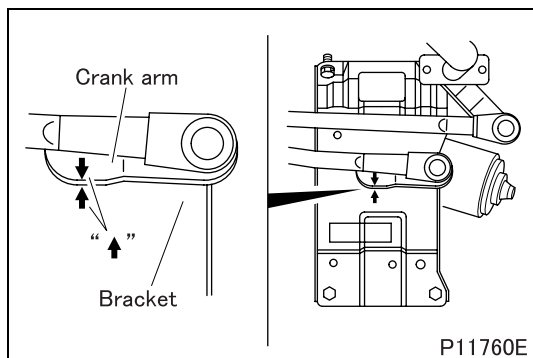
#### ■ Installation: Crank arm

- Align wiper motor and bracket with mating mark “↑” of crank arm to install.

- **Do not remove crank arm unless it is defective. The crank arm is installed in a position precisely adjusted to the park position of wiper motor and bracket.**

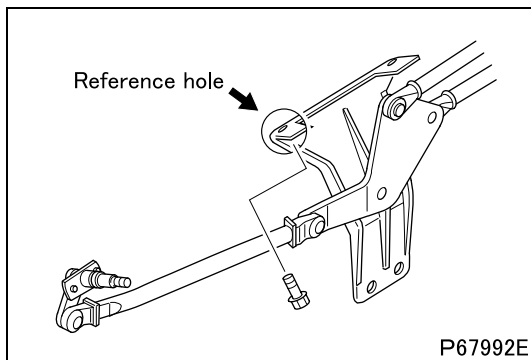
## ■ Installation: Wiper link

- Wiper link has a reference hole for installation.
- Tighten bolt starting with the location identified by the reference hole.

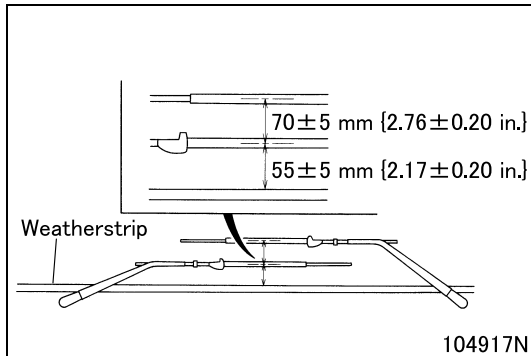
## ■ Installation: Wiper arm and blade

- Install wiper arm and blade to wiper link from the end face of weatherstrip to the dimension shown in illustration.

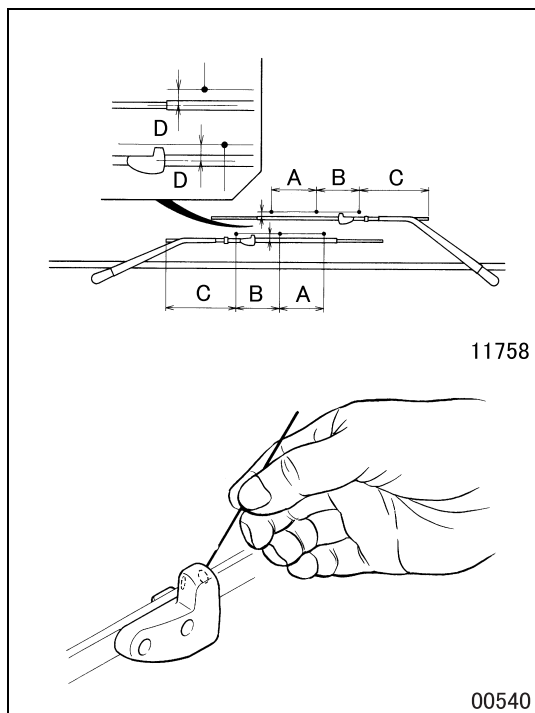
**■ Inspection: Washer nozzle**

- Make sure that the target landing position of washer fluid is to the dimensions shown in the table below.

- Be careful not to damage the spray hole of washer nozzle with wire.

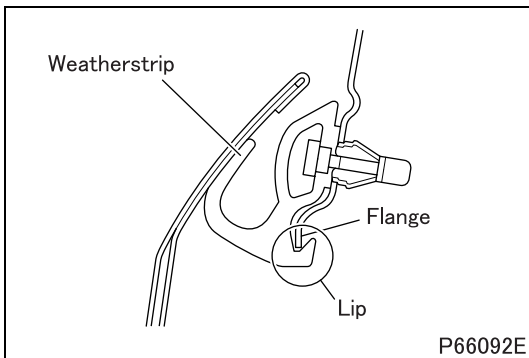
### ■ Installation: Weatherstrip

- Install the weatherstrip securely by fitting the lip into the flange.

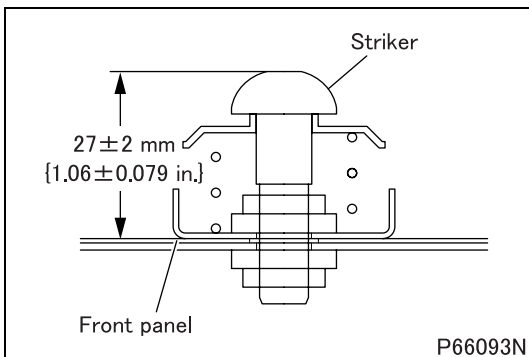
### ■ Installation: Striker

- Adjust until the gap dimension between the front panel and striker shown in the illustration is obtained. Install the striker.

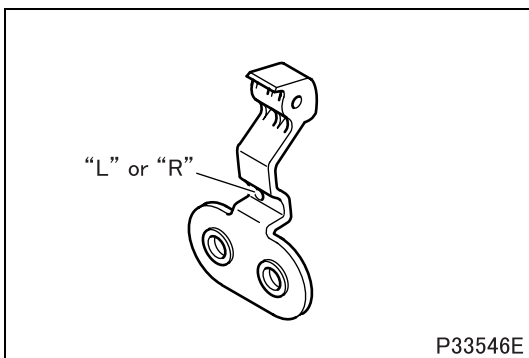
### ■ Installation: Front panel hinge

- Front panel hinges are marked with a letter ("L" or "R") indicating the installation position. Be sure to install them on the specified side according to the identification mark.

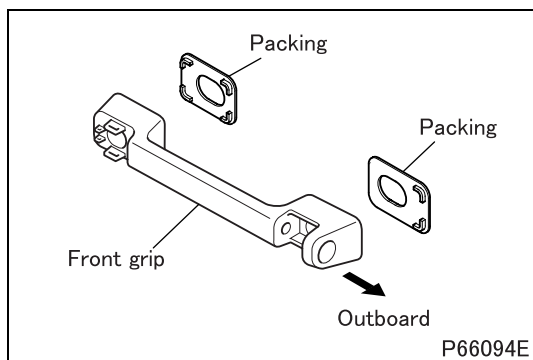
## ■ Installation: Packing

- Install packings in the illustrated direction.

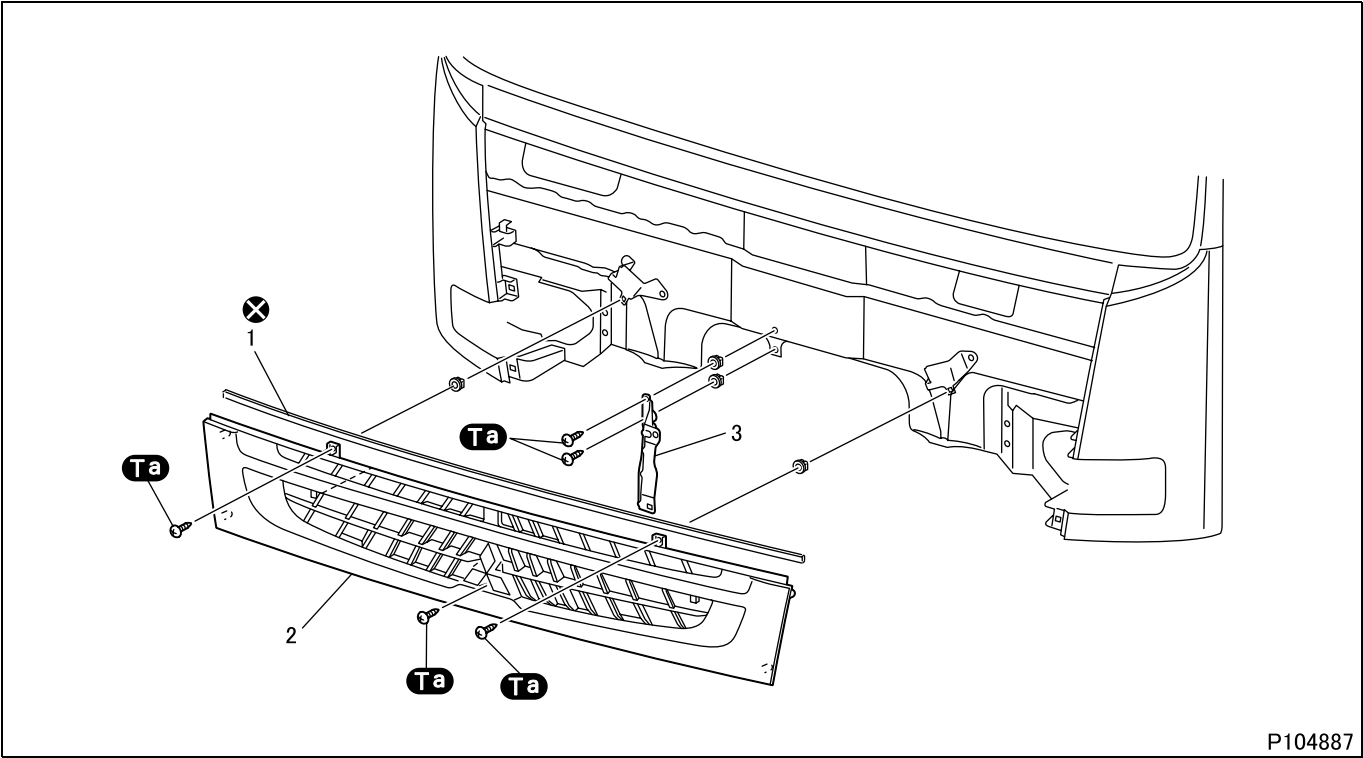
- 1 Front grille weatherstrip
- 2 Front grille
- 3 Grille stay center

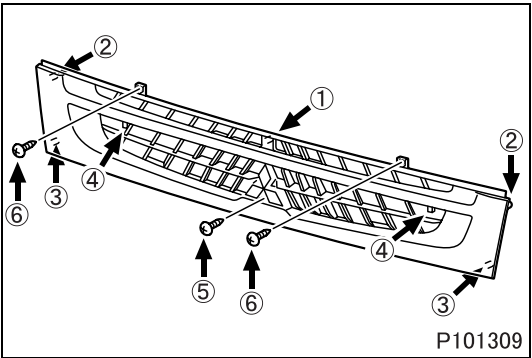
### ■ Installation: Front grille

- Install the front grille by following the sequence shown in the illustration.

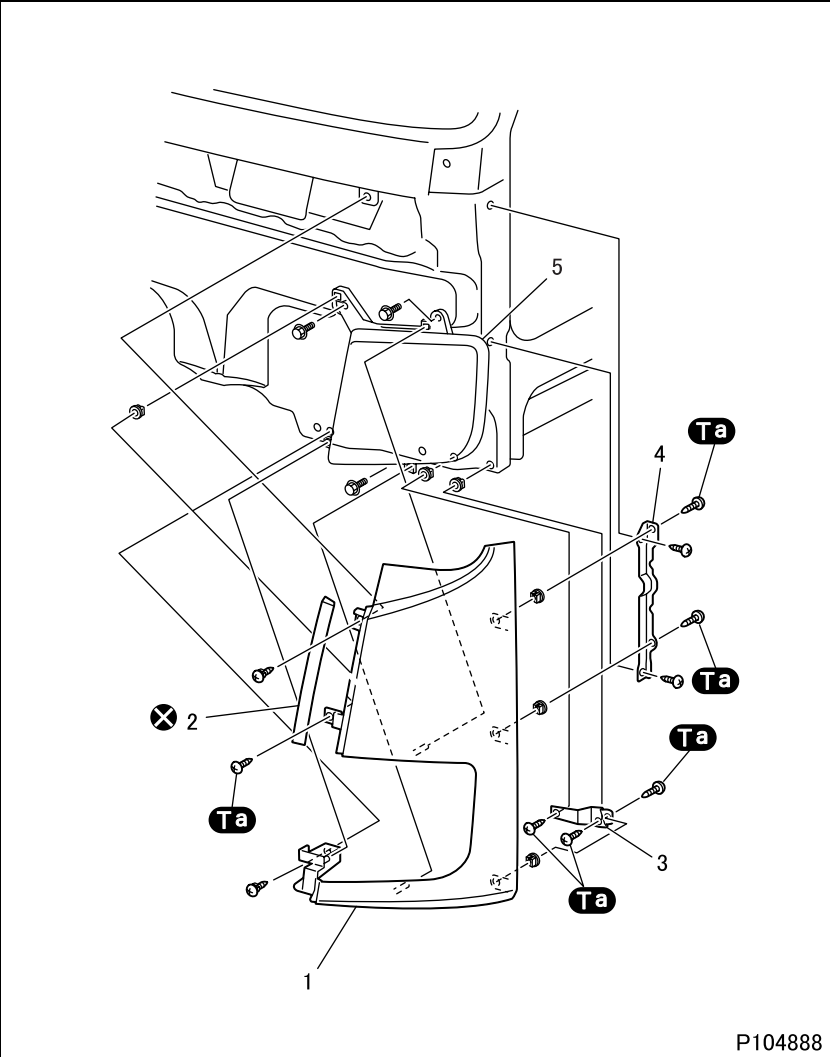
- 1 Corner panel
- 2 Corner panel weatherstrip
- 3 Corner panel lower bracket
- 4 Corner panel bracket
- 5 Headlamp and front turn signal lamp

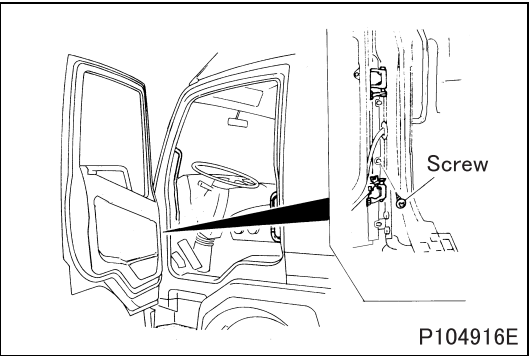
### ■ Removal: Corner panel

- Open the door. Remove the three screws through the gap.
- Close the door. Remove the three screws from the front of the cab.
- Remove the corner panel by pulling it away from the vehicle.

- If you open the door while the corner panel is protruding from the vehicle, the corner panel and door may make contact, resulting in deformation and other damage.

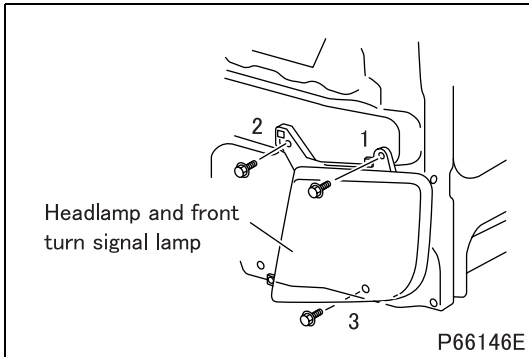
### ■ Installation: Headlamp and front turn signal lamp

- Install the headlamp and front turn signal lamp by following the sequence shown in the illustration.

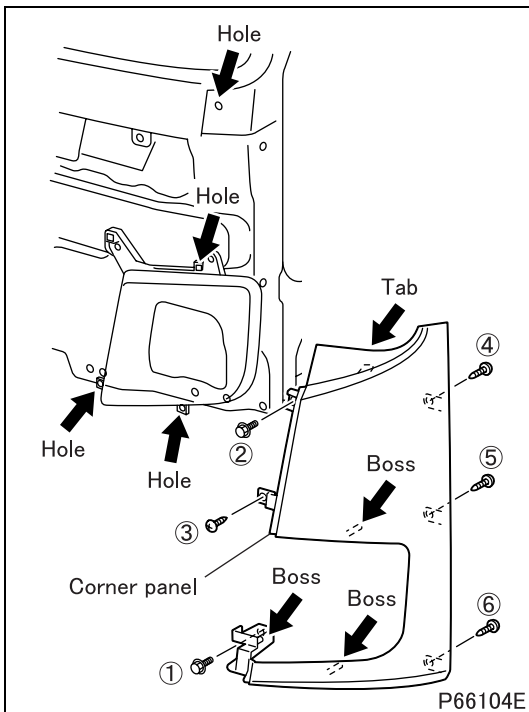
- Hook the tab of the corner panel onto holes on the cab side.
- Insert the bosses of the corner panel to the hole of headlamp.
- Install the corner panel by following the sequence shown in the illustration.

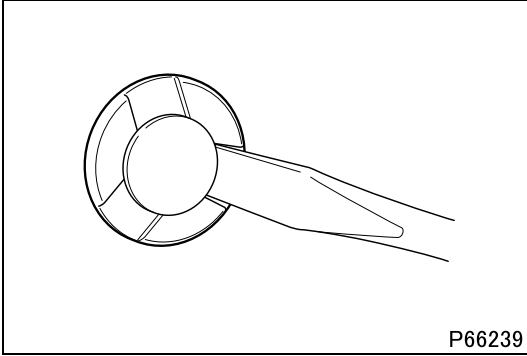
**■ Removal: Clip**

- To remove a clip, unlock it by prying up as shown with a screwdriver.

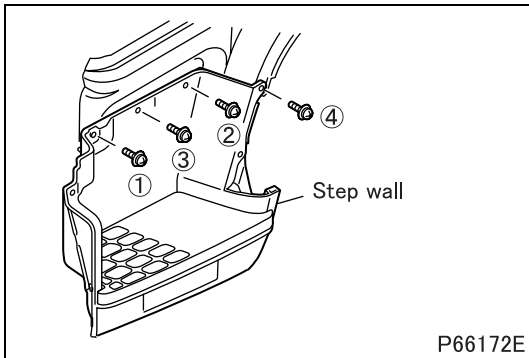
**■ Installation: Step wall**

- Install the step wall by following the sequence shown in the illustration.

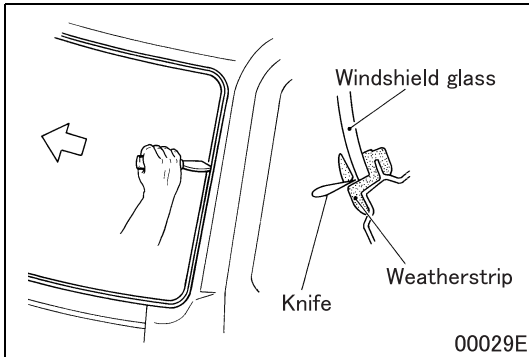
### ■ Removal: Windshield glass

- Cut weatherstrip with knife at the area as illustrated.
- Support windshield glass, and remove by pressing it from inside the cab.

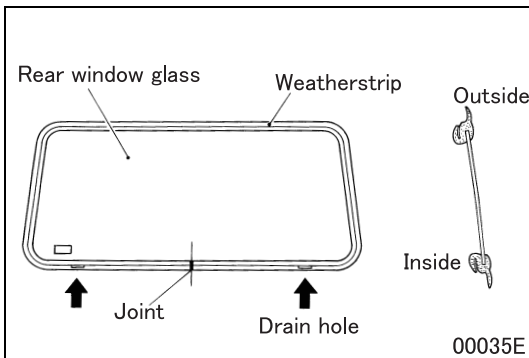
### ■ Installation: Rear window weatherstrip and rear window glass

- Fit the rear of the window weatherstrip round the rear window glass so that the joint of weatherstrip comes at the bottom of the glass.
- Except for the point mentioned above, install the rear window glass in the same manner as the windshield glass.

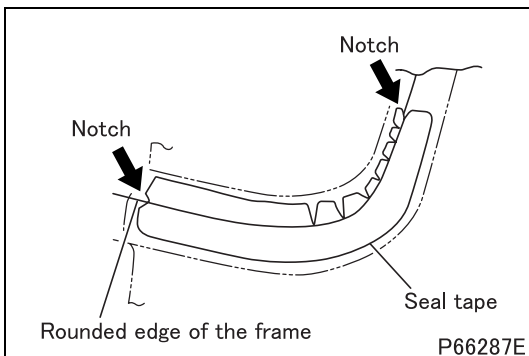
### ■ Installation: Seal tape

- Peel off the liner paper only from the upper half of the seal tape.
- Holding the lower half of the seal tape, align the notches with the rounded edge of the frame and attach the upper half to the frame.
- Peel off the liner paper from the lower half of the seal tape. Attach the lower half to the frame while taking care not to make creases.

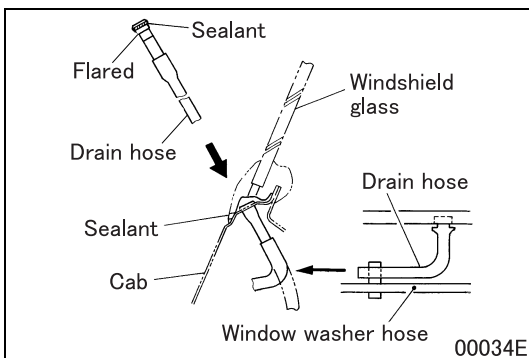
### ■ Installation: Drain hose

- Fill the area around the flange of drain hose with sealant, and press the drain hose in until its flared area fits into cab. Carefully smooth down excess sealant that is squeezed out so that the hose opening is not clogged.
- Secure drain hose at the middle of the vehicle together with windshield washer hose.

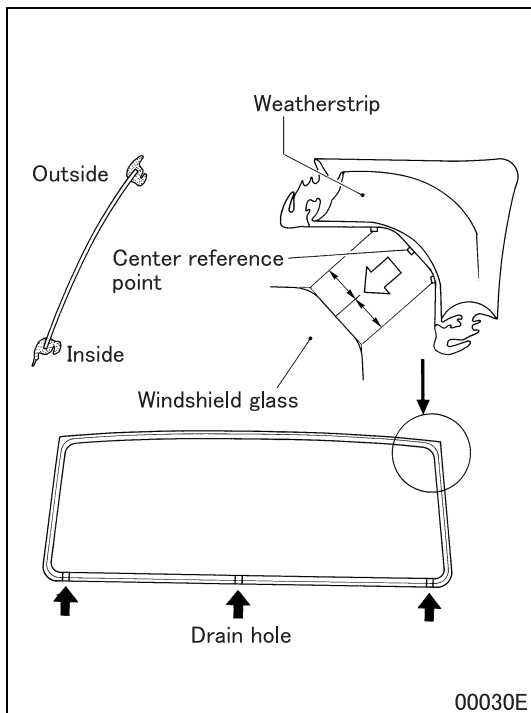
## ■ Installation: Windshield weatherstrip and windshield glass

- Install the weatherstrip with its center reference point aligned with the center of the cut at each corner of the glass.

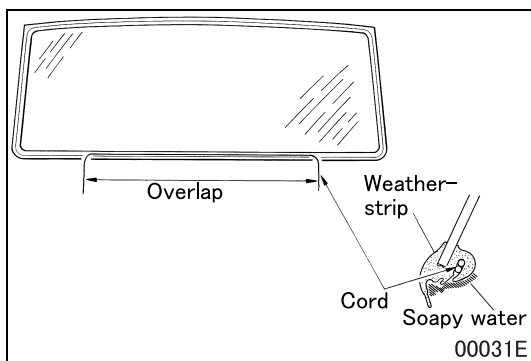
- Put a piece of strong cord in the cab flange fitting groove in the weatherstrip with its end portions overlapped.
- Apply soapy water to weatherstrip.

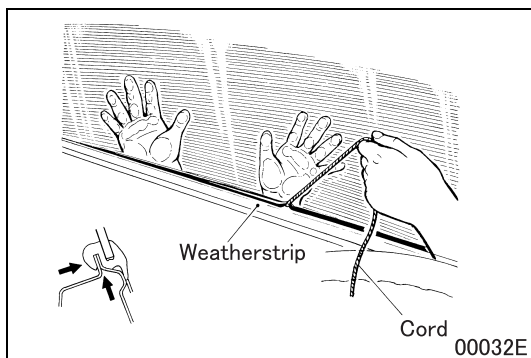
- With the glass strongly pushed from outside, pull out the cord by its ends from inside the cab to gradually fit the flange of the cab in the inner groove of the weatherstrip.

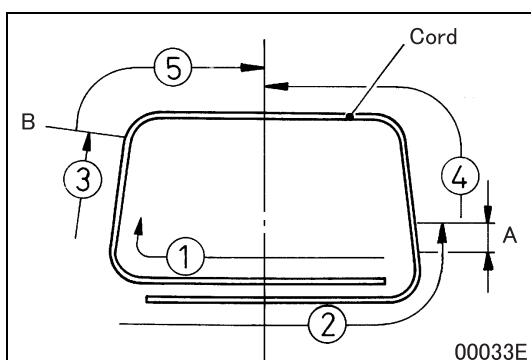
- Pull the cord in the numerical order of steps as shown. At the same time, while tapping with a rubber-headed mallet from outside the cab, settle the windshield glass in place in the weatherstrip.

A: Approx. 100 mm from the beginning of straight portion

B: Up to the end of straight portion

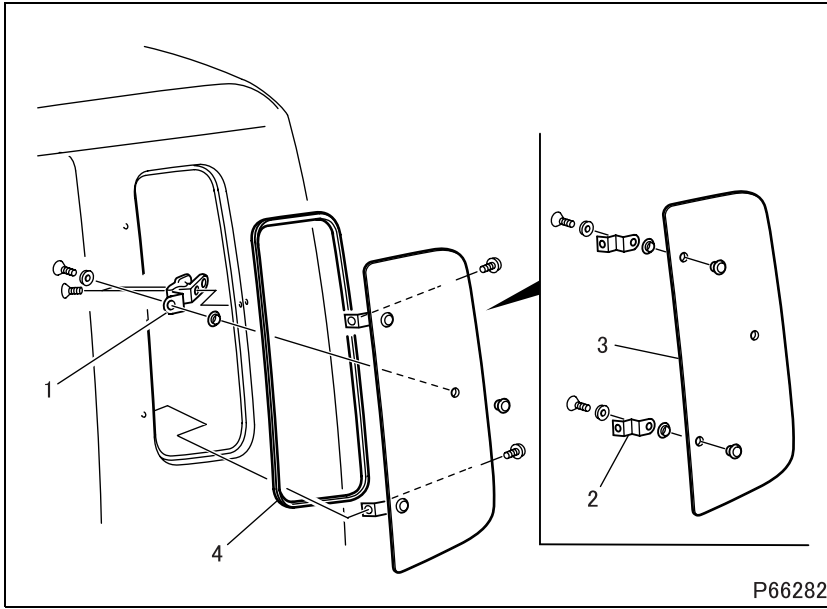
- 1 Side window link
- 2 Side window hinge
- 3 Side window glass
- 4 Side window weatherstrip

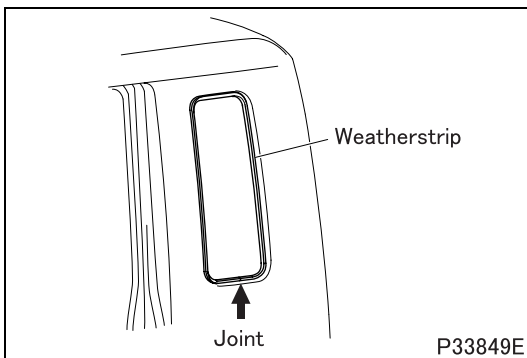
### ■ Installation: Weatherstrip

- Install the weatherstrip such that its joint is positioned at the bottom-center of the glass.
