# FE.FG

## SERVICE MANUAL 2008 Model FOREWORD

This Service Manual contains maintenance and repair methods for the Mitsubishi Fuso Truck FE. FG Series. Read this manual carefully as an aid in providing correct, efficient maintenance. Please note that the information and specifications contained within this manual may change without notice. This is due to product modifications and continued vehicle improvements that are made throughout the model years. Should you encounter any discrepancy in the information provided, please do not hesitate to contact your nearest Mitsubishi Fuso Dealer or Mitsubishi Fuso Truck of America, Inc.

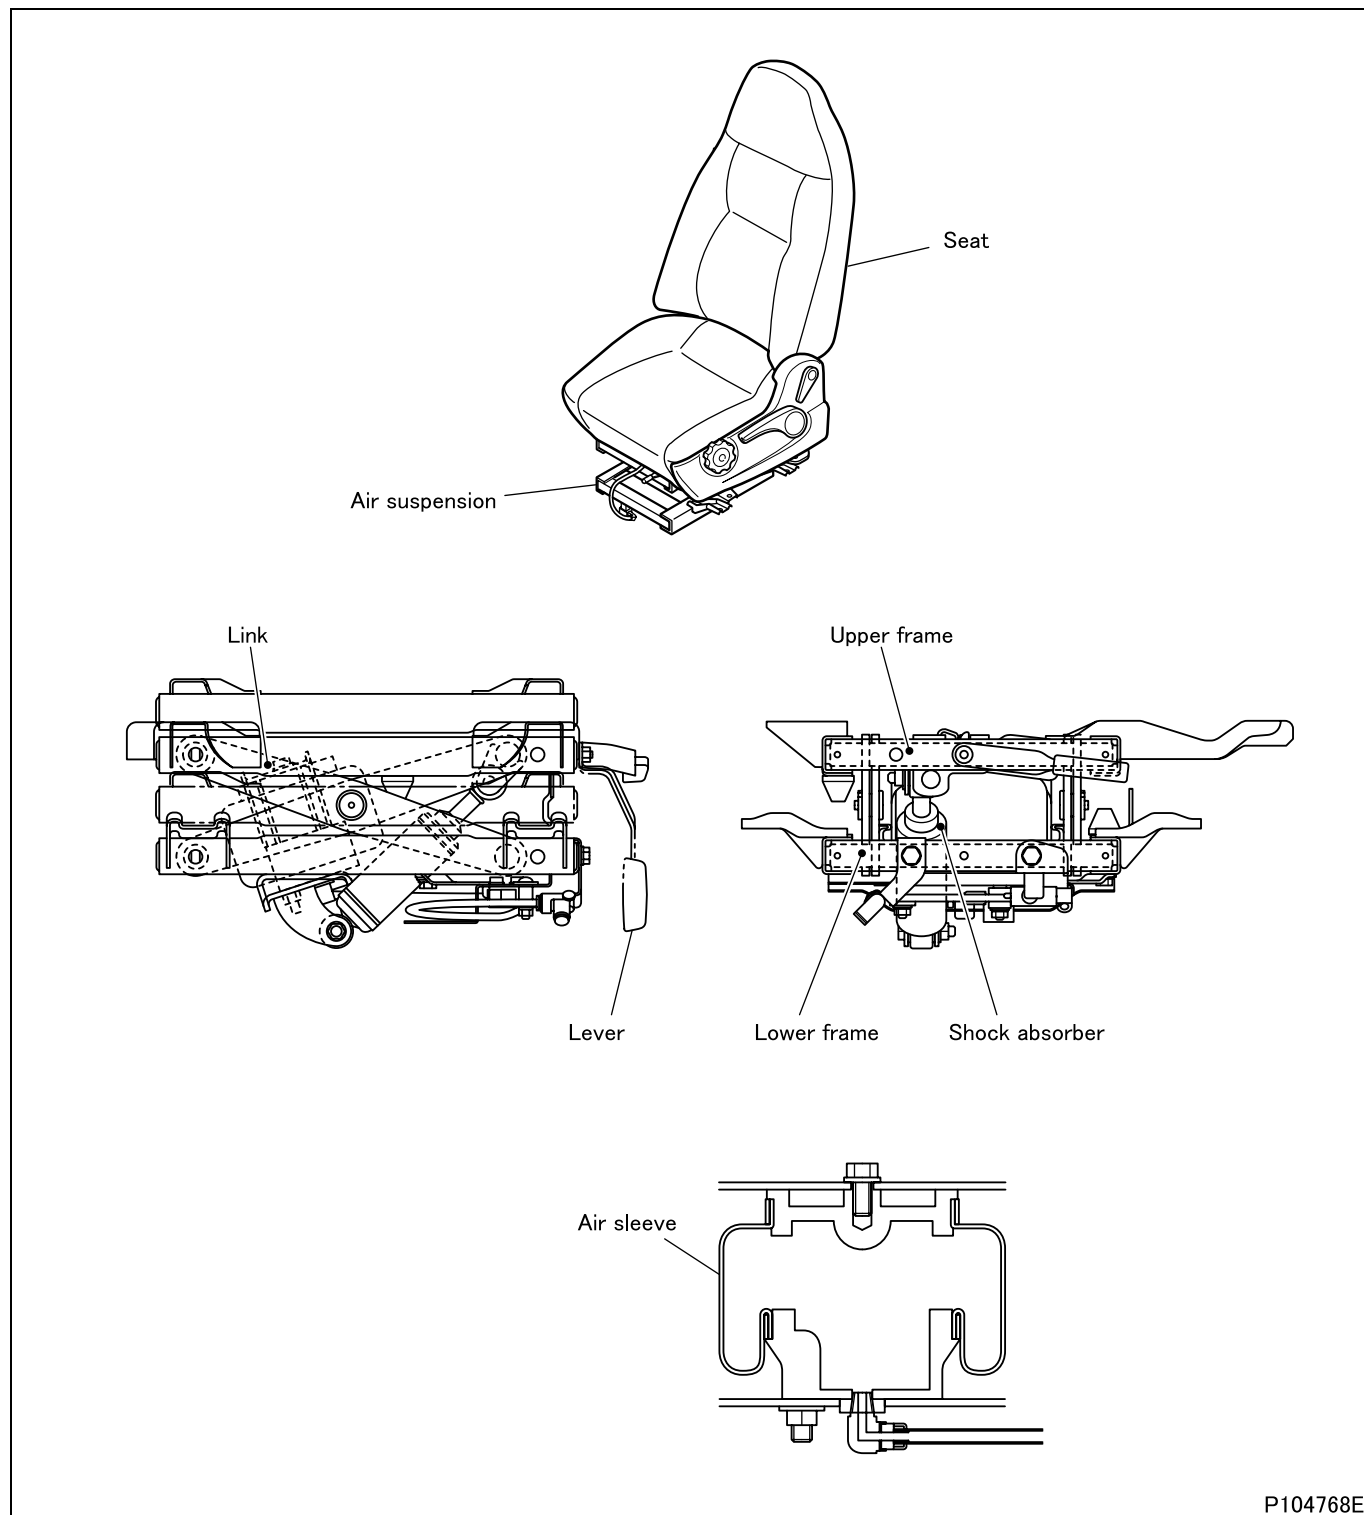
P104768E

- The air suspension seat maintains the seat cushion height constant irrespective of the weight of occupants. It is provided with a mechanism which consists of cam, mechanical valves, etc. and supplies air pressure to the air sleeve automatically for constant seat cushion height.

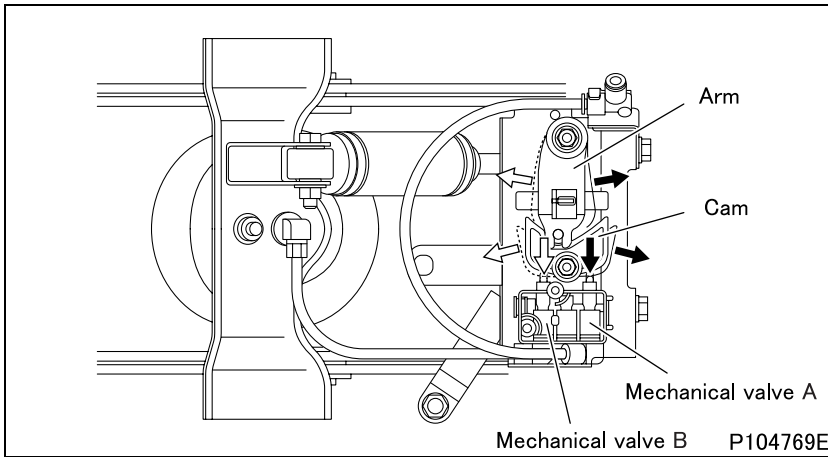
### 1.1 Operation of mechanical valves

- The air passage of the mechanical valves A and B opens or closes depending on the movement of the arm and the cam.

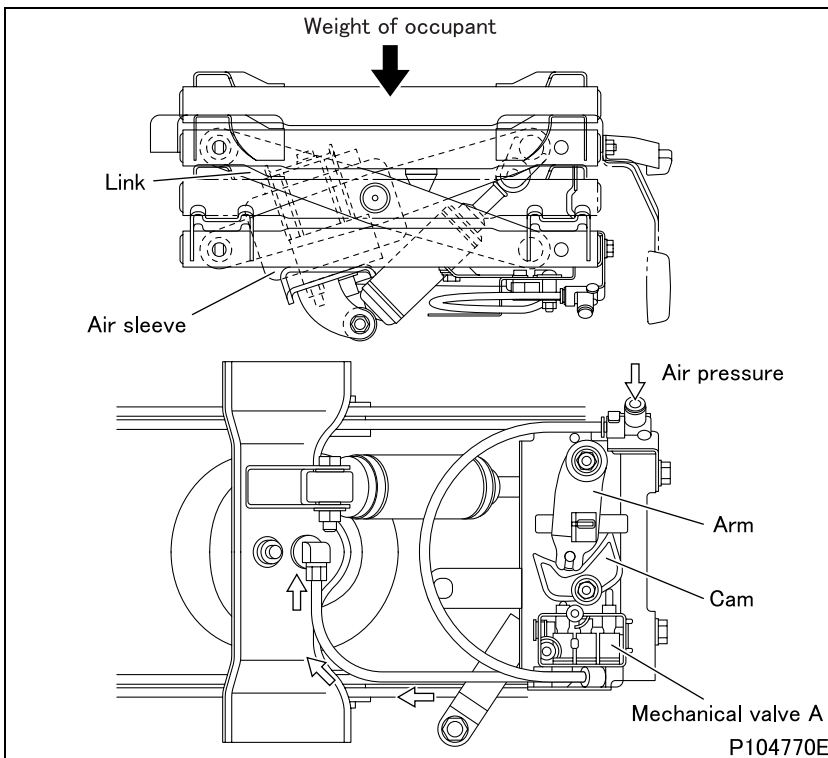
### 1.2 Operation of air suspension when seat is occupied

- When the weight of an occupant is applied on the seat, the link is pressed down. This allows the arm to rotate the cam slightly, opening the air passage through the valve.
- Then, air pressure is supplied and the link is raised.

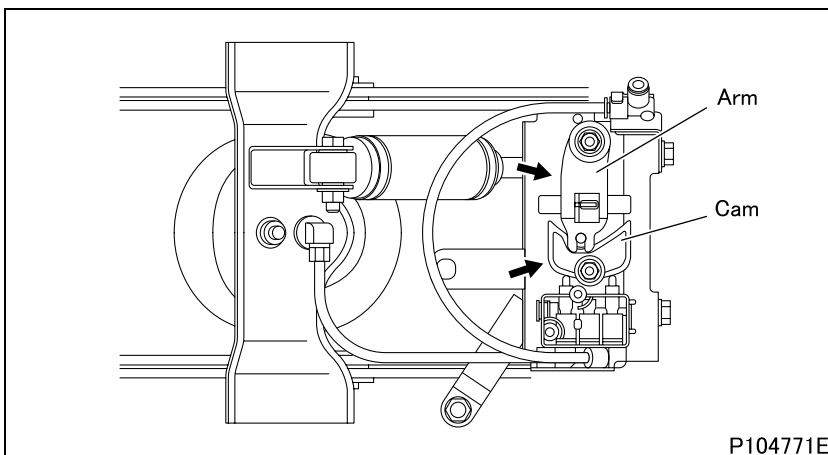
- When the link is raised, the cam is pushed back. Thus, the seat cushion returns to the original position.

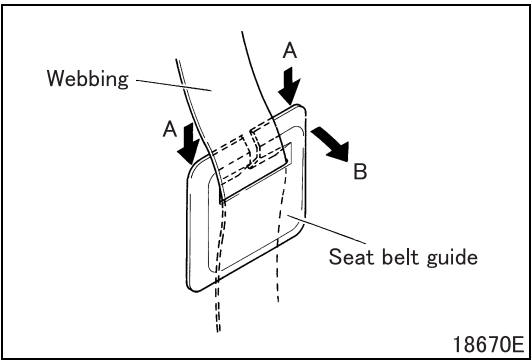
## ■ Removal: Seat belt guide

- To detach the seat belt guide, pull the top of the guide toward you in direction B while holding it down in direction A.

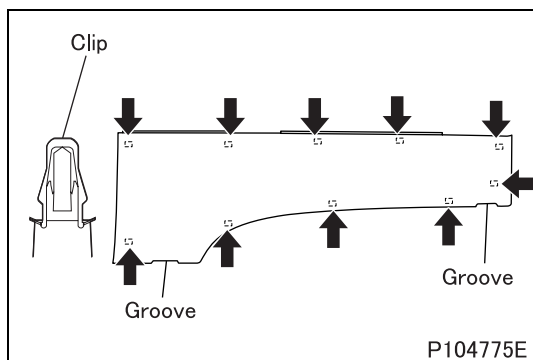
### ■ Removal: Upper passenger panel

- To remove the upper passenger panel, pull the panel toward you by making use of its grooves.

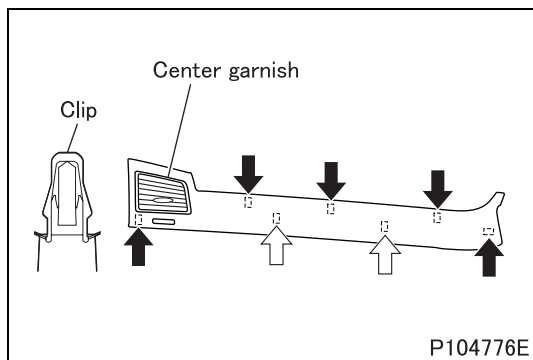
### ■ Removal: Center garnish

- Remove the clips around the center air outlet.
- Pull the center garnish straight toward you, using care that it will not damage the clips in ← marked parts.

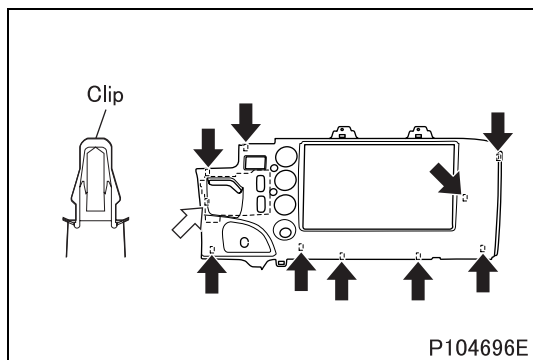
## ■ Removal: Upper center panel and switch plate

◀ : Clip on upper center panel side (9 places)

◁ : Clip on switch plate side (1 place)

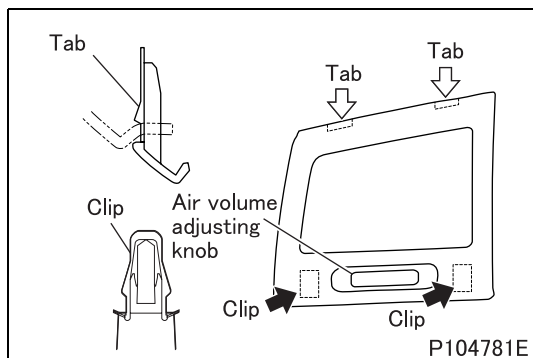
### ■ Removal: Driver air outlet garnish

- Be sure to set air volume adjusting knob to neutral position before removing the garnish.

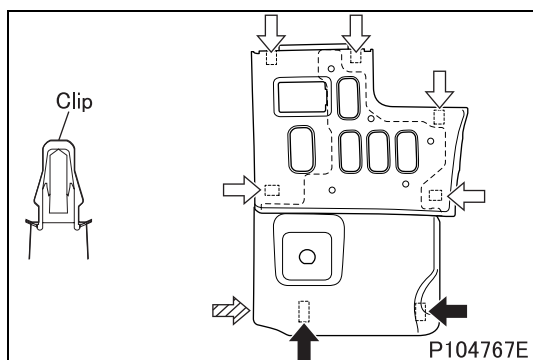
### ■ Removal: Lower driver panel and upper driver panel

↔ : Clip on upper driver panel side (5 places)

← : Clip on lower driver panel side (2 places)

- Remove the panels while pushing the ↗ part of lower driver panel towards steering. Be careful not to damage the tabs of side driver panel.

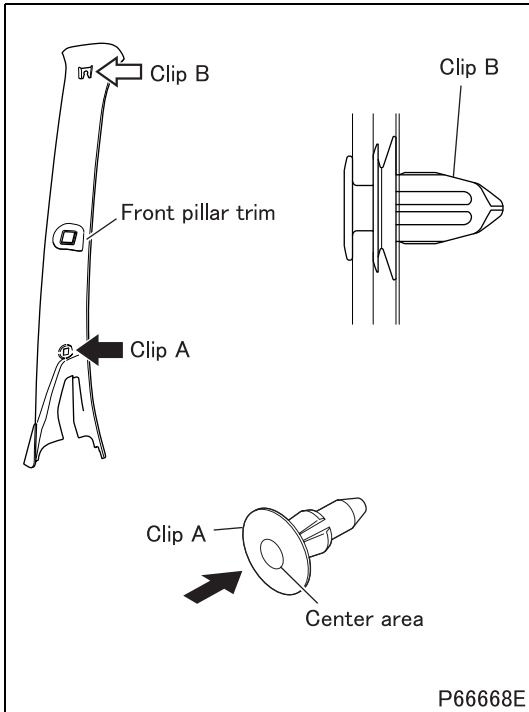
### ■ Removal: Front pillar trim

- Push at center area of clip A to remove clips A from front pillar trim.
- To unclip the front pillar trim, put your hands under the trim near at the clips B and pull it carefully toward you so as not to damage it.

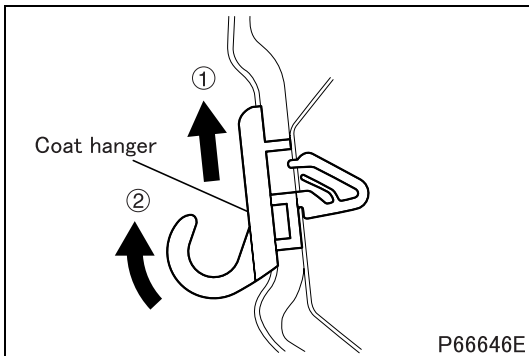
### ■ Removal: Coat hanger

- To detach the coat hanger from the rear trim, pull it in direction 2 while pushing it up in direction 1.

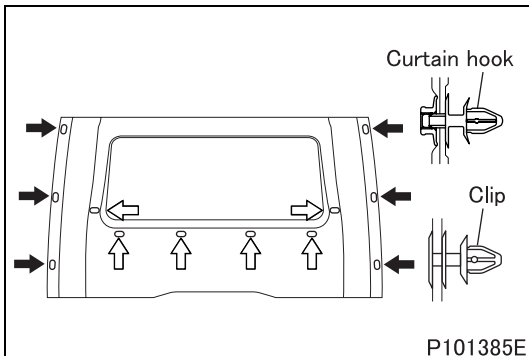
### ■ Removal: Rear trim

← : Clip

- When removing clips and curtain hooks, put your hands under the rear trim near at the clips and pull it carefully toward you so as not to damage it.

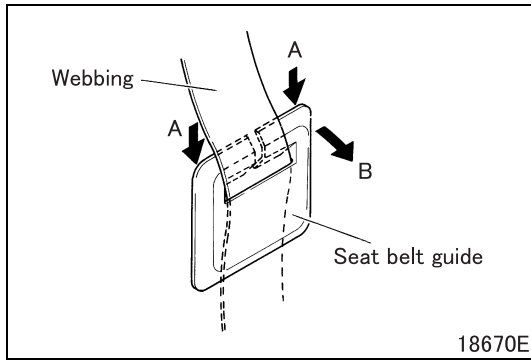
## ■ Removal: Seat belt guide

- To detach the seat belt guide, pull the top of the guide toward you in direction B while holding it down in direction A.

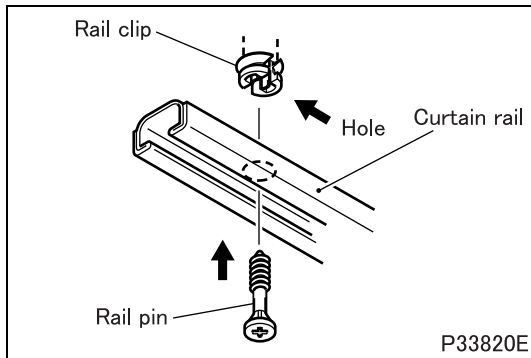
## ■ Installation: Curtain rail

- Fit the rail pin by pushing it into the hole of the rail clip to install the curtain rail.

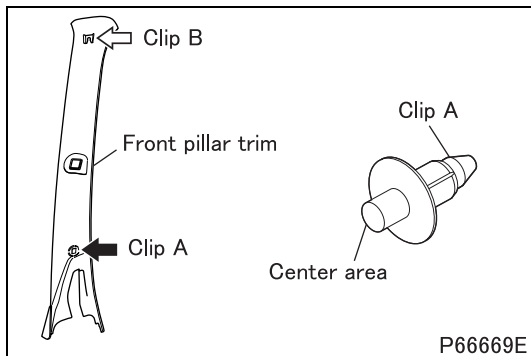
## ■ Installation: Front pillar trim

- Install the front pillar trim by pushing the center area of clip A as shown in the drawing.

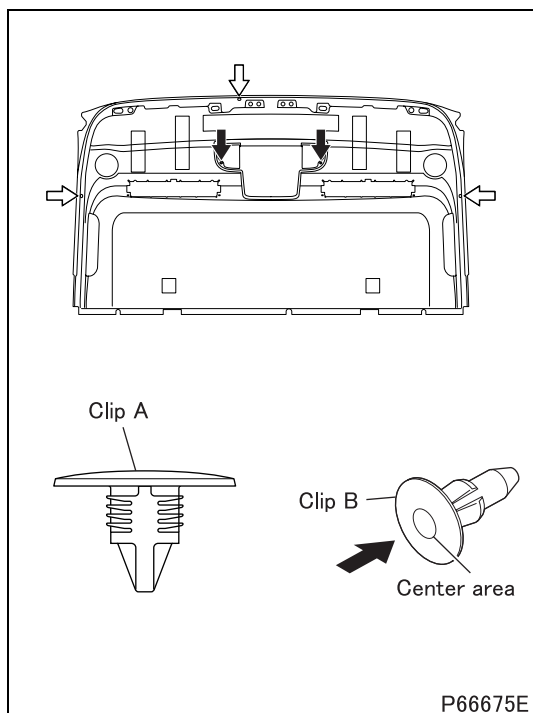
## ■ Removal: Front head lining

- Remove clips A (3 places marked with ⇐ ) to remove the front head lining.
- Remove clips B (2 places marked with ← ) from the front head lining by pushing the center area.

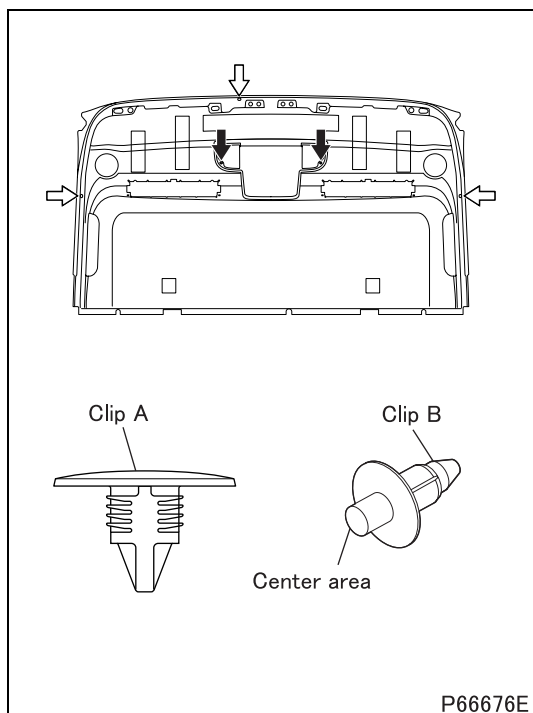
## ■ Installation: Front head lining

- Install clips B (2 places marked with ← ) to the front head lining by pushing the center area as shown in the drawing.
- Install clips A (3 places marked with ⇐ ) to install the front head lining.

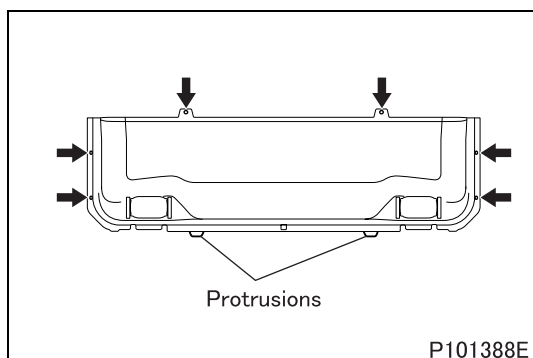
## ■ Installation: Rear head lining

- Insert protrusions of rear head lining into the grooves of the panel on the cab side and install the rear head lining with clips (6 places).

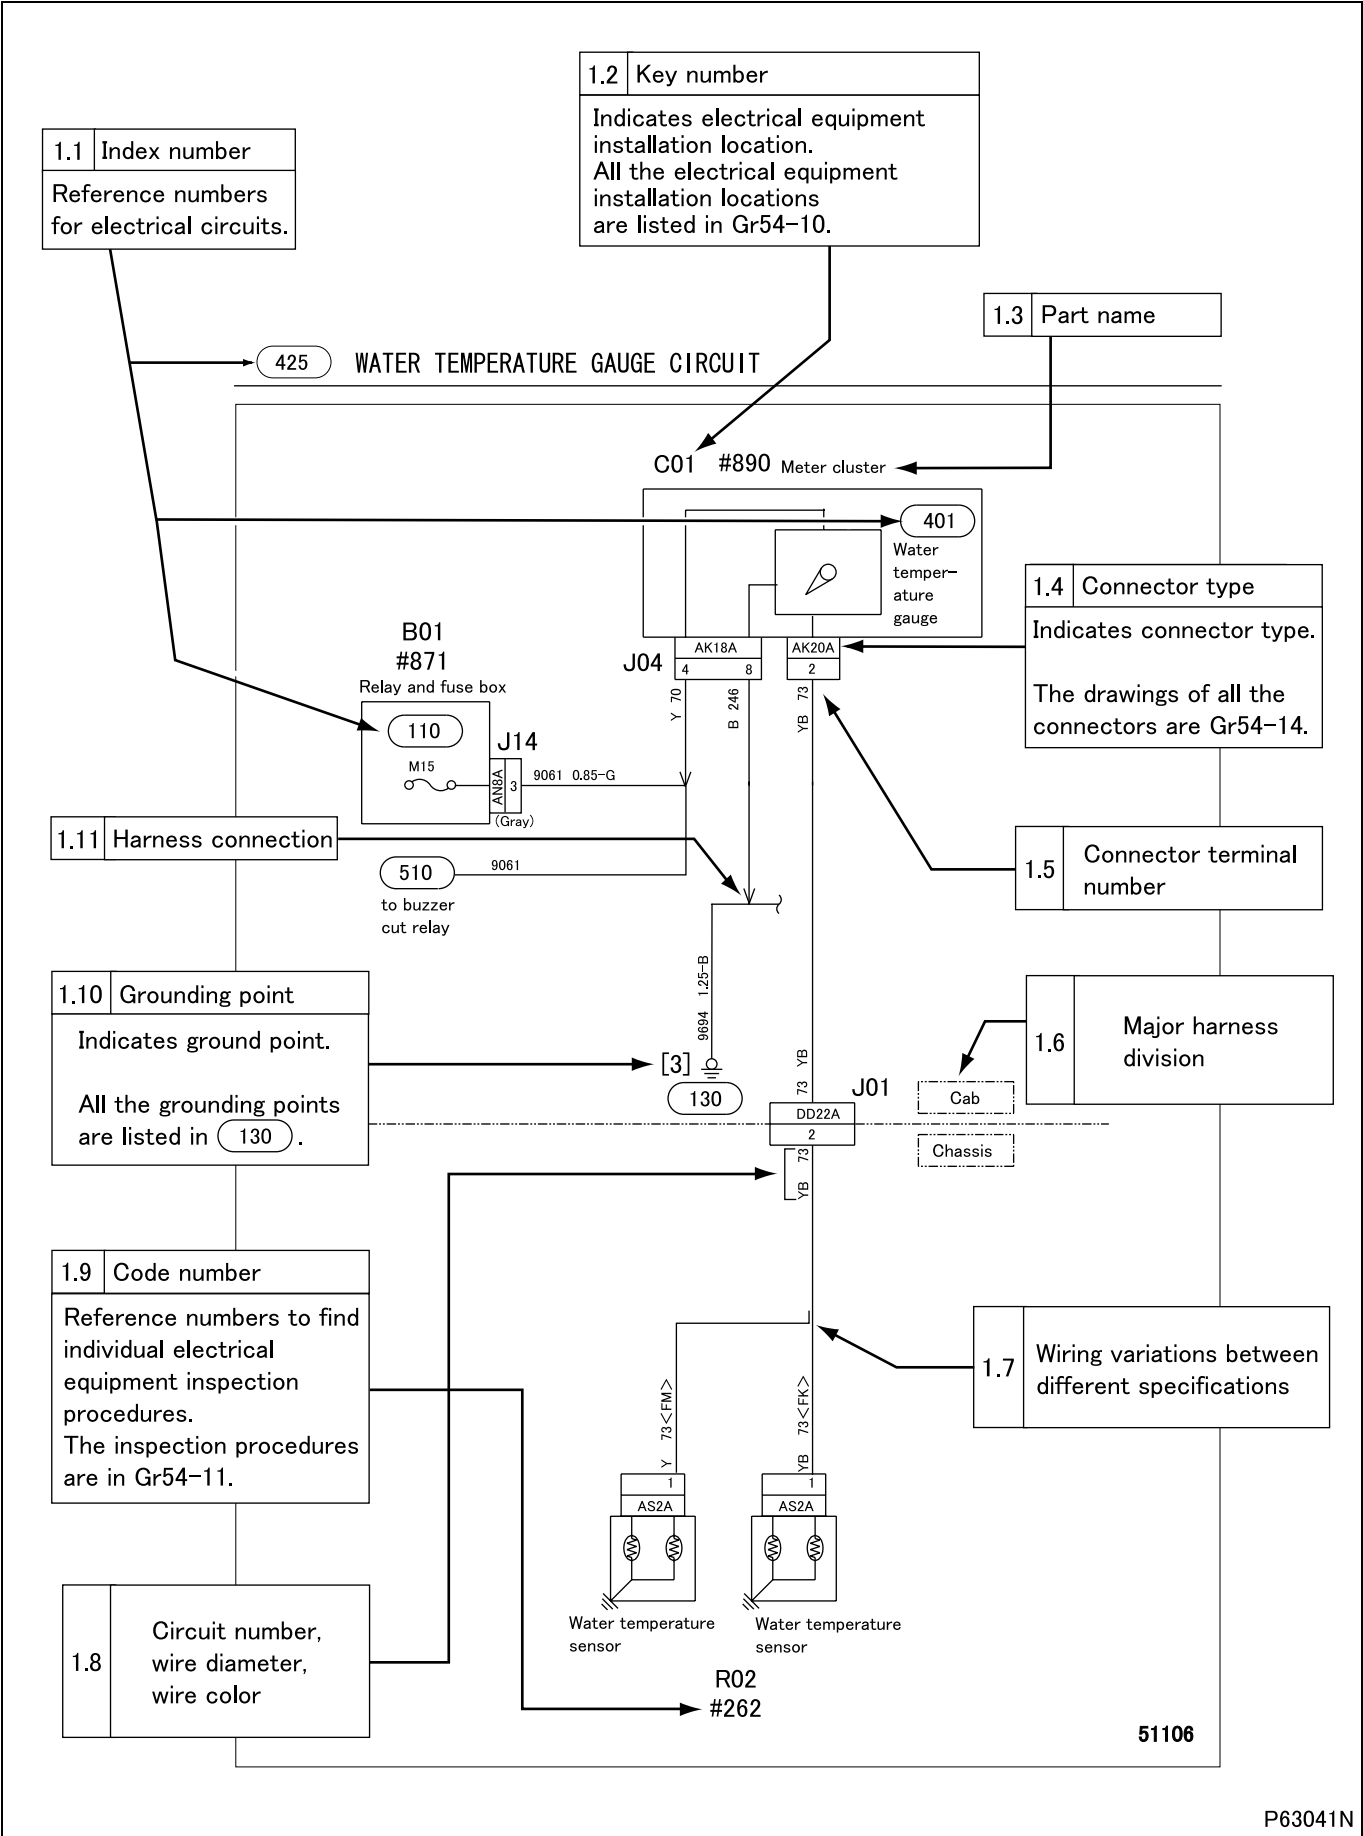
## HOW TO READ CIRCUITS (ELECTRICAL)

## 1.1 Index number: (100) to (999)

- Index numbers are used as reference numbers for electrical circuits. Each electrical circuit has been assigned its own index number.

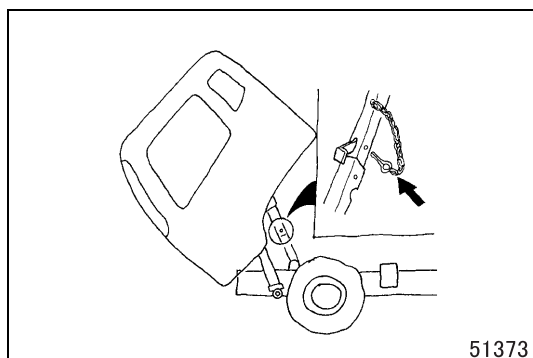
- After tilting the manual tilt type cab, be sure to engage the stopper with the lock lever to lock the cab stay securely.

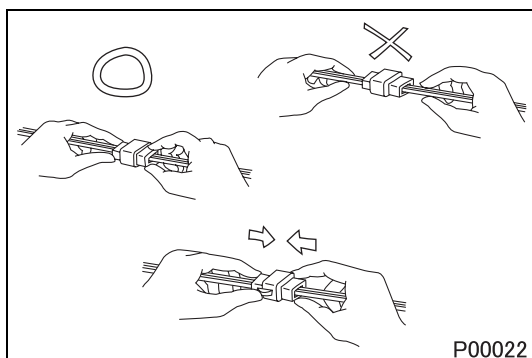
- When separating connectors, grasp the connectors themselves rather than the harnesses.
- To separate locking connectors, first push them in the direction of the arrows. To reconnect locking connectors, push them together until they click.

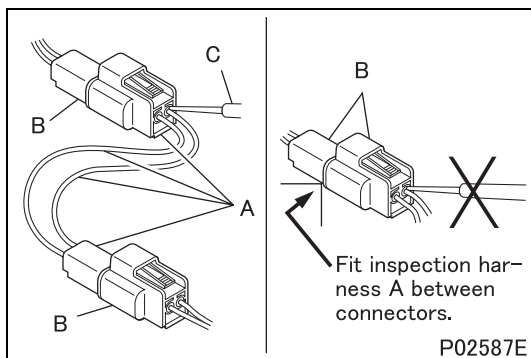
##### (1.2) Non-waterproof connectors

- Perform the inspection by inserting a test probe C into the wire-entry sides of the connectors. An extra-narrow probe is required for control unit connectors, which are smaller than other types of connector. Do not force a regular-size probe into control unit connectors since this would cause damage.

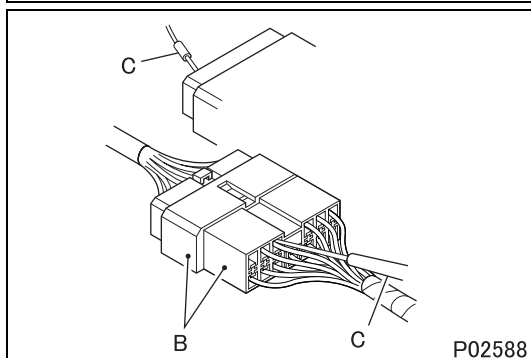
#### (2) Inspections with connectors separated

##### (2.1) Inspections on female terminals

- Perform the inspection by carefully inserting a test probe into the terminals. Do not force the test probe into the terminals since this could deform them and cause poor connections.

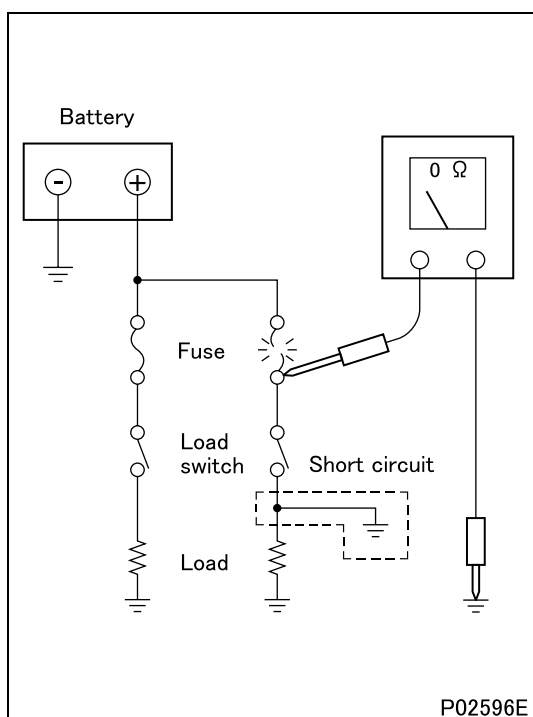
## 1.3 Inspections when a fuse blows

- Remove the fuse, then measure the resistance between ground and the fuse's load side.  
Next, close the switch of each circuit connected to the fuse. If the resistance measurement between any switch and ground is zero, there is a short circuit between the switch and the load. If the resistance measurement is not zero, the circuit is not currently short-circuited; the fuse probably blew due to a momentary short circuit.
- The main causes of short circuits are as follows:
  - Harnesses trapped between chassis parts
  - Harness insulation damage due to friction or heat
  - Moisture in connectors or circuitry
  - Human error (accidental short-circuiting of components)

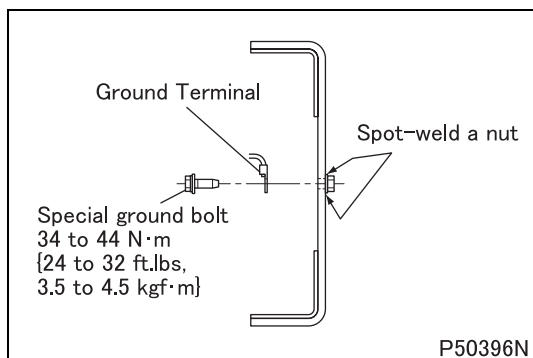
## 1.4 Inspection of chassis ground

- A special ground bolt is used to tighten a ground terminal. When servicing the ground point, be sure to follow the procedures described below:
  - When reinstalling the ground bolt  
Tighten the ground bolt to the specified torque.
  - When relocating the ground point  
A special ground bolt must be used. Spot-weld a nut to a frame and tighten the ground bolt to the specified torque. Be sure to apply touch-up paint to the welded point.

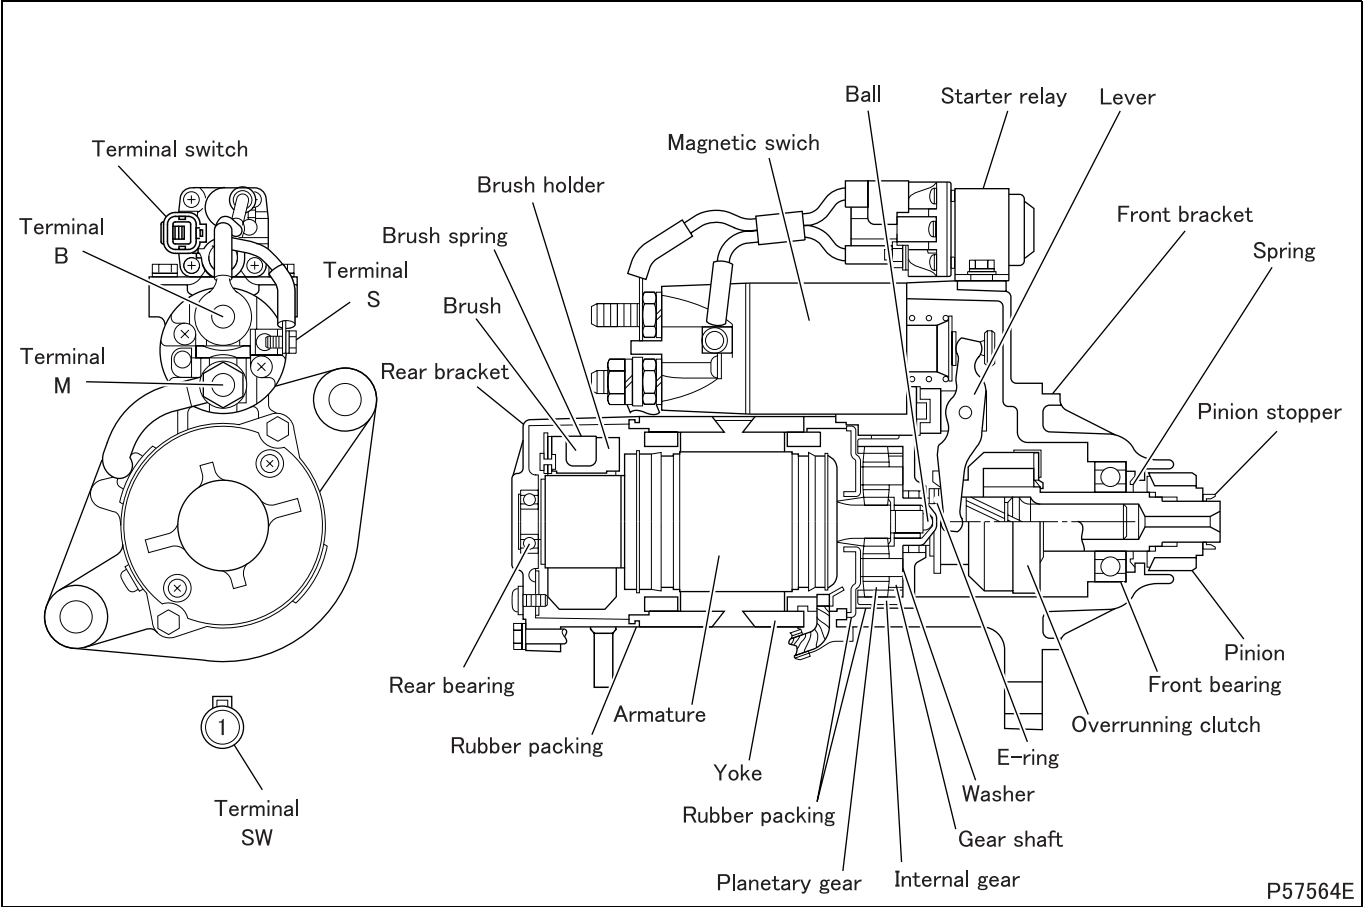
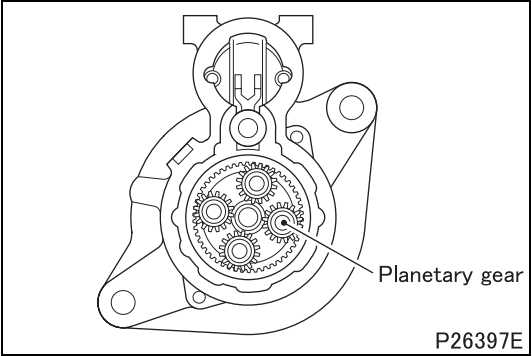
- This starter uses planetary gears as its reduction gearing mechanism.

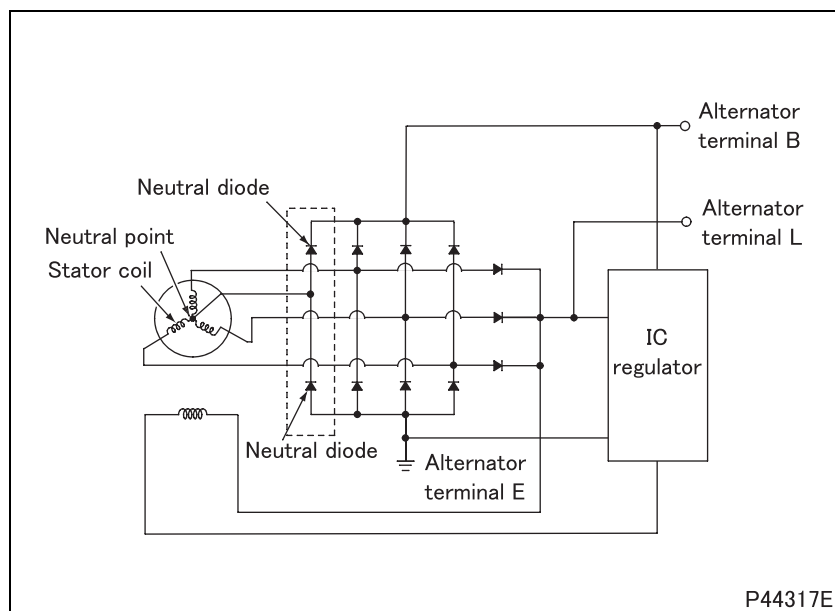
- The alternator is the same as the current alternator except that neutral diodes have been added.
- These neutral diodes enable this alternator to provide higher DC output during operation at high speeds than the alternator without neutral diodes.

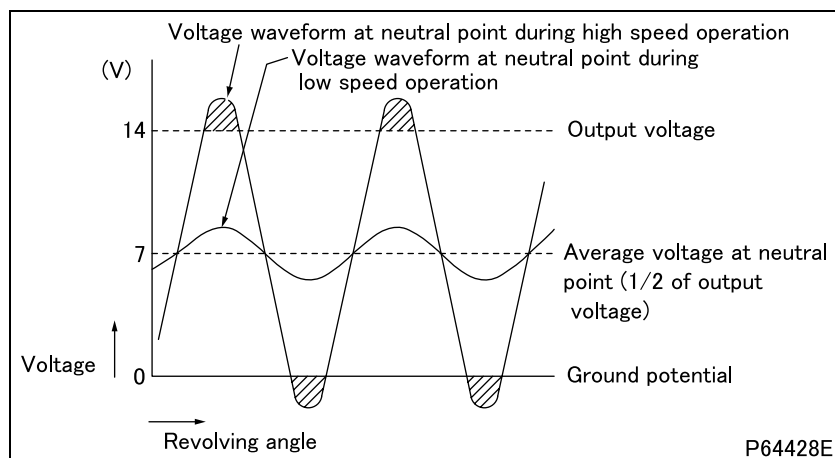
- The potential at the neutral point varies up and down with the neutral point DC voltage ( $1/2$  of output voltage) as a center as shown.
- When the alternator is operated at high speeds, the voltage at the neutral point can increase to exceed the output voltage (14 V) and decrease to become lower than the ground voltage (0 V). To adjust these over-voltage and under-voltage (shaded portions of diagram) the current from the excess voltages is taken by neutral diodes and added to the DC output.

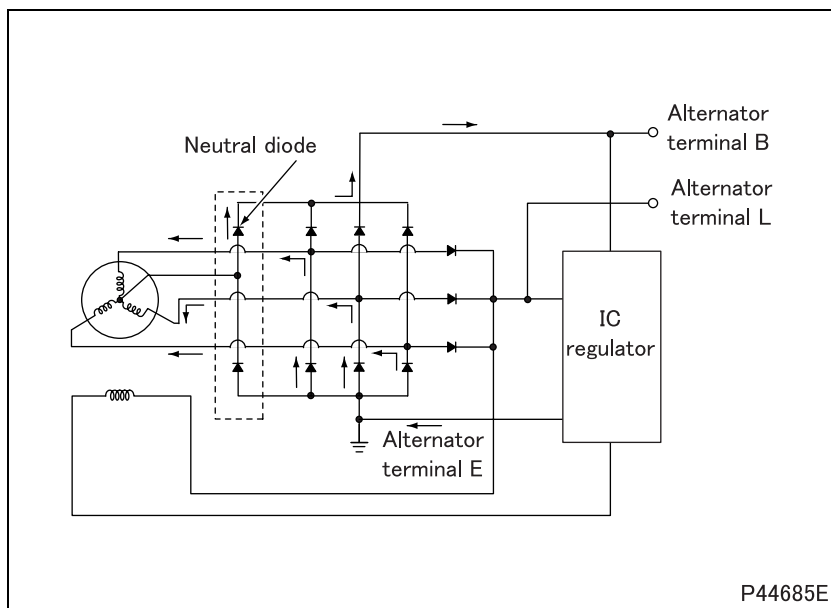
- When the voltage at neutral point is in the range from 0 to 14 V, the other six diodes are operated. Neutral diodes are not operated.

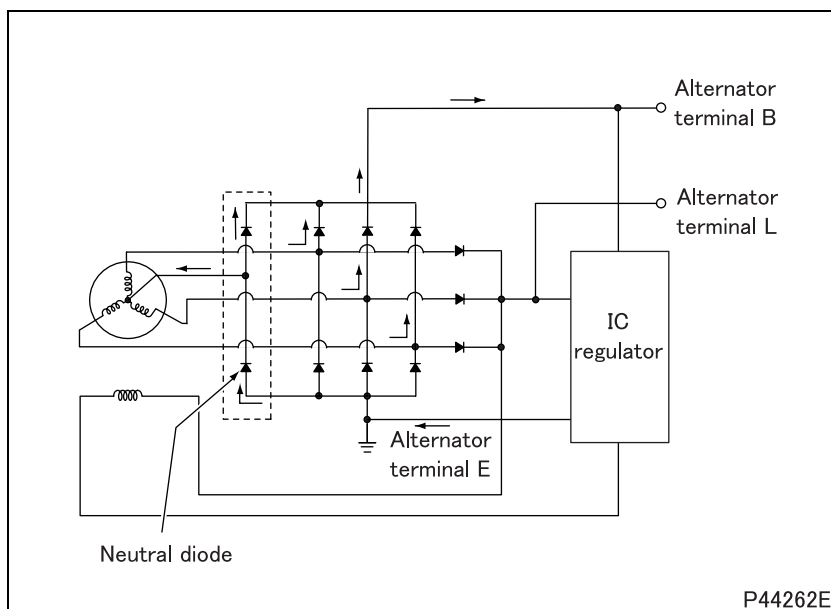
- The positive neutral diode adds extra output to the DC output for supply to each electric equipment.

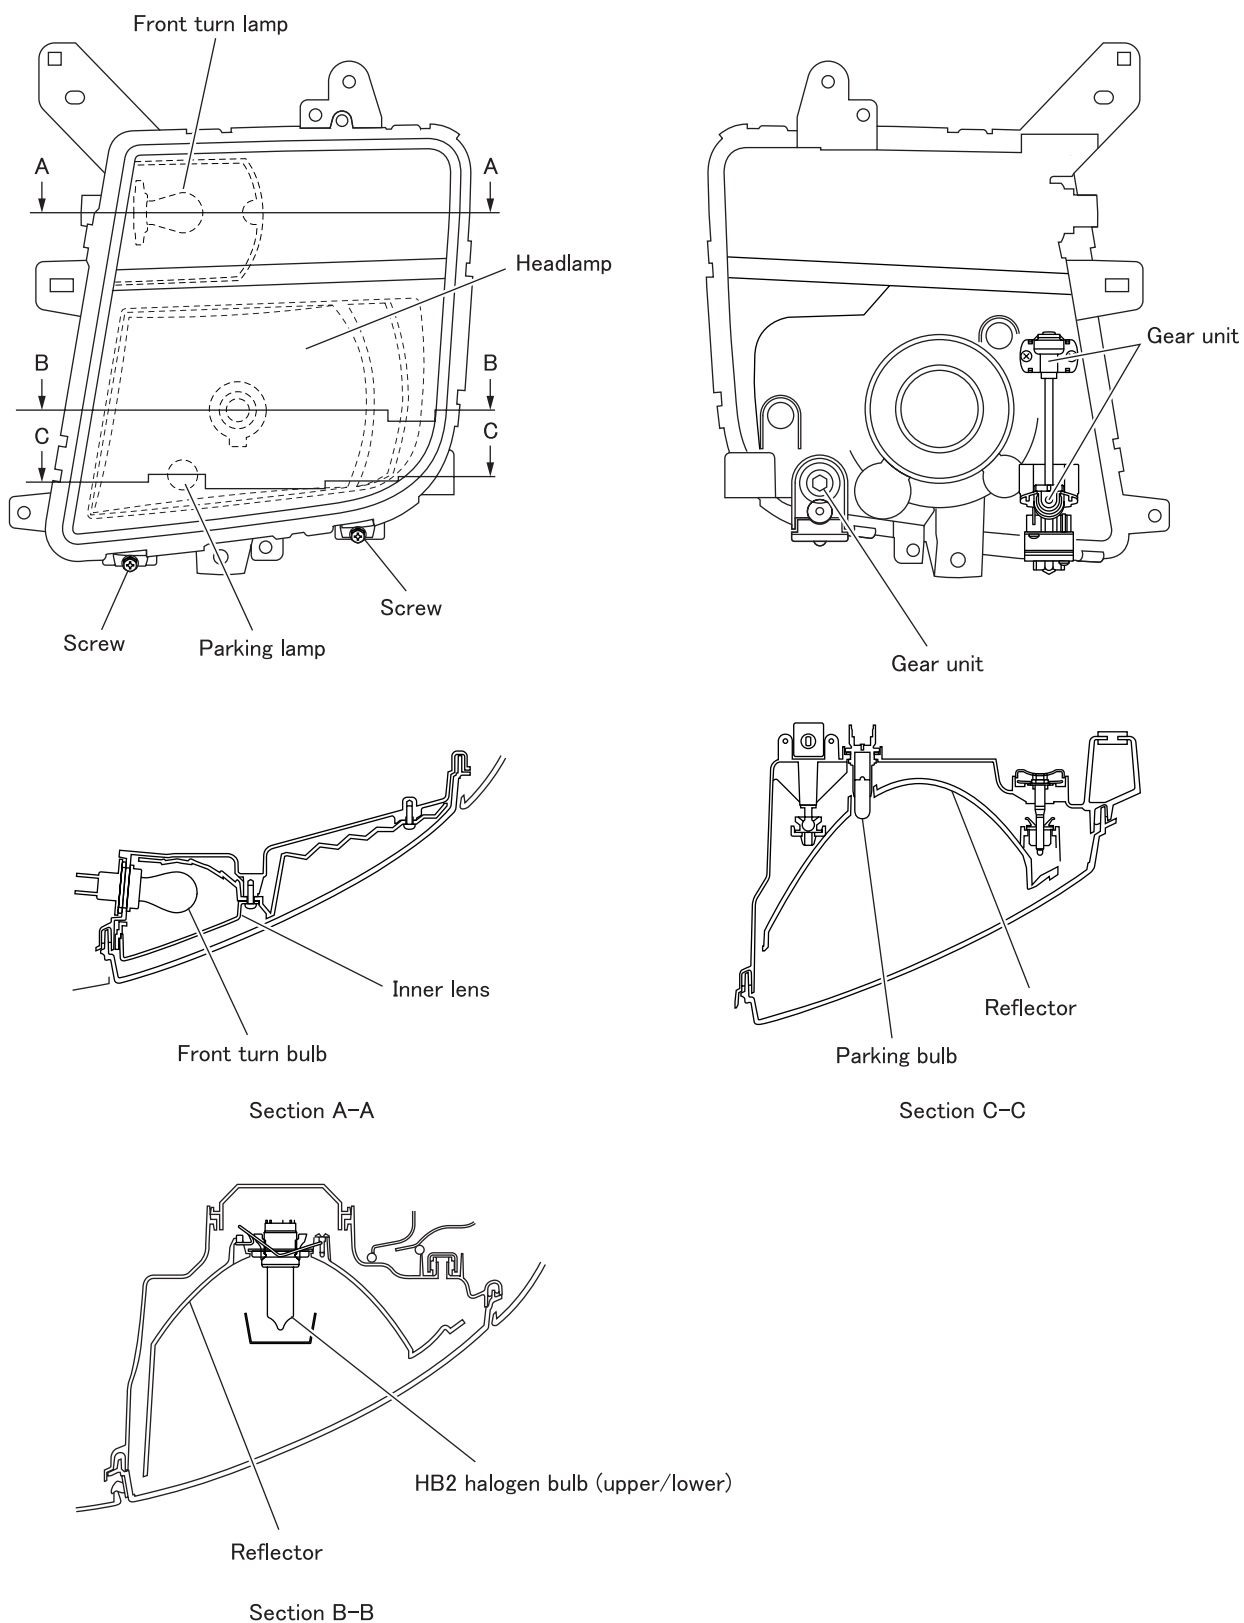
P103822E

(The drawings show the parts for the left-hand side headlamp.)

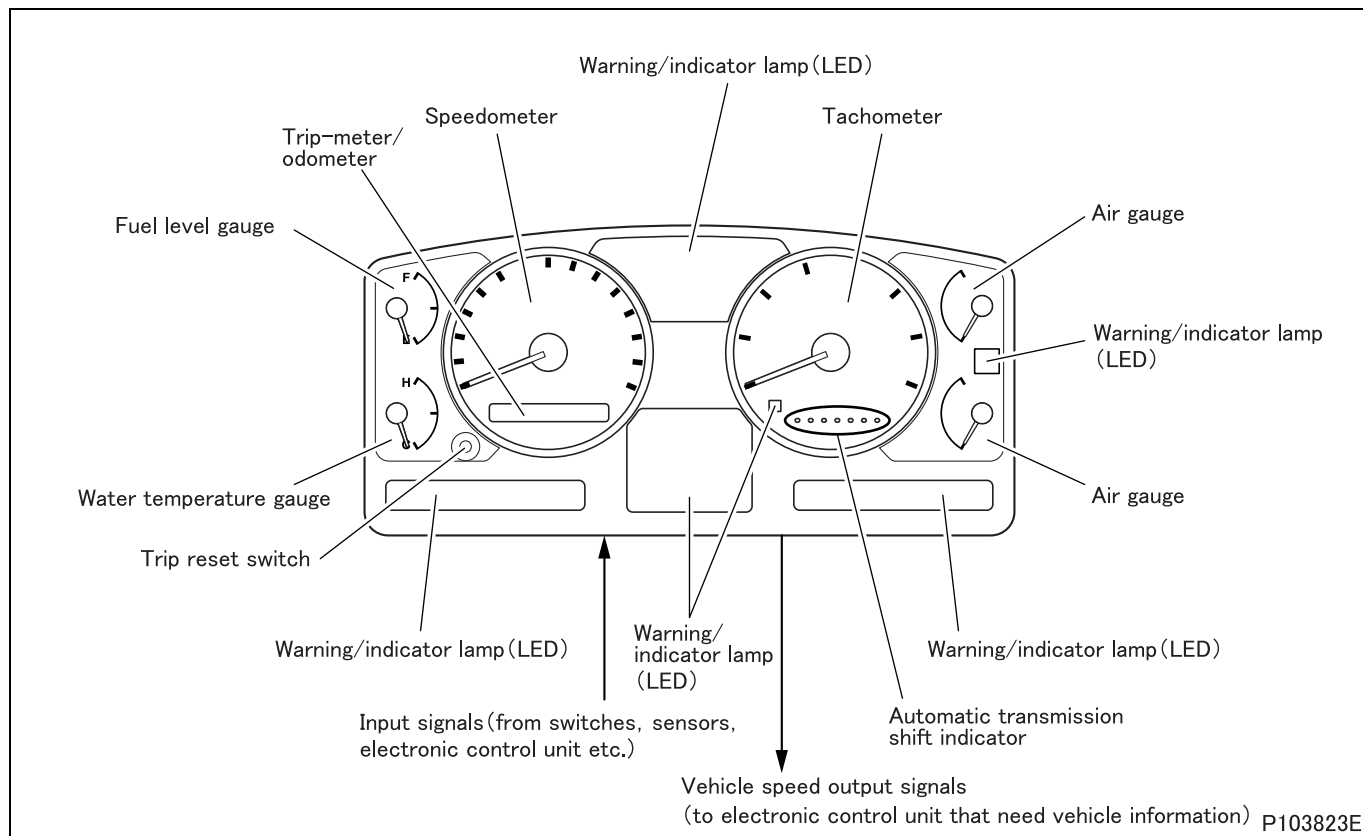
- The meter cluster incorporates a CPU, which contains the following functions.
  - The instrument drive function.
  - The lighting and alarm control (LAC) function.
  - The indicator and warning lamp indication warning function.
  - The buzzer sounding function.
- The meter cluster incorporates a pulse divider, which outputs signals from the speed sensor to each electronic control unit.

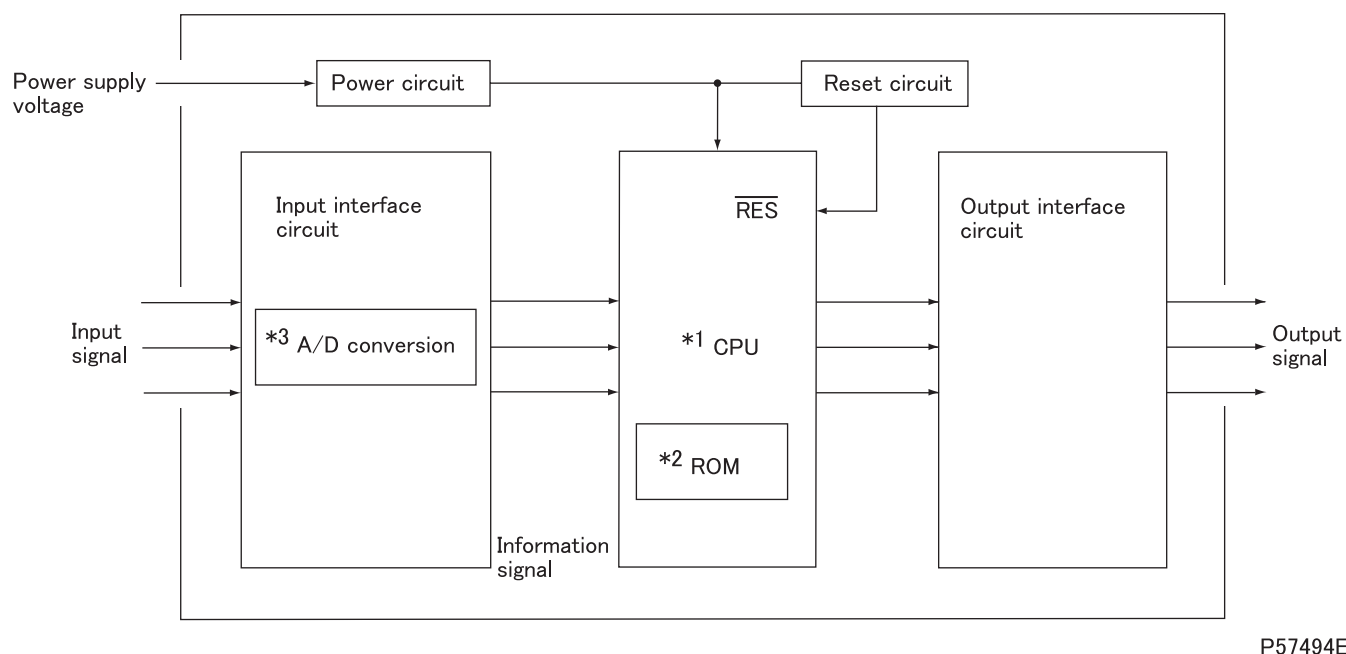
- Internally, the LAC is essentially made up of the input interface circuit, \*<sup>1</sup>CPU, \*<sup>2</sup>ROM, and output interface circuit.
  - \*<sup>1</sup>CPU:

An abbreviation for Central Processing Unit. It compares the input information and the information stored in the ROM, makes a decision and sends commands to the outputs.
  - \*<sup>2</sup>ROM:

An abbreviation for Analog/Digital conversion. It converts analog signals to digital signals. This conversion enables calculation to be made in the CPU.
- The CPU compares the received signals with the data in the ROM, makes a decision, and sends the results to the output interface circuit.
- The output interface circuit transmits these results to each system as output signals to instruct operations.
- Performing these series of operations continuously enables optimum control of each function.

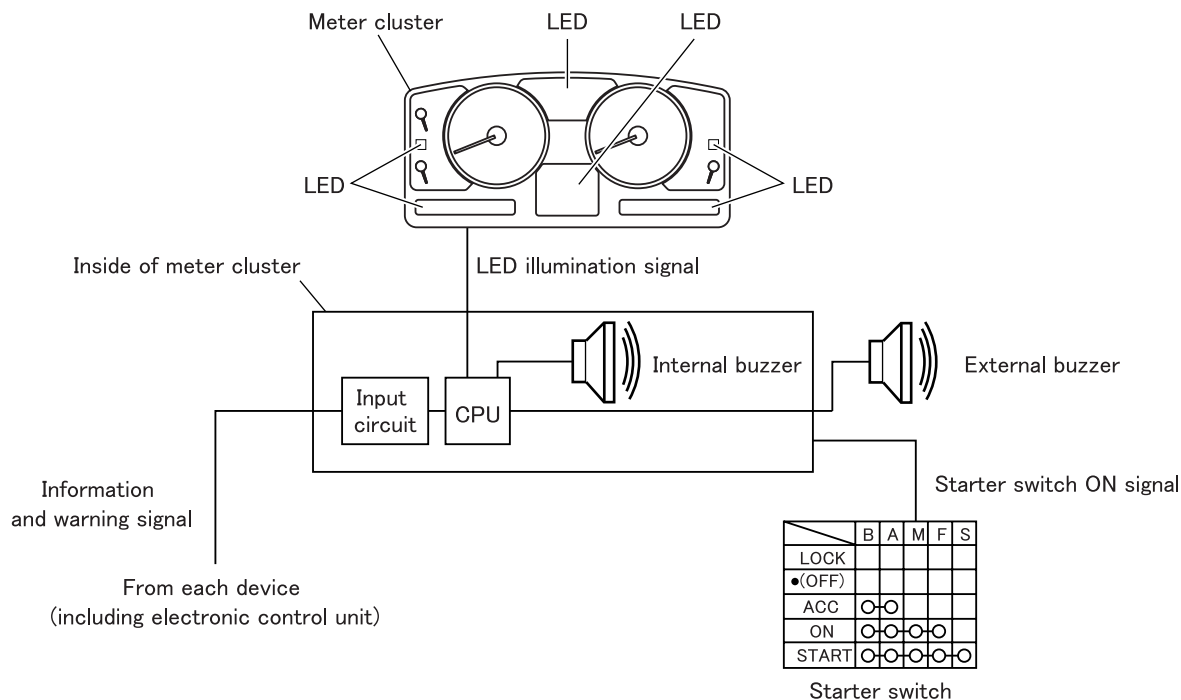
P101016E

- The indicator and warning lamp indication warning function is intended to advise the driver of necessary vehicle information adequately through symbols and buzzers.
- Information signals from various systems are sent to the central processing unit (CPU) in the meter cluster. The some signals are sent from CPU to appropriate LEDs in the meter cluster for character display and other signals are provided for the internal buzzer in the meter cluster or external buzzer for aural warning.

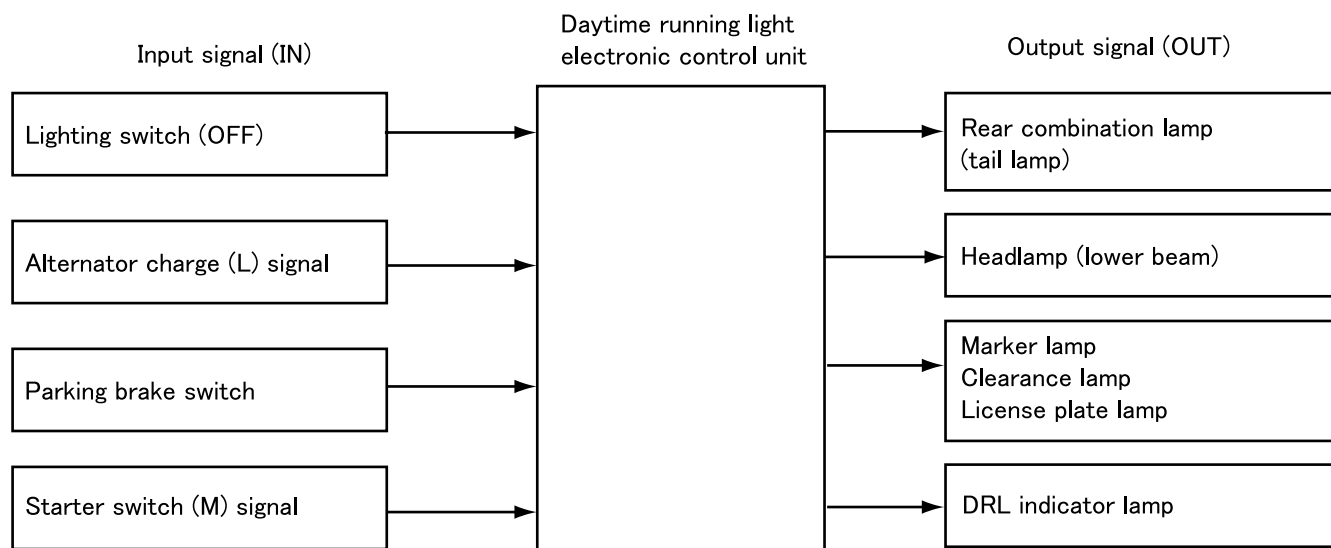
P58722E

- In a daytime running light (DRL) system, regardless the position of lighting switch while engine is running, the dipped beam of the headlamp and the tail lamp of the rear combinations, position lamp, license plate lamp will light on.
- Except for that the lighting switch is OFF or when the passing switch is ON, the same lamps as usual switch operation will light.

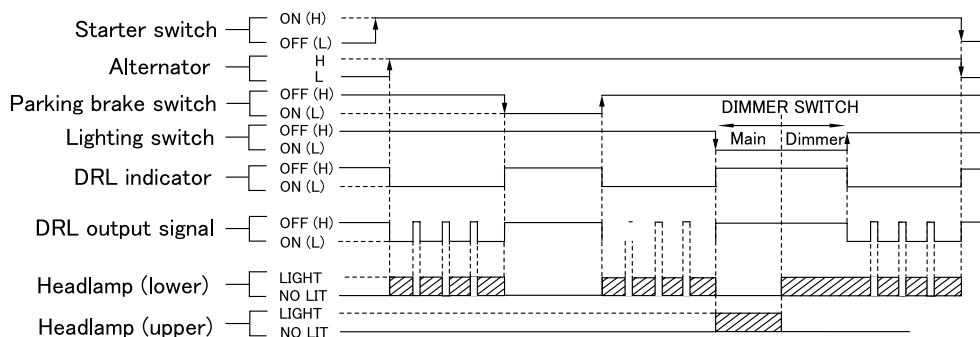
P36413E

Headlamps repeat ON/OFF operations at 120 Hz according to the above timing chart. Because of the cyclic ON/OFF operations, the headlamps are dimmer than when the headlamp switch is ON.

- After the engine starts, when alternator begins generating electricity with starter switch in the ON position, headlamps light.
- When parking brake switch is ON, the DRL turns off to switch off the headlamps.
