# FE.FG

## SERVICE MANUAL 2008 Model FOREWORD

This Service Manual contains maintenance and repair methods for the Mitsubishi Fuso Truck FE. FG Series. Read this manual carefully as an aid in providing correct, efficient maintenance. Please note that the information and specifications contained within this manual may change without notice. This is due to product modifications and continued vehicle improvements that are made throughout the model years. Should you encounter any discrepancy in the information provided, please do not hesitate to contact your nearest Mitsubishi Fuso Dealer or Mitsubishi Fuso Truck of America, Inc.

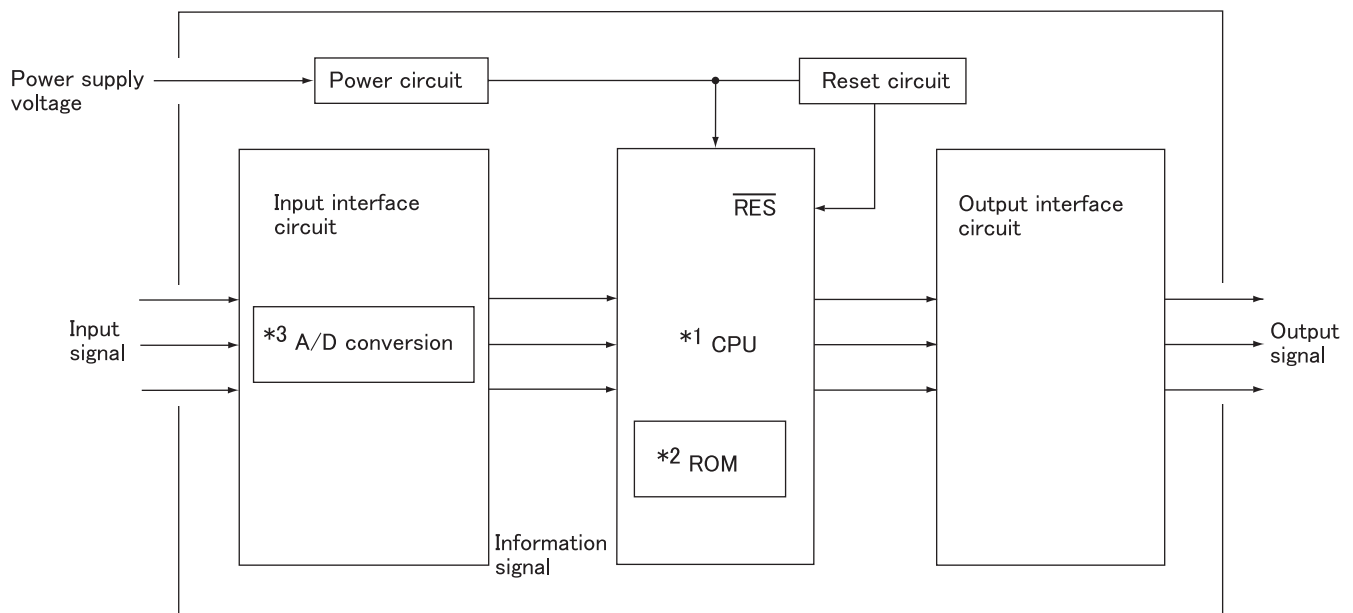
P57494E

- Internally, the MUTIC is essentially made up of the input interface circuit, \*<sup>1</sup>CPU, \*<sup>2</sup>ROM, and output interface circuit.
  - \*<sup>1</sup>CPU:  
An abbreviation for Central Processing Unit. It compares the input information and the information stored in the ROM, makes a decision and sends commands to the outputs.

- Performing these series of operations continuously enables optimum control of each function.

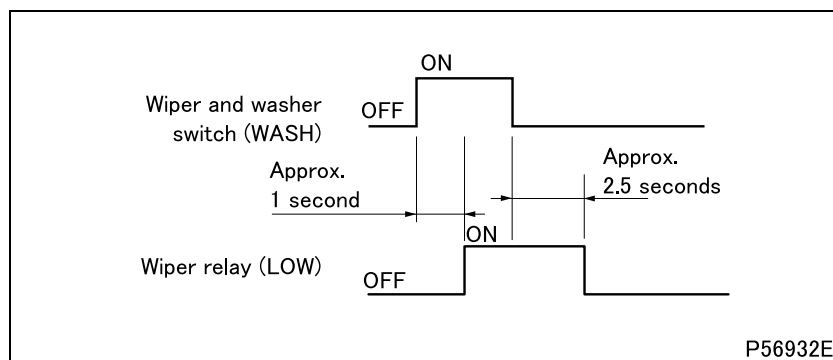
- This function causes the windshield wipers to operate a few times at low speed when the windshield washer switch is turned ON.
- As shown in the drawing, the MUTIC introduces a short delay between detecting the ON condition of the wiper and washer switch (washer switch) and activating the wiper relay.

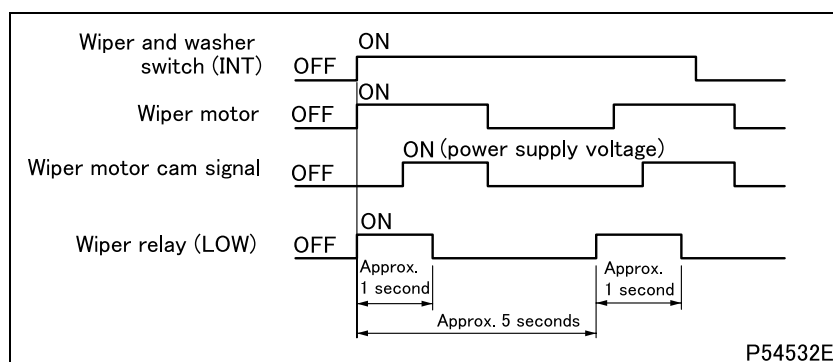
- MUTIC control causes intermittent wiper operation to take place as shown in the drawing.

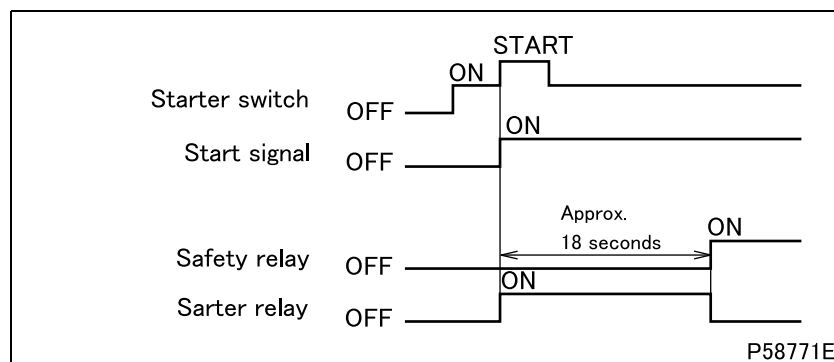
- This function is provided to prevent starter over-run.
- If the starter operates for longer than a predetermined period following engine startup, the engine electronic control unit deems that it has been energized continuously for too long. The engine electronic control unit then stops the flow of current to the starter and starter relay, thereby preventing the starter from seizing.
- If the engine electronic control unit determines, based on the engine speed signal it receives, that the engine has run at or above the specified speed for longer than the specified time period after start-up, the unit trips the safety relay open.

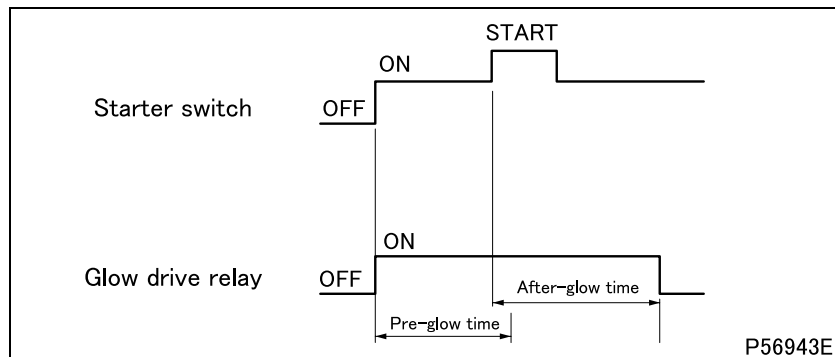
The preheating is operated with a pre-glow before the engine starts and an after-glow after the engine starts. They are controlled by the starter switch (S terminal) signal, engine water temperature signal and the engine rotation signal.

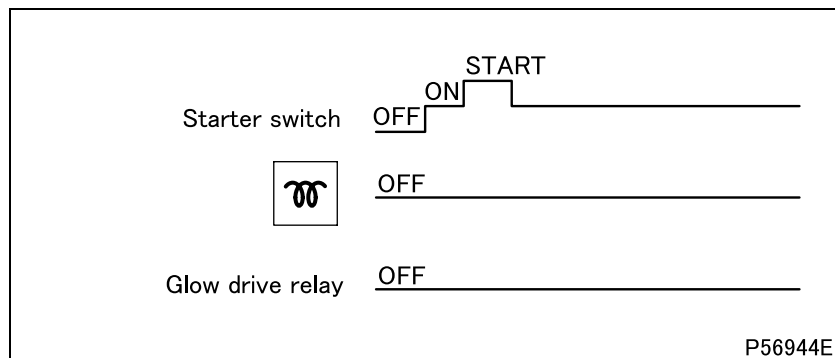
- When the engine coolant temperature is 60°C {140°F} or more.

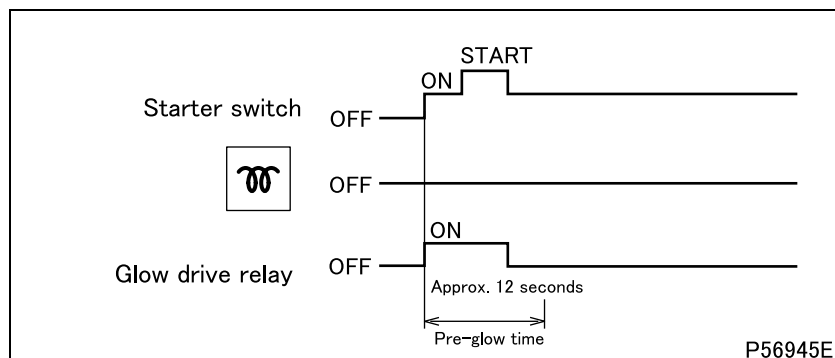
- When the engine coolant temperature is 0 to 60°C {32 to 140°F}.

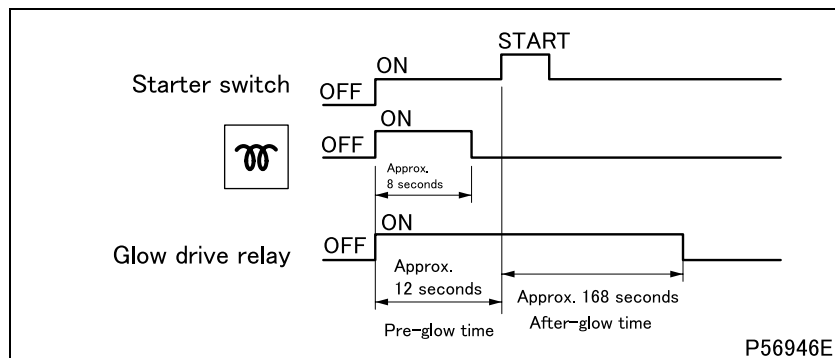
- When the engine coolant temperature is 0°C {32°F} or less.

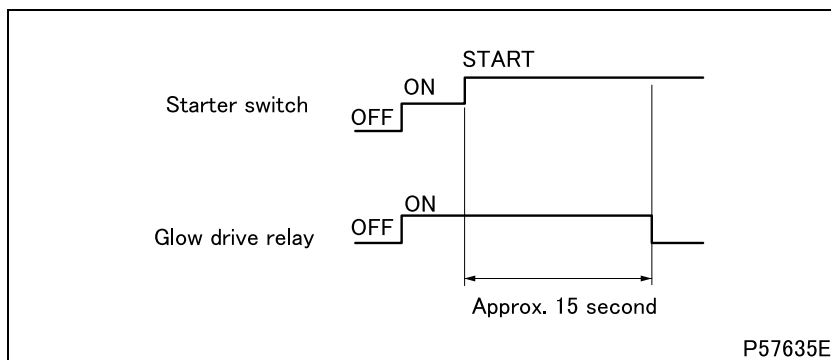
- In case the contact point operating the glow relay in engine electronic control unit has melted, the preheating indicator lamp flashes to warn this abnormality.
- Operation mode turns glow relay activation signal to OFF only after all the following conditions are met.
  - Where the engine coolant temperature is 60°C {140°F} or less.
  - Starter switch signal is ON for 15 seconds continuously.
  - Starter switch (S terminal) signal is ON.

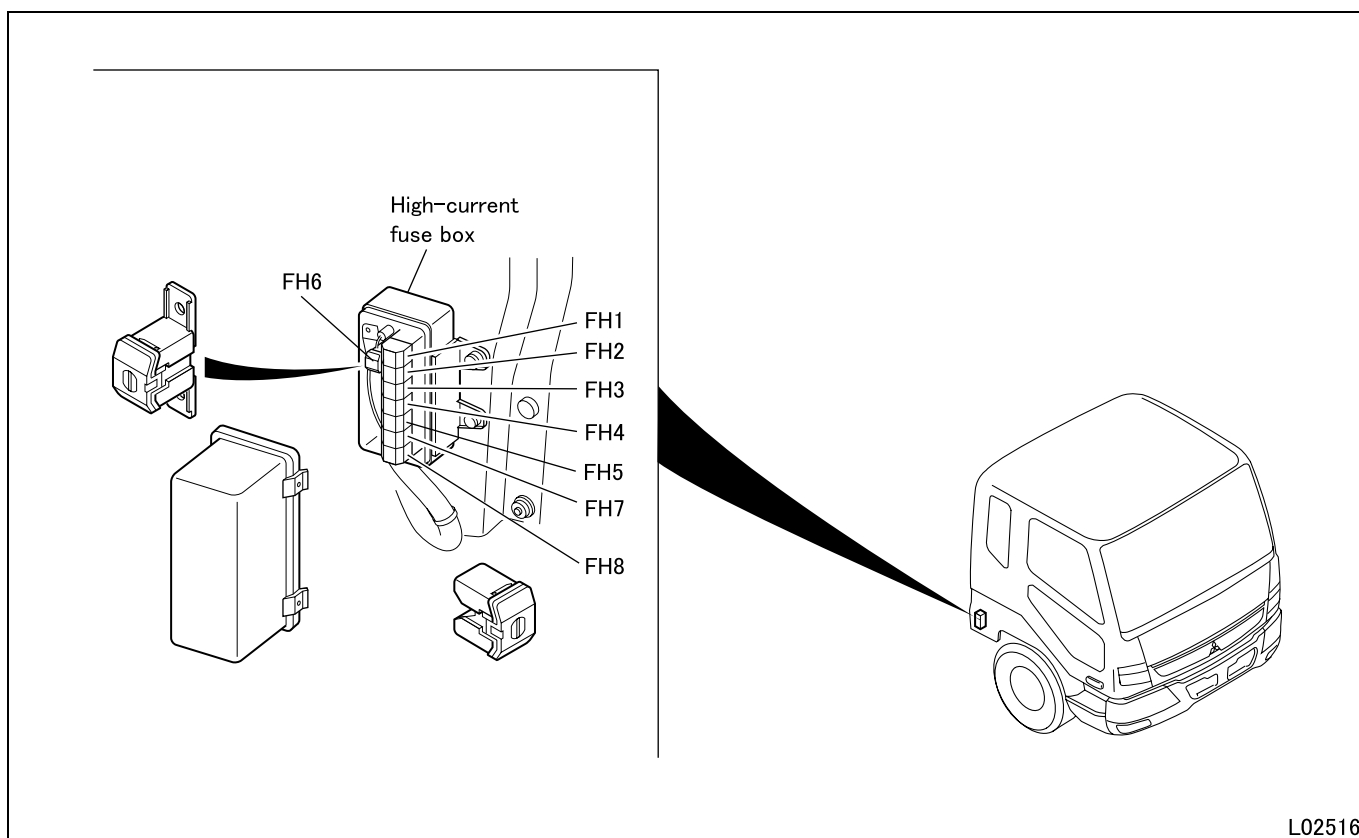
# HIGH-CURRENT FUSE BOX

- To prevent possible injury, be sure to disconnect the negative (–) cable of the battery and insulate it with tape before removing high-current fuses.
- With the negative (–) cable of the battery connected, some high-current fuses are always under battery voltage. An arc will be generated when any of these high-current fuses is replaced without disconnecting the battery negative cable, and this could cause the related electric devices to be damaged.
- If a fuse blows out, identify and remedy the cause, then replace the fuse.
- Be sure to use the fuse with the specified ampere.

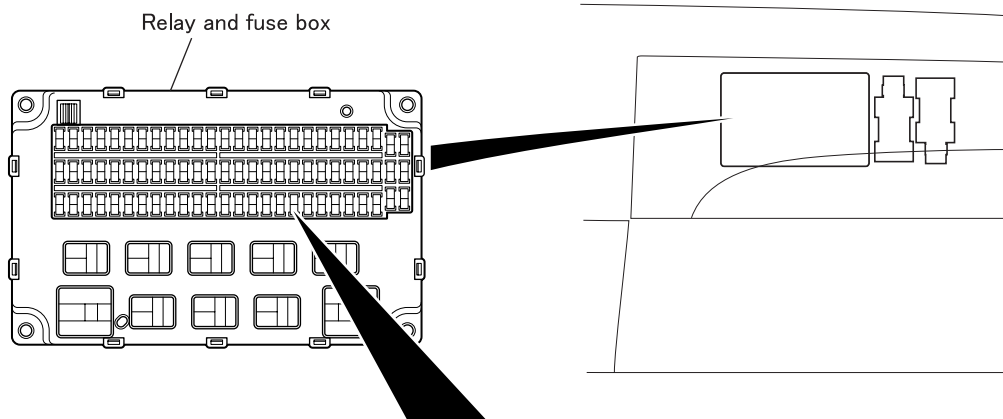
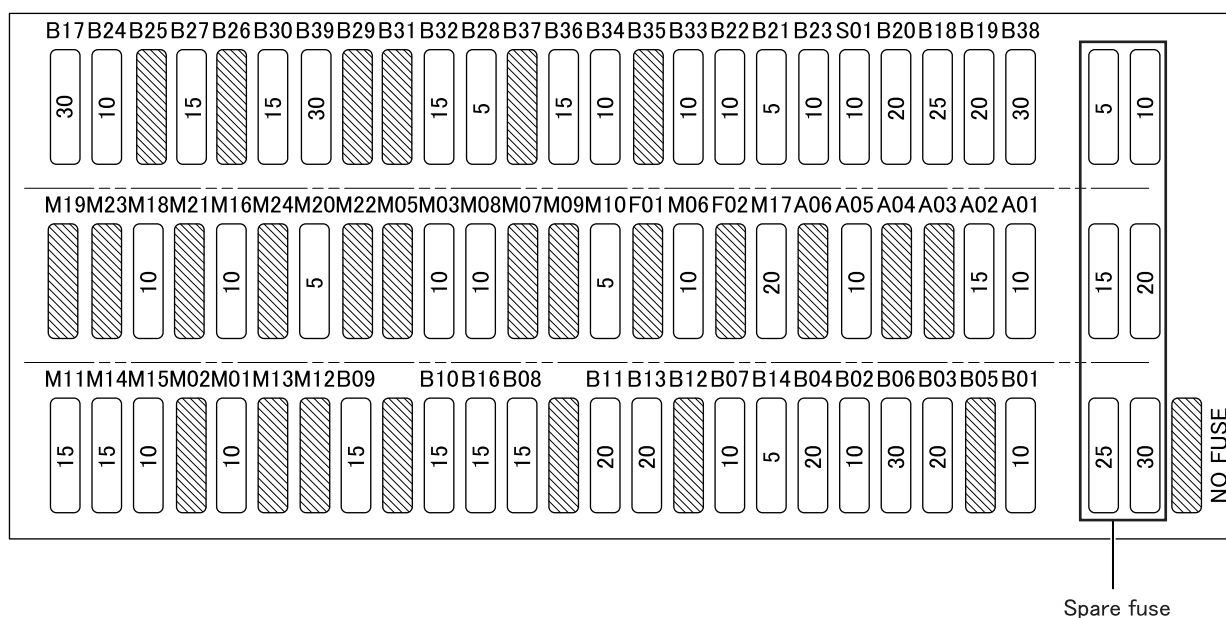
# RELAY AND FUSE BOX

- To prevent possible injury, be sure to disconnect the negative (–) cable of the battery and insulate it with tape before removing fuses.
- With the negative (–) cable of the battery connected, some fuses are always under battery voltage. An arc will be generated when any of these high-current fuses is replaced without disconnecting the battery negative cable, and this could cause the related electric devices to be damaged.
- If a fuse blows out, identify and remedy the cause, then replace the fuse.
- Be sure to use a fuse with the specified ampere.

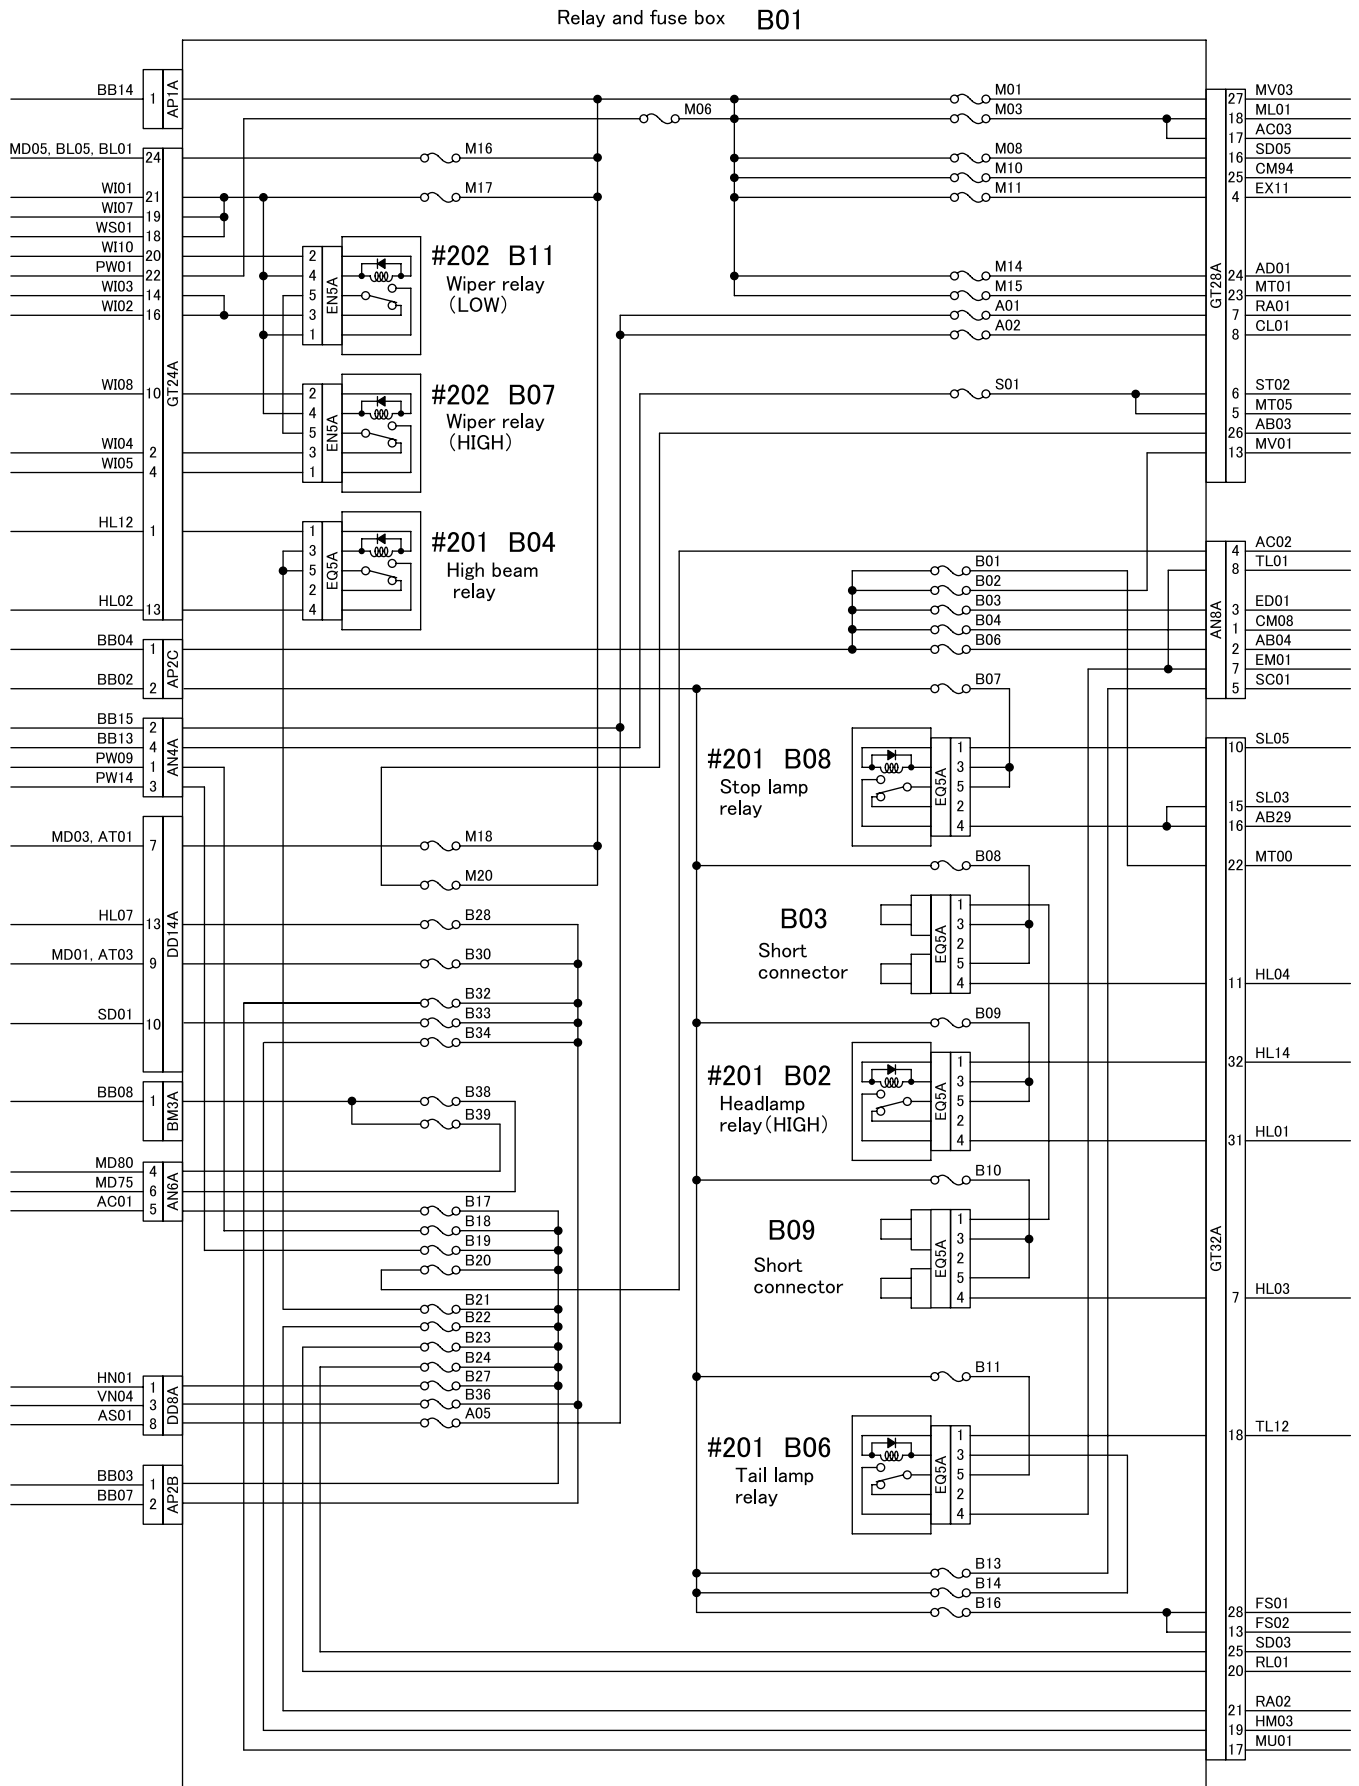
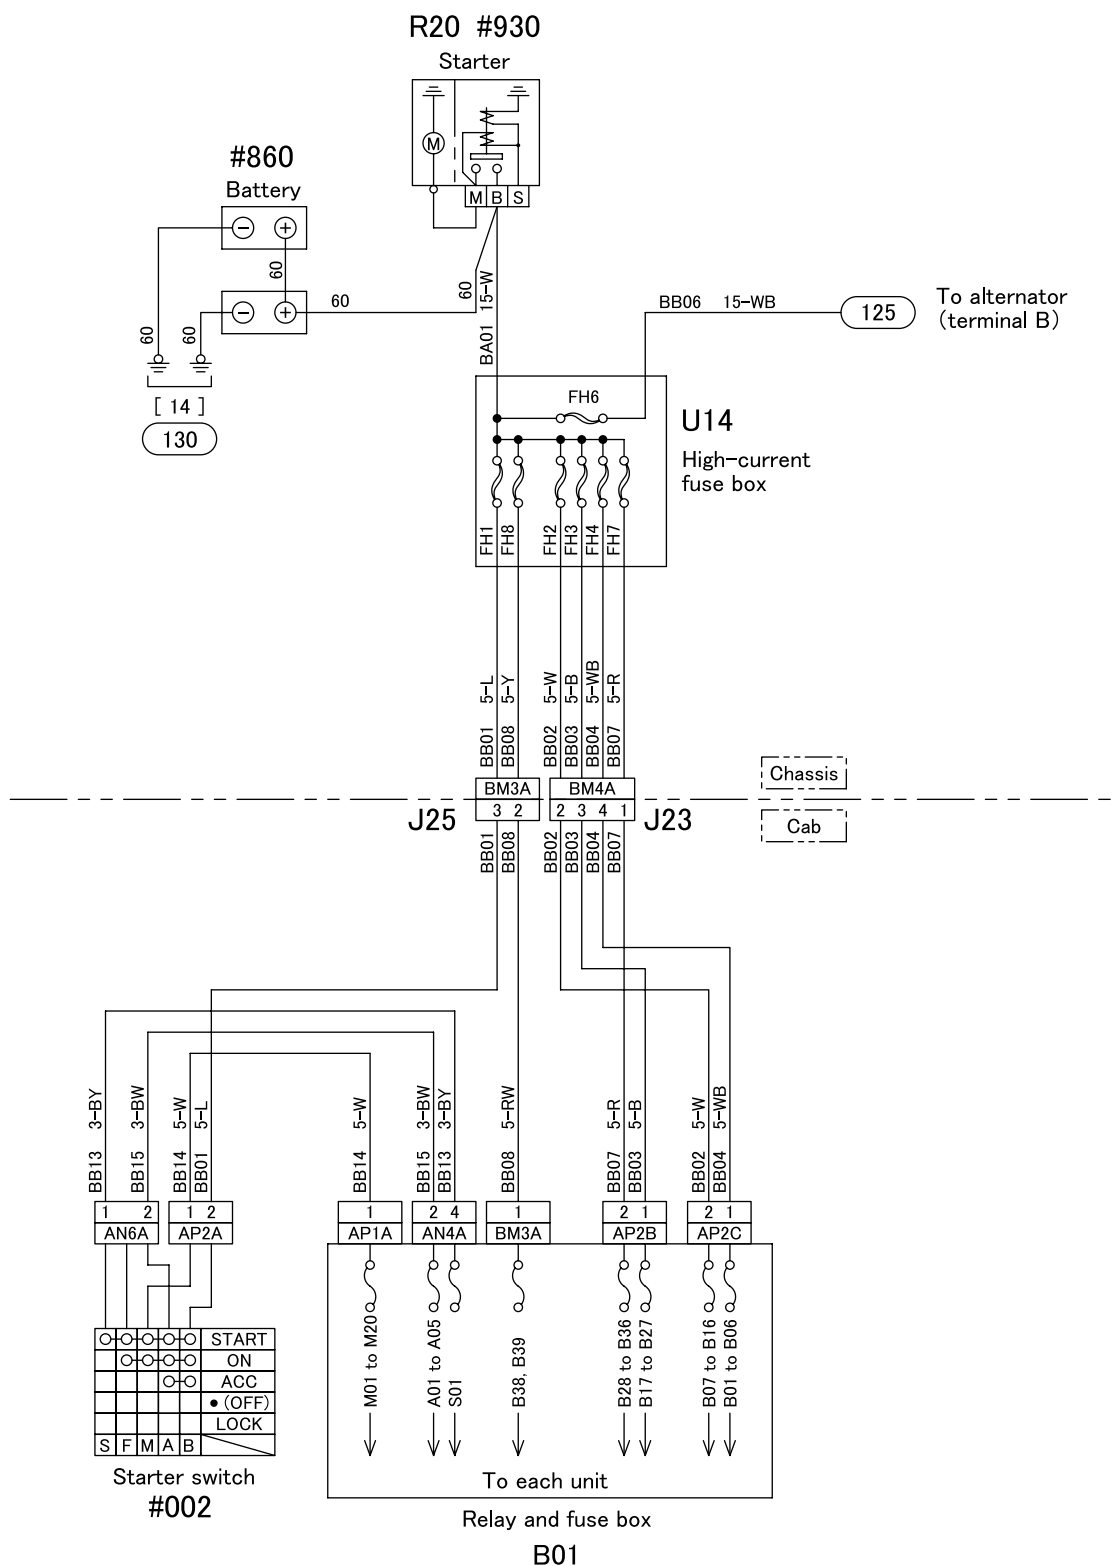
# 104 RELAY AND FUSE BOX CIRCUIT

Battery to fuse

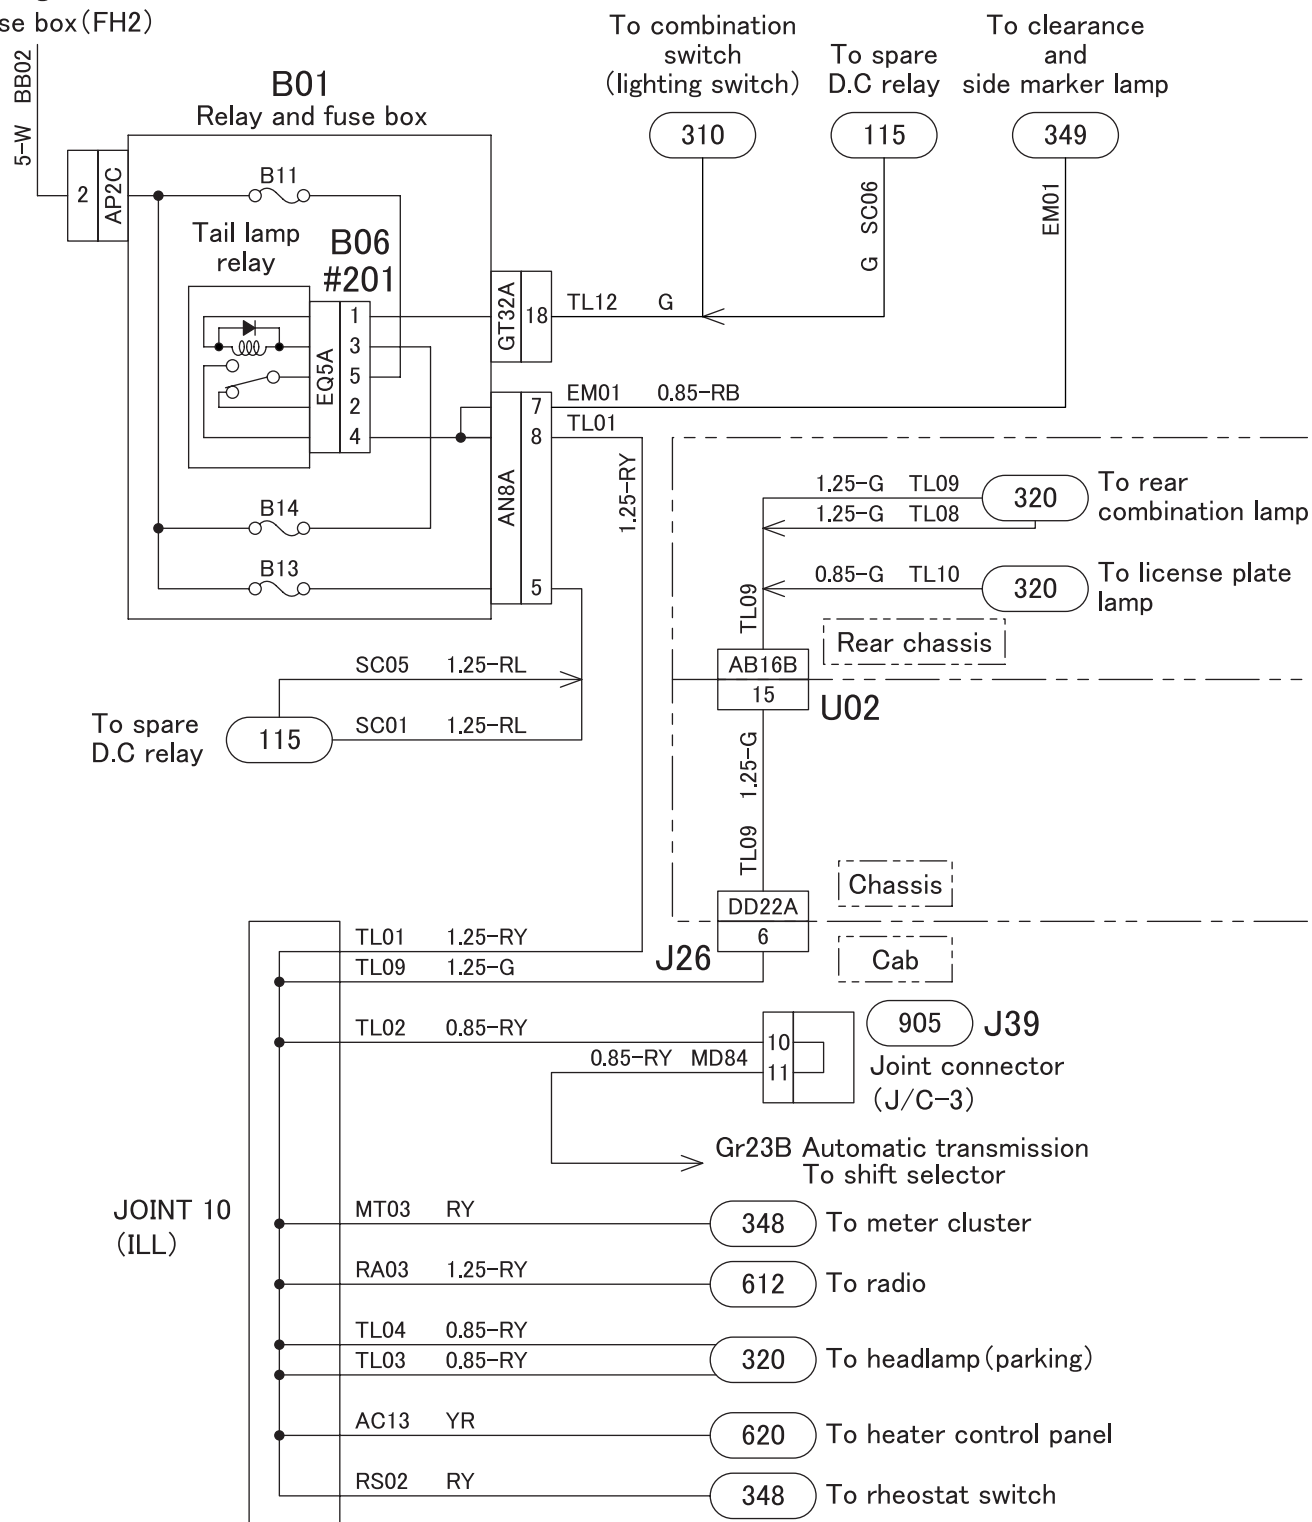
# Relay and fuse box (Fuse B11 to B14)

To high-current  
fuse box (FH2)

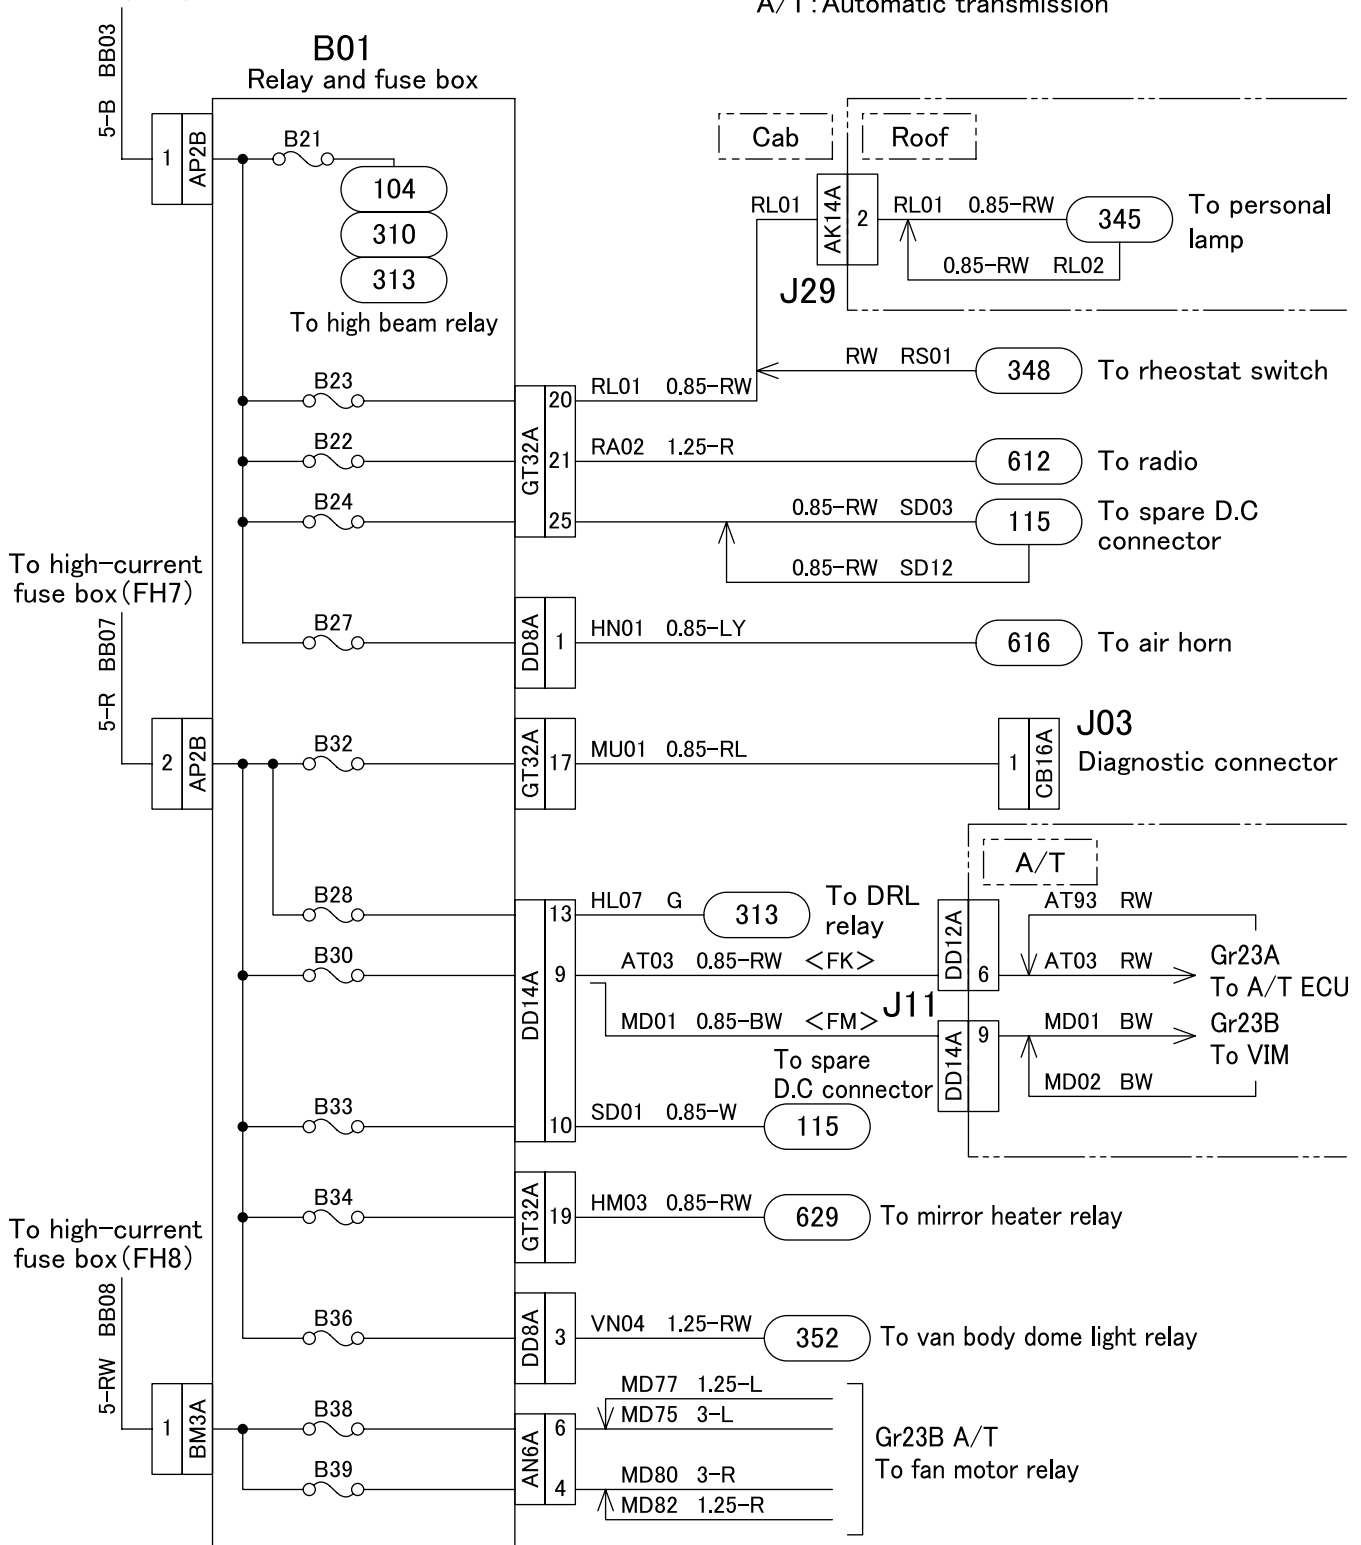
# Relay and fuse box (Fuse B21 to B39)

To high-current  
fuse box (FH3)

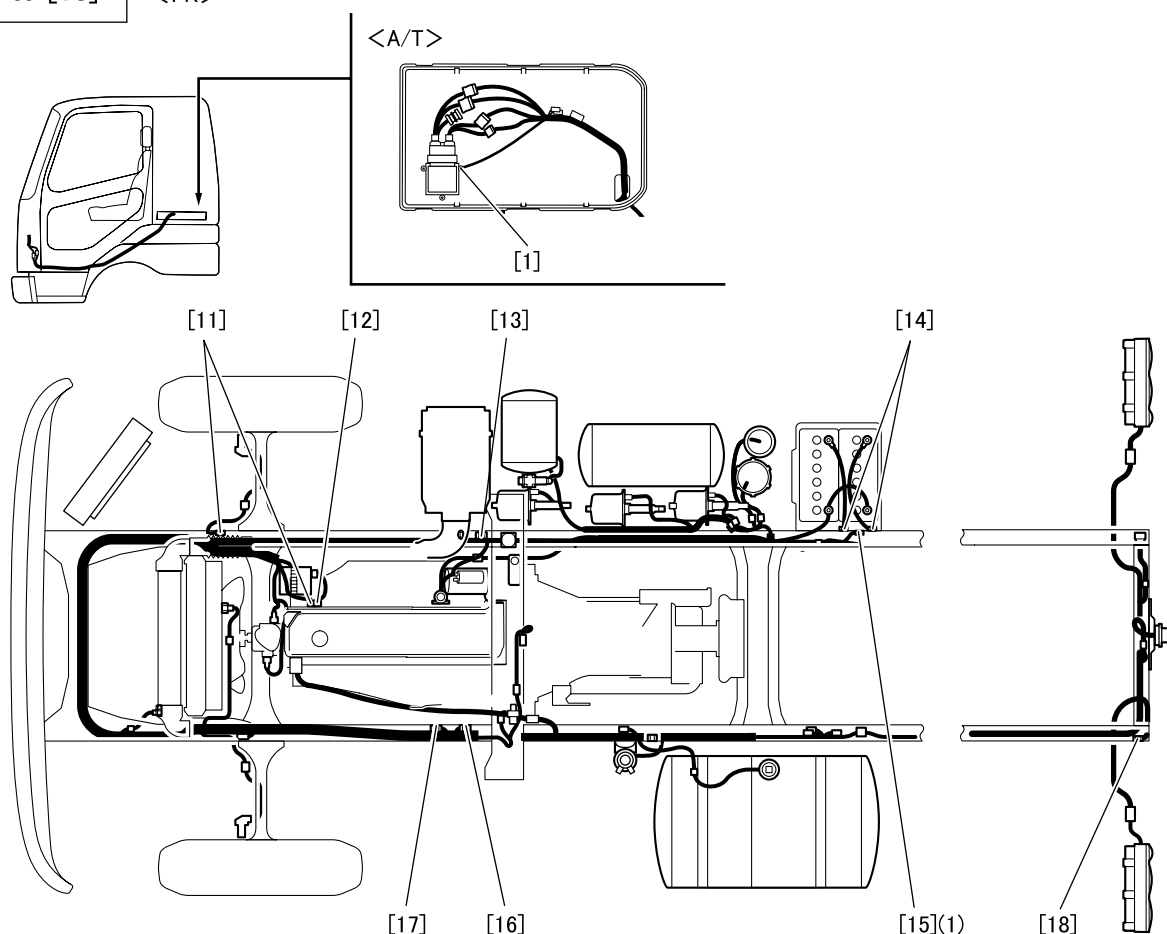
[1] to [18] <FK>

| Location | Circuit No. | Wire diameter<br>-wire color | Destination | Remarks |
|---|---|---|---|---|
| [1] | ATE0 | B | A/T ECU | A/T ECU case ground <FK (A/T)> |

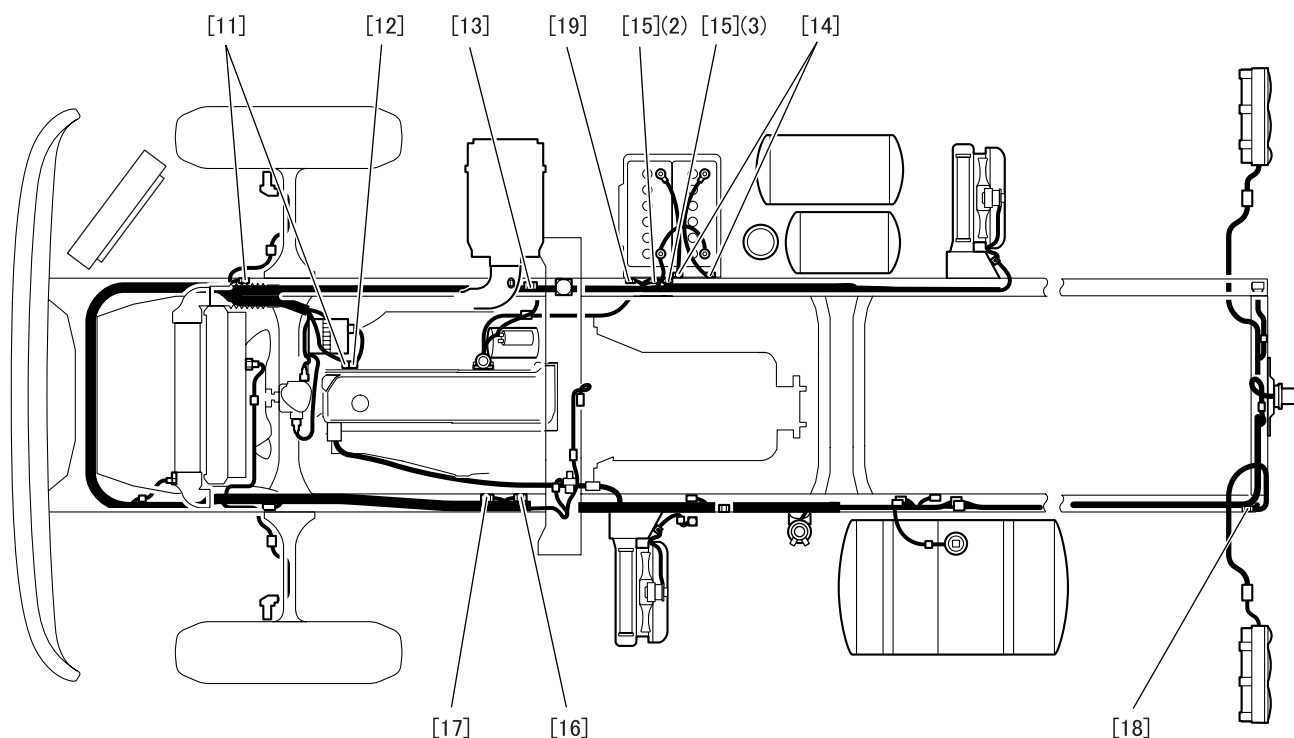
[11] to [19] &lt;FM&gt;

| Location | Circuit No. | Wire diameter<br>-wire color | Destination | Remarks |
|---|---|---|---|---|
| [11] | GEE2 | 20-BL | Alternator | Alternator ground |

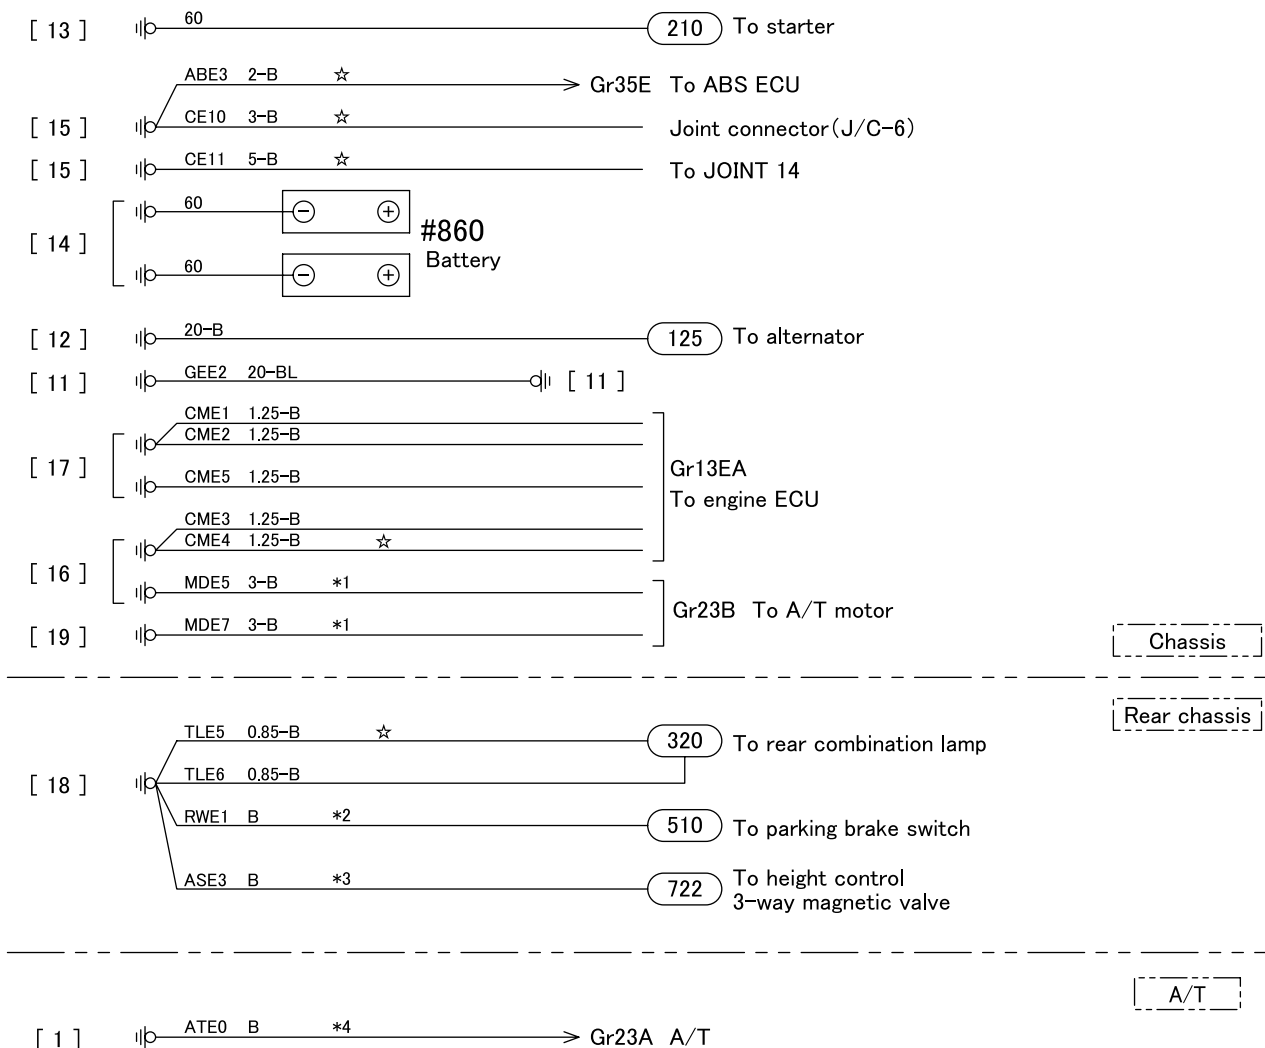
## Entire ground

- This diagram indicates grounding points.
- See the following pages for branching of grounding (wiring for ☆)  
(in circuit No. order).

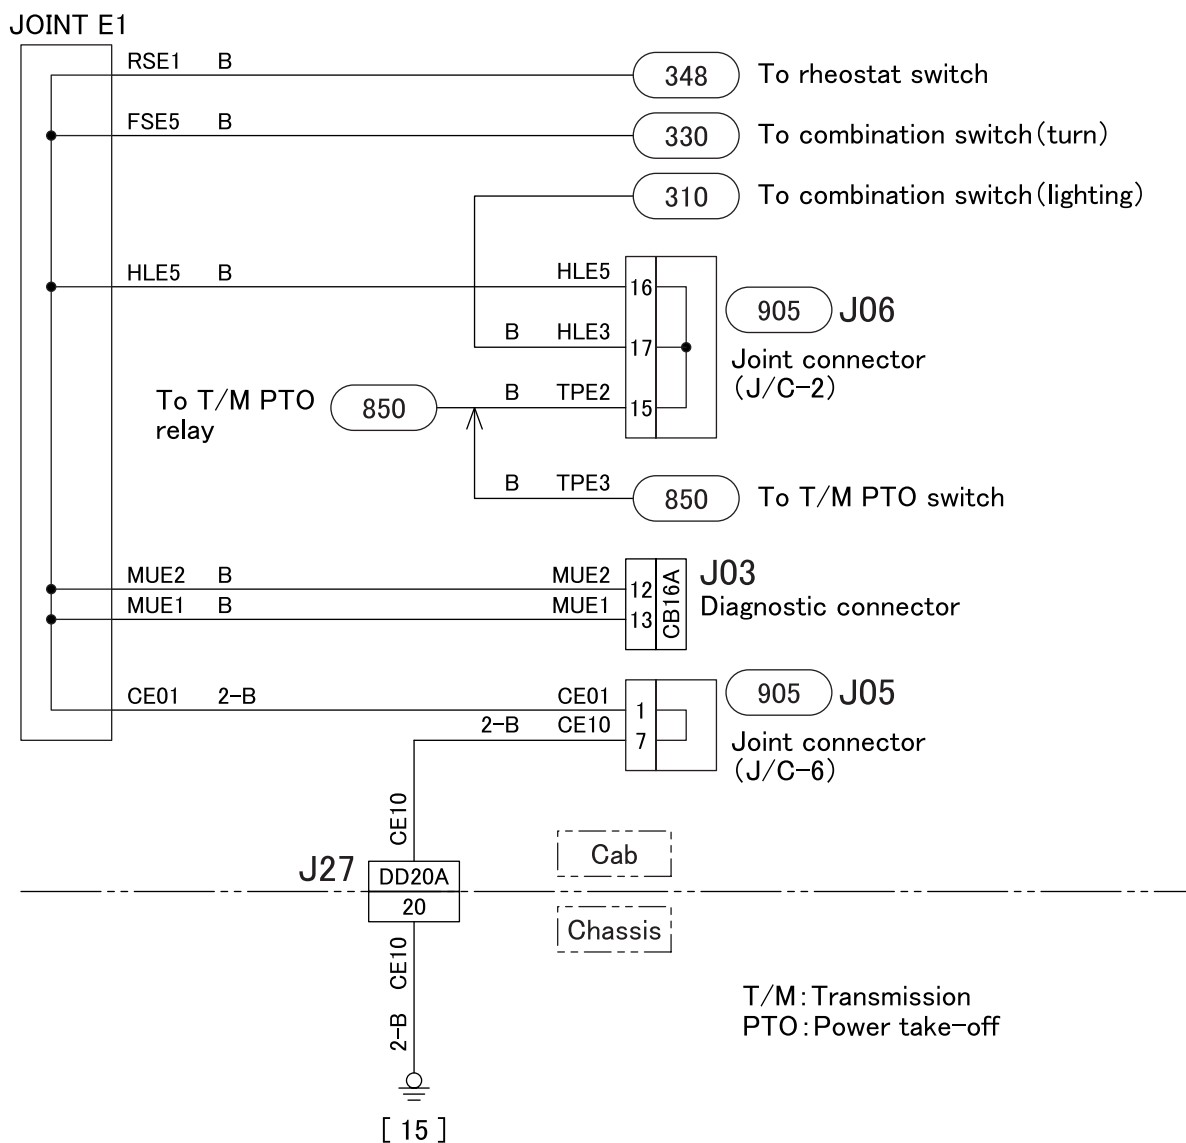
<JOINT E1>

Circuit No. CE10 chassis ground

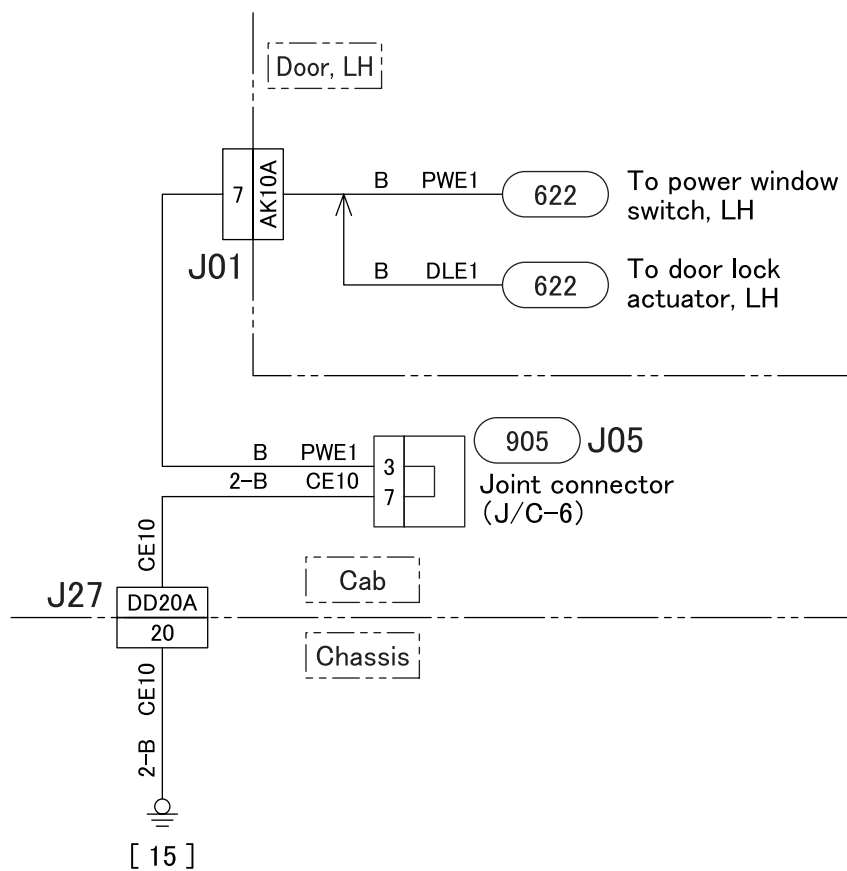
<Circuit No. PWE1>

Circuit No. CE10 chassis ground

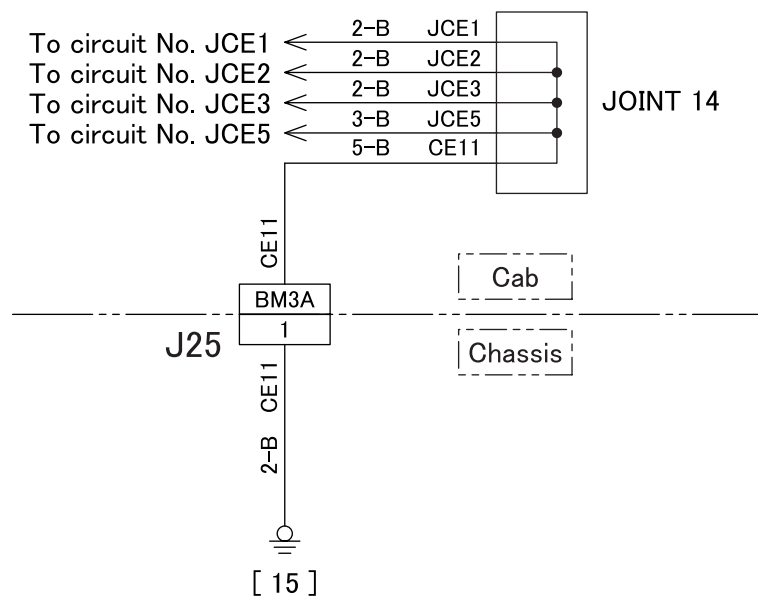
<Main ground>

Circuit No. CE11 chassis ground

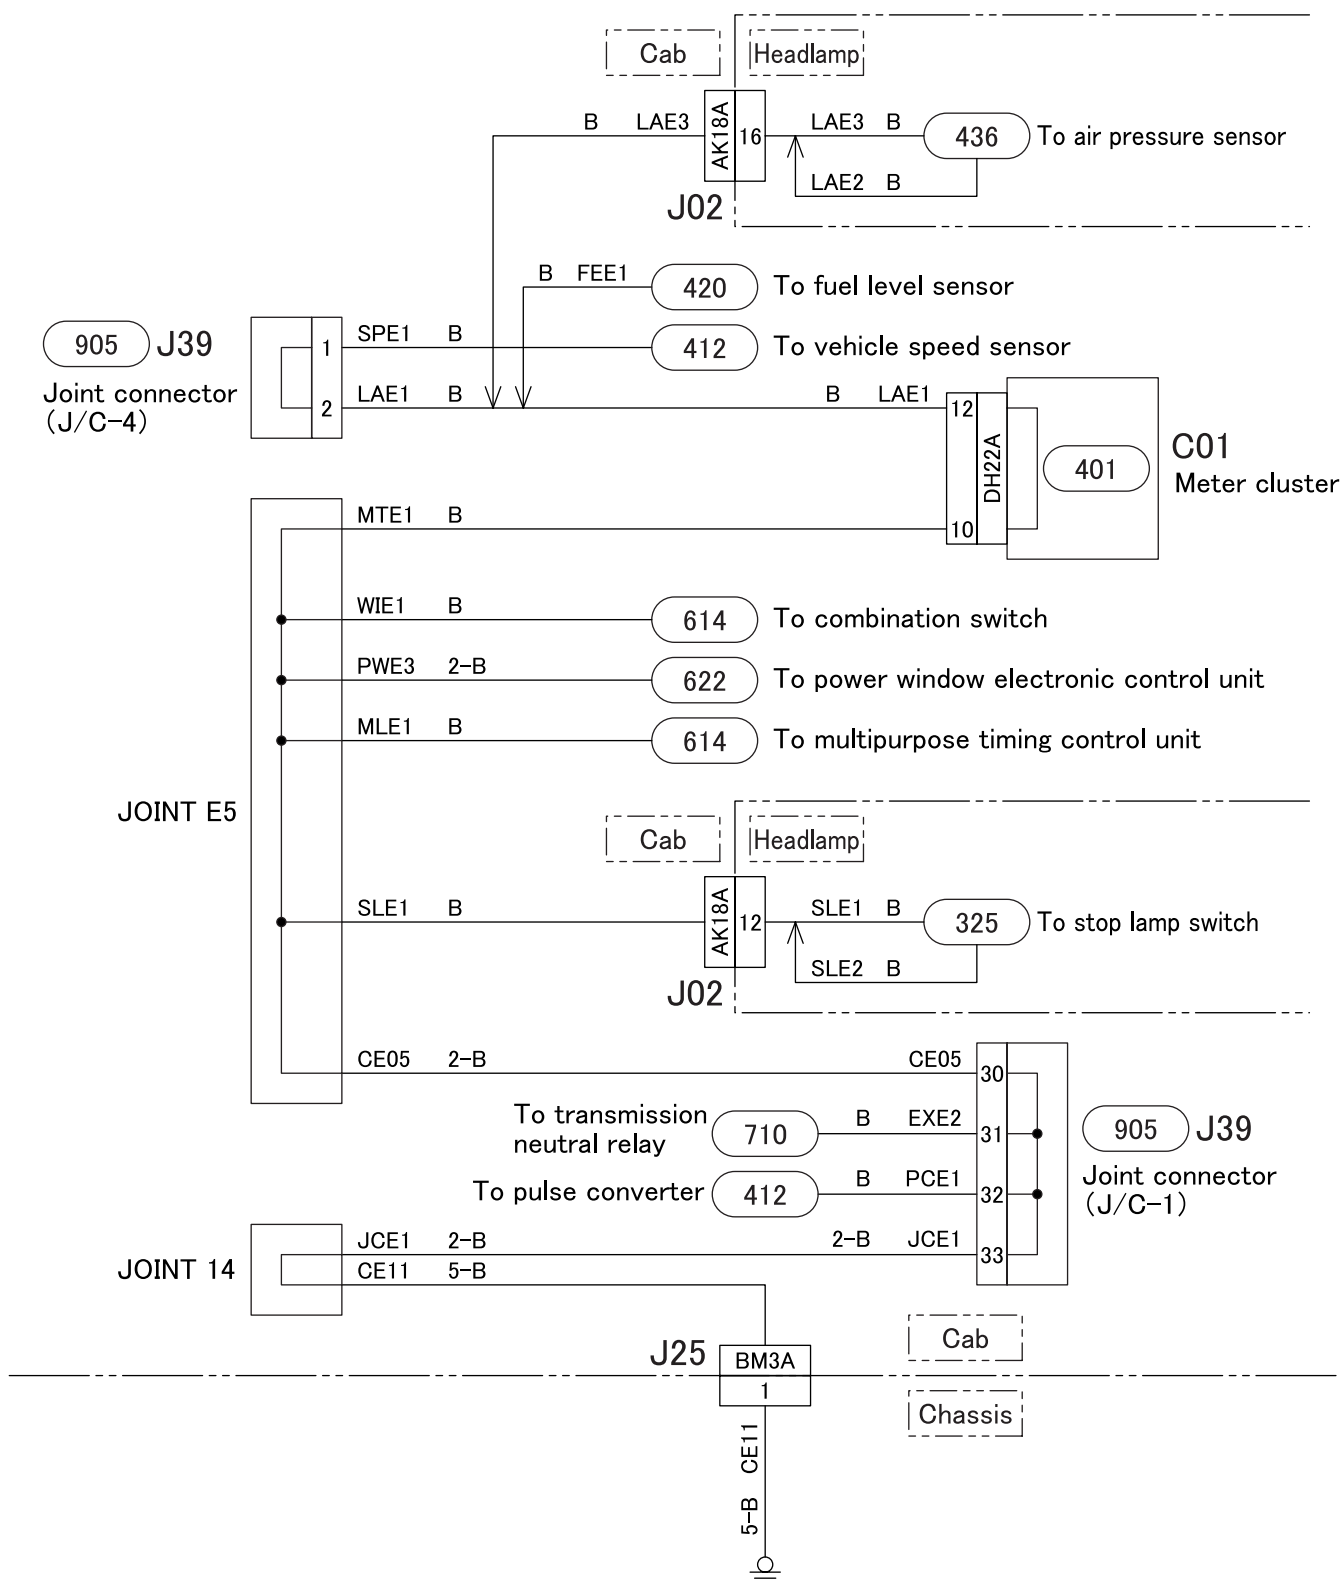
&lt;JOINT E5&gt;

Circuit No. CE11 chassis ground

&lt;Circuit No. JCE1&gt;
