# FE.FG

## SERVICE MANUAL 2008 Model FOREWORD

This Service Manual contains maintenance and repair methods for the Mitsubishi Fuso Truck FE. FG Series. Read this manual carefully as an aid in providing correct, efficient maintenance. Please note that the information and specifications contained within this manual may change without notice. This is due to product modifications and continued vehicle improvements that are made throughout the model years. Should you encounter any discrepancy in the information provided, please do not hesitate to contact your nearest Mitsubishi Fuso Dealer or Mitsubishi Fuso Truck of America, Inc.

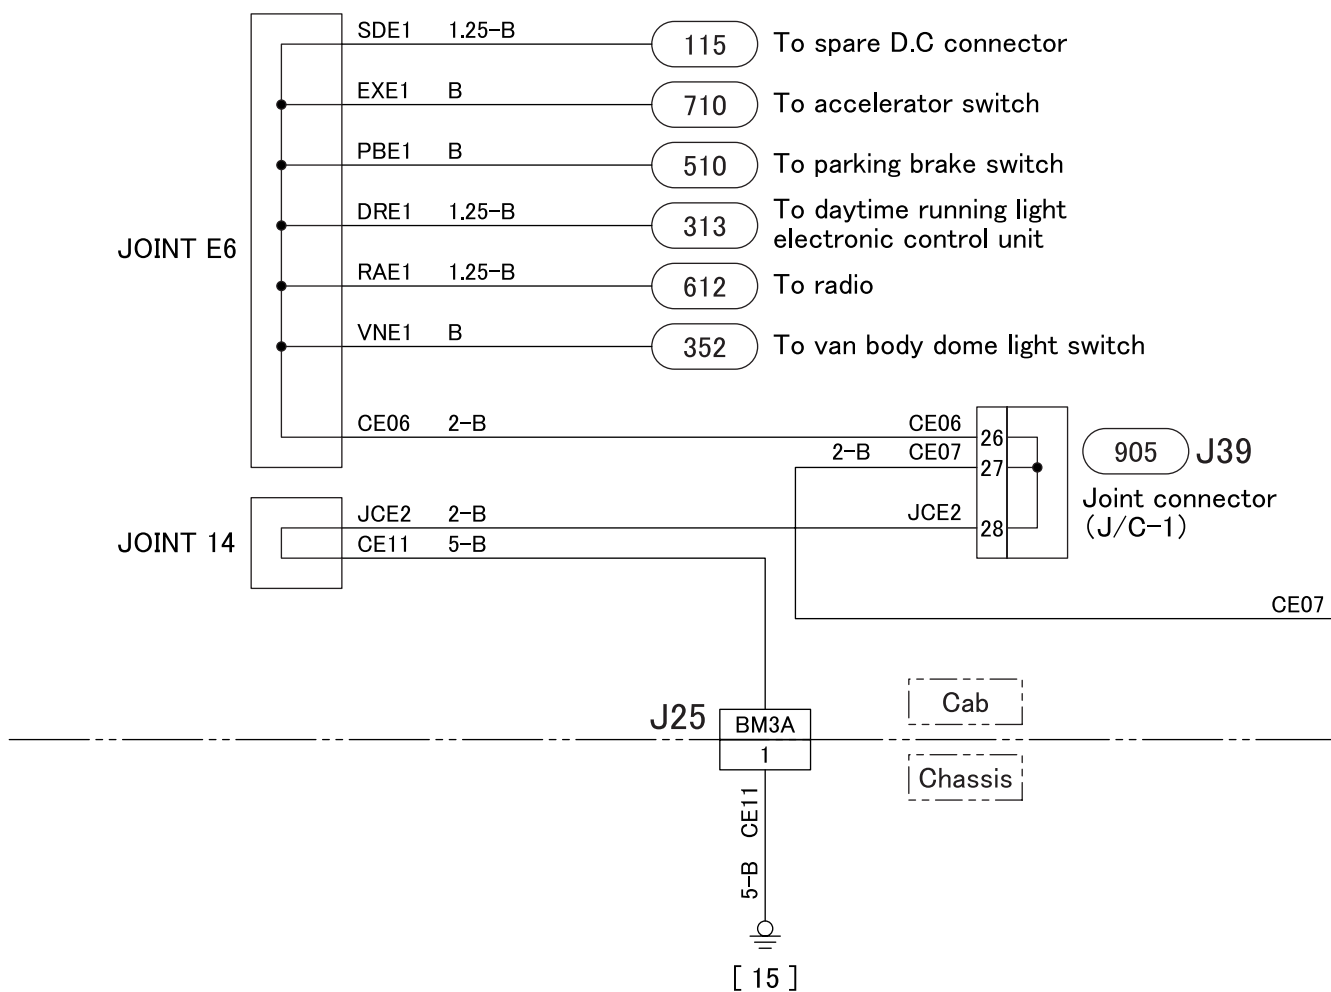
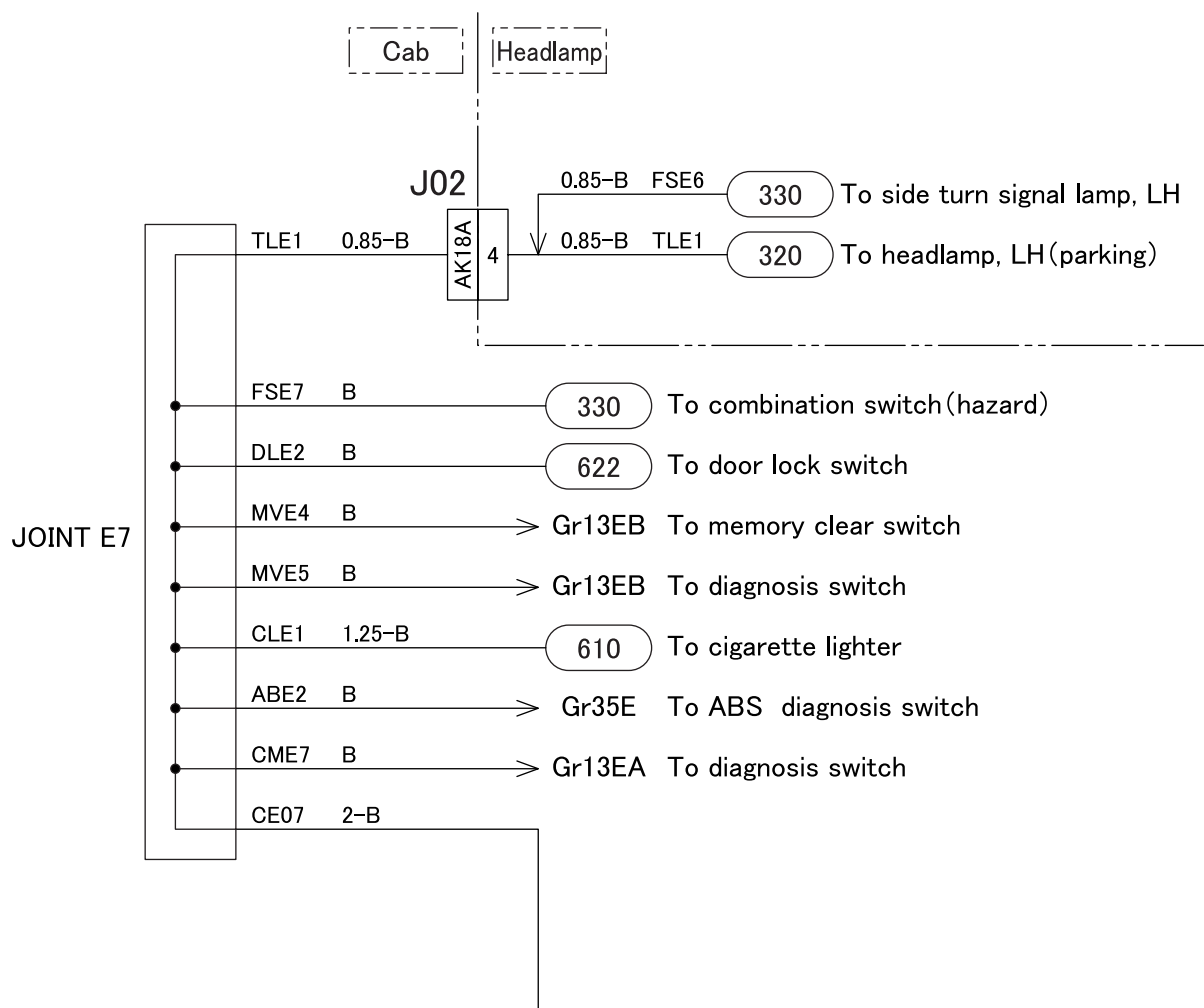
<JOINT E6, JOINT E7>

Circuit No. CE11 chassis ground

<Circuit No. JCE2>

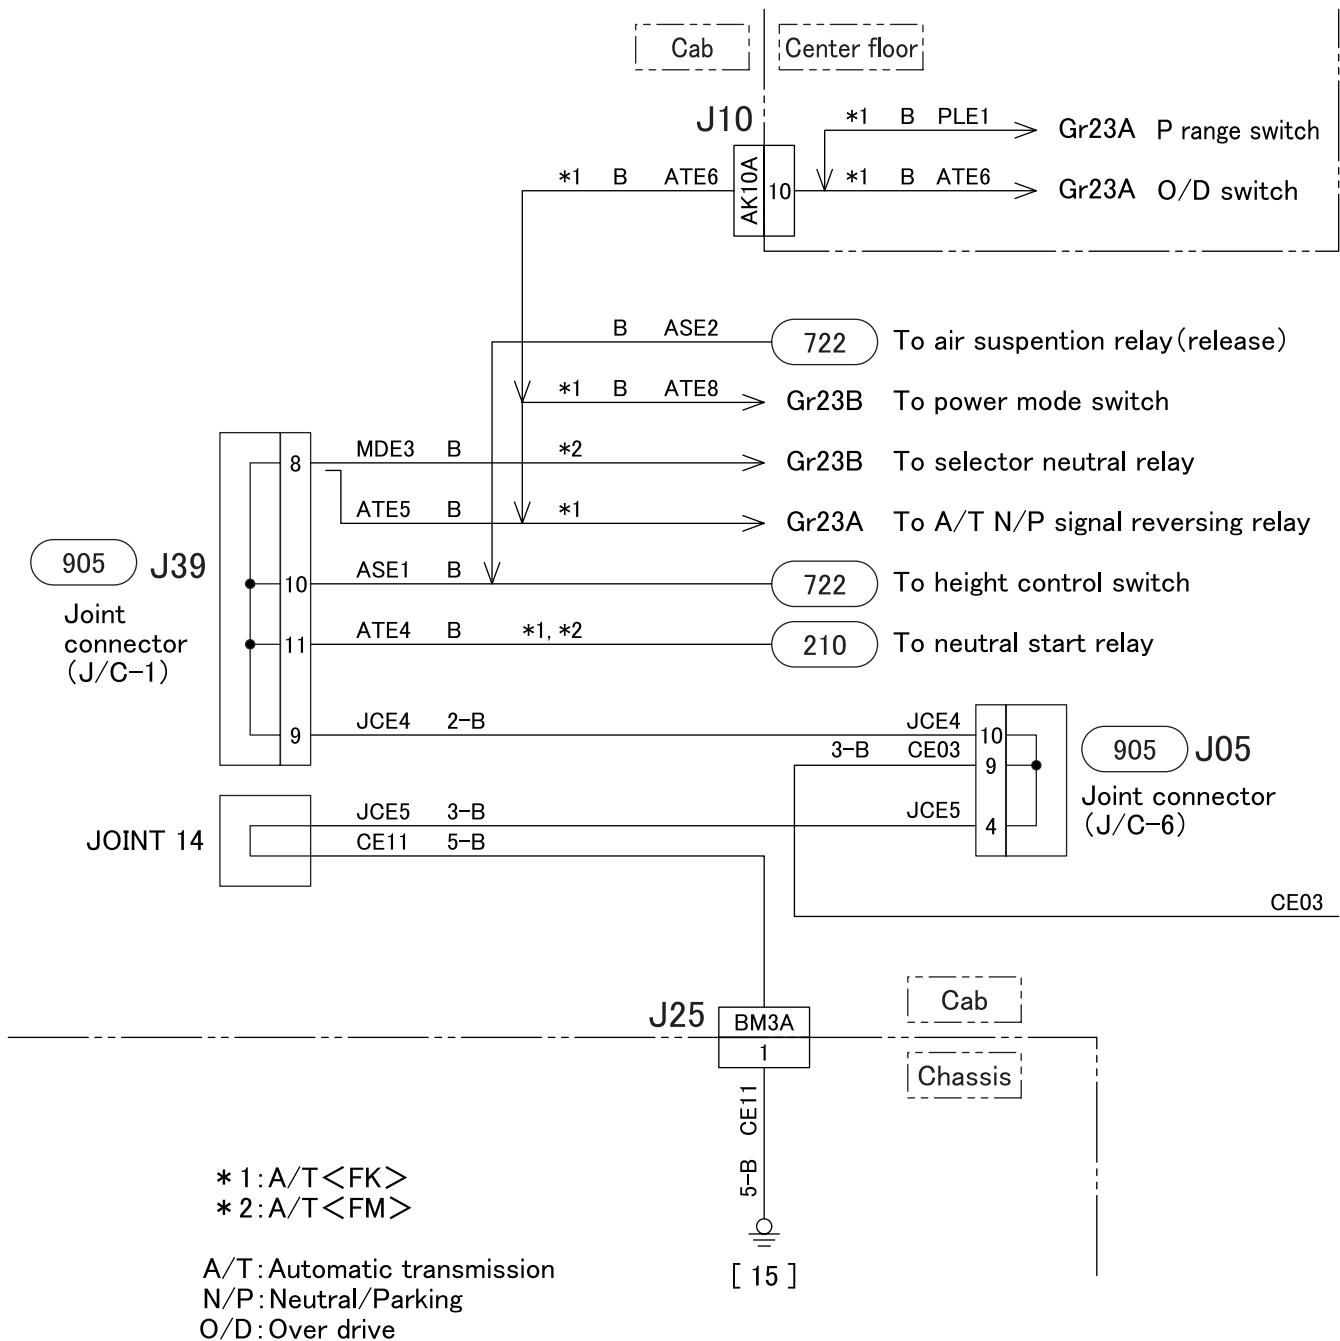
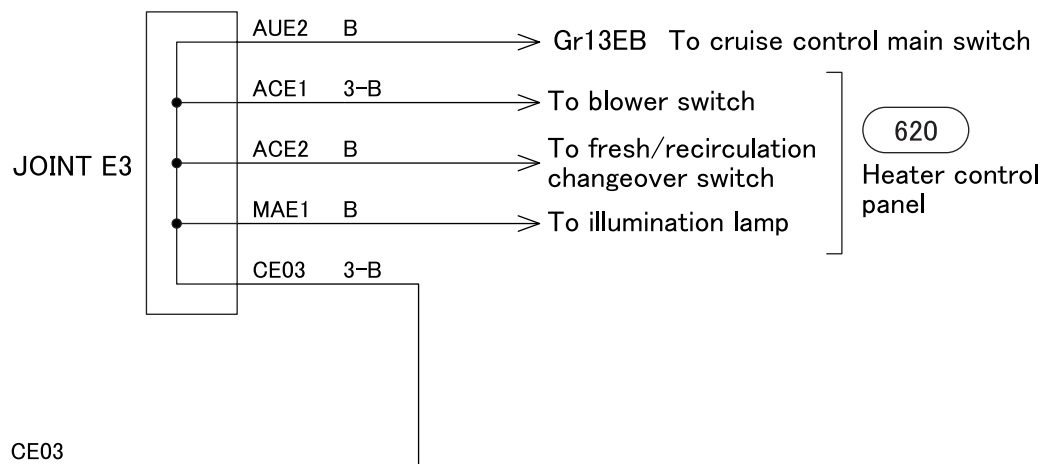
<JOINT E3>

Circuit No. CE11 chassis ground

<Circuit No. JCE5>

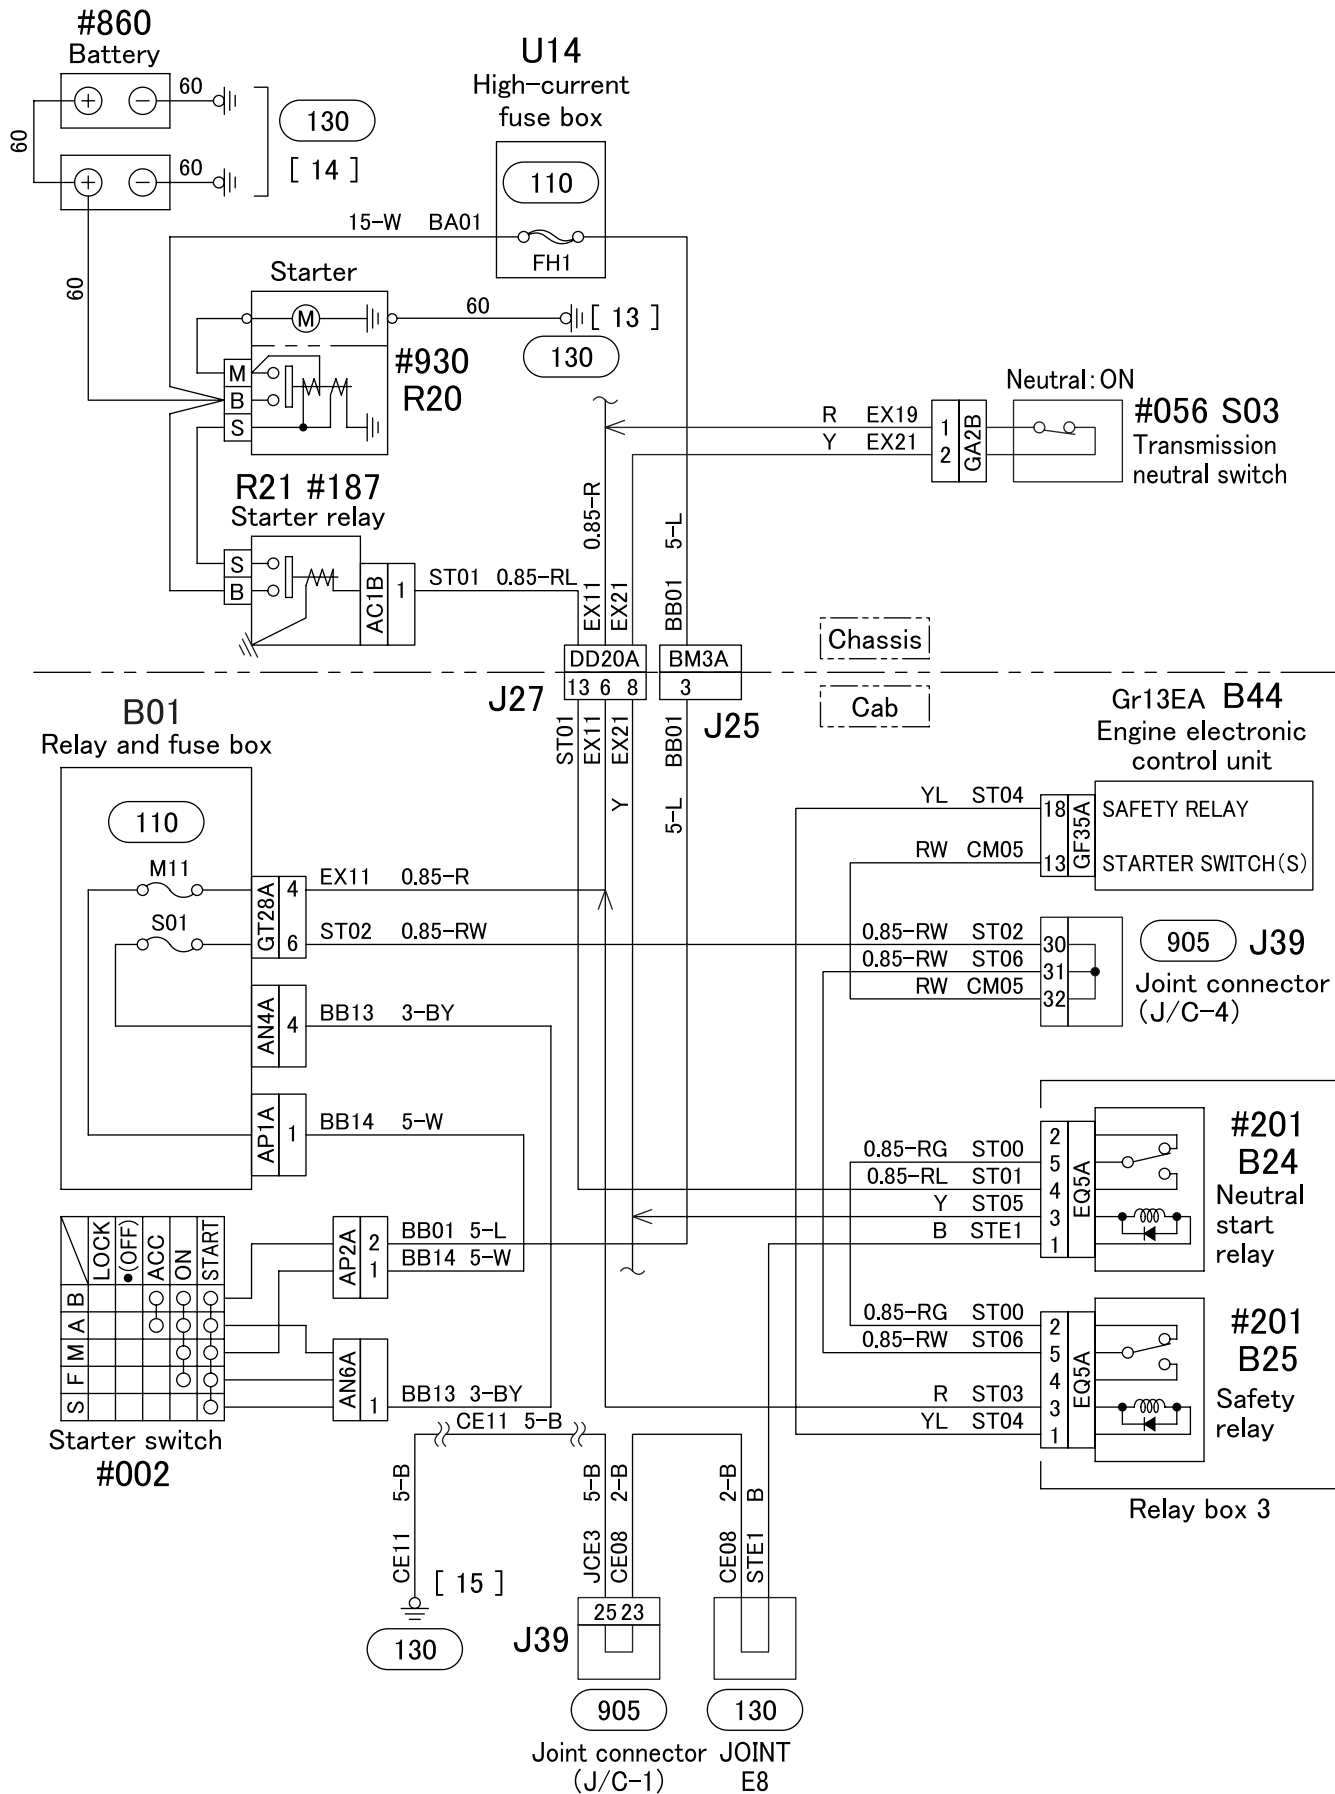
<Manual transmission>

## 210 ENGINE STARTING CIRCUIT

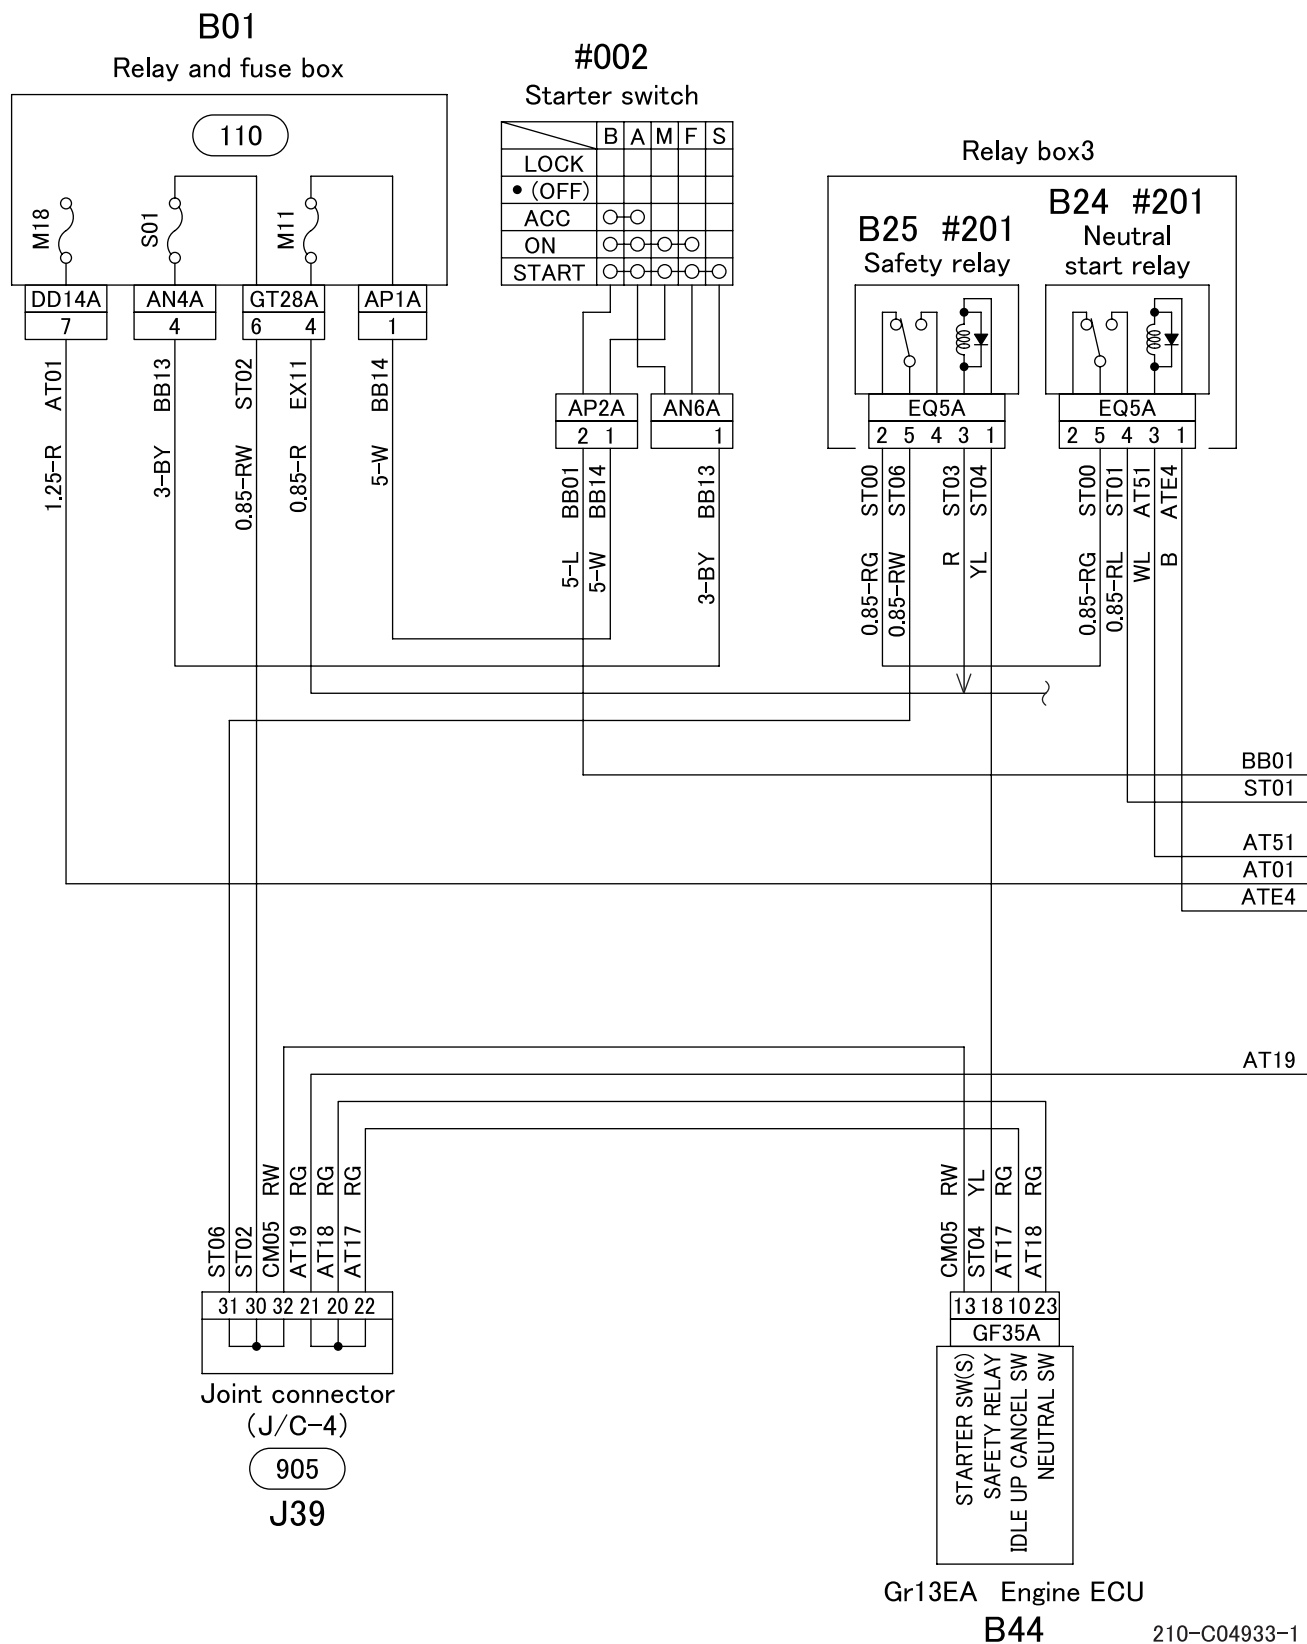
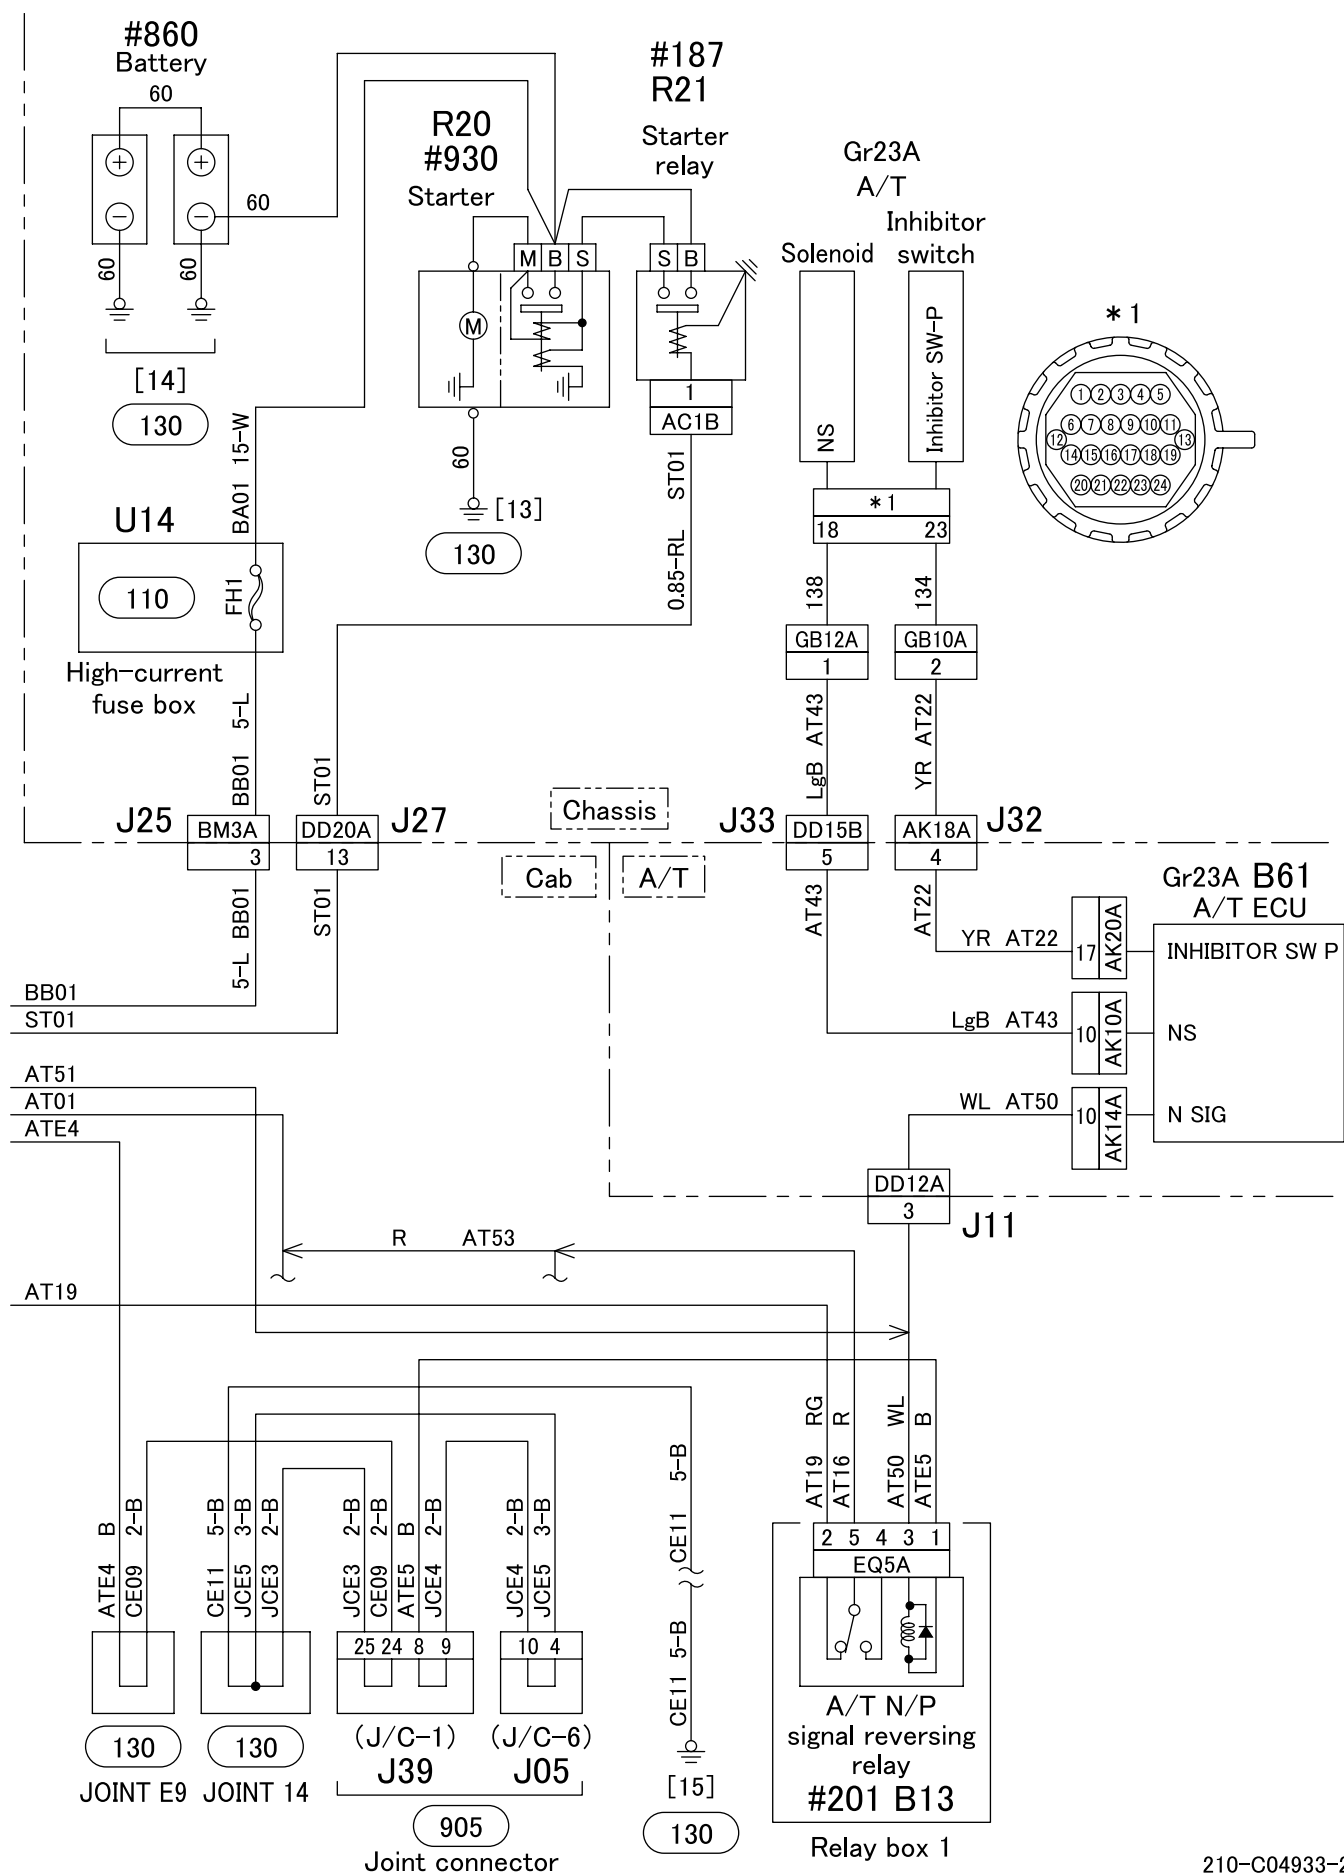
<Automatic transmission (FK)>

# 210 ENGINE STARTING CIRCUIT

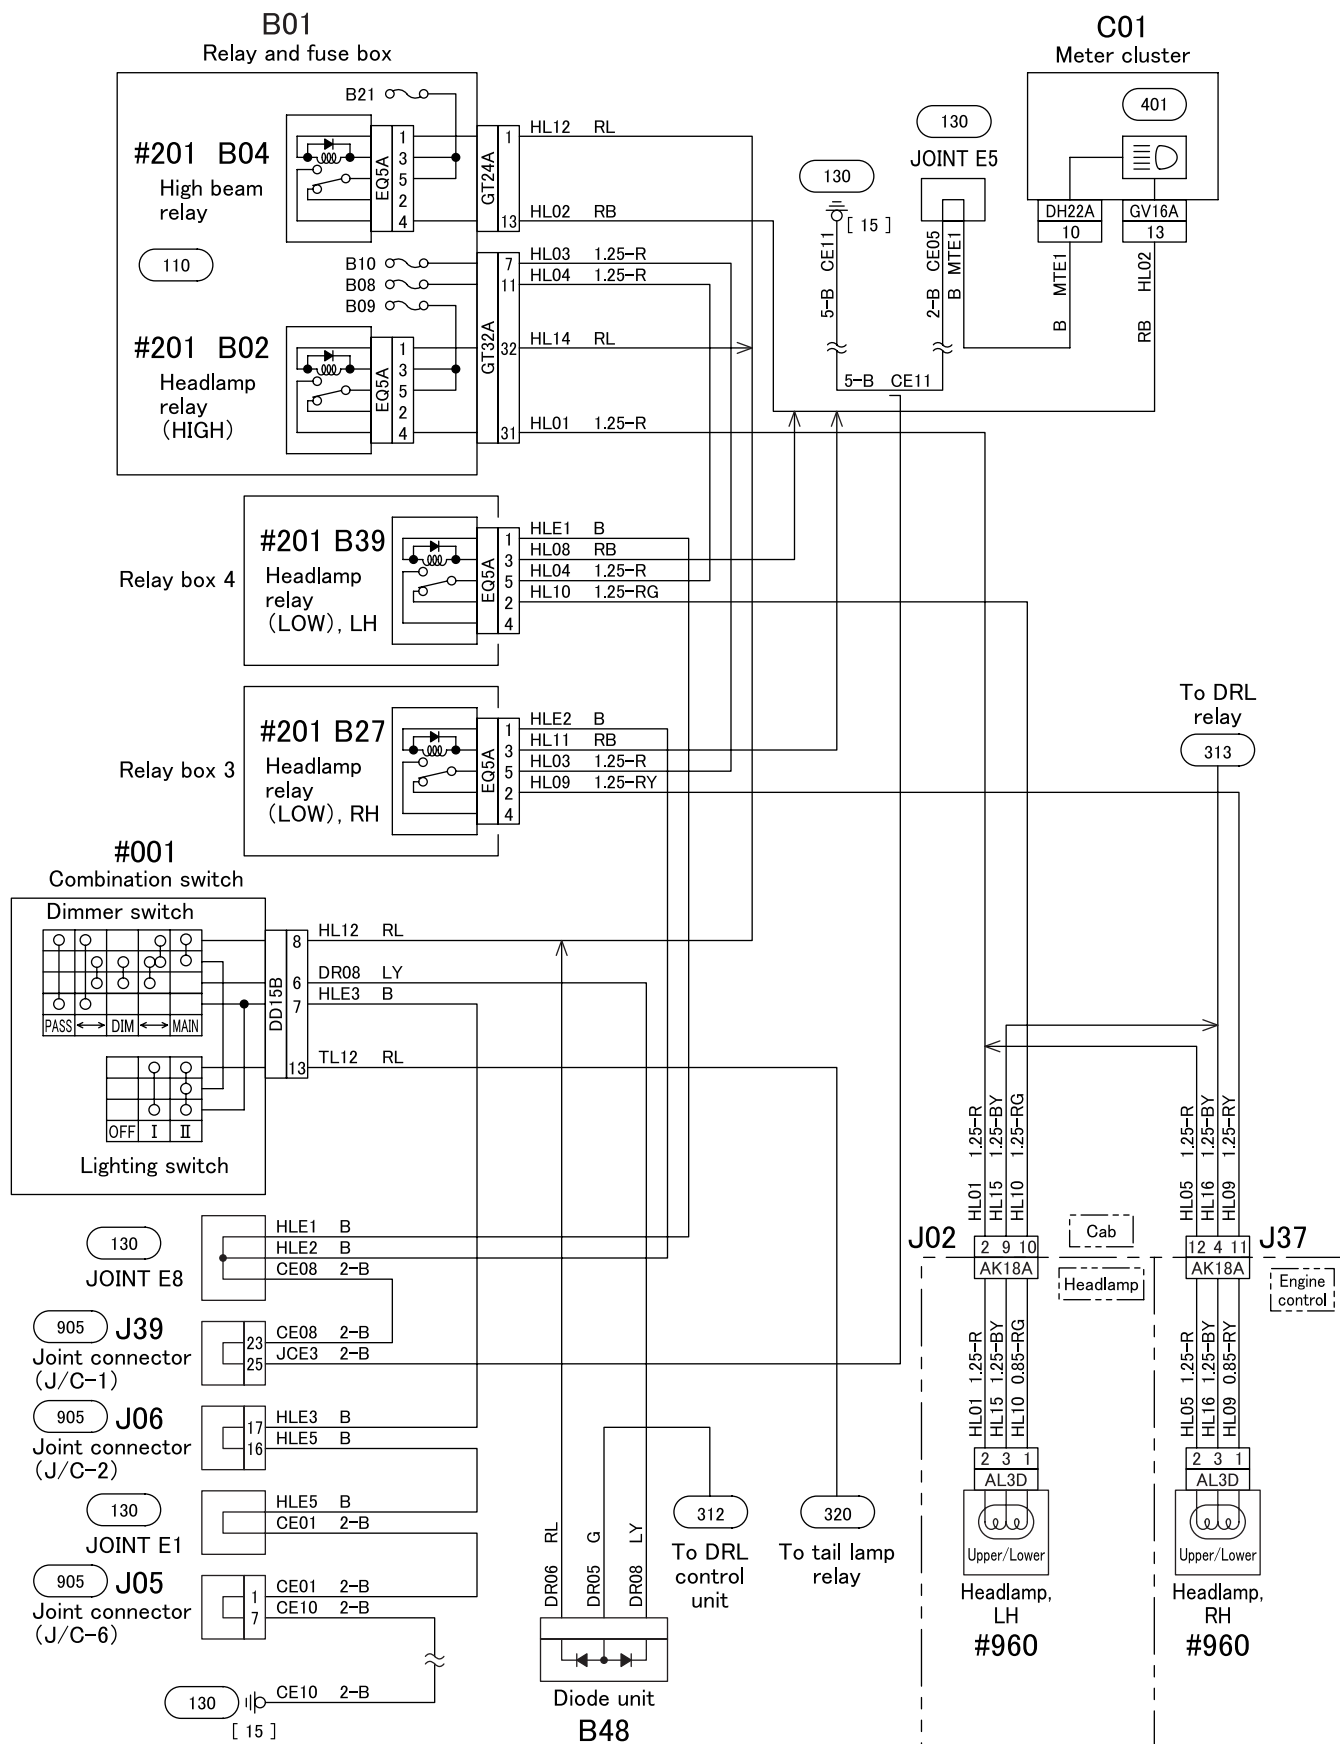
# 310 HEADLAMP CIRCUIT

DRL : Daytime running light

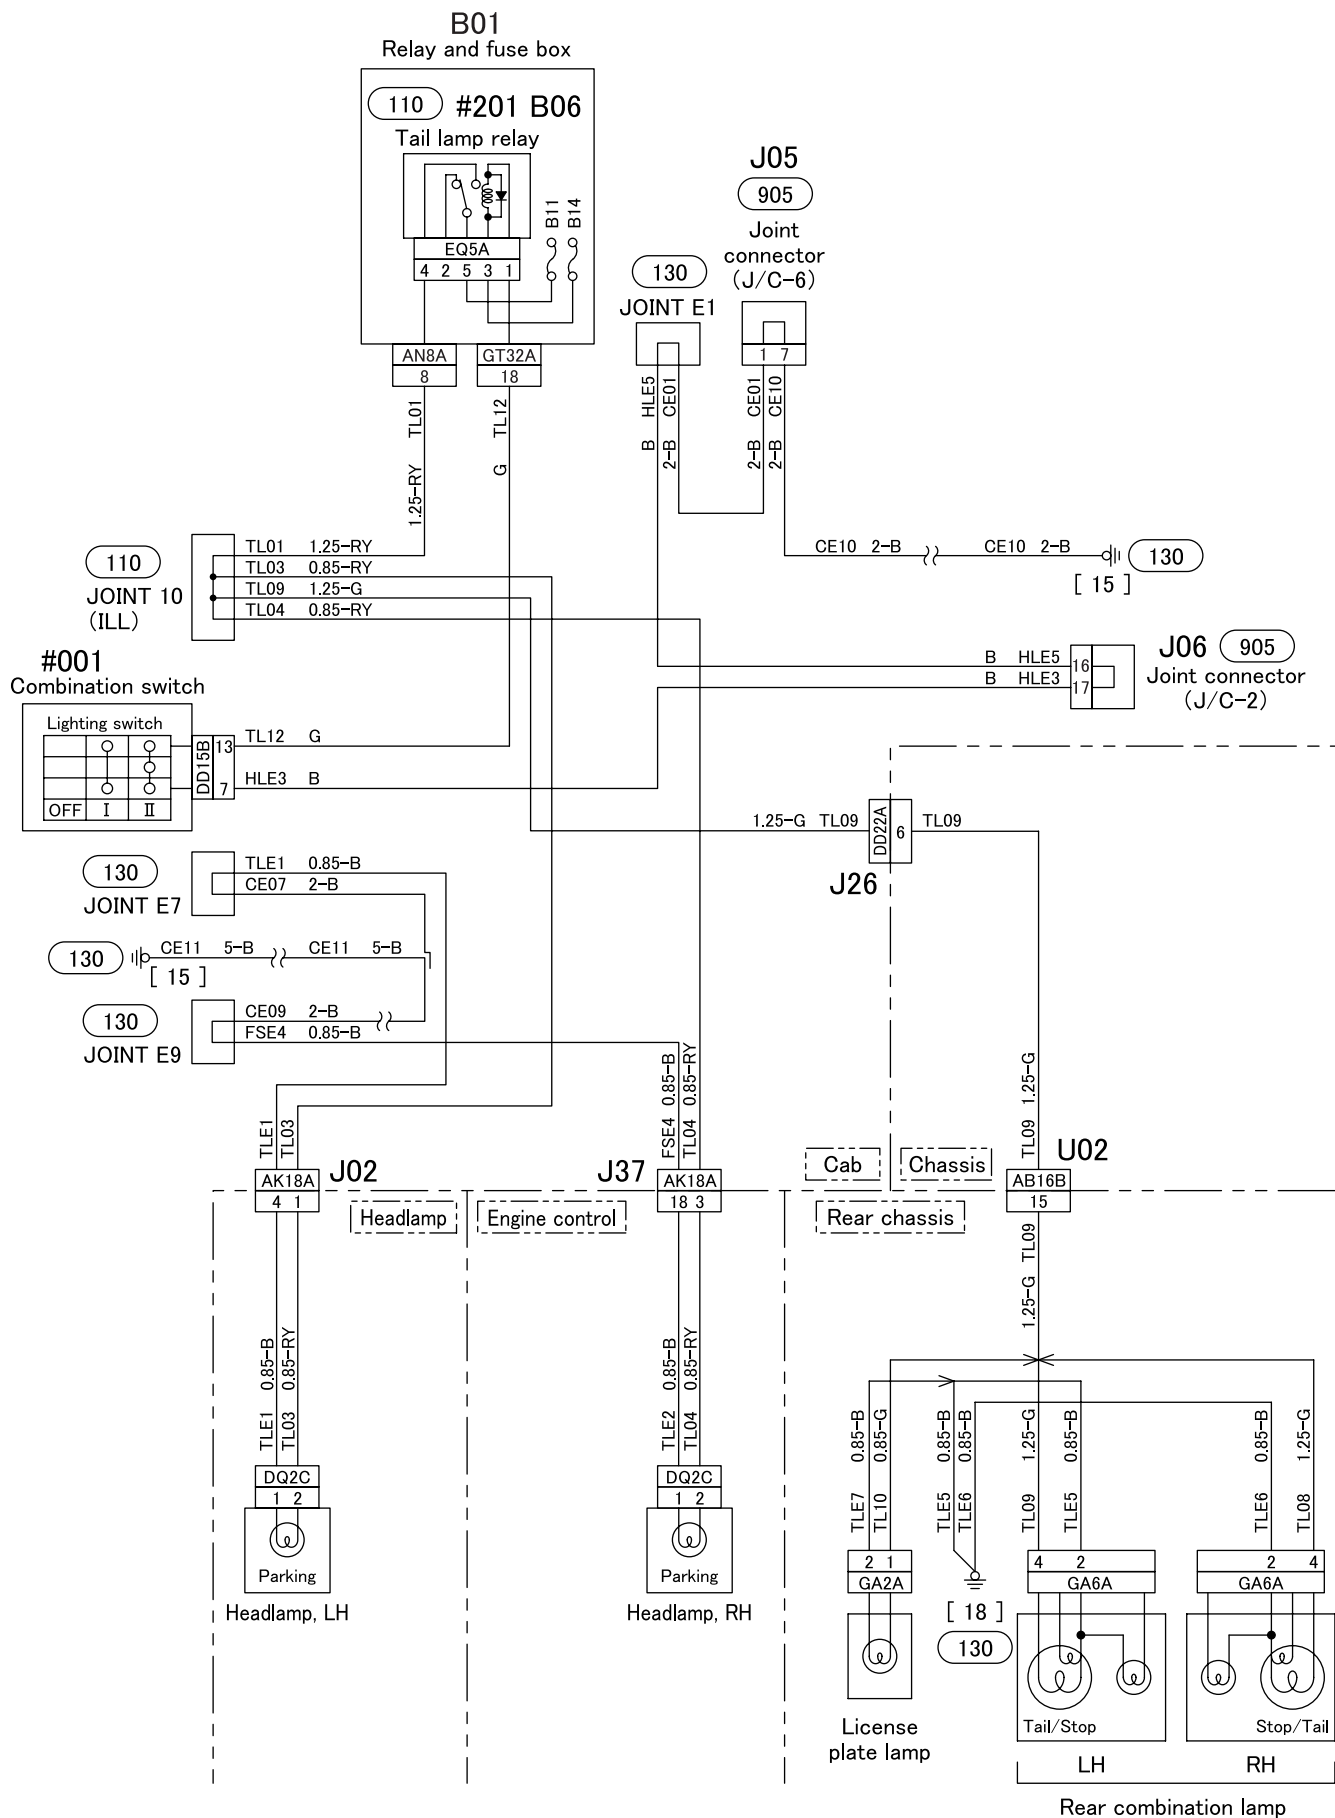
# 320 TAIL, CLEARANCE AND LICENSE PLATE LAMPS CIRCUIT

The diagram illustrates the electrical system of a vehicle, showing the following components and their connections:

- Rear combination lamp, LH:** Includes Tail/Stop and Turn lamps. Connected to TLE5 (0.85-B), FS27 (0.85-GY), and TLE6 (0.85-B).
- Rear combination lamp, RH:** Includes Turn and Stop/Tail lamps. Connected to FS08 (0.85-GB), TLE6 (0.85-B), and TLE5 (0.85-B).

Wire colors and terminal numbers are indicated throughout the diagram. The diagram is divided into sections by dashed lines, representing different parts of the vehicle's electrical system.

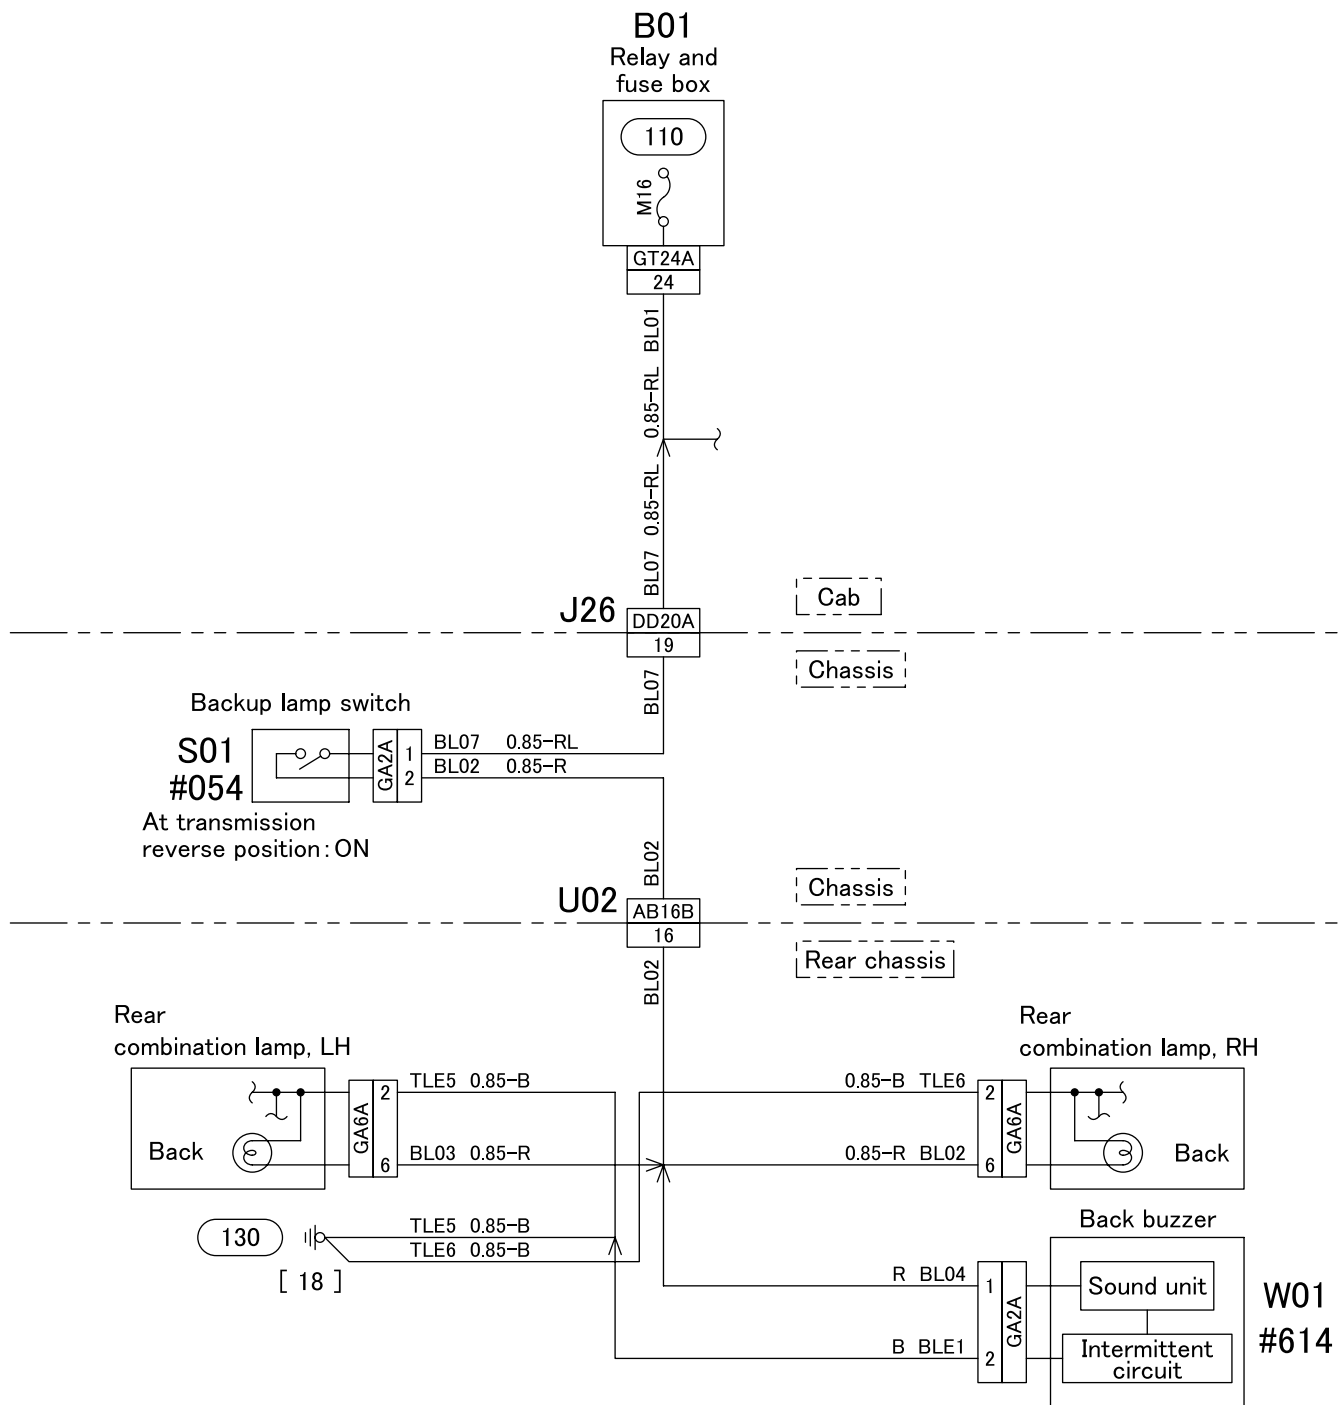
# 340 BACKUP LAMP CIRCUIT

<Manual transmission>

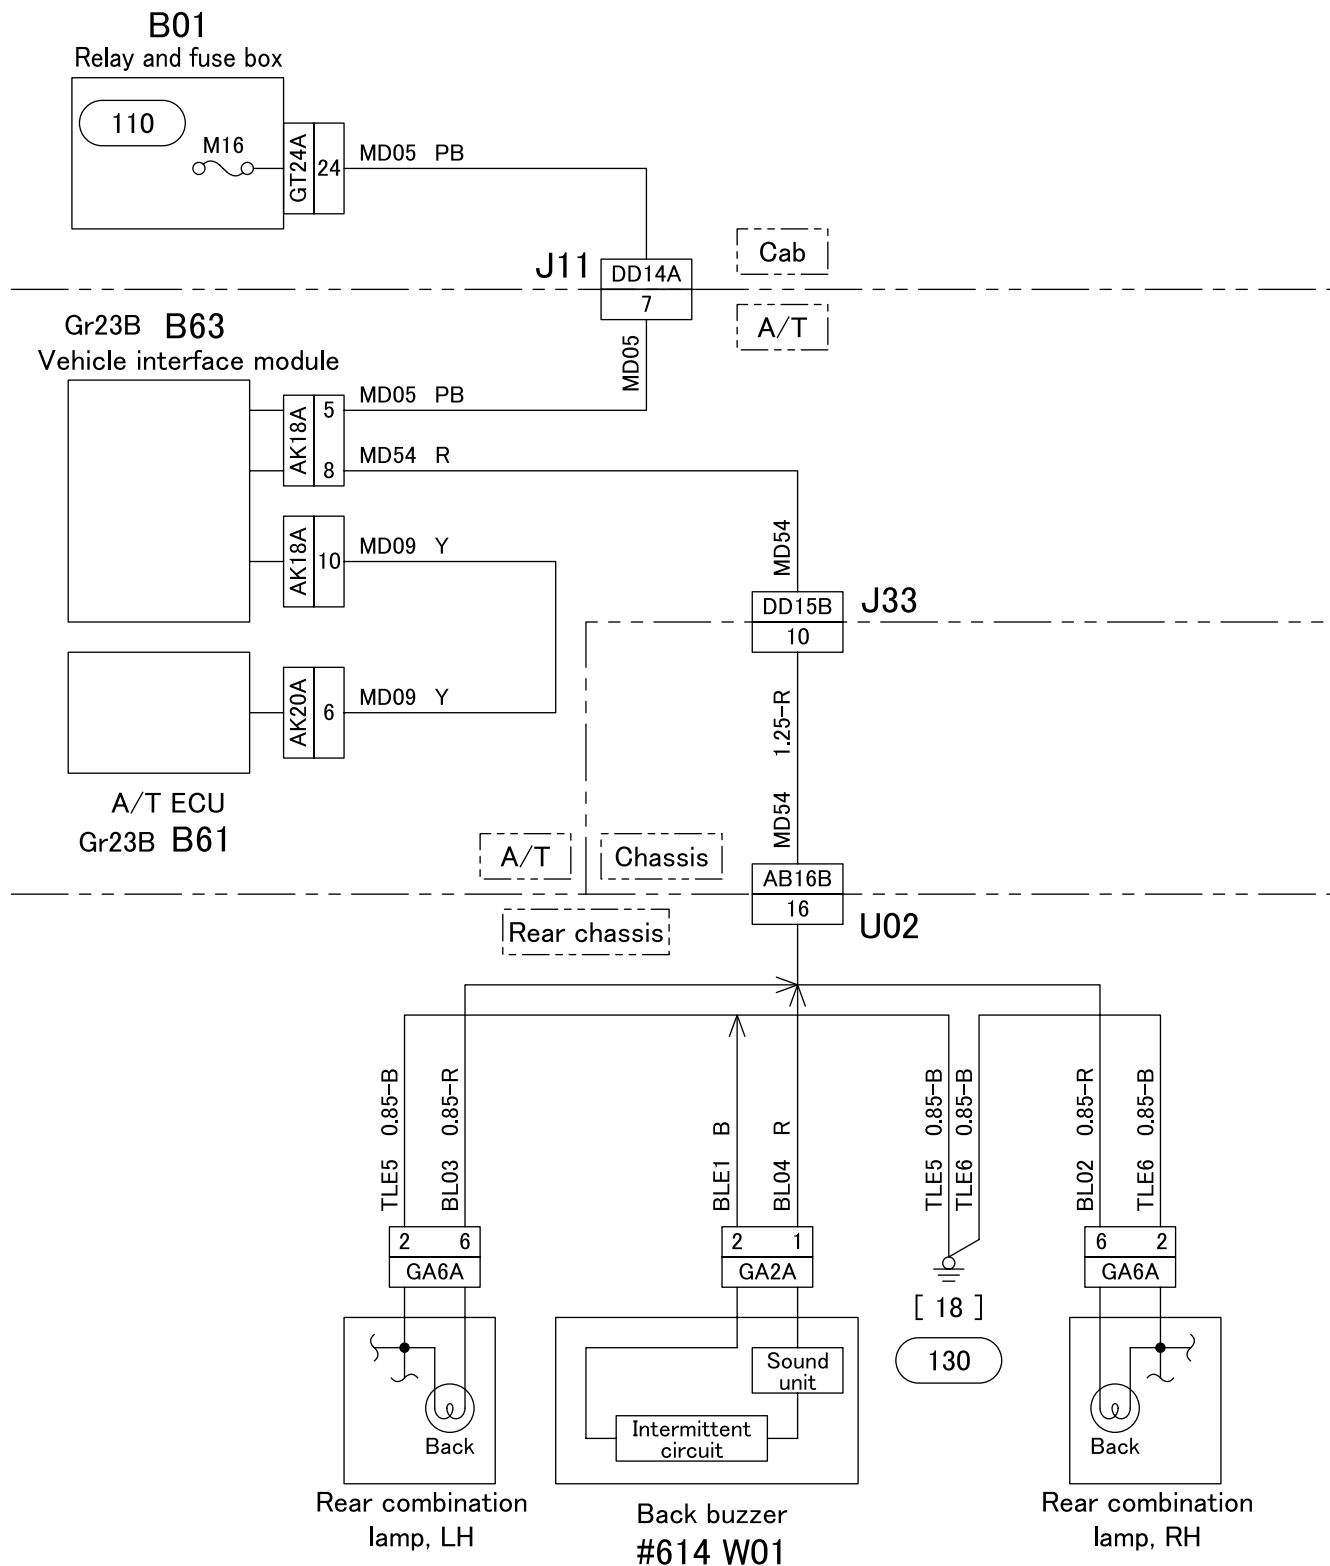
# 340 BACKUP LAMP CIRCUIT

<Automatic transmission (FM) >

A/T:Automatic transmission  
ECU:Electronic control unit
