# FE.FG

## SERVICE MANUAL 2008 Model FOREWORD

This Service Manual contains maintenance and repair methods for the Mitsubishi Fuso Truck FE. FG Series. Read this manual carefully as an aid in providing correct, efficient maintenance. Please note that the information and specifications contained within this manual may change without notice. This is due to product modifications and continued vehicle improvements that are made throughout the model years. Should you encounter any discrepancy in the information provided, please do not hesitate to contact your nearest Mitsubishi Fuso Dealer or Mitsubishi Fuso Truck of America, Inc.

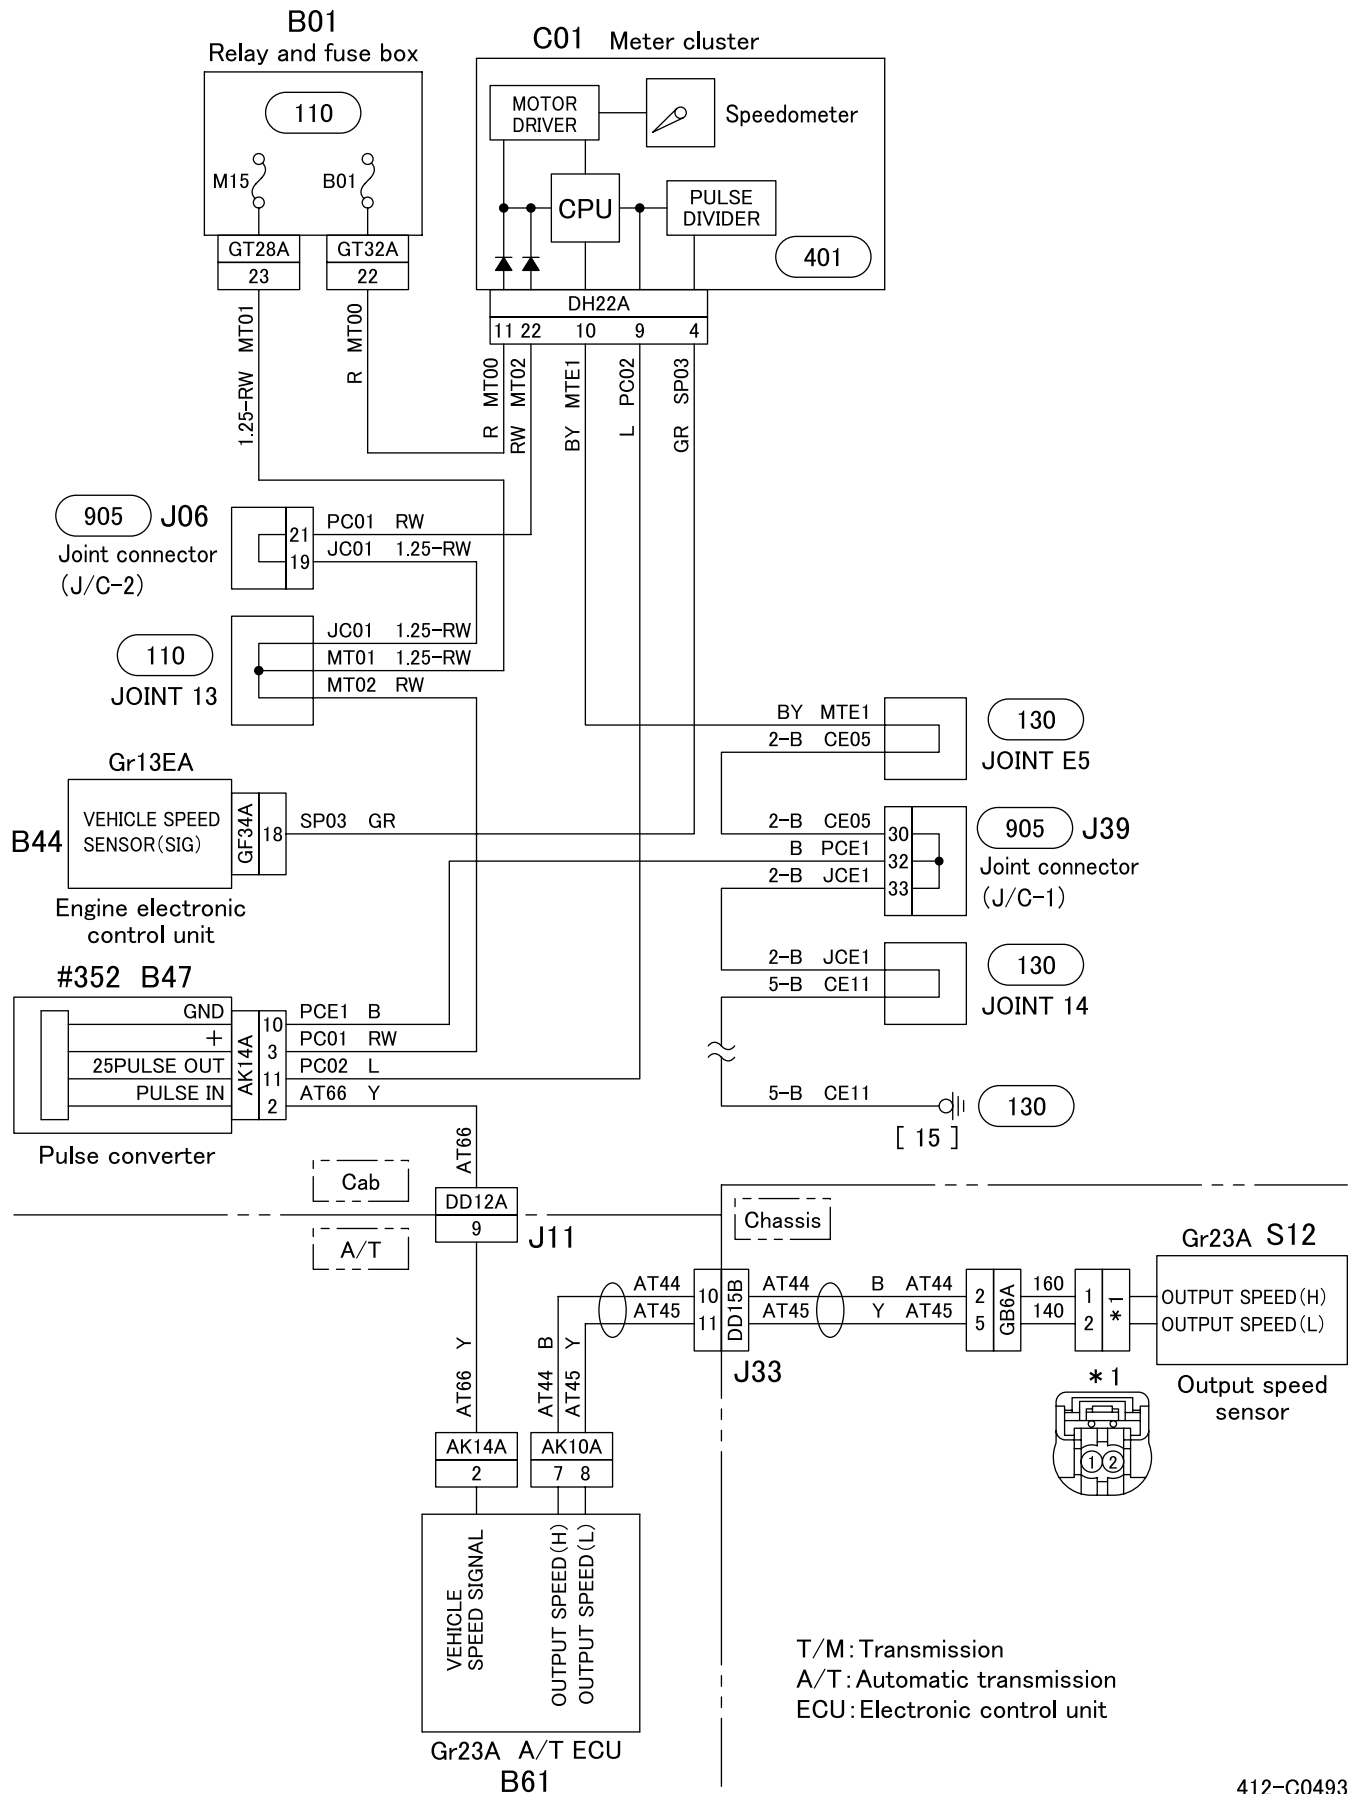
# 412 SPEEDOMETER CIRCUIT

<Automatic transmission (FK)>

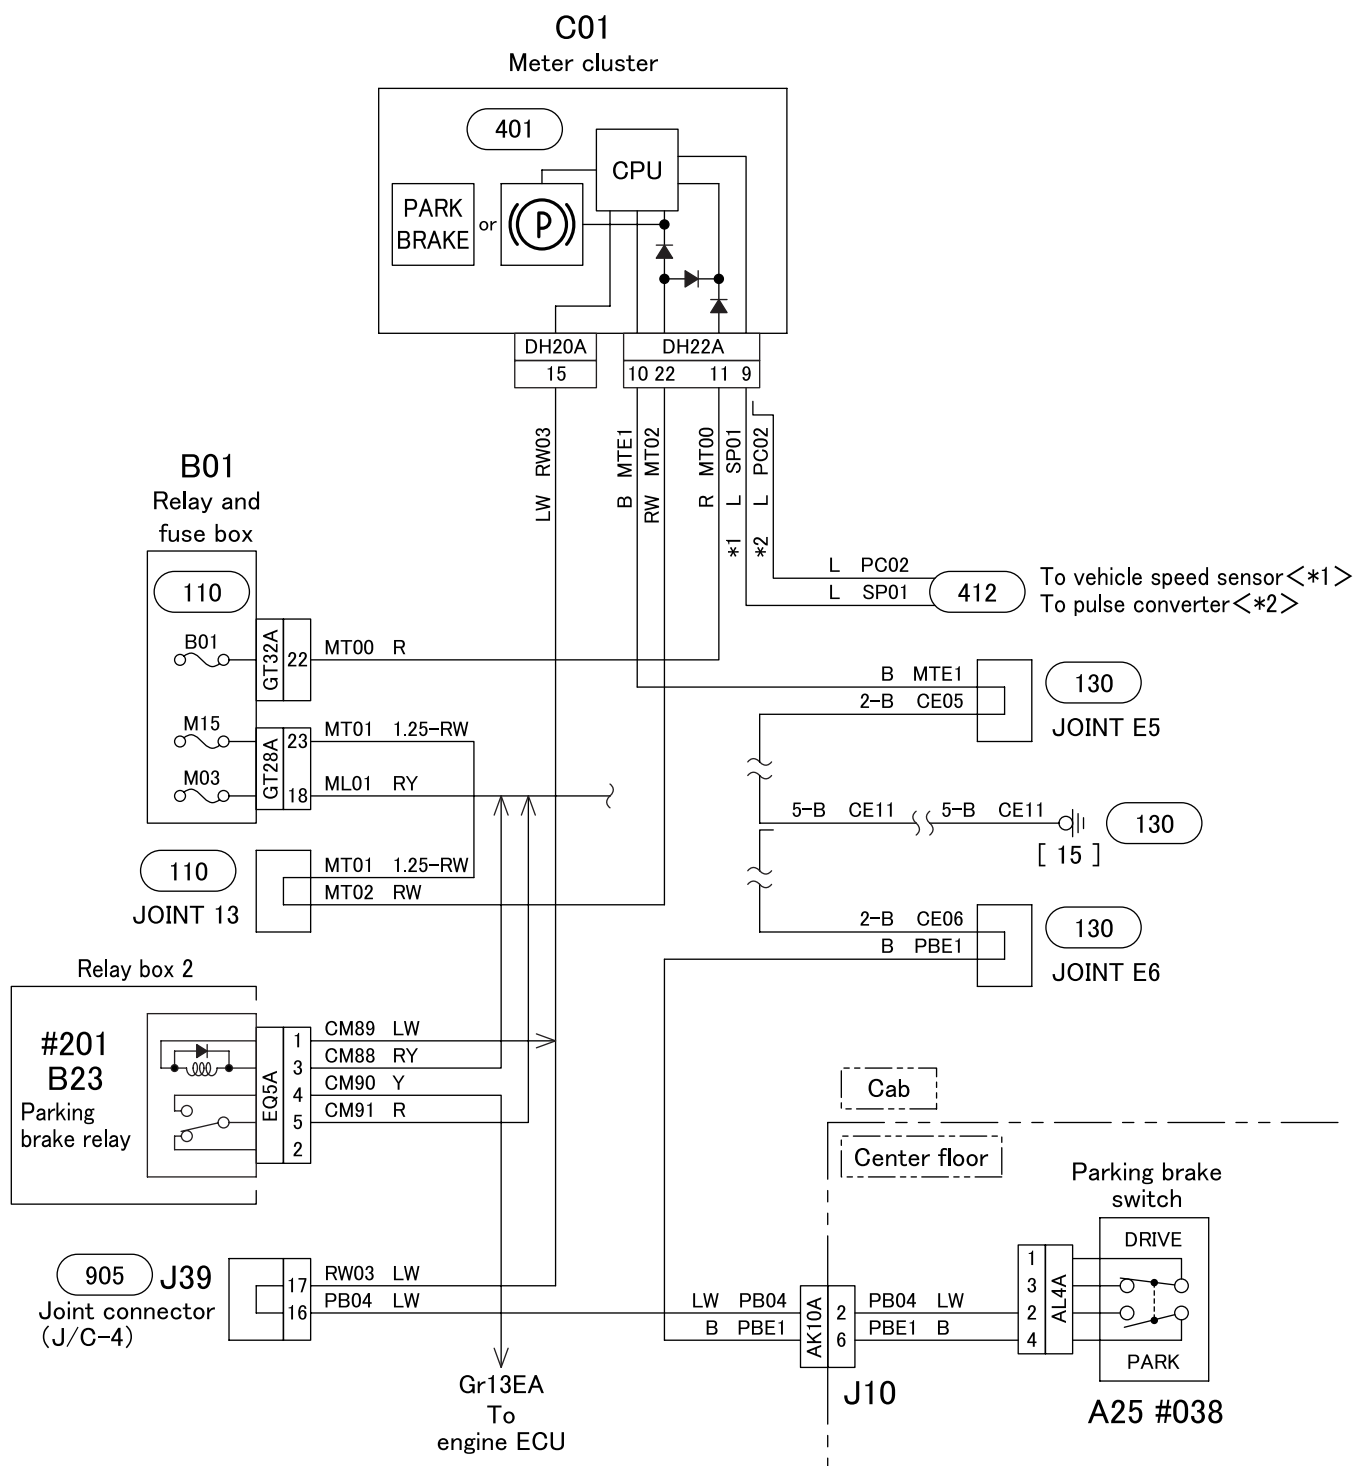
# 510 PARKING BRAKE INDICATOR CIRCUIT

<Center parking brake>

\* 1: Manual transmission  
\* 2: Automatic transmission

ECU: Electronic control unit

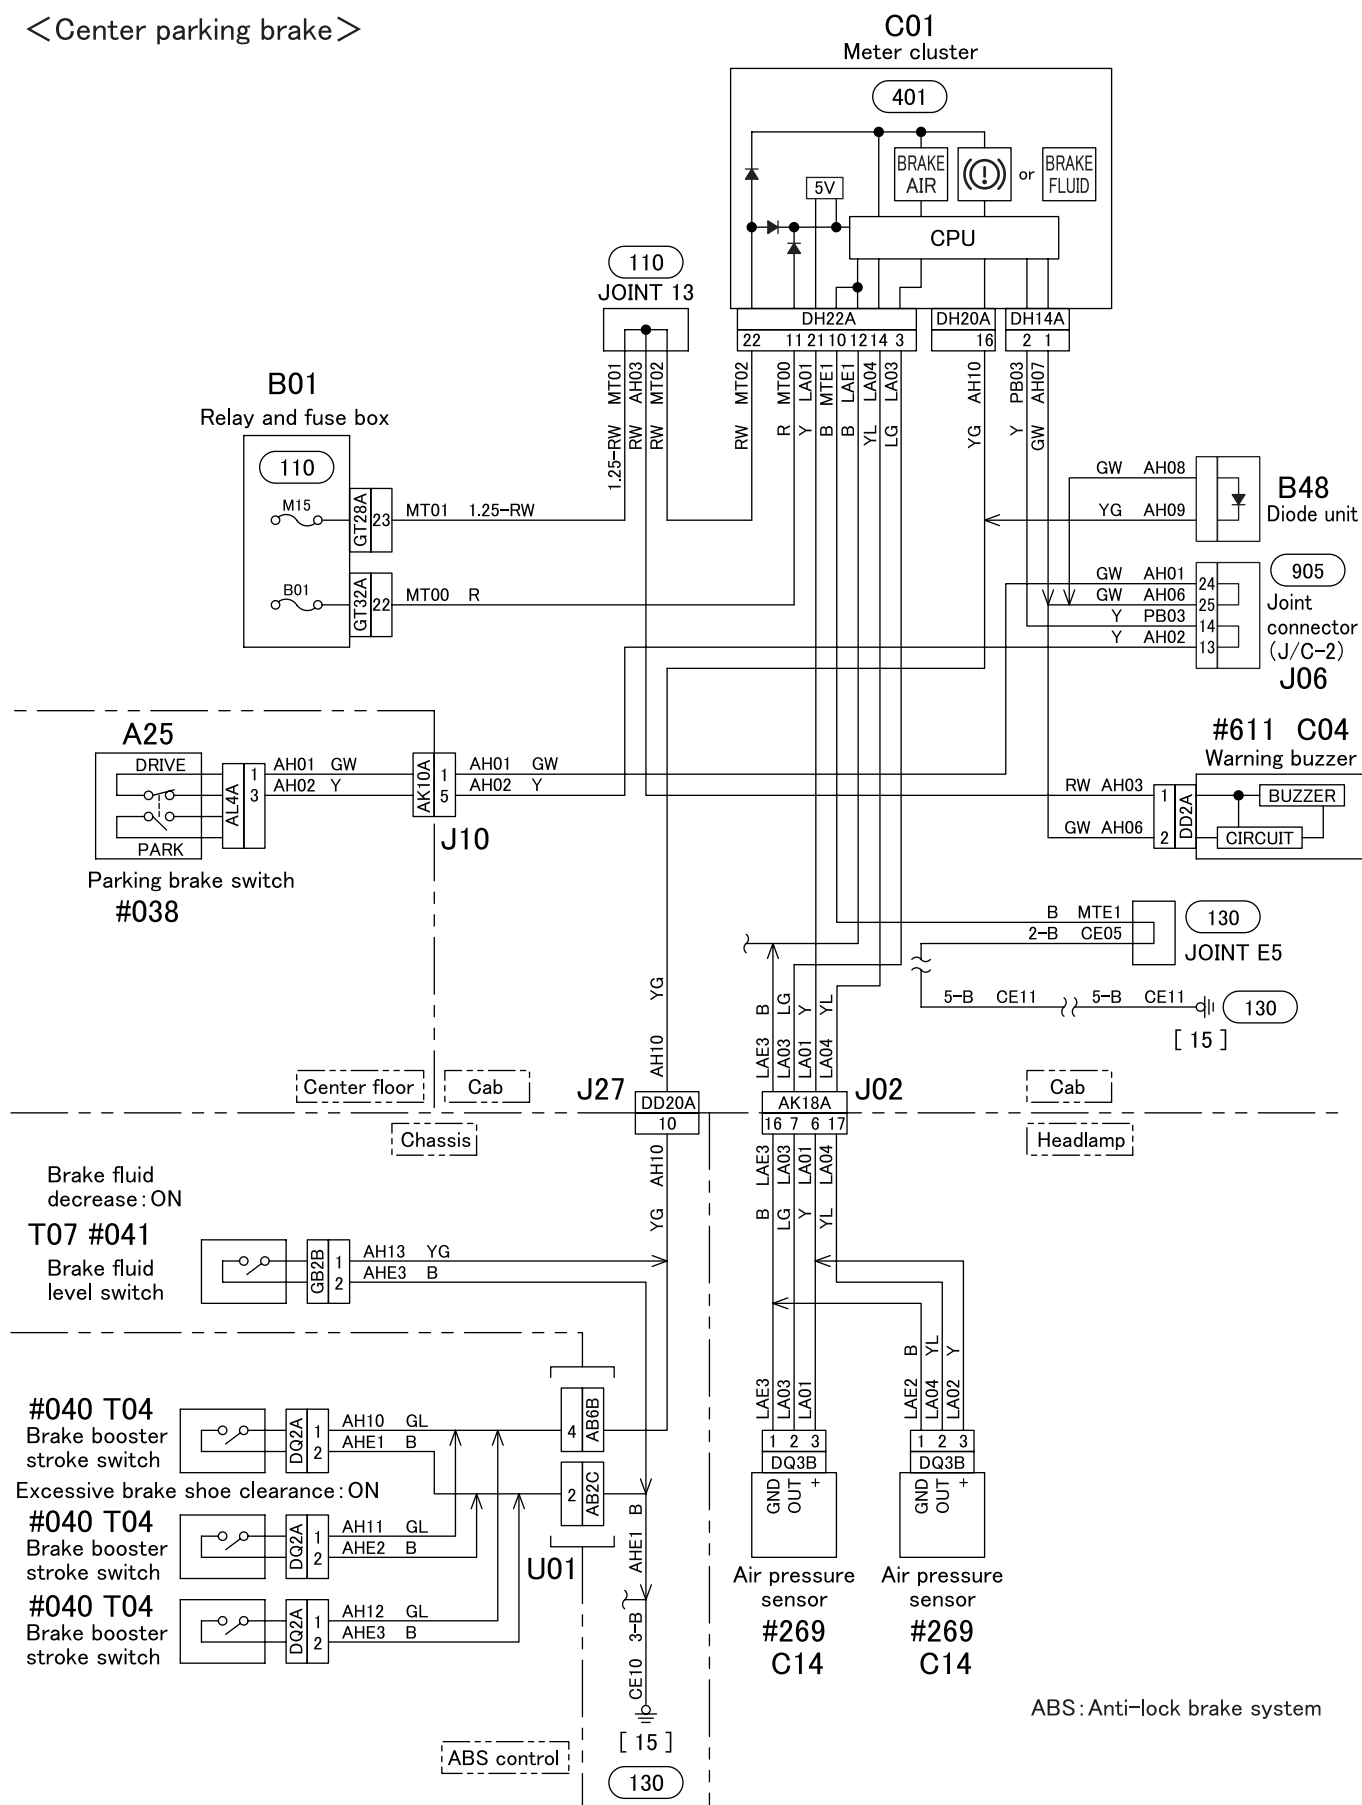
## 515 BRAKE WARNING CIRCUIT

<Center parking brake>

ABS : Anti-lock brake system

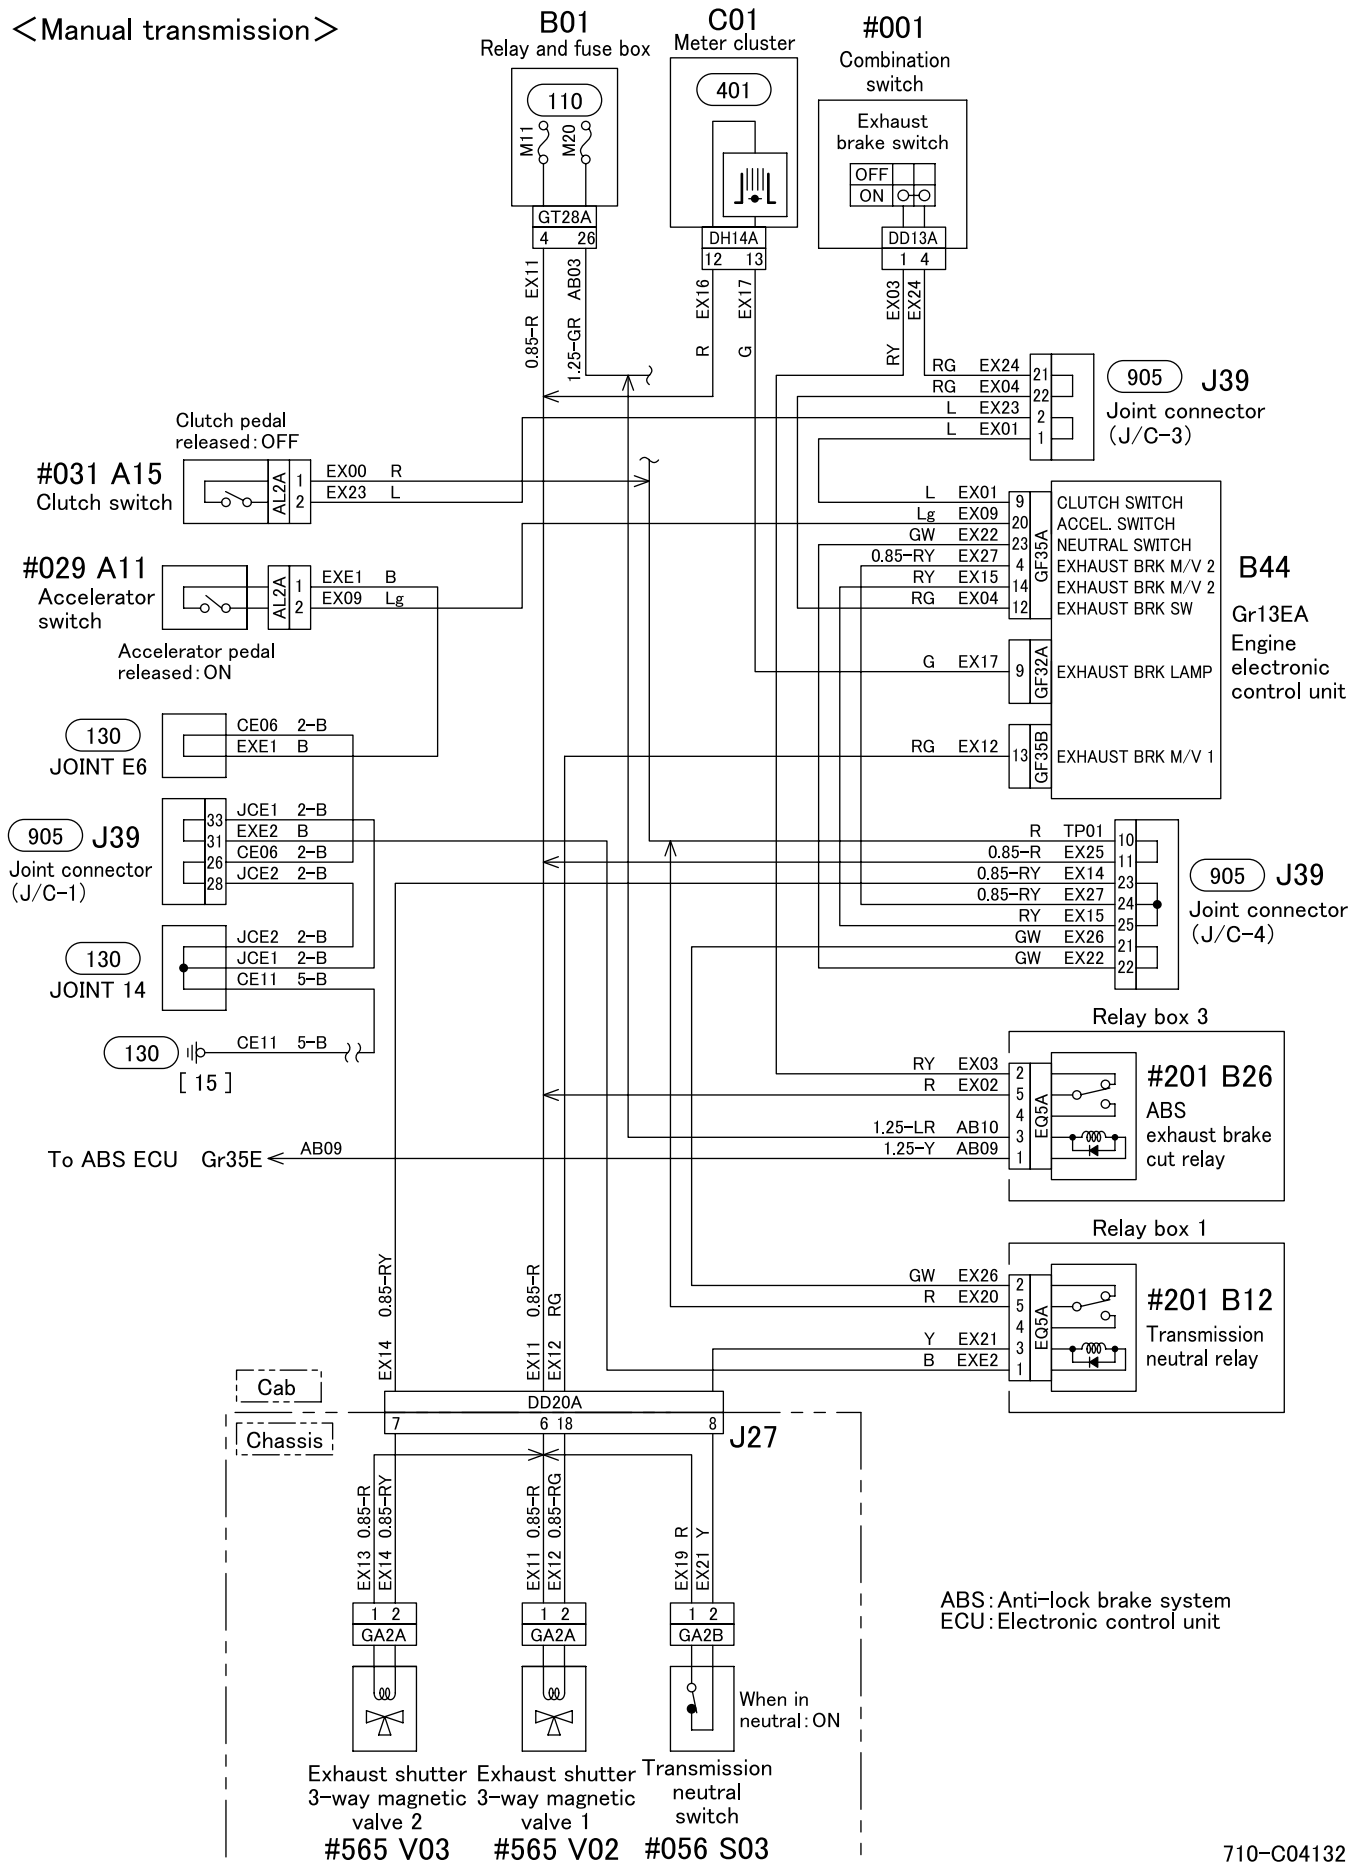
# 710 EXHAUST BRAKE CIRCUIT

<Manual transmission>

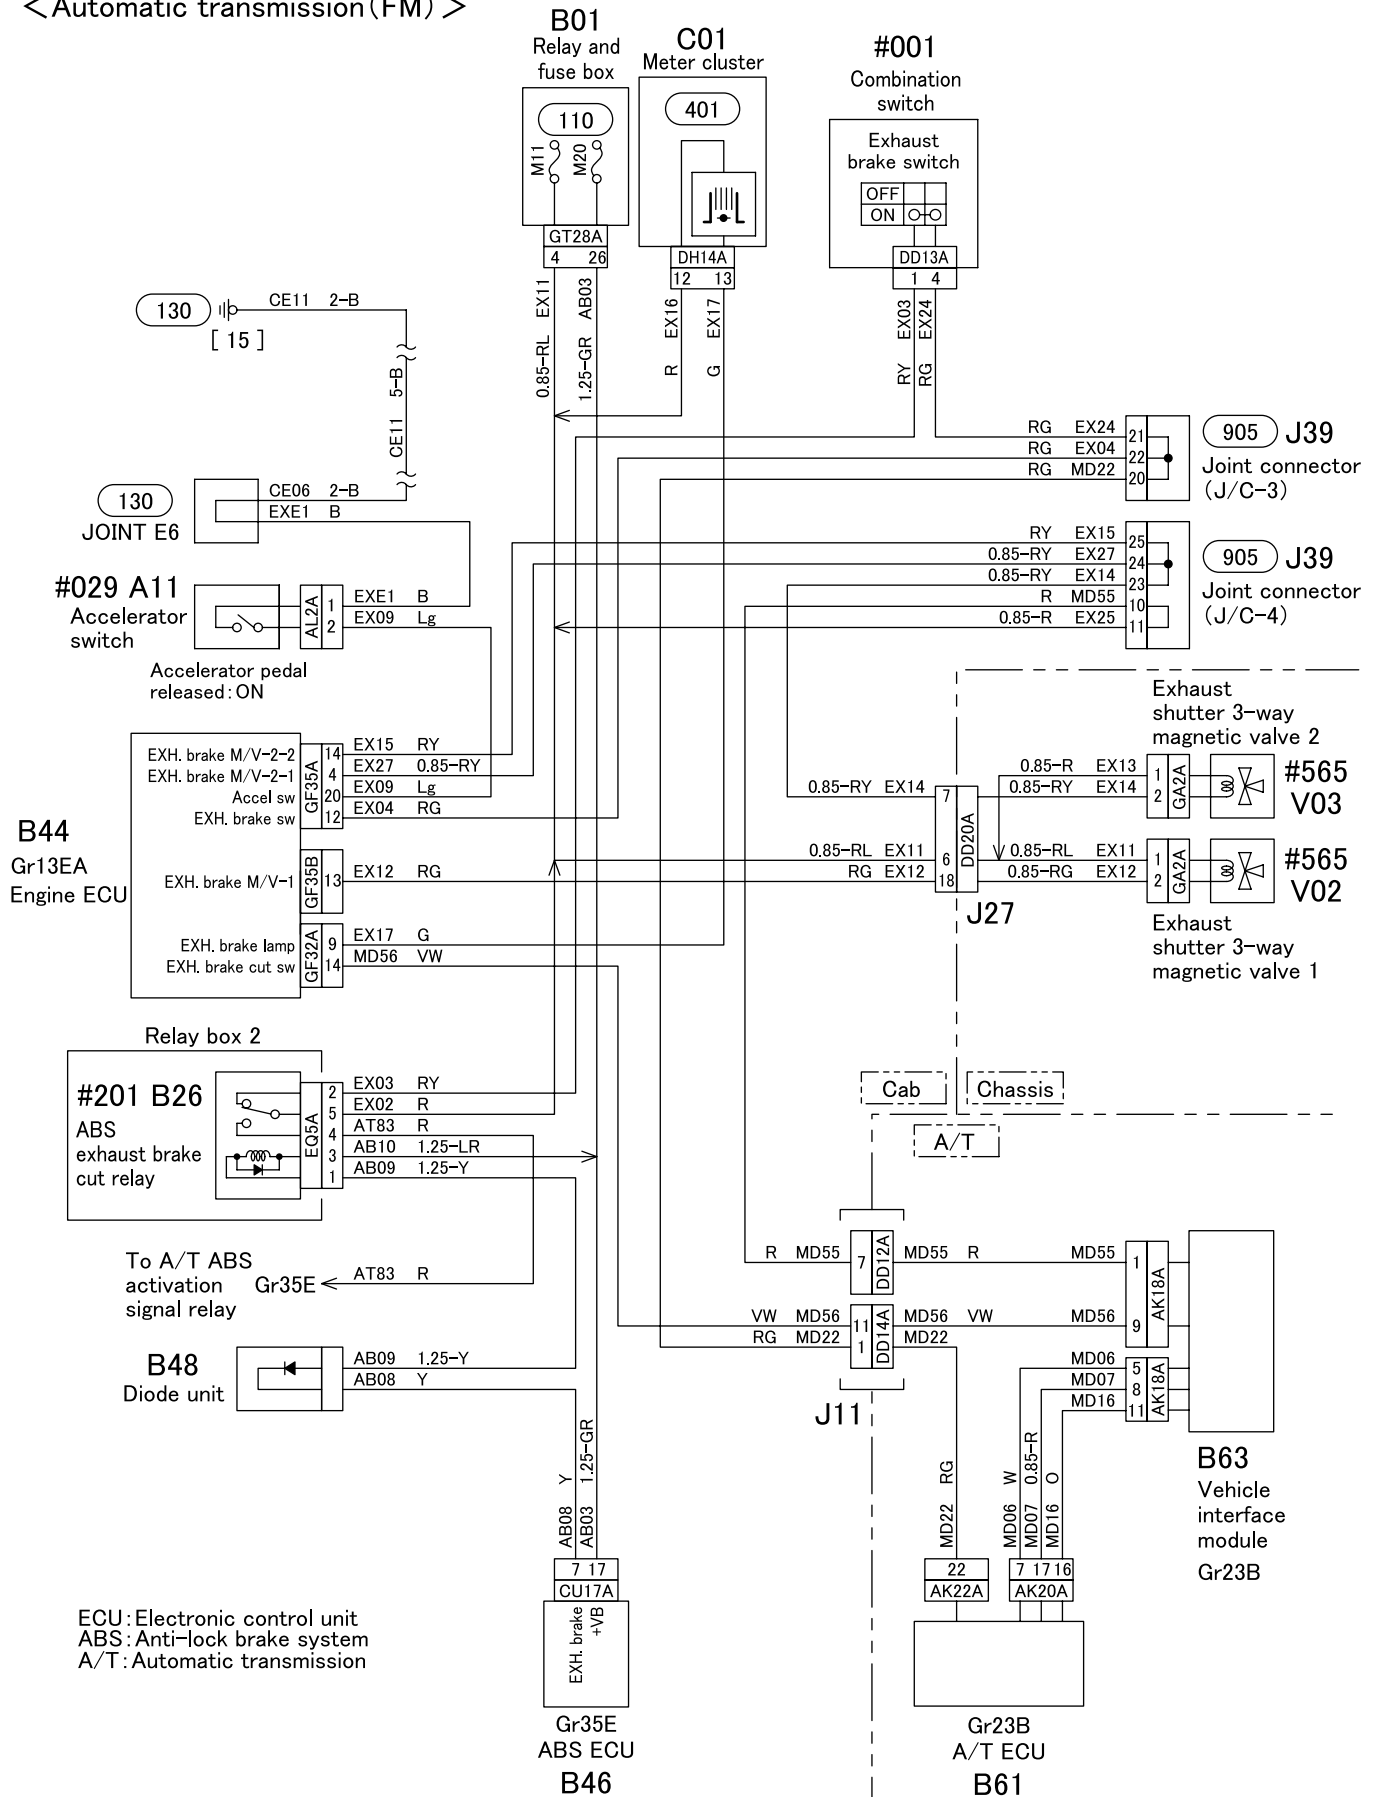
# 710 EXHAUST BRAKE CIRCUIT

<Automatic transmission (FM)>

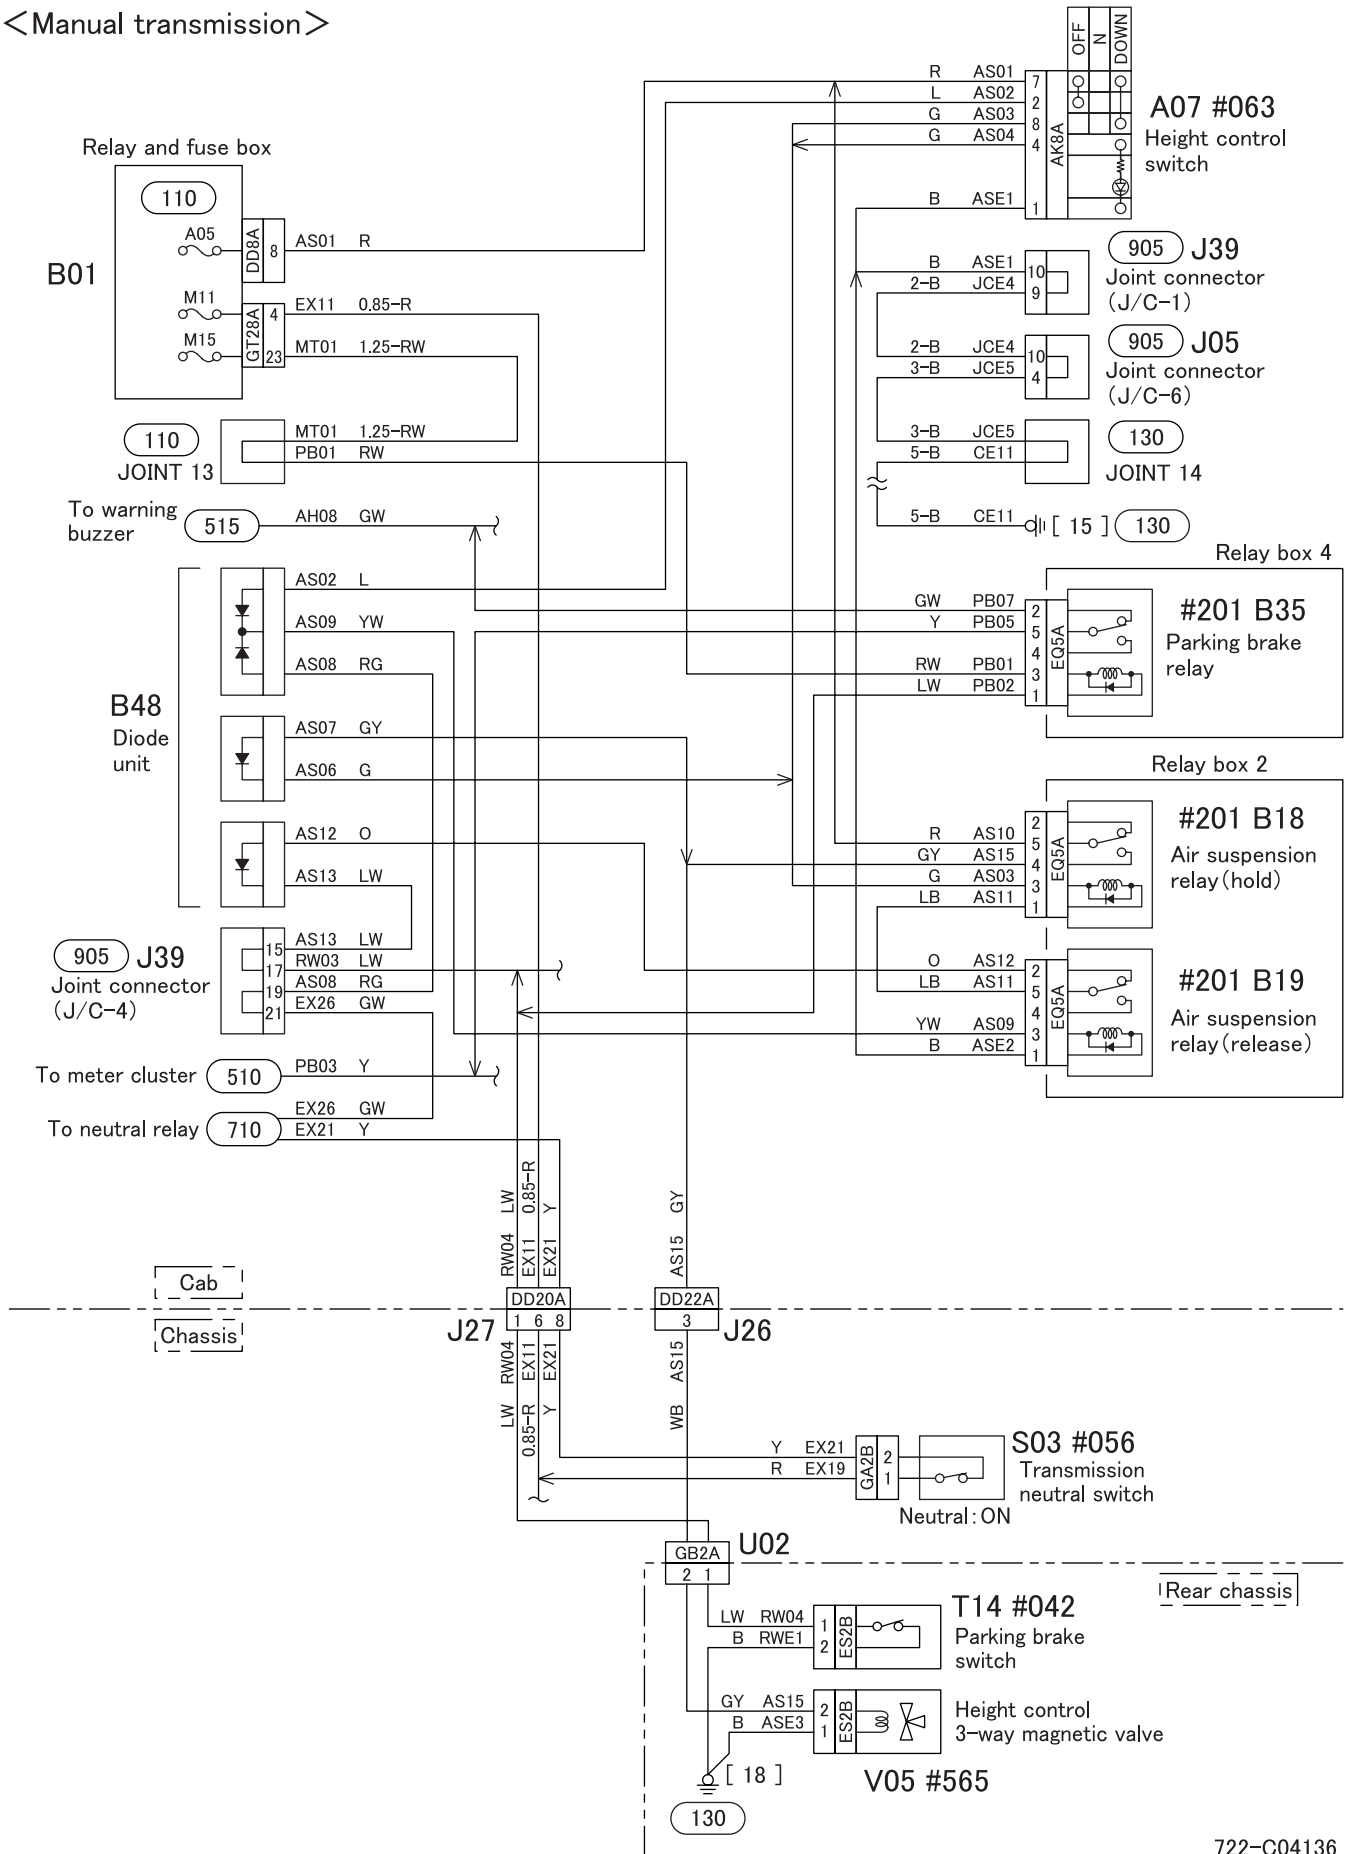
<Manual transmission>

# 722 AIR SUSPENSION CIRCUIT

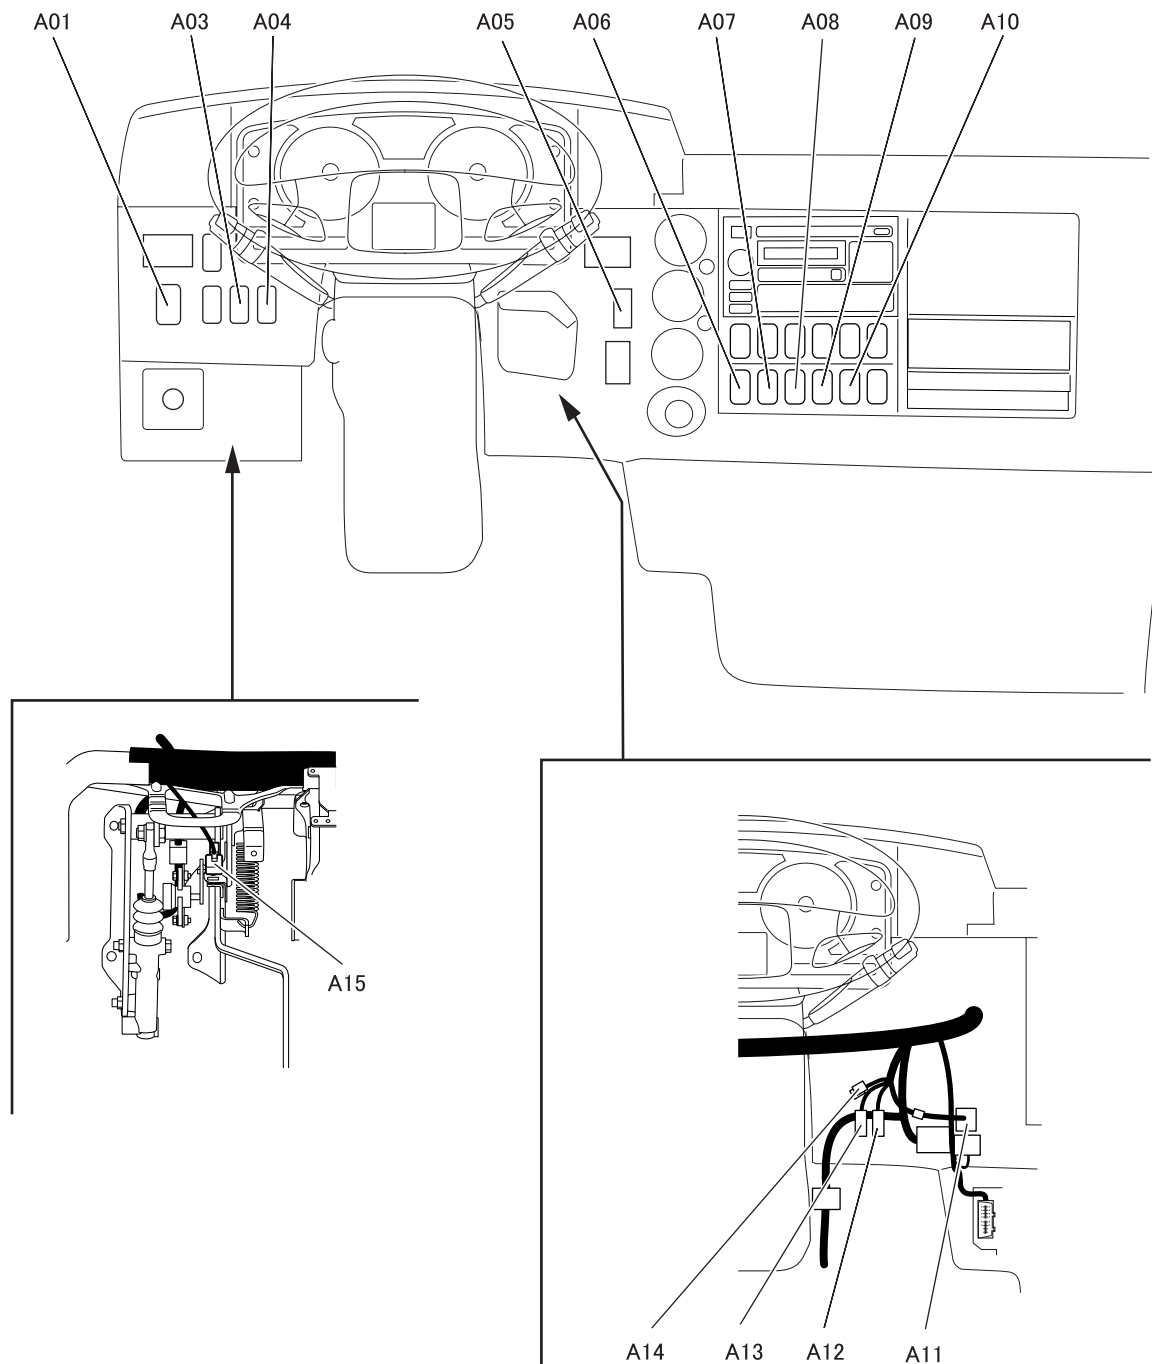
A01 to 15

- A01 Rheostat switch
- A03 Engine oil level check switch
- A04 Door lock switch
- A05 Cruise control main switch
- A06 Power mode switch <FK (A/T)>
- A07 Height control switch
- A08 Mirror heater switch
- A09 Van body dome light switch
- A10 DPF cleaning switch

- A11 Accelerator switch
- A12 Diagnosis switch <MVCU, Engine ECU>
- A13 Memory clear switch <MVCU>
- A14 Diagnosis switch <ABS ECU>
- A15 Clutch switch

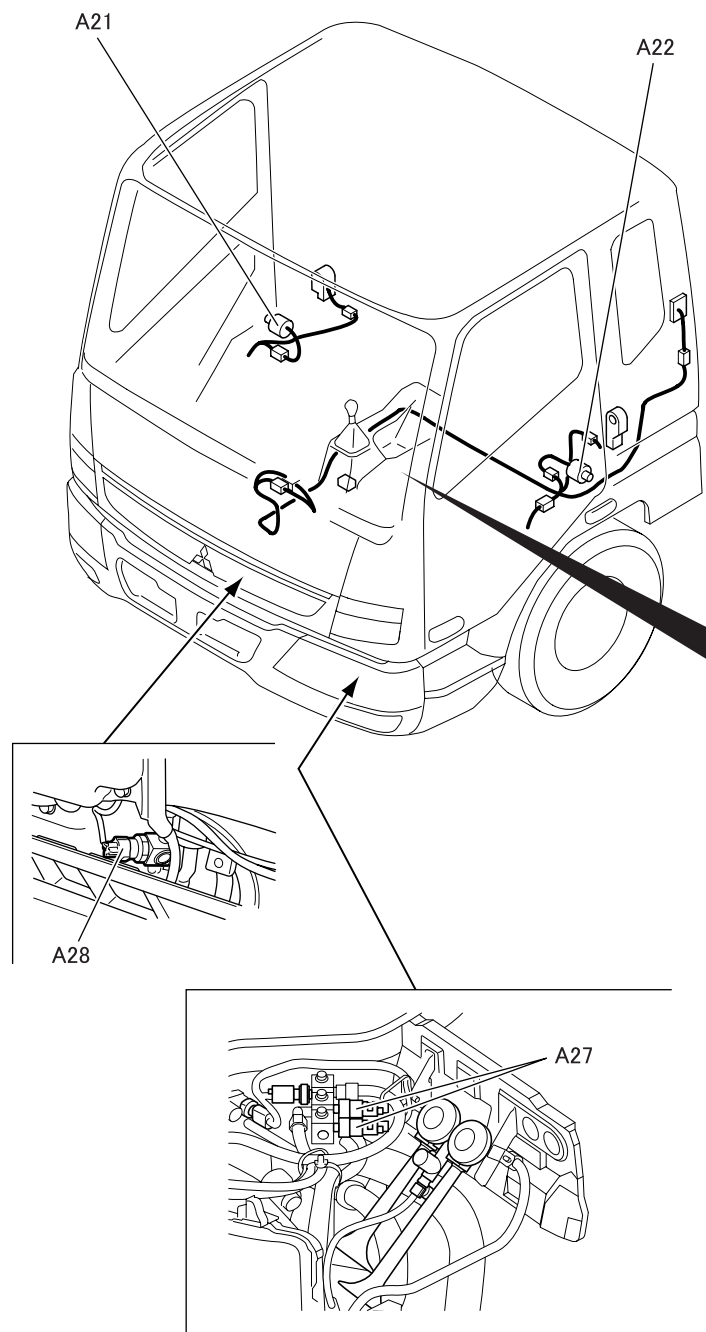
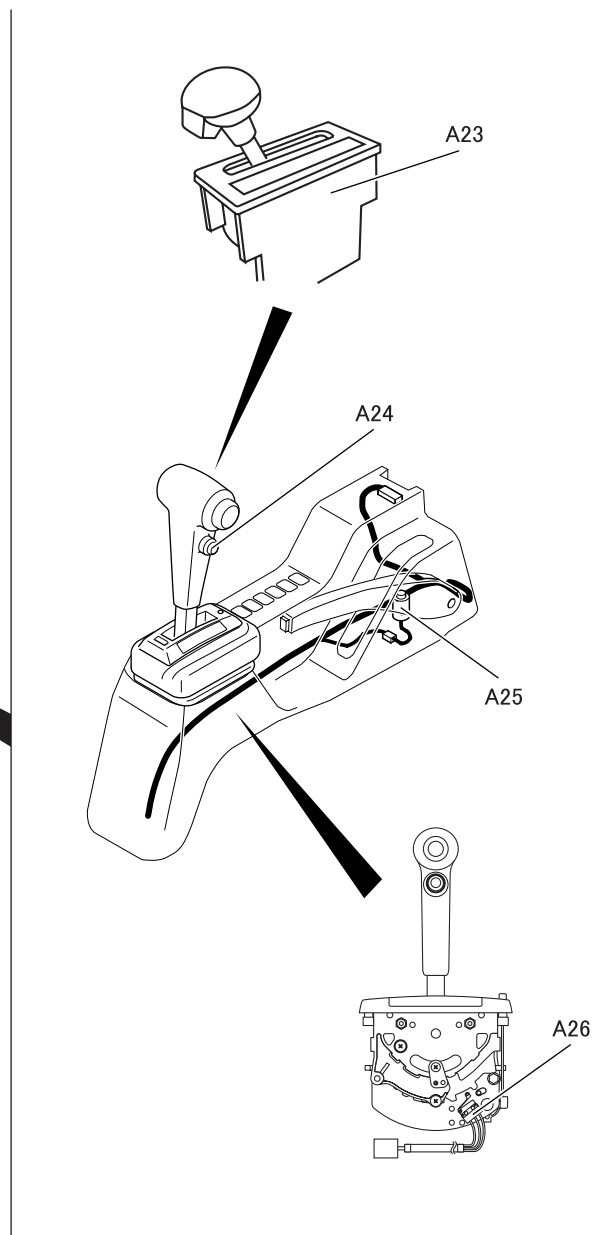
## A21 to 28

- A21 Door switch, RH
- A22 Door switch, LH
- A23 Range selector <FM (A/T)>
- A24 O/D switch <FK (A/T)>
- A25 Parking brake switch <Center parking brake>
- A26 P range switch <FK (A/T)>
- A27 Stop lamp switch
- A28 Dual pressure switch <With air-conditioner>

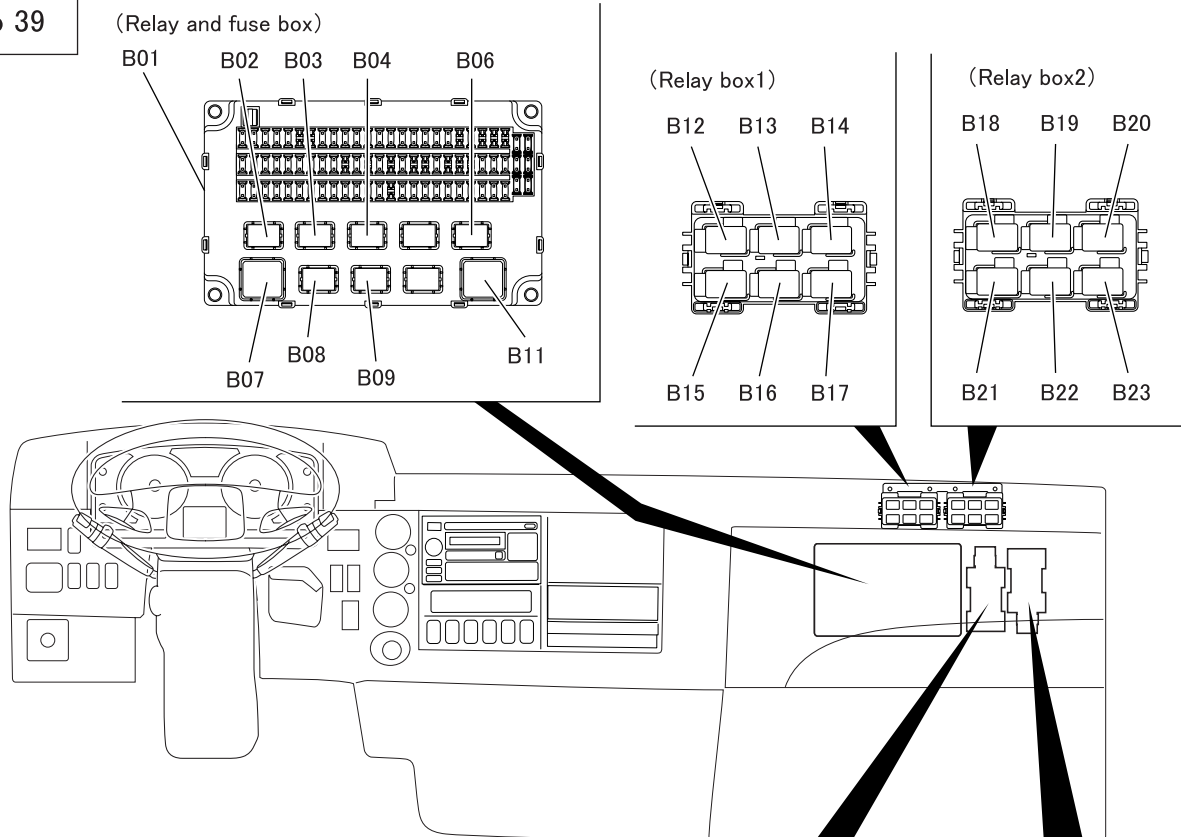
B01 to 39

- B01 Relay and fuse box
- B02 Headlamp relay (HIGH)
- B03 Short connector
- B04 High beam relay
- B06 Tail lamp relay
- B07 Wiper relay (HIGH)
- B08 Stop lamp relay

- B09 Short connector
- B11 Wiper relay (LOW)
- B12 Transmission neutral relay <M/T>  
P shift lock relay <FK (A/T)>
- B13 Fan motor relay1 <FM (A/T)>  
A/T N/P signal reversing relay <FK (A/T)>

- B31 EDU relay
- B32 ECU main relay
- B33 Van body dome light relay
- B34 Condenser fan relay
- B35 Parking brake relay <Wheel park>
- B36 DRL relay
- B37 Air-conditioner compressor relay
- B38 Mirror heater relay
- B39 Headlamp relay (LOW), LH

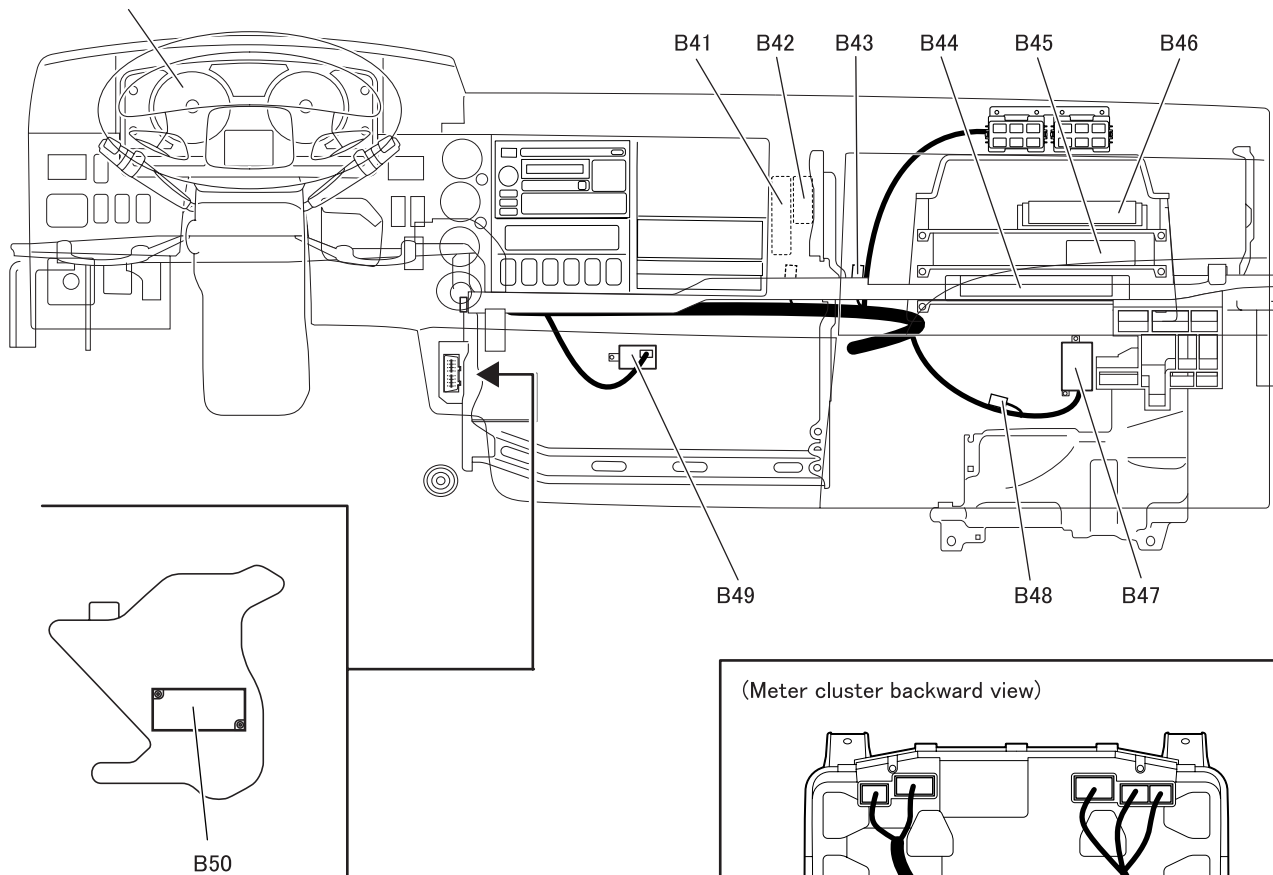
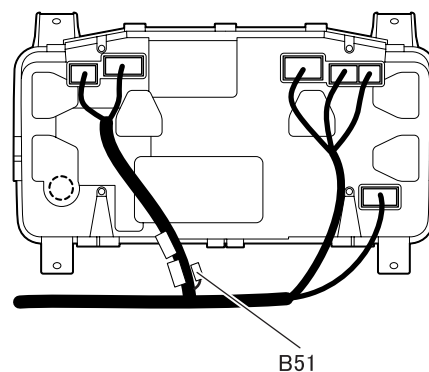
## Meter cluster

- B41 Power window ECU
- B42 Flasher unit
- B43 Resistor unit
- B44 Engine ECU
- B45 MVCU
- B46 ABS ECU
- B47 Pulse converter <A/T>
- B48 Diode unit
- B49 Daytime running light ECU
- B50 Multipurpose timing control unit
- B51 Resistor unit

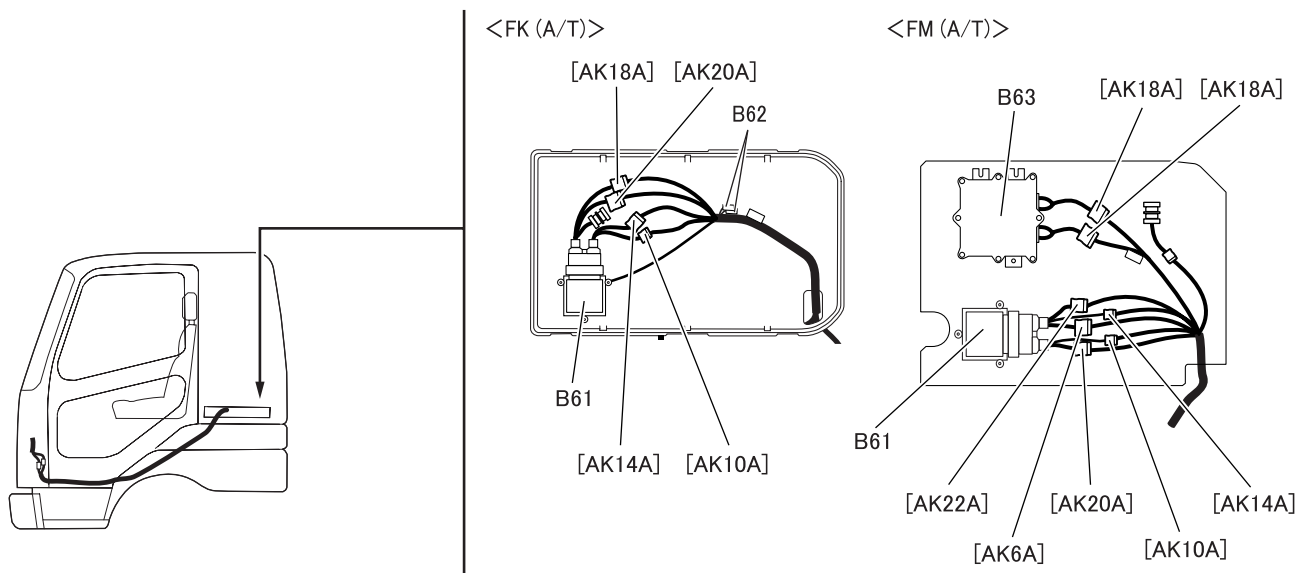
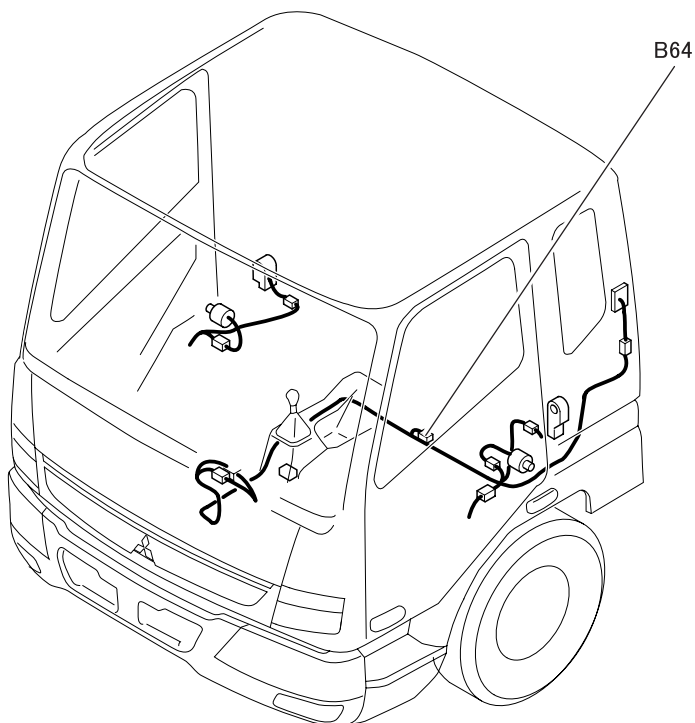
B61 to 64

- B61 A/T ECU
- B62 Diode unit <FK (A/T)>  
Resistor unit <FK (A/T)>
- B63 Vehicle interface module <FM (A/T)>
- B64 Diode unit <FK (A/T)>
