# FE.FG

## SERVICE MANUAL 2008 Model FOREWORD

This Service Manual contains maintenance and repair methods for the Mitsubishi Fuso Truck FE. FG Series. Read this manual carefully as an aid in providing correct, efficient maintenance. Please note that the information and specifications contained within this manual may change without notice. This is due to product modifications and continued vehicle improvements that are made throughout the model years. Should you encounter any discrepancy in the information provided, please do not hesitate to contact your nearest Mitsubishi Fuso Dealer or Mitsubishi Fuso Truck of America, Inc.

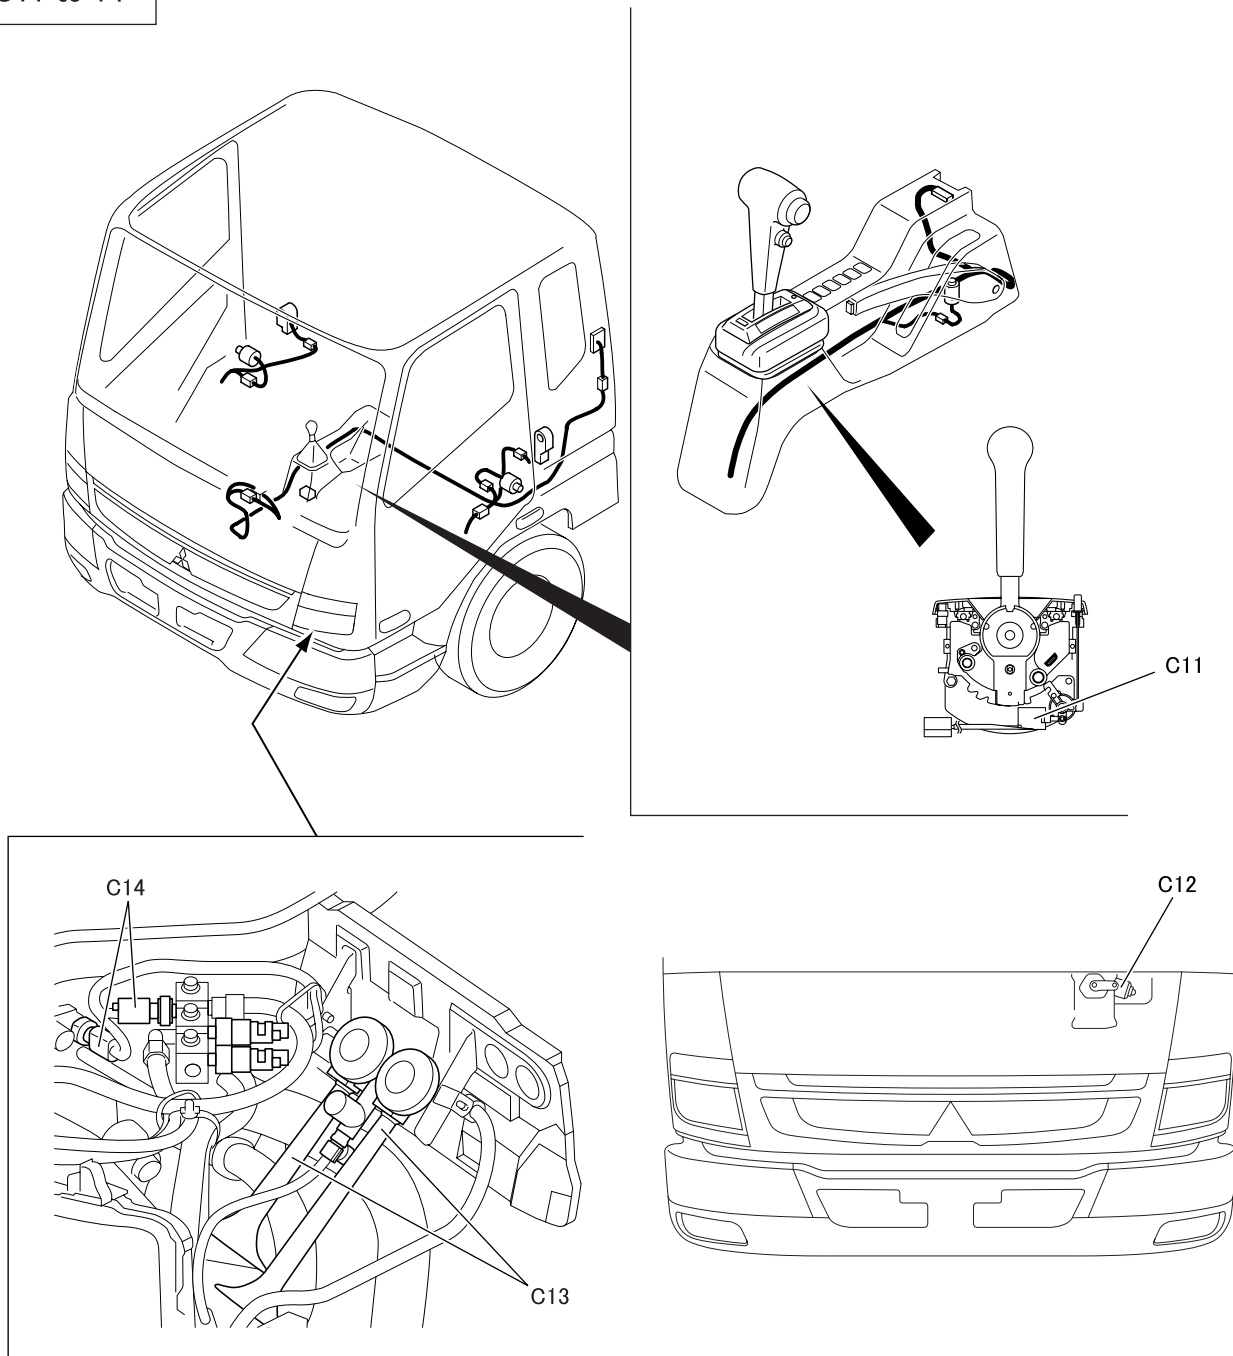
C11 to 14

- C11 Shift lock actuator <FK (A/T)>  
 C12 Wiper motor  
 C13 Air horn  
 C14 Air pressure sensor

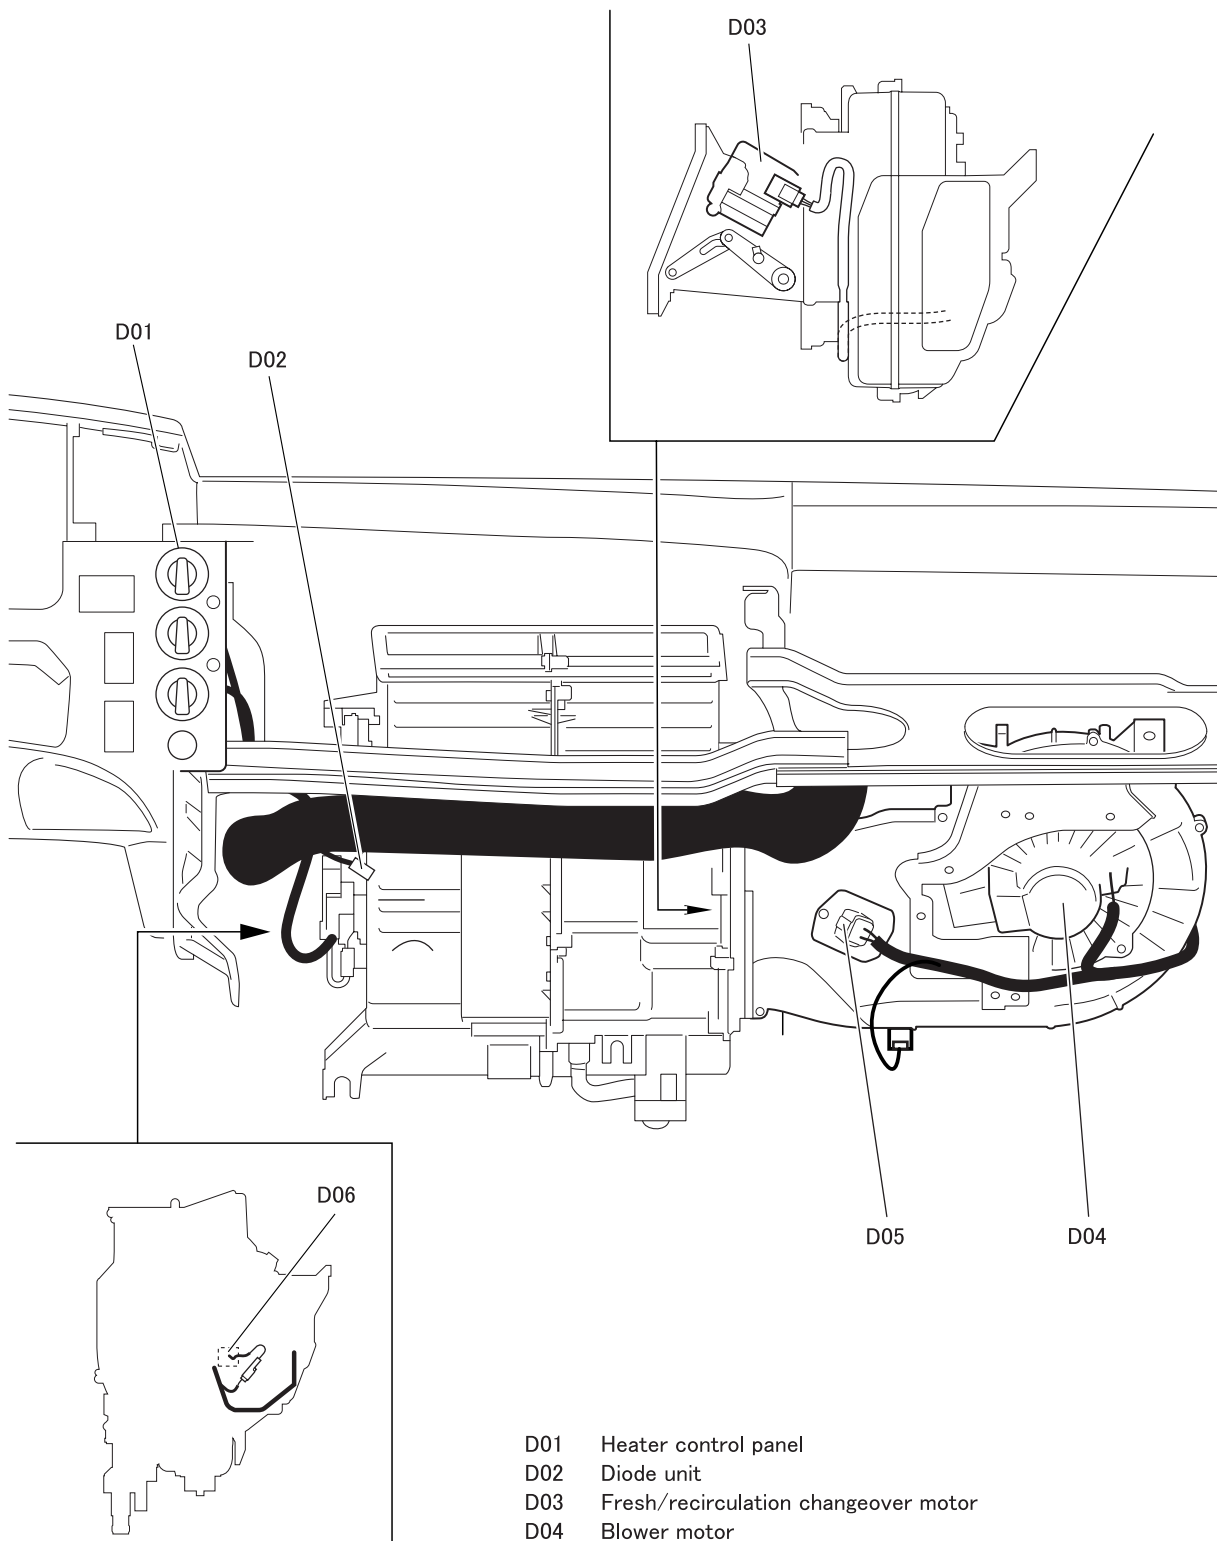
D01 to 06

- D01 Heater control panel
- D02 Diode unit
- D03 Fresh/recirculation changeover motor
- D04 Blower motor
- D05 Blower resistor
- D06 Thermostat

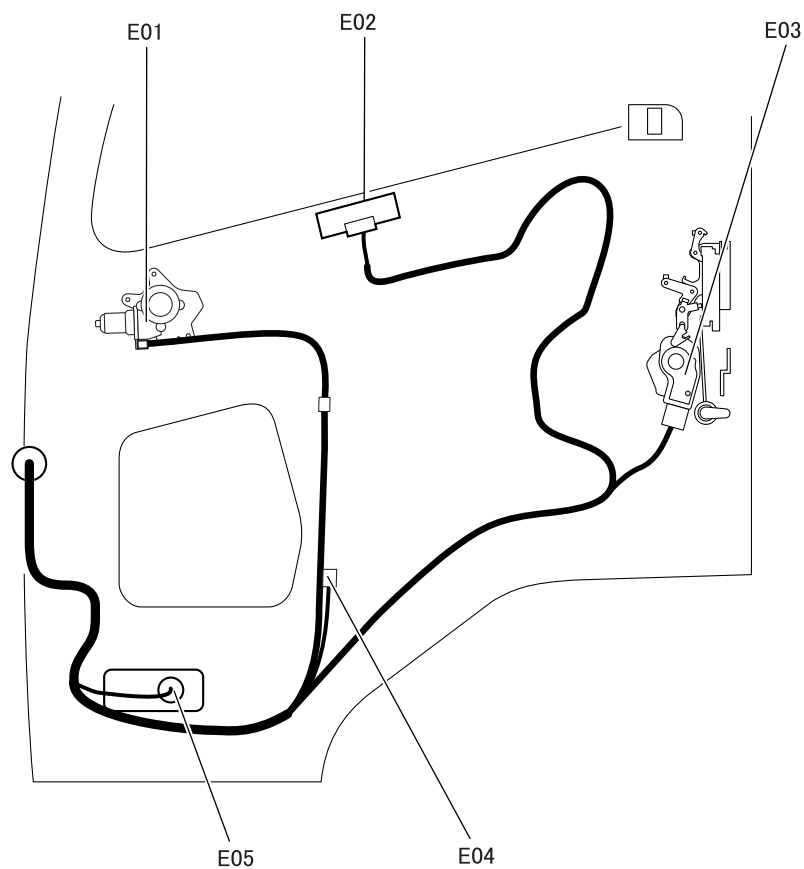
E01 to 05

This illustrations show the right side door, the left side door is symmetrical.

- E01 Power window motor
- E02 Power window switch
- E03 Door lock actuator
- E04 Mirror heater connector
- E05 Front side turn signal lamp <FK61>

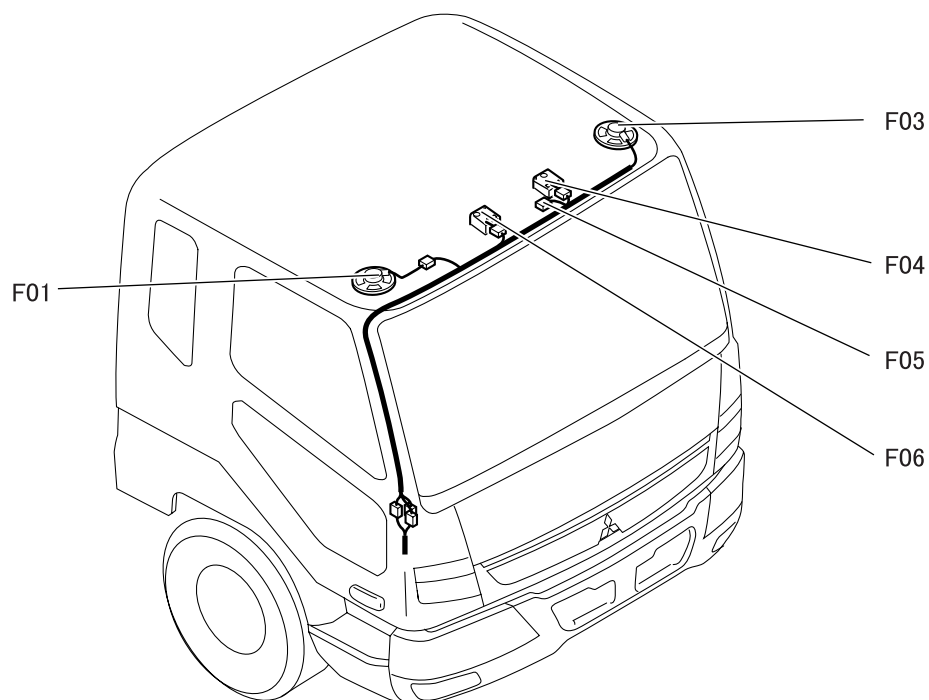
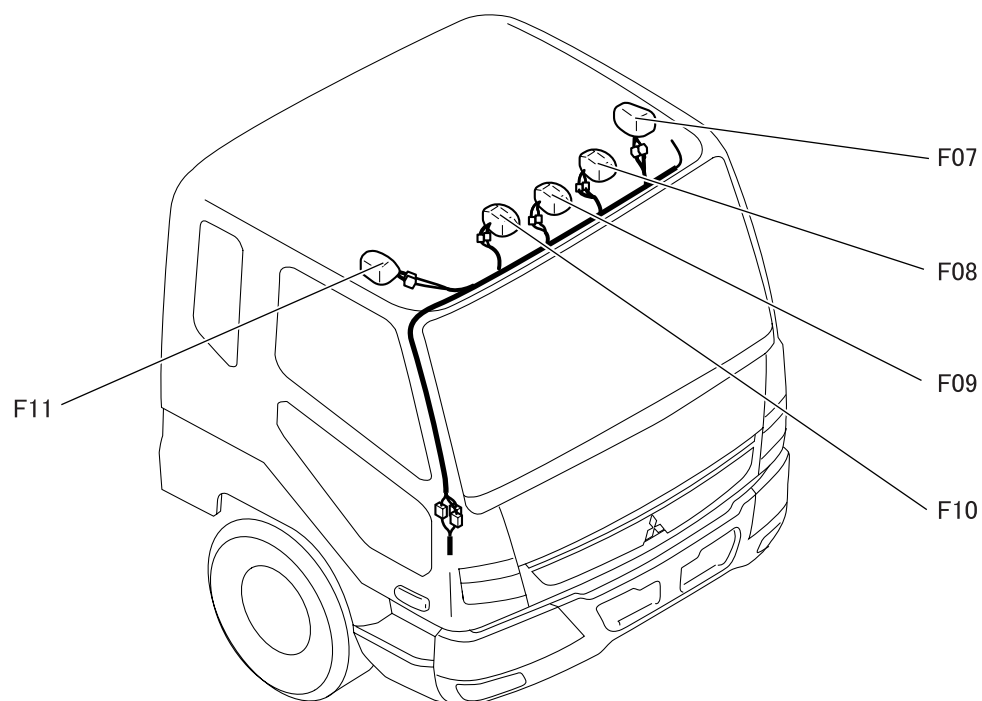
F01 to 11

F01 Speaker, RH  
F03 Speaker, LH  
F04 Personal lamp, LH  
F05 Spare D.C connector  
F06 Personal lamp, RH

F07 Clearance and side marker lamp, LH  
F08 Identification lamp, LH  
F09 Identification lamp, CENTER  
F10 Identification lamp, RH  
F11 Clearance and side marker lamp, RH

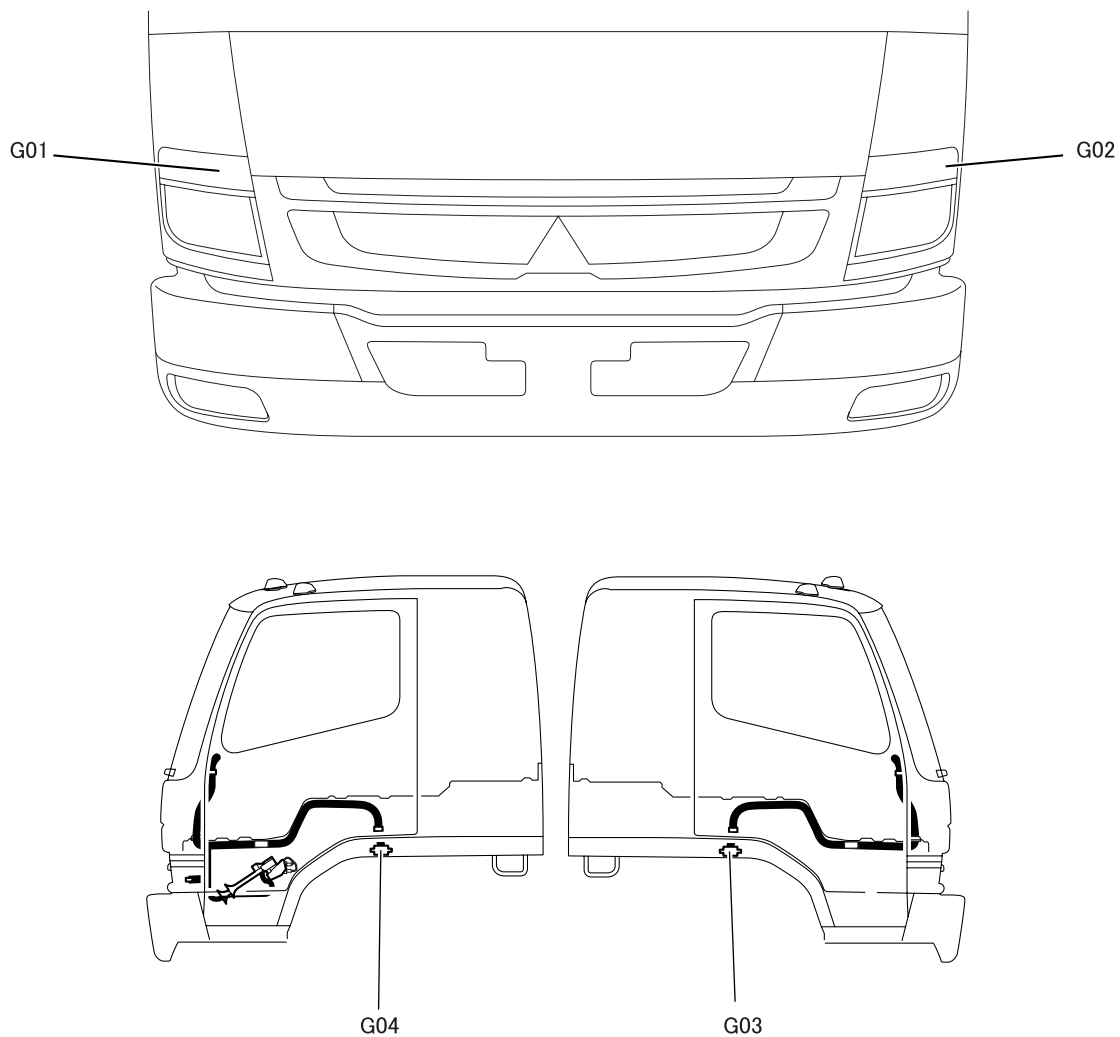
G01 to 04

- G01 Front turn signal lamp, RH
- G02 Front turn signal lamp, LH
- G03 Side turn signal lamp, RH <Except FK61>
- G04 Side turn signal lamp, LH <Except FK61>

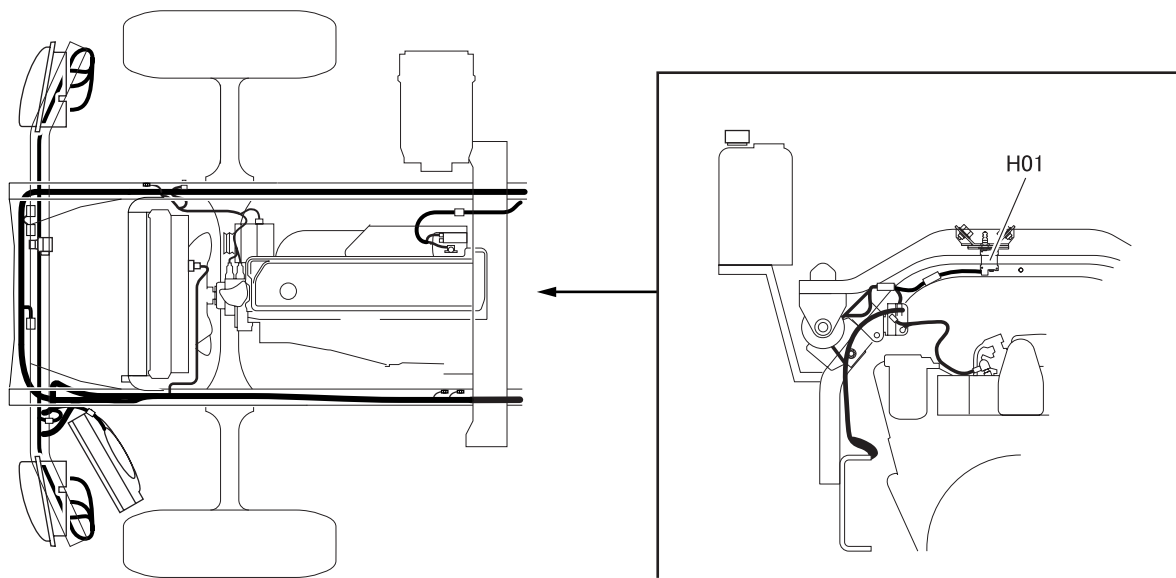
H01 Cab tilt lock switch

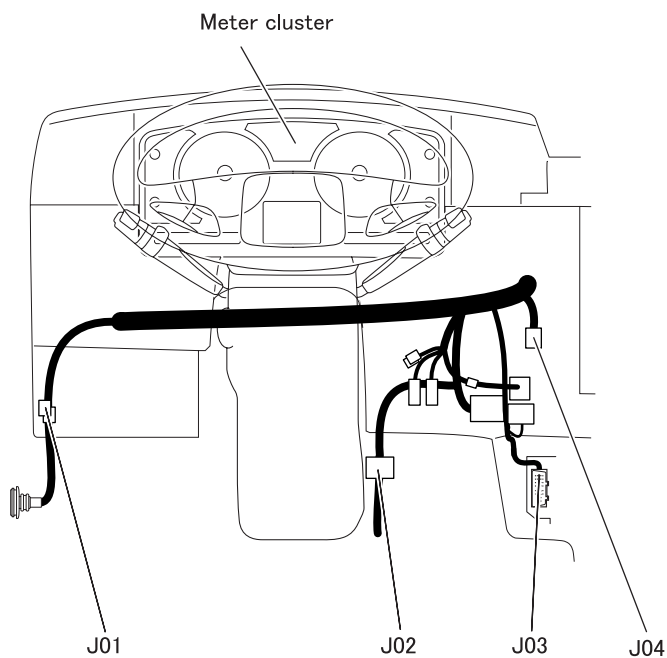
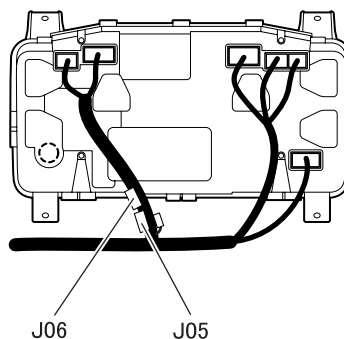
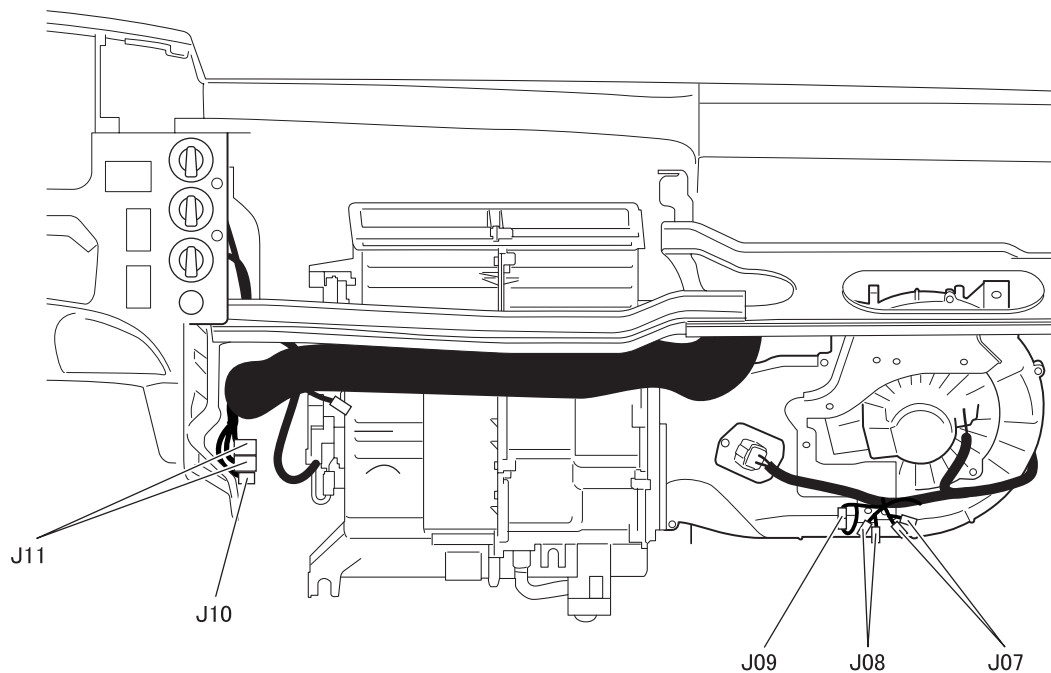
J01 to 11

- J01 Connection of cab harness and door harness, LH
- J02 Connection of cab harness and headlamp harness
- J03 Diagnostic connector
- J04 Connection of cab harness and front panel harness
- J05 Joint connector (J/C-6)
- J06 Joint connector (J/C-2)
- J07 Connector (for cab back)
- J08 Connector (for mixer)
- J09 Connector
- J10 Connection of cab harness and center floor harness
- J11 Connection of cab harness and A/T harness

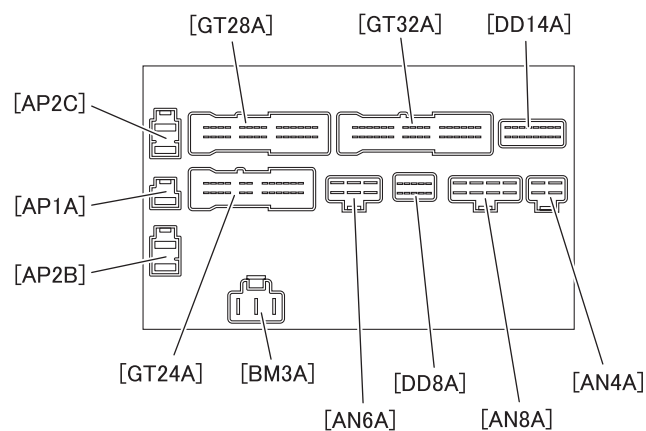
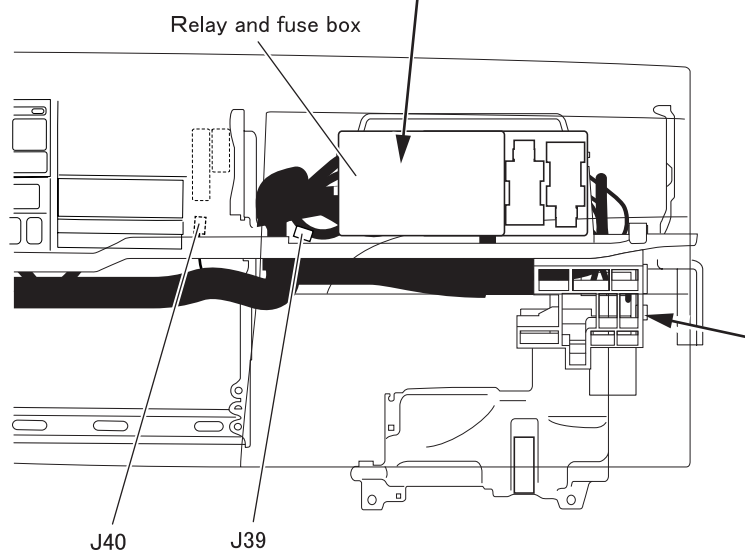
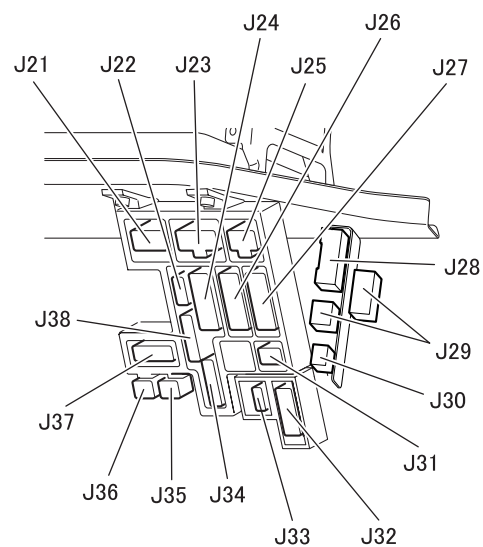
## J21 to 40

- J21-27 Connection of cab harness and chassis harness
- J28 Connection of cab harness and door harness, RH
- J29 Connection of cab harness and roof harness
- J30 Connection of cab harness and floor harness, RH
- J31 Connection of cab harness and chassis harness
- J32, J33 Connection of chassis harness and A/T harness
- J34-38 Connection of cab harness and engine control harness
- J39 Joint connector (J/C-1, 3, 4)
- J40 Spare D.C connector

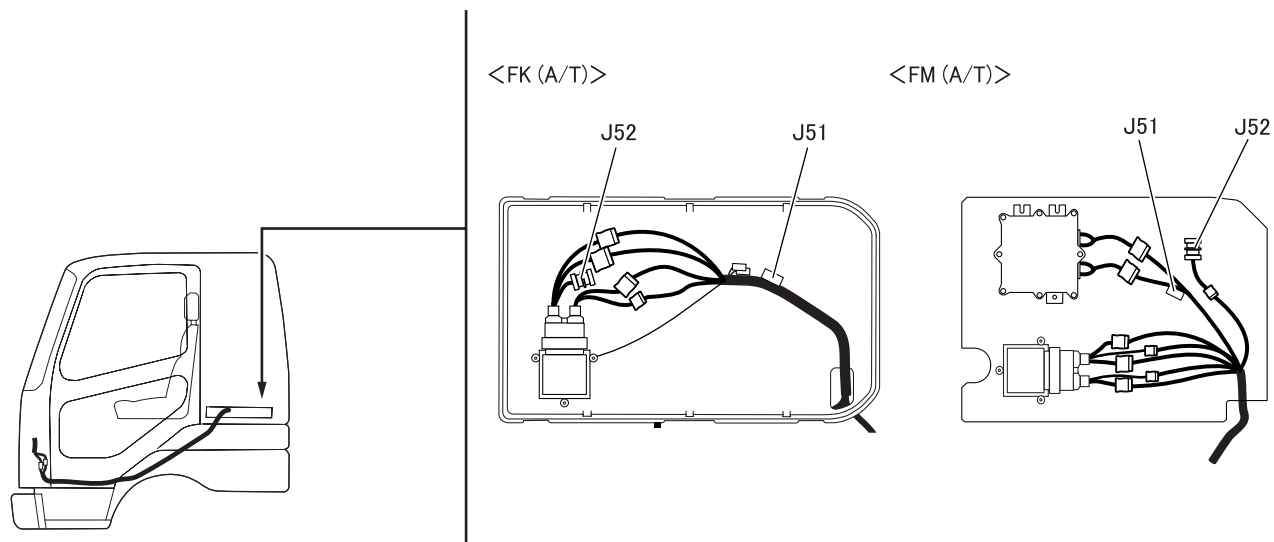
J51 to 52

- J51 Joint connector (J/C) <A/T>
- J52 Diagnostic connector (for allison exclusive diagnosis tool)

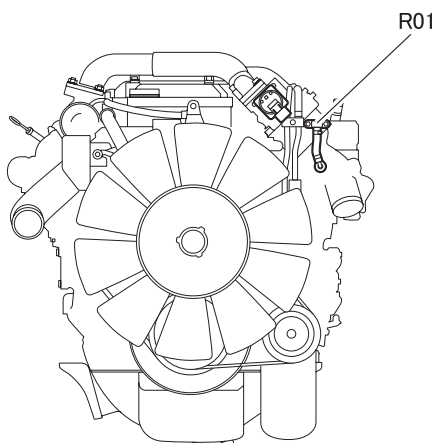
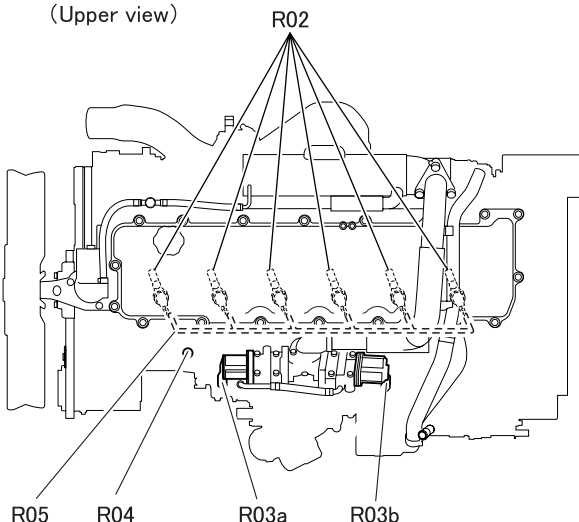
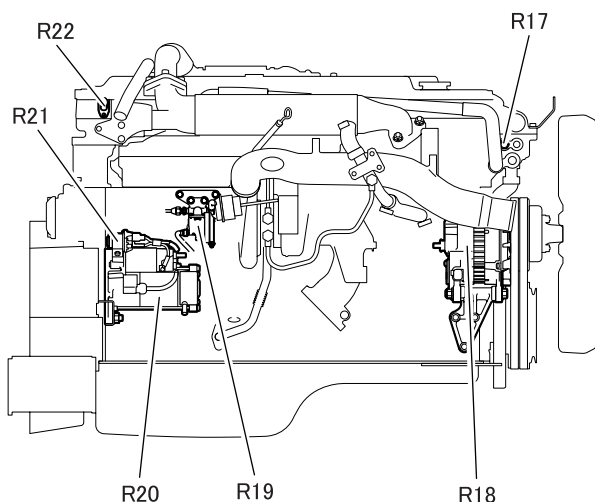
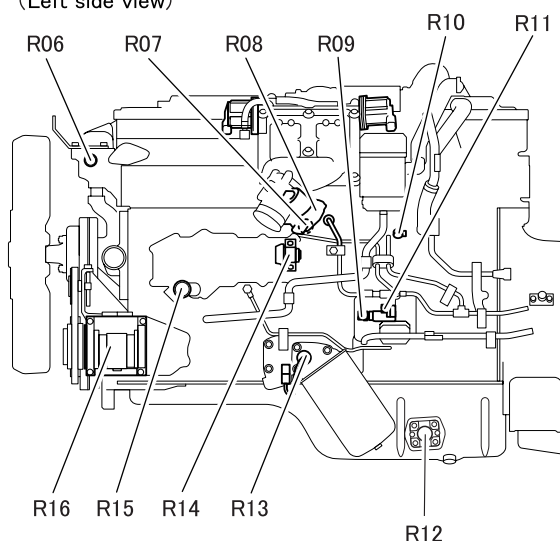
## R01 to 22

- R01 Boost pressure sensor
- R02 Injector magnetic valve
- R03a EGR valve 1  
(building into motor, position sensor)
- R03b EGR valve 3  
(building into motor, position sensor)
- R04 Boost air temperature sensor
- R05 Glow plug
- R06 Overheating switch
- R07 Common rail pressure sensor
- R08 Throttle actuator  
(building into motor, position sensor)
- R09 Fuel temperature sensor (Inlet)
- R10 Fuel temperature sensor (Outlet)

- R11 Suction control valve
- R12 Engine oil level sensor
- R13 Engine oil bypass alarm switch
- R14 Glow relay
- R15 Engine oil pressure switch
- R16 Magnetic clutch
- R17 Water temperature sensor  
(connects to engine electronic control unit)
- R18 Alternator
- R19 Waste gate magnetic valve
- R20 Starter
- R21 Starter relay
- R22 Cylinder recognition sensor

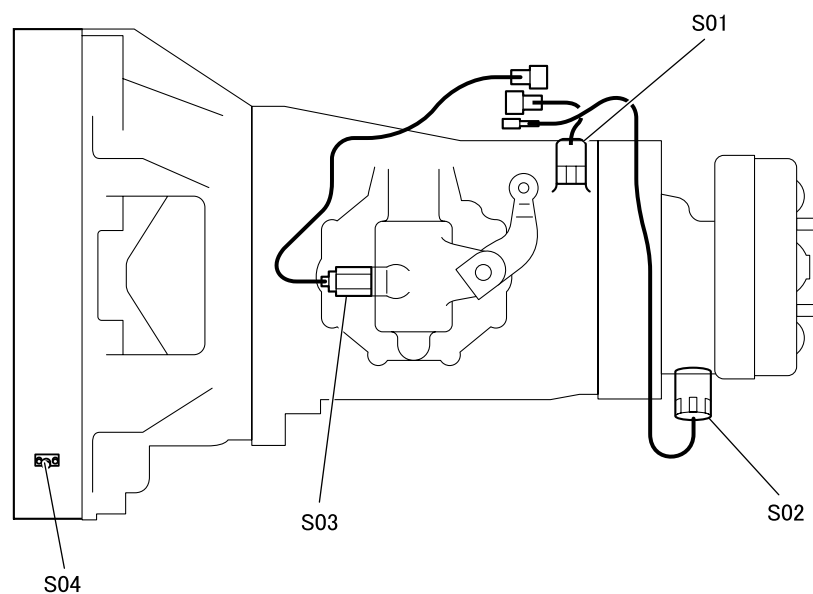
S01 to 04

- S01 Backup lamp switch
- S02 Vehicle speed sensor
- S03 Transmission neutral switch
- S04 Engine speed sensor

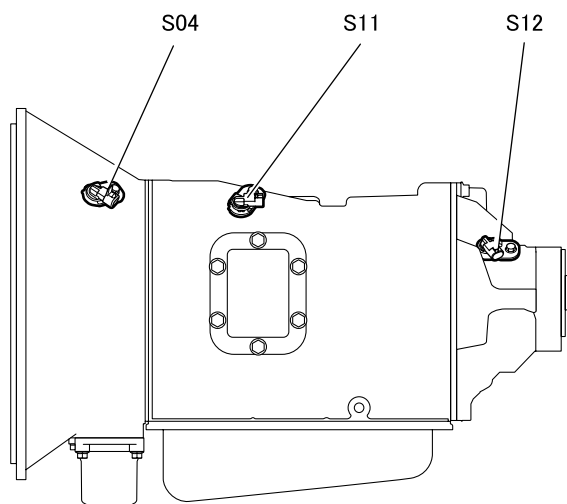
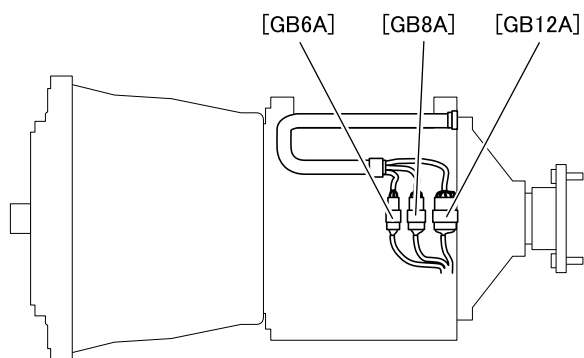
S04 to 12

S04 Engine speed sensor  
S11 Turbine speed sensor  
S12 Output speed sensor

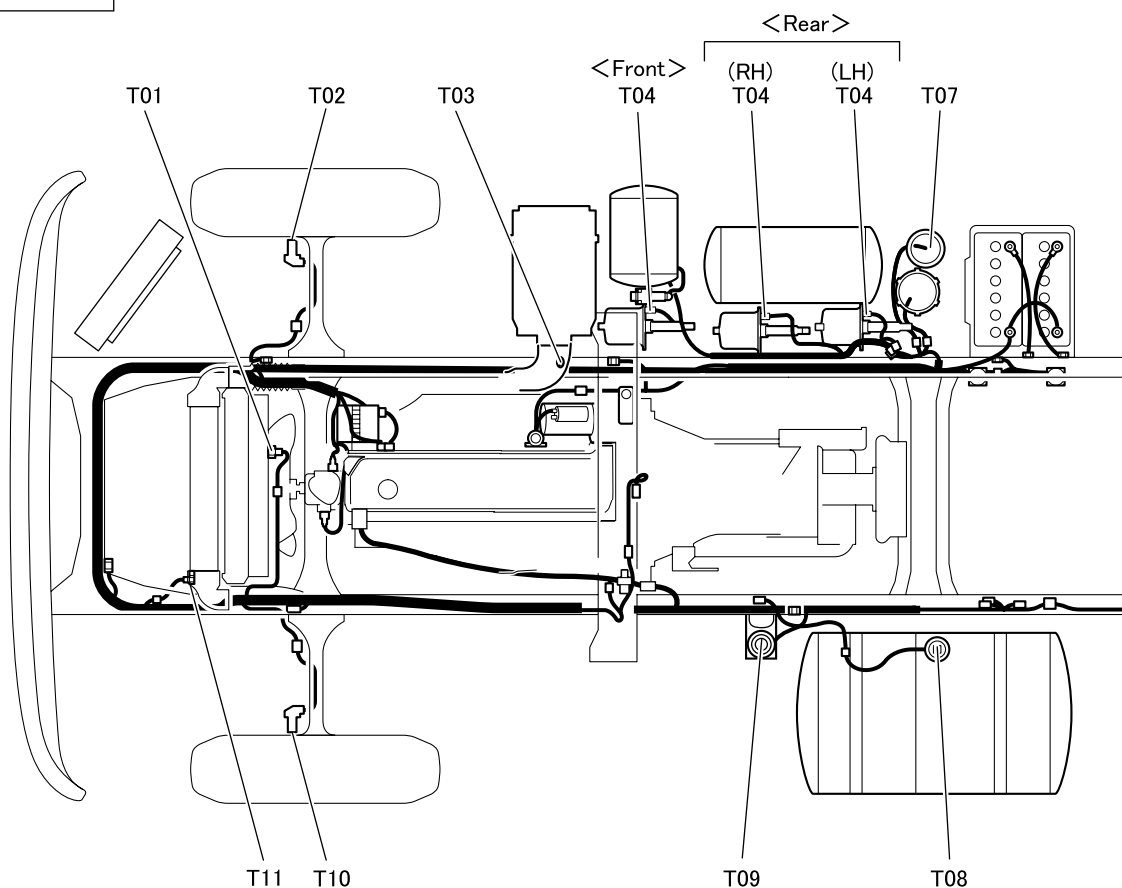
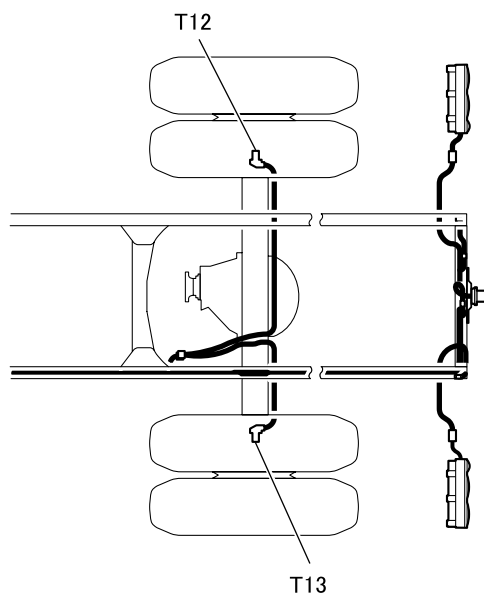
T01 to 13

- T01 Water level sensor
- T02 Front wheel speed sensor, RH
- T03 Air flow sensor
- T04 Brake booster stroke switch
- T07 Brake fluid level switch
- T08 Fuel level sensor
- T09 Water separator sensor
- T10 Front wheel speed sensor, LH
- T11 Intake air temperature sensor
- T12 Rear wheel speed sensor, RH
- T13 Rear wheel speed sensor, LH

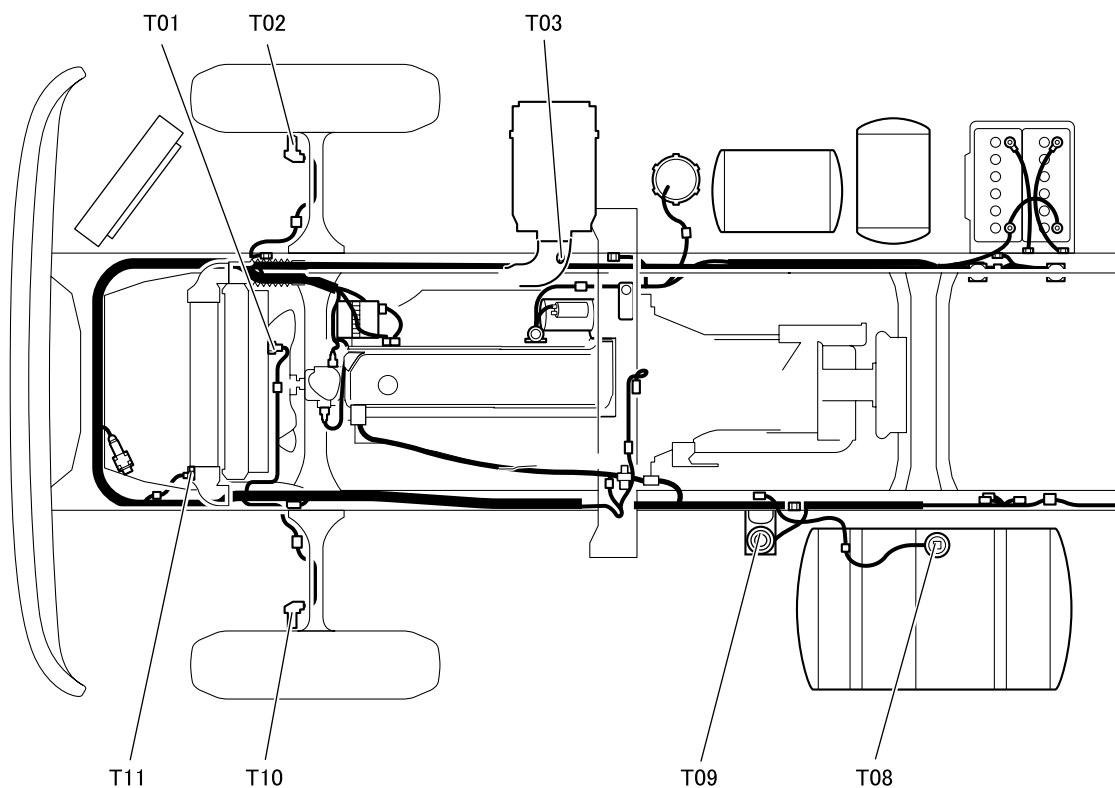
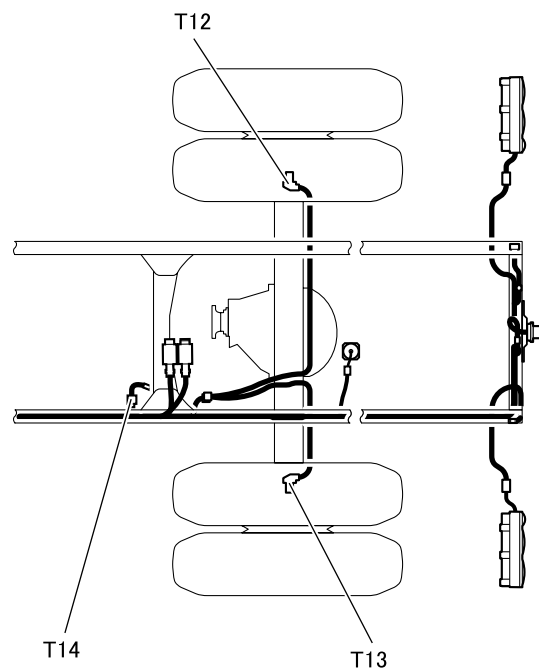
T01 to 14

- T01 Water level sensor
- T02 Front wheel speed sensor, RH
- T03 Air flow sensor
- T08 Fuel level sensor
- T09 Water separator sensor
- T10 Front wheel speed sensor, LH
- T11 Intake air temperature sensor
- T12 Rear wheel speed sensor, RH
- T13 Rear wheel speed sensor, LH
- T14 Parking brake switch

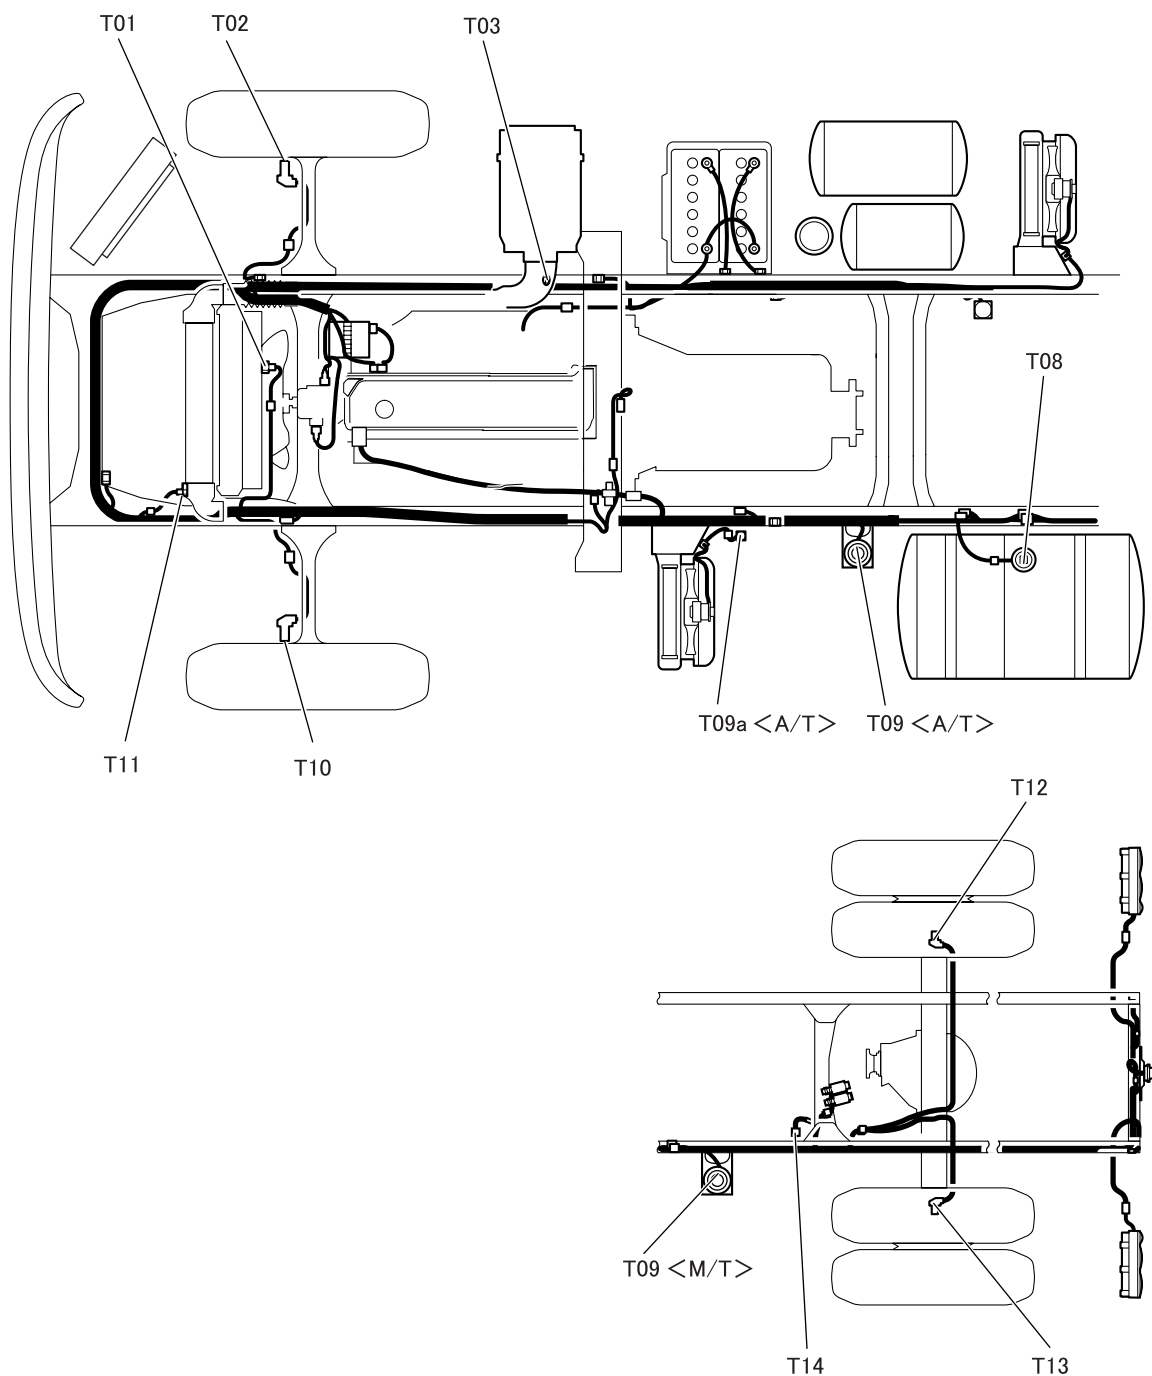
T01 to 14

- T01 Water level sensor
- T02 Front wheel speed sensor, RH
- T03 Air flow sensor
- T08 Fuel level sensor
- T09 Water separator sensor
- T09a A/T fluid temperature switch
- T10 Front wheel speed sensor, LH
- T11 Intake air temperature sensor
- T12 Rear wheel speed sensor, RH
- T13 Rear wheel speed sensor, LH
- T14 Parking brake switch

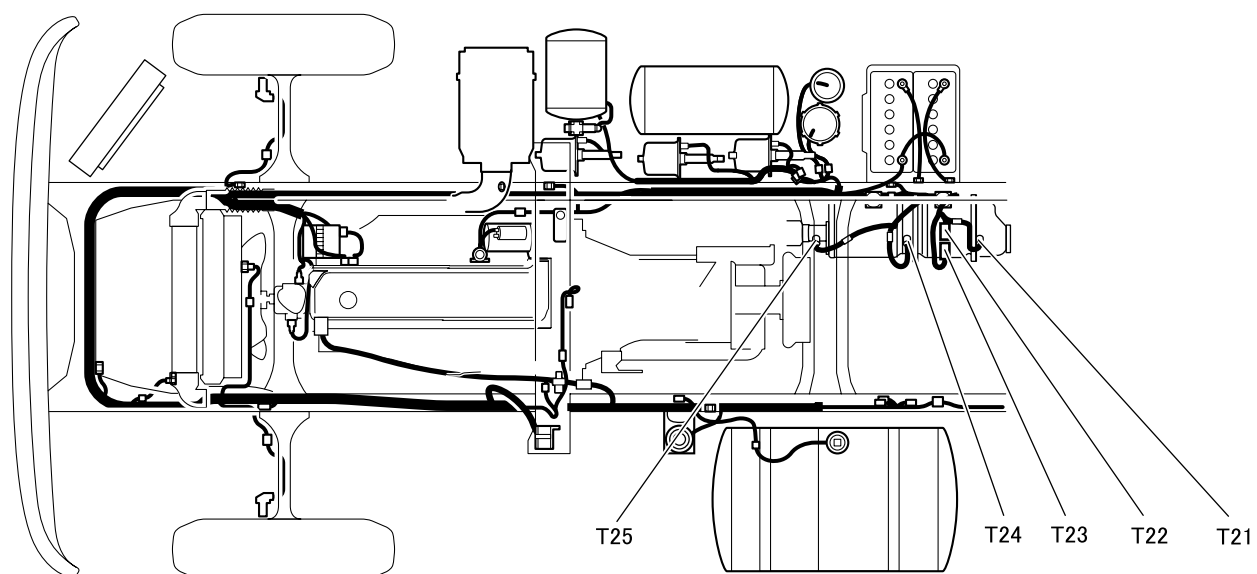
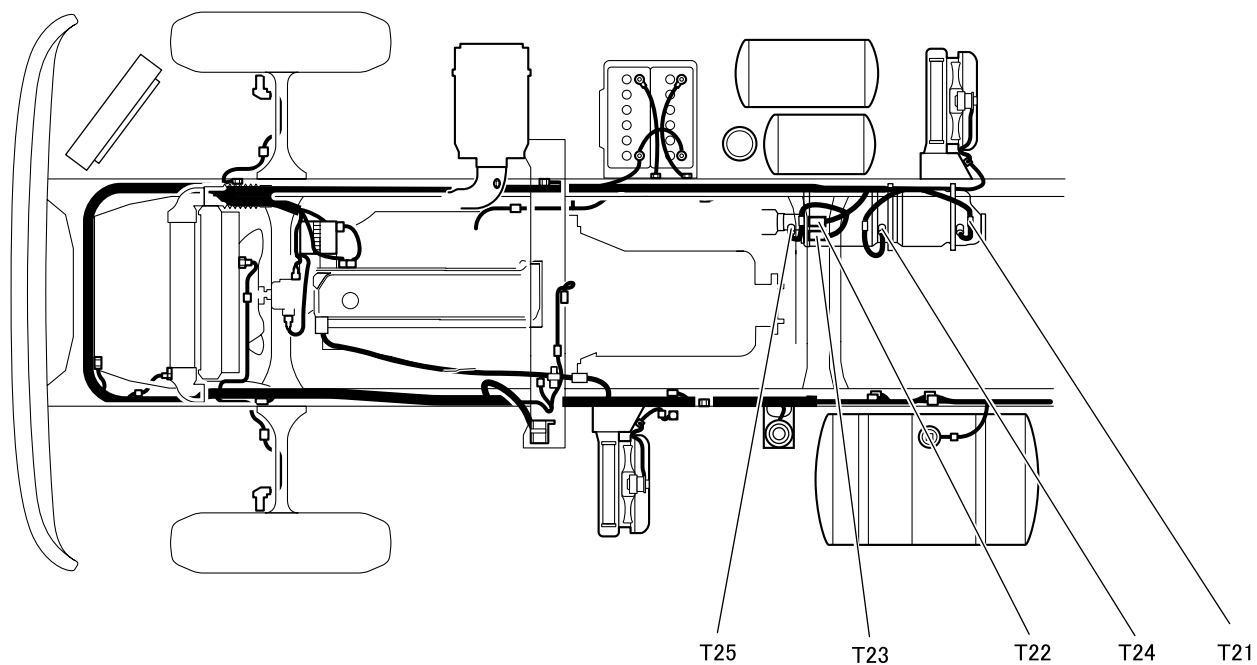
## T21 to 25

- T21 DPF temperature sensor 2
- T22 DPF absolute pressure sensor
- T23 DPF differential pressure sensor
- T24 DPF temperature sensor 1
- T25 Catalytic temperature sensor

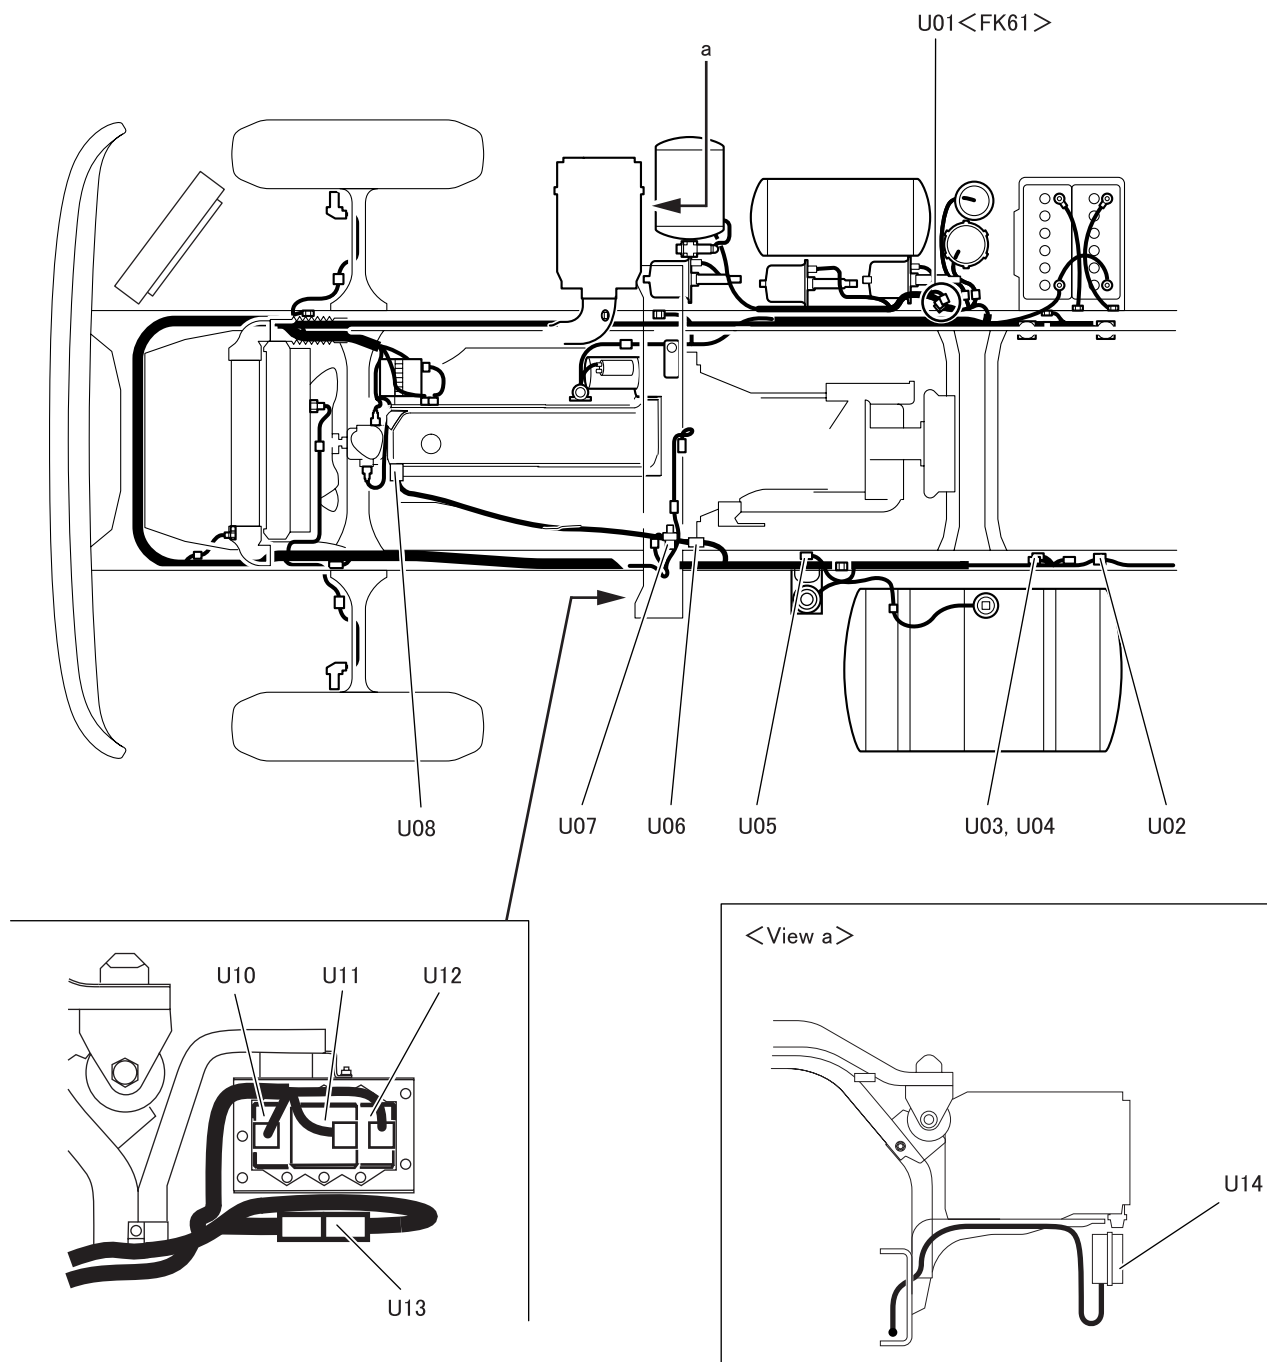
U01 to 14

- U01 Connection of chassis harness and anti-lock brake system control harness
- U02 Connection of chassis harness and rear chassis harness
- U03 Van body dome light connector
- U04 Spare tail lamp connector
- U05 Transmission power take-off control switch connector
- U06 Connection of chassis harness and engine harness
- U07 Transmission power take-off load sensor connector

- U08 Connection of engine harness and injector harness
- U10 EGR EDU 3
- U11 Throttle EDU
- U12 EGR EDU 1
- U13 Connection of engine harness and engine control harness
- U14 High-current fuse box

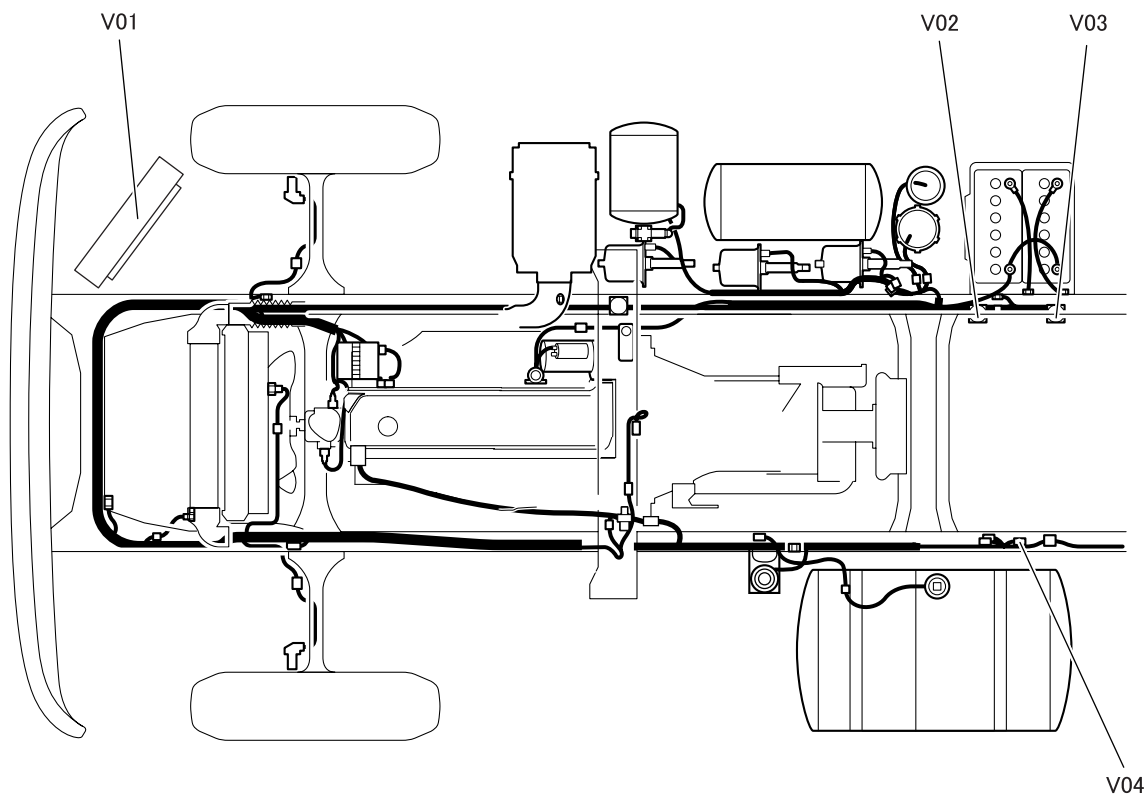
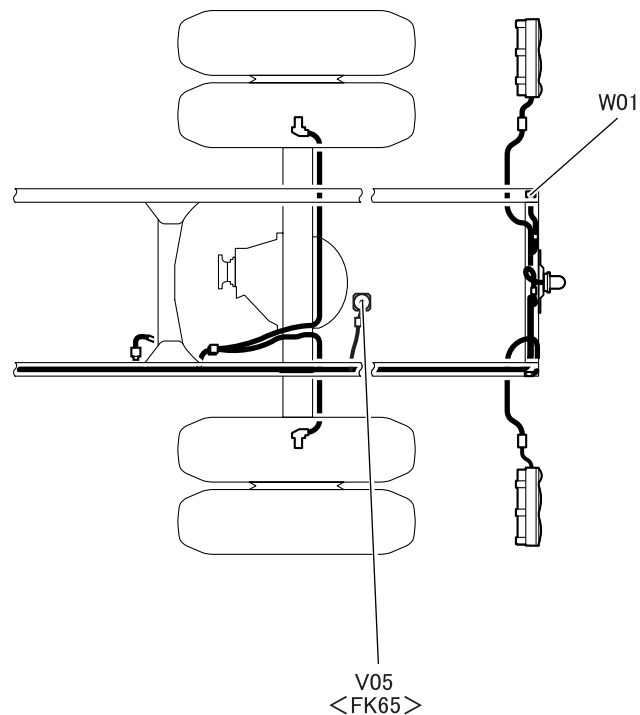
V01 to 05, W01 <FK>

- V01 Condenser fan motor
- V02 Exhaust shutter 3-way magnetic valve 1
- V03 Exhaust shutter 3-way magnetic valve 2
- V04 Transmission power take-off  
3-way magnetic valve connector
- V05 Height control 3-way magnetic valve

- W01 Back buzzer
