# FE.FG

## SERVICE MANUAL 2008 Model FOREWORD

This Service Manual contains maintenance and repair methods for the Mitsubishi Fuso Truck FE. FG Series. Read this manual carefully as an aid in providing correct, efficient maintenance. Please note that the information and specifications contained within this manual may change without notice. This is due to product modifications and continued vehicle improvements that are made throughout the model years. Should you encounter any discrepancy in the information provided, please do not hesitate to contact your nearest Mitsubishi Fuso Dealer or Mitsubishi Fuso Truck of America, Inc.

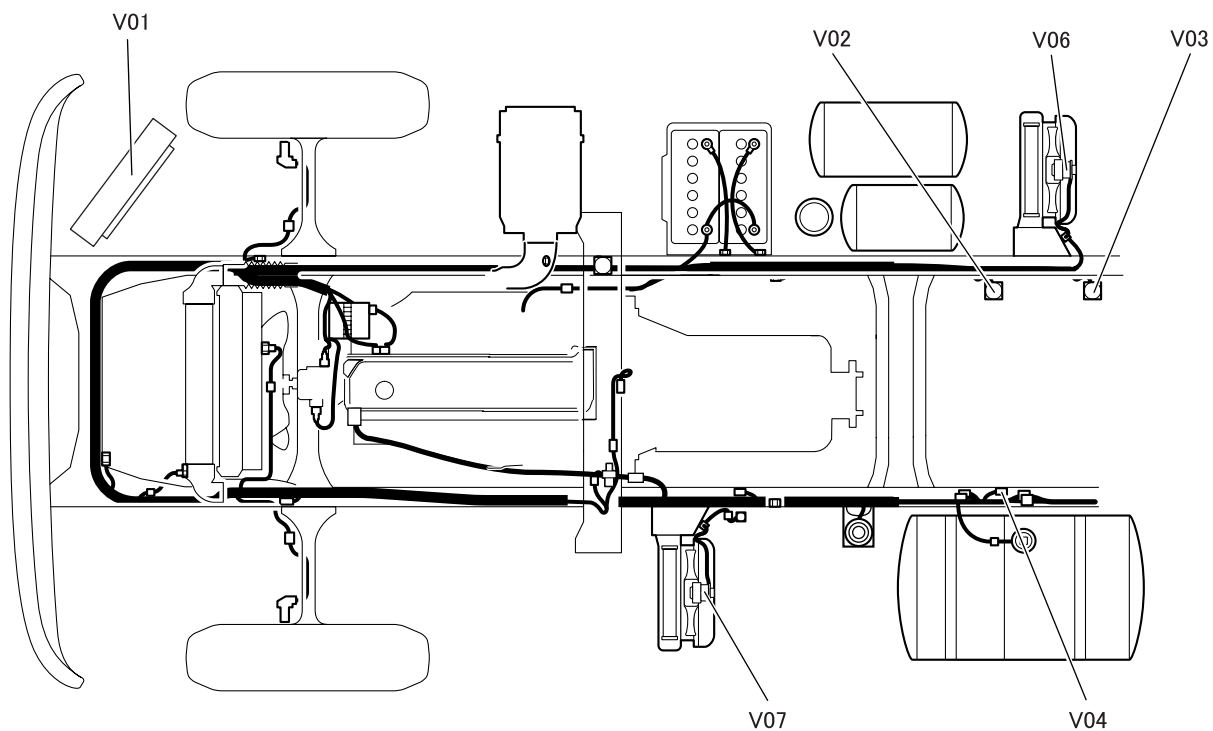
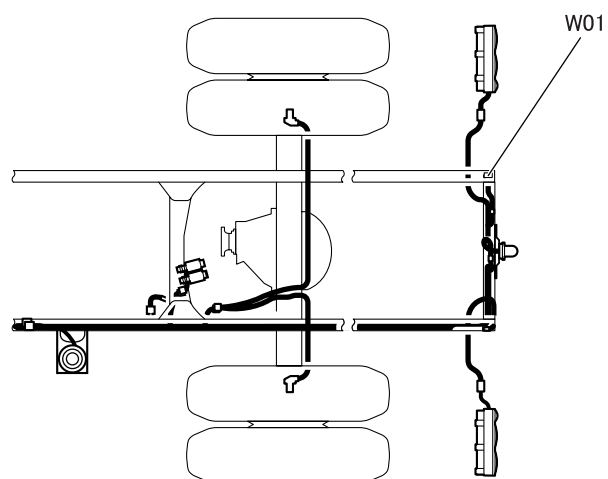
V01 to 07, W01 &lt;FM&gt;

- V01 Condenser fan motor
- V02 Exhaust brake 3-way magnetic valve 1
- V03 Exhaust brake 3-way magnetic valve 2
- V04 Transmission power take-off  
3-way magnetic valve connector
- V06 Motor 2 <A/T>
- V07 Motor 1 <A/T>

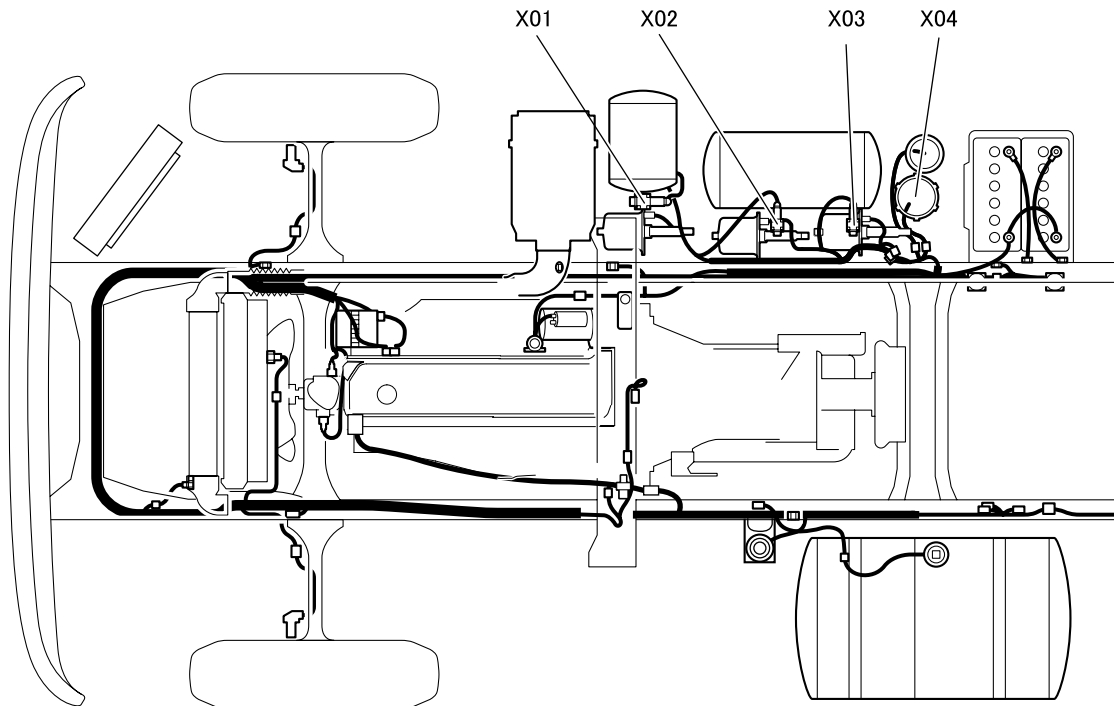
**X01 to 04**

- X01    ABS control valve (front)
- X02    ABS control valve, LH (rear)
- X03    ABS control valve, RH (rear)
- X04    Air dryer

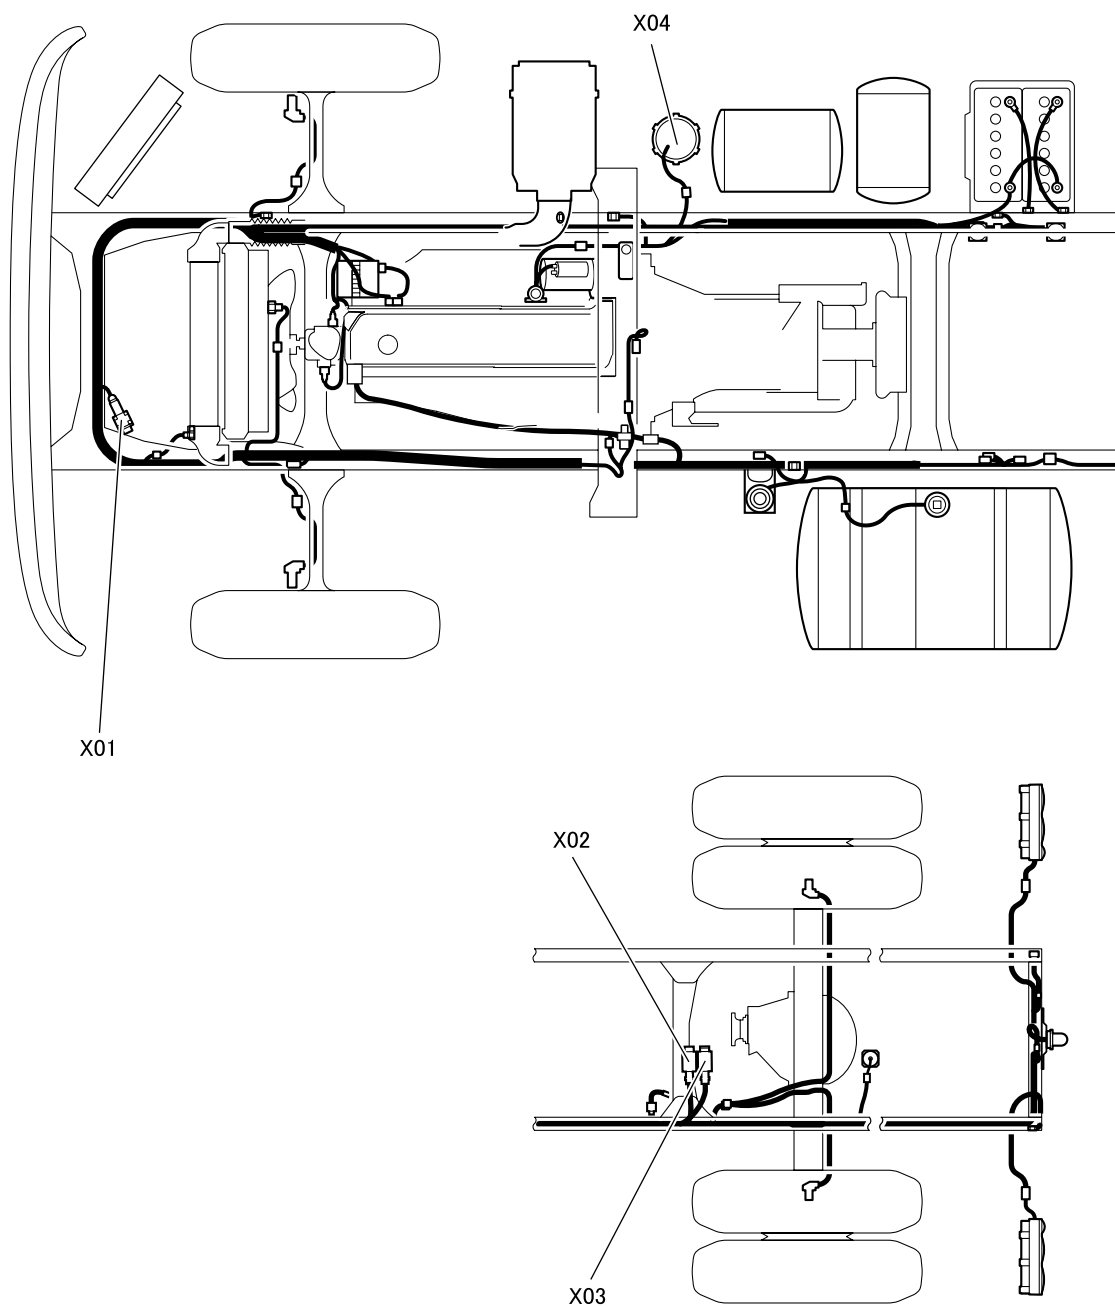
## X01 to 04

- X01 ABS control valve (front)
- X02 ABS control valve, LH (rear)
- X03 ABS control valve, RH (rear)
- X04 Air dryer

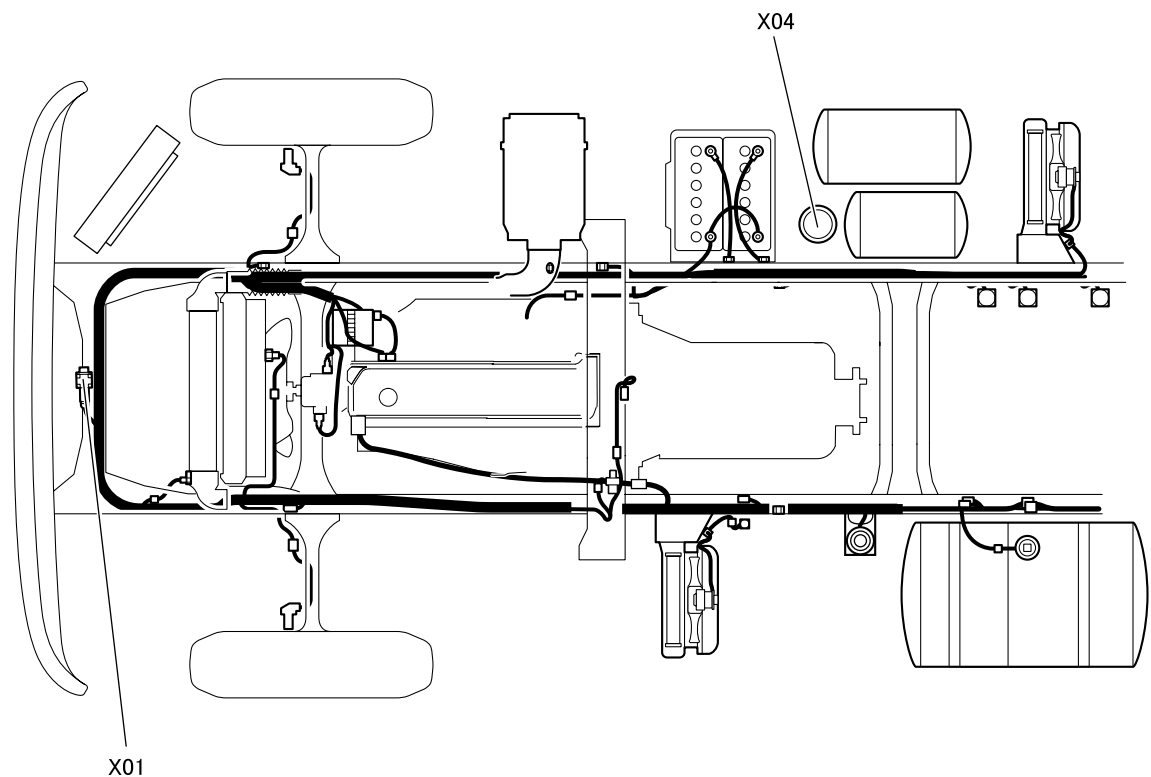
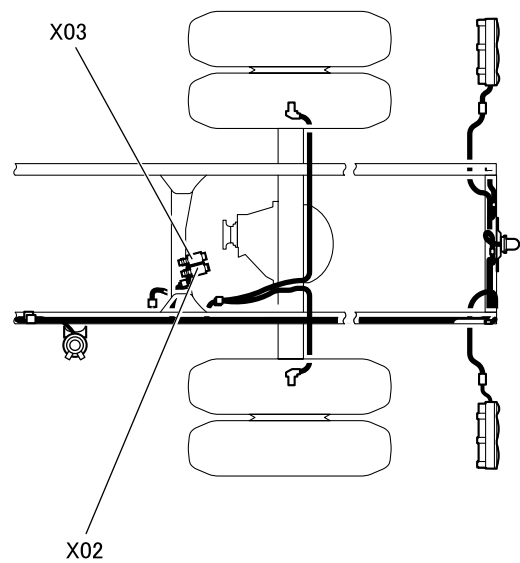
X01 to 04

- X01 ABS control valve (front)
- X02 ABS control valve, LH (rear)
- X03 ABS control valve, RH (rear)
- X04 Air dryer

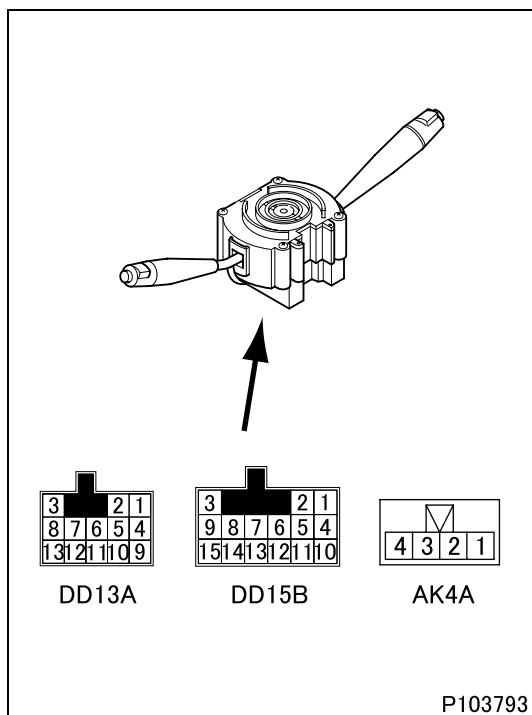
## #001 Inspection of combination switch

AK4A connector connection table <Auto cruise>

- If any fault is found, replace the switch. (See Gr37.)

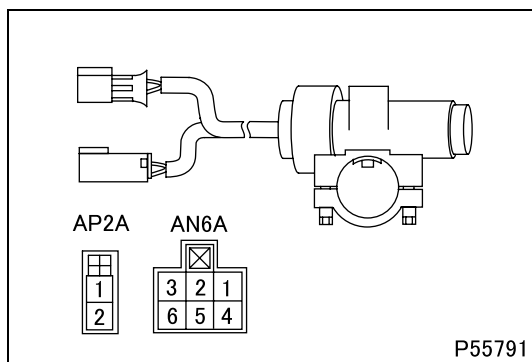
## #002 Inspection of starter switch

AP2A, AN6A connector connection table

- Terminal numbers within parentheses ( ) show terminals of AP2A.
- If any fault is found, replace the switch. (See Gr37.)

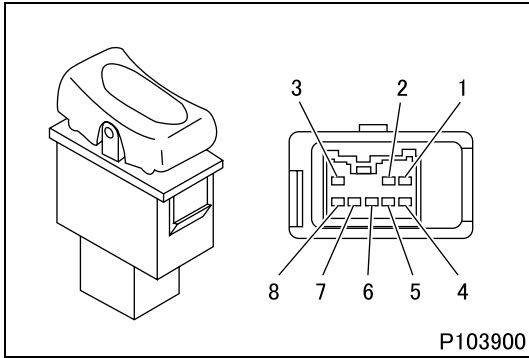
### #007 Inspection of cruise control main switch

- If any fault is found, replace the switch.

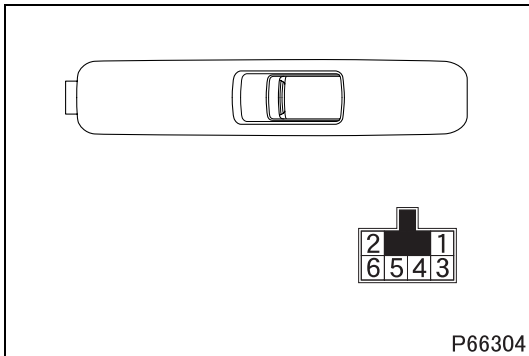
### #026 Inspection of power window switch (assistant driver's seat side)

- If any fault is found, replace the switch. (See Gr43.)

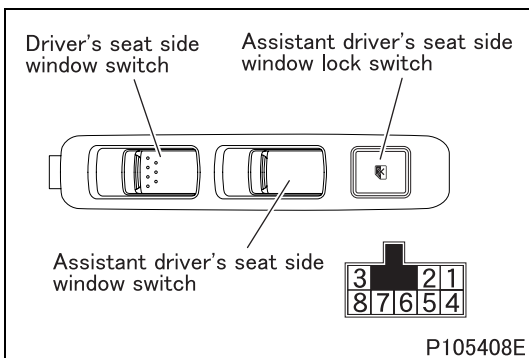
### #027 Inspection of power window switch (driver's seat side)

- If any fault is found, replace the switch. (See Gr43.)

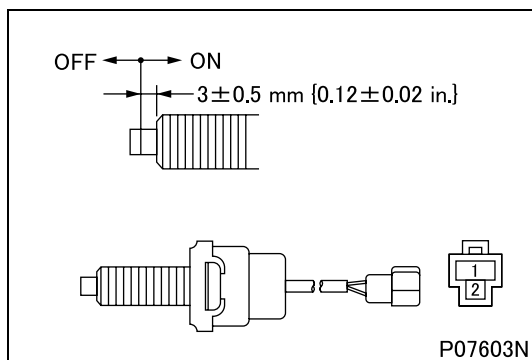
## #029 Inspection of accelerator switch

| Switch position | Continuity terminal |
|---|---|
| ON | 1–2 |

- If any fault is found, replace the switch.

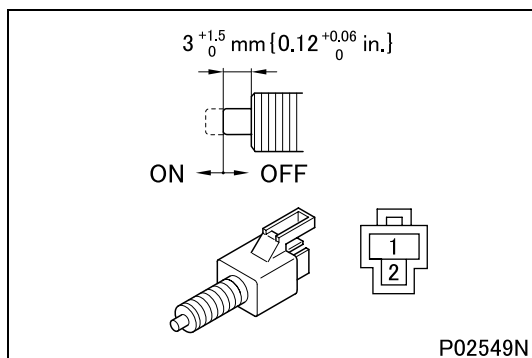
## #031 Inspection of clutch switch

| Switch position | Continuity terminal |
|---|---|
| ON | 1–2 |

- If any fault is found, replace the switch. (See Gr21.)

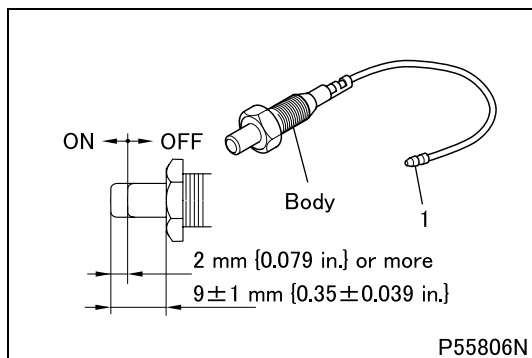
## #035 Inspection of door switch

| Switch position | Continuity terminal |
|---|---|
| ON | 1–body |

- If any fault is found, replace the switch. (See Gr43.)

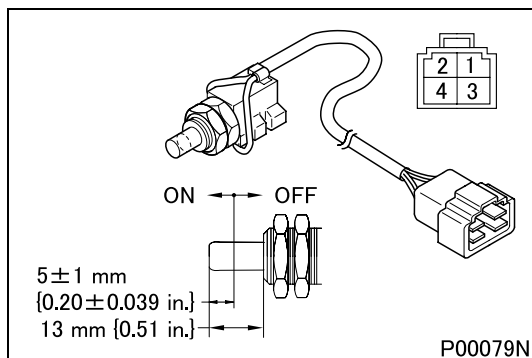
## #038 Inspection of parking brake switch

| Switch position | Continuity terminal |
|---|---|
| ON (PARK) | 2–4 |

- If any fault is found, replace the switch. (See Gr36A.)

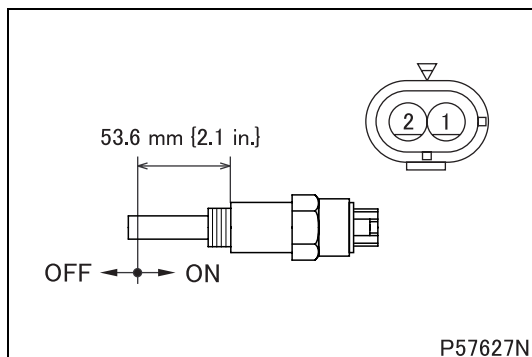
## #040 Inspection of brake booster stroke switch

| Switch position | Continuity terminal |
|---|---|
| ON | 1–2 |

- If any fault is found, replace the switch. (See Gr35A.)

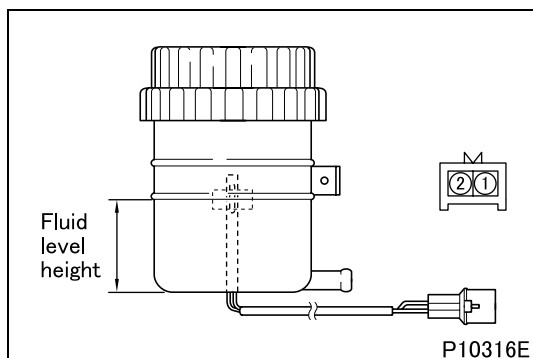
#### #041 Inspection of brake fluid level switch

- Gradually drain brake fluid from the brake fluid tank.

| Standard value | $57^{+3.5}_{-0.5}$ mm { $2.24^{+0.14}_{-0.02}$ in.}<br>(equivalent to 345 cm <sup>2</sup> {21.1 cu.in., 0.345 L}) |

- If the measured value deviates from the standard value, replace the brake fluid tank. (See Gr35A.)

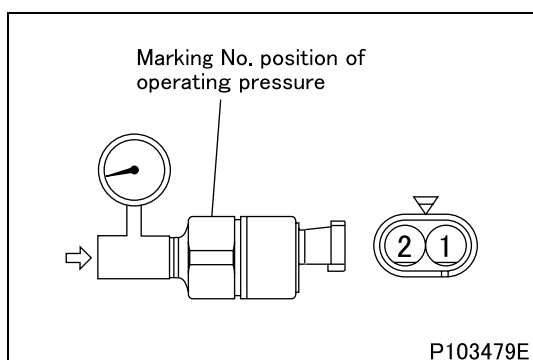
#### #042 Inspection of stop lamp switch

- Perform the following checks, and if any fault is found, replace the switch.

| Standard value<br>(operating pressure) | $490 \pm 19.6$ kPa<br>{ $71 \pm 2.8$ psi, $5.0 \pm 0.2$ kgf/cm <sup>2</sup> } |

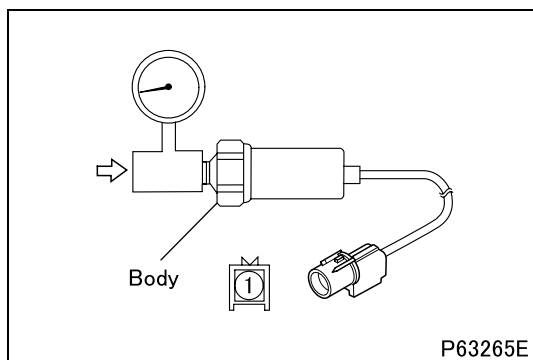
## #044 Inspection of engine oil pressure switch

- Perform the following checks, and if any fault is found, replace the switch.

- Gradually apply air pressure to the switch starting from 0 kPa {0 psi, 0 kgf/cm<sup>2</sup>}.
- Measure the degree of air pressure at the moment when continuity is detected between terminals 1 and body, and make sure to confirm if the value meets the standard.

| Standard value<br>(operating pressure) | 49 ± 9.8 kPa<br>{7.1 ± 1.4 psi, 0.5 ± 0.1 kgf/cm <sup>2</sup> } |

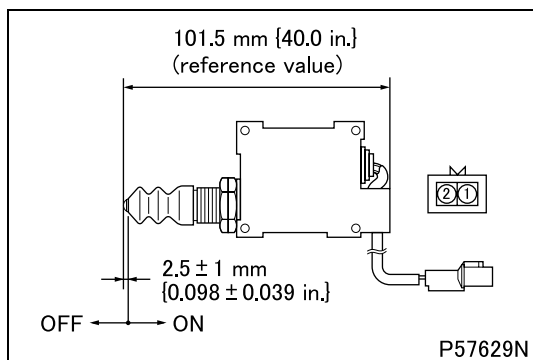
## #045 Inspection of cab tilt lock switch

| Switch position | Continuity terminal |
|---|---|
| ON | 1-2 |

- If any fault is found, replace the switch. (See Gr42.)

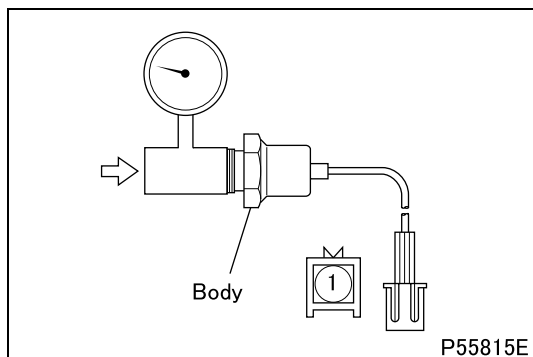
## #053 Inspection of engine oil bypass alarm switch

- Perform the following checks, and if any fault is found, replace the switch. (See Gr12.)

- Gradually apply air pressure to the switch starting from 0 kPa {0 kgf/cm<sup>2</sup>}.
- Measure the degree of air pressure at the moment when continuity is detected between terminals 1 and body, and make sure to confirm if the value meets the standard.

| Standard value<br>(ON pressure) | 185 <sup>+49</sup> / <sub>0</sub> kPa {27 <sup>+7.1</sup> / <sub>0</sub> psi, 1.9 <sup>+0.5</sup> / <sub>0</sub> kgf/cm <sup>2</sup> } |

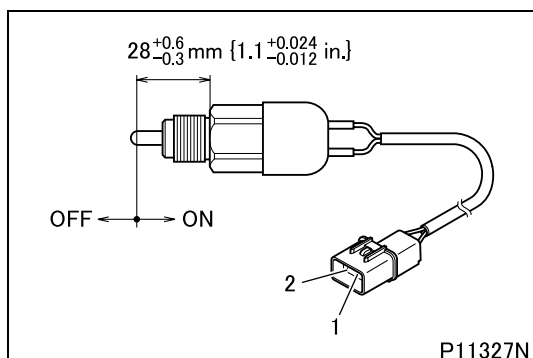
## #054 Inspection of backup lamp switch

| Switch position | Continuity terminal |
|---|---|
| ON | 1-2 |

- If any fault is found, replace the switch. (See Gr22A.)

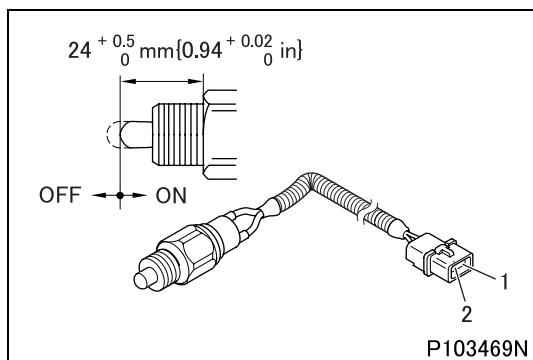
**#056 Inspection of transmission neutral switch**

- If any fault is found, replace the switch. (See Gr22A.)

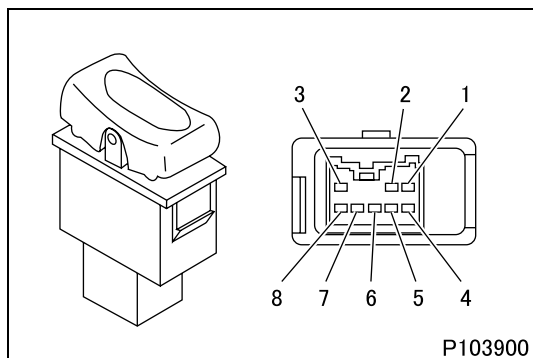
**#063 Inspection of height control switch**

| Switch position | Continuity terminal | Indicator light |
|---|---|---|
| DOWN | 7–8 | (+) 4–1 (–) |

- If any fault is found, replace the switch.

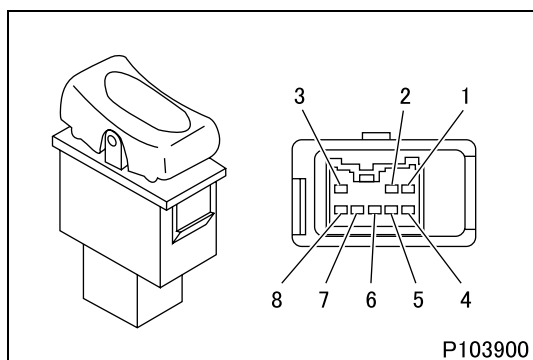
**#087 Inspection of switch**

- Perform the following checks, and if any fault is found, replace the switch.
- Van body dome light switch
- Power mode switch

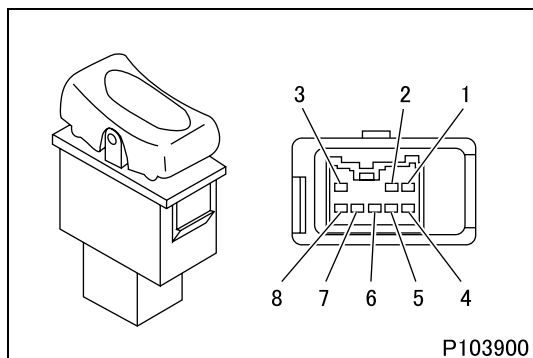
**#092 Inspection of engine oil level check switch**

- If any fault is found, replace the switch.

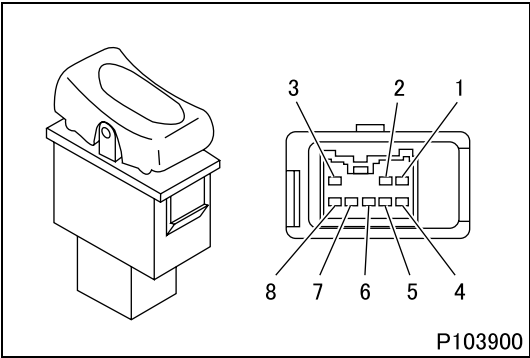
## #094 Inspection of door lock switch

| Switch position | Continuity terminal |
|---|---|
| UNLK | 2-7 |

- If any fault is found, replace the switch.

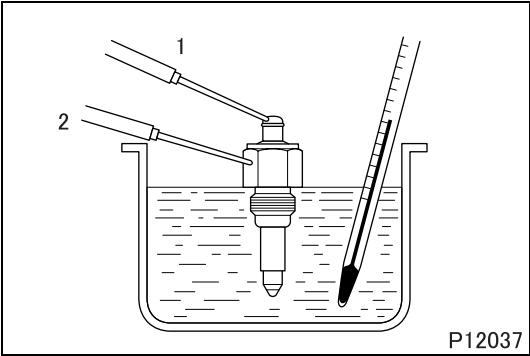
## #160 Inspection of overheating switch

- Dip the switch in a container filled with engine oil.
- Raise the oil temperature to the specified values and stir the oil.
- Measure the operating temperature between terminals 1 and 2 (body) respectively.

| | When temperature decrease (ON→OFF) | 99.5 to 112.5°C {211 to 235°F} |

- If the measured value deviates from the standard value, replace the switch. (See Gr14.)

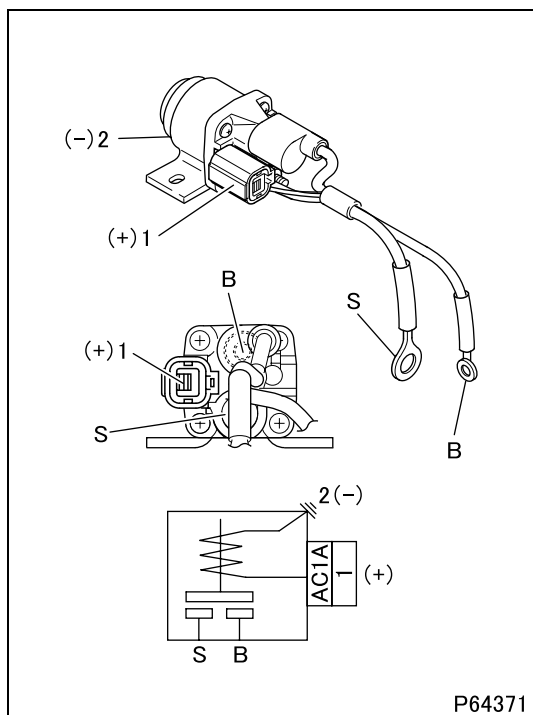
## #187 Inspection of starter relay

- Perform continuity check and operation check, and if any fault is found, replace the relay.

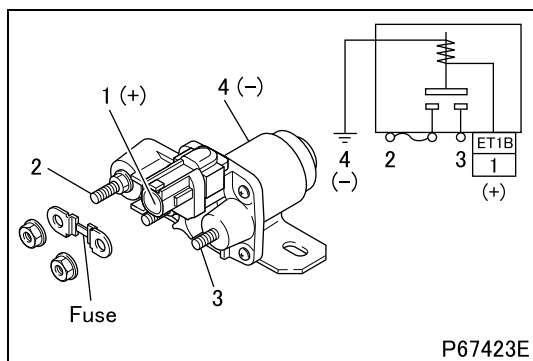
## #195 Inspection of glow relay

- Perform continuity check and operation check, and if any fault is found, replace the relay.

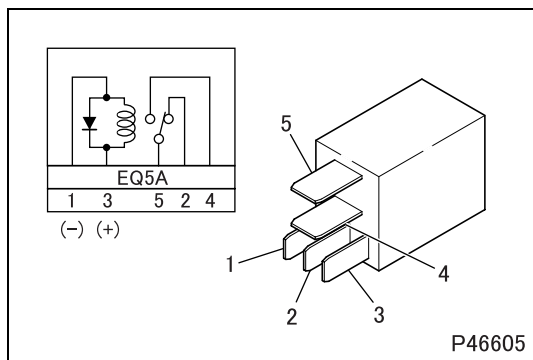
## #201 Inspection of relay (normally-open type, 5-pin)

- Perform continuity check and operation check, and if any fault is found, replace the relay.

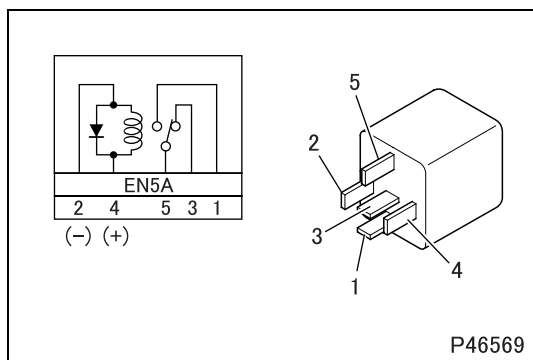
## #202 Inspection of relay (normally-open type, 5-pin)

- Perform continuity check and operation check, and if any fault is found, replace the relay.

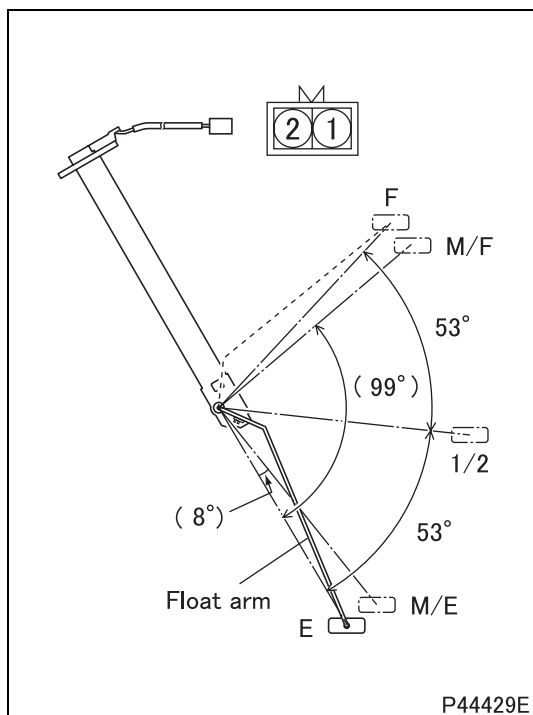
### #258 Inspection of fuel level sensor

- Perform the following checks, and if any fault is found, replace the sensor. (See Gr13A.)
- Measure the resistance between terminals 1 and 2 with the float arm at FULL, MIDDLE FULL, 1/2, MIDDLE EMPTY and EMPTY positions.

| | E (EMPTY) | 150 $\pm$ 10 $\Omega$ |

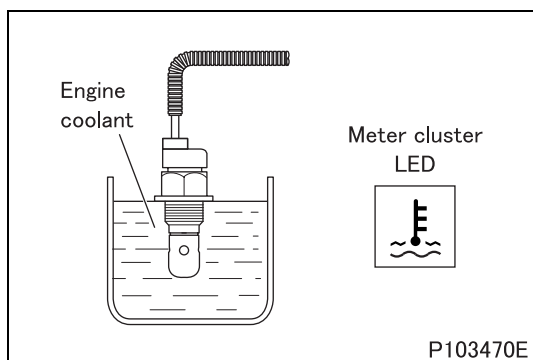
### #259 Inspection of water level sensor

- Remove the water level sensor from the radiator.
- Turn the starter switch ON.
- Dip the water level sensor in a container filled with engine coolant, and check that the meter cluster warning lamp goes on and out under the following conditions.

- If any fault is found, replace the sensor. (See Gr14.)

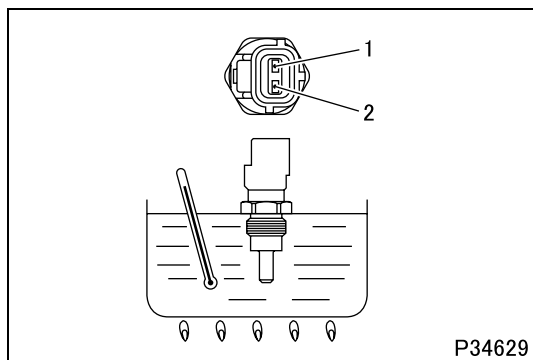
### #262 Inspection of water temperature sensor

- Dip the sensor in a container filled with engine oil.
- Raise the oil temperature to the specified one while stirring the oil.
- Measure the resistance between terminals 1 and 2.

| | 110°C {230°F} | 147.1 $\pm$ 2 $\Omega$ |

- If the measured value deviates from the standard value, replace the sensor. (See Gr14.)

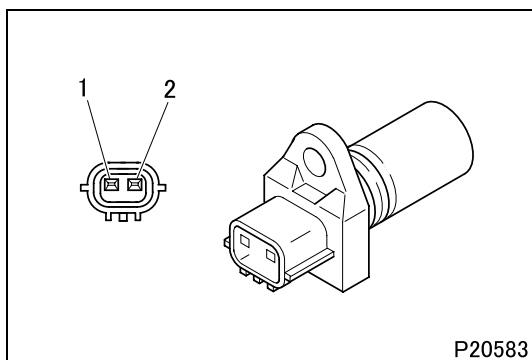
P20583

### #263 Inspection of engine speed sensor

| Standard value<br>(at 20°C {68°F}) | 125.5 ± 17 Ω |

- If the measured value deviates from the standard value, replace the sensor. (See Gr11.)

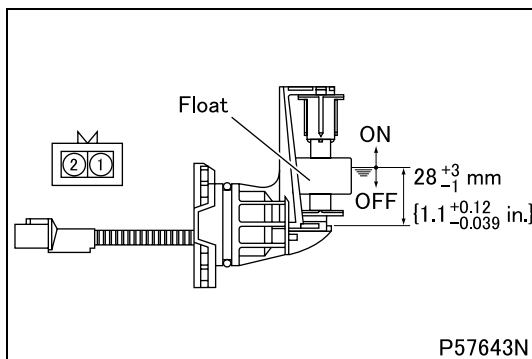
P57643N

### #264 Inspection of engine oil level sensor

- If any fault is found, replace the sensor. (See Gr12.)

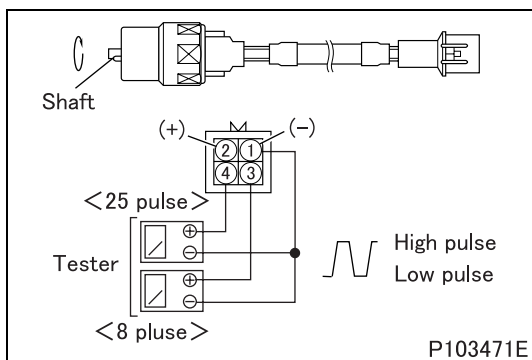
P103471E

### #265 Inspection of vehicle speed sensor

- If the measurement is not within the range of the standard value, replace the sensor. (See Gr22A, B and 23A, B.)

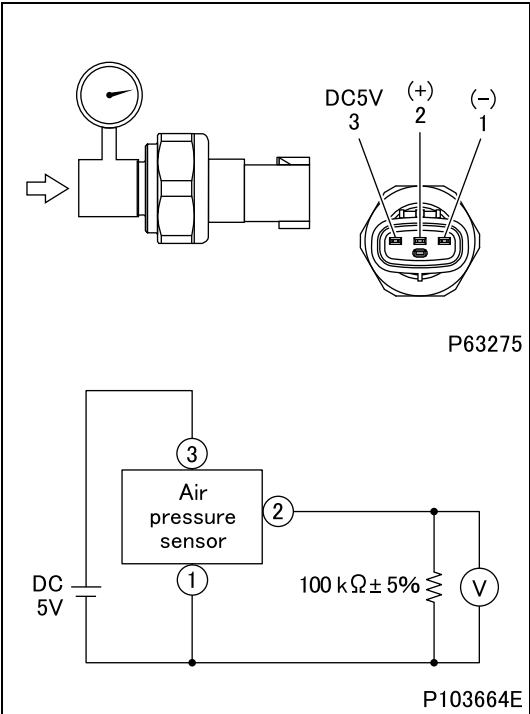
## #269 Inspection of air pressure sensor

- Apply air pressure to the air pressure sensor with 5 Volts DC applied between the terminals 1 and 3.
- Measure voltage between the terminals 1 and 2 at each air pressure.

| | 1.47 MPa {215 psi, 15 kgf/cm <sup>2</sup> } | 4.5 V |

- If measured value deviated from the standard value, replace the sensor.

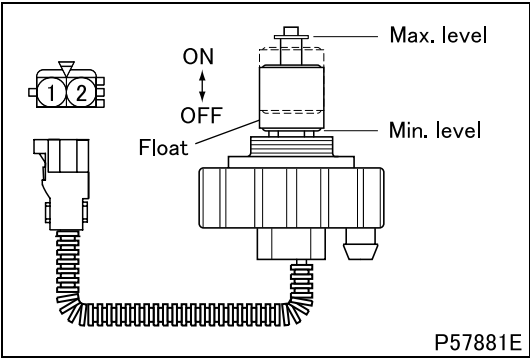
## #274 Inspection of water separator sensor

- If any fault is found, replace the sensor. (See Gr13A.)

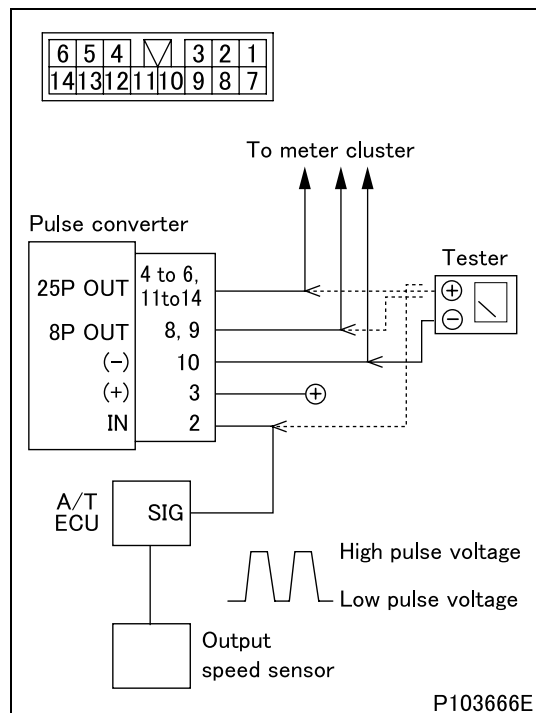
## #352 Inspection of pulse converter

- Check the pulse converter and automatic transmission electronic control unit in the on-vehicle state.
- Slowly rotate the wheels using a chassis dynamo, etc. in the state of starter switch ON.
- Measure the maximum voltage (high pulse voltage) and the minimum voltage (low pulse voltage) in each of the output terminals of the pulse converter.

- If the measurement deviates from the standard value, replace the pulse converter.

- If the measurement complies with the standard value, replace the pulse converter as the signal from the automatic transmission electronic control unit is judged to be normal.
- If the measurement deviates from the standard value, check the automatic transmission. (See Gr23A, B.)

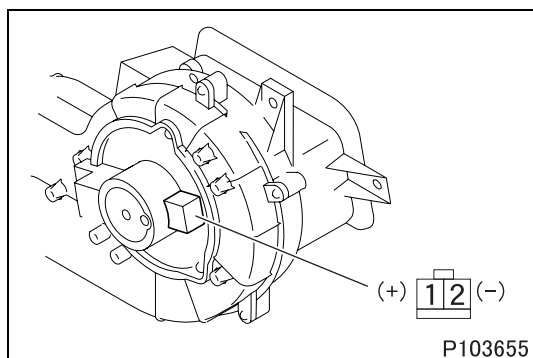
## #411 Inspection of blower motor

- Make sure that the motor operates when battery voltage is applied between terminals 1 and 2.
- If any fault is found, replace the motor. (See Gr55.)

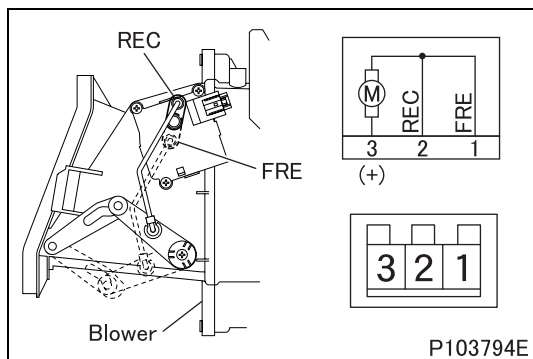
## #415 Inspection of fresh/recirculation changeover motor

- Perform the following checks, and if any fault is found, replace the motor. (See Gr55.)
- Make sure that the motor operates when DC12V is applied between each terminal.

- Stop applying DC12V if the lever stops spontaneously at the REC or FRE position.

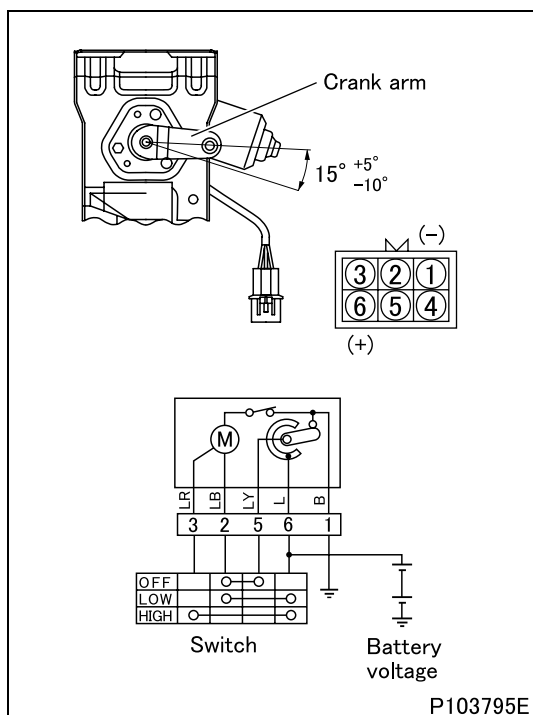
## #422 Inspection of wiper motor

- Connect a switch to wiper motor as shown.
- Check the motor for correct operation as follows. If any fault is found, replace the motor. (See Gr51.)

- Set switch to LOW position to let the motor rotate at low speed.
- When the crank arm is in a position other than automatic stop position (outside the angles shown), set switch to OFF position.
- Check to see that the crank arm stops at the automatic stop position (within the angles range shown).

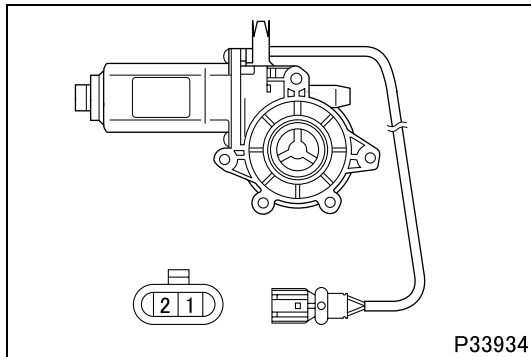
## #423 Inspection of power window motor

- Make sure that the motor operates when battery voltage is applied between terminals 1 and 2.

- If any fault is found, replace the motor. (See Gr43.)

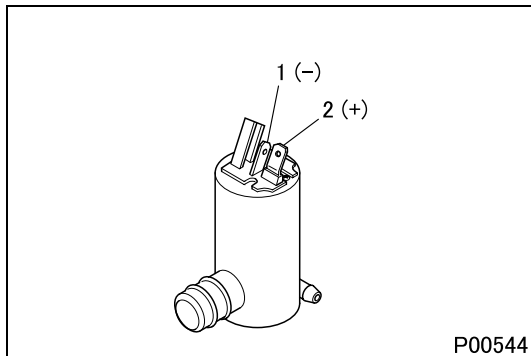
## #428 Inspection of windshield washer motor

- Make sure that the motor operates when battery voltage is applied between each terminals.
- If any fault is found, replace the motor. (See Gr51.)

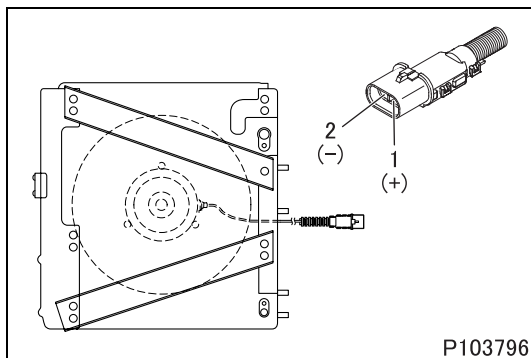
## #431 Inspection of condenser fan motor

- Make sure that the motor operates when battery voltage is applied between terminals 1 and 2.
- If any fault is found, replace the condenser. (See Gr55.)

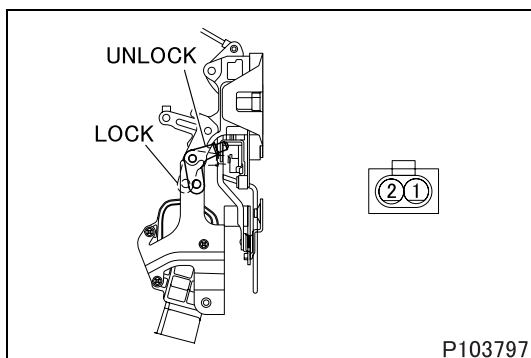
## #510 Inspection of door lock actuator (on assistant driver's seat side)

- Apply battery voltage between terminals 1 and 2 and confirm that the actuator operates.

- If any fault is found, replace the actuator. (See Gr43.)

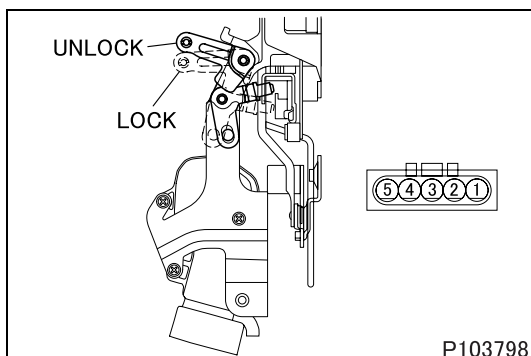
## #511 Inspection of door lock actuator (on driver's seat side)

- Apply battery voltage between terminals 4 and 5 and confirm that the actuator operates.

- If any fault is found, replace the actuator. (See Gr43.)

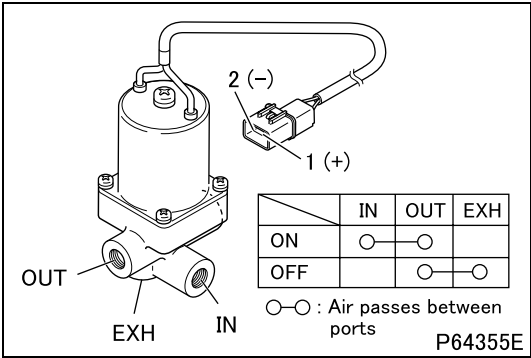
## #565 Inspection of 3-way magnetic valve

### <Type-1>

- Perform the following checks, and if any fault is found, replace the 3-way magnetic valve.

- Air pressure when inspected: 981 kPa {140 psi, 10 kgf/cm<sup>2</sup>}

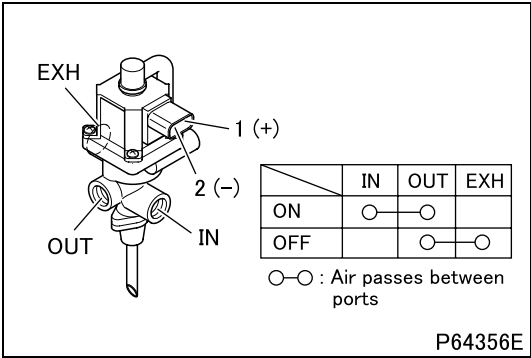
### <Type-2>

- Perform the following checks, and if any fault is found, replace the 3-way magnetic valve.

- Air pressure when inspected: 981 kPa {140 psi, 10 kgf/cm<sup>2</sup>}

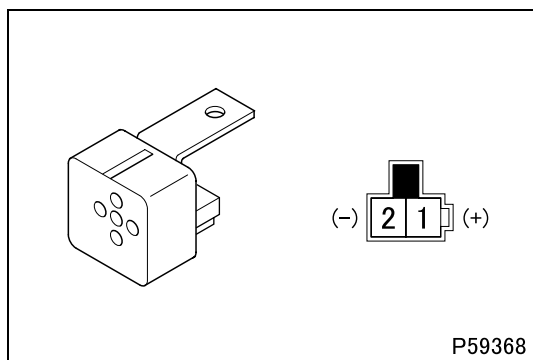
## #611 Inspection of warning buzzer

- Make sure that the buzzer sounds when battery voltage is applied between terminals 1 and 2.
- If any fault is found, replace the buzzer.

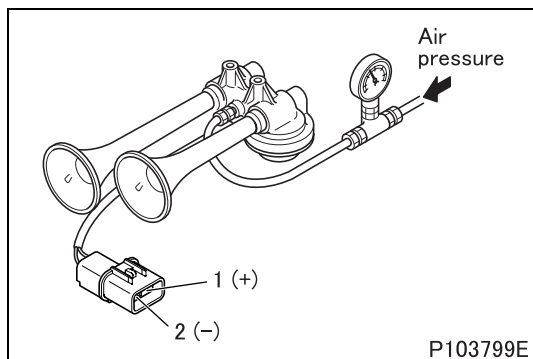
## #612 Inspection of air horn

- Apply DC voltage between terminals 1 and 2.
- Gradually apply air pressure to the horn starting from 0 kPa {0 psi, 0 kgf/cm<sup>2</sup>}.
- Measure the air pressure when the horn sounds.

| Standard value | 195 to 980 kPa<br>{28 to 142 psi, 2 to 10 kgf/cm <sup>2</sup> } |

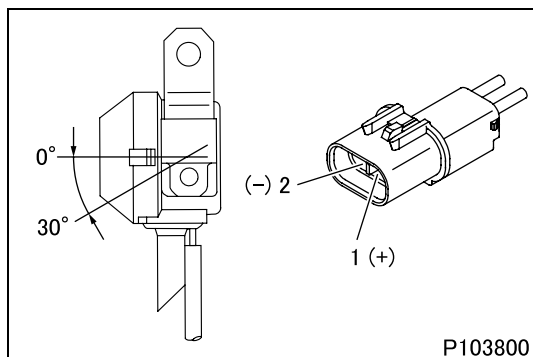
## #614 Inspection of back buzzer

- Make sure to confirm if the buzzer intermittently sounds by applying the battery voltage between terminals 1 and 2.
- If any fault is found, replace the buzzer.

- Beware that if the installed angle of the buzzer is out of the range as illustrated, water in the buzzer will not be drained normally.

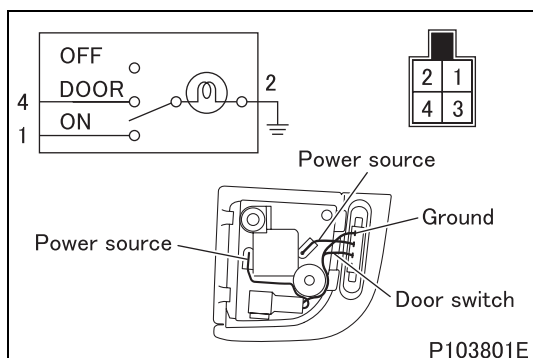
## #652 Inspection of personal lamp

- If any fault is found, replace the lamp.
- Shown in the illustration is the back side of the driver's seat side lamp.

The assistant driver's seat side lamp is symmetrical to driver's seat side lamp.

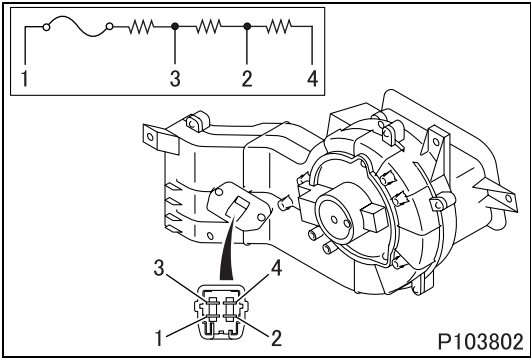
## #750 Inspection of blower resistor

- Measure resistance values between each terminals.

- If the measured value deviates from the standard value, replace the blower resistor. (See Gr55.)

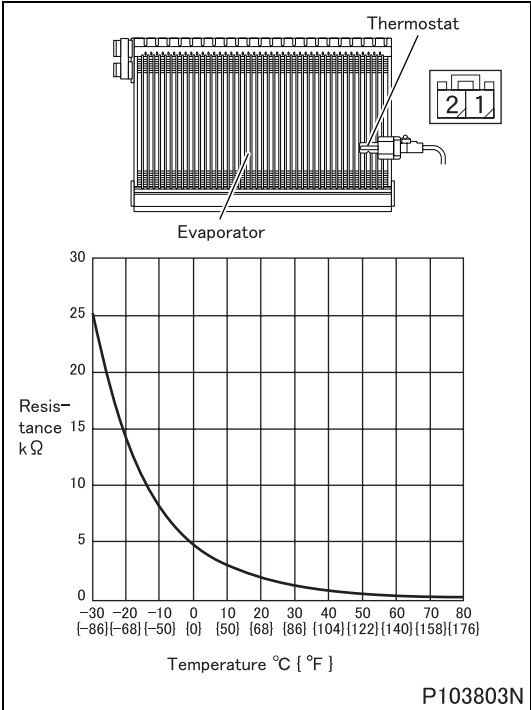
## #751 Inspection of thermostat

- Change surrounding temperatures of the thermostat and measure resistance between the terminals 1 and 2.
- If measured value deviates from the temperature characteristic curve shown at the left, replace the thermostat. (Standard resistance: 4.852  $k\Omega$  at 0 $^{\circ}C$ ) (See Gr55.)

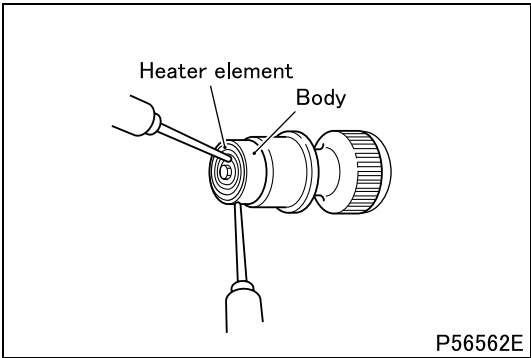
## #754 Inspection of cigarette lighter

- Perform the following checks, and if any fault is found, replace the cigarette lighter.
- Make sure that there is continuity between heater element and body.

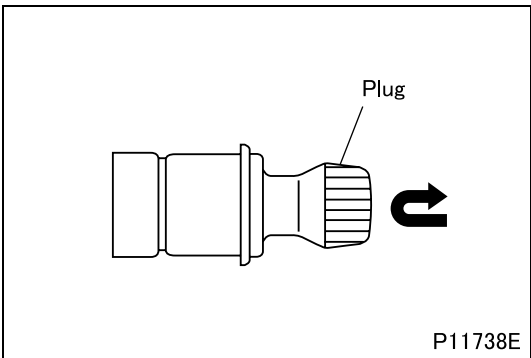
- Make sure that when plug is pushed in by hand, it immediately returns to its original position.
- Place the starter switch at ACC or ON position.
- Push plug into the socket in the cab.
- Measure the time required for plug to automatically return.

| Standard value | 15 $\pm$ 5 seconds |

- Check to see that heater element is red-hot.

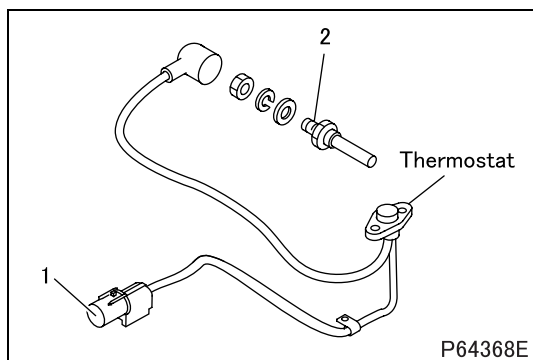
## #758 Inspection of air dryer

### (1) Inspection of thermostat

- Perform the following check. If any fault is found, replace the thermostat. (See Gr35A, B.)
- While varying the temperature around the thermostat, measure the temperatures when the continuity is established and is lost between terminals 1 and 2.

| Standard value | Lowering the temperature | Temperature when continuity is established (ON temperature) | $4 \pm 4^{\circ}\text{C}$ { $39 \pm 39^{\circ}\text{F}$ } |

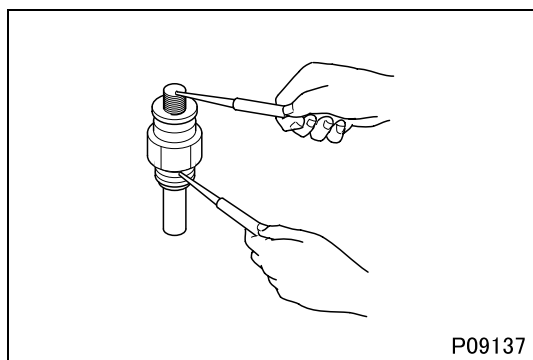
### (2) Inspection of heater

- Measure the resistance of heater as shown.

| Standard value | 8.2 $\Omega$ or less |

• If the measured value is out of the standard value, replace the heater. (See Gr35A, B.)

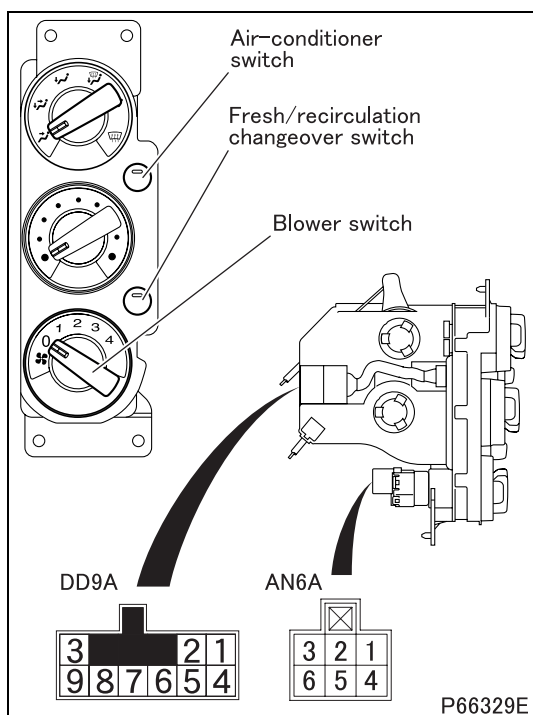
## #763 Inspection of heater control panel

- Perform the following checks, and if any fault is found, replace the heater control panel. (See Gr55.)

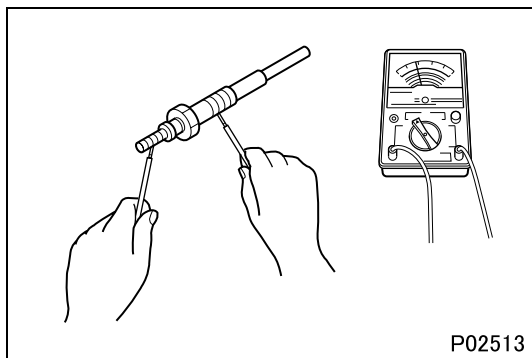
### #764 Inspection of glow plug

- Measure resistance value of glow plug as shown.

- If the measured value deviates from the standard value, replace the glow plug. (See Gr11.)

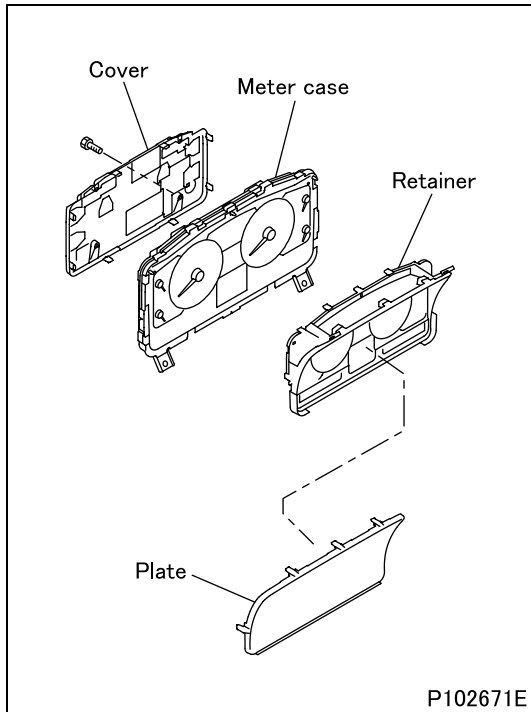
## #890 Meter cluster

- Each sensor signal is converted into digital signal in the meter cluster and then the value is indicated by the corresponding meter on the cluster. Therefore, a signal meter inspection cannot be performed.  
Each meter should be checked indirectly by checking its related harnesses and parts.
- If the related harnesses and parts are normal but the meter indication is faulty, replace the meter cluster.

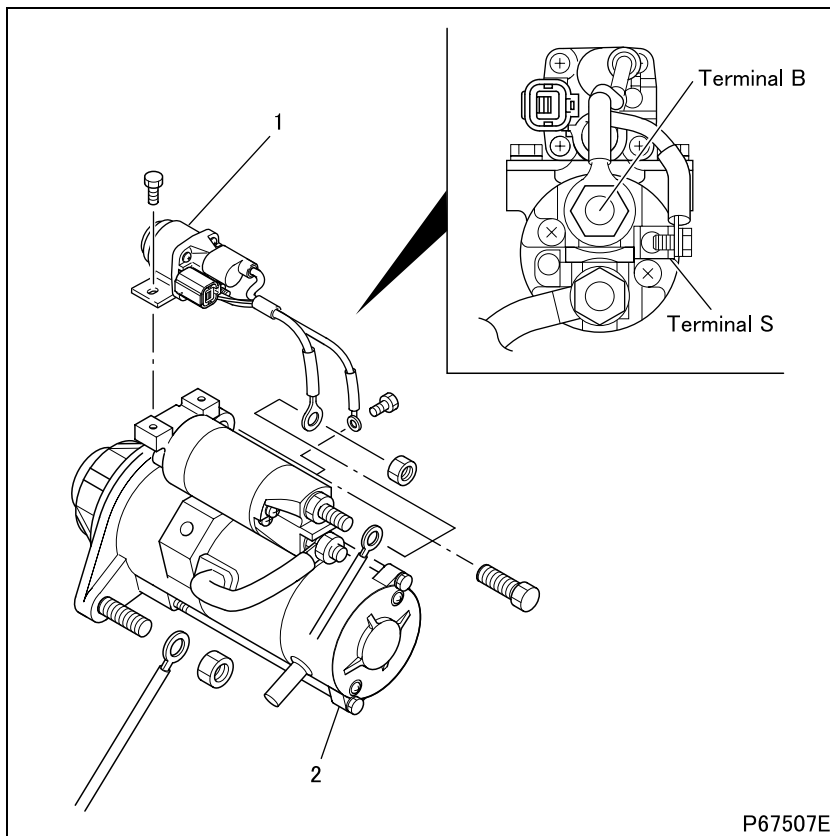
## ● Removal sequence

- 1 Starter relay
- 2 Starter

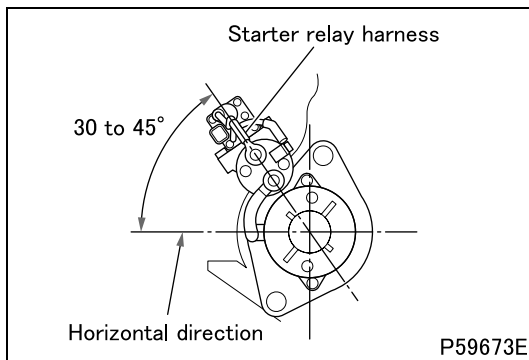
- To prevent the interference with the air intake hose, route the starter relay harness within the range shown in the drawing.
