# FE.FG

## SERVICE MANUAL 2008 Model FOREWORD

This Service Manual contains maintenance and repair methods for the Mitsubishi Fuso Truck FE. FG Series. Read this manual carefully as an aid in providing correct, efficient maintenance. Please note that the information and specifications contained within this manual may change without notice. This is due to product modifications and continued vehicle improvements that are made throughout the model years. Should you encounter any discrepancy in the information provided, please do not hesitate to contact your nearest Mitsubishi Fuso Dealer or Mitsubishi Fuso Truck of America, Inc.

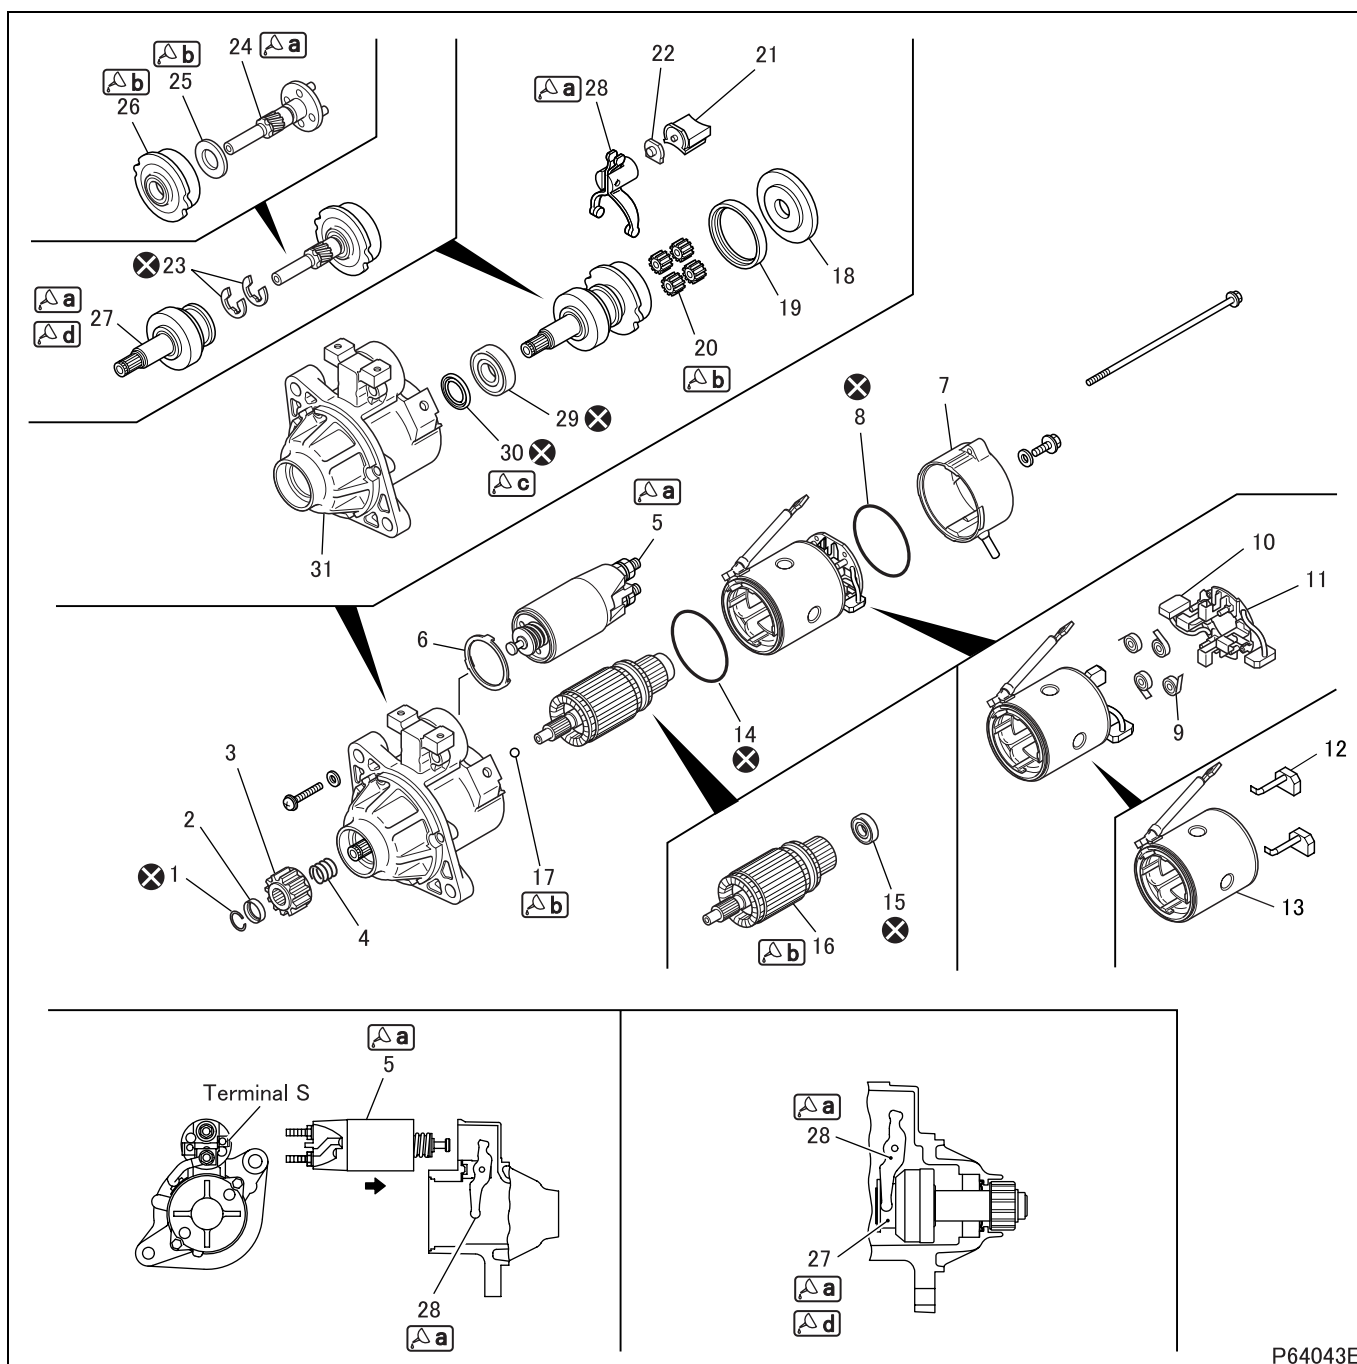
P64043E

## ● Disassembly sequence

- Do not remove the rear bearing unless defects are evident.
- It is not necessary to remove the pinion when only the motor section needs to be disassembled for inspection, like when inspecting brushes and related parts.
- Be sure to remove the pinion before disassembling any other parts.

- Whenever the magnetic switch is replaced, the pinion gap must be adjusted.
- The rubber packing is serviceable if any defect is not found.

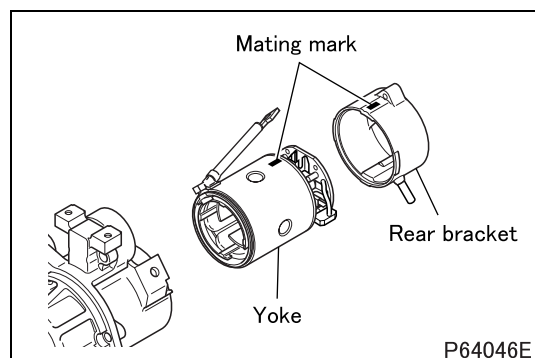
## ■ Mating mark: Rear bracket and yoke

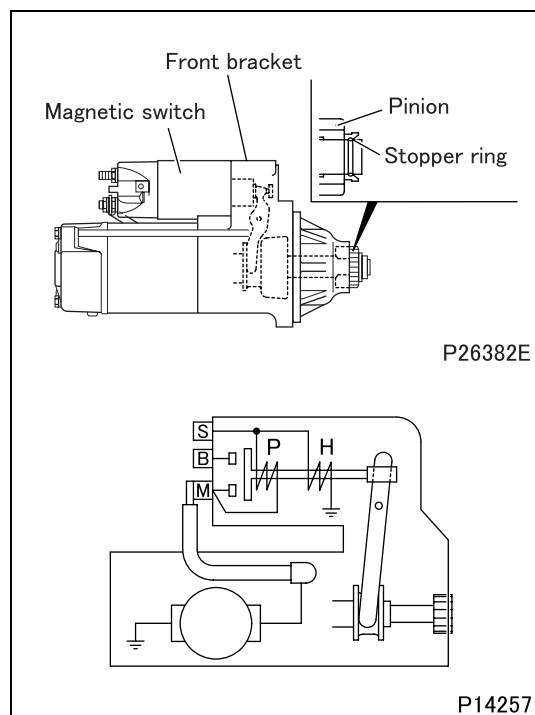
## ■ Disassembly: Pinion

- For removal of the pinion, current must be supplied to the starter such that the pinion springs out.

- Do not energize the pull-in coil P for longer than 10 seconds, and do not energize the holding coil H for longer than 30 seconds. If these periods are exceeded, the coils may overheat and burn out.
- To make the pinion spring out, be sure to energize the starter such that its parts are positioned correctly. If the starter is not energized and the lever is pulled to make the pinion come out, the front bracket and/or lever may be damaged by the shock inflicted upon them when the stopper ring is removed.
- When current is supplied to the starter, a large current (100 A or higher) will flow. For inspection purposes, use booster cables or similarly thick cables. It is also important to ensure that all connections are secure.

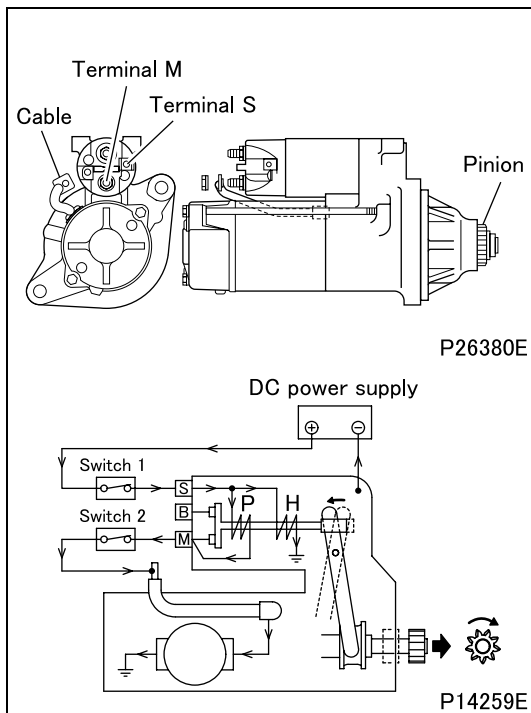
- Connect the starter as illustrated.
- The following operations are performed with current supplied to the starter. Thus, the entire procedure for removal of the pinion must be completed within 30 seconds.
- Turn ON switches 1 and 2 to supply current to the starter. The pinion will spring out and rotate.

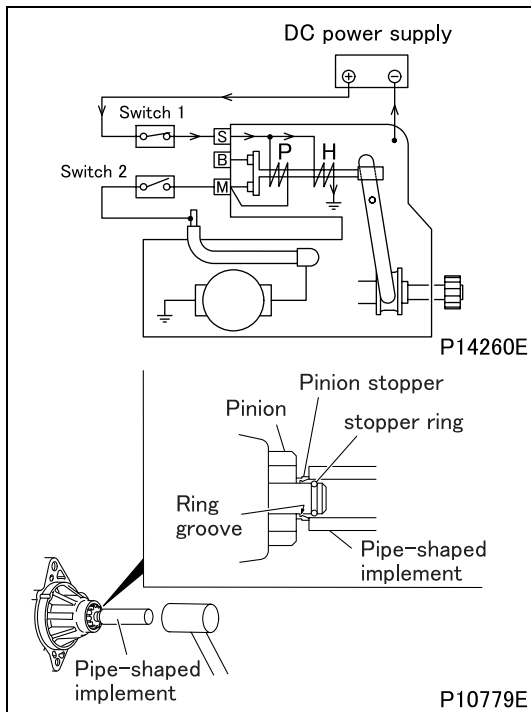
- After the pinion starts to rotate, quickly (within five seconds) turn OFF switch 2 to stop the pinion's rotation.

- When switches 1 and 2 are turned ON, the pull-in coil P and holding coil H are both energized. The circuit is connected such that no voltage is applied to starter terminal B, so current flows to the pull-in coil while the pinion rotates. To prevent the pull-in coil from burning out, it is essential to turn OFF switch 2 quickly (within five seconds) after the pinion starts to rotate.

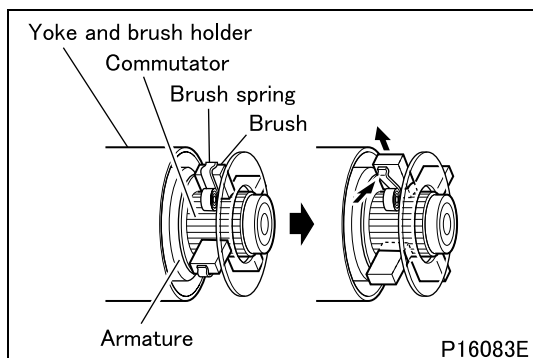
## ■ Disassembly: Yoke and brush holder

- Use the following method to remove the yoke and brush holder in order to prevent the commutator of the armature from being damaged by the brushes.
- Lift the brushes away from the commutator and hold them lifted by applying the brush springs against the sides of the brush springs.

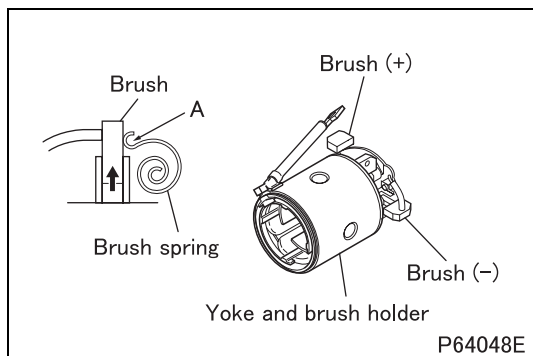
- Pull part A of each brush spring and pull up the brushes.
- Hold the brushes in position with the brush springs as illustrated.
- Remove the yoke and brush holder.

- To install the yoke and brush holder, follow the removal sequence in reverse.  
(See “**■ Disassembly: Yoke and brush holder**”.)

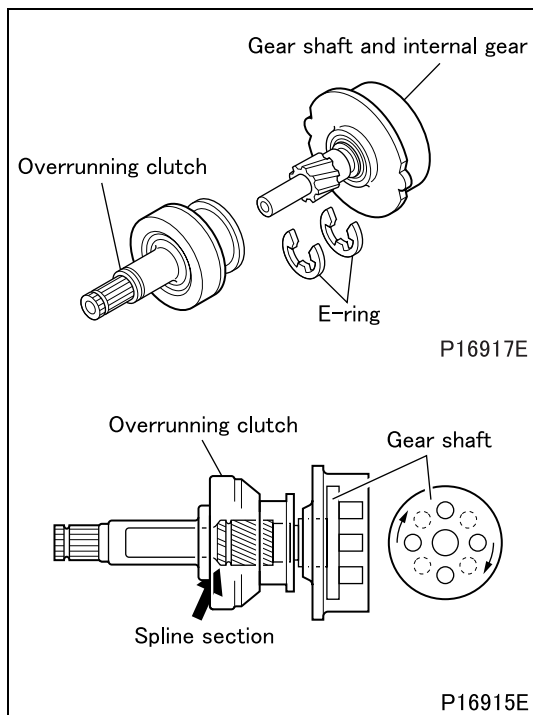
## ■ Disassembly: Gear shaft and internal gear

- Remove the E-rings and then the gear shaft and internal gear from the overrunning clutch. Proceed as follows if the gear shaft cannot be removed due to interference of the splined section of gear shaft with internal parts of the overrunning clutch.
- Press the gear shaft against the overrunning clutch.
- Turn the gear shaft approx. 1/8 of a turn to change the position of splined section.

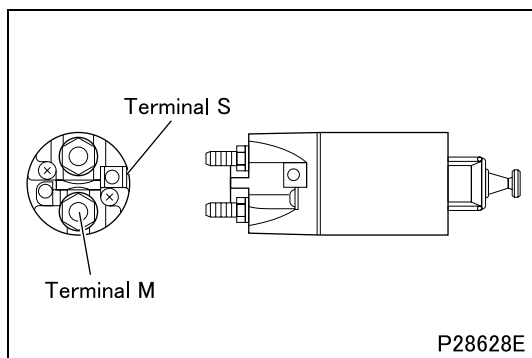
#### (1) Test for coil open circuit

- Check that continuity exists between terminals S and M.

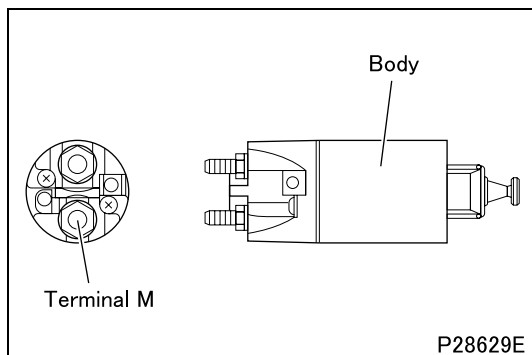
- Check that continuity exists between terminal M and the body.

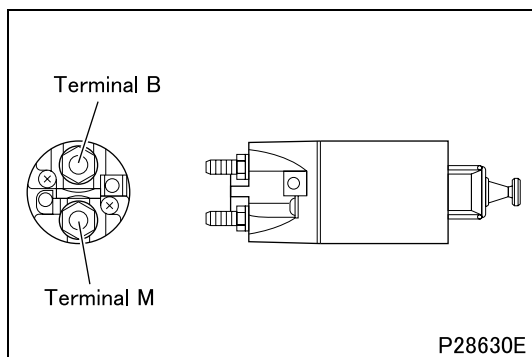
#### (2) Test for fused-together contacts

- Check that continuity does not exist between terminals B and M.

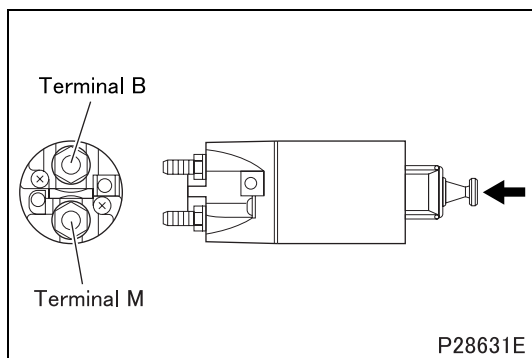
#### (3) Test for contact-to-contact continuity

- Push in the end of the magnetic switch to close the internal contacts. Then, check that continuity exists between terminals B and M.

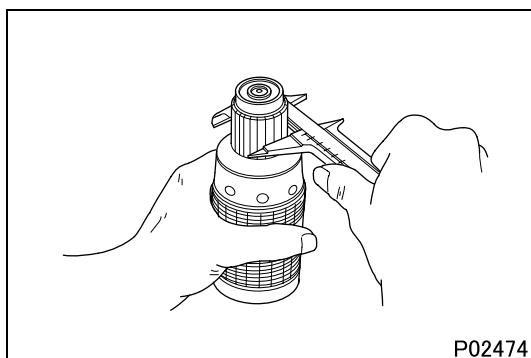
#### (3) Commutator outside diameter

- If the measurement is out of specification, replace the armature.

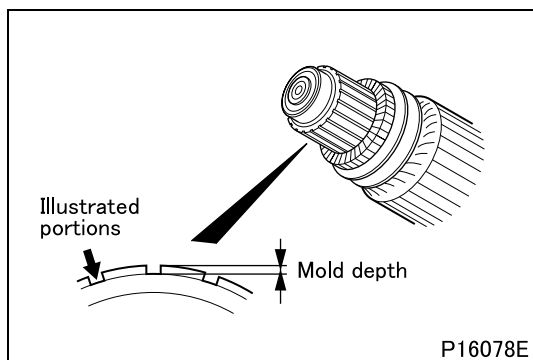
## (6) Mold depth between segments

- If the measurement is lower than the specified limit, rectify or replace the armature.
- To rectify the armature, grind the illustrated portions.

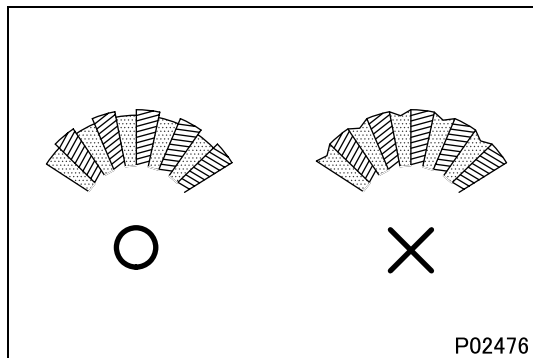
- If the mold is worn as illustrated, rectify or replace the armature.

O : Acceptable

x : Unacceptable

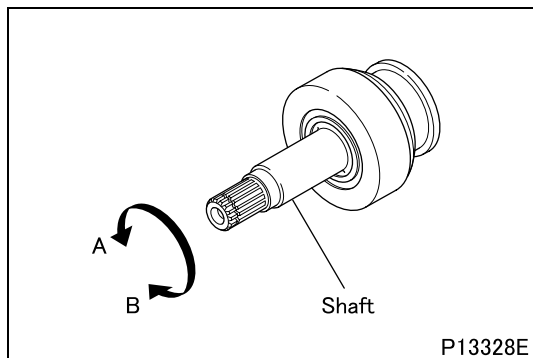
## ■ Inspection: Overrunning clutch

- If the following inspections reveal any abnormality, replace the overrunning clutch.
- Turn the shaft in direction B and check that it rotates smoothly.
- Turn the shaft in direction A and check that it locks.

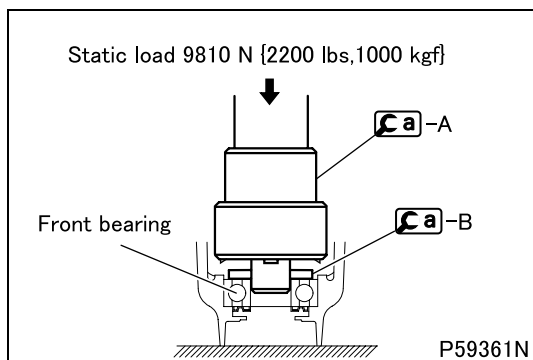
## ■ Assembly: Front bearing

- Press-fit the front bearing using **Ca**-A and **Ca**-B.

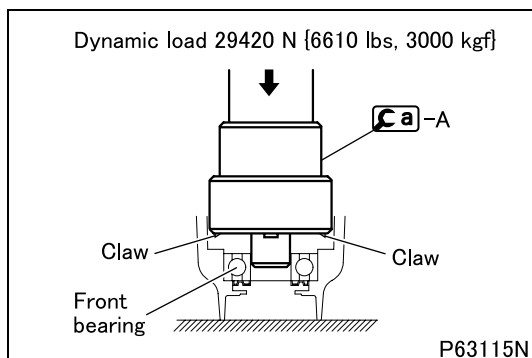
- After the press fitting, caulk the front bearing using the claws on **Ca-A**.

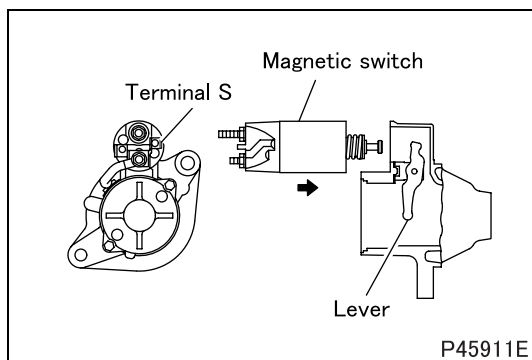
**■ Assembly: Magnetic switch**

- Fit the magnetic switch onto the lever with terminal S aligned as illustrated.

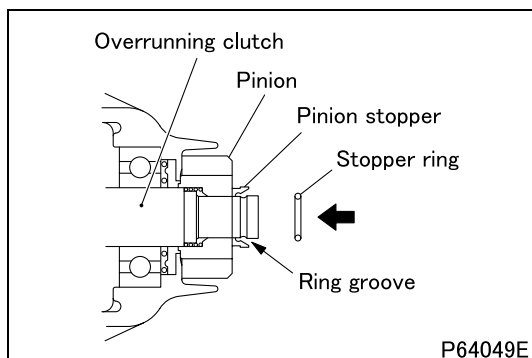
**■ Assembly: Pinion**

- For installation of the pinion, it is not necessary to supply current to the starter.
  - Fit the pinion stopper and pinion onto the overrunning clutch, making sure they are oriented as illustrated.
  - Fit the stopper ring into the ring groove of the overrunning clutch.

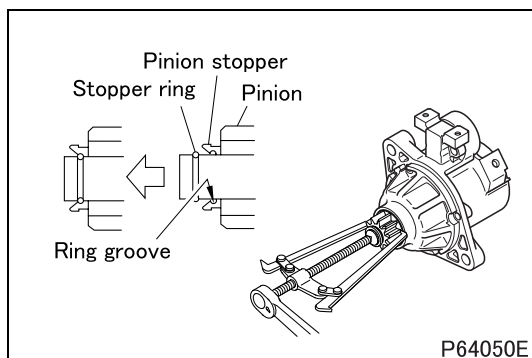
- Pull the pinion hard and securely fit the stopper ring into the ring groove of the pinion stopper.

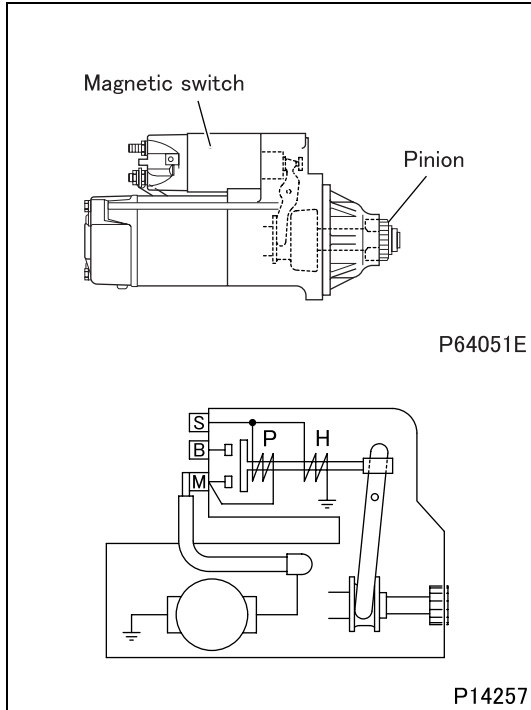
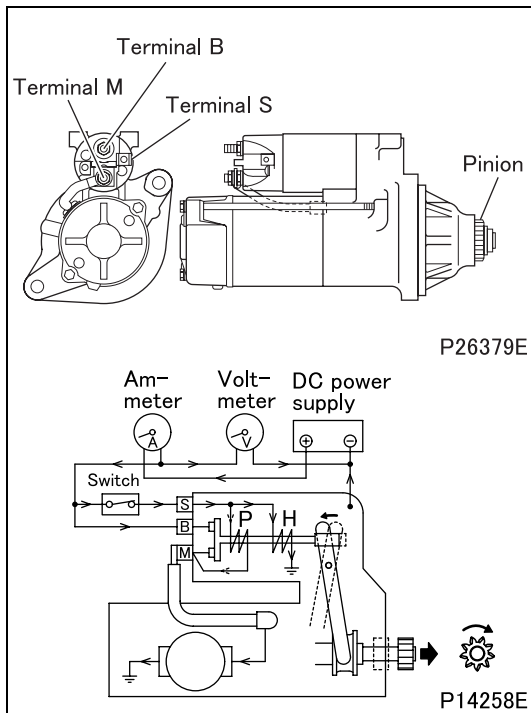
### ■ Inspection: Performance and pinion gap

- After assembling the starter, perform inspections with current supplied to it.

- Measure the current and the starter's rotational speed. To measure the rotational speed, shine a stroboscope on the pinion.
- Turn OFF the switch to de-energize the starter.
- If either measurement is out of specification, disassemble and inspect the starter again.

- When the switch is turned ON, the pull-in coil P and holding coil H are both energized. When the large current from the DC power supply flows from terminal B to terminal M, the supply of current to the pull-in coil P is cut; only the holding coil H remains energized. To prevent the holding coil from burning out, it is essential to complete all operations within 30 seconds.

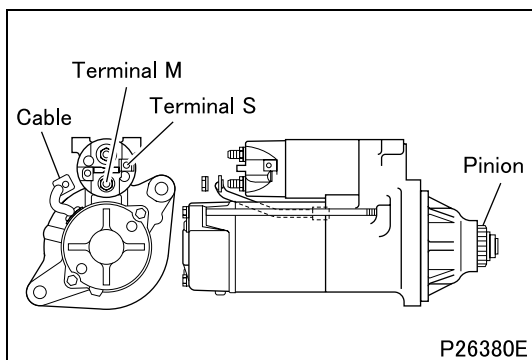
## (2) Pinion gap

- Connect the starter as illustrated.

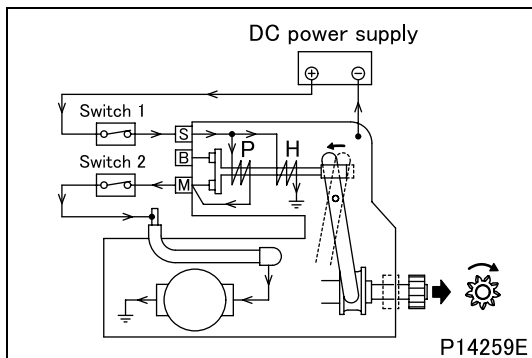
- The following operations are performed with current supplied to the starter. Thus, the entire procedure for measurement of the pinion gap must be completed within 30 seconds.
- Turn ON switches 1 and 2 to supply current to the starter. The pinion will spring out and rotate.

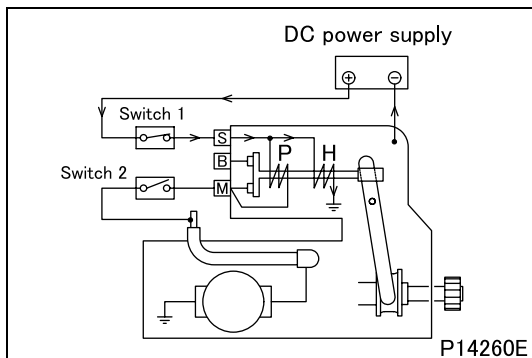
- After the pinion starts to rotate, quickly (within five seconds) turn OFF switch 2 to stop the pinion's rotation.

- When switches 1 and 2 are turned ON, the pull-in coil P and holding coil H are both energized. The circuit is connected such that no voltage is applied to starter terminal B, so current flows to the pull-in coil while the pinion rotates. To prevent the pull-in coil from burning out, it is essential to turn OFF switch 2 quickly (within five seconds) after the pinion starts to rotate.

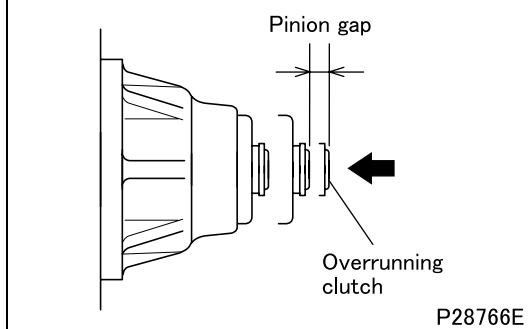
- Pull out the end of the overrunning clutch and then lightly push in the end of the overrunning clutch and measure the amount of movement in the axial direction, i.e., the pinion gap.
- Turn OFF switch 1 to de-energize the starter.
- If the measurement is out of specification, replace the lever.

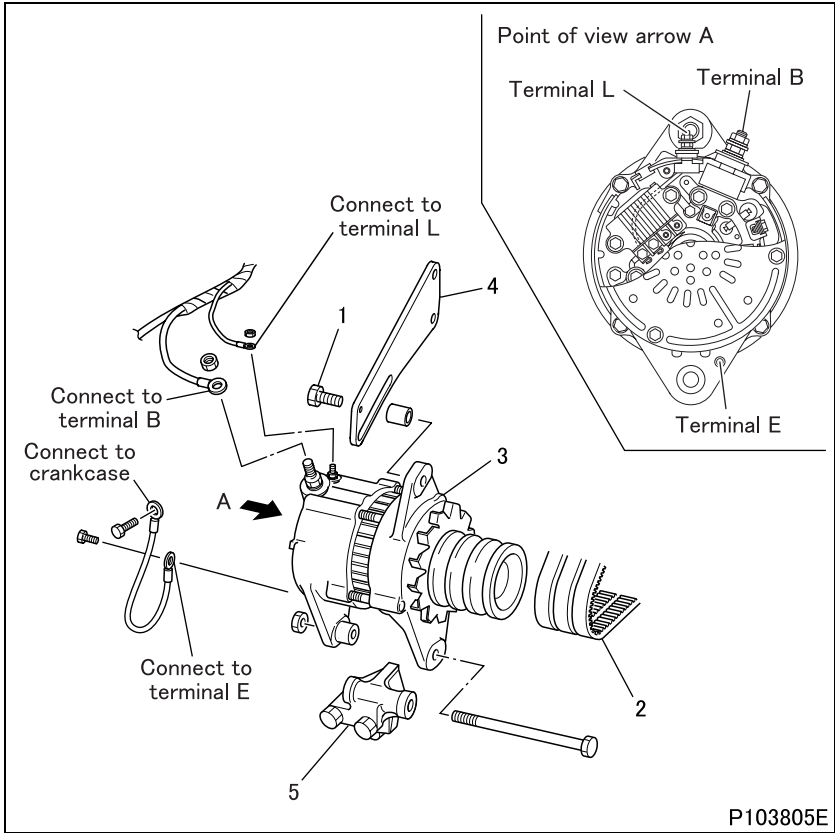
## ● Removal sequence

- 1 Adjusting bolt
- 2 Belt
- 3 Alternator
- 4 Adjusting plate
- 5 Bracket

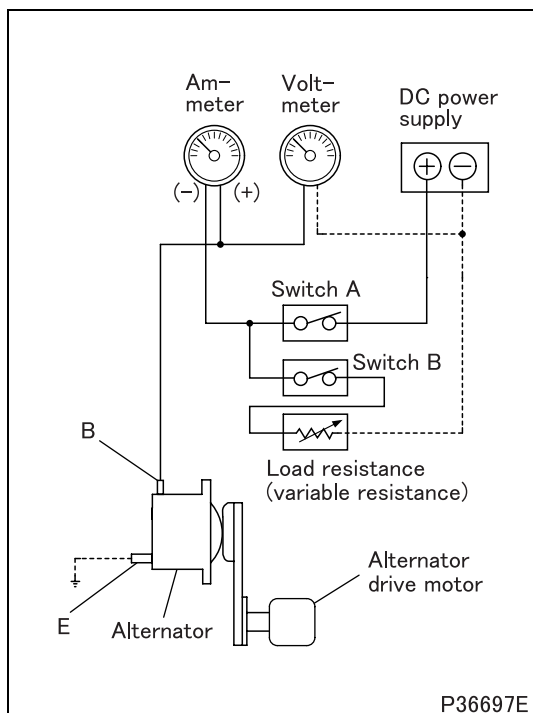
### ■ Inspection: Alternator

#### (1) Alternator output current (bench test)

- Increase load resistance to the maximum (condition under which the load current hardly flows).
- Turn switch A and B ON.
- Run alternator at 5000 rpm for 30 minutes by adjusting load resistance so that electric current can conform to the following standard.

- Measure the current at each specified revolution of alternator.
- If the measured value is lower than the standard value, disassemble and check alternator.

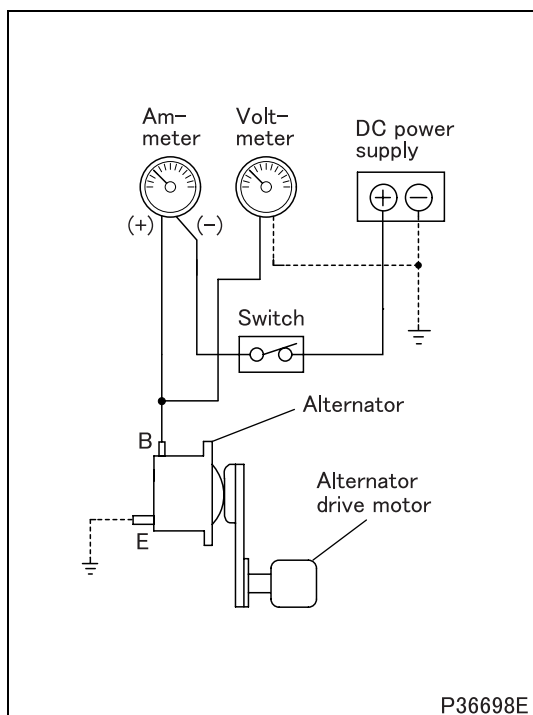
#### (2) Adjustment voltage of regulator (bench test)

- Connect the alternator as illustrated.

- Turn switch ON.
- Run alternator at low speeds.
- Increase the speed of alternator to 5000 rpm and measure the voltage (adjustment voltage) at this speed. At the same time, make sure that the current is 10 amperes or less at 5000 rpm.
- If the measured value deviates from the standard value, do as follows:
  - If higher than the standard value: Replace the regulator.
  - If lower than the standard value: Inspect the alternator related parts before replacing the regulator.

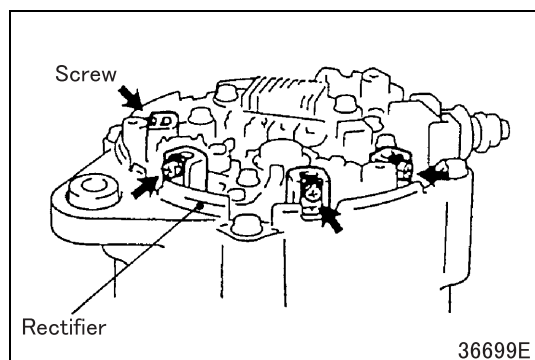
#### ■ Disassembly: Drive frame

- Remove screw and separate the stator outlet terminal and the rectifier.

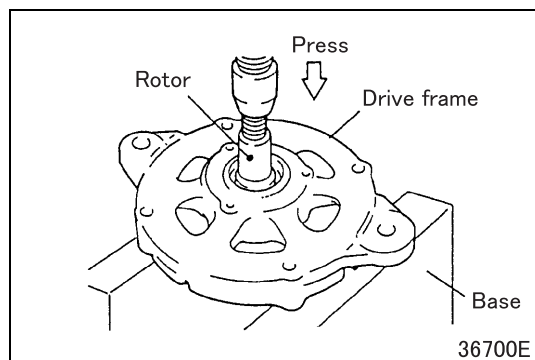
#### ■ Disassembly: Rotor

- Using a press, remove the rotor from the drive frame.

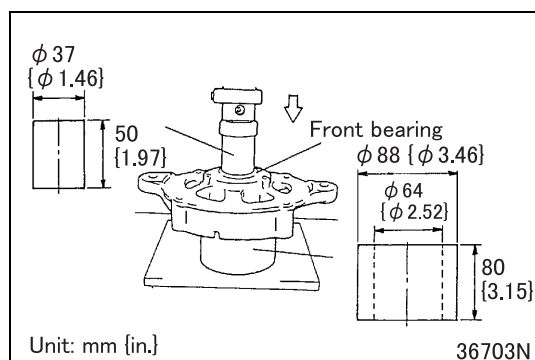
#### ■ Disassembly: Front bearing

- Using a press, remove the front bearing from the drive frame.

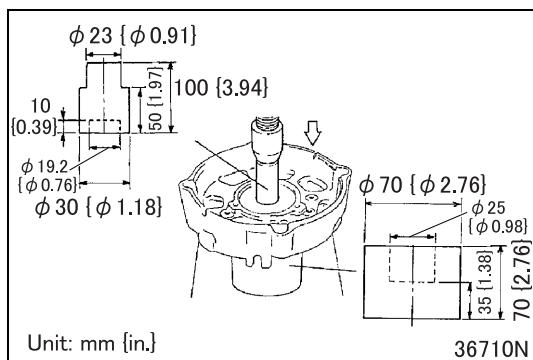
## ■ Disassembly: Rear bearing

- Using a press, remove the rear bearing from the rear frame.

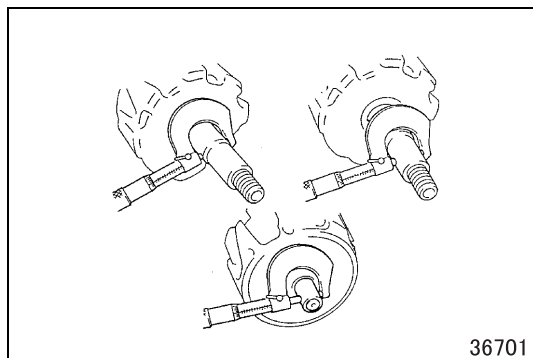
## ■ Inspection: Rotor

- Measure the outer diameter of the portion as shown.
- If the measured value deviates from the standard value, replace the rotor.

| Location | Maintenance item | Standard value | Limit | Remedy |
|---|---|---|---|---|
| 5 | Outer diameter of the portion that presses into the front bearing | 25.00 to 25.01<br>{0.9842 to 0.9846} | 24.99<br>{0.9838} | Replace |

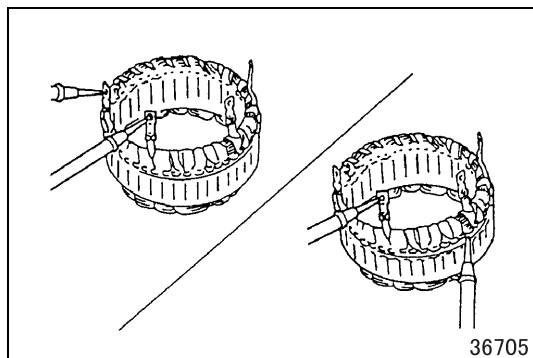
## ■ Inspection: Stator

- Measure the resistance between the coil outlet terminals. (using a circuit tester)
- Measure the resistance between the coil outlet terminal and core. (using a megger tester)
- If the measured value deviates from the standard value, replace the stator.

| Location | Maintenance item | Standard value | Limit | Remedy |
|---|---|---|---|---|
| 10 | Resistance between the coil outlet terminals | 0.01 to 0.10 $\Omega$ | – | Replace |

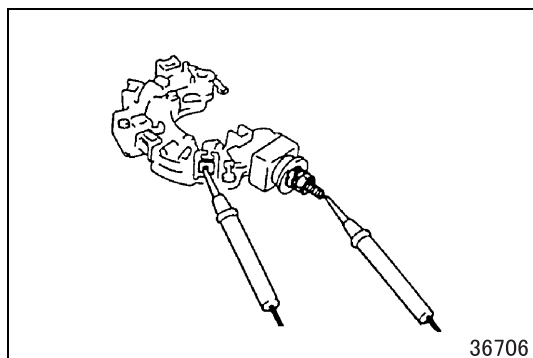
## ■ Inspection: Rectifier

- Check for continuity between the terminal B and the heat sink.
- When polarity is changed, there is continuity in one direction but not in the opposite direction.

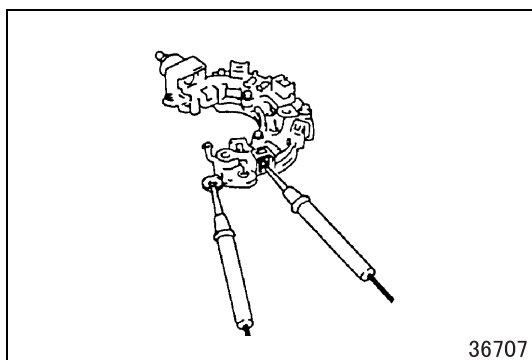
36707

- Check for continuity between the terminal (–) and the heat sink.
- When polarity is changed, there is continuity in one direction but not in the opposite direction.

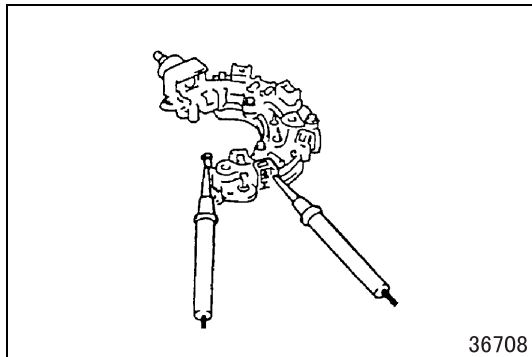
36708

- Check for continuity between the auxiliary diode terminal and the heat sink.
- When polarity is changed, there is continuity in one direction but not in the opposite direction.

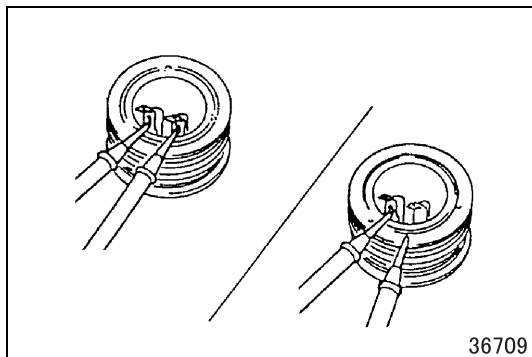
36709

#### ■ Inspection: Exciting coil

- Measure the resistance between the coil outlet terminal. (using a circuit tester)
- Measure the resistance between the coil outlet terminal and core.
- If the measured value deviates from the standard value, replace the exciting coil.

| Location | Maintenance item | Standard value | Limit | Remedy |
|---|---|---|---|---|
| 15 | Resistance between the coil outlet terminal | 2 to 3 $\Omega$ | – | Replace |

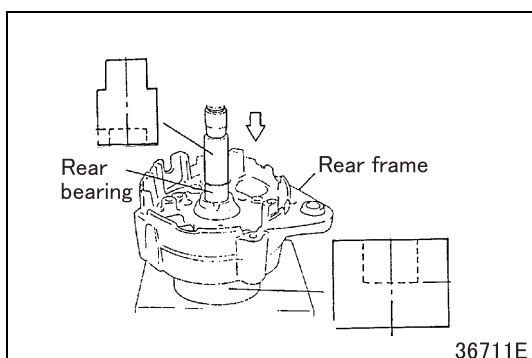
36711E

#### ■ Assembly: Rear bearing

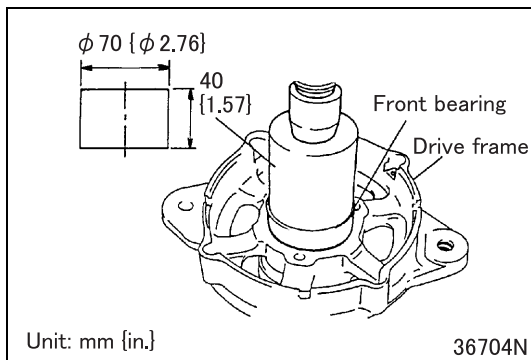
## ■ Assembly: Front bearing

- Using a press, press the front bearing into the drive frame.

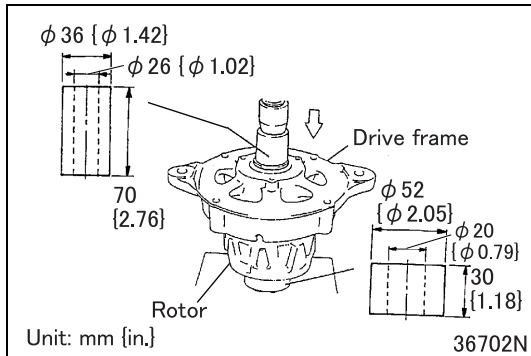
## ■ Assembly: Rotor

- Using a press, press the rotor into the bearing in the drive frame.

- Press the rotor while making sure that the rotor's shaft is perpendicular to the bearing. During pressing, make sure not to damage the portion of the rotor that presses into the rear bearing.

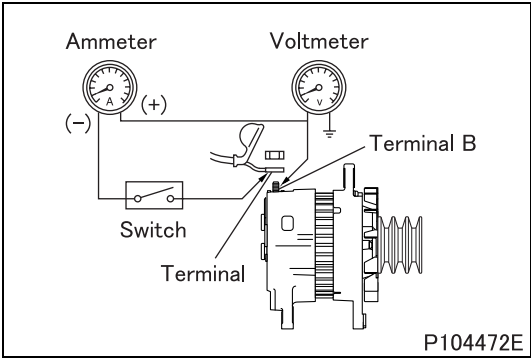
## Performance test

- The on-vehicle inspection is only a simplified check. Use a test bench for accurate checking.
- Connect the meters to the alternator as shown.

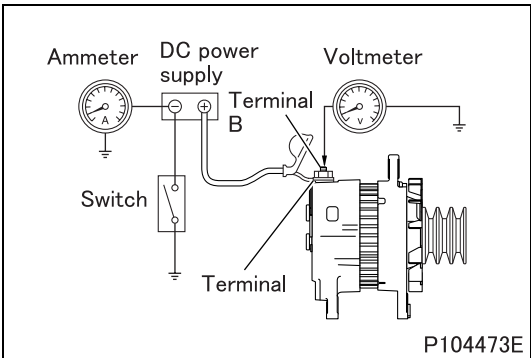
- Connect the meters to the alternator as shown.

- Turn off the switches for lamps, heater, etc. so that electric loads may not be applied during the inspection.
- Turn on switch and then start the engine.
- If the output current is 5 amperes or less when the engine speed is raised to the appropriate speed indicated below, then measure the voltage at terminal B.  
Approx. 2400 rpm
- If the output current is 10 amperes or more, do one of the following:
  - Run the engine for a while to charge the battery.
  - Replace the battery with a fully-charged one.
- If the measured value deviates from the standard value, conduct checking again on the test bench.

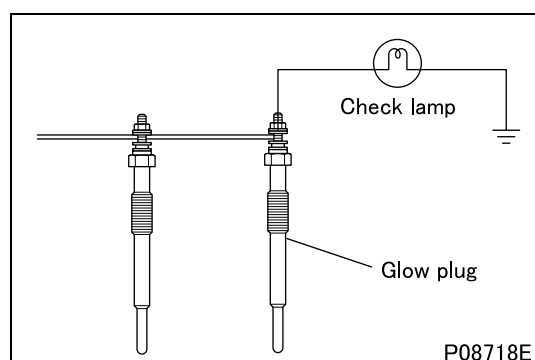
- Turn the starter switch to OFF.
- Connect a check lamp to the glow plug.

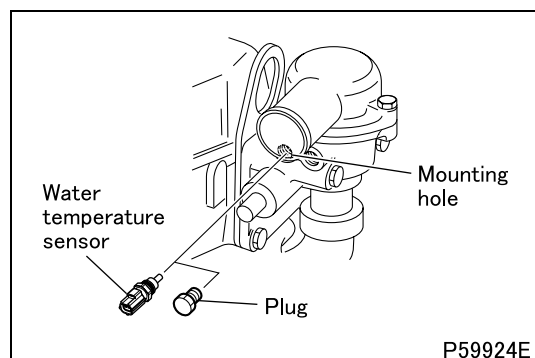
- Remove the water temperature sensor from the engine, and close the sensor mounting hole with the plug (M16 × 1.5 mm).

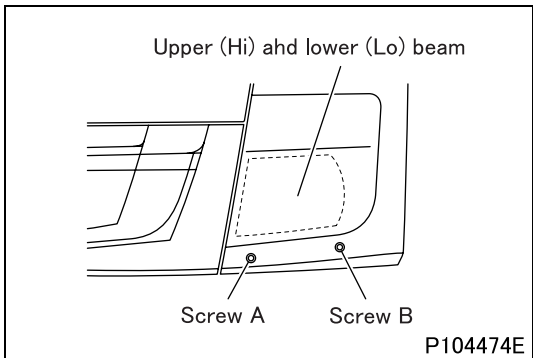
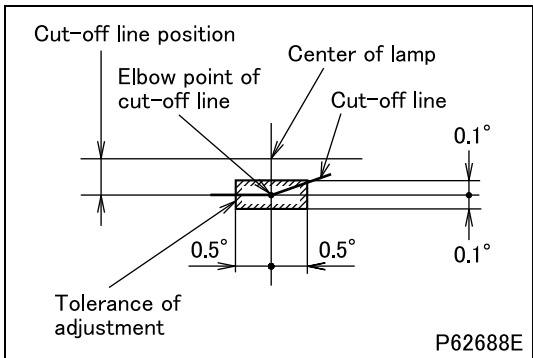
### 2.1 Adjustment of lower beam

- Turn on lower beam.
- Make adjustment by the following procedure so that the elbow point of lower beam cut-off line is in the illustrated position.
- Vertical adjustment: Adjust by turning screws A and B in this order by the same amount.
- Horizontal adjustment: Turn screw B.

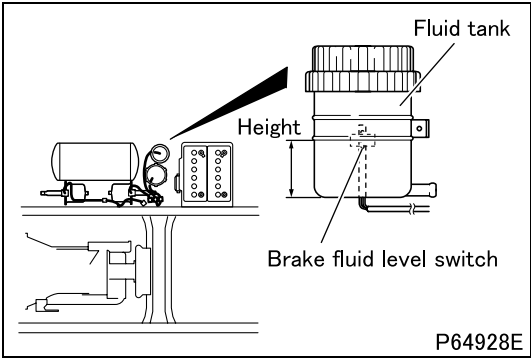
- Start engine.
- Drain the brake fluid gradually from fluid tank.

- If brake fluid is spilt on any part of the vehicle, wipe it off immediately, since the solvent in the fluid can damage the paintwork.
- Measure height of brake fluid level switch when warning lamp within the meter cluster lights.
- If the measured value deviates from the standard value, remove and check fluid tank.
- Removal, installation (See Gr35A.)
- Inspection (See #041.)

| Location | Maintenance item | Standard value | Limit | Remedy |
|---|---|---|---|---|
| - | Warning lamp lighting position for brake fluid level switch | 57 <sup>+3.5</sup> <sub>-0.5</sub> {2.24 <sup>+0.14</sup> <sub>-0.02</sub> } | - | Replace |

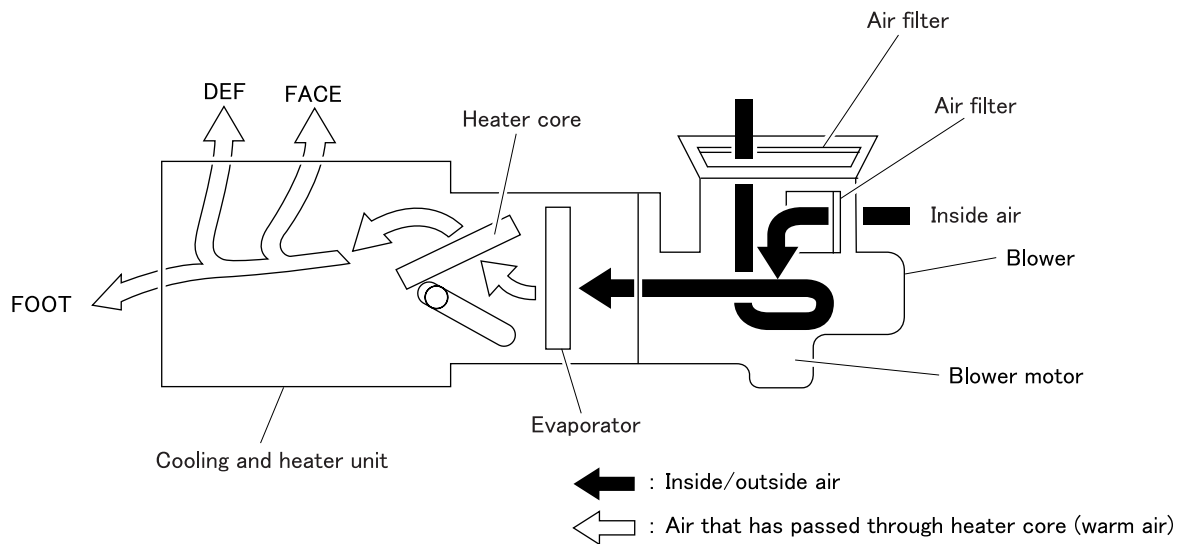
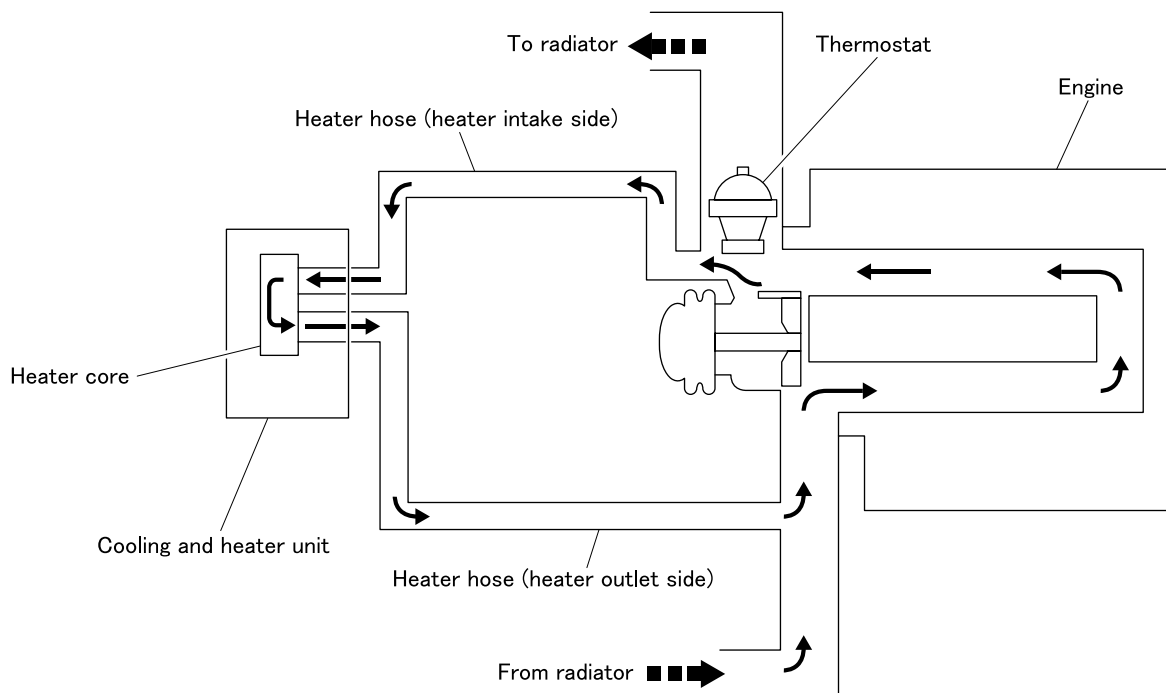
P104754E

- The blower sends air to the cooling and heater unit, where the air is heated by the heater core (heat exchanger). The warmed-up air is then sent through the ducts into the cab.
- Water (engine coolant) warmed up by the heat from the engine circulates permanently through the heater core, irrespective of whether the thermostat is open or closed.

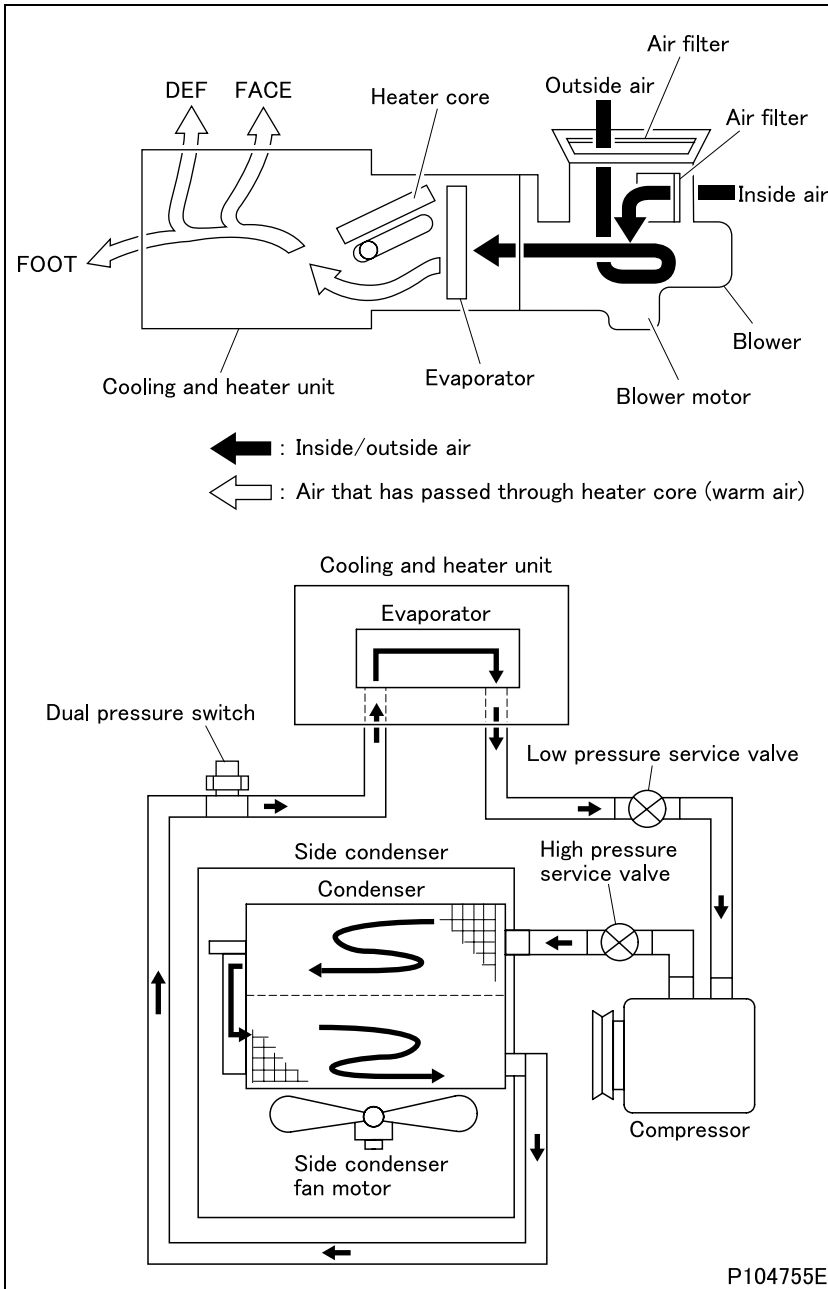
- The blower sends air to the cooling and heater unit, where the air is cooled by the evaporator. The cooled air is then sent through the ducts into the cab.
- Refrigerant in gas form is compressed by the compressor. The compressed gas is then sent to the side condenser, where it is cooled by outside air and condenses into liquid form.
- The liquid refrigerant is sprayed into the evaporator, where it quickly evaporates into gas form while at the same time absorbing heat from the surrounding air.
- The refrigerant in gas form is again sent to the compressor and is compressed there.
- When the refrigerant pressure in the high pressure line reaches the specified limit, the dual pressure switch senses this and turns itself OFF. At the same time, the magnet clutch of the compressor is turned OFF.

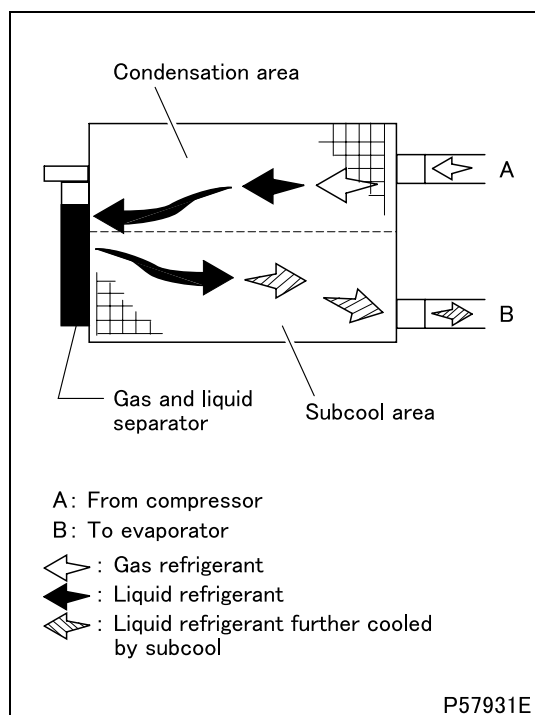
## 2.1 Subcool type side condenser

- This condenser is divided into the condensation area, gas and liquid separator (modulator tank) and subcool area. A normal condensed gas refrigerant is converted into a liquid refrigerant by cooling and remains in the gas and liquid separator (modulator tank). The subcool area further subcools the liquid refrigerant remaining in the gas and liquid separator (modulator tank) to improve the efficiency of the refrigeration cycle.

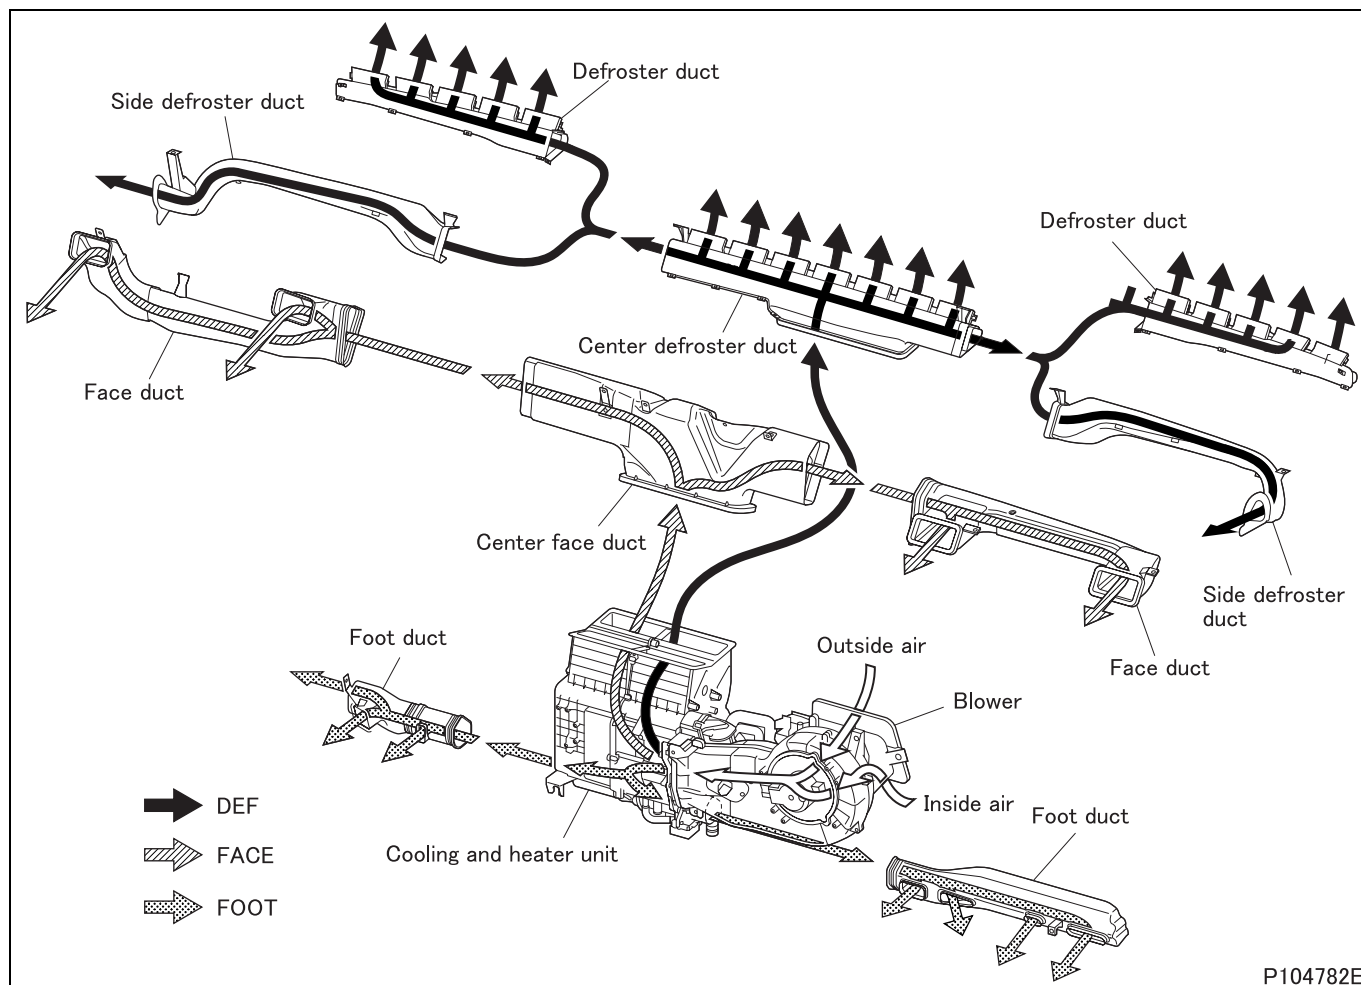
## 3. Air Duct

- The blower sends outside air or inside air through the cooling and heater unit to the ducts. The flow of air is dependent on the open/closed positions of the various dampers.
