# FE.FG

## SERVICE MANUAL 2008 Model FOREWORD

This Service Manual contains maintenance and repair methods for the Mitsubishi Fuso Truck FE. FG Series. Read this manual carefully as an aid in providing correct, efficient maintenance. Please note that the information and specifications contained within this manual may change without notice. This is due to product modifications and continued vehicle improvements that are made throughout the model years. Should you encounter any discrepancy in the information provided, please do not hesitate to contact your nearest Mitsubishi Fuso Dealer or Mitsubishi Fuso Truck of America, Inc.

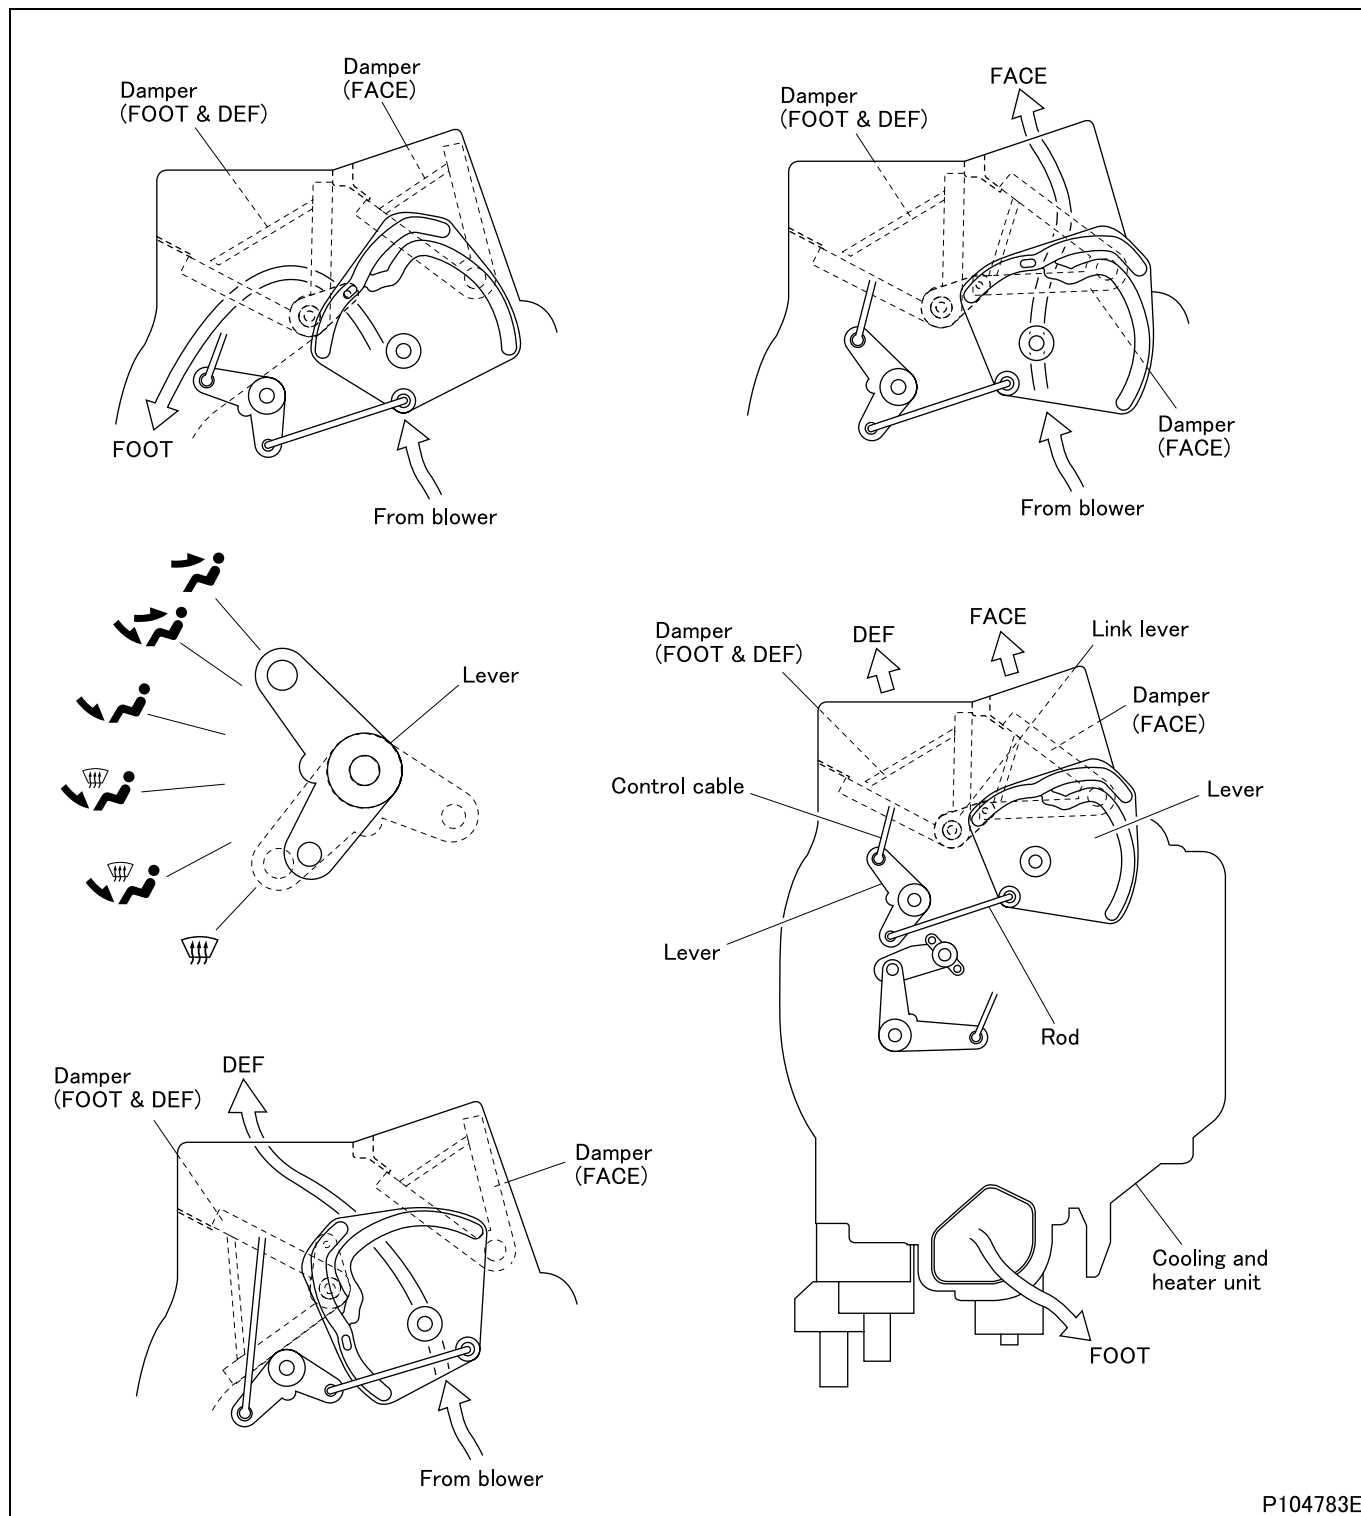
P104783E

- Mode selection (opening and closing of damper) is performed by transmission of the movement of the mode selection control cable to all parts.

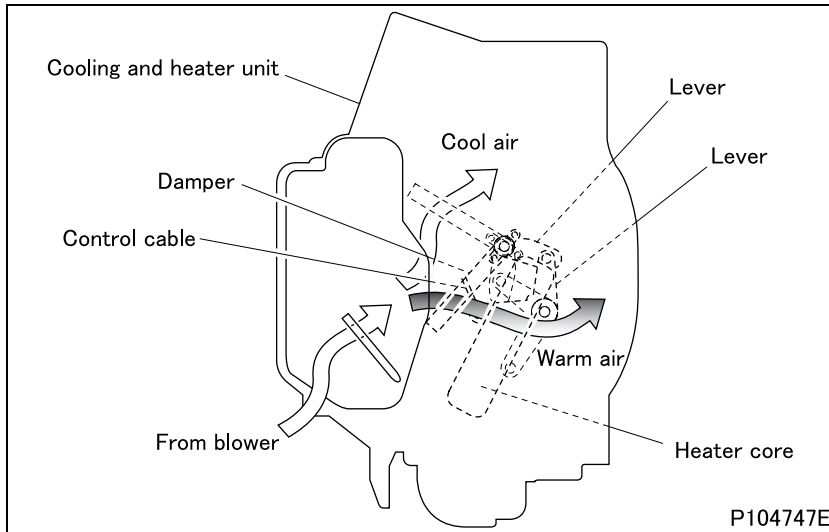
- Air mixing control is performed by changing the degree of opening of the damper with the movement of the air mix control cable to change the amount of warm air passing through the heater core and that of cool air not passing through the heater core.

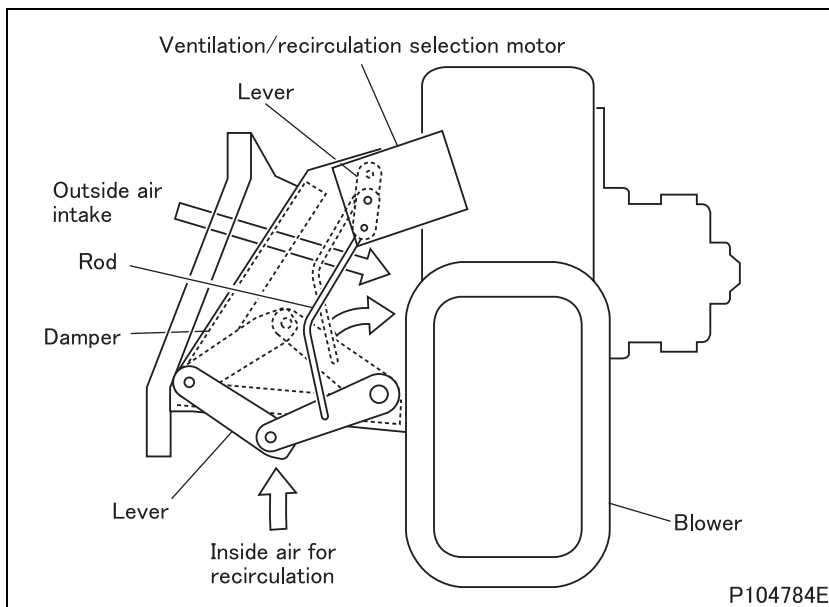
- Ventilation/recirculation selection is performed by moving the damper with the ventilation/recirculation selection motor.

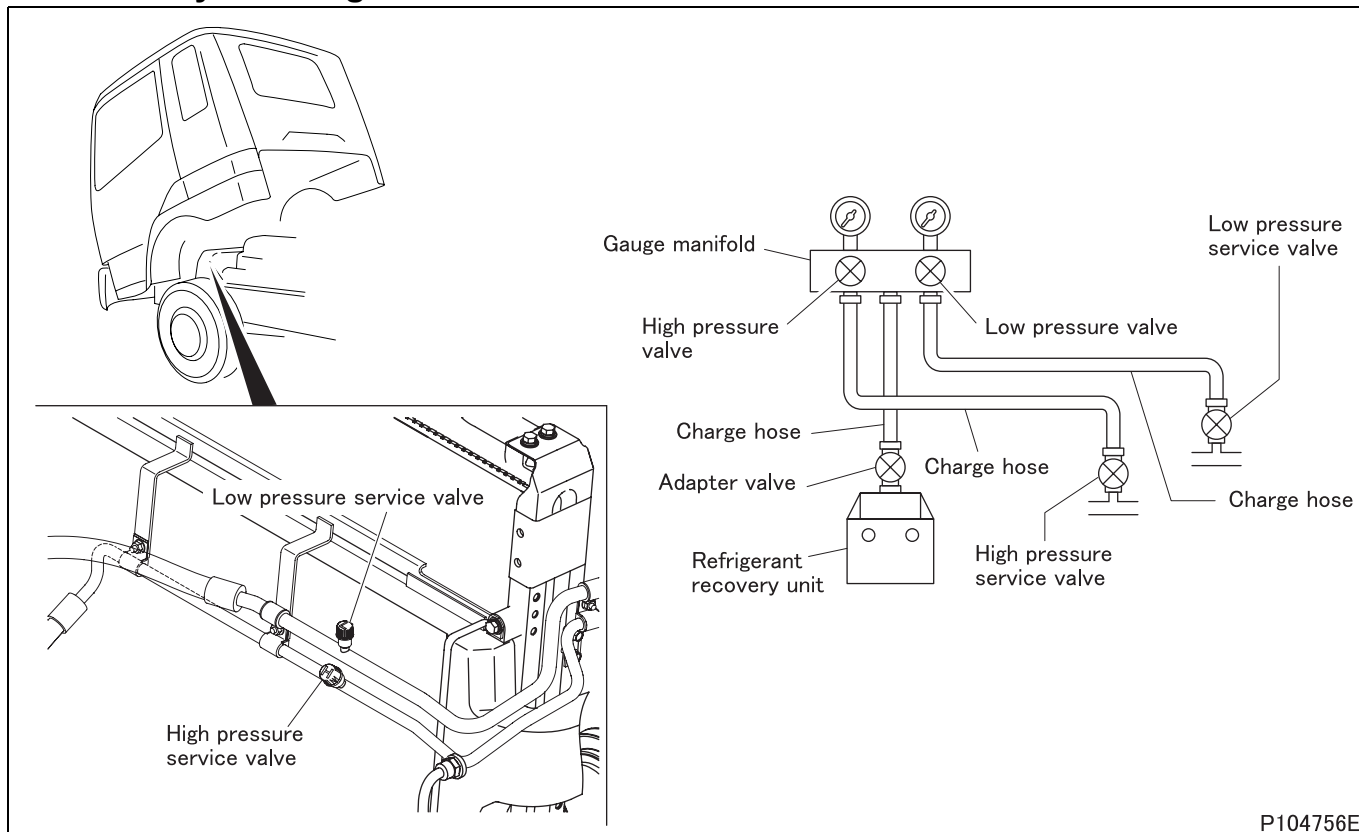
- Recover refrigerant from the air-conditioning system in accordance with the following flow chart.
- Installation of the refrigerant recovery unit

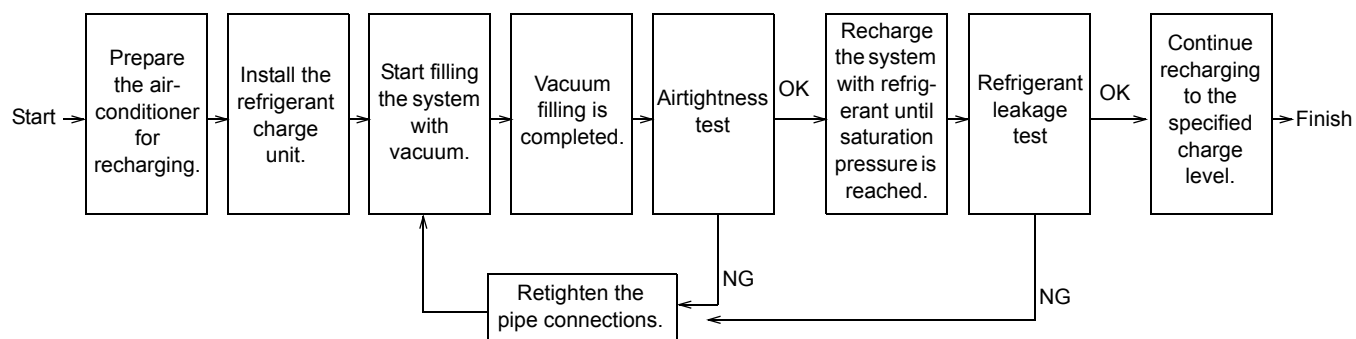
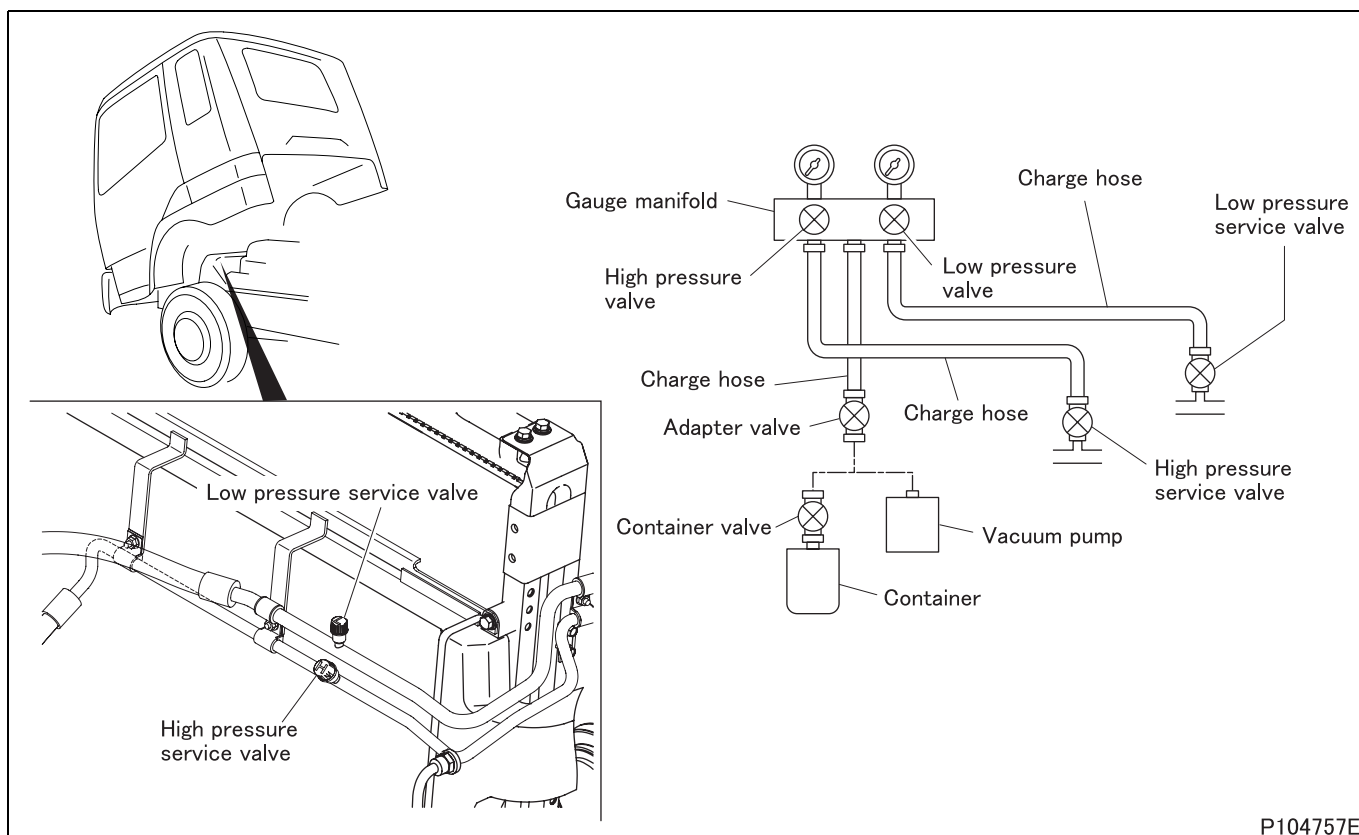
- Recharge the system with refrigerant in accordance with the following flow chart.
- Installation of the refrigerant charge unit

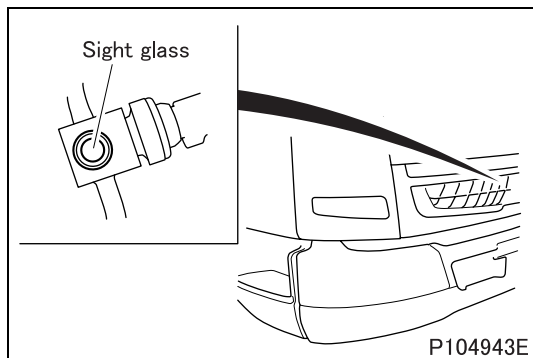
### 3. Checking Refrigerant Charge Level

- To check the refrigerant charge level, observe the flow of refrigerant through the sight glass. If the visual inspection indicates a low charge level, add refrigerant.
- The visual check should be performed under the following conditions.
  - Engine speed: 1200 rpm
  - Air-conditioner switch: ON
  - Fan speed control dial: Maximum air volume
  - Ventilation/recirculation selection: Outside air
  - Doors: Fully open

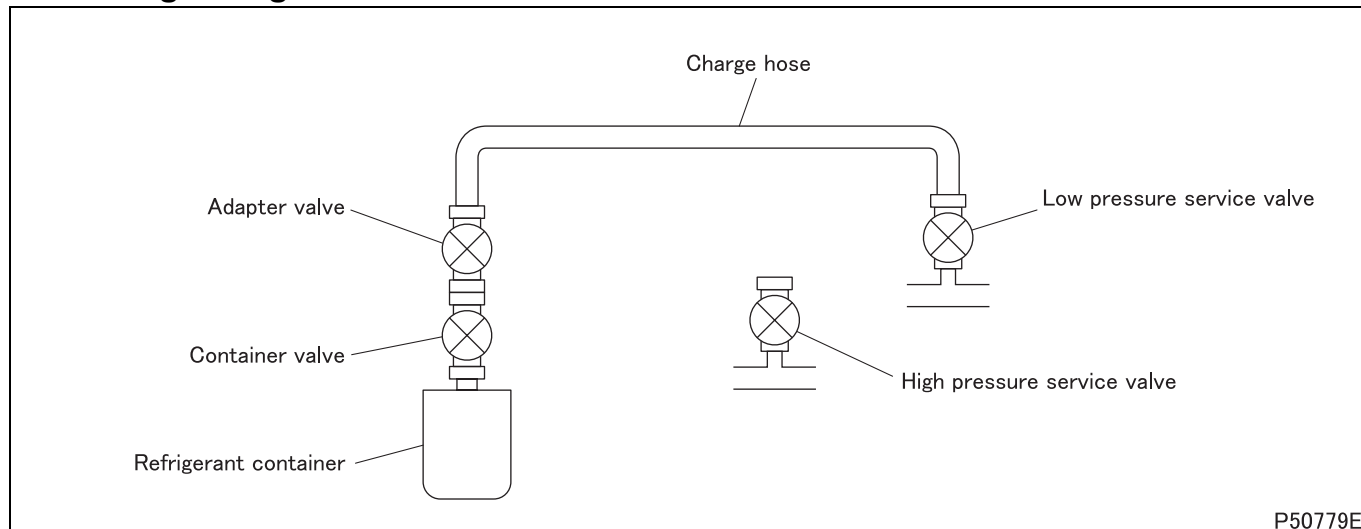
- Add refrigerant in accordance with the following flow chart.

With the adapter valve closed, connect the charge hose to the low pressure service valve.

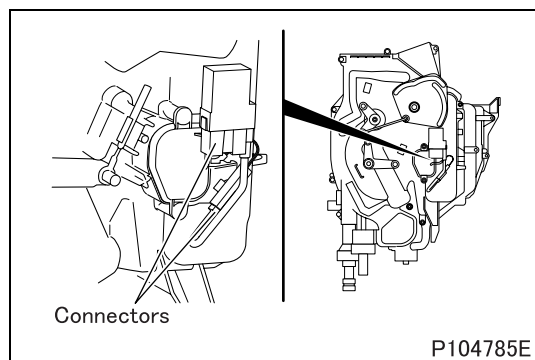
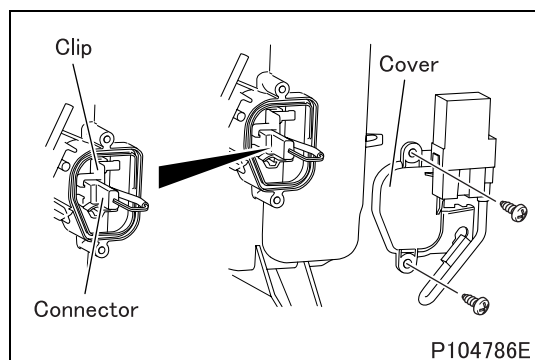
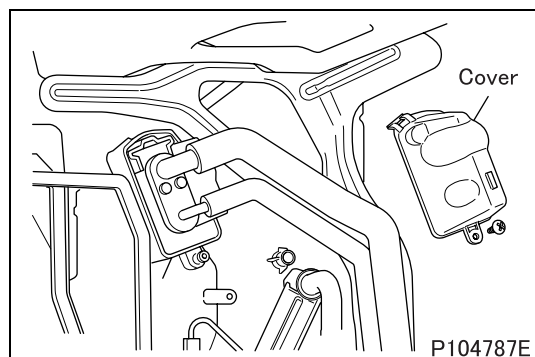
- Drain out the refrigerant. (See “1. Recovery of Refrigerant”.)
- Remove the passenger-side lower panel. (See Gr52.)
- Remove the blower. (See later section.)
- Disconnect the connectors (2 places) at the illustrated position.

- Remove the cover.
- Temporarily joint the thermostat connector with clip of evaporator.
- Remove the expansion valve cover.

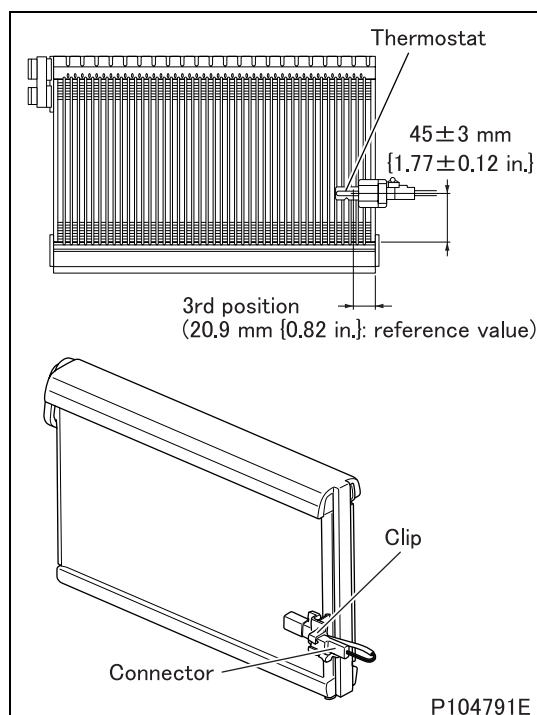
- Blow air against the fins of the evaporator to remove foreign matter.
- If air blowing is not enough, clean by hand using care not to damage the fins.

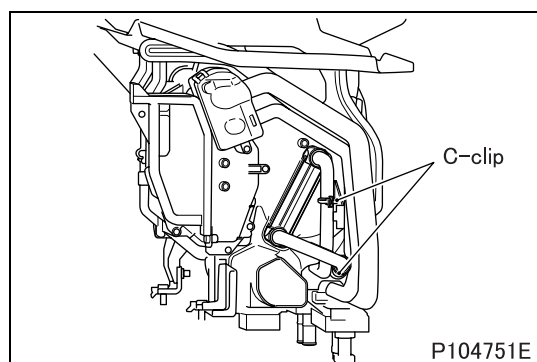
- Remove the C-clips to disassemble the joint of the heater piping.

- **The heater piping is made of soft material and easy to deform. Handle it with care.**

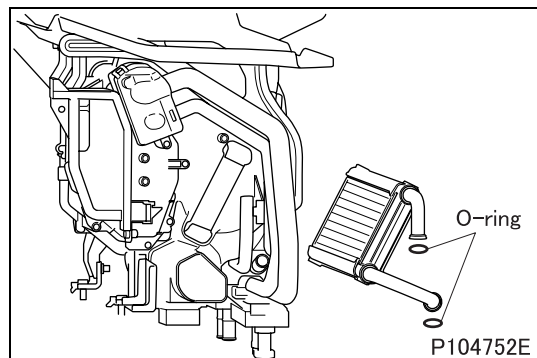
- Remove the heater core.

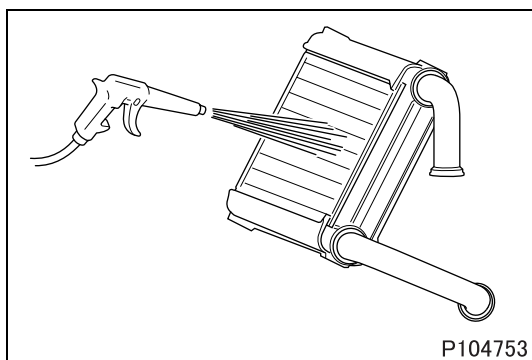
- Blow air against the fins of the heater core to remove foreign matter.
- If air blowing is not enough, clean by hand using care not to damage the fins.
- For cleaning inside the heater core, see Gr14.

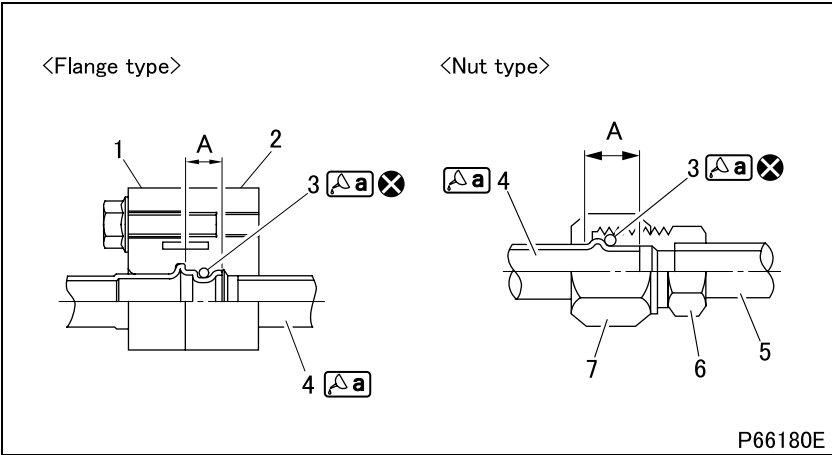
# CONNECTING AIR-CONDITIONER PIPING

- 1 Flange (pipe end) <Flange type>
- 2 Flange (mating end) <Flange type>
- 3 O-ring
- 4 Pipe
- 5 Pipe <Nut type>
- 6 Union <Nut type>
- 7 Nut <Nut type>

A: Refrigerating machine oil application area  
⊗: Non-reusable parts

- There are 2 types of air-conditioner pipe/hose connections: flange type and nut type. When connecting/tightening the connections, observe the following precautions.

- The connected parts are sealed by the O-ring. Be careful not to damage the O-ring, such as by twisting.
- The O-rings are exclusively designed for HFC-134a refrigerant and are not reusable. The O-rings are available at the MITSUBISHI HEAVY INDUSTRIES, LTD. service stations.
- Never tighten the nut-type connection by rotating the union. This will deform the piping, allowing refrigerant to leak out. Tighten by rotating the nut while holding the union in position.

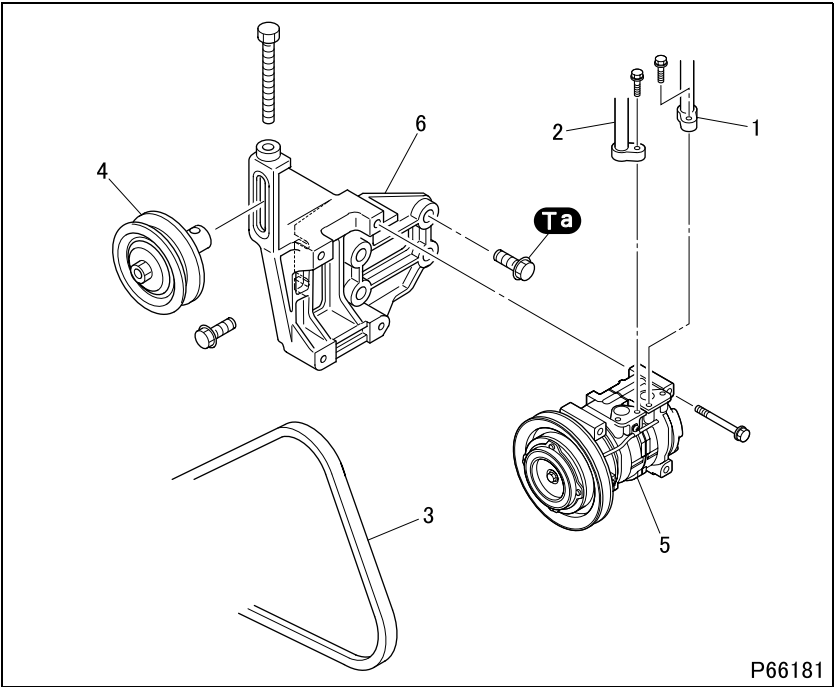
- 1 Discharge hose (high pressure side) (See the CONNECTING AIR-CONDITIONER PIPING section.)
- 2 Suction hose (low pressure side) (See the CONNECTING AIR-CONDITIONER PIPING section.)
- 3 V-belt
- 4 Pulley
- 5 Compressor
- 6 Compressor bracket

| Mark | Parts to be tightened | Tightening torque | Remarks |
|---|---|---|---|
| <b>Ta</b> | Bolt (compressor bracket mounting) | 45 to 65 {33 to 48, 4.6 to 6.6} | — |

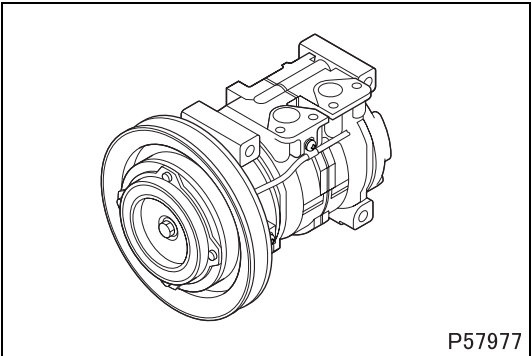
### ■ Inspection: Compressor

- Check the compressor proper for malfunction and oil leakage.
- If there is anything wrong with the compressor, replace it or have it overhauled at a nearest MITSUBISHI HEAVY INDUSTRIES, LTD. service station.

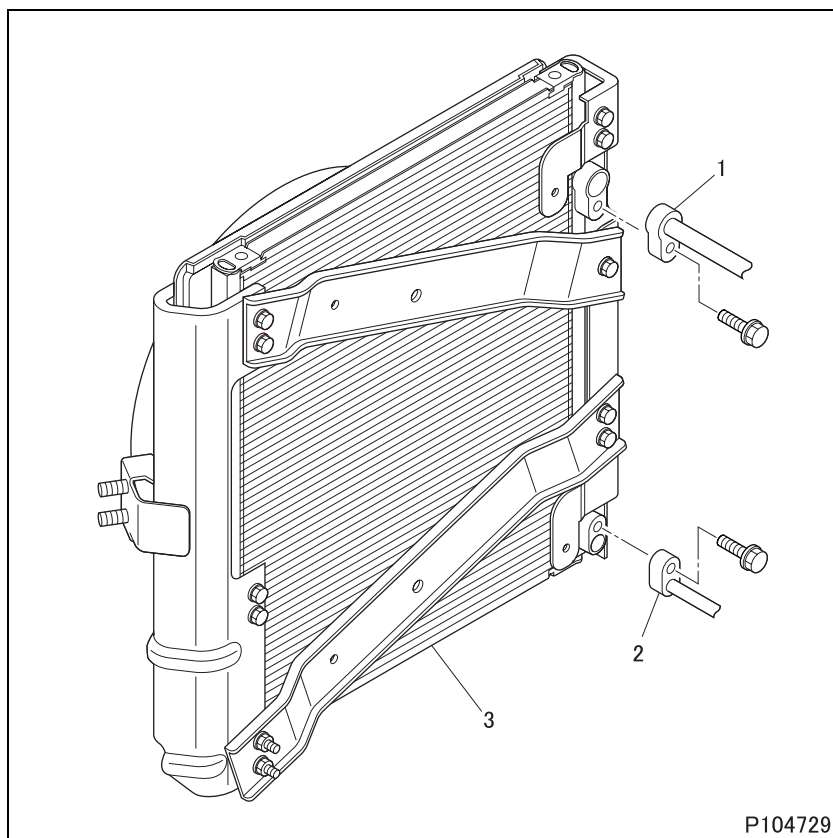
# CONDENSER

- 1 Discharge hose (compressor end)  
(See the CONNECTING AIR-CONDITIONER PIPING section.)
- 2 Liquid hose (cooling unit end)  
(See the CONNECTING AIR-CONDITIONER PIPING section.)
- 3 Condenser

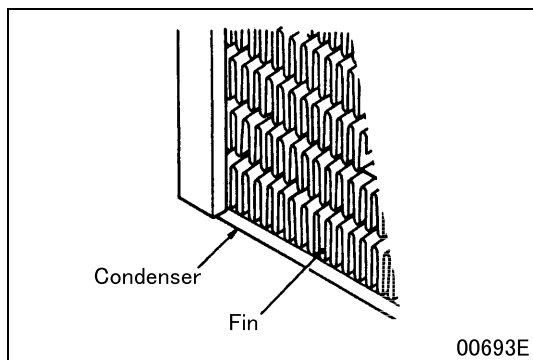
## ■ Inspection: Condenser

- If the condenser fins are clogged with dirt, dust or other foreign matter, wash it out. Any deformed fins should be straightened using a spatula or the like.

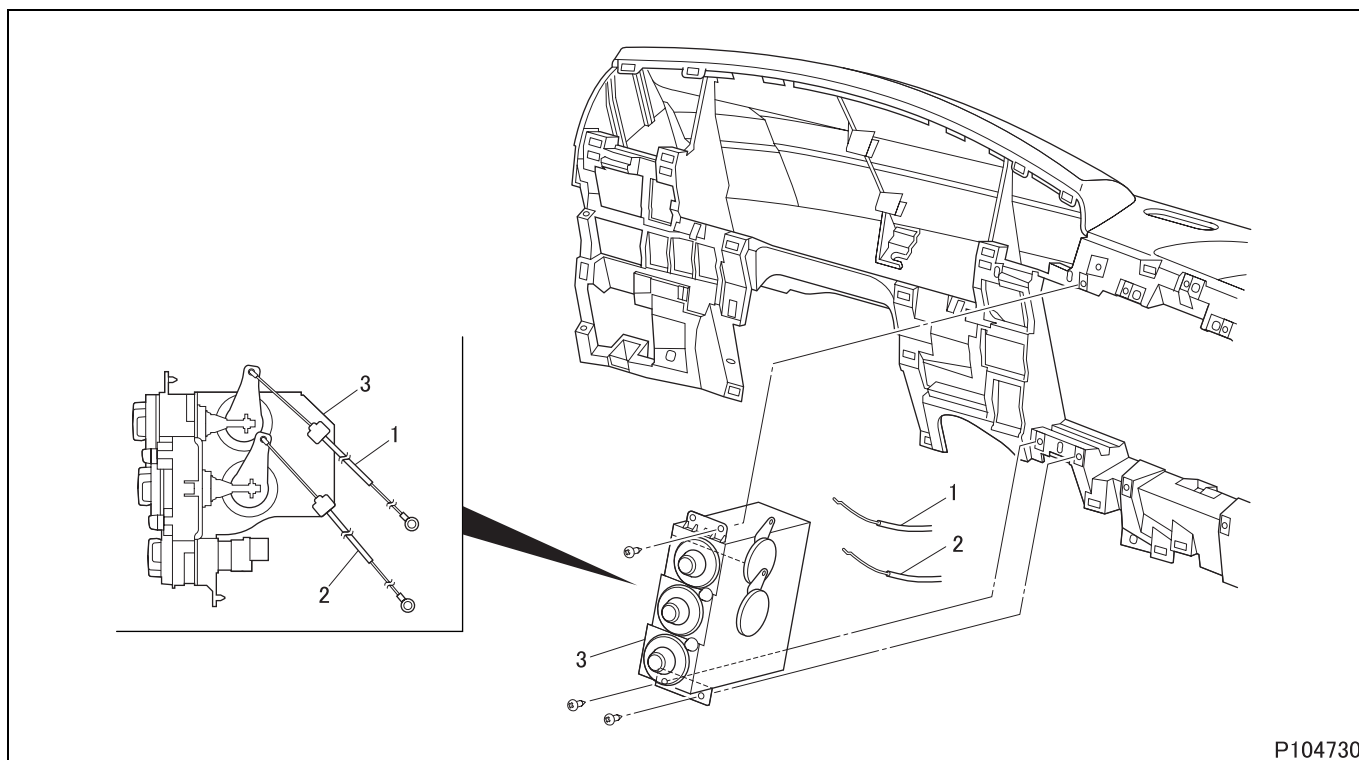
P104730

3 Air-conditioner control

- Do not disconnect the cable from air-conditioner or ventilation control except for replacement of the cable to prevent deformation of clip tab of air-conditioner or ventilation control.

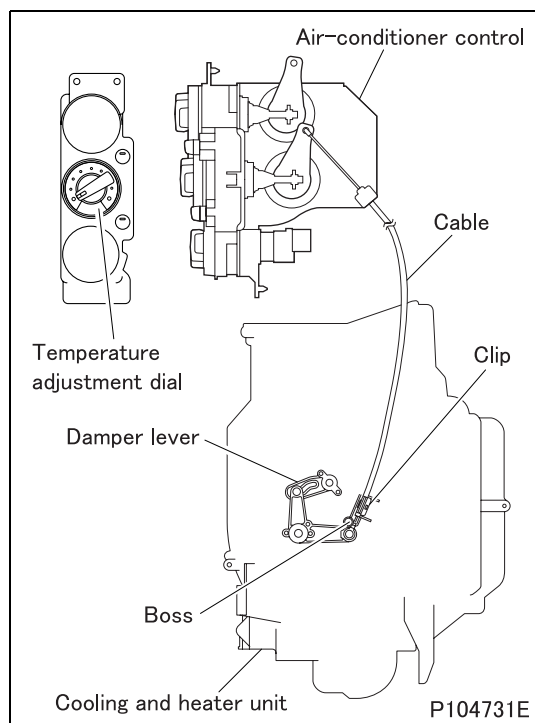
### ■ Installation: Air mix control cable

- Fully turn the temperature adjusting dial to the left to set to the MAX COOL position.
- Install the air mix control cable on the air mix damper lever of the cooling and heater unit.
- Lightly pull the air mix control cable. Securely fix it with a clip at the position where the air mix damper lever of the cooling and heater unit comes into contact with the locating boss.

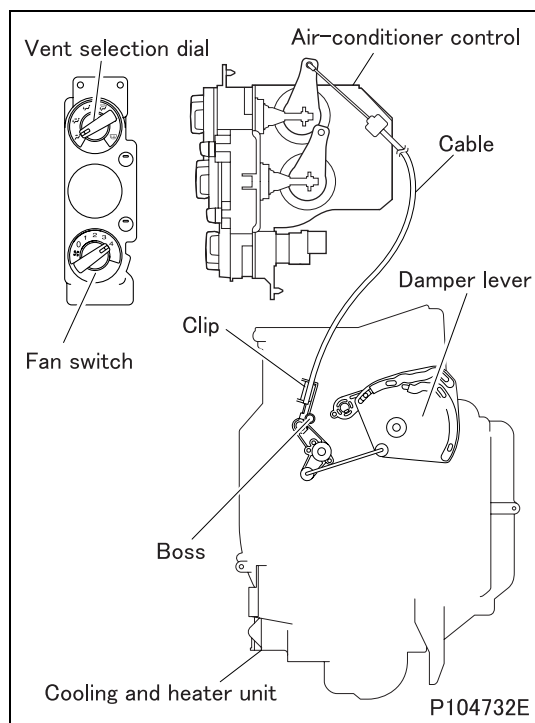
### ■ Installation: Mode selection control cable

- Set the vent selection dial of air-conditioner control to FACE position.
- Install the mode selection control cable on the mode selection damper lever of the cooling and heater unit.
- Lightly pull the mode selection control cable. Securely fix it with a clip at the position where the mode selection damper lever of the cooling and heater unit comes into contact with the locating boss.
- After installing mode selection control cable, set the fan switch to the 4th position and be sure to turn the vent selection dial to check the operation.

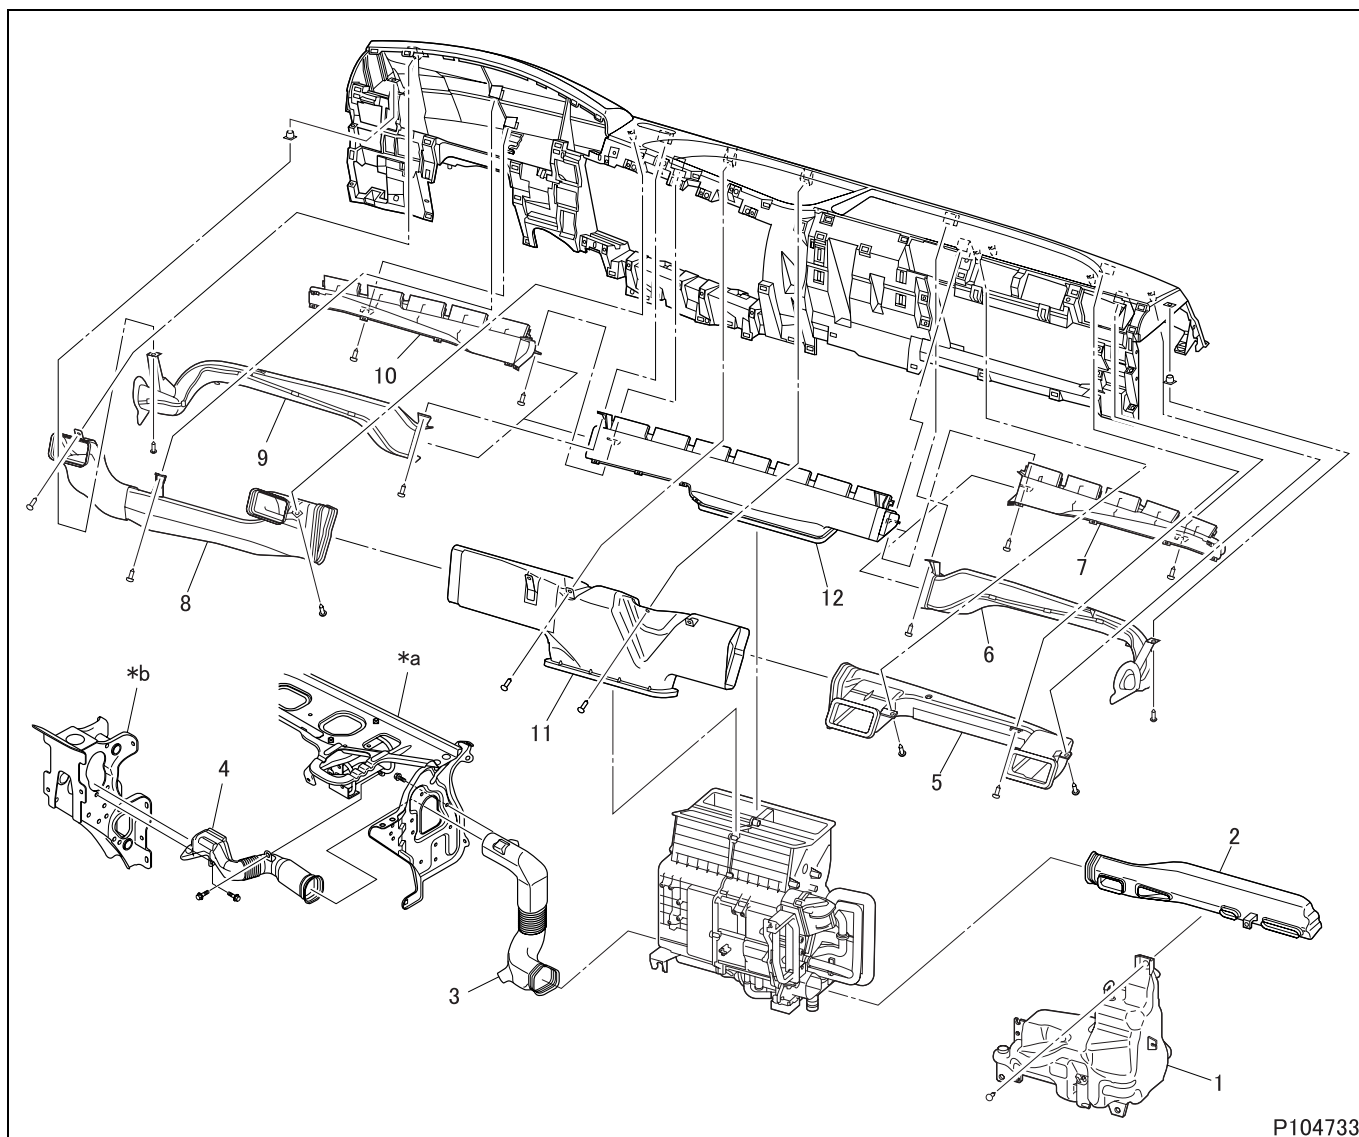
P104733

| 1 Washer tank | 9 Side defroster duct |
| 2 Foot duct | 10 Defroster duct |
| 4 Foot duct | 12 Center defroster duct |
| 6 Side defroster duct | *a: Instrument panel frame |
| 7 Defroster duct | *b: Steering column bracket |

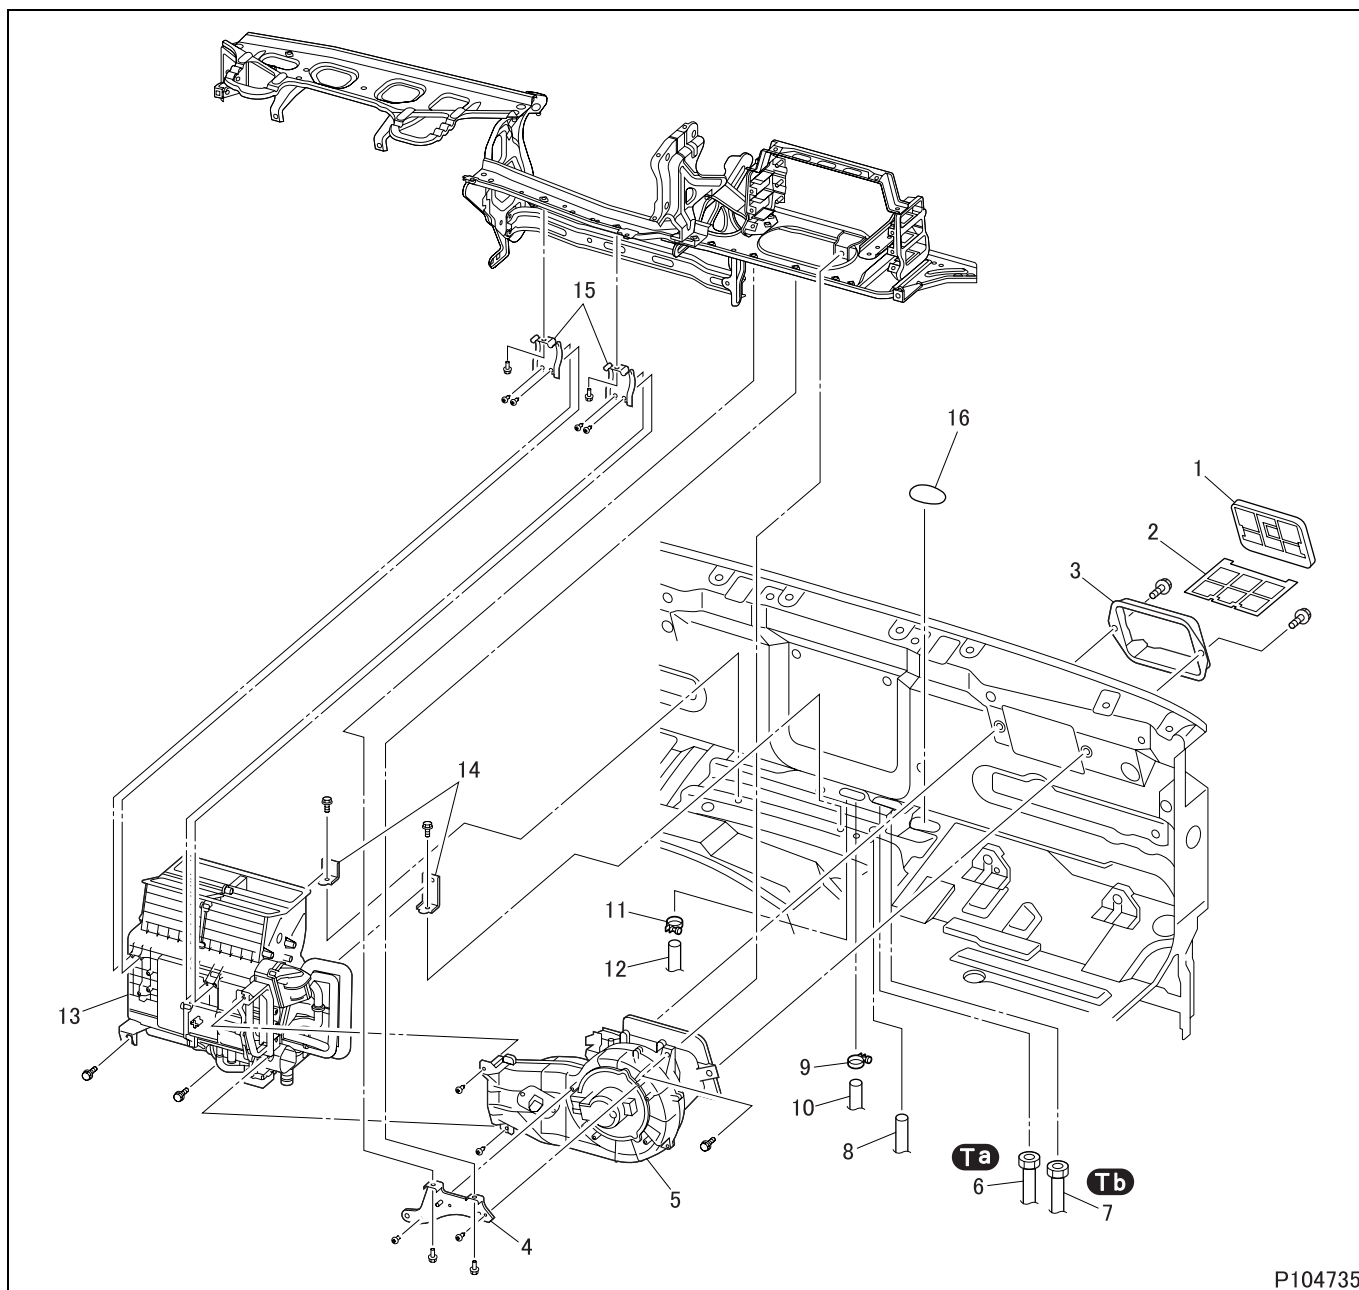
# COOLING AND HEATER UNIT, BLOWER

| 6 Air-conditioner hose (high pressure side) | 14 Heater lower bracket |
| 7 Air-conditioner hose (low pressure side) | 15 Heater bracket |
| 8 Drain hose | 16 Plug <Without air-conditioner> |

- Discharge refrigerant before disconnecting air-conditioner hose. (See “Recovery of Refrigerant”.)

| Mark | Parts to be tightened | Tightening torque | Remarks |
|---|---|---|---|
| <b>Ta</b> | Air-conditioner hose (high pressure side) | 21 to 25 {15 to 18, 2.1 to 2.5} | – |
| <b>Tb</b> | Air-conditioner hose (low pressure side) | 30 to 34 {22 to 25, 3.1 to 3.5} | – |

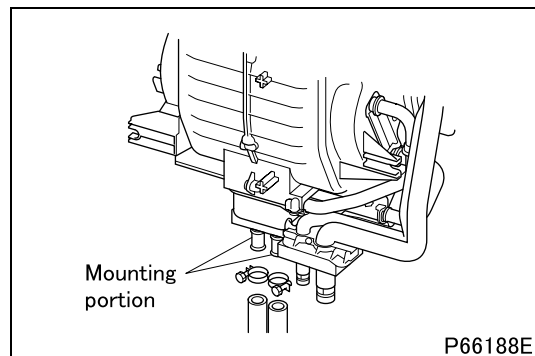
#### ■ Removal: Hose clamp and heater hose

- Remove the hose clamp and heater hose, taking care not to damage the hose mounting portion of the heater unit.

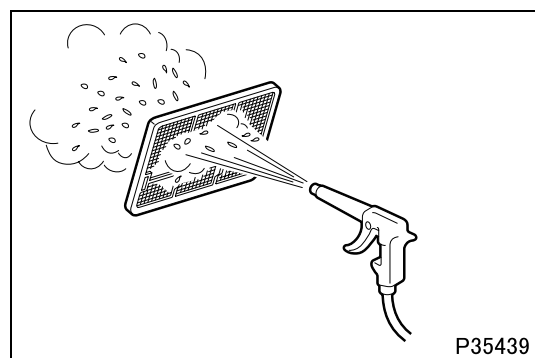
#### ■ Cleaning: Air filter

- After removing the air filter, blow water or air to it to remove dust and dirt.
