SERVICE BULLETIN

SERVICE BULLETIN		No.: MSB-99E22-001	
	Date: 1999-11-15	<Model>	<M/Y>
Subject:	CHANGE IN POSITION OF PAINT MARKS ON M/T SHIFT AND SELSECT CABLE ASSEMBLY	GALANT(EA0)	97-10
Group:	MANUAL TRANSAXLE	Draft No.: 99AL021617	
INFORMATION	OVERSEAS SERVICE DEPT

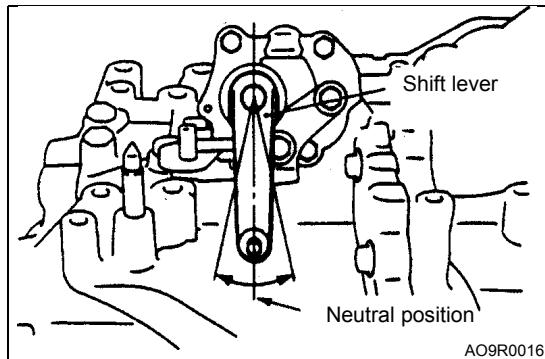
► A ◀ SHIFT CABLE AND SELECT CABLE ASSEMBLY/SHIFT CABLE CONNECTION/SELECT CABLE CONNECTION

- Set the transmission side shift lever and the passenger compartment side shift lever to the neutral position.

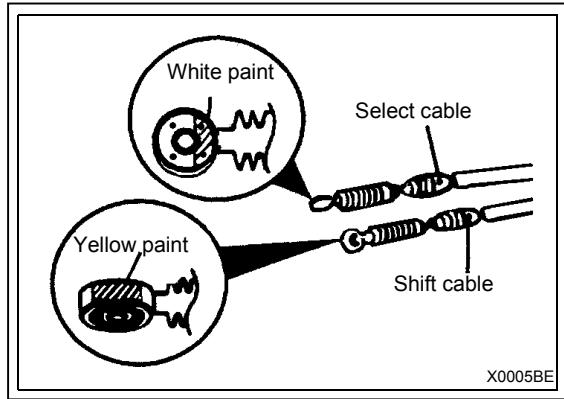
<Old>

Paint marks on the M/T shift and select cable assembly have been changed in position in order for the marks to be more clearly seen after installation of the assembly has been done.

- For the transmission side, the white and yellow paint marks on the shift and select cable ends should face the snap pins.

Install the transmission side shift cable with its end painted yellow toward the body top end. Install the transmission side select cable with its end painted white toward the snap pin end.
