GROUP 55A

HEATER, AIR CONDITIONING AND VENTILATION

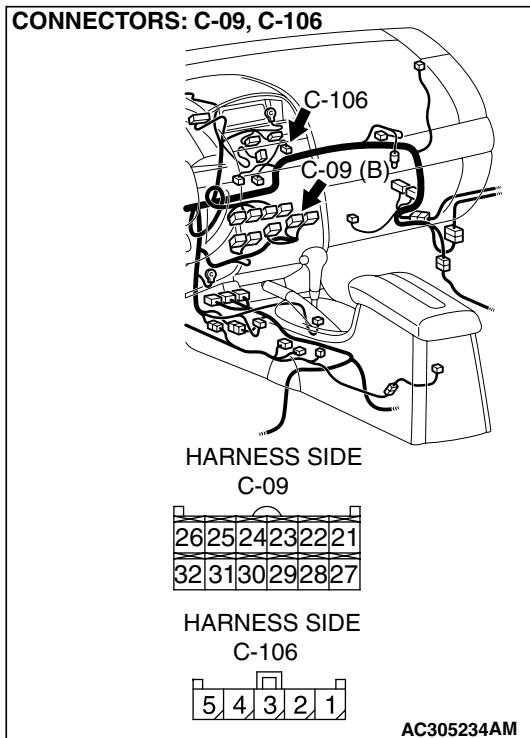
STEP 7. Check the wiring harness between outside/inside air selection damper control motor connector C-106 (terminals 4 and 5) and A/C-ECU C-09 (terminals 28 and 29).
