GROUP 52B

SUPPLEMENTAL RESTRAINT SYSTEM (SRS)

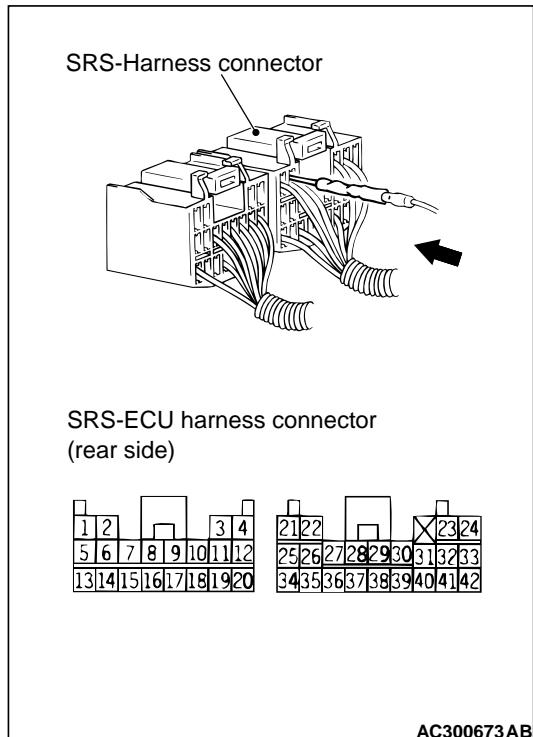
If checks are carried out by using the SRS-ECU harness connector, observe the following procedures: Insert the special tool (probe in the harness set) MB991222 into connector from harness side (rear side), and connect the tester to this probe. If any tool than special tool is used, damage to the harness and other components will result. Never insert the probe directly to the terminals from the front of the connector. The terminals are plated to increase their conductivity, so that if they are touched directly by the probe, the plating may break, which will cause drops in reliability.

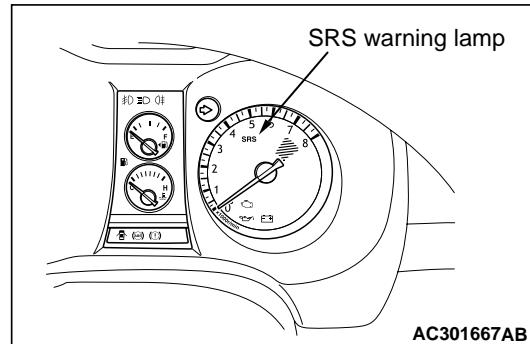
SRS WARNING LAMP CHECK

1. Check that the SRS warning lamp comes on when the ignition switch is turned ON.
2. Check that the SRS warning lamp illuminates for about 7 seconds and then goes out.
3. If this is not the cause, check the diagnosis codes.

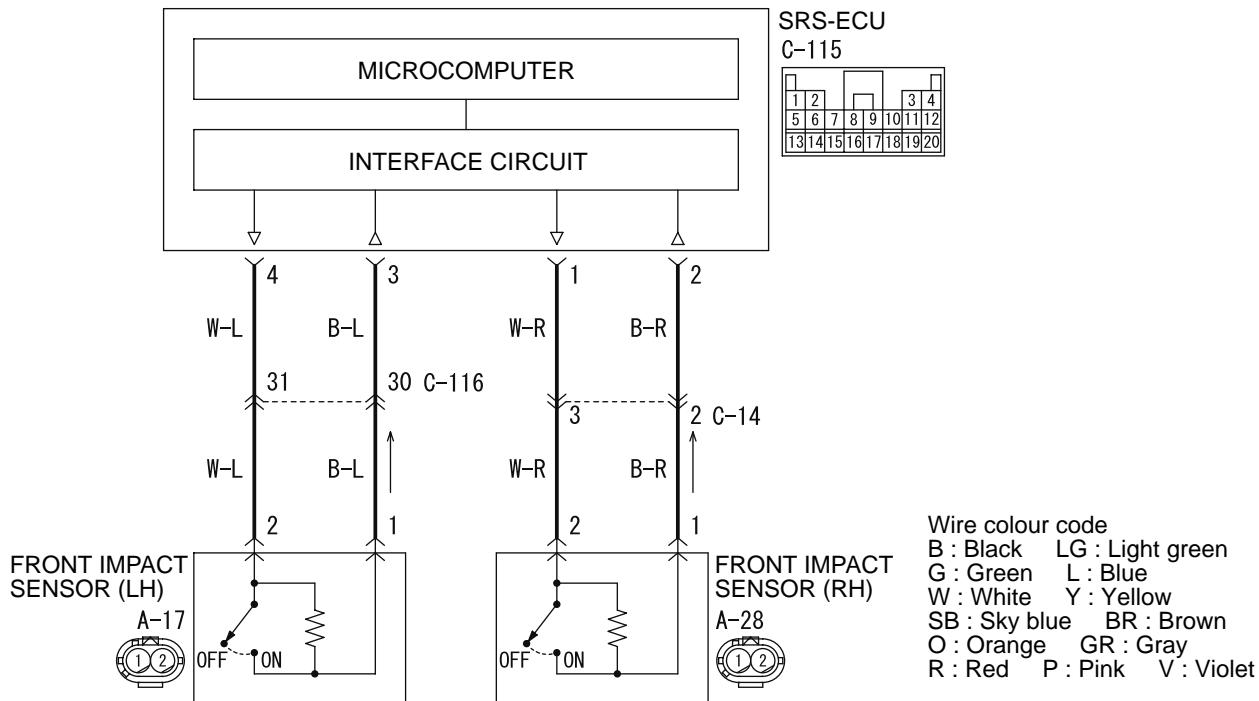
Front Impact Sensor Circuit

- When the left and right front impact sensors detect a collision, the switches inside the sensors turn ON.

Code No.	Trouble causes
1A	• Left front impact sensor or its wiring shorted
1B	• Left front impact sensor or wiring open circuit
1C	• Short to the power supply in the left front impact sensor harness
1D	• Short to body earth in the left front impact sensor harness
2A	• Right front impact sensor or its wiring shorted
2B	• Right front impact sensor or wiring open circuit
2C	• Short to the power supply in the right front impact sensor harness
2D	• Short to body earth in the right front impact sensor harness

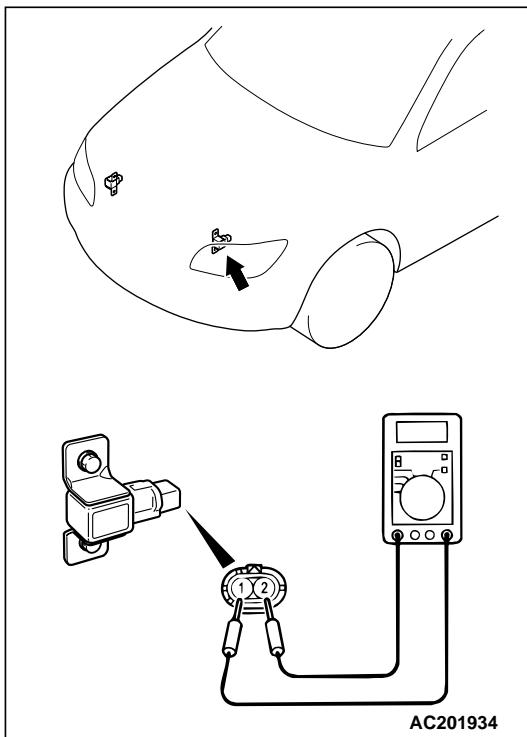
(1) Measure the resistance between terminals and

(2) Check for continuity between the terminal and bracket.

Standard value: $820 \pm 82 \Omega$

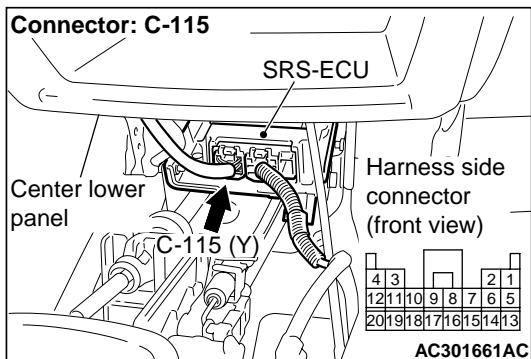
STEP 2. Measure the resistance and voltage at SRS-ECU connector C-115.

(1) Disconnect SRS-ECU connector C-115 and measure at the harness side (rear side).

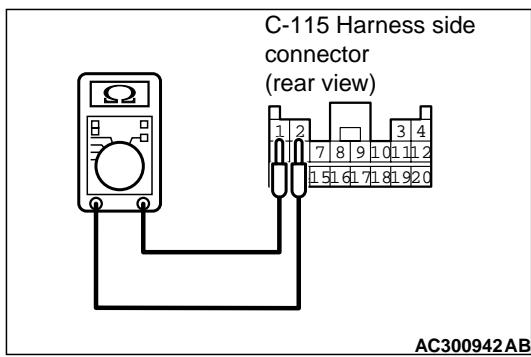
(2) Measure the resistance between terminal 3 and terminal 4.

OK: $820 \pm 82 \Omega$

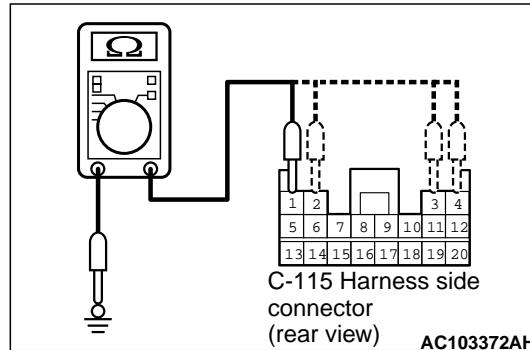
(3) Measure the resistance between terminal 1 and terminal 2.

OK: $820 \pm 82 \Omega$

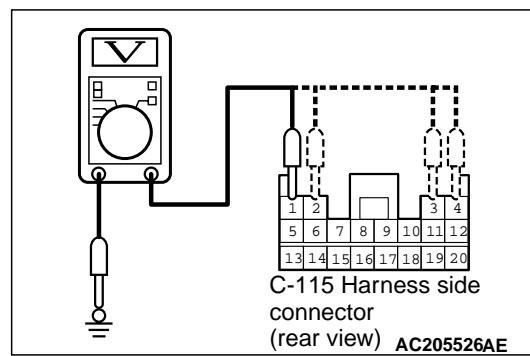
(4) Measure the resistance between terminal 1, 2, 3, 4 and body earth.

OK: $2 M\Omega$ or more

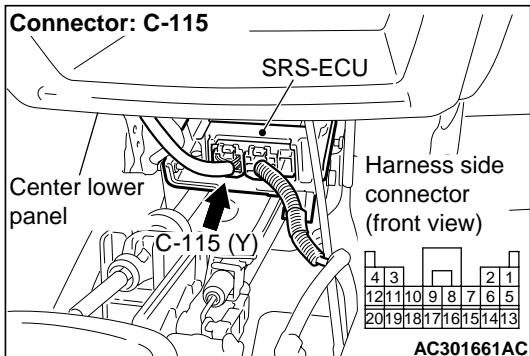
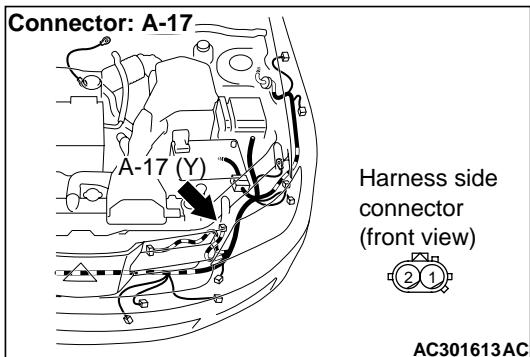
STEP 3. Connector check: SRS-ECU connector C-115, front impact sensor (LH) connector A-17, intermediate connector C-116, front impact sensor (RH) connector A-28 and intermediate connector C-14

YES : Check the harness wires for open or short circuit between SRS-ECU connector C-115 (terminal No.3 and 4) and front impact sensor (LH) connector A-17 (terminal No.1 and 2), SRS-ECU connector C-115 (terminal No.1 and 2) and front impact sensor (RH) connector A-28 (terminal No.2 and 1), and repair if necessary. Then go to Step 4.

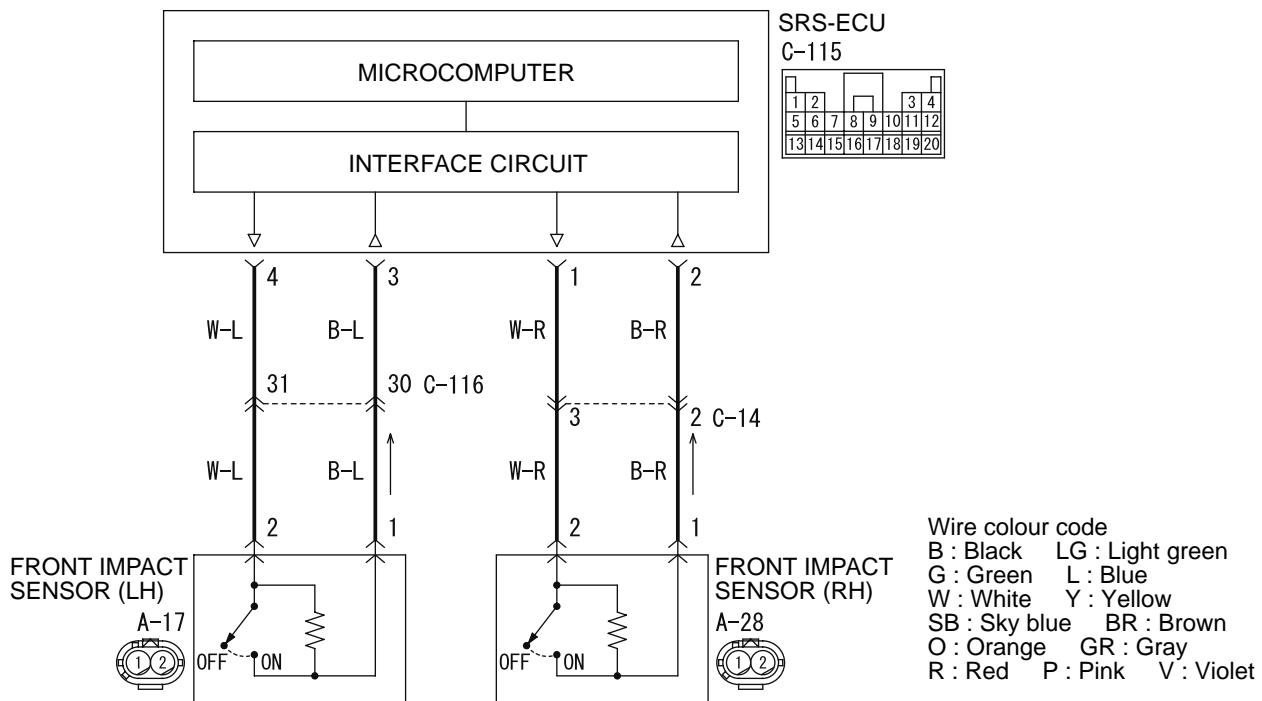
Front Impact Sensor Circuit

AC301793AB
W3Z02E04AA

Code No.	Trouble causes
11	<ul style="list-style-type: none"> • Short circuit in front impact sensor or harness • Short circuit in front impact sensor harness leading to the vehicle body eart. • Short circuit in front impact sensor harness leading to the power suppl.
12	<ul style="list-style-type: none"> • Open circuit in either left or right front impact sensor or harnes. • Short circuit in front impact sensor harness leading to the power suppl.
13	<ul style="list-style-type: none"> • Open circuit in both left and right front impact sensor or harness • Short circuit in front impact sensor harness leading to the power supply

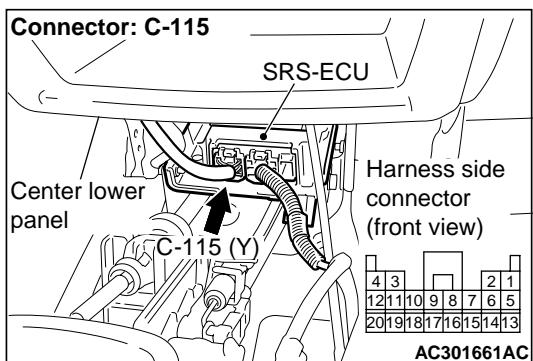
STEP 2. Measure the resistance at SRS-ECU connector C-115.

(1) Disconnect SRS-ECU connector C-115 and measure at the harness side (rear side).

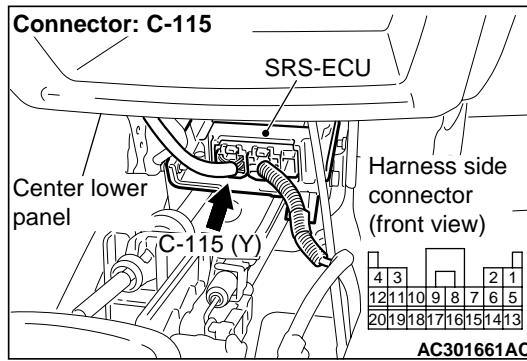
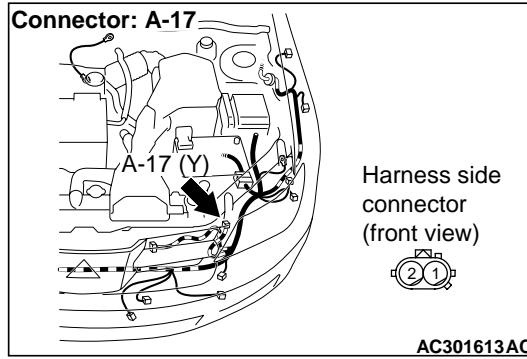
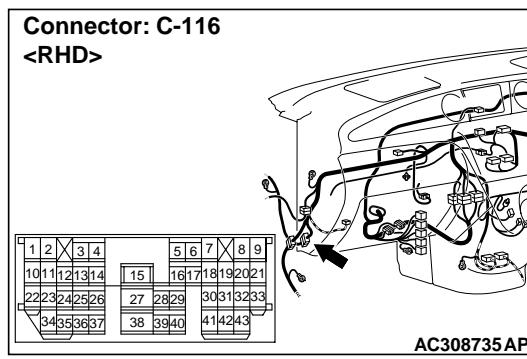
STEP 3. Connector check: SRS-ECU connector C-115, front impact sensor (LH) connector A-17 and intermediate connector C-116

YES : Check the harness wires for open or short circuit between SRS-ECU connector C-115 (terminal No.3 and 4) and front impact sensor (LH) connector A-17 (terminal No.1 and 2), and repair if necessary. Then go to Step 6.

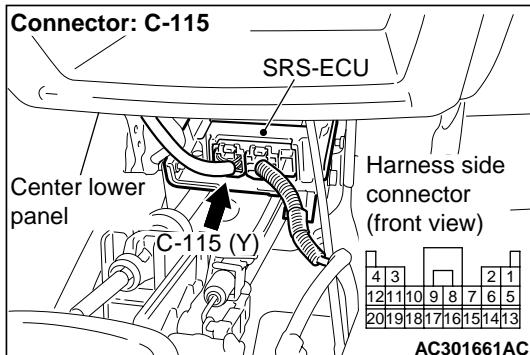
STEP 4. Measure the resistance at SRS-ECU connector C-115.

(1) Disconnect SRS-ECU connector C-115 and measure at the harness side (rear side).

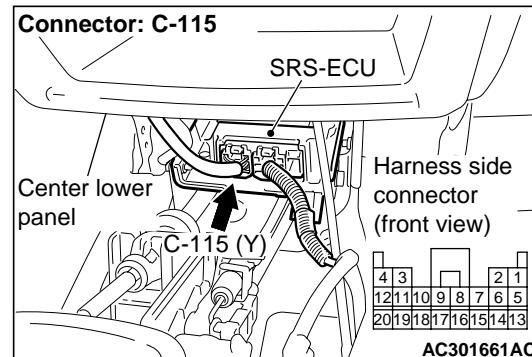
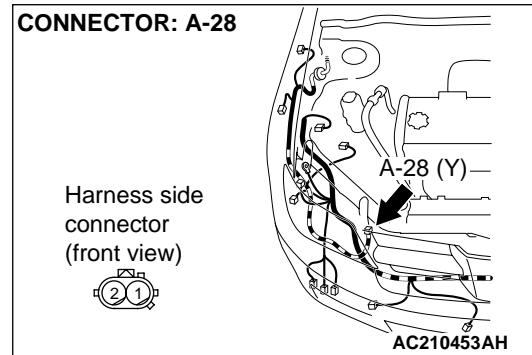
STEP 5. Connector check: SRS-ECU connector C-115, front impact sensor (RH) connector A-28 and intermediate connector C-14

YES : Check the harness wires for open or short circuit between SRS-ECU connector C-115 (terminal No.1 and 2) and front impact sensor (RH) connector A-28 (terminal No.2 and 1), and repair if necessary. Then go to Step 6.

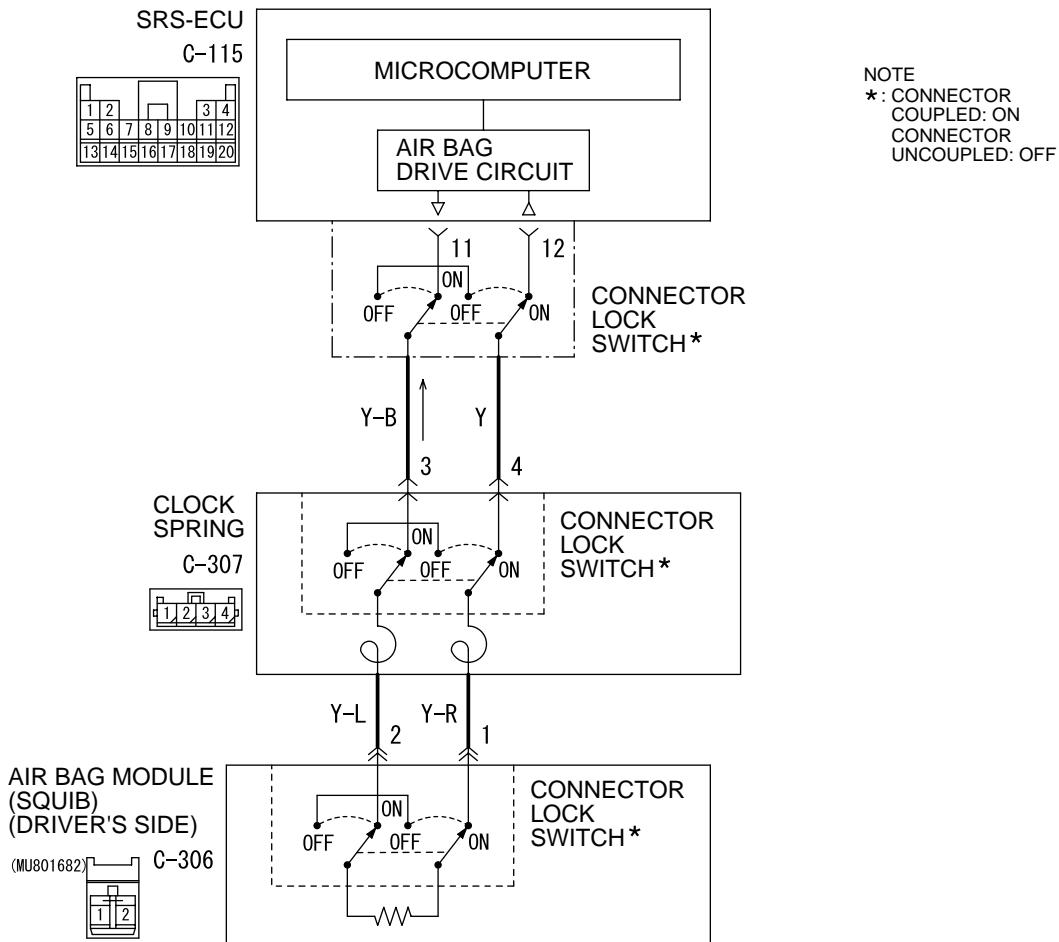
Driver's Air Bag Module (Squib) Circuit

*: CONNECTOR
COUPLED: ON
CONNECTOR
UNCOUPLED: OFF

- Improper engaged connector or defective short spring*
- Short circuit in the clock spring
- Short circuit between the driver's air bag module (squib) circuit terminals
- Damaged connector(s)
- Malfunction of the SRS-ECU

NOTE: *The squib circuit connectors integrate a "short" spring (which prevents the air bag from deploying unintentionally due to static electricity by shorting the positive wire to the earth wire in the squib circuit when the connectors are disconnected). Therefore, if connector C-115, C-307 or C-306 is damaged or improperly engaged, the short spring may not be released when the connector is connected.

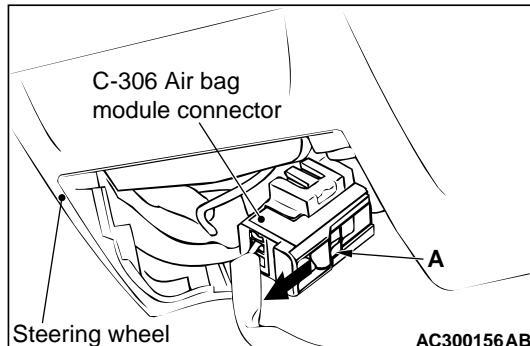
- (2) By sliding the A section (in the figure) of air bag module connector C-306 in the arrow direction, disconnect the connector.

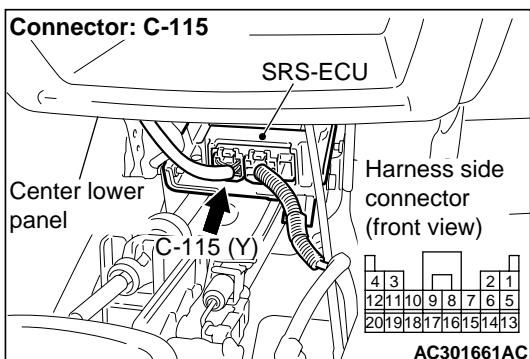
STEP 6. Measure the resistance at the SRS-ECU connector C-115.

(1) Disconnect SRS-ECU connector C-115.

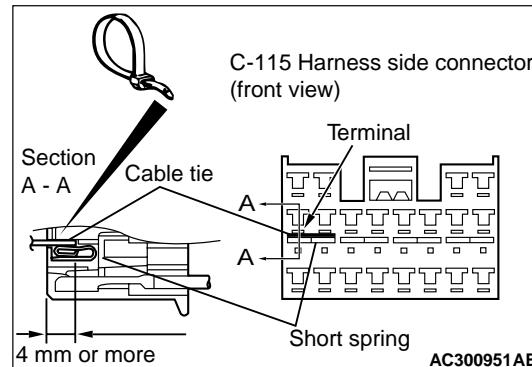
Insert an insulator such as a cable tie to a depth of 4 mm or more, otherwise the short spring will not be released.

(3) Insert a cable tie [3 mm wide, 0.5 mm thick] between terminals 11, 12 and the short bar to release the short spring.

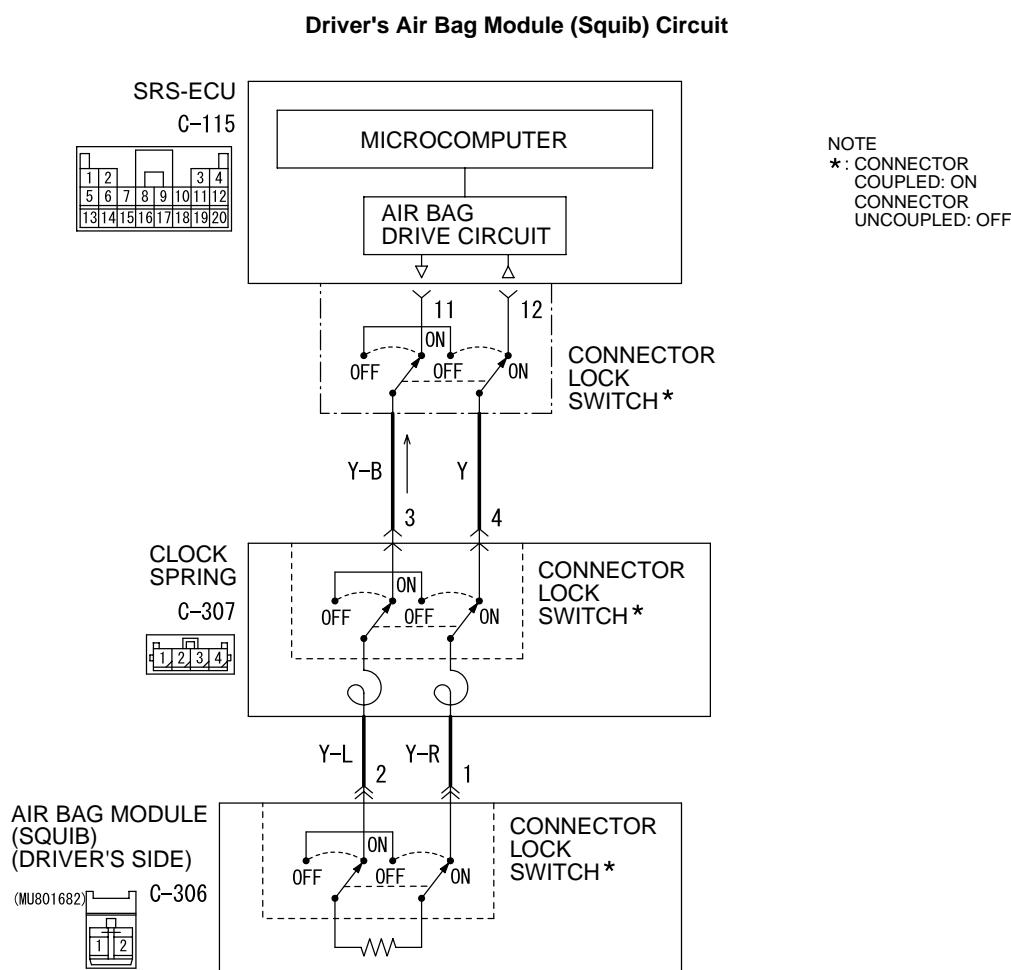
Code No.22: Driver's air bag module (squib) system (open-circuited in the squib circuit)

- Open circuit in the clock spring
- Open circuit due to improper neutral position of the clock spring
- Open circuit in the driver's air bag module (squib) circuit
- Disengaged driver's air bag module (squib) connector
- Improper connector contact
- Malfunction of the SRS-ECU

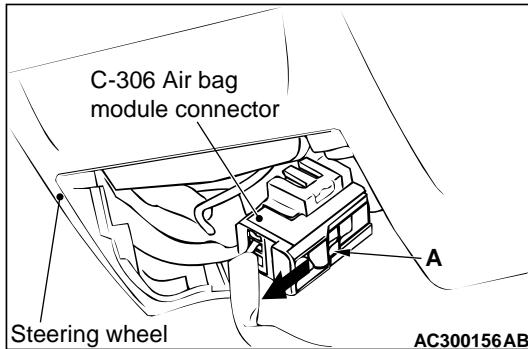
(2) By sliding the A section (in the figure) of air bag module connector C-306 in the arrow direction,

disconnect the connector.

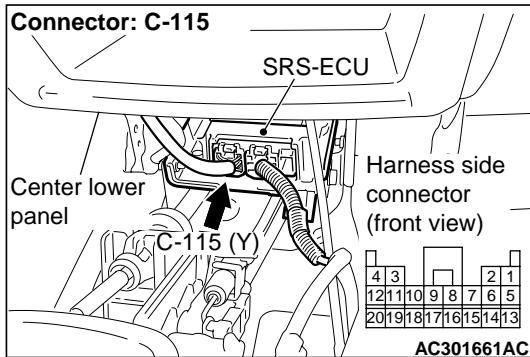
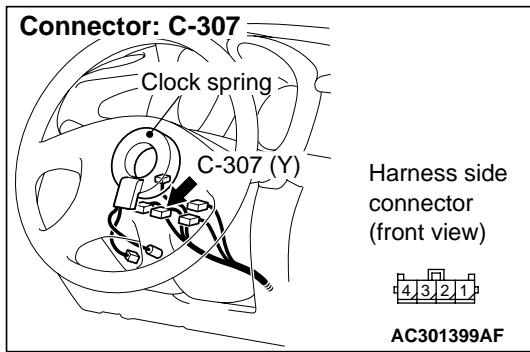
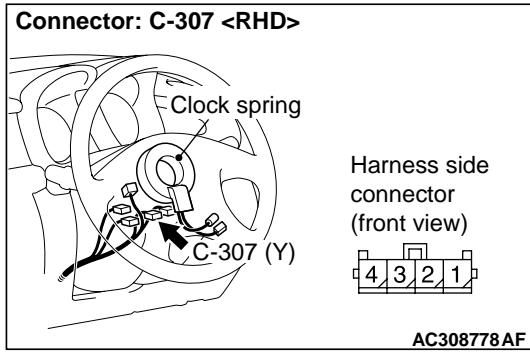
STEP 3. Measure the resistance between the SRS-ECU connector C-115 (terminal No.11 and 12) and the clock spring connector C-307 (terminal No.3 and 4).

(1) Disconnect SRS-ECU connector C-115 and clock spring connector C-307.

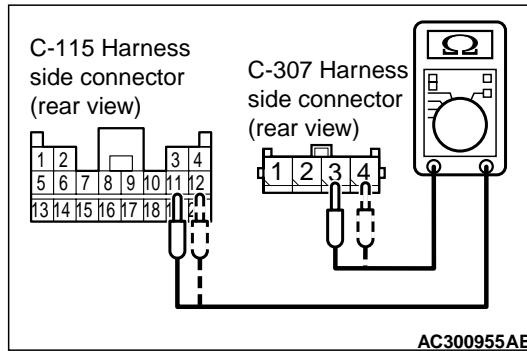
Do not insert a test probe into the terminal from its front side directly as the connector contact pressure may be weakened.

(2) Measure the resistance between the following terminals.

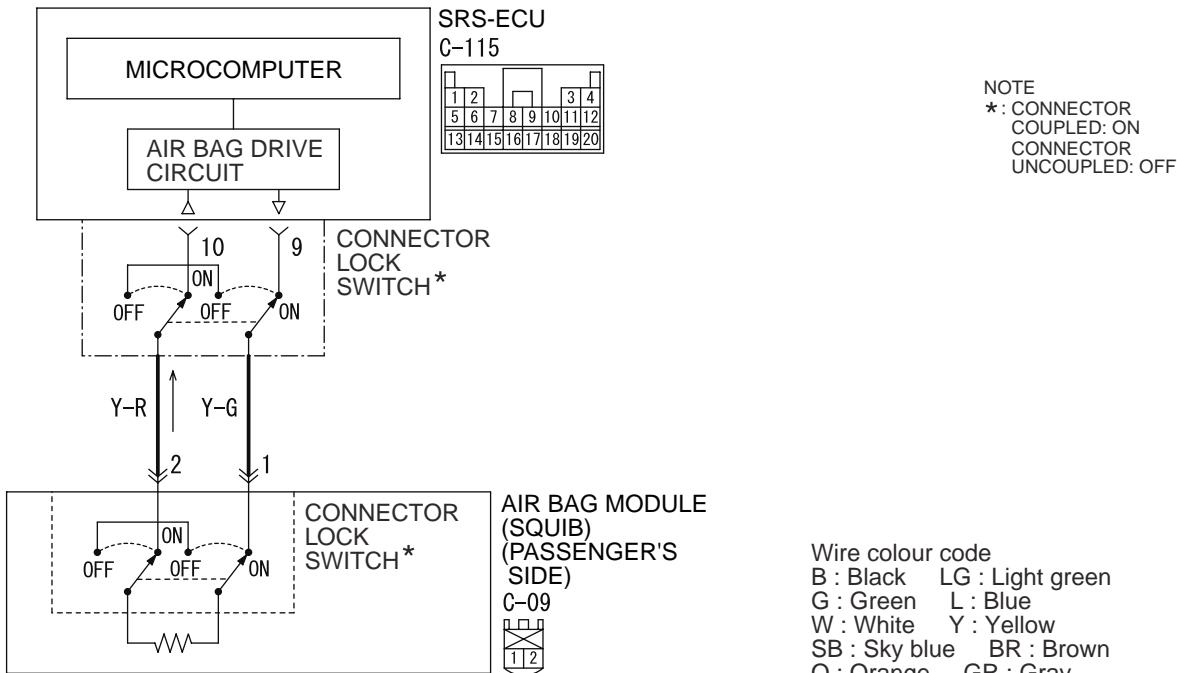
Passenger's (Front) Air Bag Module (Squib) Circuit

Code No.24: Passenger's (front) air bag module (squib) system (short-circuited between terminals of the squib circuit)

- Improper engaged connector or defective short spring*
- Short circuit between the passenger's air bag module (squib) circuit terminals
- Damaged connector(s)
- Malfunction of the SRS-ECU

NOTE: *: The squib circuit connectors integrate a "short" spring (which prevents the air bag from deploying unintentionally due to static electricity by shorting the positive wire to the earth wire in the squib circuit when the connectors are disconnected). Therefore, if connector C-115 or C-09 is damaged or improperly engaged, the short spring may not be released when the connector is connected.

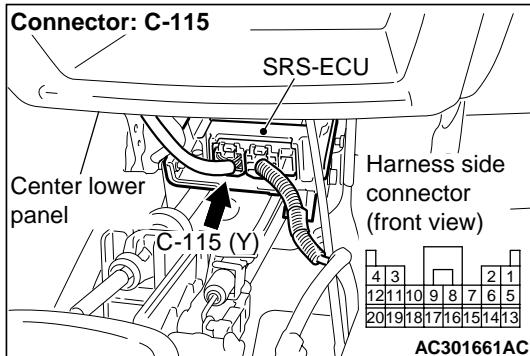
STEP 2. Connector check: SRS-ECU connector C-115

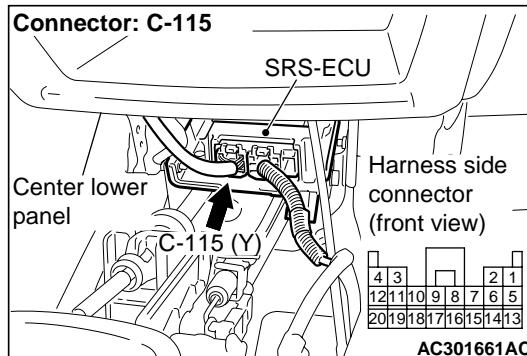
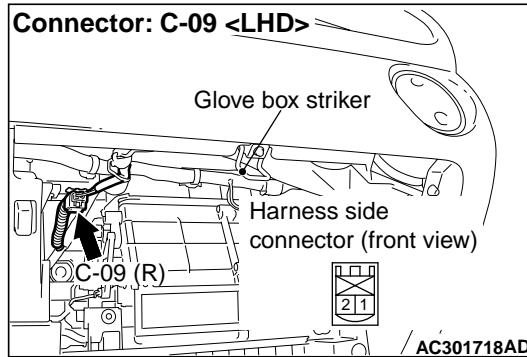
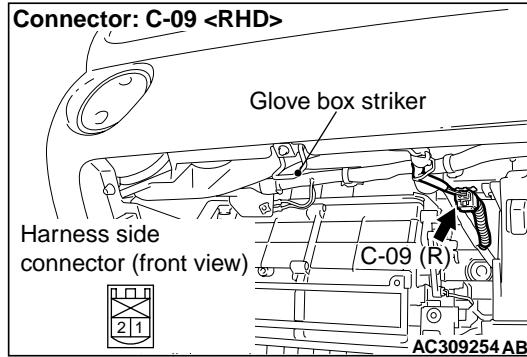
STEP 3. Connector check: SRS-ECU connector C-115 and passenger's air bag module connector C-09 (Check whether the diagnosis code is reset.)

- (2) Disconnect connectors C-115 and C-09, and then reconnect them.
- (3) Connect the negative battery terminal.
- (4) Erase the diagnosis code memory, and check the diagnosis code.

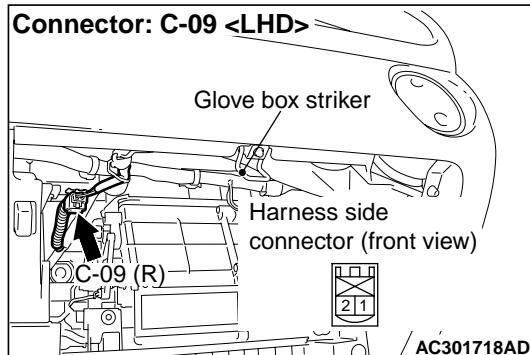
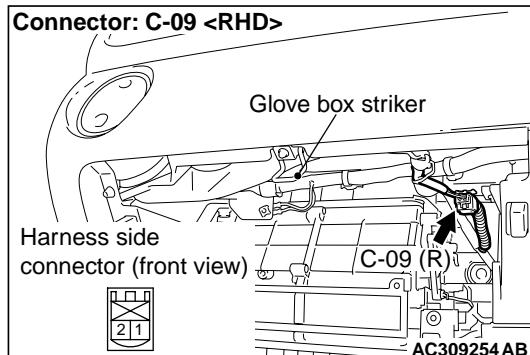
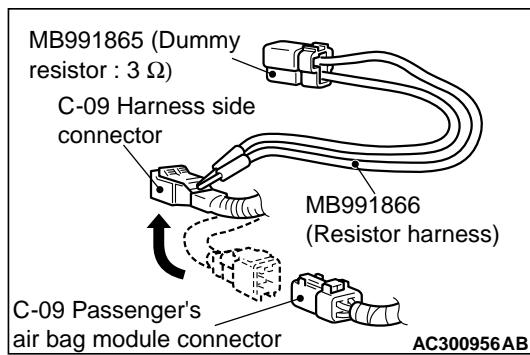
**STEP 4. Check the passenger's air bag module.
(Check whether the diagnosis code is reset.)**

(2) Unclip passenger's air bag module connector C-09.

(3) Connect special tool dummy resistor (MB991865) to special tool resistor harness (MB991866).

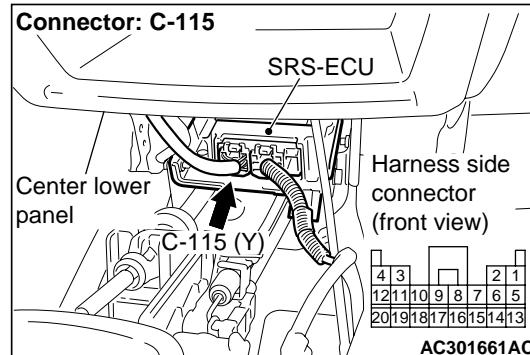
STEP 5. Measure the resistance at SRS-ECU connector C-115.

(1) Disconnect SRS-ECU connector C-115.

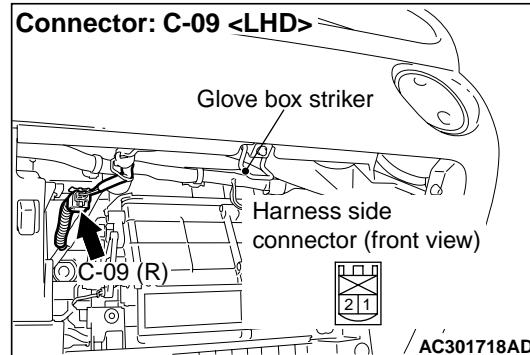
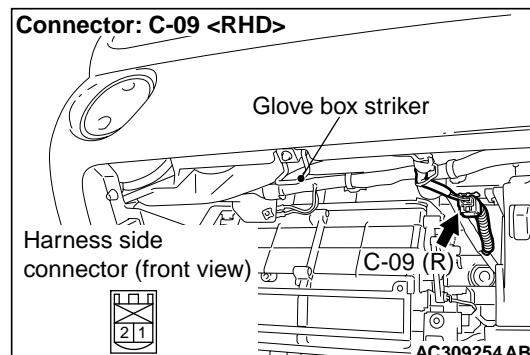
(2) Unclip passenger's air bag module connector C-09.

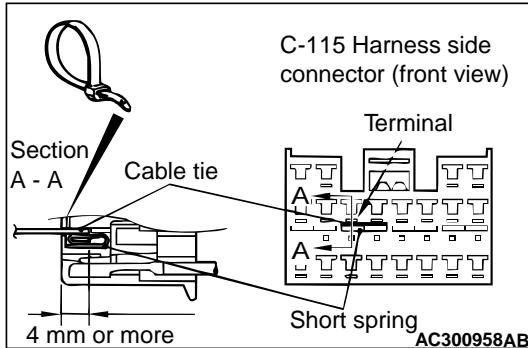
Insert an insulator such as a cable tie to a depth of 4 mm or more, otherwise the short spring will not be released.

(4) Insert a cable tie [3 mm wide, 0.5 mm thick] between terminals 9, 10 and the short spring to release the short spring.

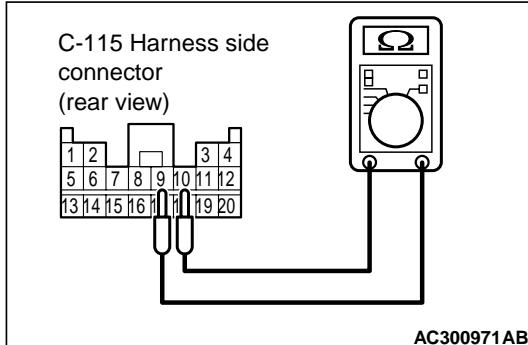
Do not insert a test probe into the terminal from its front side directly as the connector contact pressure may be weakened.

(5) Measure the resistance between C-115 harness side connector terminals 9 and 10.

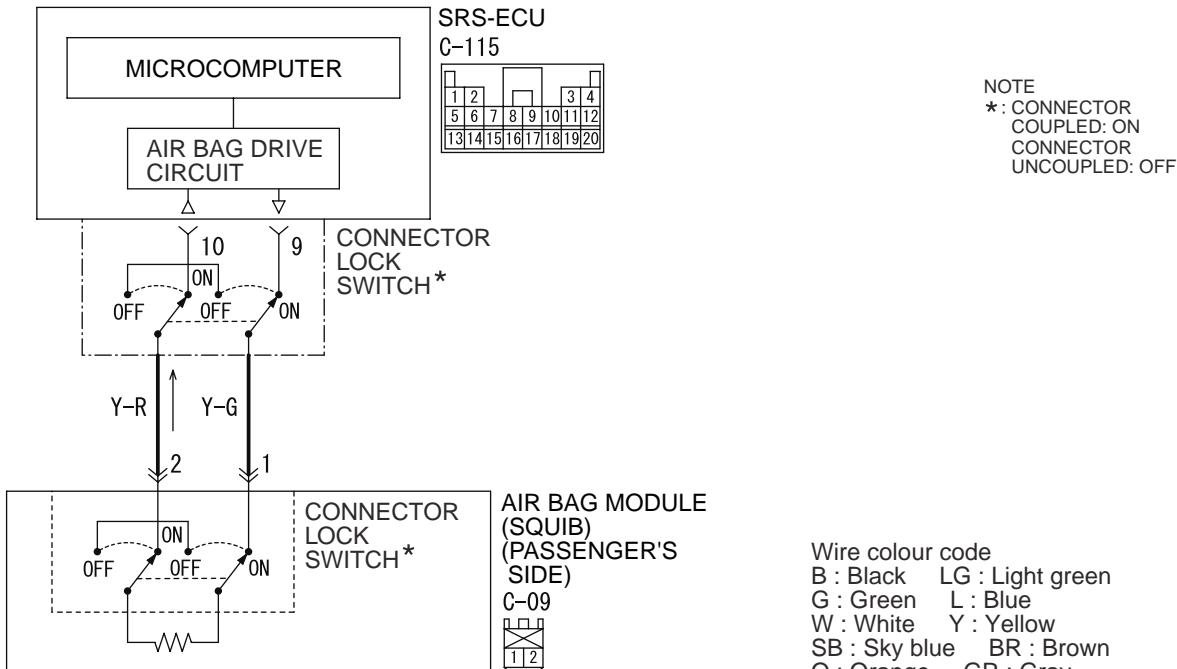
Passenger's (Front) Air Bag Module (Squib) Circuit

Code No.25: Passenger's (front) air bag module (squib) system (open-circuited in the squib circuit)

- Open circuit in the passenger's air bag module (squib) circuit
- Improper connector contact
- Malfunction of the SRS-ECU

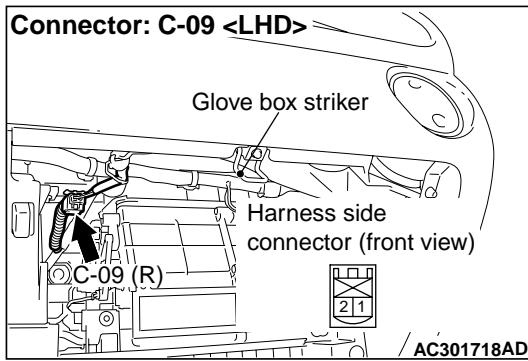
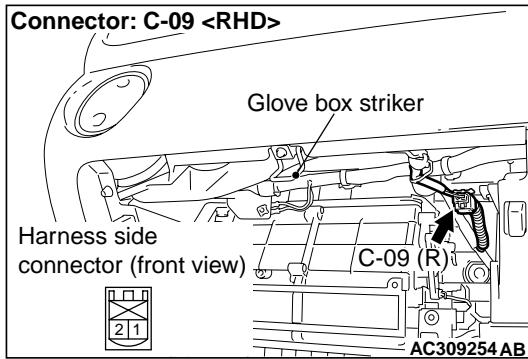
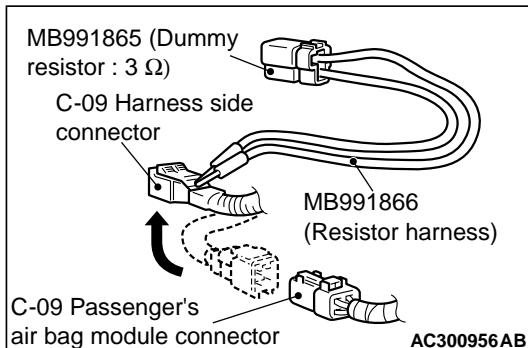
(2) Unclip passenger's air bag module connector C-09.

(3) Connect special tool dummy resistor (MB991865)

to special tool resistor harness (MB991866).

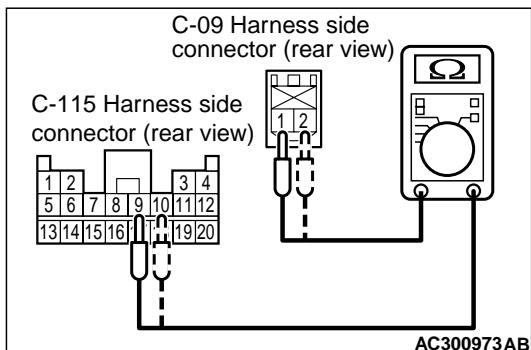
Do not insert a test probe into the terminal from its front side directly as the connector contact pressure may be weakened.

(3) Measure the resistance between the following terminals.

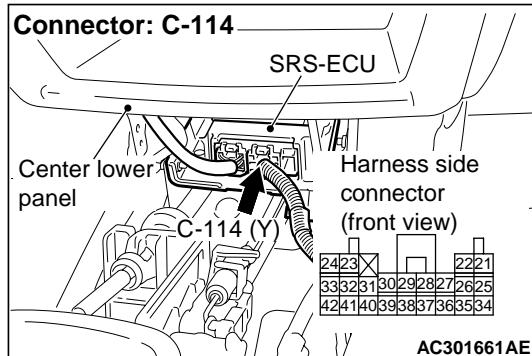
STEP 2. Connector check: SRS-ECU connector C-114

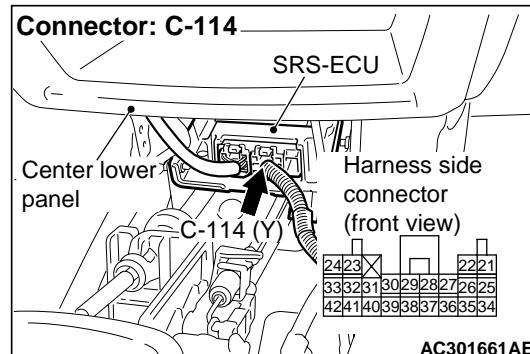
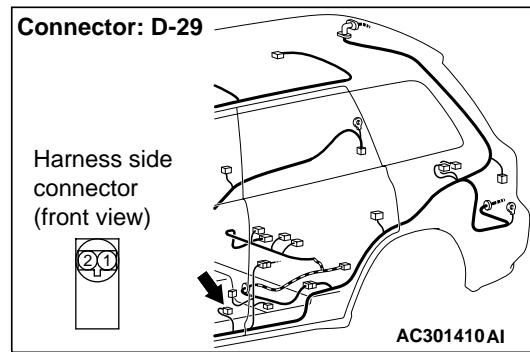
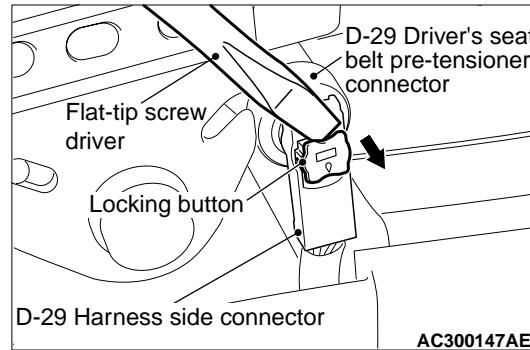
STEP 3. Connector check: SRS-ECU connector C-114 and driver's seat belt pre-tensioner connector D-29. (Check whether the diagnosis code is reset.)

- (2) Disconnect connectors C-114 and D-29, and then reconnect them. For connector D-29, use a flat-tipped screwdriver to pull out the locking button at the harness side connector, and then disconnect the connector.

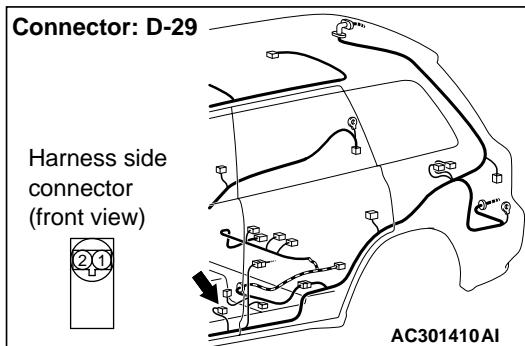
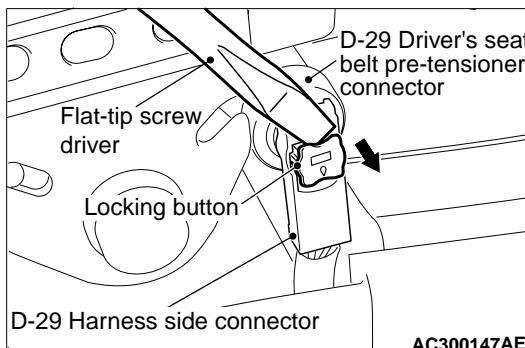
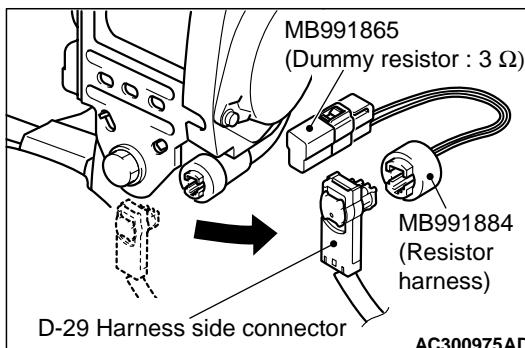
STEP 4. Check the driver's seat belt pre-tensioner. (Check whether the diagnosis code is reset.)

(2) Disconnect driver's seat belt pre-tensioner connector D-29. Use a flat-tipped screwdriver to pull out the locking button at the harness side connector, and then disconnect the connector.

(3) Connect special tool dummy resistor (MB991865)

to special tool resistor harness (MB991884).

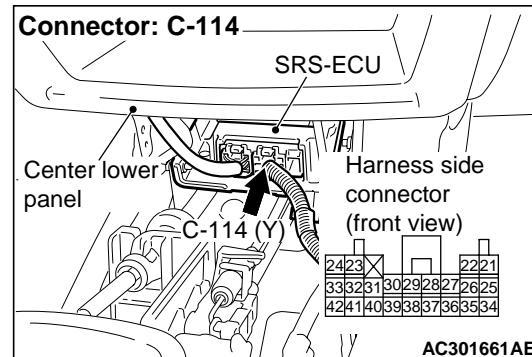
STEP 5. Measure the resistance at the SRS-ECU connector C-114.

(1) Disconnect SRS-ECU connector C-114.

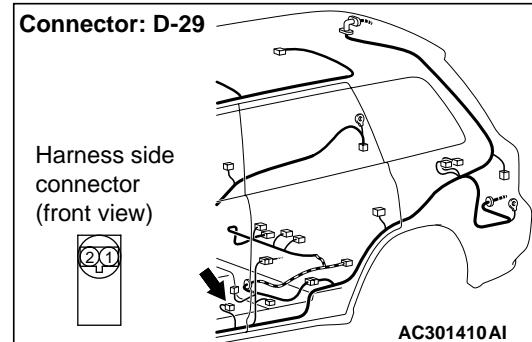
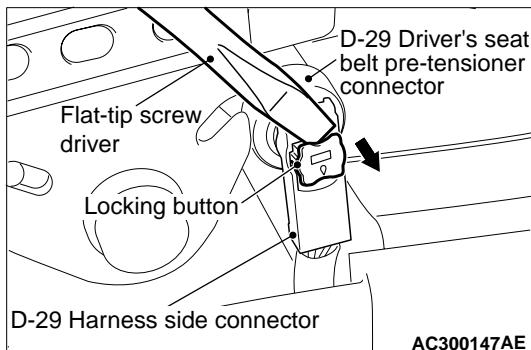
To prevents the air bag from deploying unintentionally, disconnect the driver's seat belt pre-tensioner connector D-29 to short the squib circuit.

(2) Disconnect driver's seat belt pre-tensioner connector D-29. Use a flat-tipped screwdriver to pull out the locking button at the harness side connector, and then disconnect the connector.

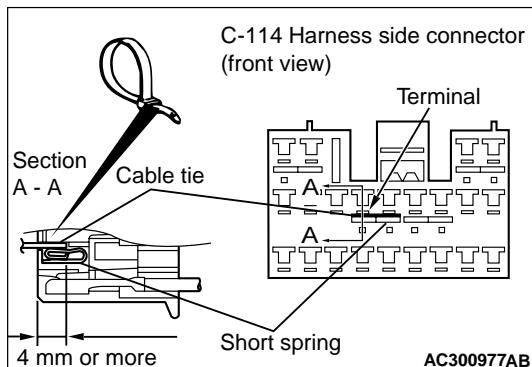
Insert an insulator such as a cable tie to a depth of 4mm or more, otherwise the short bar will not be released.

(3) Insert a cable tie [3 mm wide, 0.5 mm thick] between terminals 29, 30 and the short bar to release the short spring.

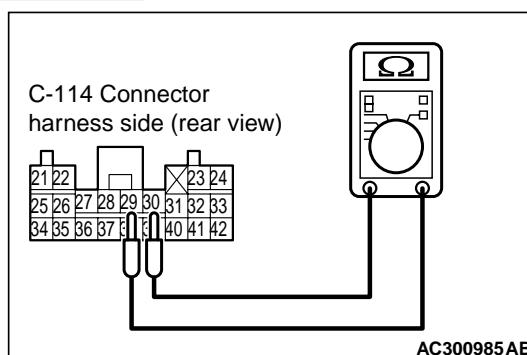
Do not insert a test probe into the terminal from its front side directly as the connector contact pressure may be weakened.

(4) Measure the resistance between C-114 harness side connector terminals 29 and 30.

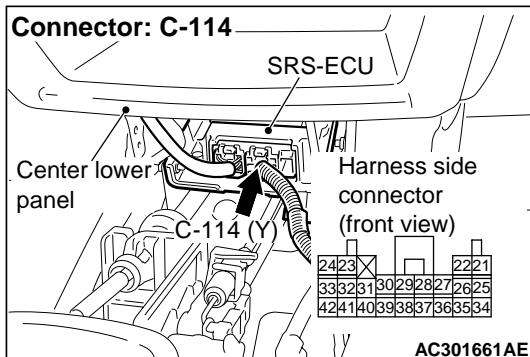
STEP 6. Connector check: SRS-ECU connector C-114, driver's seat belt pre-tensioner connector D-29 and intermediate connector D-31

YES : Check the harness wires for short circuit between SRS-ECU connector C-114 (terminal No.29 and 30) and driver's seat belt pre-tensioner connector D-29 (terminal No.2 and 1), and repair if necessary. Then go to Step 7.

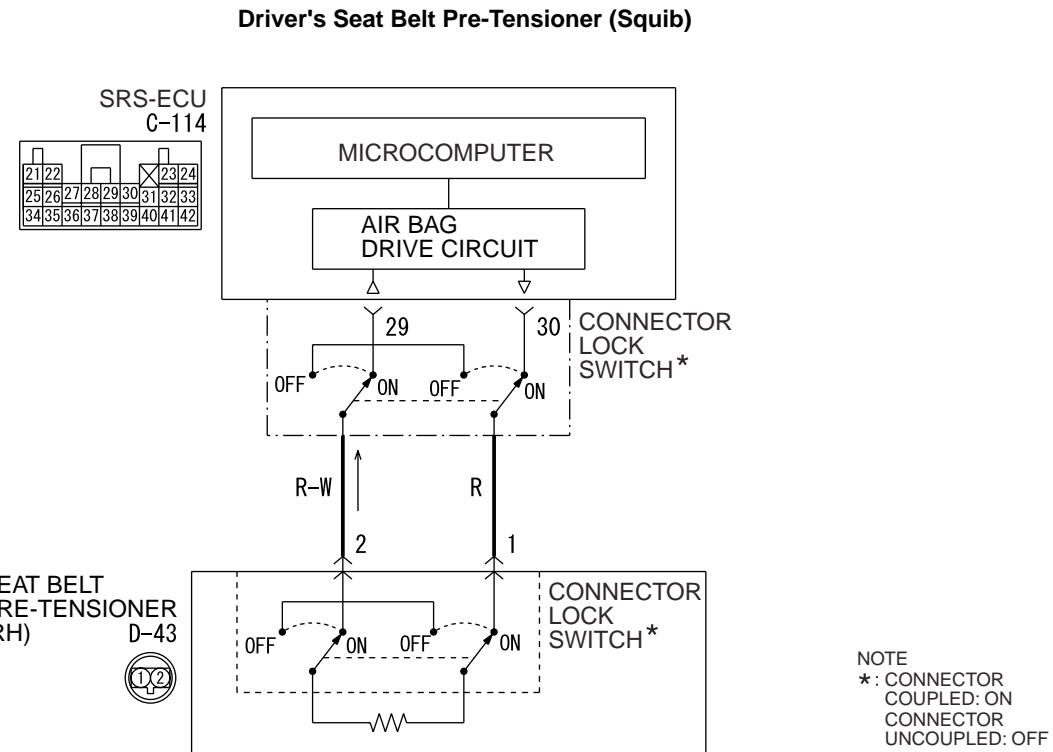
Code No.26: Driver's pre-tensioner (squib) system (short-circuited between terminals of the squib circuit) <R.H. drive vehicles>

- Improper engaged connector or defective short spring*

- Short circuit between the driver's seat belt pre-tensioner (squib) circuit terminals
- Damaged connector(s)
- Malfunction of the SRS-ECU

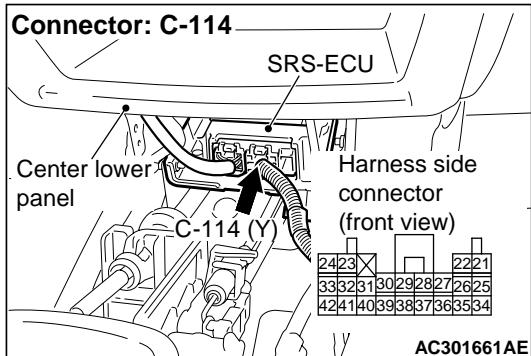
STEP 2. Connector check: SRS-ECU connector C-114

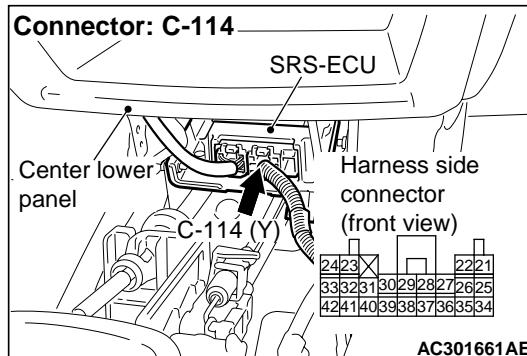
Connector: D-43

STEP 3. Connector check: SRS-ECU connector C-114 and driver's seat belt pre-tensioner connector D-43. (Check whether the diagnosis code is reset.)

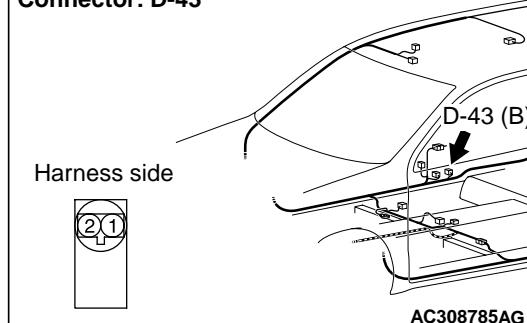
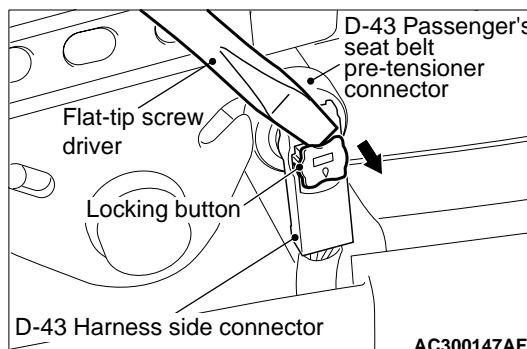
- (2) Disconnect connectors C-114 and D-43, and then reconnect them. For connector D-43, use a flat-tipped screwdriver to pull out the locking button at the harness side connector, and then disconnect the connector.

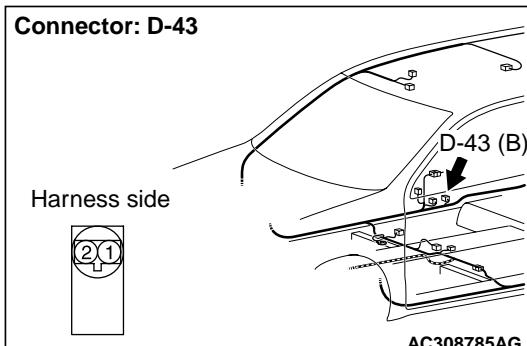
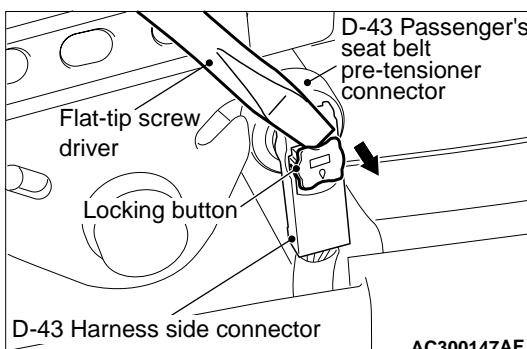
(2) Disconnect driver's seat belt pre-tensioner connector D-43. Use a flat-tipped screwdriver to pull out the locking button at the harness side connector, and then disconnect the connector.

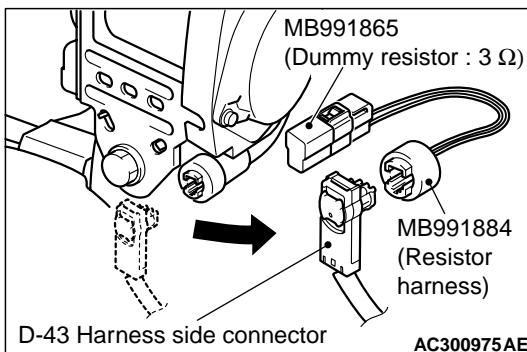
(3) Connect special tool dummy resistor (MB991865) to special tool resistor harness (MB991884).
 (4) Connect special tool (MB991884) to the D-43 harness side connector.
 (5) Connect the negative battery terminal.
 (6) Erase diagnosis code memory, and then check the diagnosis code.

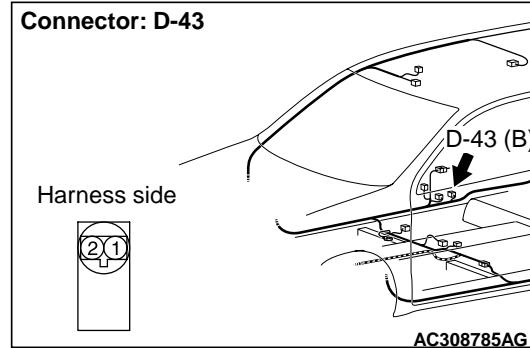
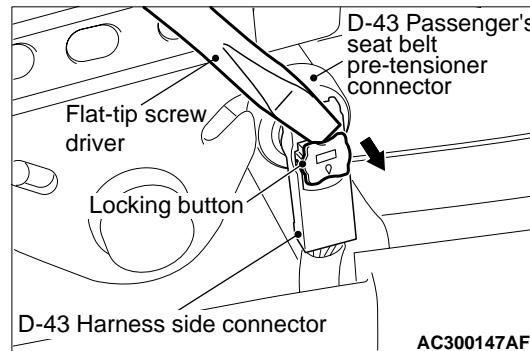
To prevents the air bag from deploying unintentionally, disconnect the driver's seat belt pre-tensioner connector D-43 to short the squib circuit.

(2) Disconnect driver's seat belt pre-tensioner connector D-43. Use a flat-tipped screwdriver to pull out the locking button at the harness side

connector, and then disconnect the connector.

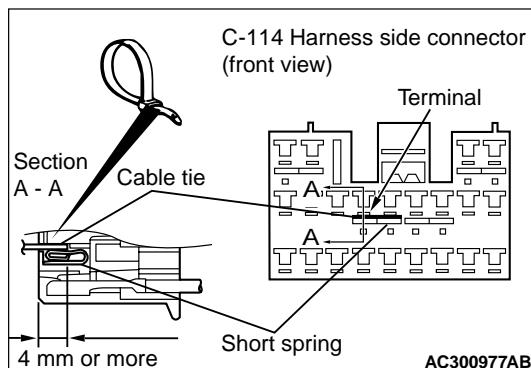
Insert an insulator such as a cable tie to a depth of 4mm or more, otherwise the short bar will not be released.

(3) Insert a cable tie [3 mm wide, 0.5 mm thick] between terminals 29, 30 and the short bar to release the short spring.

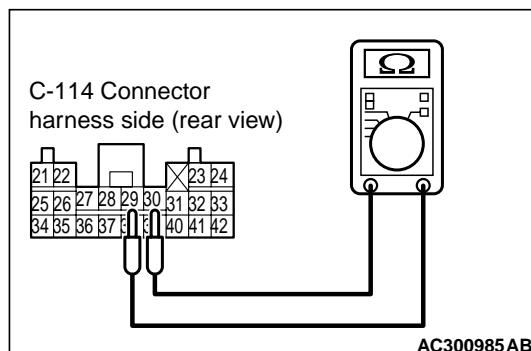
Do not insert a test probe into the terminal from its front side directly as the connector contact pressure may be weakened.

(4) Measure the resistance between C-114 harness side connector terminals 29 and 30.

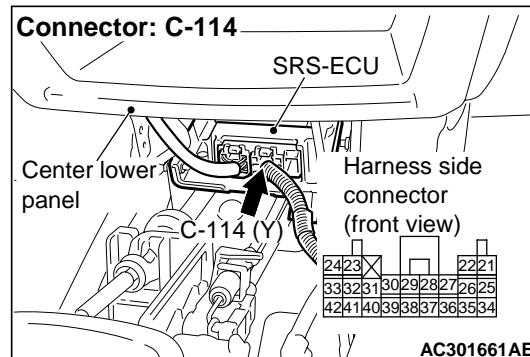
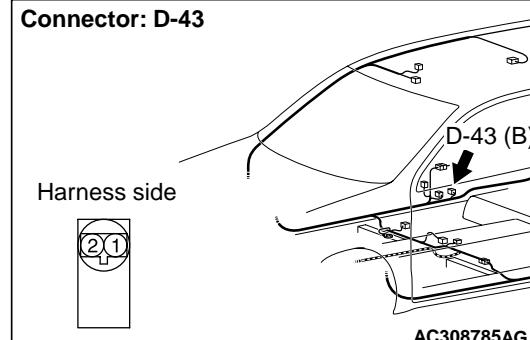
Connector: D-43

STEP 6. Connector check: SRS-ECU connector C-114 and driver's seat belt pre-tensioner connector D-43

YES : Check the harness wires for short circuit between SRS-ECU connector C-114 (terminal No.29 and 30) and driver's seat belt pre-tensioner connector D-43 (terminal No.2 and 1), and repair if necessary. Then go to Step 7.
