GROUP 52B

SUPPLEMENTAL RESTRAINT SYSTEM (SRS)

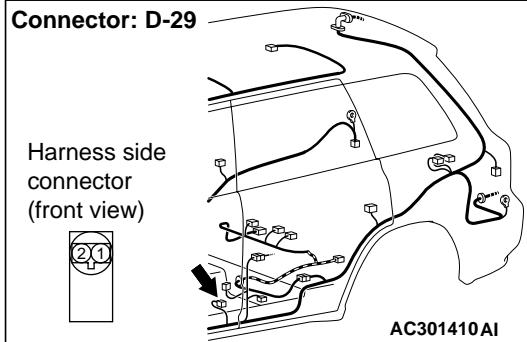
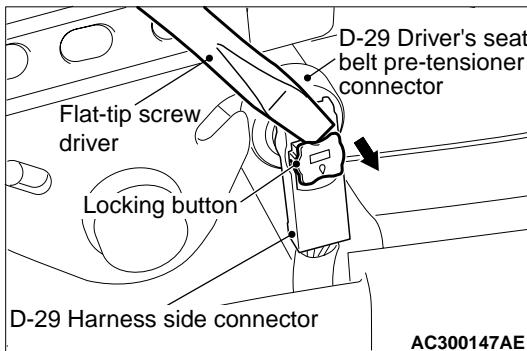
(2) Disconnect driver's seat belt pre-tensioner connector D-29. Use a flat-tipped screwdriver to pull out the locking button at the harness side connector, and then disconnect the connector.

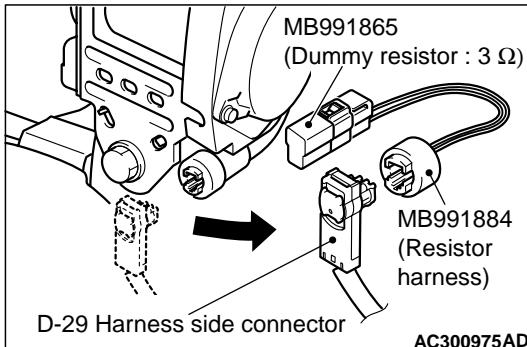
- (3) Connect special tool dummy resistor (MB991865) to special tool resistor harness (MB991884).
- (4) Connect special tool (MB991884) to the D-29 harness side connector.
- (5) Connect the negative battery terminal.
- (6) Erase diagnosis code memory, and then check

the diagnosis code.

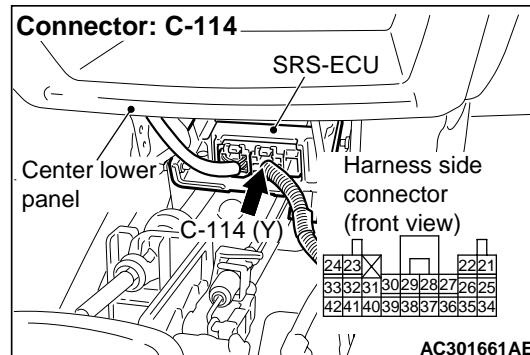
STEP 2. Measure the resistance between SRS-ECU connector C-114 (terminal No.29 and 30) and the driver's seat belt pre-tensioner D-29 (terminal No.1 and 2).

- (1) Disconnect SRS-ECU connector C-114 and driver's seat belt pre-tensioner connector D-29, and measure at the wiring harness side. For connector D-29, use a flat-tipped screwdriver to pull out the locking button at the harness side

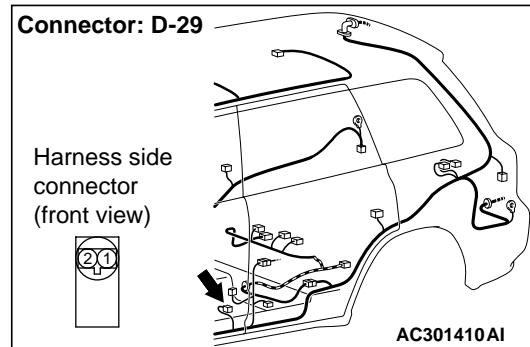
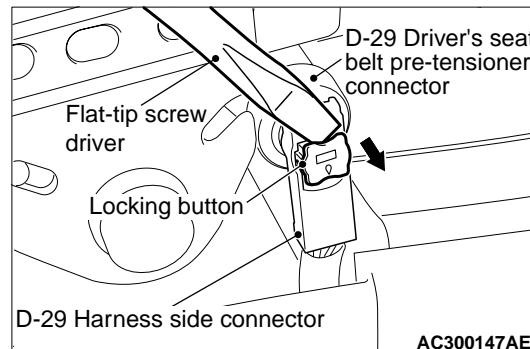
connector, and then disconnect the connector.

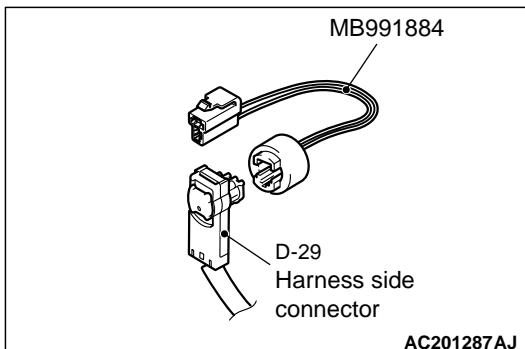
(2) Connect D-29 harness side connector to special tool resistor harness (MB991884).

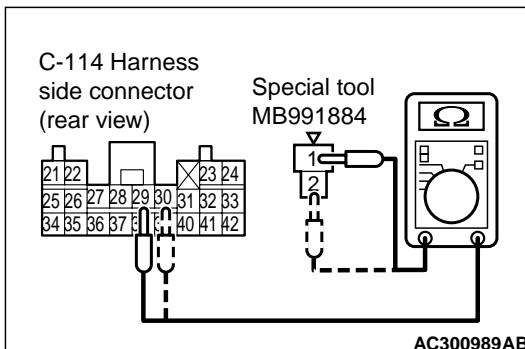
Do not insert a test probe into the terminal from its front side directly as the connector contact pressure may be weakened.

(3) Measure the resistance between the following terminals.

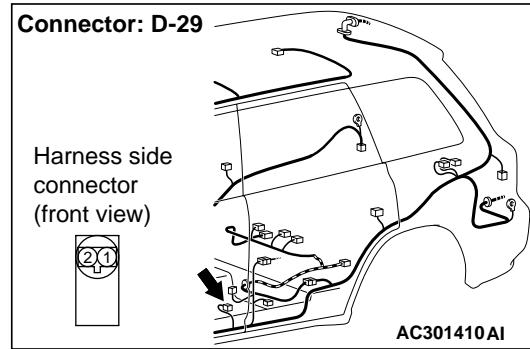
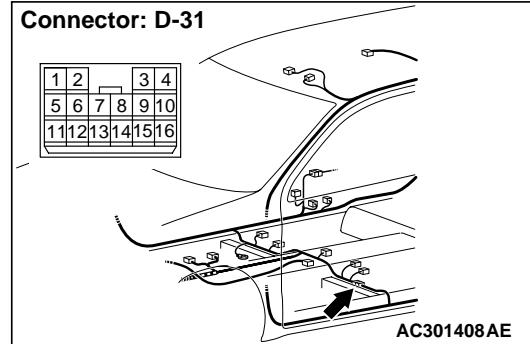
STEP 3. Connector check: SRS-ECU connector C-114, driver's seat belt pre-tensioner connector D-29 and intermediate connector D-31

YES : Check the harness wires for open circuit between SRS-ECU connector C-114 (terminal No.29 and 30) and driver's seat belt pre-tensioner connector D-29 (terminal No.2 and 1), and repair if necessary. Then go to Step 4.

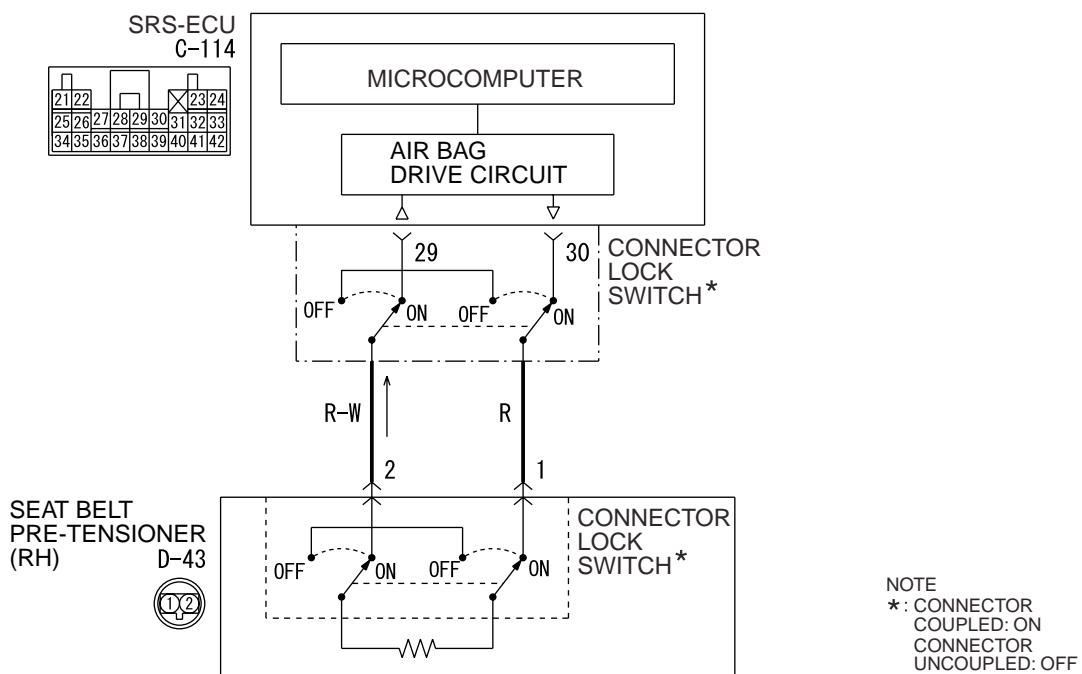
Driver's Seat Belt Pre-Tensioner (Squib)

OPERATION

The SRS-ECU judges how severe a collision is by detecting signals from the front impact sensors and the front air bag analog G-sensor. If the impact is over a predetermined level, the SRS-ECU outputs an ignition signal. At this time, if the front air bag safing G-sensor is on, the pre-tensioner will deploy.

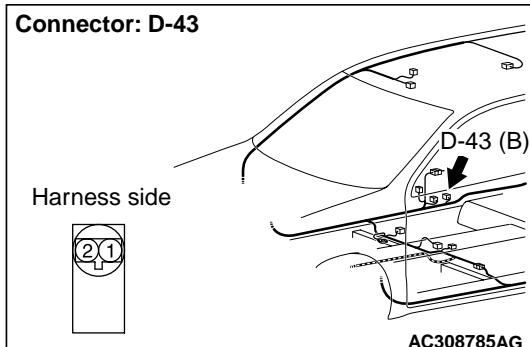
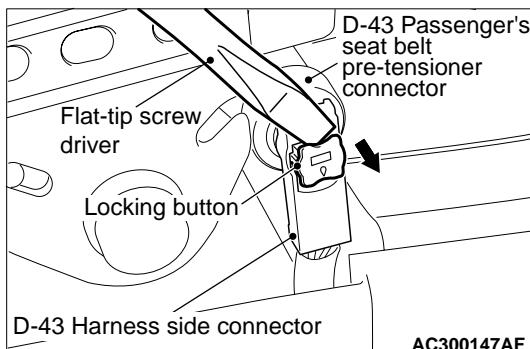
(2) Disconnect driver's seat belt pre-tensioner connector D-43. Use a flat-tipped screwdriver to pull out the locking button at the harness side connector, and then disconnect the connector.

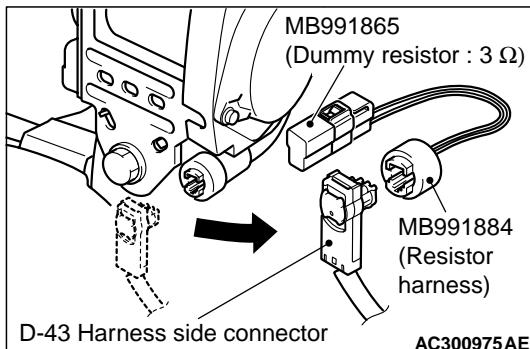
- (3) Connect special tool dummy resistor (MB991865) to special tool resistor harness (MB991884).
- (4) Connect special tool (MB991884) to the D-43 harness side connector.
- (5) Connect the negative battery terminal.
- (6) Erase diagnosis code memory, and then check the diagnosis code.

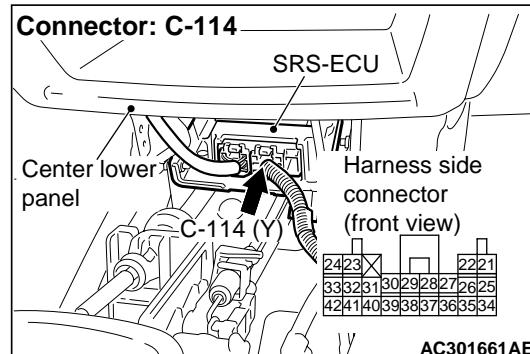
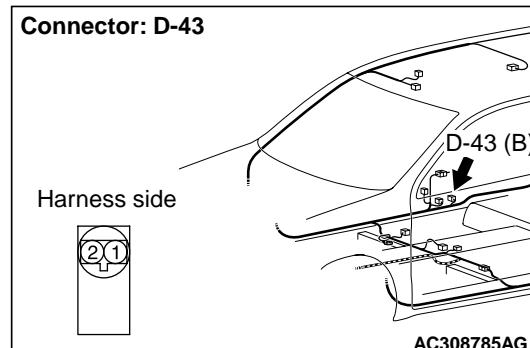
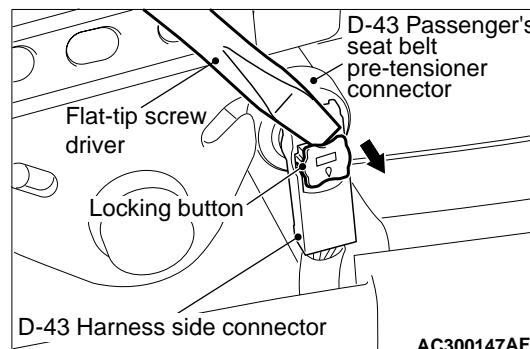
STEP 2. Measure the resistance between SRS-ECU connector C-114 (terminal No.29 and 30) and the driver's seat belt pre-tensioner D-43 (terminal No.1 and 2).

- (1) Disconnect SRS-ECU connector C-114 and driver's seat belt pre-tensioner connector D-43, and measure at the wiring harness side. For connector D-43, use a flat-tipped screwdriver to pull out the locking button at the harness side connector, and then disconnect the connector.

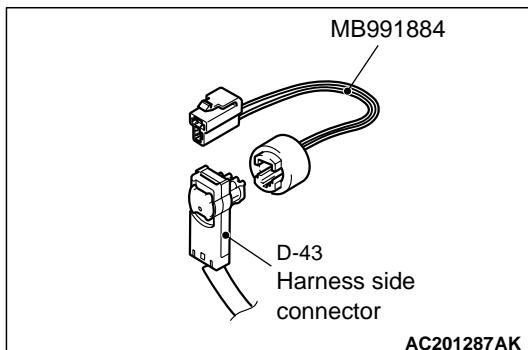
(2) Connect D-43 harness side connector to special tool resistor harness (MB991884).

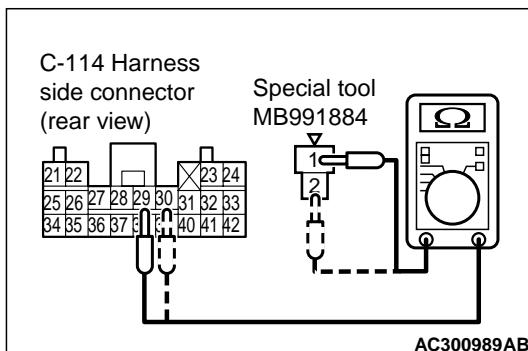
Do not insert a test probe into the terminal from its front side directly as the connector contact pressure may be weakened.

(3) Measure the resistance between the following terminals.

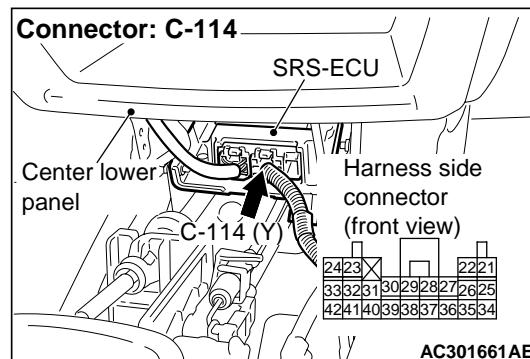
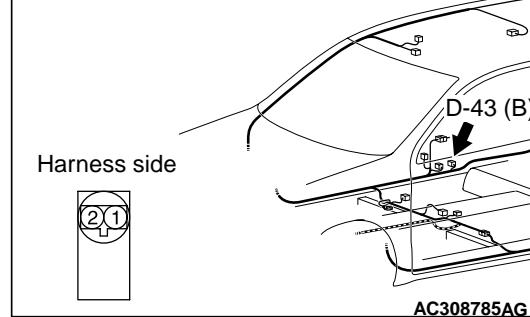
Connector: C-114

STEP 3. Connector check: SRS-ECU connector C-114 and driver's seat belt pre-tensioner connector D-43

YES : Check the harness wires for open circuit between SRS-ECU connector C-114 (terminal No.29 and 30) and driver's seat belt pre-tensioner connector D-43 (terminal No.2 and 1), and repair if necessary. Then go to Step 4.

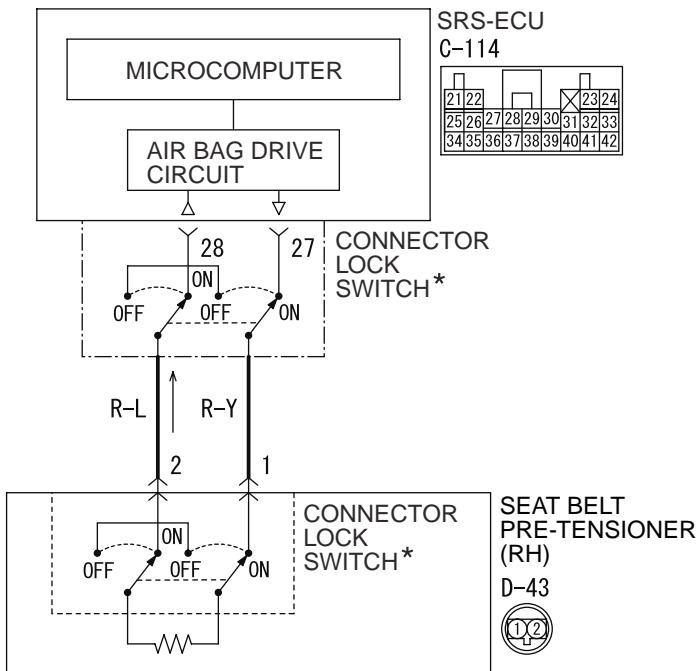
Passenger's (Front) Seat Belt Pre-tensioner (Squib)

OPERATION

The SRS-ECU judges how severe a collision is by detecting signals from the front impact sensors and the front air bag analog G-sensor. If the impact is over a predetermined level, the SRS-ECU outputs an ignition signal. At this time, if the front air bag safing G-sensor is on, the pre-tensioner will deploy.

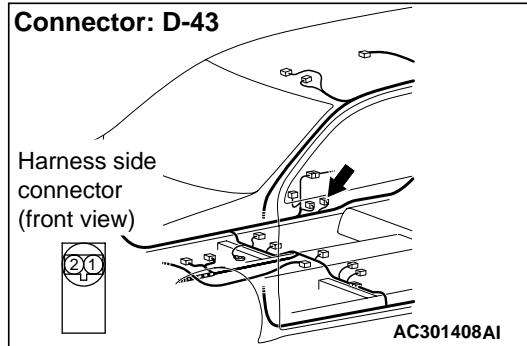
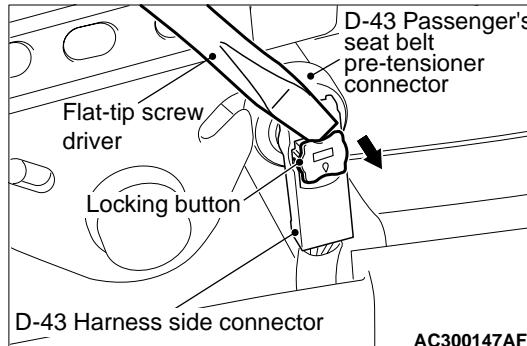
- (2) Disconnect connectors C-114 and D-43, and then reconnect them. For connector D-43, use a flat-tipped screwdriver to pull out the locking button at the harness side connector, and then disconnect the connector.
- (3) Connect the negative battery terminal.
- (4) Erase the diagnosis code memory, and check the diagnosis code.

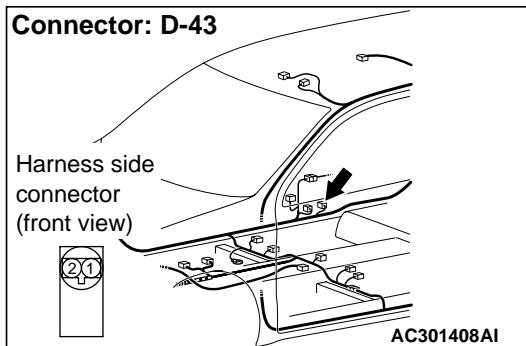
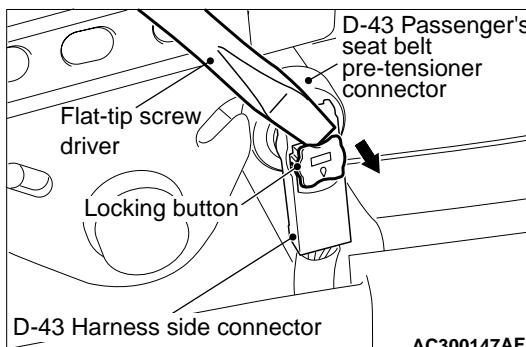
(2) Disconnect passenger's seat belt pre-tensioner connector D-43. Use a flat-tipped screwdriver to pull out the locking button at the harness side connector, and then disconnect the connector.

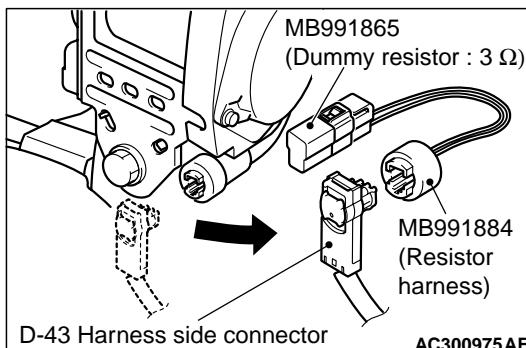
(3) Connect special tool dummy resistor (MB991865) to special tool resistor harness (MB991884).

- (4) Connect special tool (MB991884) to the D-43 harness side connector.
- (5) Connect the negative battery terminal.
- (6) Erase diagnosis code memory, and then check the diagnosis code.

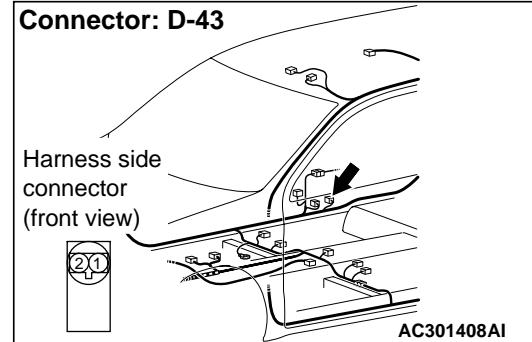
To prevents the air bag from deploying unintentionally, disconnect the passenger's seat belt pre-tensioner connector D-43 to short the squib circuit.

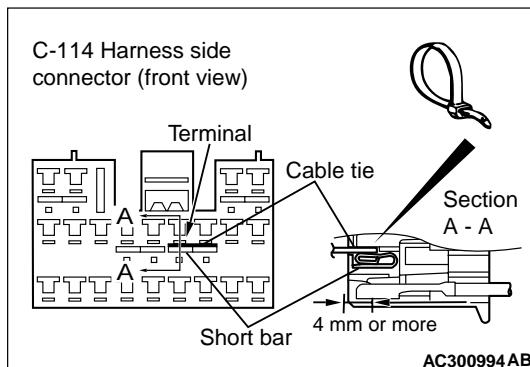
Insert an insulator such as a cable tie to a depth of 4 mm or more, otherwise the short bar will not be released.

(3) Insert a cable tie [3 mm wide, 0.5 mm thick] between terminals 27, 28 and the short bar to release the short spring.

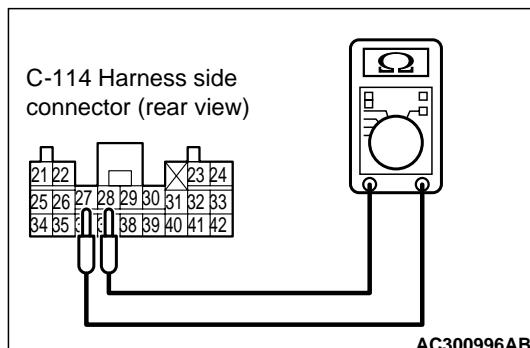
Do not insert a test probe into the terminal from its front side directly as the connector contact pressure may be weakened.

(4) Measure the resistance between C-114 harness side connector terminals 27 and 28.

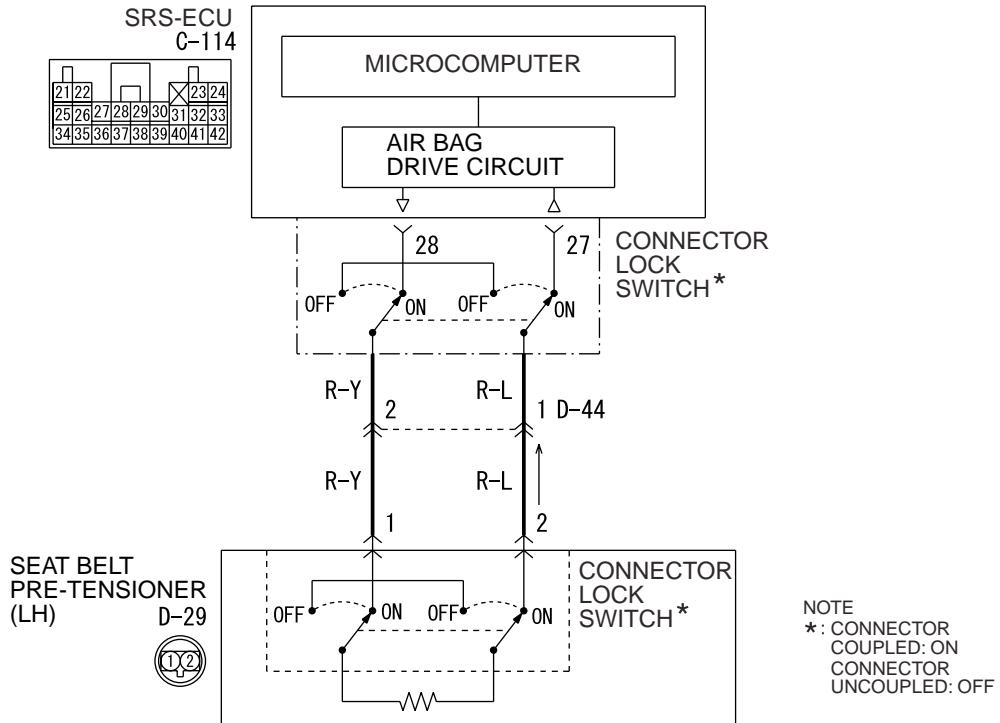
Code No.28: Passenger's (front) seat belt pre-tensioner (squib) system (short-circuit between terminals of the squib circuit) <R.H. drive vehicles>

Passenger's (Front) Seat Belt Pre-tensioner (Squib)

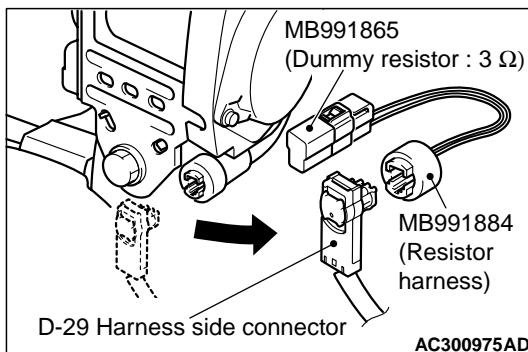
(3) Connect special tool dummy resistor (MB991865) to special tool resistor harness (MB991884).

- (4) Connect special tool (MB991884) to the D-29 harness side connector.
- (5) Connect the negative battery terminal.
- (6) Erase diagnosis code memory, and then check the diagnosis code.

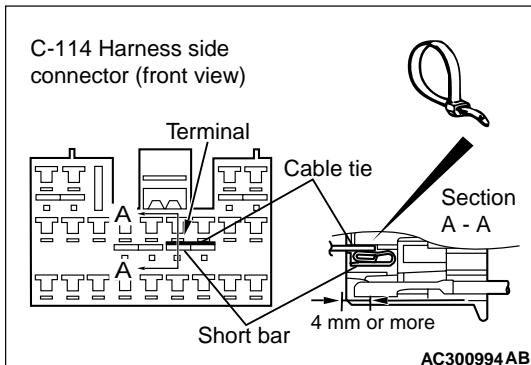
Insert an insulator such as a cable tie to a depth of 4 mm or more, otherwise the short bar will not be released.

(3) Insert a cable tie [3 mm wide, 0.5 mm thick] between terminals 27, 28 and the short bar to release the short spring.

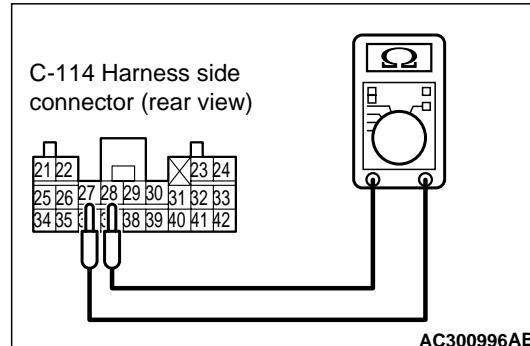
Do not insert a test probe into the terminal from its front side directly as the connector contact pressure may be weakened.

(4) Measure the resistance between C-114 harness side connector terminals 27 and 28.

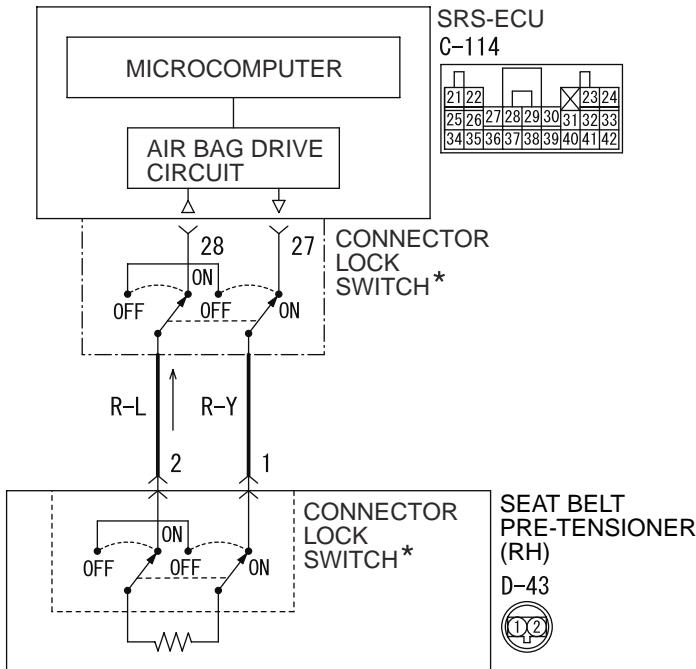
Code No.29: Passenger's (front) seat belt pre-tensioner (squib) system (open-circuited in the squib circuit) <L.H. drive vehicles>

Passenger's (Front) Seat Belt Pre-tensioner (Squib)

NOTE
*: CONNECTOR
COUPLED: ON
CONNECTOR
UNCOPLED: OFF

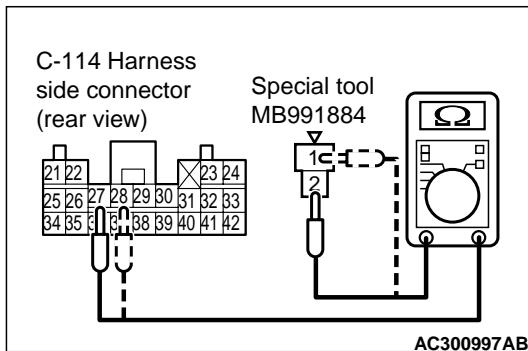
Do not insert a test probe into the terminal from its front side directly as the connector contact pressure may be weakened.

(3) Measure the resistance between the following terminals.

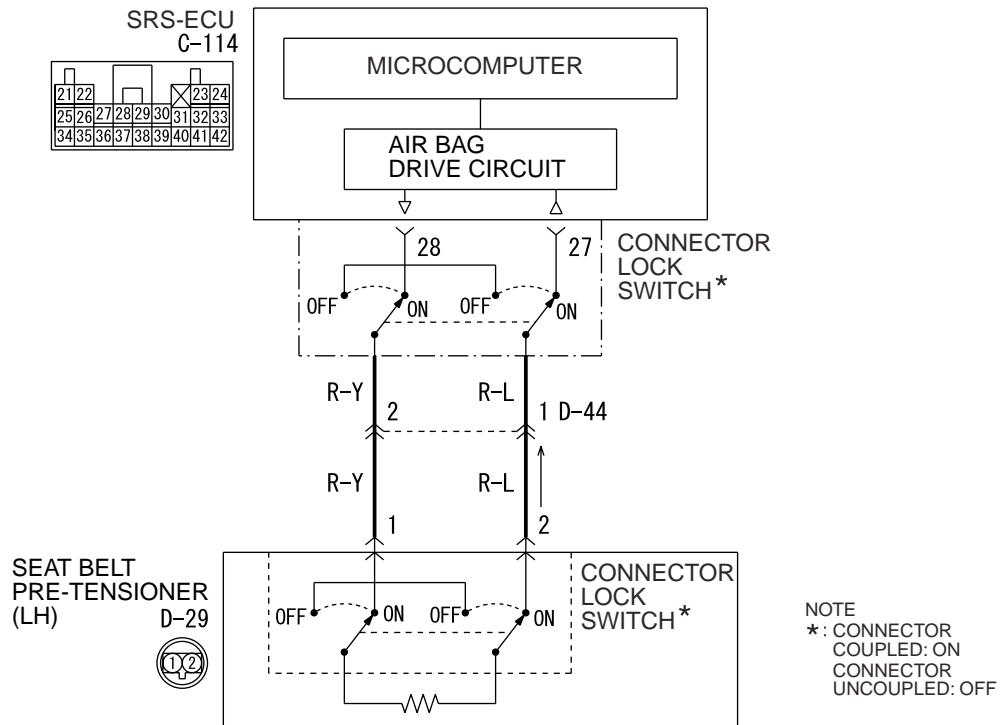
Code No.29: Passenger's (front) seat belt pre-tensioner (squib) system (open-circuited in the squib circuit) <R.H. drive vehicles>

Passenger's (Front) Seat Belt Pre-tensioner (Squib)

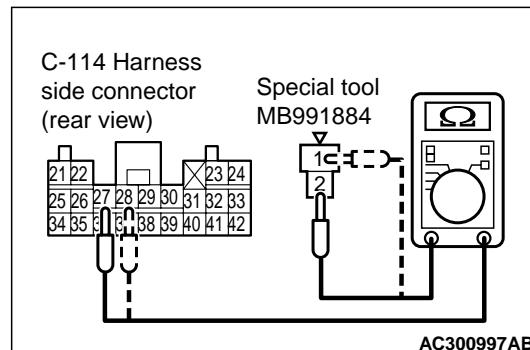
Do not insert a test probe into the terminal from its front side directly as the connector contact pressure may be weakened.

(3) Measure the resistance between the following terminals.

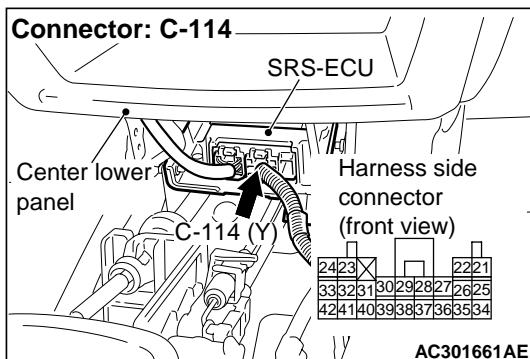
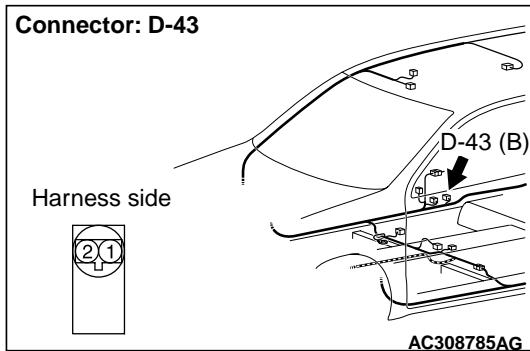
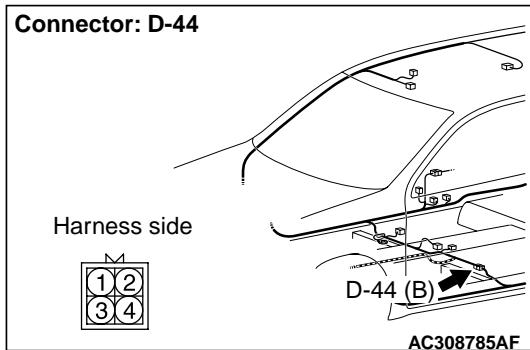
STEP 3. Connector check: SRS-ECU connector C-114, passenger's seat belt pre-tensioner connector D-29 and intermediate connector D-44

YES : Check the harness wires for open circuit between SRS-ECU connector C-114 (terminal No.27 and 28) and passenger's seat belt pre-tensioner connector D-29 (terminal No.2 and 1), and repair if necessary. Then go to Step 4.

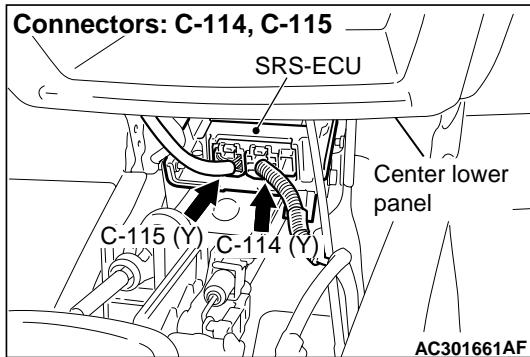
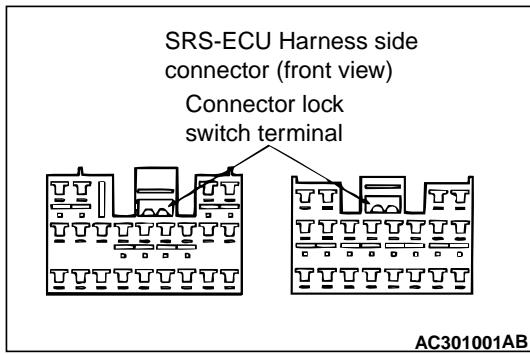
DIAGNOSIS PROCEDURE**STEP 1. Connector check: SRS-ECU connector C-114 and C-115**

(1) Disconnect SRS-ECU connectors C-114 and C-115.

(2) Check the connector lock switch terminal inside

the harness side connector for improper contact or deformation.

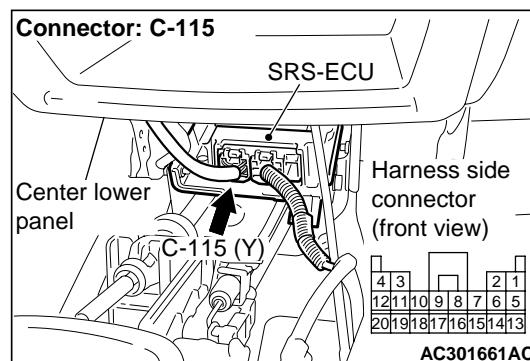
STEP 2. Measure the voltage at the SRS-ECU connector C-115.

(1) Disconnect the negative battery terminal.

(2) Disconnect SRS-ECU connector C-115.

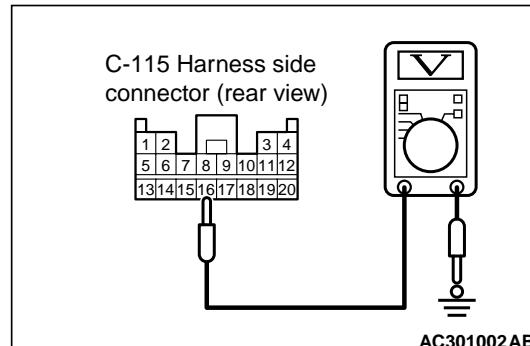
Do not insert a test probe into the terminal from its front side directly as the connector contact pressure may be weakened.

(5) Measure the voltage between C-115 harness side connector terminal 16 and body earth.

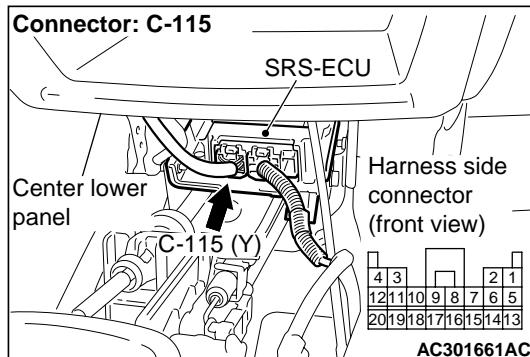
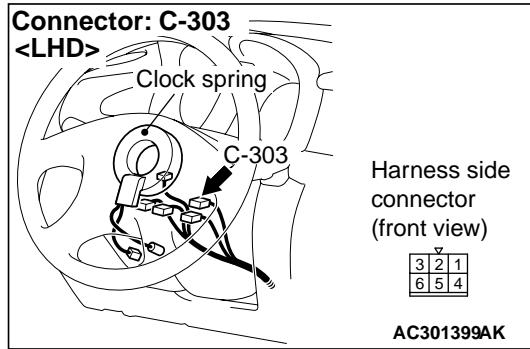
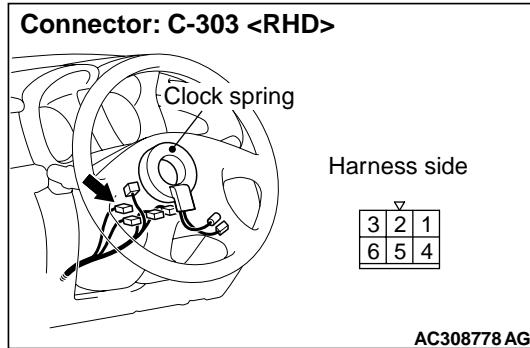
STEP 3. Connector check: SRS-ECU connector C-115, ignition switch connector C-303, junction block connector C-203 and C-205

YES : Check the harness wire for open circuit between SRS-ECU connector C-115 (terminal No.16) and the ignition switch connector C-303 (terminal No.2), and repair if necessary. Then go to Step 8.

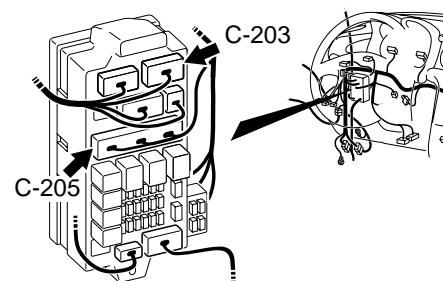
Connectors: C-203, C-205 <LHD>

Junction Block (Front View)

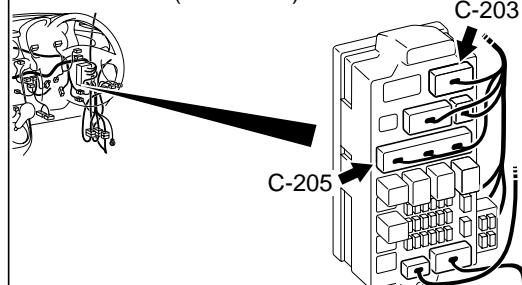
Connectors: C-203, C-205 <RHD>

Junction Block (Front View)

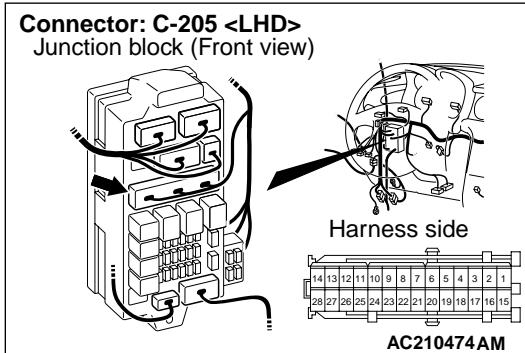
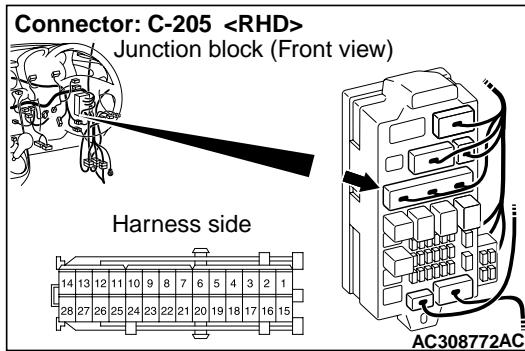
STEP 5. Measure the resistance at the junction block connector C-205.

- (1) Disconnect junction block connector C-205, and measure at the wiring harness side.

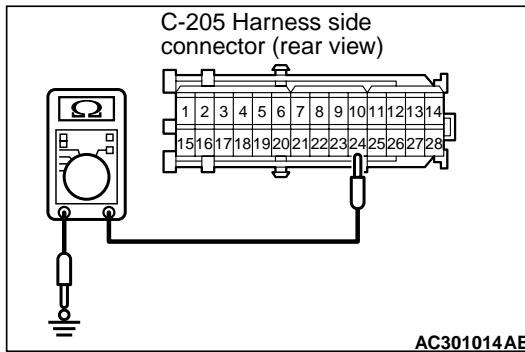
Do not insert a test probe into the terminal from its front side directly as the connector contact pressure may be weakened.

- (2) Measure the resistance between terminal 24 and body earth.

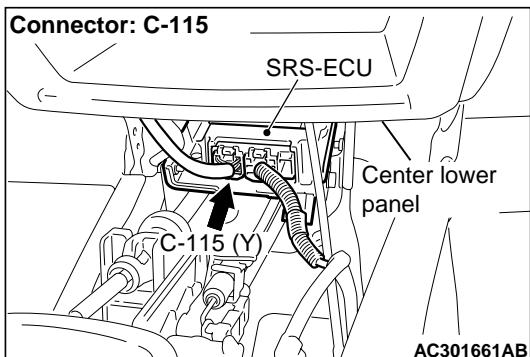
STEP 6. Measure the resistance at the SRS-ECU connector C-115.

(1) Disconnect SRS-ECU connector C-115, and measure at the wiring harness side.

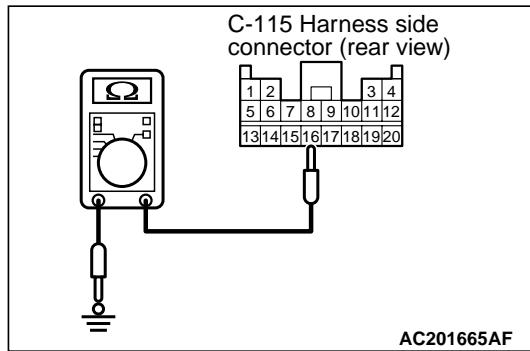
Do not insert a test probe into the terminal from its front side directly as the connector contact pressure may be weakened.

(2) Measure the resistance between terminal 16 and body earth.

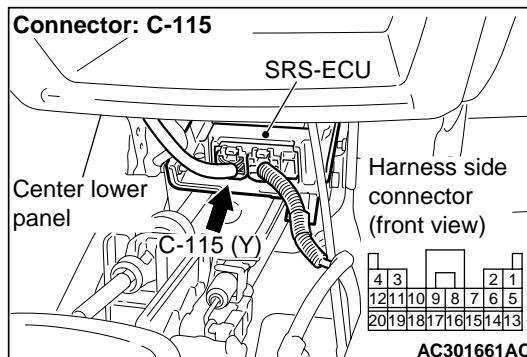
STEP 7. Connector check: SRS-ECU connector C-115 and junction block connector C-205

YES : Check the harness wire for short circuit between SRS-ECU connector C-115 (terminal No.16) and junction block connector C-205 (terminal No.24), and repair if necessary. Then go to Step 8.

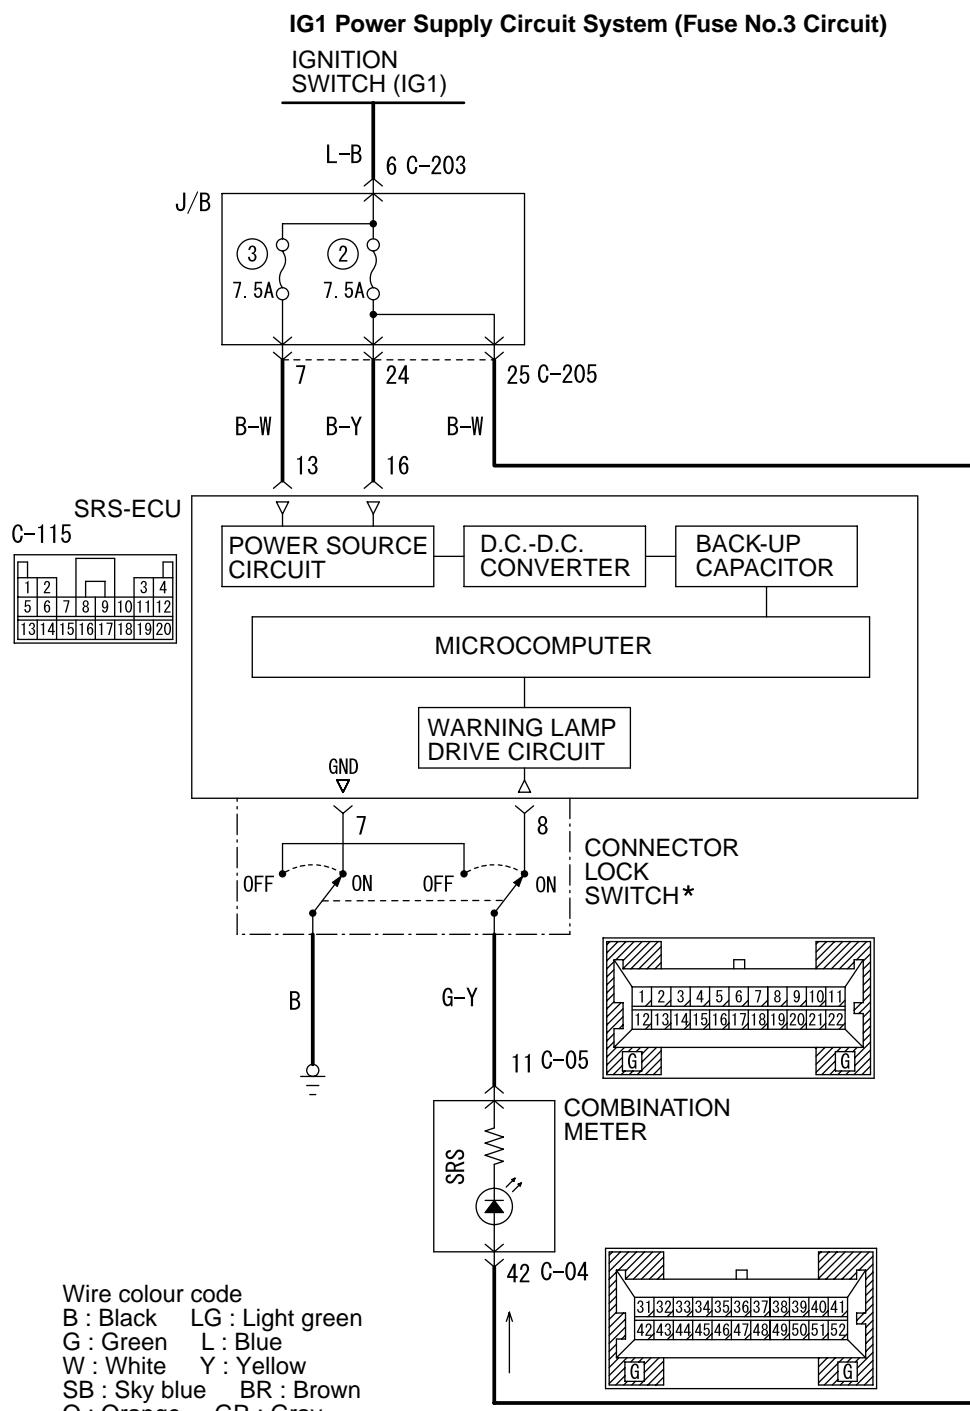
Code No.42: Power supply voltage (IG1 (B) voltage) drops abnormally.

OPERATION

- The SRS-ECU is powered from the ignition switch (IG1).

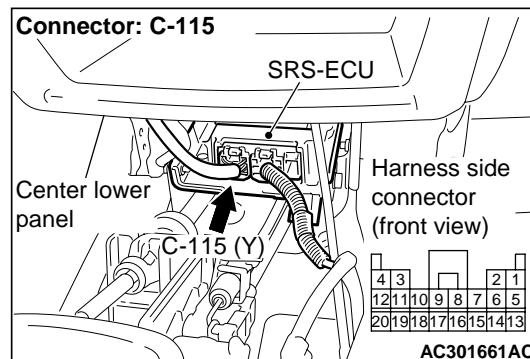
STEP 2. Measure the voltage at SRS-ECU connector C-115.

(1) Disconnect the negative battery terminal.

(2) Disconnect SRS-ECU connector C-115.

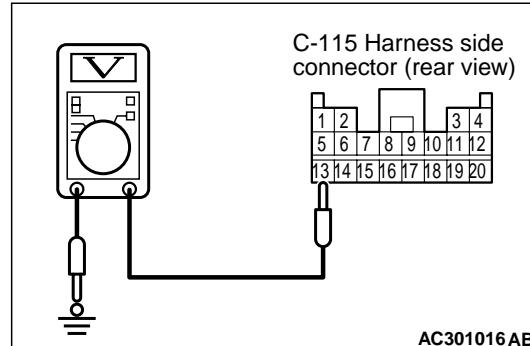
Do not insert a test probe into the terminal from its front side directly as the connector contact pressure may be weakened.

(5) Measure the voltage between C-115 harness side connector terminal 13 and body earth.

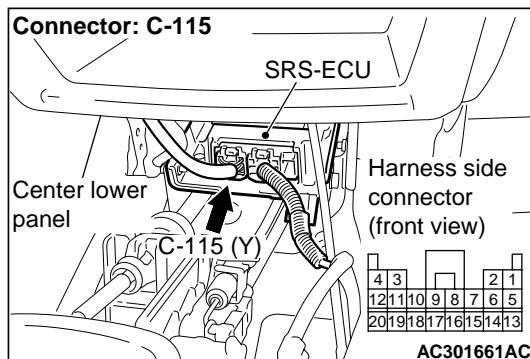
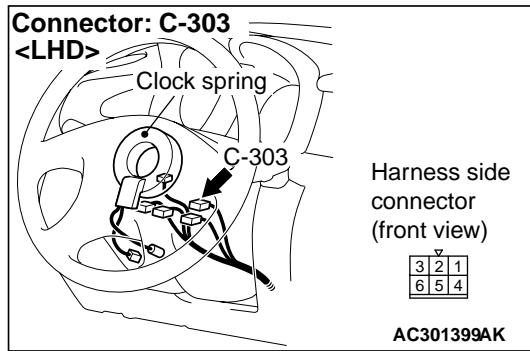
STEP 3. Connector check: SRS-ECU connector C-115, ignition switch connector C-303, junction block connector C-203 and C-205

YES : Check the harness wire for open circuit between SRS-ECU connector C-115 (terminal No.13) and the ignition switch connector C-303 (terminal No.2), and repair if necessary. Then go to Step 8.

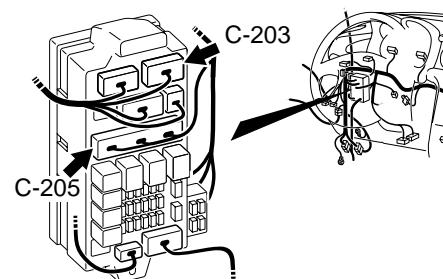
Connectors: C-203, C-205 <LHD>

Junction Block (Front View)

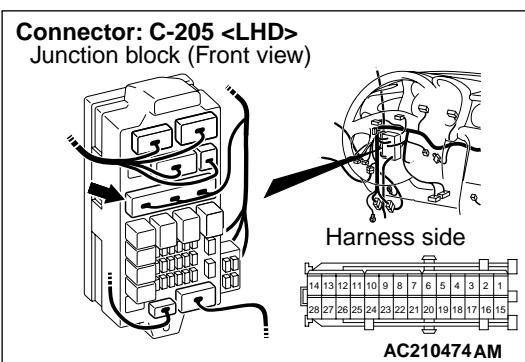
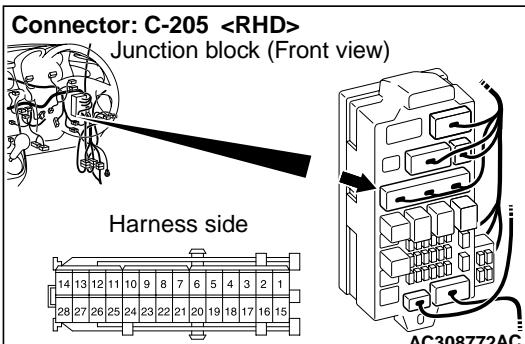
STEP 5. Measure the resistance at the junction block connector C-205.

- (1) Disconnect junction block connector C-205, and

measure at the wiring harness side.

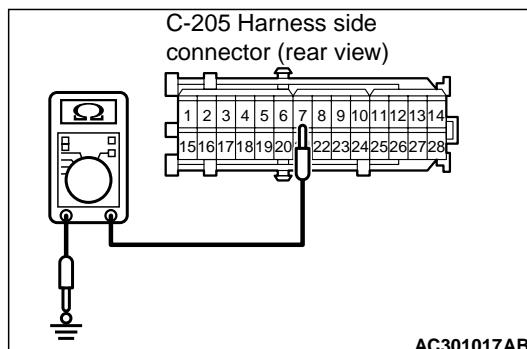
Do not insert a test probe into the terminal from its front side directly as the connector contact pressure may be weakened.

- (2) Measure the resistance between terminal 7 and body earth.

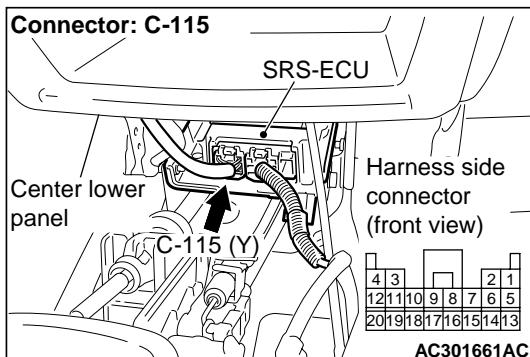
STEP 6. Measure the resistance at the SRS-ECU connector C-115.

(1) Disconnect SRS-ECU connector C-115, and measure at the wiring harness side.

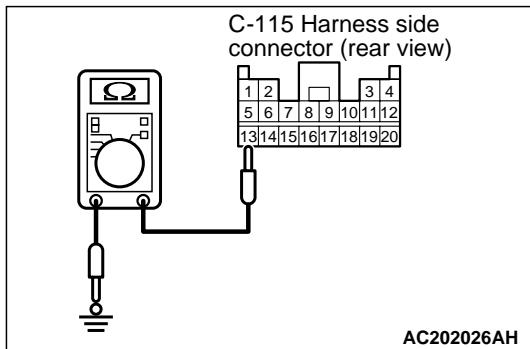
Do not insert a test probe into the terminal from its front side directly as the connector contact pressure may be weakened.

(2) Measure the resistance between terminal 13 and body earth.

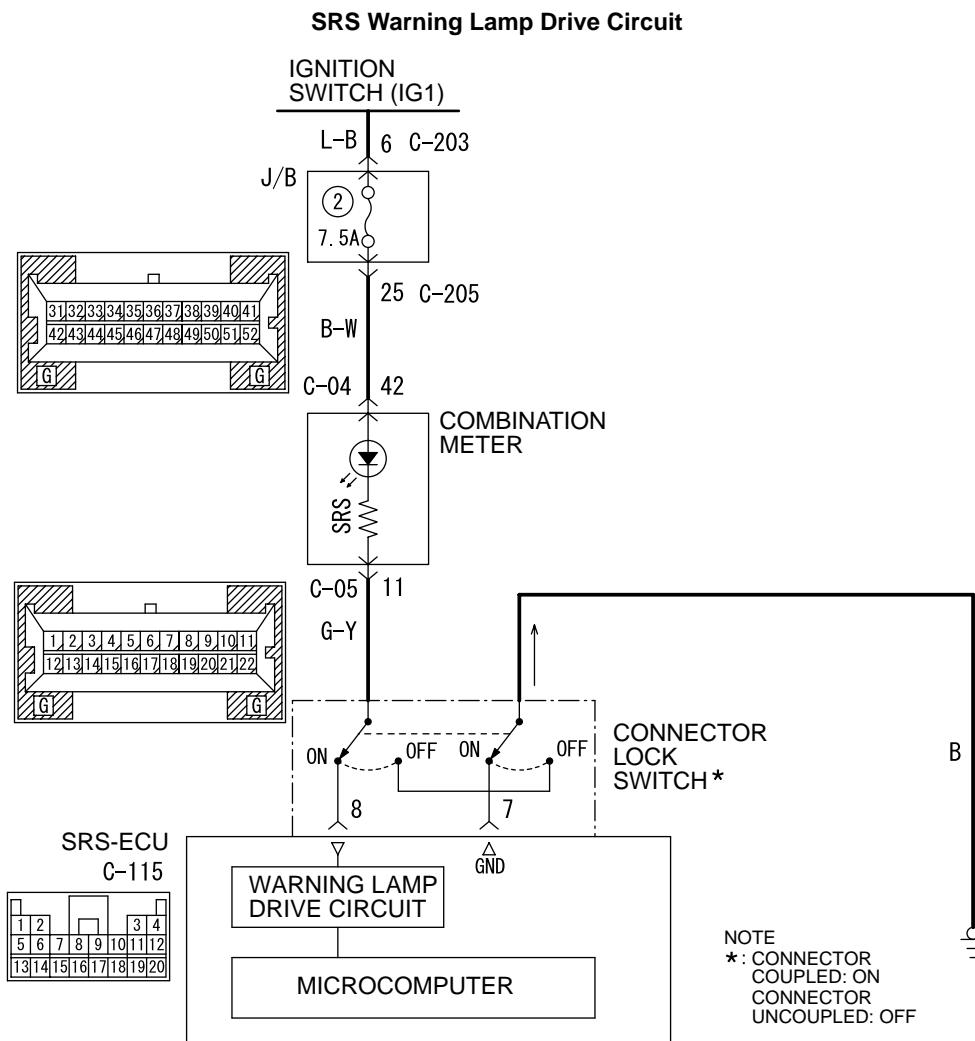
Code No.43: SRS warning lamp circuit open-circuited (Lamp does not illuminate).

Wire colour code

B : Black LG : Light green G : Green L : Blue W : White Y : Yellow SB : Sky blue
BR : Brown O : Orange GR : Gray R : Red P : Pink V : Violet

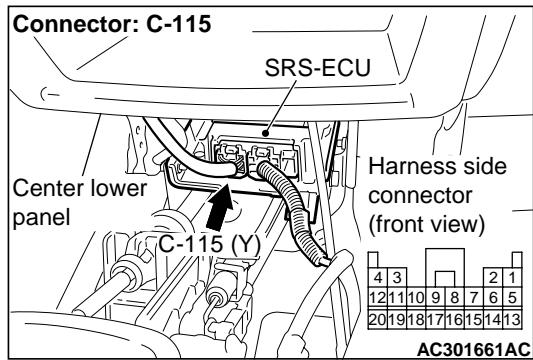
STEP 1. Check the SRS warning lamp.

- (1) Disconnect the negative battery terminal.

- (2) Disconnected the SRS-ECU connector C-115.

- (3) Connect the negative battery terminal.

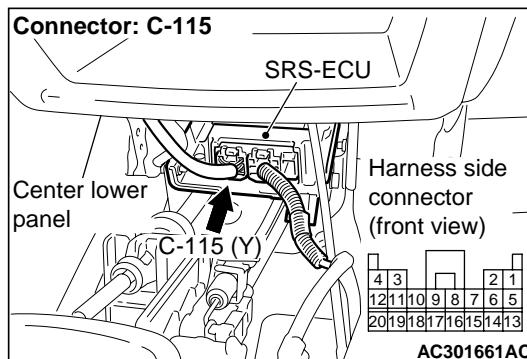
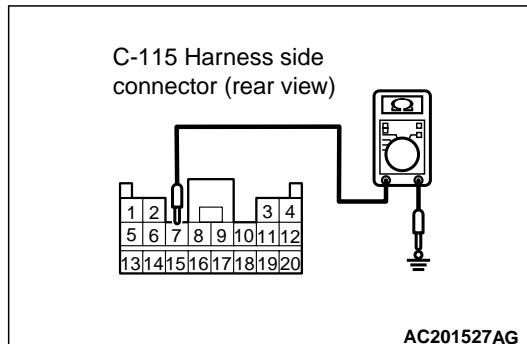
STEP 2. Measure the resistance at the SRS-ECU connector C-115.

- (2) Disconnected the SRS-ECU connector C-115.

Do not insert a test probe into the terminal from its front side directly as the connector contact pressure may be weakened.

- (5) Measure the resistance between C-115 harness side connector terminal 7 and earth.

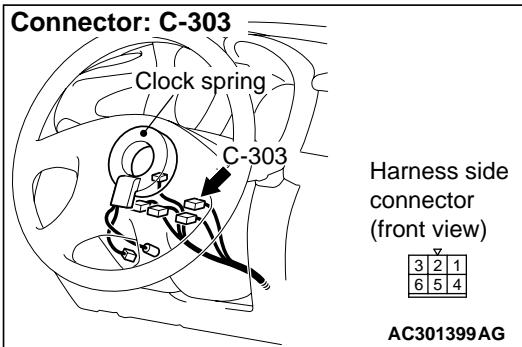
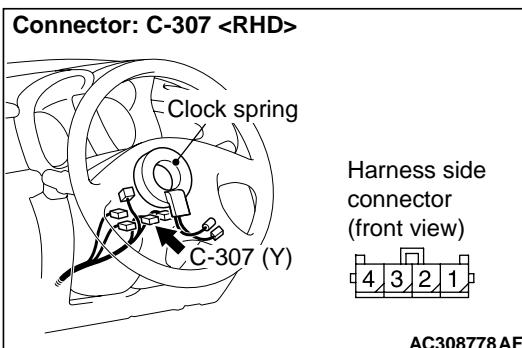
STEP 3. Check the harness for open circuit between ignition switch connector C-303 (terminal No.2) and combination meter C-04 (terminal No.42), and between combination meter C-05 (terminal No.11) and SRS-ECU connector C-115 (terminal No.8).

NOTE: After inspecting intermediate connectors C-05, C-04, C-205 and C-203 inspect the wiring harness. If intermediate connectors C-05, C-04, C-205 and C-203 are damaged, repair or replace them. Then go to Step 5.

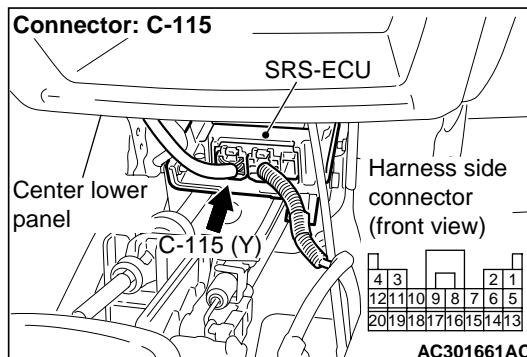
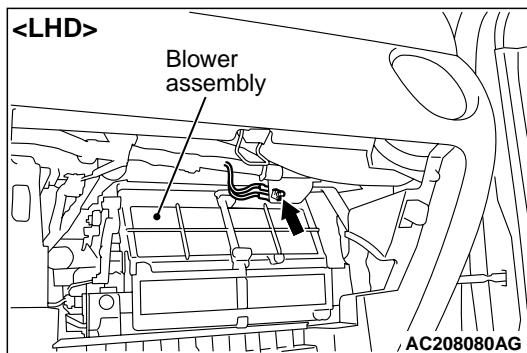
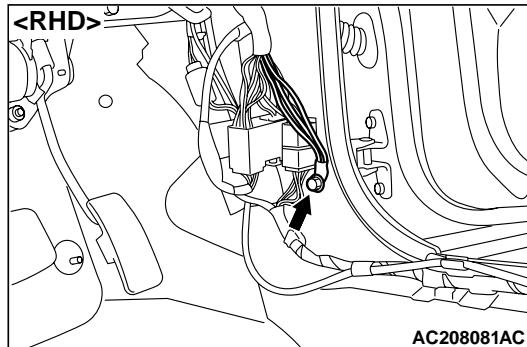
STEP 4. Connector check: SRS-ECU connector C-115 and earth

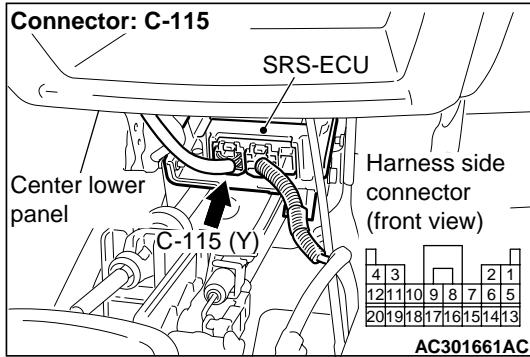
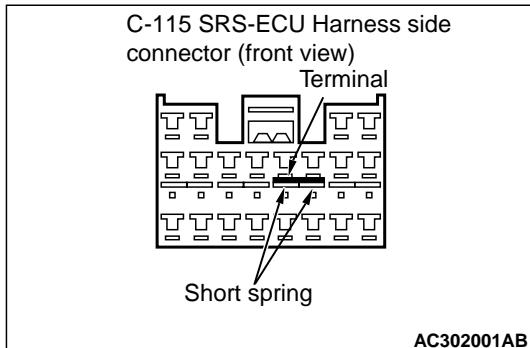
DIAGNOSIS PROCEDURE**STEP 1. Connector check: SRS-ECU connector C-115**

(1) Disconnect SRS-ECU connectors C-115.

(2) Check the short spring for the warning lamp inside the harness side connector for improper contact or deformation.

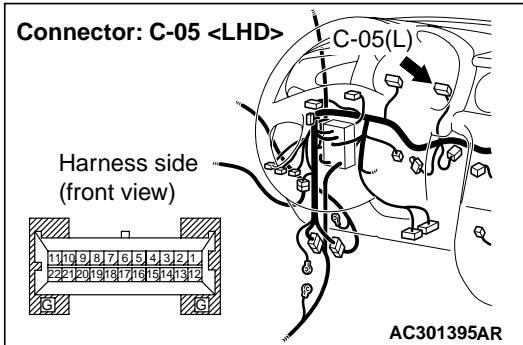
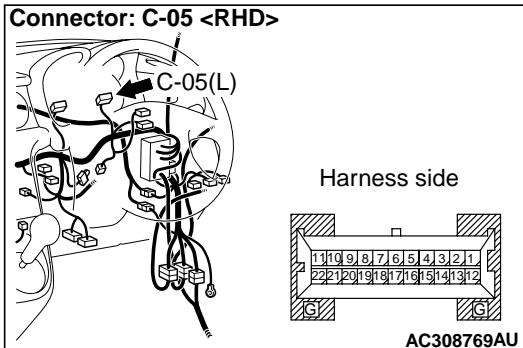
STEP 2. Check the SRS warning lamp.

(1) Disconnect the negative battery cable.

(2) Disconnect the combination meter connector C-05.

(3) Connect the negative battery cable.

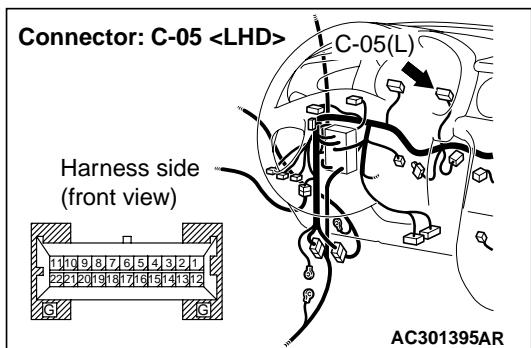
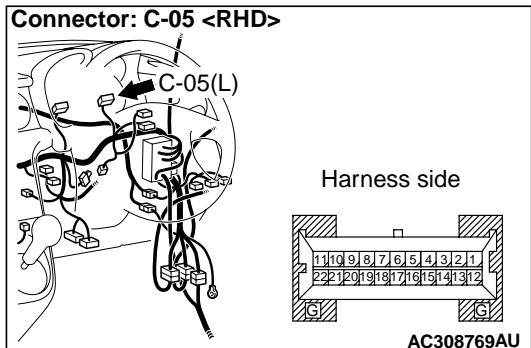
STEP 3. Check the harness for short circuit to earth between SRS-ECU connector C-115 (terminal No.8) and combination meter connector C-05 (terminal No.11).
