GROUP 52B

SUPPLEMENTAL RESTRAINT SYSTEM (SRS)

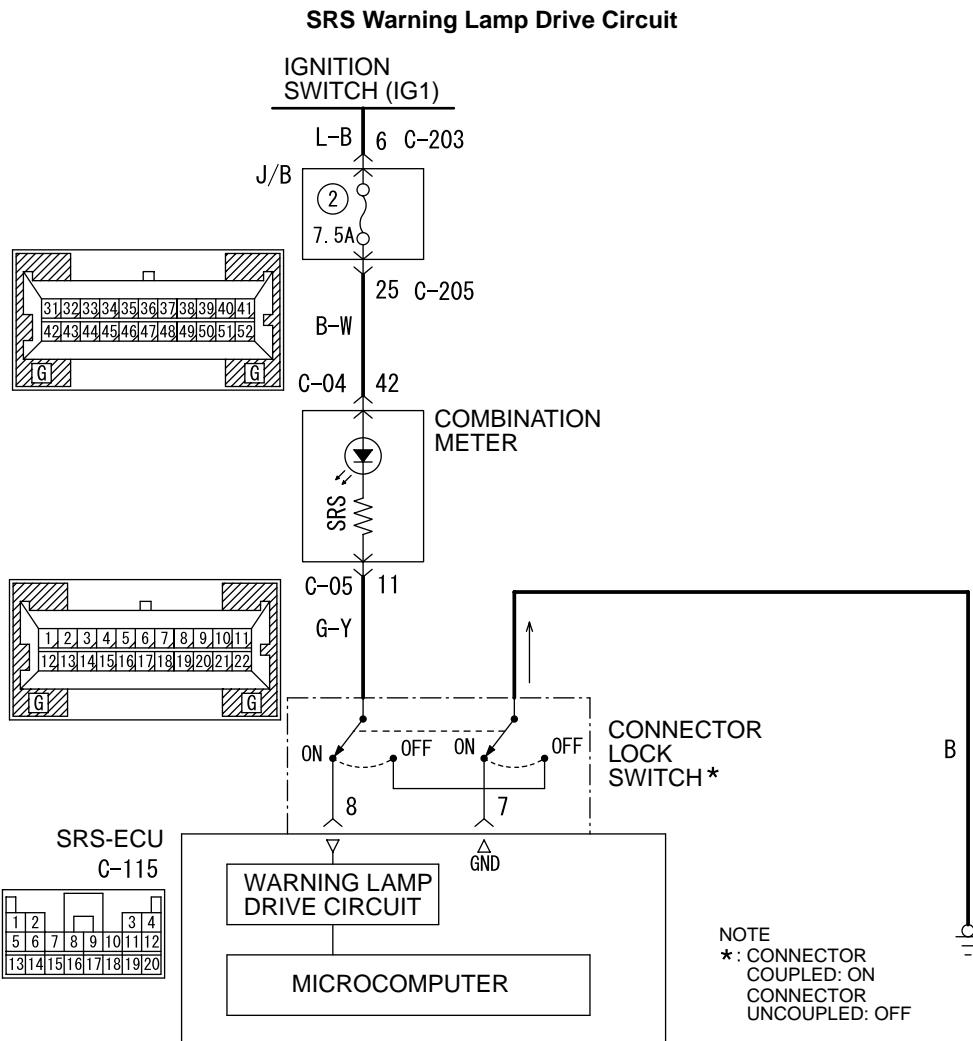
Code No.44: SRS warning lamp circuit malfunction

Wire colour code

B : Black LG : Light green G : Green L : Blue W : White Y : Yellow SB : Sky blue
 BR : Brown O : Orange GR : Gray R : Red P : Pink V : Violet

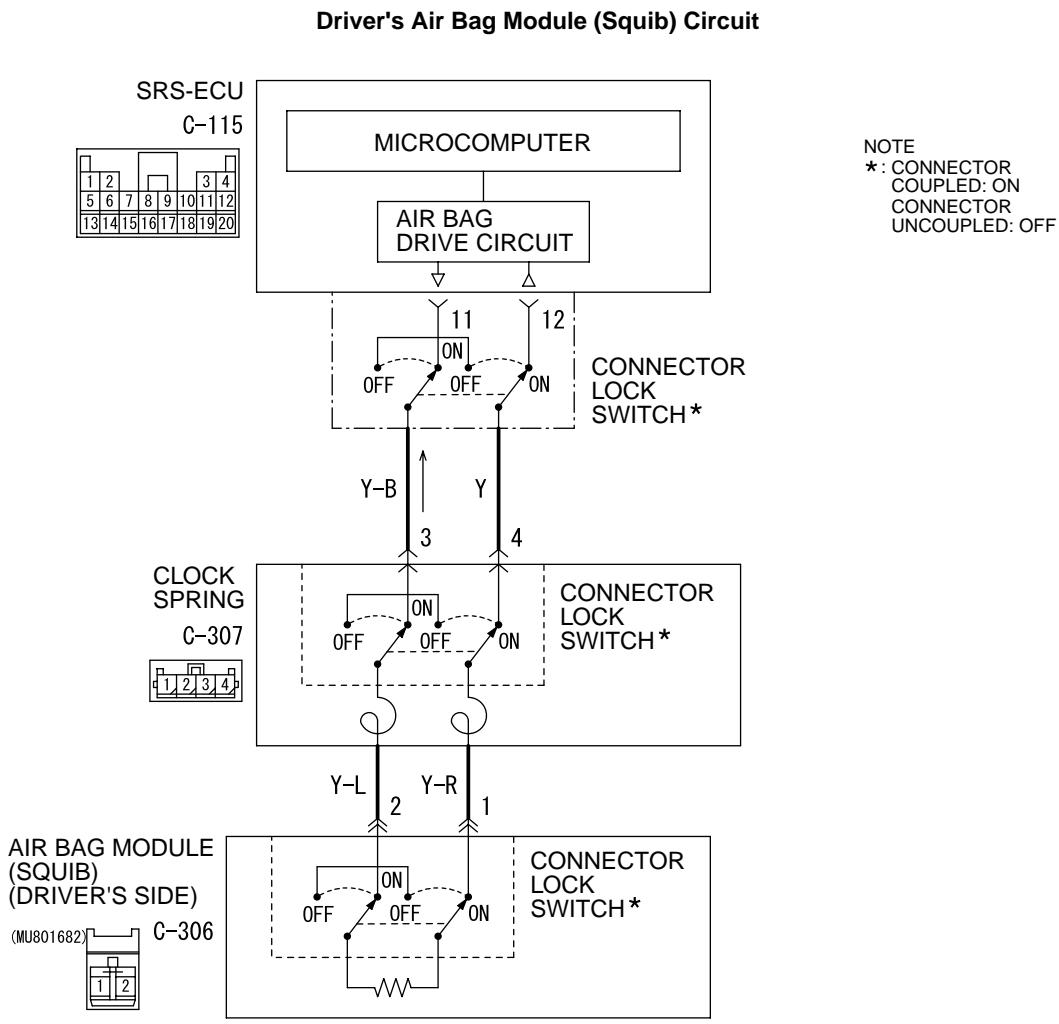
Code No.61: Driver's air bag module (squib) system (short-circuited to the power supply)

Wire colour code

B : Black LG : Light green G : Green L : Blue W : White Y : Yellow SB : Sky blue
BR : Brown O : Orange GR : Gray R : Red P : Pink V : Violet

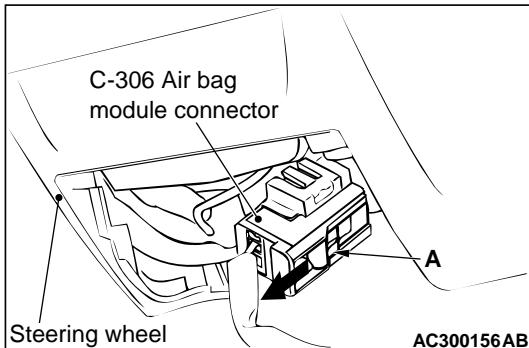
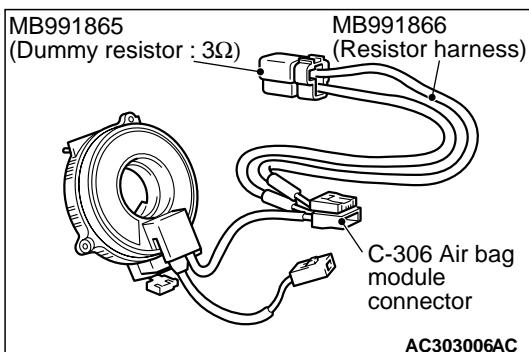
(2) By sliding the A section (in the figure) of air bag module connector C-306 in arrow direction, disconnect the connector.

(3) Connect special tool dummy resistor (MB991865) to special tool resistor harness (MB991866).

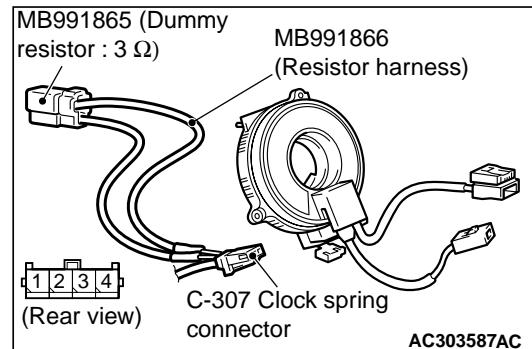
STEP 2. Check the clock spring. (Check whether the diagnosis code is reset.)

(2) Disconnect the clock spring connector C-307.

(3) Connect special tool dummy resistor (MB991865) to special tool resistor harness (MB991866).

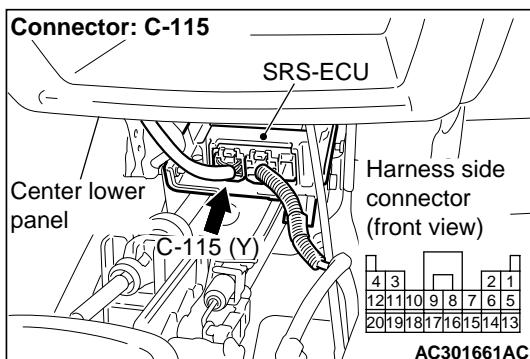
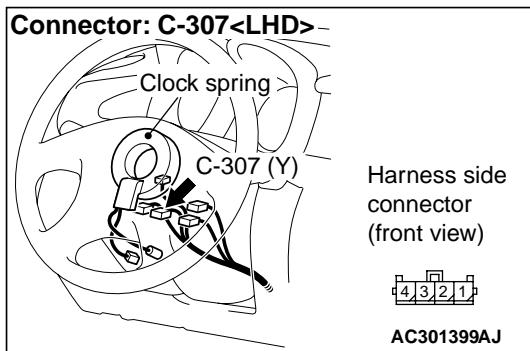
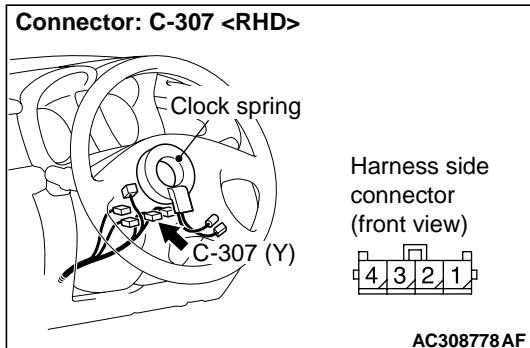
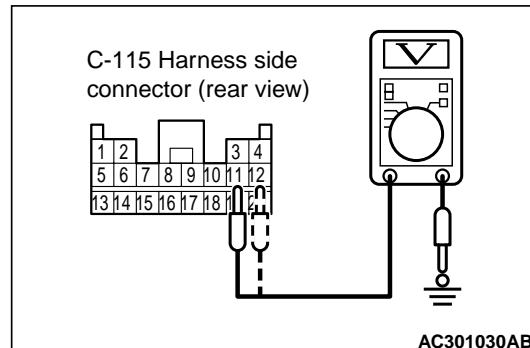
STEP 3. Measure the voltage at the SRS-ECU connector C-115.

(1) Disconnect SRS-ECU connector C-115.

To prevents the air bag from deploying unintentionally, disconnect the clock spring connector C-307 to short the squib circuit.

Do not insert a test probe into the terminal from its front side directly as the connector contact pressure may be weakened.

(4) Measure the voltage between C-115 harness side connector terminals 11, 12 and body earth.

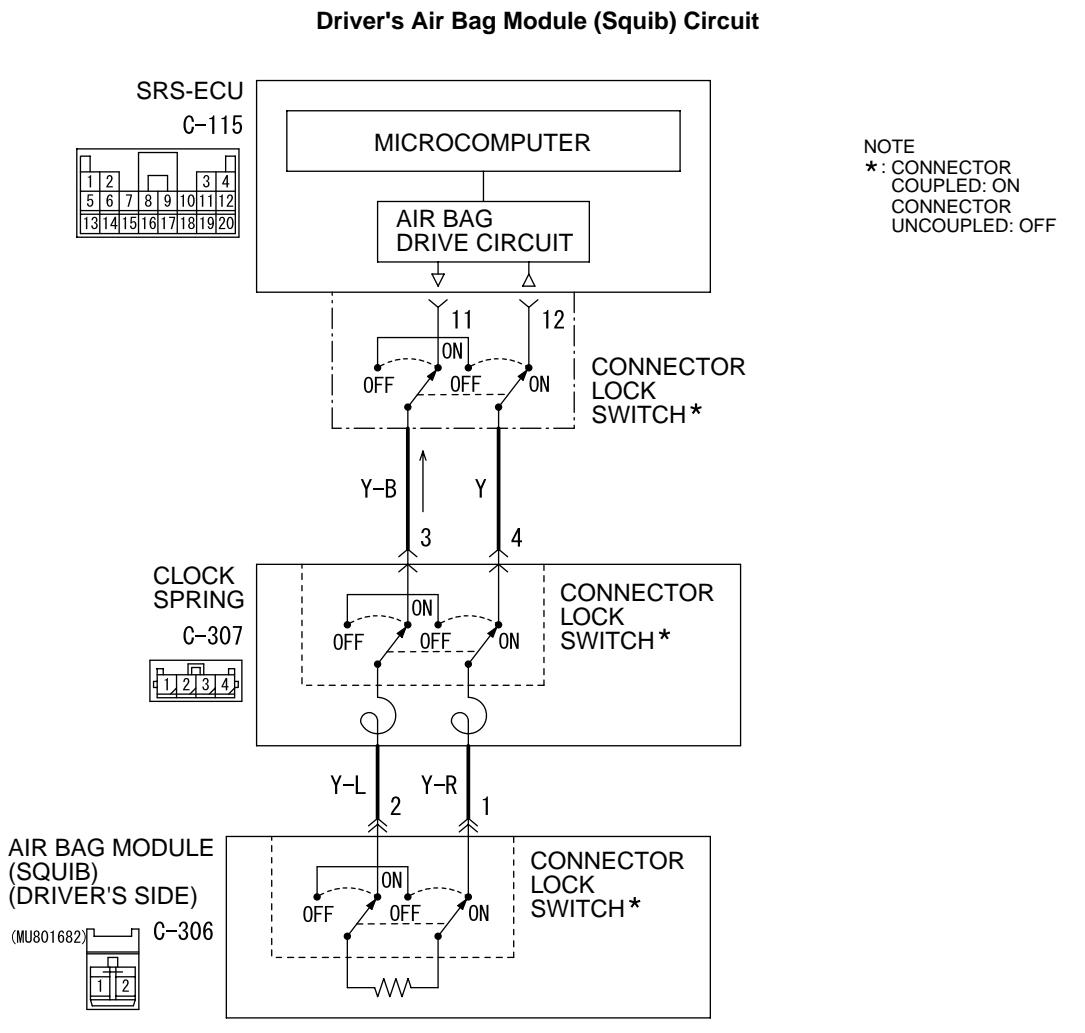
Code No.62: Driver's air bag module (squib) system (short-circuited to the earth)

Wire colour code

B : Black LG : Light green G : Green L : Blue W : White Y : Yellow SB : Sky blue
 BR : Brown O : Orange GR : Gray R : Red P : Pink V : Violet

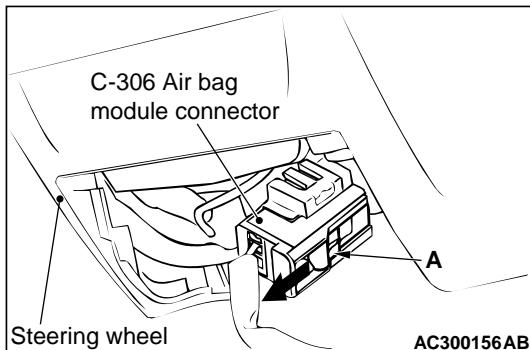
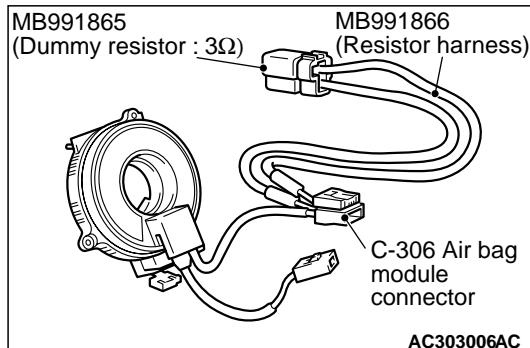
(2) By sliding the A section (in the figure) of air bag module connector C-306 in arrow direction, disconnect the connector.
 (3) Connect special tool dummy resistor (MB991865) to special tool resistor harness (MB991866).

Do not insert a test probe into the terminal from its front side directly as the connector contact pressure may be weakened.

(4) Insert special tool (MB991866) into clock spring side air bag module connector C-306 by backprobing.
 (5) Connect the negative battery terminal.

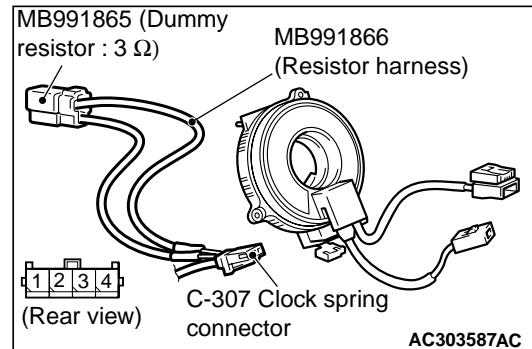
STEP 2. Check the clock spring.

(2) Disconnect the clock spring connector C-307.
 (3) Connect special tool dummy resistor (MB991865) to special tool resistor harness (MB991866).

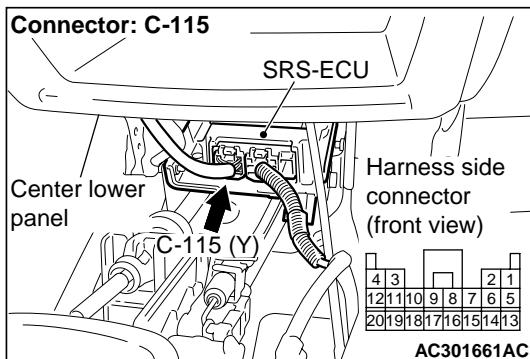
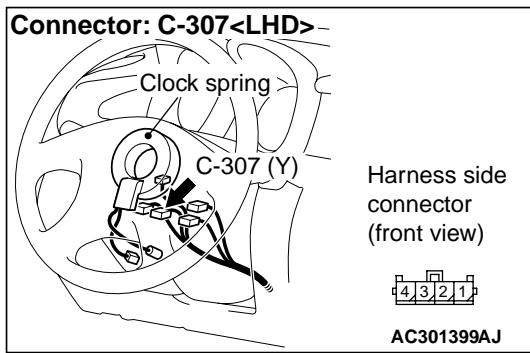
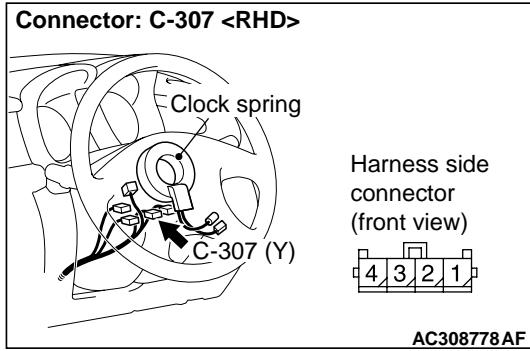
STEP 3. Check the driver's air bag module circuit at the SRS-ECU connector C-115.

(1) Disconnect SRS-ECU connector C-115.

To prevents the air bag from deploying unintentionally, disconnect the clock spring connector C-307 to short the squib circuit.

(2) Disconnect the clock spring connector C-307.

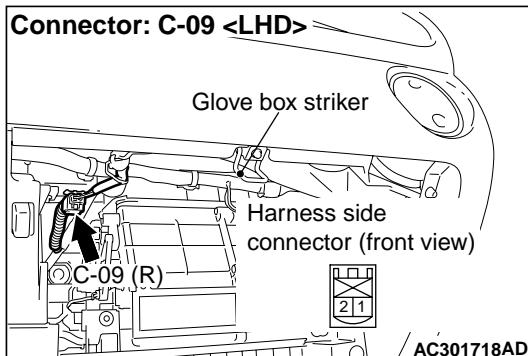
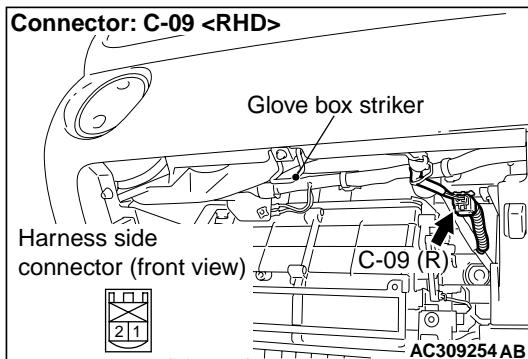
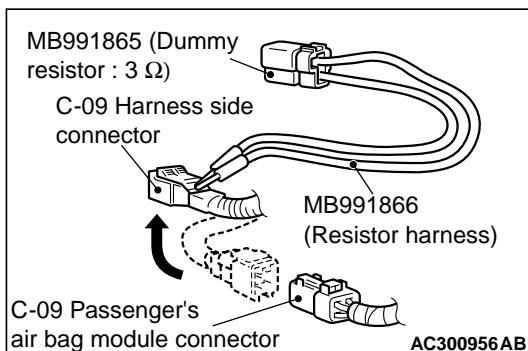
STEP1. Check the passenger's air bag module.
(Check whether the diagnosis code is reset.)

(2) Unclip passenger's air bag module connector C-09.

(3) Connect special tool dummy resistor (MB991865) to special tool resistor harness (MB991866).

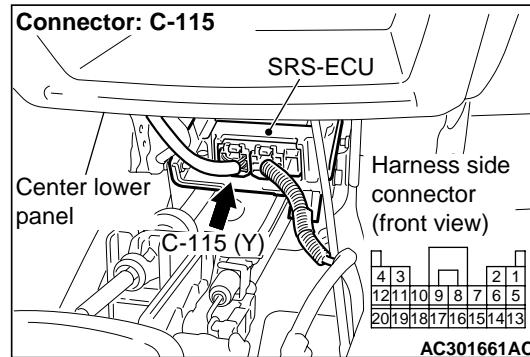
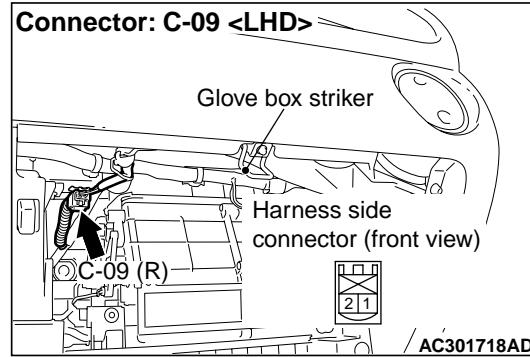
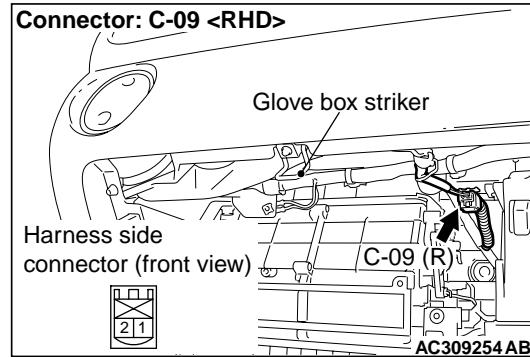
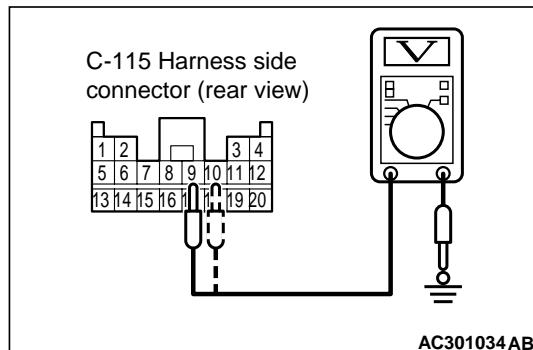
STEP 2. Measure the voltage at the SRS-ECU connector C-115.

(1) Disconnect SRS-ECU connector C-115.

**To prevents the air bag from deploying unintentionally, disconnect the passenger's air bag module connector C-09 to short the squib circuit.**

Do not insert a test probe into the terminal from its front side directly as the connector contact pressure may be weakened.

(4) Measure the voltage between C-115 harness side connector terminals 9, 10 and body earth.

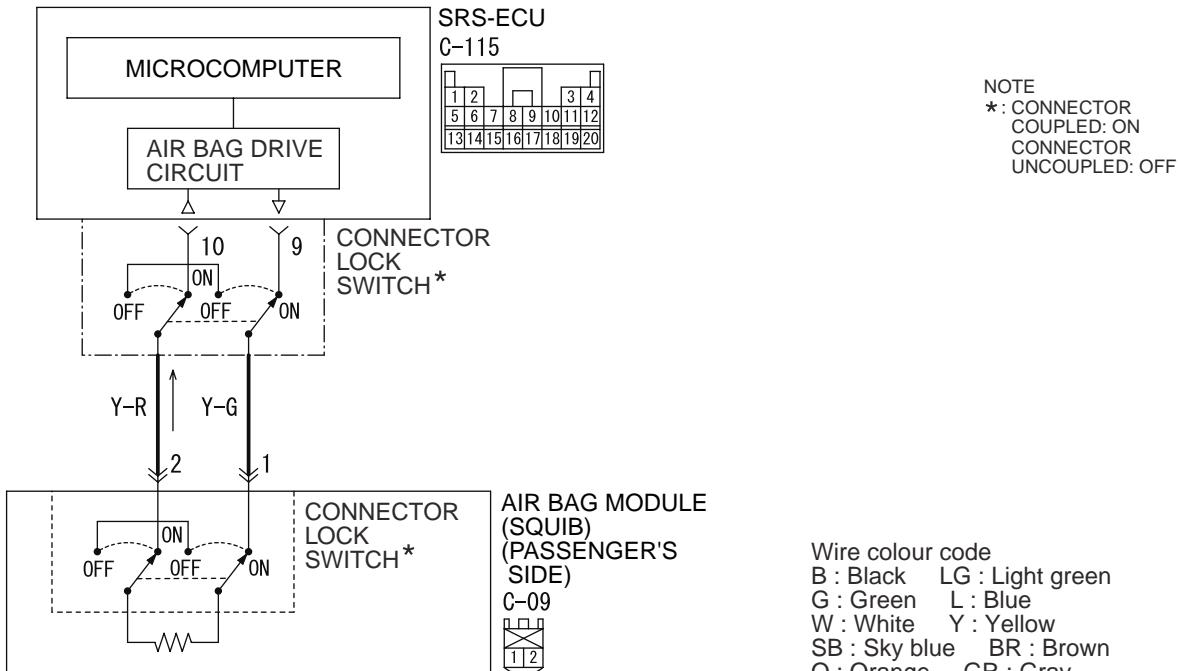
Passenger's (Front) Air Bag Module (Squib) Circuit

- The SRS-ECU judges how severe a collision is by detecting signals from the front impact sensors and the front air bag analog G-sensor. If the impact is over a predetermined level, the SRS-ECU outputs an ignition signal. At this time, if the front air bag safing G-sensor is on, the SRS air bag will inflate.
- The ignition signal is input to the air bag module via the clock spring to inflate the air bag.

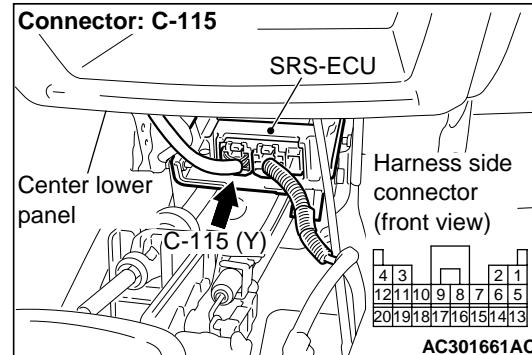
STEP 2. Measure the resistance at the SRS-ECU connector C-115. (Check whether the diagnosis code is reset.)

(1) Disconnect SRS-ECU connector C-115.

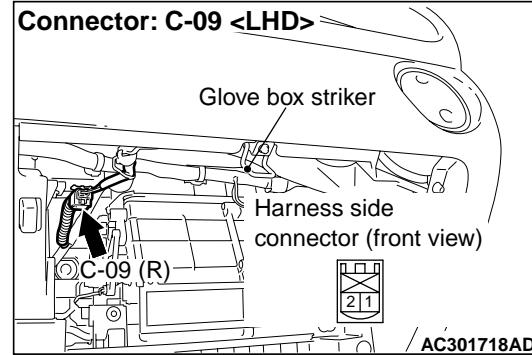
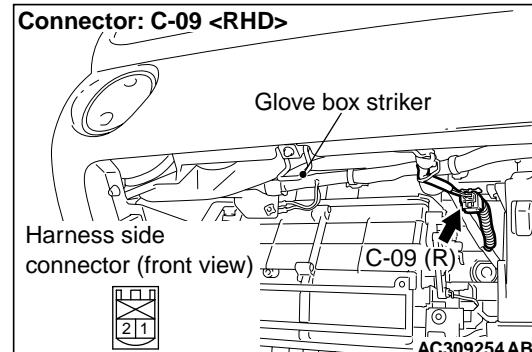
To prevents the air bag from deploying unintentionally, disconnect the passenger's air bag module connector C-09 to short the squib circuit.

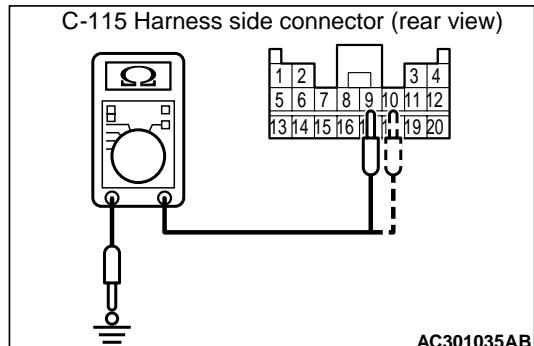
Do not insert a test probe into the terminal from its front side directly as the connector contact pressure may be weakened.

(3) Measure the resistance between C-115 harness side connector terminals 9, 10 and body earth.

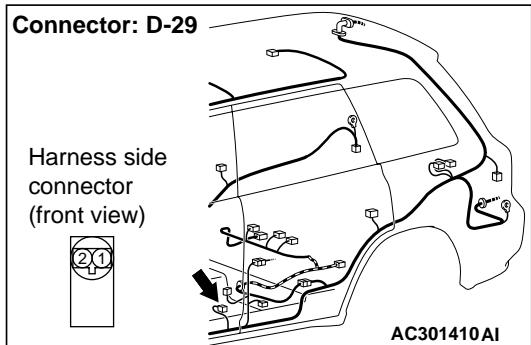
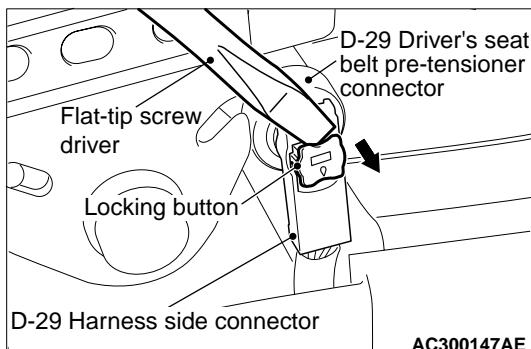
(2) Disconnect driver's seat belt pre-tensioner connector D-29. Use a flat-tipped screwdriver to pull out the locking button at the harness side connector, and then disconnect the connector.

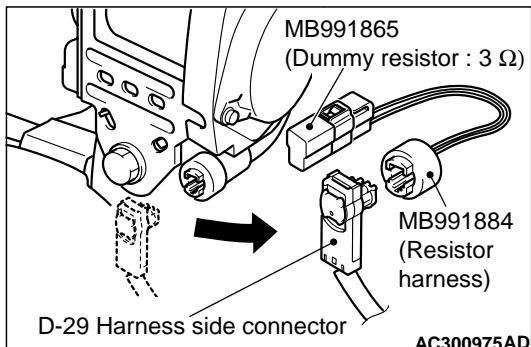
(3) Connect special tool dummy resistor (MB991865) to special tool resistor harness (MB991884).
 (4) Connect special tool (MB991884) to the D-29 harness side connector.
 (5) Connect the negative battery terminal.
 (6) Erase diagnosis code memory, and check the diagnosis code.

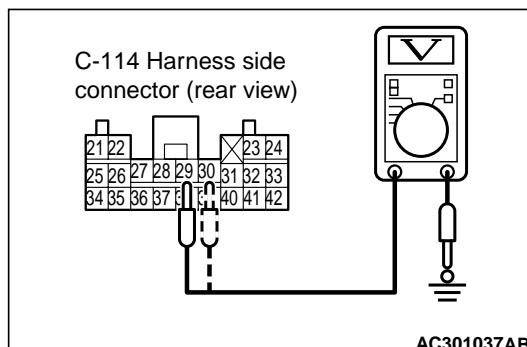
Do not insert a test probe into the terminal from its front side directly as the connector contact pressure may be weakened.

(4) Measure the voltage between C-114 harness side connector terminals 29, 30 and body earth.

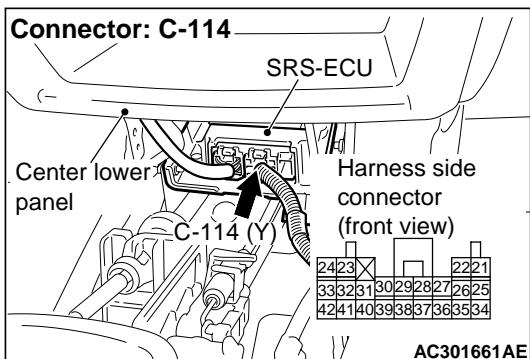
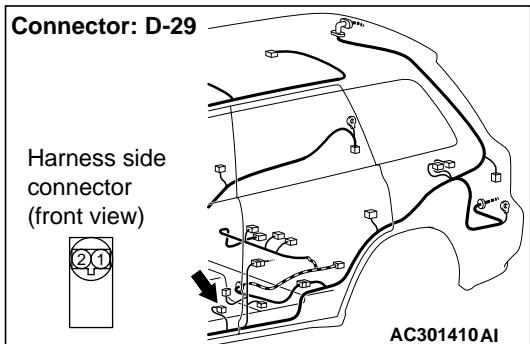
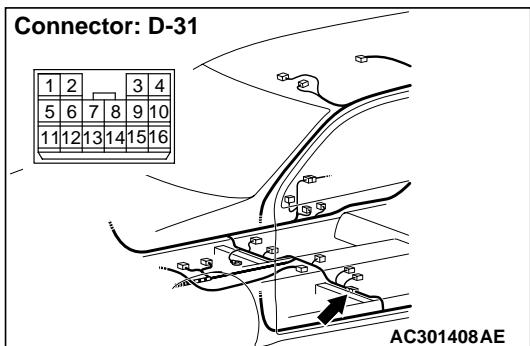
STEP 3. Connector check: SRS-ECU connector C-114, driver's seat belt pre-tensioner connector D-29 and intermediate connector D-31

YES : Check the harness wires for short circuit to power supply between SRS-ECU connector C-114 (terminal No.29 and 30) and driver's seat belt pre-tensioner connector D-29 (terminal No.2 and 1), and repair if necessary. Then go to Step 4.

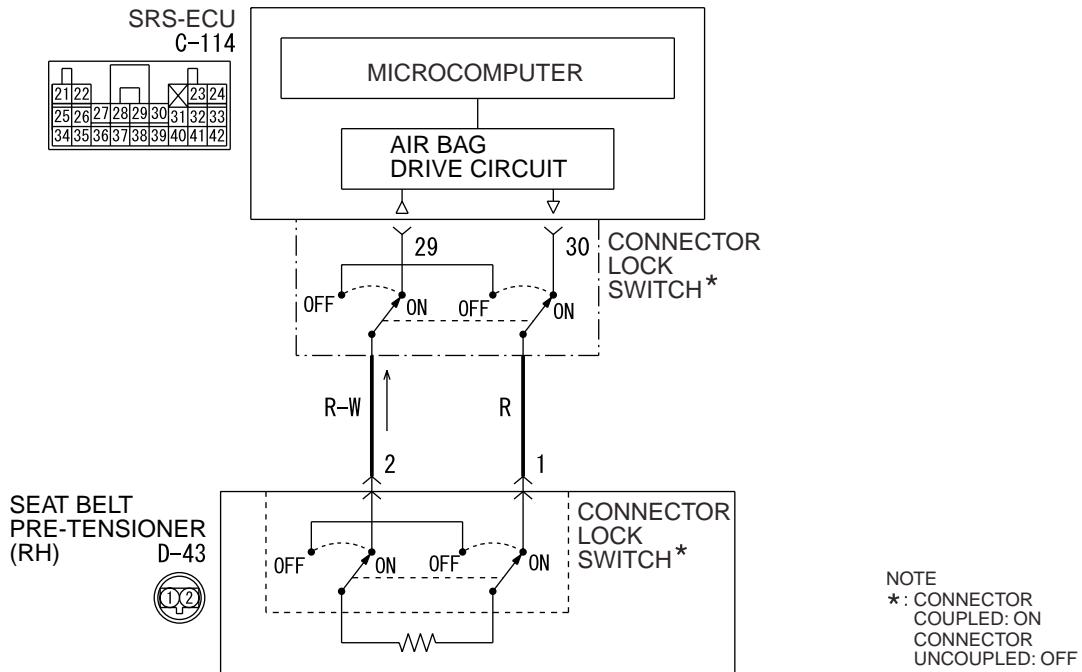
**Code No.66: Driver's seat belt pre-tensioner (squib) system (short-circuited to the power supply)
<R.H. drive vehicles>**

Driver's Seat Belt Pre-Tensioner (Squib)

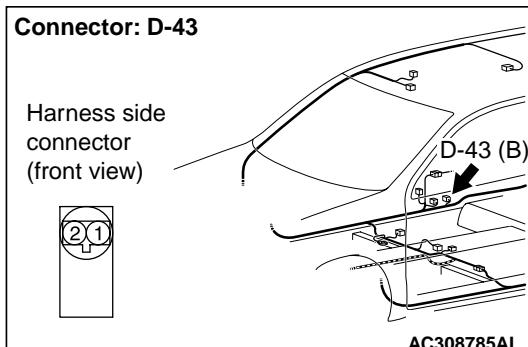
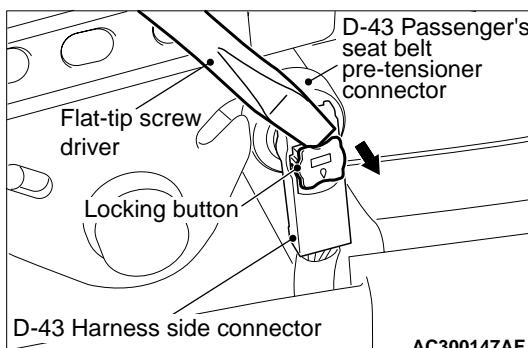
- (2) Disconnect driver's seat belt pre-tensioner connector D-43. Use a flat-tipped screwdriver to pull out the locking button at the harness side connector, and then disconnect the connector.

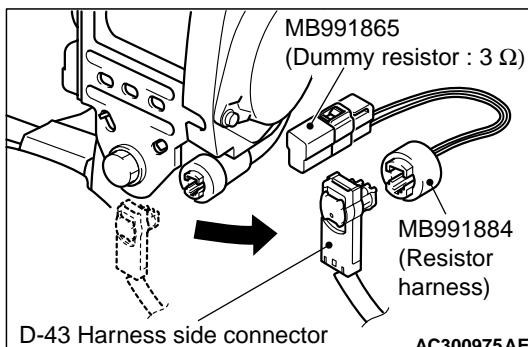
- (3) Connect special tool dummy resistor (MB991865) to special tool resistor harness (MB991884).
- (4) Connect special tool (MB991884) to the D-43 harness side connector.
- (5) Connect the negative battery terminal.
- (6) Erase diagnosis code memory, and check the diagnosis code.

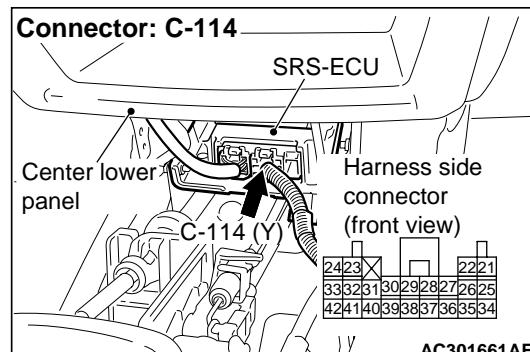
- (1) Disconnect SRS-ECU connector C-114.
- (2) Disconnect driver's seat belt pre-tensioner connector D-43. Use a flat-tipped screwdriver to pull out the locking button at the harness side connector, and then disconnect the connector.
- (3) Turn the ignition switch to the "ON" position.

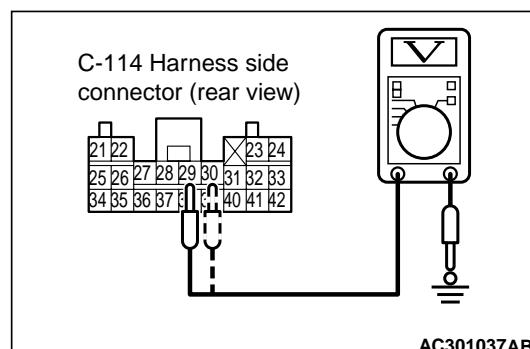
Do not insert a test probe into the terminal from its front side directly as the connector contact pressure may be weakened.

- (4) Measure the voltage between C-114 harness side connector terminals 29, 30 and body earth.

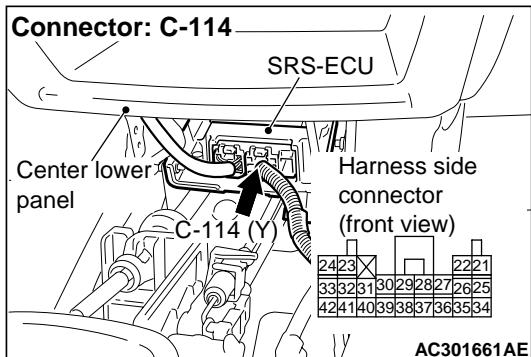
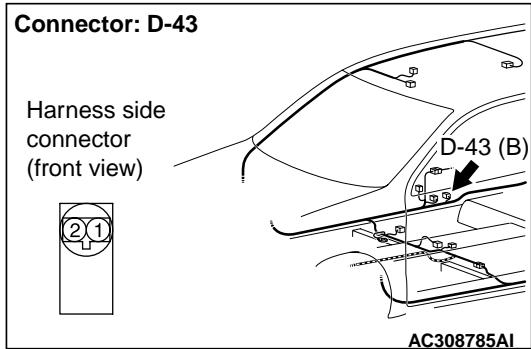
STEP 3. Connector check: SRS-ECU connector C-114 and driver's seat belt pre-tensioner connector D-43

YES : Check the harness wires for short circuit to power supply between SRS-ECU connector C-114 (terminal No.29 and 30) and driver's seat belt pre-tensioner connector D-43 (terminal No.2 and 1), and repair if necessary. Then go to Step 4.

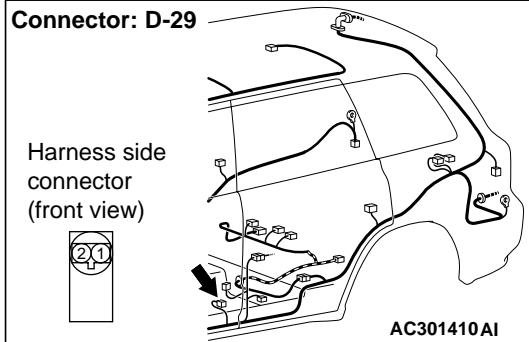
(2) Disconnect driver's seat belt pre-tensioner connector D-29. Use a flat-tipped screwdriver to pull out the locking button at the harness side connector, and then disconnect the connector.

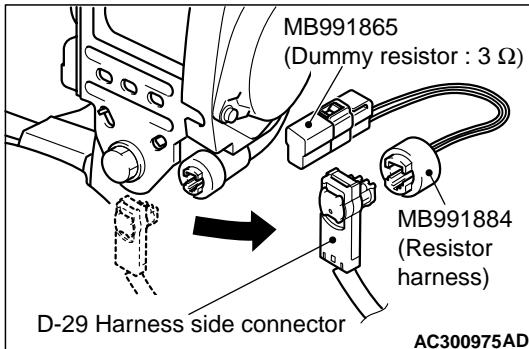
- (3) Connect special tool dummy resistor (MB991865) to special tool resistor harness (MB991884).
- (4) Connect special tool (MB991884) to the D-29 harness side connector.
- (5) Connect the negative battery terminal.

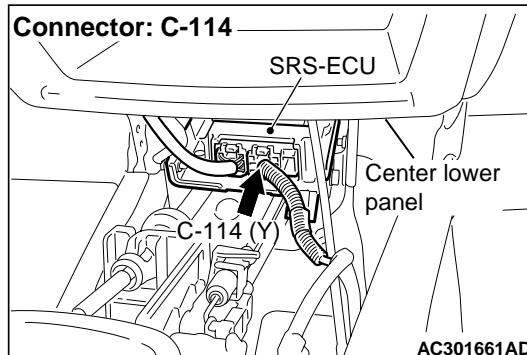
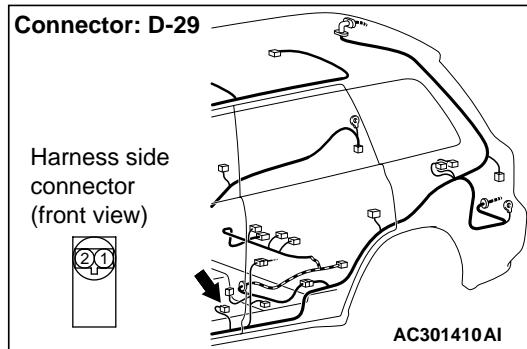
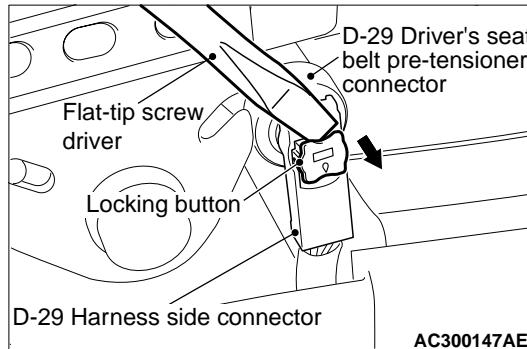
STEP 2. Measure the resistance at the SRS-ECU connector C-114.

(1) Disconnect SRS-ECU connector C-114.

- (2) Disconnect driver's seat belt pre-tensioner connector D-29. Use a flat-tipped screwdriver to pull out the locking button at the harness side connector.

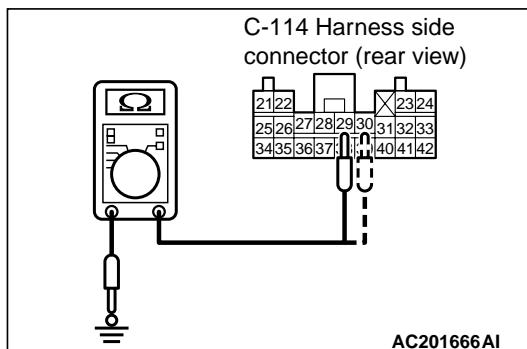
Do not insert a test probe into the terminal from its front side directly as the connector contact pressure may be weakened.

(3) Measure the resistance between C-114 harness side connector terminals 29, 30 and body earth.

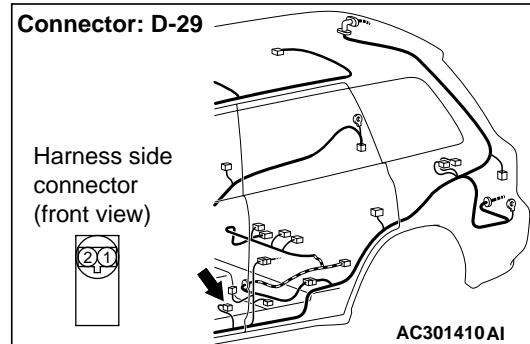
STEP 3. Connector check: SRS-ECU connector C-114, driver's seat belt pre-tensioner connector D-29 and intermediate connector D-31

YES : Check the harness wires for short circuit to the earth between SRS-ECU connector C-114 (terminal No.29 and 30) and driver's seat belt pre-tensioner connector D-29 (terminal No.2 and 1), and repair if necessary. Then go to Step 4 .

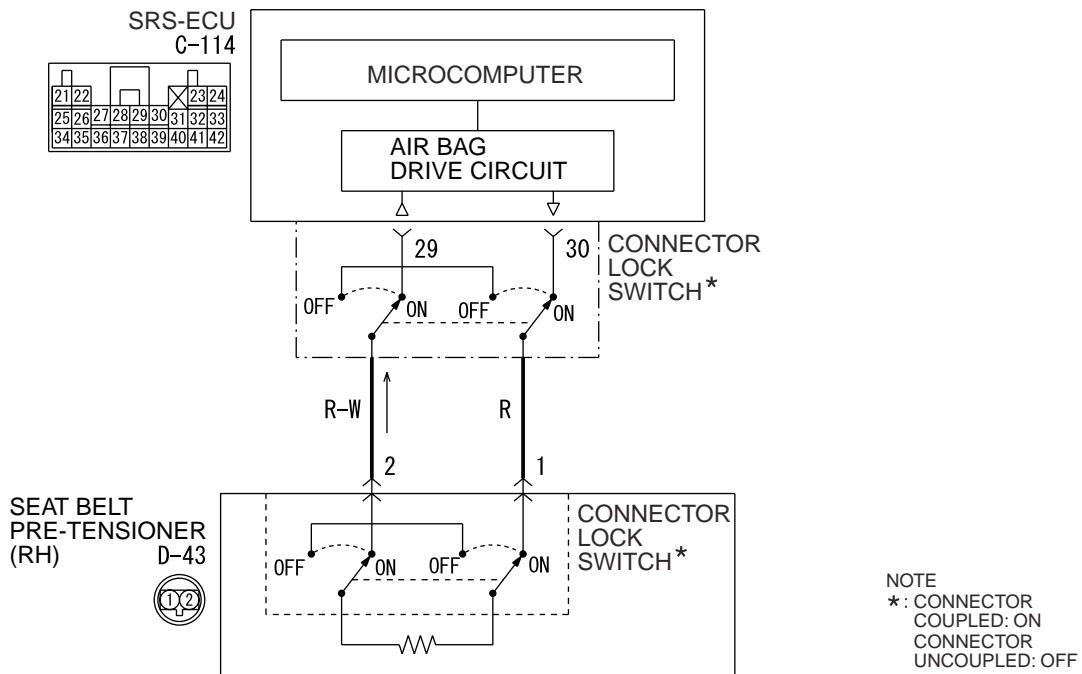
Code No.67: Driver's seat belt pre-tensioner (squib) system (short-circuited to the earth) <R.H. drive vehicles>

Driver's Seat Belt Pre-Tensioner (Squib)

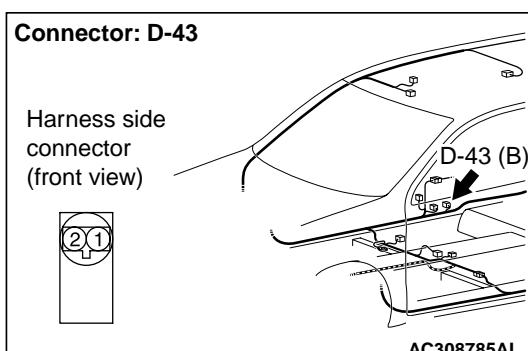
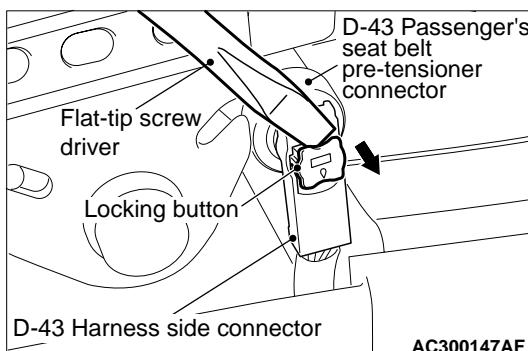
(2) Disconnect driver's seat belt pre-tensioner connector D-43. Use a flat-tipped screwdriver to pull out the locking button at the harness side connector, and then disconnect the connector.

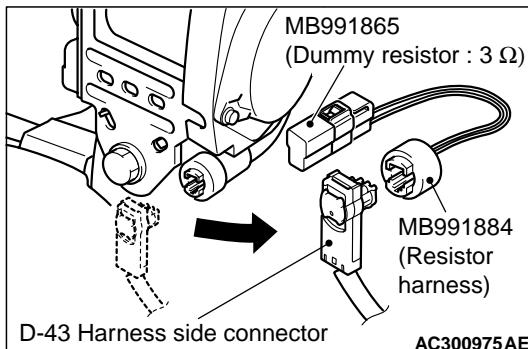
- (3) Connect special tool dummy resistor (MB991865) to special tool resistor harness (MB991884).
- (4) Connect special tool (MB991884) to the D-43 harness side connector.
- (5) Connect the negative battery terminal.

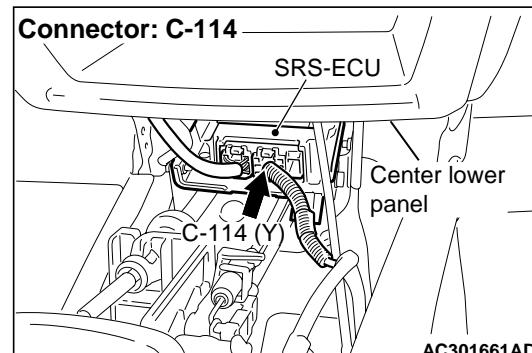
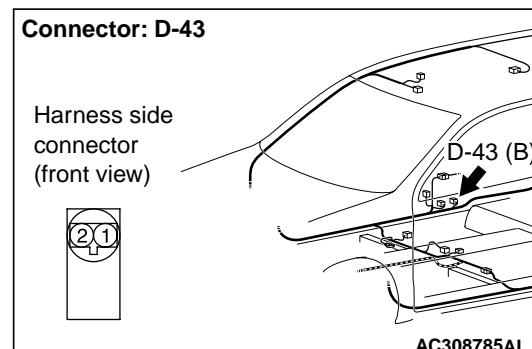
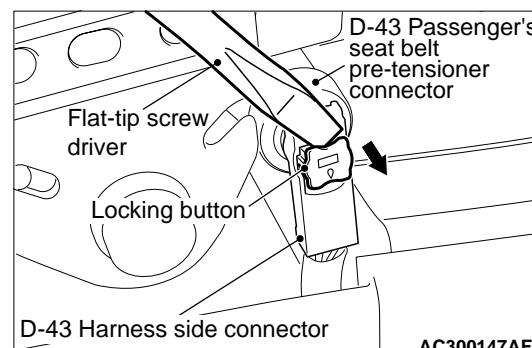
STEP 2. Measure the resistance at the SRS-ECU connector C-114.

(1) Disconnect SRS-ECU connector C-114.

- (2) Disconnect driver's seat belt pre-tensioner connector D-43. Use a flat-tipped screwdriver to pull out the locking button at the harness side connector.

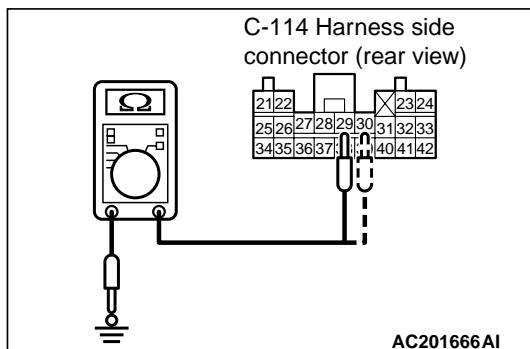
Do not insert a test probe into the terminal from its front side directly as the connector contact pressure may be weakened.

(3) Measure the resistance between C-114 harness side connector terminals 29, 30 and body earth.

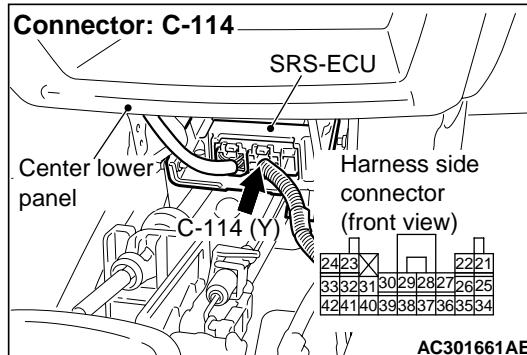
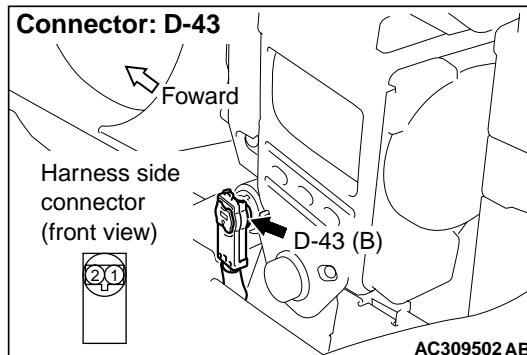
STEP 3. Connector check: SRS-ECU connector C-114 and driver's seat belt pre-tensioner connector D-43

YES : Check the harness wires for short circuit to the earth between SRS-ECU connector C-114 (terminal No.29 and 30) and driver's seat belt pre-tensioner connector D-43 (terminal No.2 and 1), and repair if necessary. Then go to Step 4 .

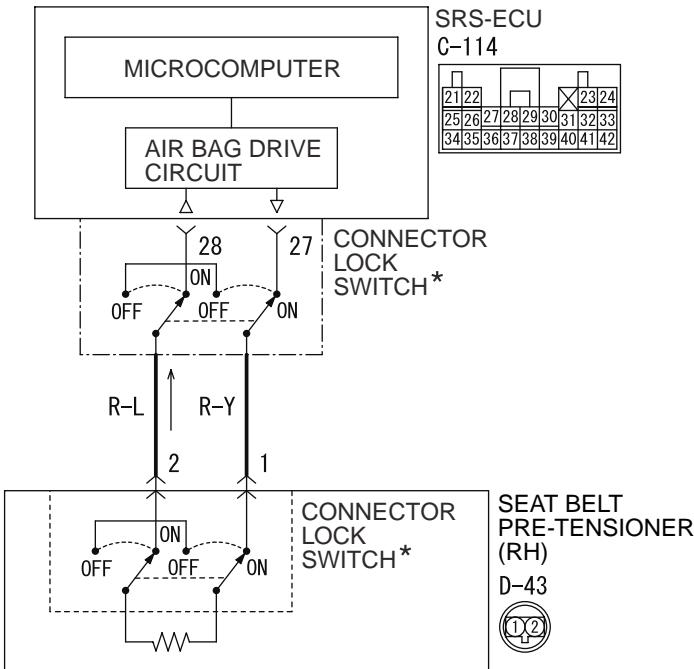
Code No.68: Passenger's (front) seat belt pre-tensioner (squib) system (short-circuited to the power supply) <L.H. drive vehicles>

Passenger's (Front) Seat Belt Pre-tensioner (Squib)

NOTE
*: CONNECTOR
COUPLED: ON
CONNECTOR
UNCOPLED: OFF

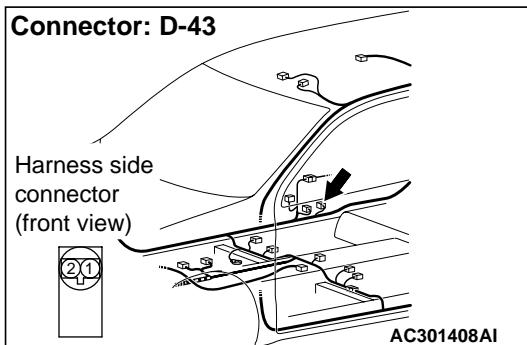
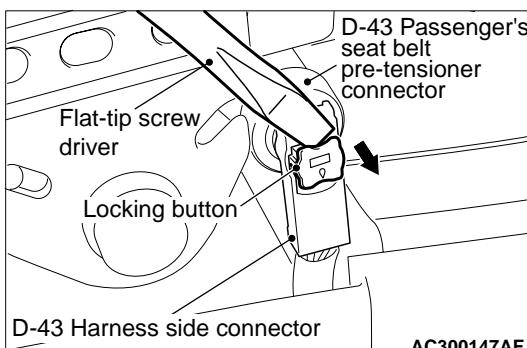
(2) Disconnect passenger's seat belt pre-tensioner connector D-43. Use a flat-tipped screwdriver to pull out the locking button at the harness side connector, and then disconnect the connector.

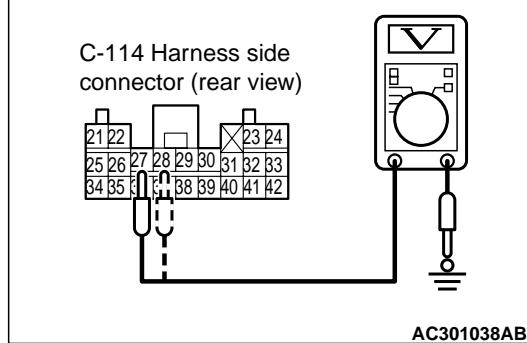
Do not insert a test probe into the terminal from its front side directly as the connector contact pressure may be weakened.

(4) Measure the voltage between C-114 harness

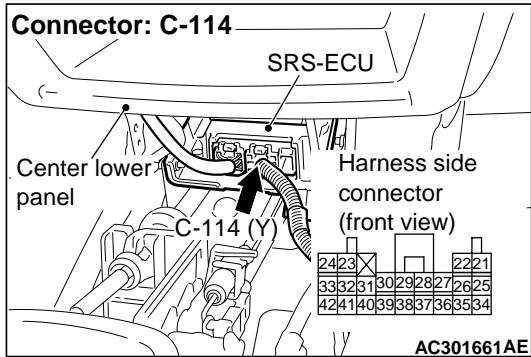
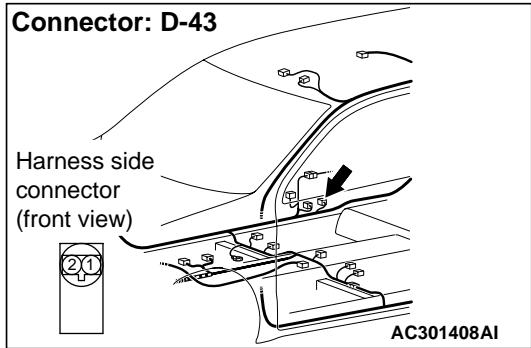
STEP 3. Connector check: SRS-ECU connector C-114 and passenger's seat belt pre-tensioner connector D-43

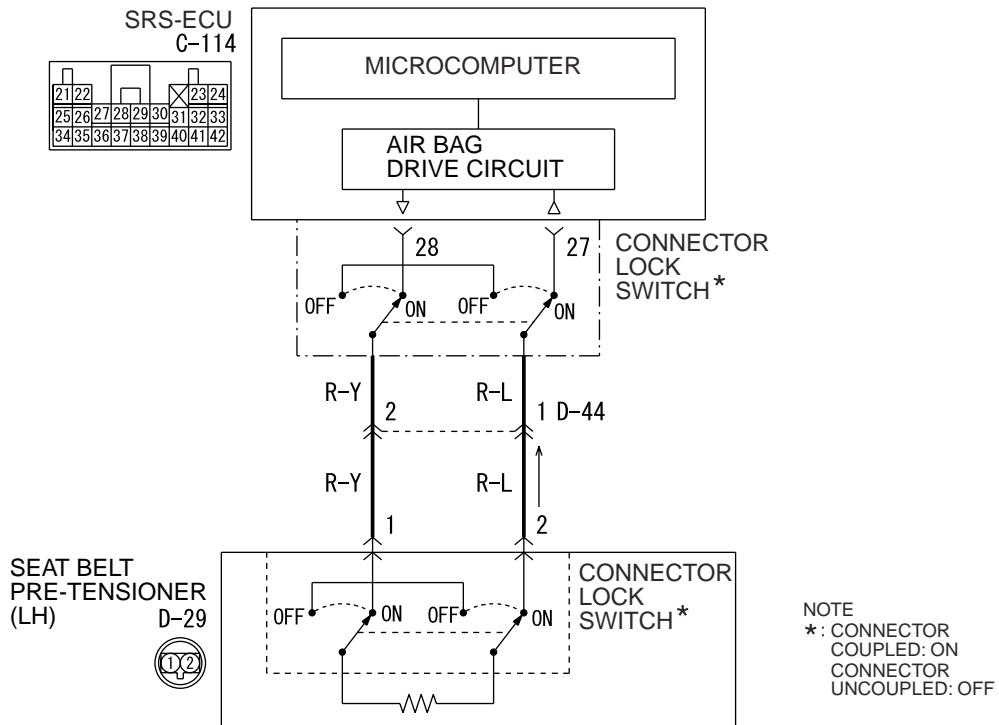
Passenger's (Front) Seat Belt Pre-tensioner (Squib)

Code No.68: Passenger's (front) seat belt pre-tensioner (squib) system (short-circuited to the power supply) <R.H. drive vehicles>

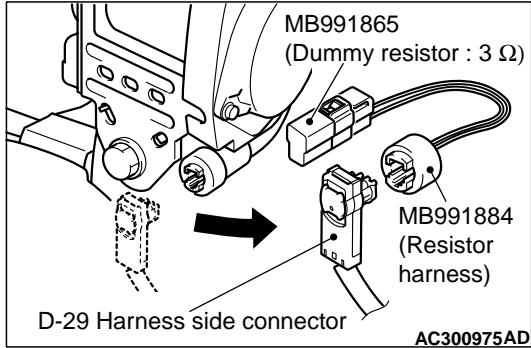
- (3) Connect special tool dummy resistor (MB991865) to special tool resistor harness (MB991884).
- (4) Connect special tool (MB991884) to the D-29 harness side connector.
- (5) Connect the negative battery terminal.
- (6) Erase diagnosis code memory, and then check

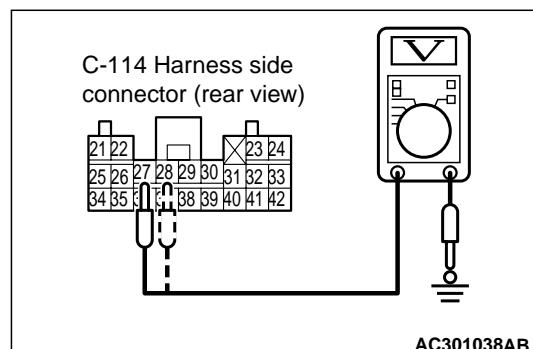
Do not insert a test probe into the terminal from its front side directly as the connector contact pressure may be weakened.

(4) Measure the voltage between C-114 harness side connector terminals 27, 28 and body earth.

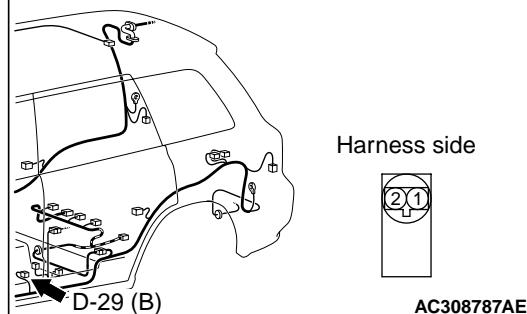
Connector: D-29

STEP 3. Connector check: SRS-ECU connector C-114, passenger's seat belt pre-tensioner connector D-29 and intermediate connector D-44

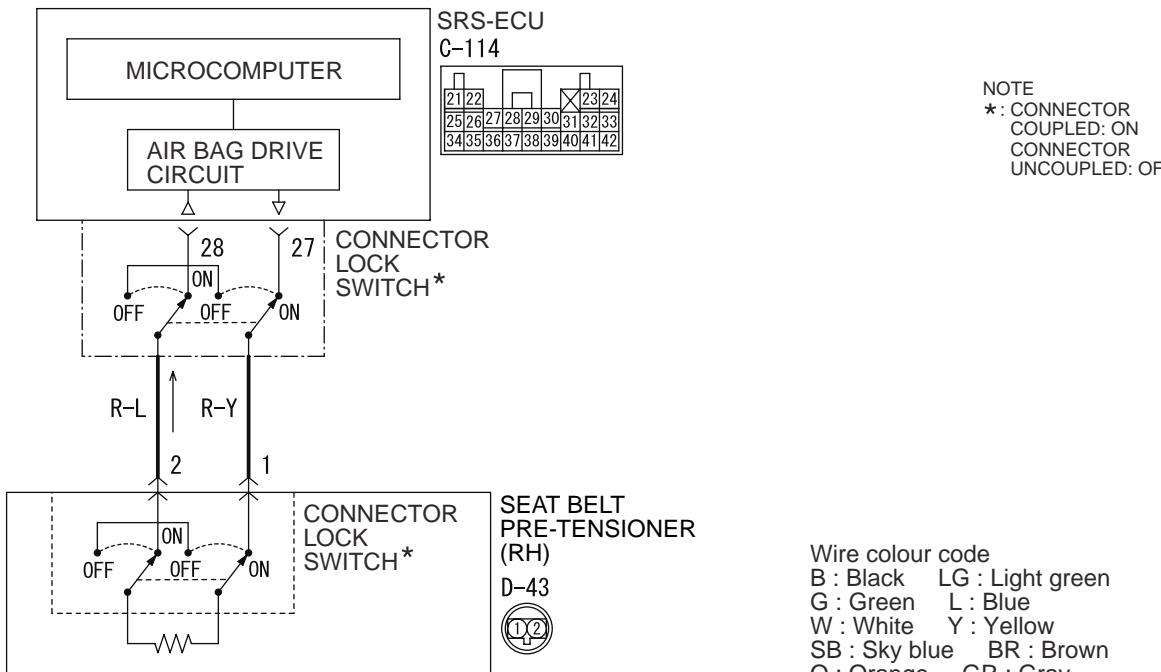
Passenger's (Front) Seat Belt Pre-tensioner (Squib)

**Code No.69: Passenger's (front) seat belt pre-tensioner (squib) system (short-circuited to the earth)
<L.H. drive vehicles>**

The SRS-ECU judges how severe a collision is by detecting signals from the front impact sensors and the front air bag analog G-sensor. If the impact is over a predetermined level, the SRS-ECU outputs an ignition signal. At this time, if the front air bag safing G-sensor is on, the pre-tensioner will deploy.

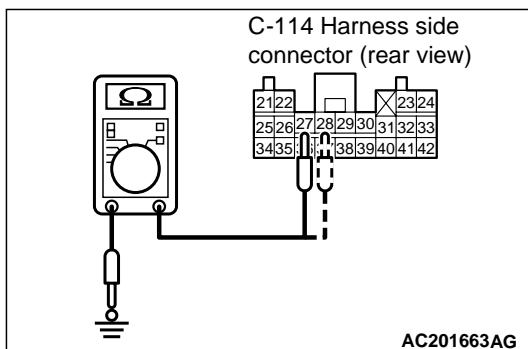
Do not insert a test probe into the terminal from its front side directly as the connector contact pressure may be weakened.

(3) Measure the resistance between C-114 harness side connector terminals 27, 28 and body earth.
