GROUP 52B

SUPPLEMENTAL RESTRAINT SYSTEM (SRS)

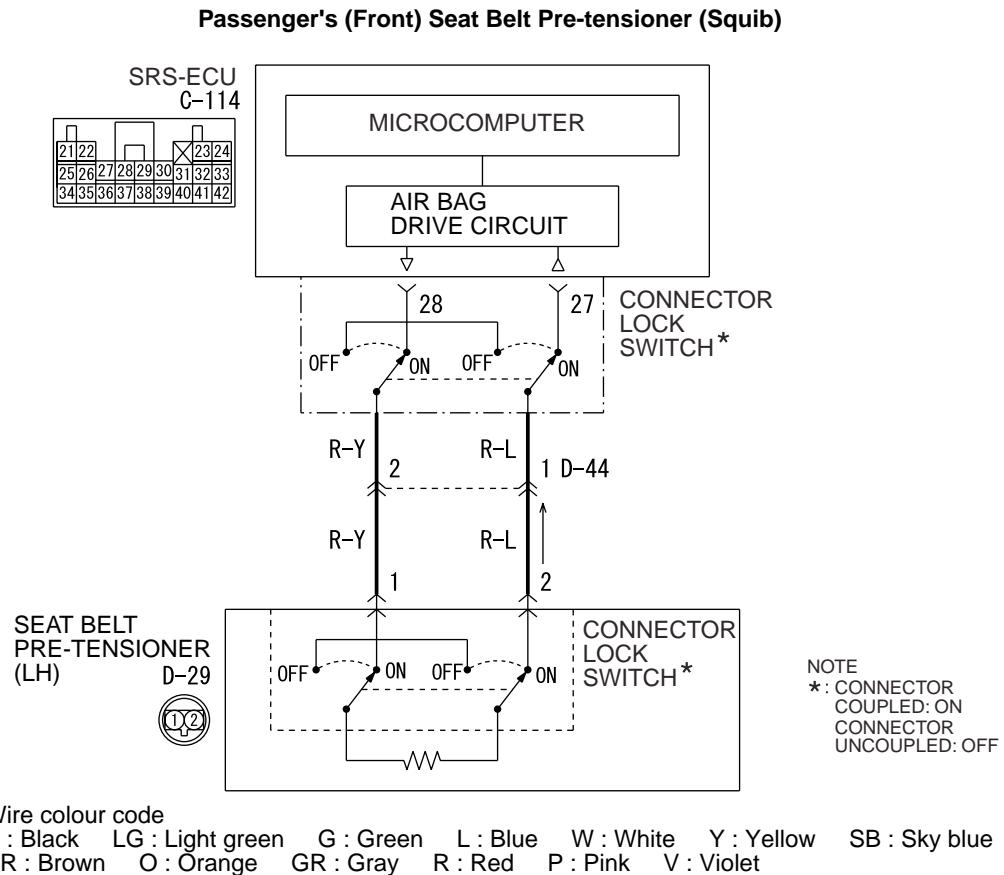
Code No.69: Passenger's (front) seat belt pre-tensioner (squib) system (short-circuited to the earth)
<R.H. drive vehicles>

The SRS-ECU judges how severe a collision is by detecting signals from the front impact sensors and the front air bag analog G-sensor. If the impact is over a predetermined level, the SRS-ECU outputs an ignition signal. At this time, if the front air bag safing G-sensor is on, the pre-tensioner will deploy.

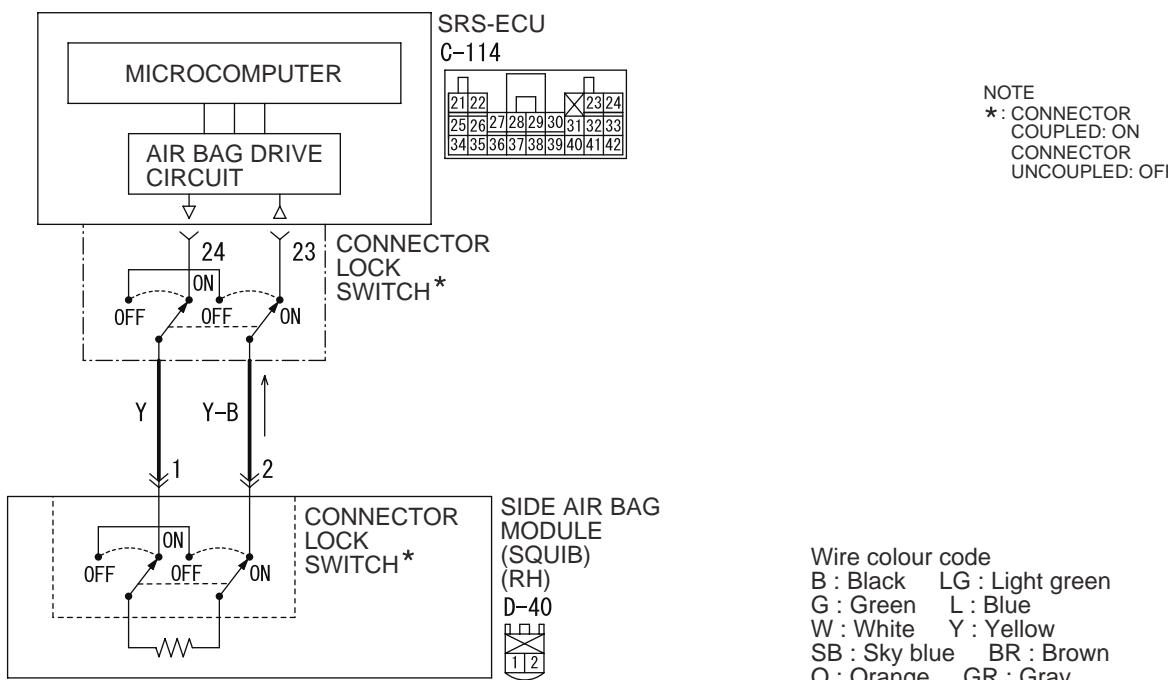
Side Air Bag Module (RH) (Squib) Circuit

Code No.71: Side air bag module (squib) (RH) system (short-circuited between terminals of the squib circuit)

- The SRS-ECU judges how severe a collision is by detecting signals from the left and right side impact sensors. If the impact is over a predetermined level, the SRS-ECU outputs an ignition signal. At this time, if the side air bag safing G-sensor is on, the SRS side air bag will inflate.
- The ignition signal is input to the side air bag module to inflate the side air bag.

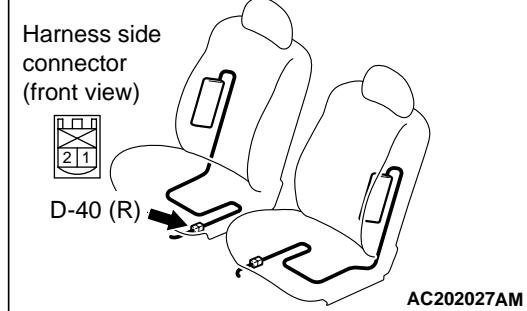
Connector: D-40

- (2) Disconnect connectors C-114 and D-40, and then reconnect them.

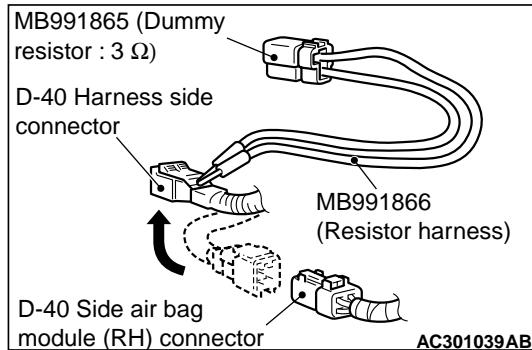
(3) Connect special tool dummy resistor (MB991865) to special tool resistor harness (MB991866).

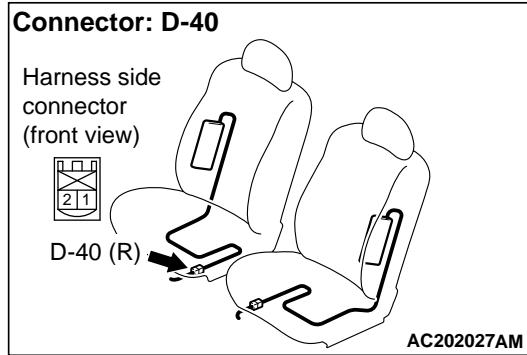
(1) Disconnect SRS-ECU connector C-114.

To prevents the air bag from deploying unintentionally, disconnect the side air bag module (RH) connector D-40 to short the squib circuit.

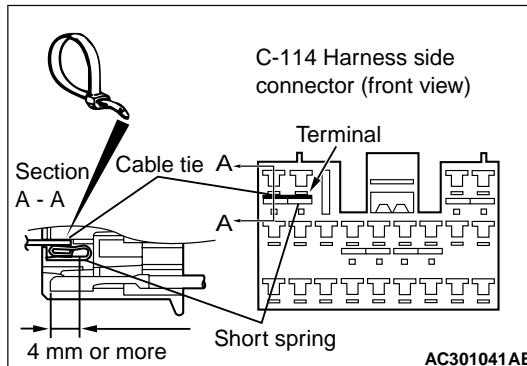
Insert an insulator such as a cable tie to a depth of 4mm or more, otherwise the short spring will not be released.

(3) Insert a cable tie [3 mm wide, 0.5 mm thick] between terminals 23, 24 and the short spring to release the short spring.

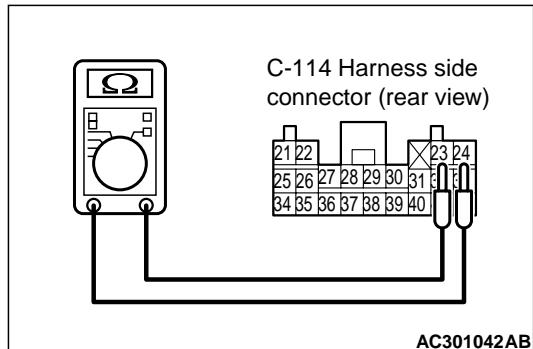
Do not insert a test probe into the terminal from its front side directly as the connector contact pressure may be weakened.

(4) Measure the resistance between C-114 harness side connector terminals 23 and 24.

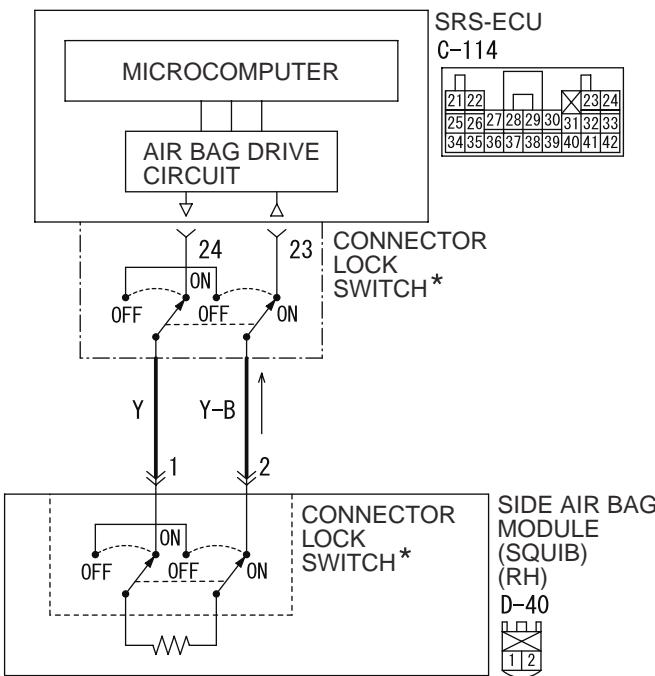
Side Air Bag Module (RH) (Squib) Circuit

- Open circuit in the side air bag module (RH) (squib) circuit
- Improper connector contact
- Malfunction of the SRS-ECU

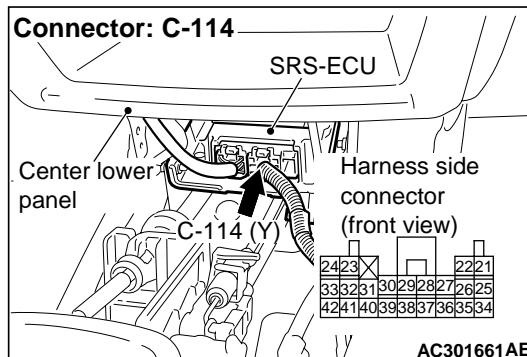
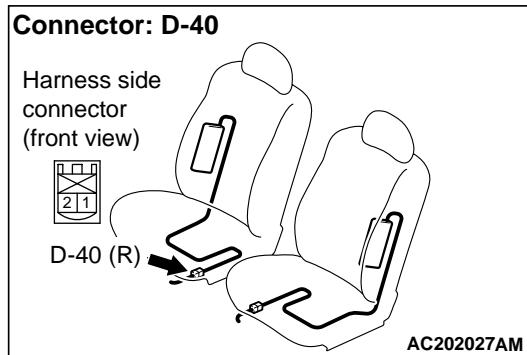
STEP 2. Measure the resistance between SRS-ECU connector C-114 (terminal No.23 and 24) and the side air bag module (RH) connector D-40 (terminal No.2 and 1).

(1) Disconnect SRS-ECU connector C-114 and side air bag module (RH) connector D-40.

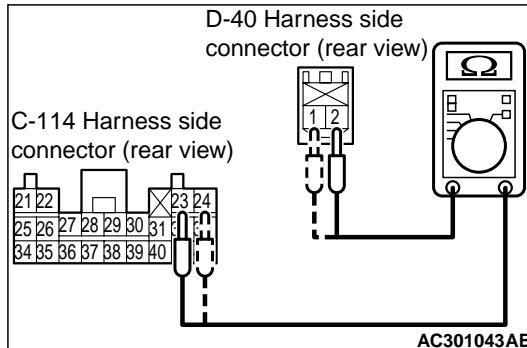
Do not insert a test probe into the terminal from its front side directly as the connector contact pressure may be weakened.

(2) Measure the resistance between the following terminals.

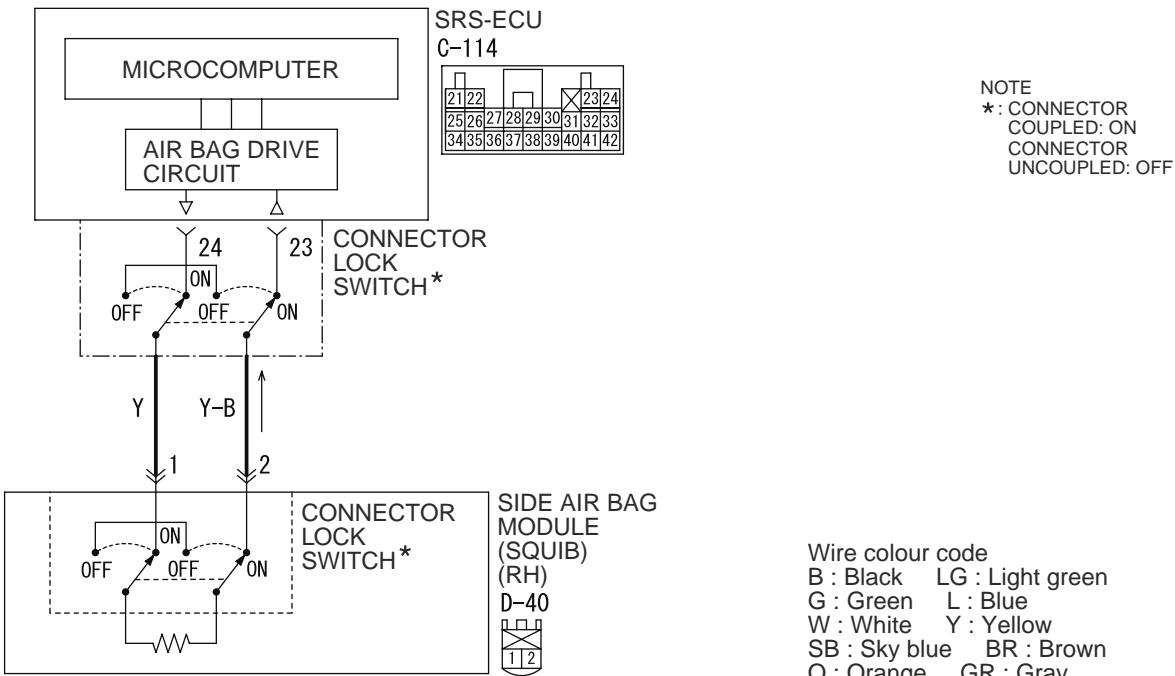
Side Air Bag Module (RH) (Squib) Circuit

- The SRS-ECU judges how severe a collision is by detecting signals from the left and right side impact sensors. If the impact is over a predetermined level, the SRS-ECU outputs an ignition signal. At this time, if the side air bag safety G-sensor is on, the SRS side air bag will inflate.
- The ignition signal is input to the side air bag module to inflate the side air bag.

- Damaged wiring harnesses or connectors
- Short to the power supply in the side air bag module (RH) (squib) harness
- Malfunction of the SRS-ECU

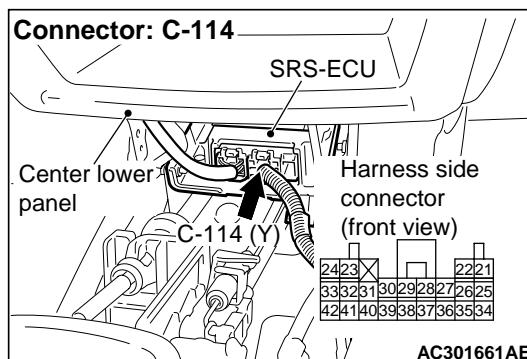
STEP 2. Measure the voltage at the SRS-ECU connector C-114.

(1) Disconnect SRS-ECU connector C-114.

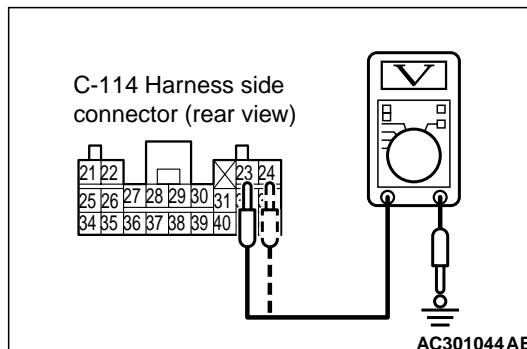
Do not insert a test probe into the terminal from its front side directly as the connector contact pressure may be weakened.

(4) Measure the voltage between C-114 harness side connector terminals 23 and 24 and body earth.

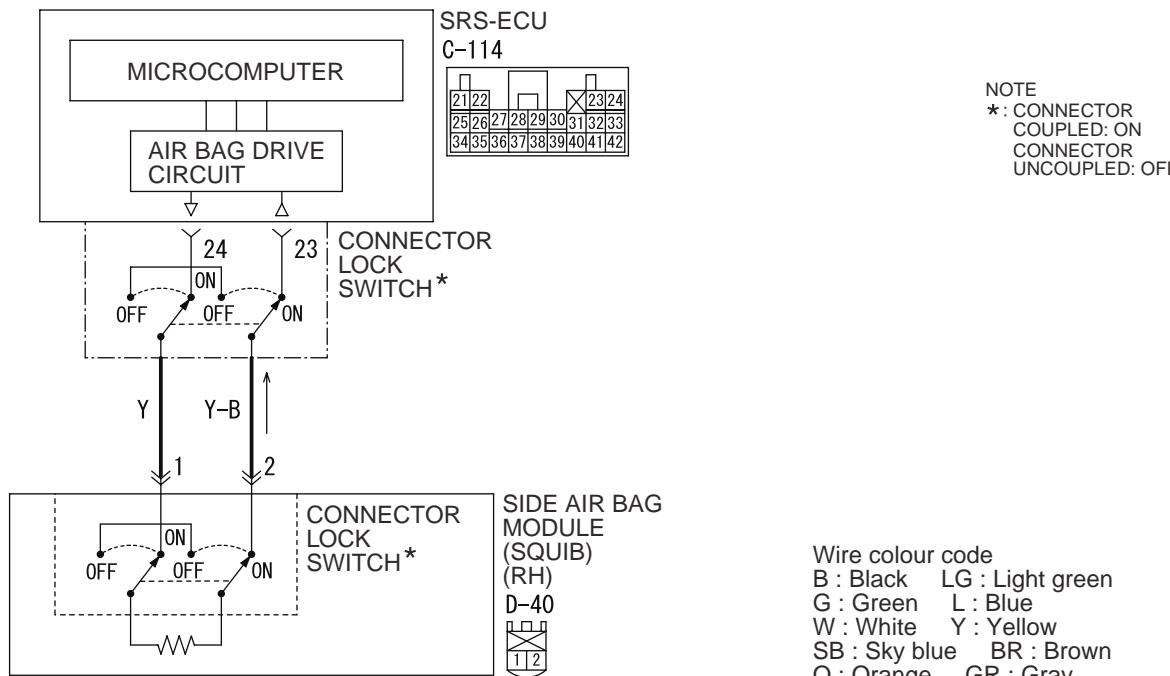
Side Air Bag Module (RH) (Squib) Circuit

- The SRS-ECU judges how severe a collision is by detecting signals from the left and right side impact sensors. If the impact is over a predetermined level, the SRS-ECU outputs an ignition signal. At this time, if the side air bag safing G-sensor is on, the SRS side air bag will inflate.

- Damaged wiring harnesses or connectors
- Short to earth in the side air bag module (RH) (squib) harness
- Malfunction of the SRS-ECU

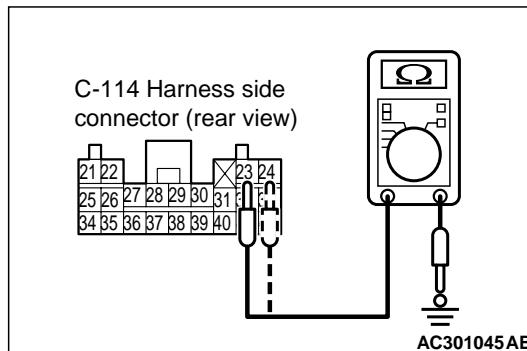
Do not insert a test probe into the terminal from its front side directly as the connector contact pressure may be weakened.

(3) Measure the resistance between C-114 harness side connector terminals 23, 24 and body earth.

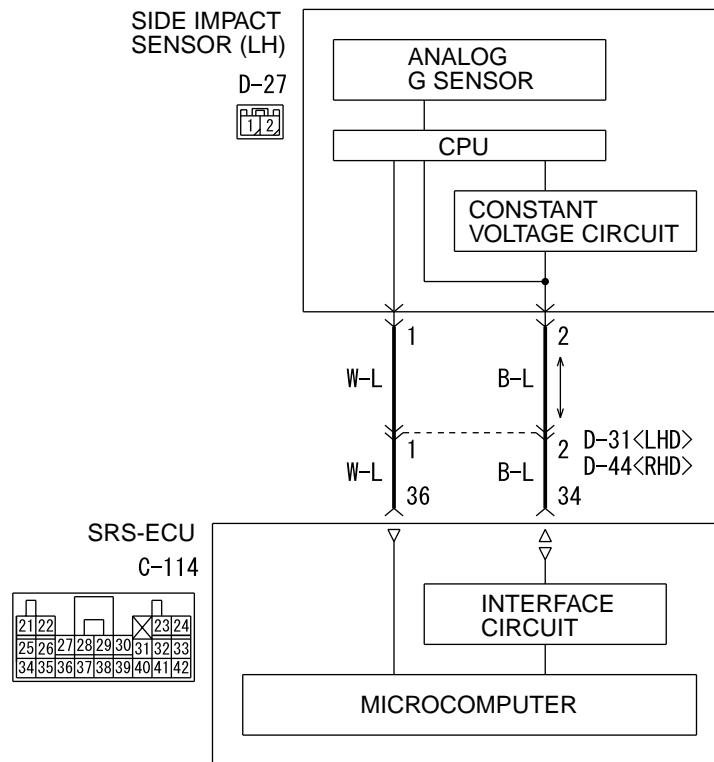
Side Impact Sensor(LH) Power Supply Circuit

- Damaged wiring harnesses or connectors
- Malfunction of the side impact sensor (LH)
- Malfunction of the SRS-ECU

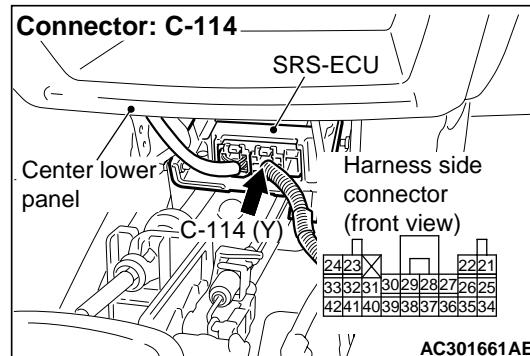
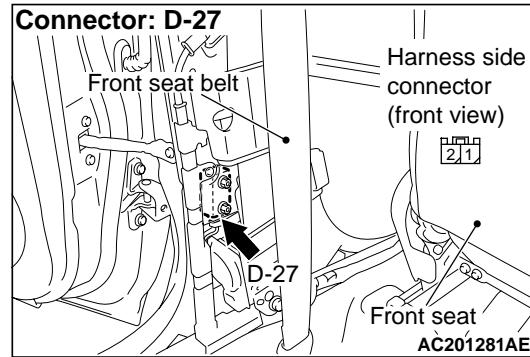
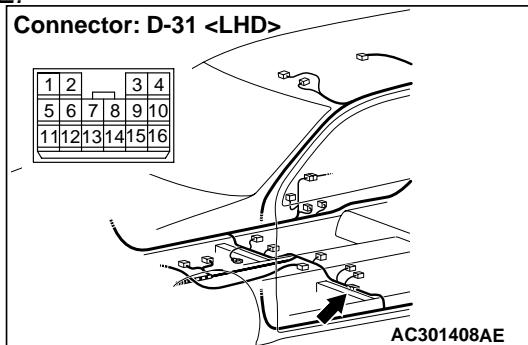
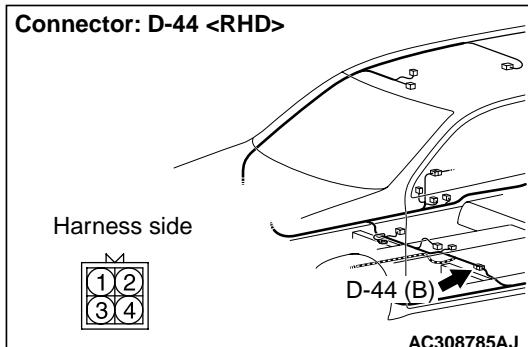
STEP 2. Check the harness wires for open circuit or short circuit between SRS-ECU connector C-114 (terminal No.34 and 36) and side impact sensor (LH) connector D-27 (terminal No.1 and 2).

After inspecting intermediate connector D-31 <L.H. drive vehicles> or D-44 <R.H. drive vehicles> inspect the wiring harness. If the intermediate connector D-31 <L.H. drive vehicles> or D-44 <R.H. drive vehicles> is damaged, repair or replace it. Then go to Step 3. If any harness wires between SRS-ECU connector C-114 and side impact sensor (LH) connector D-27 are damaged, repair or replace it.

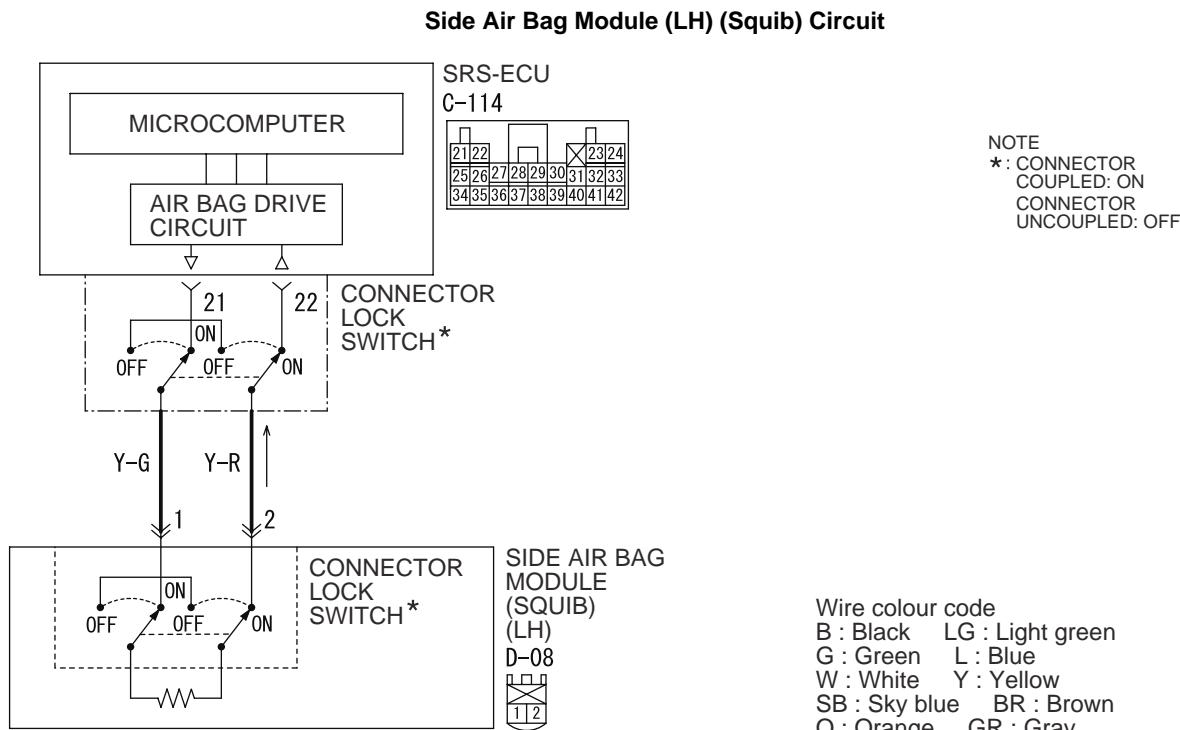
Code No.81: Side air bag module (squib) (LH) system (short-circuited between terminals of the squib circuit)

- The SRS-ECU judges how severe a collision is by detecting signals from the left and right side impact sensors. If the impact is over a predetermined level, the SRS-ECU outputs an ignition signal. At this time, if the side air bag safing G-sensor is on, the SRS side air bag will inflate.
- The ignition signal is input to the side air bag module to inflate the side air bag.

- Improper engaged connector or defective short spring*
- Short circuit between the side air bag module (LH) (squib) circuit terminals
- Damaged connector(s)
- Malfunction of the SRS-ECU

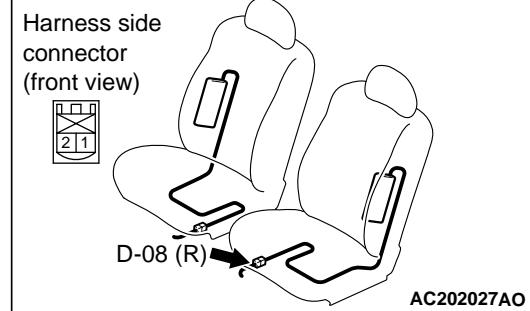
Connector: D-08

- (2) Disconnect connectors C-114 and D-08, and then reconnect them.

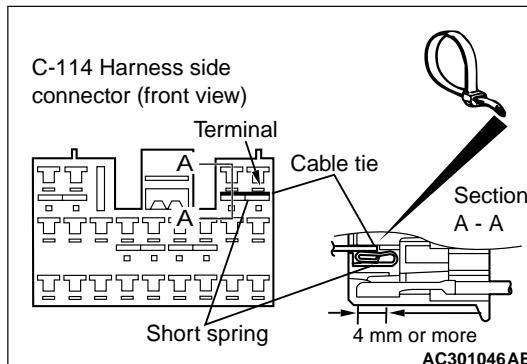
Insert an insulator such as a cable tie to a depth of 4mm or more, otherwise the short spring will not be released.

(3) Insert a cable tie [3 mm wide, 0.5 mm thick] between terminals 21, 22 and the short spring to release the short spring.

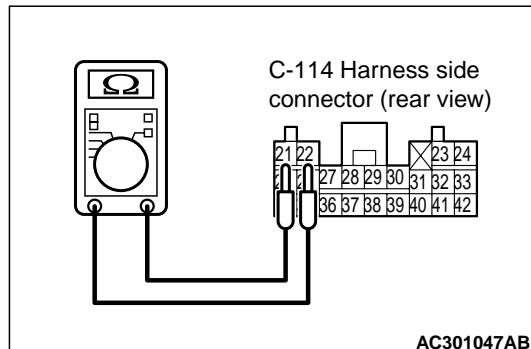
Do not insert a test probe into the terminal from its front side directly as the connector contact pressure may be weakened.

(4) Check for continuity between C-114 harness side connector terminals 21 and 22.

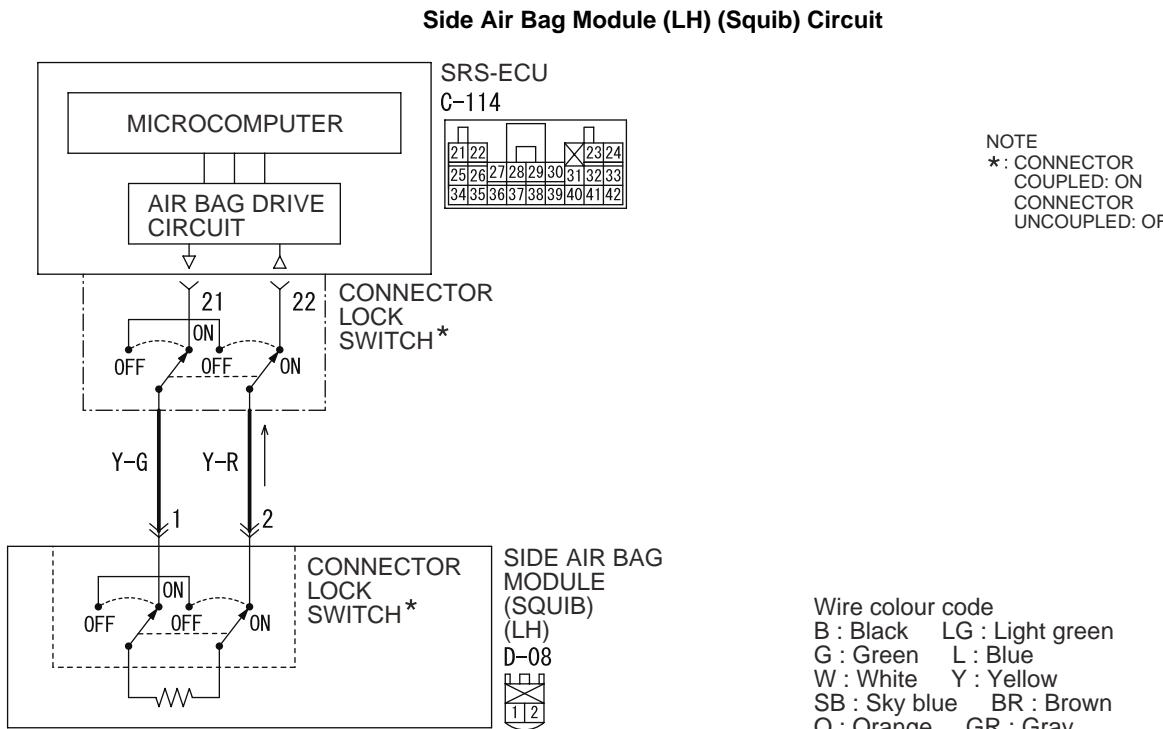
Code No.82: Side air bag module (squib) (LH) system (open-circuited in the squib circuit)

- The SRS-ECU judges how severe a collision is by detecting signals from the left and right side impact sensors. If the impact is over a predetermined level, the SRS-ECU outputs an ignition signal. At this time, if the side air bag safety G-sensor is on, the SRS side air bag will inflate.
- The ignition signal is input to the side air bag module to inflate the side air bag.

- Open circuit in the side air bag module (squib) (LH) circuit
- Improper connector contact

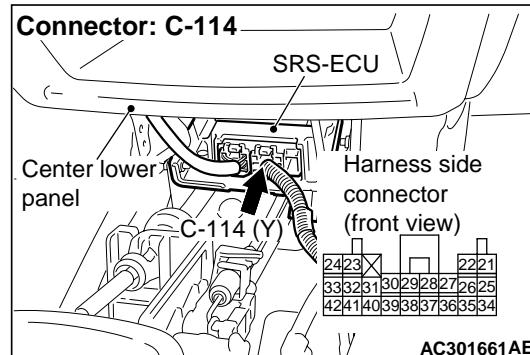
STEP 2. Measure the resistance between the SRS-ECU connector C-114 (terminal No.21 and 22) and the side air bag module (LH) connector D-08 (terminal No.1 and 2).

(1) Disconnect SRS-ECU connector C-114.

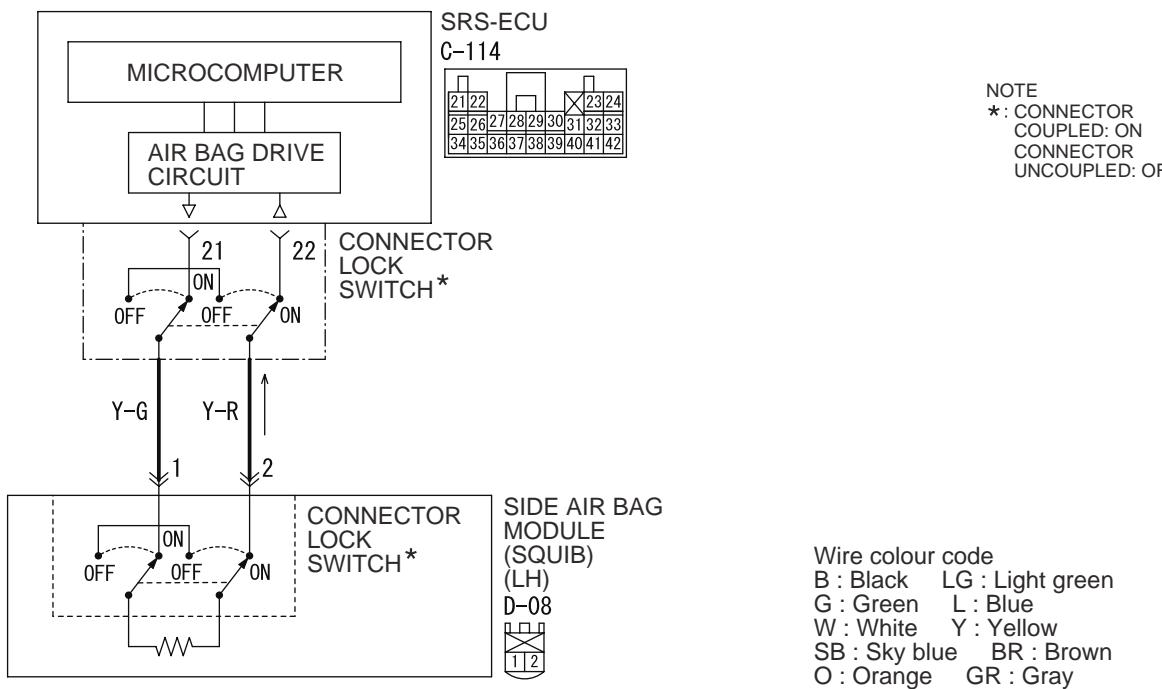
Side Air Bag Module (LH) (Squib) Circuit

- The SRS-ECU judges how severe a collision is by detecting signals from the left and right side impact sensors. If the impact is over a predetermined level, the SRS-ECU outputs an ignition signal. At this time, if the side air bag safety G-sensor is on, the SRS side air bag will inflate.
- The ignition signal is input to the side air bag module to inflate the side air bag.

- Damaged wiring harnesses or connectors
- Short to the power supply in the side air bag module (LH) (squib) harness
- Malfunction of the SRS-ECU

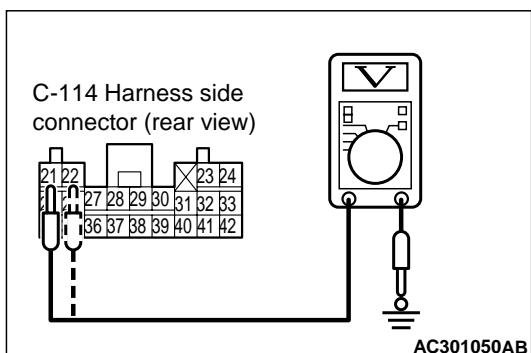
Do not insert a test probe into the terminal from its front side directly as the connector contact pressure may be weakened.

(4) Measure the voltage between C-114 harness side connector terminals 21, 22 and body earth.

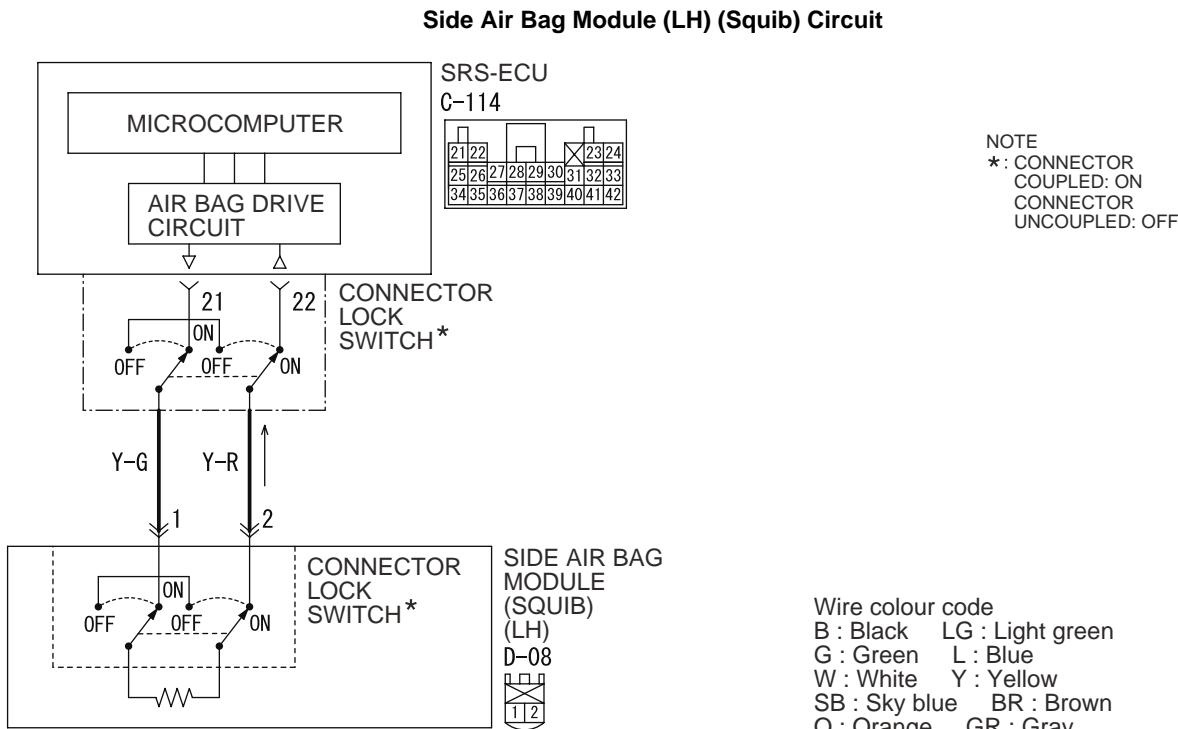
Code No.86: Side air bag module (squib) (LH) system (short-circuited to the earth)

- The SRS-ECU judges how severe a collision is by detecting signals from the left and right side impact sensors. If the impact is over a predetermined level, the SRS-ECU outputs an ignition signal. At this time, if the side air bag safety G-sensor is on, the SRS side air bag will inflate.
- The ignition signal is input to the side air bag module to inflate the side air bag.

- Damaged wiring harnesses or connectors
- Short to earth in the left hand side air bag module (squib) harness

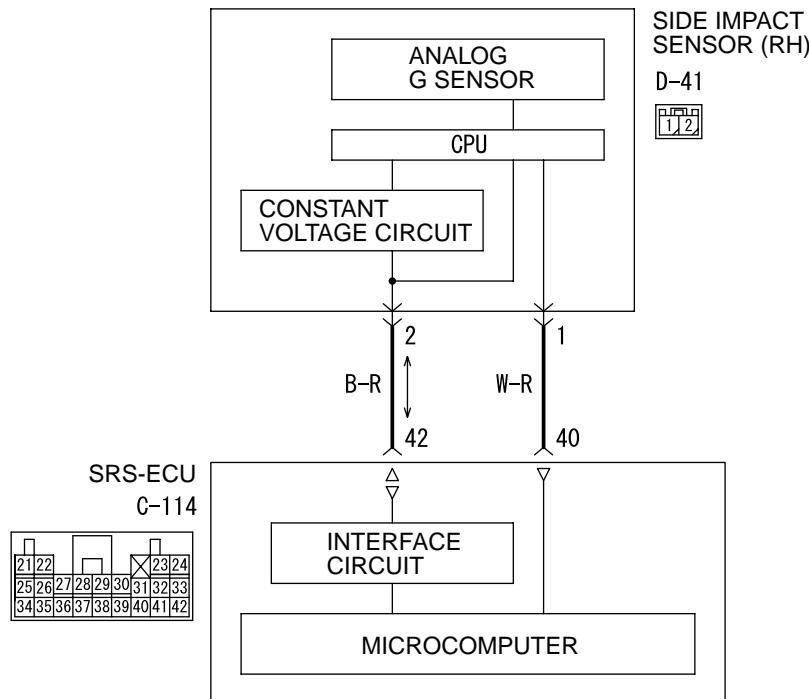
Side Impact Sensor (RH) Circuit

Code No.89: Side impact sensor (RH) communication error Code No.96: Side impact sensor (RH) communication impossible

- Damaged wiring harnesses or connectors
- Malfunction of the side impact sensor (RH)
- Malfunction of the SRS-ECU

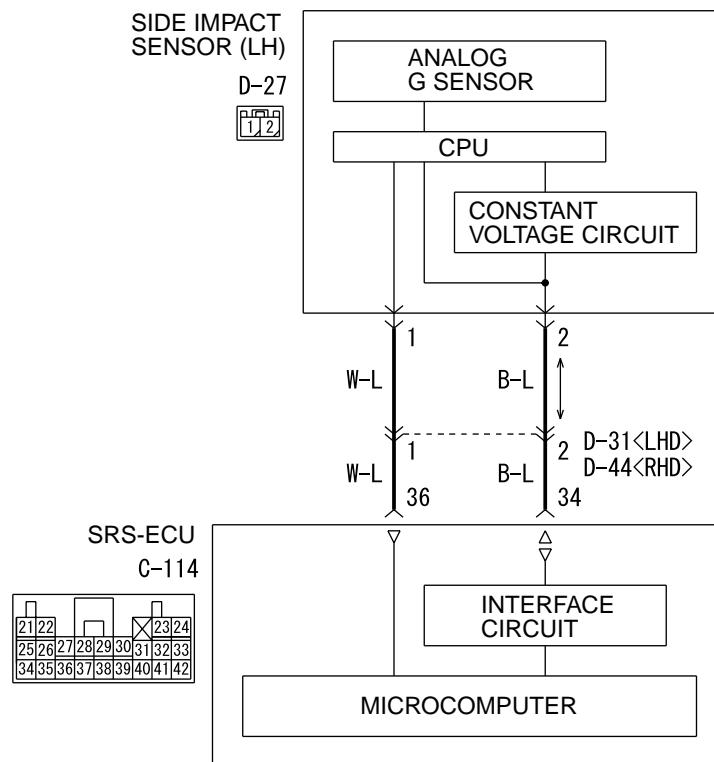
Side Impact Sensor(LH) Power Supply Circuit

Code No.91: Side impact sensor (LH) voltage error

This diagnosis code will set when the power supply voltage to the side impact sensor (LH) remains less than a predetermined value for 5 seconds. However, if the system returns to normal condition, code number 91 will be erased automatically and the SRS warning lamp will go out.

- Damaged wiring harness or connectors
- Malfunction of the side air bag module (LH) (squib)
- Malfunction of the SRS-ECU

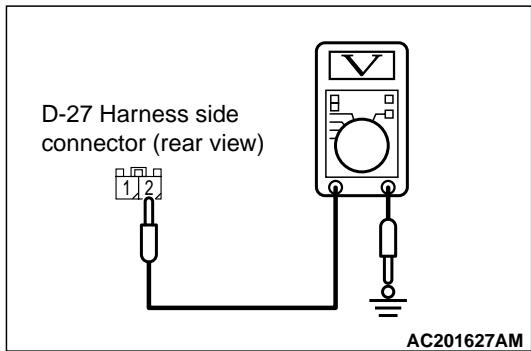
Do not insert a test probe into the terminal from its front side directly as the connector contact pressure may be weakened.

(5) Measure the voltage between D-27 harness side

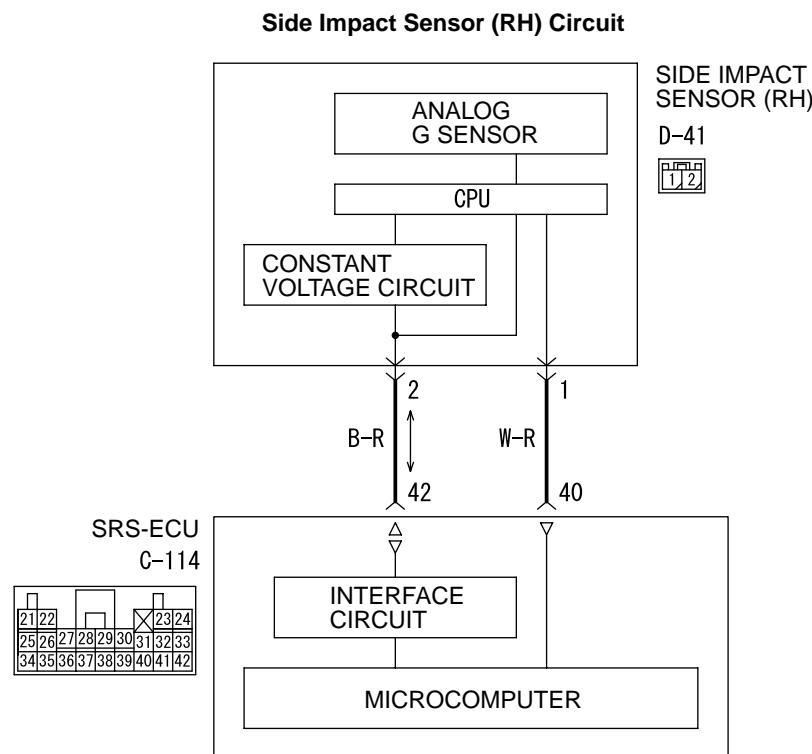
Code No.94: Side Impact Sensor (RH) voltage error

This diagnosis code is set if the power supply voltage of the side impact sensor (RH) drops below the rated value for a continuous period of 5 seconds or more. However, diagnosis code number 94 will be automatically cleared and the SRS warning lamp will switch off if the condition returns to normal.

- Damaged wiring harnesses or connectors
- Malfunction of the side air bag module (RH) (squib)
- Malfunction of the SRS-ECU

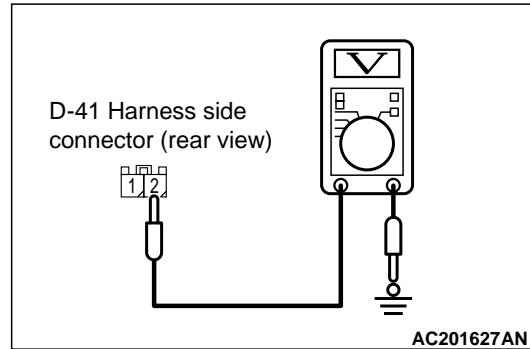
Do not insert a test probe into the terminal from its front side directly as the connector contact pressure may be weakened.

- (5) Measure the voltage between the D-41 harness side connector terminal 2 and body earth.

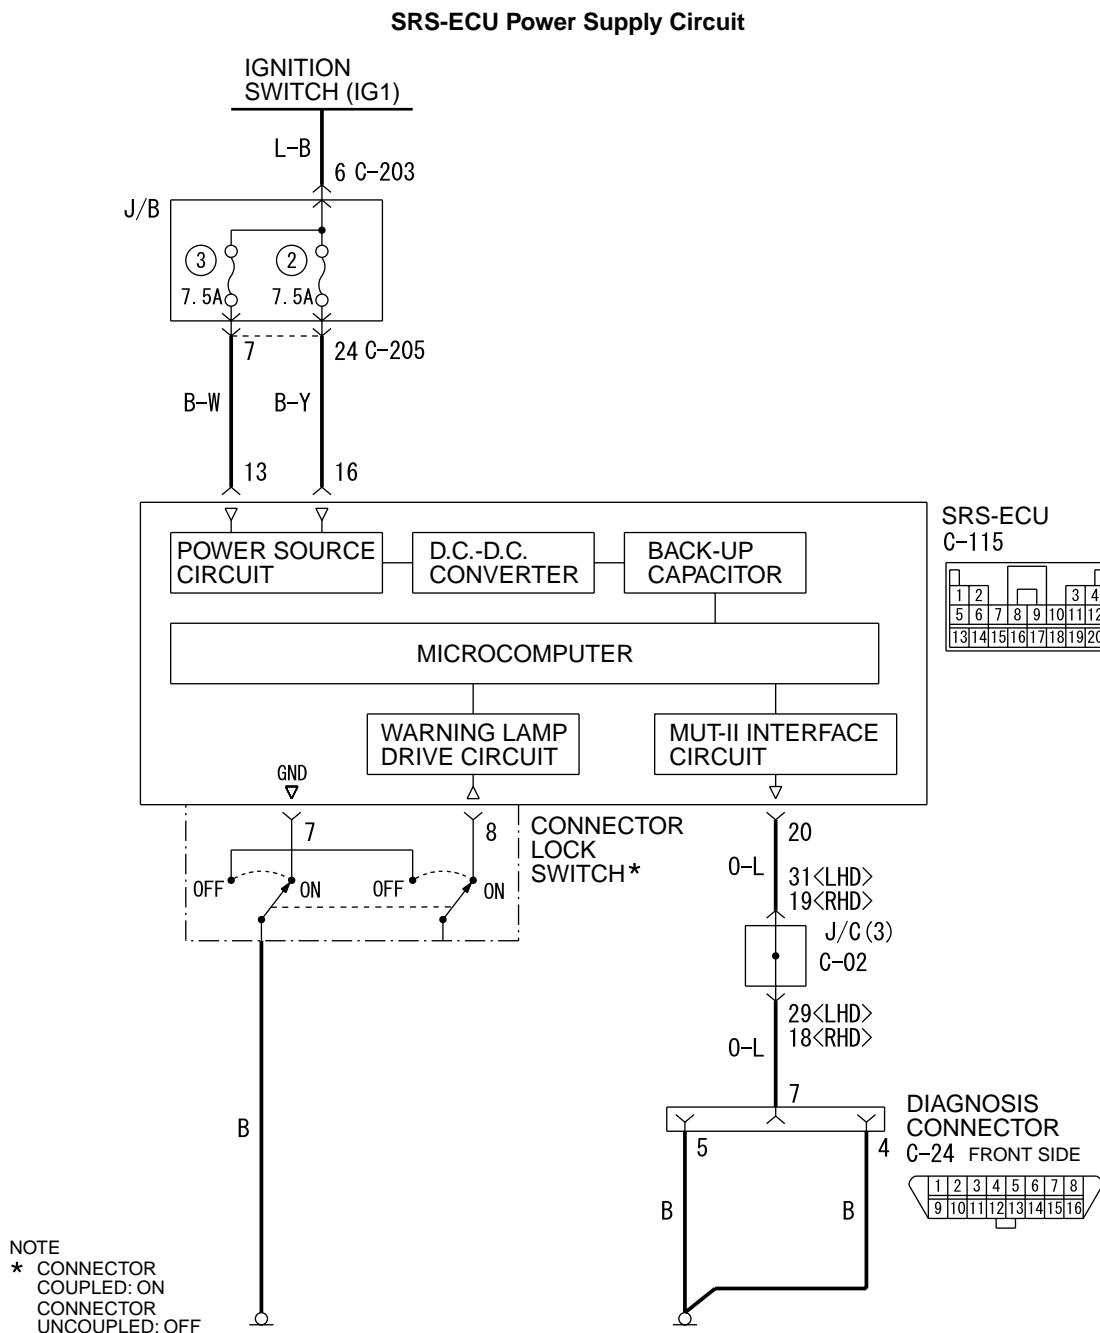
INSPECTION PROCEDURE 1: Communication with MUT-II/III is not possible. (Communication is not possible with SRS).

If communication is not possible with the SRS only, the cause is probably an open circuit in the on-board diagnostic output circuit of the SRS or in the power circuit (including earth circuit).

- Damaged wiring harnesses or connectors
- Malfunction of the SRS-ECU

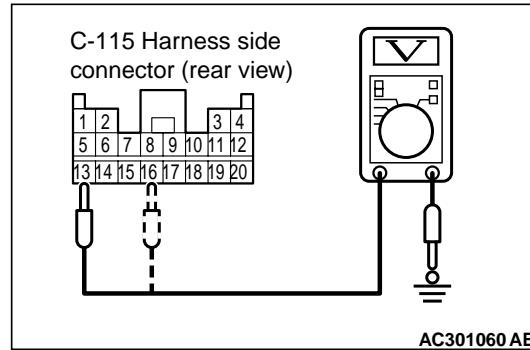
Do not insert a test probe into the terminal from its front side directly as the connector contact pressure may be weakened.

(4) Measure the voltage between terminals 13, 16 and body earth.

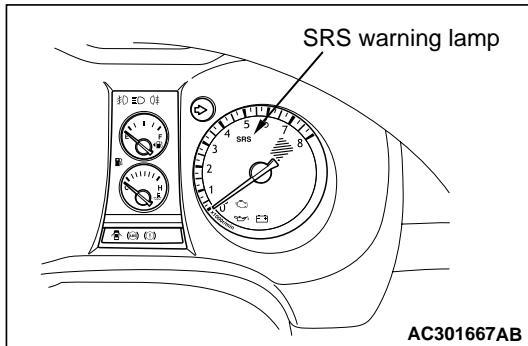
SRS WARNING LAMP CHECK

Turn the ignition key to the "ON" position. Does the SRS warning lamp illuminate for about 7 seconds, turn off and then remain extinguished for at least 5 seconds? If yes, SRS system is functioning properly. If no, consult page [P.52B-11](#).

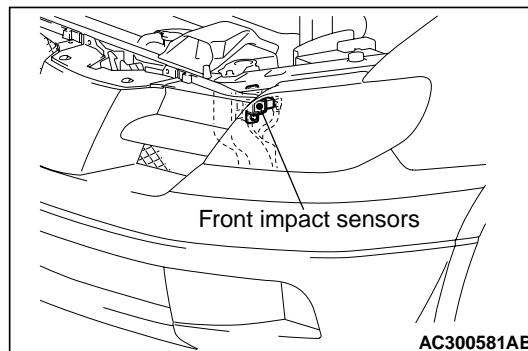
FRONT IMPACT SENSORS

1. Check the front side member and front impact sensor for deformation or rust.
2. Check the front impact sensor for dents, cracks, deformation or rust.
3. Check the sensor harnesses for binding, the connectors for damage, and the terminals for deformation.

NOTE: The figures show front impact sensors (LH). The side impact sensors (RH) is symmetrical with the side impact sensors (LH).

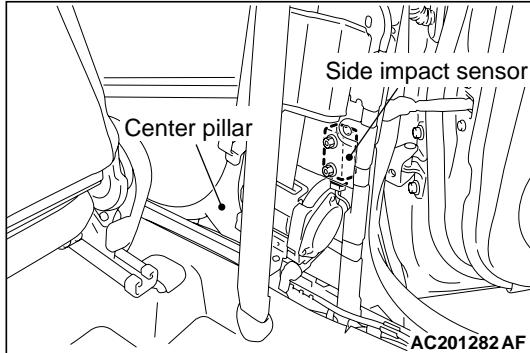
1. Check the centre pillar for deformation or rust.
2. Check the side impact sensors for dents, cracks, deformation and rust.
3. Check the connector for damage and the terminals for deformation.

NOTE: The figures show side impact sensors (RH). The side impact sensors (LH) is symmetrical with the side impact sensors (RH).

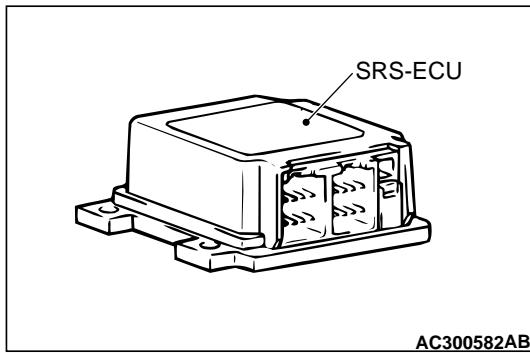
1. Check the SRS-ECU case and brackets for dents, cracks, deformation or rust.
2. Check the connector for damage, and check the terminals for deformation or rust.

Replace the SRS-ECU if it fails the visual checks above (Refer to [P.52B-178](#)).

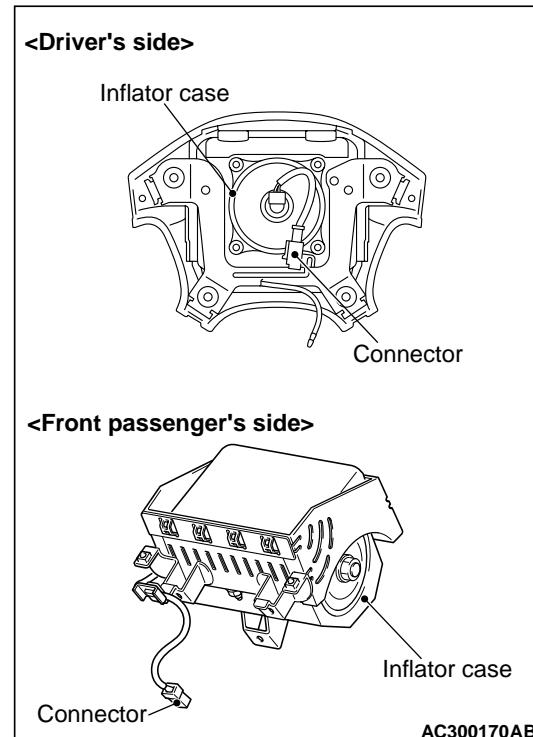
1. Remove the air bag module, steering wheel and clock spring (Refer to [P.52B-179](#)).
2. Check the pad cover for dents, cracks or deformation.

3. Check the connector for damage and deformed terminals, and check the harness for binding.
4. Check the air bag inflator case for dents, cracks or deformation.

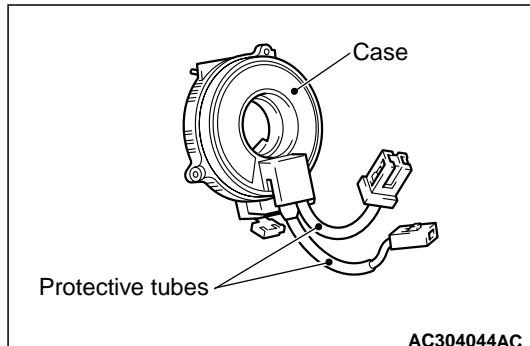
6. Check the clock spring connectors and protective tube for damage, and terminals for deformities.
7. Visually check the case for damage.

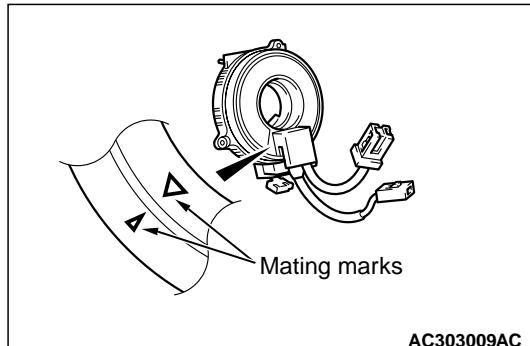
If the clock spring's mating mark is not properly aligned, the steering wheel may not be completely rotational during a turn, or the flat cable within the clock spring may be severed, obstructing normal operation of the SRS and possibly leading to serious injury to the vehicle's driver or front passenger.

8. Align the mating marks of the clock spring and, after turning the vehicle's front wheels to straight-ahead position, install the clock spring to the column switch.

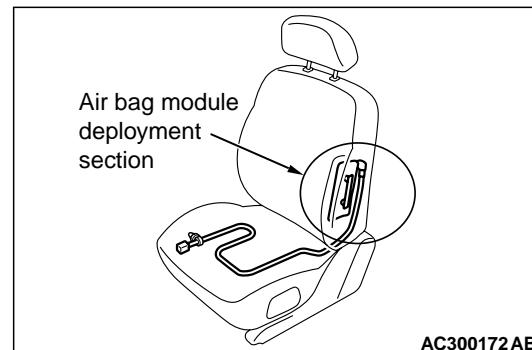
FRONT SEATBACK ASSEMBLY WITH SIDE AIR BAG MODULE

1. Check the side air bag module deployment section in the seat for dents and deformation.
2. Check the harness for binds, the connector for damage and the terminals for deformation.
