GROUP 52B

SUPPLEMENTAL RESTRAINT SYSTEM (SRS)

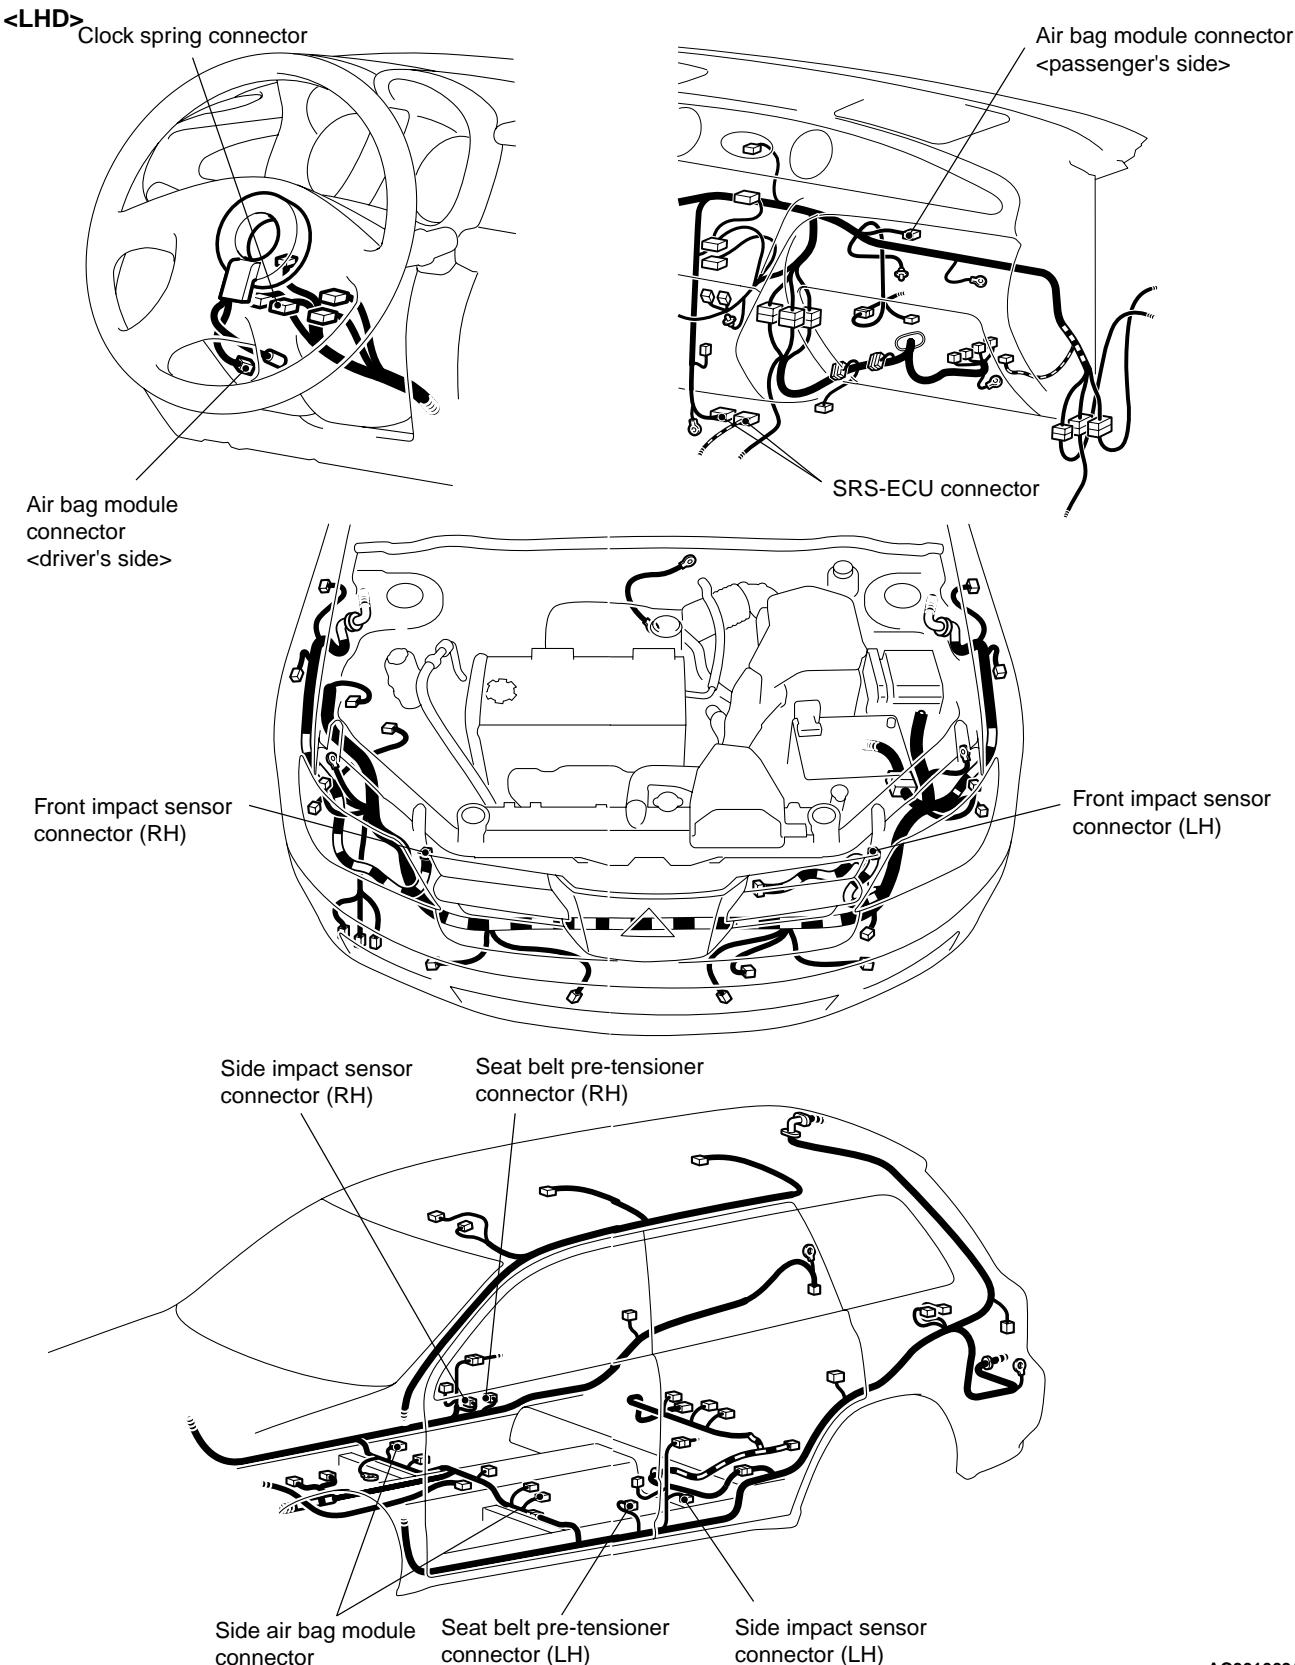
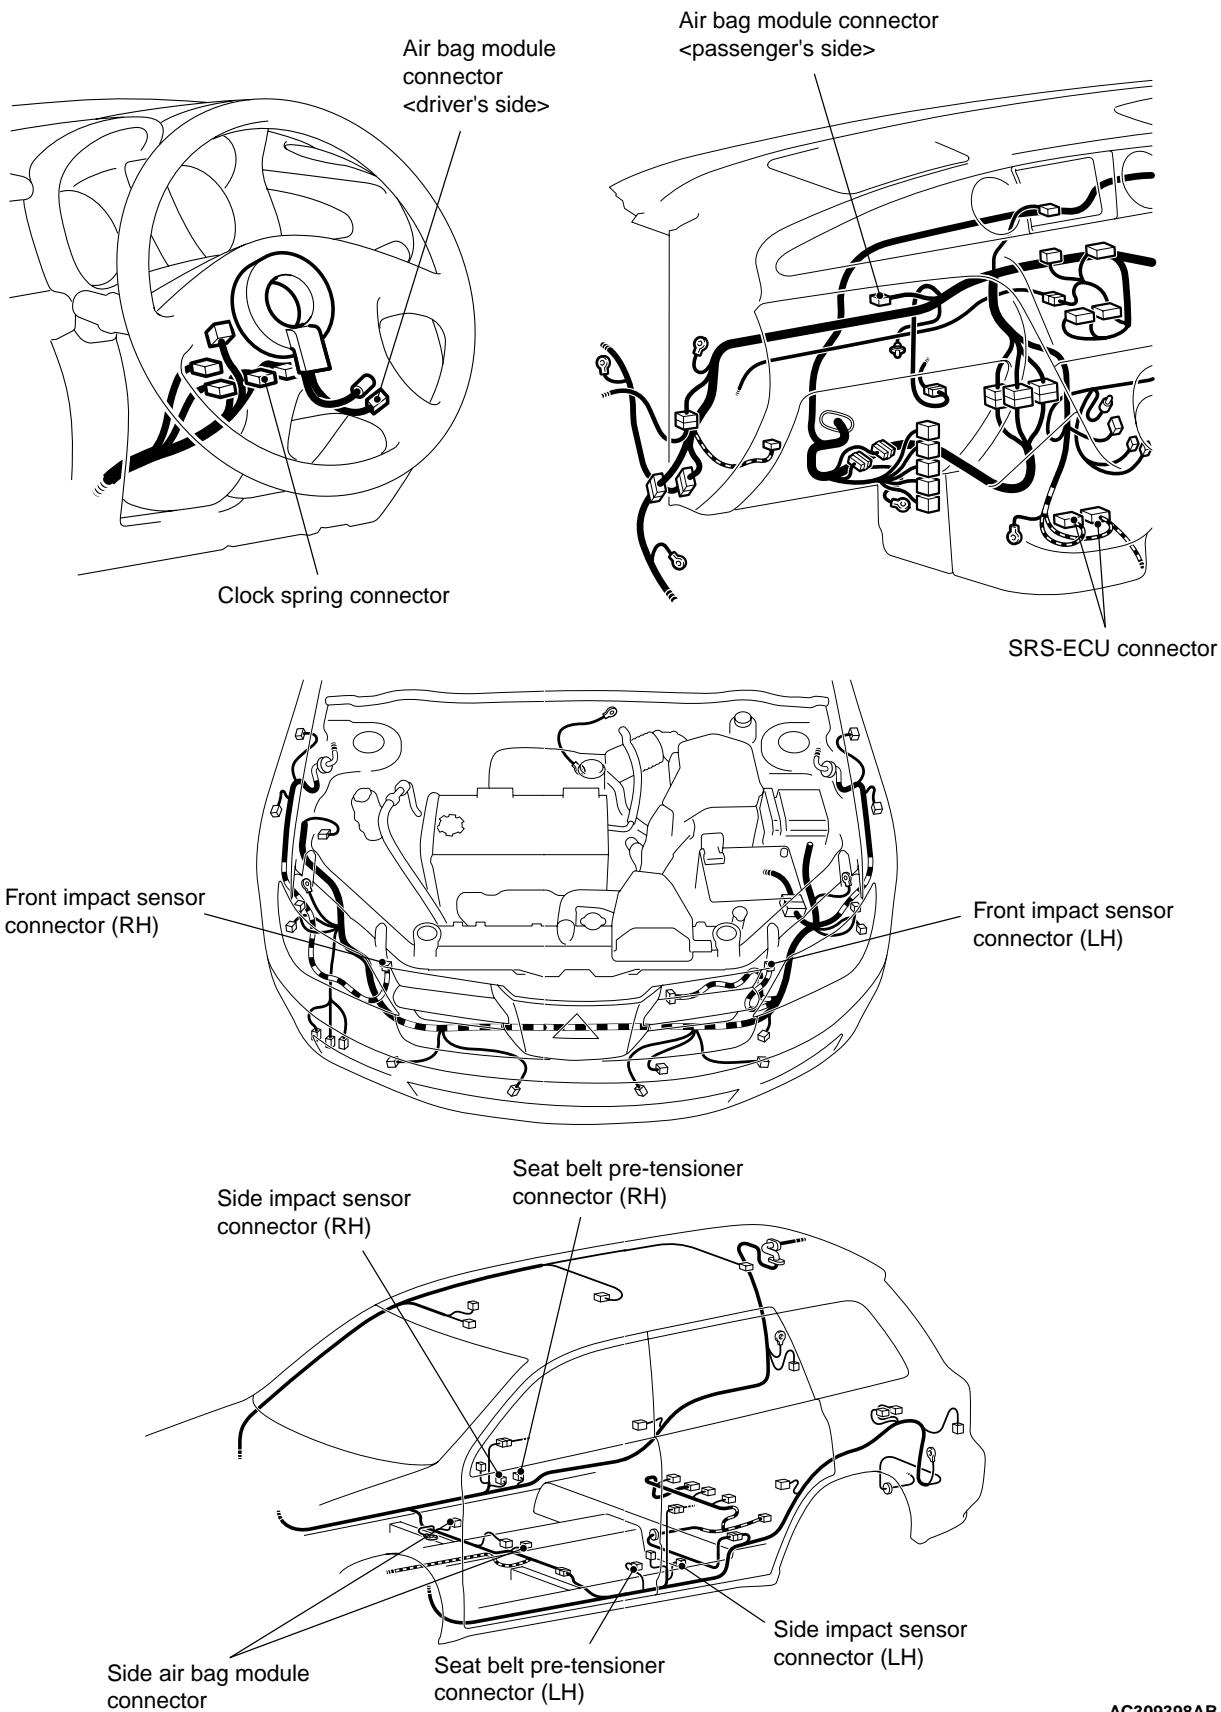
AC309398AB

1. Check connector for poor connection.

2. Check harnesses for binds, connectors for damage, and terminals for deformation.
REPLACE ANY CONNECTORS OR HARNESS THAT FAIL THE VISUAL INSPECTION (Refer to [P.52B-3](#)).

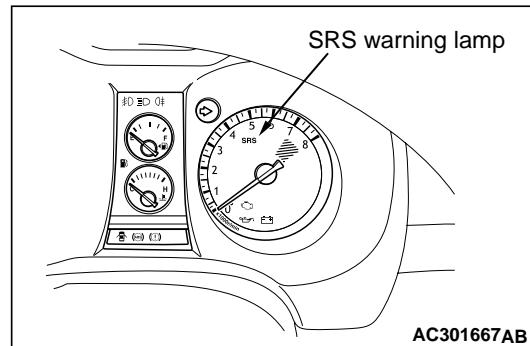
AC301667AB

Reconnect the negative battery terminal. Turn the ignition key to the "ON" position. Does the SRS warning lamp illuminate for about 7 seconds, turn off and then remain extinguished for at least 5 seconds? If yes, SRS system is functioning properly. If no, consult page [P.52B-11](#).

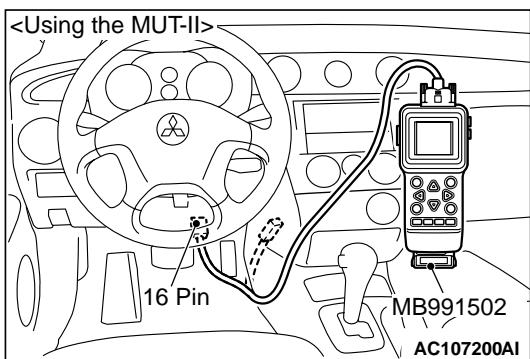
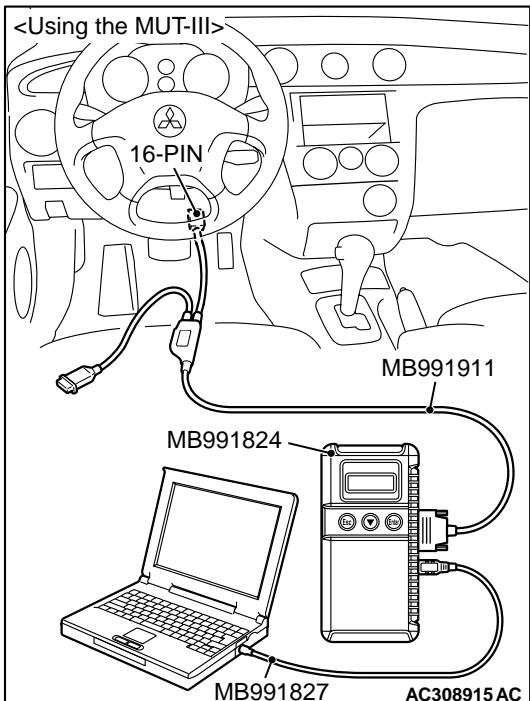
Refer to that the ignition switch is "LOCK" (OFF) when connecting or disconnecting MUT-II/III.

1. Connect the MUT-II/III to the diagnosis connector (Refer to GROUP 00 – How to Use Troubleshooting/Inspection Service Points P.00-6).

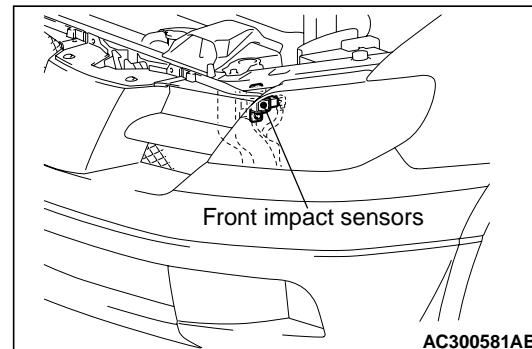
Front impact sensor

1. Check the front side member and front impact sensor for deformation or rust.
2. Check the front impact sensor for dents, cracks, deformation or rust.
3. Check the sensor harnesses for binding, the connectors for damage, and the terminals for deformation.

NOTE: The figures show front impact sensors (LH). The side impact sensors (RH) is symmetrical with the side impact sensors (LH).

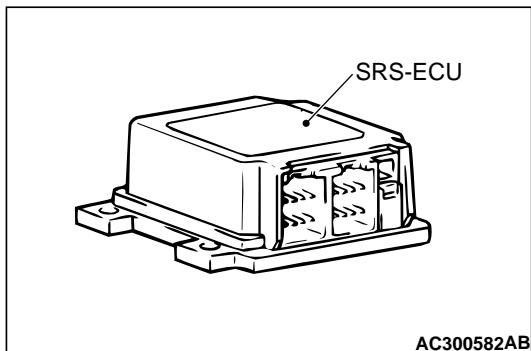
1. Check the SRS-ECU case and brackets for dents, cracks or deformation.
2. Check the connector for damage, and the terminals for deformation.
3. Check the SRS-ECU and bracket for installation condition.

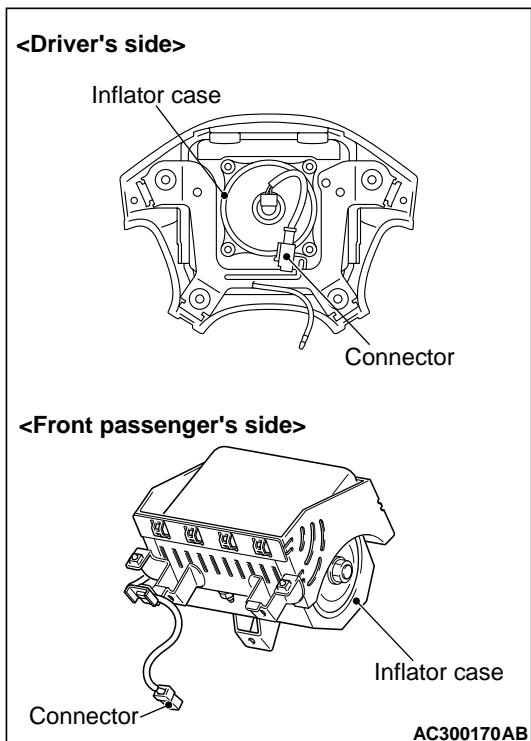
Air bag modules

1. Check the pad cover for dents, cracks or deformation.
2. Check the connector for damage, terminals deformities, and the harness for binding.
3. Check the air bag inflator case for dents, cracks or deformities.
4. Check the air bag modules for proper installation.

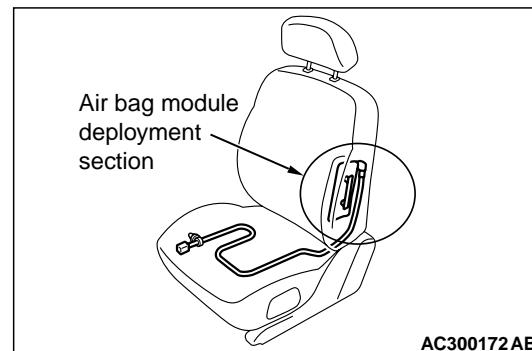
Front seatback assembly (Side air bag module)

1. Check the side air bag module deployment section in the seat for dents and deformation.
2. Check the connectors for damage, the terminals for deformation, and the harness for binds.

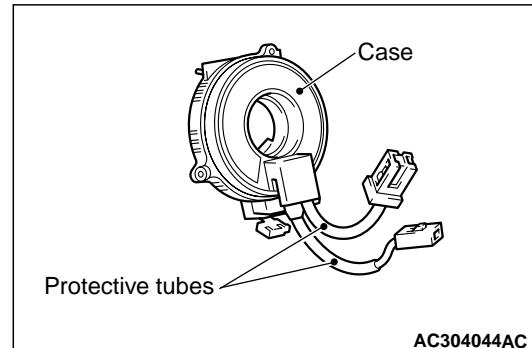
Clock spring

1. Check the clock spring connectors and protective tube for damage, and the terminals for deformation.
2. Visually check the case for damage.

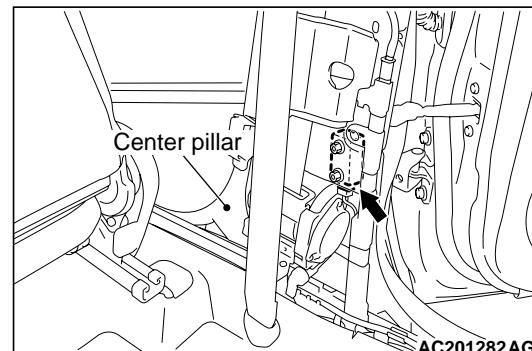
Side impact sensor

1. Check the centre pillar for deformation or rust.
2. Check the side impact sensors for dents, cracks, deformation and rust.
3. Check the connector for damage and the terminals for deformation.

NOTE: The figures show side impact sensors (RH). The side impact sensors (LH) is symmetrical with the side impact sensors (RH).

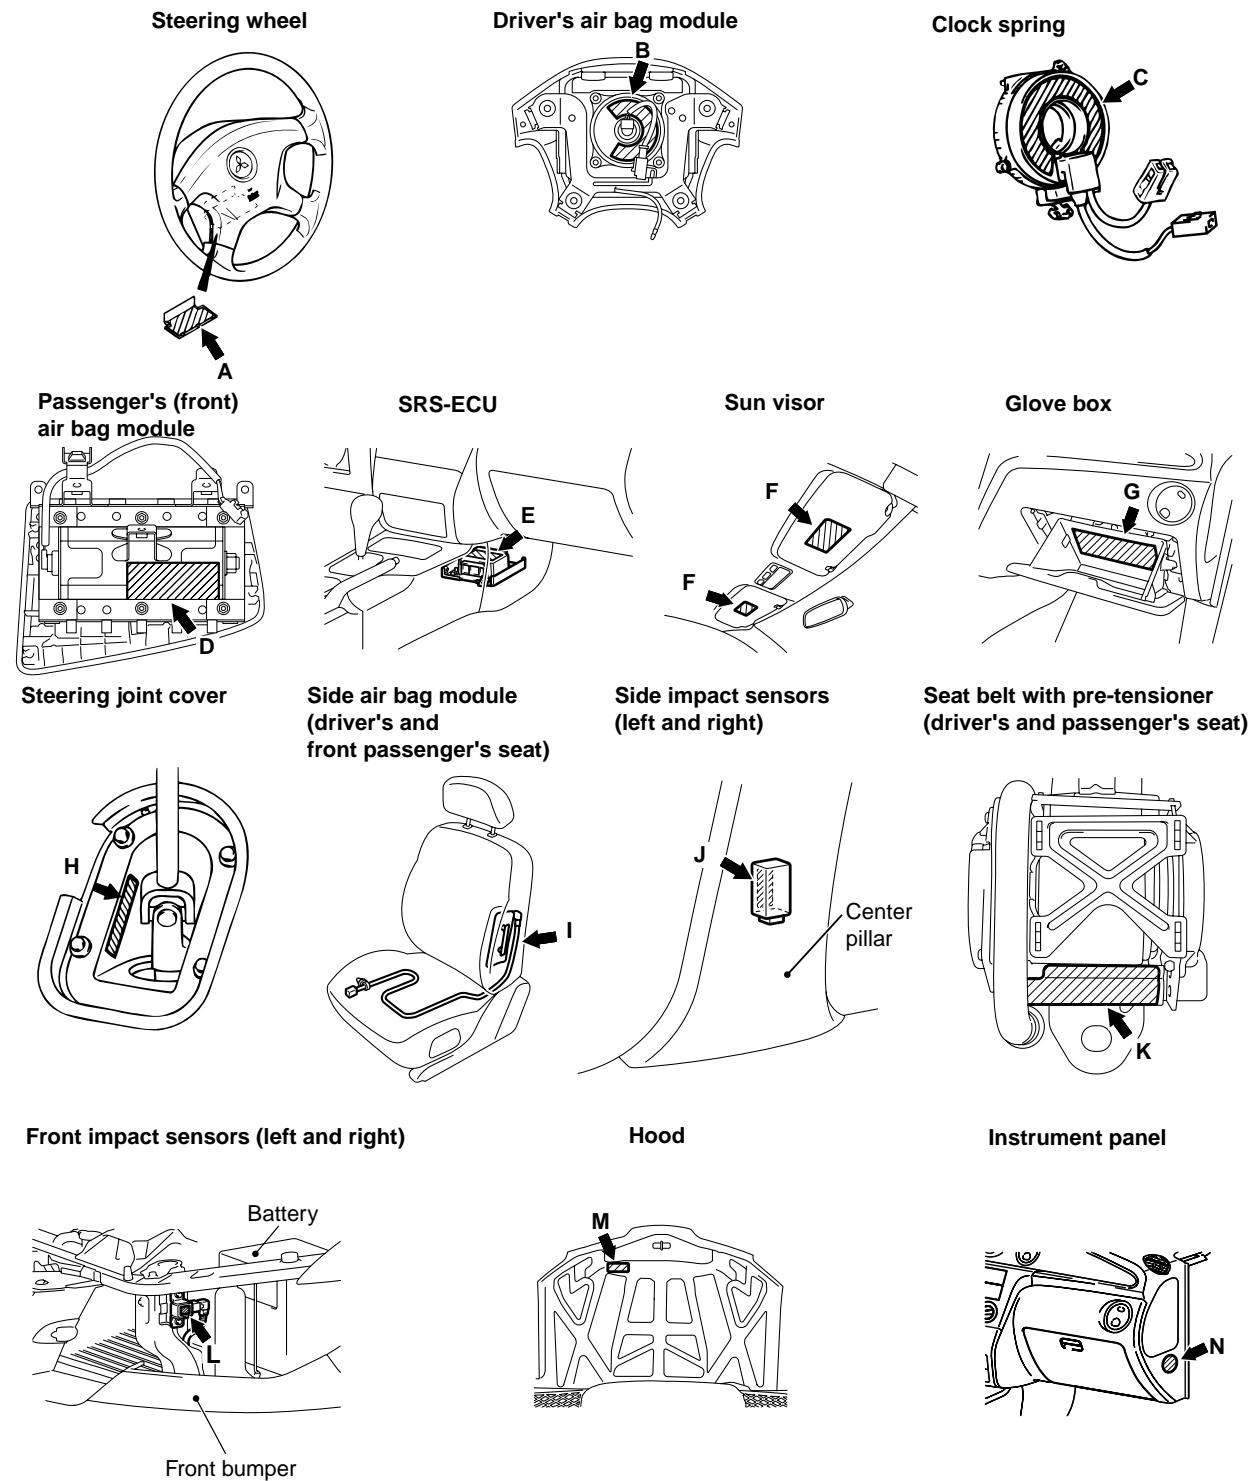
AC309289AB

Caution labels on the SRS are attached in the vehicle as shown. Follow label instructions when servicing the SRS. If the label(s) are dirty or damaged, replace with new one(s).

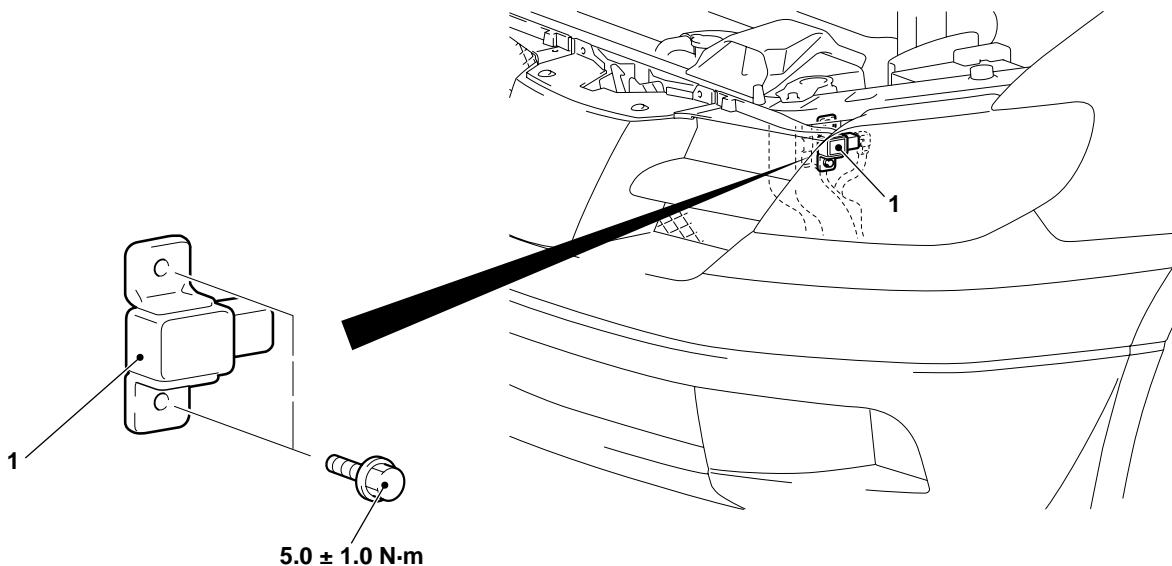
AC300078AB

Removal step
 1. Front impact sensor

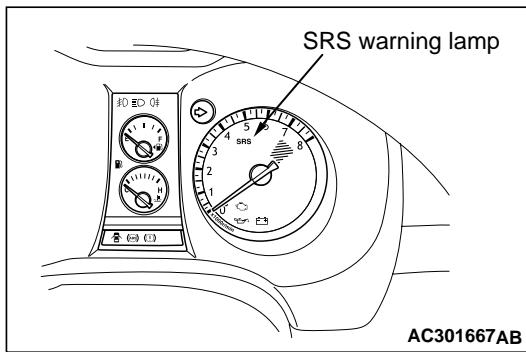
3. Does the SRS warning lamp illuminate for about 7 seconds, and then remain extinguished for at least 5 seconds after turning OFF?
4. If no, refer to troubleshooting (Refer to [P.52B-11](#)).

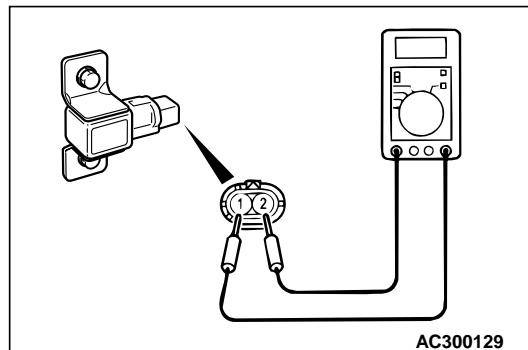
2. Measure the resistance between terminals and check whether it is within the standard value.

Standard value: $820 \pm 82 \Omega$

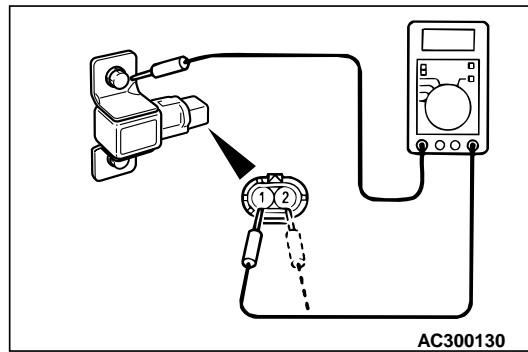
3. Check the continuity between the terminal and bracket. If there is a continuity, the insulation is malfunctioned, and replace the sensor with a new one.
4. Check the head lamp support pane for deformation and rust.

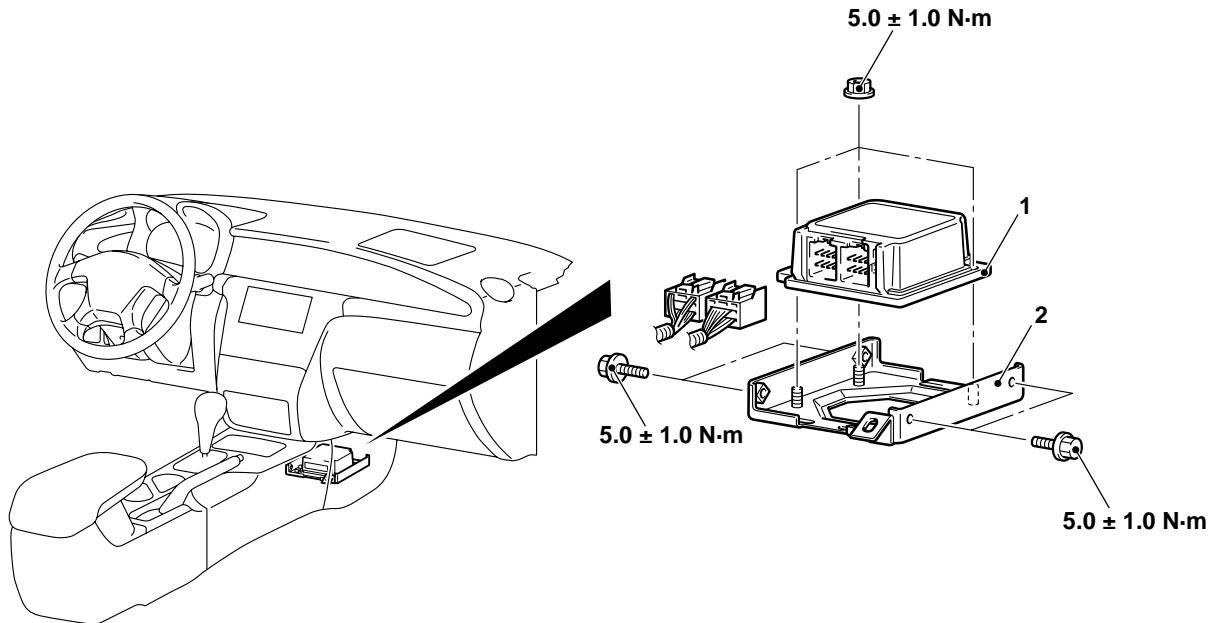
AC300137AB

Removal steps

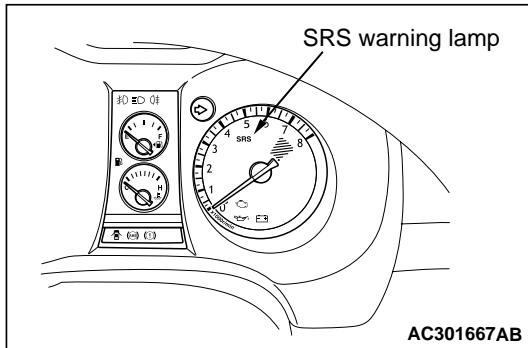
3. Does the SRS warning lamp illuminate for about 7 seconds, and then remain extinguished for at least 5 seconds after turning OFF?
4. If no, refer to troubleshooting (Refer to [P.52B-11](#)).

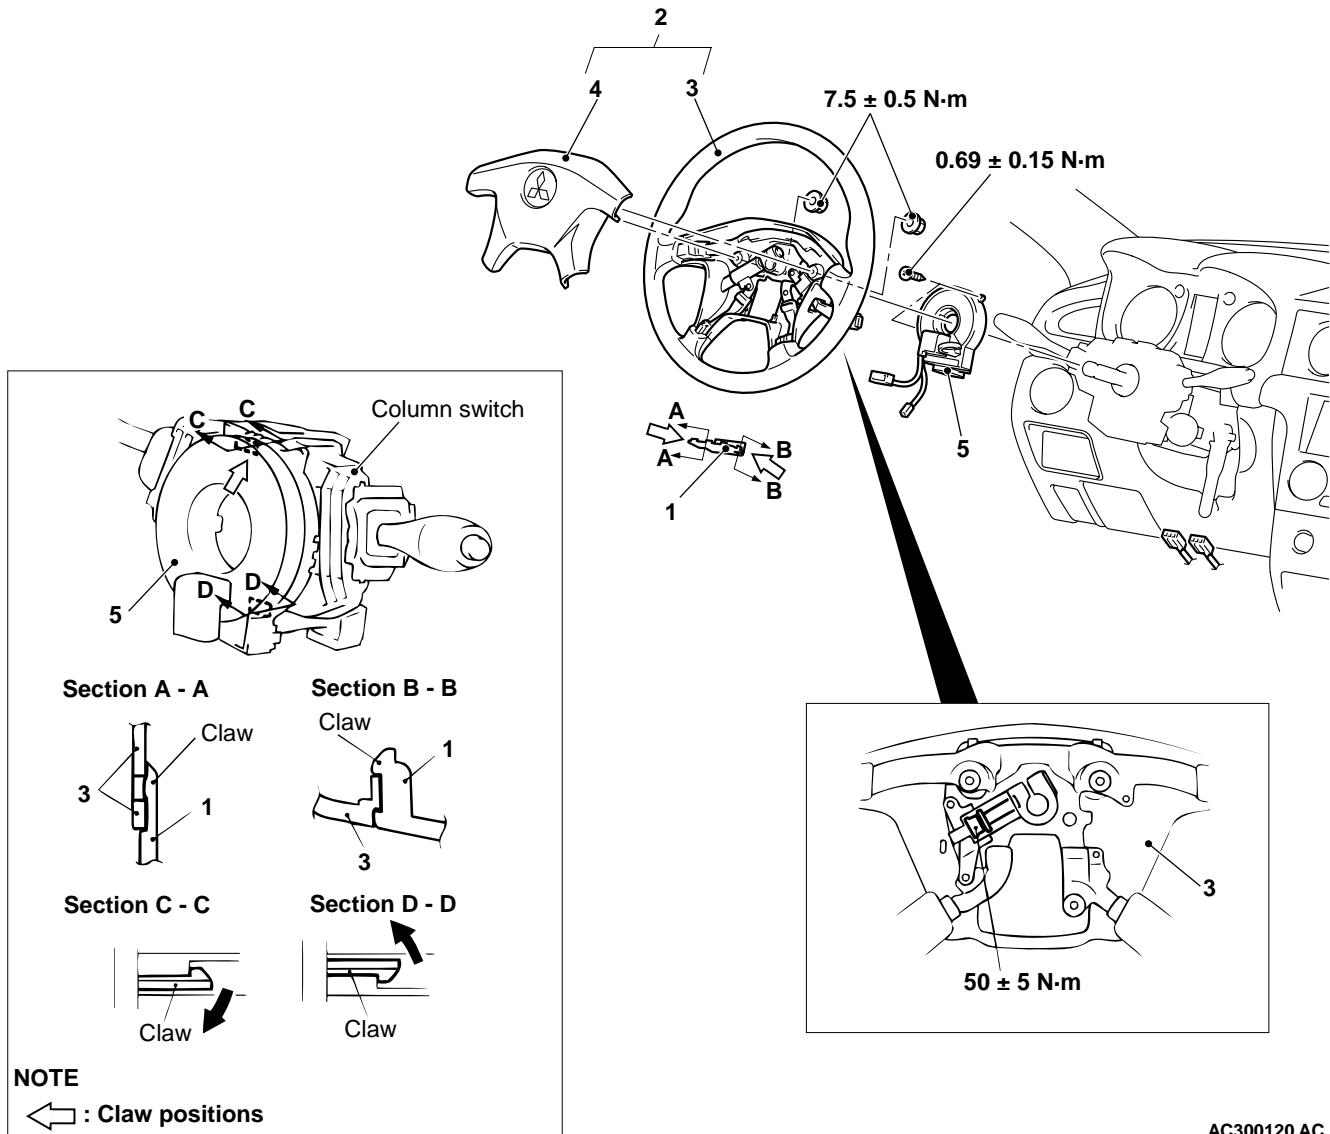
<Air bag module (driver's side) and clock spring>

Air bag module removal steps

- <<A>> 1. Cover
- <> 2. Steering wheel and air bag module assembly
- <<C>> 3. Steering wheel
- <<C>> 4. Air bag module

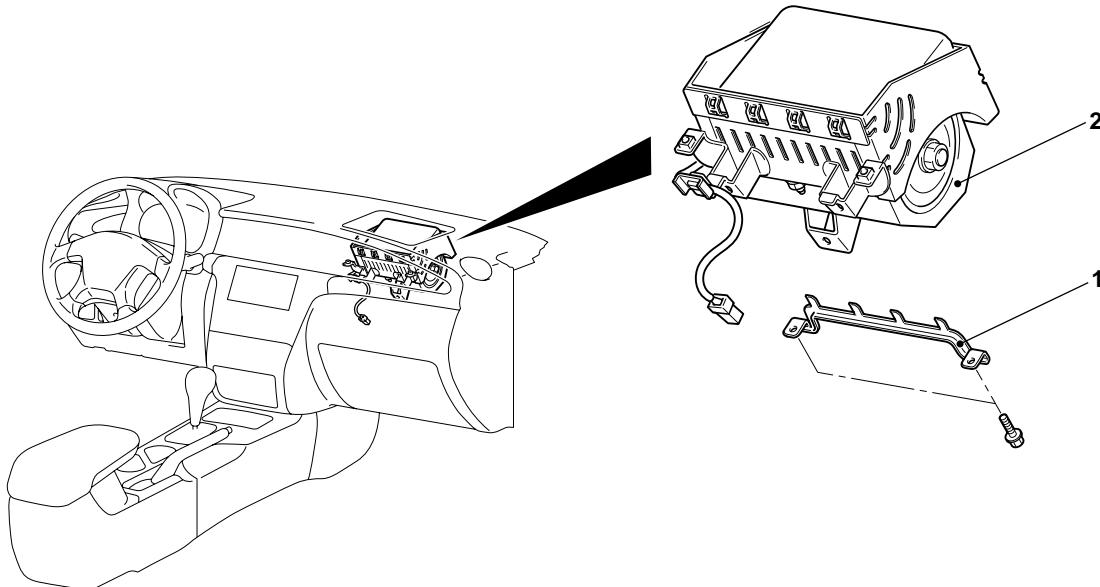
AC300153AB

Air bag module removal steps

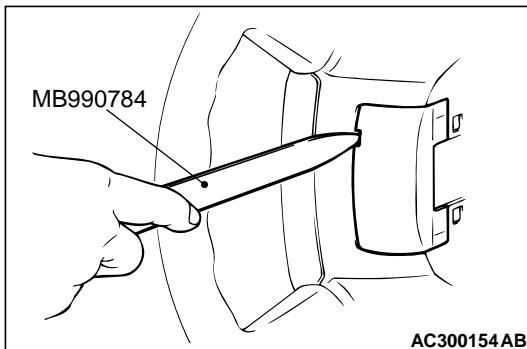
Insert the special tool ornament remover (MB990784) as shown in the illustration to remove the cover.

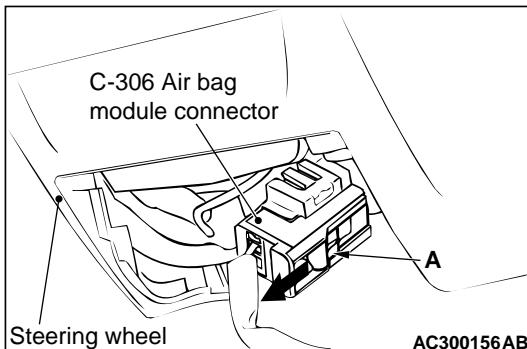
1. By sliding the A section (in the figure) of the air bag module connector in the arrow direction, disconnect the connector.

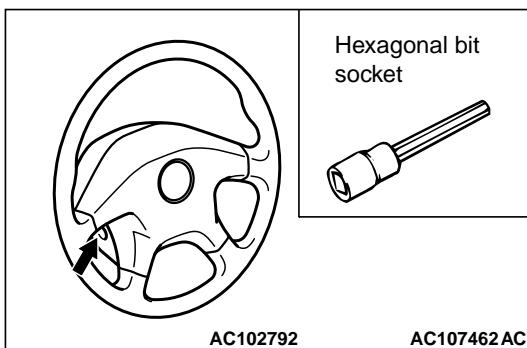
2. Insert the hexagonal bit socket into the arrow section in the figure. Completely loosen the bolt, and then remove the steering wheel air bag module assembly.

NOTE: Use a hexagonal bit socket or a hexagonal wrench having an effective length of 75 mm or more in the hexagonal section and the diameter of 8 mm or more.

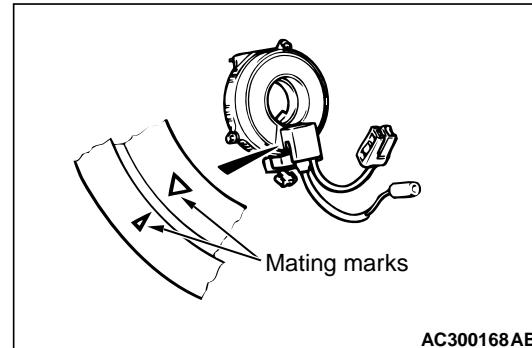
2. Align the mating marks of the clock spring.

- (1) Turn the clock spring clockwise fully. Then turn it back approximately 3 3/4 turns counterclockwise to align the mating marks.
- (2) Then install the clock spring to the column switch.

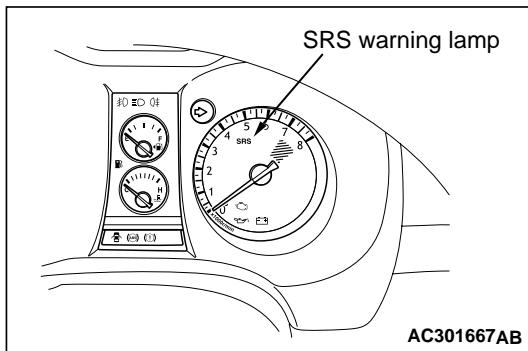
3. Does the SRS warning lamp illuminate for about 7 seconds, and then remain extinguished for at least 5 seconds after turning OFF?
4. If no, refer to troubleshooting (Refer to [P.52B-11](#)).

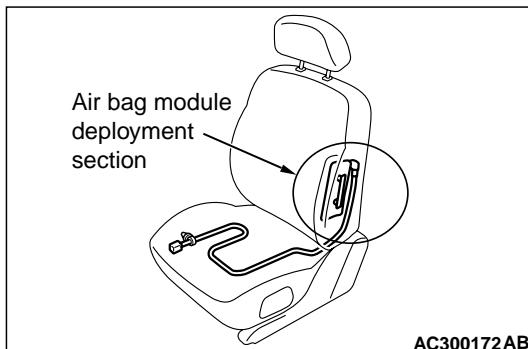
1. Check the air bag module deployment section for dents or deformation.
2. Check the connector for damage, the terminals for deformation, and the harness for binds.

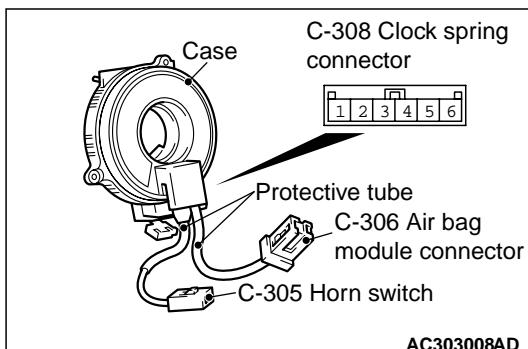
CLOCK SPRING CHECK

If any malfunction is found in the following inspections, replace the clock spring with a new one.

1. Check the connectors and protective tube for damage, and the terminals for deformation.
2. Visually check the case for damage.
3. Check to see that there is a charge (continuity) between the C-308 clock spring connector terminal 1 and C-305 horn switch.

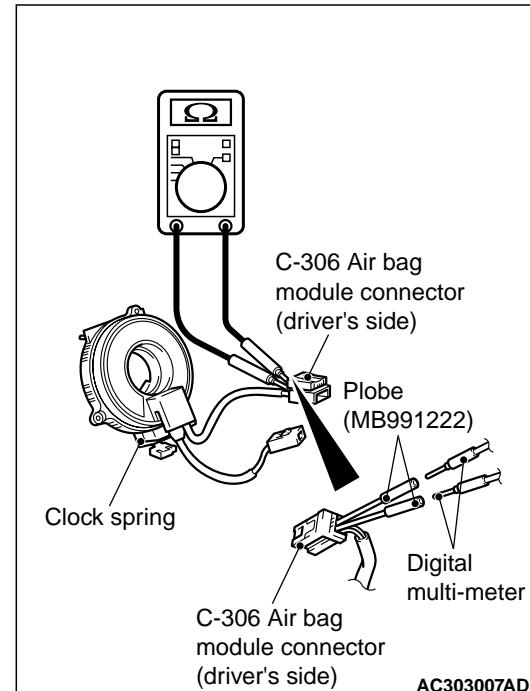
Do not directly insert a probe, etc. into the terminal from the front of the connector.

4. Insert the special tool harness set (MB991222) from behind the C-306 air bag module connector (driver's side).
5. As shown in the Figure, connect the circuit tester to the special tool harness set (MB991222) and check to see that there is a charge between the terminals.

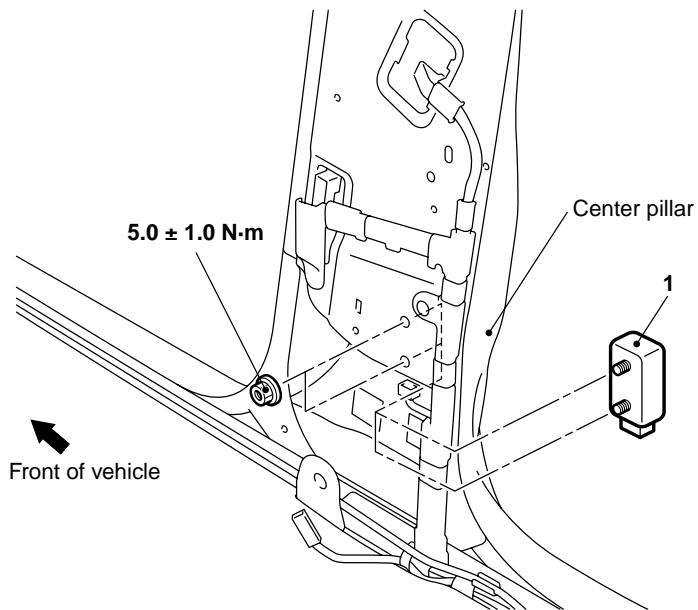
AC300142AB

Removal steps

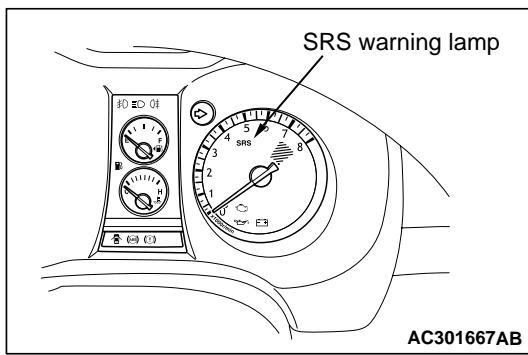
3. Does the SRS warning lamp illuminate for about 7 seconds, and then remain extinguished for at least 5 seconds after turning OFF?
4. If no, refer to troubleshooting (Refer to [P.52B-11](#)).

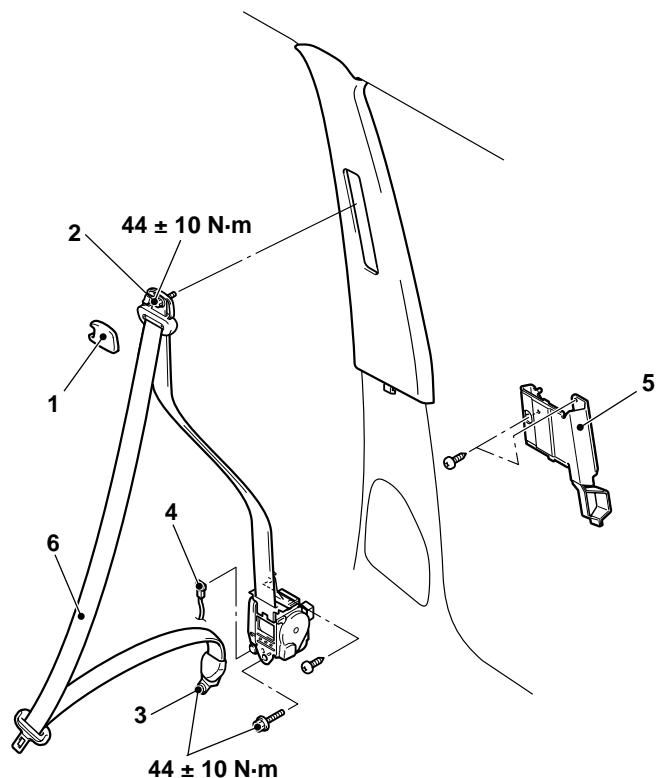
Removal steps

- >>A<< • Pre-installation inspection
- 6. Seat belt with pre-tensioner
- 5. Bracket
- >>B<< 4. Pre-tensioner connector connection

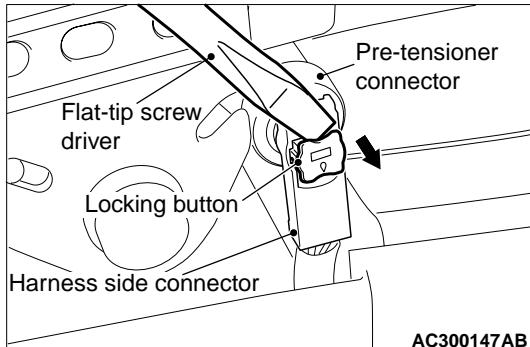
1. Use a flat-tipped screwdriver to pull out forward and unlock the locking button of the harness-side connector.
2. Disconnect the pretensioner connector.

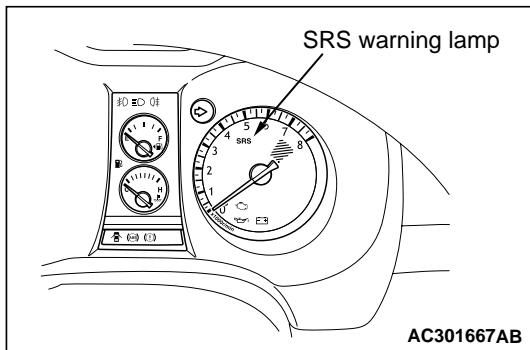
3. Does the SRS warning lamp illuminate for about 7 seconds, and then remain extinguished for at least 5 seconds after turning OFF?
4. If no, refer to troubleshooting (Refer to [P.52B-11](#)).

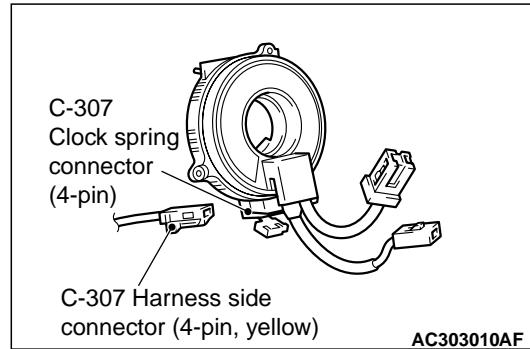
4. Remove the connection between the C-307 clock spring connector (4-pin) and the harness side connector (4-pin, yellow).

NOTE: Once disconnected from the instrument panel wiring harness, both electrodes of the clock spring connector short automatically. This prevents the driver's air bag from accidental deployment caused by static, etc.

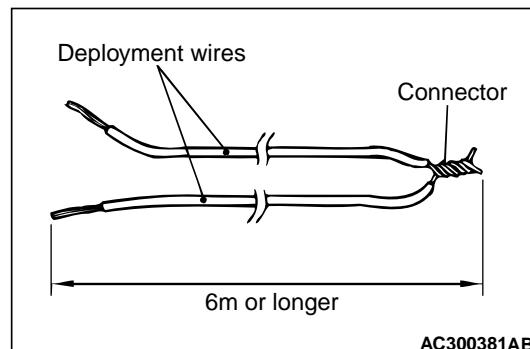
5. Obtain two suitable wires, which are 6 meters or longer, as deployment wires. Then connect the wires at one end to short.
6. Touch the vehicle's body with bare hands to discharge static in you.

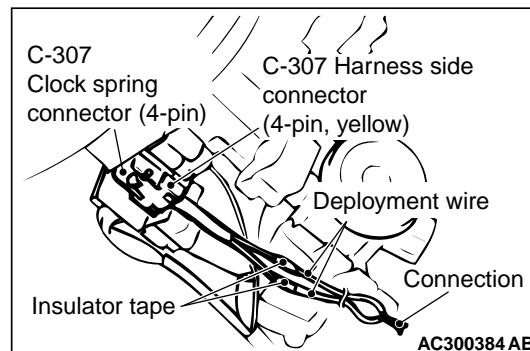
- Cut with a pliers, etc. the instrument panel wiring harness shown in the figure of the instructions, while the C-307 clock spring connector is disconnected.

NOTE: The disconnection location should be sufficiently away from the C-307 harness side connector with consideration to the expansion harness connection location upon disconnections.

- Connect the deployment wires on the two instrument panel wiring harnesses disconnected, cover the connection areas with insulation tape and then pull out the deployment wires outside the vehicle.
- Connect the C-307 harness side connector connected with an expansion harness to the C-307 clock spring connector.

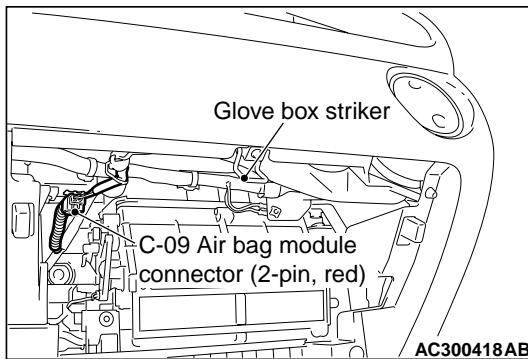
2. Disconnect the negative and positive battery cables from the battery terminals, and then remove the battery from the vehicle.
3. Remove the glove box (Refer to GROUP 52A – Instrument Panel <LHD>[P.52A-2](#) or Instrument Panel <RHD>[P.52A-8](#)).

4. Remove the connection between the C-09 air bag module (front passenger's side) connector (2-pin, red) and the harness side connector (2-pin, red).

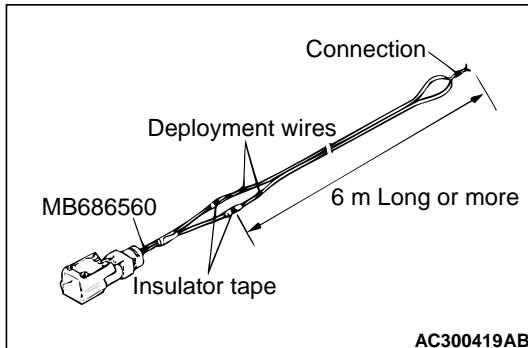
5. Connect deployment wires longer than 6 m to each special tool SRS air bag adapter harness (MB686560) and insulate the connections with plastic tape. Also, connect the deployment wires in the other ends to short, thereby preventing the passenger's air bag from accidental deployment caused by static etc.

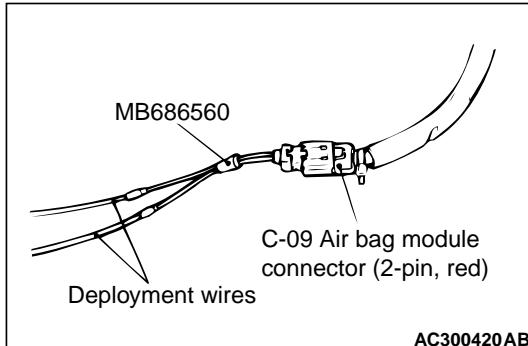
6. Connect the C-09 air bag module (front passenger's side) connector (2-pin, red) to special tool SRS air bag adapter harness (MB686560) and move the deployment wires out of the vehicle.

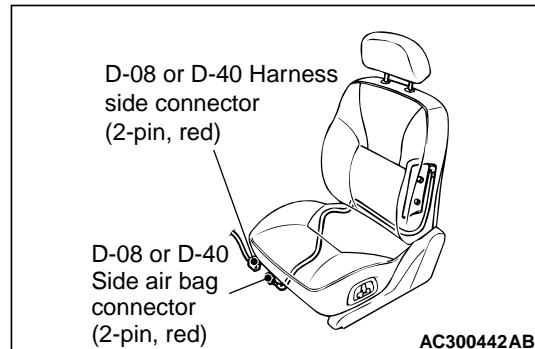
3. Remove the connection between the D-08 or D-40 side air bag module connector (2-pin, red) and the harness side connector (2-pin, red).

NOTE: Once disconnected from the side air bag wiring harness, both electrode of the side air bag module connector short automatically. This prevents the side air bag from accidental deployment caused by static etc.

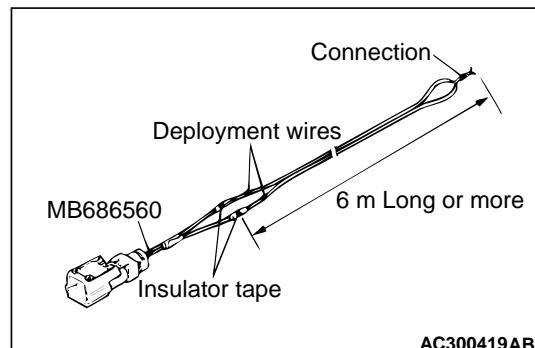
4. Connect deployment wires longer than 6 m to each special tool SRS air bag adapter harness (MB686560) and insulate the connections with plastic tape. Also, connect the deployment wires in the other ends to short, thereby preventing the passenger's air bag from accidental deployment caused by static etc.

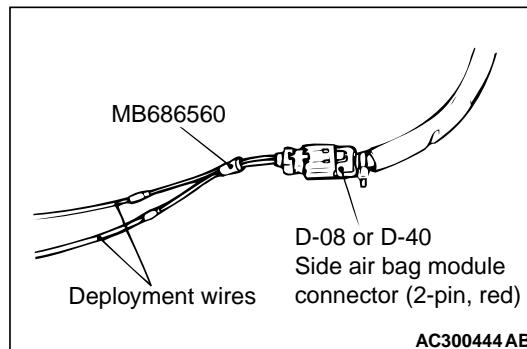
5. Connect the D-08 or D-40 side air bag module connector (2-pin, red) to special tool SRS air bag adapter harness (MB686560) and move the deployment wire out of the vehicle.

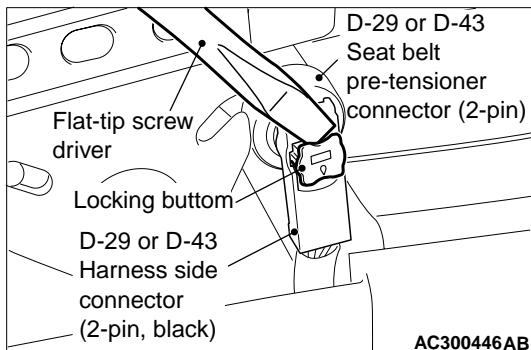
4. Execute the following steps to disconnect the connection between D-29 or D-43 seat belt pre-tensioner connector (2-pin) and harness side connector (2-pin, black).

- (1) Use a flat-tipped screwdriver to pull out forward and unlock the locking button of the harness-side connector (2-pin, black).
- (2) Disconnect the D-29 or D-43 harness side connector.

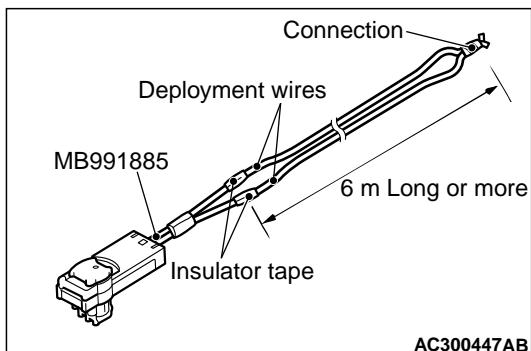
5. Connect deployment wires longer than 6 m to each special tool SRS air bag adapter harness (MB991885) and insulate the connections with plastic tape. Also, connect the deployment wires in the other ends to short, thereby preventing the passenger's air bag from accidental deployment caused by static etc.

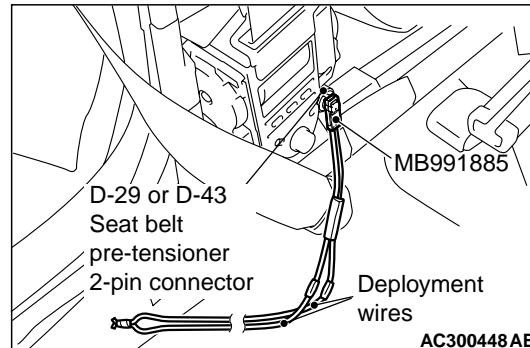
6. Connect the D-29 or D-43 seat belt pre-tensioner 2-pin connector (red) to special tool SRS air bag adapter harness (MB991885) and move the deployment harness out of the vehicle.

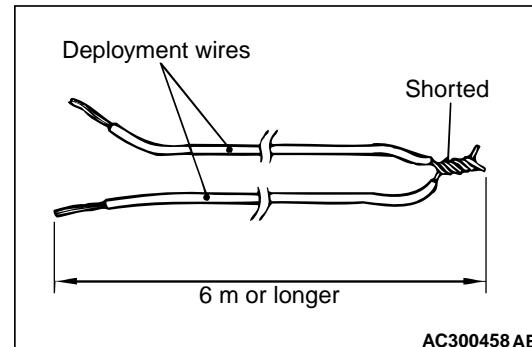
3. Obtain two suitable wires, which are 6 meters or longer, as deployment wires. Then connect the wires at one end to short.
4. Touch the vehicle's body with bare hands to discharge static in you.

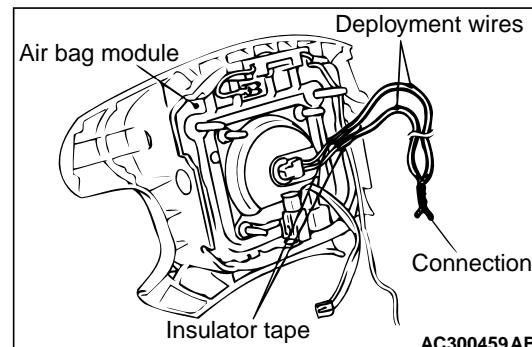
5. Using pliers, cut the driver's air bag module connector from the harnesses. Connect the deployment wires to each harness that has been cut and insulate the connections with plastic tape.

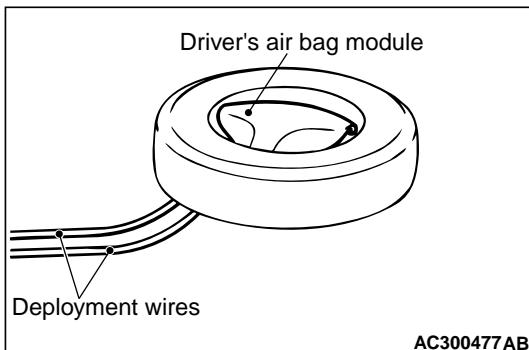
6. Install a nut to the bolt behind the driver's air bag module and tie thick wire there for securing.
7. Route the deployment wires connected to the driver's air bag module beneath an old tyre and wheel assembly. Then, using the wire tied to the bolt, secure the driver's air bag module to the tyre and wheel assembly with the deployment surface facing up.

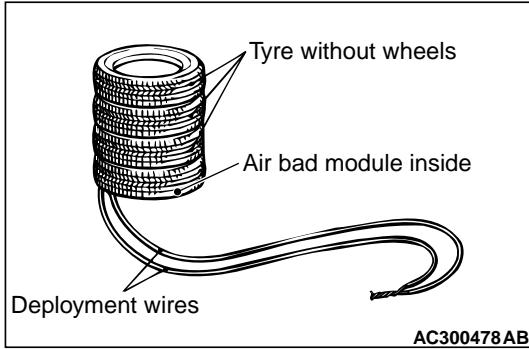
8. Place three old tyres without wheels on the tyre secured with the driver's air bag module.

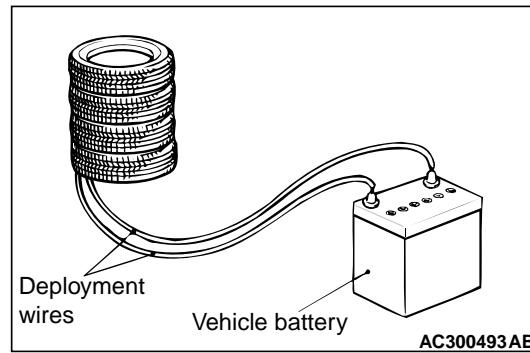
9. At a location as far away from the air bag module as possible, and from a shielded position, disconnect the two connected wires from each other, and connect them, to the two terminals of the battery (which has been removed from the vehicle) to deploy the air bag.
10. Discard the deployed air bag module as specified in Deployed Air Bag Module and Operated Seat Belt Pre-tensioner Disposal (Refer to [P.52B-203](#)).

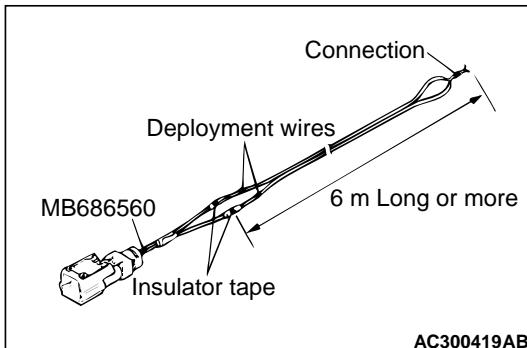
3. Connect deployment wires longer than 6 m to each special tool SRS air bag adapter harness (MB686560) and insulate the connections with plastic tape. Also, connect the deployment wires in the other ends to short, thereby preventing the passenger's air bag from accidental deployment caused by static etc.

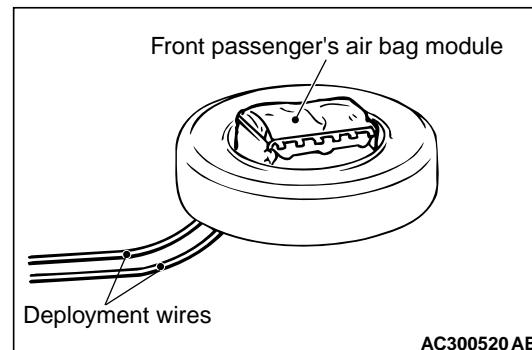
4. Connect the deployment wires to special tool SRS air bag adapter harness (MB686560), pass it beneath the tyre and wheel assembly, and connect it to the air bag module.

- **The adapter harness below the wheel should be loose. If it is too tight, the reaction when the air bag deploys could damage the adapter harness.**
- **During deployment, the connector of special tool SRS air bag adapter harness (MB686560) must not be between the tyres.**

5. Pass the thick wire through the air bag module mounting hole, and then secure the air bag module to an old tyre with a wheel in it so that the pad on the module is facing upwards.

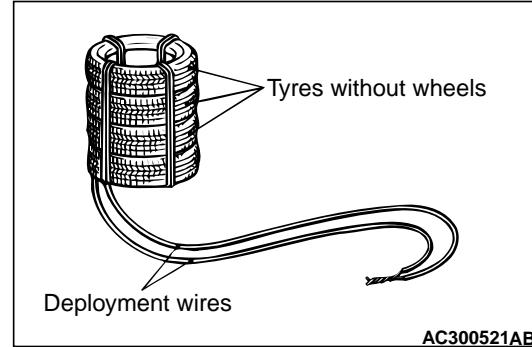
6. Place three old tyres without wheels on top of the tyre secured to the air bag module, and secure all tyres together with ropes (four locations).
