GROUP 52B

SUPPLEMENTAL RESTRAINT SYSTEM (SRS)

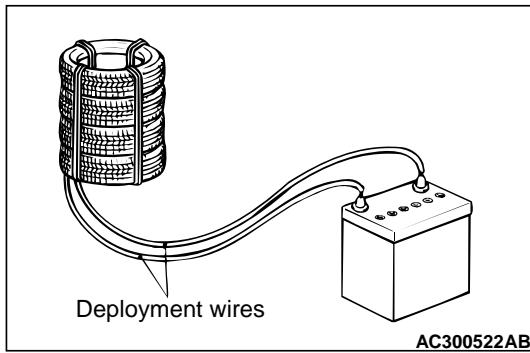
7. At a location as far away from the air bag module as possible, and from a shielded position, disconnect the two connected wires from each other, and connect them to the two terminals of the battery (which has been removed from the vehicle) to deploy the air bag.
8. Discard the deployed air bag module as specified in Deployed Air Bag Module and Operated Seat Belt Pre-tensioner Disposal (Refer to [P.52B-203](#)).

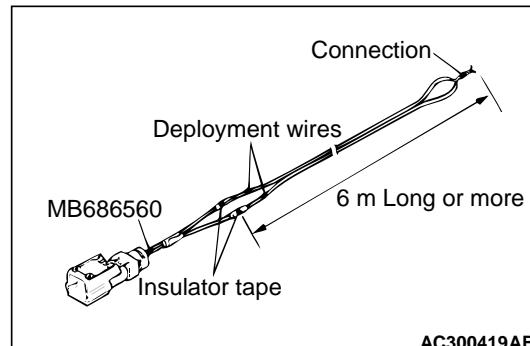
3. Connect deployment wires longer than 6 m to each special tool SRS air bag adapter harness (MB686560) and insulate the connections with plastic tape. Also, connect the deployment wires in the other ends to short, thereby preventing the passenger's air bag from accidental deployment caused by static etc.

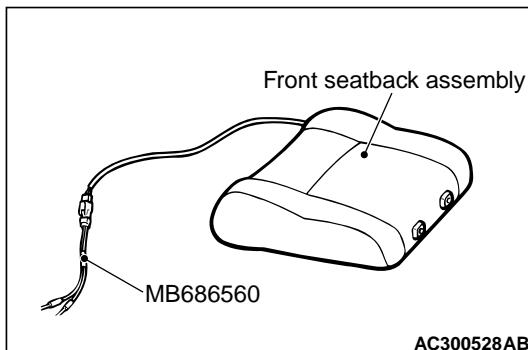
4. Place the front seatback assembly with its back contact with the earth.
5. Connect the special tool SRS air bag adapter harness (MB686560) with the deployment wires to the side air bag module connector.

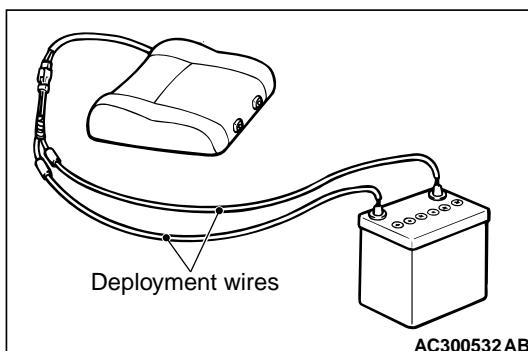
6. Disconnect the deployment wires as far from the front seatback assembly possible and connect the harnesses to the battery removed from the vehicle. Then, deploy.

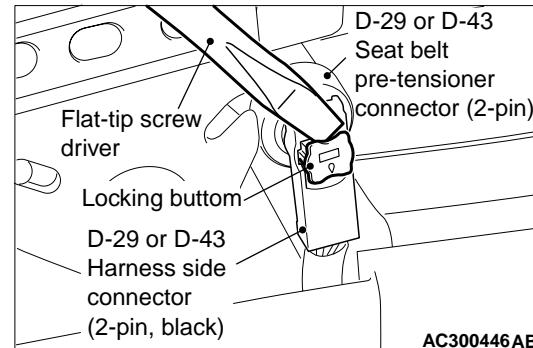
3. Use a flat-tipped screwdriver to unlock the locking button of the harness-side connector (2-pin, black) by drawing it toward you in two stages.
4. Disconnect the D-29 or D-43 harness side connector.

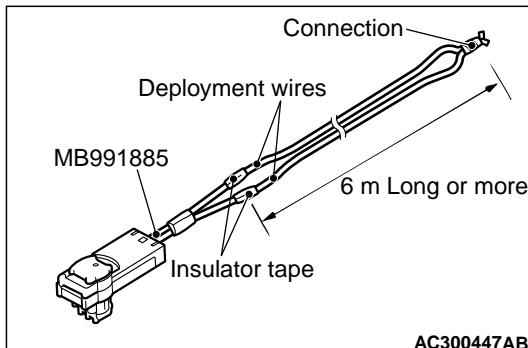
5. Connect deployment wires longer than 6 m to each special tool SRS air bag adapter harness (MB991885) and insulate the connections with plastic tape. Also, connect the deployment wires in the other ends to short, thereby preventing the passenger's air bag from accidental deployment caused by static etc.
6. Connect the special tool SRS air bag adapter harness (MB991885), which the deployment wires is attached to, to the seat belt pre-tensioner connector.

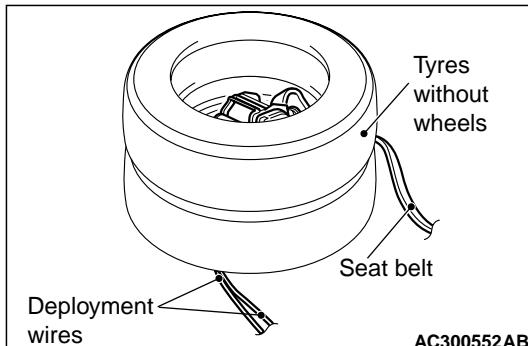
The adapter harness below the wheel should be loose. If it is too tight, the reaction when the seat belt pre-tensioner operates could damage the adapter harness.

7. Pass the thick wires through the hole on the seat belt pre-tensioner bracket and secure them to the front (raised part) of the wheel on two place.

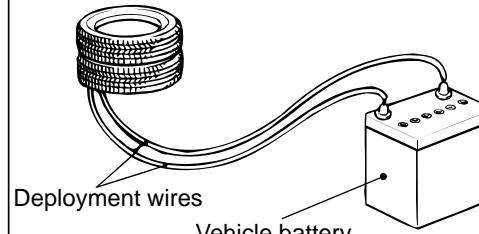
<Seat belt pre-tensioner>

8. Pull the seat belt out the outside of the tyre, and then place one tyre without a wheel inside on top of the existing tyre.

Before operation, check carefully to be sure that no one is nearby.

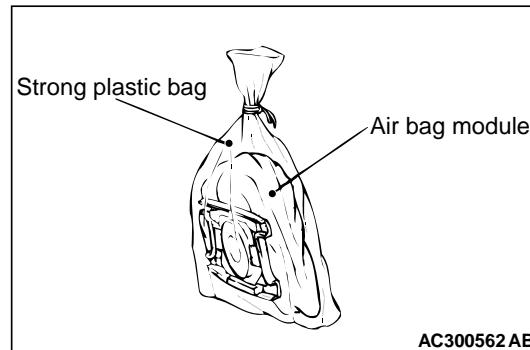
AC300562AB

3. There may be material on the deployed air bag module or the operated seat belt pre-tensioner, that could irritate the eye and/or skin. Wear gloves and safety glasses when handling a deployed air bag module or the operated seat belt pre-tensioner.

4. Tightly seal the air bag module and seat belt pre-tensioner in a strong plastic bag for disposal.
5. Be sure to always wash your hands after completing this operation.
