# SERVICE MANUAL

DATSUN 240Z SPORTS  
MODEL S30 SERIES

## SECTION ST

### STEERING

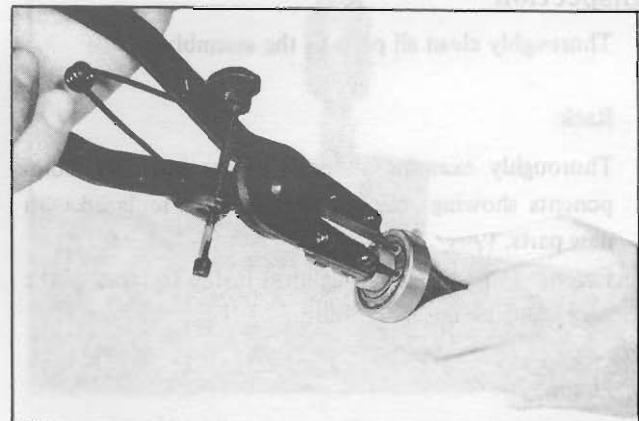
*Fig. ST-22 Removing snap ring*

10. Remove the snap ring and draw out the bearing from the pinion.

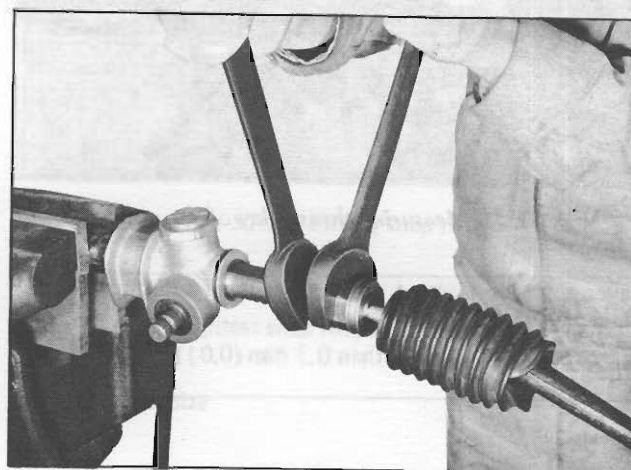
*Fig. ST-38 Locking the stopper nut*

21. Tighten the inner socket portion until the ball seat reaches the rack end, and lock with the stopper nut.

Stopper nut tightening torque:  
7 to 9 kg-m (50.6 to 65.1 ft-lb)
