Suspension Squeaking Noise

If you encounter a squeaking noise in the front suspension on a 1995 Legacy (sedan up to VIN S*217985, station wagon up to VIN 5*320378) and a visual inspection of the spring and saddle area shows signs of contact, bend the flange on the lower saddle of the front strut.

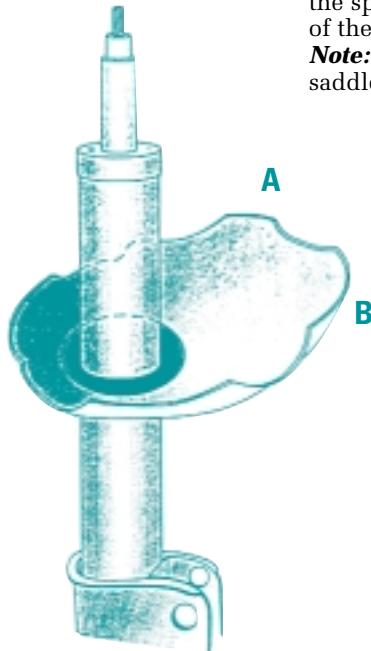
Note: The area causing the noise will be identified by a shiny area on the spring and saddle.

To inspect the suspension:

- Raise the vehicle on a lift.
- Inspect the saddle and spring area of the front struts.
- To eliminate the noise, it is necessary to bend the saddle away from the spring.
- Refer to the illustration on this page. Bend the saddle away from the spring in two areas.
 - A: Bend area "A" outward 2 mm,
 - B: Bend area "B" outward 1 mm.
- Apply undercoating to affected areas of the strut and spring to prevent rust.
- Lower the vehicle and confirm the repair.
