20. Instrument Panel Assembly

EXTERIOR/INTERIOR TRIM

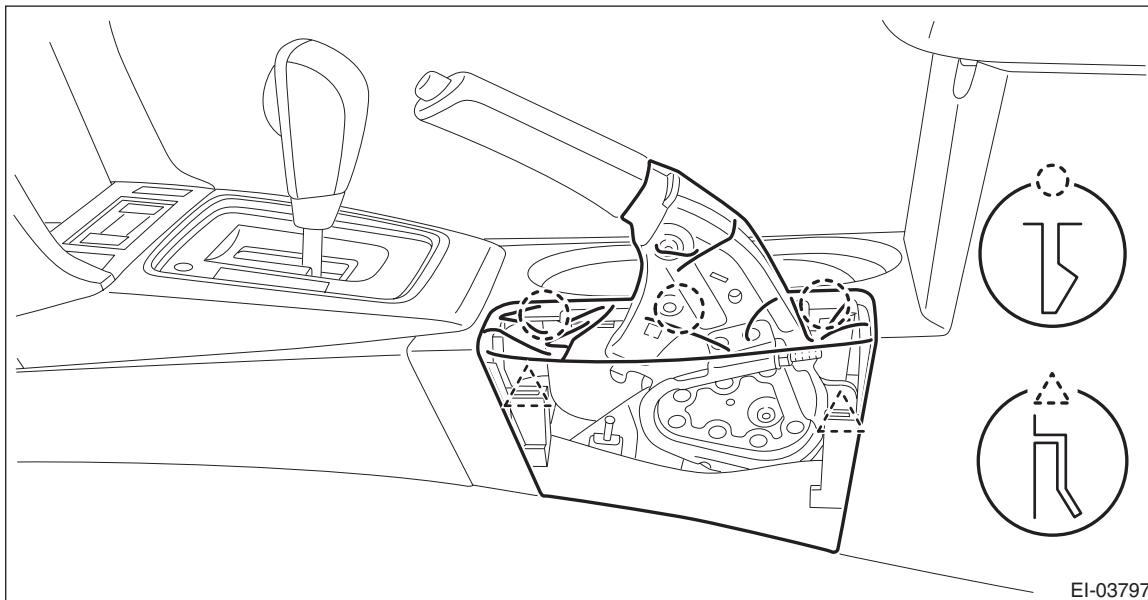
- 3) Release the claws, and then remove the boot - hand brake.

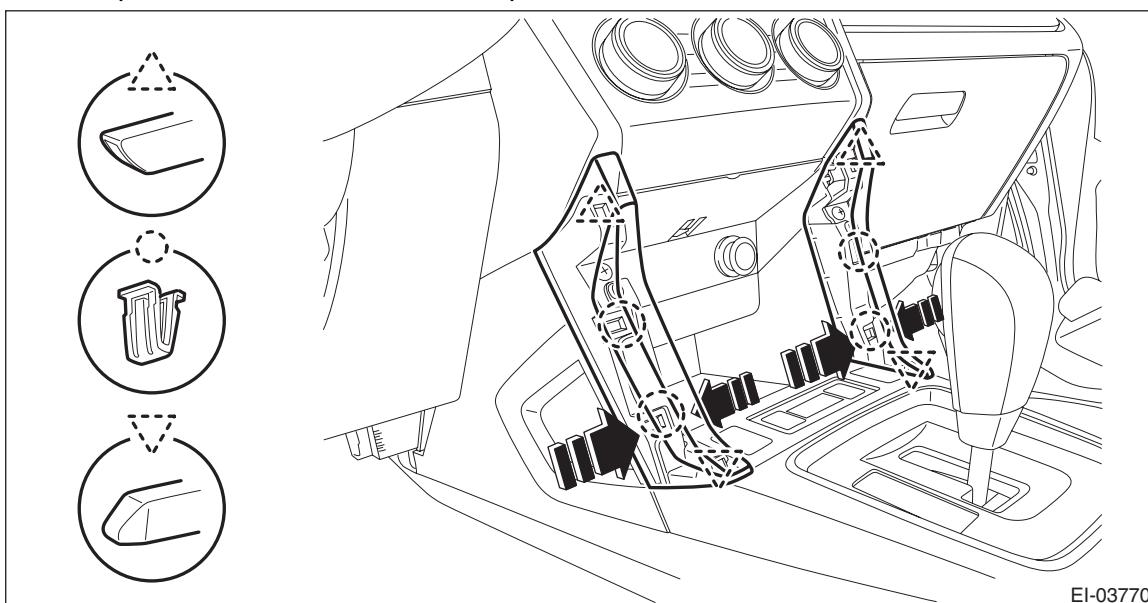
- 4) Release the clips, and remove the ornament panel - console.

Removal is easier if you grab the arrow sections from right and left and pull them at the same time.

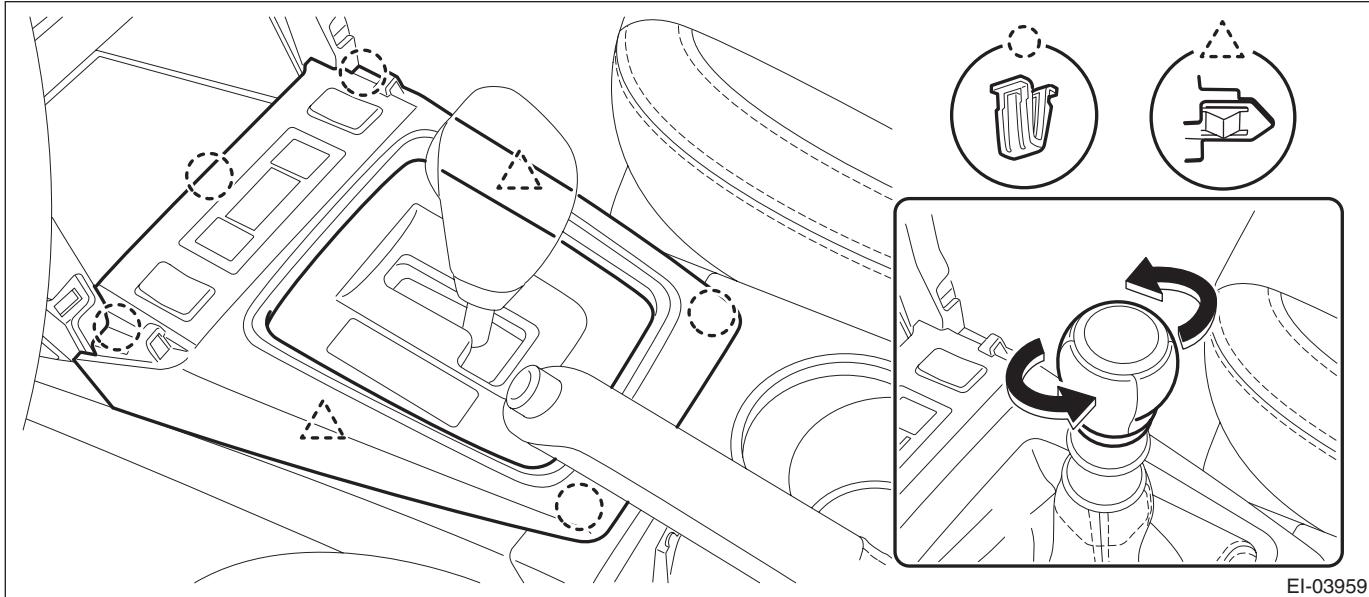
5) Remove the cover - shift lever.

(1) Remove the shift knob. (MT model)

(2) Release the clips and claws, then pull up the cover - shift lever.

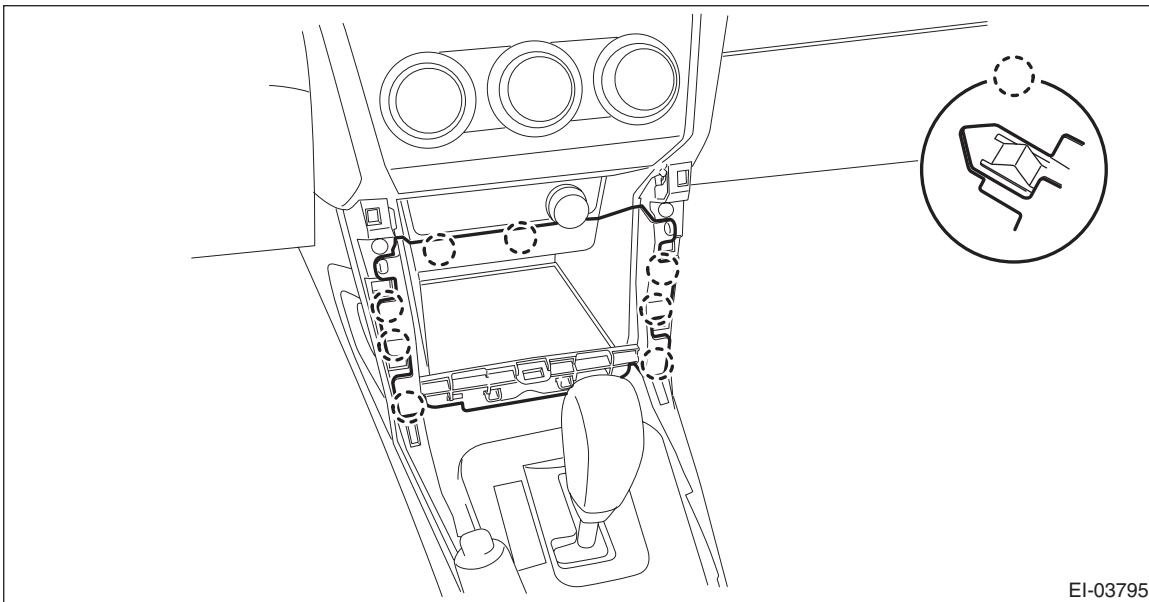
6) Release the claws, and remove the tray assembly - CTR LWR.

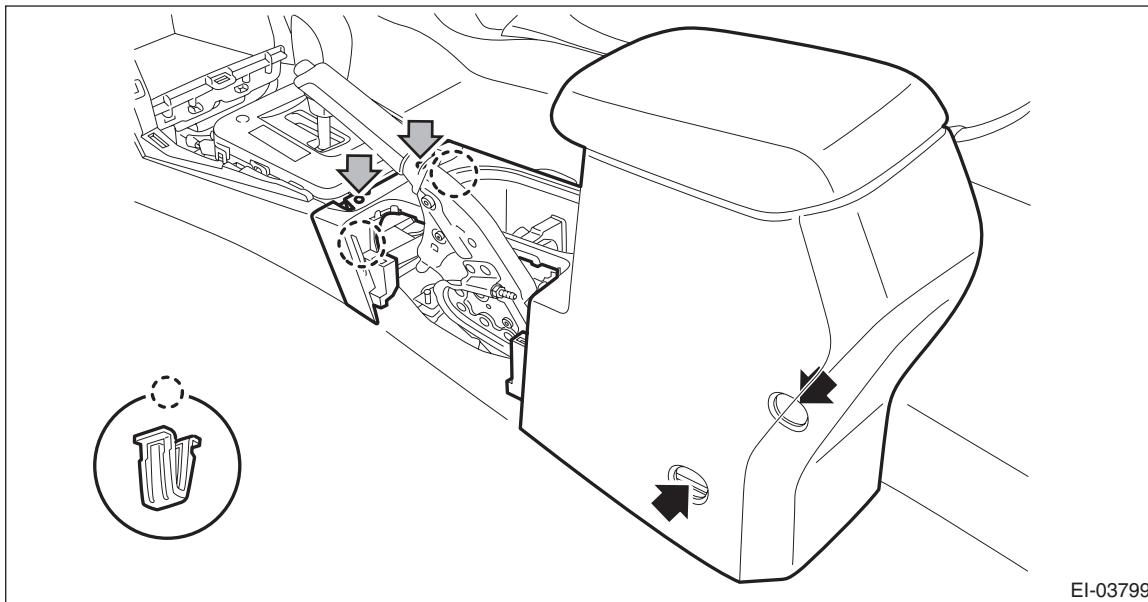
7) Remove the console box assembly.

- (1) Move the seat forward, and remove the bolts after detaching the left and right caps.
- (2) Remove the screws and clips, disconnect the harness connector and remove the console box assembly.

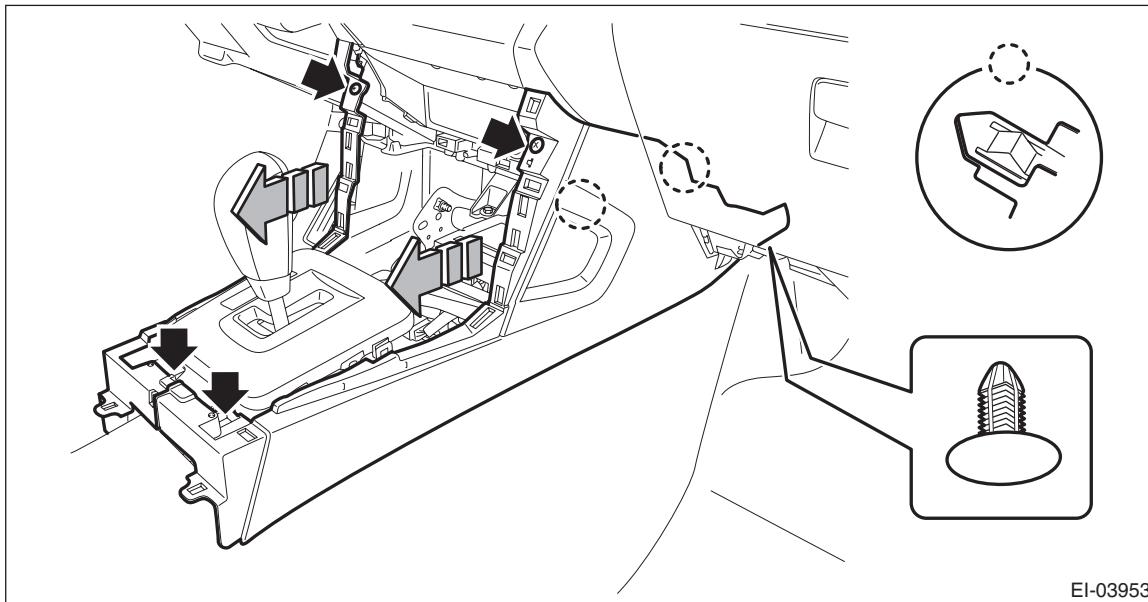
8) Remove the left and right panel center LWR.

- (1) Remove the screws and clips.
- (2) Release the claws, and then pull the panel center LWR to remove.

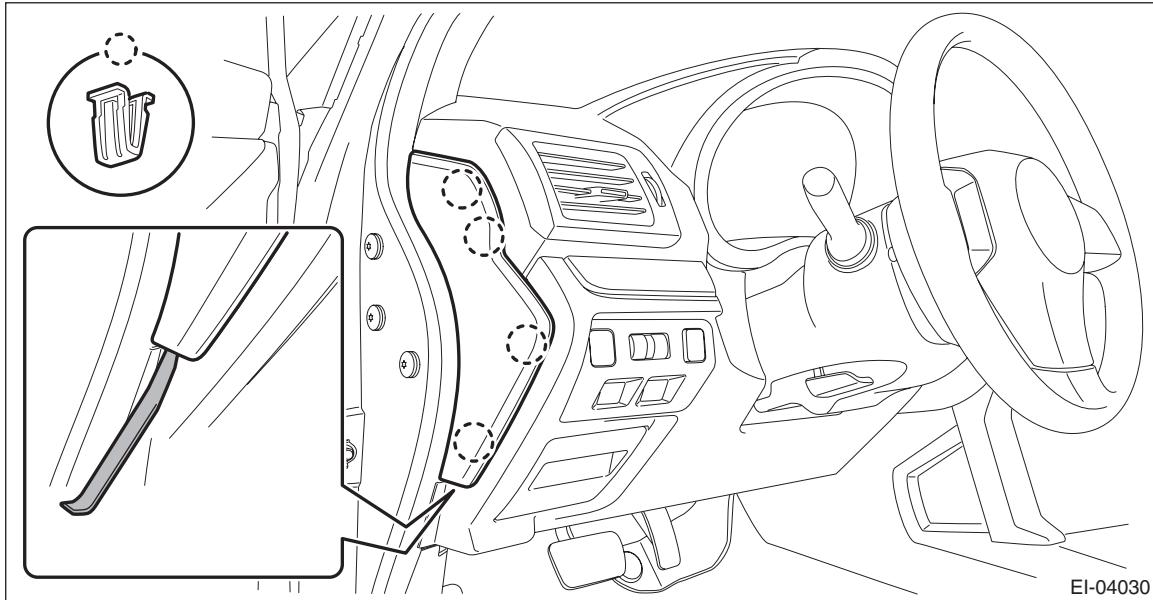
9) Remove the clips, and remove the cover - instrument panel side LH.

Using a plastic remover, open the cover - instrument panel side LH.

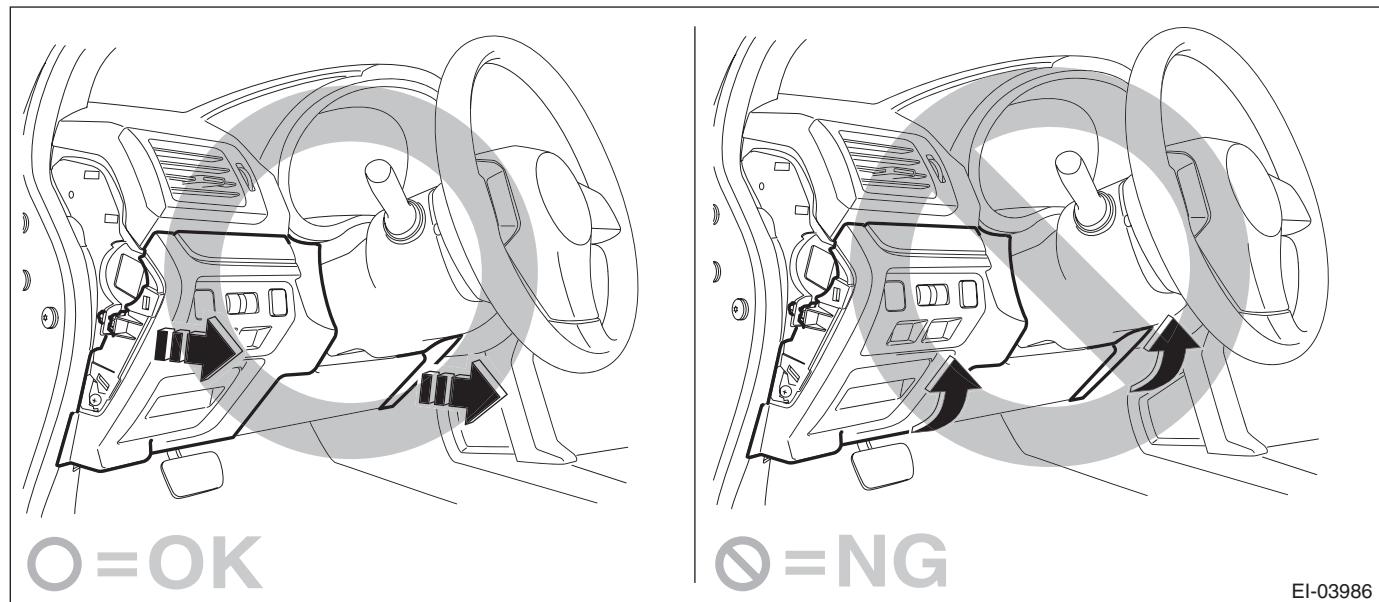
10) Remove the cover assembly - instrument panel LWR driver INN and OUT.

When removing the cover assembly - instrument panel LWR driver, be sure to pull it toward you. If attempting to remove by turning it upward, the claws may be damaged.

(1) Remove the screws and release the clips and claws.

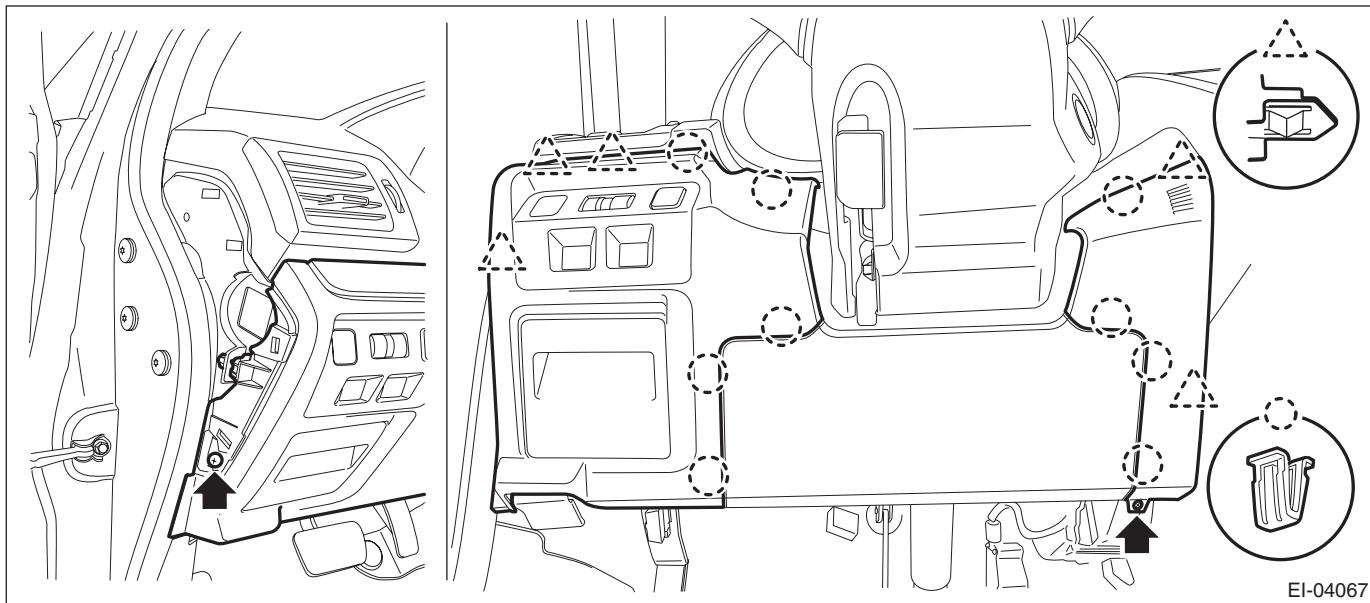
(2) Disconnect the harness connectors, and remove the cover assembly - instrument panel LWR driver INN and OUT.

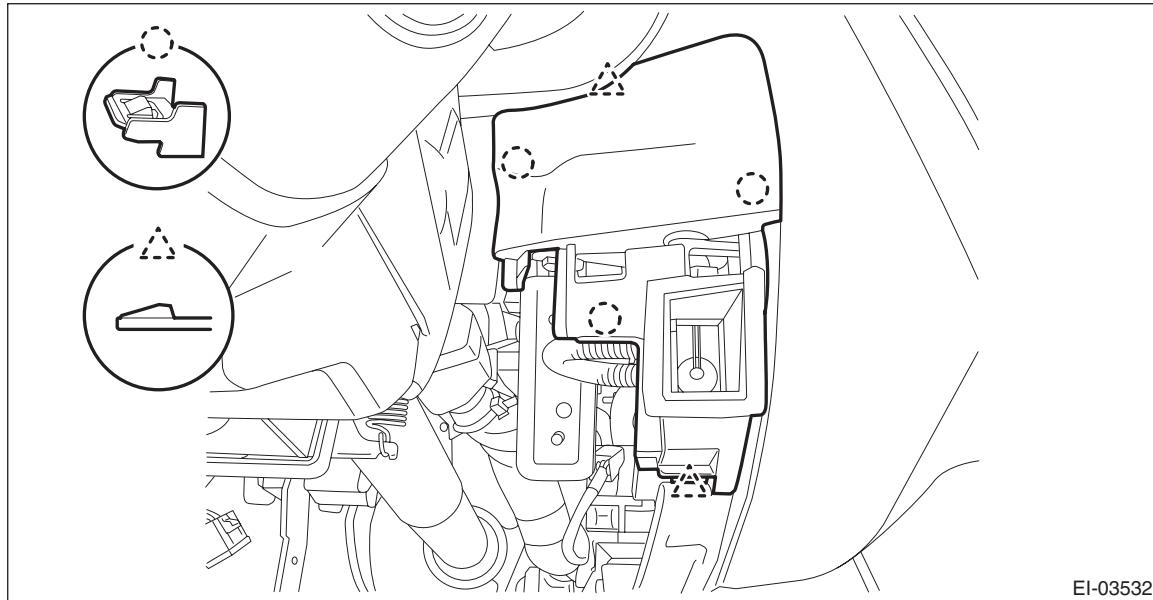
11) Remove the cover switch - starter. (Model without keyless access)

- (1) Release the claws and remove the cover switch - starter.
- (2) Disconnect the connector and aspirator hose.

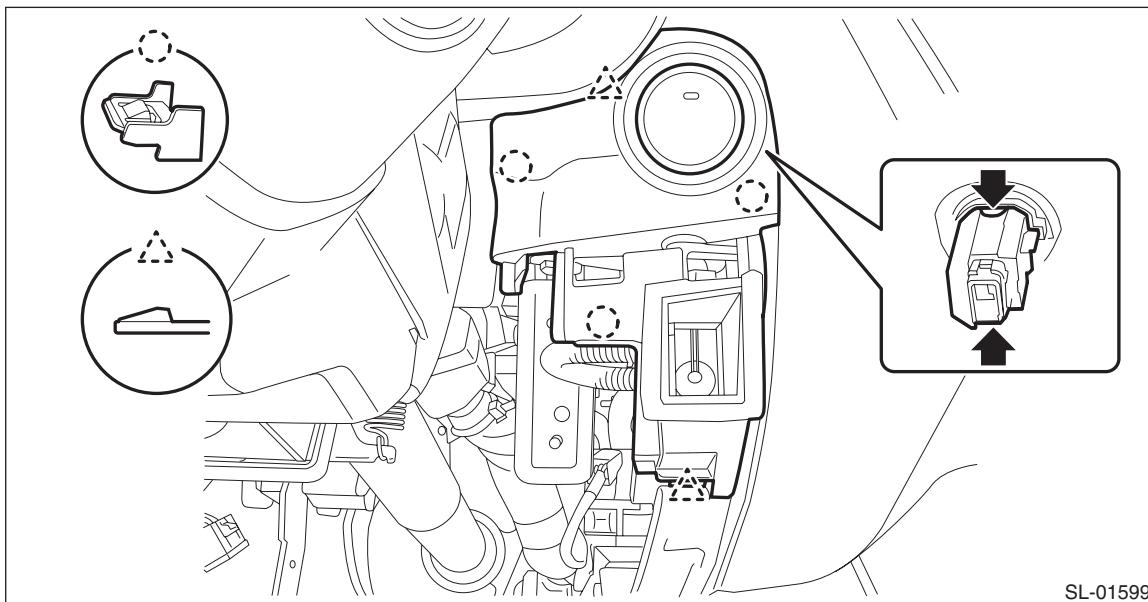
12) Remove the panel - switch. (Model with keyless access)

- (1) Release the claws of the push button ignition switch, and disconnect the connector.
- (2) Release the claws, and then remove the panel - switch.
- (3) Disconnect the connector and aspirator hose.

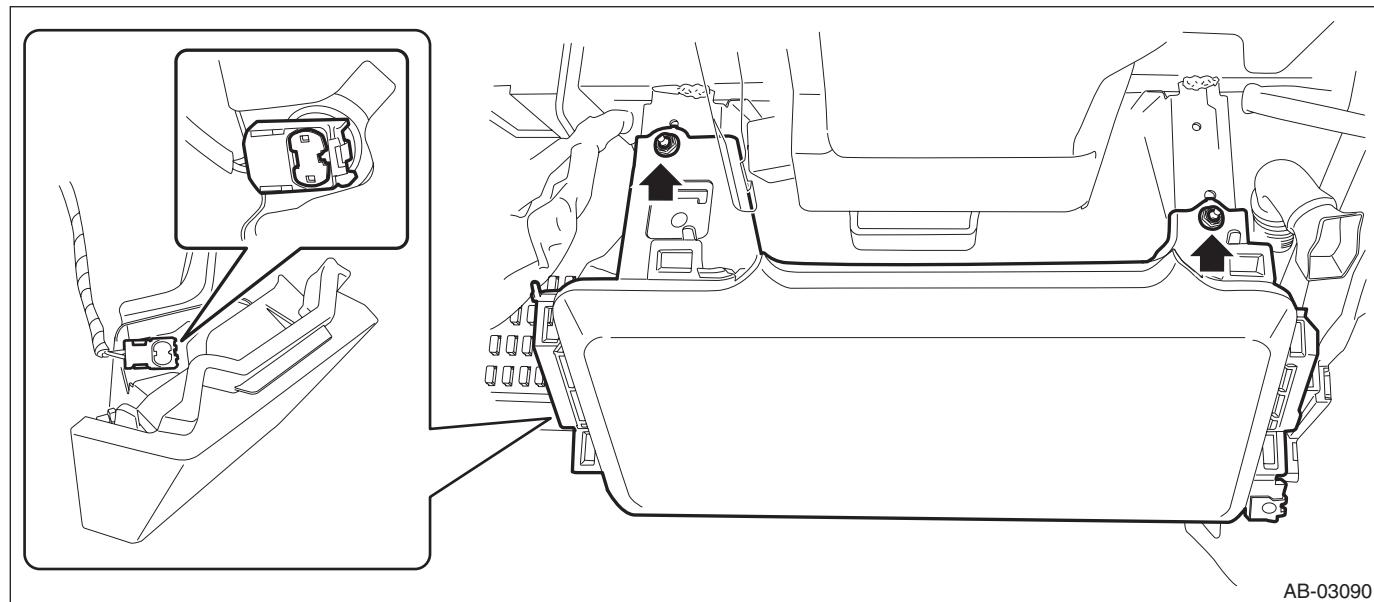
13) Remove the nuts to remove the knee airbag module and disconnect the harness connector. (Model with knee airbag) <Ref. to AB-21, DRIVER'S AIRBAG MODULE, KNEE AIRBAG MODULE, CURTAIN AIRBAG MODULE AND PRETENSIONER, PROCEDURE, Airbag Connector.>

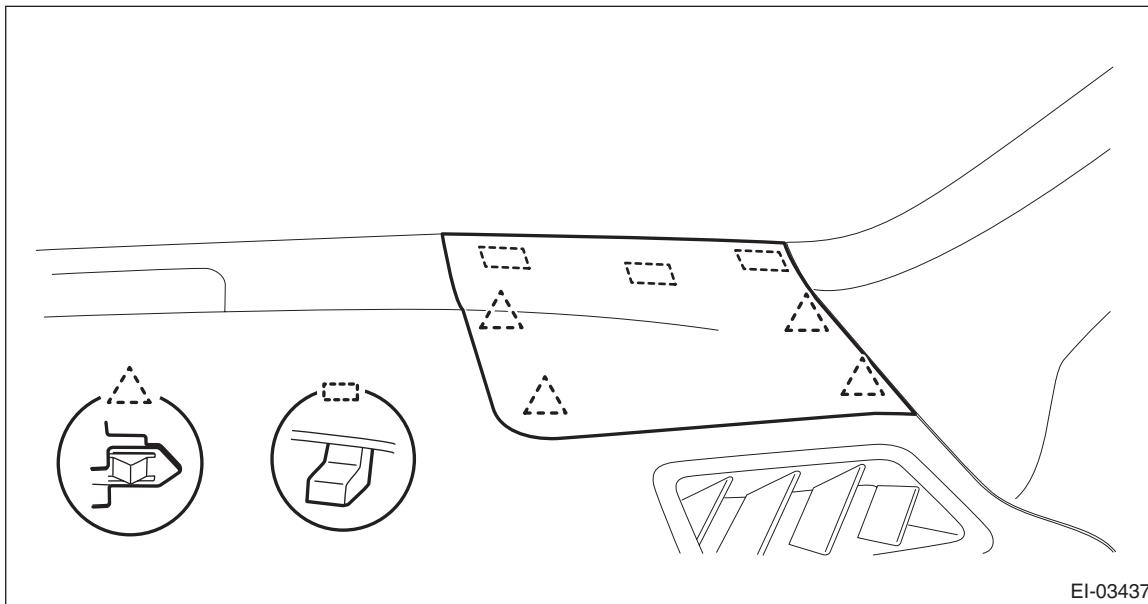
14) Release the clips and claws, then detach the left and right grille speaker side.

Remove the grille speaker side by using a plastic remover.

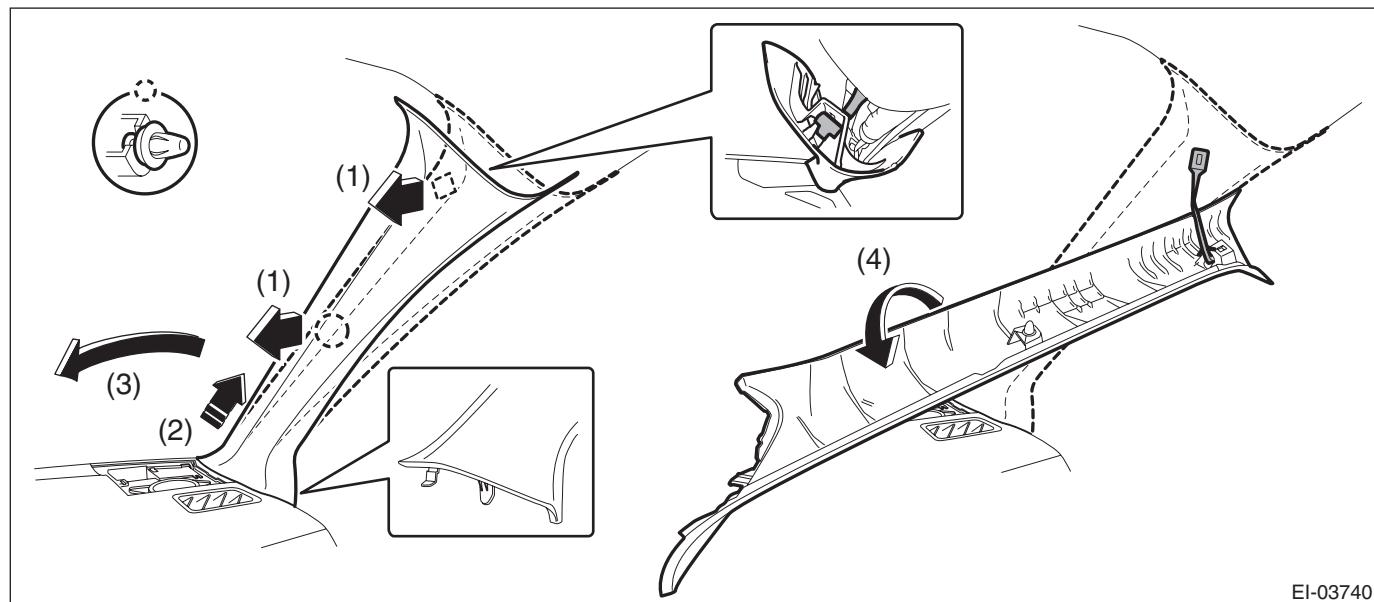
15) Remove the trim panel - front pillar UPR on the left and right sides.

- (1) Pull the trim panel - front pillar UPR towards the center of the vehicle to release the clips.
- (2) Pull out the end portion of the trim panel - front pillar UPR.
- (3) Pull out the trim panel - front pillar UPR towards the center of the vehicle.
- (4) Rotate the trim panel - front pillar UPR, release the tether clips, and remove the trim panel - front pillar UPR.

Do not use tools when releasing the tether clip. If the tether clip is damaged, replace it with a new tether clip.

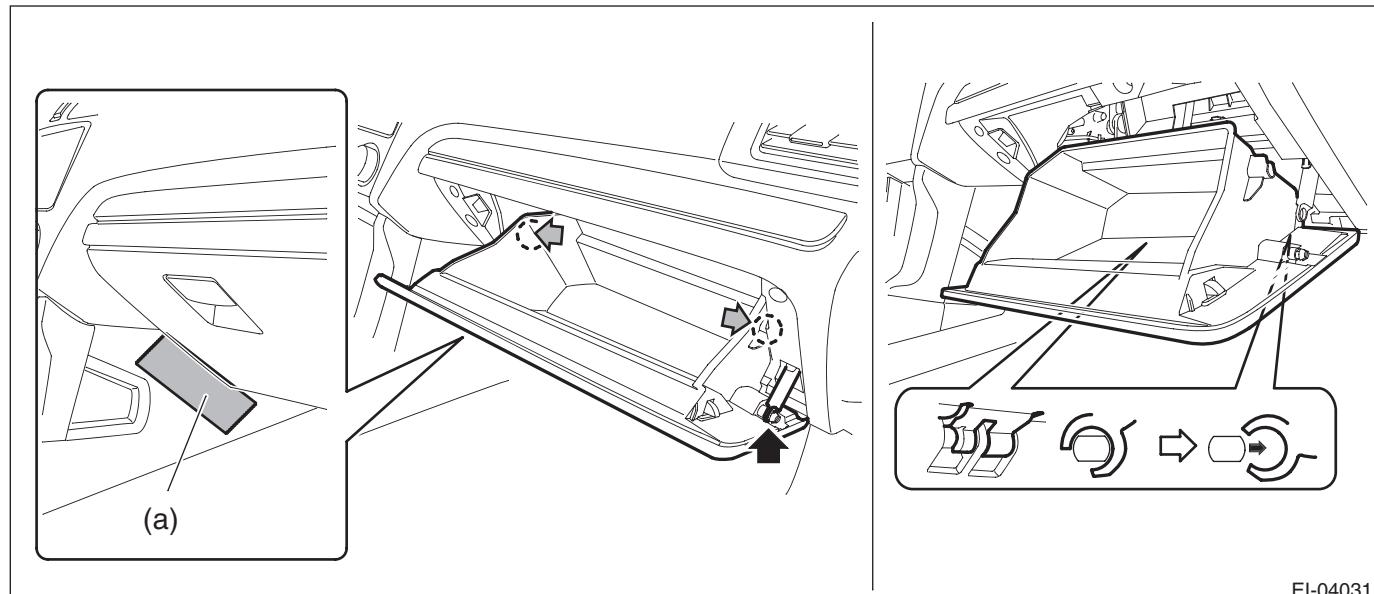
EI-04031

16) Remove the pocket assembly.

- (1) Attach the protective tape (a) to the panel center LWR.
- (2) Remove the damper complete - pocket.
- (3) Release the stoppers and remove the pocket assembly by pulling it toward you.

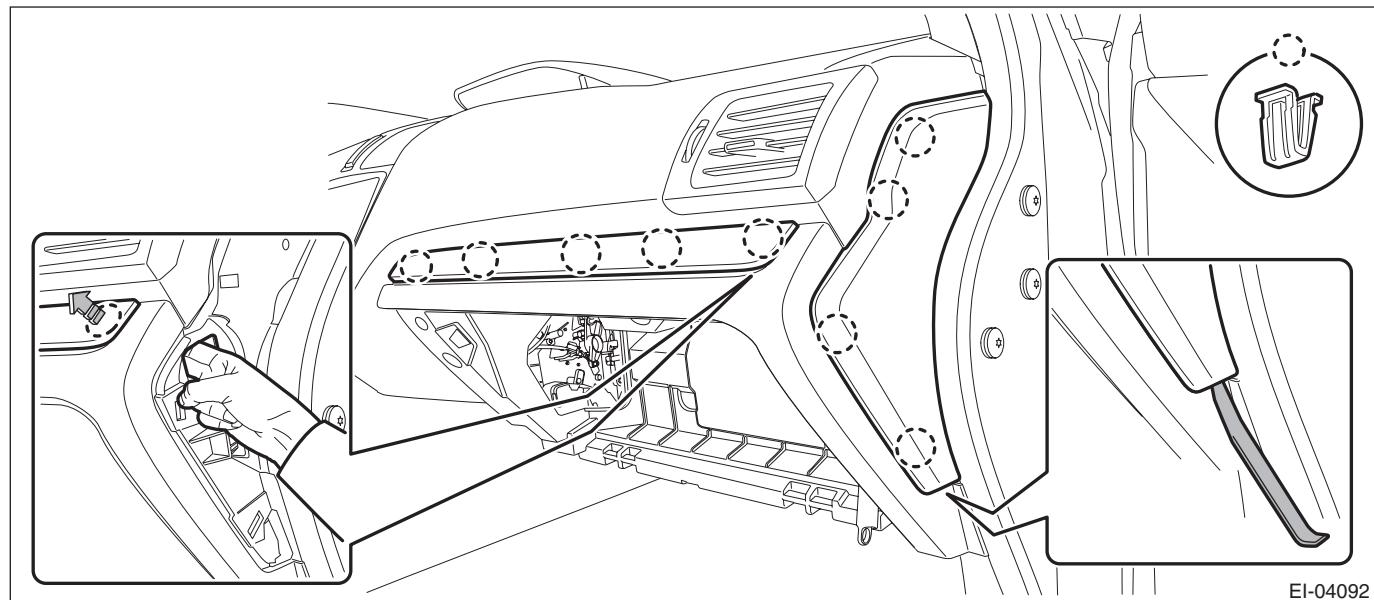
EI-04092

- (1) Release the clips, and remove the ornament - panel assembly passenger.

To facilitate the removal, push the clip of the ornament - panel assembly passenger from the backside.

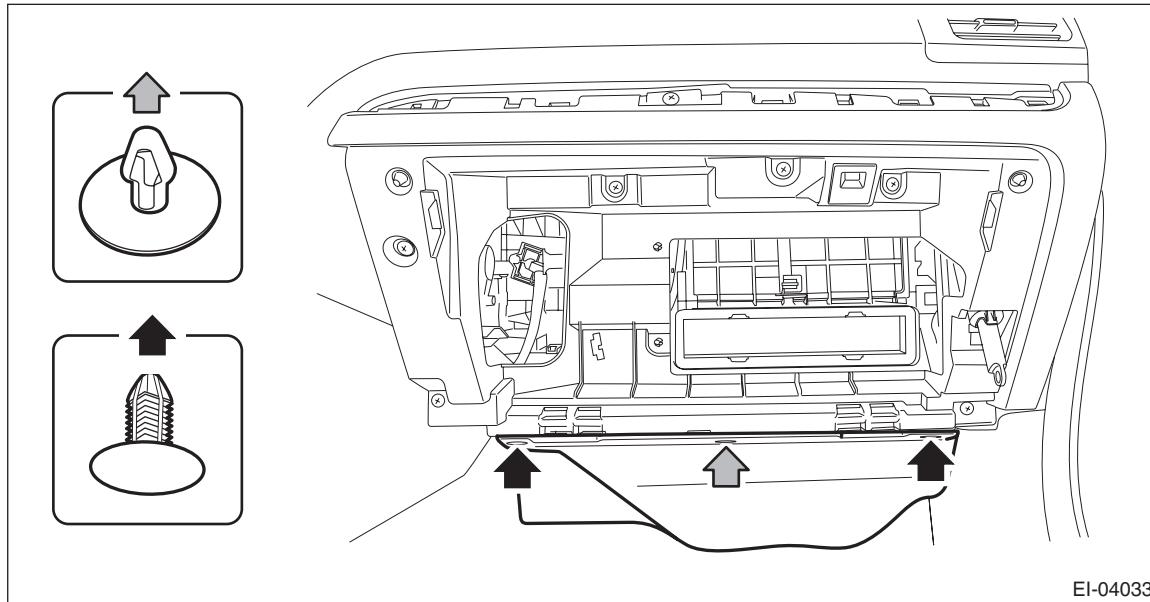
(2) Release the clips, and remove the glove box under cover.

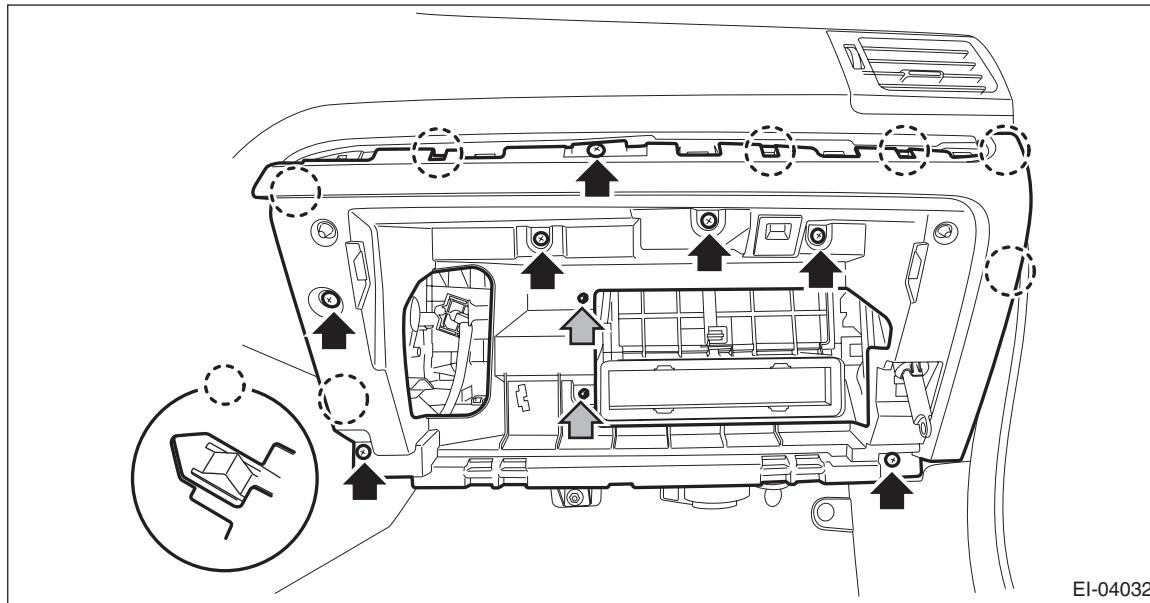
(3) Remove the clips, and remove the cover - instrument panel side RH.

(4) Remove the screws, claws and harness clamp, then remove the back panel - pocket.

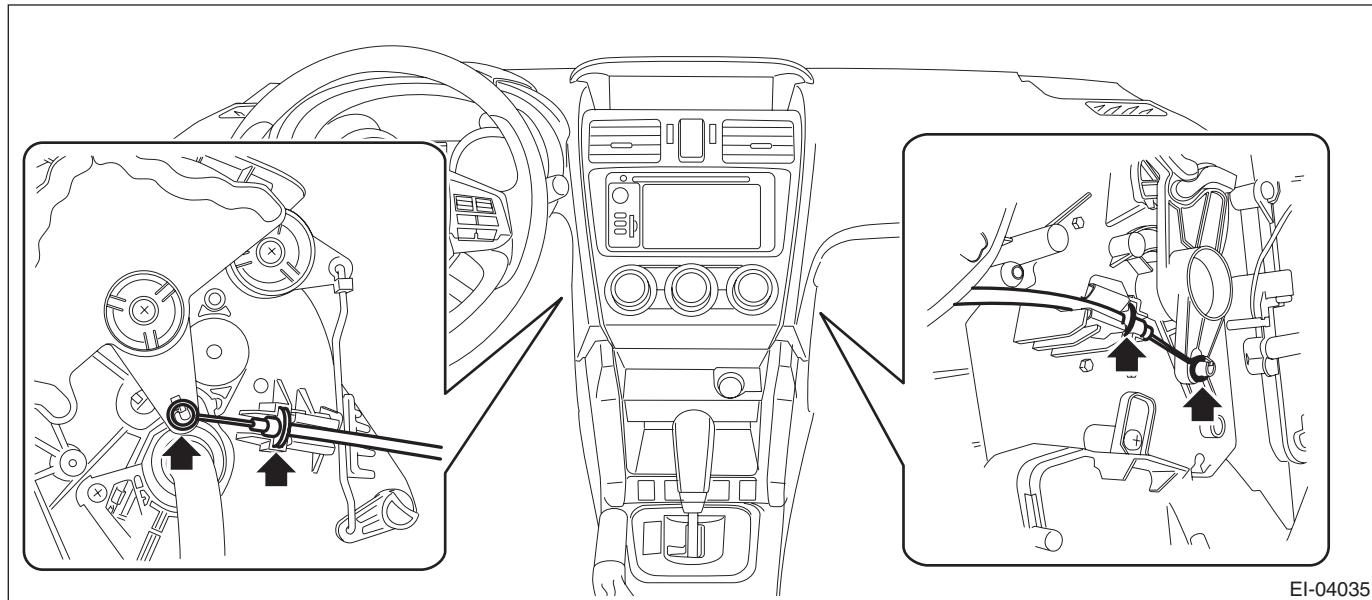
18) On manual A/C models, disconnect the control cables from both sides of the heater & cooling unit.

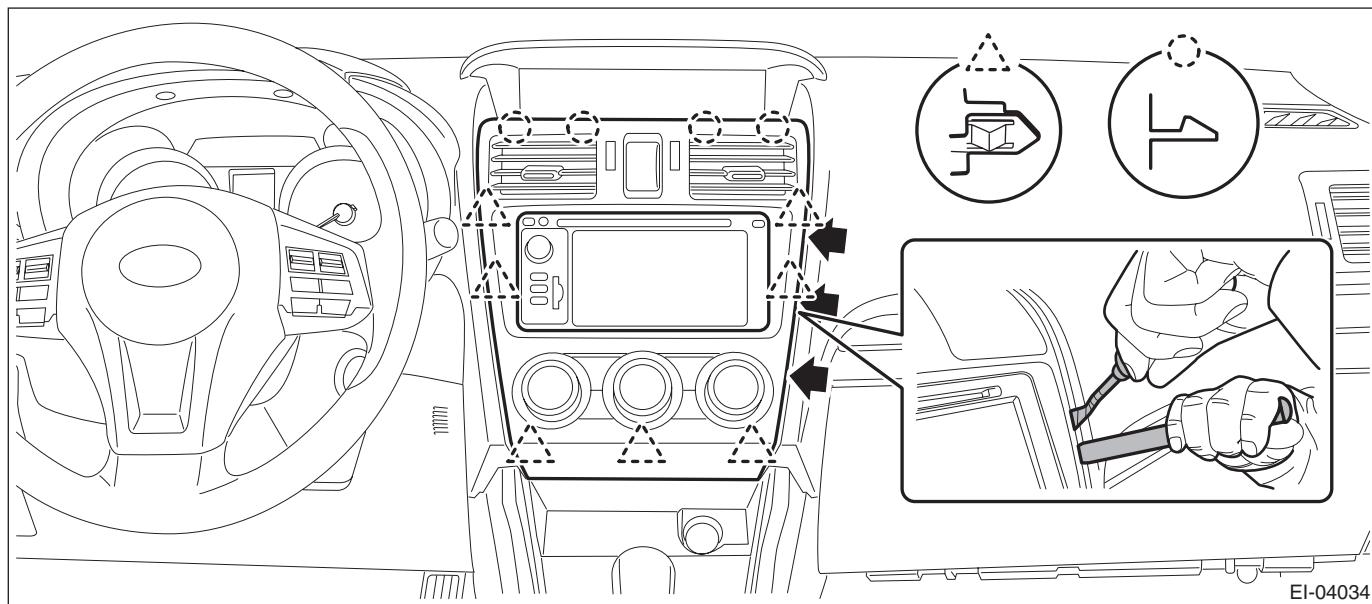
19) Remove the panel center assembly.

- Do not put your finger on the fin of the air vent grille. Doing so may damage the fin.
- Pull the panel center assembly slowly. Pulling with excessive force may damage the connector on the back.

- (1) Insert a plastic remover to the three areas shown by the arrows, and slightly lift up the panel center assembly.
- (2) With the panel center assembly lifted up slightly, release the claw by using a clip remover wrapped with protective tape.
- (3) Release the rest of the claws, and pull out the panel center assembly.
- (4) Disconnect the connectors, and remove the panel center assembly.

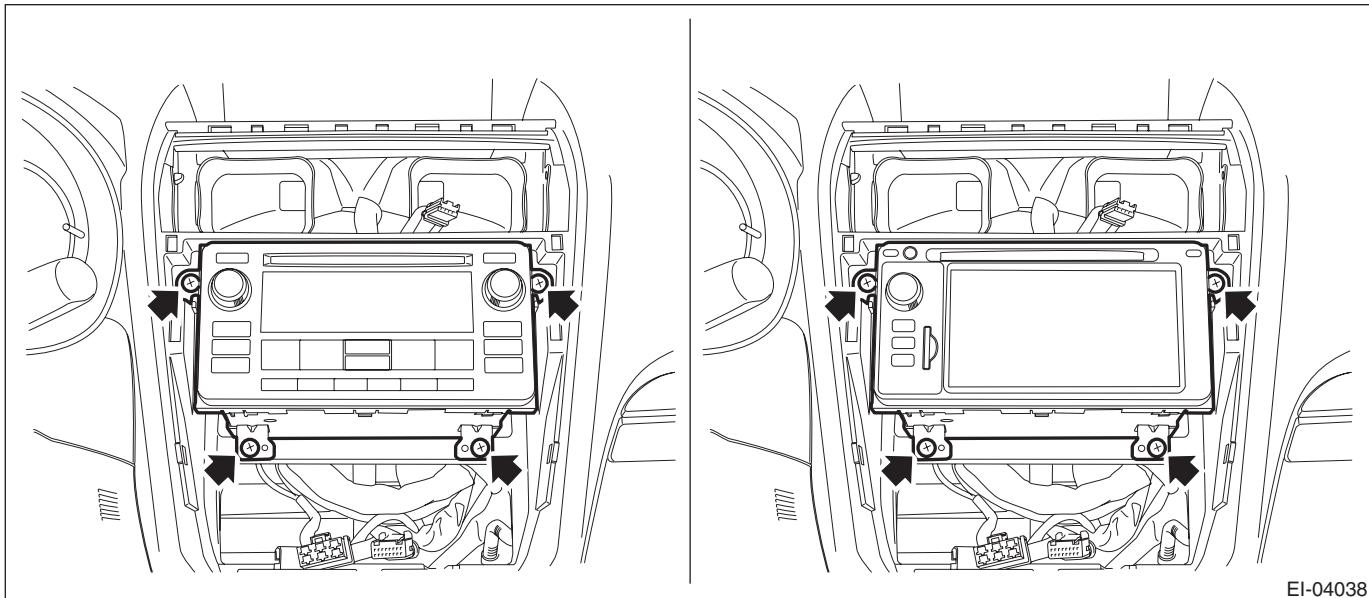
20) Remove the audio assembly or navigation assembly.

(1) Remove the screws, and partially pull out the audio assembly or navigation assembly.

(2) Disconnect the connectors, and remove the audio assembly or navigation assembly.

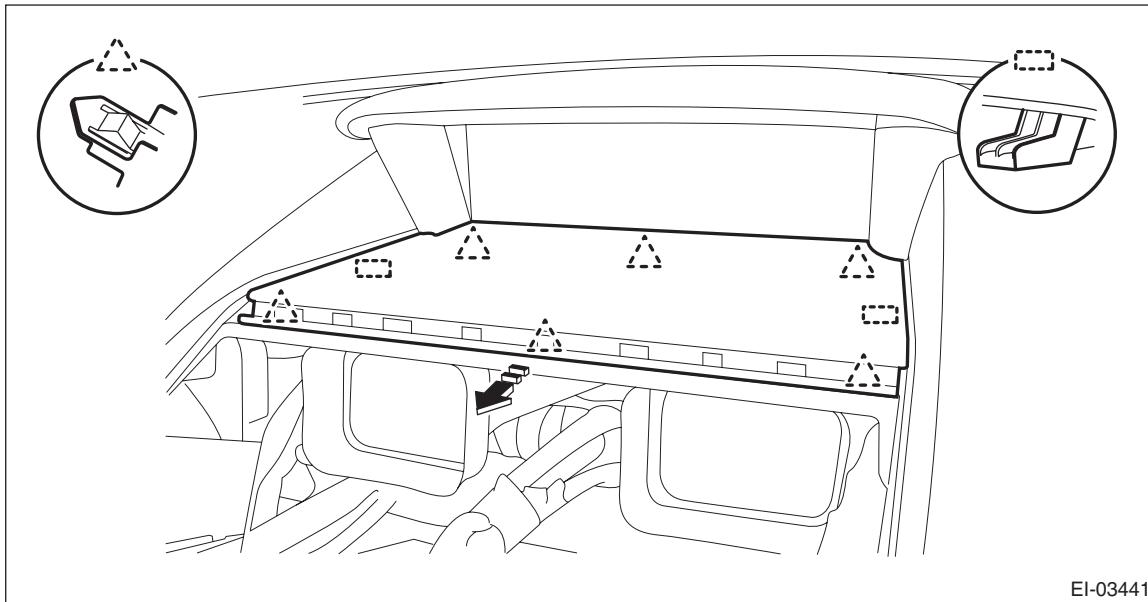
(1) Disconnect the claws and then remove the cover center UPR.

Lightly push up the back of the cover center UPR, hook the finger to the end portion and pull it toward you to remove it.

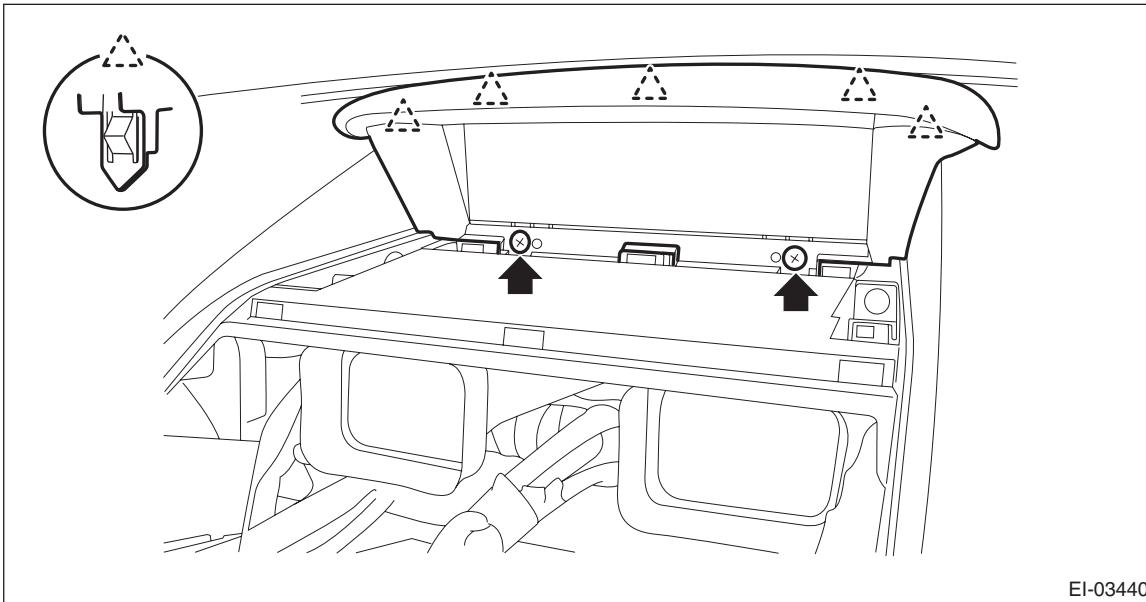
(2) Release the claws and then remove the panel - display UPR and the panel - display LWR.

Remove the panel - display UPR & panel - display LWR and the multi-function display assembly as a unit.

(3) Disconnect the connector and remove the multi-function display assembly.

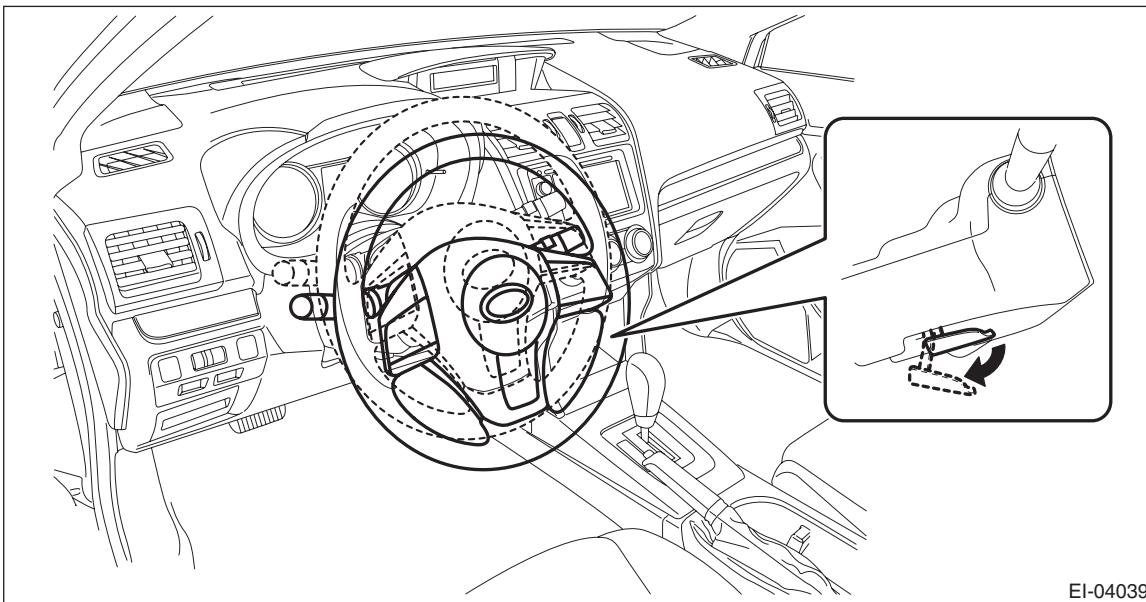
(1) Release the lock, tilt the steering column to the lowest end and fully extend the column by the telescopic system.

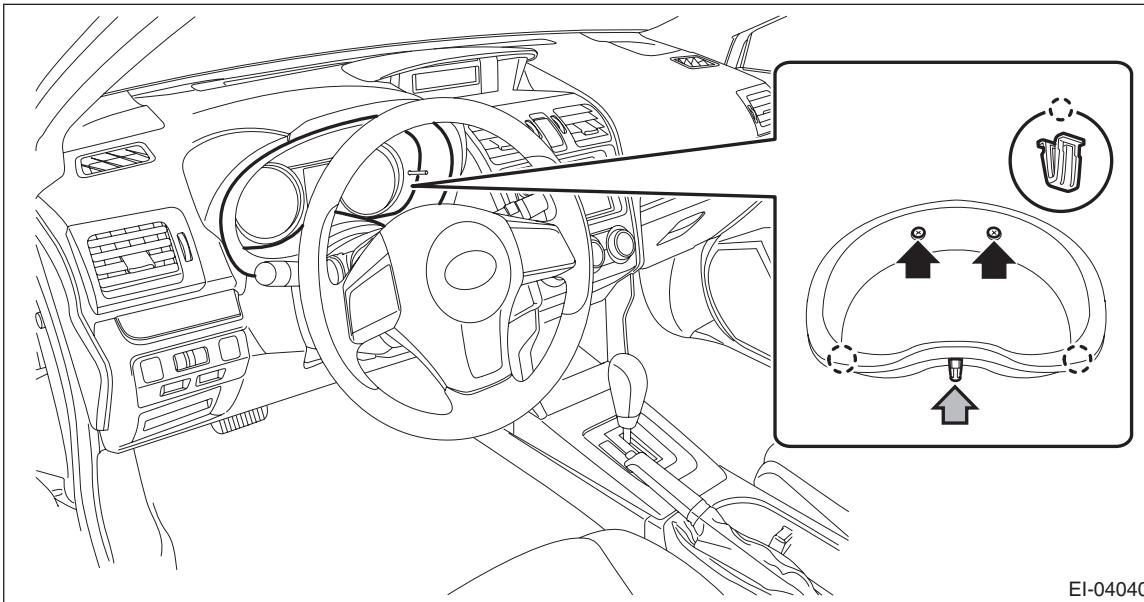
(2) Release the screws and clips, then detach the visor - combination meter.

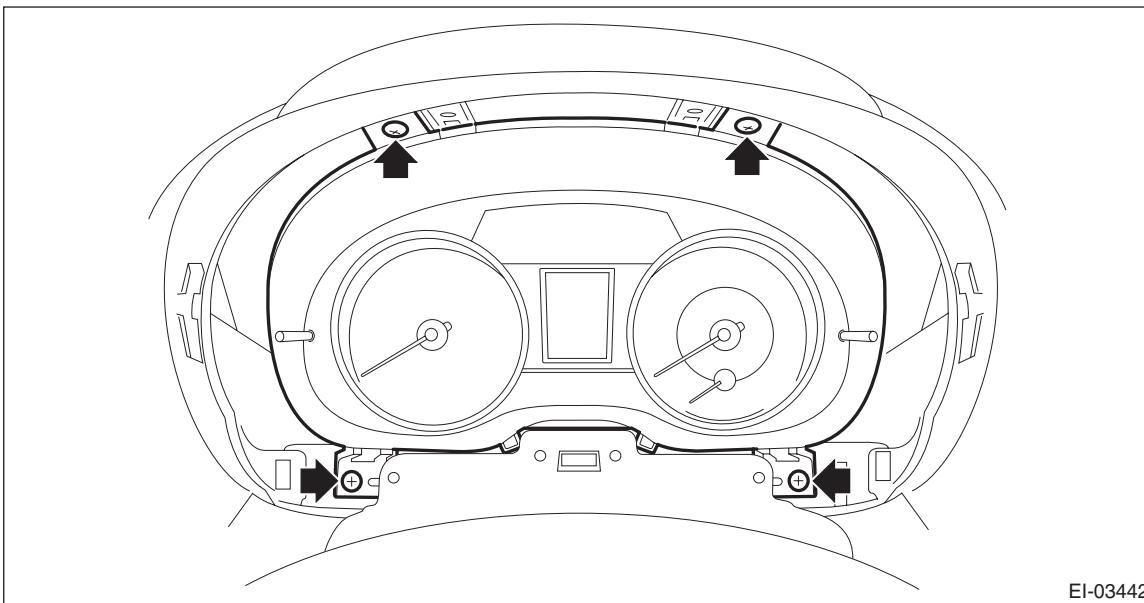
(3) Remove the screws, disconnect the connector and remove the combination meter assembly.

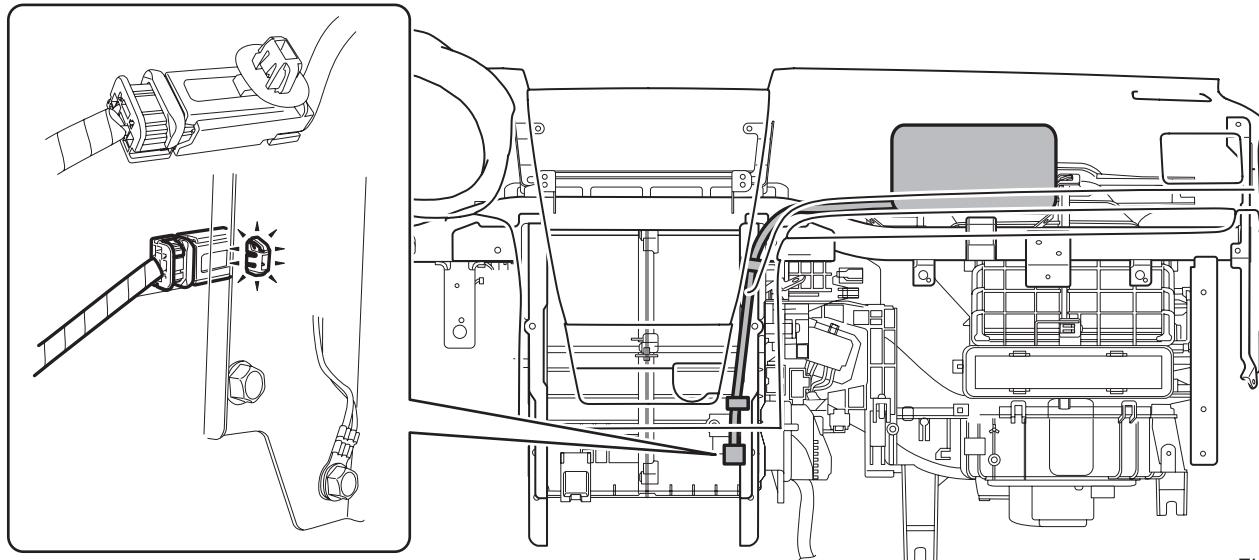
EI-04004

23) Disconnect the passenger's airbag module connector. <Ref. to AB-20, PASSENGER'S AIRBAG MODULE, PROCEDURE, Airbag Connector.>

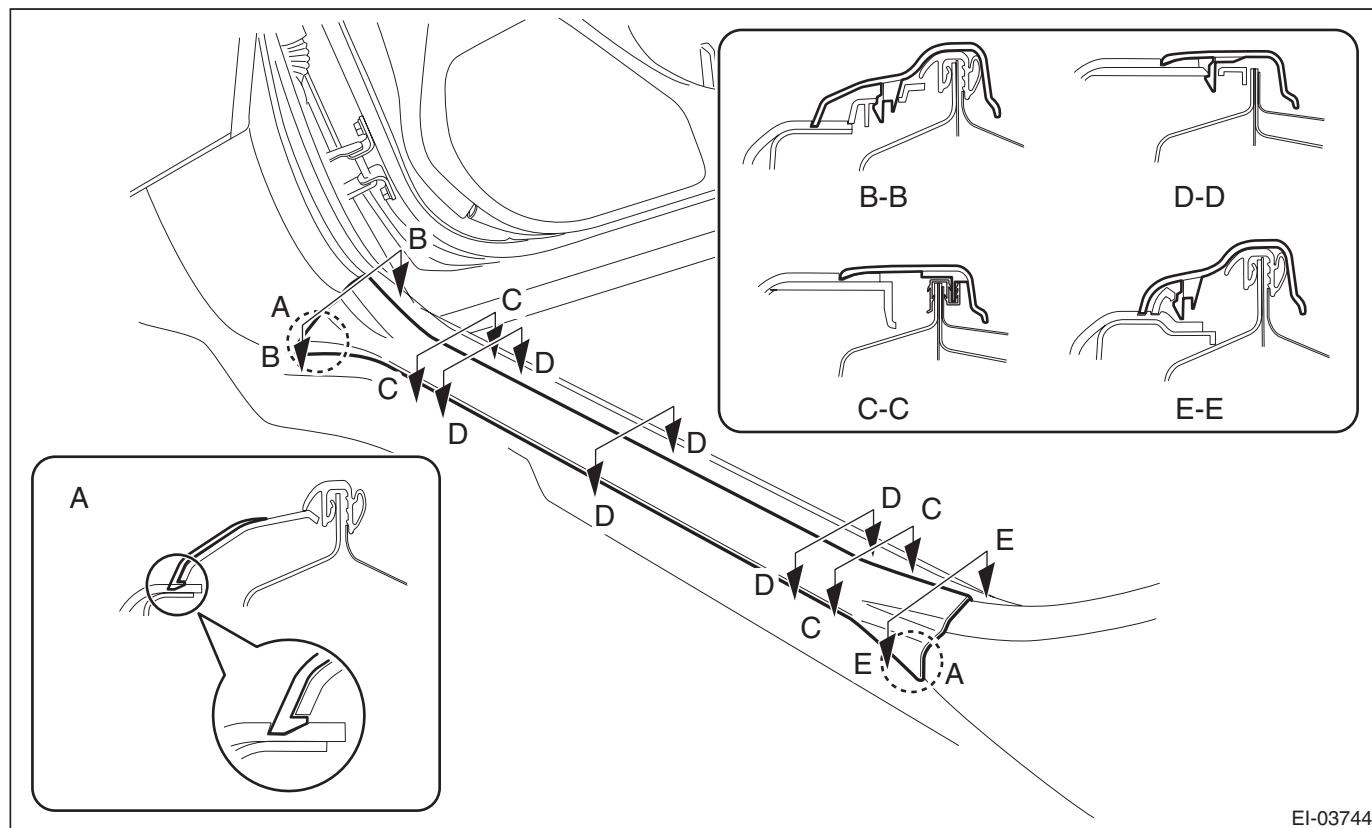
EI-03744

25) Release the claws, and then remove the cover side sill - front INN on LH and RH sides.

Do not pull with excessive force. Doing so may damage the claws of the cover side sill - front INN.
