20. Instrument Panel Assembly

EXTERIOR/INTERIOR TRIM

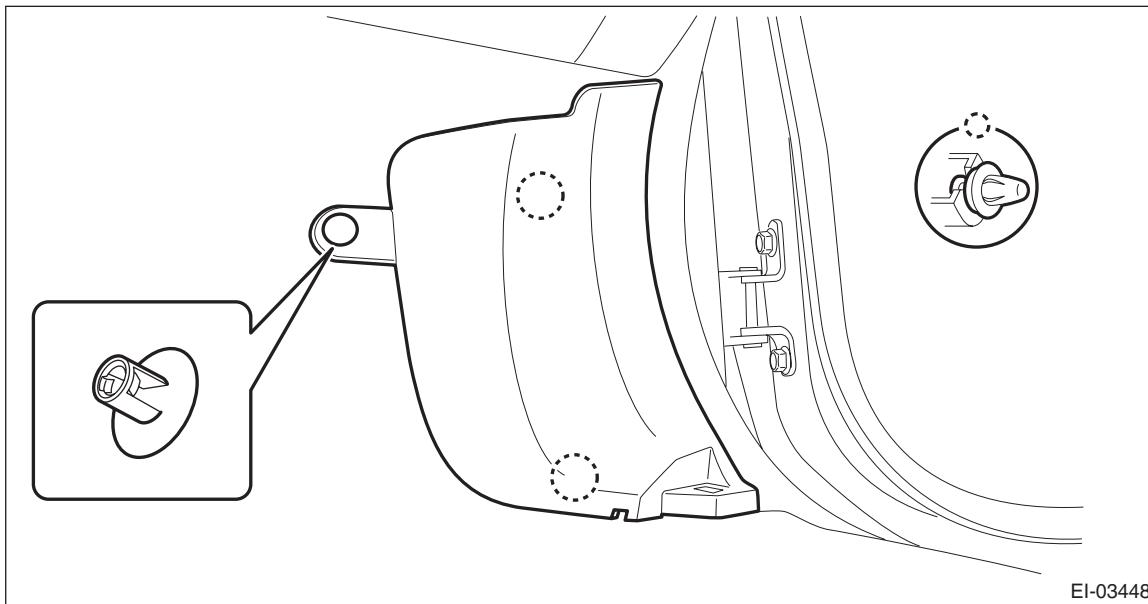
26) Remove the clip, and remove the cover side sill - front on LH and RH sides.

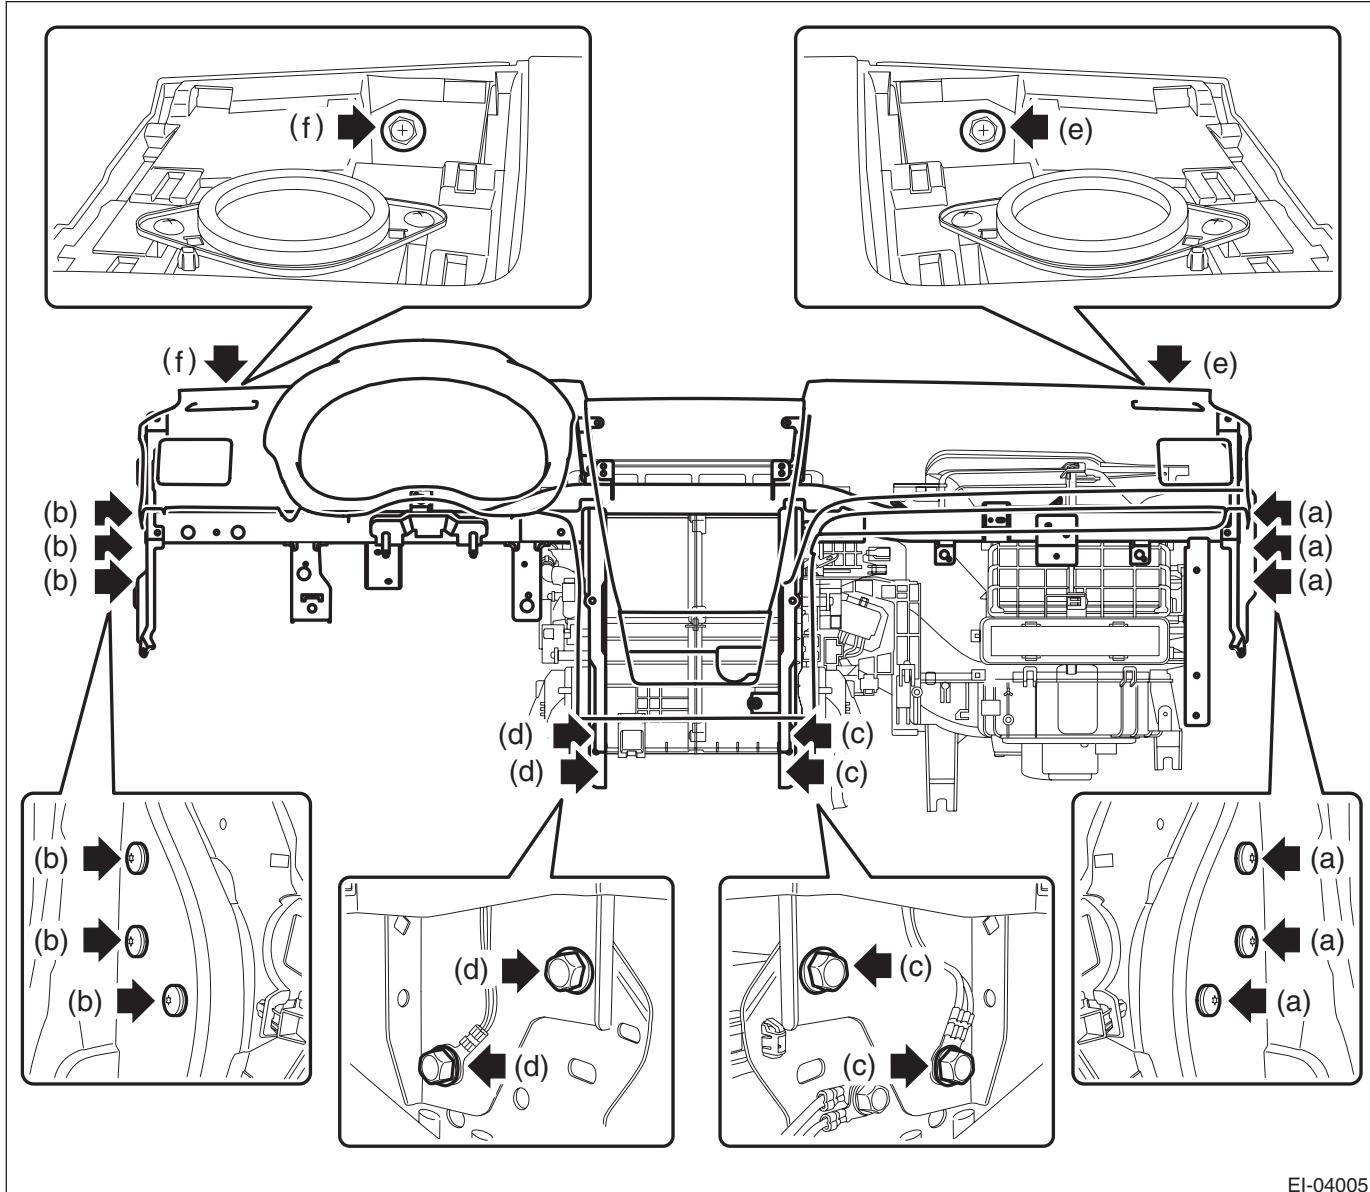
EI-04005

- (1) Remove the fuse box and relay box.
- (2) Disconnect all harness clamps and connectors of the instrument panel harness.
- (3) Remove the TORX® bolt. (a), (b)

- (4) Remove the bolts at the floor center. (c), (d)

(5) Remove the bolt. (e), (f)

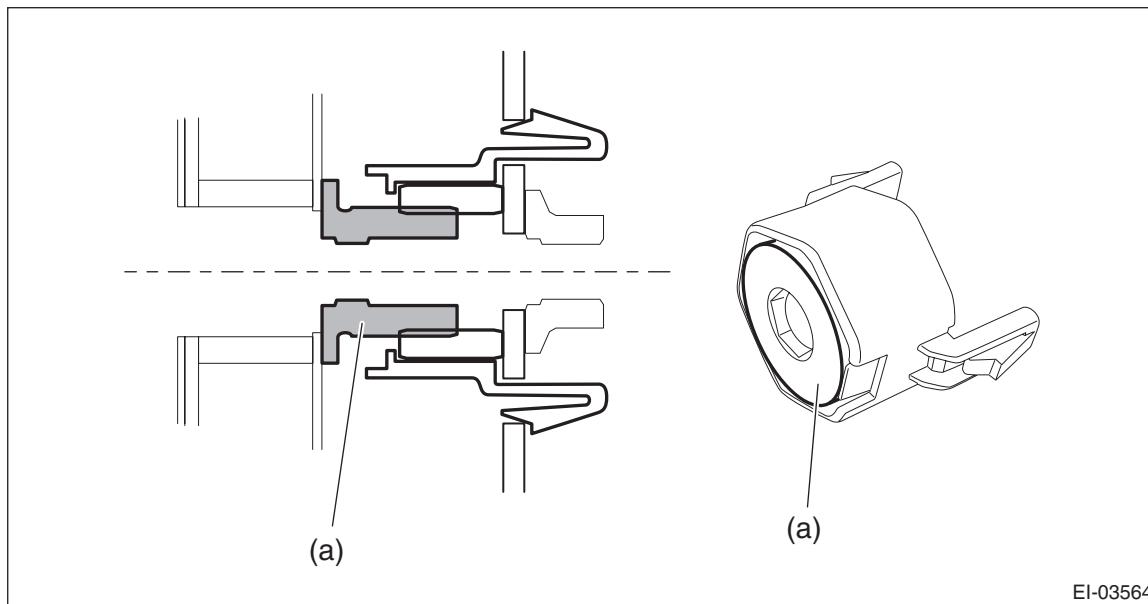
(6) Loosen the adjuster portion (a) of the adjuster - clip space. (only LH side of the beam COMPL - steering)

Hexagon wrench: 8 mm (0.31 in)

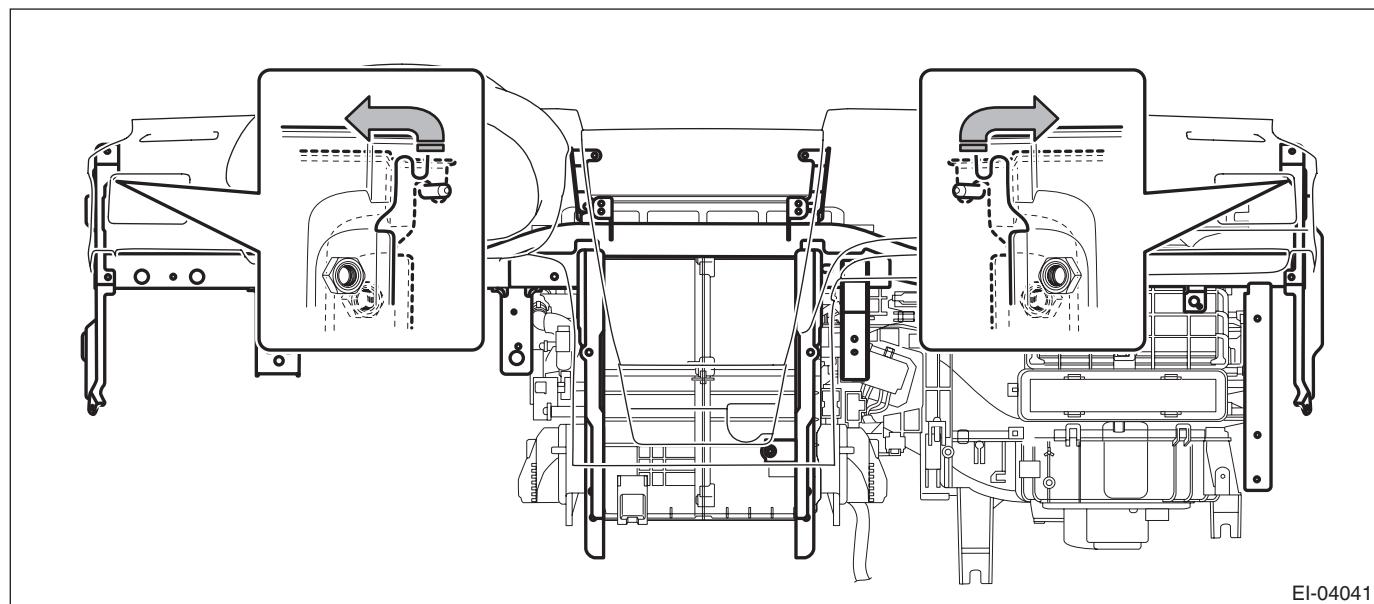
(7) Slightly lift the instrument panel assembly together with the beam COMPL - steering to detach the left and right pins. Then pull it toward you to remove the assembly.

- Check that all harness clamps and connectors are detached.
- The instrument panel assembly and the beam COMPL - steering are heavy. Always work in a team of two persons when removing them from the vehicle, so as not to damage the vehicle interior.

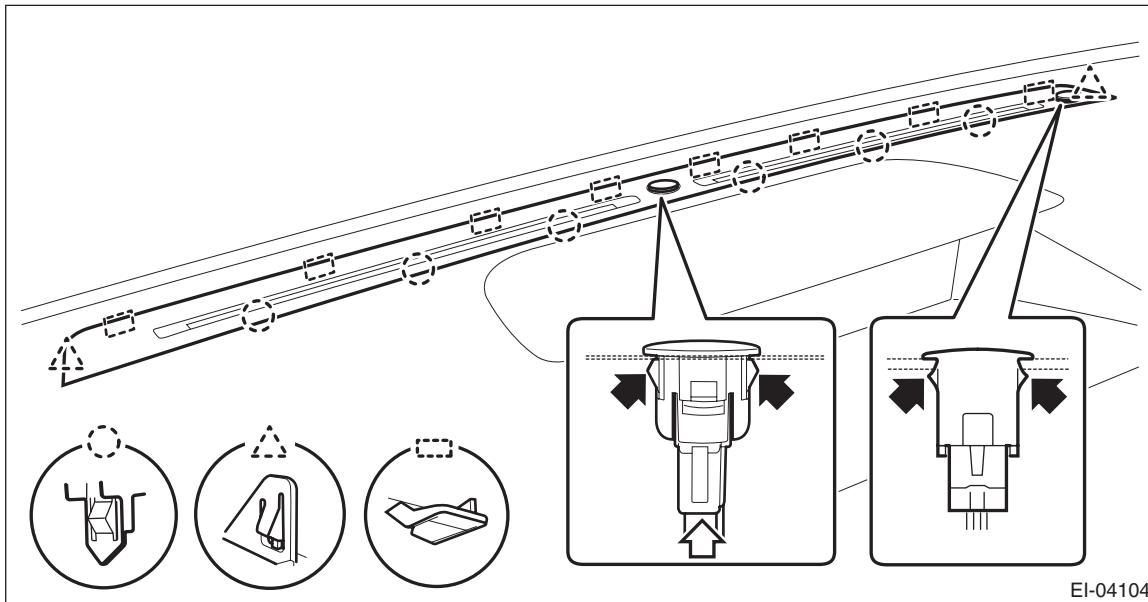
29) Remove the panel COMPL - instrument UPR.

- (1) Disconnect the connector of the sensor - sunload.
- (2) Disconnect the connector of the sensor - automatic light. (Model with automatic light function)
- (3) Release the claws, and remove the panel COMPL - instrument UPR.

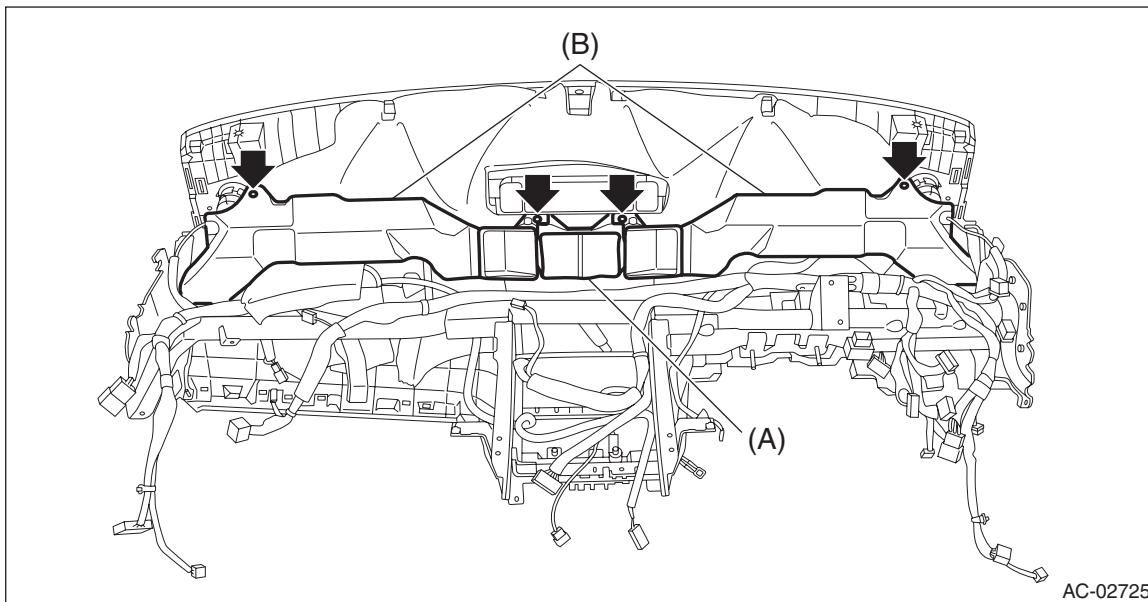
30) Remove the screws and remove the front (A) and side vent duct (B) LH, RH.

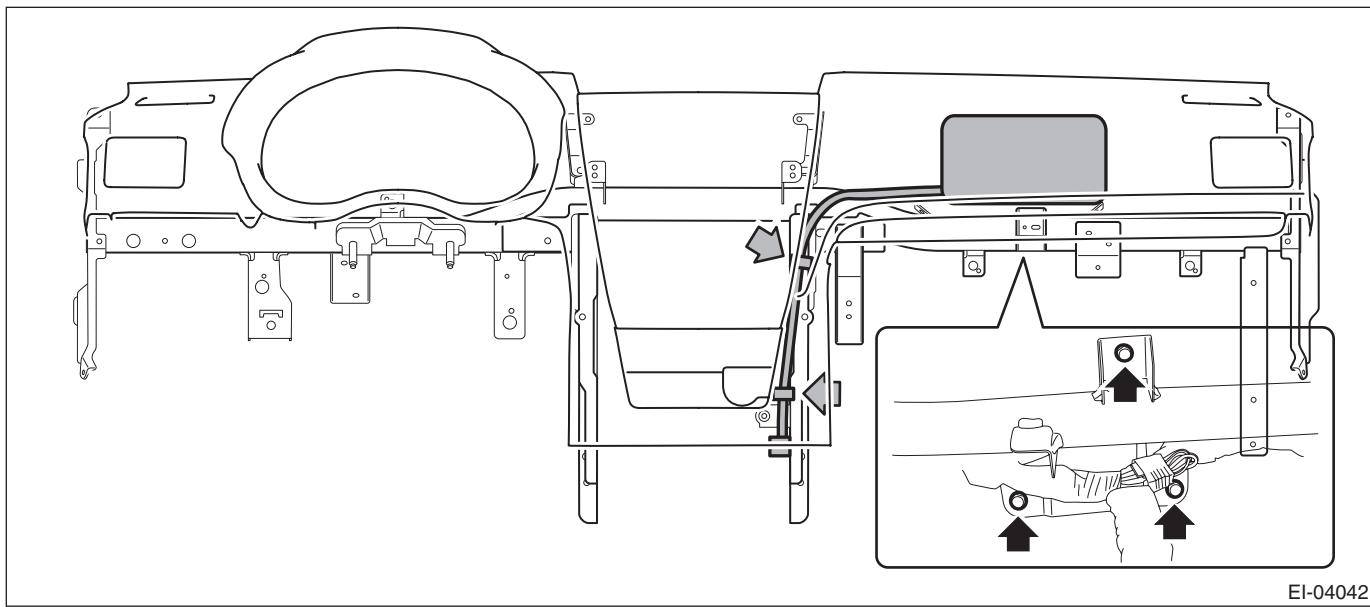
- 31) Separate the panel COMPL - instrument and the beam COMPL - steering.
(1) Remove the clamps and bolts of the passenger's airbag module harness.

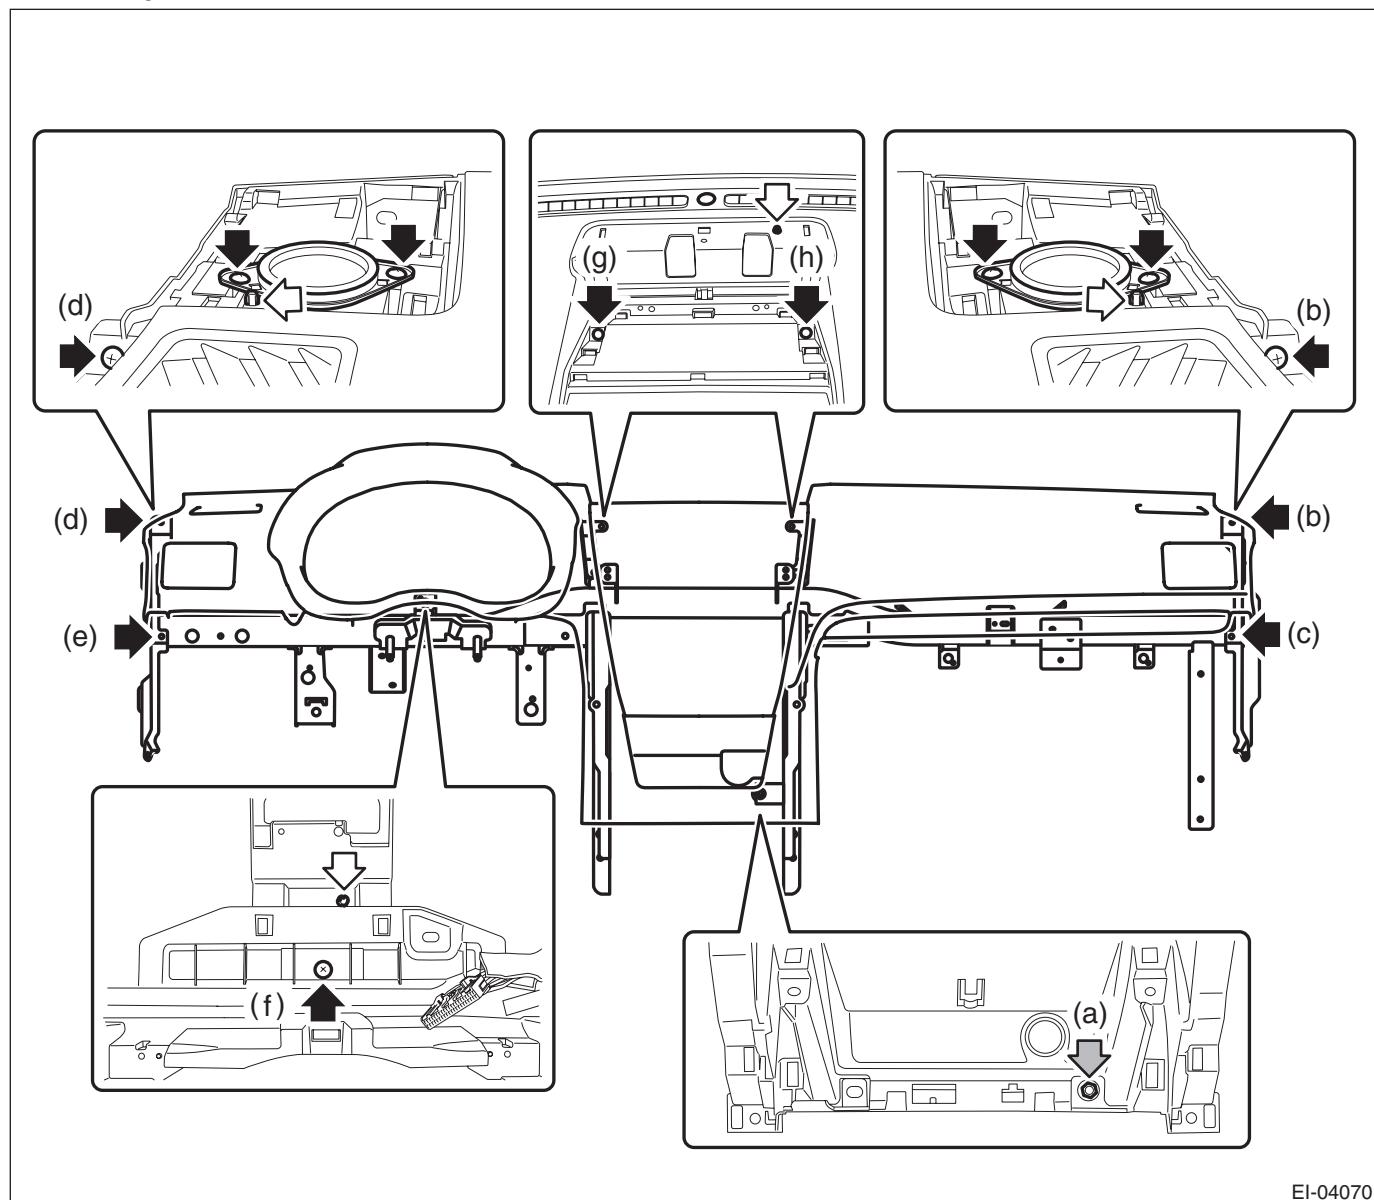
EI-04070

- (2) Remove the left and right speakers.

- (3) Disconnect the front accessory socket connector.
- (4) Remove the nut (a) and screws (b), (c), (d), (e), (f), (g) and (h).

(5) While being careful with the harness, separate the panel COMPL - instrument and the beam COMPL - steering.

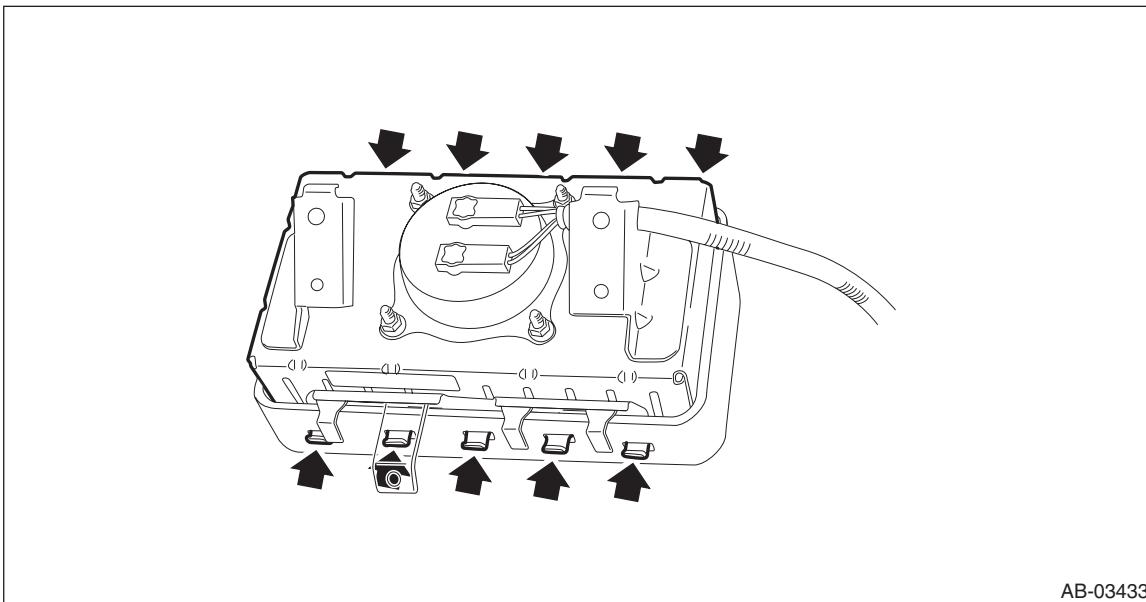
32) Remove the claws, and remove the passenger's airbag module.

Passenger's airbag module: 7.5 N·m (0.76 kgf·m, 5.5 ft-lb)

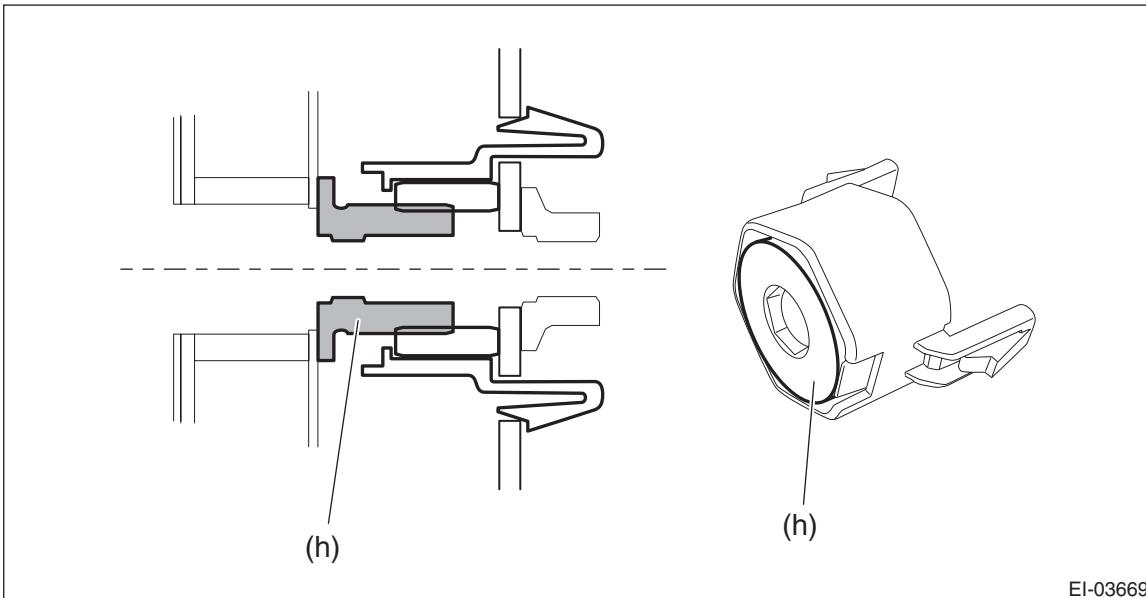
(1) Position the instrument panel assembly and the beam COMPL - steering to the vehicle body and tighten the adjuster - clip space.

Tighten so that there is no gap between the adjuster portion (h) and the body.

Adjuster - clip space: 0.4 — 4 N·m (0.04 — 0.41 kgf·m, 0.3 — 2.95 ft-lb)

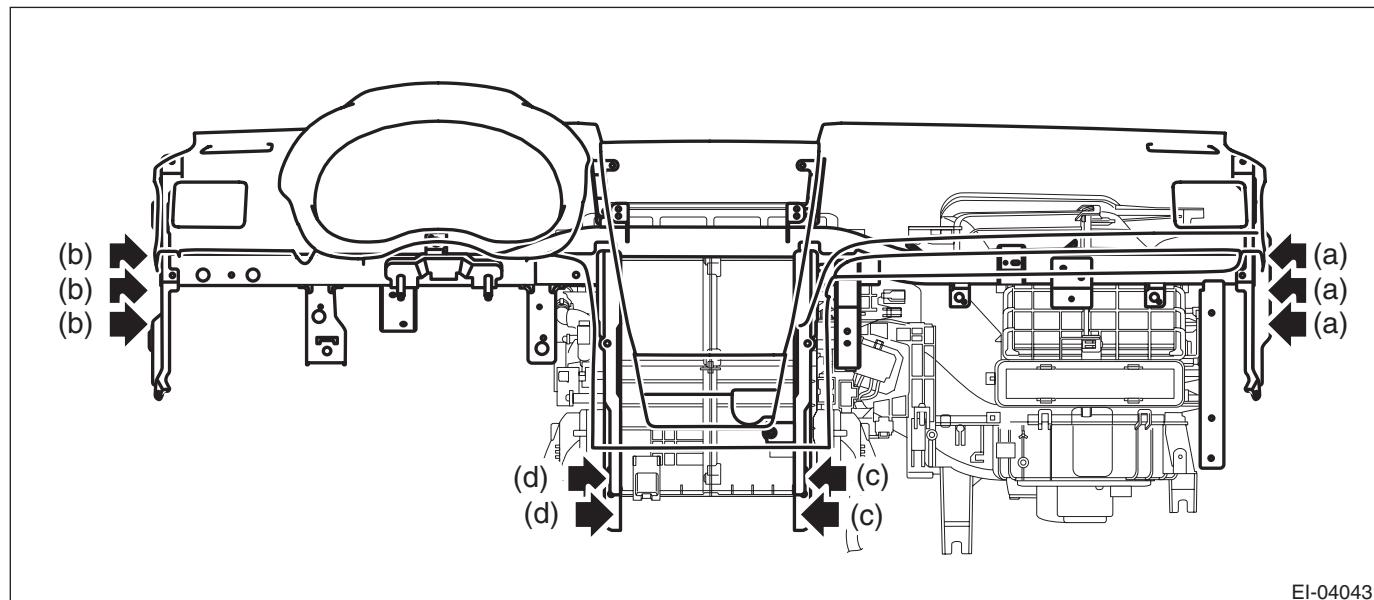
(2) Temporarily tighten the bolts (a), (b), (c) and (d) of the beam COMPL - steering.

(3) Tighten the beam COMPL - steering in the order from (a) to (d) to the specified torque.

Beam COMPL - steering: 25 N·m (2.55 kgf·m, 18.4 ft-lb)

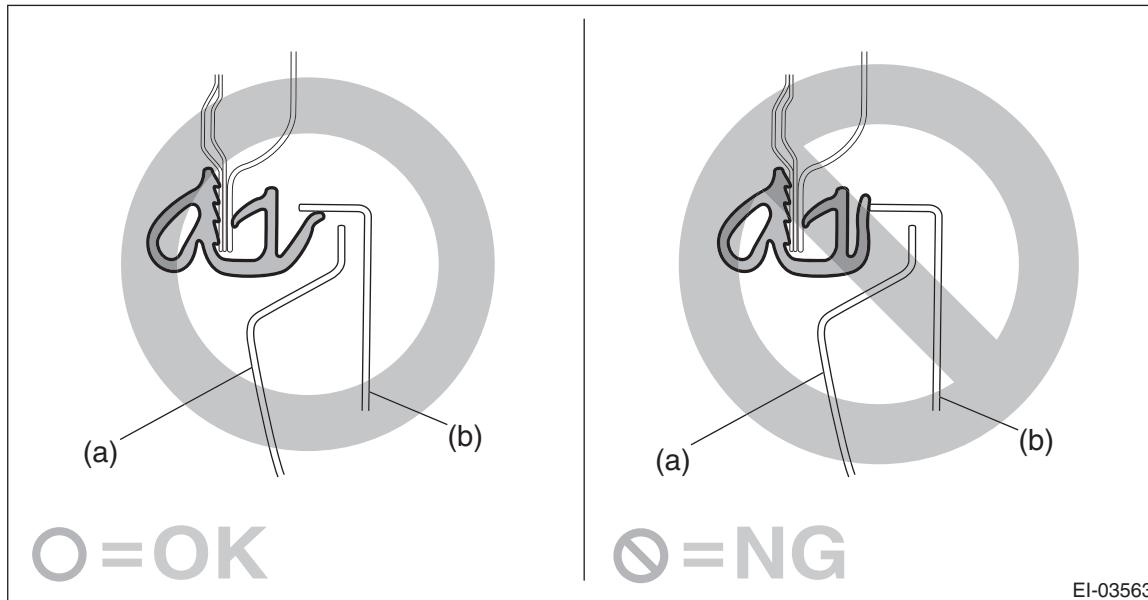
- After installing the panel center assembly, check that the air vent grille of the panel center assembly is inserted correctly into the air vent duct.
- When installing the cover - instrument panel side (a), make sure that the body side weather strip - flange front does not come inside the panel COMPL instrument (b).
