## 12. Extension Case Oil Seal

### CONTINUOUSLY VARIABLE TRANSMISSION

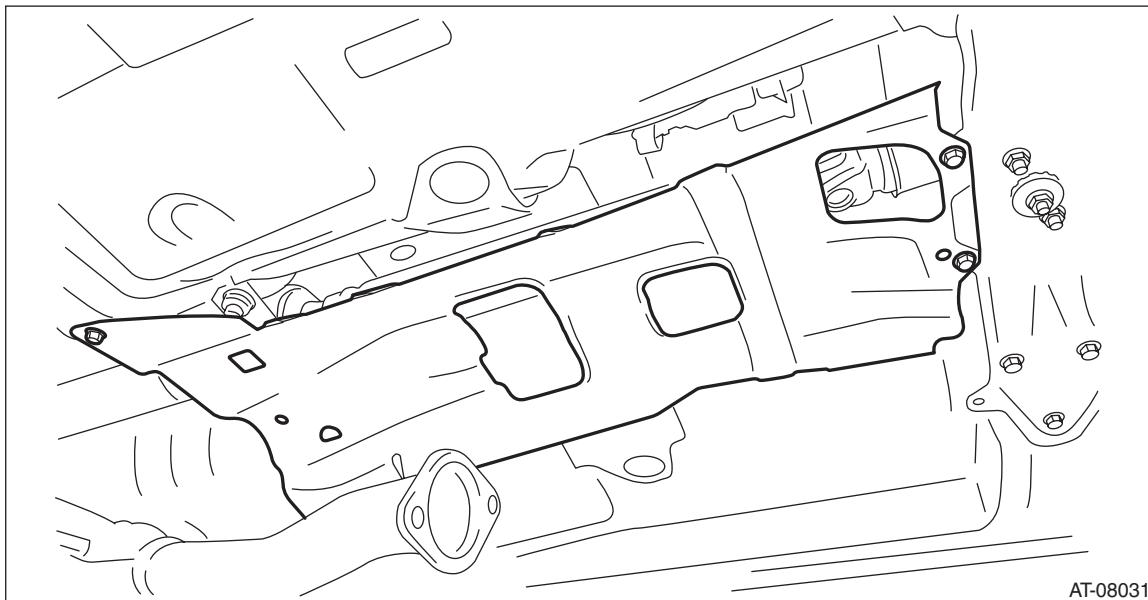
- 1) Lift up the vehicle.
- 2) Remove the center exhaust pipe.<Ref. to EX(H4DO)-14, REMOVAL, Center Exhaust Pipe.>
- 3) Remove the center exhaust cover.

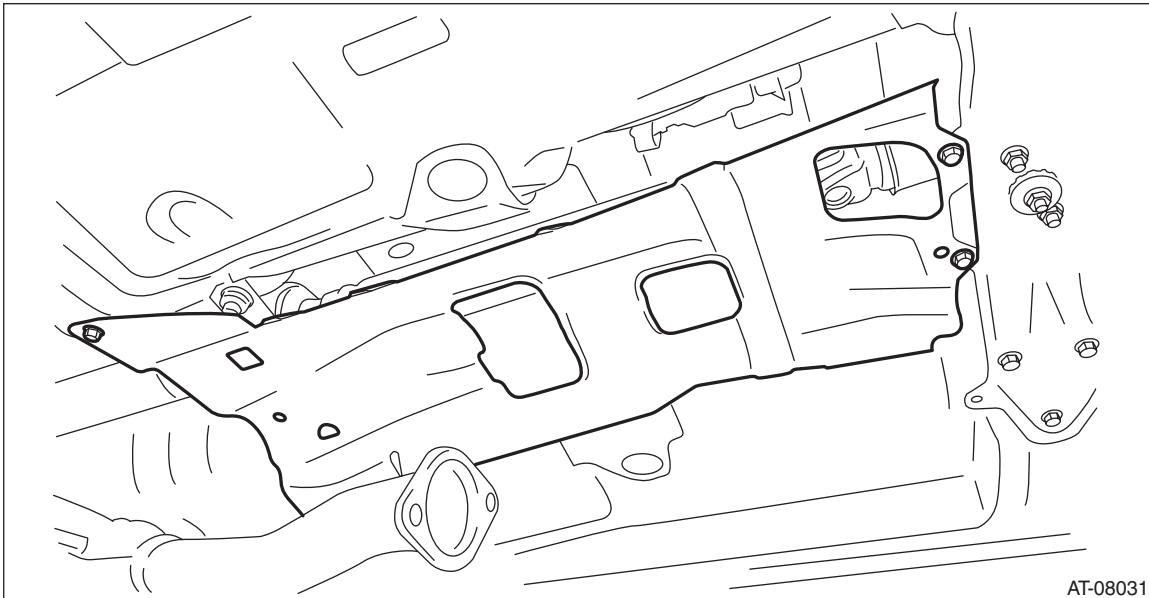
9) Install the center exhaust cover.

**Tightening torque:**

**18 N·m (1.8 kgf·m, 13.3 ft-lb)**
