# DATUM POINTS

## Body Structure

### 2. Datum Points S906540

#### A: LOCATION S906540A13

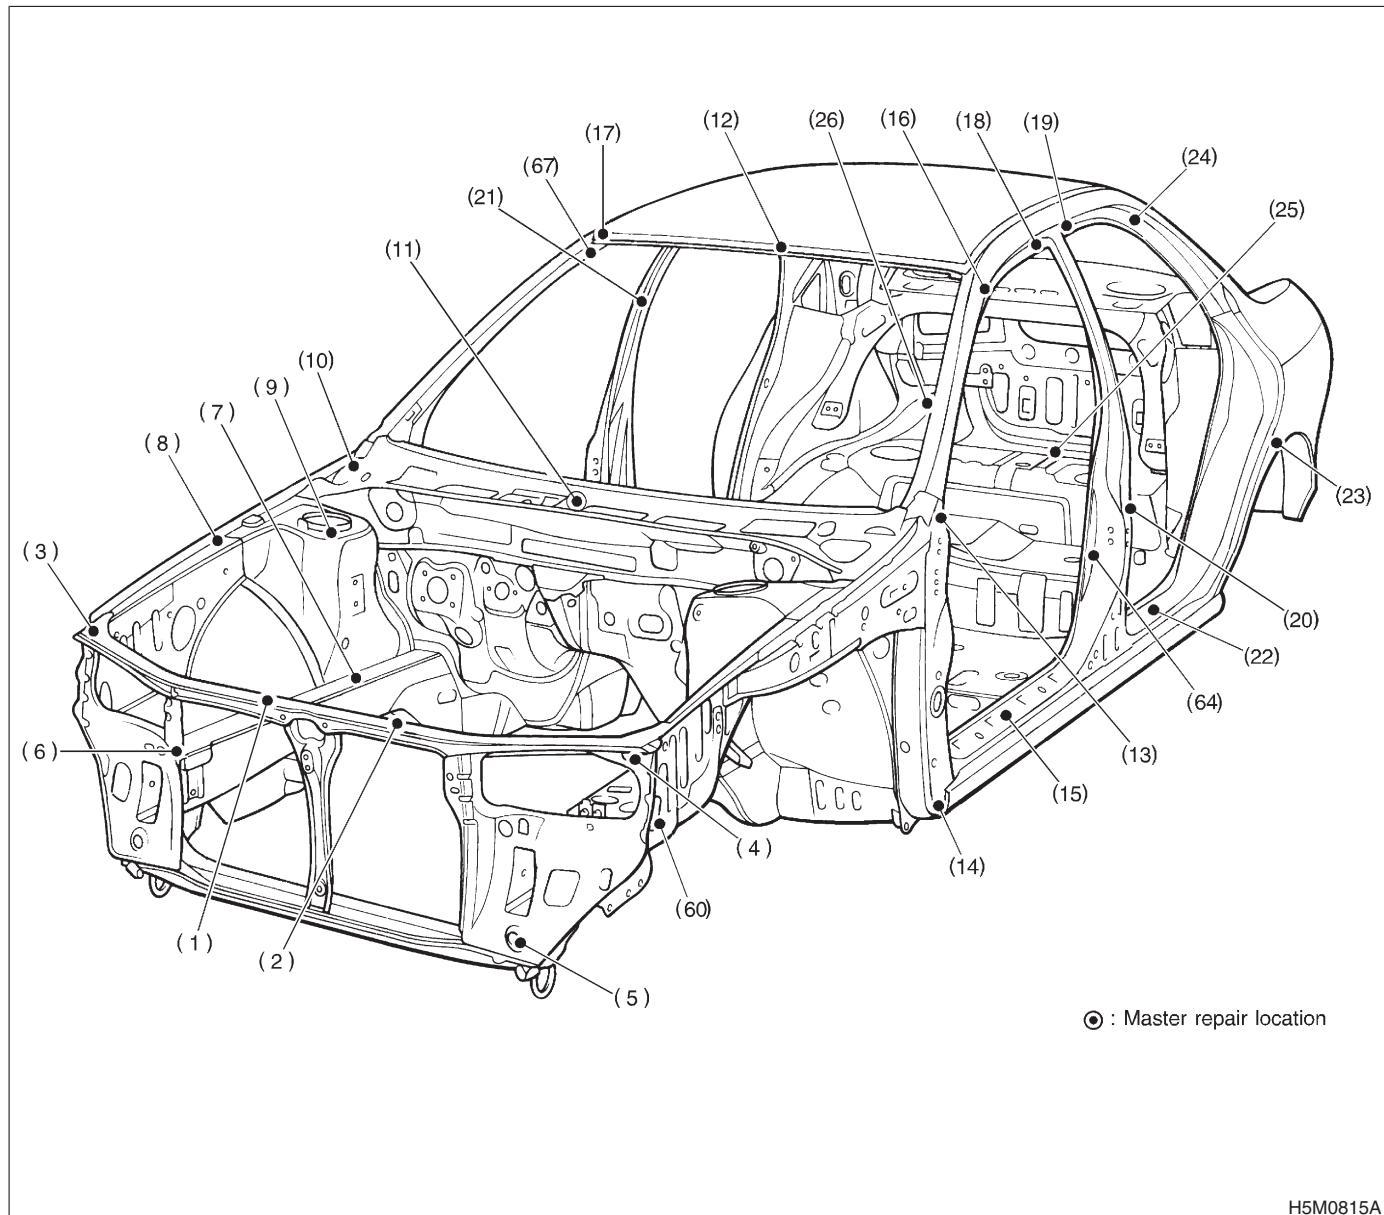
H5M0815A

- Sedan and wagon

(1) Radiator panel (UPR) repair bolt hole M8 (Right)	(10) Hood hinge attaching bolt hole M8 (Symmetrical)	(20) Center pillar gauge hole 10 mm (0.39 in) dia. (Symmetrical)

(2) Radiator panel (UPR) repair bolt hole M8 (Left)	(11) Cowl panel mounting hole 5 mm (0.20 in) dia. (Located in center of vehicle.)	(21) Belt anchor attaching bolt hole (Symmetrical)

(3) Fender attaching bolt hole M6 (Symmetrical)	(12) Front rail (Inner) mirror attaching bolt hole 8 mm (0.31 in) dia.	(22) Wax coat hole, 20 mm (0.79 in) dia. (Symmetrical)

(4) Headlight attaching bolt hole M6 (Symmetrical)	(13) Fender attaching bolt hole M6 (Symmetrical)	(23) Rear door switch attaching hole 20 mm (0.79 in) dia. (Symmetrical)

(5) Radiator panel side gauge hole 24 mm (0.94 in) dia. (Symmetrical)	(14) Front pillar gauge hole 20 mm (0.79 in) dia. (Symmetrical)	(24) Retainer attaching square hole 7 mm (0.28 in) (Symmetrical)

(6) Front bumper mounting hole 14 x 17 mm (0.55 x 0.67 in) dia. (Symmetrical)	(15) Wax coat hole, 20 mm (0.79 in) dia. (Symmetrical)	(25) Spare tire attaching bolt hole M8

(7) Front crossmember attaching bolt hole 12.4 mm (0.488 in) dia. (Symmetrical)	(16) Retainer attaching square hole 7 mm (0.28 in) (Symmetrical)	(26) Air draw hole 7 mm (0.28 in) dia. (Symmetrical)

(8) Fender attaching bolt hole M6 (Symmetrical)	(17) Sun visor attaching hole 20 mm (0.79 in) dia. (Symmetrical)	(60) Fender attaching bolt hole M6 (Symmetrical)

(9) Front strut mounting hole 10 mm (0.39 in) dia. (Symmetrical)	(18) Retainer attaching square hole 7 mm (0.28 in) (Symmetrical)	(64) Door switch attaching hole 20 mm (0.79 in) dia. (Symmetrical)

(19) Retainer attaching square hole 7 mm (0.28 in) (Symmetrical)	(67) Front glass attaching hole Right 6.5 mm (0.256 in) dia. Left 6.5 x 10 mm (0.256 x 0.39 in) dia.

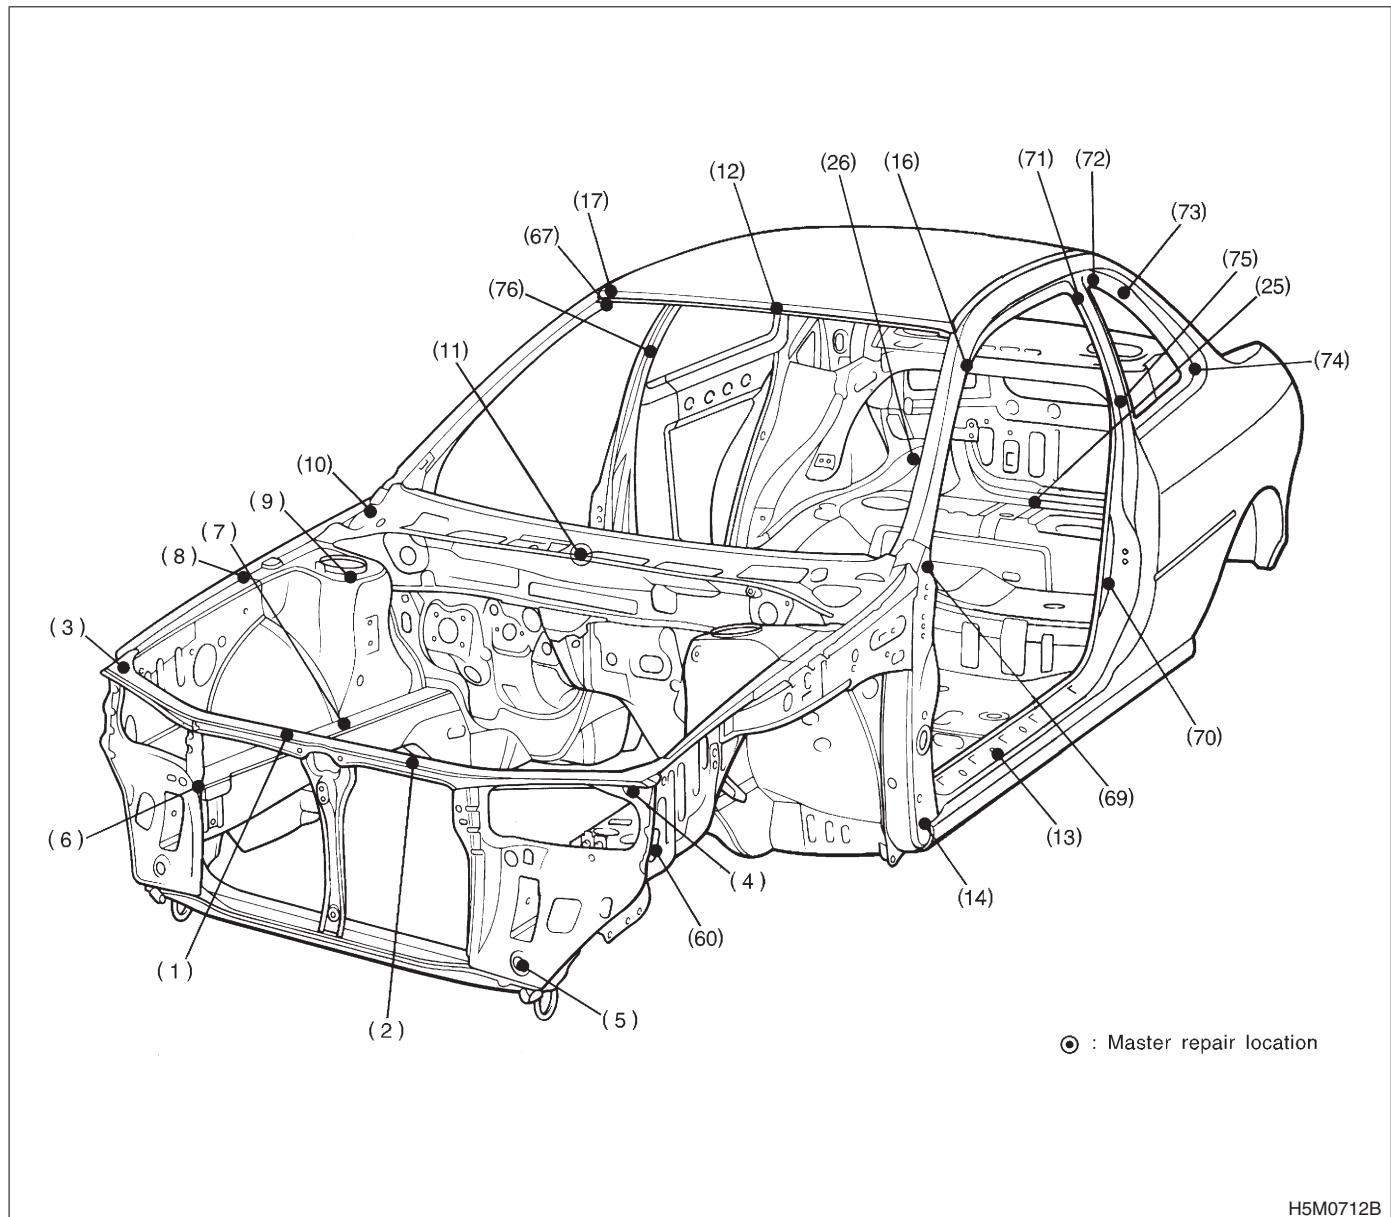
### • Coupe

(1) Radiator panel (UPR) repair bolt hole M8 (Right)	(11) Cowl panel mounting hole 5 mm (0.20 in) dia. (Located in center of vehicle.)	(70) Door switch attaching hole 13.5 mm (0.531 in) dia. (Symmetrical)

(2) Radiator panel (UPR) repair bolt hole M8 (Left)	(12) Front rail (Inner) mirror attaching bolt hole 8 mm (0.31 in) dia.	(71) Retainer attaching square hole 8 mm (0.31 in). (Symmetrical)

(3) Fender attaching bolt hole M6 (Symmetrical)	(13) Fender attaching bolt hole M6 (Symmetrical)	(72) Rear quarter glass attaching hole 8 mm (0.31 in) dia. (Symmetrical)

(4) Headlight attaching bolt hole M6 (Symmetrical)	(14) Front pillar gauge hole 20 mm (0.79 in) dia. (Symmetrical)	(73) Rear quarter glass attaching hole 7 mm (0.28 in) dia. (Symmetrical)

(5) Radiator panel side gauge hole 24 mm (0.94 in) dia. (Symmetrical)	(16) Retainer attaching square hole 7 mm (0.28 in) (Symmetrical)	(74) Rear quarter glass attaching hole 8 x 5.5 mm (0.31 x 0.217 in) dia. (Symmetrical)

(6) Front bumper mounting hole 14 x 17 mm (0.55 x 0.67 in) dia. (Symmetrical)	(17) Sun visor attaching hole 20 mm (0.79 in) dia. (Symmetrical)	(75) Retainer attaching square hole 8 mm (0.31 in). (Symmetrical)

(7) Front crossmember attaching bolt hole 12.4 mm (0.488 in) dia. (Symmetrical)	(25) Spare tire attaching bolt hole M8	(76) Seat belt anchor attaching bolt hole 16 mm (0.63 in) dia. (Symmetrical)

(8) Fender attaching bolt hole M6 (Symmetrical)	(26) Air draw hole 7 mm (0.28 in) dia. (Symmetrical)	
(9) Front strut mounting hole 10 mm (0.39 in) dia. (Symmetrical)	(60) Fender attaching bolt hole M6 (Symmetrical)

(10) Hood hinge attaching bolt hole M8 (Symmetrical)	(67) Front glass attaching hole Right 6.5 mm (0.256 in) dia. Left 6.5 x 10 mm (0.256 x 0.39 in) dia.

(69) Wax coat hole 20 mm (0.79 in) dia. (Symmetrical)

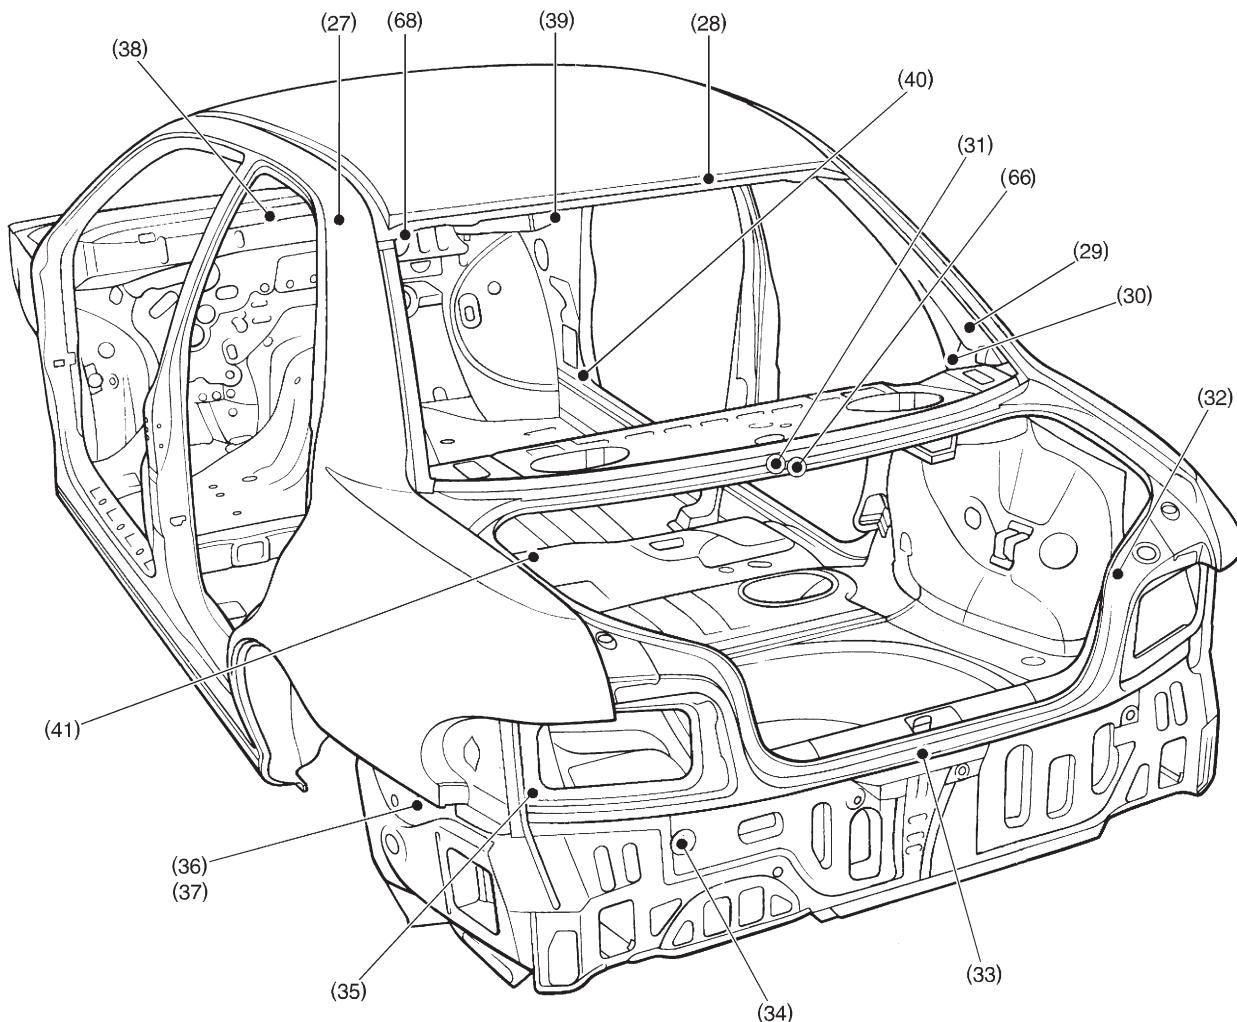
H5M0816A

#### • Sedan and coupe

◎ : Master repair location

- (27) Rear pillar (Inner) gauge hole 8 mm (0.31 in) dia. (Symmetrical)
- (28) Rear roof trim attaching hole 8 mm (0.31 in) dia. (Symmetrical)
- (29) Rear quarter trim attaching hole 8 mm (0.31 in) dia. (Symmetrical)

- (30) Seat belt anchor attaching bolt hole (Symmetrical)
- (31) Reinforcement (Rear panel rear) repair locator (Located in center of vehicle)
- (32) Rear corner patch at flange (Symmetrical)

- (33) Rear skirt (UPR) cutout (Repair locator)
- (34) Rear skirt gauge hole 20 mm (0.79 in) dia. (Symmetrical)
- (35) Rear combination light mounting hole 9 mm (0.35 in) dia. (Symmetrical)

- (36) Rear quarter bumper side gauge hole 20 mm (0.79 in) dia. (Left)
- (37) Rear quarter bumper side gauge hole 20 mm (0.79 in) dia. (Right)
- (38) Instrument panel attaching square hole 22 x 34.5 mm (0.87 x 1.358 in) (Right)

- (39) Steering support beam attaching bolt hole M8 (Symmetrical)
- (40) Front pillar (Inner) gauge hole 10 mm (0.39 in) dia. (Symmetrical)
- (41) Floor mat attaching clip hole 8 mm (0.31 in) dia. (Symmetrical)

- (66) Rear panel (Center) repair locator (Located in center of vehicle.)
- (68) Rear glass attaching hole (Right): 6.5 mm (0.256 in) dia. (Left): 6.5 x 10 mm (0.256 x 0.39 in) dia.

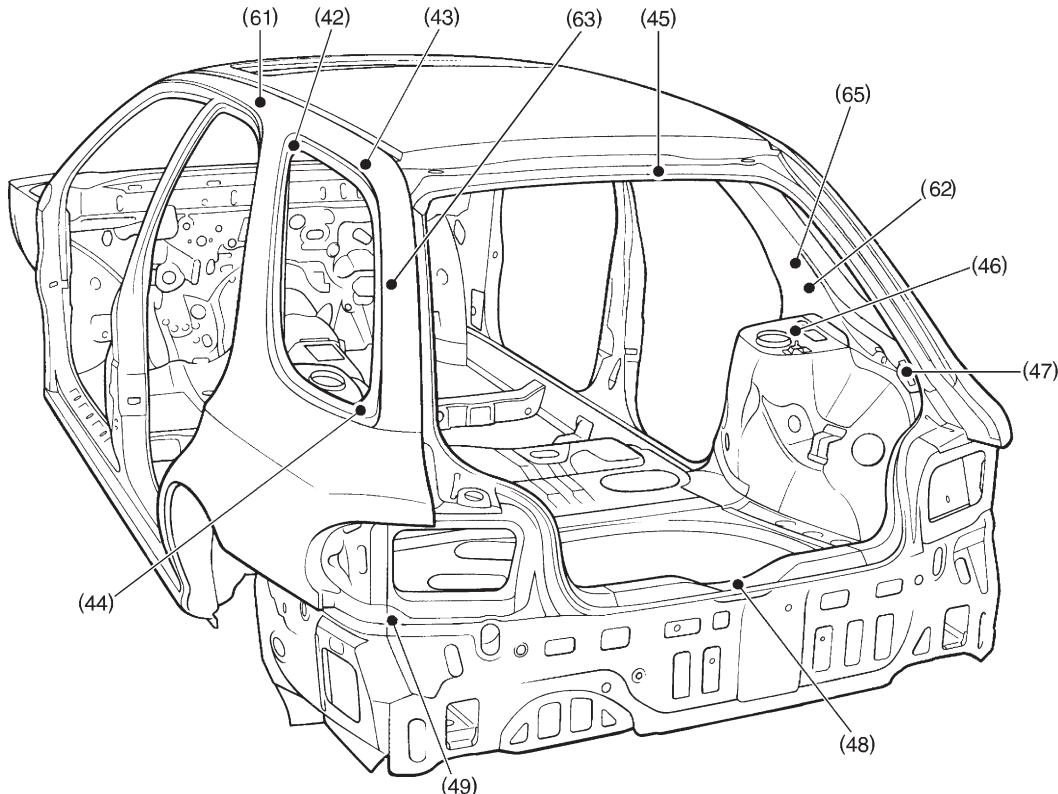
H5M0817A

### • Wagon

- (42) Rear quarter glass attaching hole 8 mm (0.31 in) dia. (Symmetrical)
- (43) Roof rail attaching hole 10 mm (0.39 in) dia. (Symmetrical)
- (44) Rear quarter glass attaching hole 8 x 15 mm (0.31 x 0.59 in) dia. (Symmetrical)
- (45) Rear roof trim attaching hole 8 mm (0.31 in) dia. (Symmetrical)

- (46) Rear strut mounting hole 10 mm (0.39 in) dia. (Symmetrical)
- (47) Rear gate stay attaching bolt hole M8 (Symmetrical)
- (48) Child seat anchor attaching bolt hole
- (49) Rear combination light mounting hole 10 mm (0.39 in) dia. (Symmetrical)

- (61) Side rail (Inner) gauge hole 8 mm (0.31 in) dia. (Symmetrical)
- (62) Rear quarter trim attaching hole 8 mm (0.31 in) dia. (Symmetrical)
- (63) Rear quarter harness attaching clip hole 7 mm (0.28 in) dia. (Symmetrical)
- (65) Seat belt anchor attaching bolt hole (Symmetrical)

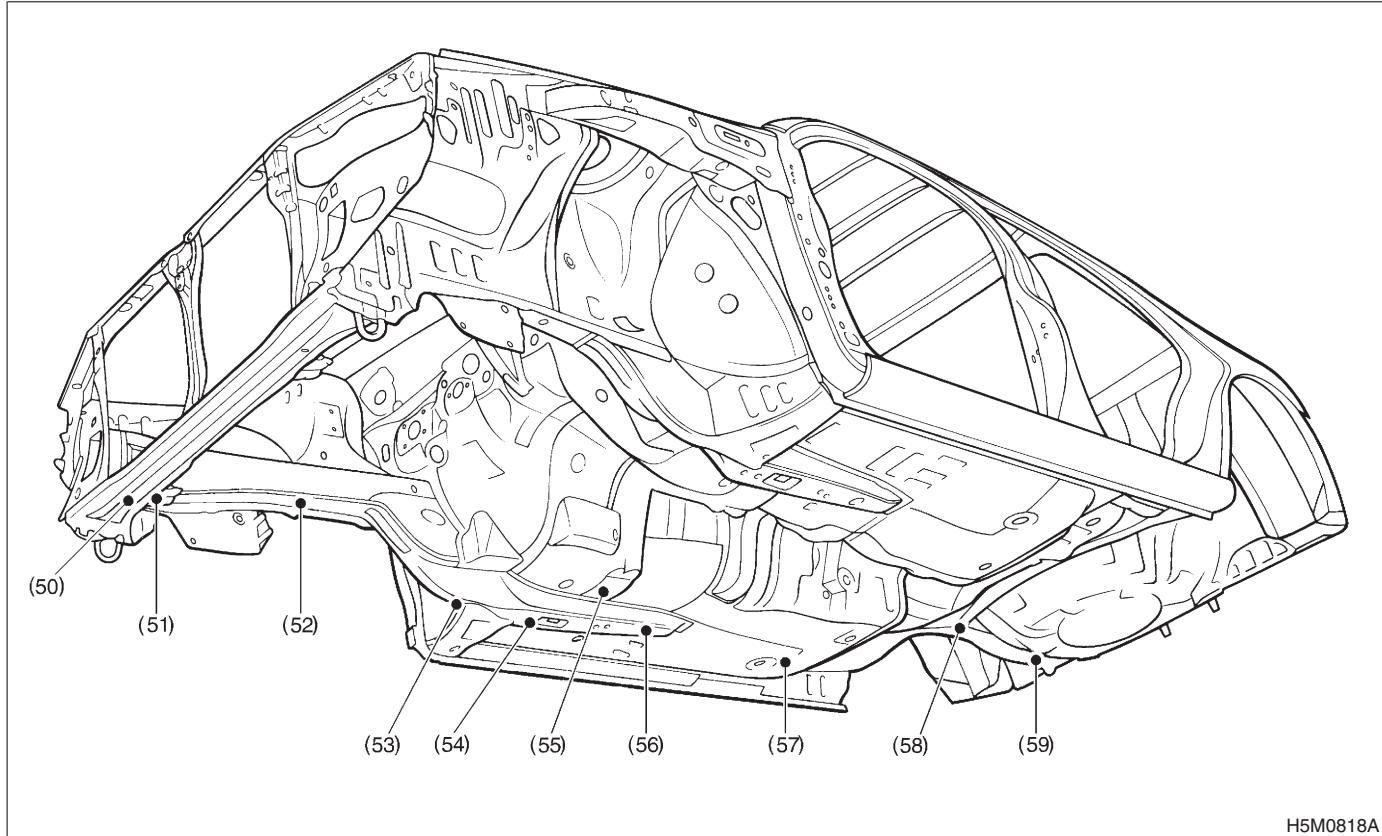
H5M0818A

3. UNDER BODY S906540A1306

(50) Radiator panel (LWR) frame gauge hole 15 mm (0.59 in) dia. (Symmetrical)  
(51) Front side frame gauge hole 20 mm (0.79 in) dia. (Symmetrical)  
(52) Front crossmember attaching hole 12.4 mm (0.488 in) dia. (Symmetrical)

(53) Front suspension attaching bolt hole M14  
(54) Side frame gauge hole 20 mm (0.79 in) dia. (Symmetrical)  
(55) Transmission mount attaching bolt hole M10 (Symmetrical)  
(56) Side frame gauge hole 15 mm (0.59 in) dia. (Symmetrical)

(57) Rear differential attaching bolt hole M12 (Symmetrical)  
(58) Rear suspension attaching bolt hole M12 (Symmetrical)  
(59) Rear side frame gauge hole 15 mm (0.59 in) dia. (Symmetrical)
