6. G Sensor S401183**A: REMOVAL** S401183A18

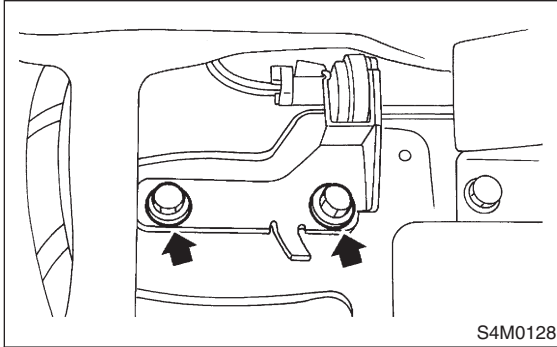
- 1) Turn ignition switch to OFF.
- 2) Remove console cover. <Ref. to EI-24 REMOVAL, Console Box.>
- 3) Disconnect connector from G sensor.
- 4) Remove G sensor from body.
