19. Rear Turn Signal Light Bulb

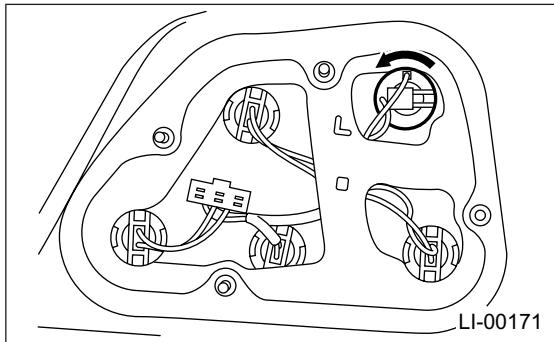
1. SEDAN

- 1) Remove the trunk side trim of rear portion.
- 2) Turn the socket and remove the bulb.

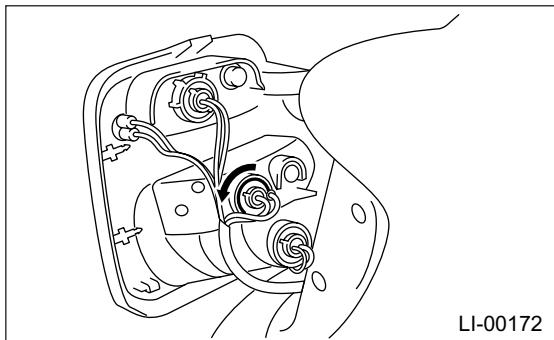
2. WAGON

- 1) Remove the rear combination light assembly.
<Ref. to LI-18, WAGON, REMOVAL, Rear Combination Light Assembly.>
- 2) Turn the socket and remove the bulb.
