## 12. Extension Case Oil Seal

### CONTINUOUSLY VARIABLE TRANSMISSION

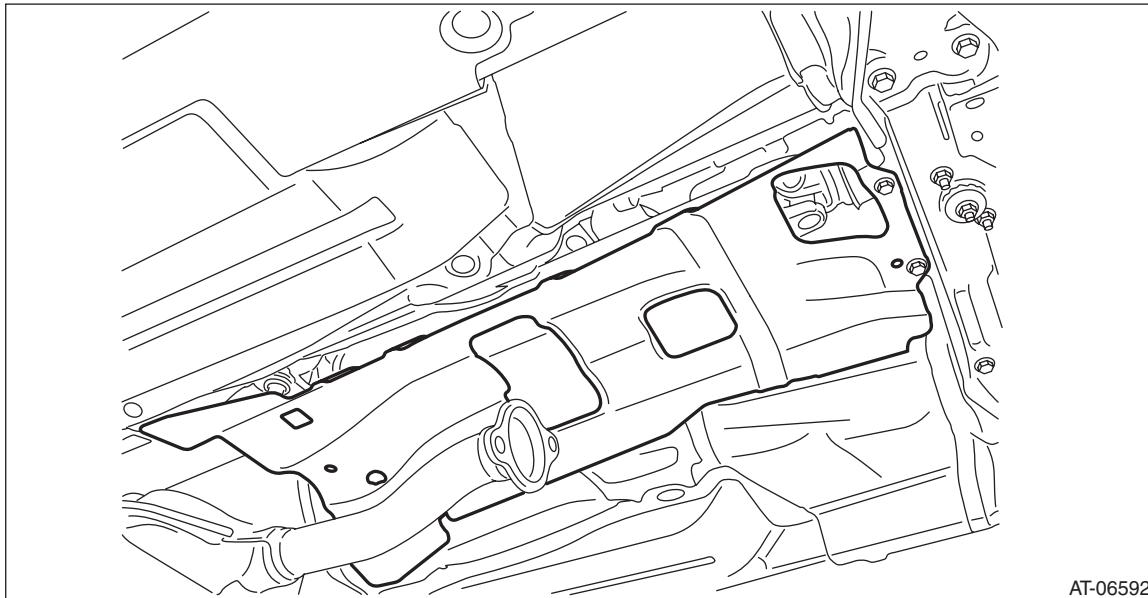
- 1) Lift up the vehicle.
- 2) Remove the center exhaust pipe. <Ref. to EX(H4DO)-13, REMOVAL, Center Exhaust Pipe.>
- 3) Remove the center exhaust cover.

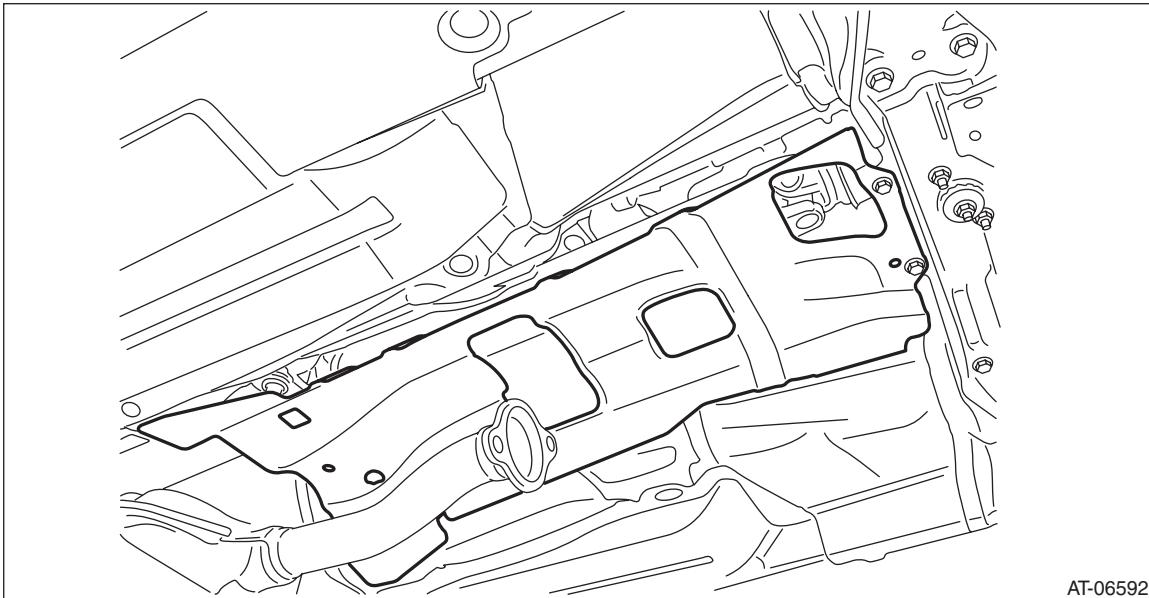
- 9) Install the center exhaust cover.

***Tightening torque:***

**18 N·m (1.8 kgf-m, 13.3 ft-lb)**
